LANDSLIDE OF APRIL 25, 1974 ON THE MANTARO RIVER, PERU

report of inspection

Kenneth L. Lee
University of California, Los Angeles

J. M. Duncan
University of California, Berkeley

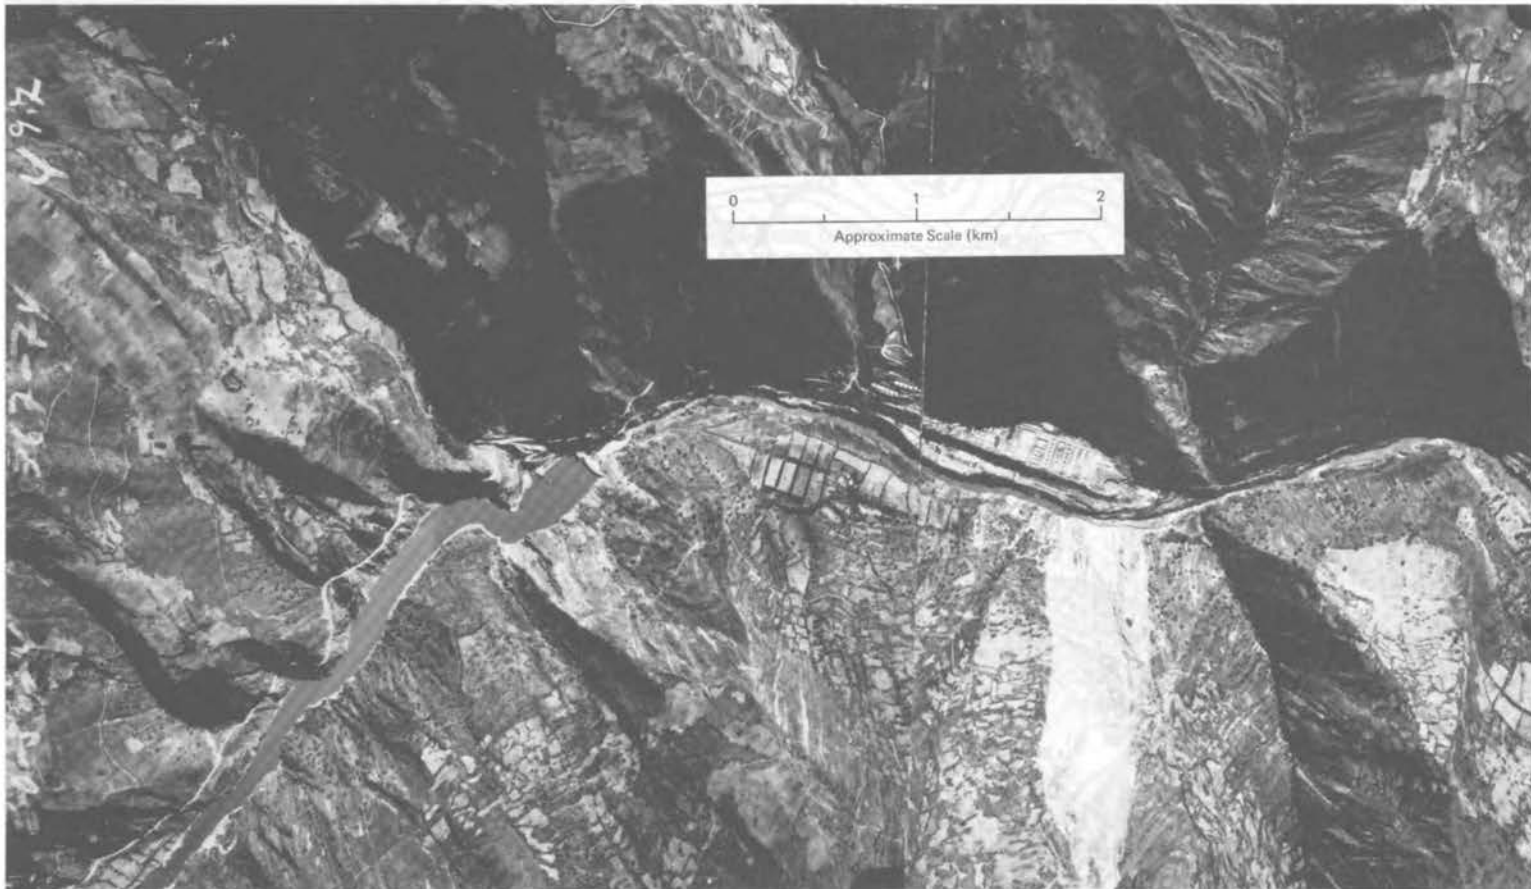
(Figure 2) shows the electrical facilities and the concrete arch dam. Note that the lake caused by the present landslide dam reached to within about 2 km of this old slide to a point just inside the right side of the photograph. This slide also dammed the river for a period of 60 days, but little other data is available.

FIGURE 2. Aerial view of Tablachaca dam and electrical station, with the scarp of a 1930 landslide in the foreground. (Defensa Civil Photograph)

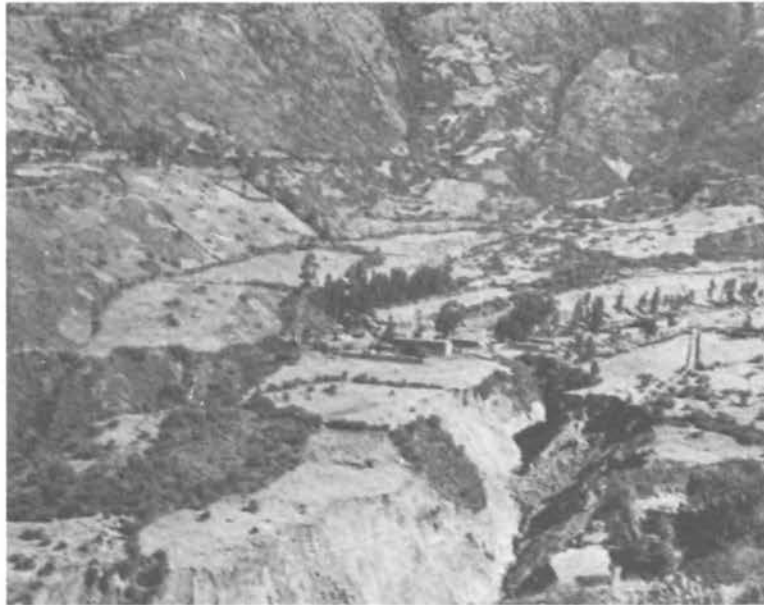
FIGURE 5. Panoramic view looking from North to South showing the community center of Mayunmarca, and the unstable slopes of the Sojosbamba ravine. (Photograph courtesy of Galdos Bustamante)

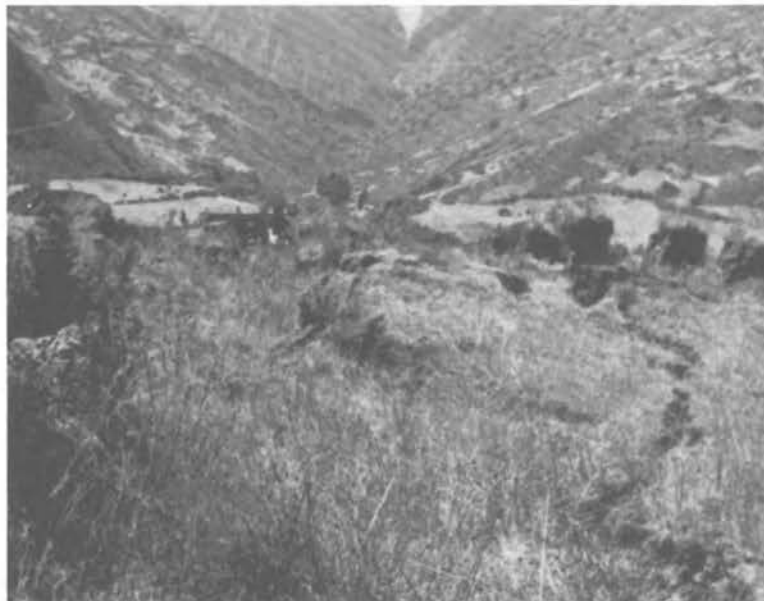
Figure 6 is another panoramic view looking down past the town of Mayunmarca in the center of the photograph, to the Mantaro river not seen, but located in the upper third of the picture. The white slide scarps in the upper part of the photograph are on the banks of Quebrada Tinte (Q5), which flows into the Mantaro river directly across from Quebrada Ccochacay (Q4). Note that the Quebrada Tinte area was also unstable before the landslide. In the foreground of Figure 6, there are some major recent ground cracks or fractures, indicating the general marginal stability of the detritus cover at that location.

FIGURE 6. Panoramic view looking from South to North showing a system of recent fractures located 300 meters from the community center of Mayunmarca. (Photograph courtesy of Galdos Bustamante)

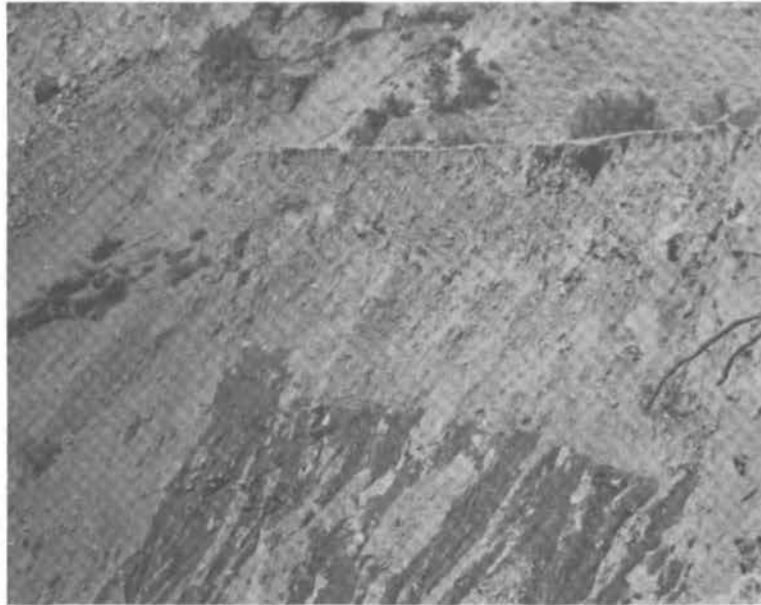
FIGURE 7. Left side of the Huachac ravine, 400 meters from Mayunmarca showing water seeping from the detritus slope. (Photograph courtesy of Galdos Bustamante)

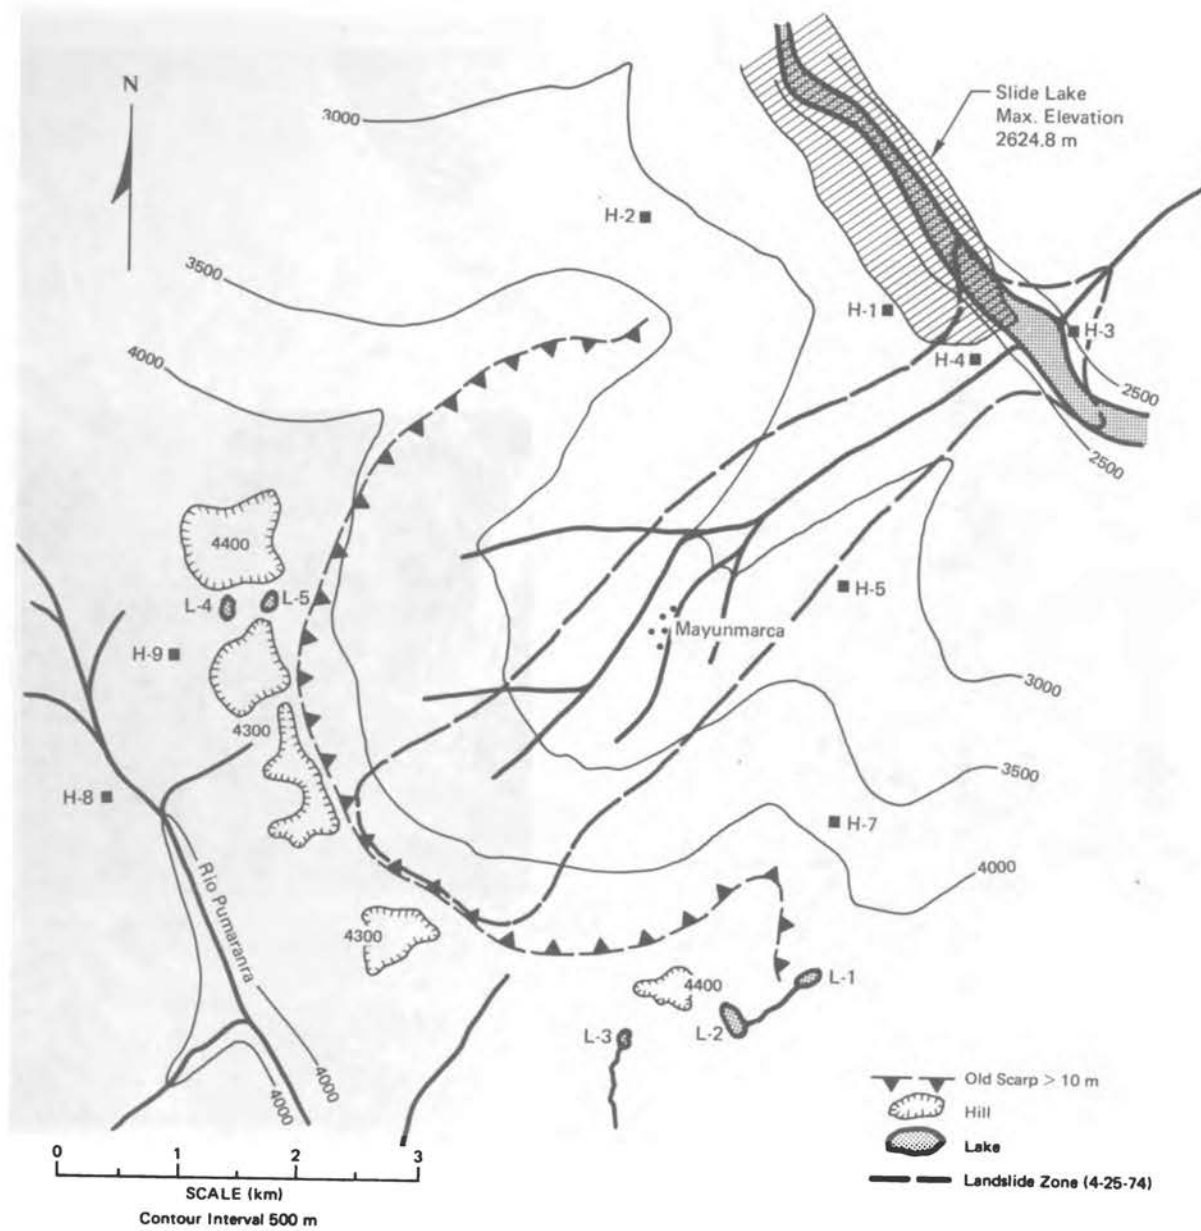
A plan view of the slide area is shown in Figure 11. Reference to Figure 3 indicates that the area which actually slid was approximately the same as the endangered area indicated by Galdos Bustamante. The entire town of Mayunmarca on the slope was carried away and the haciendas, Huaccoto (H3) and Ccochaca (H4), were buried by the slide debris. The vibrations caused by the slide movement were transmitted as seismic ground waves and recorded on several seismological stations, indicating the duration of major movements to be about three minutes, from which the 140 km/hr velocity was determined.

There is also other evidence to indicate that high velocities must have been developed. In at least one location, above the hacienda Huanupata (H1) on Figure 11, the sliding debris appeared to have become airborne as it encountered a major rock spur. A large amount of mud splatter was found on the slopes high above the river on the Quebrada Tinte side (opposite the river from the slide). Furthermore, the slide material appeared to have first flowed up the slopes of the Quebrada Tinte, across the river from the major slide, and then flowed back down 150 to 200 m to a lower final position, indicating that the debris must have been in a fairly fluid state during the sliding. Some sand boils were found in the debris near the Quebrada Tinte bank, again indicating that some of the material at least must have been in a liquefied state during the sliding with the sand boils becoming created as the debris consolidated after coming to rest between the two banks of the Mantaro river.

FIGURE 11. Plan of the Cochacay ravine area showing the limits of the landslide zone of 4/25/74.

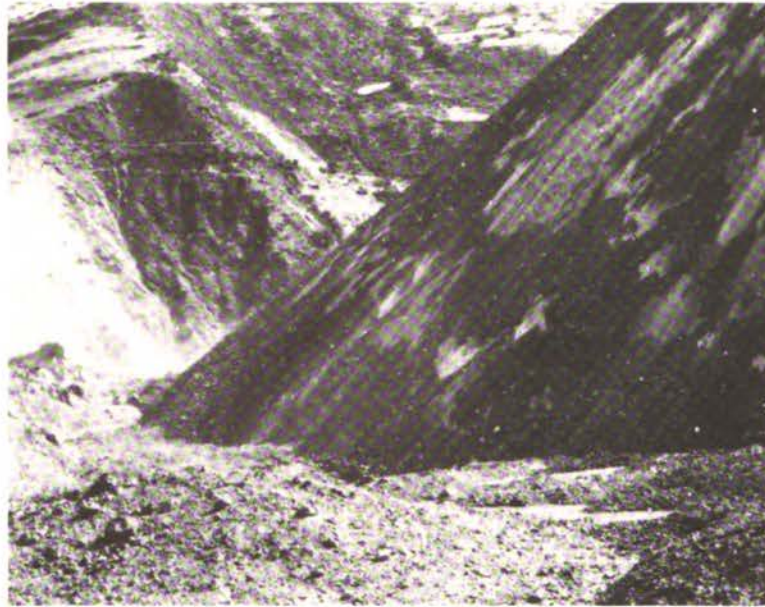
FIGURE 12. Steep slope of the Mantaro river valley opposite the main slide showing where the slide debris had run up and then fallen back down the slope. (Kojan-Hutchinson, Ref. 11)

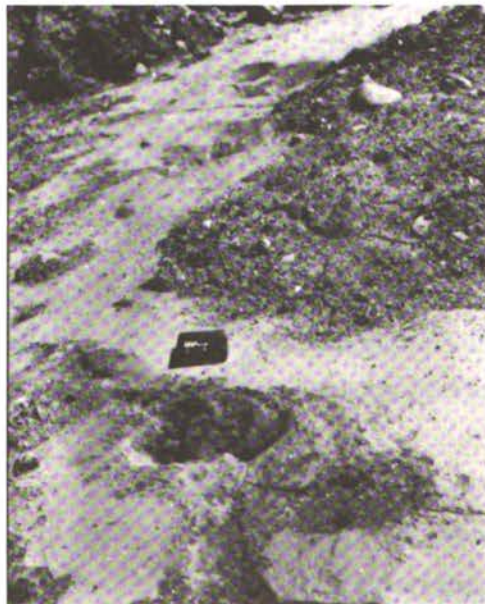
A further evidence of the liquefied state of at least part of the slide debris is the sand boil shown in Figure 13, which was typical of several such sand boils found along the trench between the rock slope and the small ridge on the debris shown in Figure 12.

FIGURE 13. Sand boils located in the fall back debris from the slope shown in Figure 12. (Kojan-Hutchinson, Ref. 11)

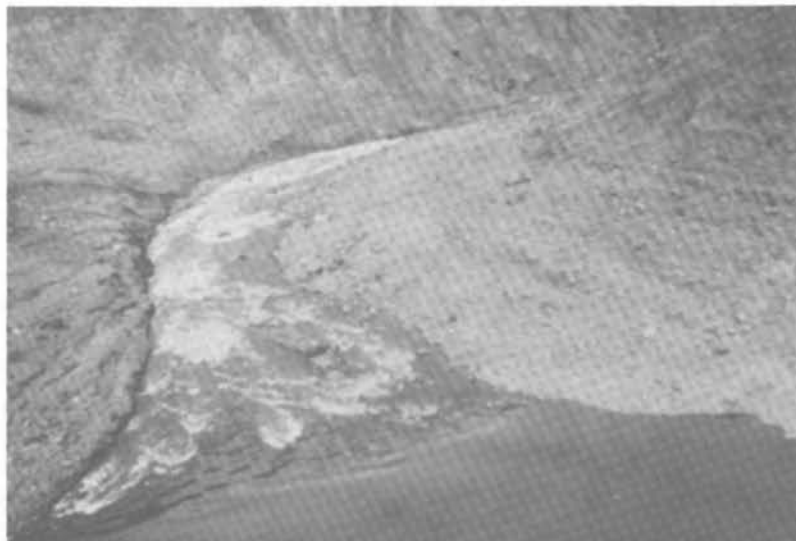
(b) After overtopping, showing nature of material exposed in the erosion slopes.

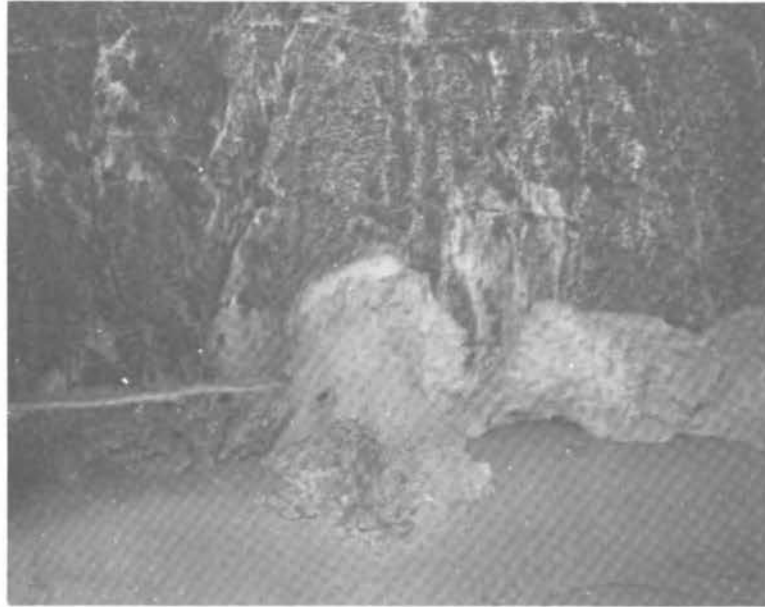
FIGURE 27. Small landslide on the lake shore caused by rising water.

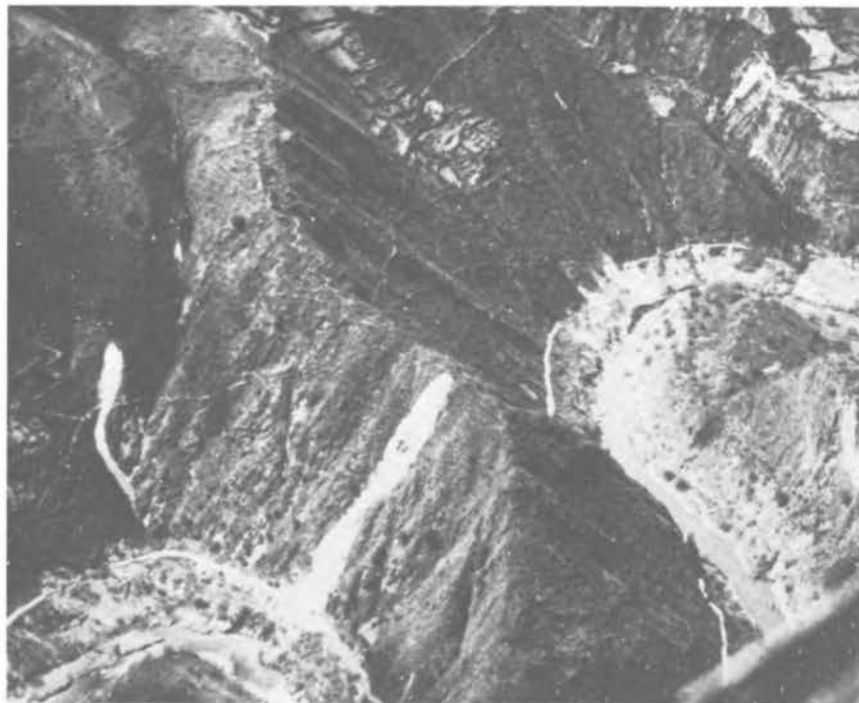
FIGURE 28. Landslide along lake shore caused by rising water.

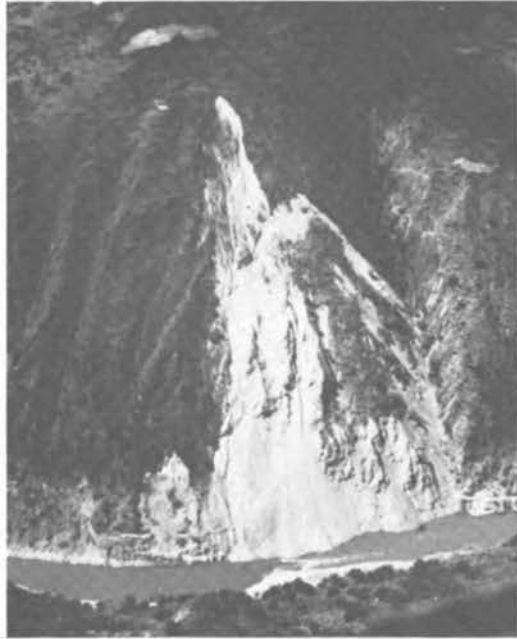
FIGURE 29. Landslide along the lake shore caused by rising water.

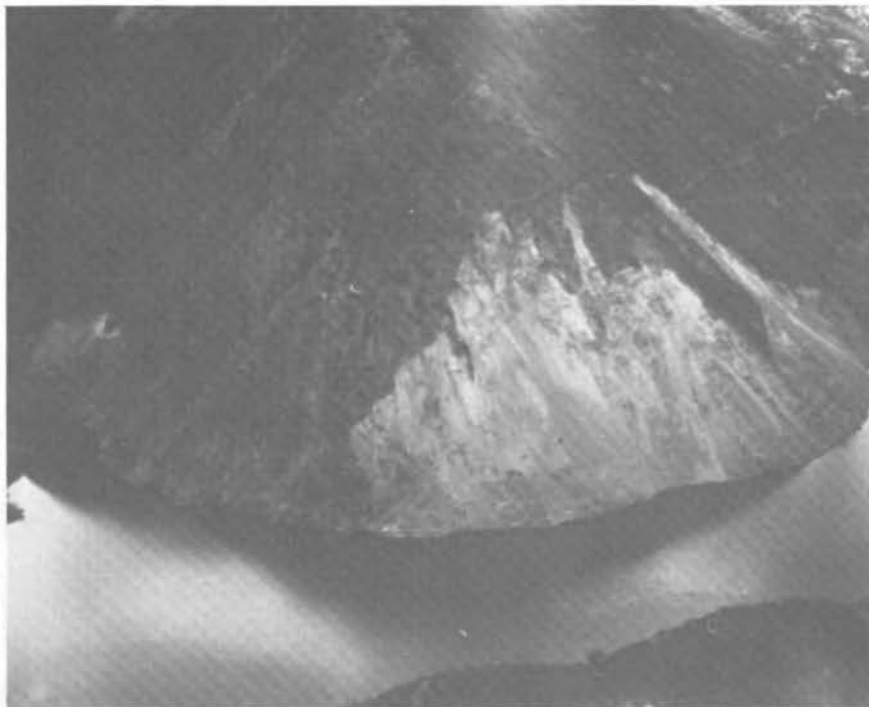
FIGURE 30. Extensive landsliding along the lake shore caused by rising water.

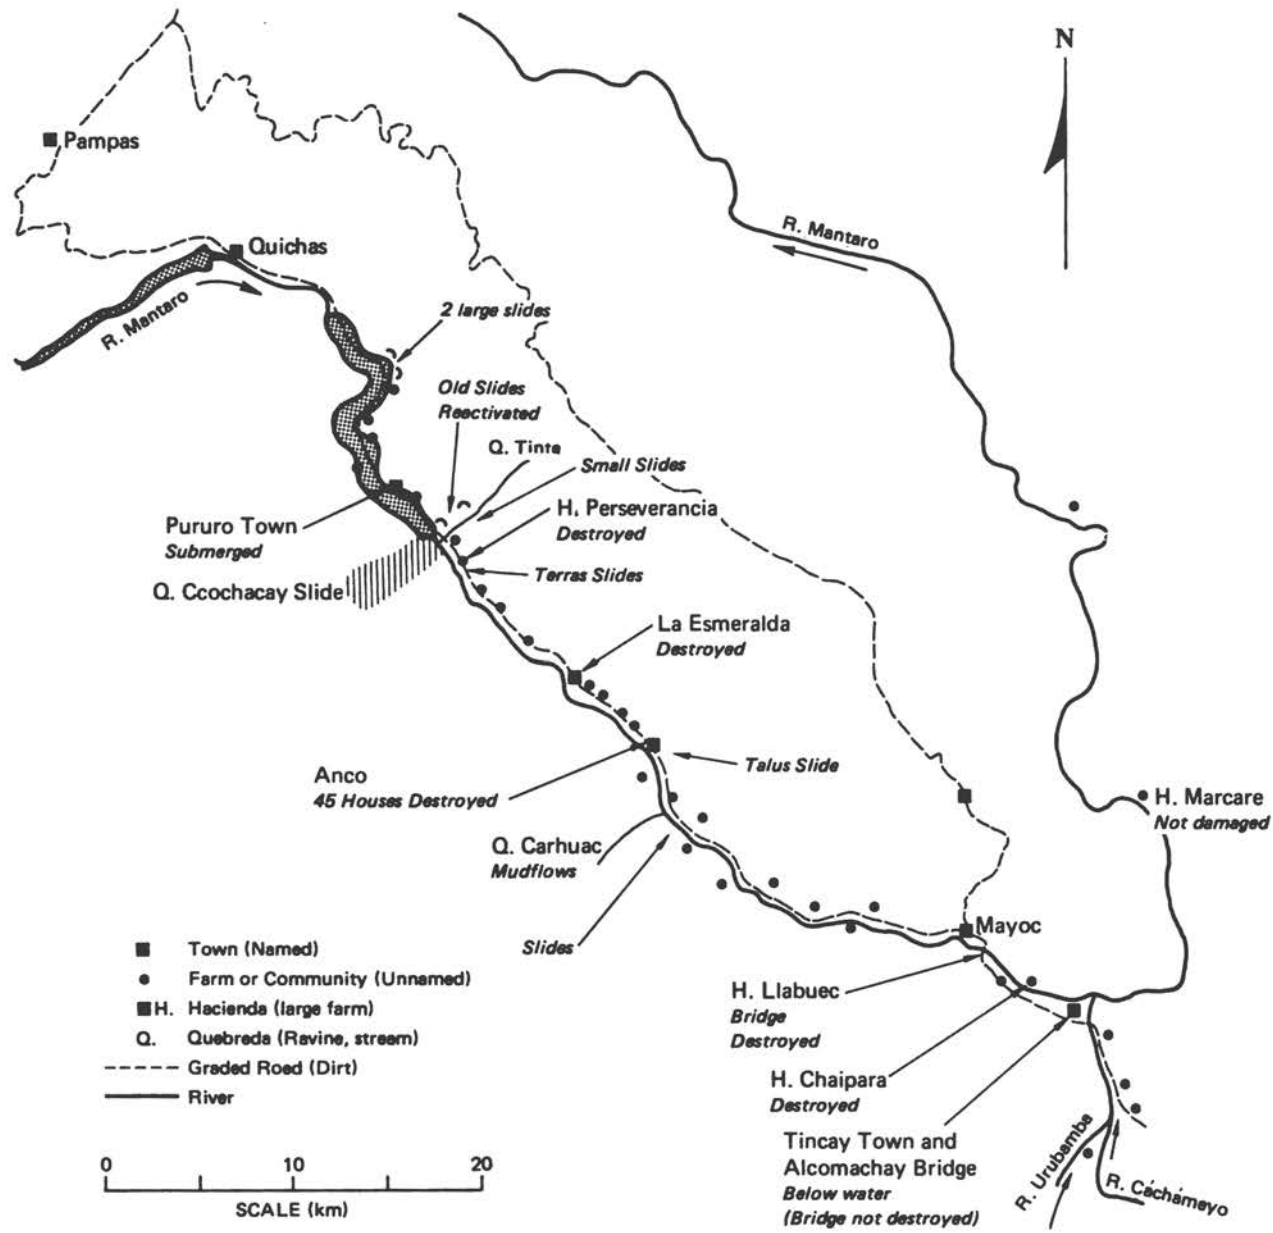
A map of the Mantaro River with notes describing types of damage caused at various locations is presented in Figure 40.

FIGURE 40. Location of major damage.
