EARTHQUAKE IN ROMANIA

MARCH 4, 1977: Δ

An Engineering Report

NATIONAL ACADEMY PRESS
Washington, D.C. 1980

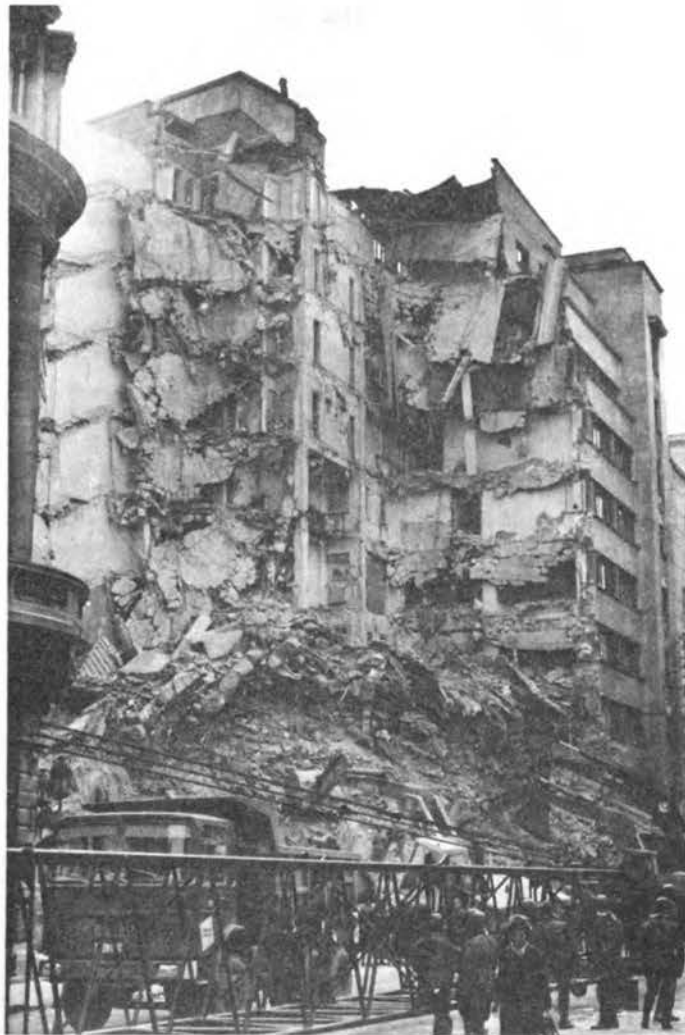
Figure 16 Collapsed building constructed prior to the 1940 Romanian earthquake.

Most of the earthquake damage was concentrated in the city of Bucharest. Thirty-five buildings collapsed, most of them near the heart of the city. Figure 16 shows one collapsed structure, and the street map of Figure 6 locates many of them. All but three of the

buildings that collapsed were built before the adoption of seismic building regulations following the earthquake of 1940. They had survived the 1940 earthquake, an event of slightly greater magnitude than the 1977 event with about the same epicenter. The strong motion of the 1940 earthquake was, of course, not recorded. Some of the buildings that collapsed during this event had been damaged in 1940, and cumulative damage may have contributed to their demise. World War II damage also occurred in the city. Typically, these older buildings were reinforced-concrete frame structures, 7-14 stories high, with a soft first story; i.e., in comparison to the upper stories where numerous interior and exterior walls provided lateral stiffness, the first story was relatively open with many windows and a few walls and partitions. Figure 17 shows one example. Furthermore, the quality of concrete was poor (mortar could be chipped away with a pen) and little reinforcing steel and few ties were to be found in the columns and beams (Fig. 18). By contrast, modern buildings that were designed in accordance with lateral-force code requirements adopted after the 1940 earthquake performed far better than their older counterparts. With three exceptions, modern buildings incurred slight to moderate structural damage at worst. Nonstructural damage, however, was extensive, cracking of in-fill masonry walls being particularly prevalent.

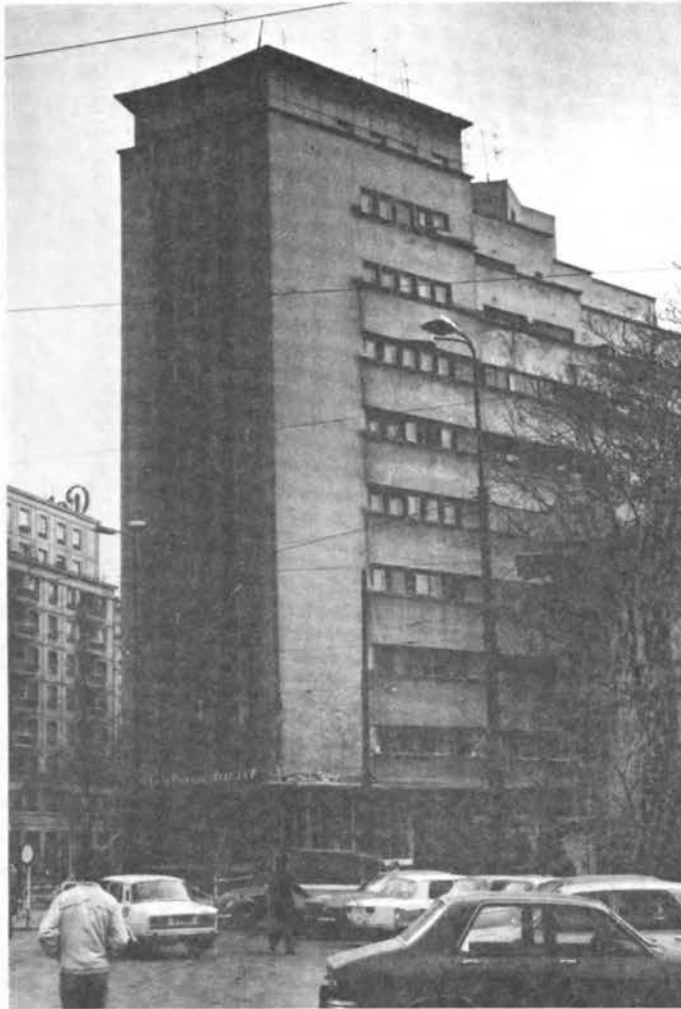
Figure 17 Apartment building with soft ground story designed and constructed prior to the 1940 Romanian earthquake.

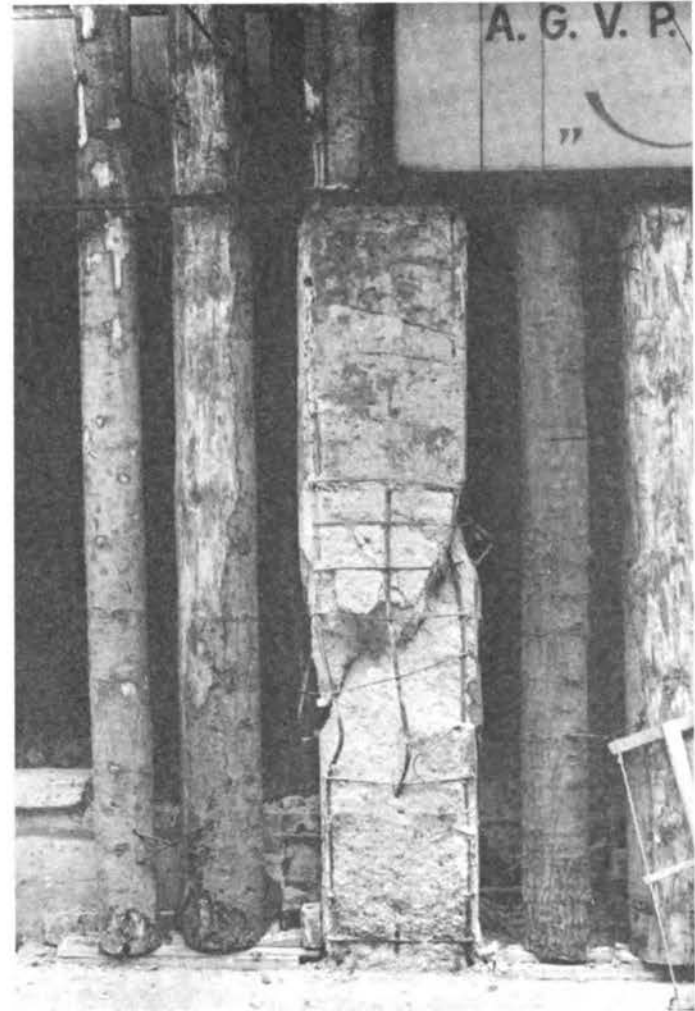
Figure 18 Column in open ground story of tall building designed and constructed before the 1940 Romanian earthquake.

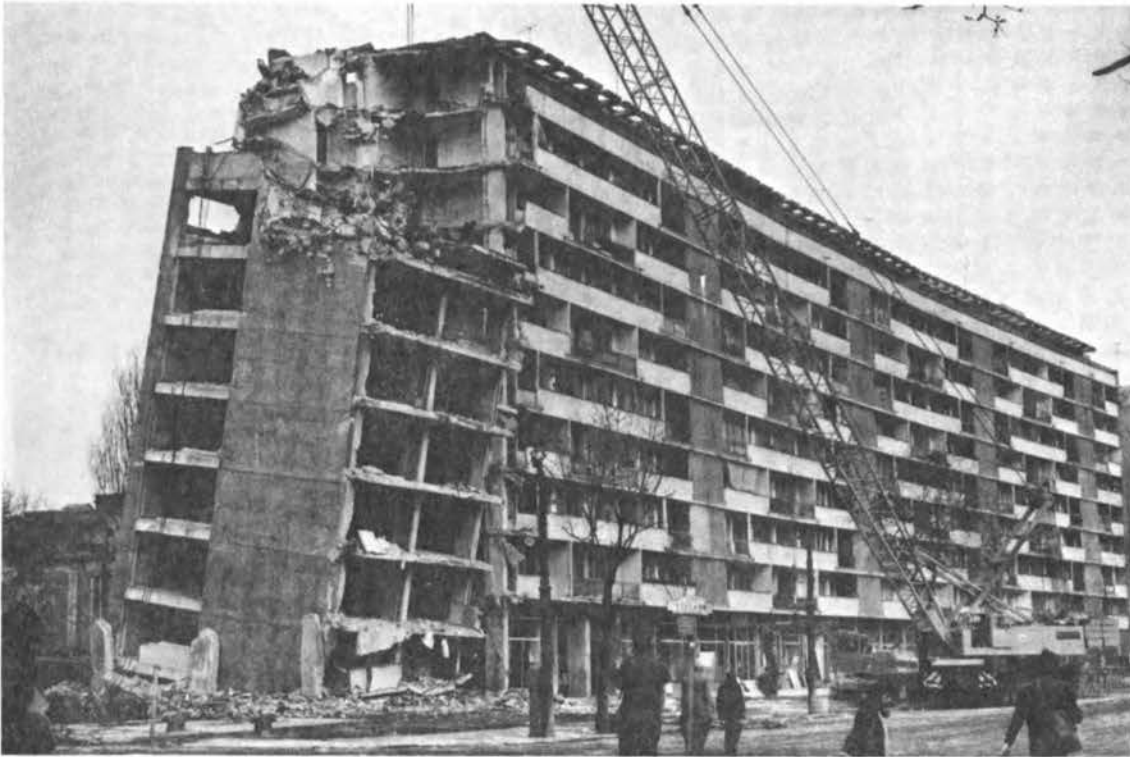
The three exceptions to good behavior of modern buildings were the collapsed computing center, a three-story flat slab building discussed in more detail later, and two apartment buildings away from the center of the city. One of the apartment buildings collapsed completely and had been removed within a few days after the earthquake. Another new apartment building (Fig. 19) collapsed at one end, where trouble had been encountered with the foundation and some underpinning work had been done. The foundation problems and the partial collapse were probably related.

Figure 19 Partial collapse of new apartment building.

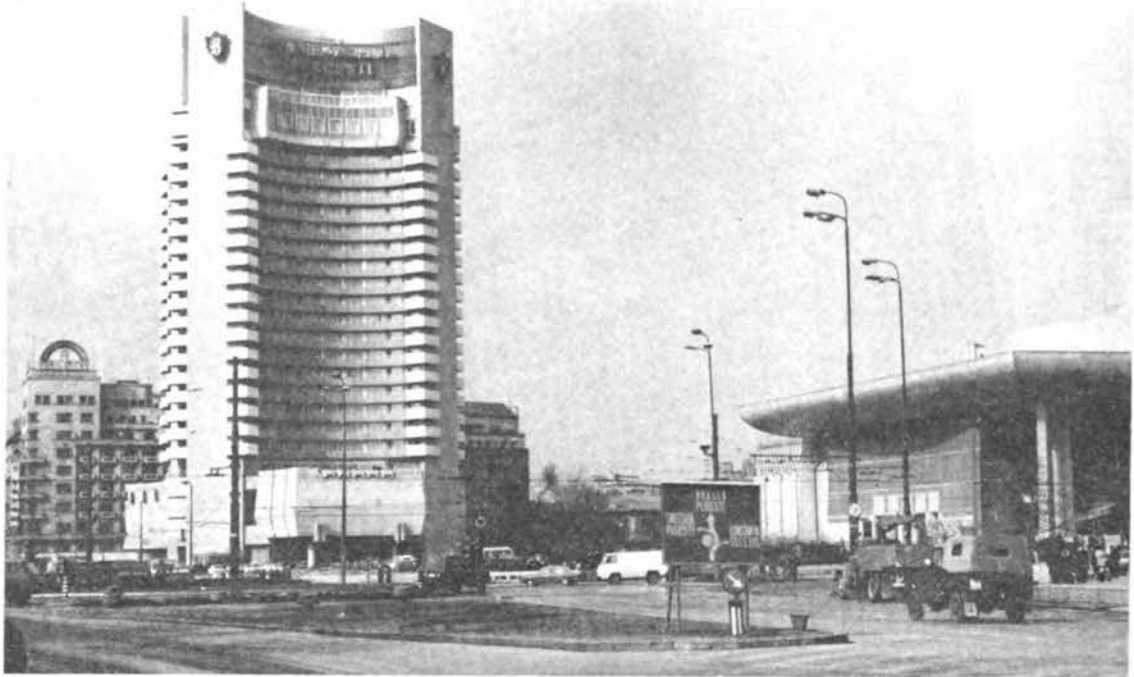
Figure 20 Inter-Continental Hotel.

The Inter-Continental Hotel (Fig. 20) is probably the best known modern building in Bucharest, at least to Americans. It is a reinforced-concrete frame and shear-wall structure, shaped in plan like an equilateral triangle with blunt vertices and concave sides. It was apparently designed as a symmetric building, without regard to torsion coupling, whereas in fact that three vertical planes of symmetry are 120 degrees apart and torsional response is strongly coupled with translational response other than in a plane of symmetry. Damage to the building was insignificant, consisting mainly of partition cracks and plaster damage.

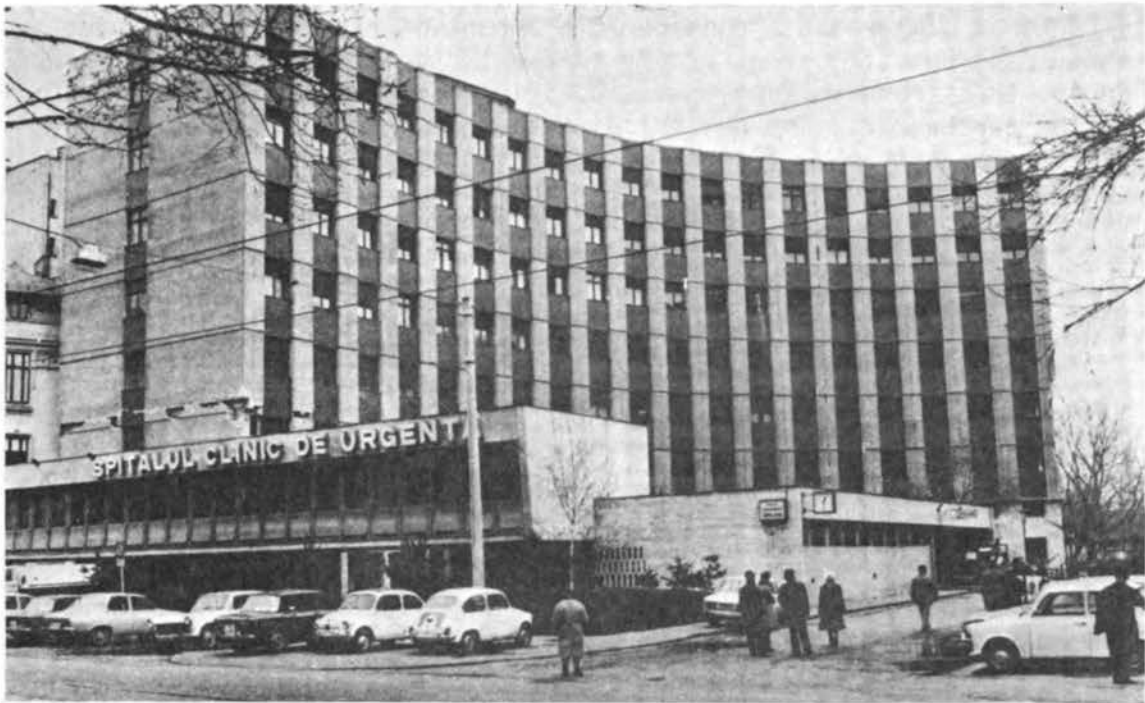
Figure 21 Emergency Hospital.

The Emergency Hospital had 635 occupied beds before the earthquake, and 600 additional patients were admitted immediately after the earthquake. At 4:00 a.m. on March 5, 1977, the hospital was ordered to be evacuated. Evacuation took over 3 hours. The building was constructed in 1970 with a relatively flexible reinforced-concrete frame. The tower (Fig. 21) is in the shape of a C. The end bents and columns of one end of the tower portion were severely damaged during the earthquake. A nonbearing masonry end wall fell out at the second and third stories (Fig. 22). Many medical supplies were lost, including water. The power was interrupted, but the hospital's emergency generator picked up the electrical load for the building. Elevators were not used after the earthquake struck. Moderate architectural damage occurred in the functional areas of the hospital.

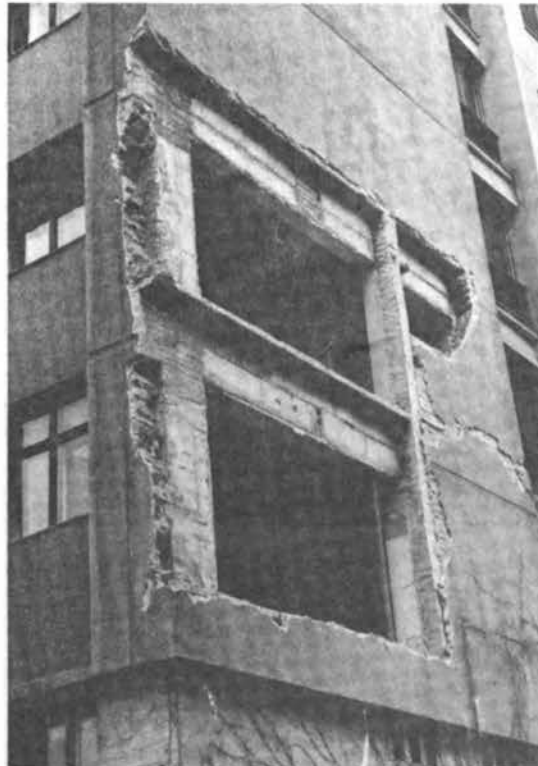
Figure 22 End wall of Emergency Hospital.

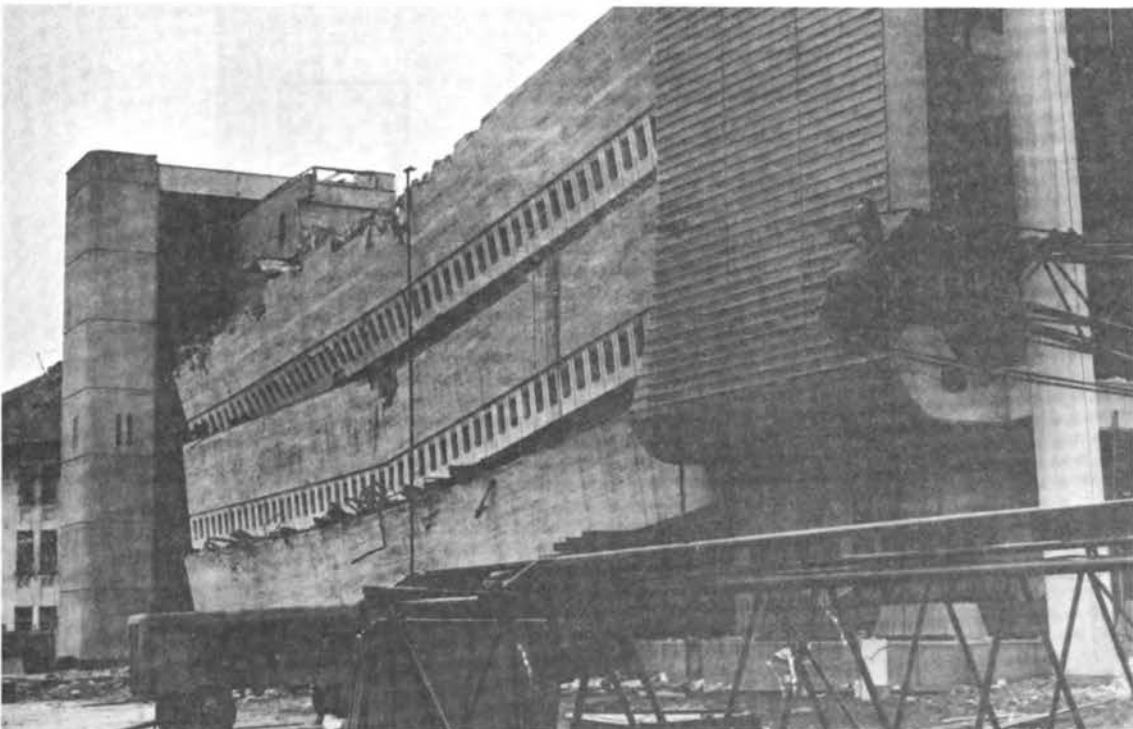
Figure 24 Collapsed computing center.

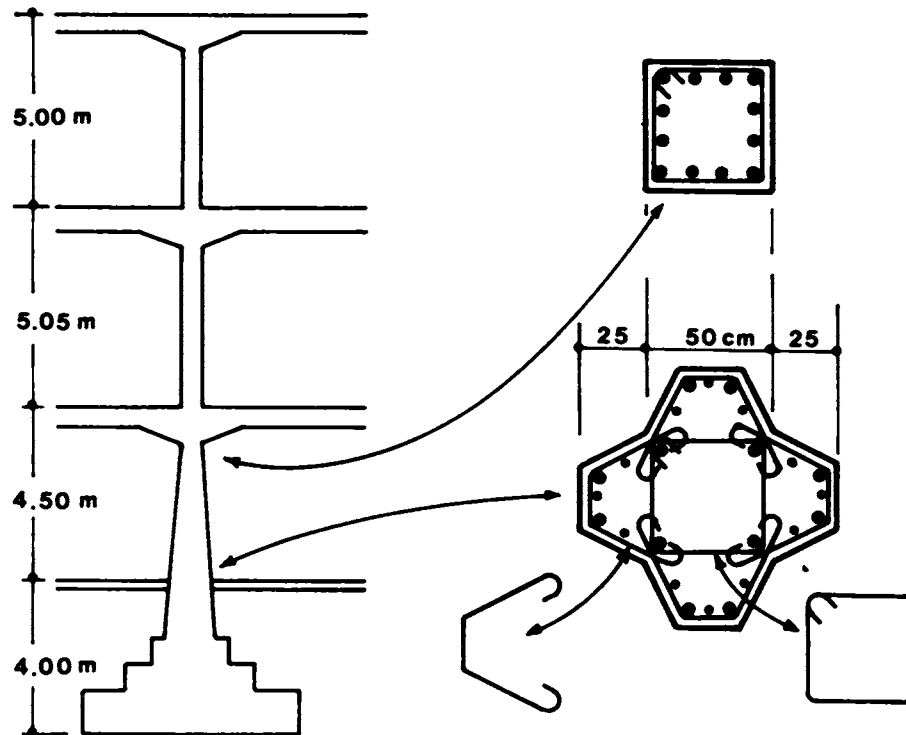
Figure 26 Computing center, typical column and slabs.

Figure 26 is a schematic diagram showing a typical column and floor and roof slabs. The roof slab was 45 cm thick and the floor slabs 55 cm. They were of cellular construction, with 6-cm cover

slabs top and bottom and 20-cm-wide ribs spaced 1.2 m center to center in both directions. The floor and roof slabs were designed as T-beams in both directions. Column capitals dropped 40 cm below the overhead floor or roof slab at each column.

The columns were reinforced in an unusual manner. A typical ground-story column had twelve 25-mm round bars extending the full height, in addition to twelve 20-mm round bars that extended from the base up to about two-thirds of the story height. Four of the twelve full-height bars were enclosed in square ties all the way; the remaining bars were outside the square ties except at the very top of the story, and were restrained by hairpin bars serving as auxiliary ties. Figure 26 shows the reinforcing scheme. All ties were 8-mm round bars. Four hairpin bars and one square tie were used in sets to restrain the vertical steel. Tie sets were spaced 15 cm apart up to the cutoff height of the twelve 20-mm bars, about two-thirds of the story height, and 20 cm apart above that height.

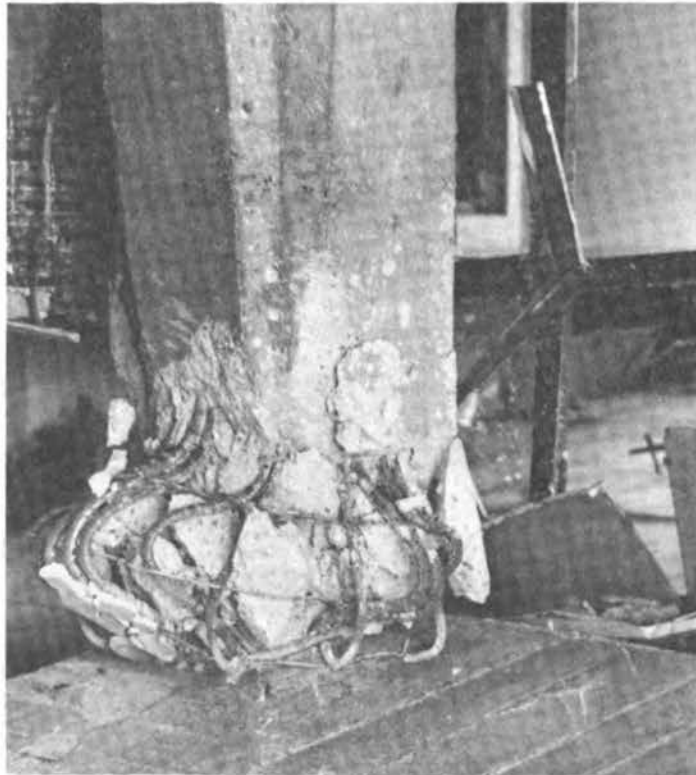
Figure 27 shows the failure of one of the ground-story columns. Some of the buckled vertical bars can be seen outside the visible

Figure 27 Computing center, column failure in ground story.

ties. Every one of the ground-story columns failed; the one shown in Figure 27 is the least damaged of the lot. All except the central column failed at the top in the manner of the column shown in Figure 27, but worse. The central column may have failed elsewhere; it was squashed nearly flat and could not be examined.

Columns in the upper stories were square and prismatic. They too had failed, nearly all of them at the top. It seems likely that the ground-story columns failed first and the upper-level columns failed when the building fell.

The main building was structurally separated from the service towers, and nearly all of the lateral stiffness of the main building derived from the columns. If only column stiffness is considered, the column bases are treated as fixed, and the floors are taken to be rigid, then the three modes of vibration and their periods are as shown in Figure 28. Thus the fundamental mode period for this idealization is in the range of very strong spectral acceleration for both horizontal components of the ground motion recorded in Bucharest. Any flexibility of the floor system or column footings, or any structural damage, would lengthen the period and put it in the range of even greater spectral acceleration. The exterior walls were of virtually no benefit because they were isolated from the ground-story columns and contained a band of steel window sash in each story, which separated them structurally from the story above.
