**EARTHQUAKE IN CAMPANIA-BASILICATA, ITALY**

**NOVEMBER 23, 1980**

**A RECONNAISSANCE REPORT**

**James L. Stratta, Consulting Structural Engineer, Menlo Park, California**  
**Luis E. Escalante, Los Angeles Department of Water and Power, California**  
**Ellis L. Krinitzsky, Waterways Experiment Station, Vicksburg, Mississippi**  
**Ugo Morelli, Federal Emergency Management Agency, Washington, D.C.**

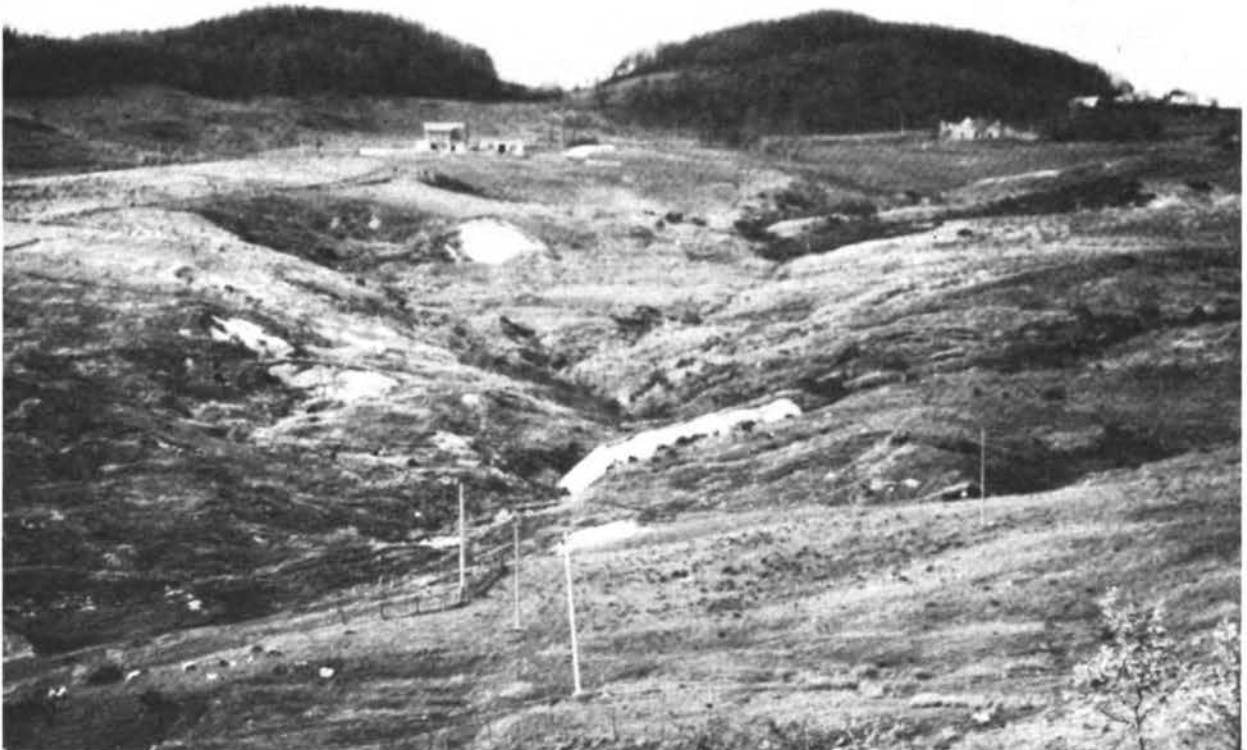
There is evidence of many shallow landslides in this region. For example, a typical situation in which there are multiple landslides in a gentle colluvial slope is shown in Figure 7 for a site near Laviano. The team saw no evidence of such landslides that were caused by the earthquake.

**Figure 7. Landslides in a gentle colluvial slope near Lavino.**

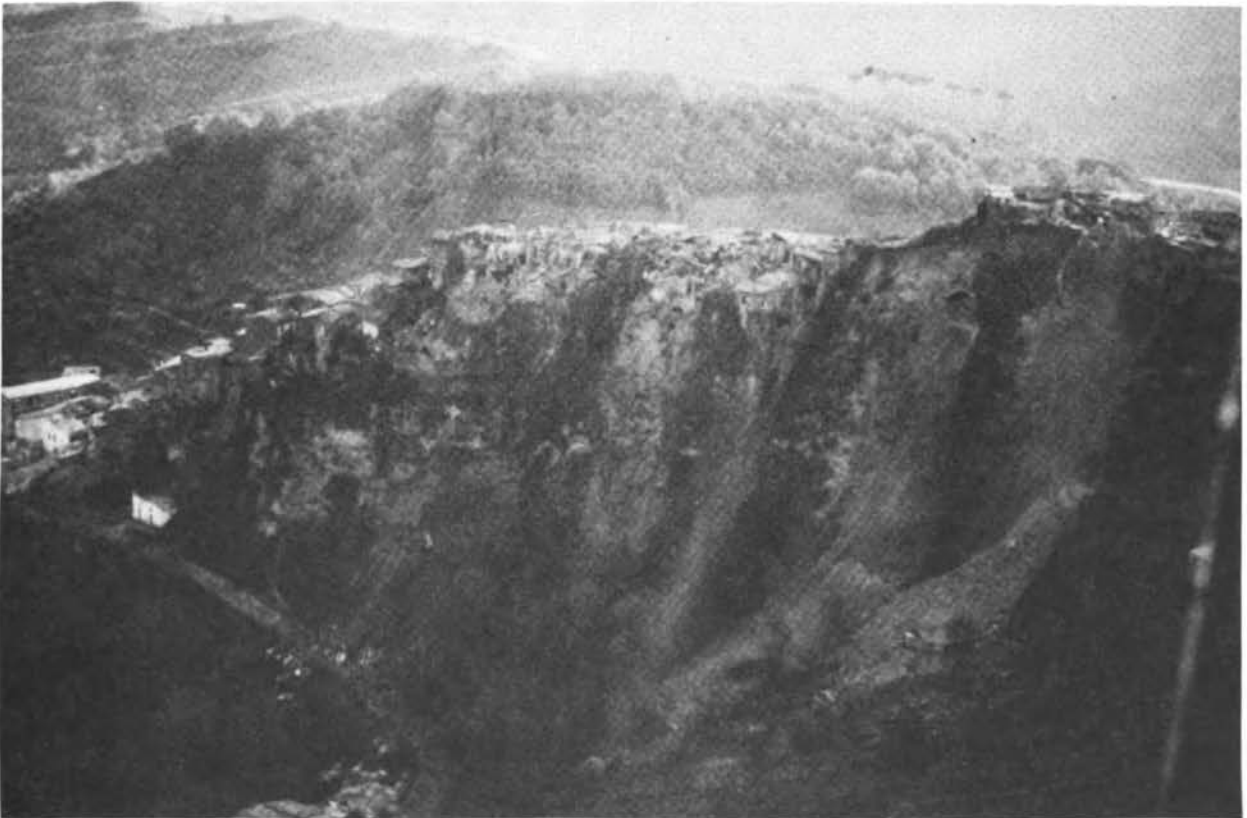
The town of Calitri is perched on a pinnacle, and along a steep ridge that is faced with a steep slope. The slope is bare from continuing shear failures that took place over a long period in weathered tuffaceous material. The condition of this slope and failures caused by the earthquake are shown in Figure 8. Only small portions of the slope were affected, but because it blocked the road below, this slide hampered rescue operations until it was removed.

**Figure 8. Landslide at Calitri.**

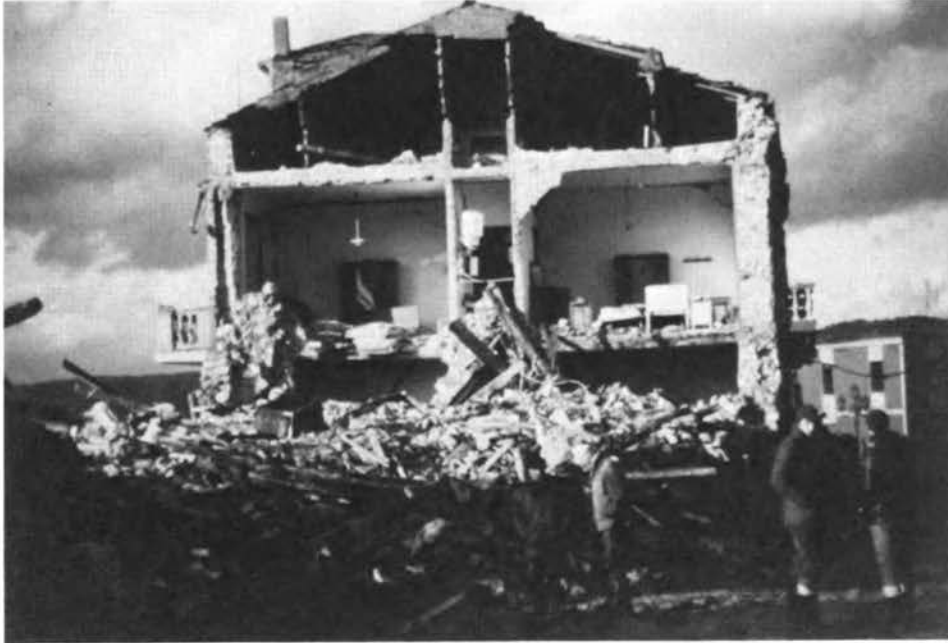
The older buildings failed because the weak unreinforced walls and the wood-floor and wood-roof systems were unanchored and had no capacity to act as diaphragms. The newer concrete-frame construction lacked seismic design and failed primarily because of the rigid but weak infill walls. The failure of these walls usually causes cracks that are propagated through the concrete columns, causing the columns to fail. The building often collapses after this series of events. This process often occurs and was vividly demonstrated during this earthquake. The contribution to failure of these infill walls is discussed in an article, "Interaction of Infill Walls and Concrete Frames During Earthquake" (Stratta and Feldman, 1971).

**Figure 9. Typical failure of residences with wood floors and roof.**

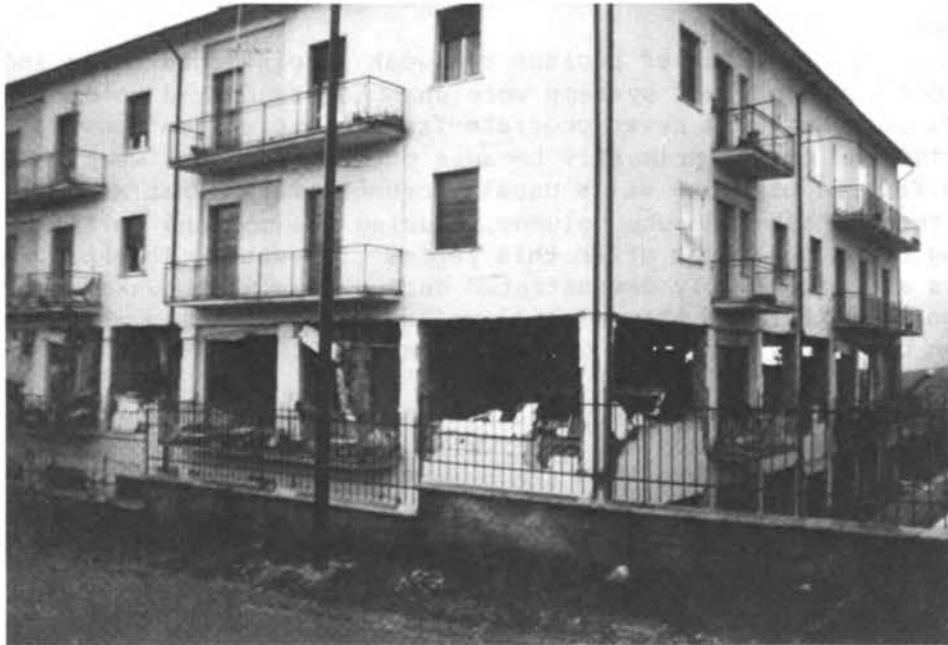
**Figure 10. Typical failure of concrete frame with infill walls. Continued shaking could have caused total collapse.**

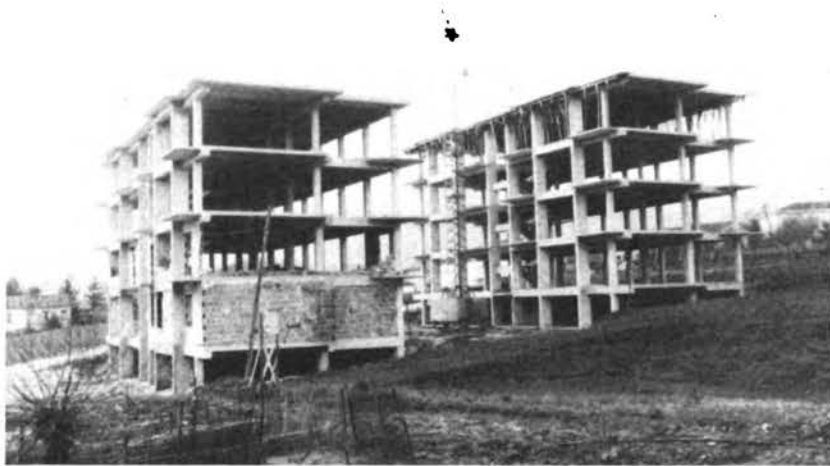
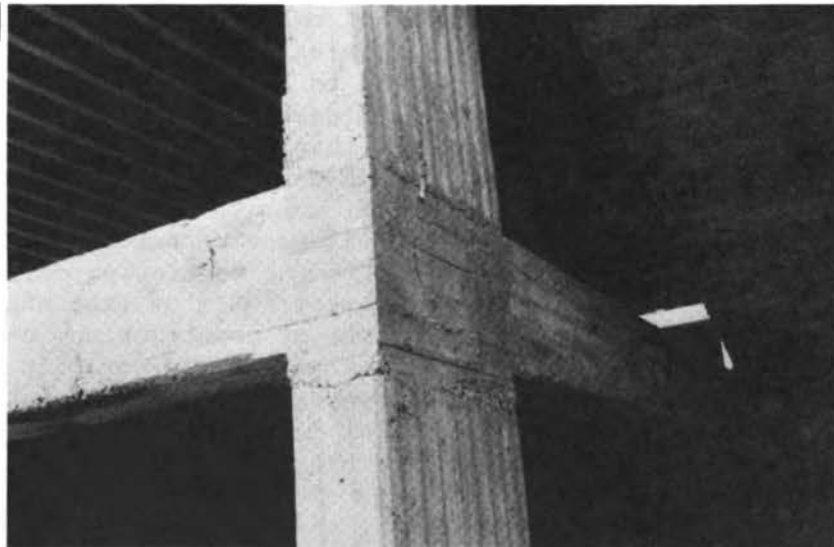
Figure 11a shows two identical structures, one with the completed frame but no walls, and the other with walls being constructed at the time of the earthquake. Note that the pure frame has not sustained any damage, but there is extensive damage to the incompleting infill walls. The infill walls are not reinforced, and Figure 11b shows that they are not tied to the concrete frames by the use of dowels or keyways.

**Figure 11. Damage to one of twin residential units under construction. (a) Note that infill walls have caused damage, but the "pure" frame had no damage. (b) Note that neither keys nor dowels were used to connect infill to frame.**

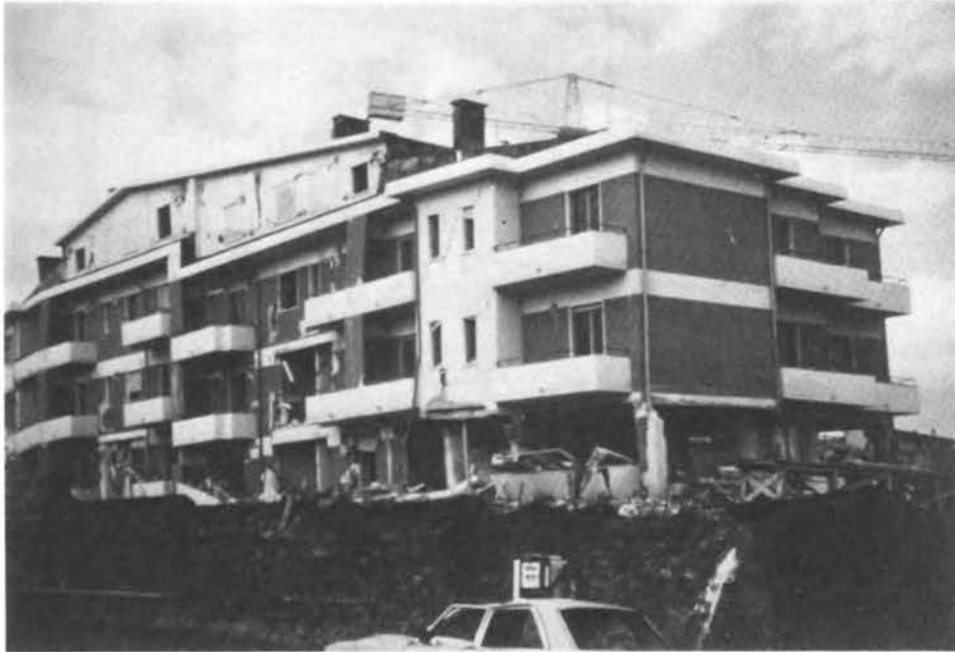
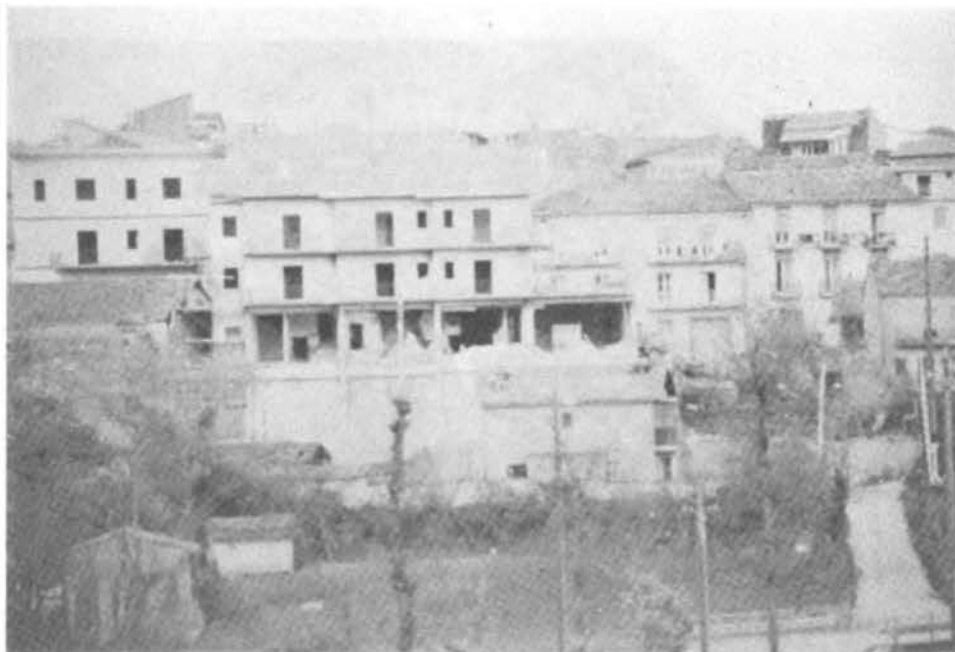
A large factor in the number of collapses undoubtedly was the duration of the shaking, as evidenced by the continuing collapses that occurred in aftershocks. As the accelerograms show, the shaking was not intense. Cumulative damage to this type of construction, caused by constant shaking over a long period, contributes greatly to eventual collapse. One structure collapsed 3 weeks after the main shocks during a period of inactivity, solely because of cumulative damage. In this case, the cumulative damage left some structures in a state of imminent collapse. For example, the structures shown in Figures 12 and 13 could easily collapse with slight additional shaking.

**Figure 12. Damage to multistoried residential units. Both of these were so badly damaged that they could easily have collapsed with slight additional shaking.**

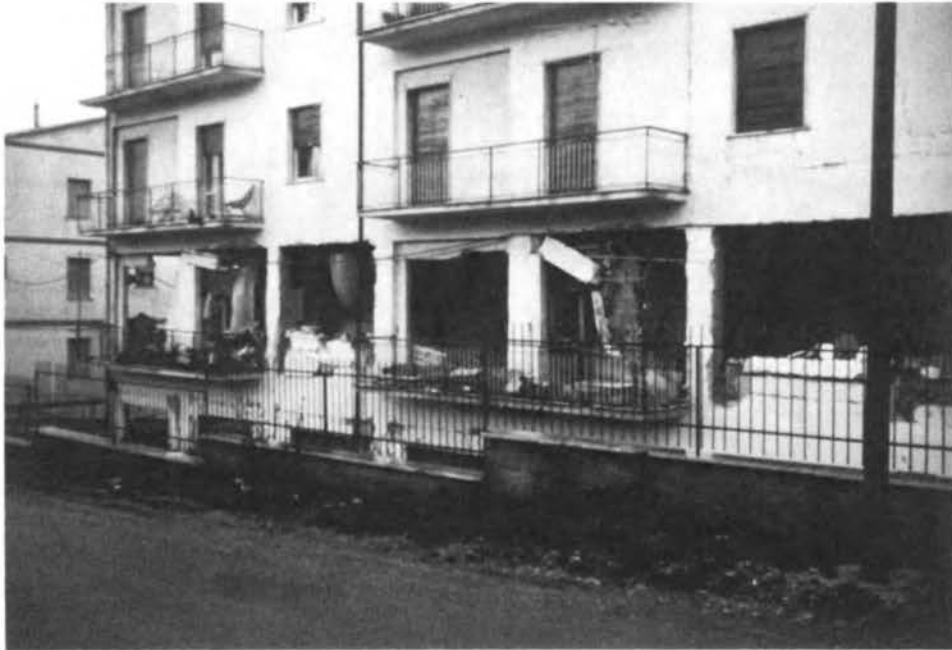
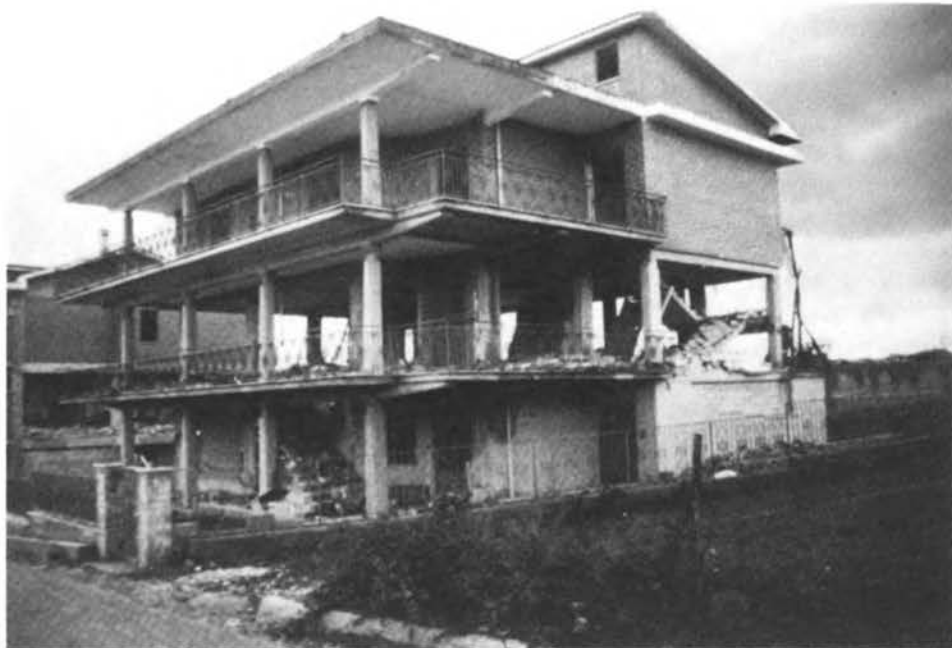
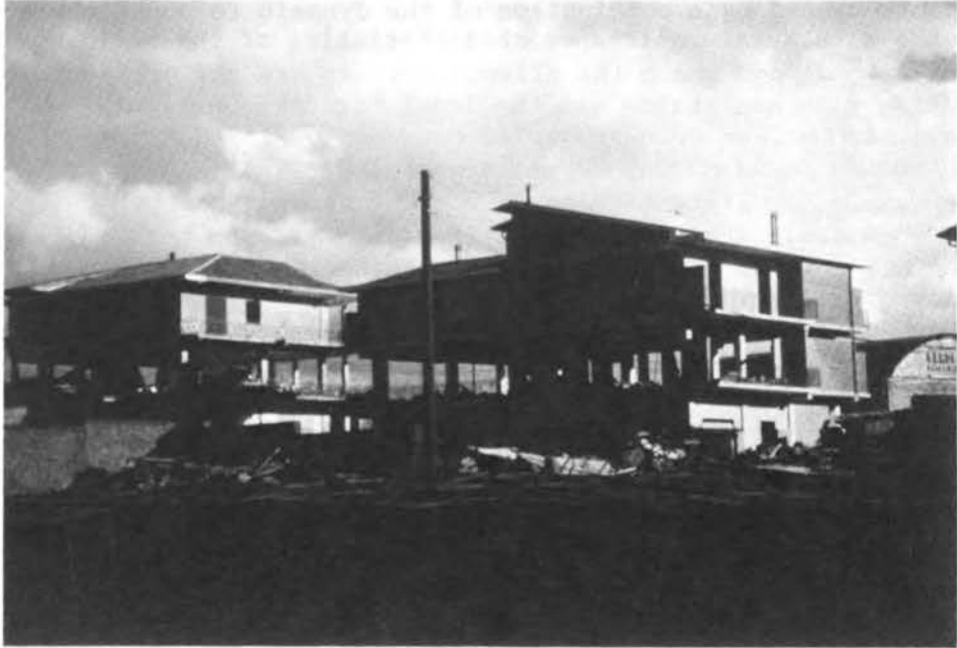
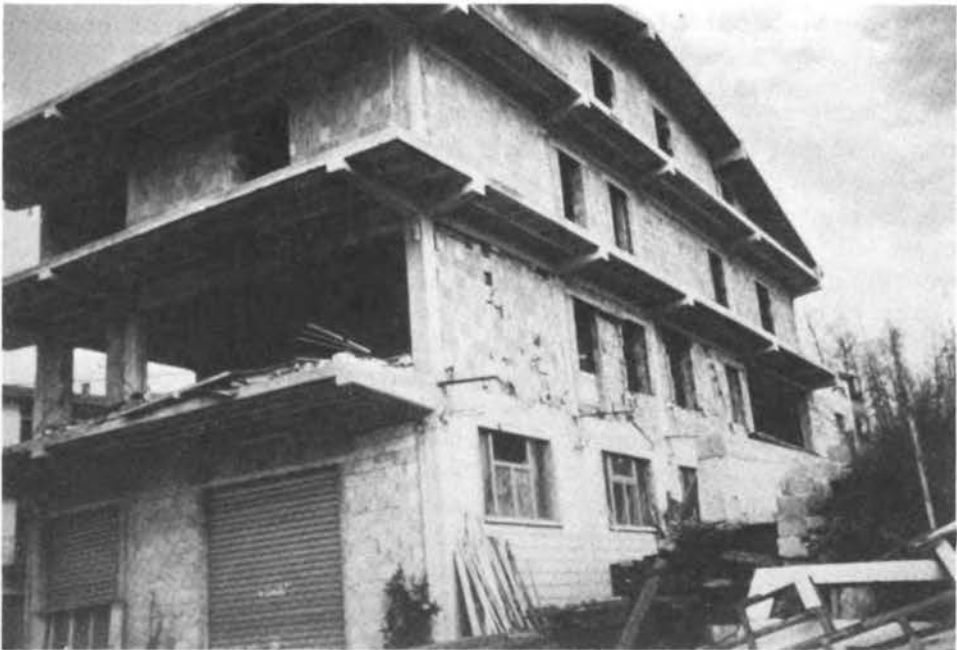
The response of some of the structures is shown in Figure 13. In many buildings, the infill walls of one particular story were damaged more extensively than walls on the other floors. This difference was

**Figure 13. Examples of damage to concrete frames with infill walls.**

**Figure 13 (cont'd). Examples of damage to concrete frames with infill walls.**

probably caused by a combination of the dynamic response characteristics and the structural resistance characteristics of the buildings. It reveals locations where the effective shear was the greatest, or where the effective resistance was the least for that particular structure. Damage can be seen to have varied between lower and upper stories.

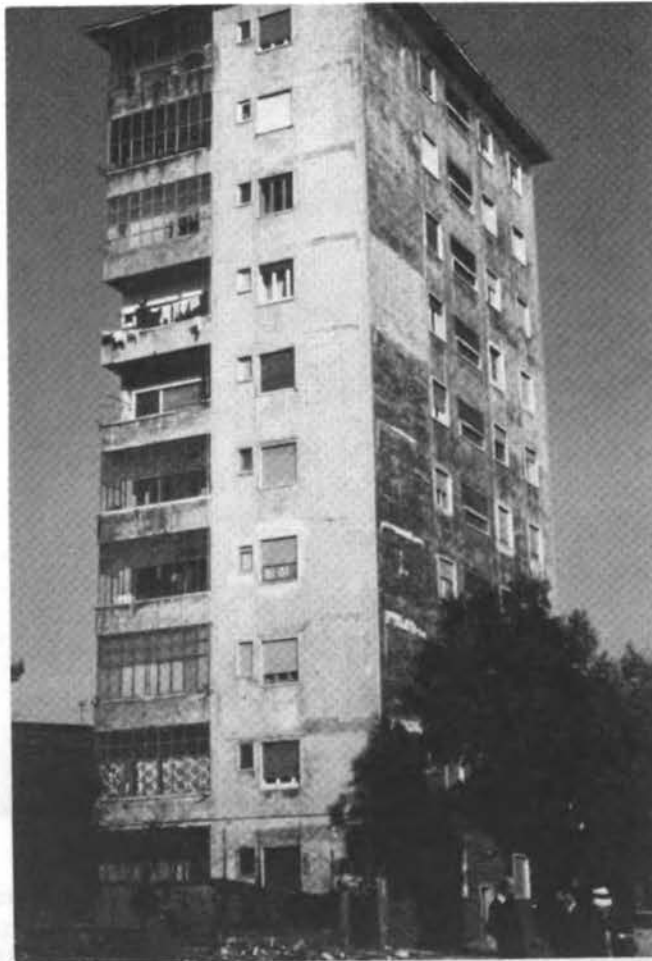
b

Naples was the largest city (population 1,225,000 in 1978) within the affected area. Visual inspection suggested a rather low intensity of shaking here. Most of the damage was to older types of construction (Figure 15a). However, two recent structures (about 30 years old) showed severe damage. A 10-story housing unit identical to the one shown in Figure 15b collapsed, killing all 52 occupants. The remaining basement of the collapsed structure is shown in Figure 15c. Close observation of the remaining two structures indicates repairs had been made in the past at floor construction joints (Figure 15d). The cause of the previous problem was not known. What appears to be an exterior shear wall is a concrete frame with infill masonry wall.

**Figure 15. Damage to concrete structures with infill walls.**  
(a) A large housing project of 5-story and 10-story units, all constructed of concrete frames with infill walls.  
(b) Shows a 10-story surviving unit, similar to the one that collapsed.

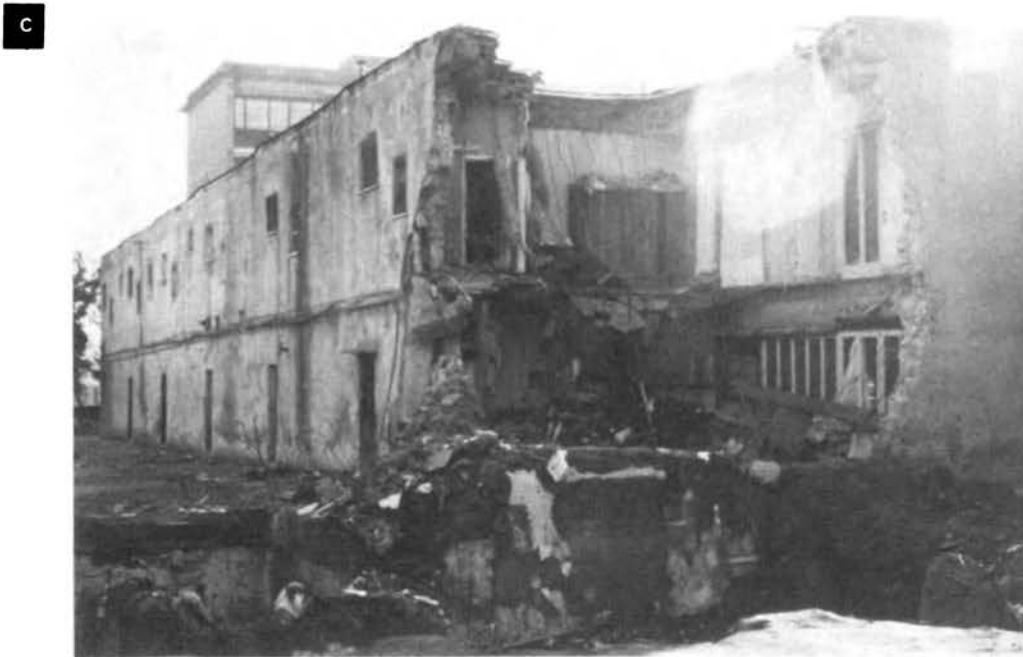
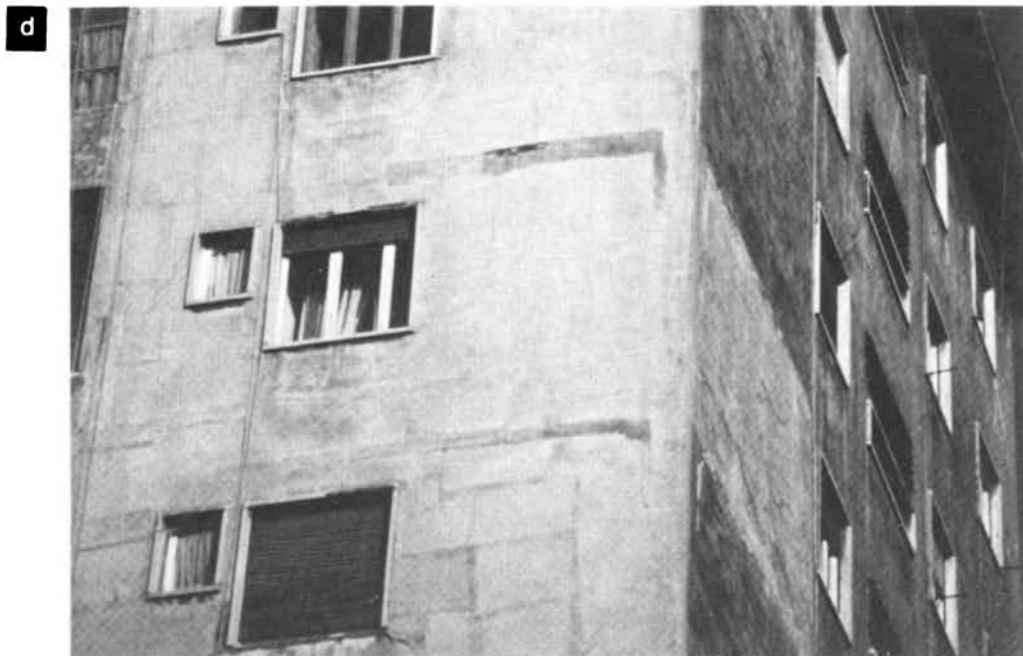
**Figure 15 (cont'd). Damage to concrete structures with infill walls. (c) Shows basement of collapsed 10-story unit. Note damage to nearby residence due to collapse of high rise unit. (d) Patchwork of some kind had been done in the past at floor lines of surviving unit.**

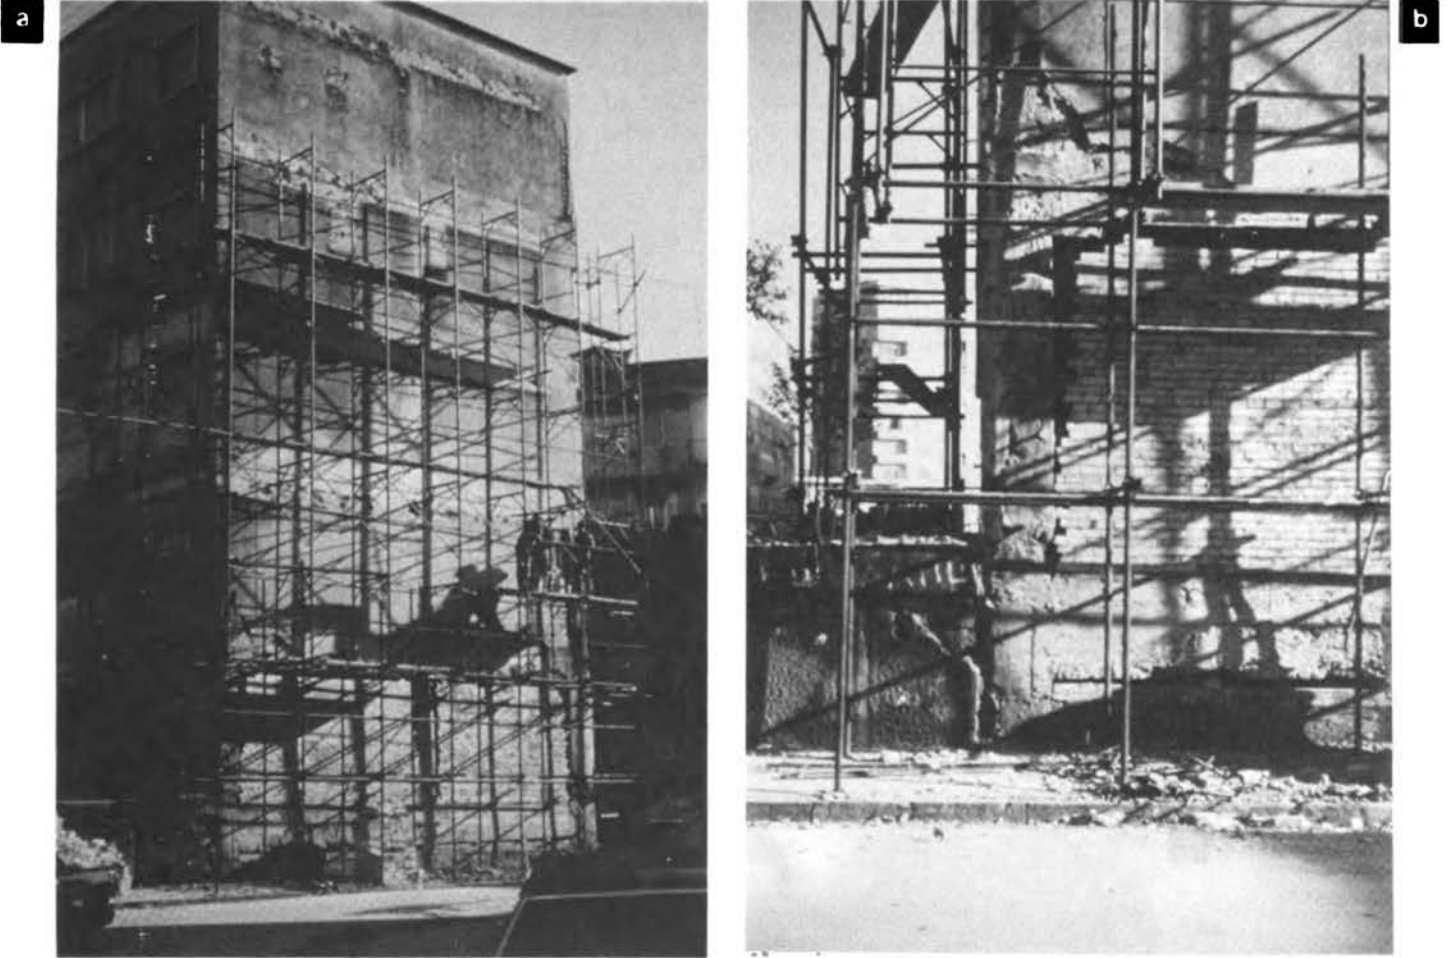
Corrective work was being done to the endwall of a 5-story unit of similar construction (Figures 16a and b). Brick was being used here as the infill wall material. These 5-story units were reported to have extensive damage to the interior walls and occupants were very fearful of remaining in the buildings. The 10-story unit in Figure 15b sits at the far end of the 5-story units located in this vicinity. An earthquake similar to the November 23 earthquake, but centered closer to this area, could cause these structures to collapse.

**Figure 16. Damage to a 5-story unit in Naples. (a) The endwall is being reconstructed. New infill material is brick. (b) Corner column has separated from wall. There is a drift of approximately 2 inches between the base and the second floor.**

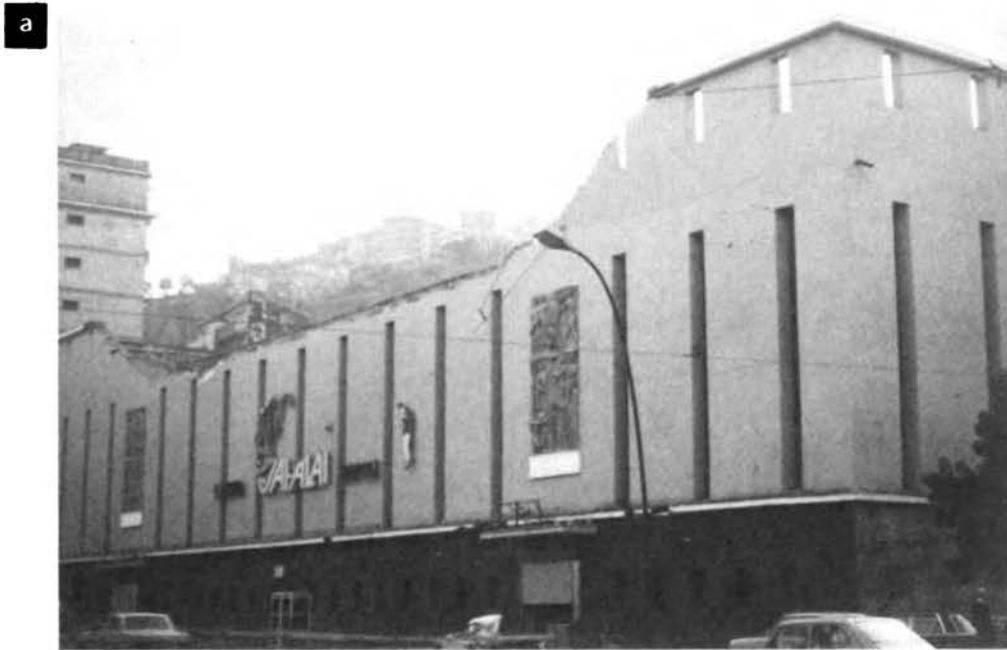
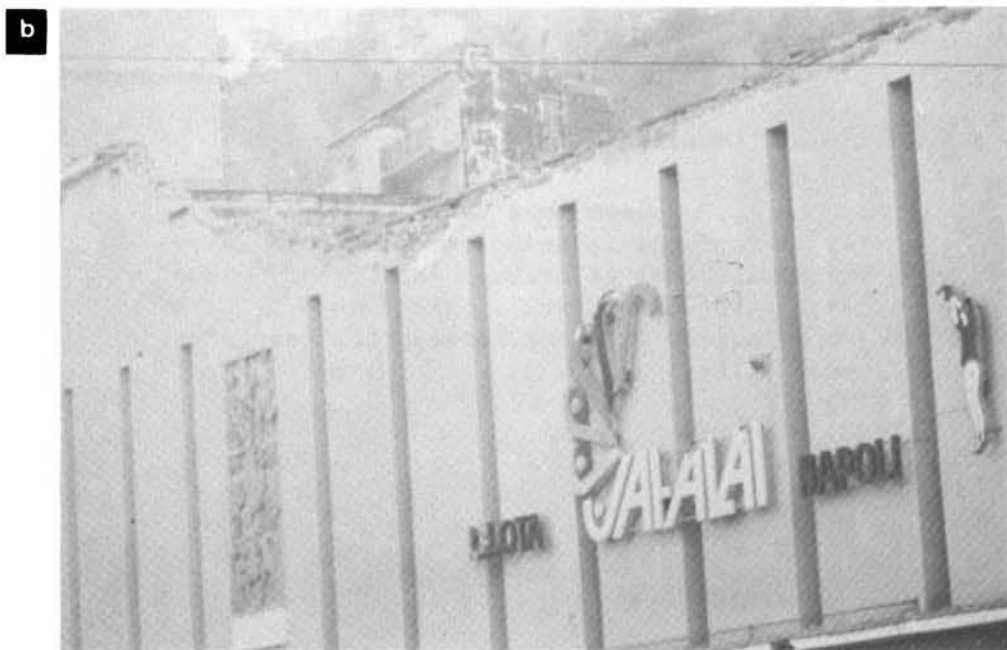
The Jai Alai arena shown in Figure 17 was damaged when its high, unbraced, and unreinforced parapet wall collapsed. The figure also shows a closer view of the damage.

Figure 17. Damage to the Jai Alai stadium. (a) The stadium had a failure of its high, unbraced parapet wall. (b) This close-up shows that the very high, unreinforced parapet was not properly anchored to the wood roof system.

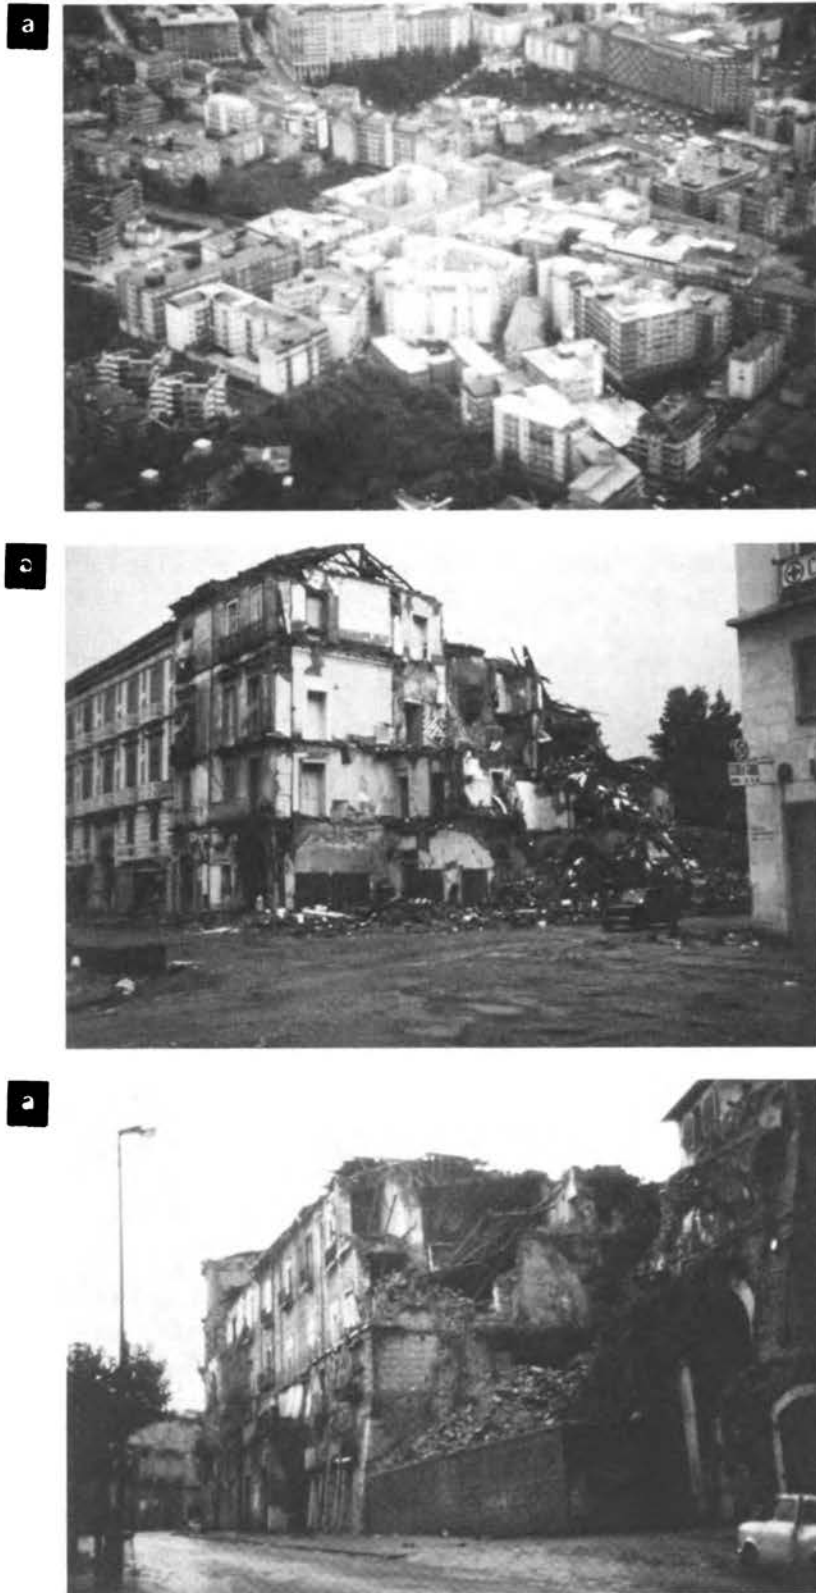
Figure 18. Damage at Avellino. (a) Aerial view. (b) Older construction collapsed. (c) The nearly total collapse of the old construction shows a large inward movement of the front wall at the second floor.

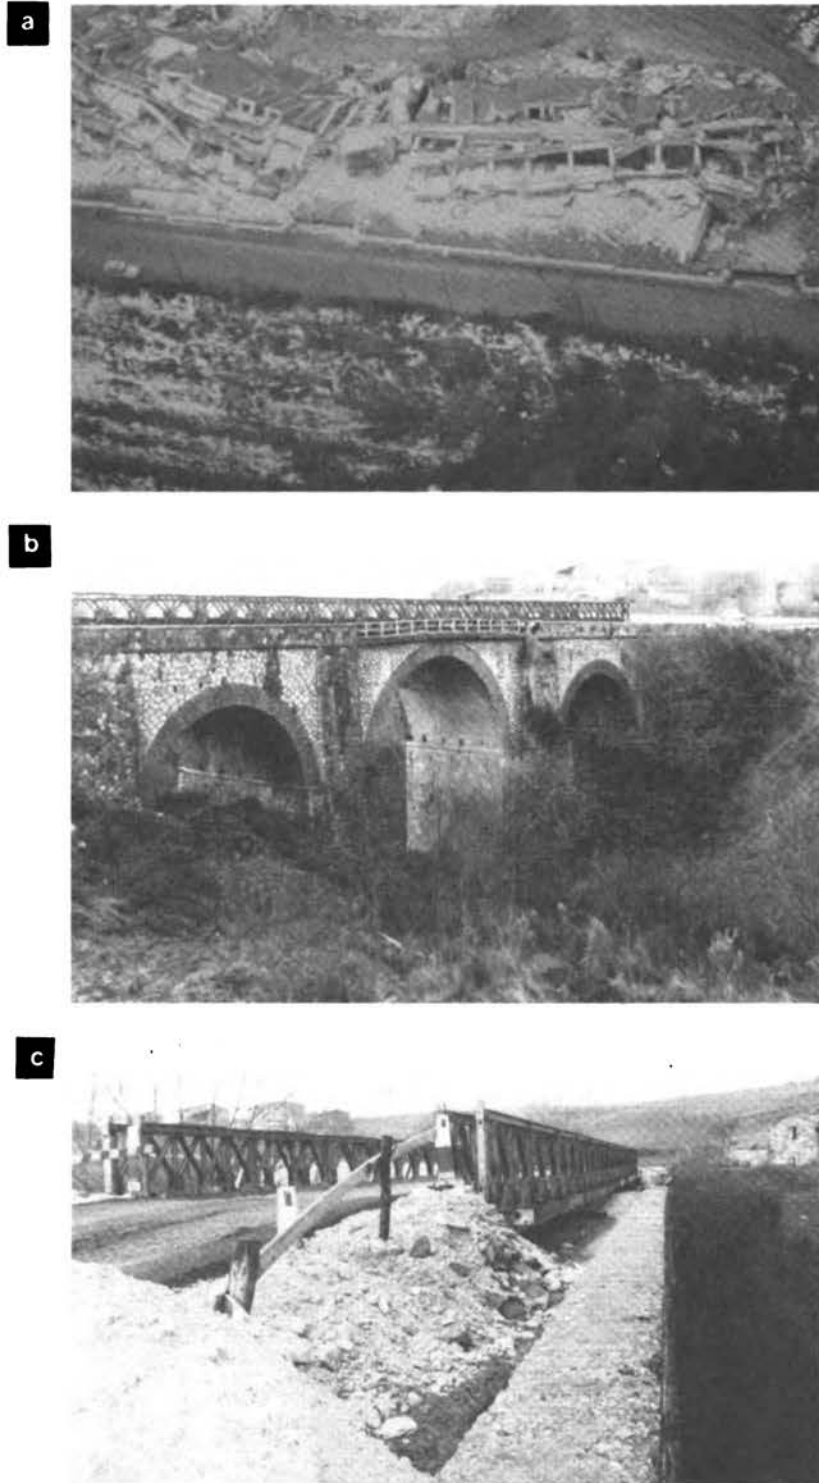
Sant' Angelo dei Lombardi was one of the most severely damaged towns (Figure 19). The aerial view shows an overview of the town, and one view of a collapsed condominium that was under construction (Figure 19d). Construction in this area should have conformed to the seismic requirements of Category 2 (7 percent lateral load, see Figure 6), but the construction details used (Figures 19e and f) do not reflect such design levels. For example, proper ties, and adequate splicing and reinforcing were lacking, and the poorly conceived use of infill walls compounded the problems.

Figure 19. Damage at Sant' Angelo dei Lombardi. (a) Aerial view of a collapsed, newly constructed housing unit. Hammerhead crane was not affected by the ground motion and is still visible at the site. (b) An important bridge near the town was heavily damaged. (c) Portable steel bridge erected over the damaged bridge.

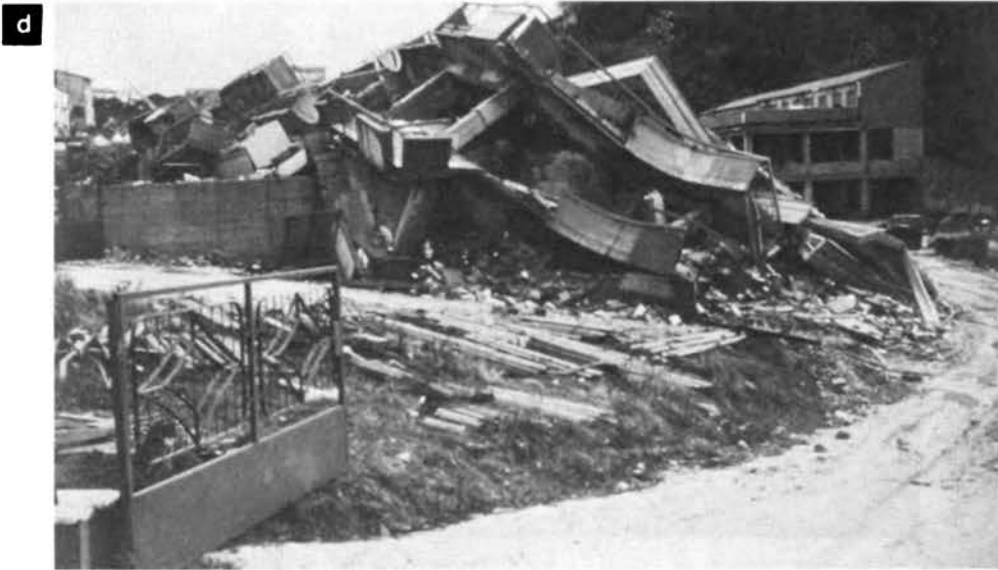
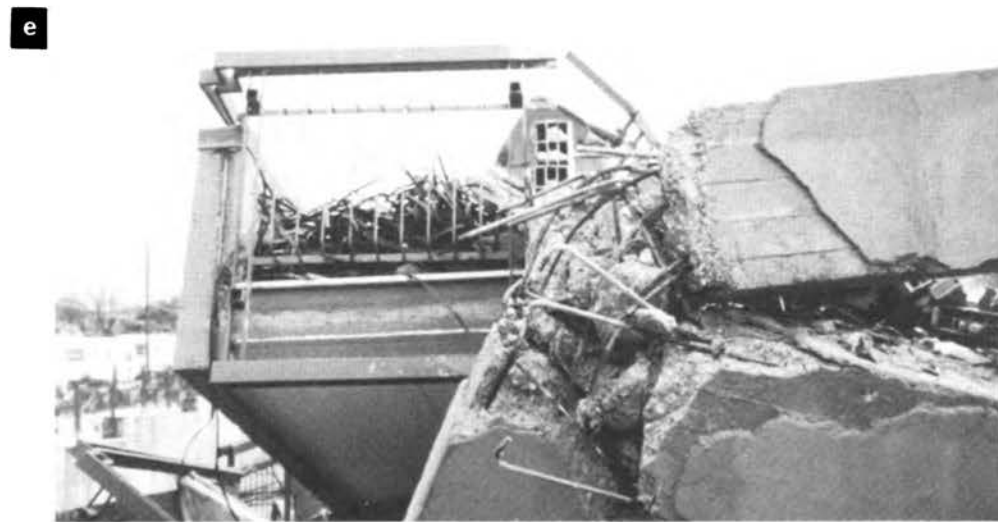
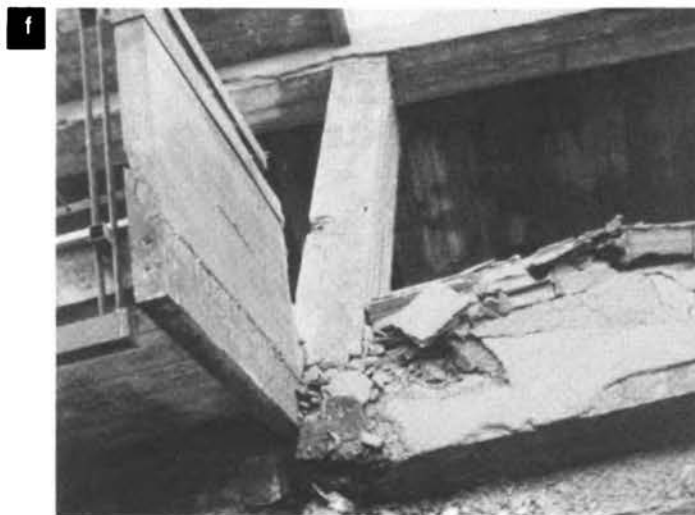
Figure 19 (cont'd). Damage at Sant' Angelo dei Lombardi  
(d) A recently constructed condominium lies in a heap of rubble. (e) and (f) Beam to column joints, and column reinforcing do not reflect seismic requirements.

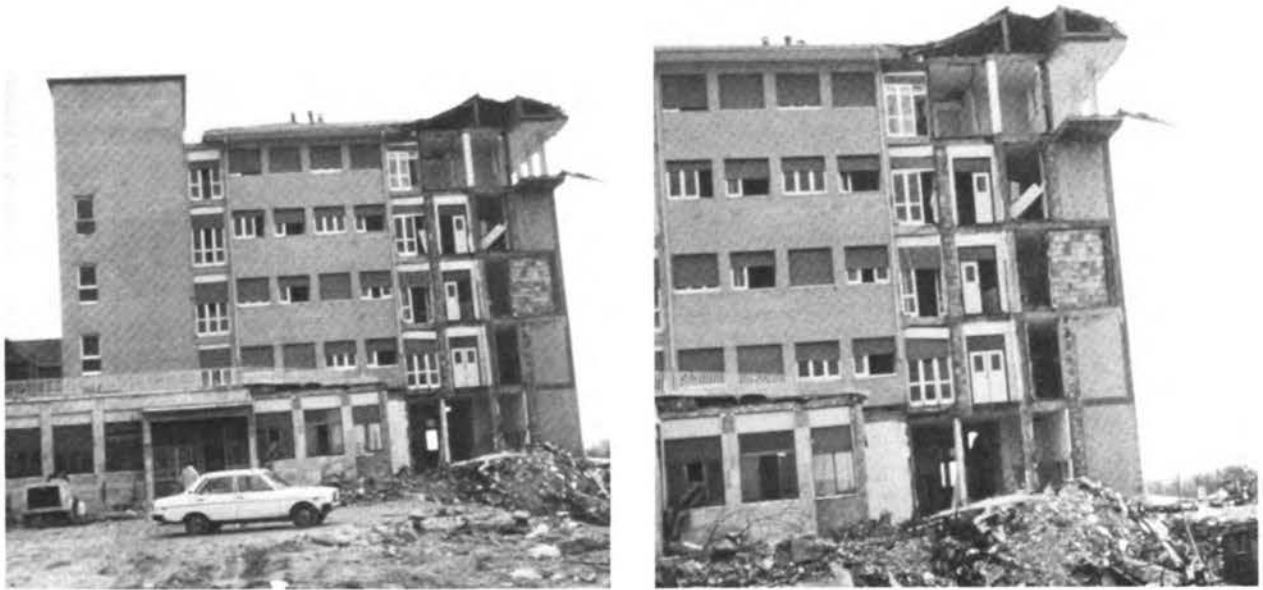
g

A wing of the local hospital collapsed, but bad weather and rescue demolition work made a detailed investigation impossible. The portion that remained standing was deemed too dangerous for closer internal inspection, because an aftershock could cause collapse (Figures 19g and h).

Figure 19 (cont'd). Damage at Sant' Angelo dei Lombardi  
(g) Two views of the damaged hospital. (h) Close-up view  
of the corner of the hospital shows the damaged walls and  
columns. An aftershock could easily cause the rest of  
this structure to collapse.

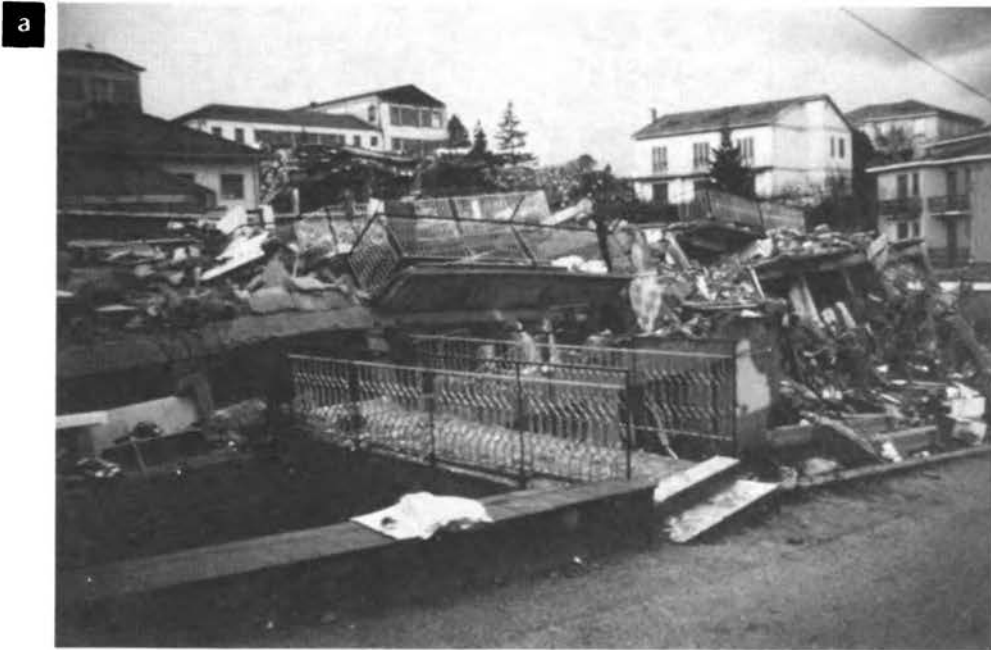
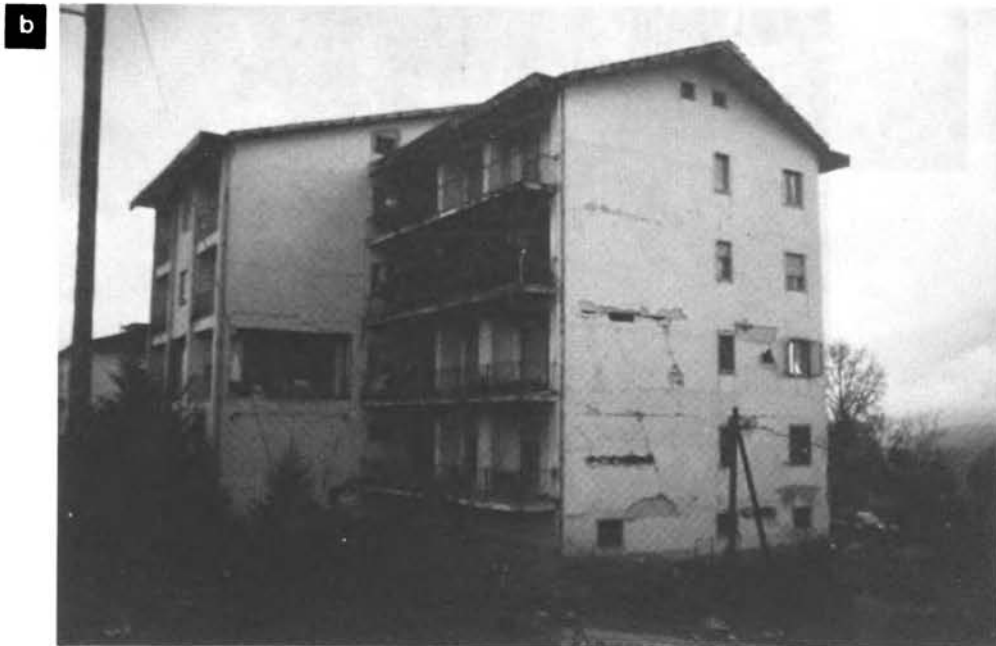
A 4-story housing unit that collapsed is shown in Figure 20a. The demolition work on this building had not yet begun; it was suspected that some of the missing were buried under this debris. Some typical damage to concrete structures and to the police station is shown (Figures 20b and c).

**Figure 20. Damage to housing and police headquarters.**  
**(a) This 4-story housing unit was totally collapsed.**  
**Debris operations had not yet reached this structure.**  
**(b) Typical damage to multistoried concrete frame units.**  
**Note the outline of the frame.**

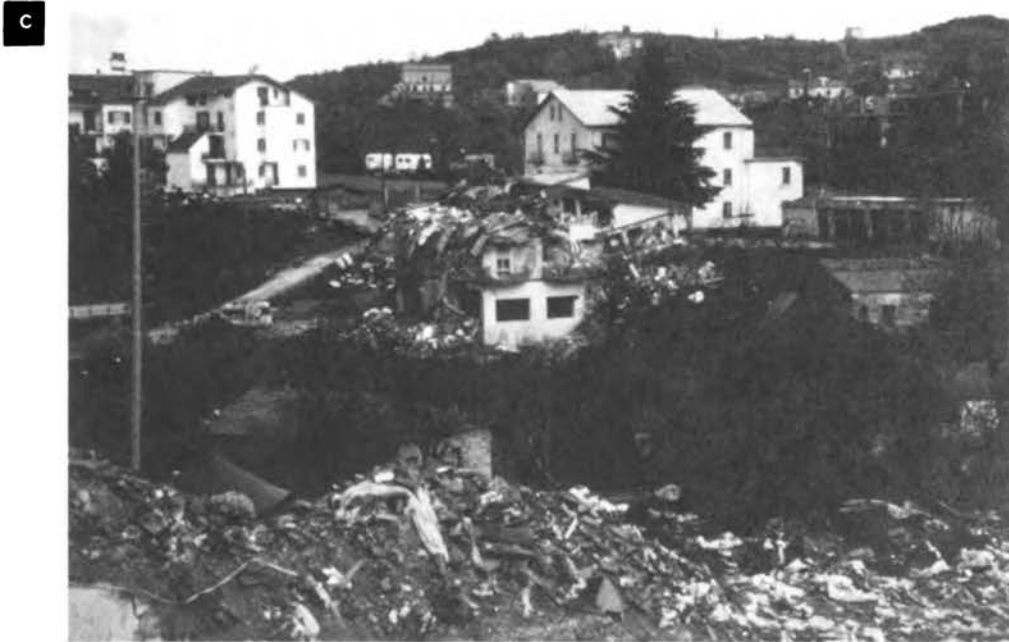
**Figure 20 (cont'd). Damage to housing and police headquarters. (c) Failure of the local police headquarters. Need for these facilities to remain operational is obvious.**

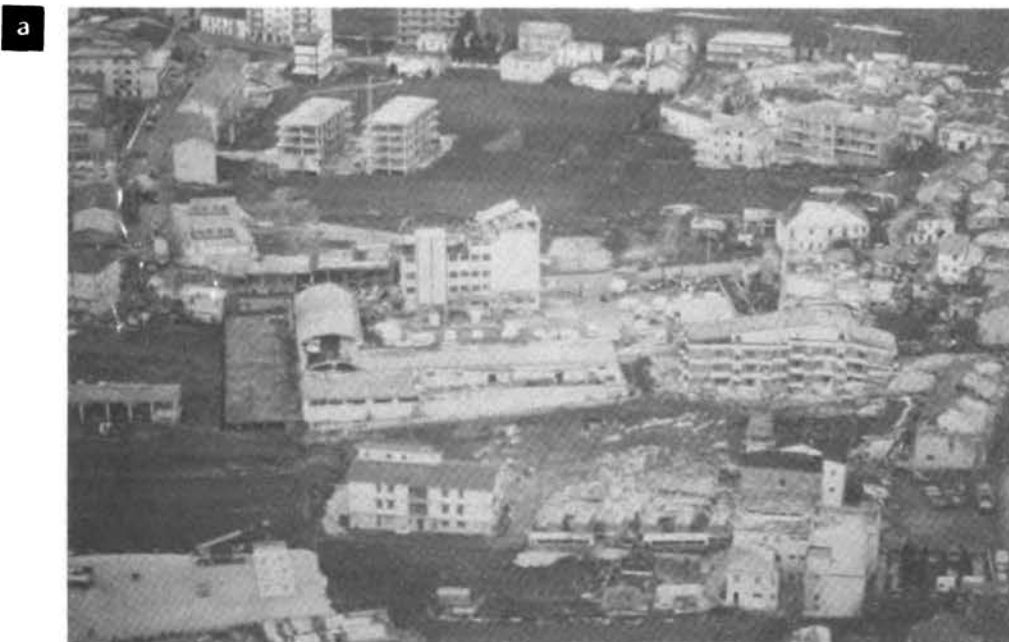
**Figure 21. Damage to the Pallante factory. (a) This aerial view shows severe damage. The two housing units in the upper left were discussed earlier; to the right is the damaged housing unit shown in Figure 12.**
