**EARTHQUAKE IN CAMPANIA-BASILICATA, ITALY**

**NOVEMBER 23, 1980**

**A RECONNAISSANCE REPORT**

**James L. Stratta, Consulting Structural Engineer, Menlo Park, California**  
**Luis E. Escalante, Los Angeles Department of Water and Power, California**  
**Ellis L. Krinitzsky, Waterways Experiment Station, Vicksburg, Mississippi**  
**Ugo Morelli, Federal Emergency Management Agency, Washington, D.C.**

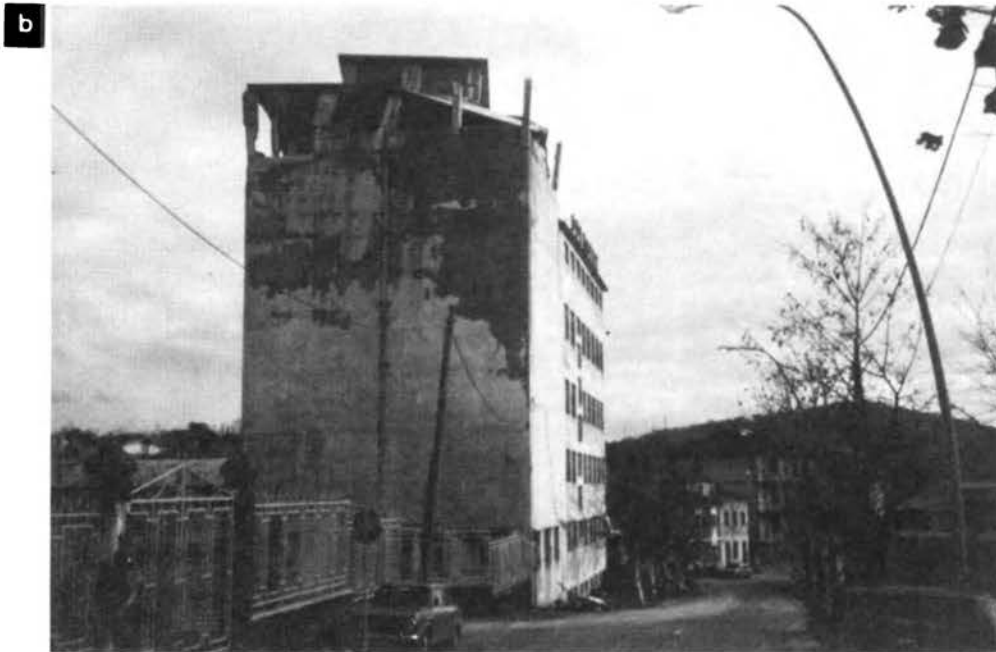
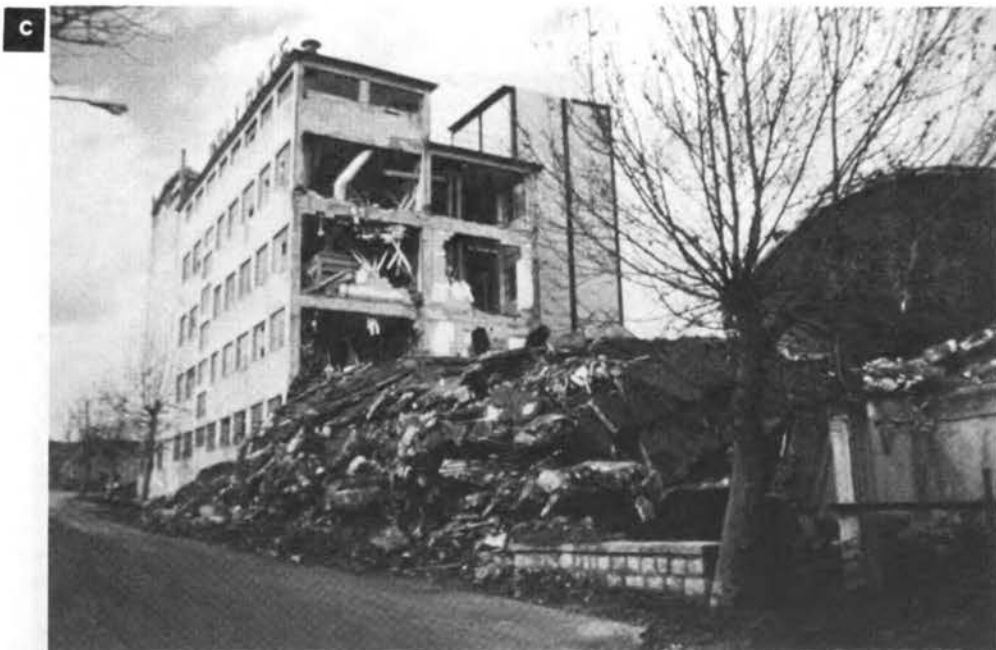
Figure 21 (cont'd). Damage to the Pallante factory.  
(b) The Pallante "pasta" factory has a concrete frame with infill walls. (c) One unit of the factory has collapsed. Some infill walls of the remaining structure have also failed. The failure occurred at a construction joint.

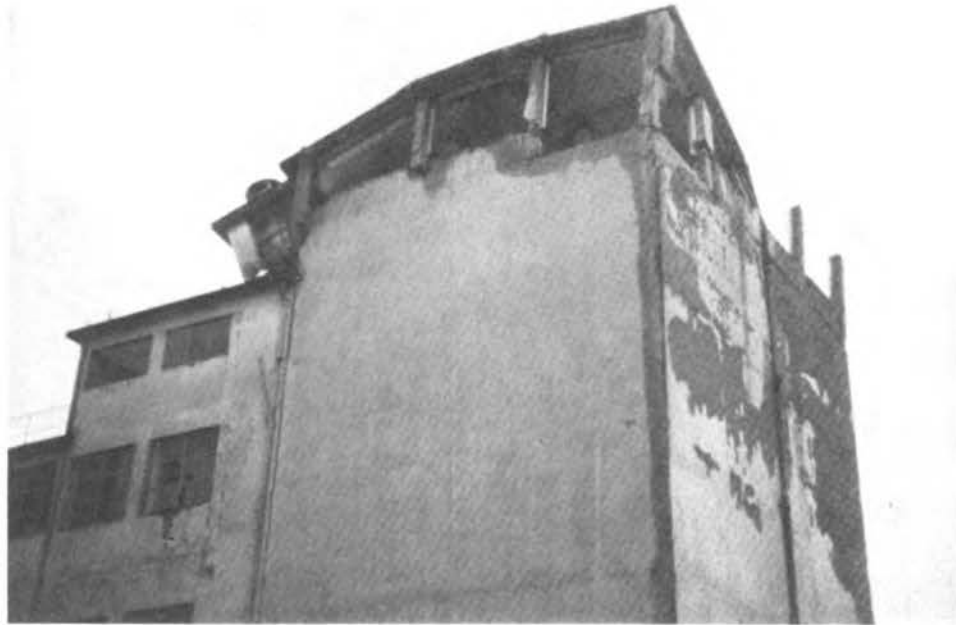
d

**Figure 21 (cont'd). Damage to the Pallante factory.  
(d) Penthouse failures at the Pallante factory.  
(e) Exterior plaster has spalled off the factory  
front, revealing infill walls.**

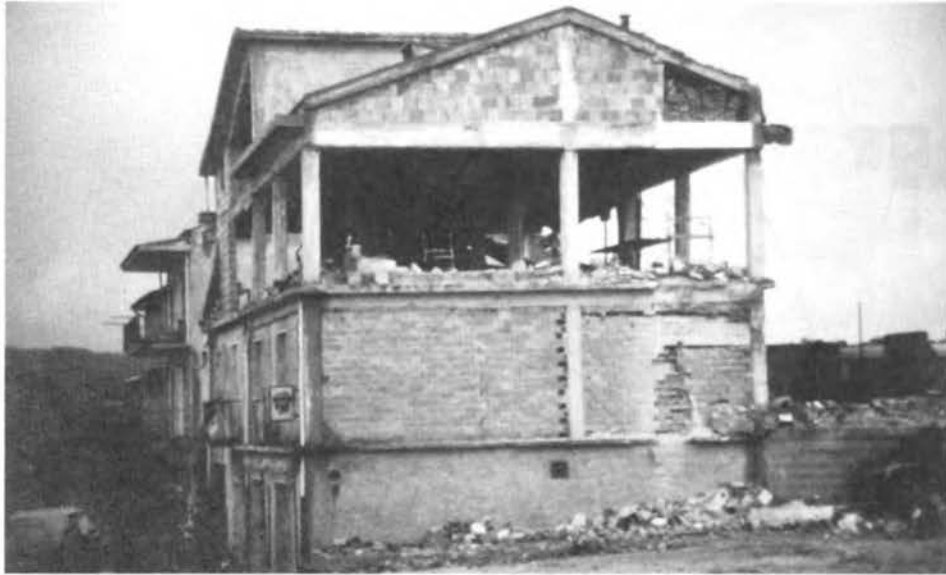
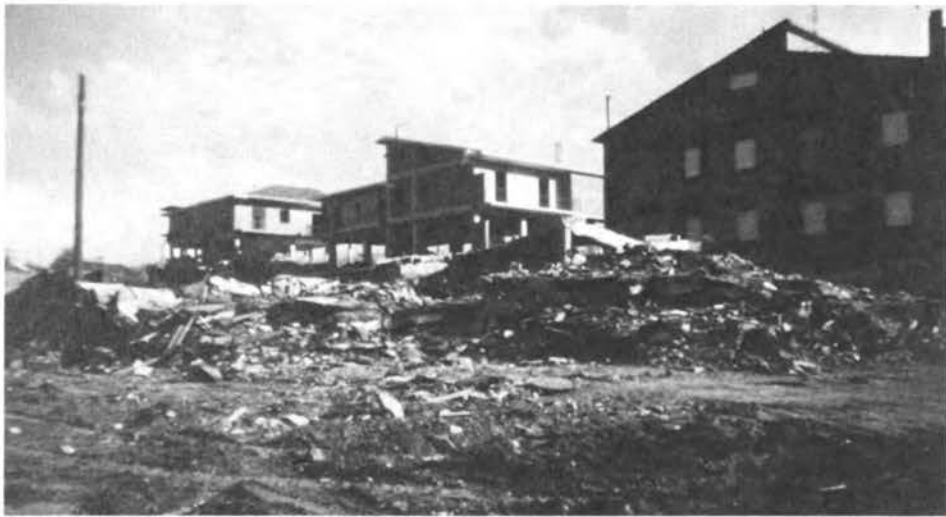
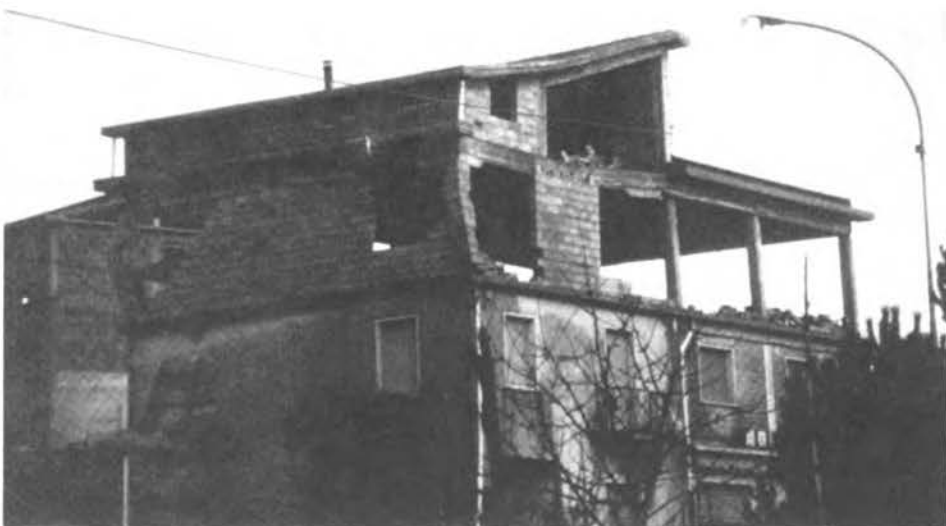
a

Figure 22. Damage in the town of Lioni. (a) Many two-story and 3-story residential units such as these suffered the typical failures caused by infill walls.

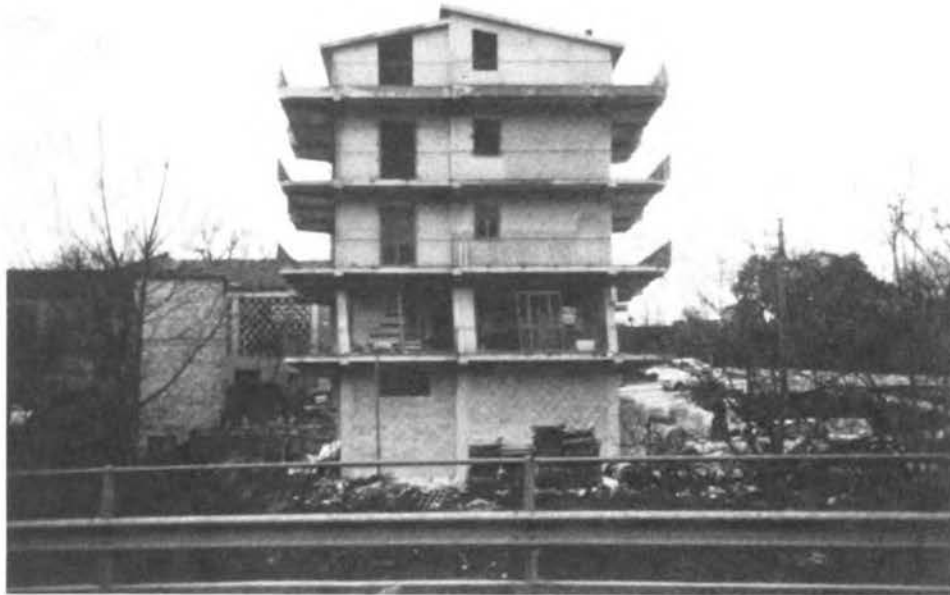
**b**

Figure 22 (cont'd). Damage in the town of Lioni.  
(b) Residential building with heavy damage to the first floor. Total collapse is imminent. (c) Prefabricated houses being installed in Lioni. The Pallante factory is in the background.

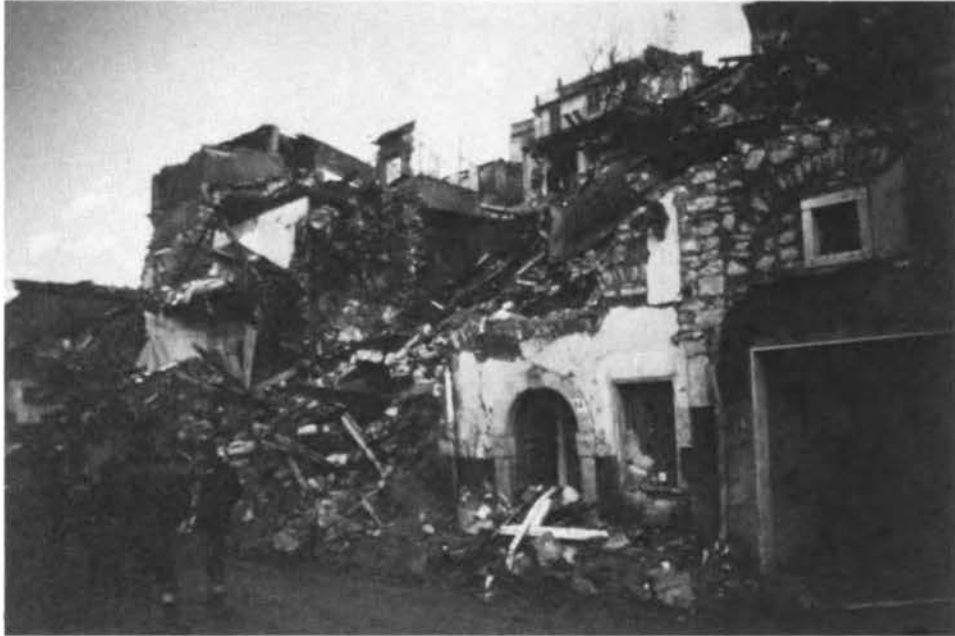
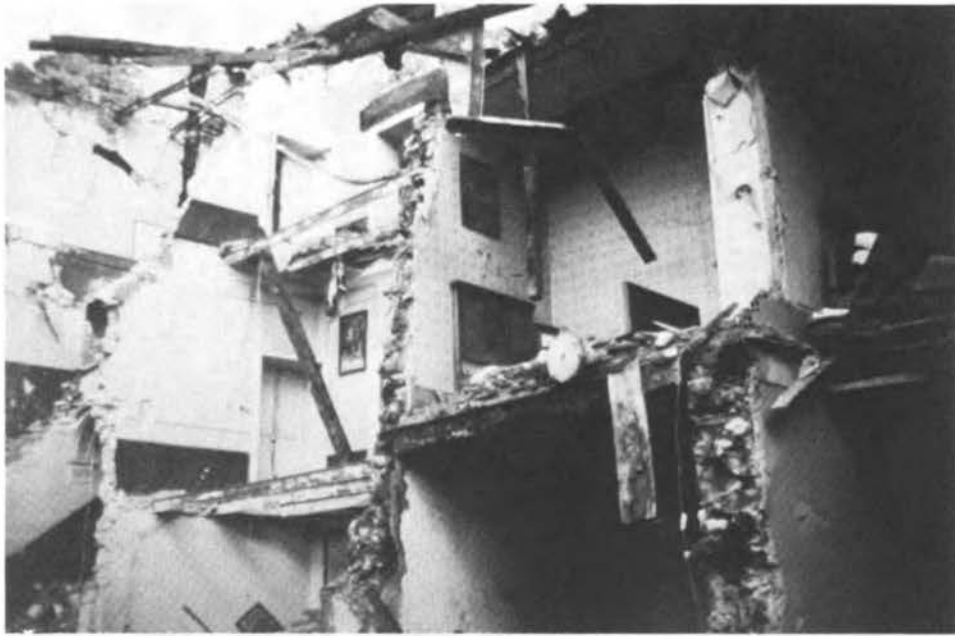
Damage typical to old construction is shown in Figure 23. Note the furniture in the room and paintings still on the walls.

**Figure 23. Typical damage to old construction. Note paintings and furniture still in place in the lower photo.**

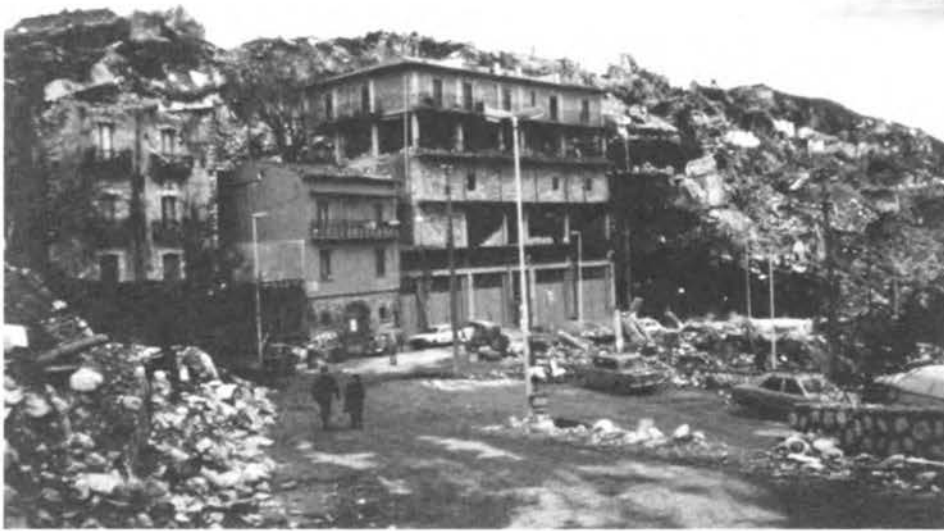
a

Figure 25. Damage in Laviano. (a) Note the complete devastation on the steep hillside behind the damaged 5-story structure. (b) Another view of the same hillside, showing the almost total collapse of structures.

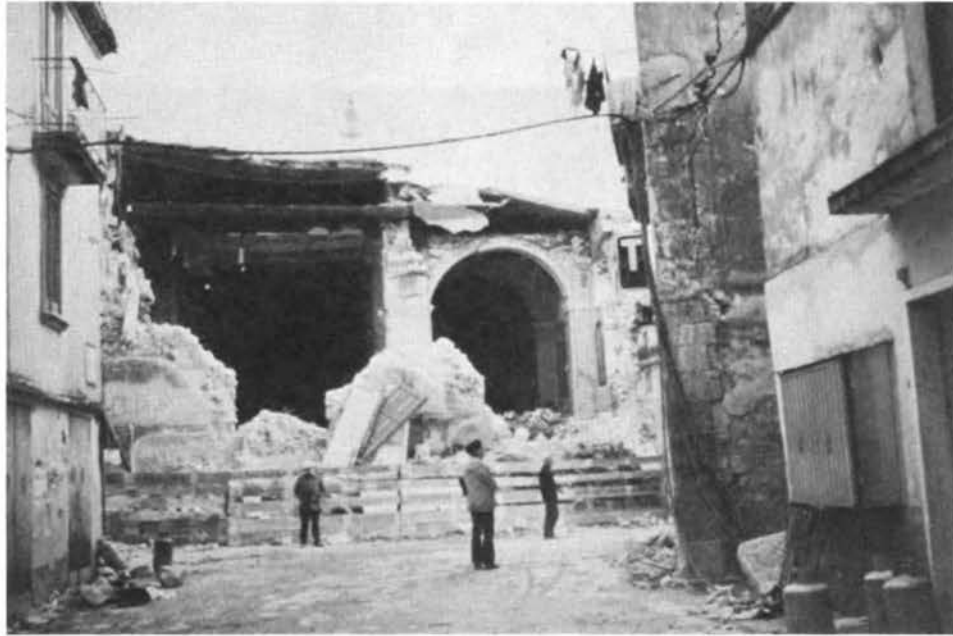
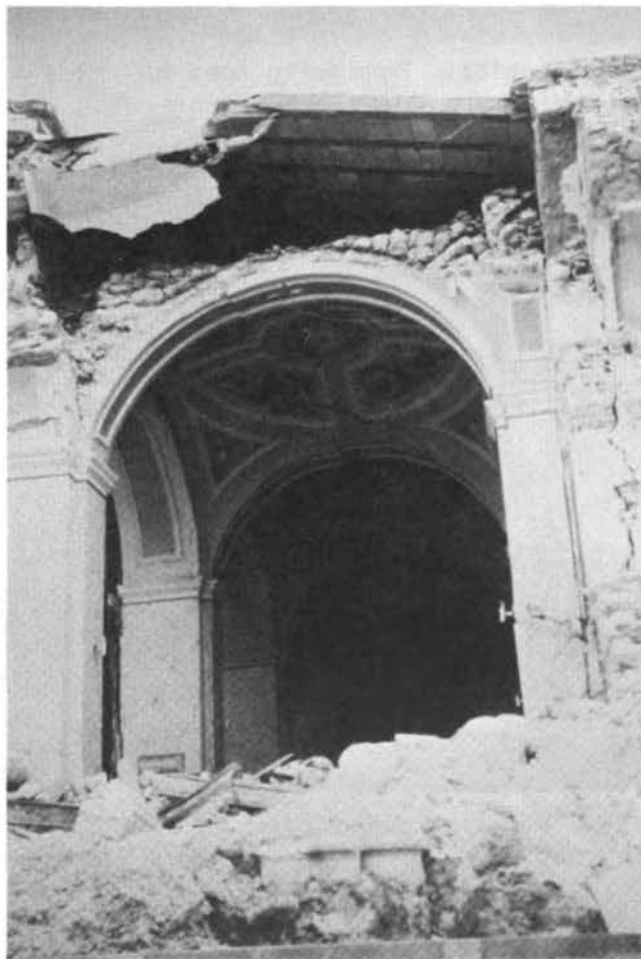
Figure 27. Damage in Balvano. Two views of the collapsed church in Balvano.

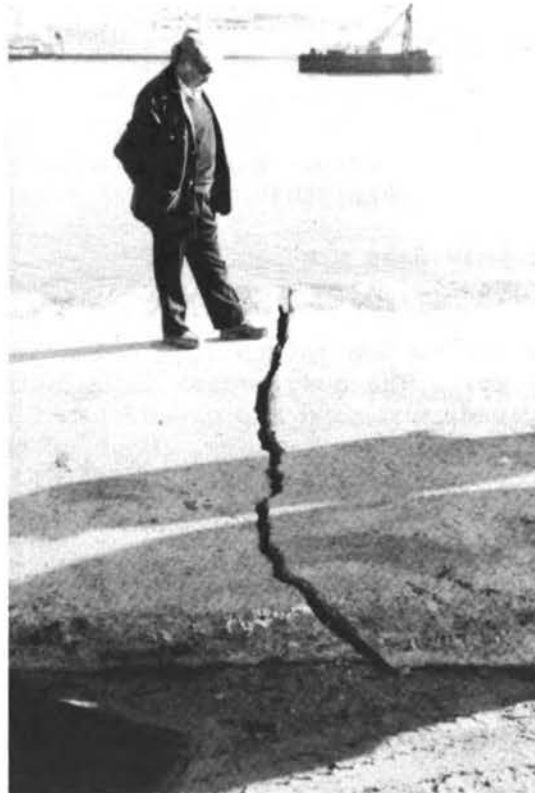
**Figure 34. Damage at the harbor of Salerno. Crack in large masonry and concrete pavement of the quay.**

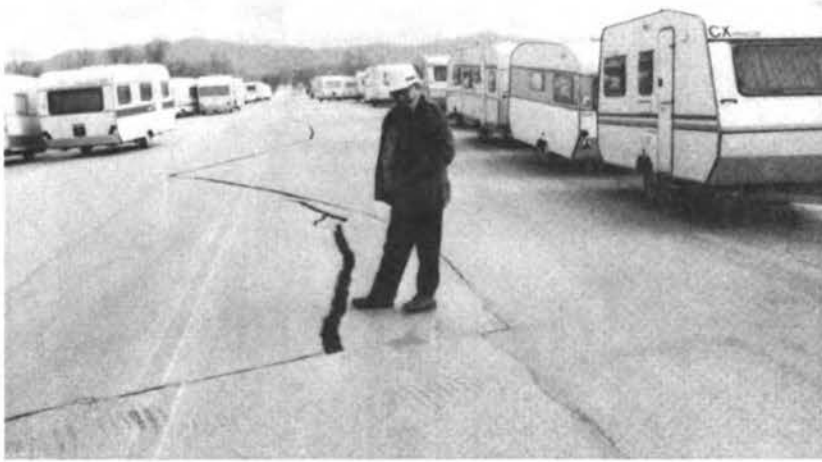
a

**Figure 36. Damage to roads. (a) Cracks in road pavement near Lioni. (b) Damage to pavement and slope of roadway near Lioni.**

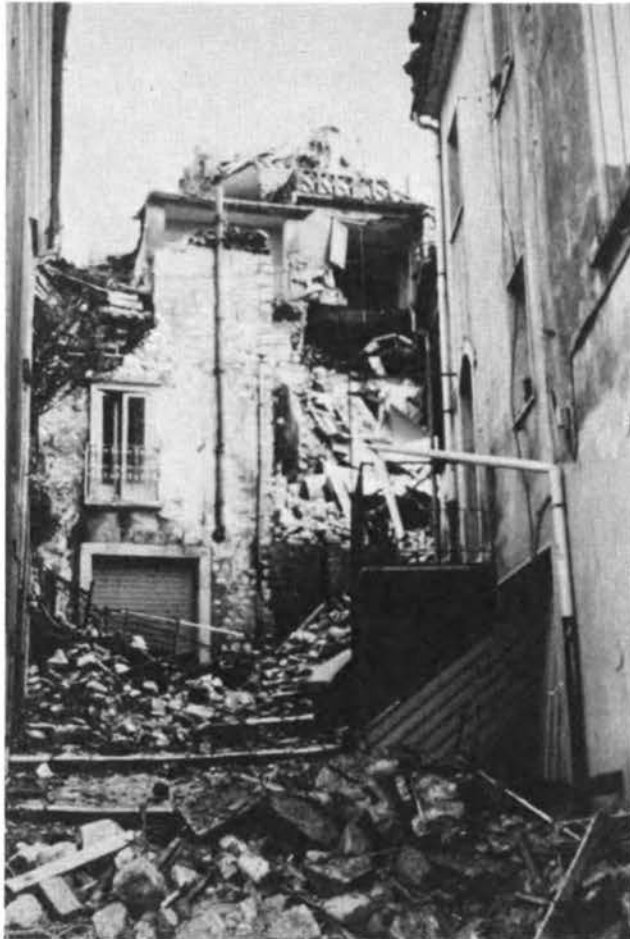
Figure 37. Narrow streets blocked with debris.
