The Central Greece Earthquakes of February-March 1981: A Reconnaissance and Engineering Report (1982)

Size
8.5 x 10

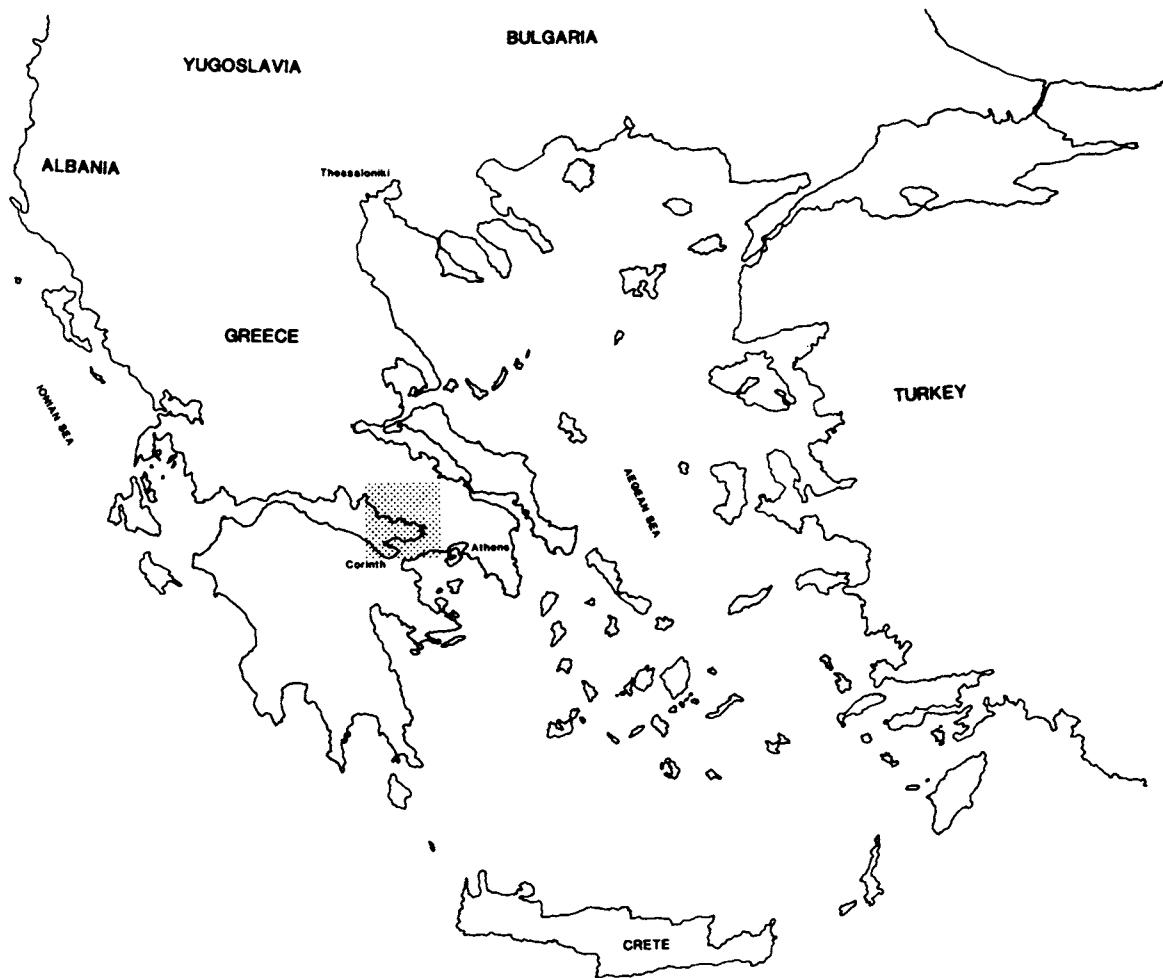
FIGURE 1.1 Epicentral area of central Greece.

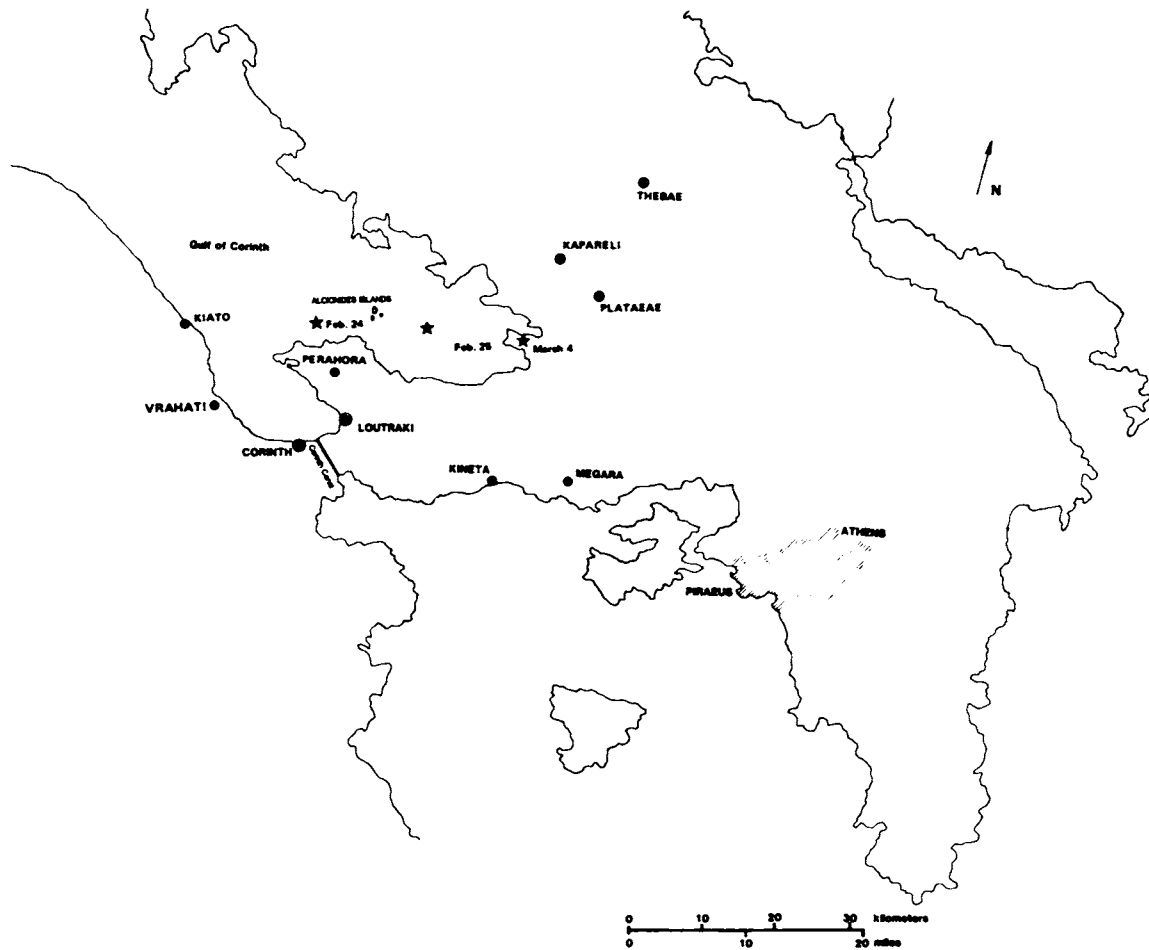
FIGURE 1.2 Epicenters of major shocks.

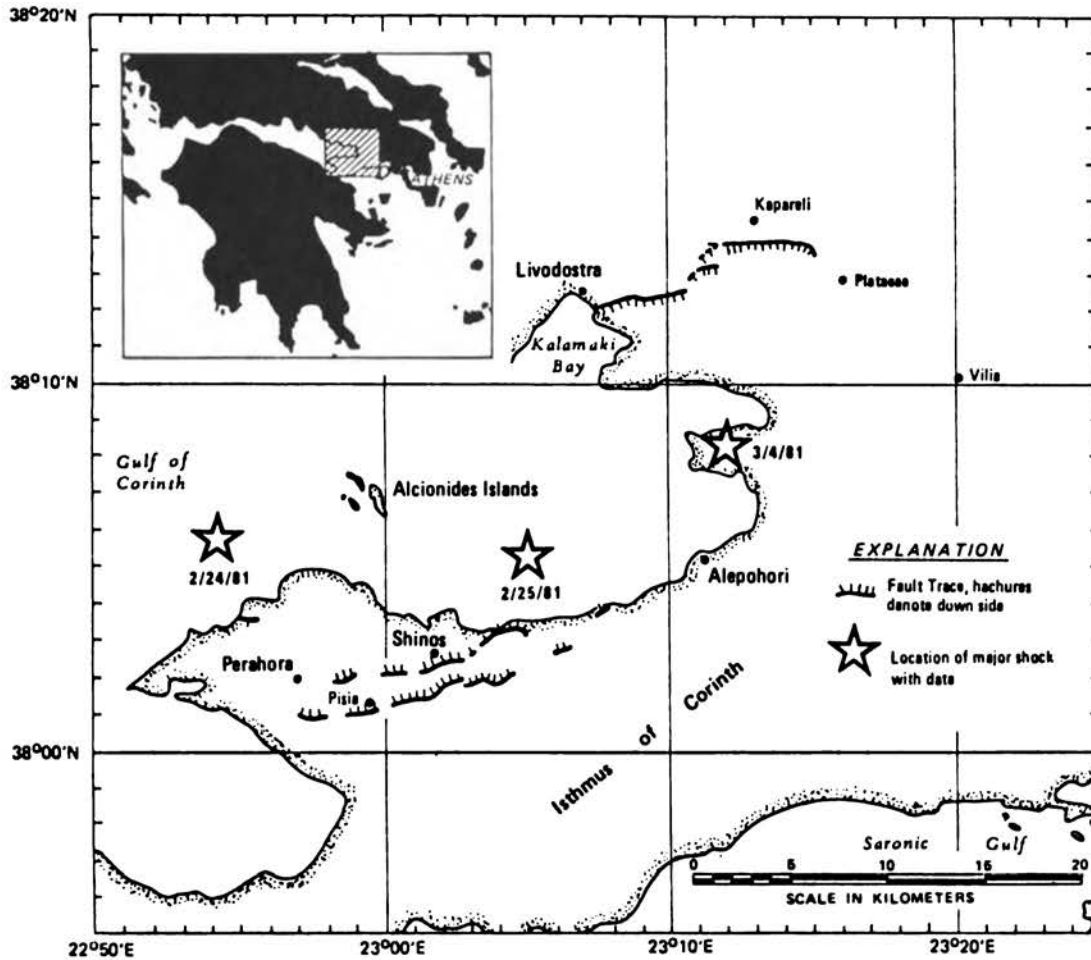
FIGURE 2.1 Location of surface ruptures.

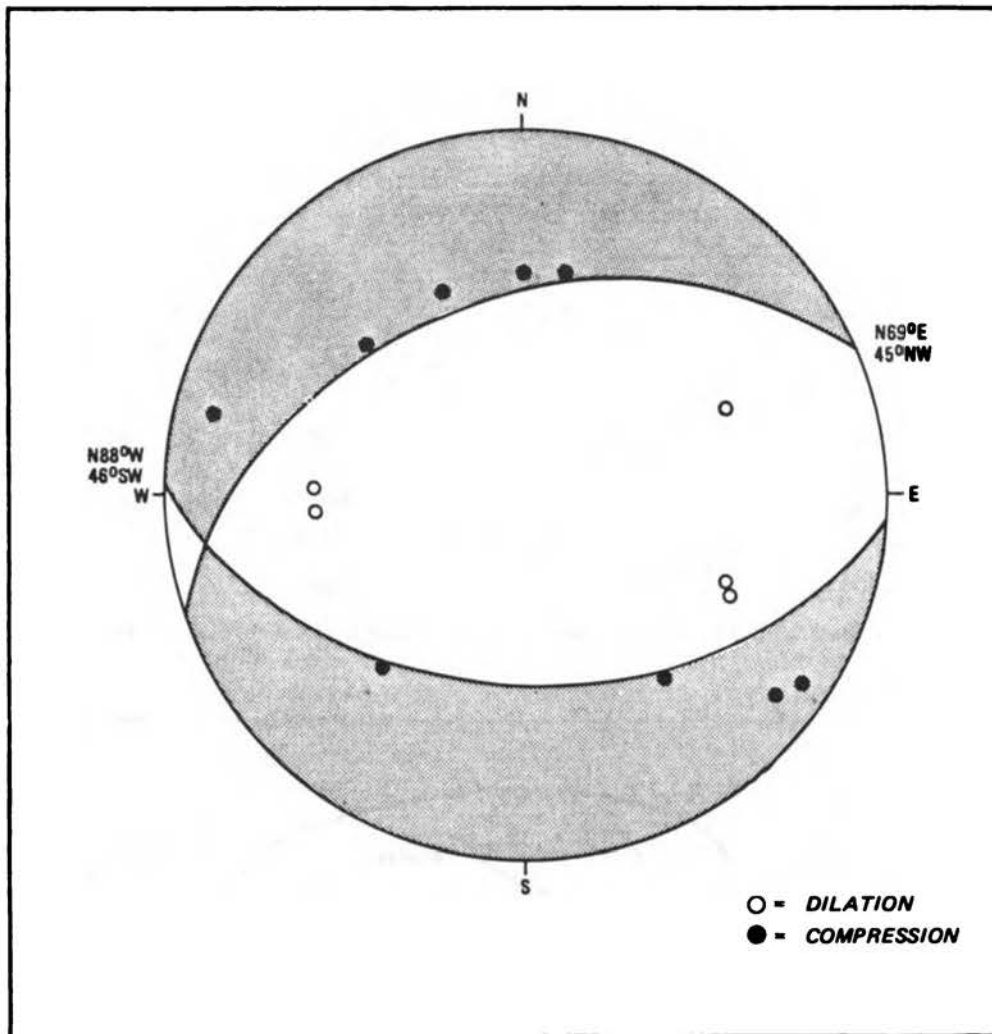
FIGURE 2.2 Focal plane solution for the magnitude 6.7 main shock of February 24, 1981. Lower hemisphere projection. (See Figure 2.1 for location.)

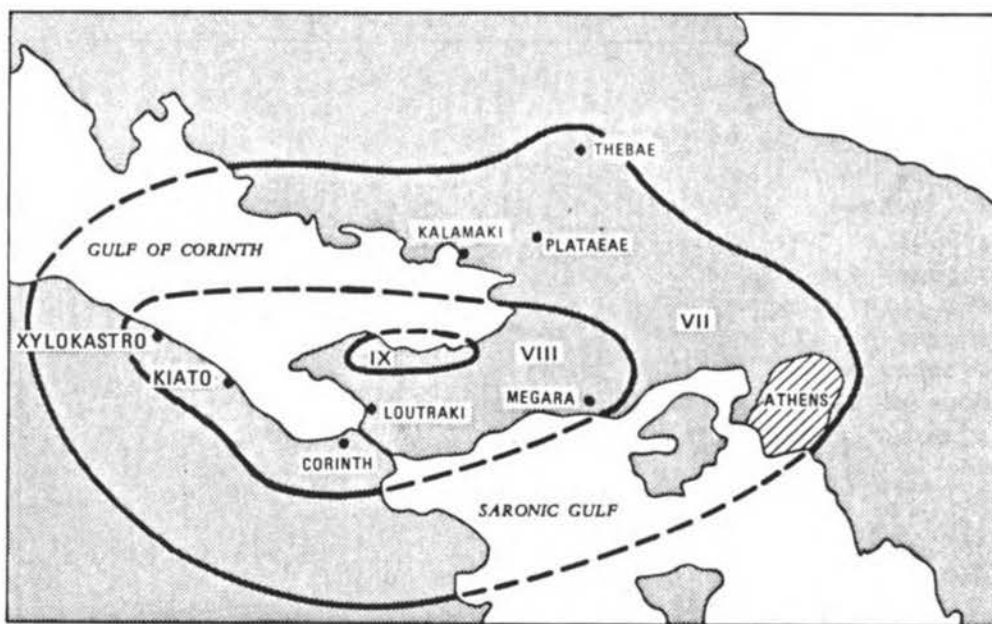
FIGURE 2.3 Isoseismal map for February 24 and 25 events.

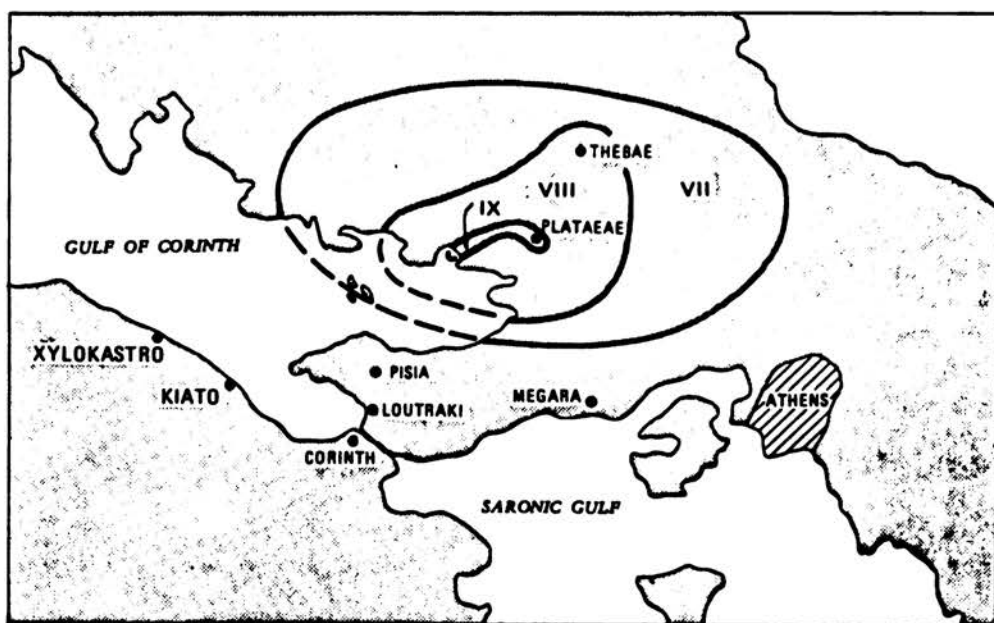
FIGURE 2.4 Isoseismal map for March 4 event.

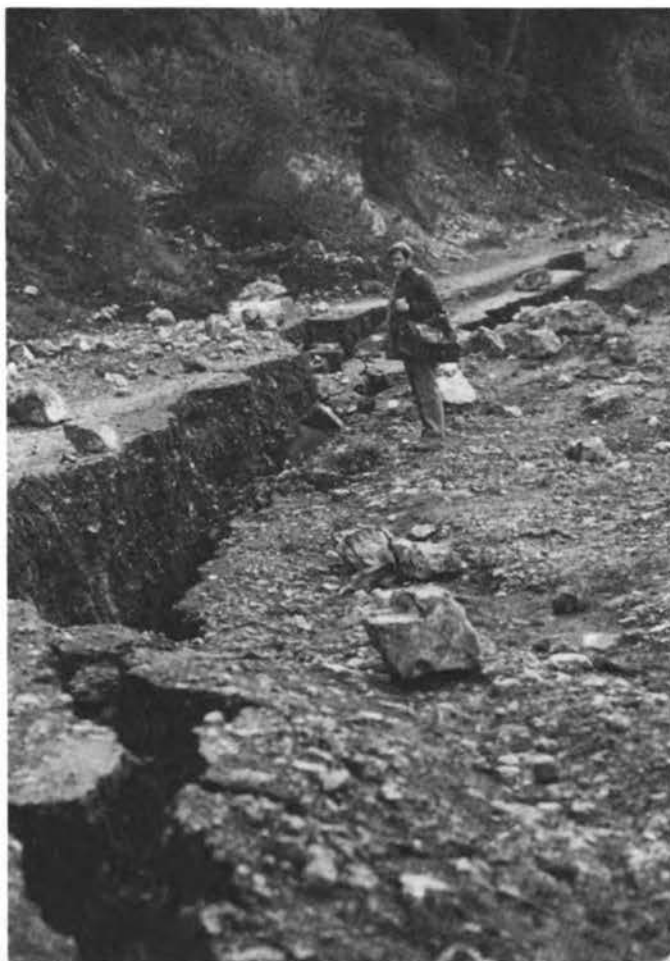
FIGURE 2.5 Ground rupture along the Shinos trace.

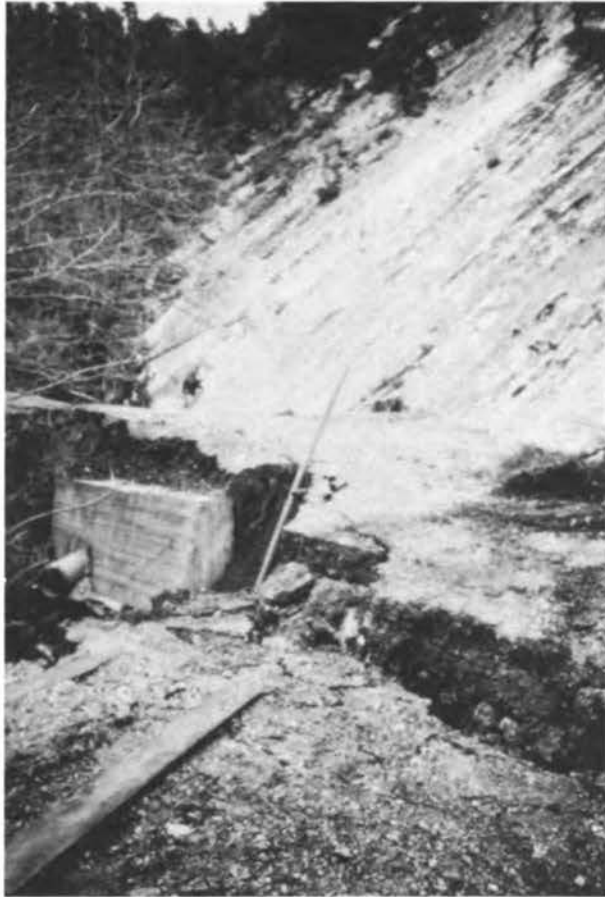
FIGURE 2.6 Ground rupture in alluvium near the base of a limestone fault surface on the Pisias trace.

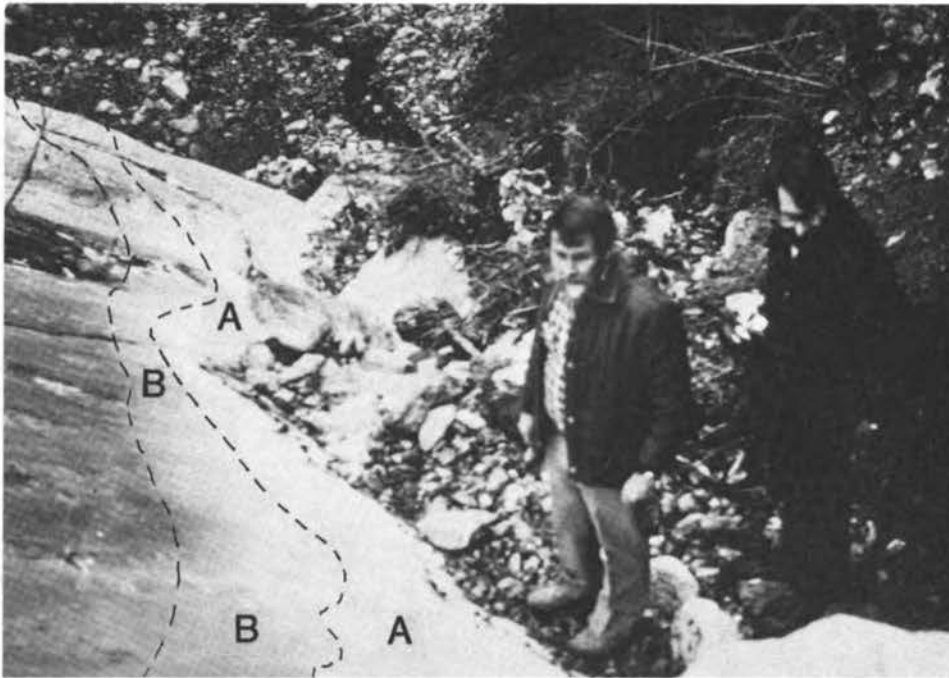
FIGURE 2.7 Dip-slip movement along the base of a limestone fault surface, Pisias trace, prior to the earthquakes of February 24 and 25. The formerly soil-covered part of the rock face is labeled "A." Weathering characteristics in area "B" indicate that at some time in the past the soil covered this area as well. This locality, then, records two recent episodes of surface rupture and dip-slip movement.

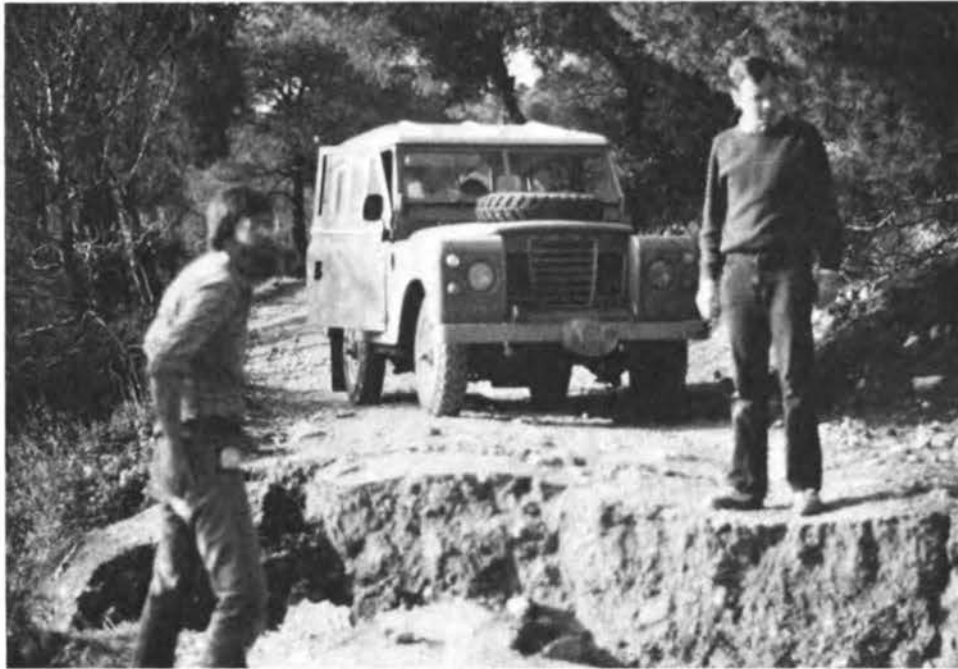
FIGURE 2.8 Vertical offset of road in the central part of the Kalamaki rupture trace.

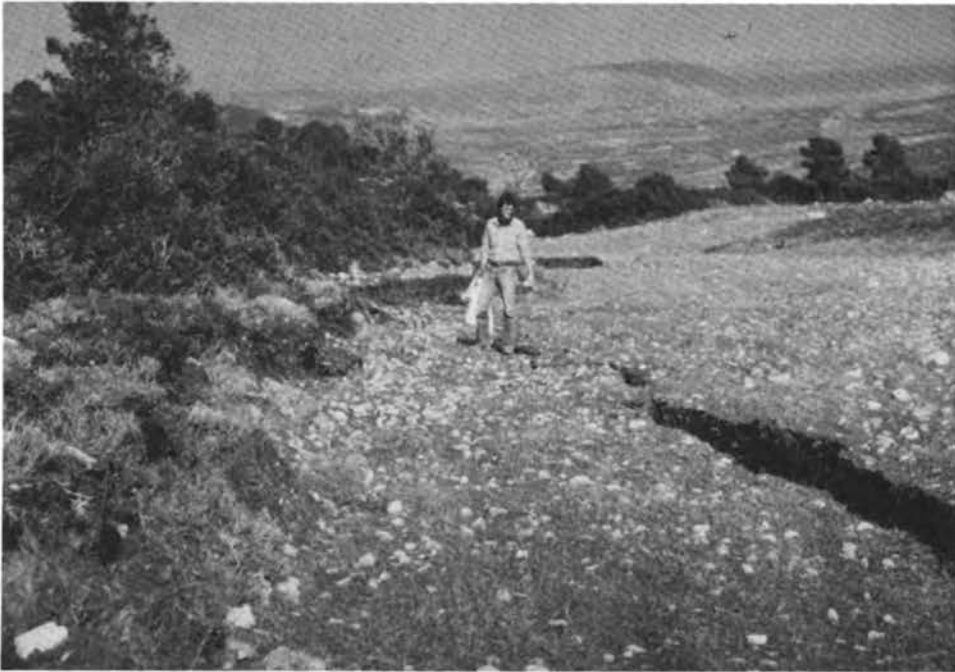
FIGURE 2.9 Eastern end of the Kalamaki trace at the location where ground motion was observed during a magnitude 5.7 earthquake on March 7, 1981. The main rupture trace is on left side of the photograph. The smaller rupture on the right is a secondary, near-surface cantilever failure in the soil, which appeared several days after the original surface break. This pattern is analogous to the relation between the southern and northern earthquakes and surface ruptures.

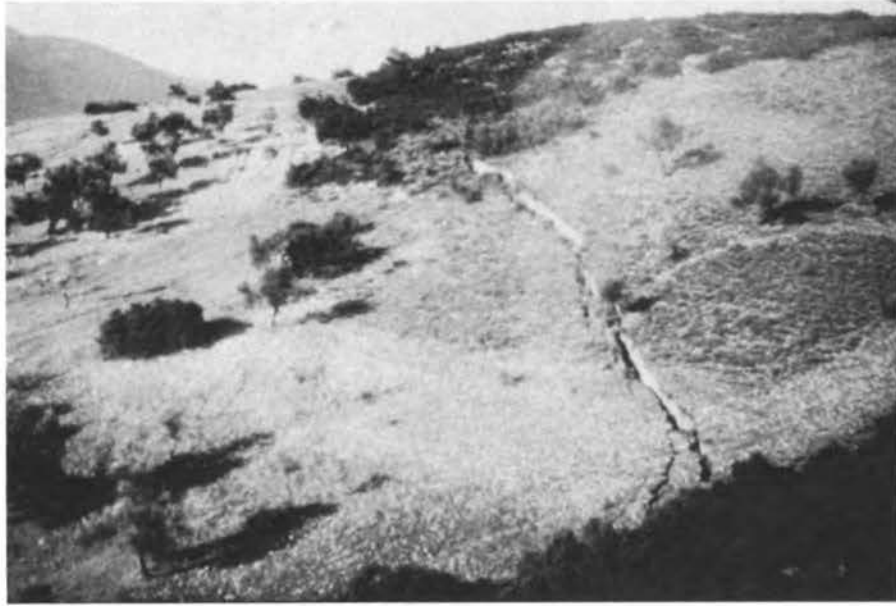
FIGURE 2.10 Ground rupture along the western end of the Kapareli trace, looking west. The average displacement is about 1 m.

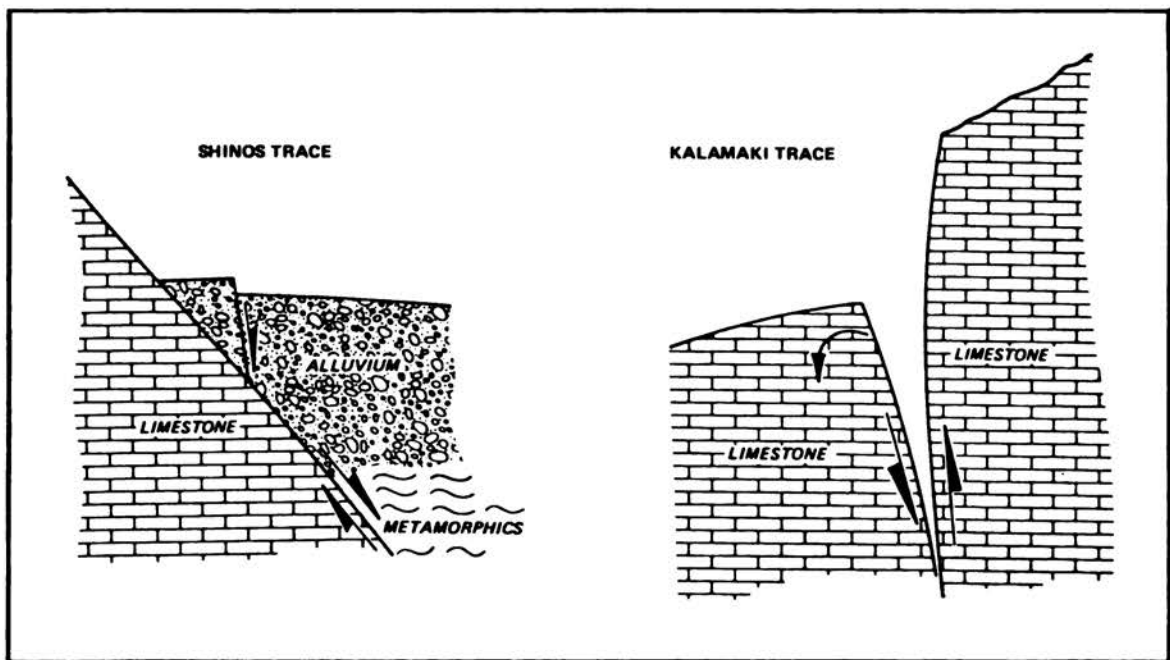
FIGURE 2.11 Close-up schematic cross section illustrating differences in the style of offset between the Shinos/Pisia and Kalamaki/Kapareli traces.

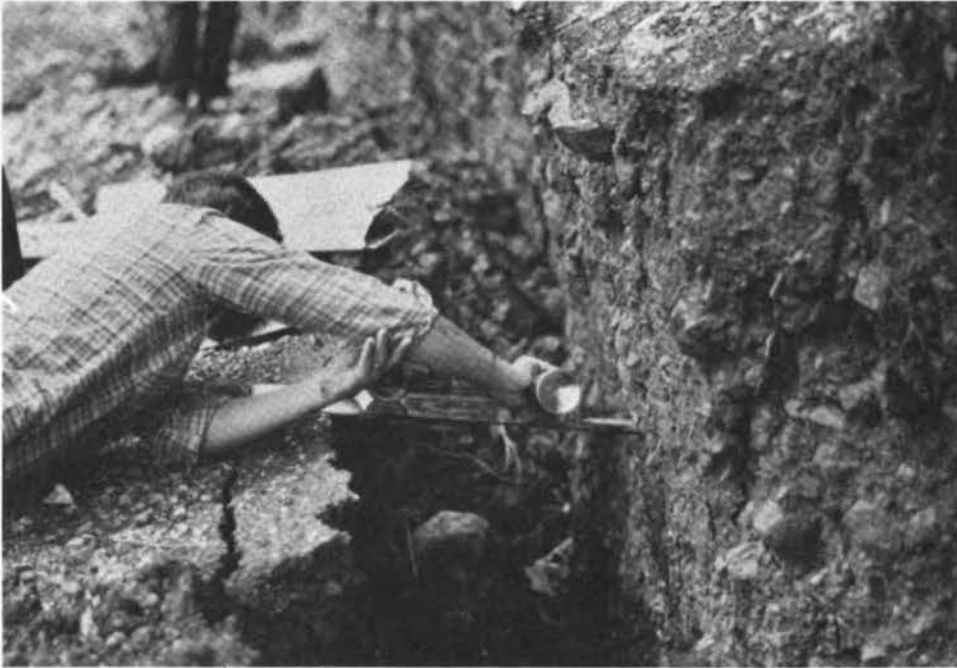
FIGURE 2.12 Typical ground rupture along the Kalamaki and Kapareli traces. At this location there were 60 cm of dip-slip displacement and 50 cm of rotational "opening" displacement.

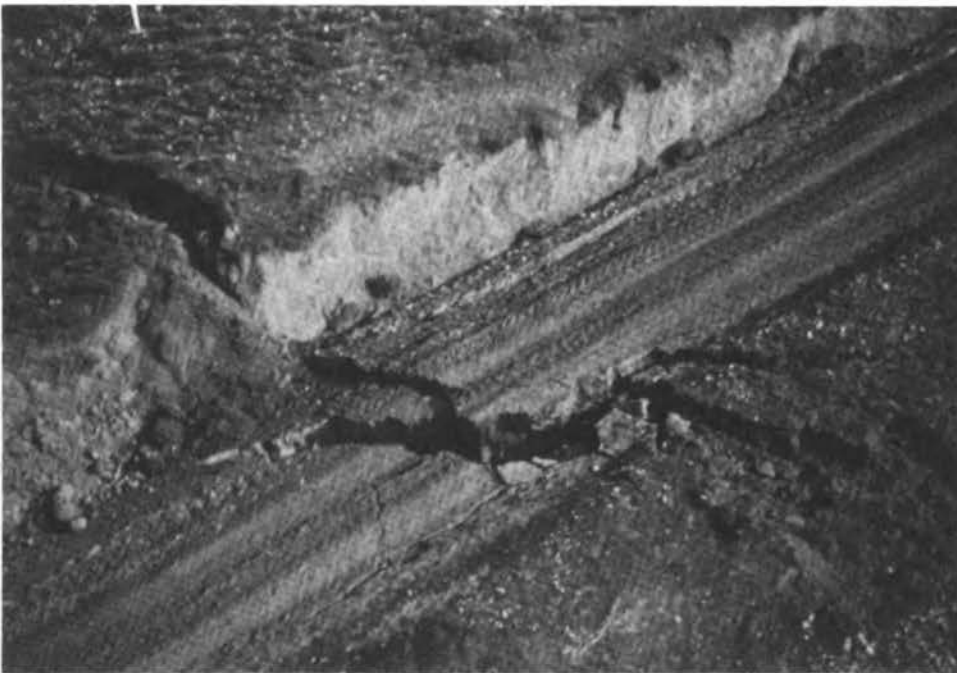
FIGURE 2.13 Part of the Kapareli surface rupture, showing combination of dip-slip and rotational "opening" displacement. In this case the opening displacement exceeded the dip-slip component.

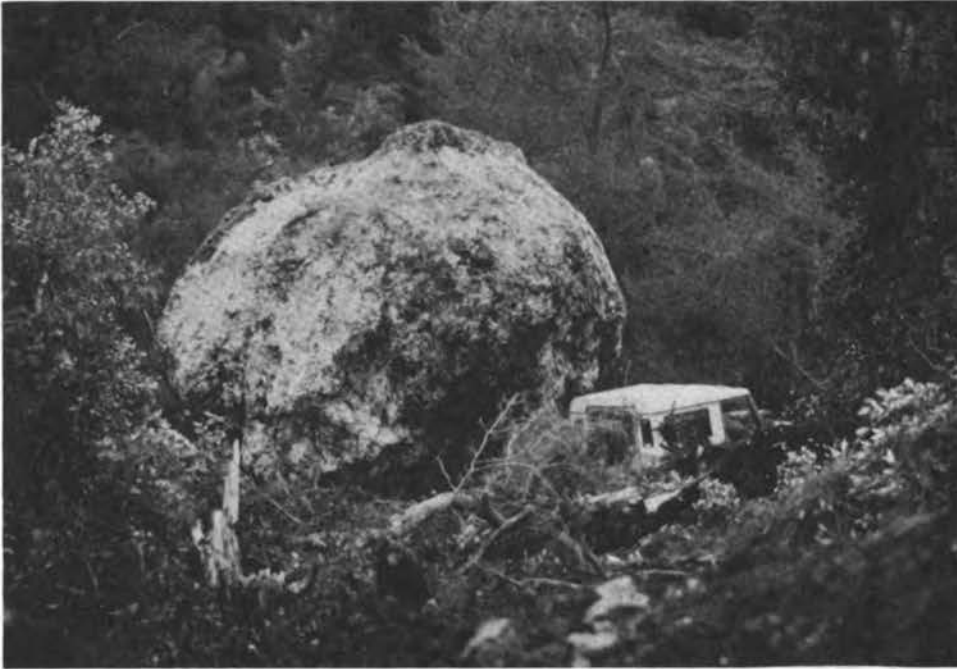
FIGURE 2.14 Large boulder heaved from the side of the mountain south of Shinos. This photograph was taken standing uphill within the swath cut by the rolling, bouncing rock.

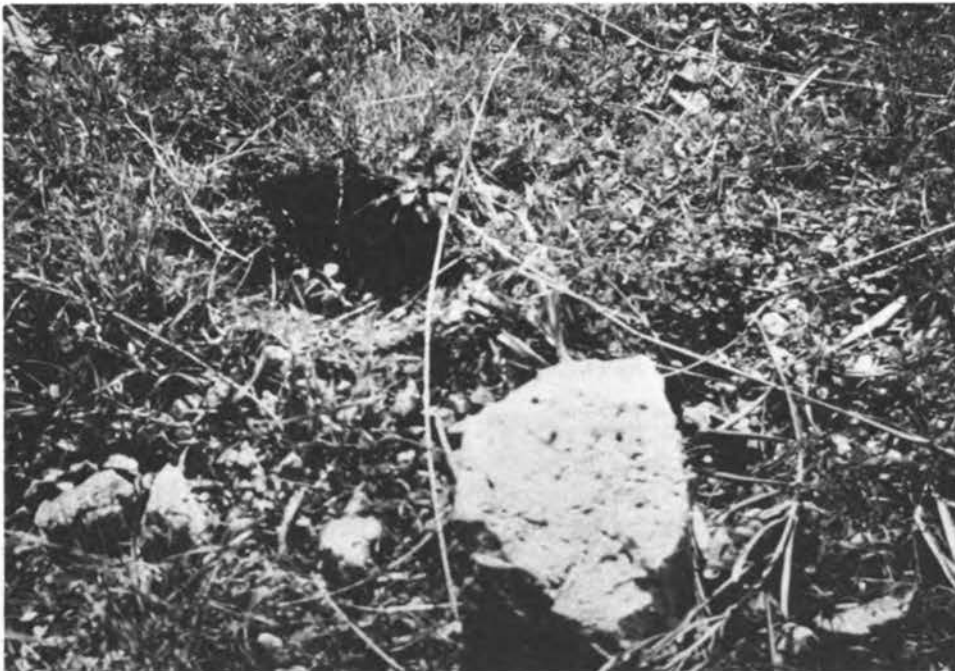
FIGURE 2.15 Typical "flipped" rock around the Kapareli and Kalamaki rupture traces. This phenomenon indicates near-field vertical acceleration of over 1.0 g during the March 4 earthquake (magnitude 6.2).

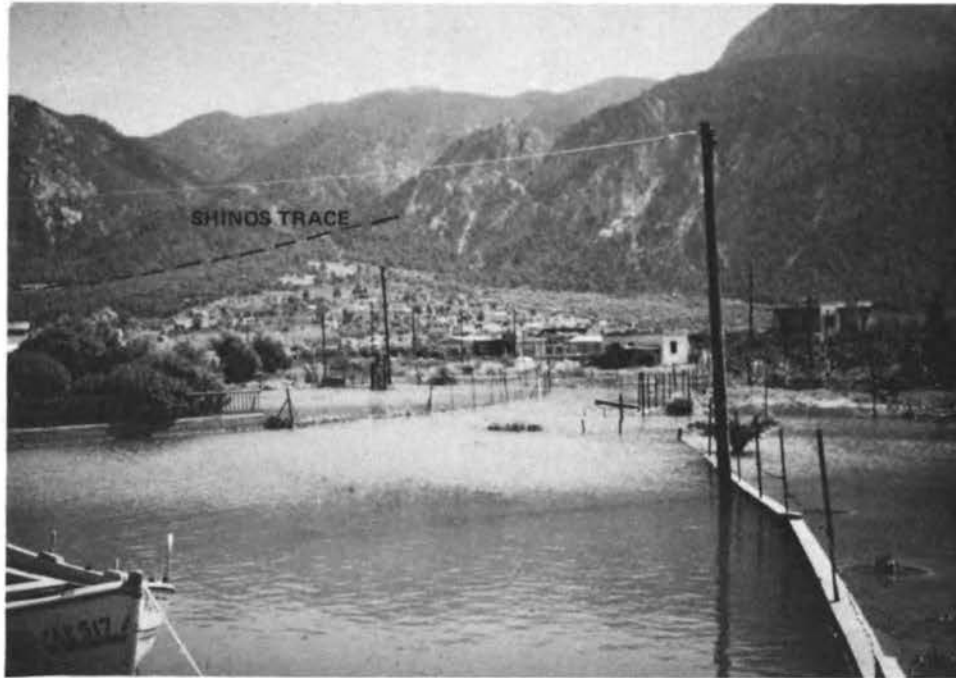
FIGURE 2.16 Subsidence of the ground surface north of the Shinos trace (looking south). A segment of the Shinos trace is shown where it crosses a large alluvial fan.

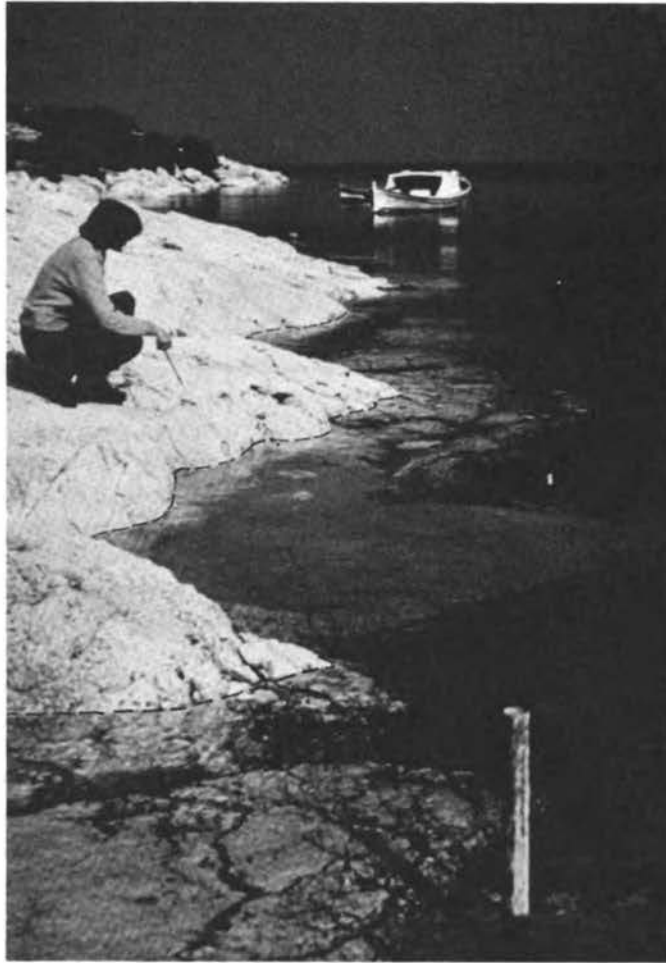
FIGURE 2.17 Submerged concrete docks north of Shinos. The dotted line indicates the present water level. At this site over 1.0 m of subsidence was documented associated with the earthquakes of February 24 and 25, 1981.

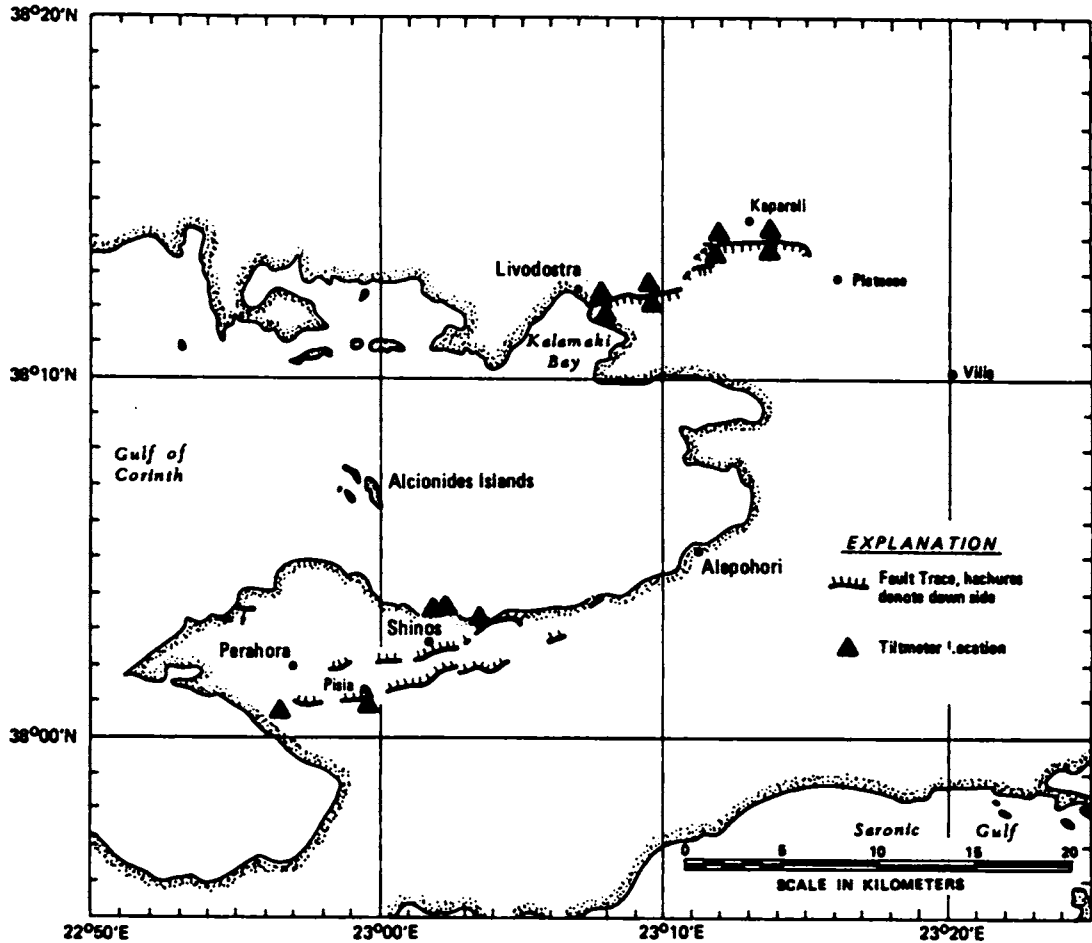
FIGURE 2.18 Location of tiltmeter plates.

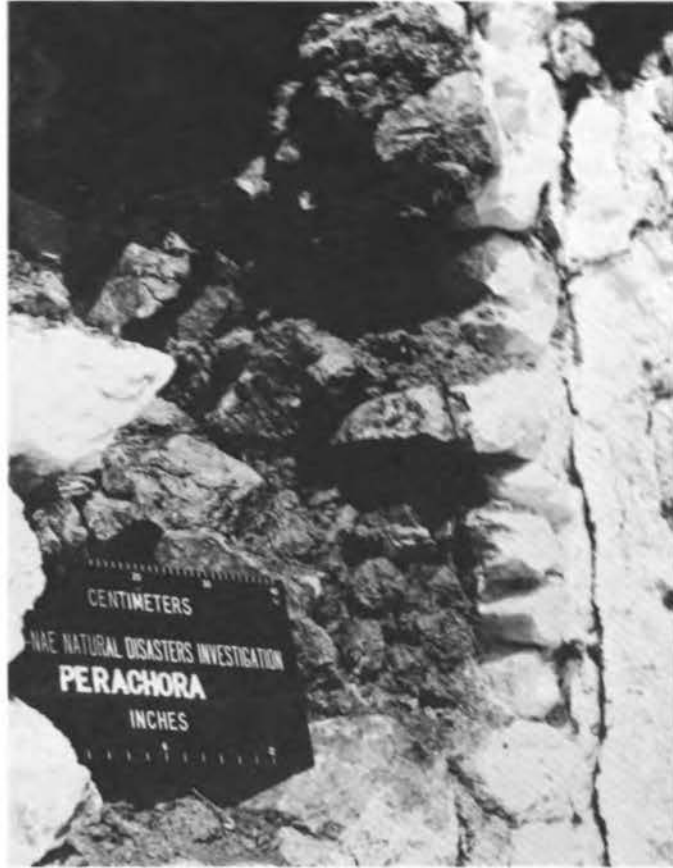
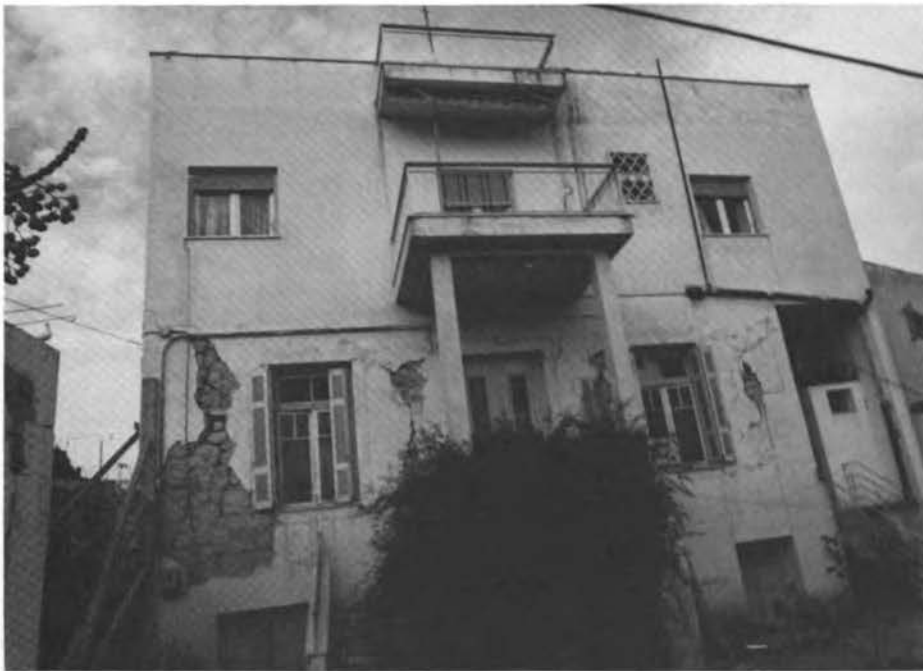
FIGURE 4.4 Additions are very vulnerable, as in this case in Megara. Usually the old building (the lower one) suffers most of the damage.

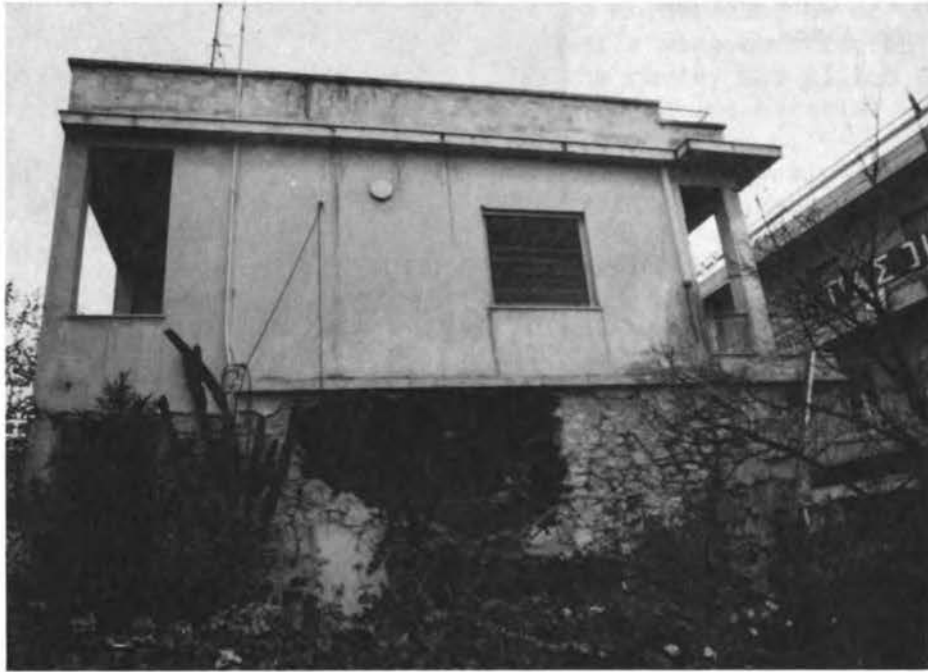
FIGURE 4.5 Addition to an existing stone masonry building (Megara).

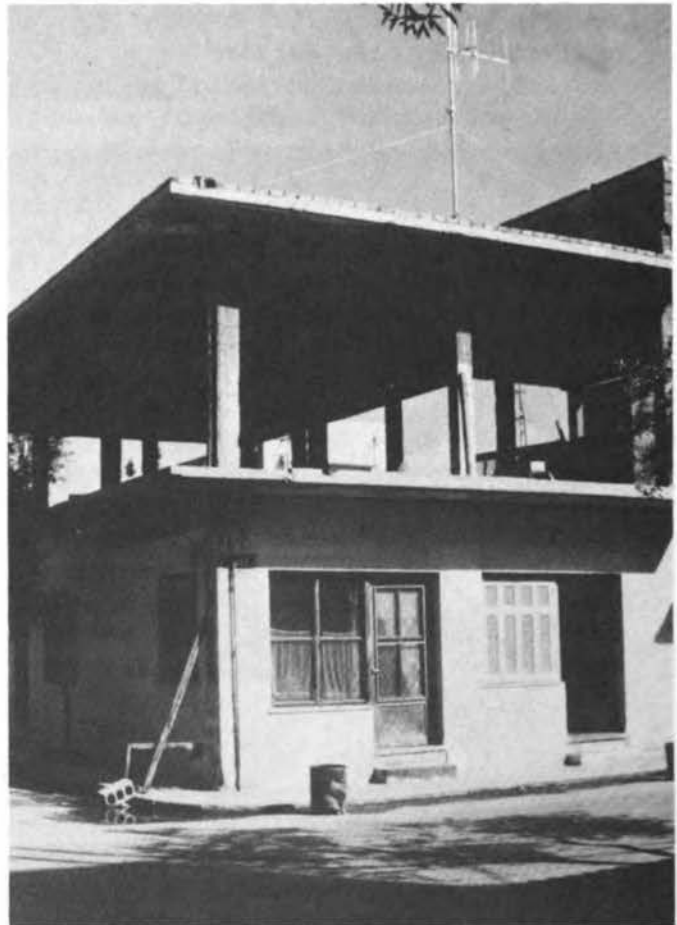
FIGURE 4.6 House with upper floor added.

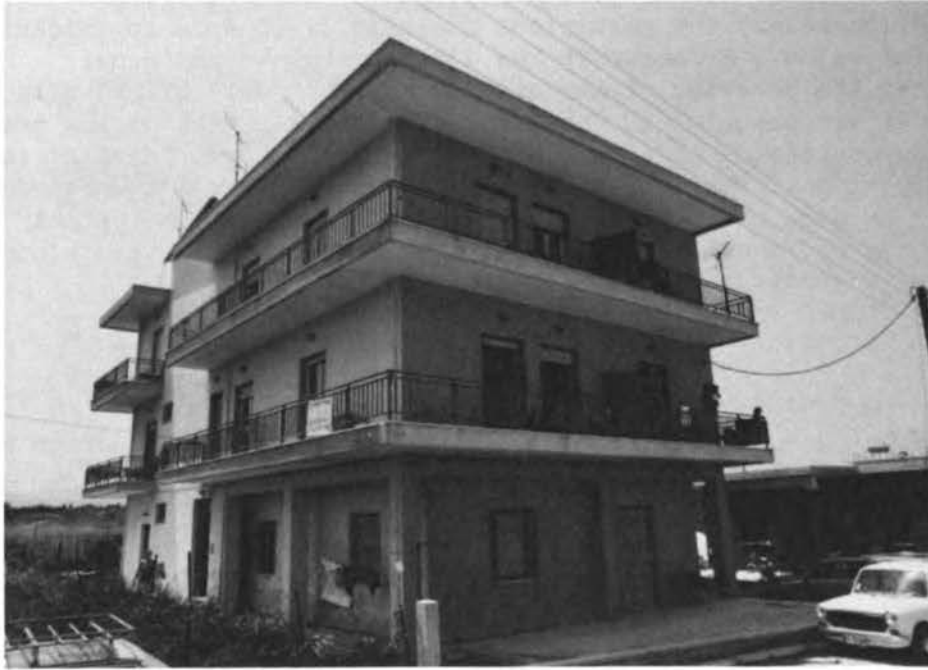
FIGURE 4.7 Undamaged building in Vrahati, founded on silty soil and mud. There is a small brook at left. The building is an addition to an old one in height and length. The old one is made of very good quality concrete blocks, produced locally by the owner. The mortar used for the masonry of these concrete blocks is cement and sand.

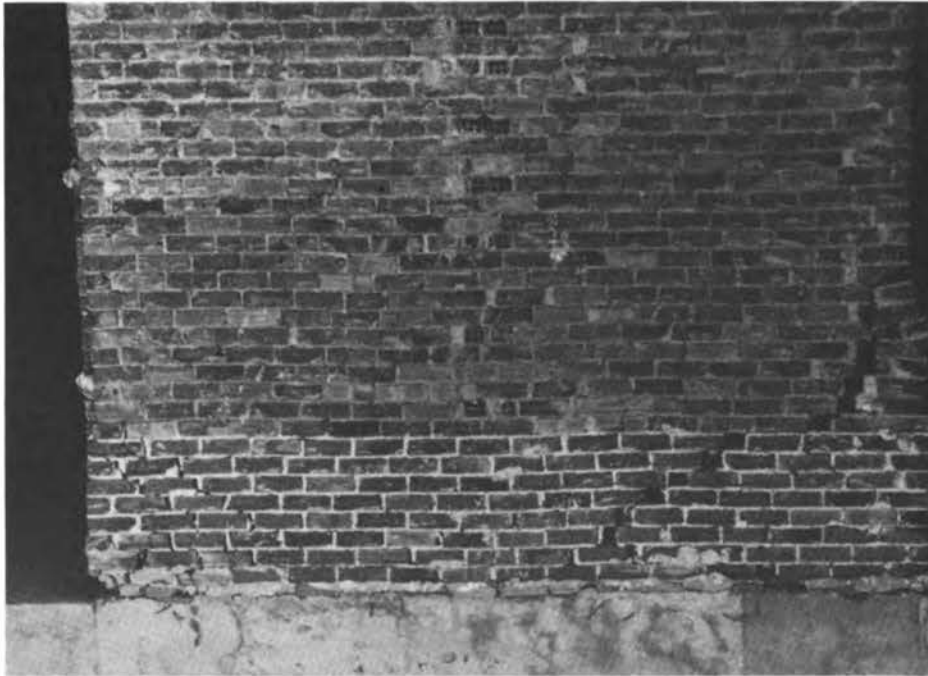
FIGURE 4.8 Solid-brick wall.

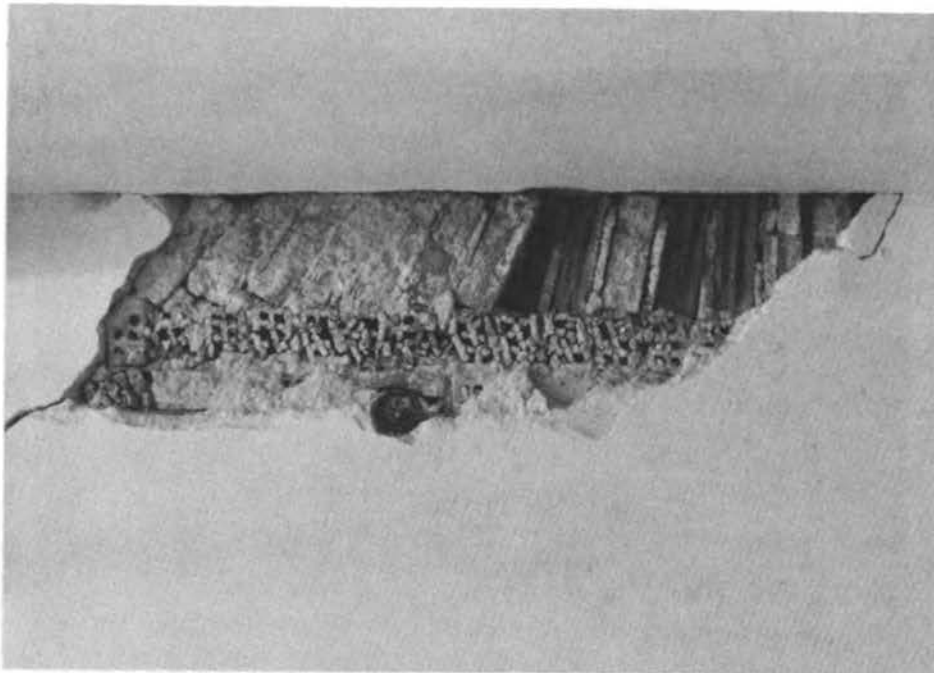
FIGURE 4.12 Detail of failure shown in Figure 4.11. Typical practice calls for the inclined bricks to be wedged under the ceiling beam. The underlying row of bricks are crushed.

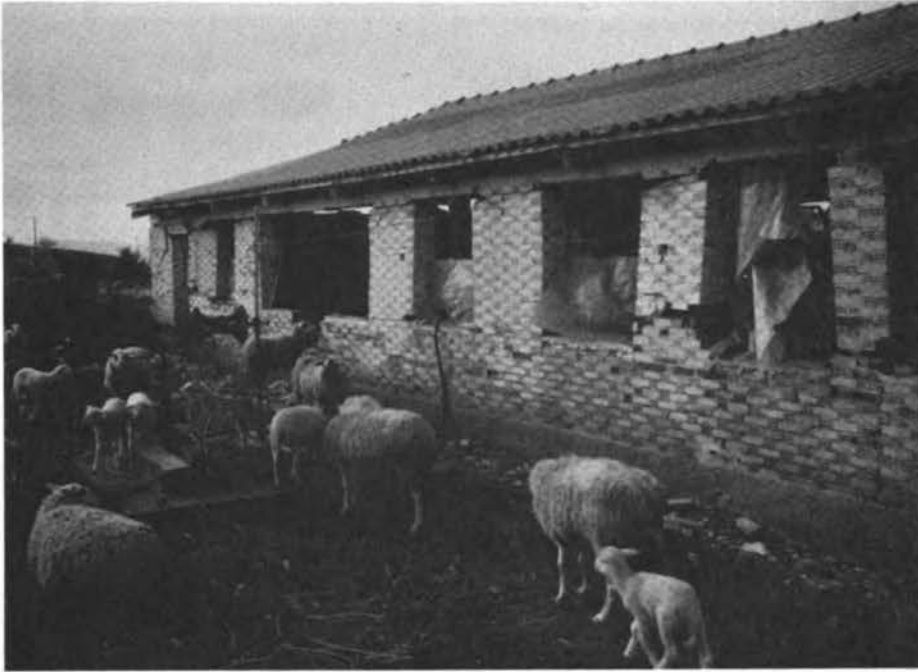
FIGURE 4.13 Farm building of block construction with light metal roof.

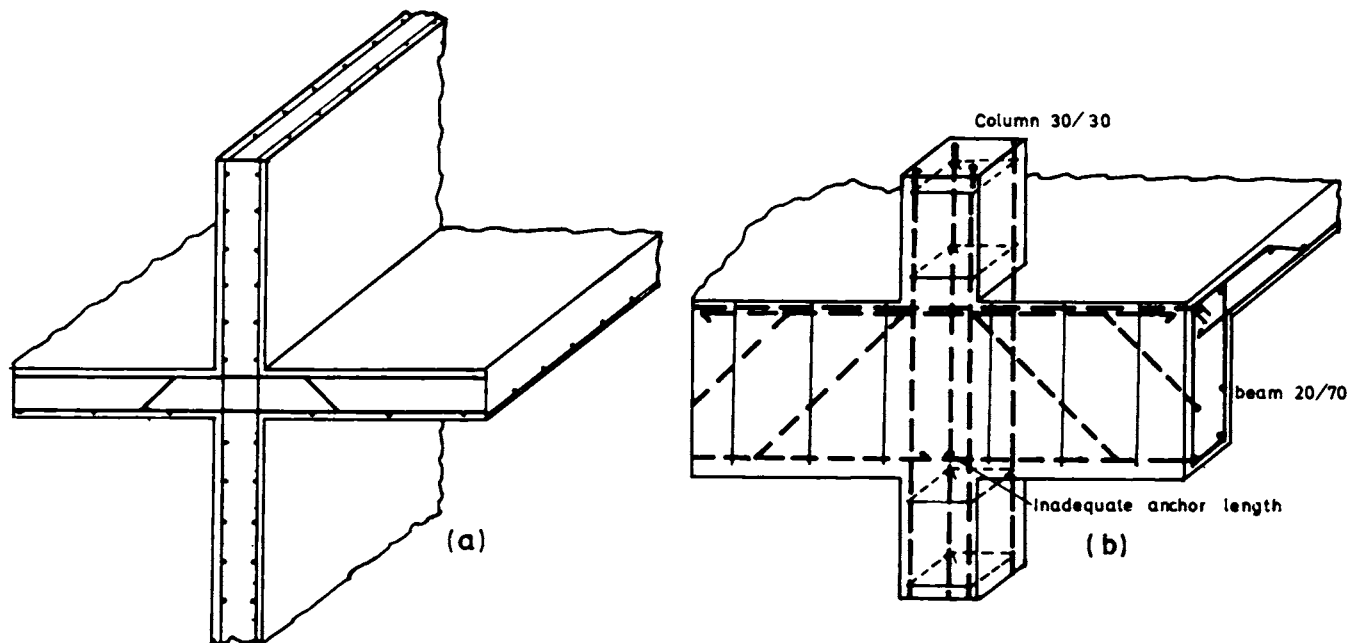
FIGURE 4.14 Typical joint between vertical and horizontal elements as usually constructed in the area. (a) Wall-slab joint. The bottom reinforcement is insufficient to resist the positive moment at the support produced by lateral forces. (b) Column-beam joint. The anchor length is inadequate because the bottom bars are not continuous through the joint.

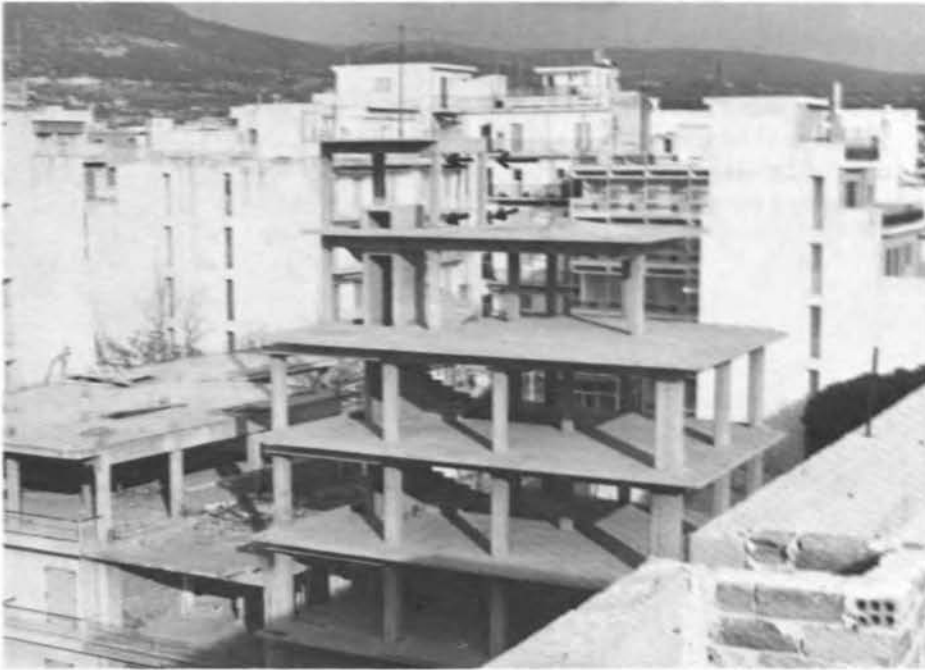
FIGURE 4.15 Eccentrically located walls in reinforced concrete frame under construction. This is a typical example of a drastic change in the plan area in a penthouse. Collapses of such penthouses were reported.

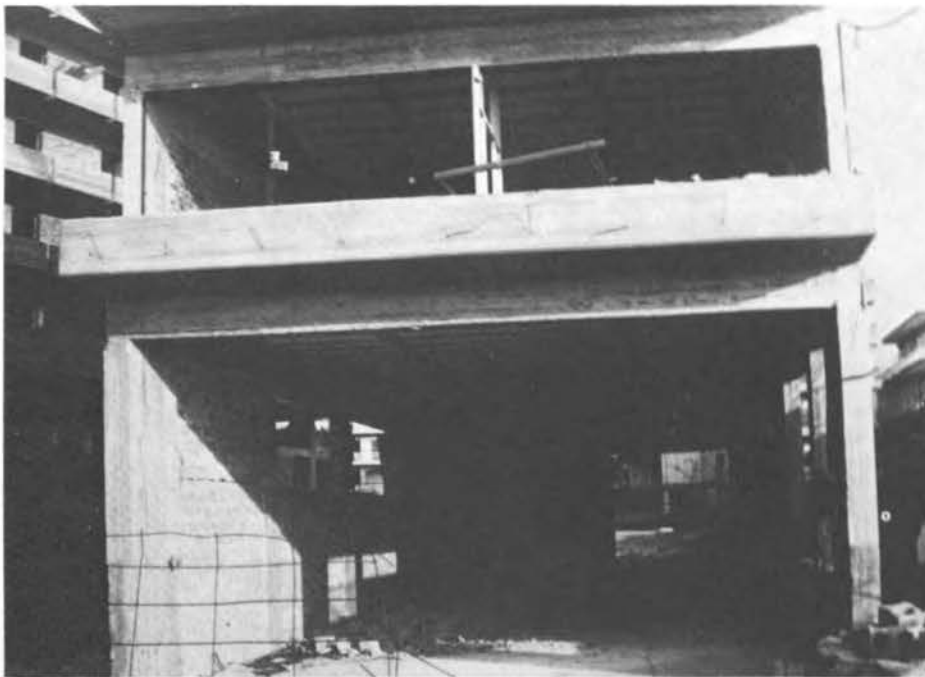
FIGURE 4.16 Difference in stiffness of framing and walls in orthogonal directions. The first story is flexible in one direction.
