The Central Greece Earthquakes of February-March 1981: A Reconnaissance and Engineering Report (1982)

Size
8.5 x 10

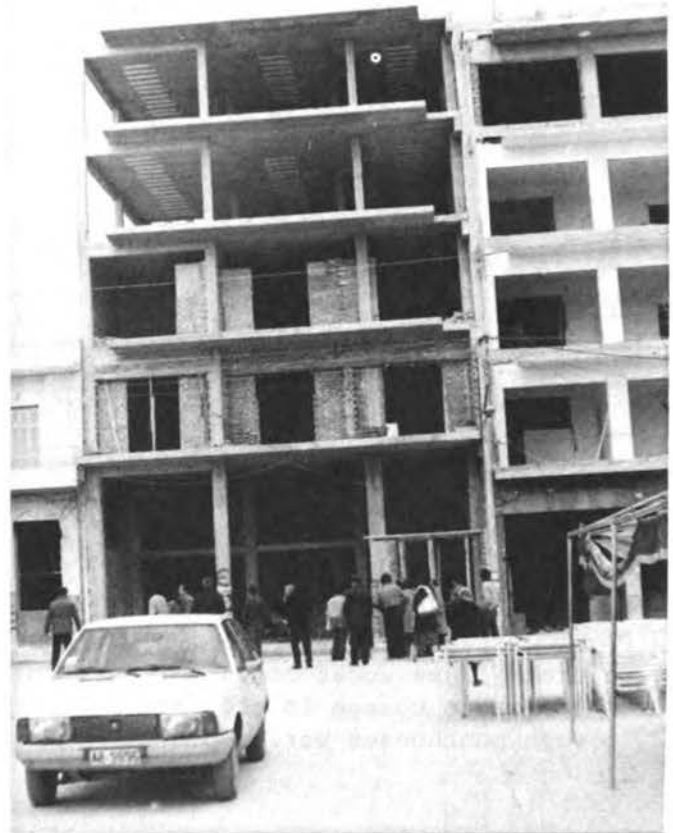
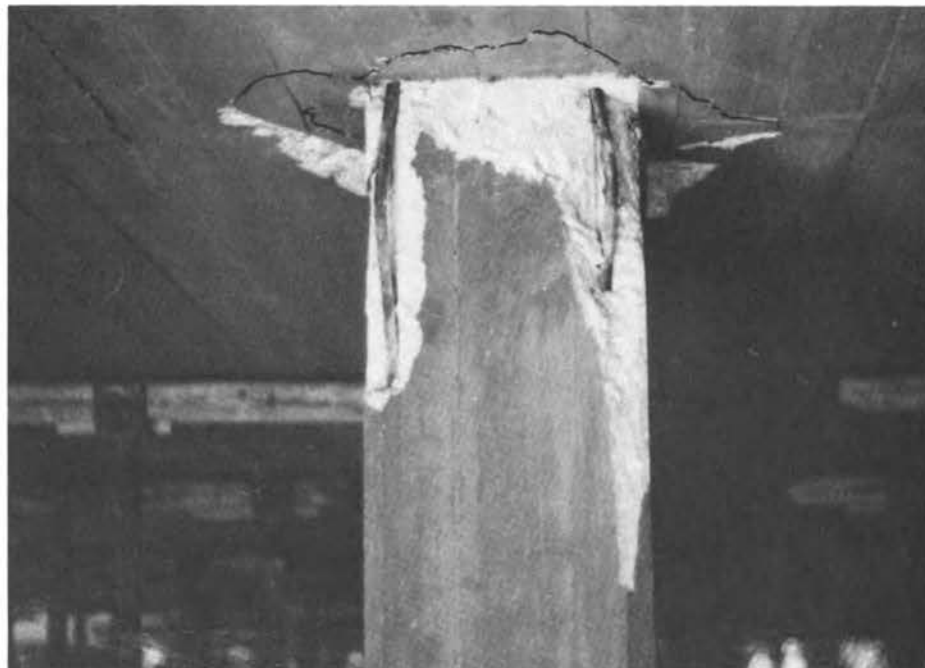
FIGURE 4.18 Typical damage of column-to-slab connections. This shows detail of damage to the building on the left in Figure 4.17.

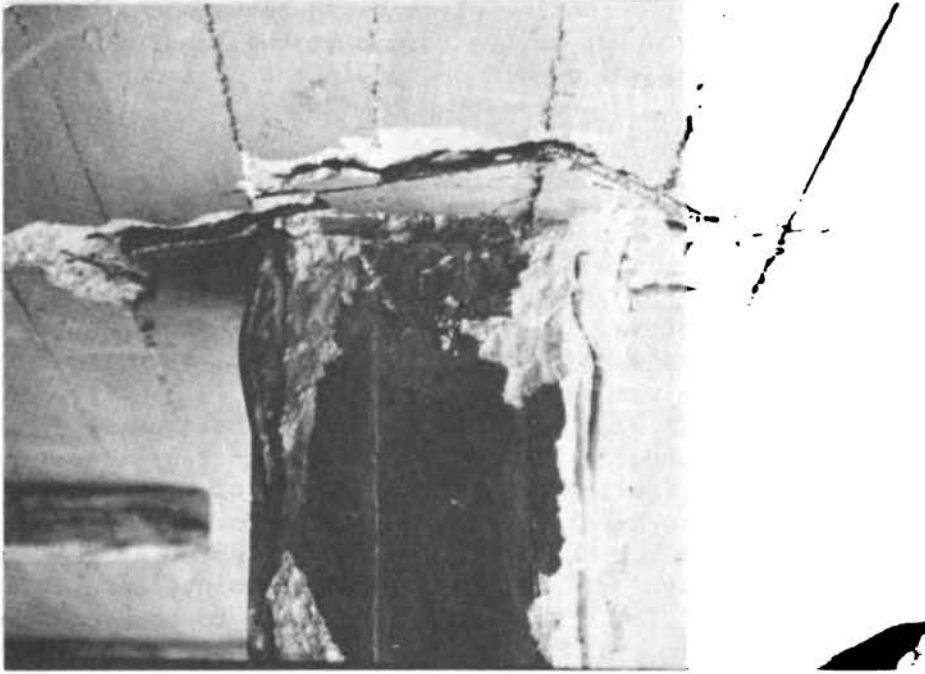
FIGURE 4.19 Typical damage of column-to-slab connections. A steel plate has been fixed at the top of the column to add support.

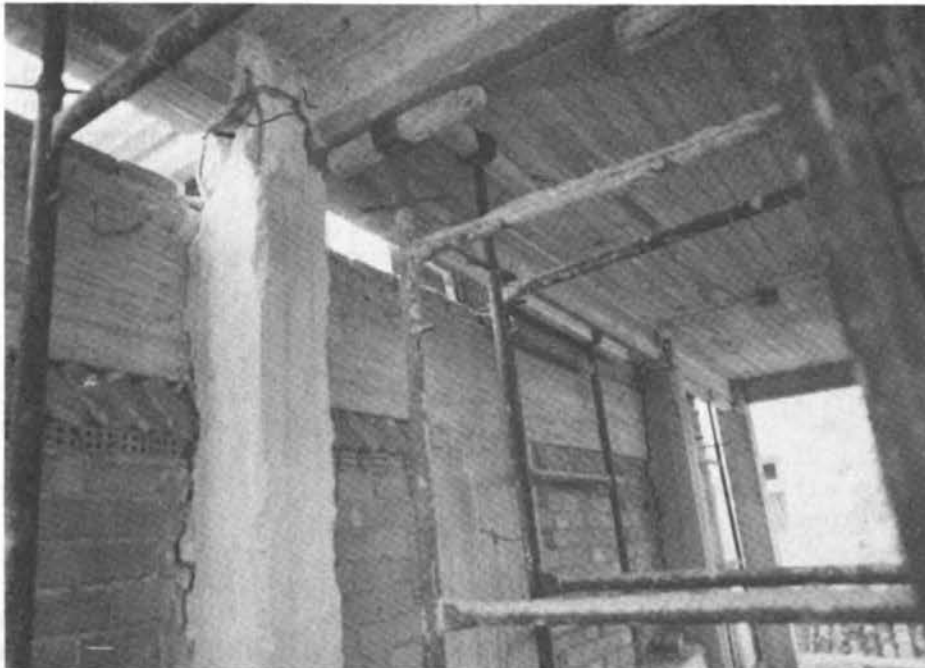
FIGURE 4.20 Hammer effect between two adjacent buildings not separated in Megara.

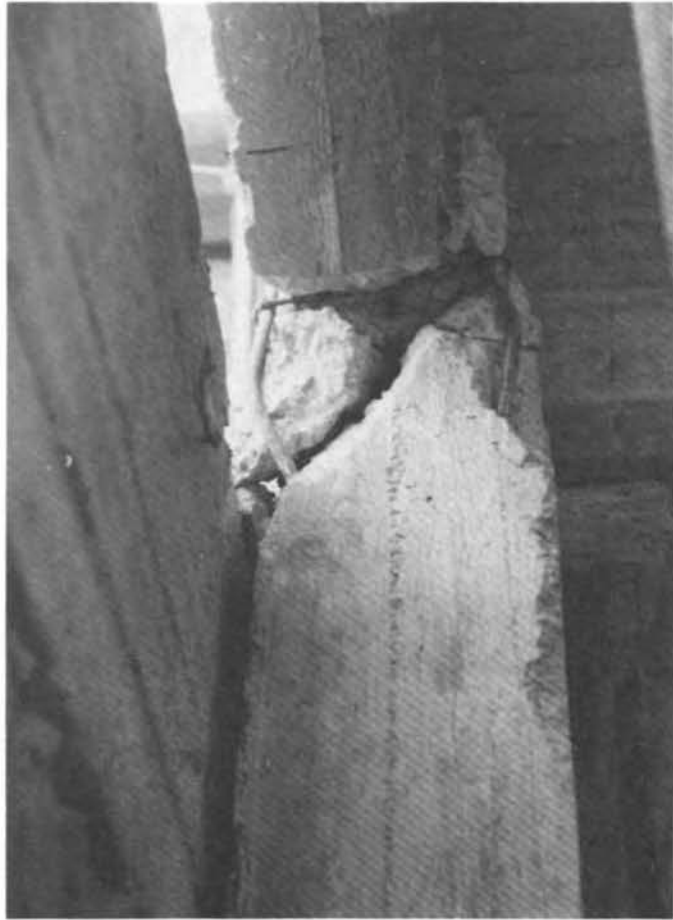
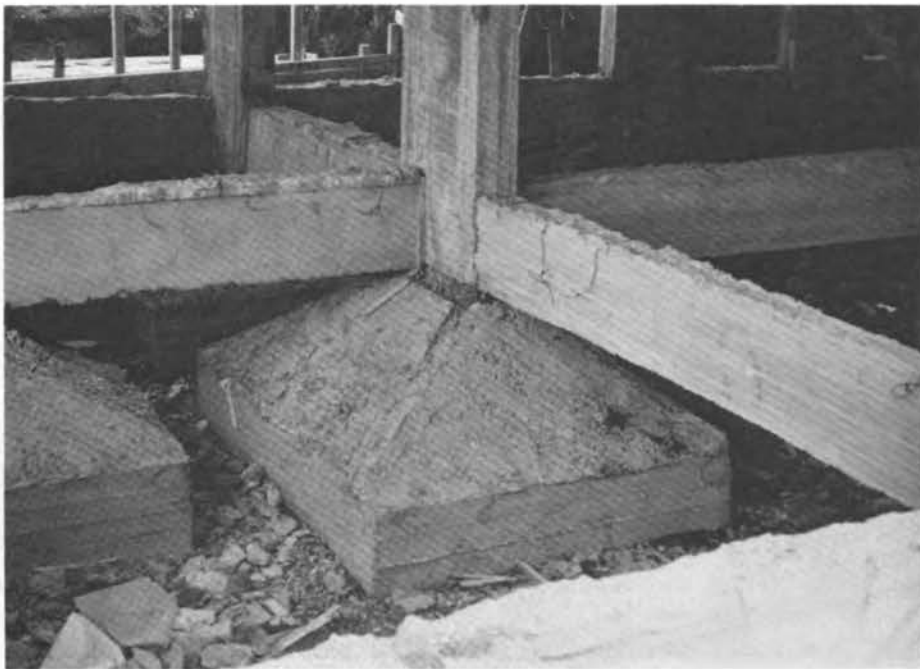
FIGURE 4.22 Spread footings with grade beams.

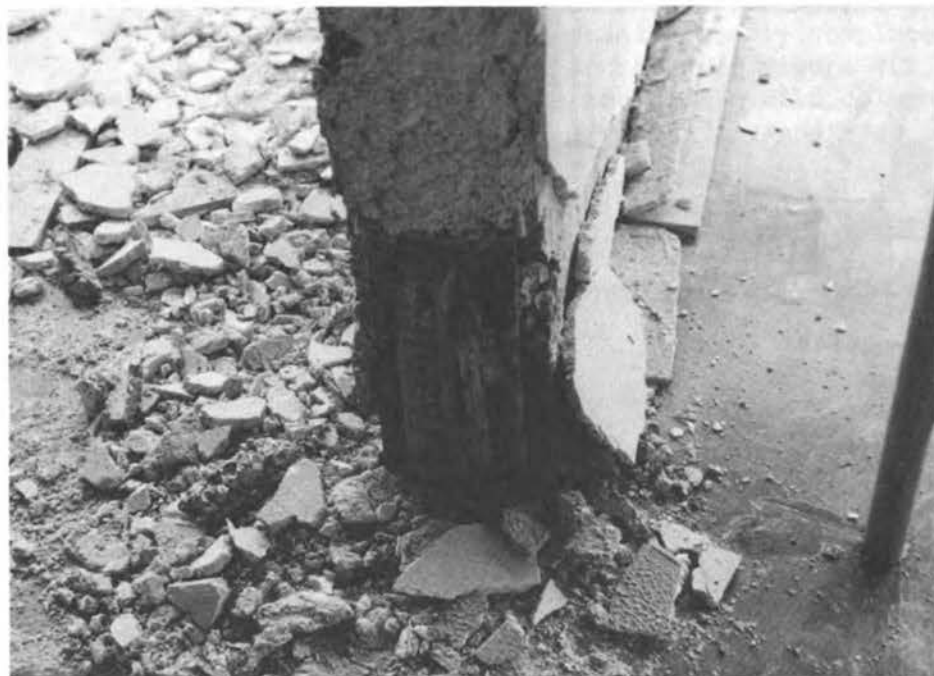
FIGURE 4.24 Poor detailing--too many steel bars appear in the lower part of the column. Most of the bars are from the lower story. The hooks opened and initiated the damage.

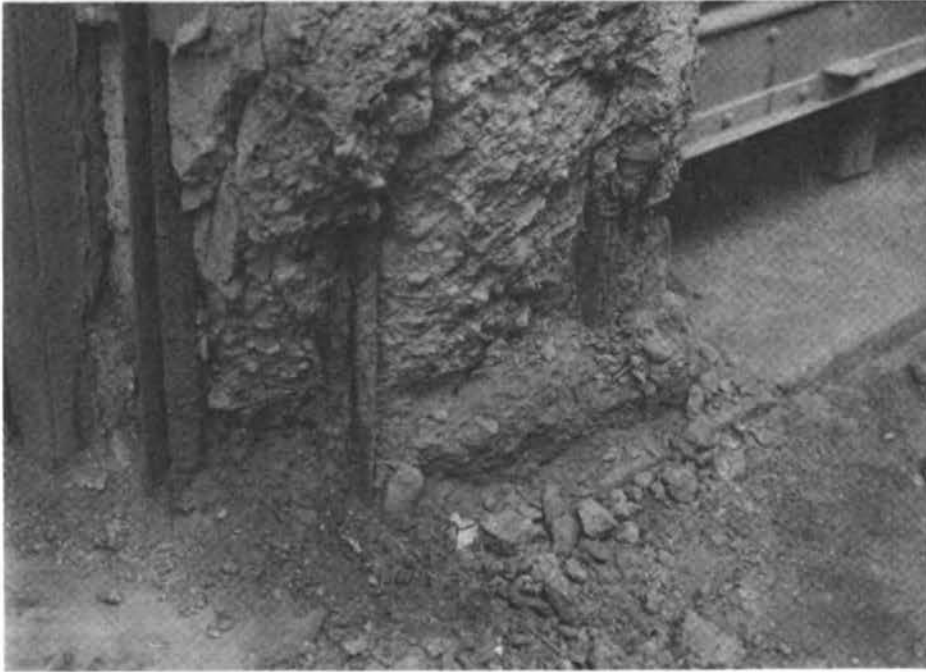
FIGURE 4.25 Nearly complete rusting of reinforcing steel bars at the bottom of a column, due to poor concrete quality.

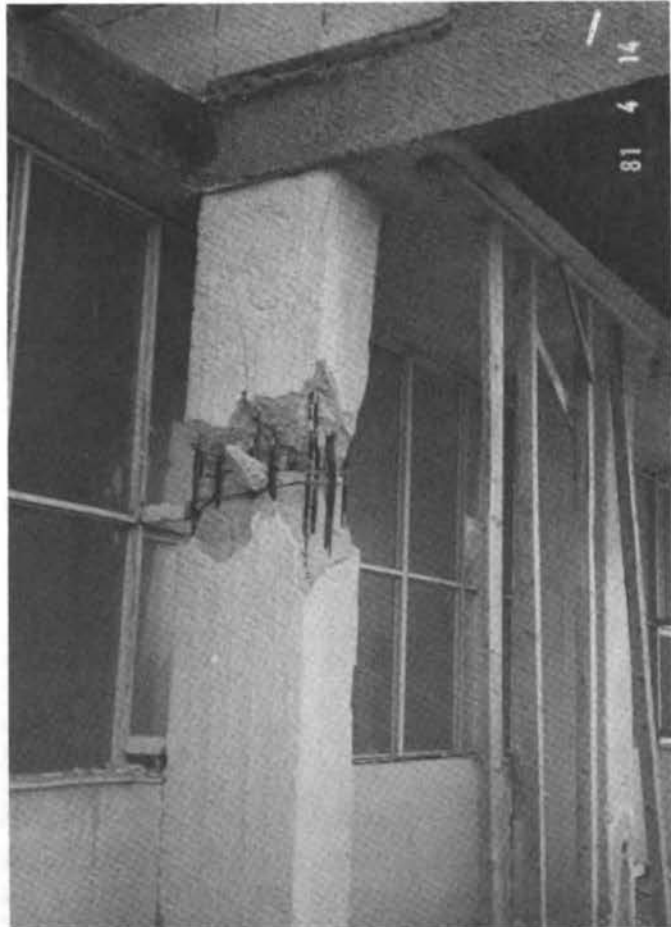
FIGURE 4.26 Typical case of damage to construction joint in the block of flats in Loutraki. Various kinds of rubbish were found in these joints in addition to steel and concrete.

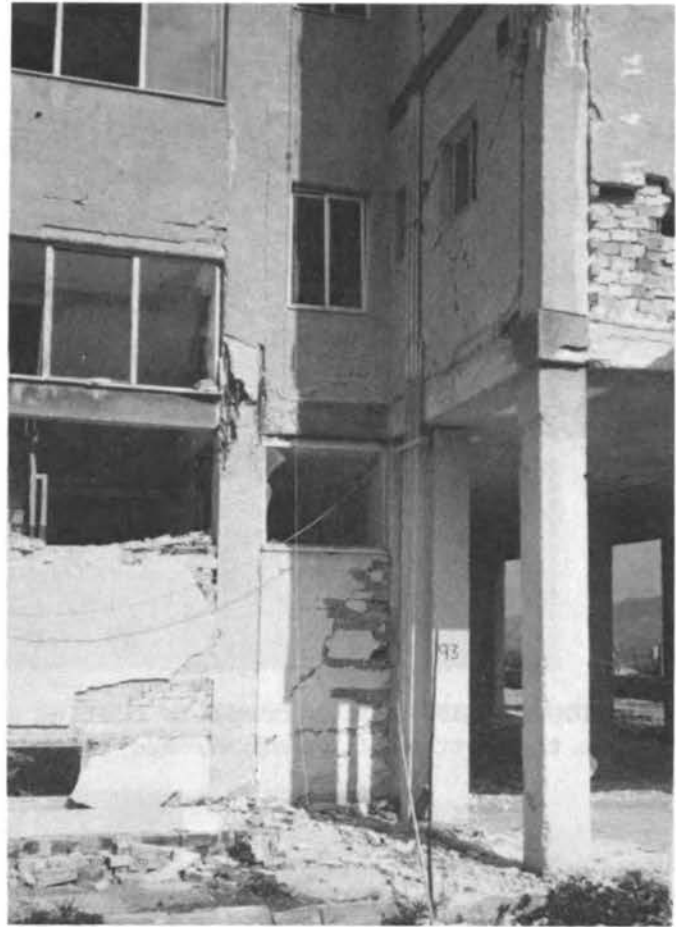
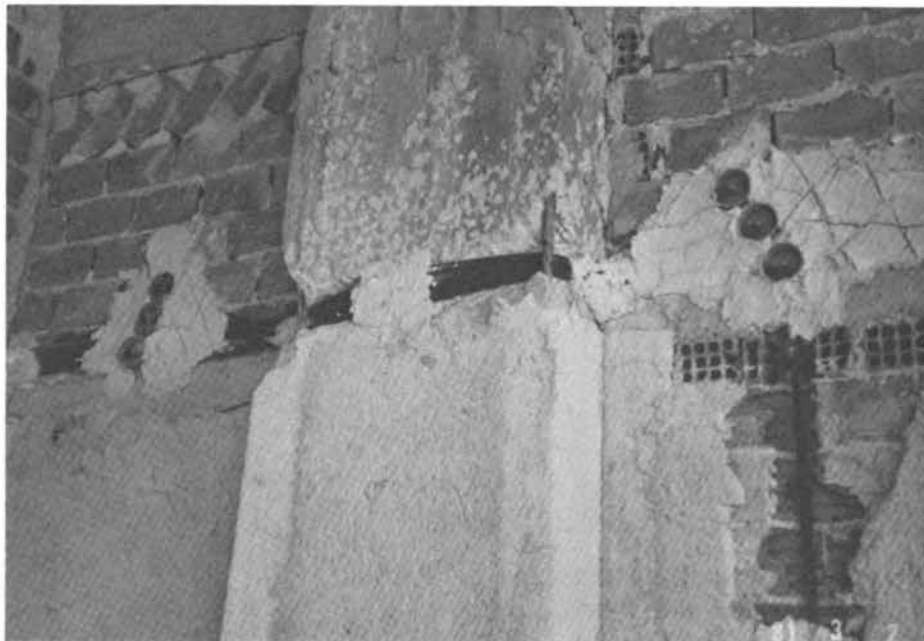
FIGURE 4.28 Conduits for electric cables pass through the column just inside the reinforcing bars and along the brick walls through channels chipped into the column and walls.

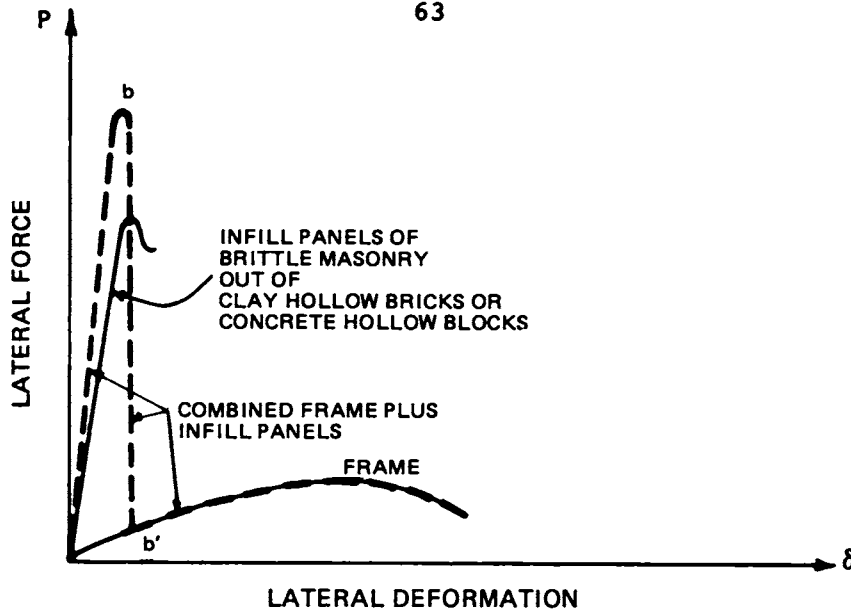
FIGURE 4.29 A combined reinforced concrete flexible frame plus brittle infill panels produces a stiff and brittle structure.

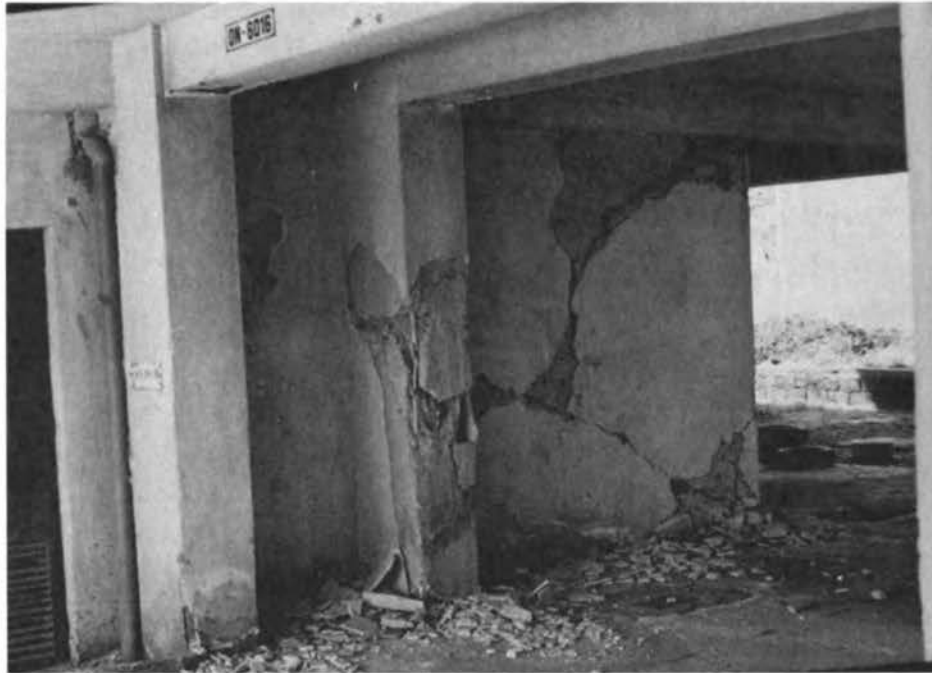
FIGURE 4.30 Typical shear failure of reinforced concrete column confined by a brick wall. The rupture of the masonry extends through the column.

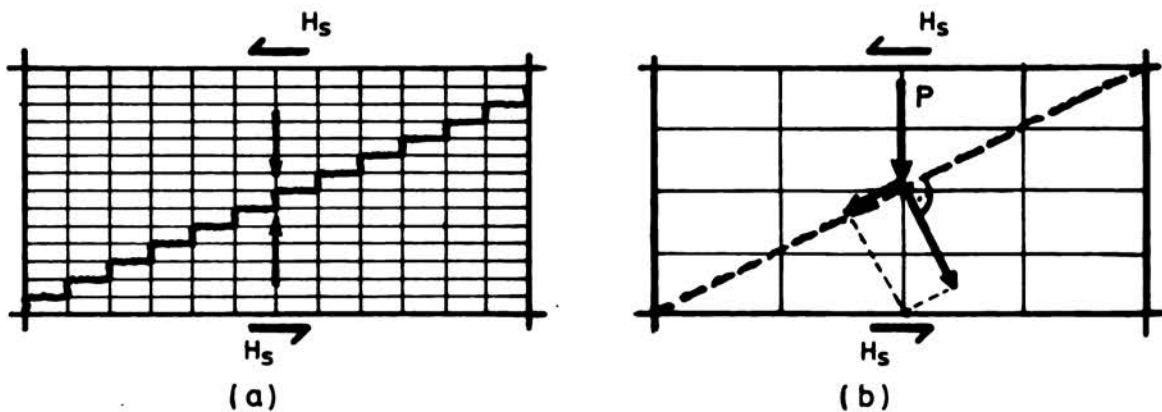
FIGURE 4.31 Infill panels with (a) small-sized good-quality bricks or concrete blocks, with cracks in joints (vertical loading transmitted to foundation), and (b) large and/or poor-quality bricks or concrete blocks, with diagonal cracks (vertical loading produces sliding forces).

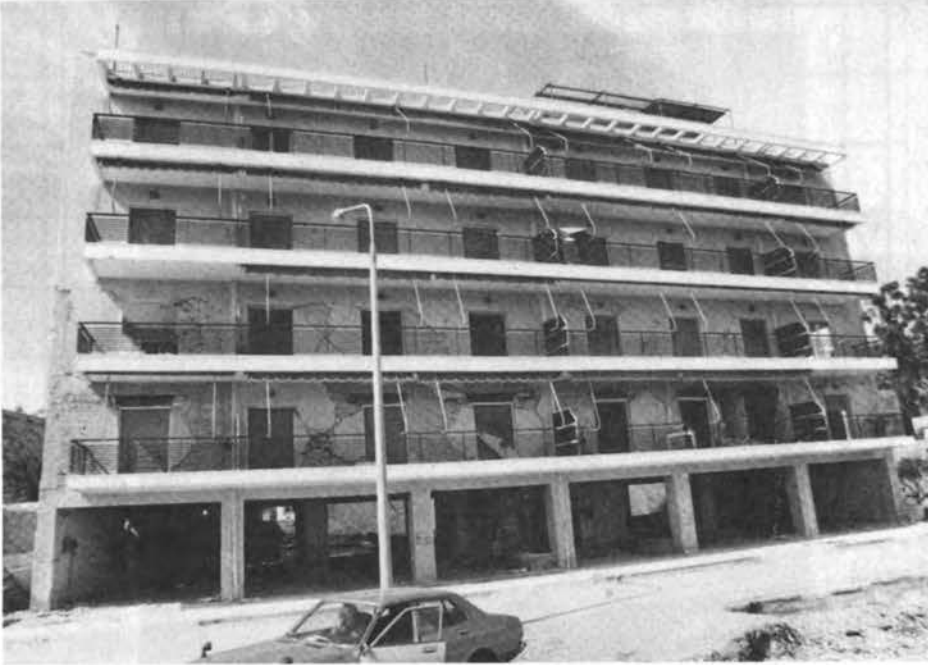
FIGURE 4.32 Typical apartment house with an open first story and no shear walls. The floor beams are flexible and the story heights are low.

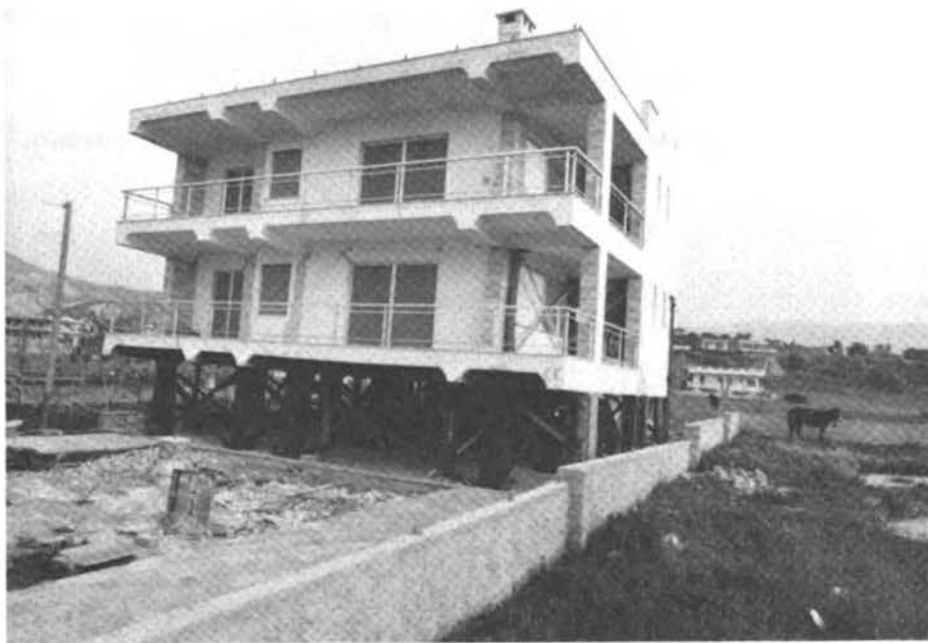
FIGURE 4.33 Modern resort apartment building in Alepohori with open first story. The damage was limited to the lower story. The heavy scaffolding (placed after the earthquake) consists of H-shaped steel beams.

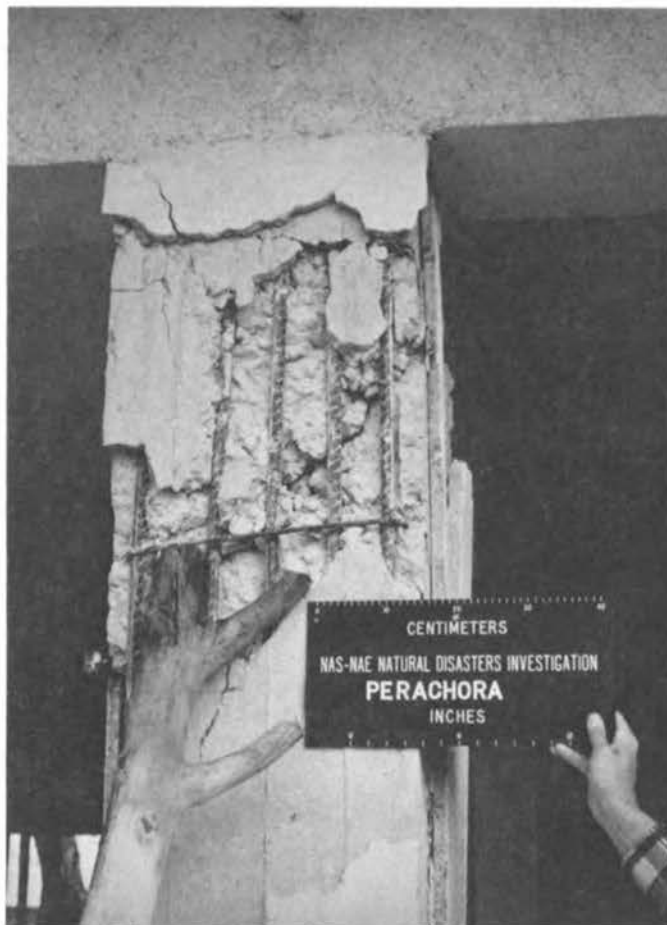
FIGURE 4.34 Column shear failure in first-floor column.

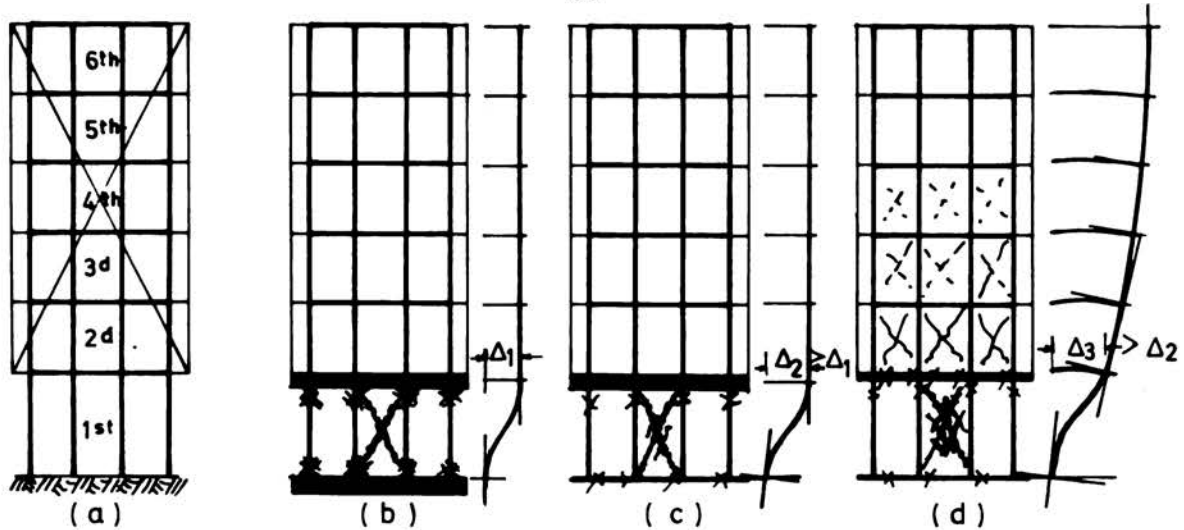
FIGURE 4.35 Typical deformation damage pattern of structures with flexible reinforced concrete frame, masonry infill panels, and an open first story: (a) elevation view; (b) strong top and bottom beams, with extended damages in the first story only; (c) strong top and weak bottom beams, with more damage in nonstructural elements and concrete walls, less damage in top parts of the columns of the first story only, and damage in the foundation; and (d) weak top and bottom beams, with more damage in nonstructural elements and concrete walls than in case (c), less damage in columns than in case (c), and extension of damage in upper stories.

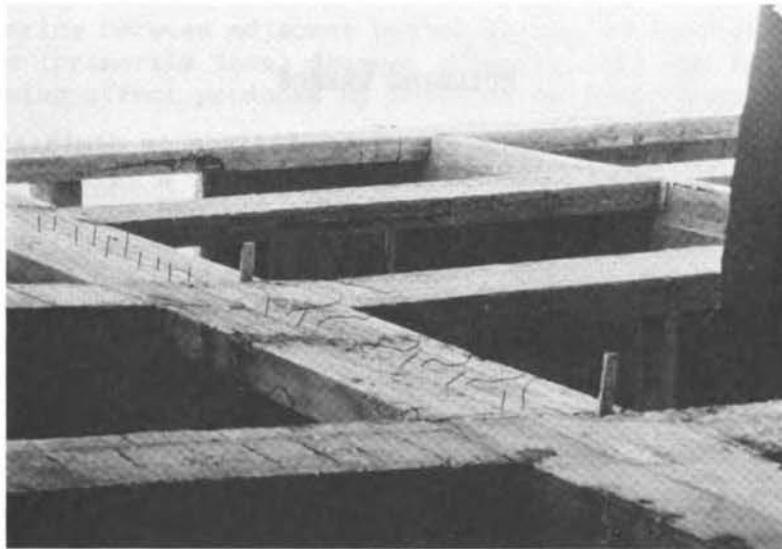
FIGURE 4.36 Poor construction quality in reinforced concrete frame. The columns run from lower right to upper left. The beams are roughly horizontal in this photograph.

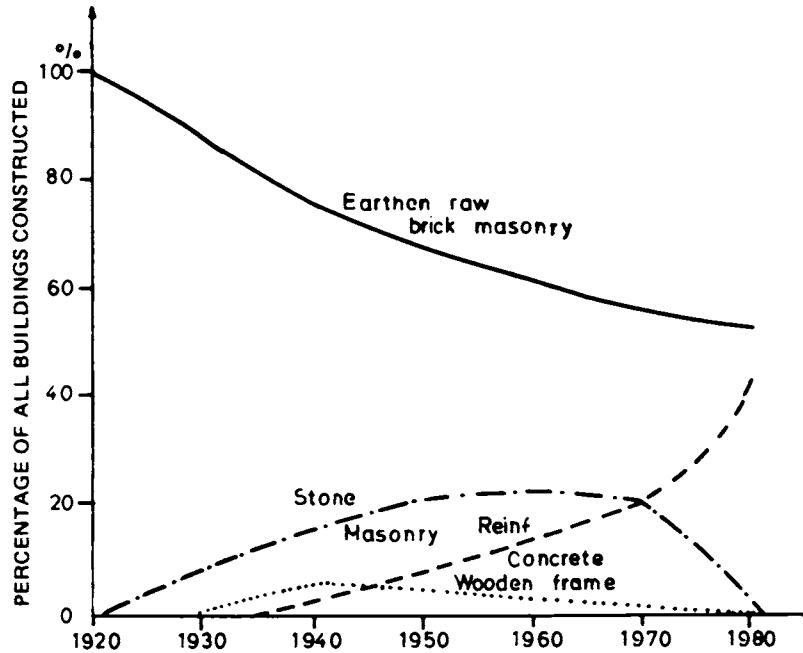
FIGURE 4.37 Statistics for the city of Kiato of various types of buildings since 1920.

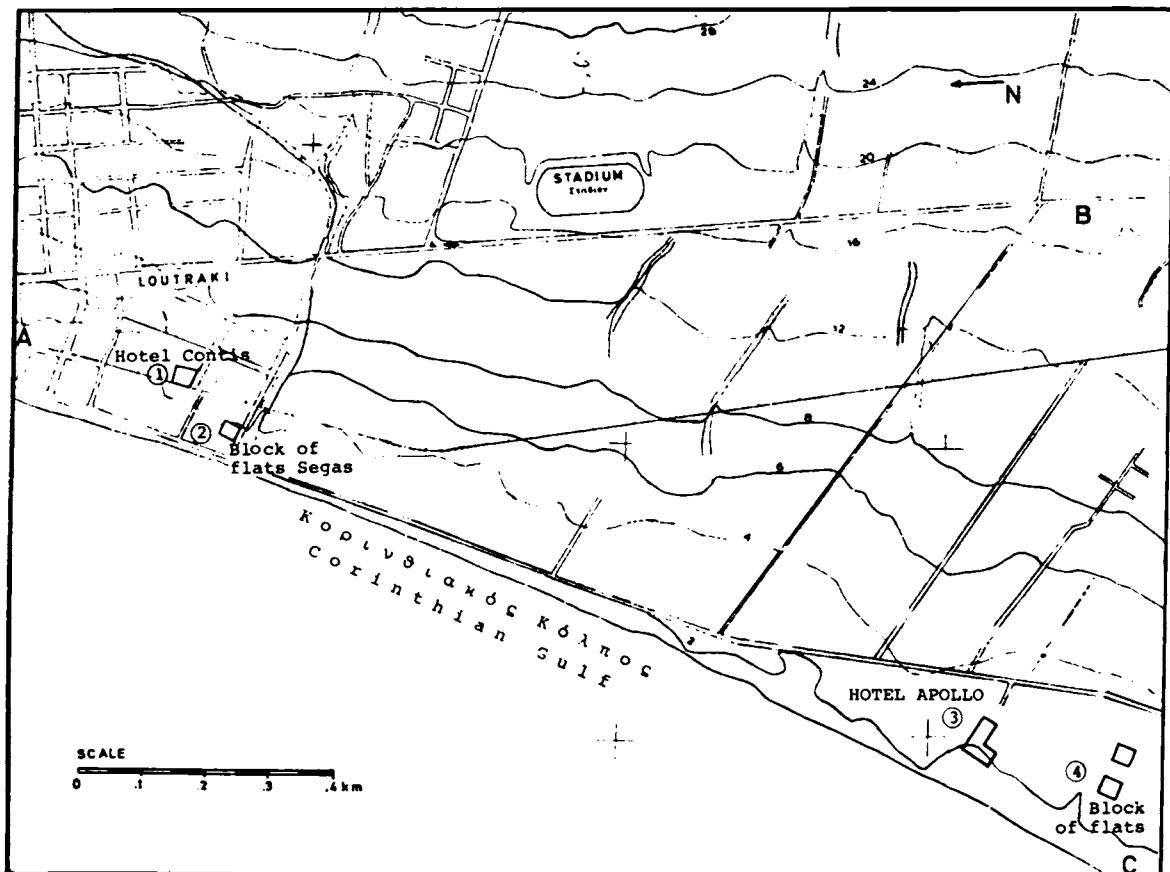
FIGURE 5.1 Topographic diagram of the south part of Loutraki.

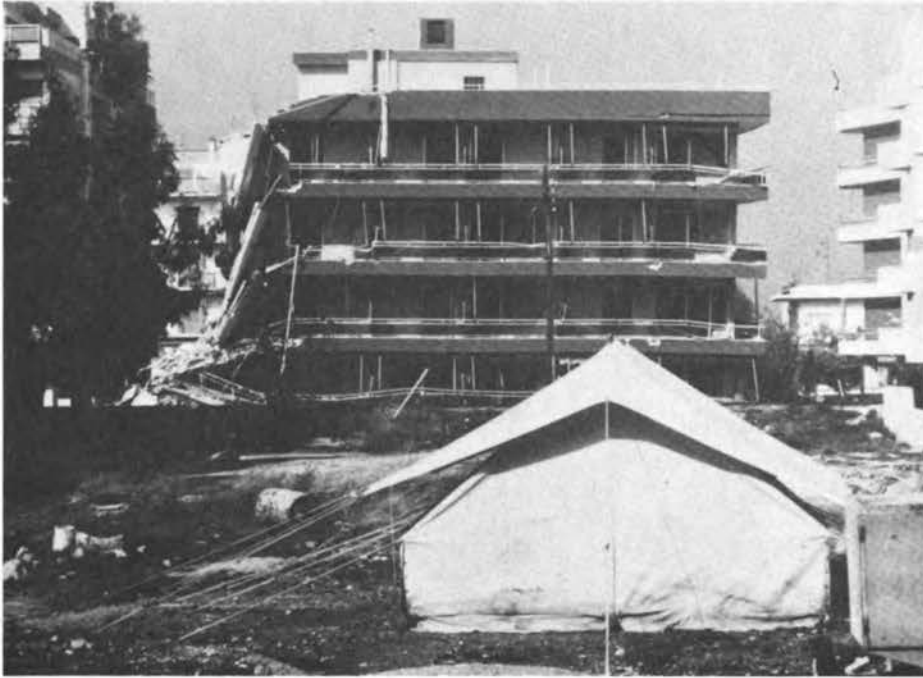
FIGURE 5.2 Partially collapsed five-story block of flats "Segas" in Loutraki. (Note temporary tent shelters in foreground.)

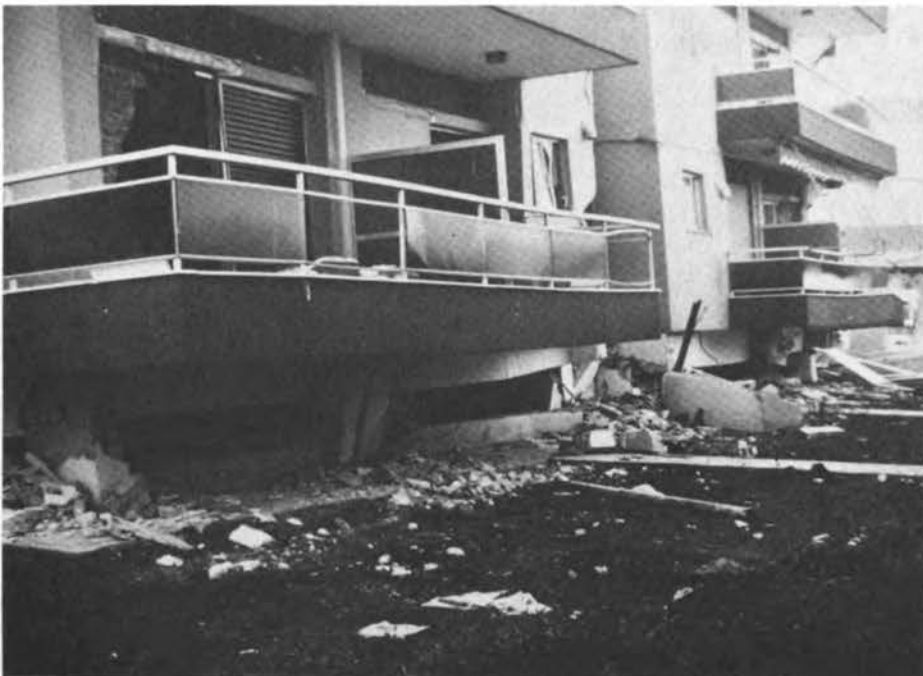
FIGURE 5.3 Failure of first-story columns.

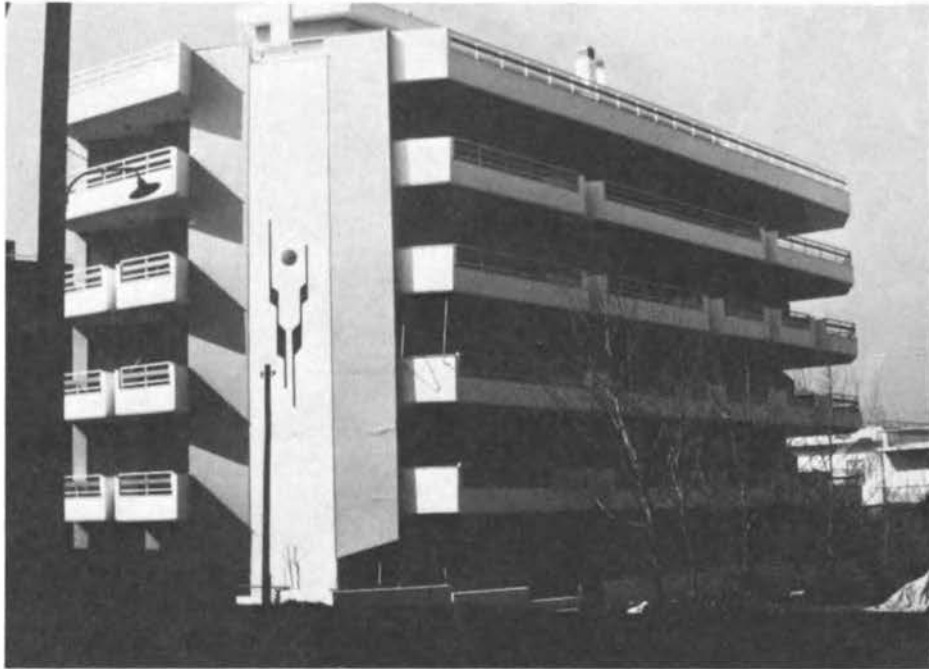
FIGURE 5.4 New apartment building with "pilotis" construction in Loutraki.

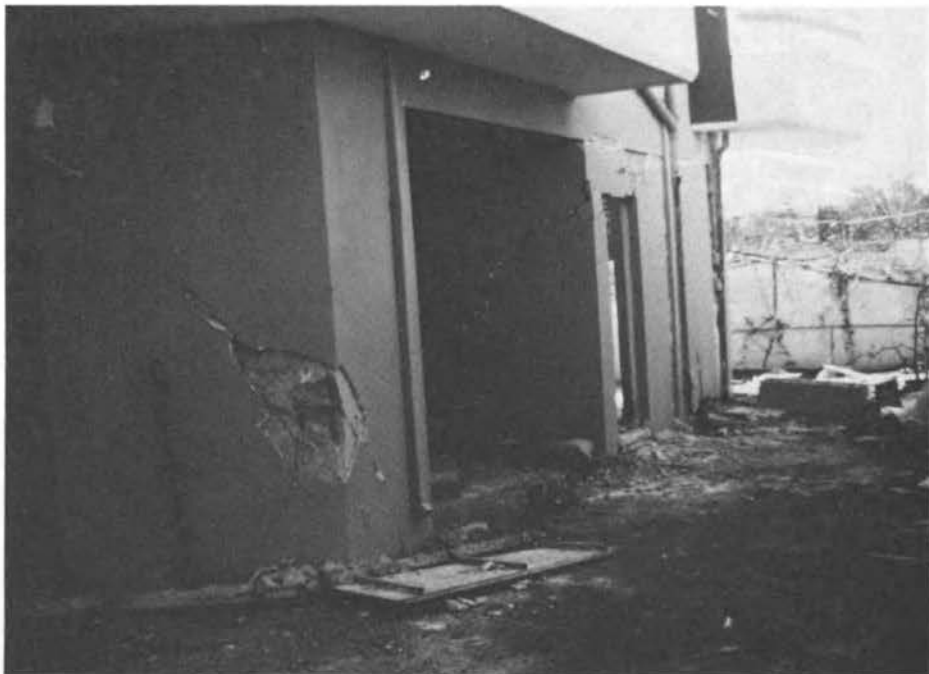
FIGURE 5.5 Failed wide column.

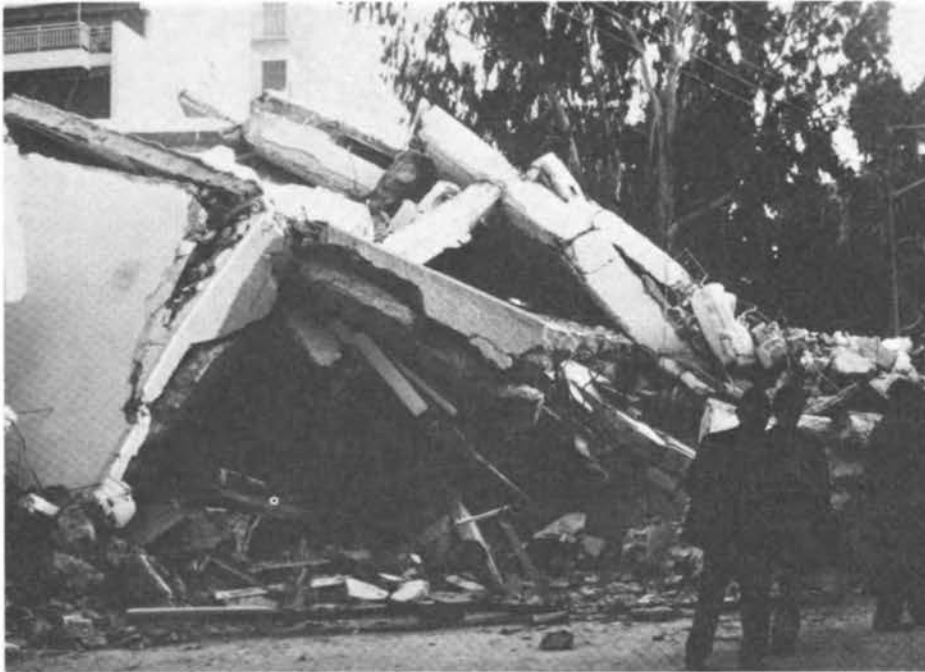
FIGURE 5.6 Collapse of Contis Hotel in Loutraki.

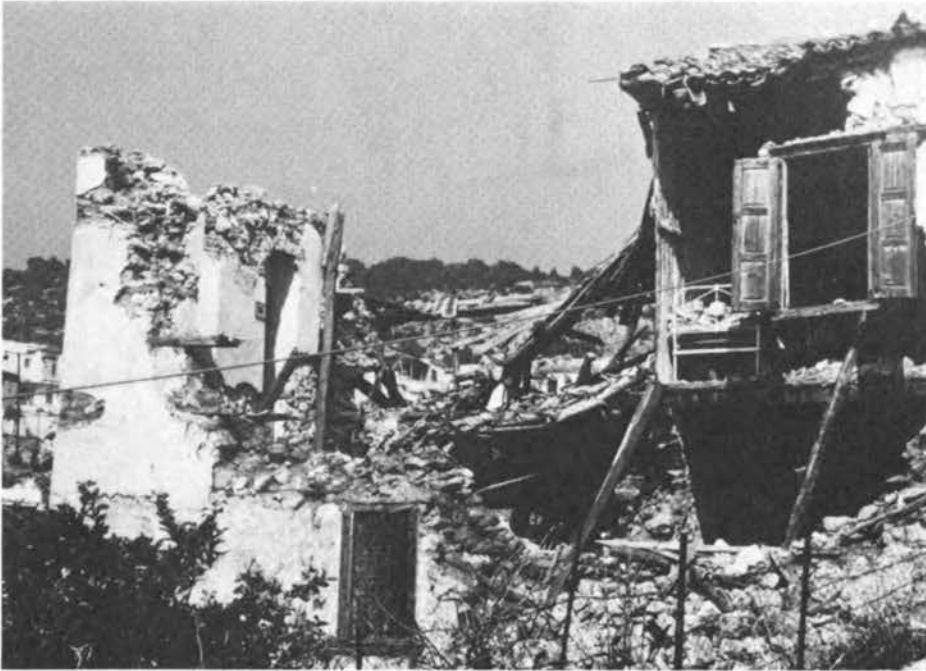
FIGURE 5.9 Stone houses in Perahora.

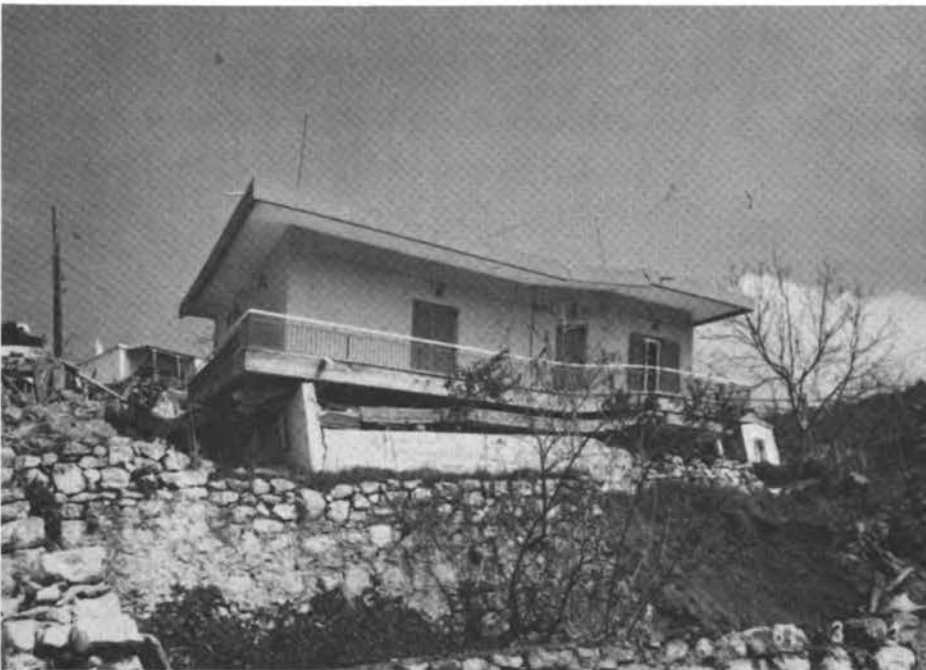
FIGURE 5.10 Damage to a three-story house built on sloping ground in Perahora. The retaining wall at the back of the house, which acts as a footing, functioned as the axis of rotation.

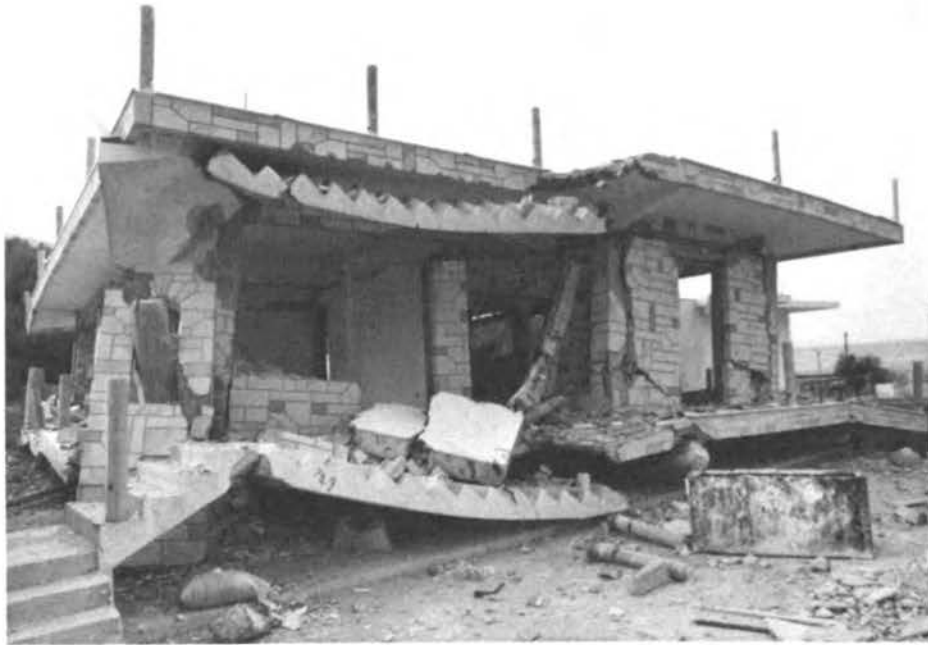
FIGURE 5.11 A two-story building in Shinos.

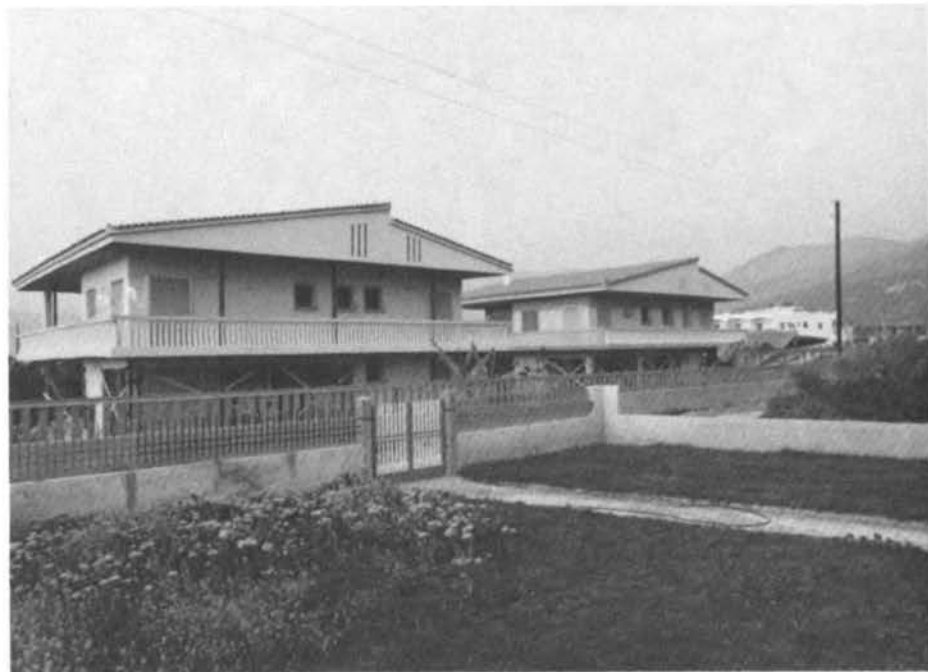
FIGURE 5.12 Three identical two-story buildings in Alepohori showed quite different behavior. The degree of damage increases from left to right. The left building is closer to the sea--no more than 60 m away--and suffered little damage to its first story. The third building collapsed totally (see Figure 5.13).

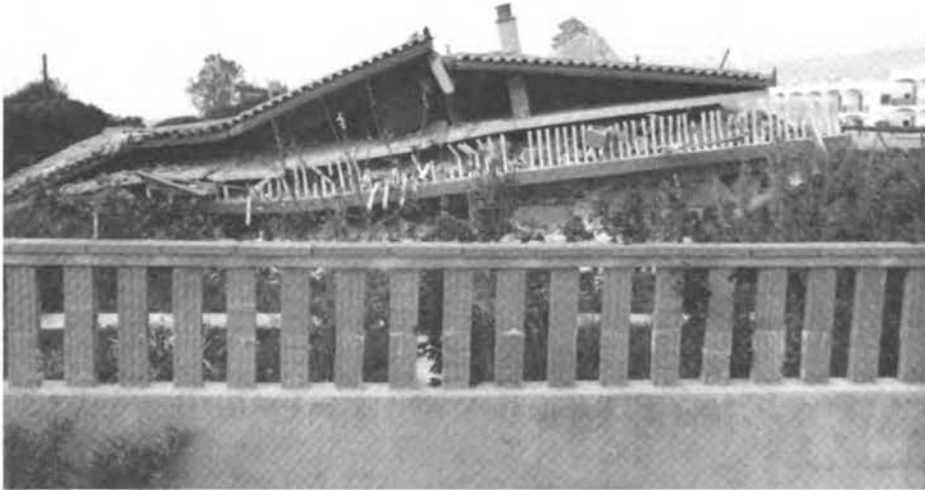
FIGURE 5.13 One building, identical to the others shown in Figure 5.12, collapsed totally.

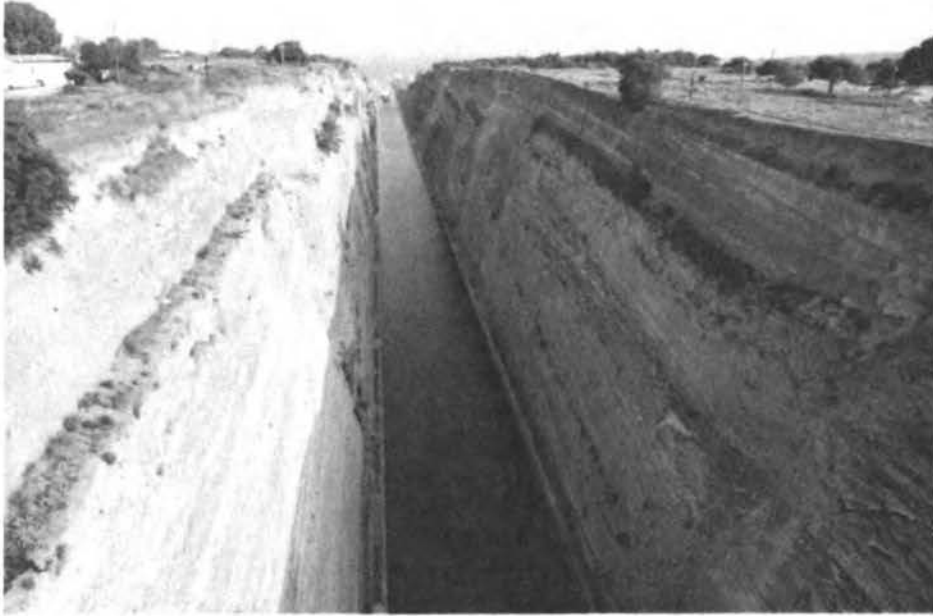
FIGURE 5.14 Corinth canal looking east from the road bridge. Note the descending beddings. At each change of elevation there is a fault.

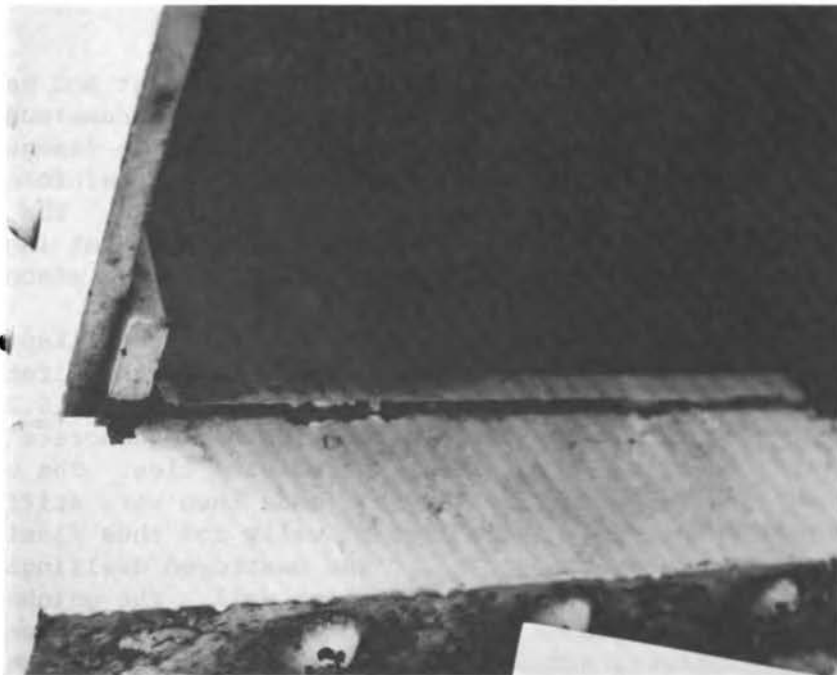
FIGURE 5.17 The hinged support of the old road bridge over the Corinth Canal at the Beotia side. Some deformations were observed.

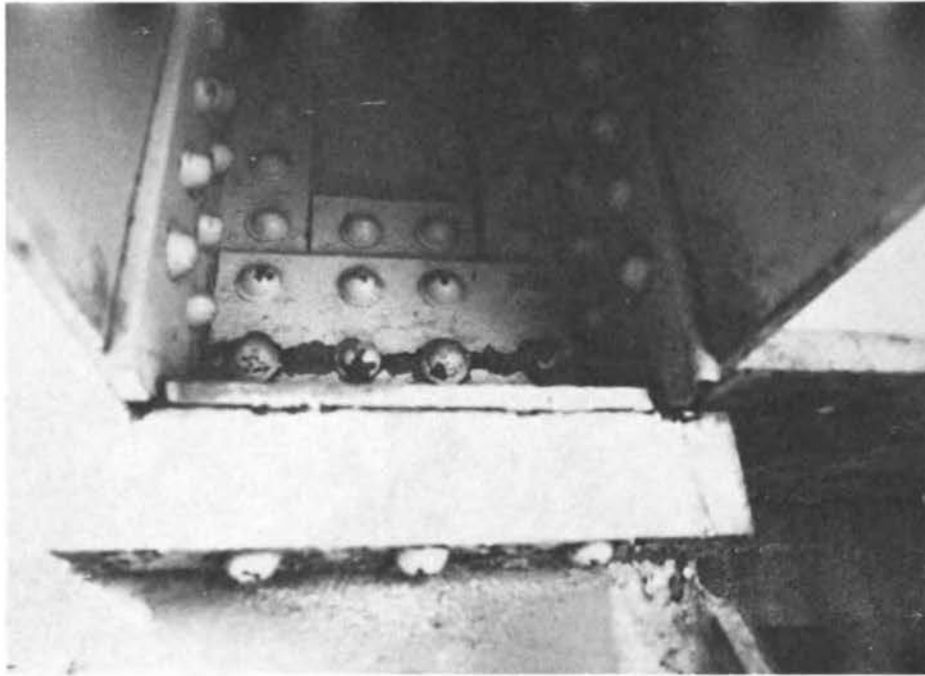
FIGURE 5.18 At the hinged support of the old road bridge over the Corinth Canal, two or three rivets that were connecting the support with the main girder broke in shear. Some tension was also observed in the L-shaped stiffening members.

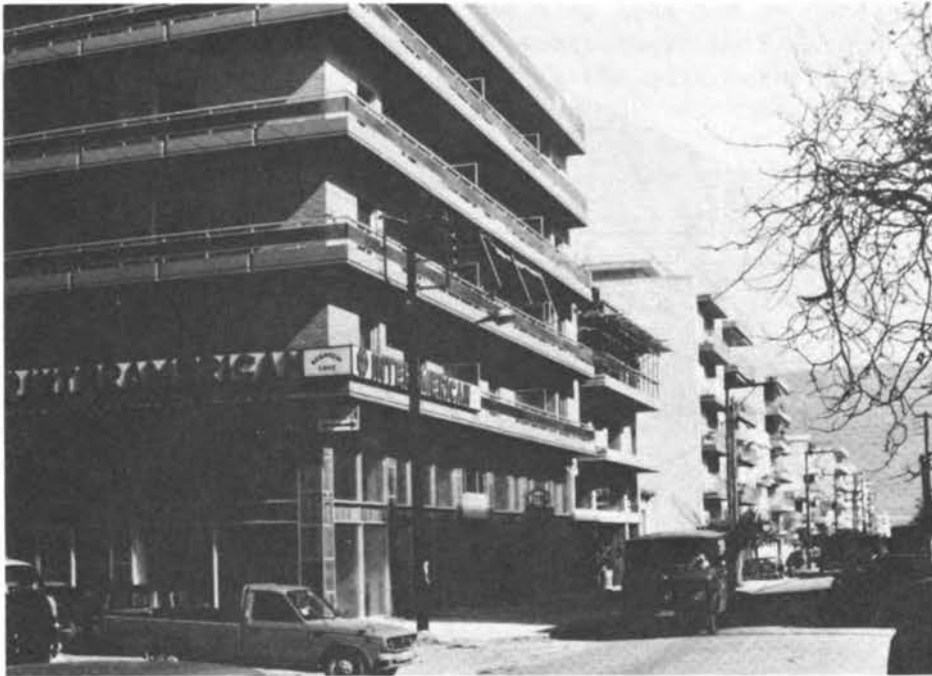
FIGURE 5.19 Office buildings in Corinth.

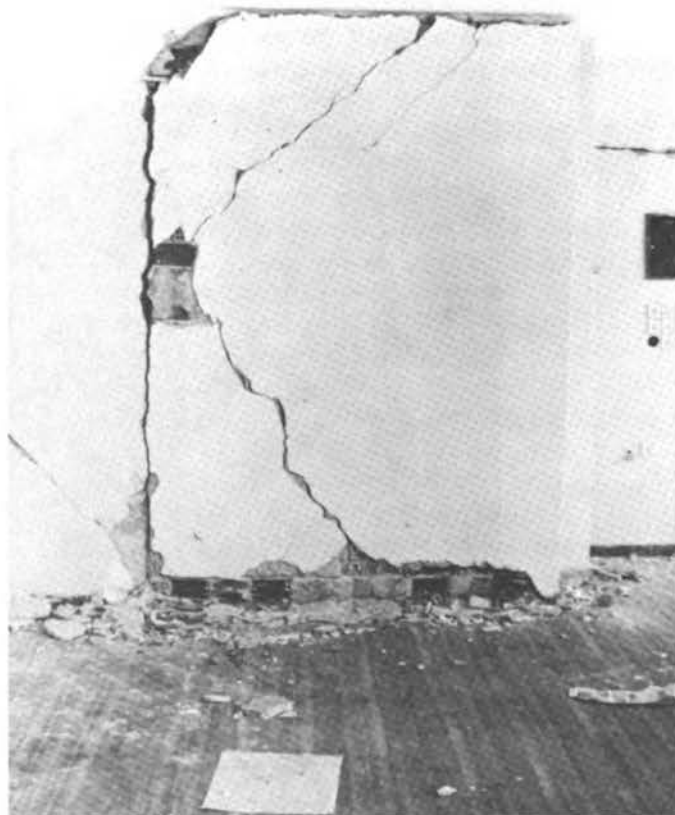
FIGURE 5.20 Infill wall damage.
