The Central Greece Earthquakes of February-March 1981: A Reconnaissance and Engineering Report (1982)

Size
8.5 x 10

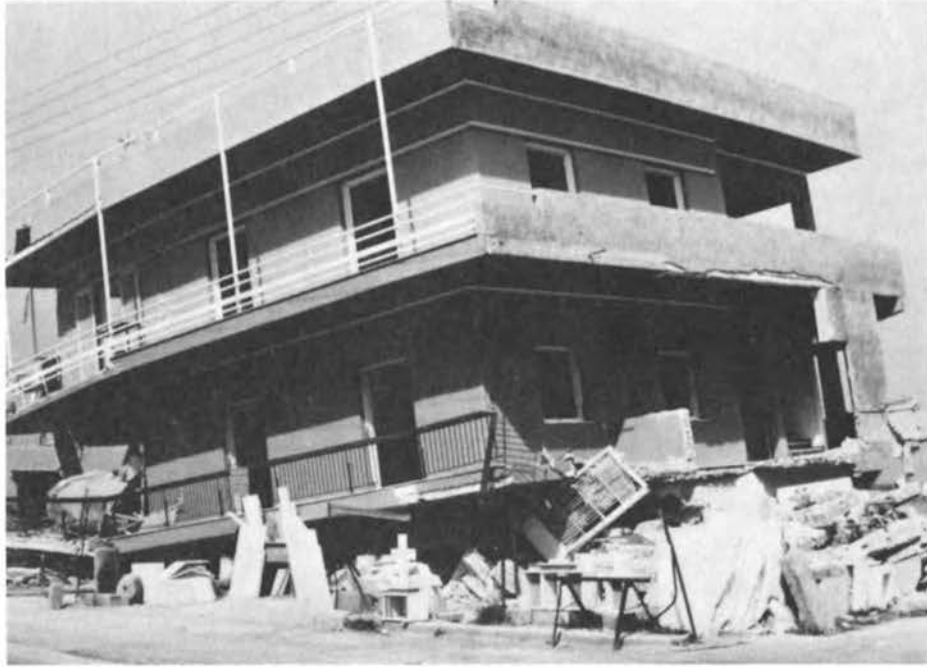
FIGURE 5.21 Collapse of three-story house in Kiato. (Lower floor was stone mason's shop.)

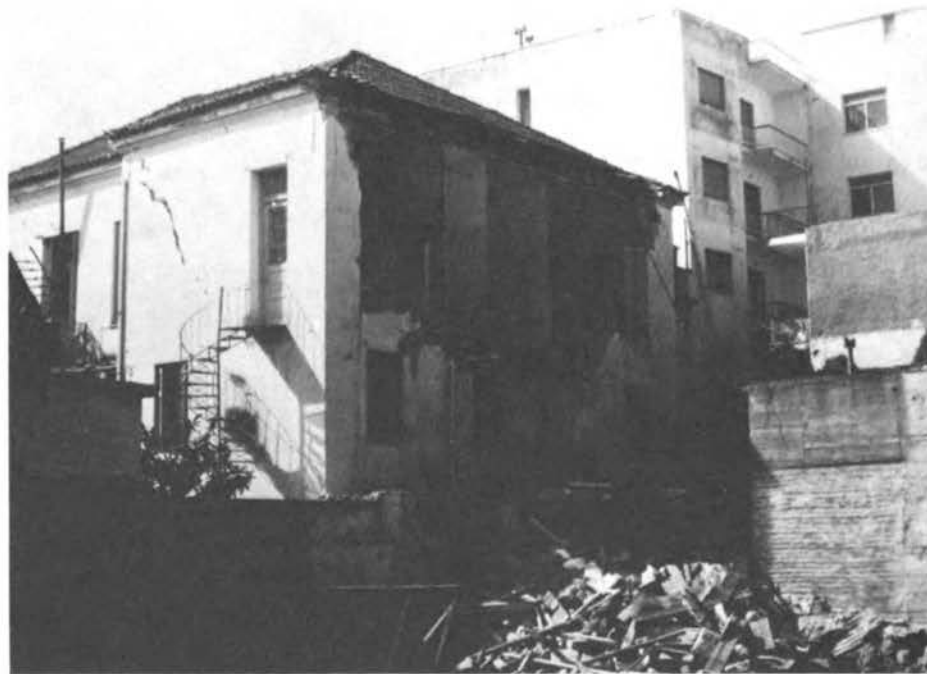
FIGURE 5.22 Older stone wall buildings in Vrahati.

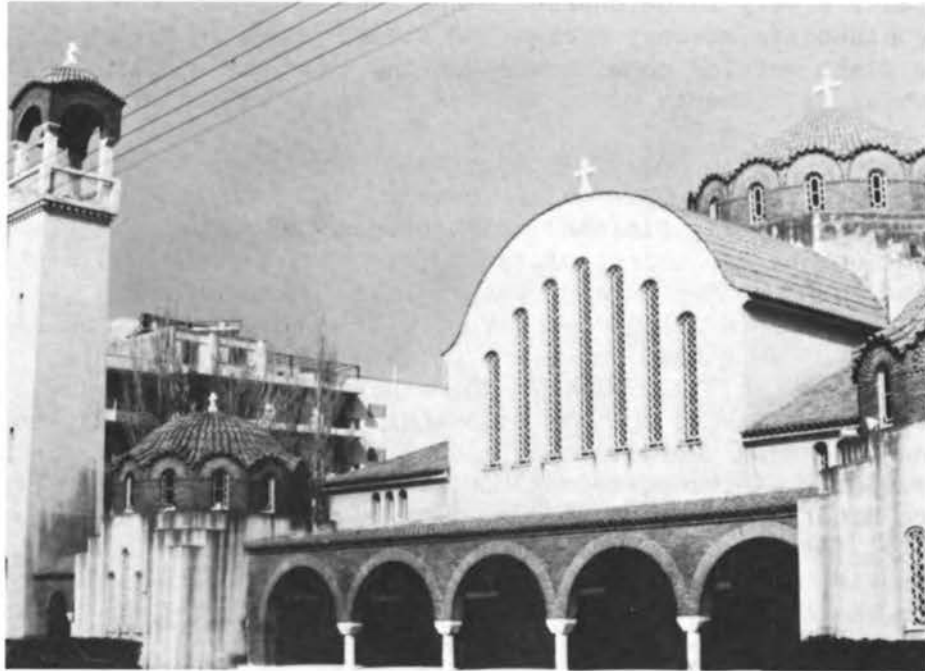
FIGURE 5.23 Undamaged church in Kiato.

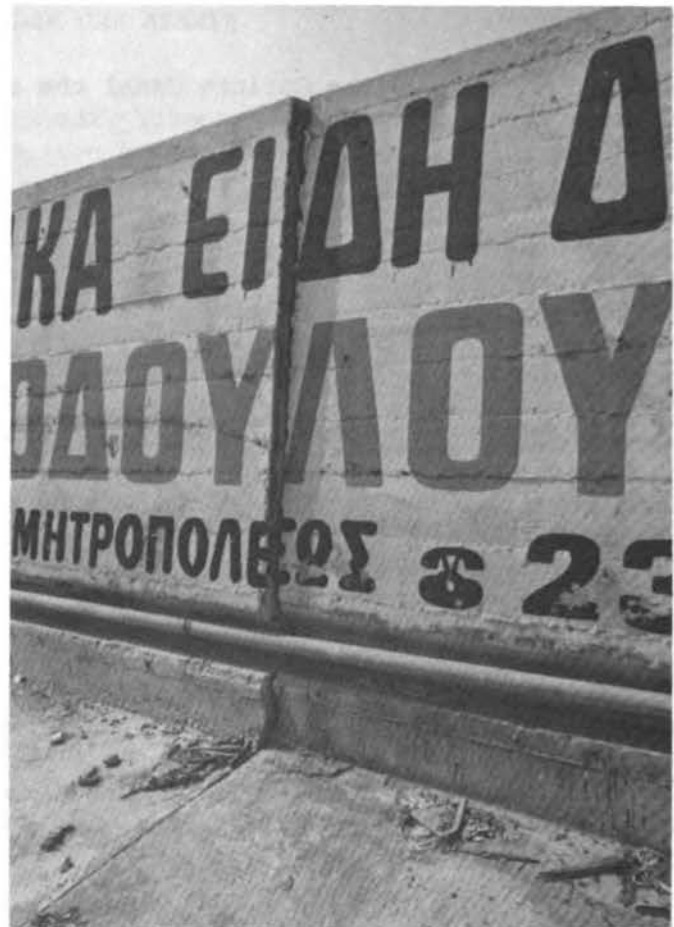
FIGURE 5.24 Jetty in Kiato. Differential settlements and rotations of the concrete blocks were observed.

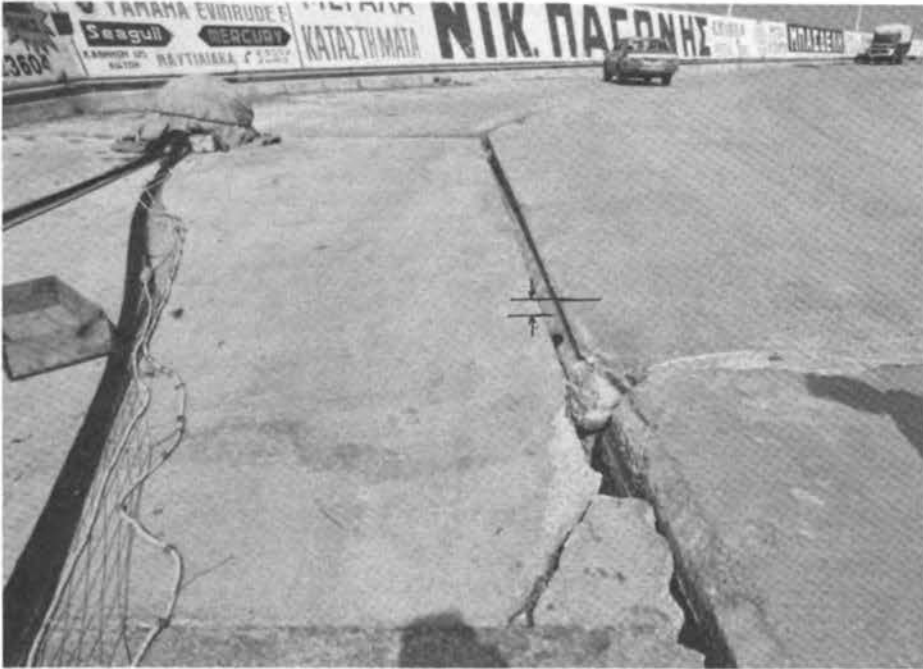
FIGURE 5.25 Jetty in Kiato. The expansion joints between the concrete blocks have been damaged. Note the differential settlement of about 20 to 30 cm.

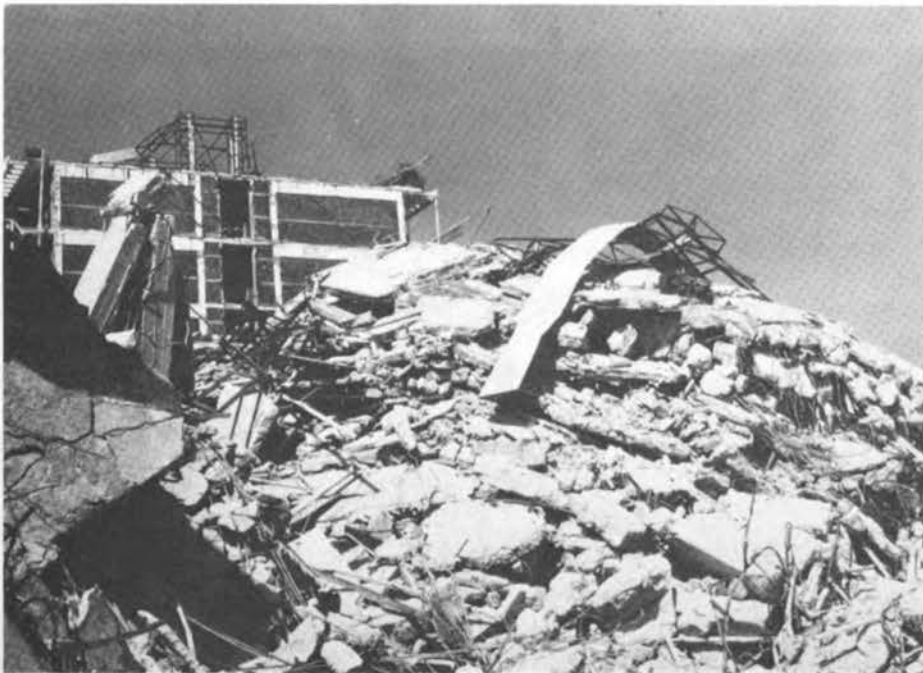
FIGURE 5.26 Collapse of nearly completed hotel in Vrahati.

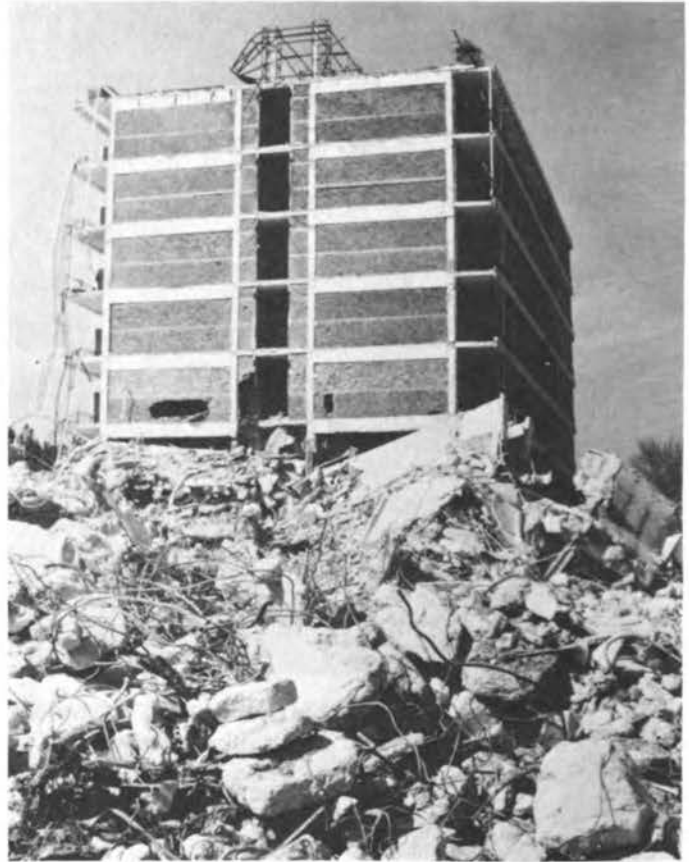
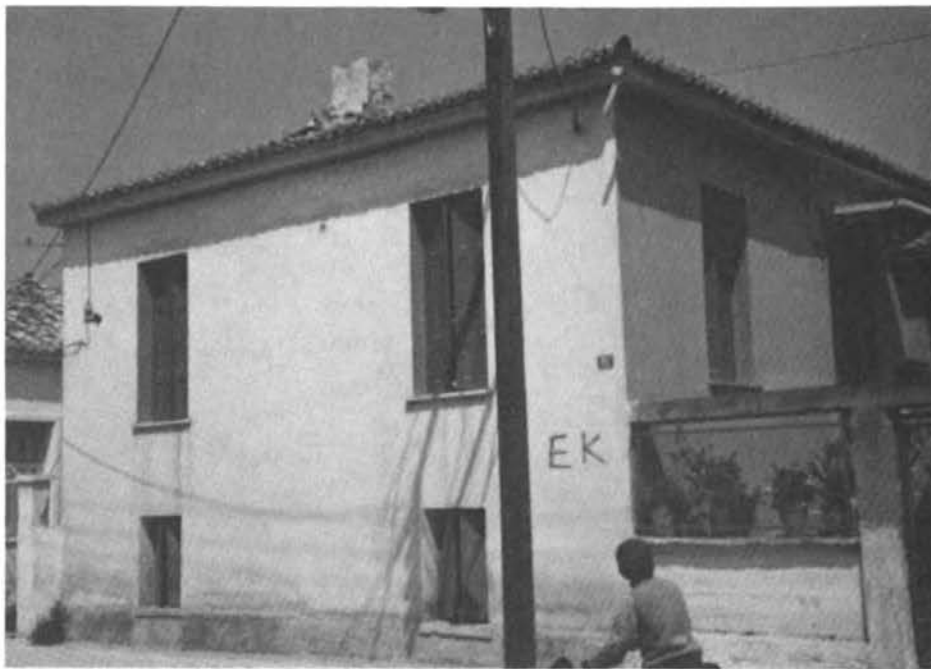
FIGURE 5.28 Some well-maintained earthen buildings in the area, including this one in Kiato, suffered no damage.

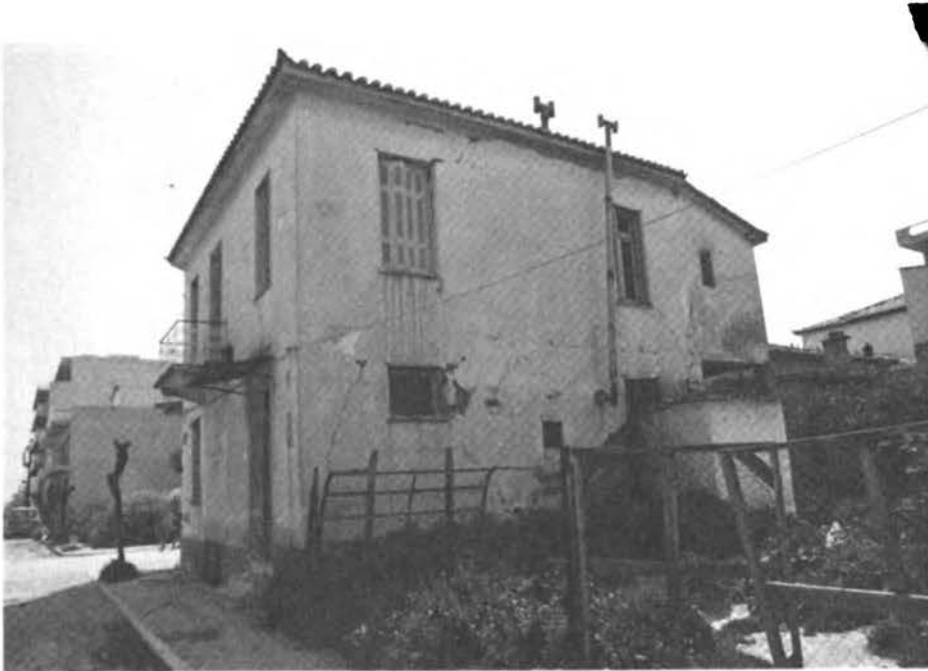
FIGURE 5.29 Many earthen buildings are about 100 years old. They have experienced two to three earthquakes as strong as the present ones and only needed the plaster surface repaired (although the repairs were not always done).

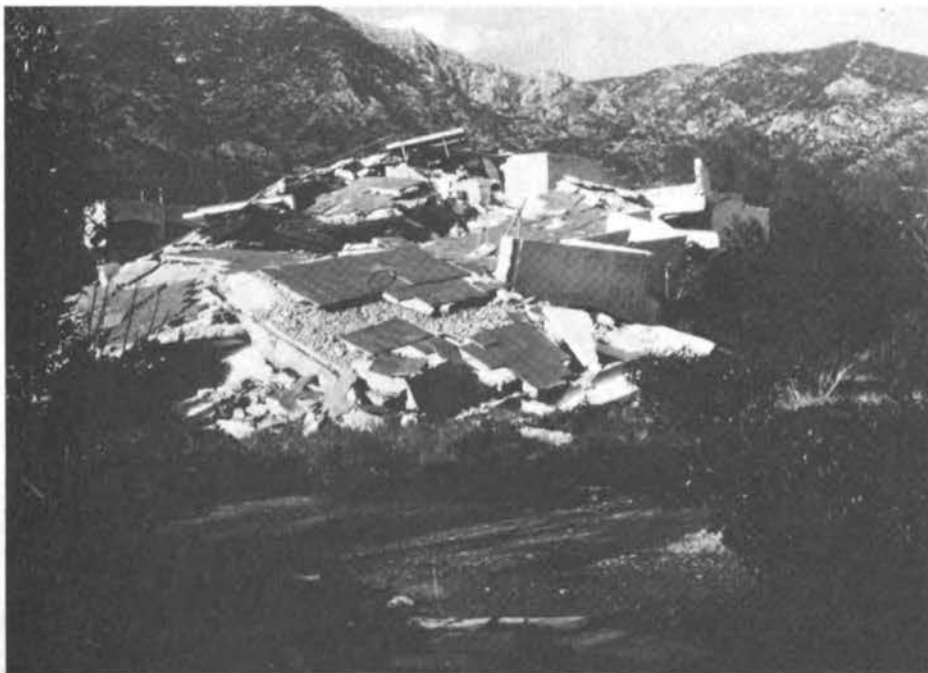
FIGURE 5.30 Collapse of Kineta bungalows.

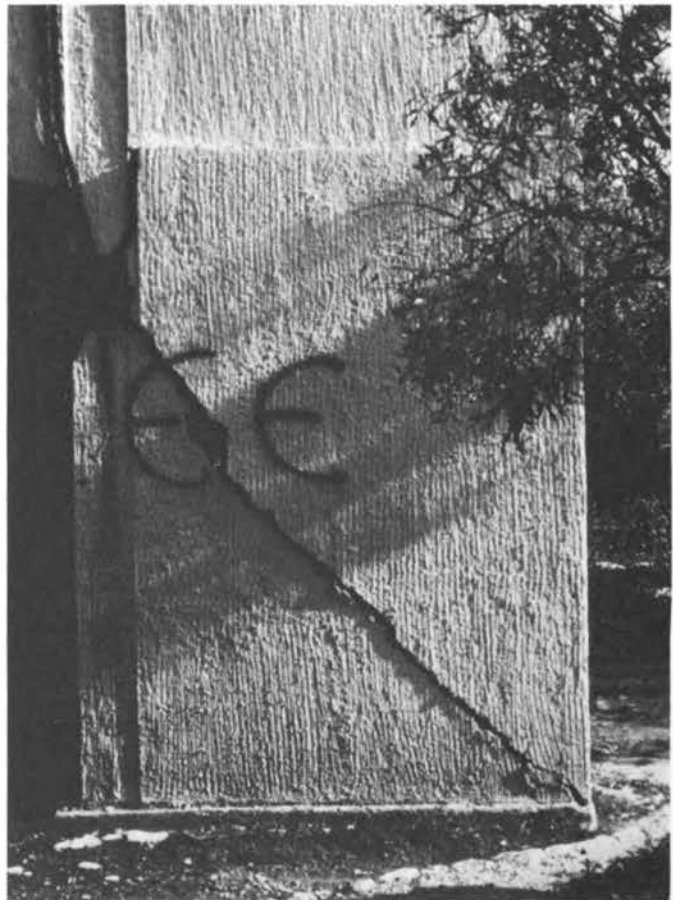
FIGURE 5.32 Damage to bungalows. EE is a designation by government officials for buildings not to be occupied.

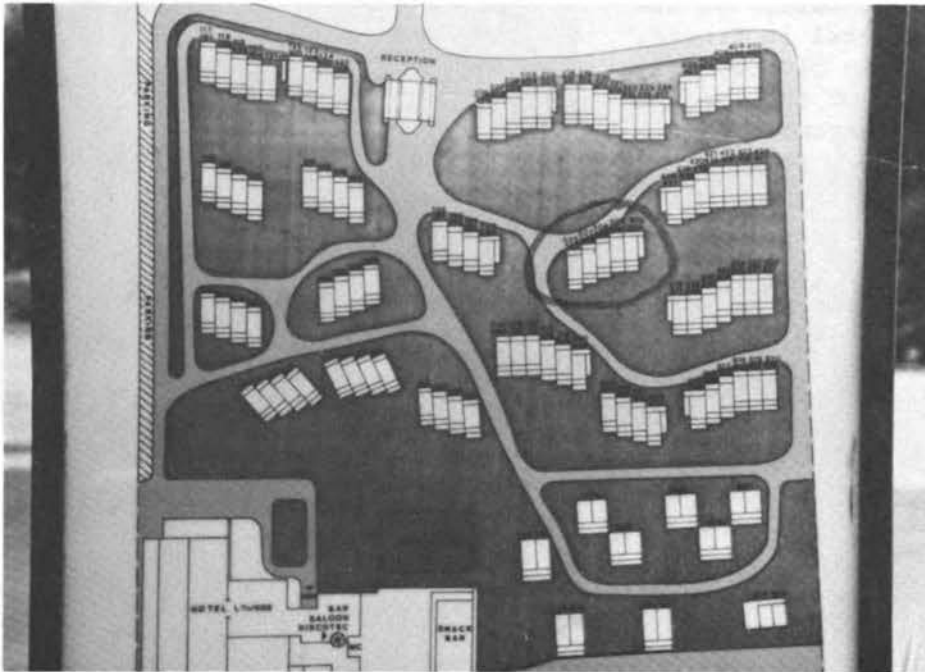
FIGURE 5.33 Map of bungalow development (circled units collapsed).

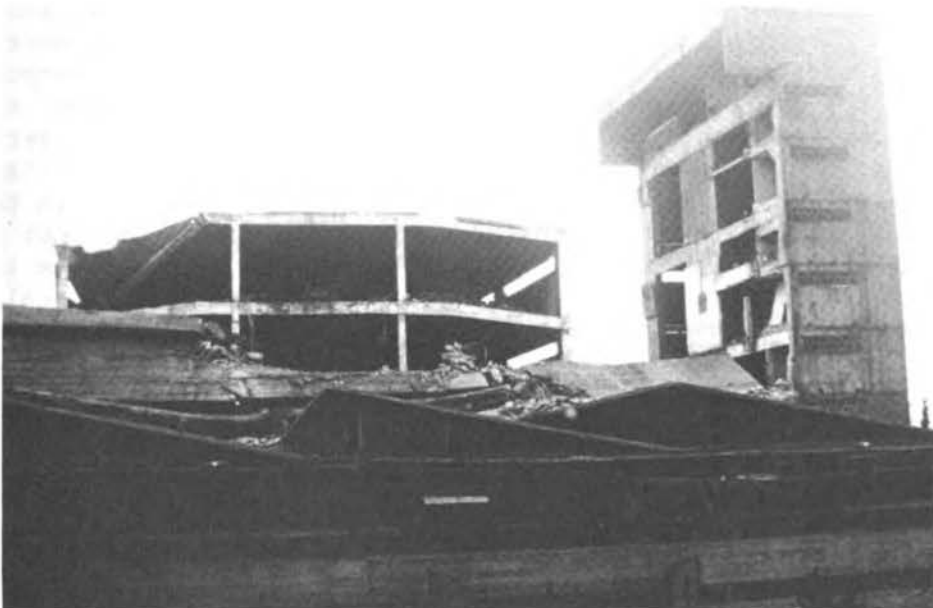
FIGURE 5.38 Ceramic factory near Isthmia (front view, with elevator shaft on right).

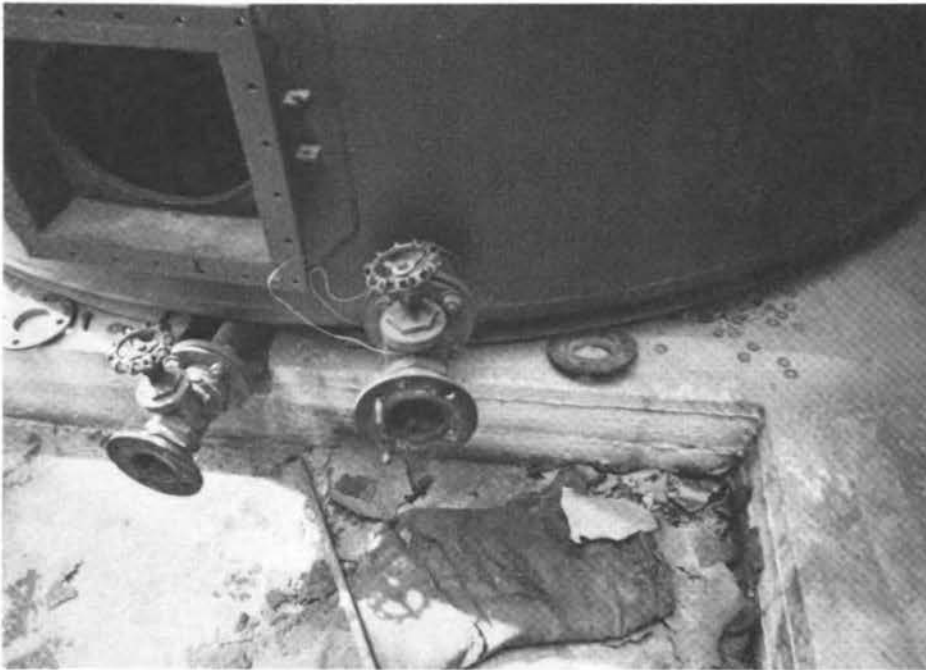
FIGURE 5.39 Winery tank in Megara. The tank tilted a little and was displaced about 3 to 4 cm. The tank overrode the steel washer.

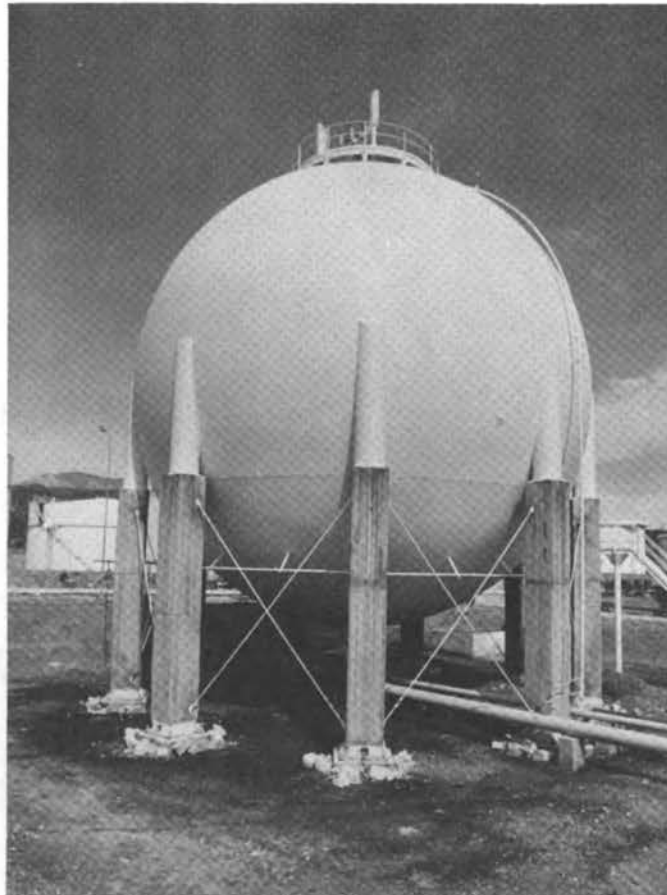
FIGURE 5.40 A huge liquid gas storage tank at the "Motor Oil" refinery suffered limited damage in the anchors of footings and the diagonal tension bars.

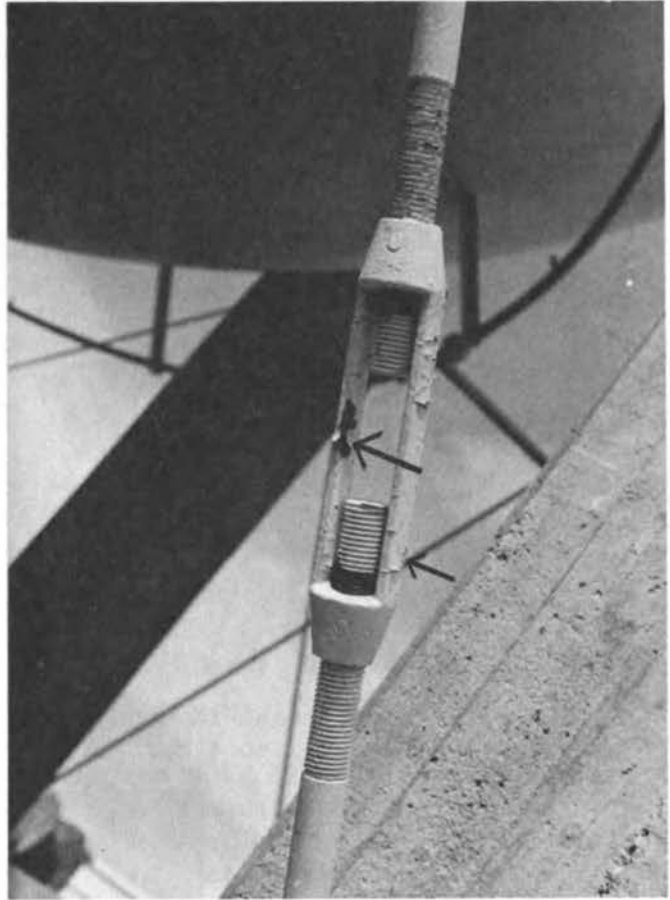
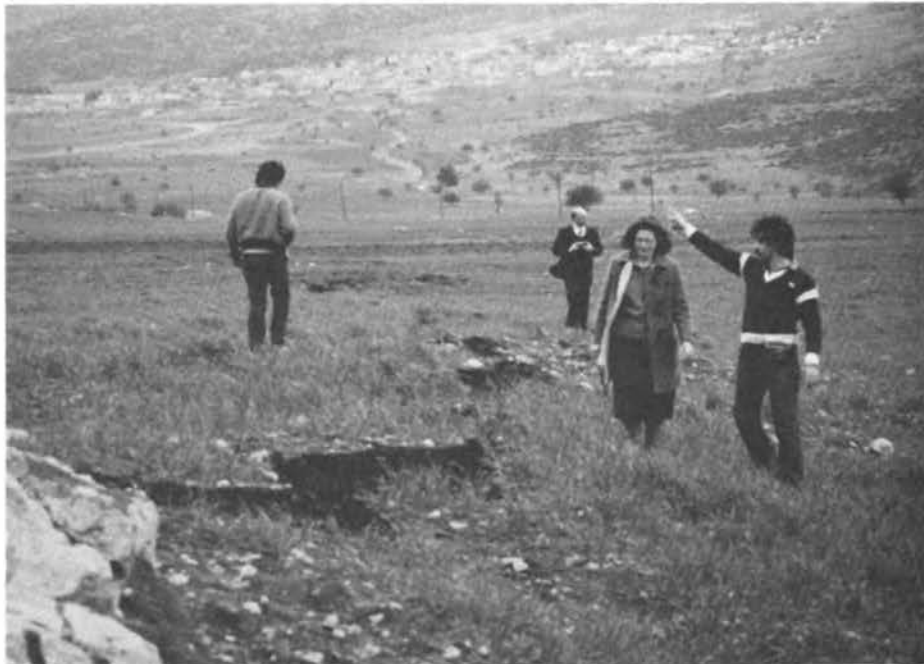
FIGURE 5.42 Village of Plataeae at end of Kapareli fault.

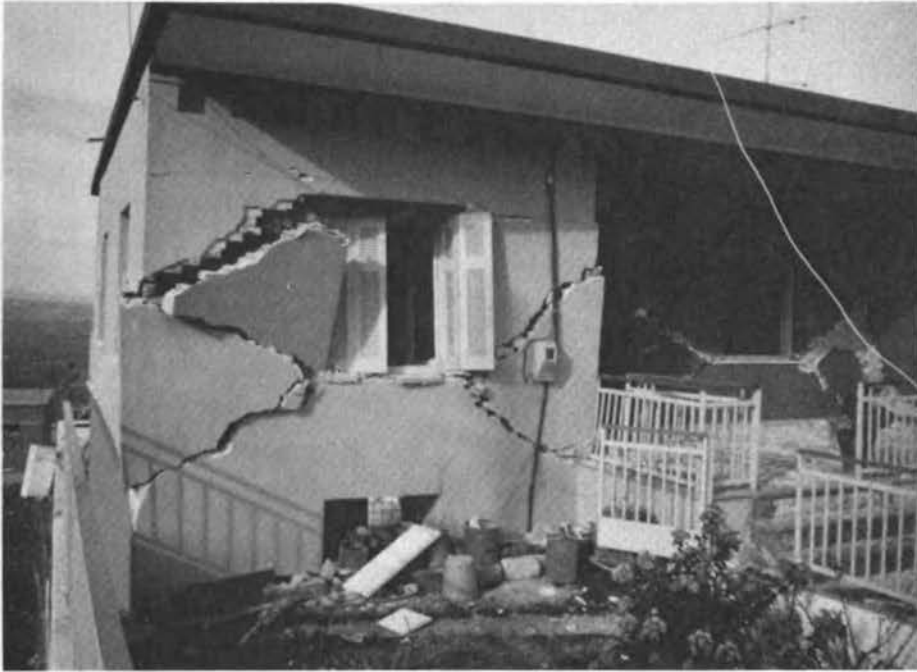
FIGURE 5.43 Damaged home in Plataeae.

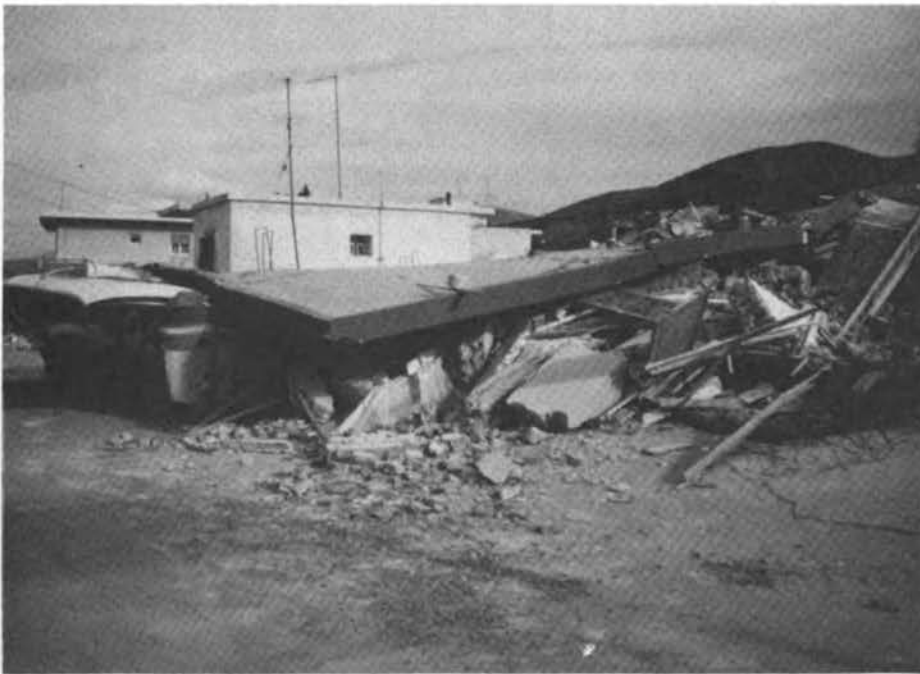
FIGURE 5.44 Building collapse on bus in Plataeae.

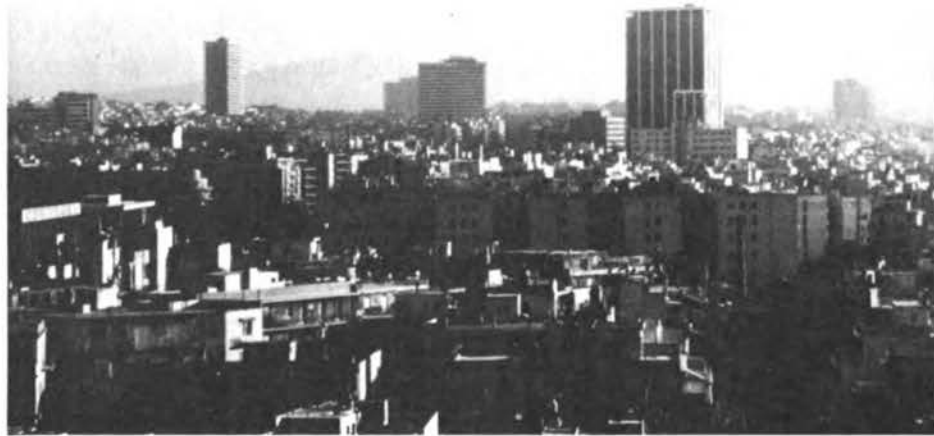
Recently constructed high-rise office buildings designed to have ductile moment-resisting frames were reported to have performed without any problems. A new apartment building (Figure 5.51) in a suburb of Athens suffered severe damage to some of its first-story columns. Above the first story the building had extensive masonry partitions. The building was of typical "pilotis" construction with wide and thin columns oriented primarily on one of the major building axes. The column shown in Figure 5.52 was the only one oriented longitudinally on the front face of the building, and it had to carry about half of the total building shear in the longitudinal direction. The overloaded column failed in shear.

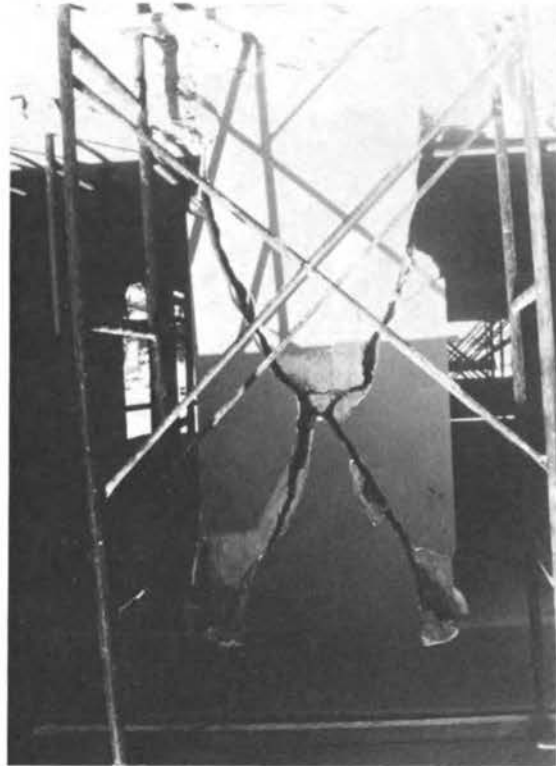
FIGURE 5.52 Heavily damaged stiff column at corner of apartment building shown in Figure 5.51.

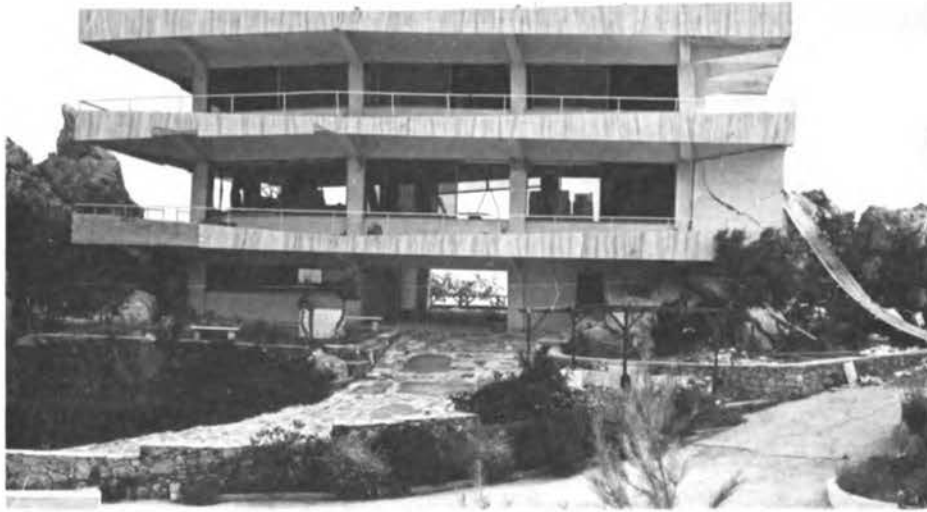
FIGURE 6.2 Vip's Hostel in Perahora. Northeast view of the building soon after the earthquake.

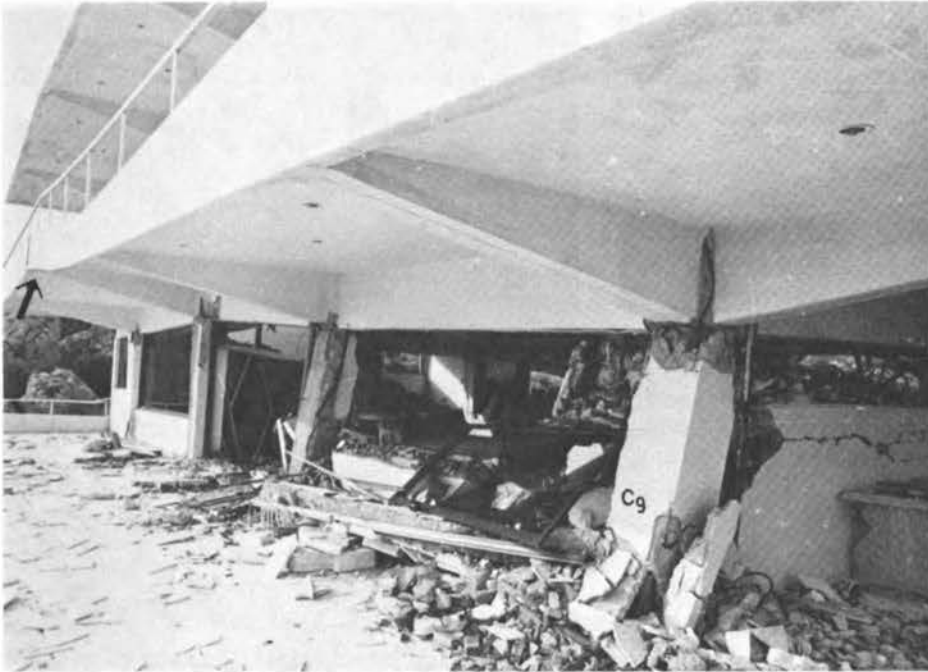
FIGURE 6.4 Vip's Hostel in Perahora. This view from the south shows part of the damaged columns in the second story. The arrow shows the large deformation of the ceiling. There are no ties in the column-to-beam connection (c₉).

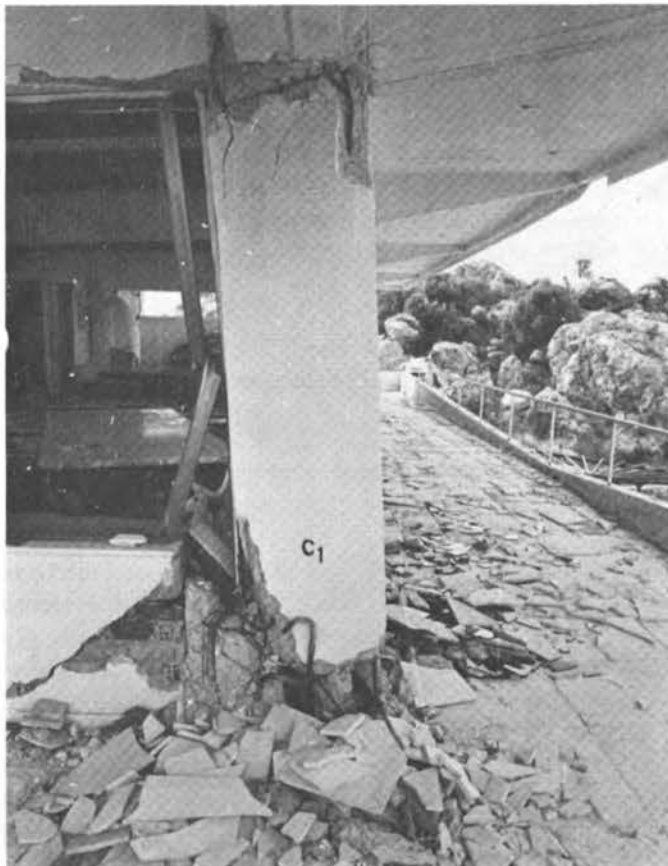
FIGURE 6.5 Vip's Hostel in Perahora. Column c₁ on the second story, viewed from the southeast.

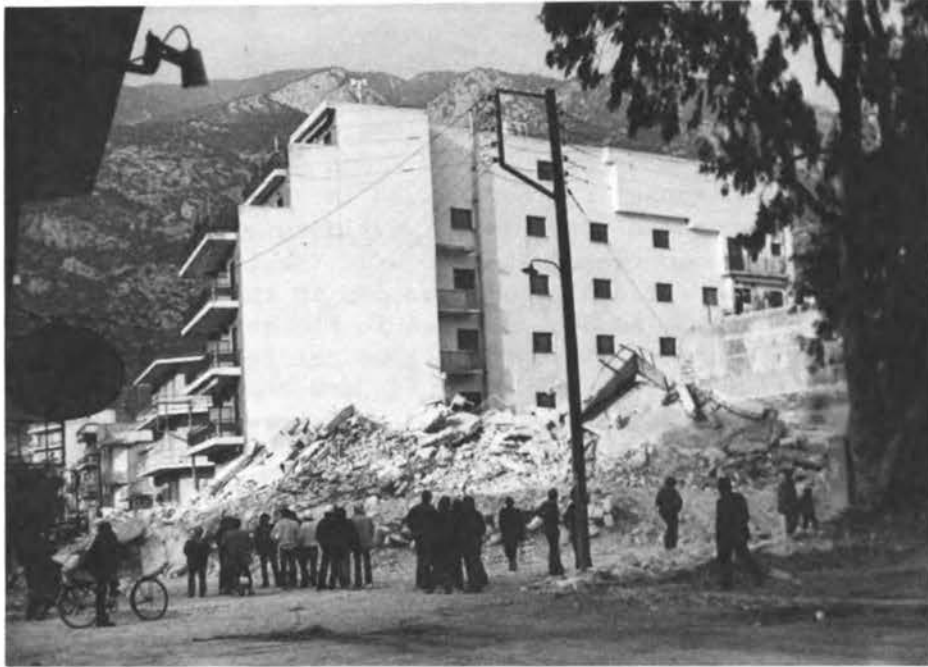
FIGURE 6.8 Contis Hotel in Loutraki. Southwest view one week after collapse. Photograph courtesy A. Manis.

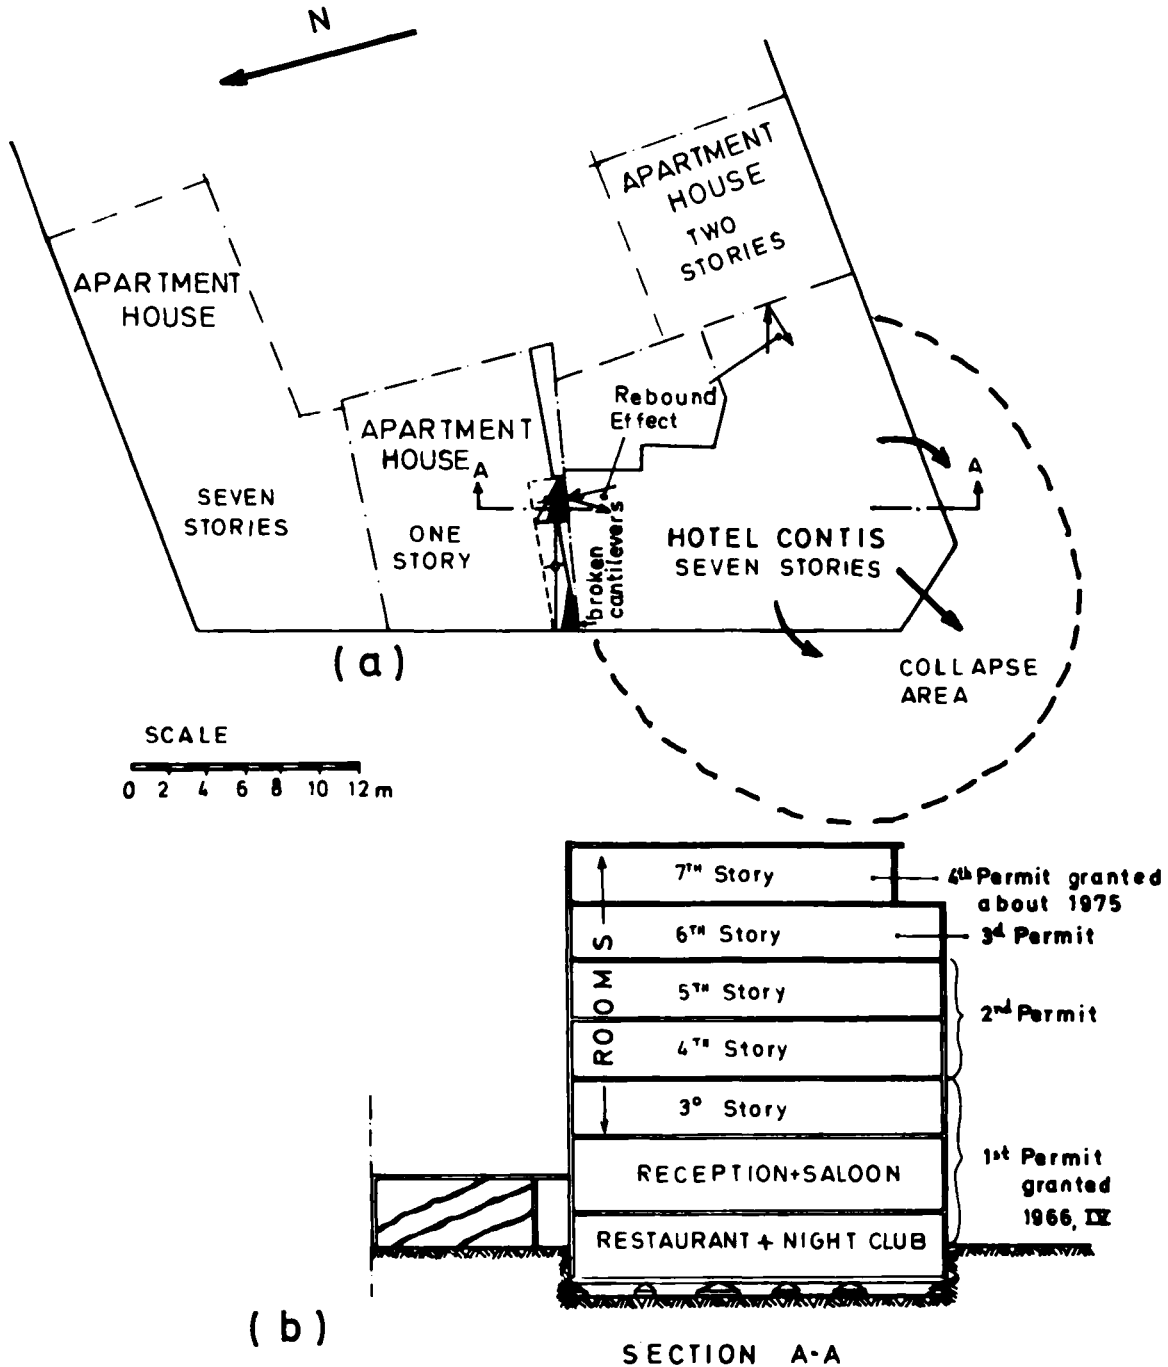
FIGURE 6.9 Contis Hotel in Loutraki. Plan and section of the building.

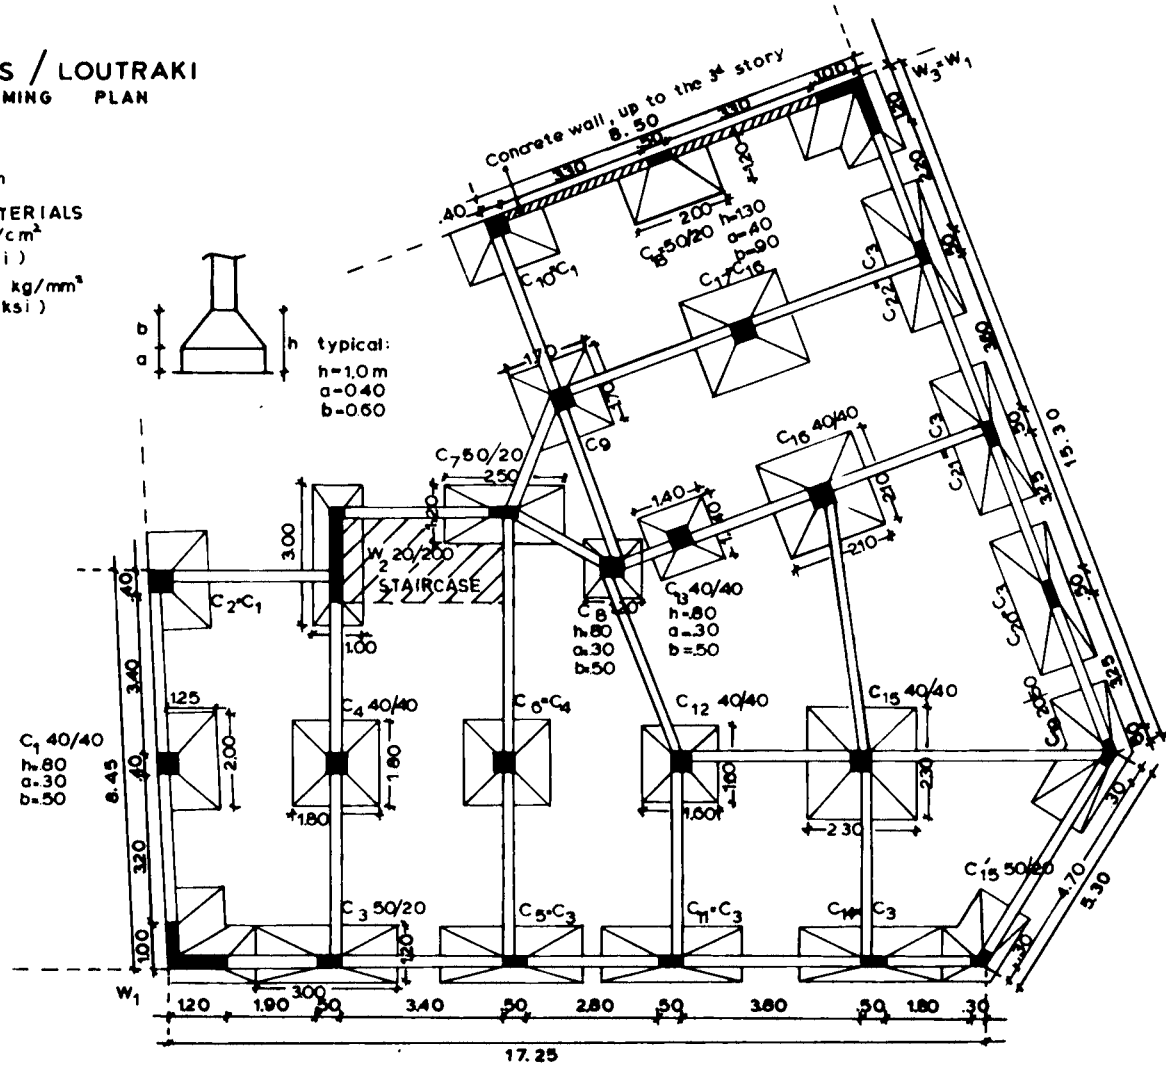
FIGURE 6.10 Contis Hotel in Loutraki. Foundation framing plan.

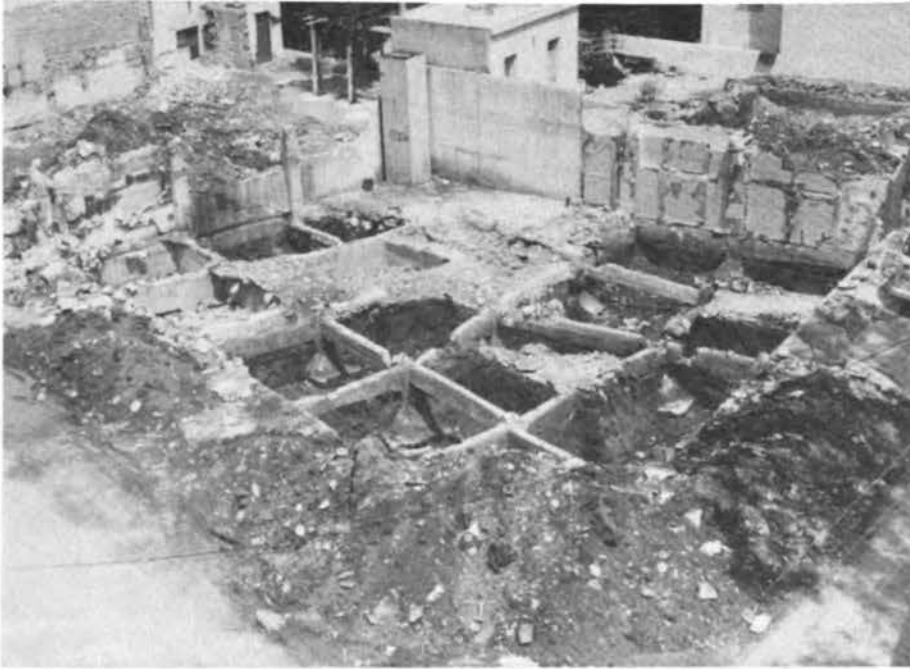
FIGURE 6.11 Contis Hotel in Loutraki. General southwest view of the foundation after removal of the debris. The tie beams are 15 by 40 cm.

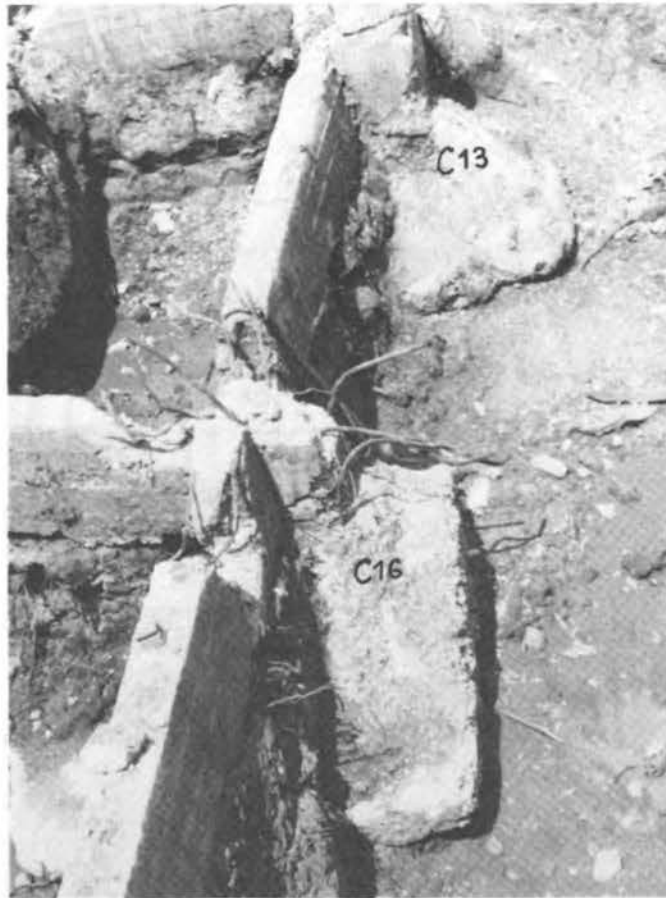
FIGURE 6.12 Contis Hotel in Loutraki. Most of the tie beams around the columns are discontinued to accommodate wastewater pipes.

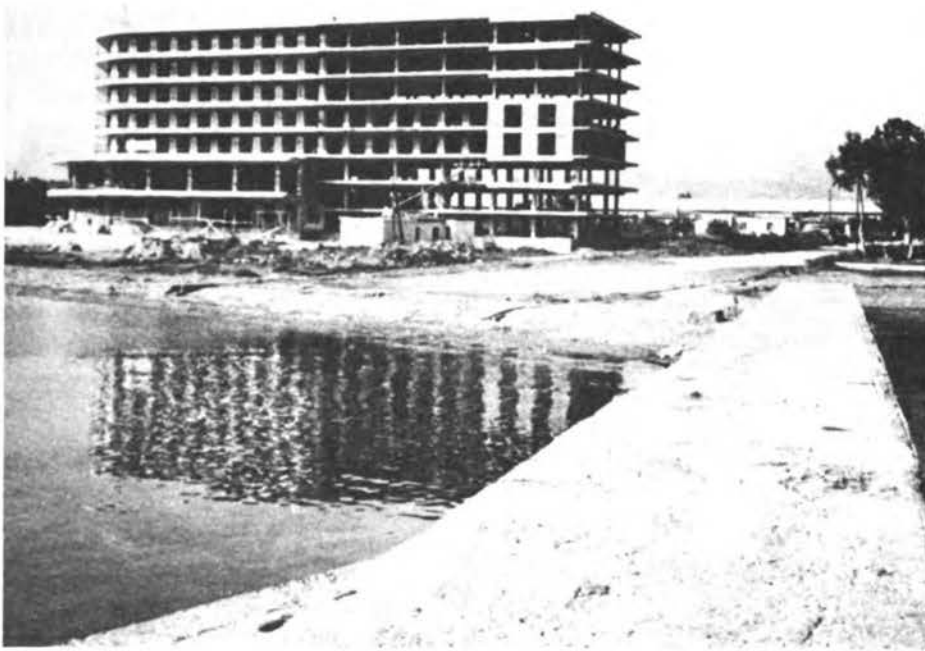
FIGURE 6.18 Galaxy Hotel in Vrahati. North view of the hotel after the earthquake. The remaining part of section III is shown in Figure 6.14a and 6.14b.

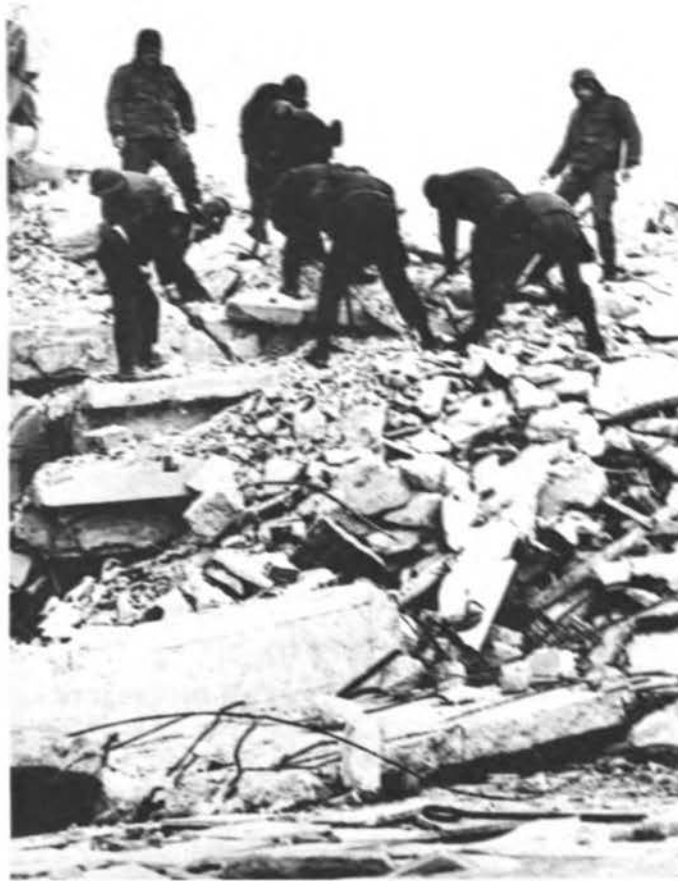
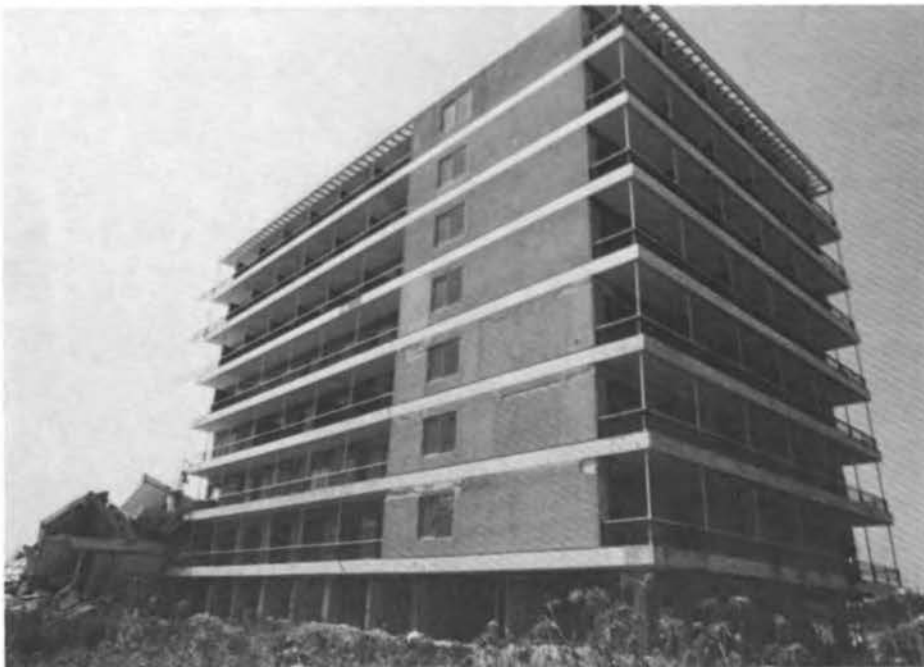
FIGURE 6.23 Galaxy Hotel in Vrahati. North view of section III. Columns and walls in the first floor were heavily damaged.

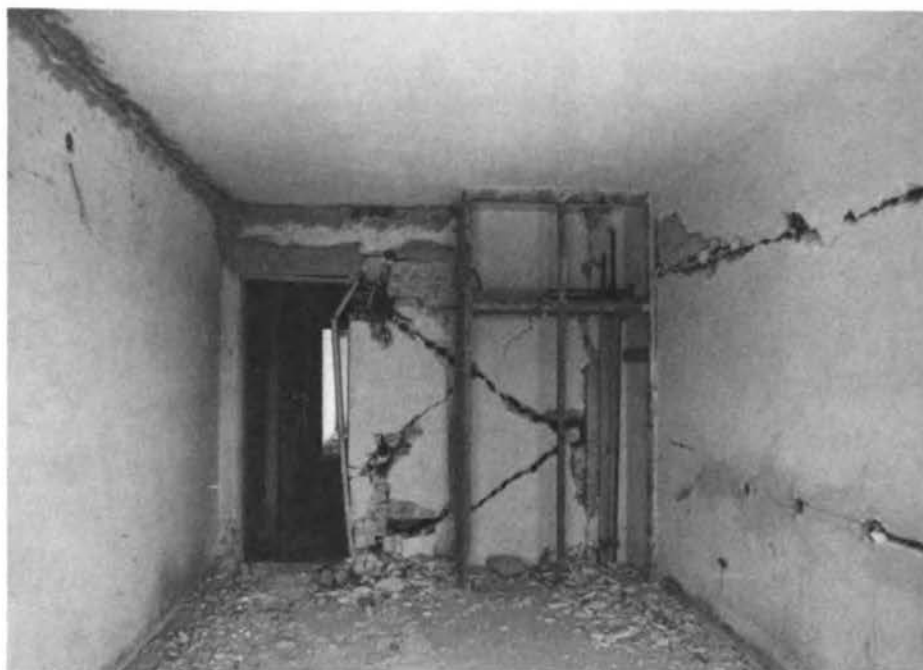
FIGURE 6.24 Galaxy Hotel in Vrahati. Inside view of a room in the second story of section III. The front brick wall extends along the long axis of section III (northwest to southeast).

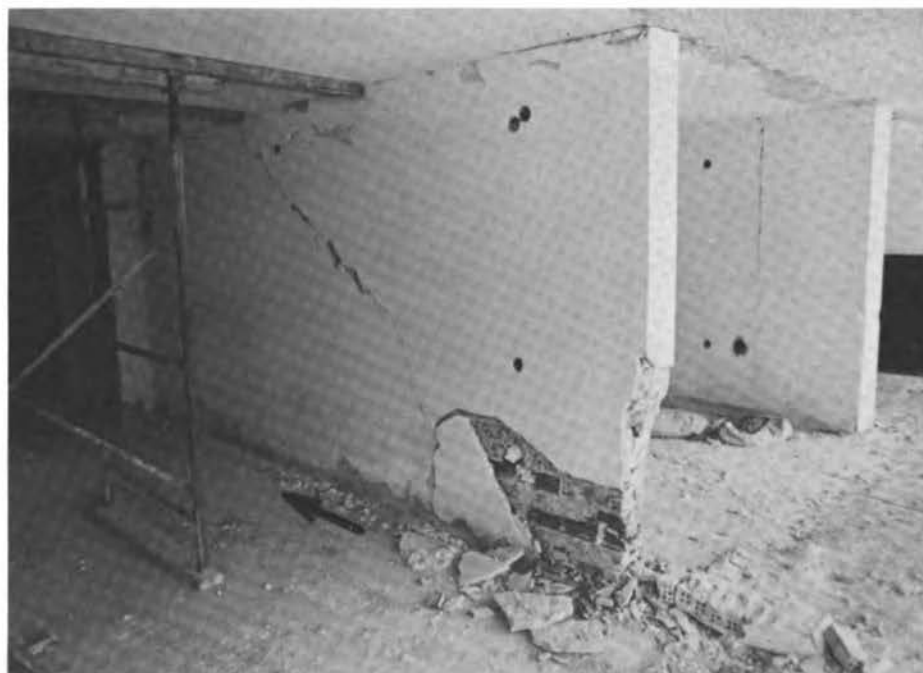
FIGURE 6.25 Galaxy Hotel in Vrahati. West view of the first story. The cracked walls are directed southwest to northeast.
