The Central Greece Earthquakes of February-March 1981: A Reconnaissance and Engineering Report (1982)

Size
8.5 x 10

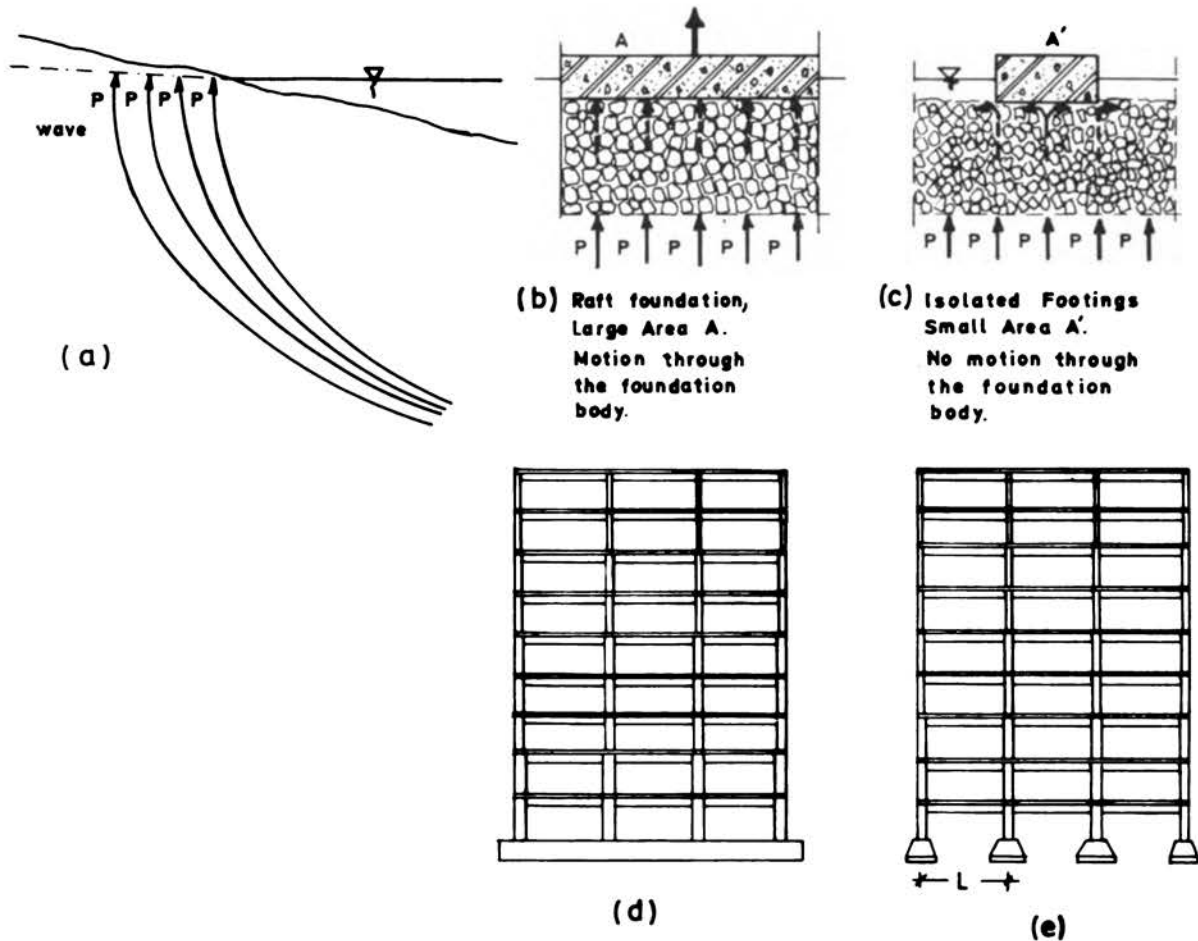
FIGURE 6.26 Incident P wave fronts (a) may disturb a foundation over porous submerged soil material (b) or they may not disturb it (c). In all cases the extra dynamic vertical pressure of the porous material should be added to the existing static pressure due to the structure. Case (d) gives a small static pressure, which is less favorable than in case (e), which gives a higher static pressure, depending on the dimensions of the footings.

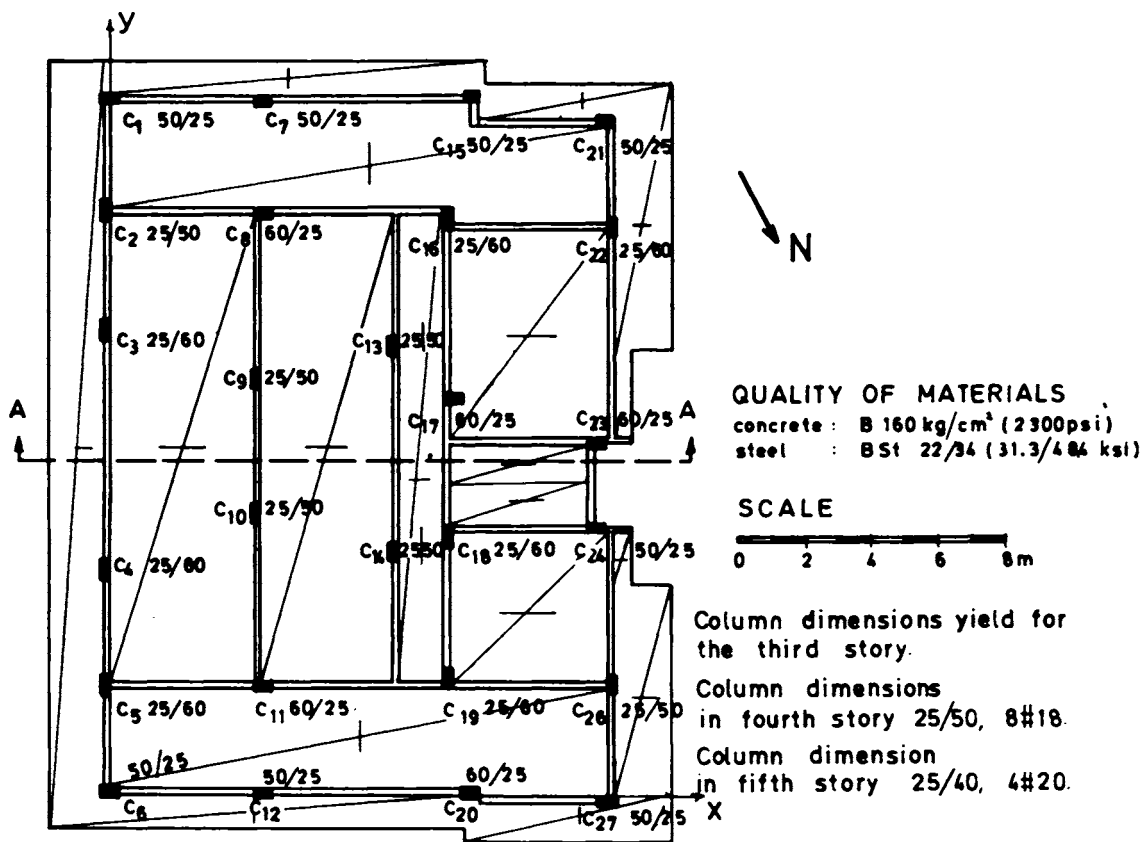
(a) Typical floor framing plan.

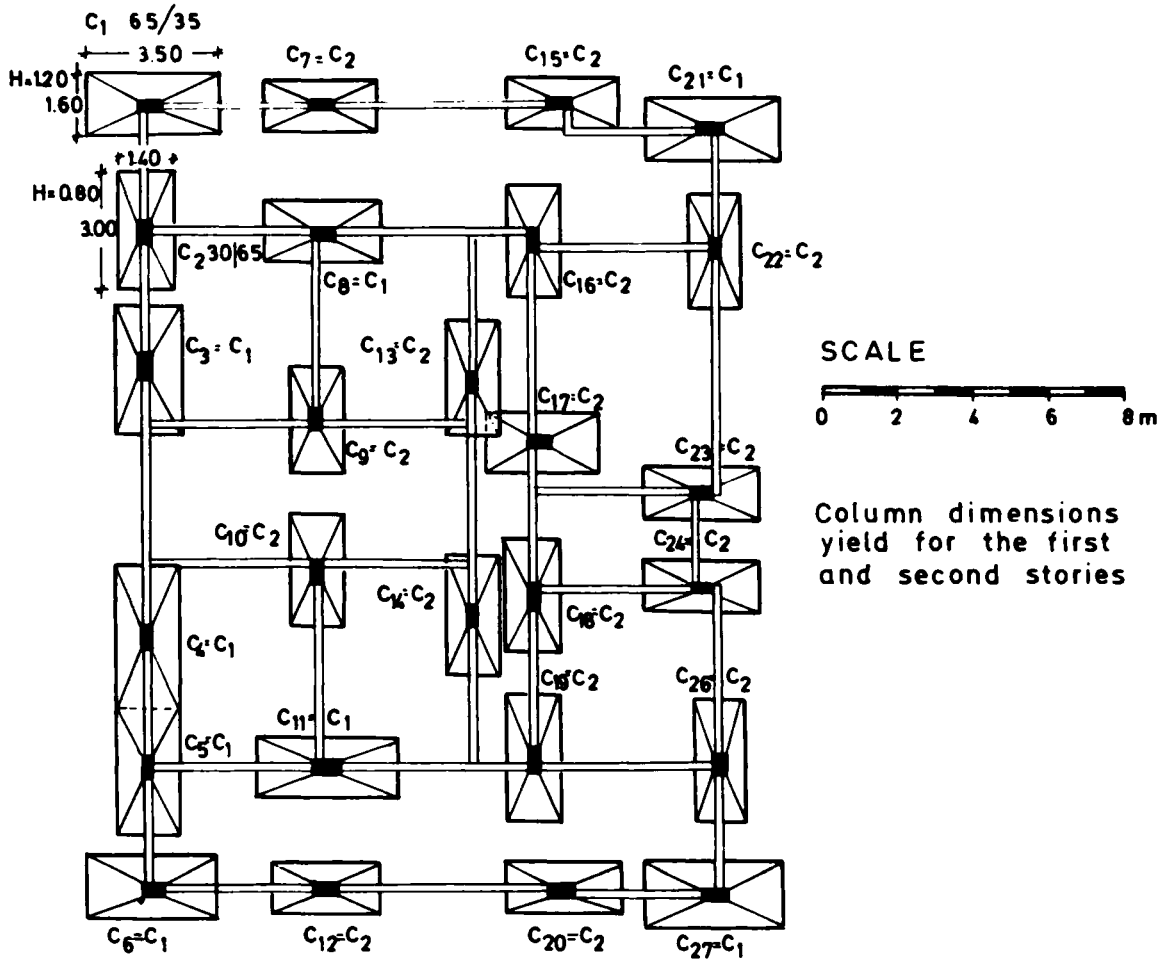
FIGURE 6.35 Block of Flats Segas in Loutraki. Foundation framing plan.

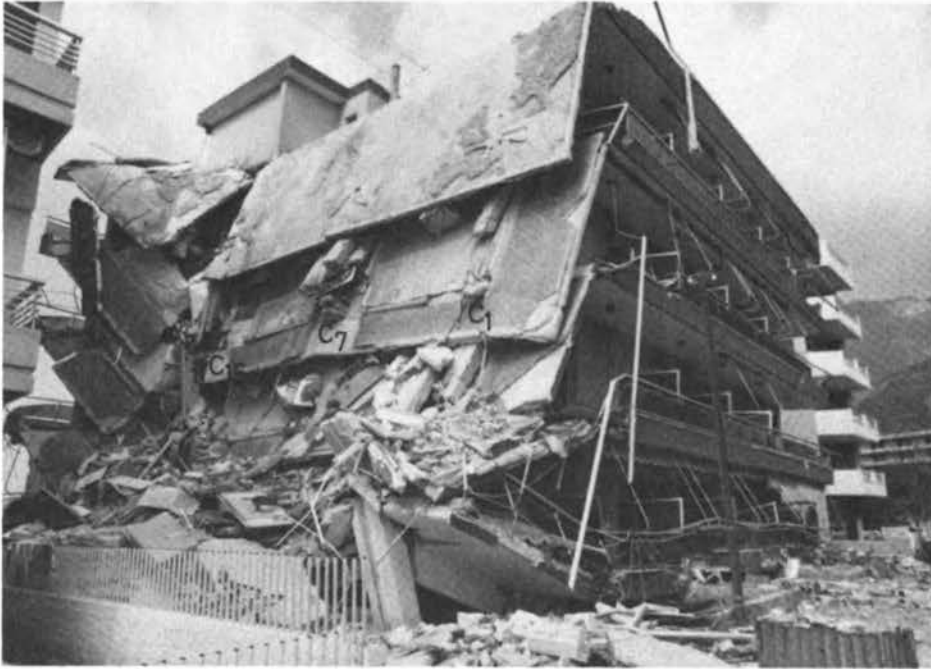
FIGURE 6.36 Block of Flats Segas in Loutraki. The structure from the southeast.

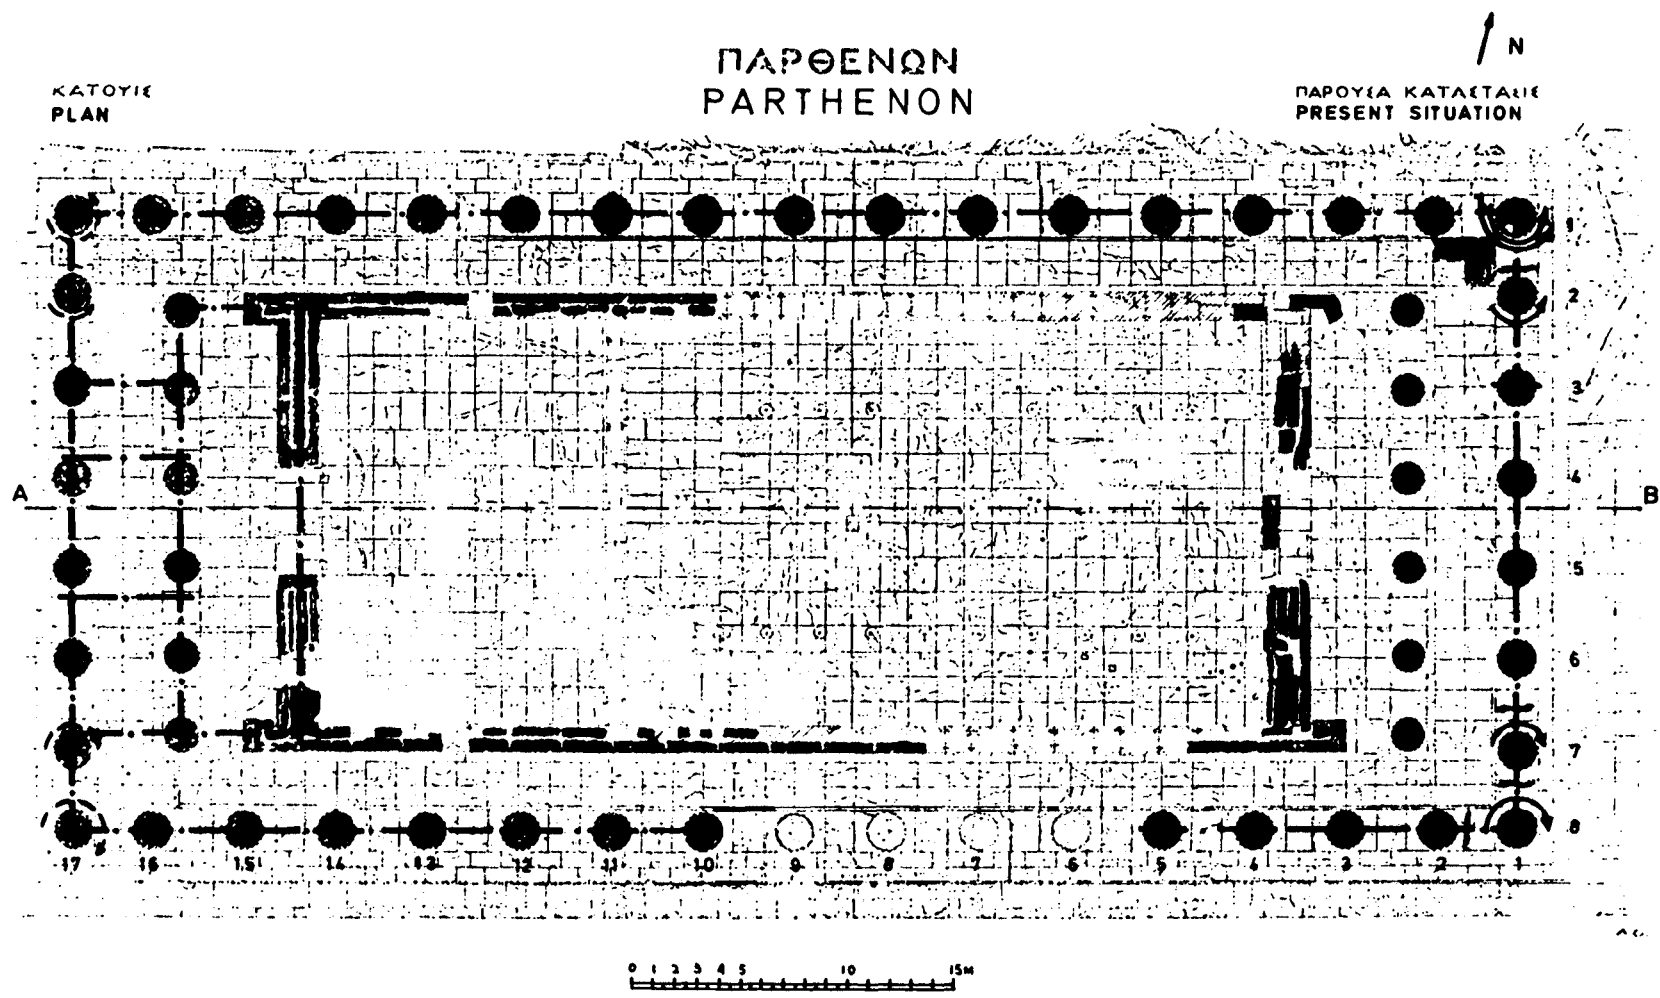
Α. Κ. ΟΡΛΑΝΔΟΣ Η ΑΡΧΙΤΕΚΤΟΝΙΚΗ ΤΟΥ ΠΑΡΘΕΝΩΝΟΣ
A.K. ORLANDOS THE ARCHITECTURE OF PARTHENON

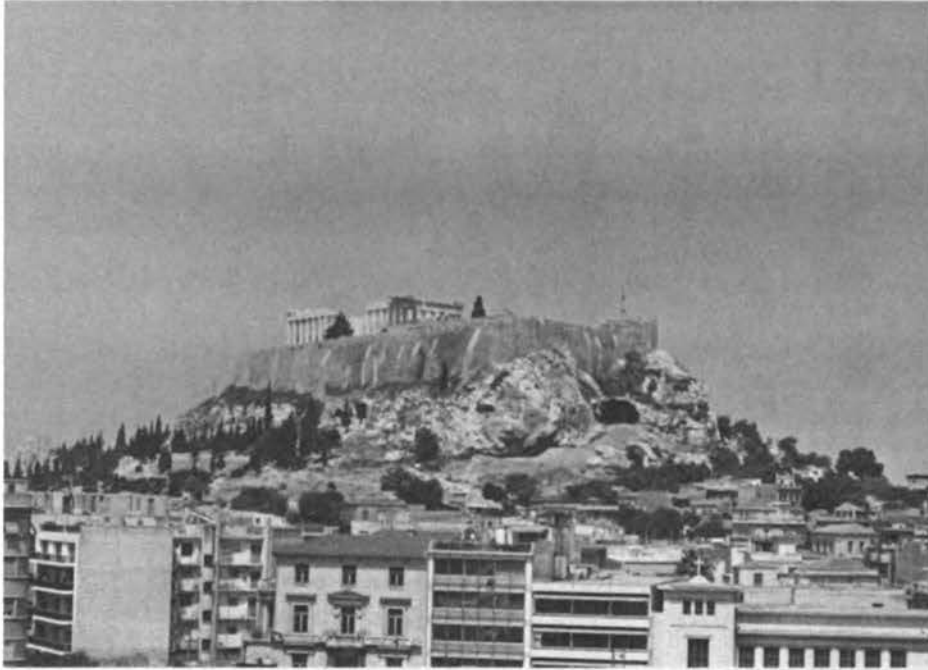
FIGURE 6.43 East view of the Parthenon on the Acropolis hill.

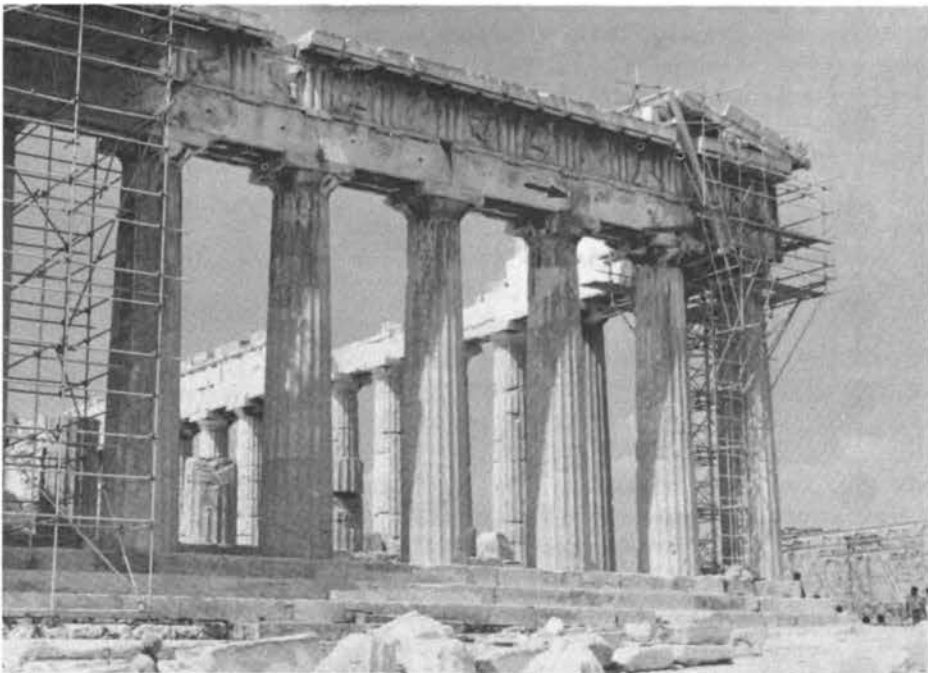
FIGURE 6.44 East view of the Parthenon. The arrow indicates a large crack in the head beam over the third pillar. There are also large cracks in the head beam between the first and second pillars.

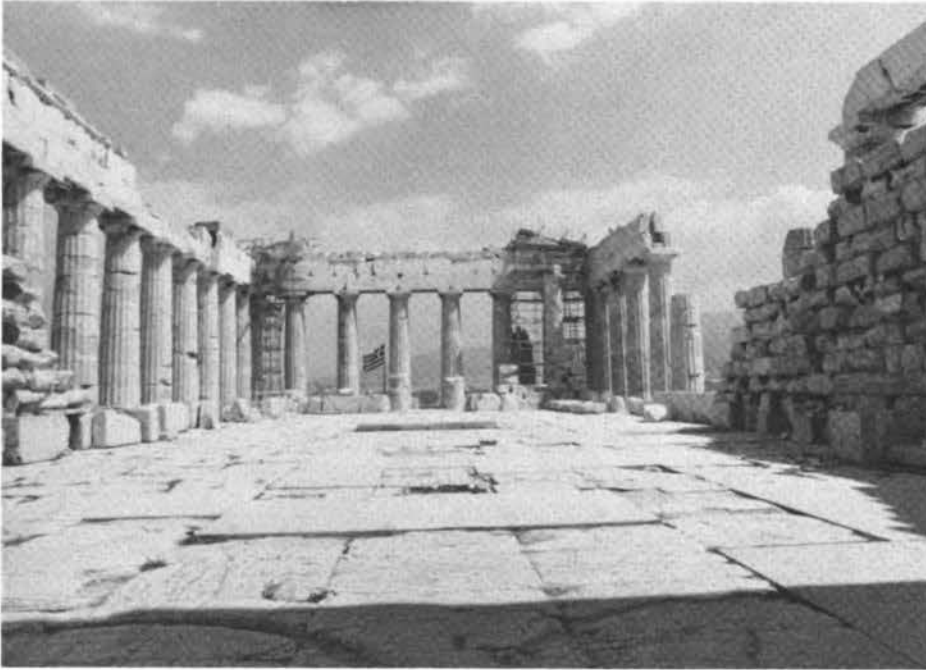
FIGURE 6.45 East side of the Parthenon viewed from the inside. The head beam is supported horizontally only at its two ends. The most damage was concentrated around these two points. Source: Dontas (1981).

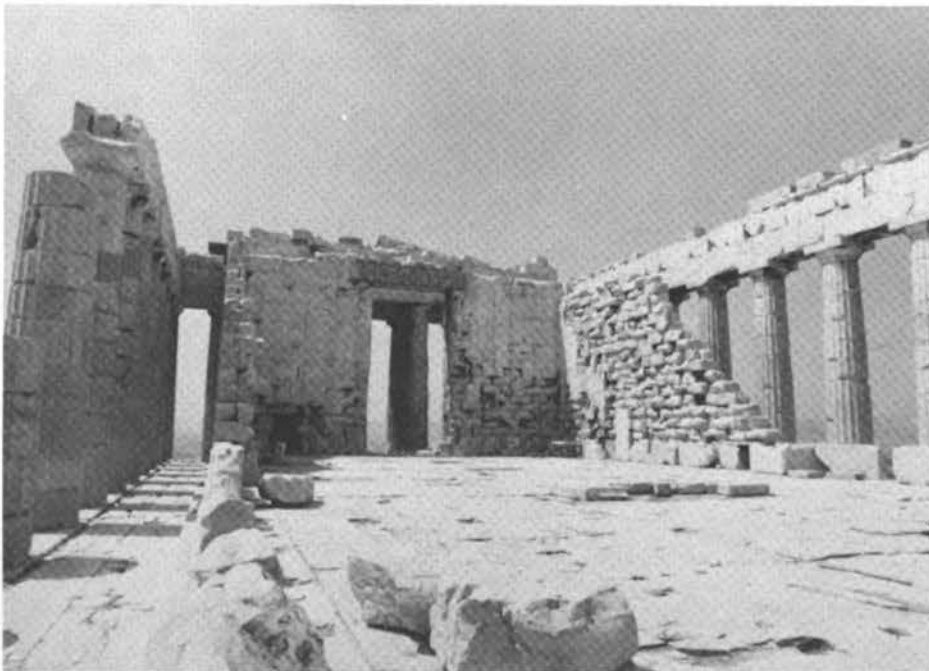
FIGURE 6.46 West side of the Parthenon viewed from the inside. The head beam in the back is connected horizontally by short beams to the inside construction (see Figure 6.42). Source: Dontas (1981).

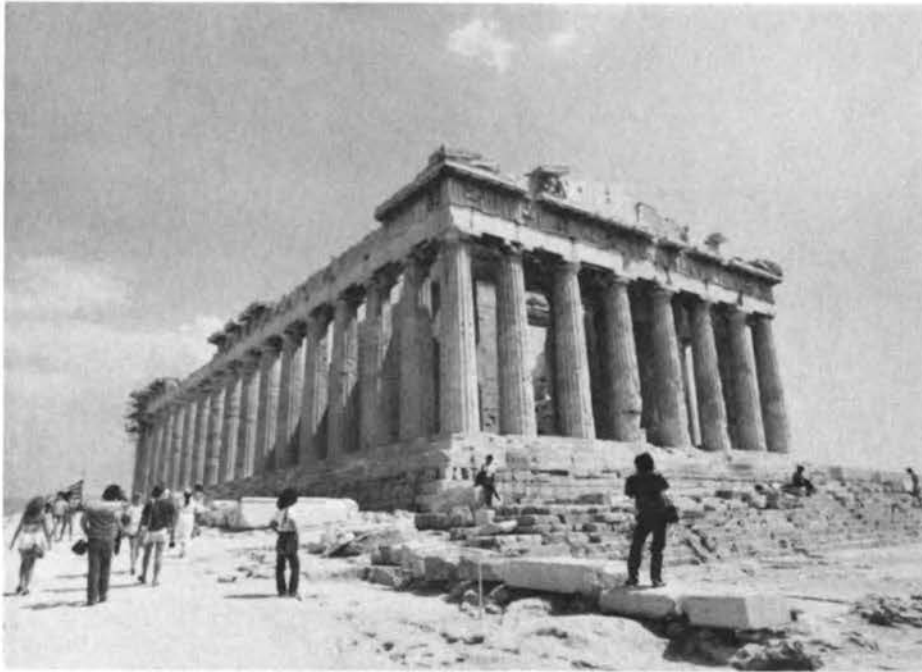
FIGURE 6.47 West view of the Parthenon as it stands now, after the earthquakes. The north and west sides are the best preserved and were least damaged by the recent earthquakes. Source: Dontas (1981).

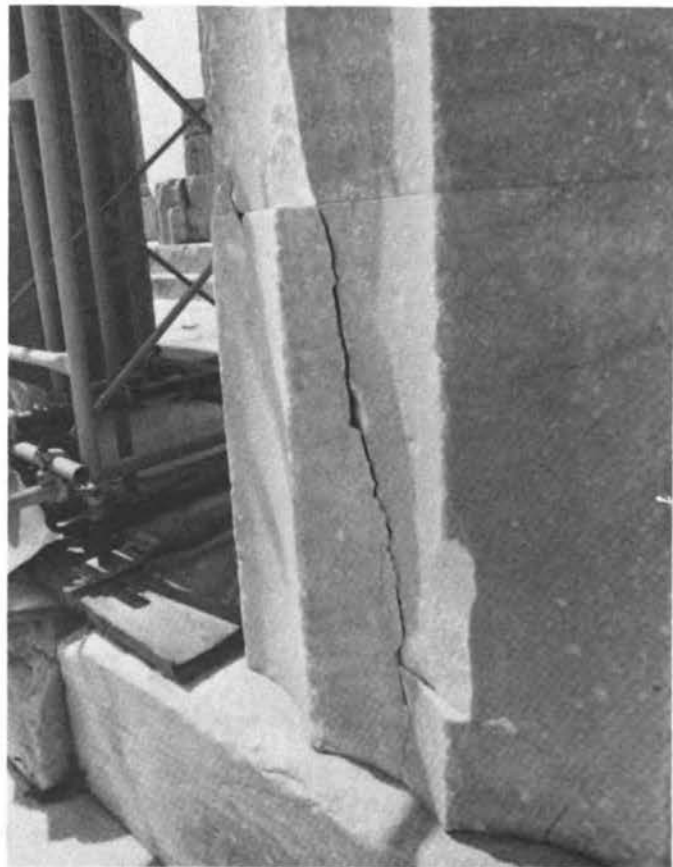
FIGURE 6.48 Pillar at the northeast corner of the Parthenon. The pillar rotated anticlockwise, which displaced its top periphery by about 5 cm. Source: Dontas (1981).

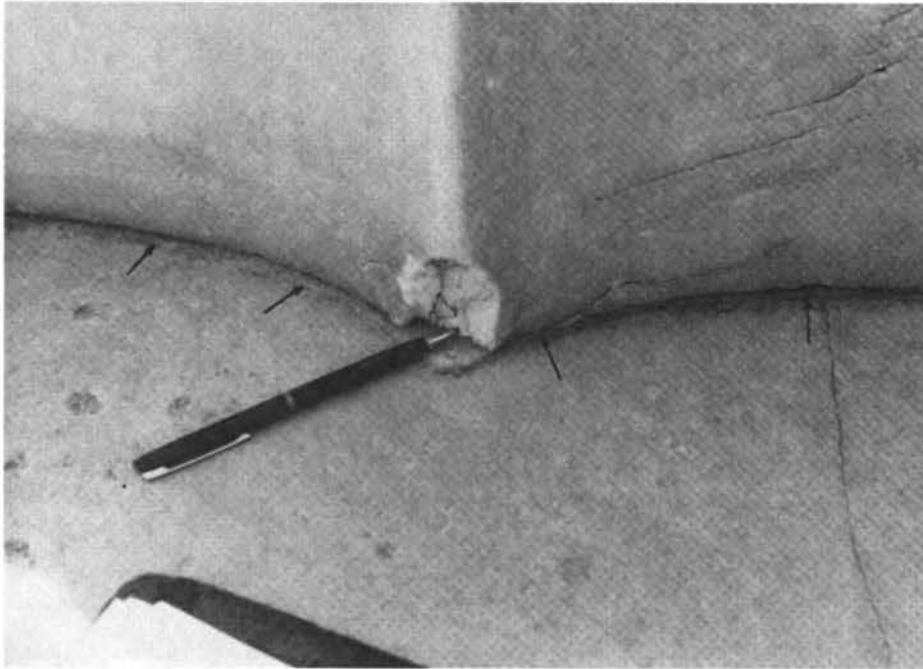
FIGURE 6.49 Lowest part of the pillar at the northeast corner of the Parthenon. This shows typical breaking of the edge of the pillar. An anticlockwise rotation and displacement of about 1-2 cm to the west was observed. Source: Dontas (1981).

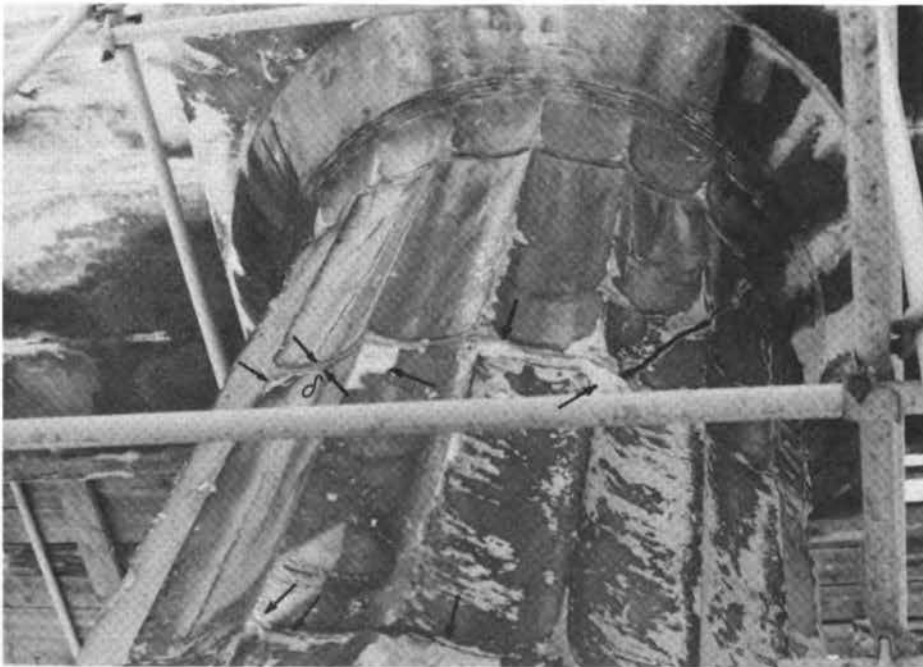
FIGURE 6.50 Upper part of the seventh pillar on the east side of the Parthenon. Arrows show spalling due to recent earthquakes. Source: Dontas (1981).

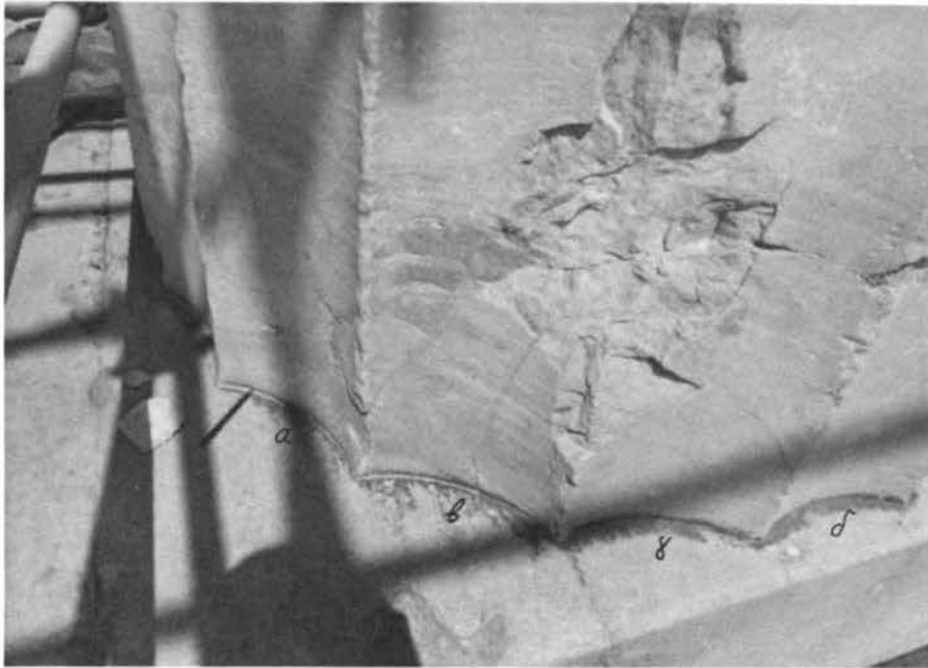
FIGURE 6.51 Lower part of the pillar at the southeast corner of the Parthenon. A clockwise rotation and displacement of the pillar to the east of about 1-2 cm was observed. Some fallen marble chips may be seen. Source: Dontas (1981).

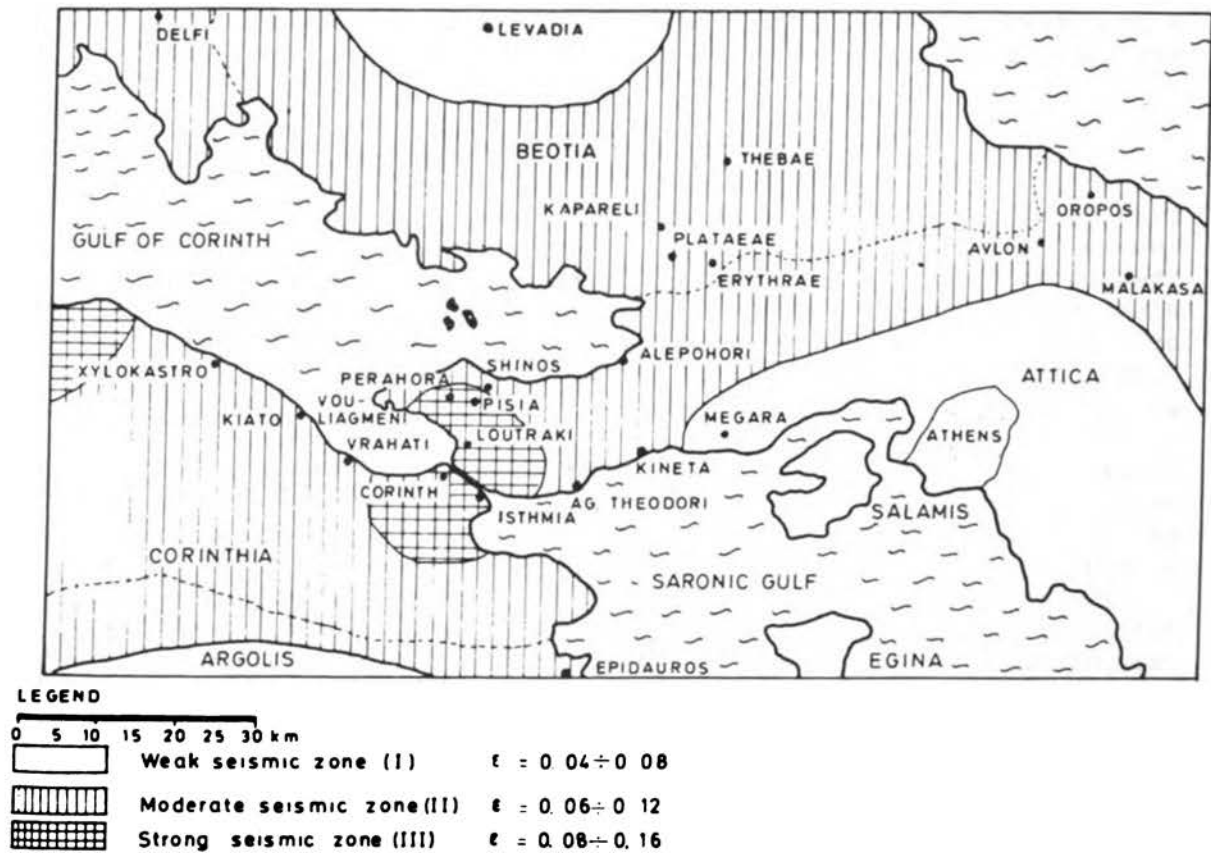
FIGURE B.1 Seismic zones of the affected area according to the existing code.
