Hurricane Iwa, Hawaii, November 23, 1982 (1983)

Hurricane Iwa, Hawaii, November 23, 1982

Committee on Natural Disasters
Commission on Engineering and Technical Systems
National Research Council

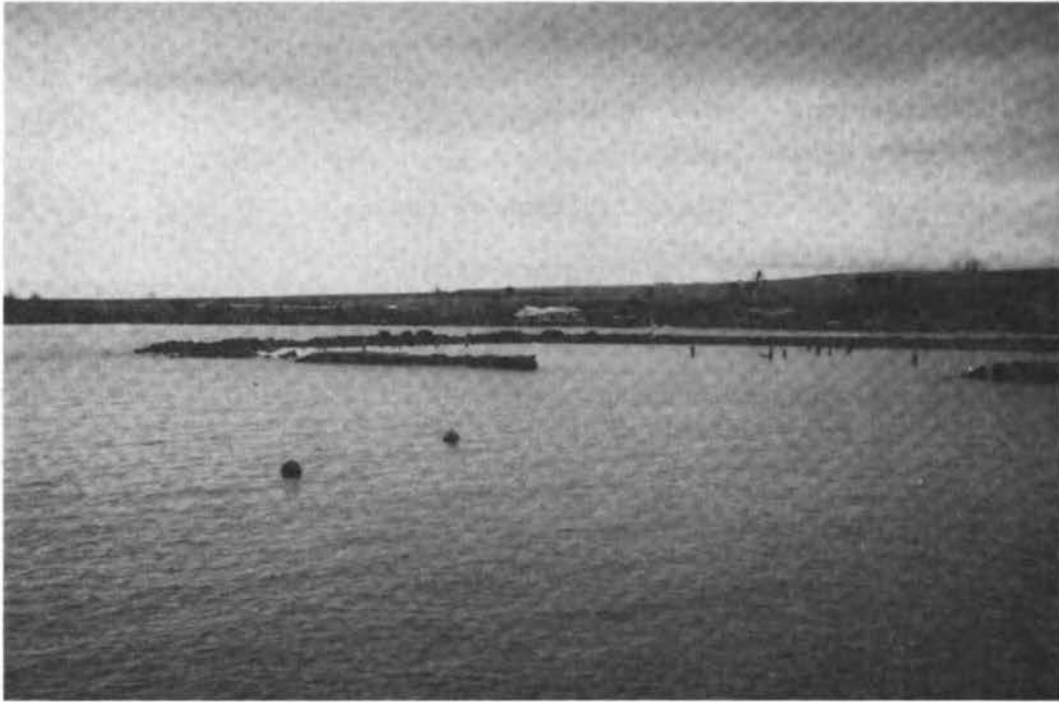
FIGURE 3.1 Damage to small-boat harbor breakwater at Port Allen, Kauai.

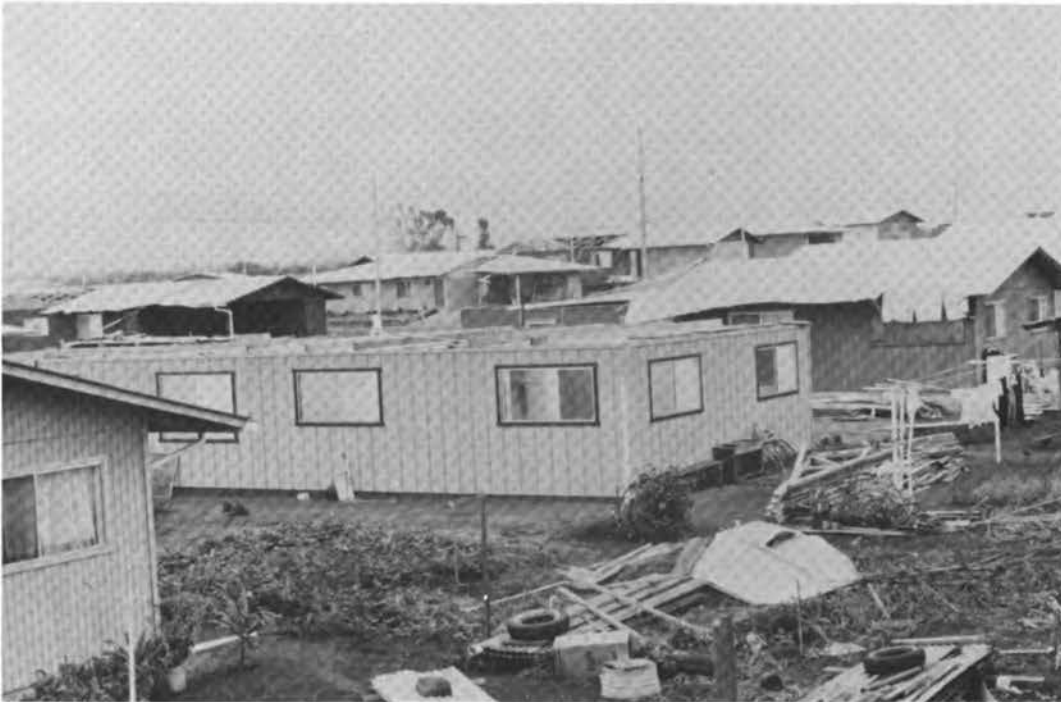
FIGURE 3.5 Damage to residential development at Kapaa Meadows, Kauai.

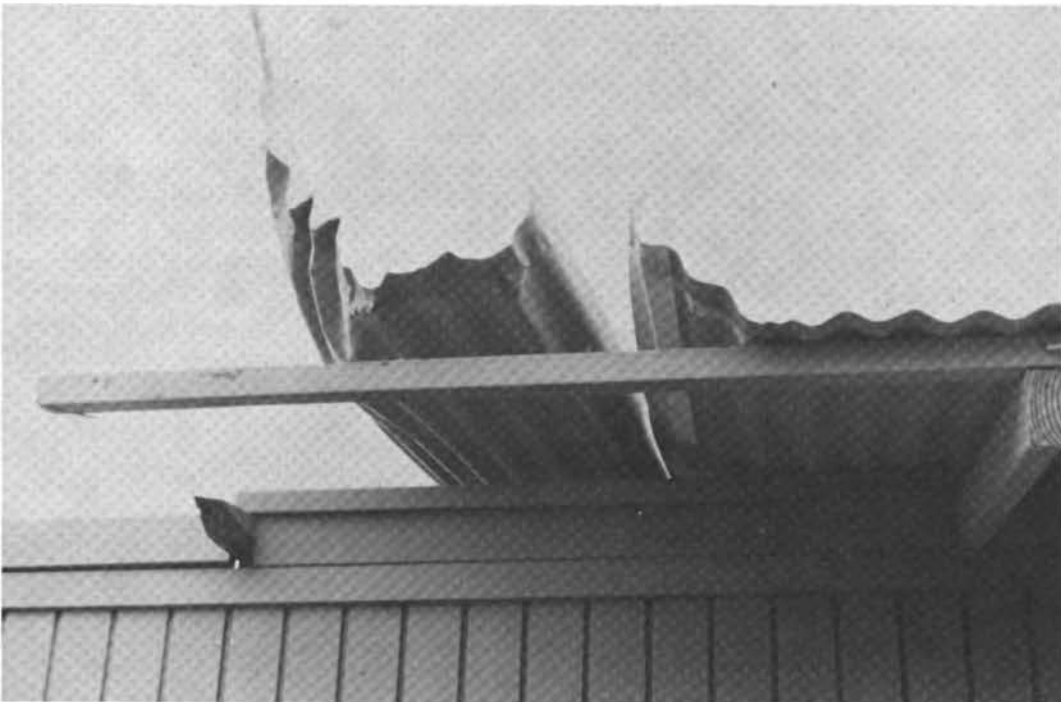
FIGURE 3.6 Light-gage corrugated metal sheeting used as roof covering.

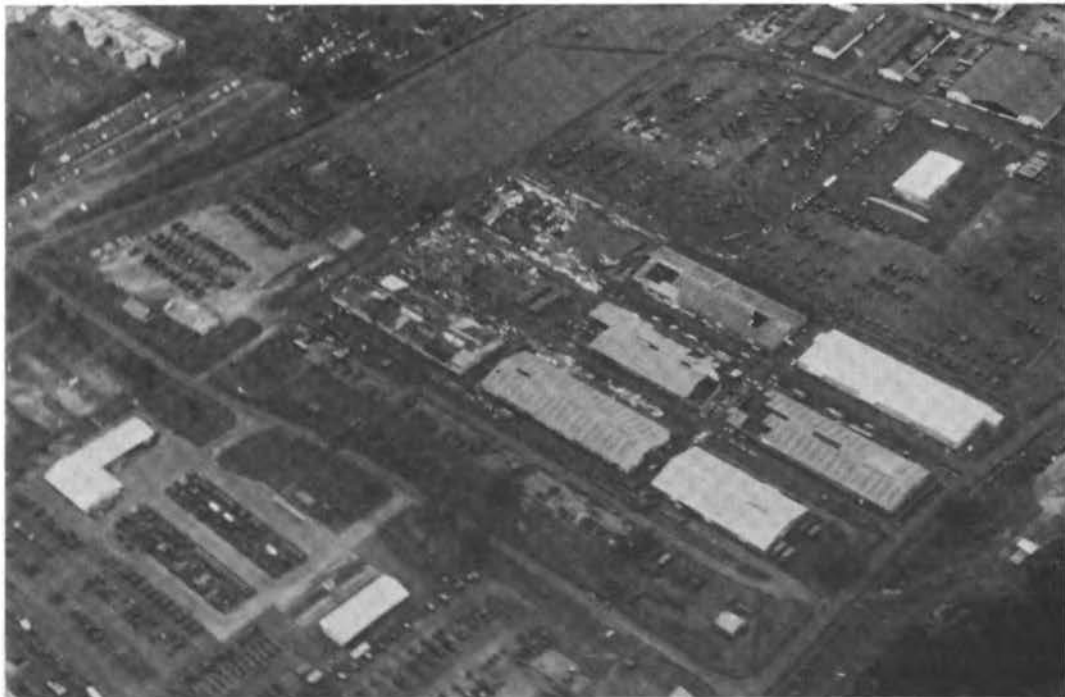
FIGURE 3.8 Damage to warehouse buildings at Schofield Barracks, Oahu.

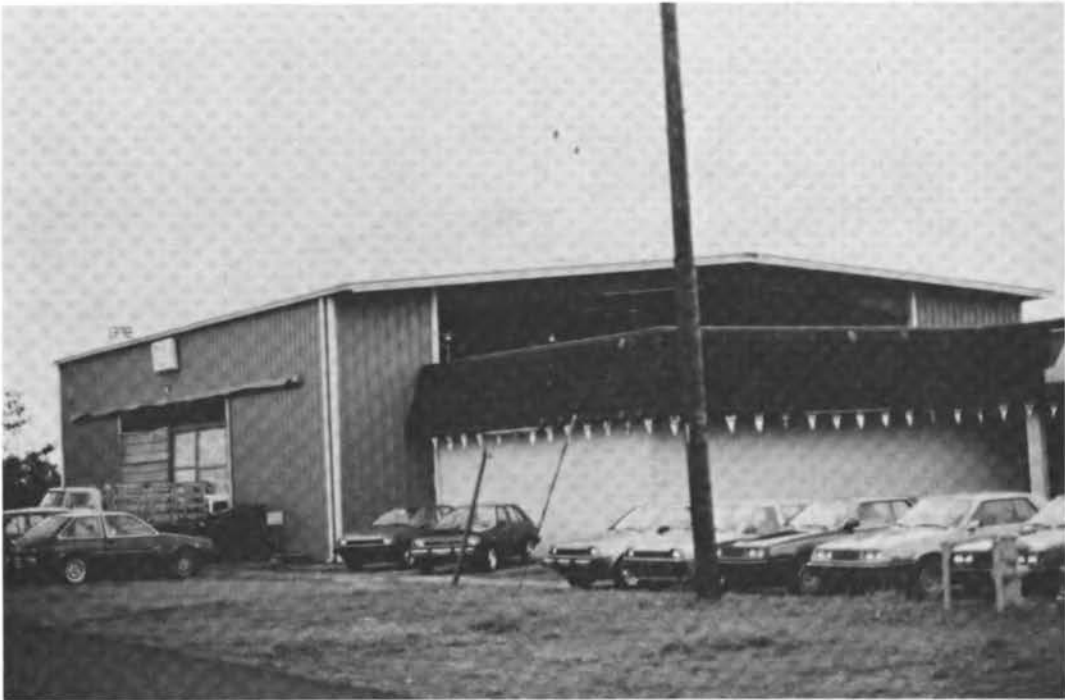
FIGURE 3.11 Damaged preengineered metal building at Kauai (note natural ventilation built into windward wall).

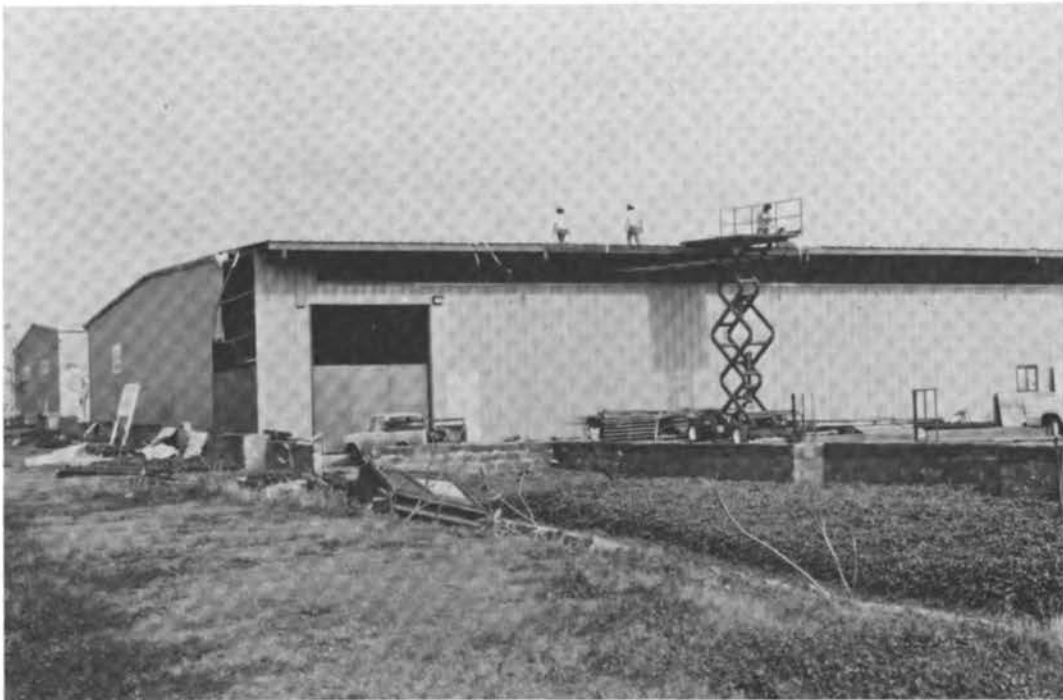
FIGURE 3.12 Damaged preengineered metal building at Kauai (note natural ventilation built into windward wall, damage sustained by roof and side wall, and roll-up doors blown off tracks).

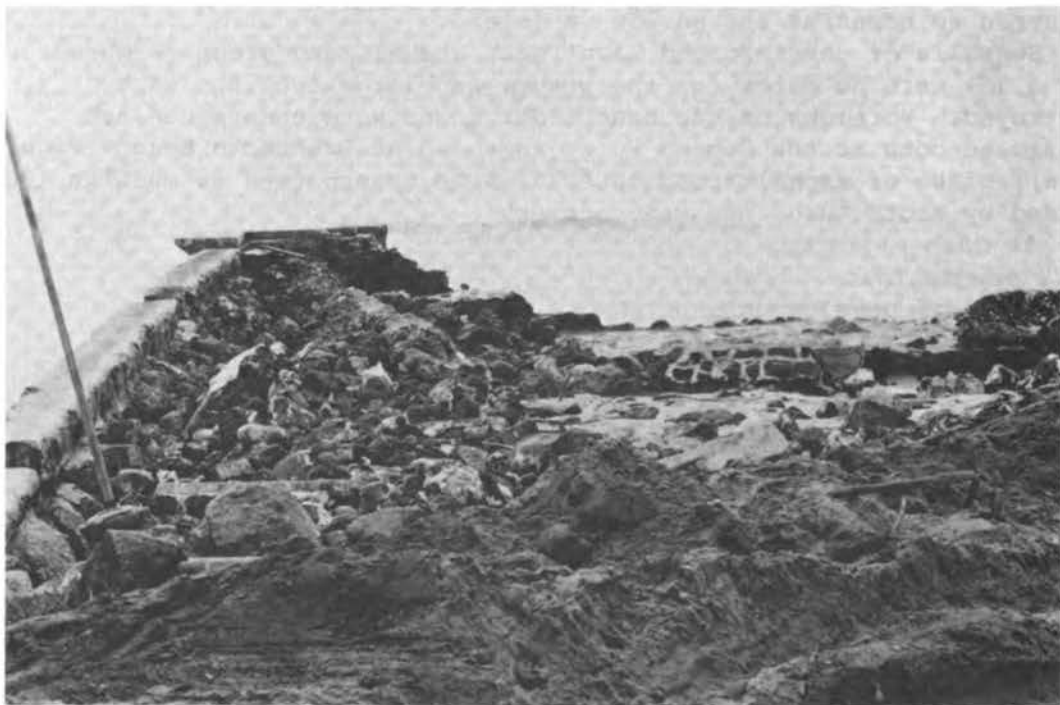
FIGURE 3.14 Damage to seawall at Poipu Beach, Kauai.

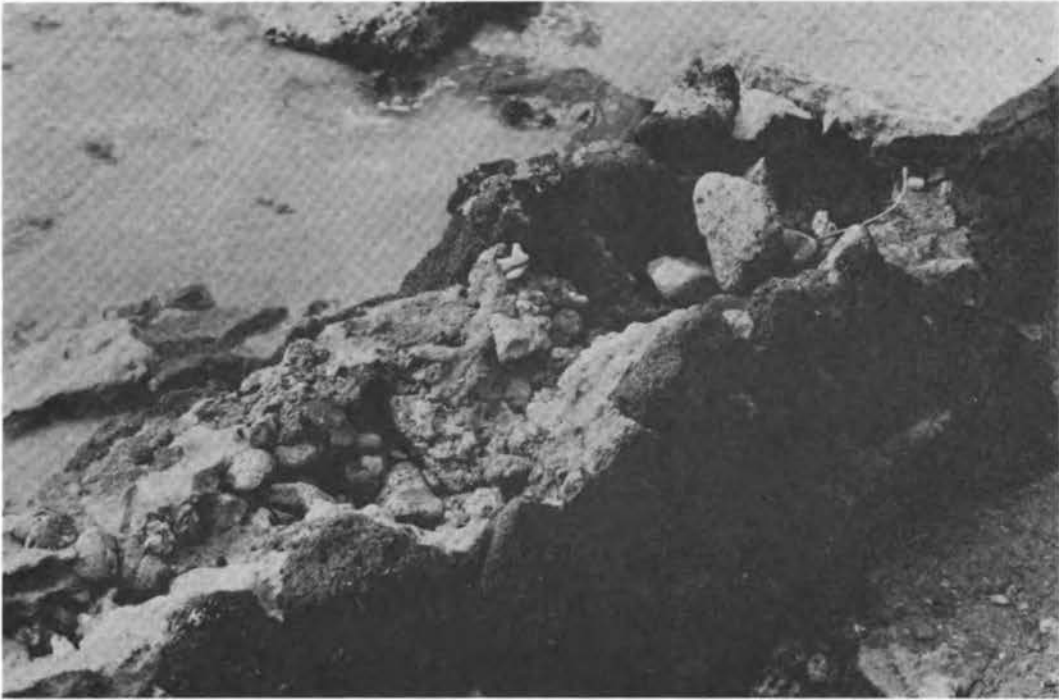
FIGURE 3.15 Damaged unreinforced grouted lava rock seawall.

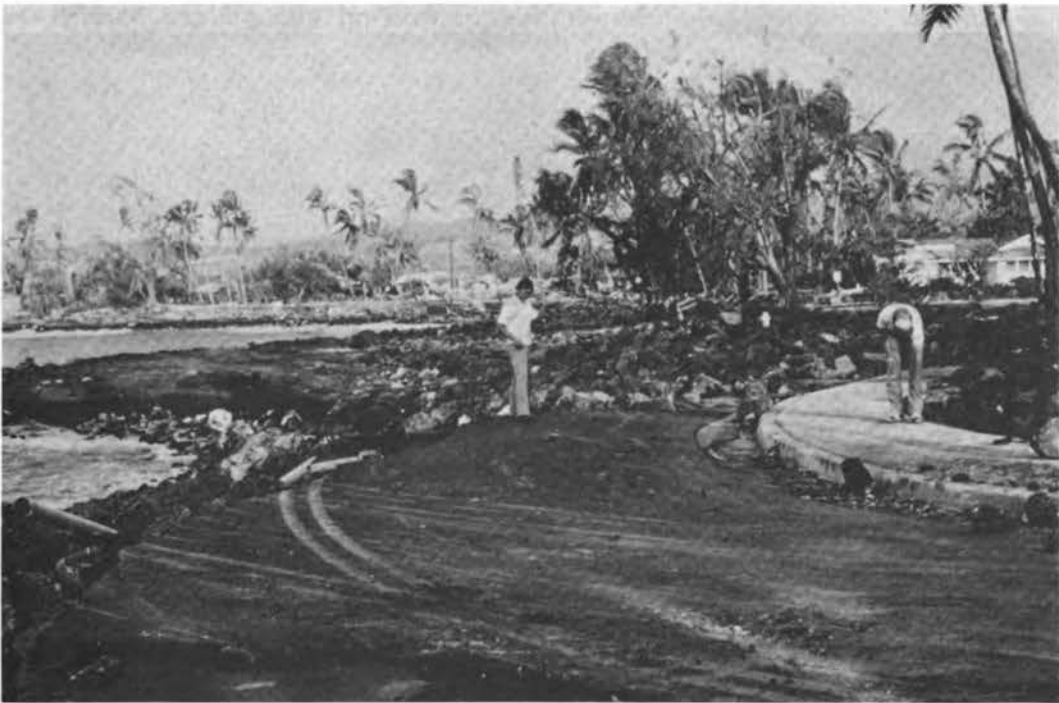
FIGURE 3.16 Undermined and destroyed section of Hoone Road at Poipu Beach, Kauai.

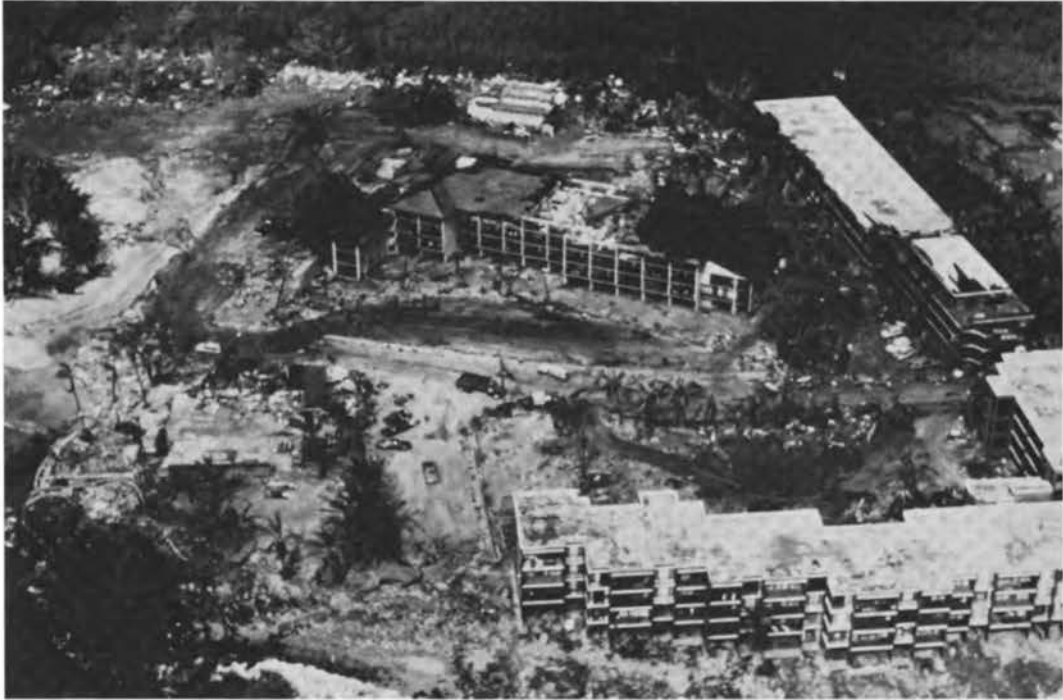
FIGURE 3.17 Damage to Kuhio Shores Resort development, Kauai (note proximity of buildings to shoreline).

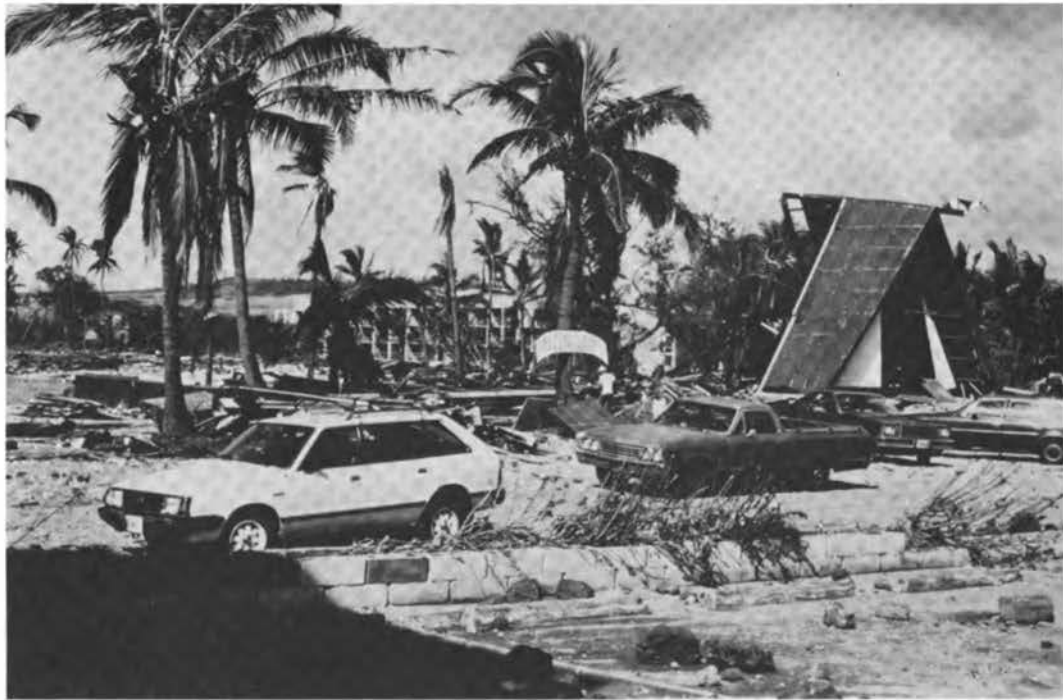
FIGURE 3.18 Damage to Beach House Restaurant at Kuhio Shores, Kauai.

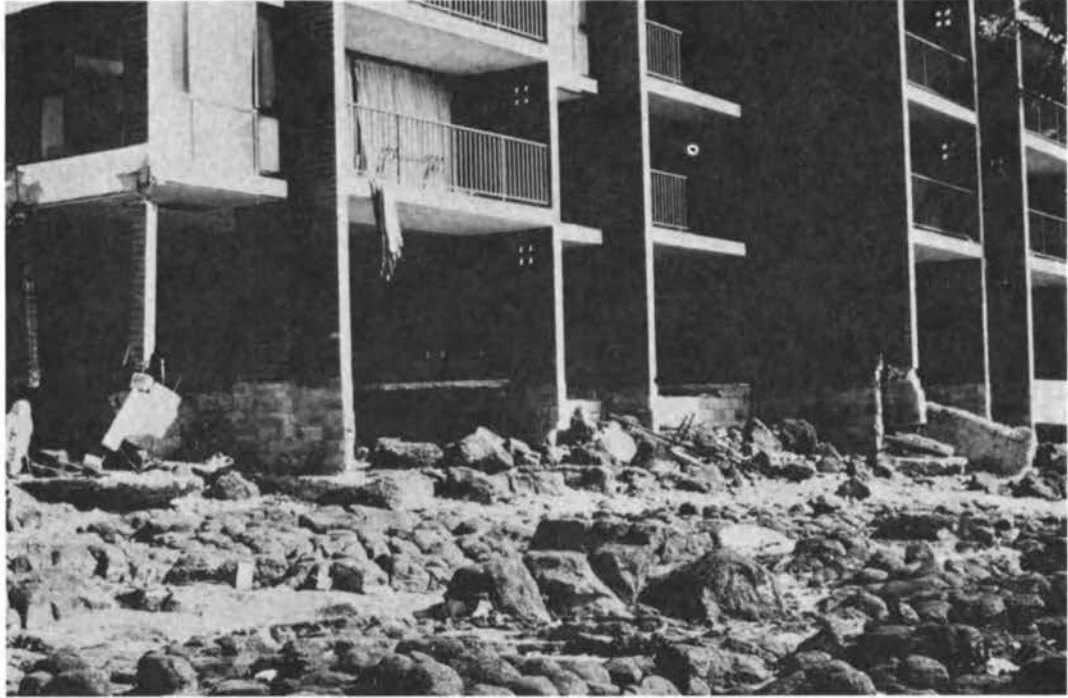
FIGURE 3.19 Damage to Kuhio Shores Condominium, Kauai (note scouring of footings).

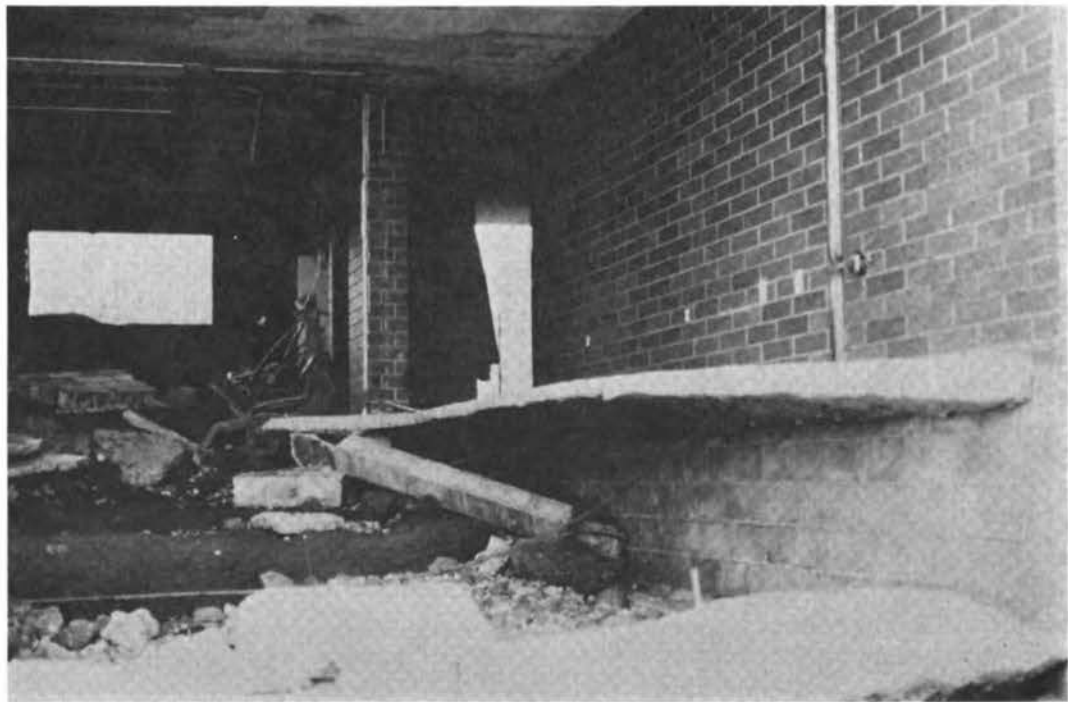
FIGURE 3.20 Damage at first-floor level of Kuhio Shores Condominium, Kauai (note variable thickness of floor slab and reinforcing steel exposed at bottom of slab).

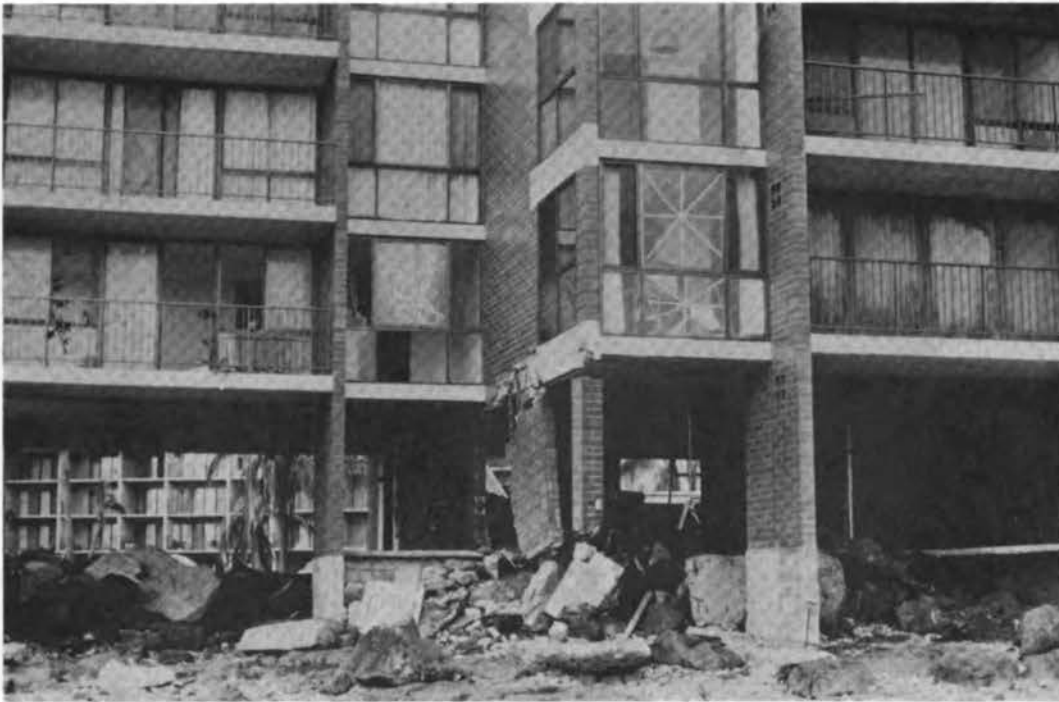
FIGURE 3.21 Damage to bearing walls of Kuhio Shores Condominium, Kauai (note large boulders transported to interior of building by storm surge and wave action).

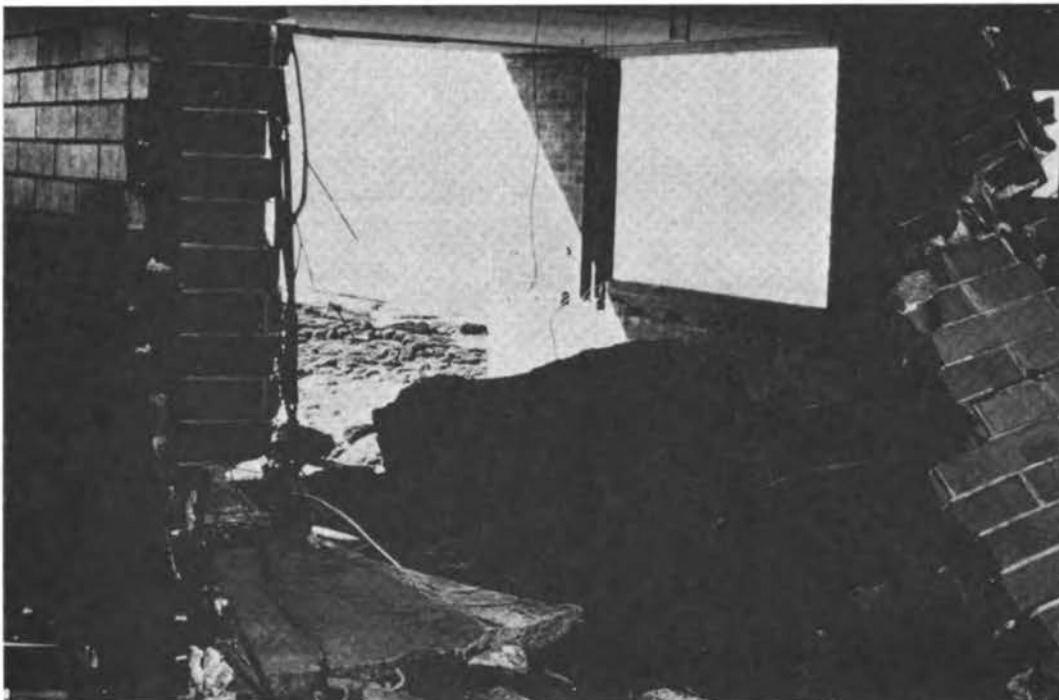
FIGURE 3.22 Damage to nonbearing wall of Kuhio Shores Condominium, Kauai.

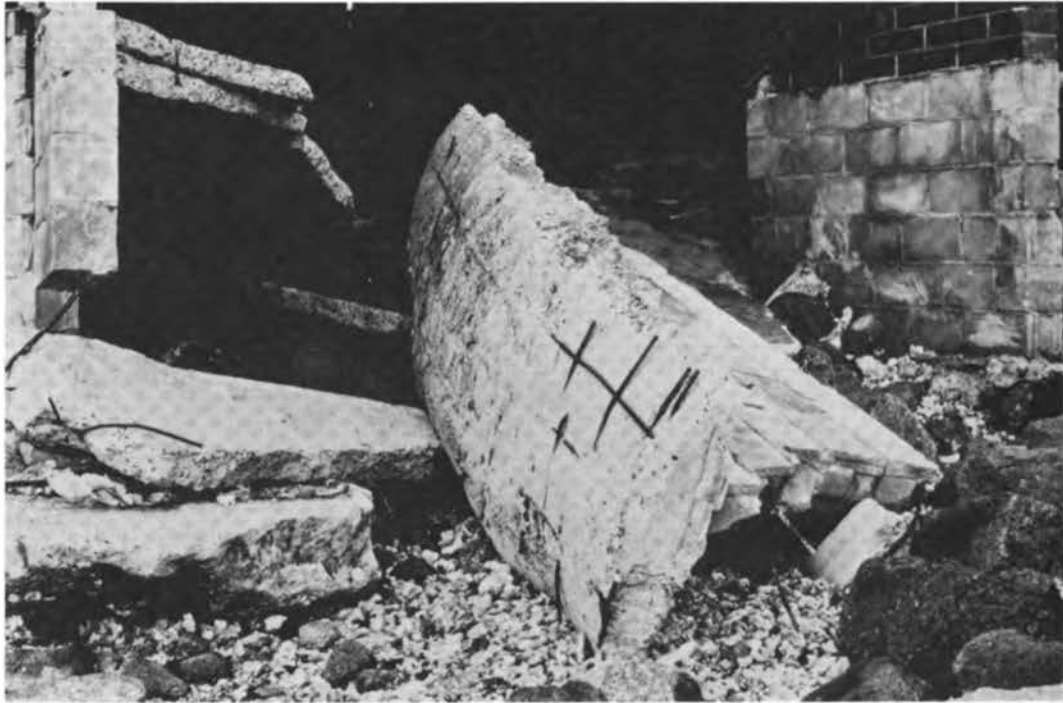
FIGURE 3.23 Damage to footing, Kuhio Shores Condominium, Kauai.

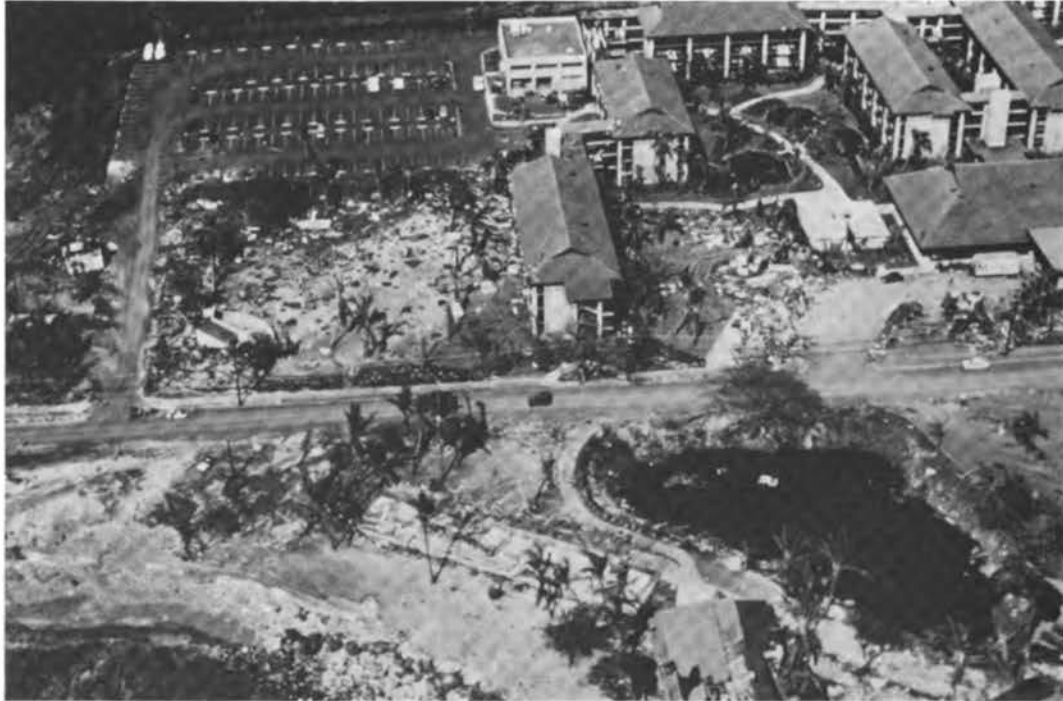
The newer section of the Sheraton-Kauai shown at the top of the photograph of Figure 3.24 was partially shielded from wave action,

FIGURE 3.24 Damage to Sheraton-Kauai at Poipu Beach due to storm surge, wave action, and wind.

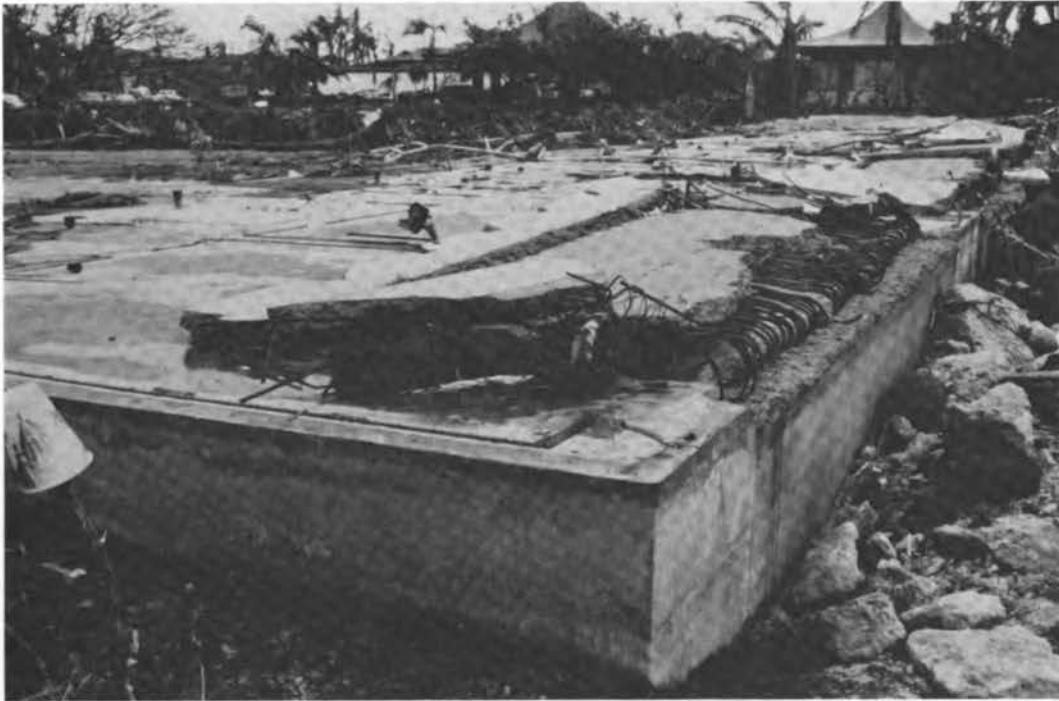
FIGURE 3.25 Remains of two-story hotel unit at Sheraton-Kauai (note lanai slab bent backwards 180 degrees).

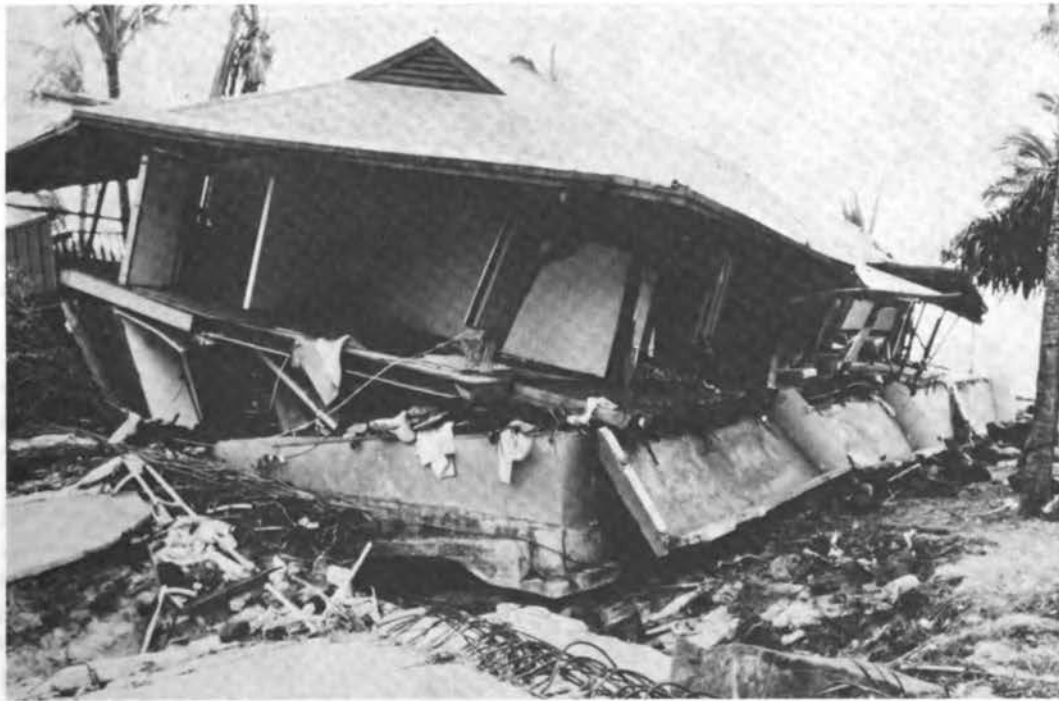
FIGURE 3.26 Damage to timber-framed unit at Sheraton-Kauai.

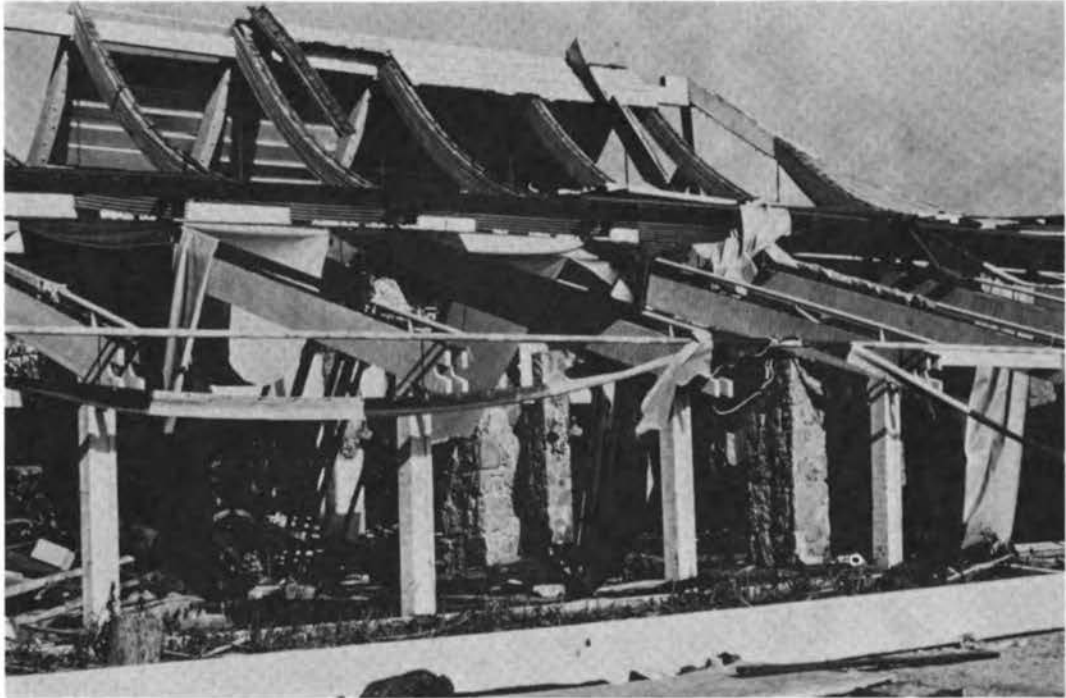
FIGURE 3.27 Flooding and wind-induced damage to Drum Lounge at Sheraton-Kauai.

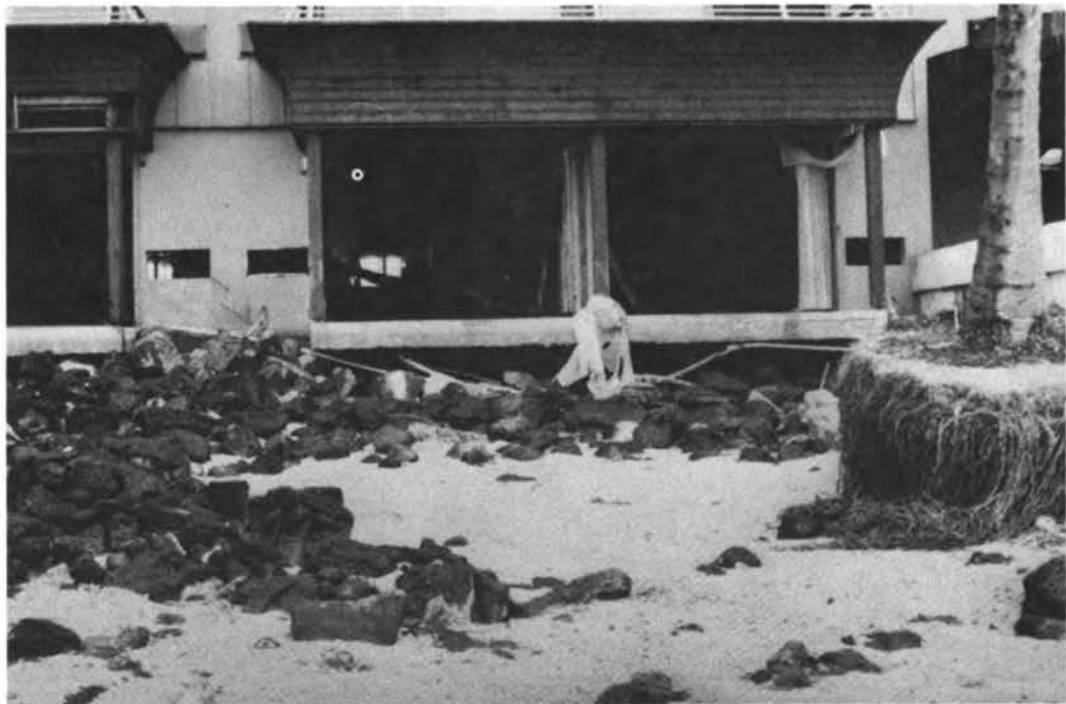
FIGURE 3.28 Erosion of footings of three-story unit at Sheraton-Kauai.

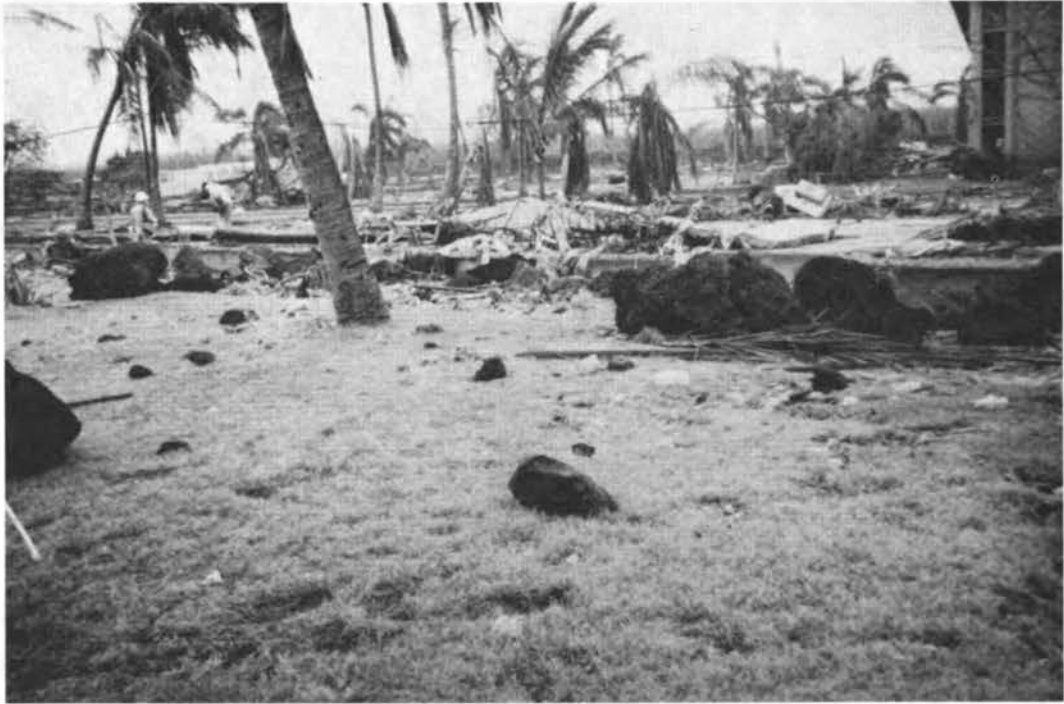
FIGURE 3.30 Waterborne debris at Sheraton-Kauai.

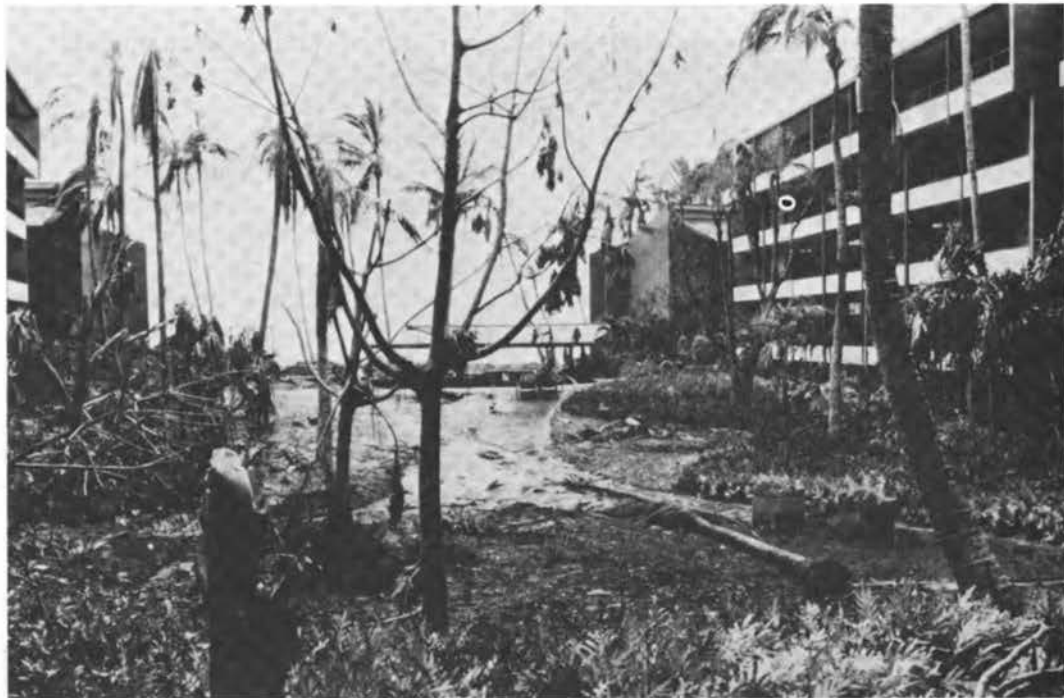
FIGURE 3.31 Wave and flooding damage at Waiohai Hotel, Kauai.

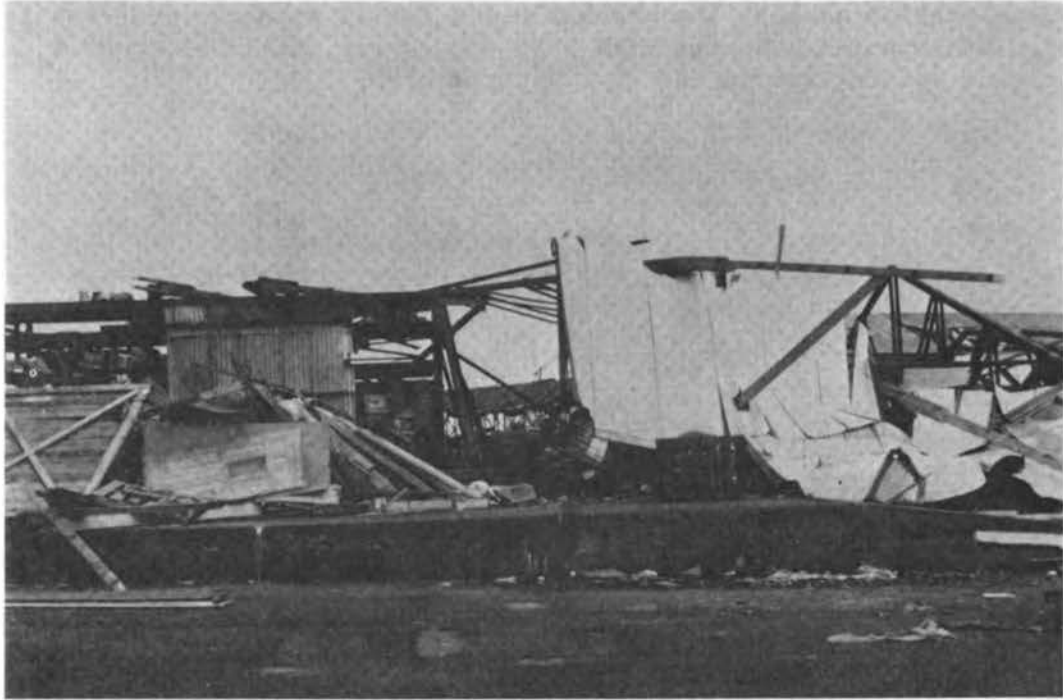
FIGURE 3.32 Wind damage to timber-framed warehouse structure at Port Allen, Kauai.

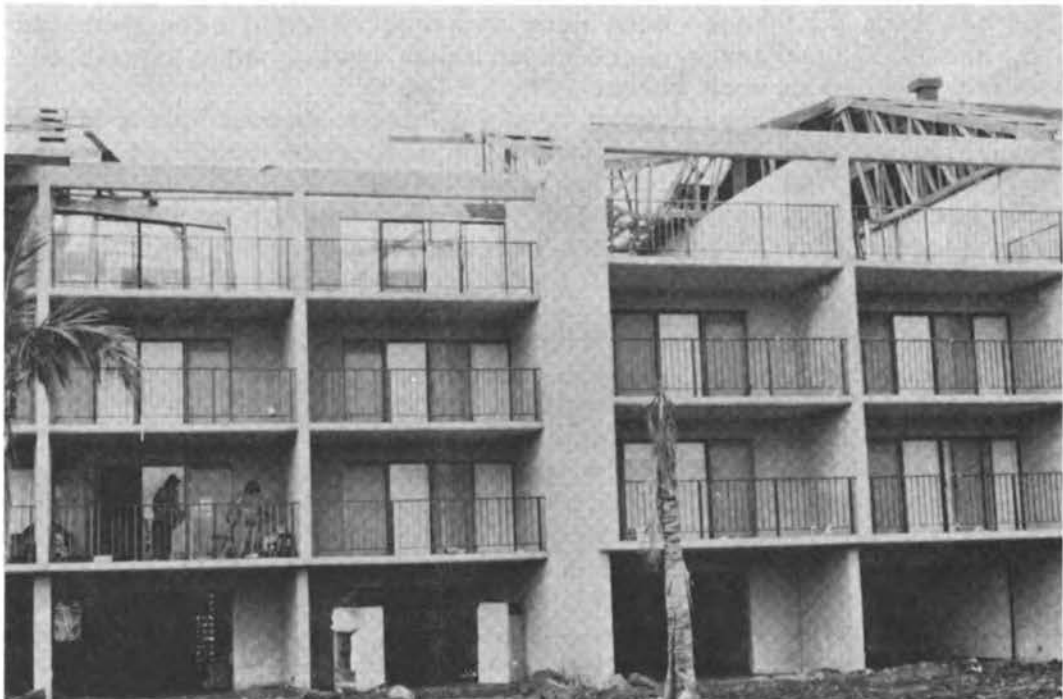
FIGURE 3.33 Wind damage to Prince Kuhio Condominium, Kauai (note geometric discontinuity in roof).

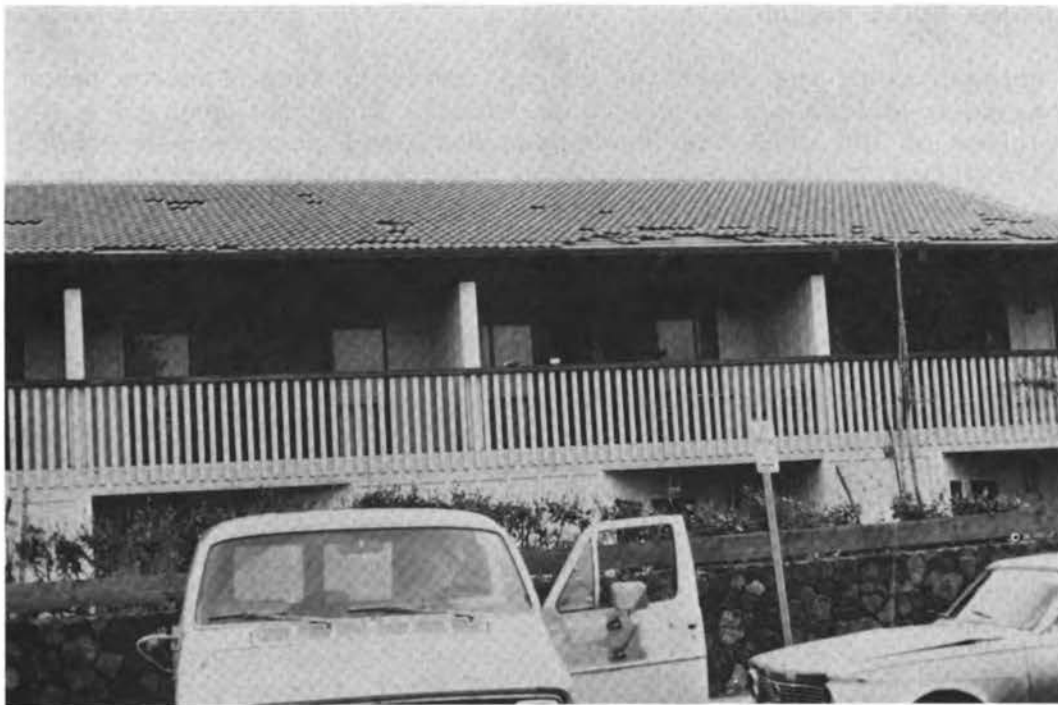
FIGURE 3.35 Cladding damage to building inland from Poipu Beach, Kauai.

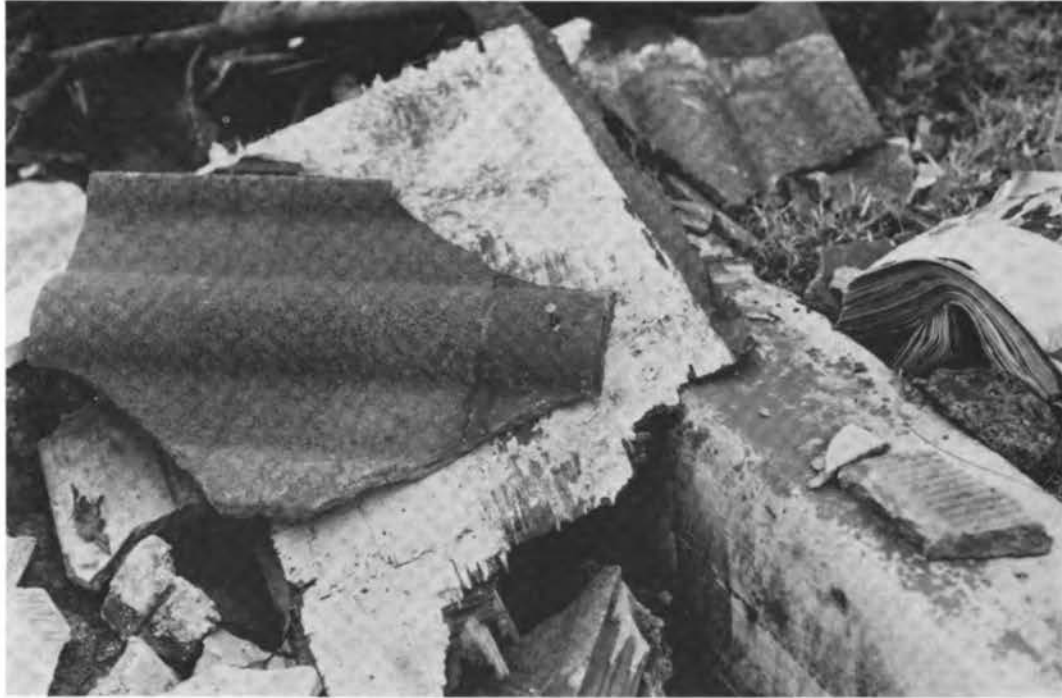
FIGURE 3.36 Monier-type roof tile (note single 8d nail fastener).

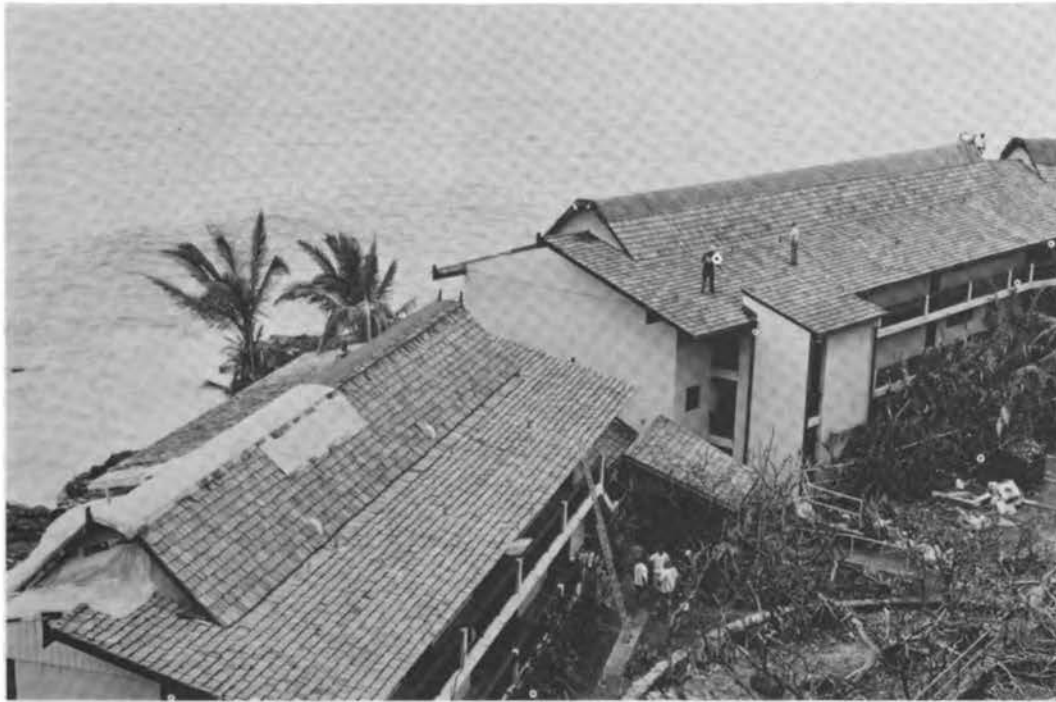
FIGURE 3.38 Cladding damage to condominiums at Makahuena Point, Kauai.

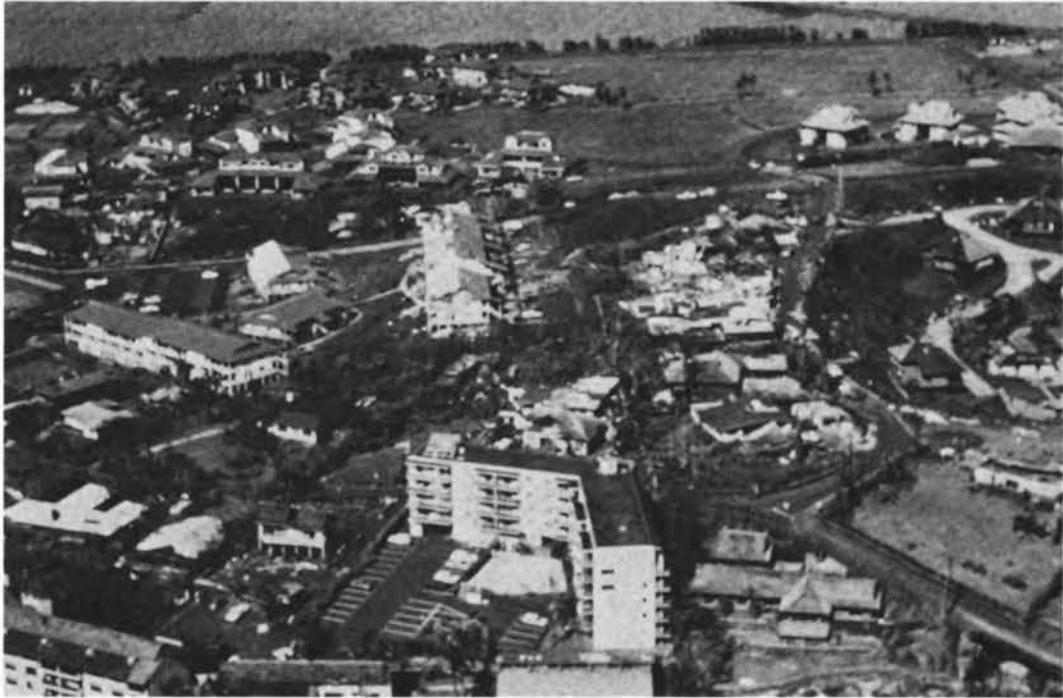
FIGURE 3.39 Poipu Shores Condominiums (L-shaped building at bottom of photograph sustained extensive missile damage).

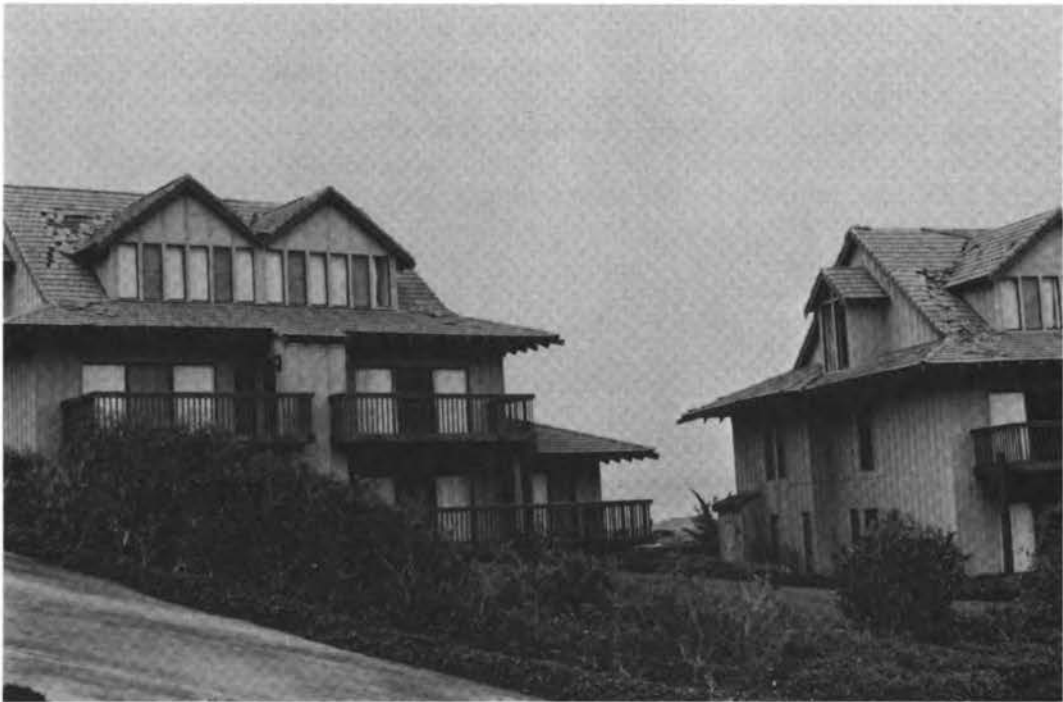
FIGURE 3.40 Minor cladding damage to homes inland from Makahuena Point, Kauai.
