Hurricane Iwa, Hawaii, November 23, 1982 (1983)

Hurricane Iwa, Hawaii, November 23, 1982

Committee on Natural Disasters
Commission on Engineering and Technical Systems
National Research Council

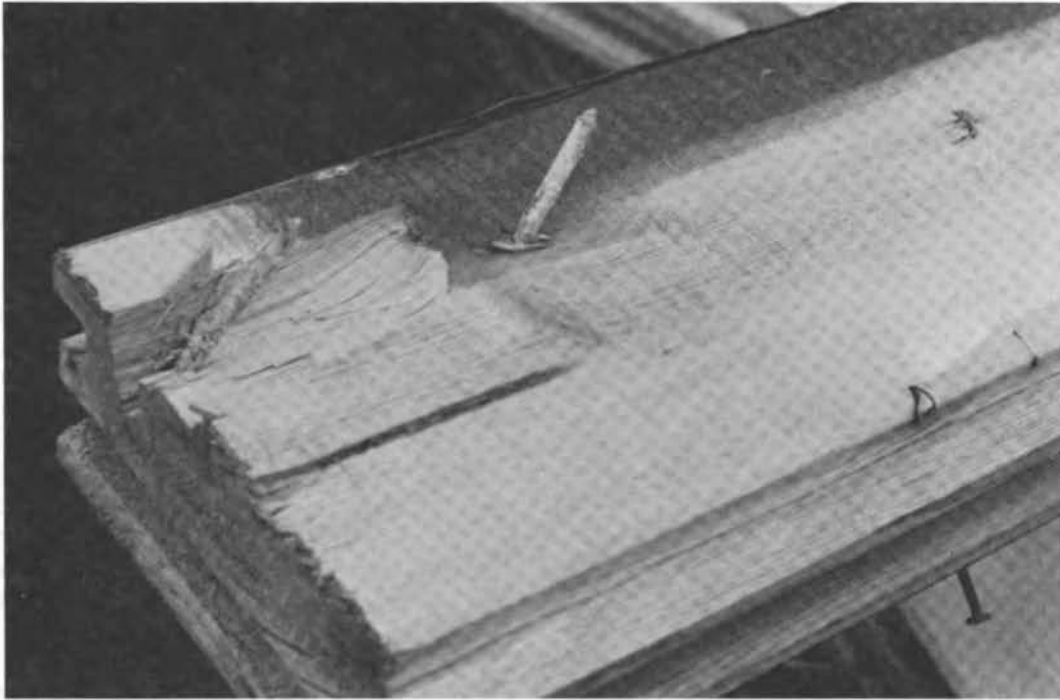
FIGURE 3.44 Roof deck fasteners (note penetration of 60d spikes is approximately 2 in.).

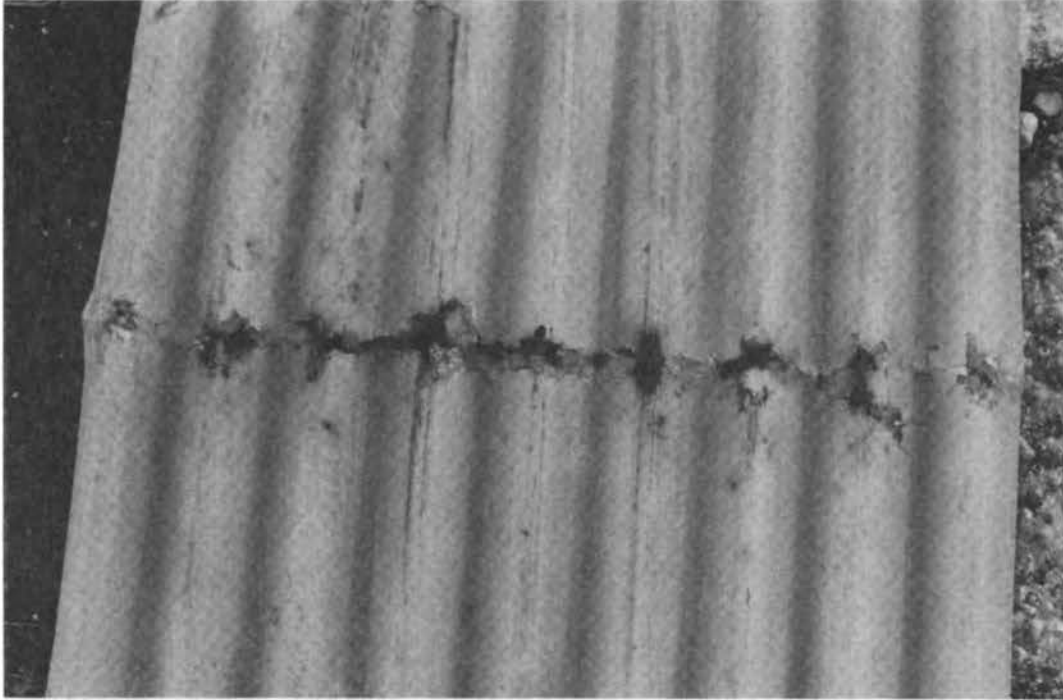
FIGURE 3.45 Light-gage corrugated metal sheeting (note sheeting has rusted through along fastener line).

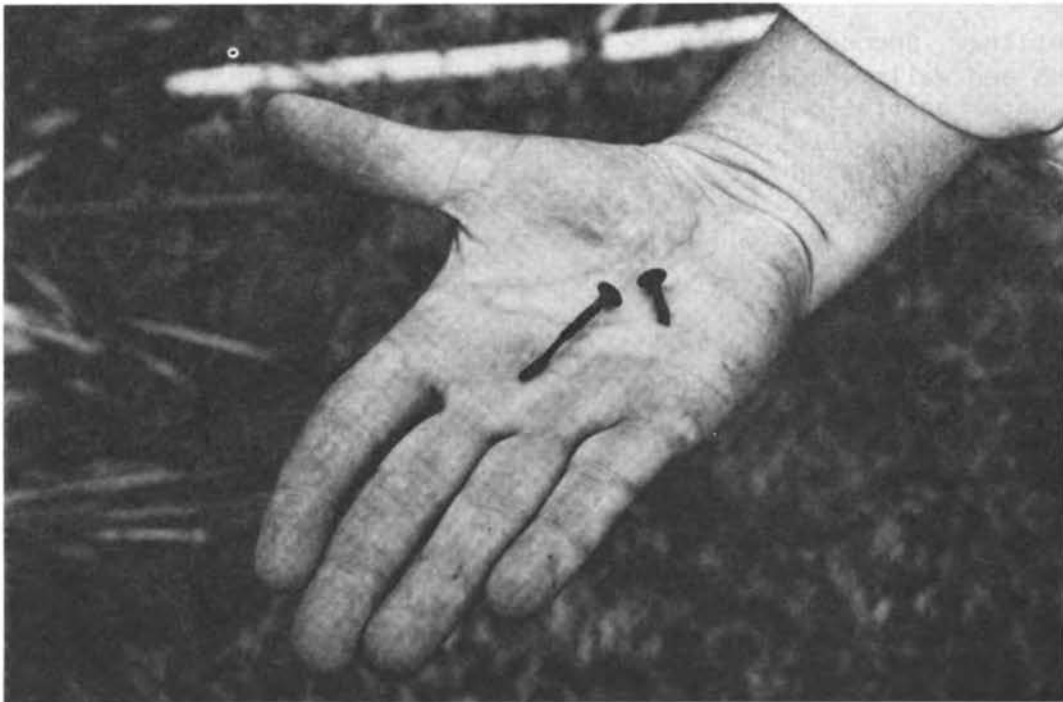
FIGURE 3.46 Corrosion of metal fasteners used to attach light-gage metal sheeting.

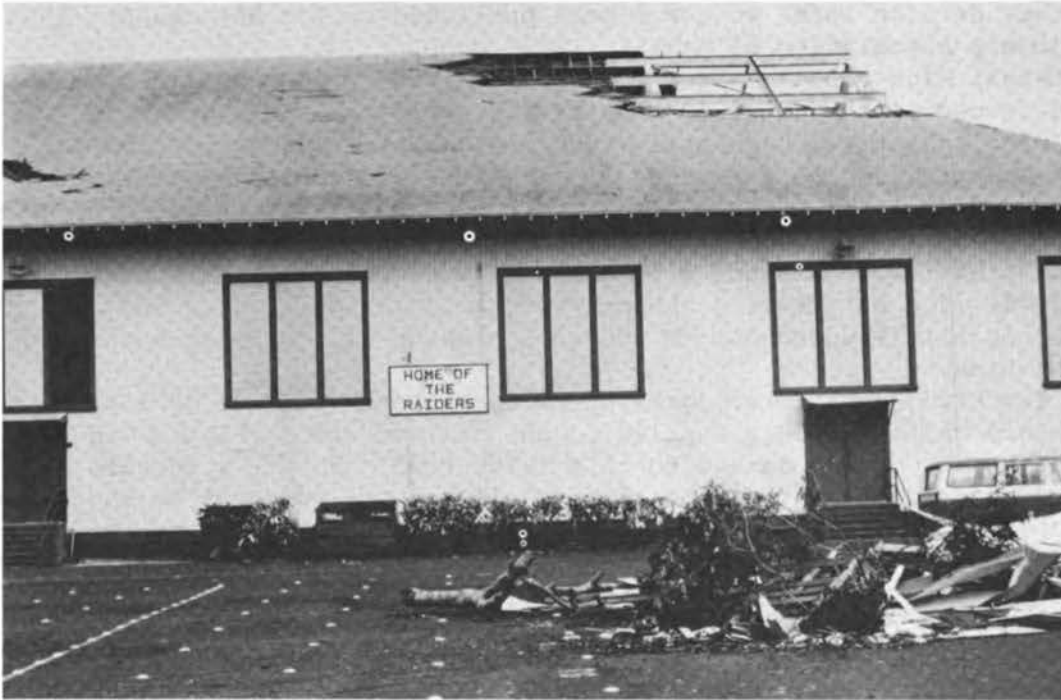
FIGURE 3.47 Wind damage to Kauai High School gymnasium.

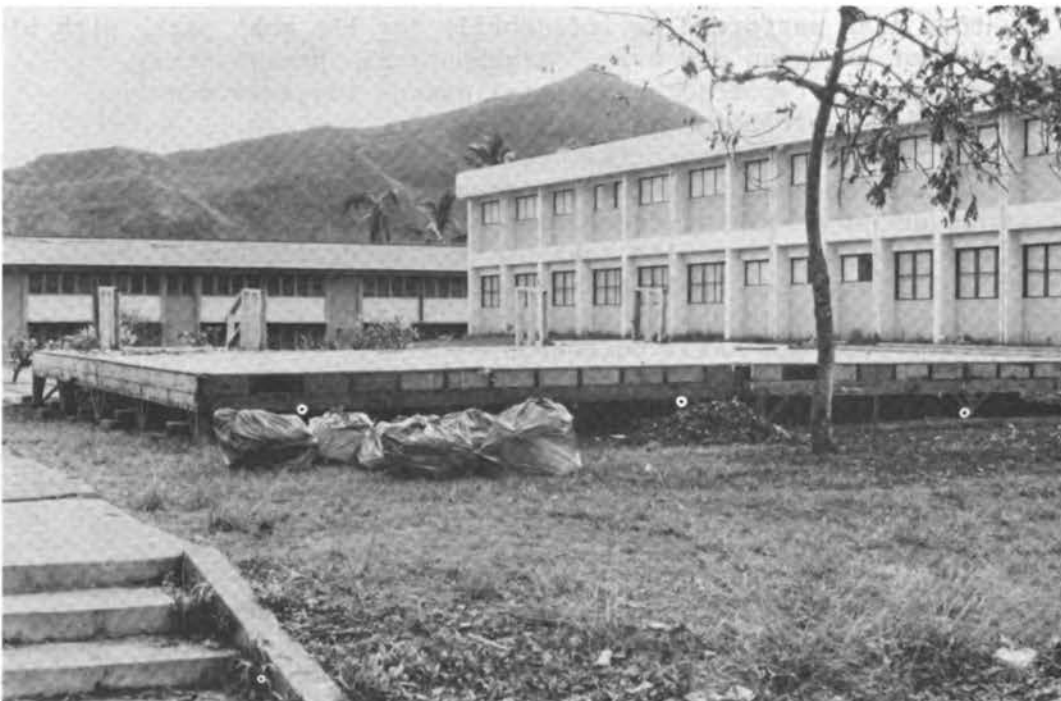
FIGURE 3.48 Kauai High School (site of heavily damaged temporary building).

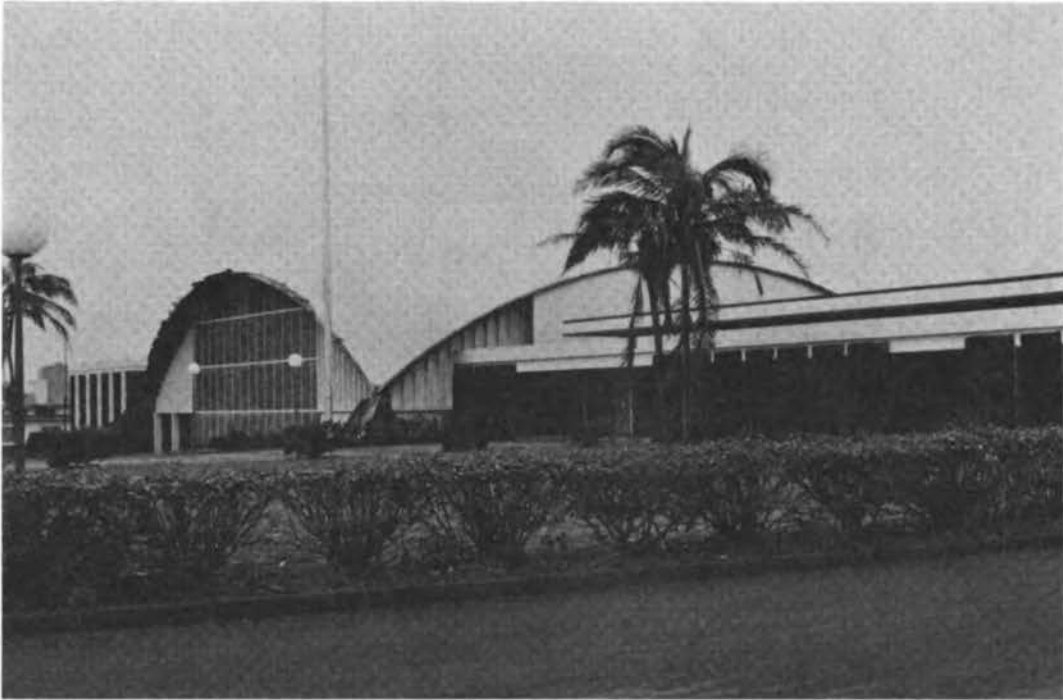
FIGURE 3.51 Convention Center at Lihue, Kauai (note minor damage to roof flashing at rake; some glass breakage occurred due to windborne debris).

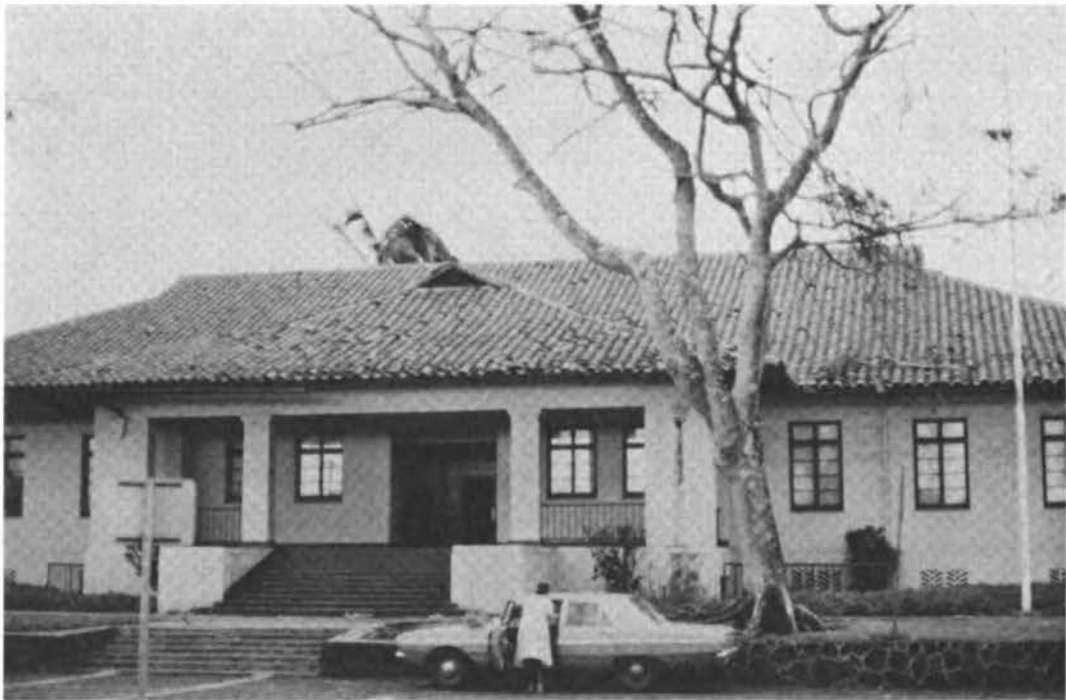
FIGURE 3.52 Minor wind damage to city building at Lihue, Kauai.

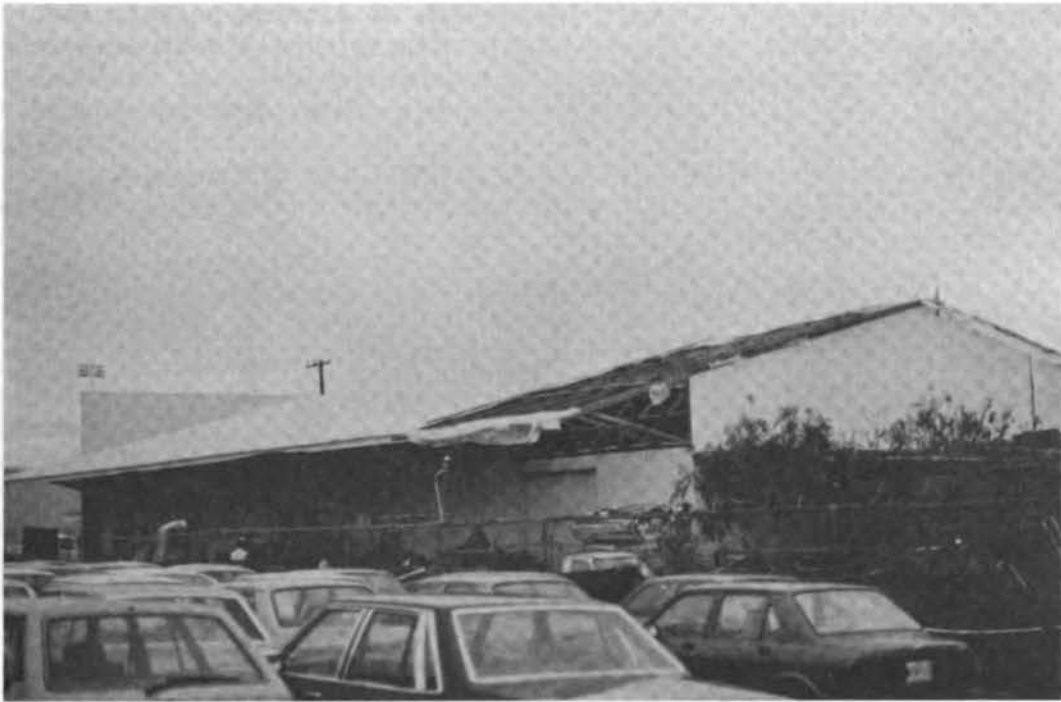
FIGURE 3.54 Damaged timber-framed warehouse building at Lihue, Kauai.

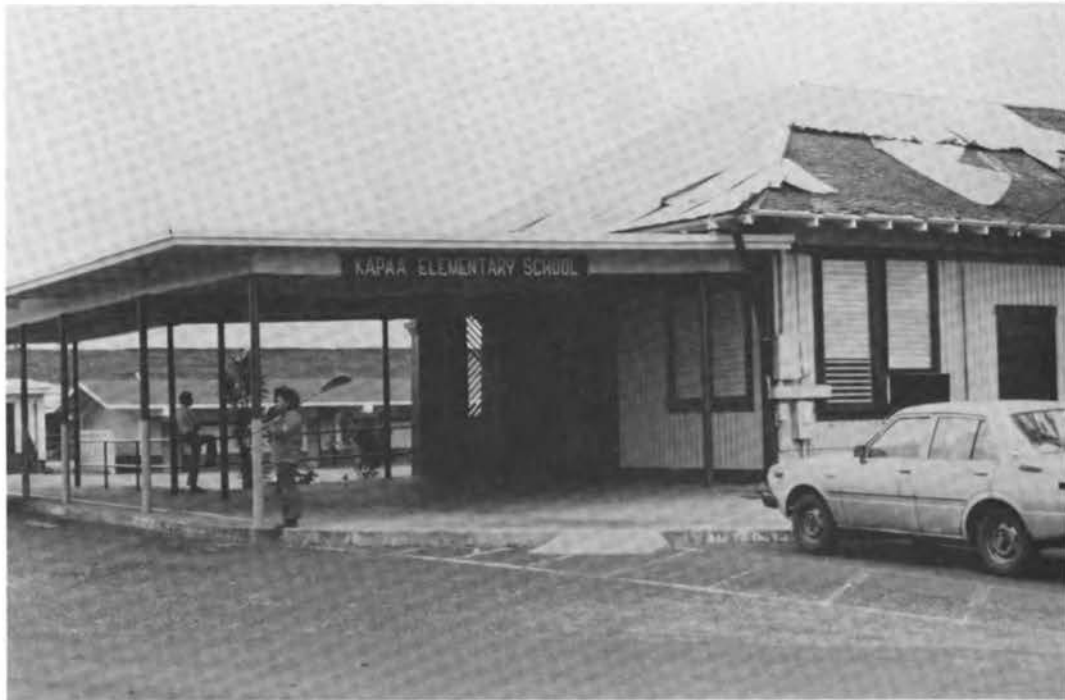
In spite of the fact that the maximum sustained wind speeds were estimated to be in the range of 50 to 55 mph, superficial cladding damage to major damage of roof coverings was widespread. At Kapaa High School (which was used as a storm shelter), four classroom buildings suffered damage that involved the loss of portions of the light-gage metal sheeting used as roof coverings. At Kapaa Elementary School most of the classroom buildings lost substantial portions of the light-gage metal roofing that had been nailed over an existing shingle roof (Figure 3.56).

FIGURE 3.56 Damage to roof covering of Kapaa Elementary School (note light-gage corrugated metal sheeting nailed over existing roof).

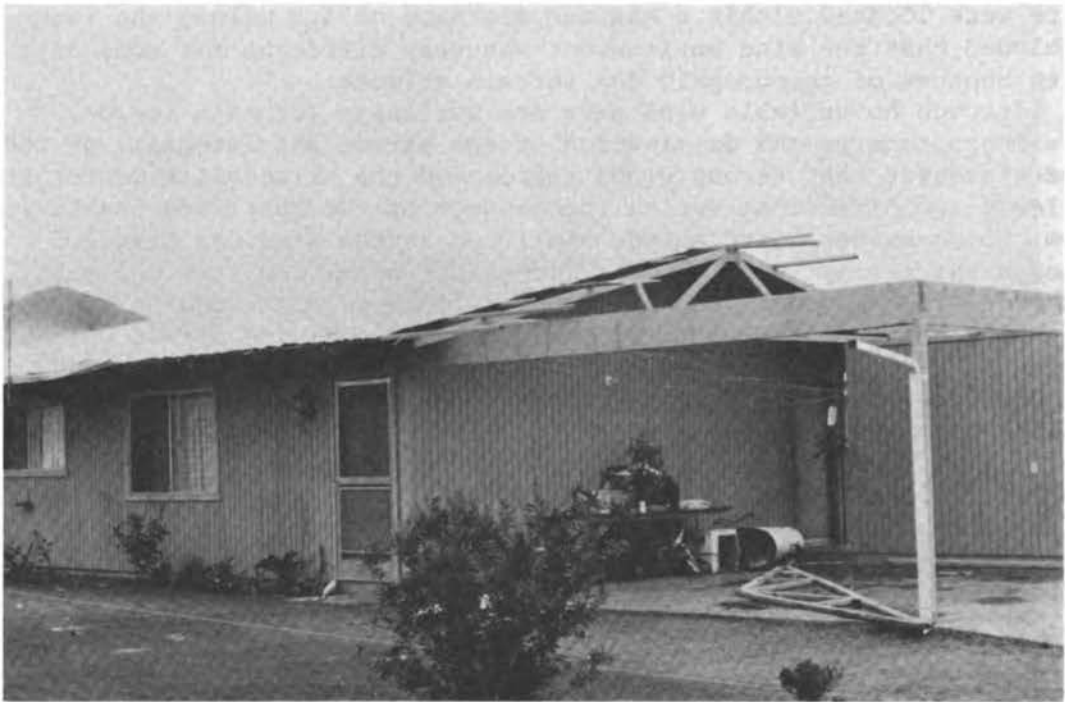
FIGURE 3.58 Loss of carport roof at Kapaa Meadows, Kauai.

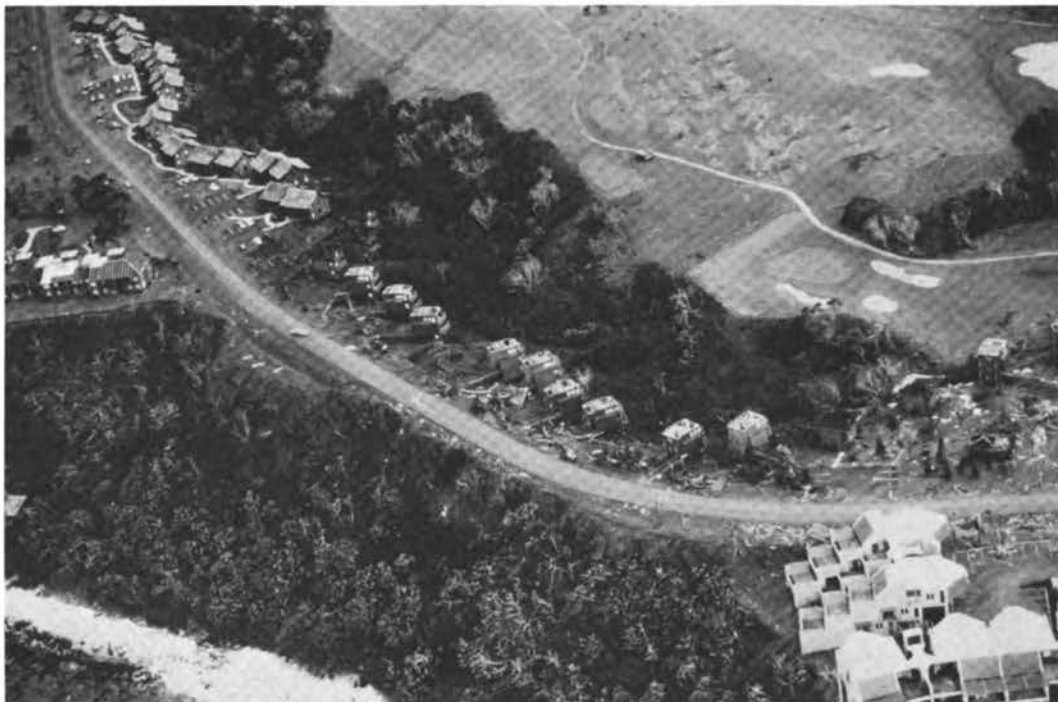
FIGURE 3.62 Aerial view of wind damage at Princeville, Kauai.

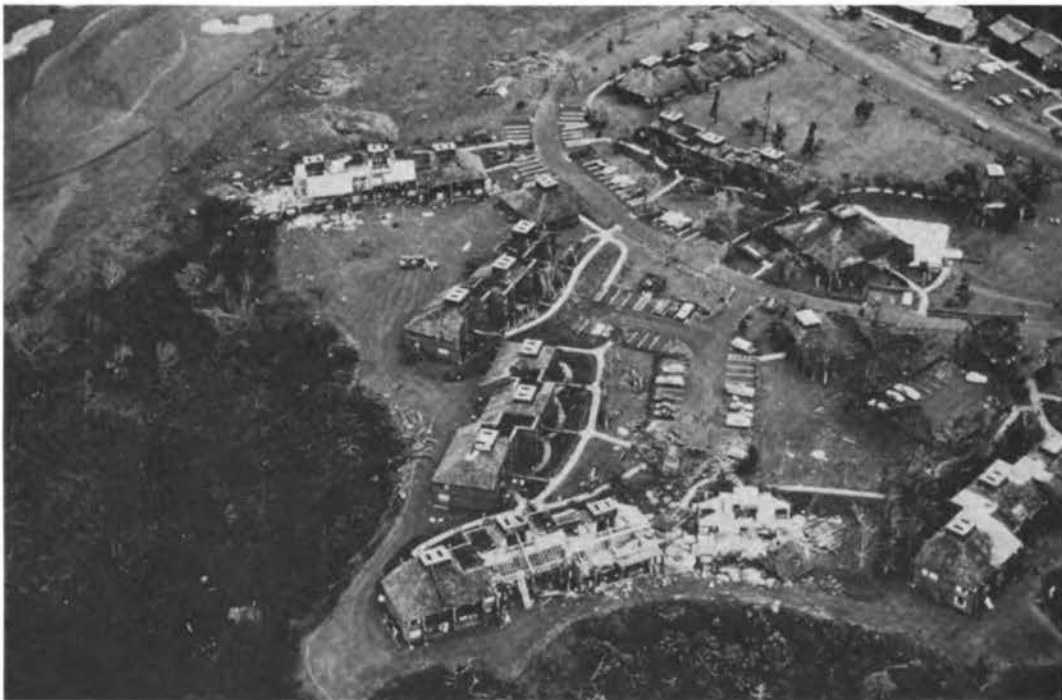
The aerial photograph of Figure 3.64 provides a panoramic view of the damage sustained at Pali Ke Kua and the lack of damage to the Hale Moi units in the upper right-hand corner (see also Figures 3.60 and 3.62). The influence of terrain exposure is clearly seen, as those units near the cliffs along the oceanfront (Figure 3.65) were subjected to amplified speeds for winds flowing over the top of the bluffs from the southwest or west. The units at Pali Ke Kua were two-story multiple-family dwellings of conventional timber-framed construction. Note the high percentage of glazed areas on the windward faces.

FIGURE 3.64 Damage at Pali Ke Kua, Princeville, Kauai (note damage to units sited near bluffs).

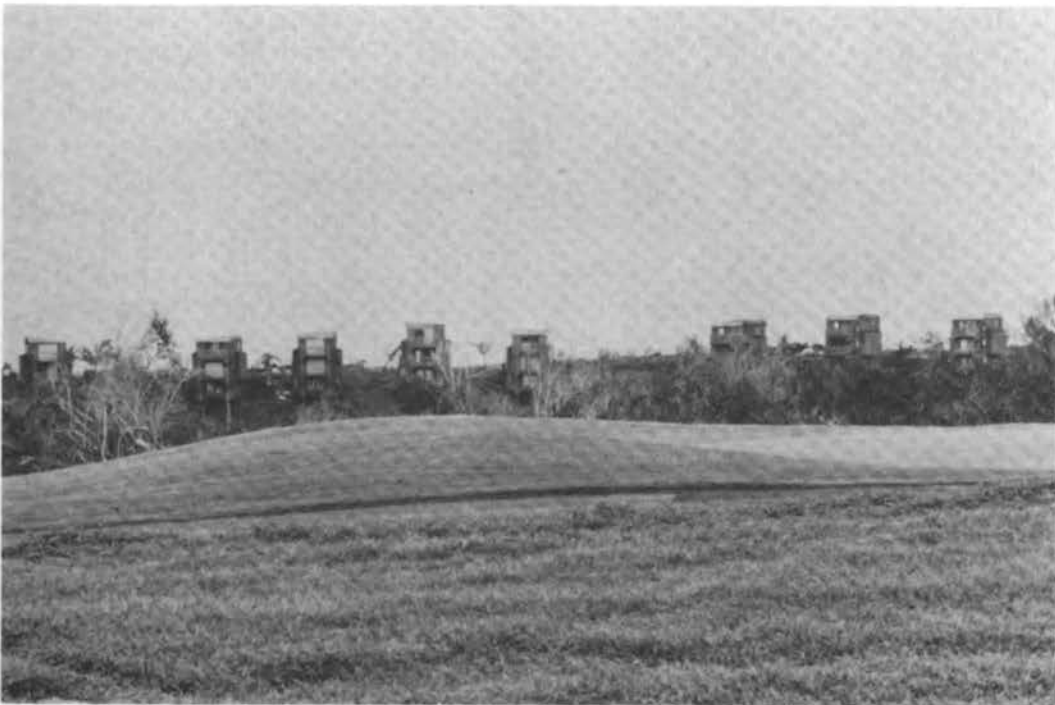
FIGURE 3.66 Wind damage to Hanalei Bay Villas, Princeville, Kauai (viewed from south).

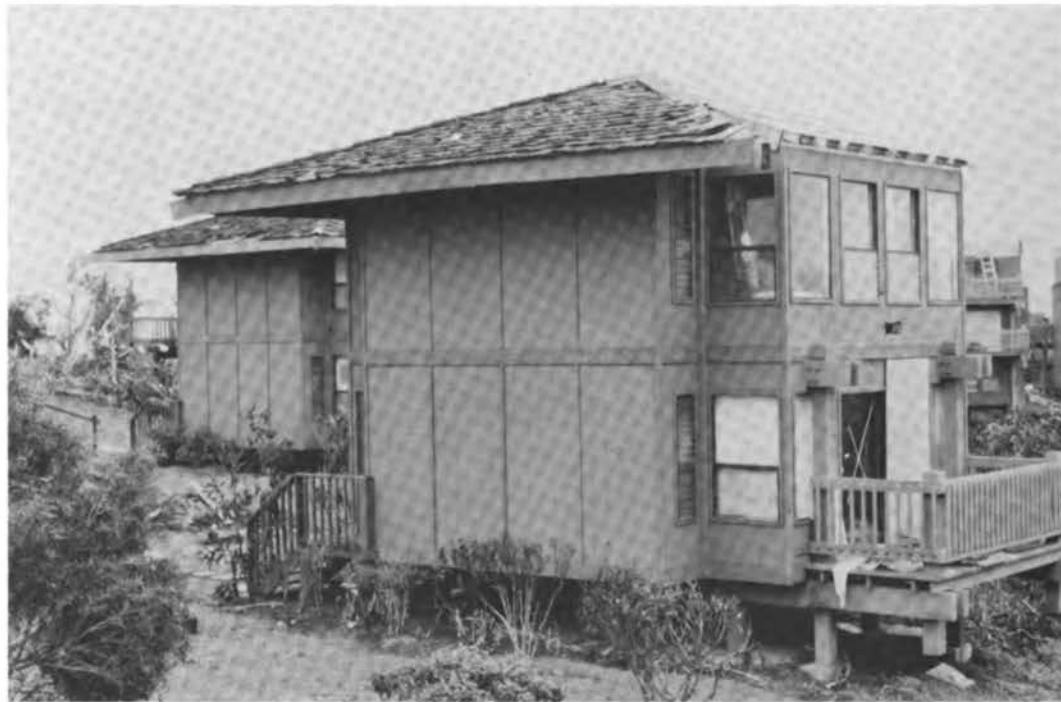
FIGURE 3.68 Damage to Hanalei Bay Villas on windward wall.

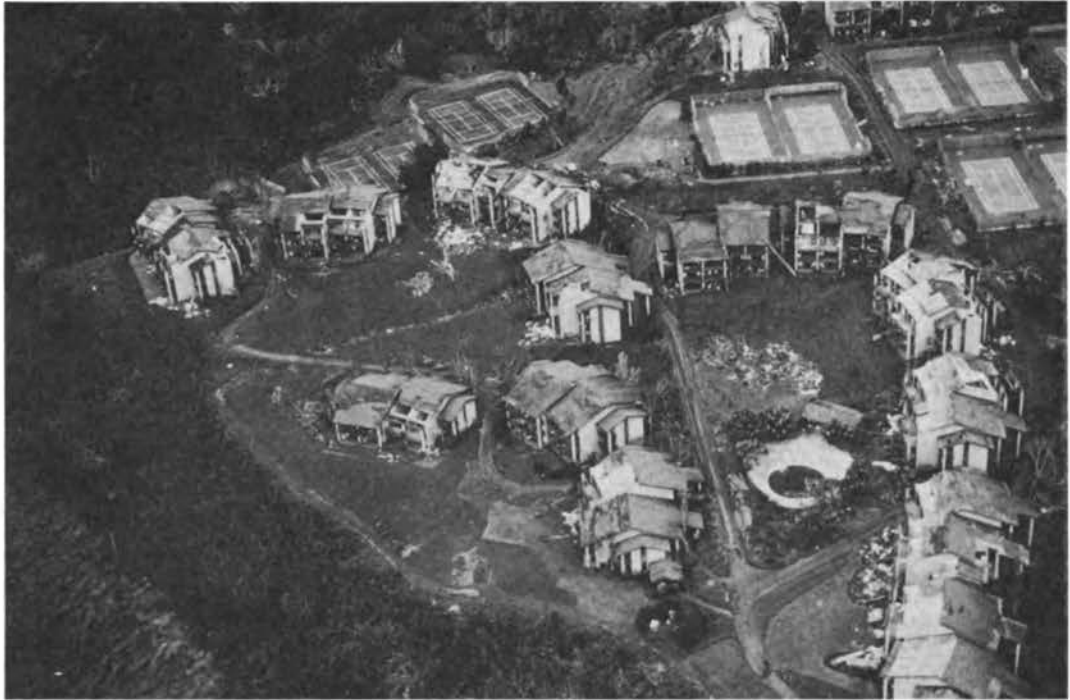
FIGURE 3.70 Damage to Hanalei Bay Resort townhouses (viewed from southeasterly direction).

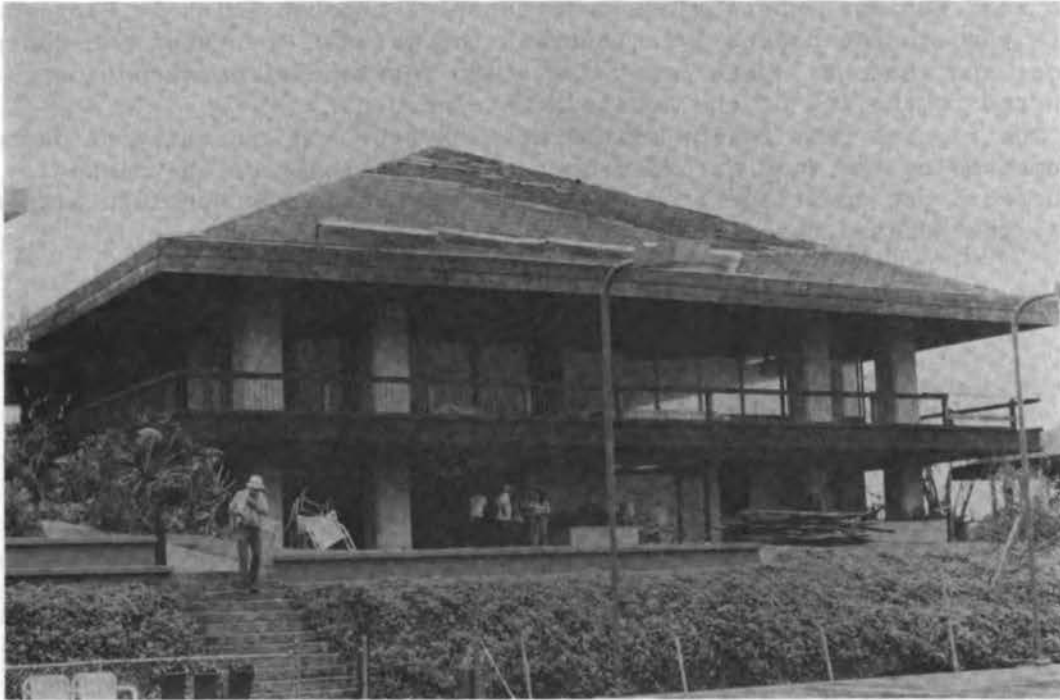
FIGURE 3.72 Wind damage to roof of Bali Hai Restaurant, Princeville, Kauai.

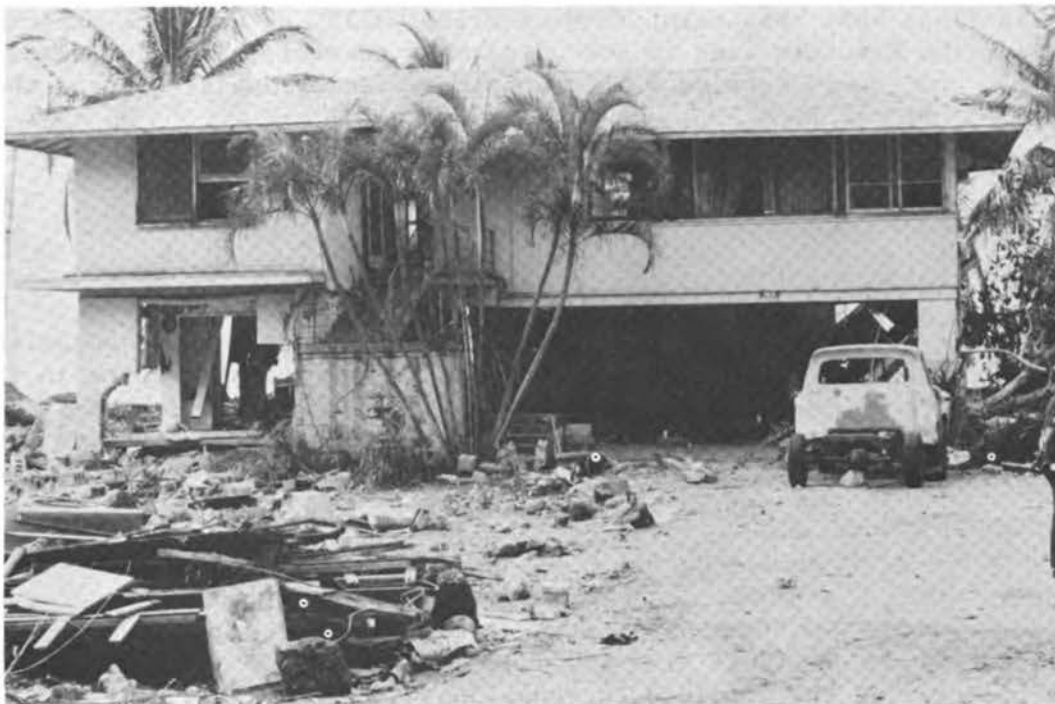
FIGURE 3.74 Damage to single-family dwelling at Makaha, Oahu.

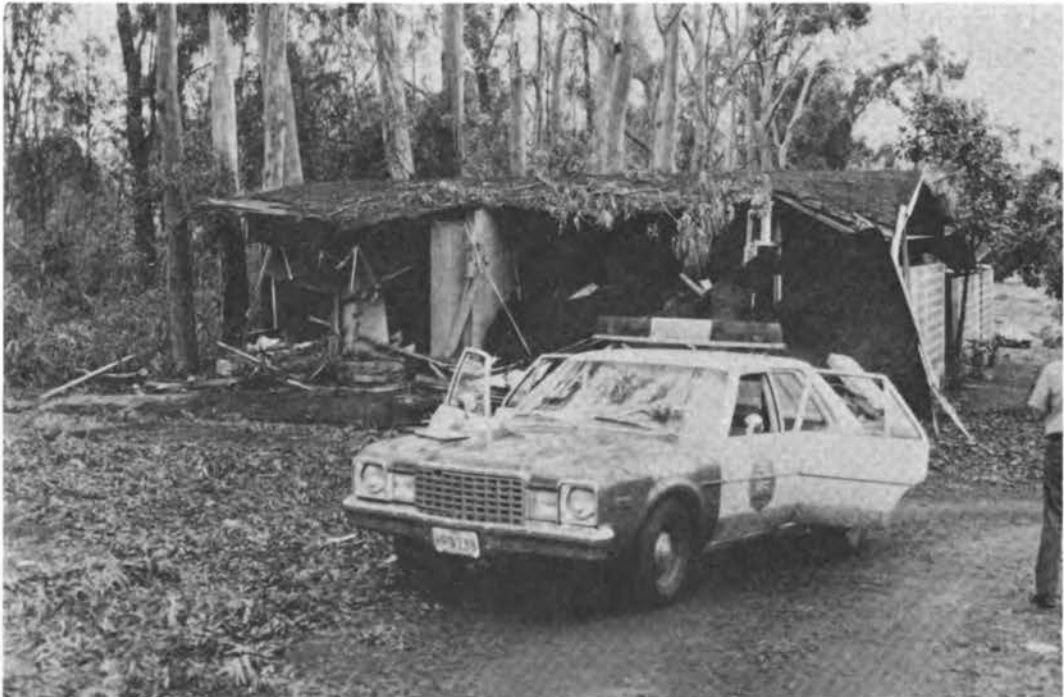
FIGURE 3.80 Eucalyptus trees in residential area of Wahiawa, Oahu (note damage to residence from falling tree).

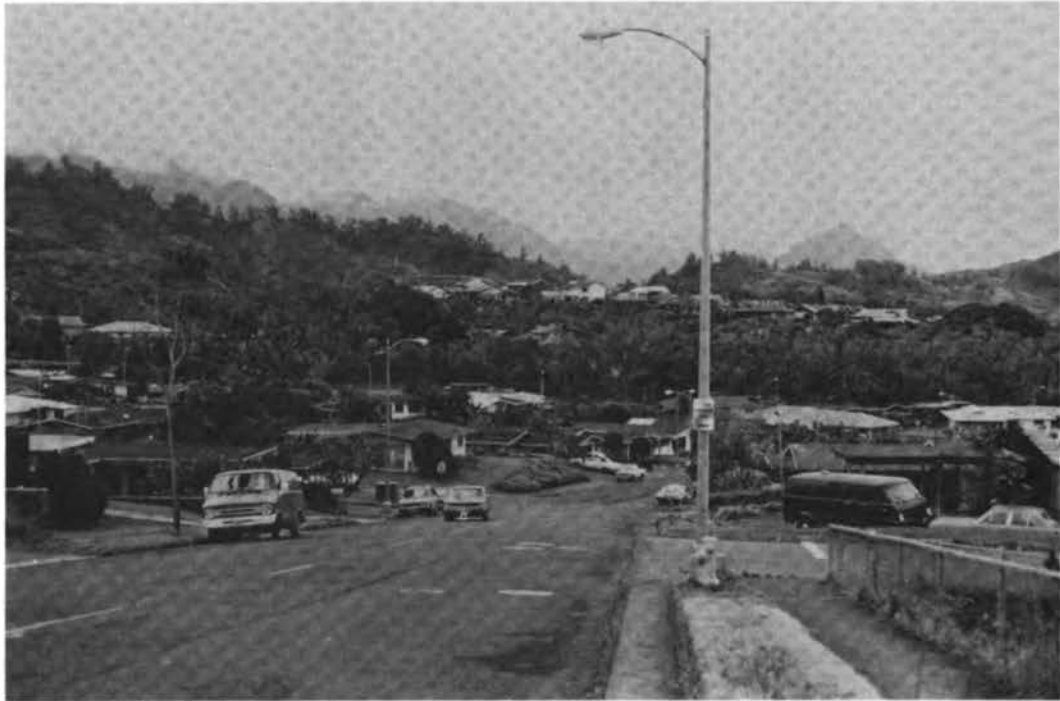
FIGURE 3.86 Roof damage to homes located along ridge line at Kaneohe, Oahu (there was little or no damage to homes not sited along the ridge in this area).

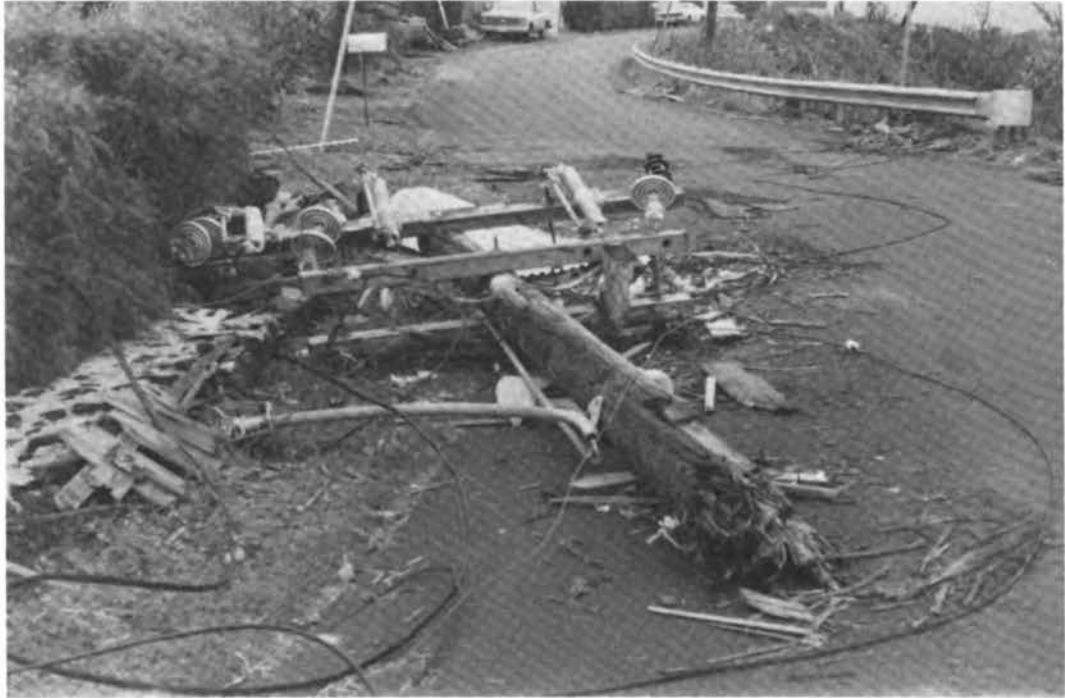
FIGURE 4.5 Power pole above Makahuena Point, Kauai, that failed at mid-pole height.

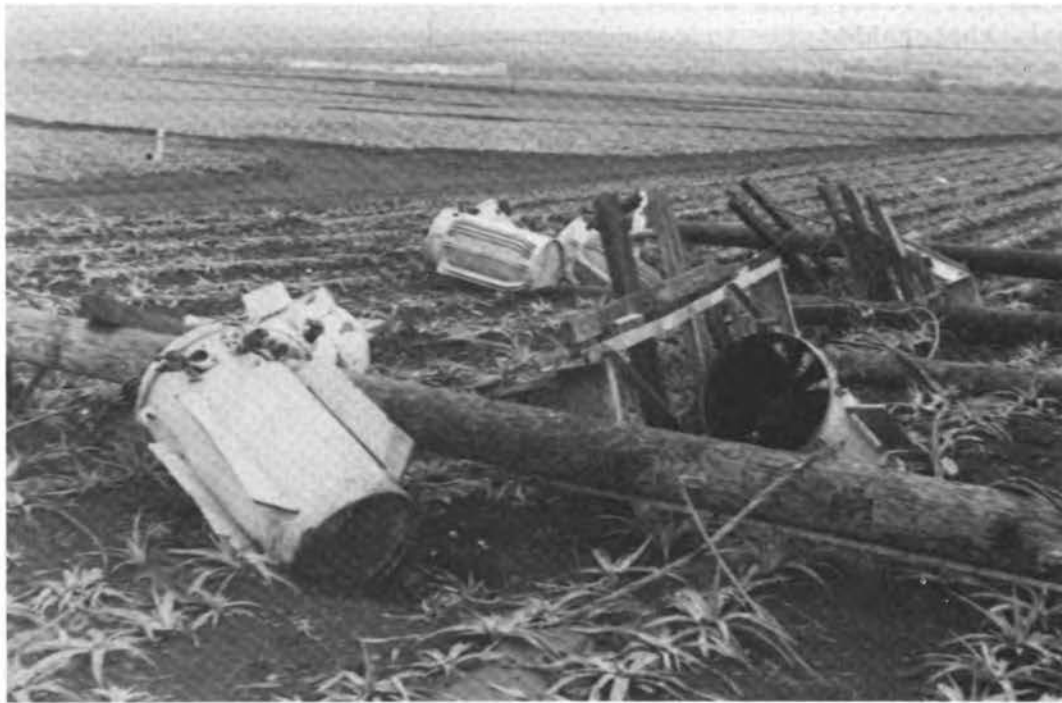
FIGURE 4.6 Pole-mounted transformers and circuit breakers damaged when wind-driven building debris knocked over a pole-supported customer substation near Kunia, Oahu.

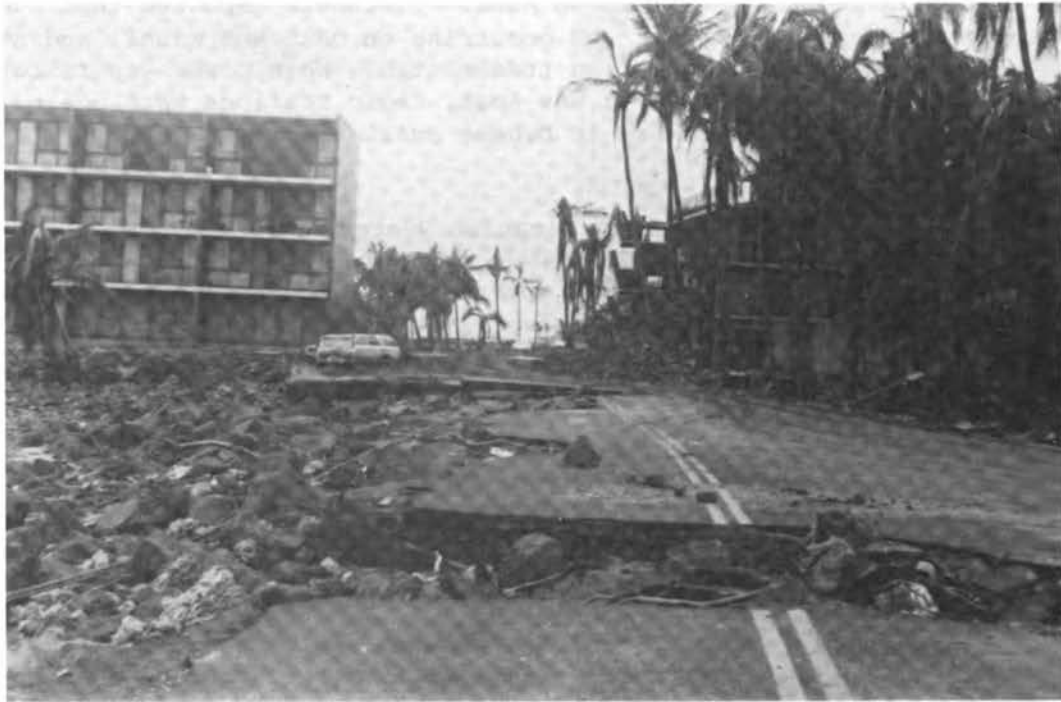
FIGURE 4.9 Severely damaged coastline road at Hoai Bay in the Poipu area of Kauai.
