Hurricane Alicia, Galveston and Houston, Texas, August 17-18, 1983 (1984)

Hurricane Alicia Galveston and Houston, Texas August 17-18, 1983

Committee on Natural Disasters
Commission on Engineering and Technical Systems
National Research Council

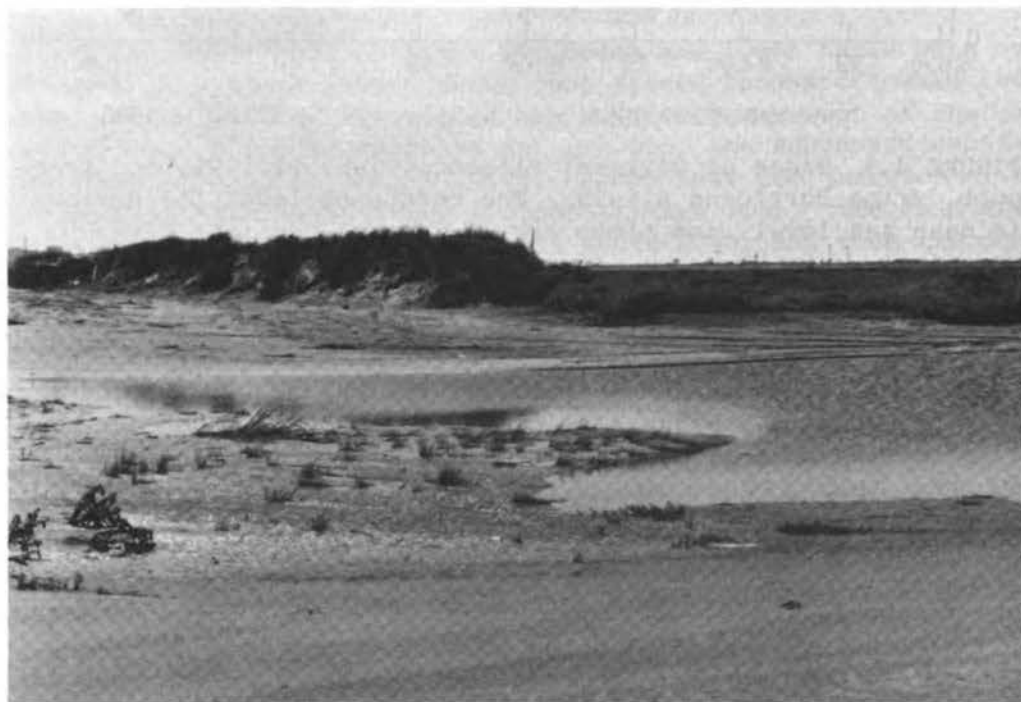
FIGURE 3.5 Front of scour channel and frontal dune on East Beach showing dune erosion. Scour channel was caused by flow confined between the dune and an adjacent beachfront condominium.

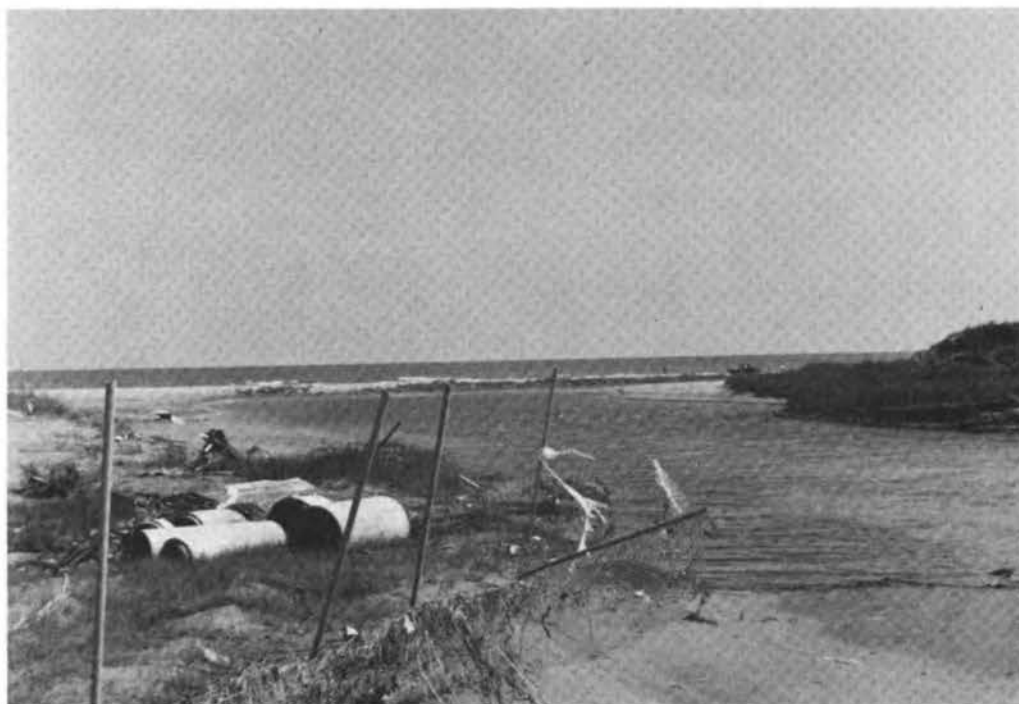
FIGURE 3.6 Landward end of the scour channel shown in Figure 3.5.

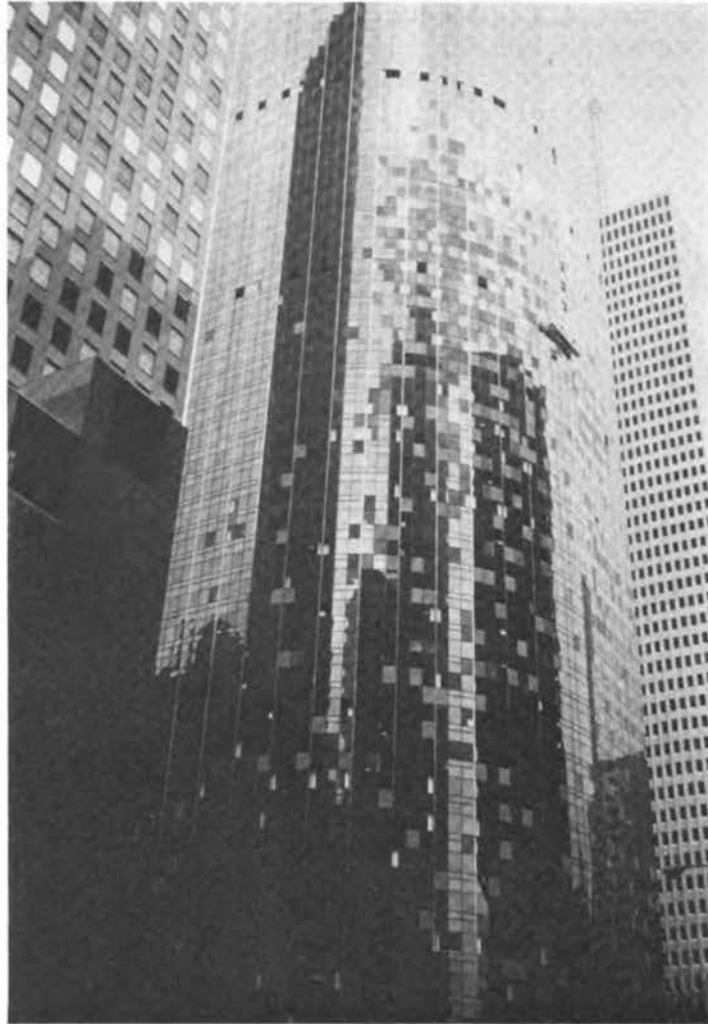
FIGURE 4.4 Closeup of damaged glass on the south-east face of the Allied Bank Building.

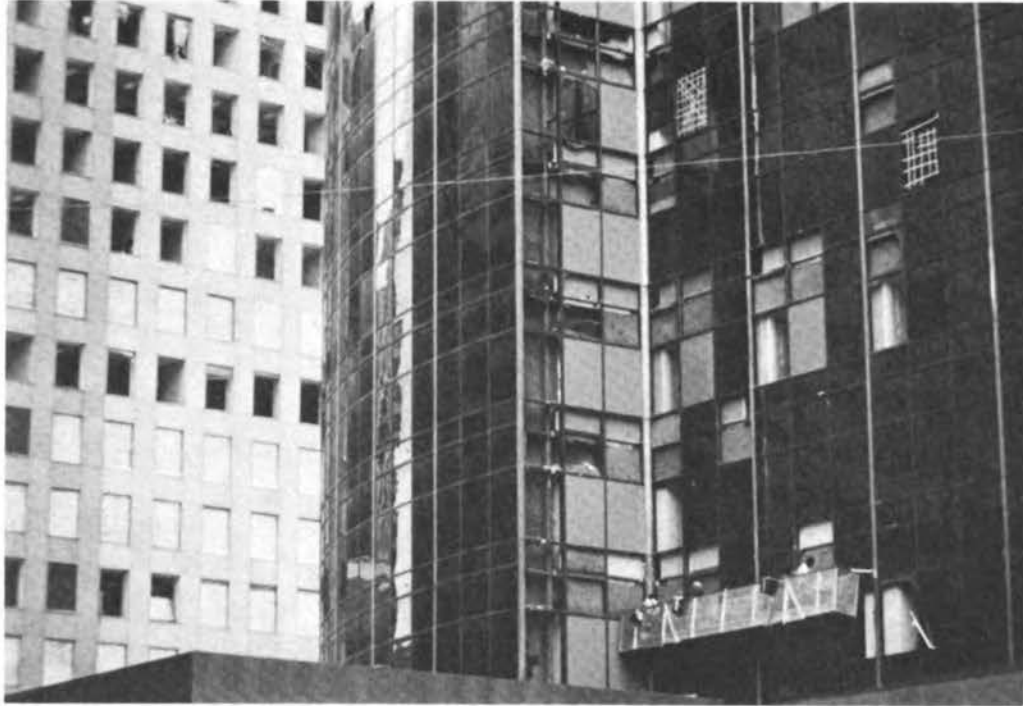
FIGURE 4.7 Window damage to the Hyatt Regency Hotel (the building in the background).

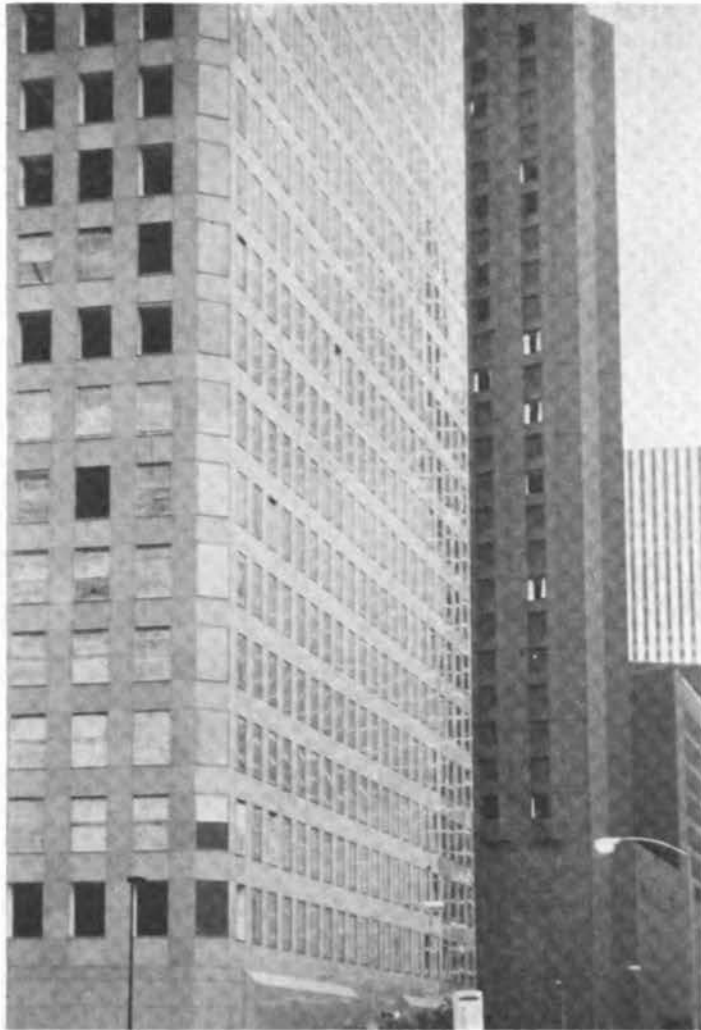
FIGURE 4.8 Closeup of glass damage to the Milam Building.

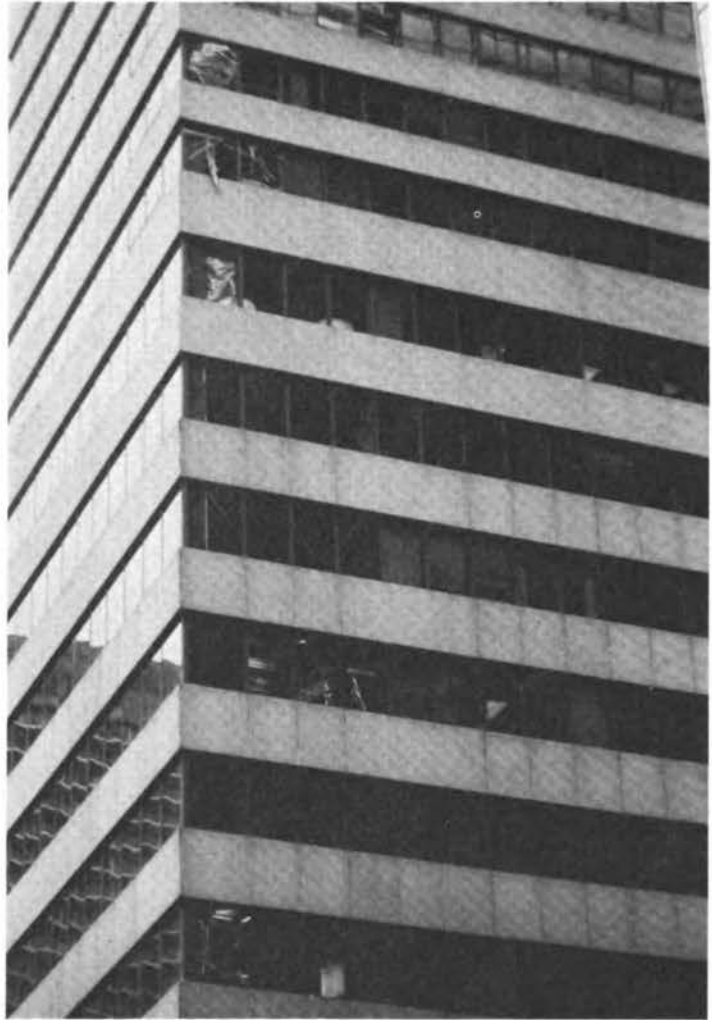
Figure 4.10 shows the nature of glass damage to the Sheraton-Houston Hotel. The damage was more significant on the northeast face of the building.

FIGURE 4.10 Window damage to the Sheraton-Houston Hotel.

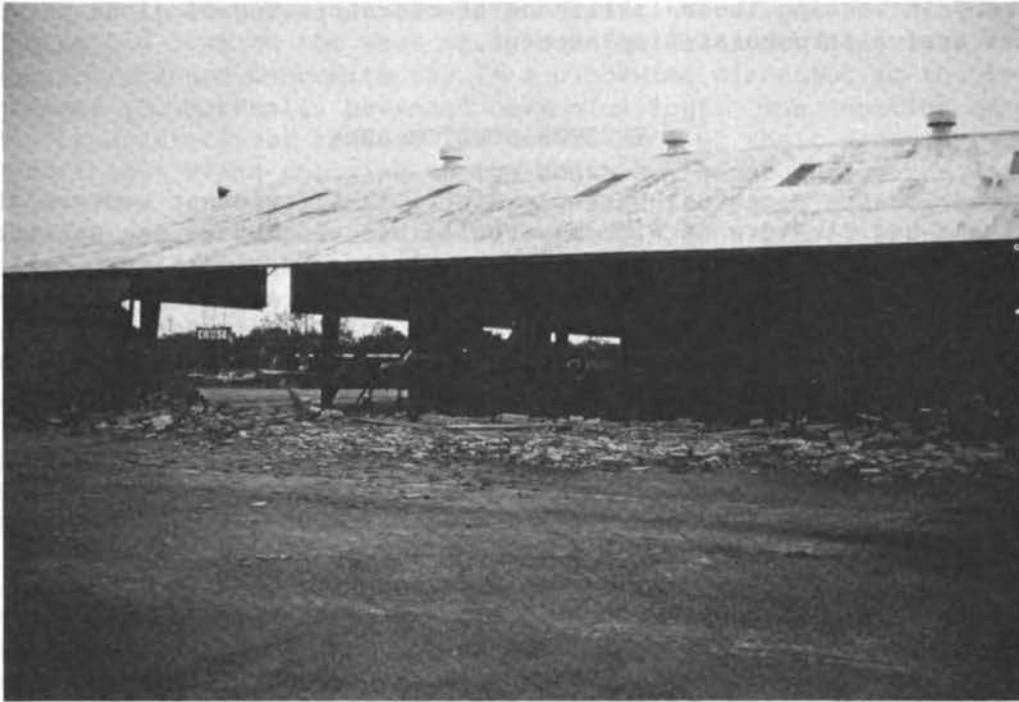
FIGURE 4.13 Collapsed brick wall of airport hangar at Hobby Airport.

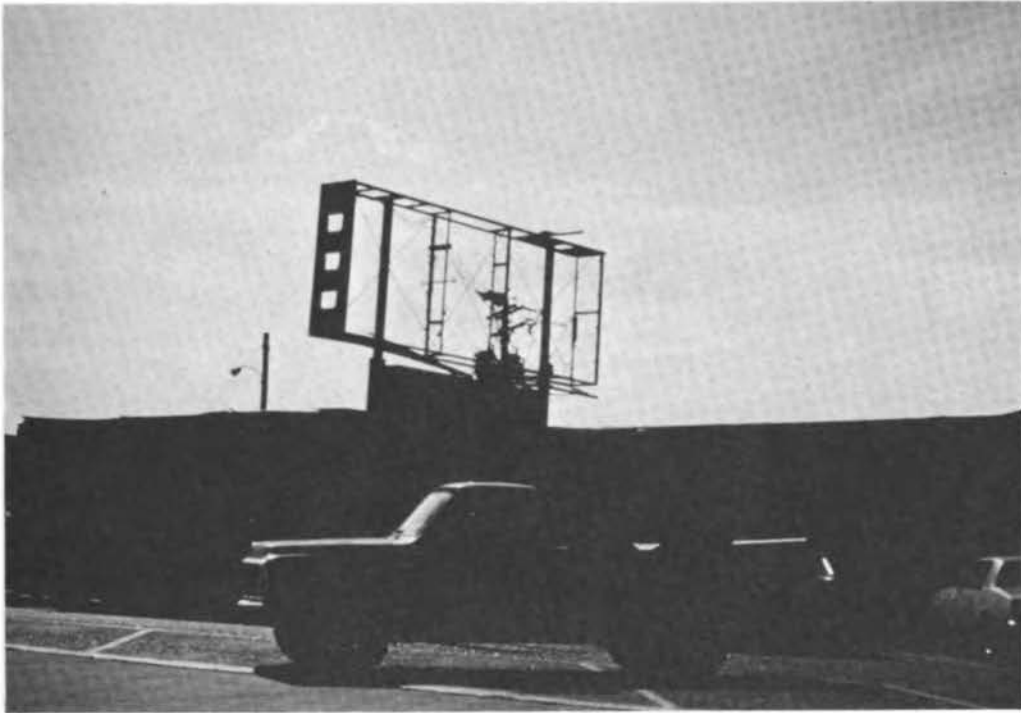
FIGURE 4.14 Damaged billboard.

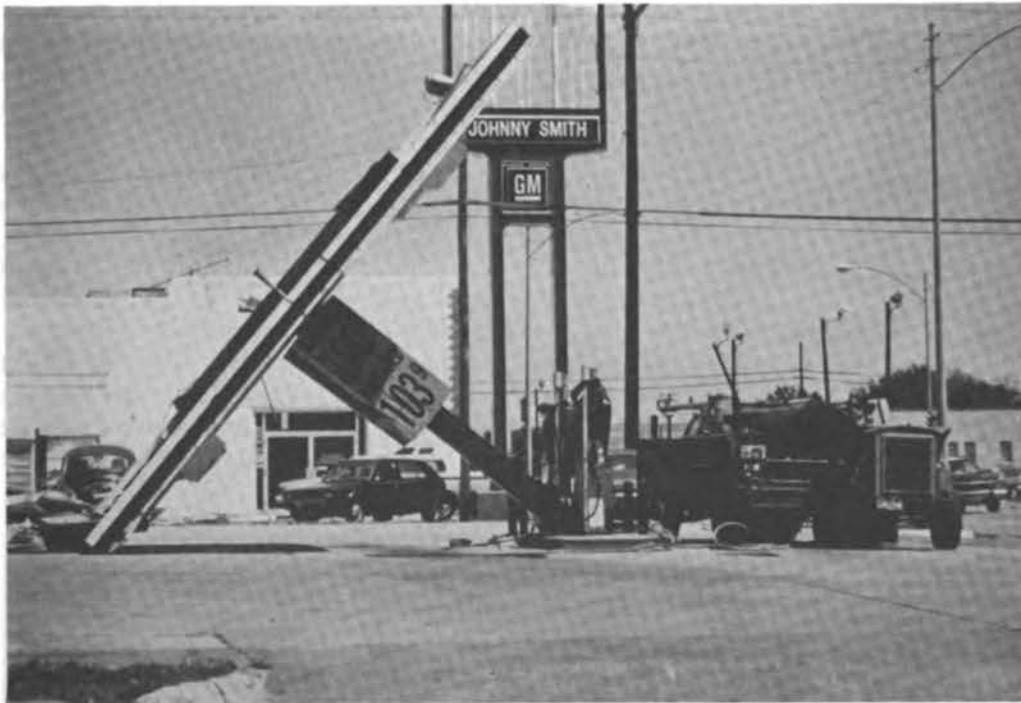
FIGURE 4.15 Example of failure of a roof support pedestal column.

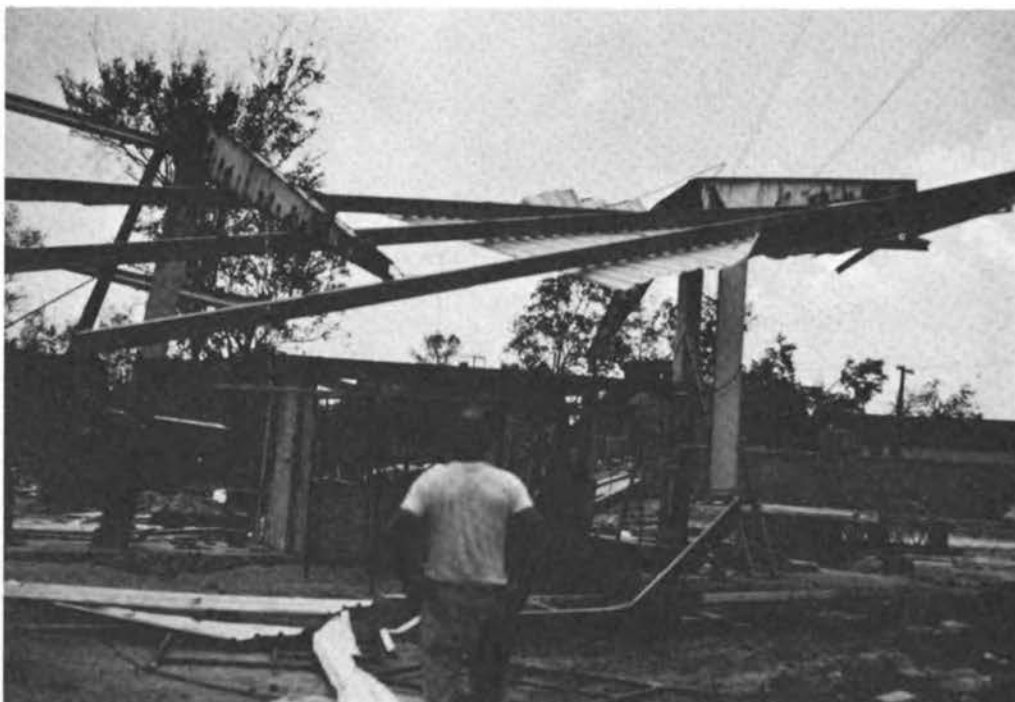
FIGURE 4.16 Failure of sheet metal roof at a gas station.

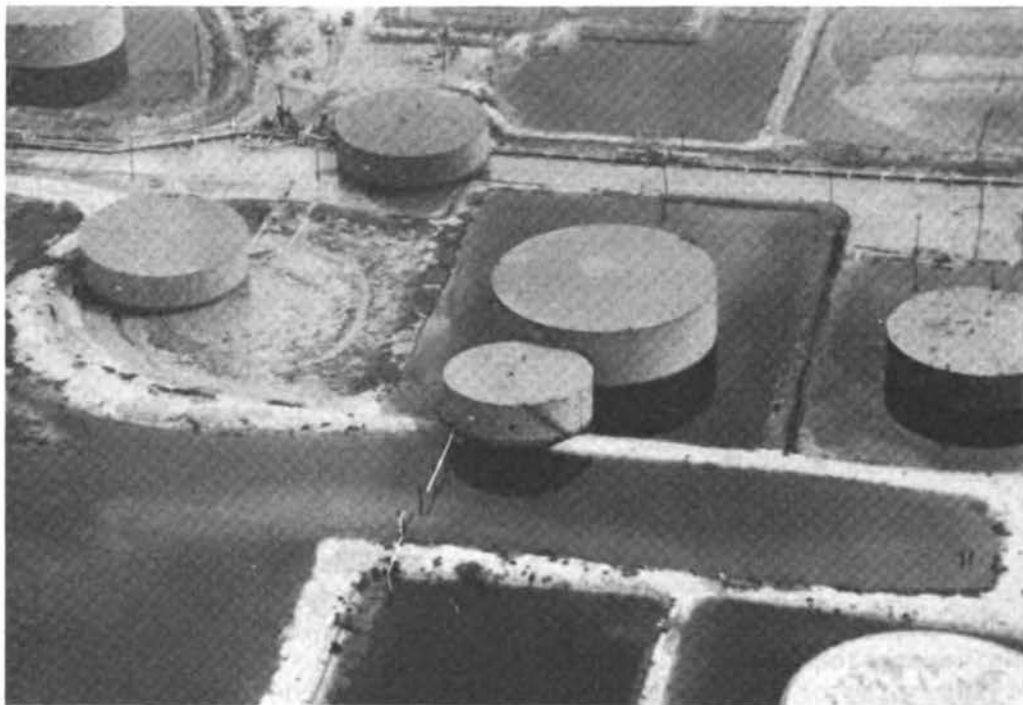
FIGURE 4.18 Displaced oil storage tanks.

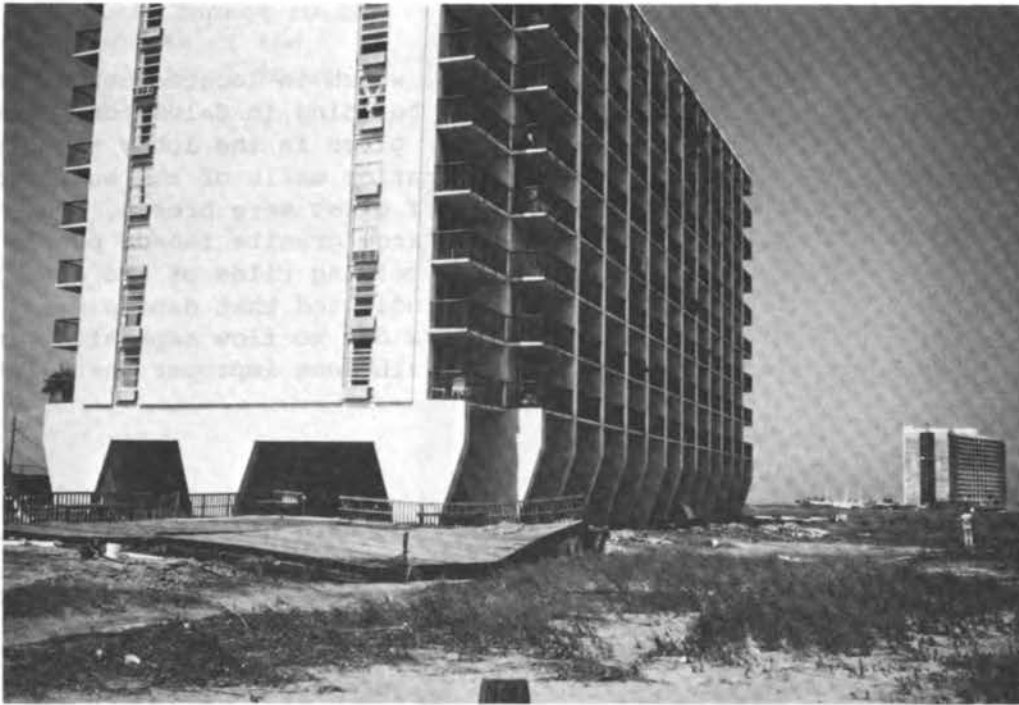
The Galvestonian is a very large high-rise condominium, crescent-shaped in plan, under construction next to the Islanders Inn on East Beach (Figure 4.19). It bore the brunt of winds, waves, and flooding directly from the Gulf. The facade of the building experienced minor damage, and extensive erosion occurred around its foundation. However, the structural integrity of the foundation was not affected (Figure 4.20). The reinforced concrete structural system performed satisfactorily.

FIGURE 4.19 General erosion and damaged deck around Islanders Inn and the Galvestonian (in the background).

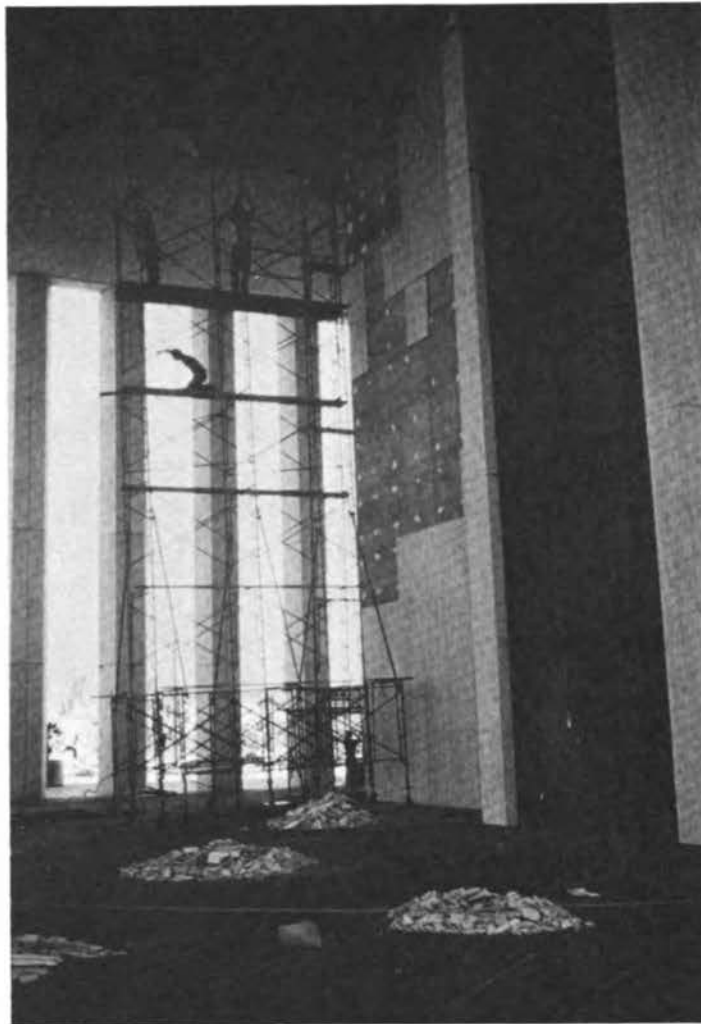
FIGURE 4.21 Damage to facade and glass of the American National Insurance Building.

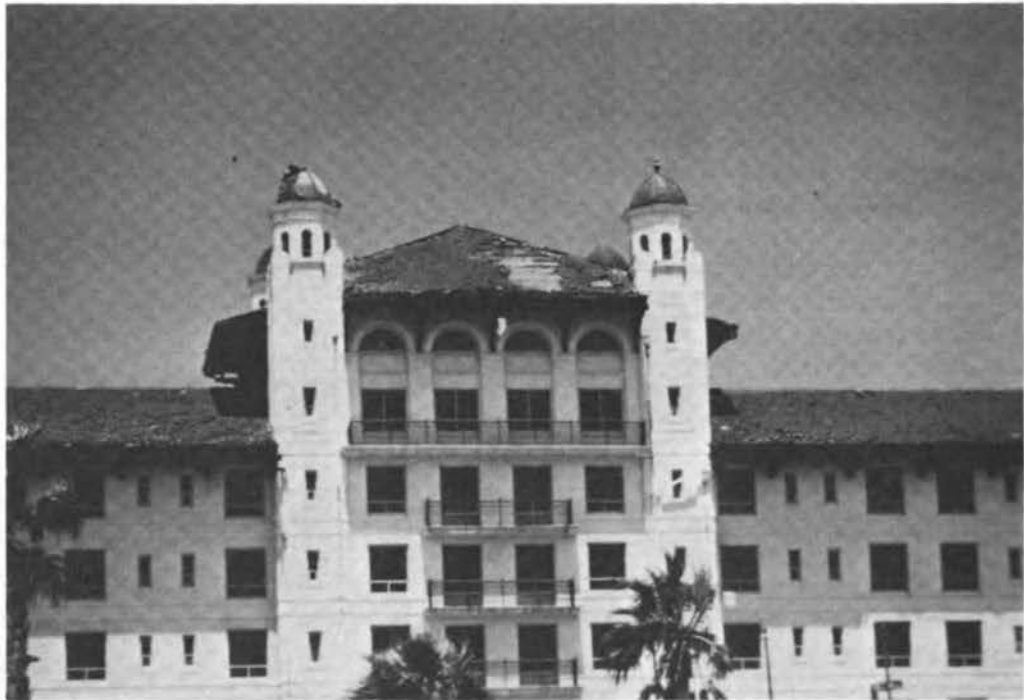
FIGURE 4.22 Damage to tiled roof of the Hotel Galvez.

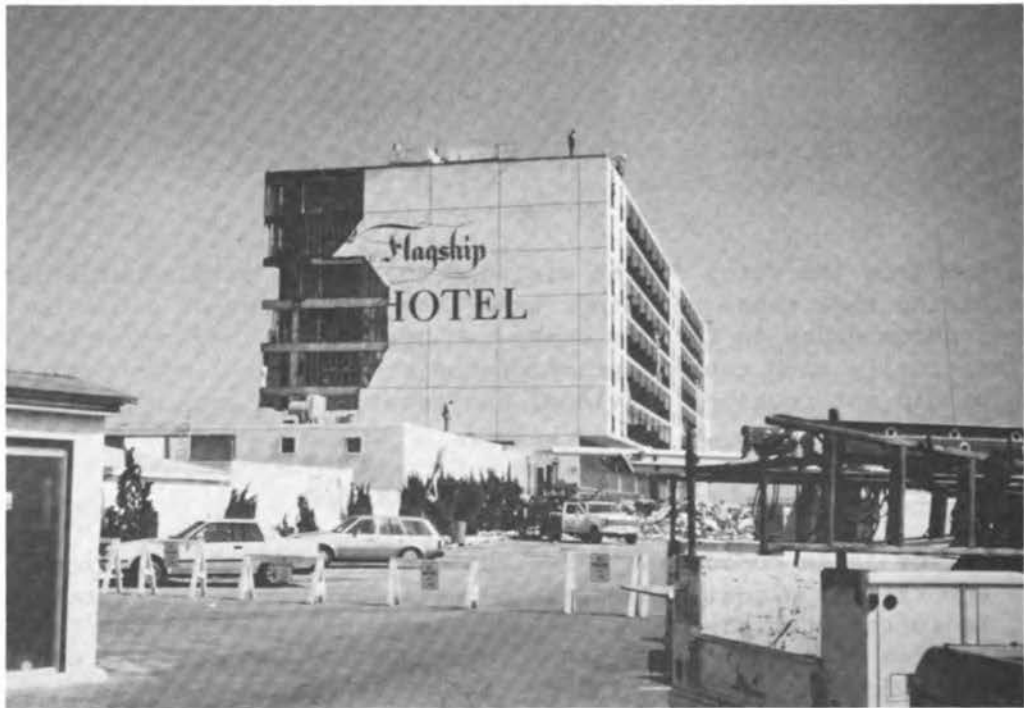
FIGURE 4.23 Damage to the facade of the Flagship Hotel.

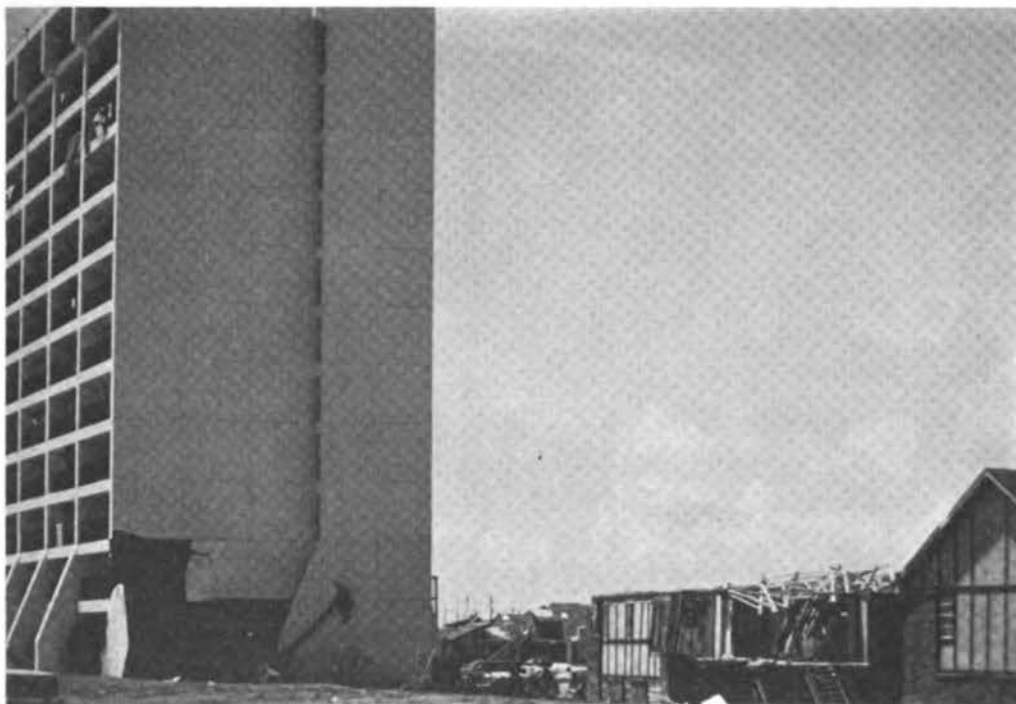
FIGURE 4.24 General view of damage to condominiums on the seawall.

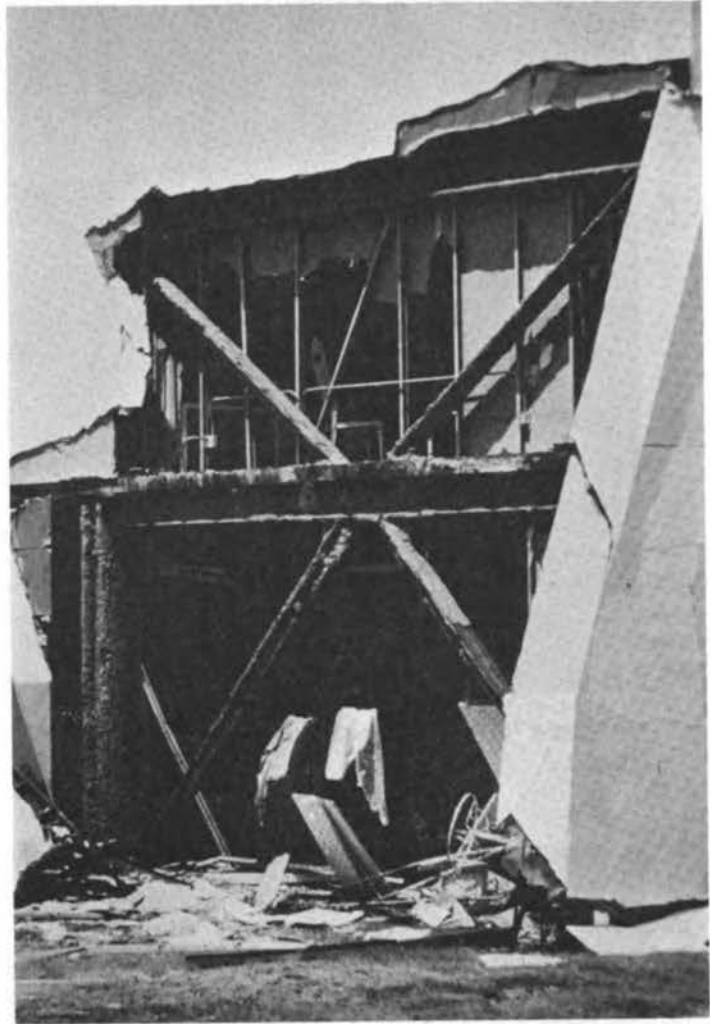
FIGURE 4.25 Closeup of damage to the facade of By-the-Sea Condominium.

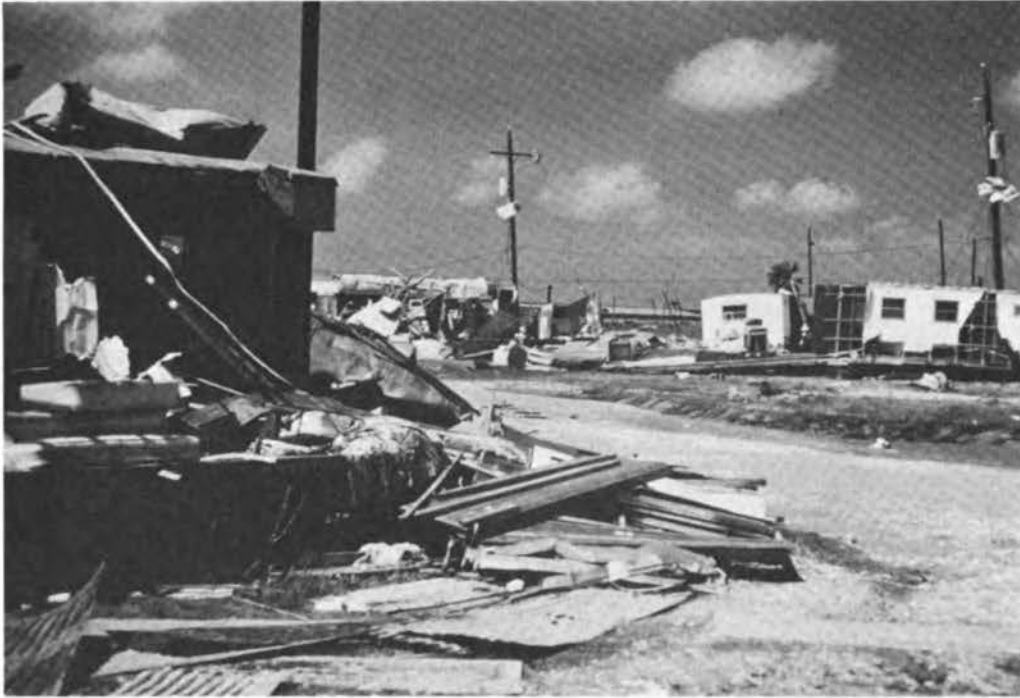
FIGURE 4.26 Damaged mobile home park on East Beach.

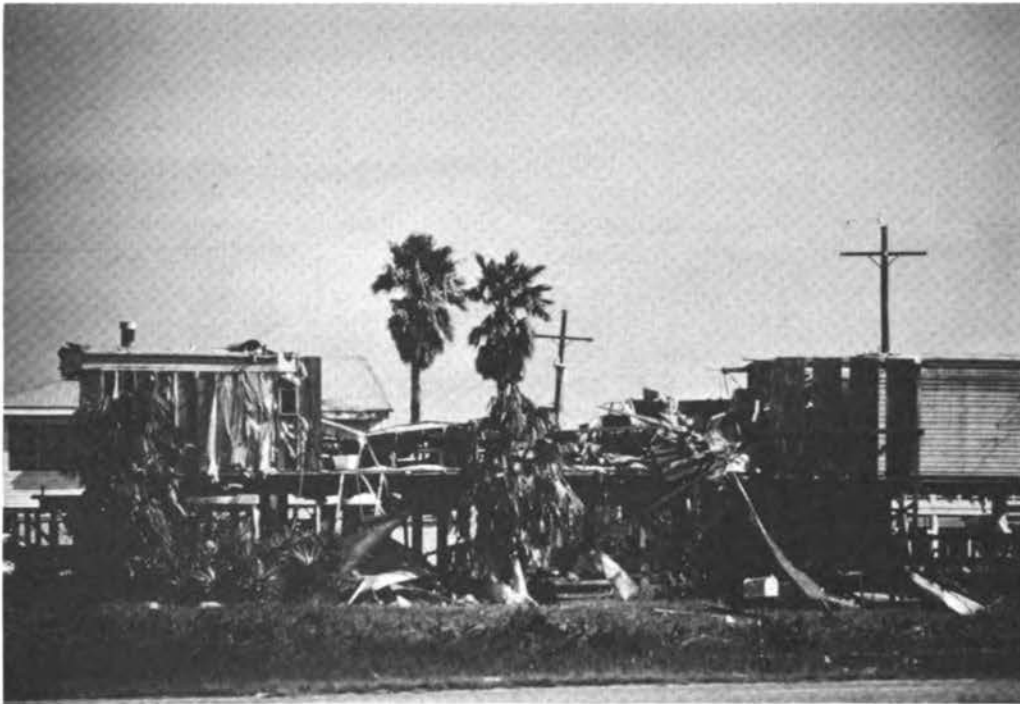
FIGURE 4.27 Damage to an elevated mobile home on West Beach.

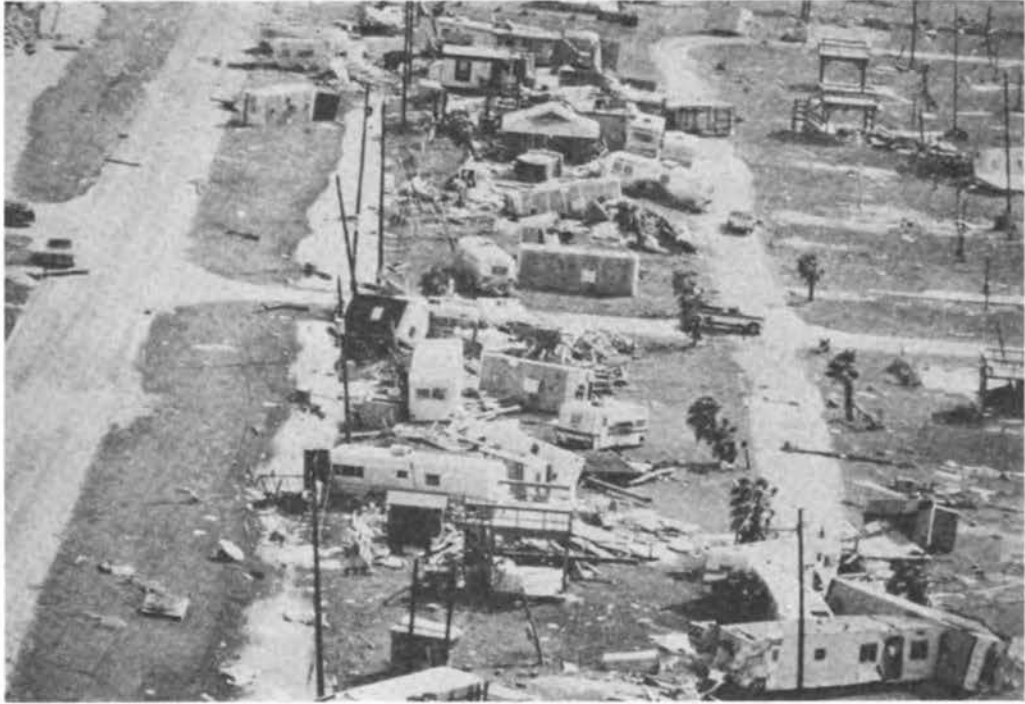
FIGURE 4.28 Damaged mobile home park on West Beach.

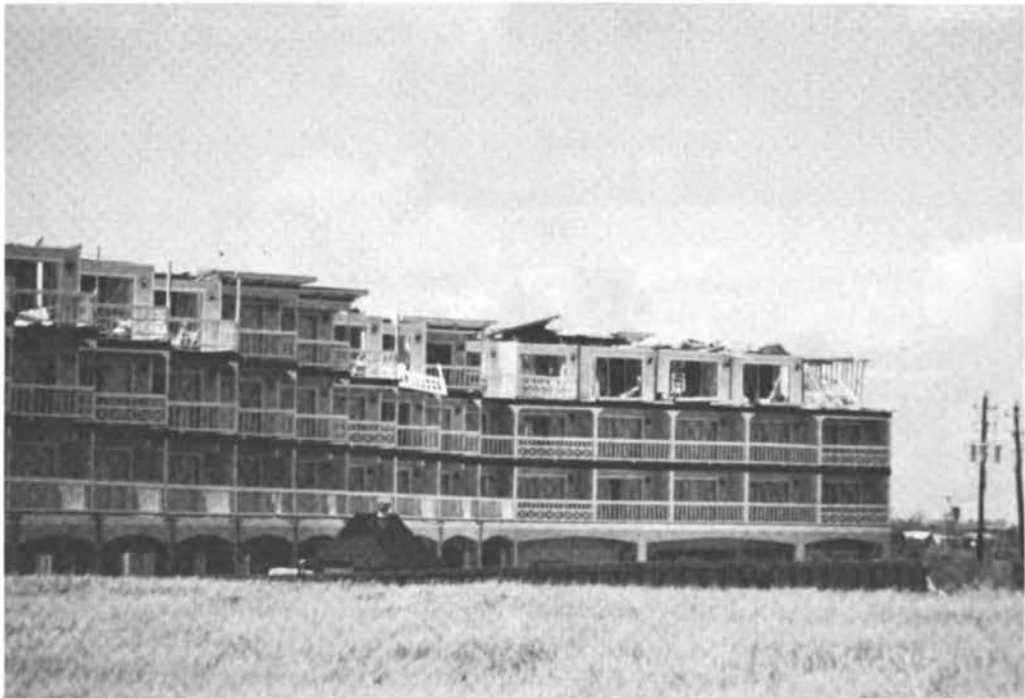
The building was extensively damaged on its eastern side (Figure 4.29). The open land between the Victoria Hotel and an adjoining complex provides conditions suitable for the wind to accelerate.

FIGURE 4.29 General view of the damaged wing of the Victoria Hotel.

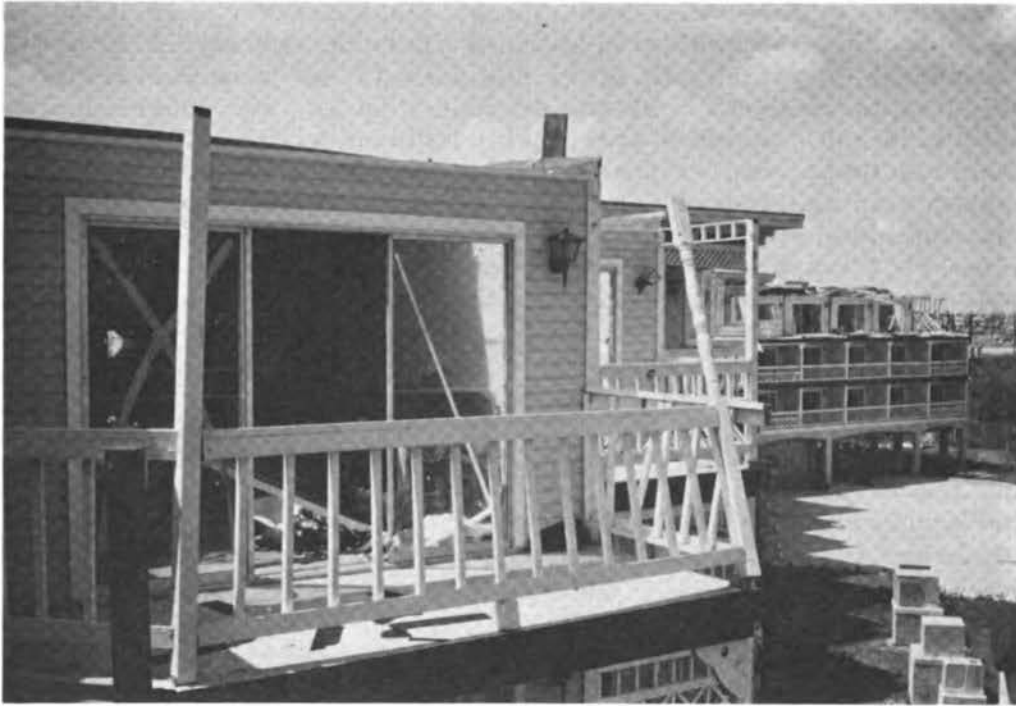
FIGURE 4.30 Closeup of a damaged unit in the Victoria Hotel.

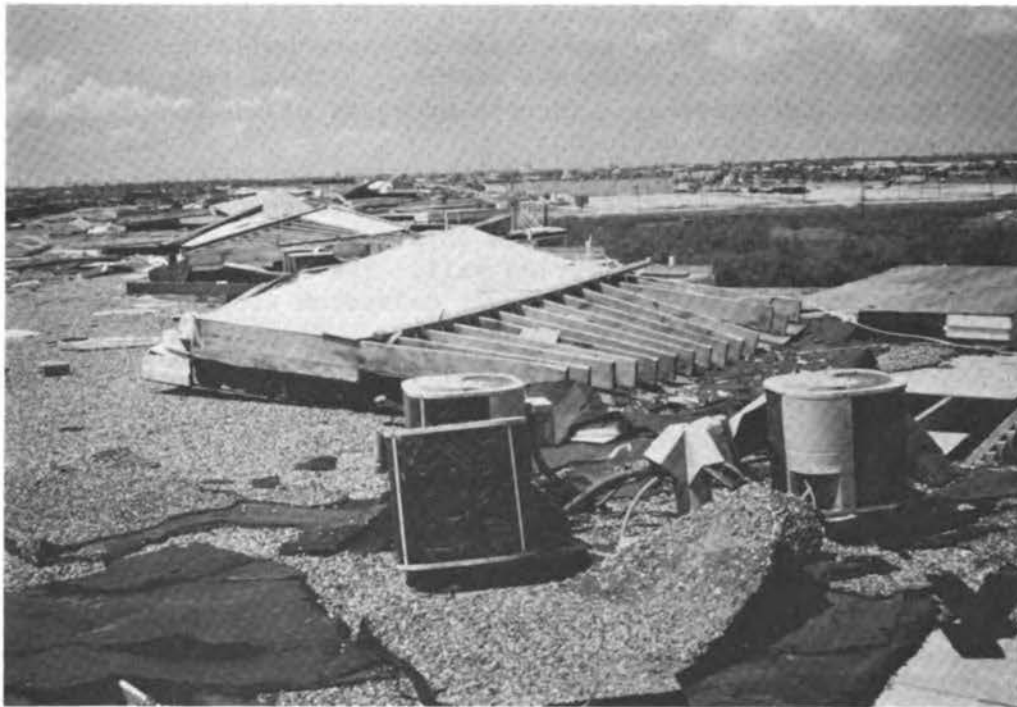
The overhang did have hurricane straps, but they were not properly tied to the main frame. This brings up an important point. The improper use of hurricane straps does not protect against wind damage during a hurricane. In fact, adequate protection depends on the number of hurricane straps, their spacing, and proper connections to the basic structural system, so that forces are redistributed to avoid concentrating stress on individual structural components at the points of attachment.

FIGURE 4.31 General view of the roof of the Victoria Hotel, showing damaged overhangs that landed on the roof.

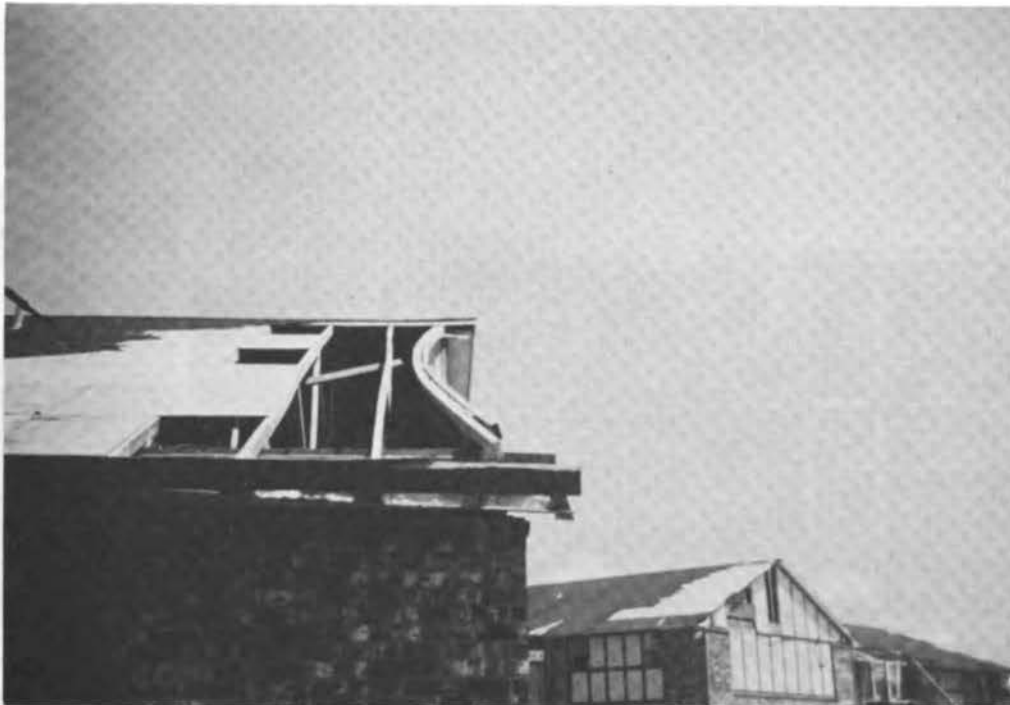
FIGURE 4.33 Damage to a roof truss caused by lack of bracing between trusses.

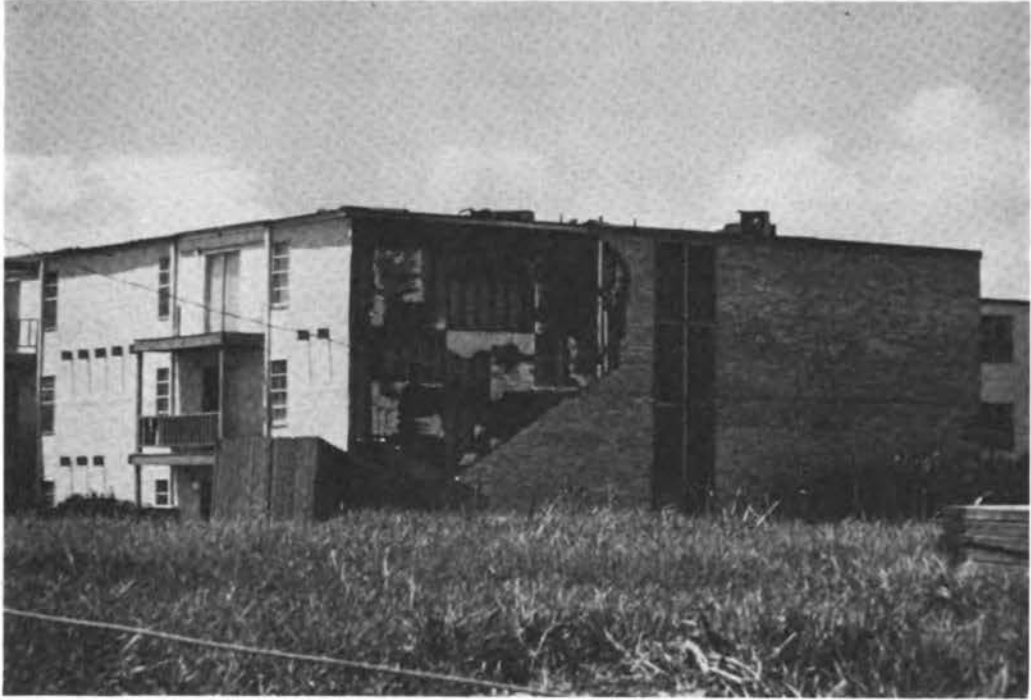
FIGURE 4.34 Failure of veneer brick walls due to lack of ties.

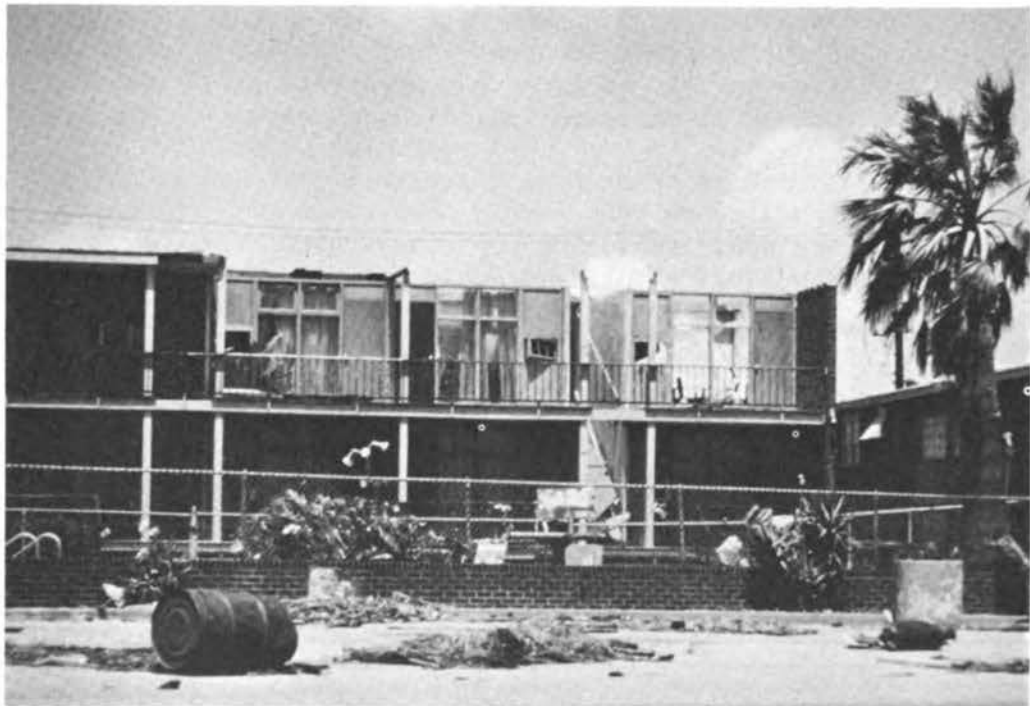
FIGURE 4.35 Partial loss of roof at a motel.

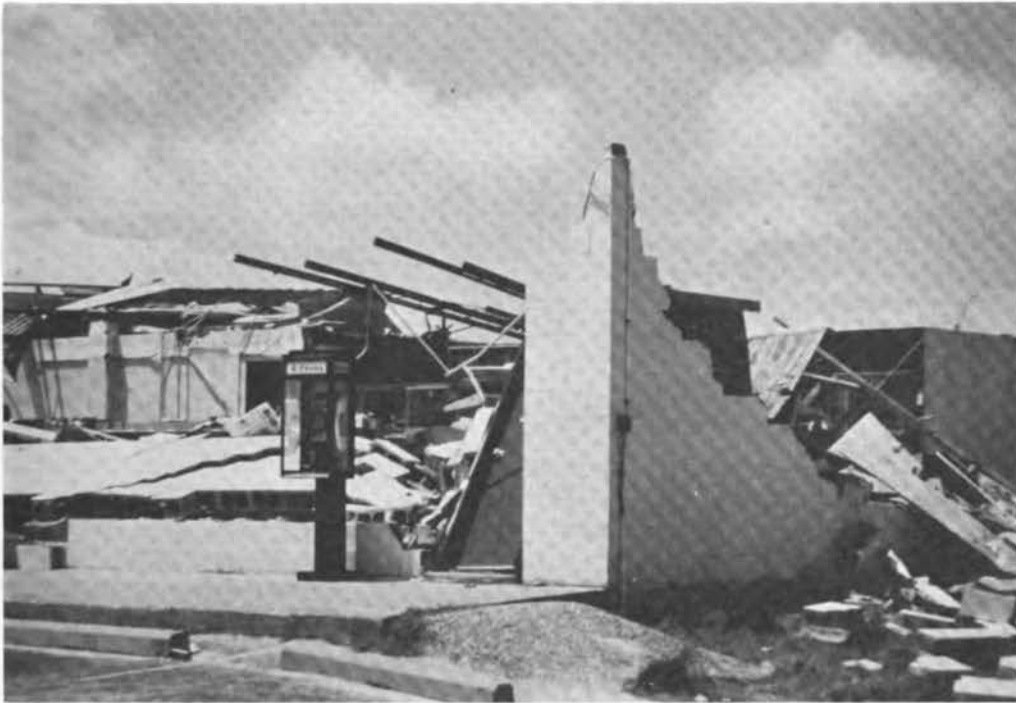
FIGURE 4.36 Typical example of the failure of one of many convenience stores.

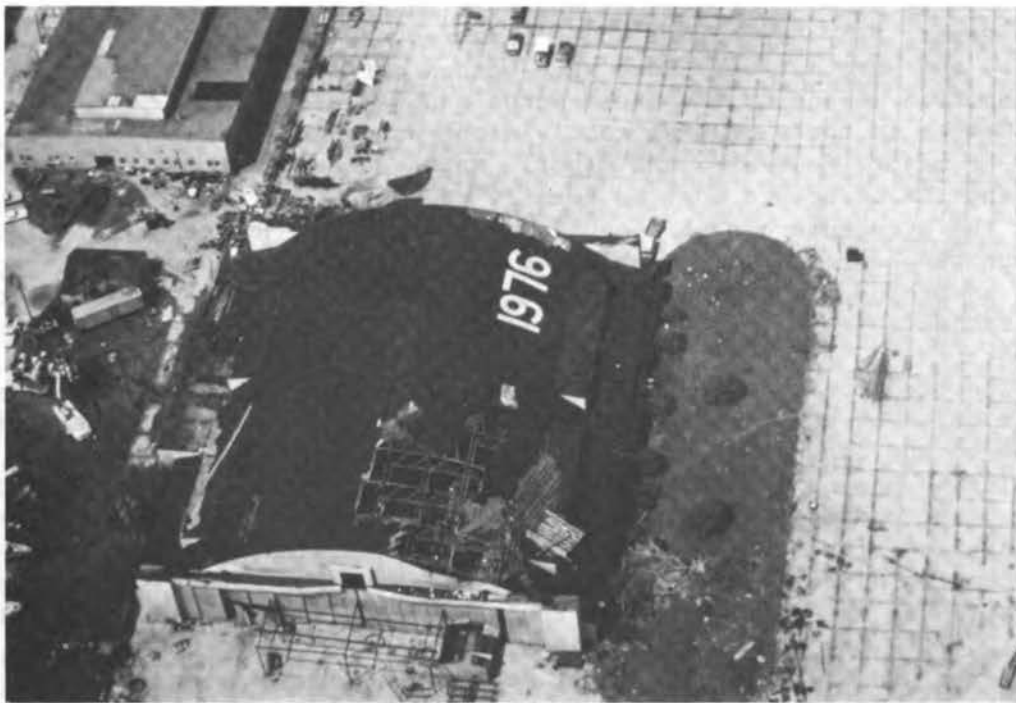
FIGURE 4.37 Wind damage to the roof of a hangar at Galveston Airport.

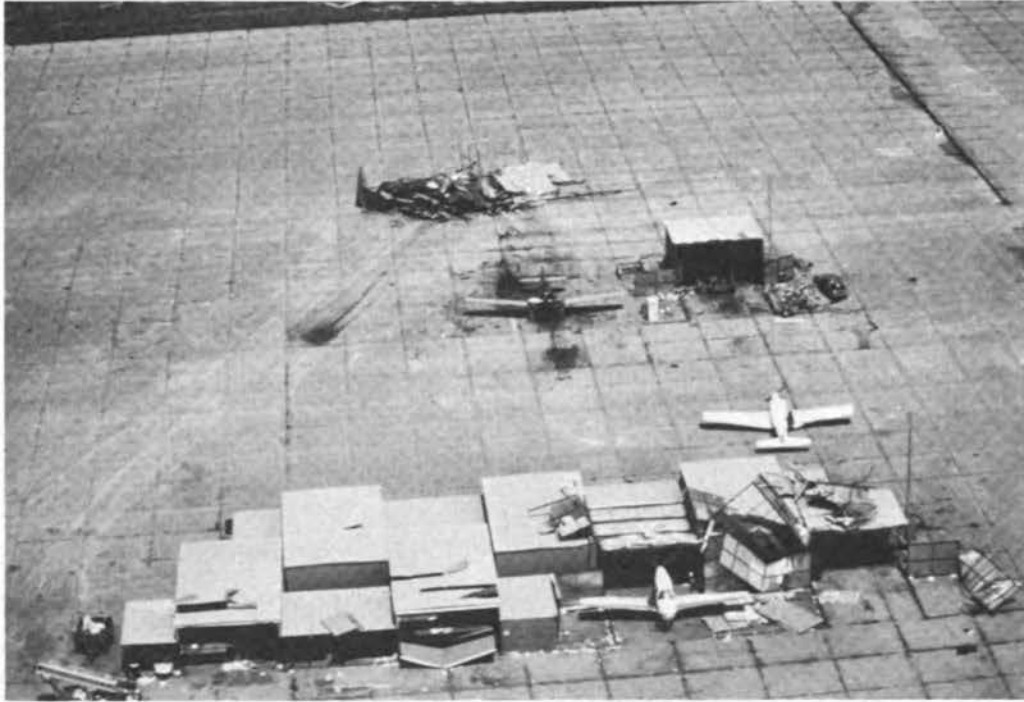
FIGURE 4.38 Damaged hangars and small aircraft at Galveston Airport.

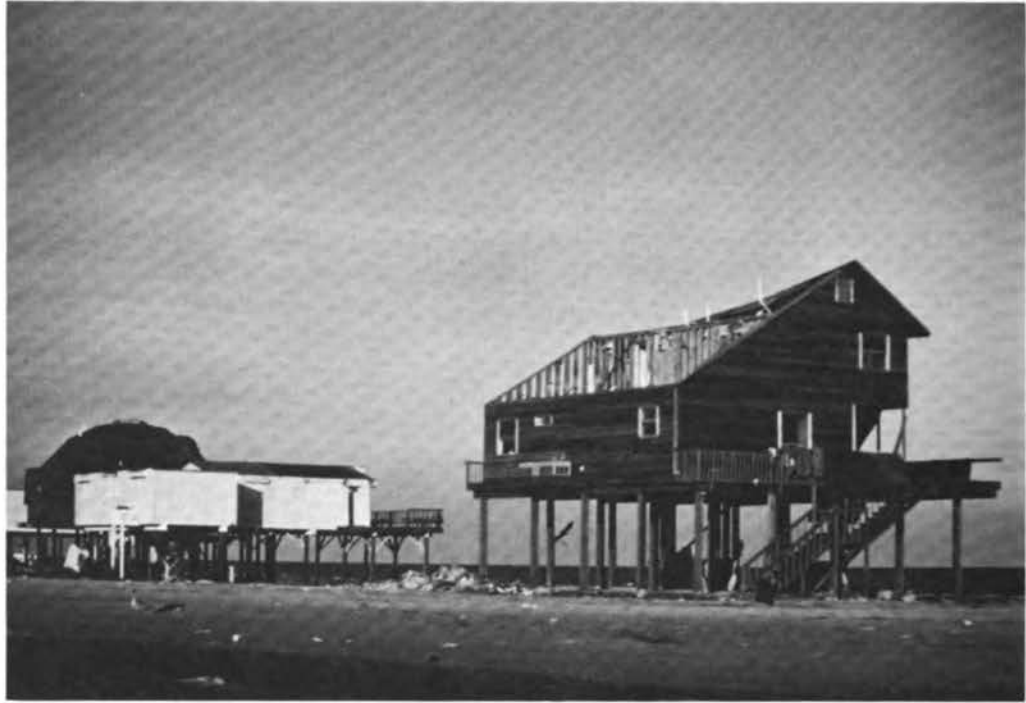
FIGURE 4.39 Example of a roof failure of a house in Terramar Beach.

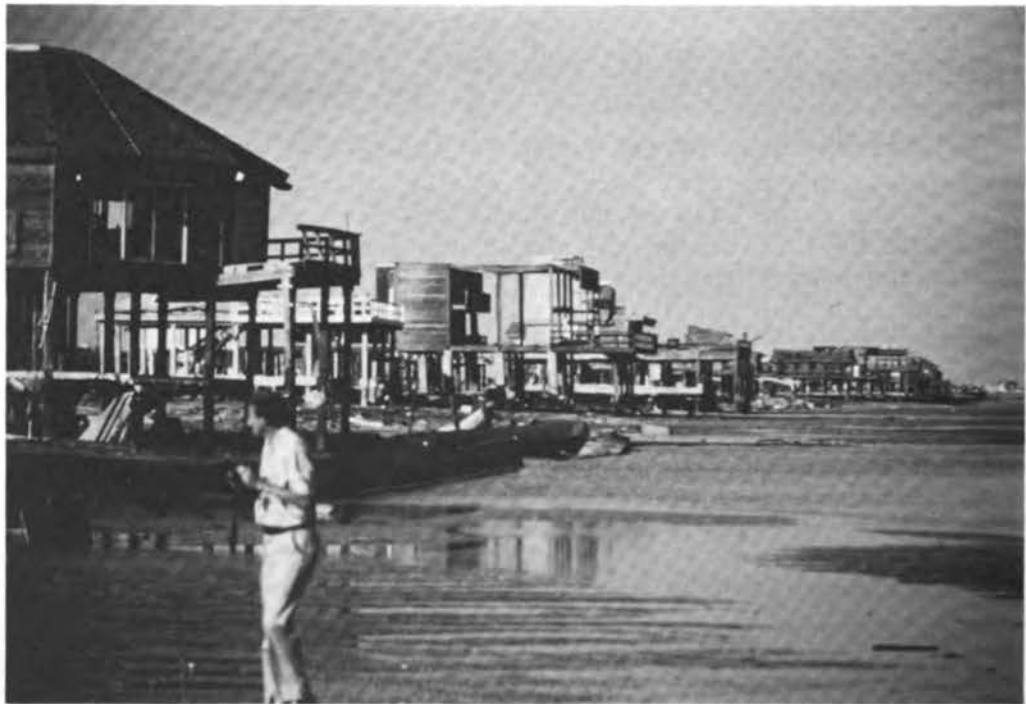
FIGURE 4.40 General view of damaged houses along Terramar Beach.
