Hurricane Alicia, Galveston and Houston, Texas, August 17-18, 1983 (1984)

Hurricane Alicia Galveston and Houston, Texas August 17-18, 1983

Committee on Natural Disasters
Commission on Engineering and Technical Systems
National Research Council

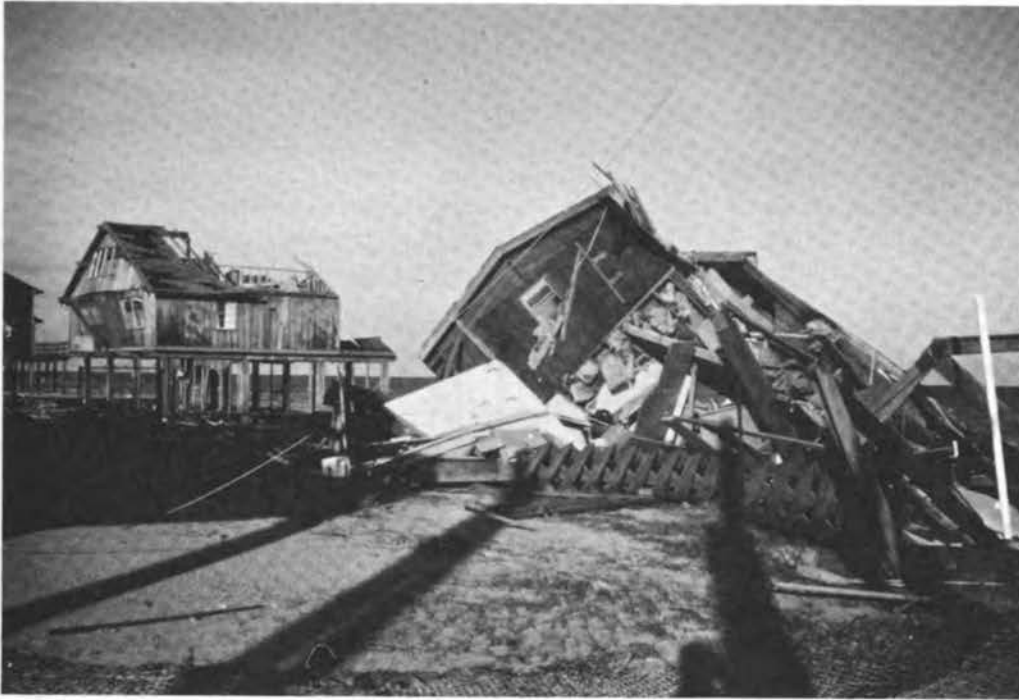
FIGURE 4.41 Example of overall collapse of a house and supporting structure.

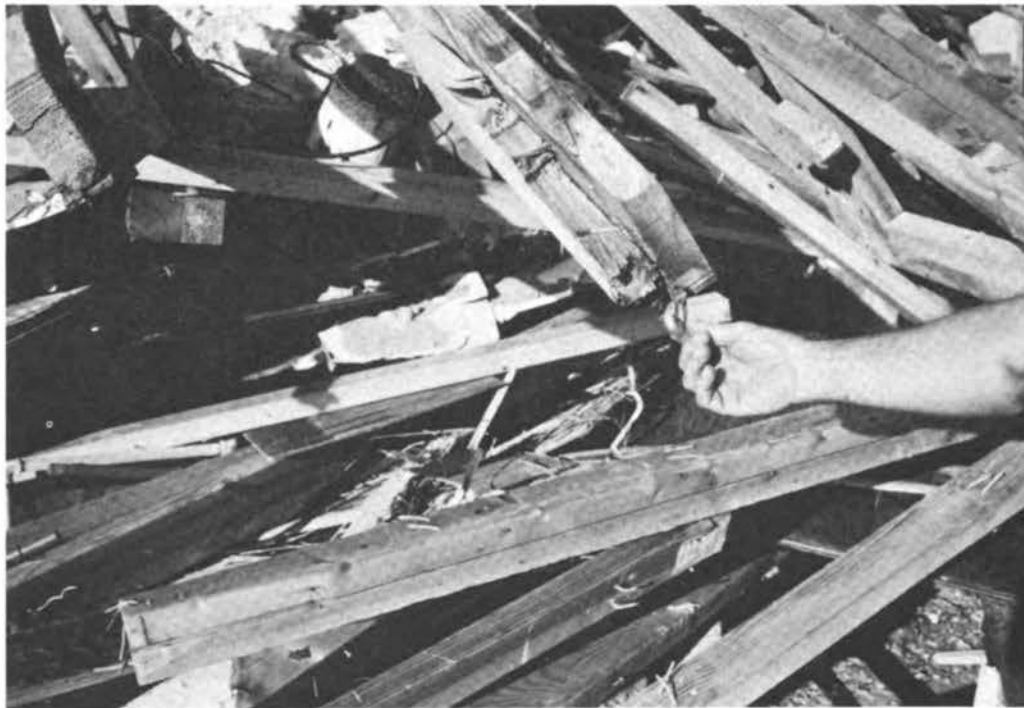
FIGURE 4.44 Details of toe nail connections.

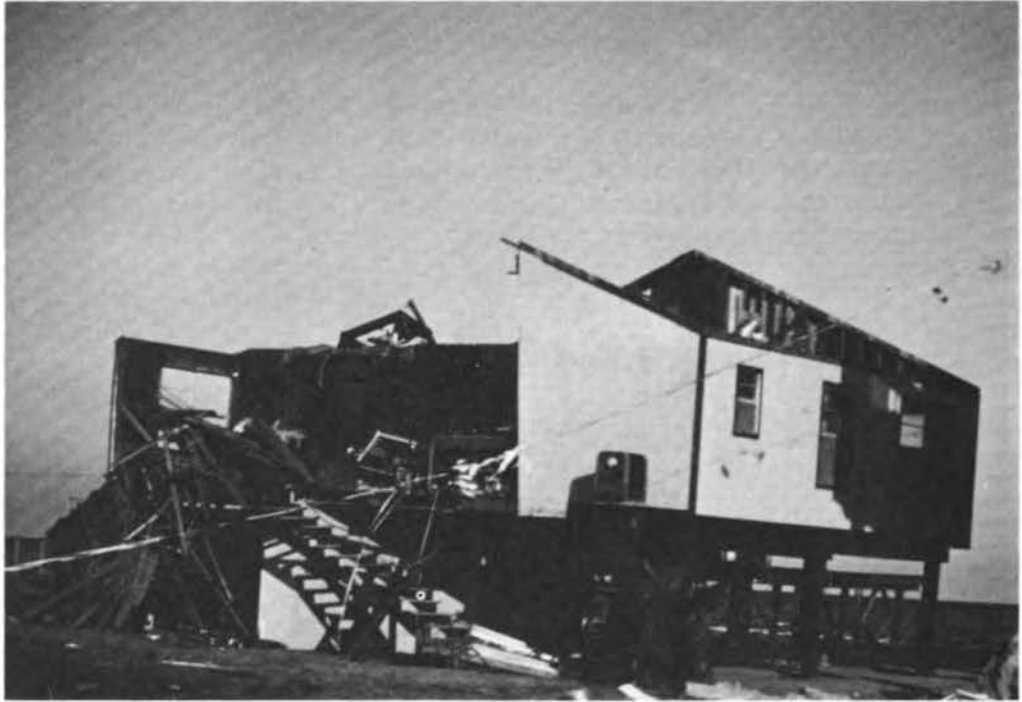
FIGURE 4.45 Damaged house fronting the Gulf in Sea Isle.

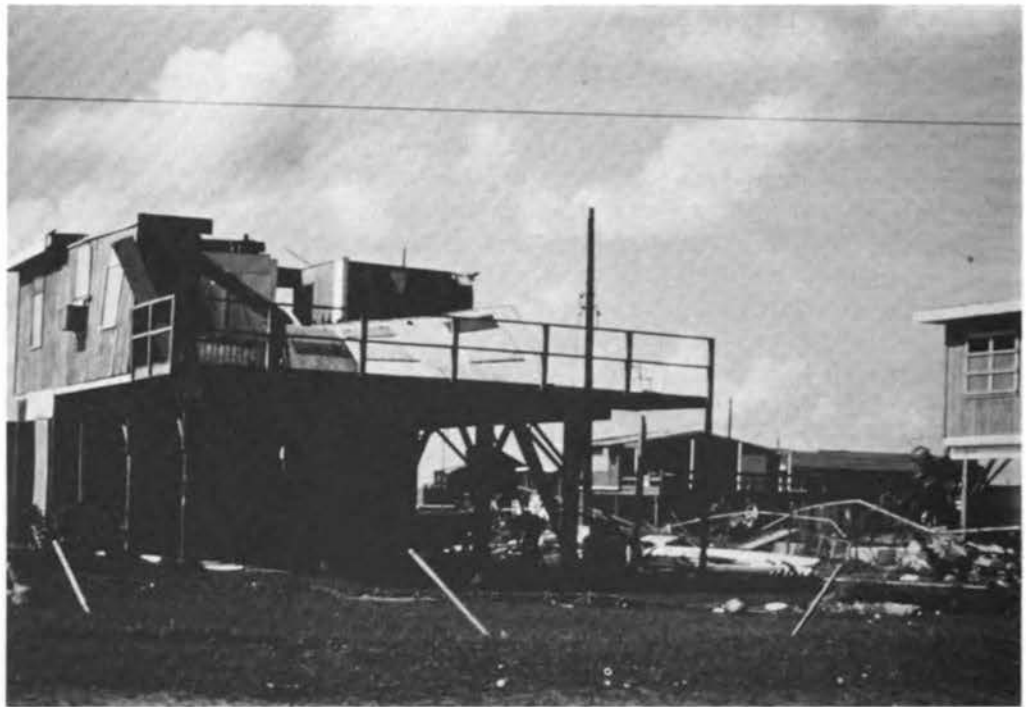
FIGURE 4.46 Damaged house in the second block from the coast in Sea Isle.

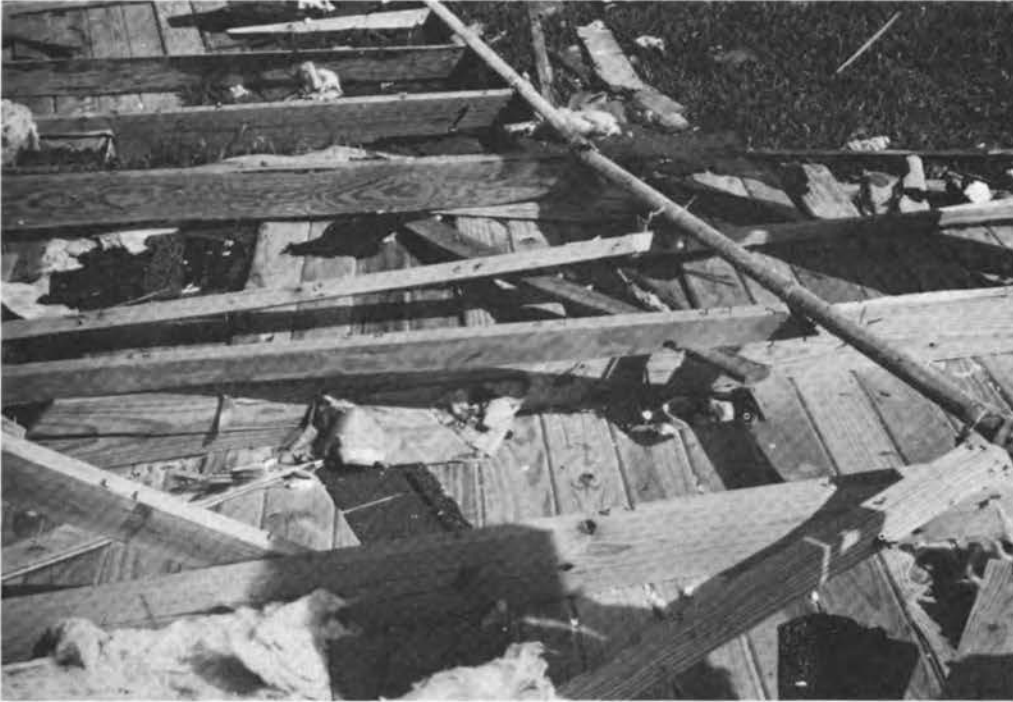
FIGURE 4.47 Details of end plate connections with rafters and hurricane clips.

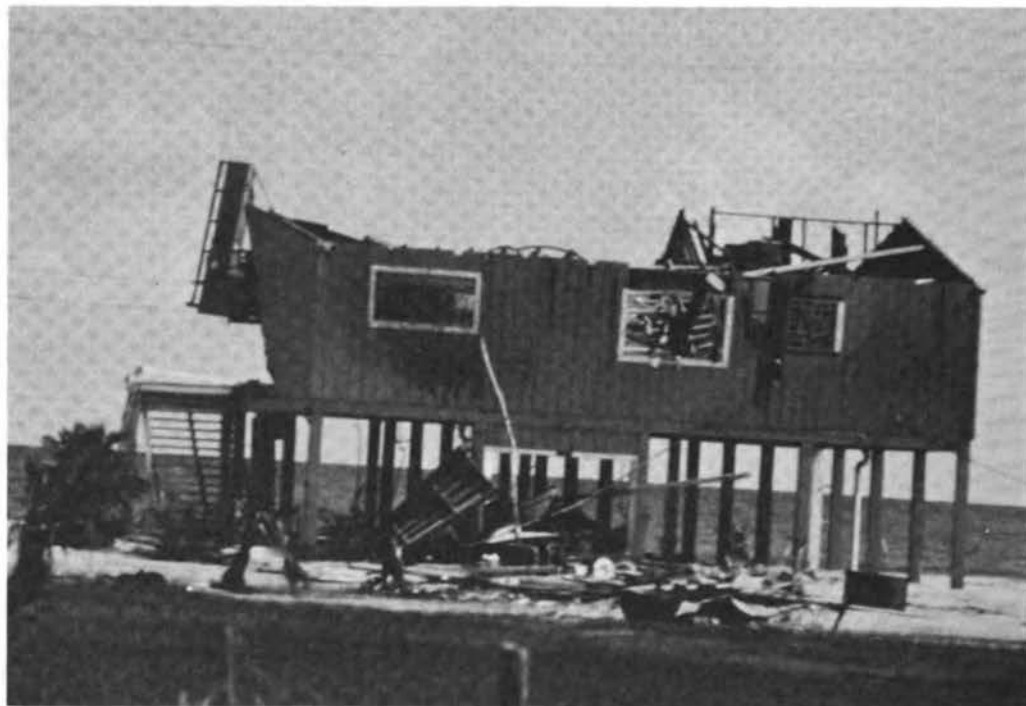
FIGURE 4.49 Damaged house in Jamaica Beach.

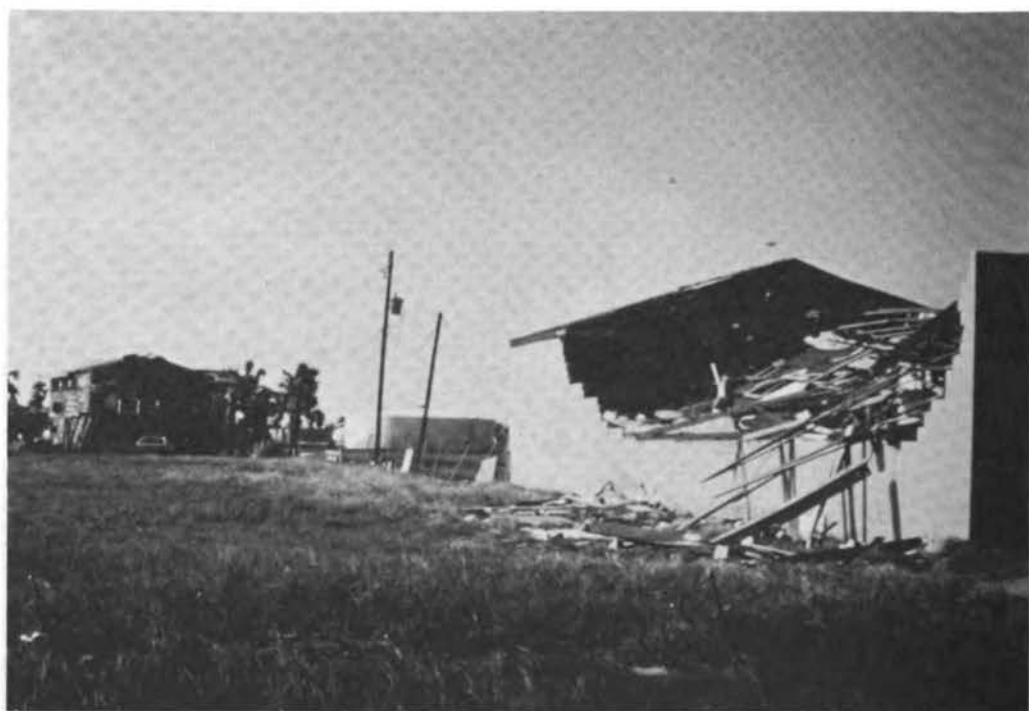
FIGURE 4.50 Damage to a large commercial warehouse building.

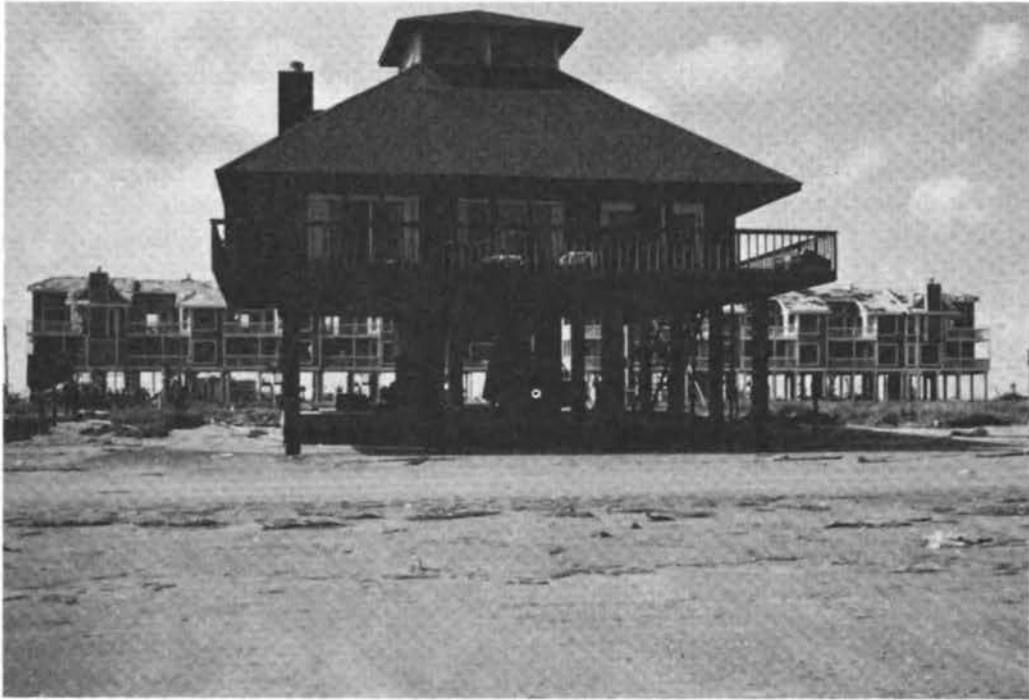
FIGURE 4.51 Example of a well-constructed house that performed very well except for erosion around the foundation.

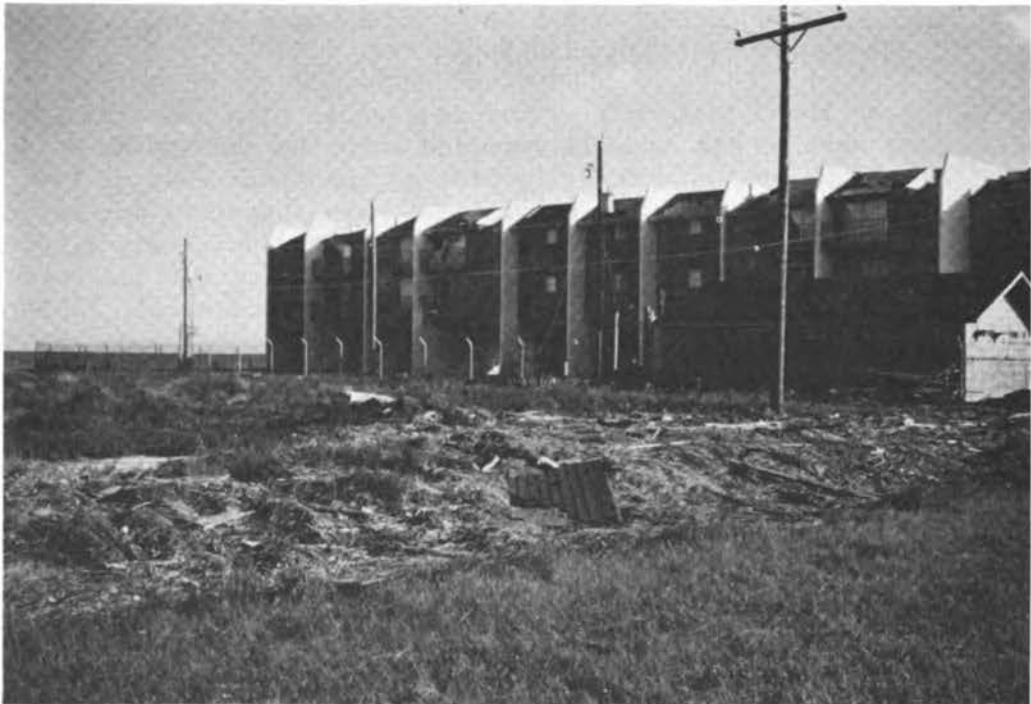
FIGURE 4.52 Damage to the roof and erosion around foundations of condominium units on the west side of San Luis Pass.

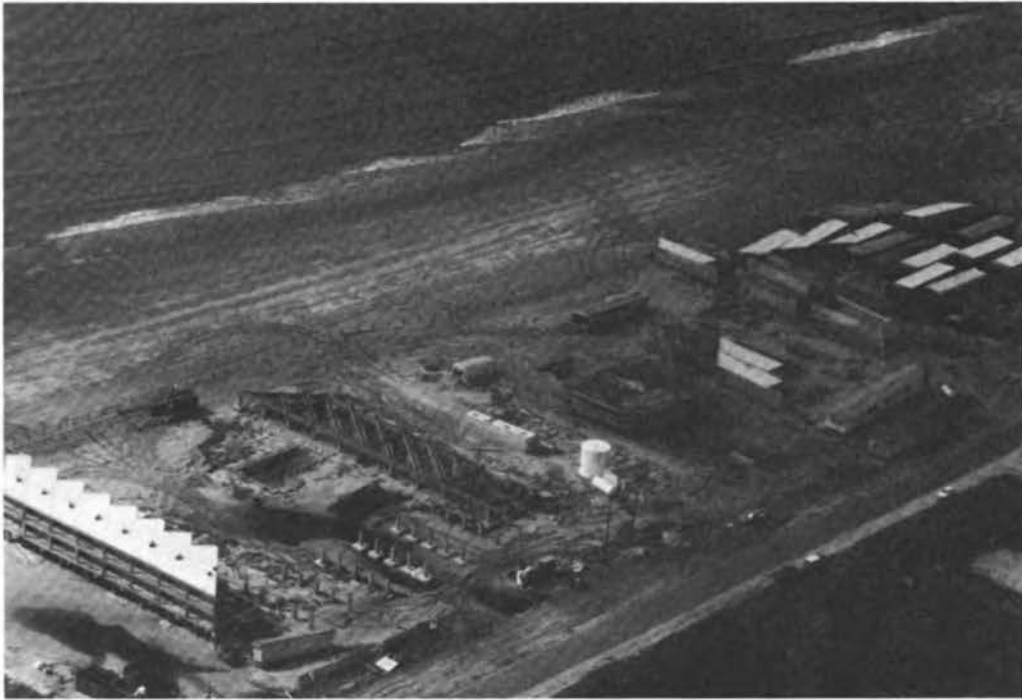
FIGURE 4.53 General view of a modular condominium project that experienced damage from wind and storm surge.

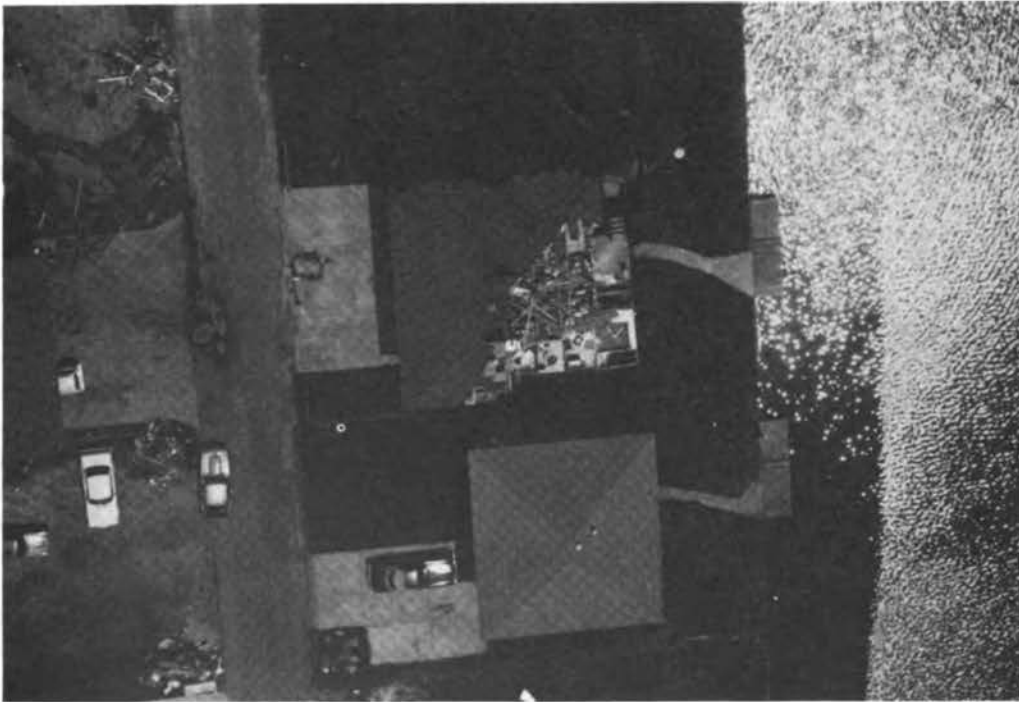
FIGURE 4.54 Aerial view of roof damage.

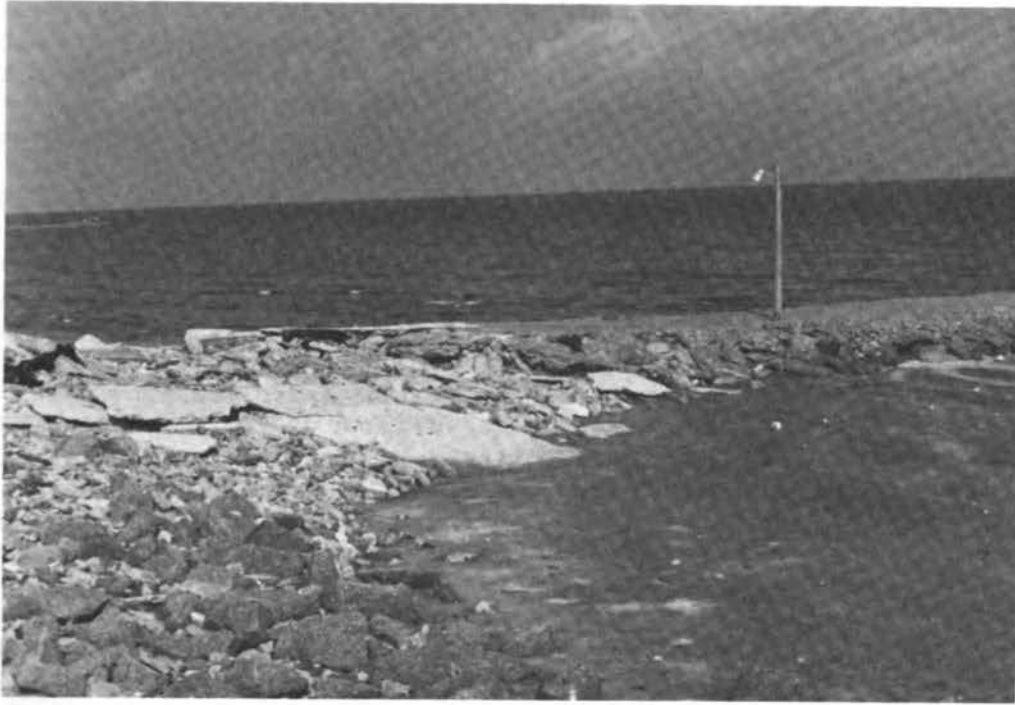
FIGURE 4.55 Damage to groin in front of the Galveston seawall.

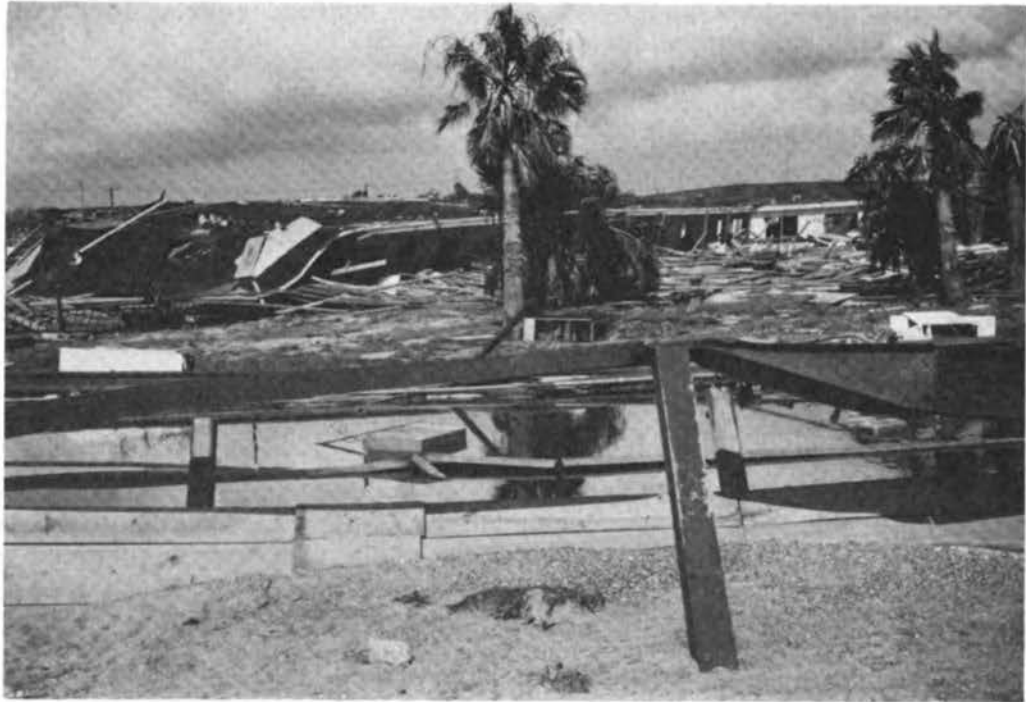
FIGURE 4.57 An elevated motel transported off its foundation by the storm surge.

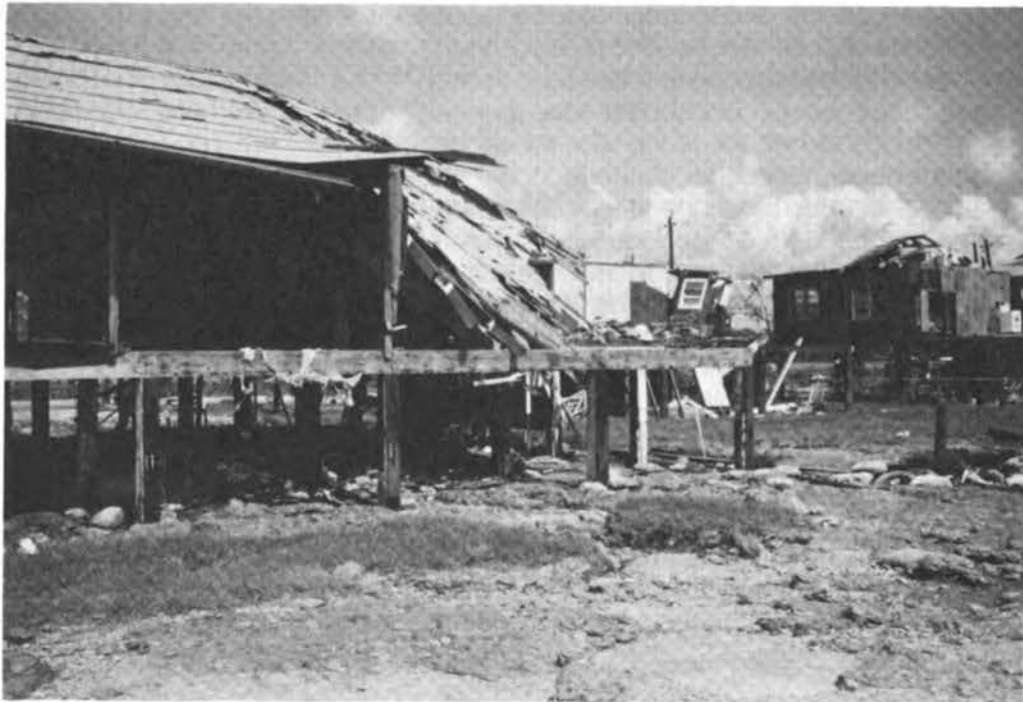
FIGURE 4.58 Bayfront house with a collapsed roof.

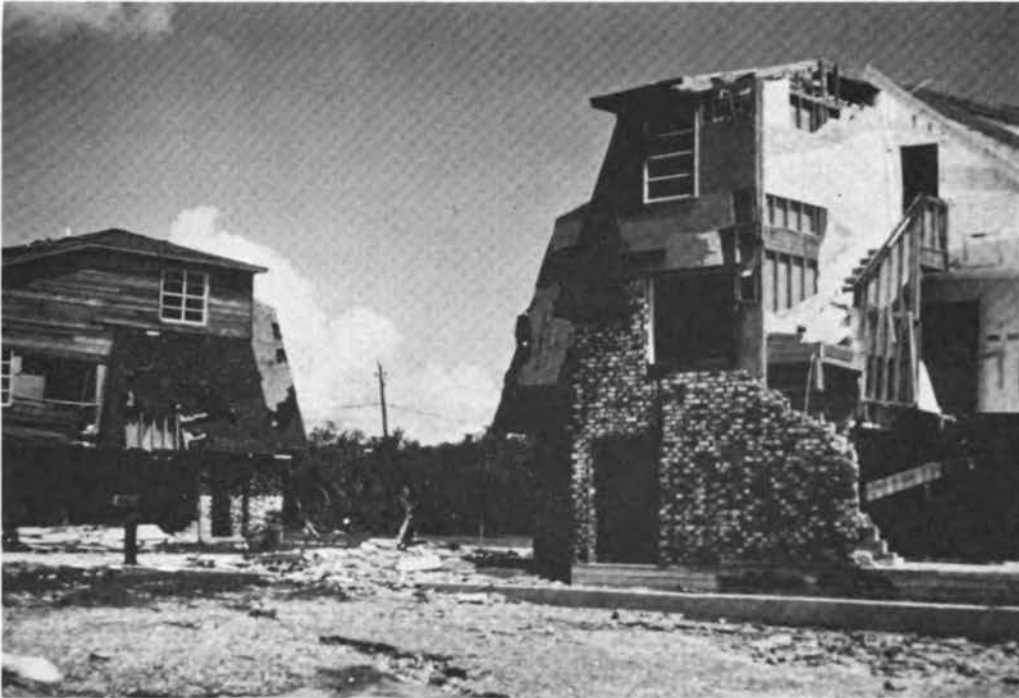
FIGURE 4.59 Failure of the roof and brick veneer wall of a condominium.

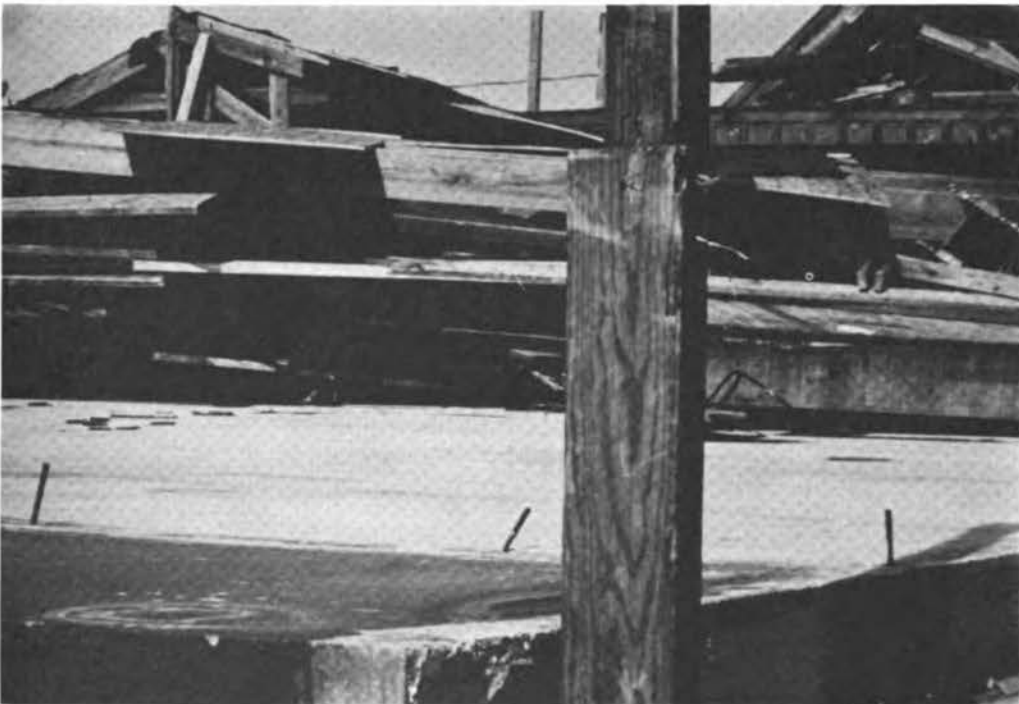
FIGURE 4.60 House washed away from its foundation slab by storm surge.

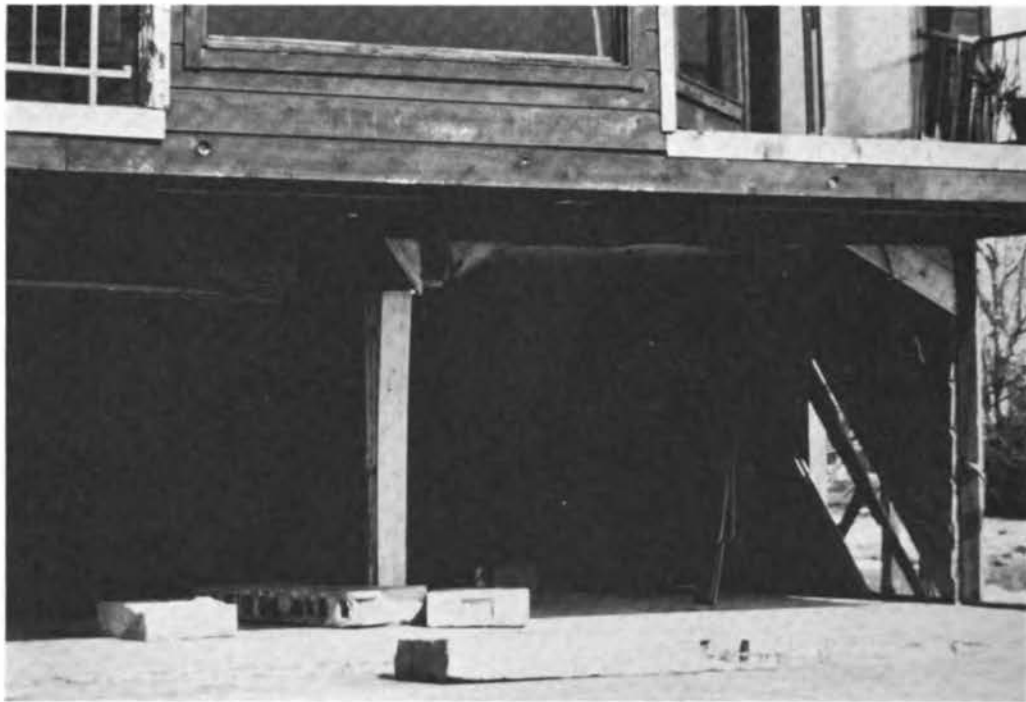
FIGURE 4.61 Damage to a grade-level enclosure.

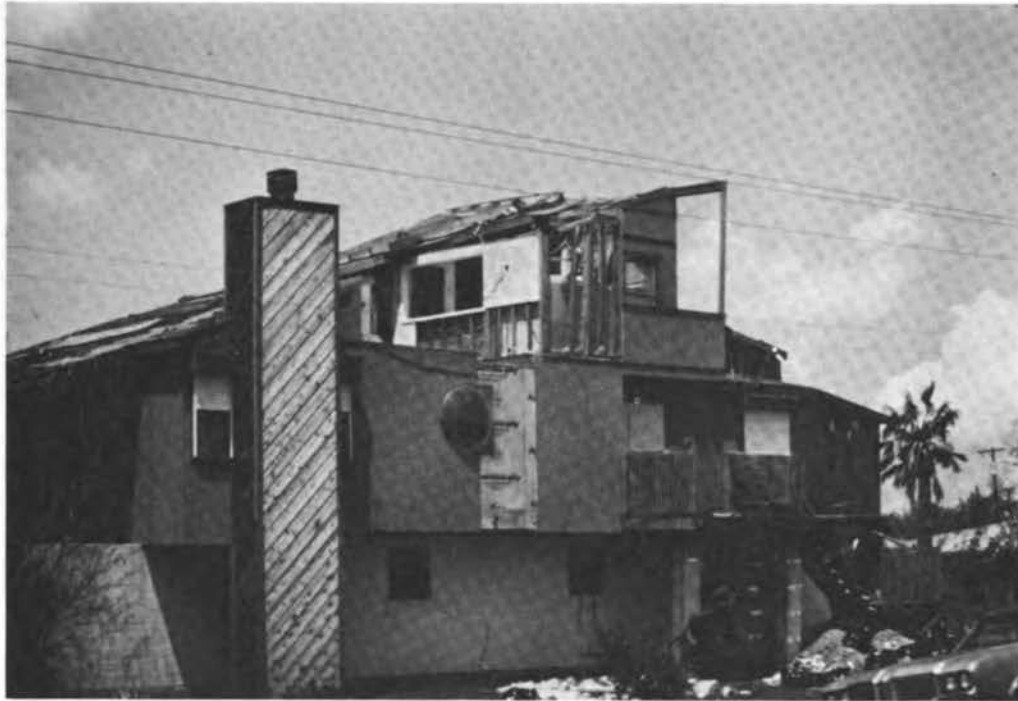
FIGURE 4.63 Roof damage to a condominium in Texas City.

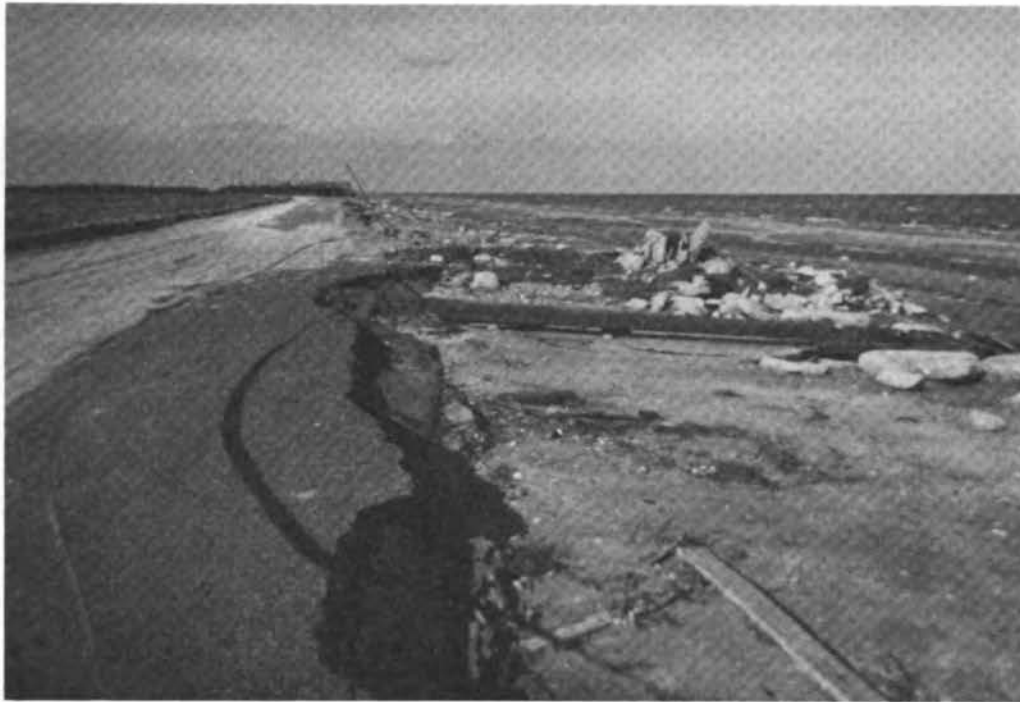
FIGURE 5.1 Typical washout of shoulder on San Luis Pass Road, Follets Island.

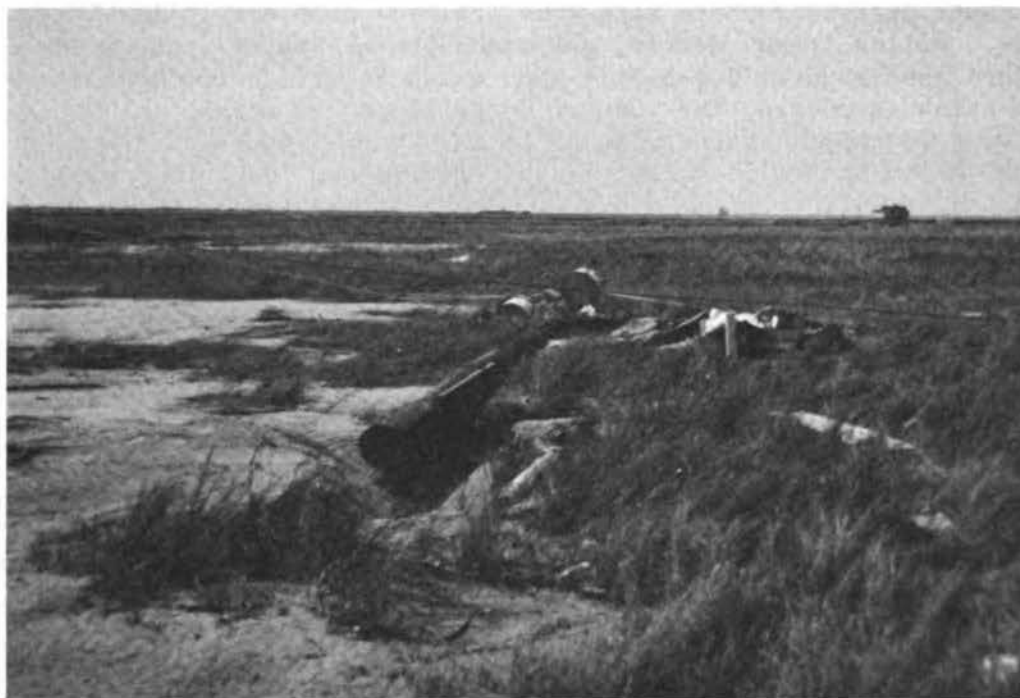
FIGURE 5.4 Typical failure of transformer pole on East Beach, Galveston Island.

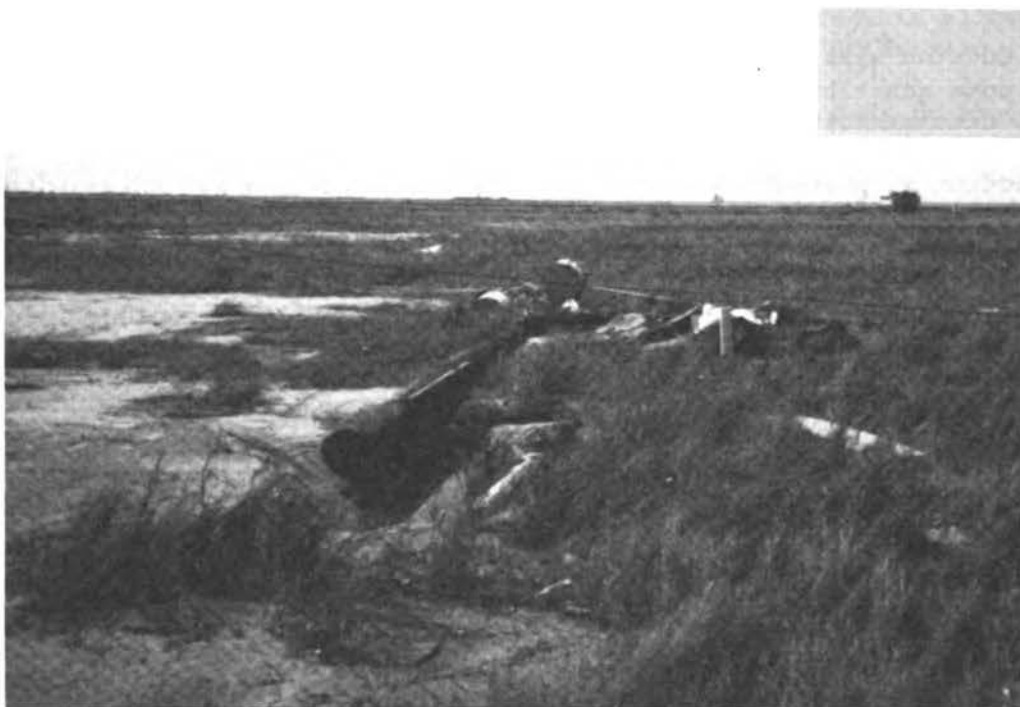
FIGURE 5.5 Typical failure of utility pole on East Beach, Galveston Island.

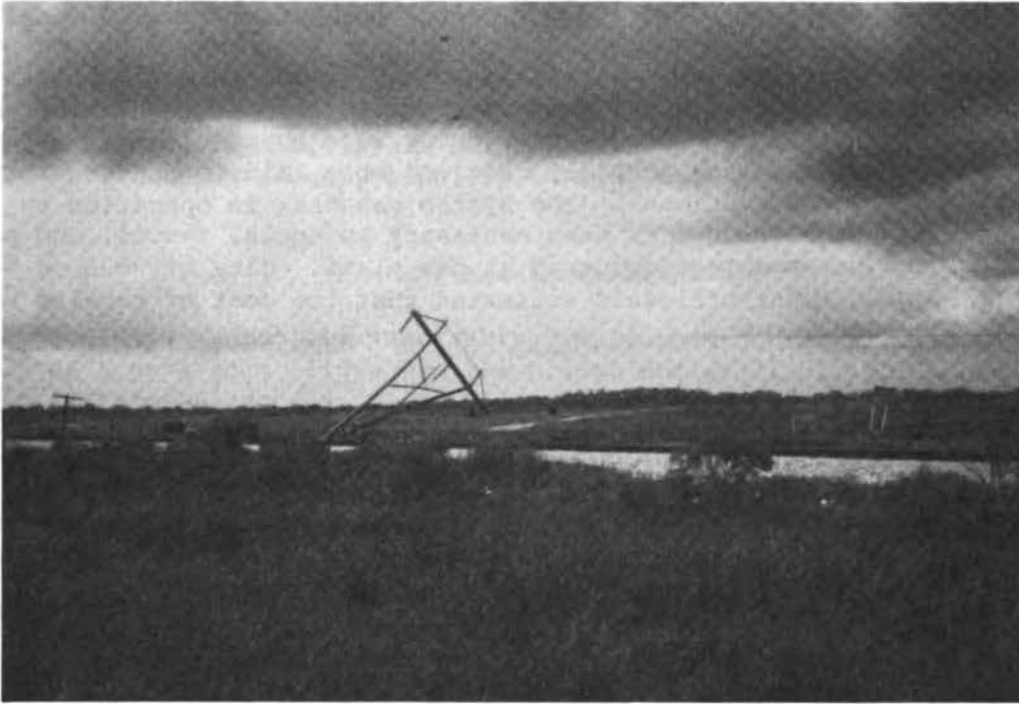
FIGURE 5.6 Failure of primary power pole near Highway 146 south of Bay City.

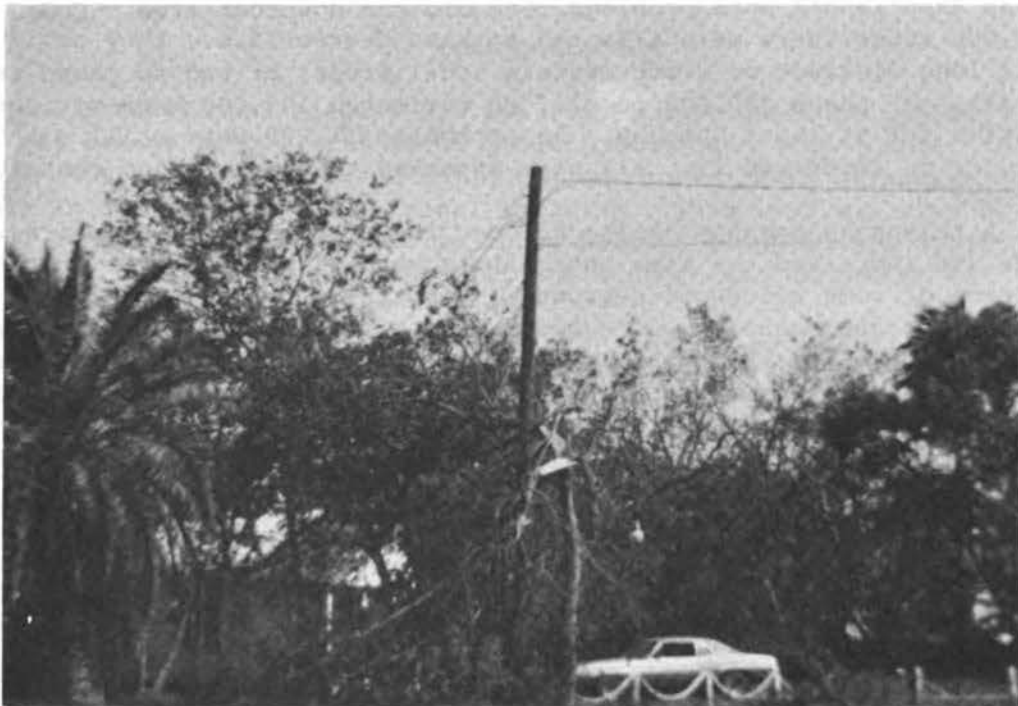
FIGURE 5.7 Typical failure of utility line caused by fallen trees in Seabrook.
