The Los Angeles, California Tornado of March 1, 1983

Committee on Natural Disasters
Commission on Engineering and Technical Systems
National Research Council

At 7:40 a.m. on March 1, 1983, the downtown metropolitan area of Los Angeles was struck by a tornado severe enough to cause significant structural damage to not only old buildings but also modern, engineered structures. The path of the tornado (see Figure 1) was such that it moved in approximately a south to north direction and passed within a quarter mile of major high-rise buildings.

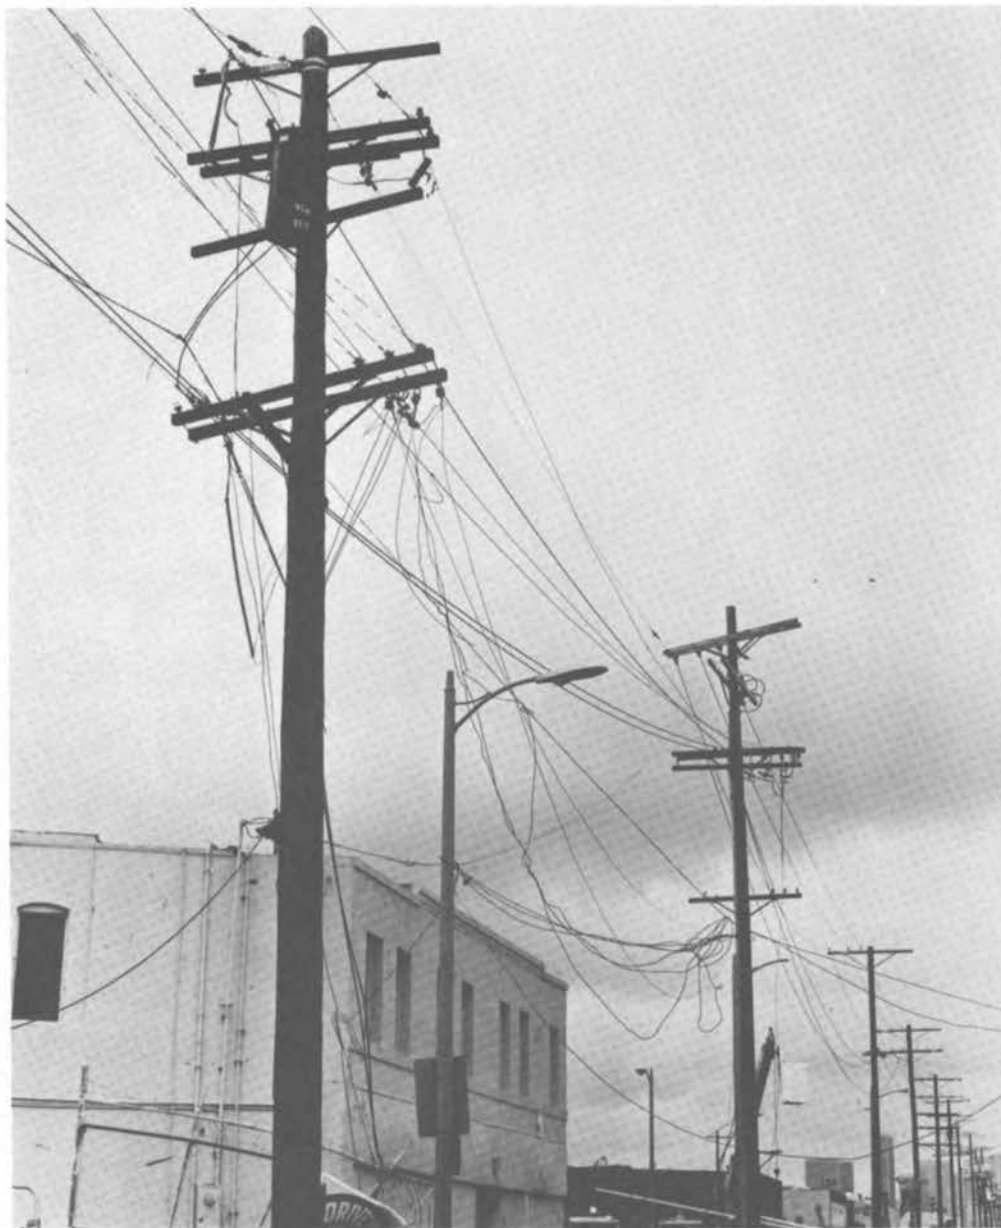
Most of the damage to the electric power system was caused by the rupture of overhead power lines by high-velocity winds (Figure 10). Almost all of the power lines in the affected area were damaged. These power lines included 34,500-V and 5,000-V subtransmission lines, 480-V and 240-V three-phase distribution lines to light industrial and commercial consumers, and 240-V and 120-V distribution lines to light commercial and residential customers.

FIGURE 10 Damage to electric power distribution lines.

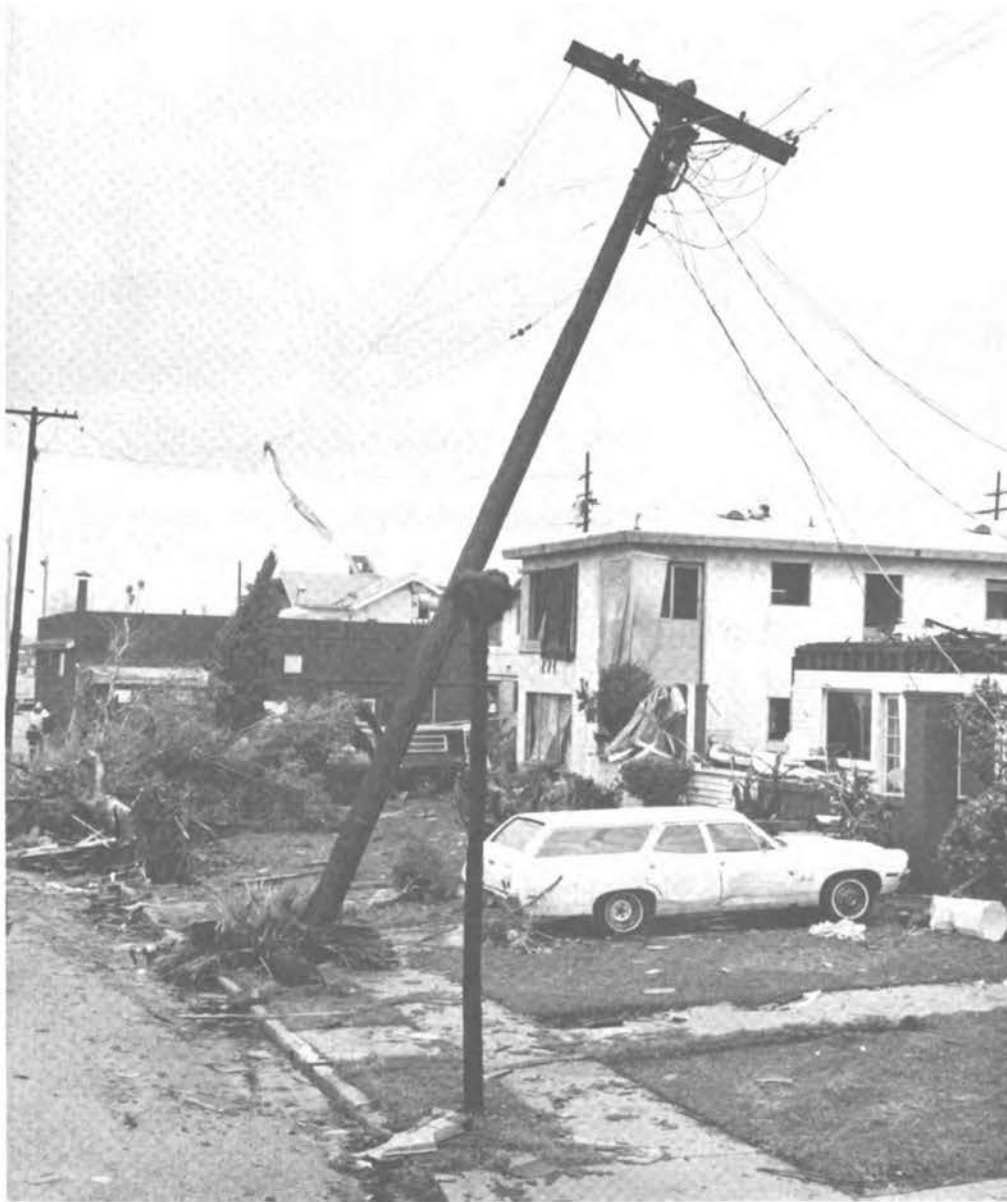
Wooden power poles were also considerably damaged. About 15 poles were displaced from their vertical alignment due to the failure of the soils in which they were embedded because of high-velocity winds (Figure 11). Other poles failed as a result of flexural or shear overstresses. Among these were 25 poles that failed at ground level and others that failed at their mid-heights or higher (Figure 12). It seemed that poles sheltered by buildings from the wind failed at or above the roof level of the buildings.

FIGURE 11 Wooden pole failure at ground level due to shear and flexural overstresses.

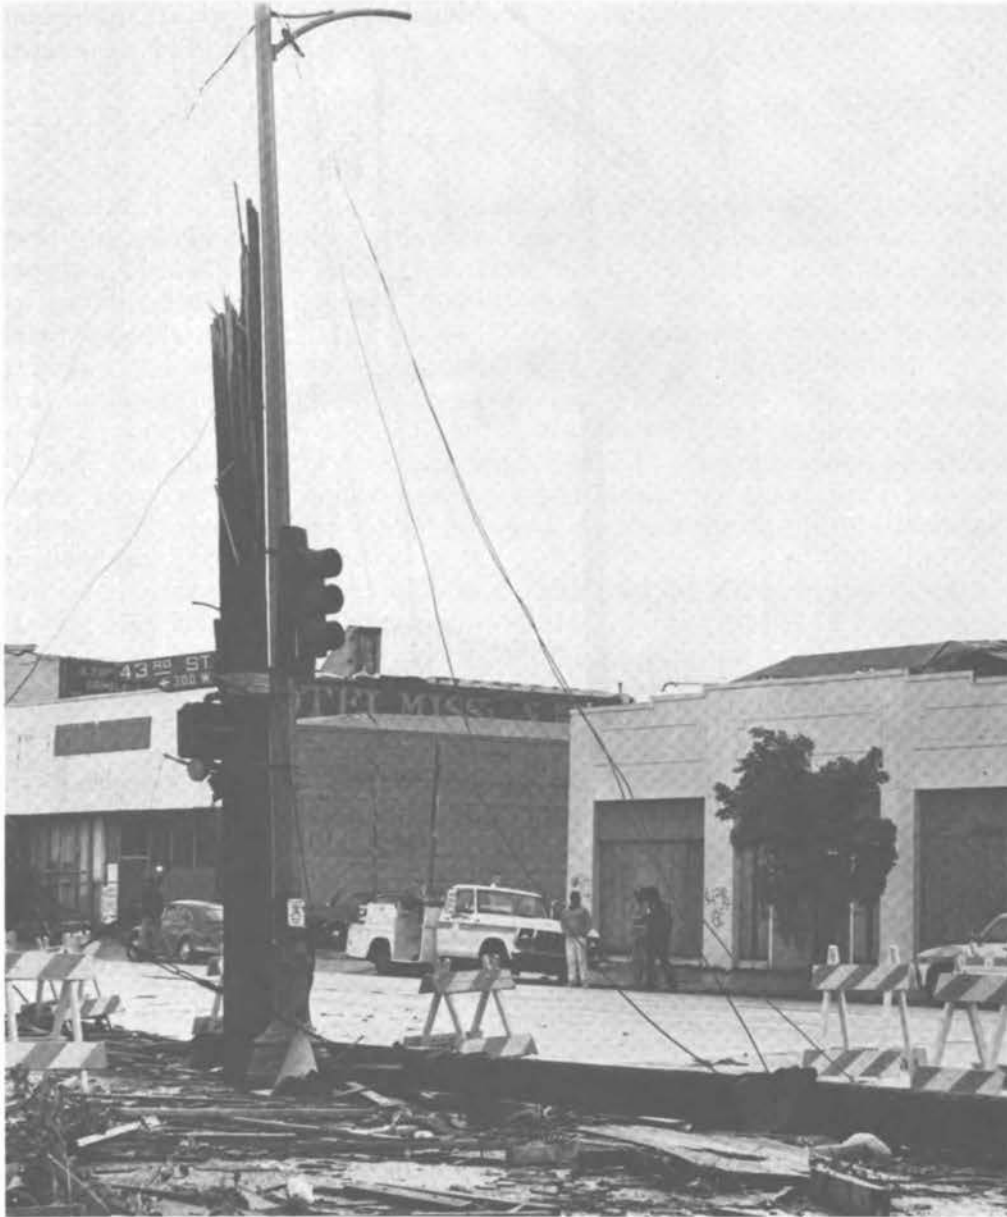
FIGURE 12 Wooden pole failure at midheight due to overstress.

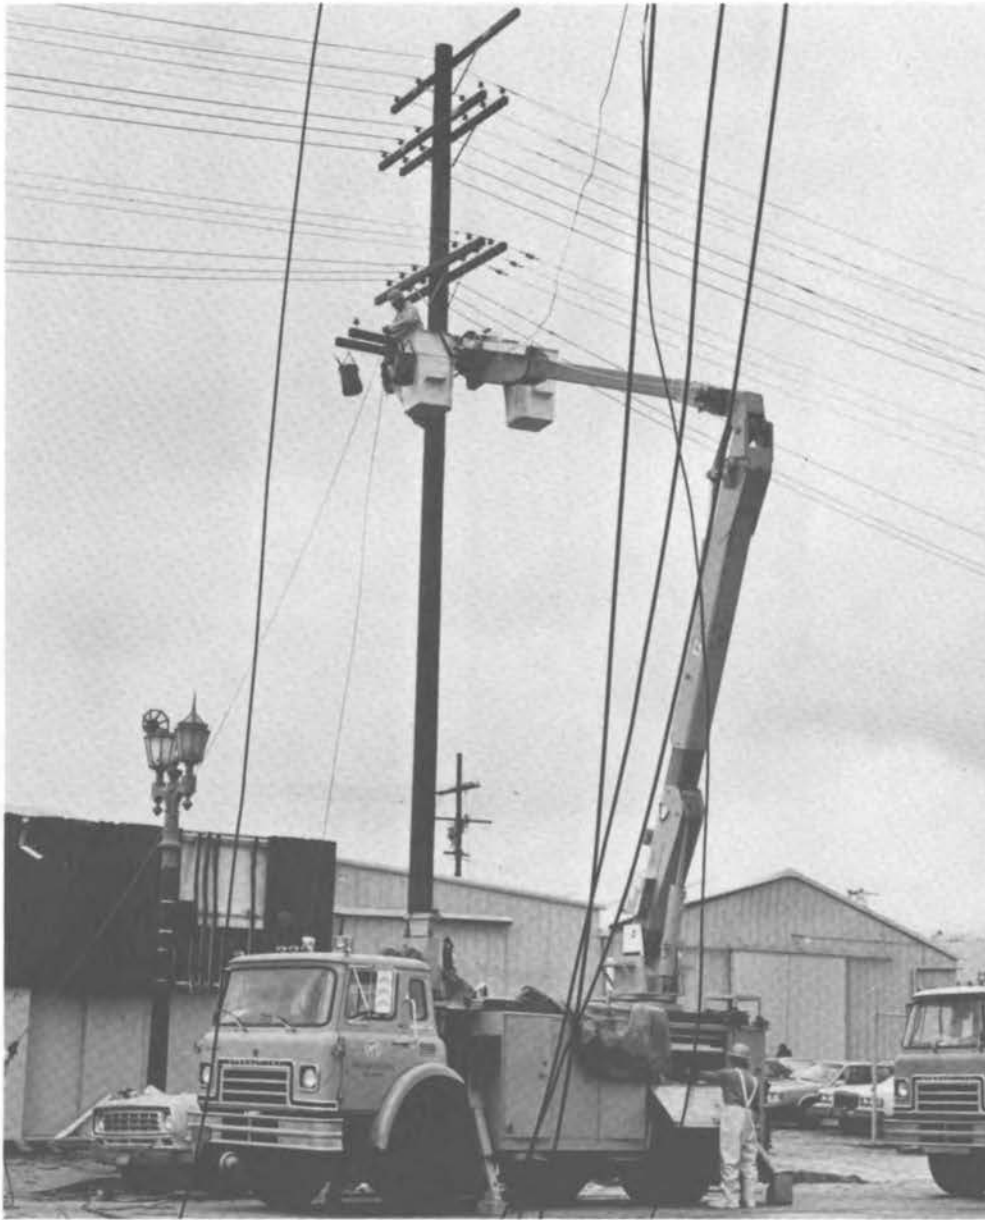
FIGURE 13 Restoration of electric power distribution lines by Los Angeles Department of Water and Power personnel.

Repair work was begun within hours (Figure 13). The Police and Fire departments were requested to evacuate those areas where electric power lines were down to protect the general public and people engaged in legitimate disaster response work. A general superintendent was also appointed to manage the entire reconstruction effort in the field. It was found that distributing and customer substations had not been damaged; all the damage was to the overhead subtransmission and distribution system. Therefore such materials as standard hardware, wooden

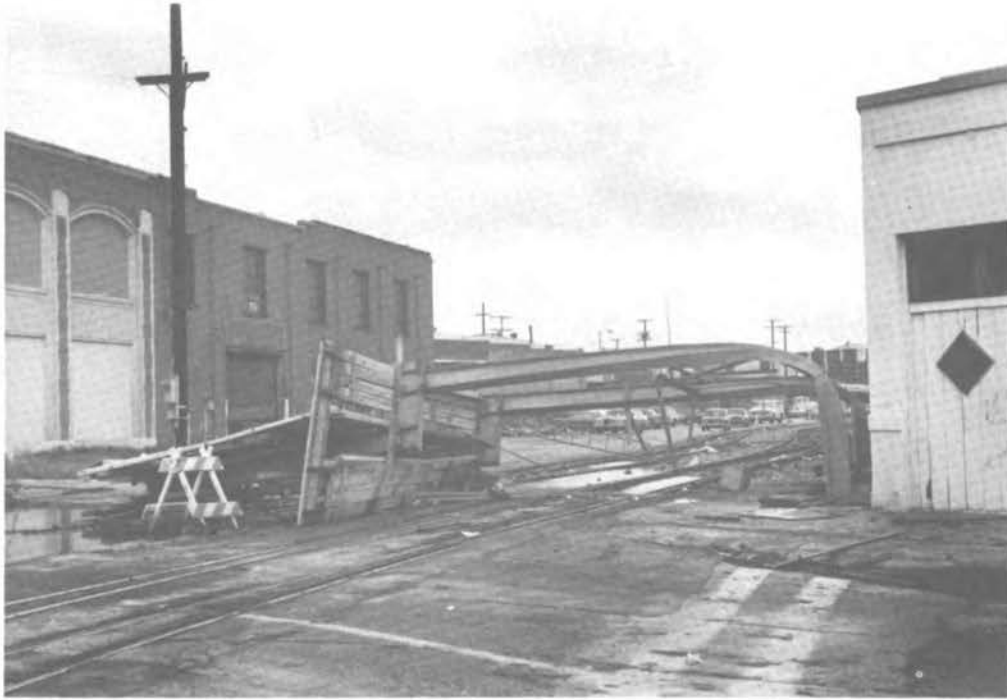
Figures 14A and 14B show the condition of a large industrial advertising sign before and after the tornado. As is clear from the condition of the sign, its failure took the form of a twisting or torsional response. Very approximate engineering estimates relating the sign's surface area and its probable moment capacity indicate that it probably experienced a wind speed greater than 150 mph.

FIGURE 14A Industrial sign collapsed by tornado.

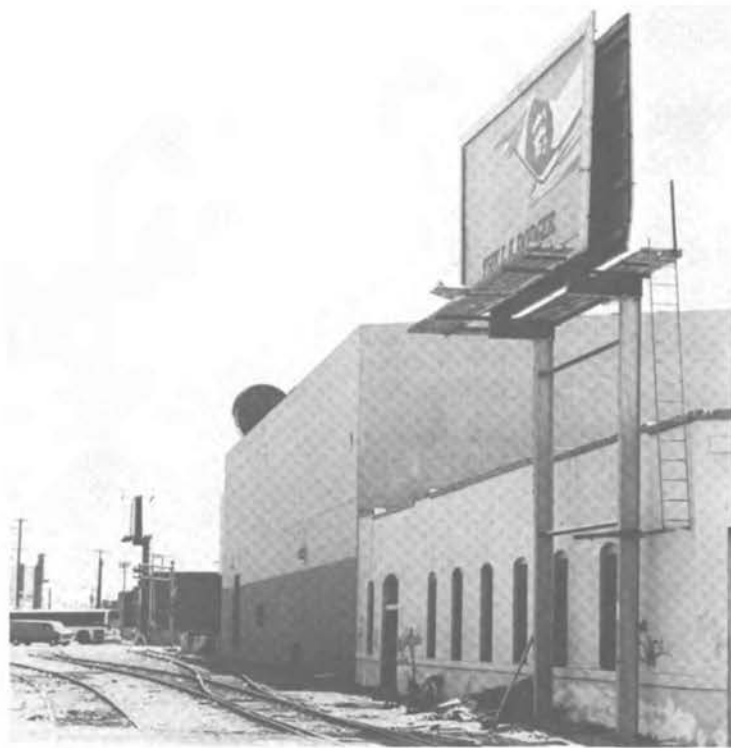
FIGURE 14B Repaired sign.

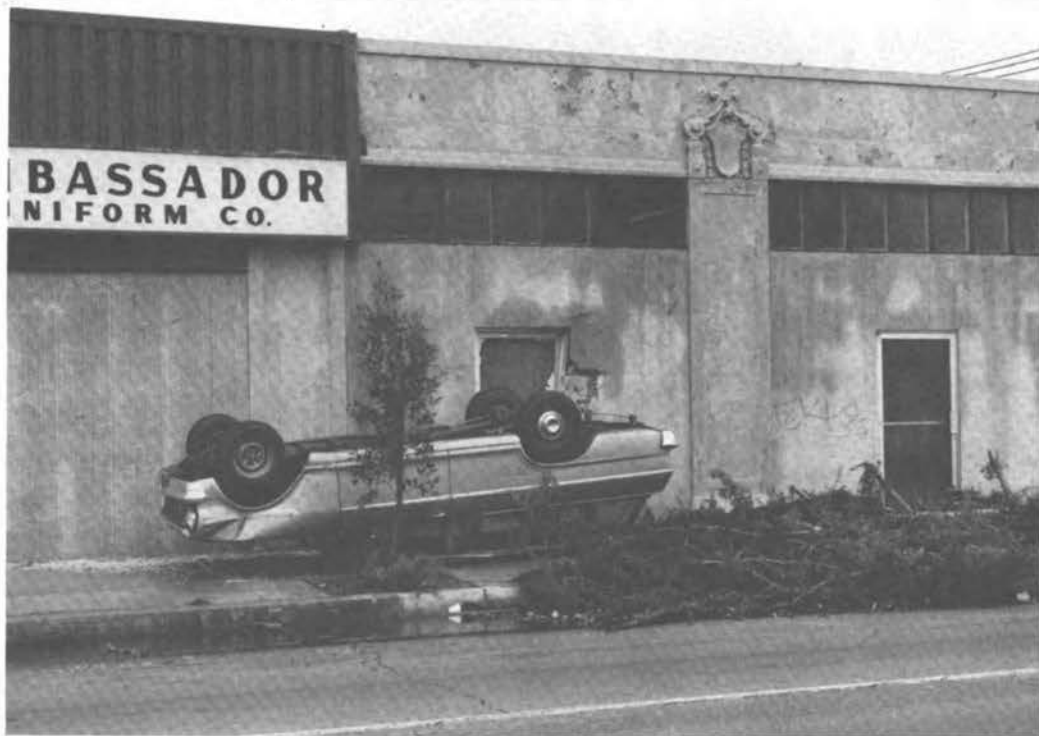
FIGURE 15 Auto overturned by tornado at 3200 South Grand Avenue.

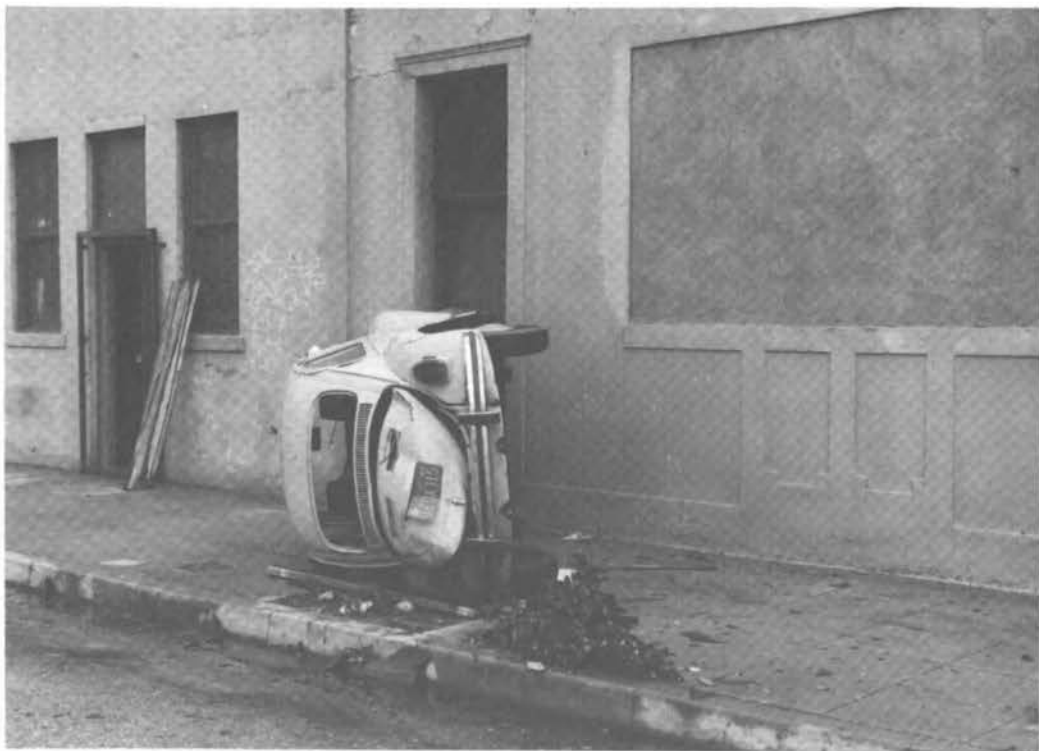
FIGURE 16 Auto overturned by tornado at 3200 South Grand Avenue.

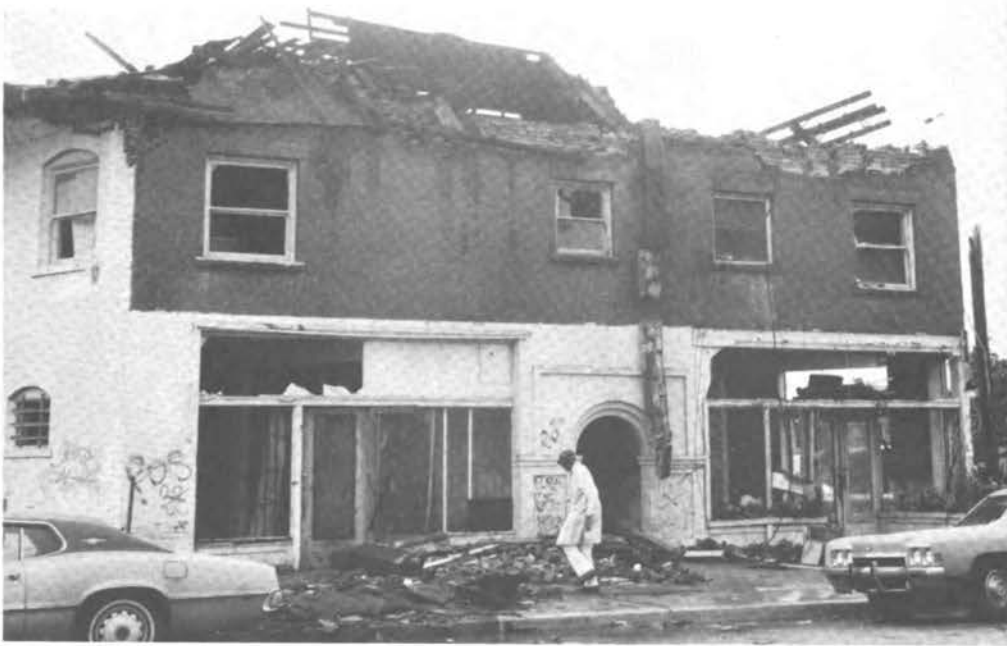
Most masonry buildings in the path of the tornado experienced extensive glass damage to their storefront windows, as shown in Figures 17 and 18. Figure 17 also shows the roof and parapet damage typical of that suffered by many unreinforced masonry buildings. The unreinforced masonry buildings that had their walls anchored to their roofs as a result of a mandatory Los Angeles City parapet stabilization program, which required parapet walls to be strengthened for earthquakes, suffered less damage than did unanchored buildings. Figures 19 and 20 give two views of an unreinforced masonry building that collapsed. This collapse was attributed in part to the lack of adequate wall anchors.

FIGURE 17 Collapsed masonry parapet.

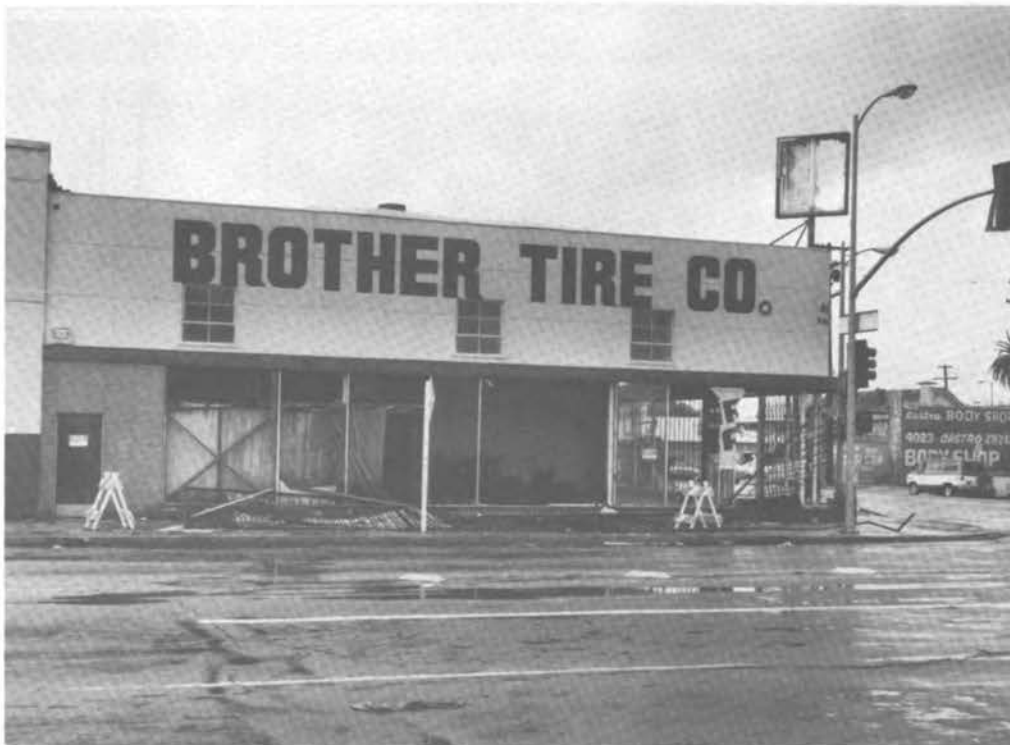
FIGURE 18 Failed storefront windows.

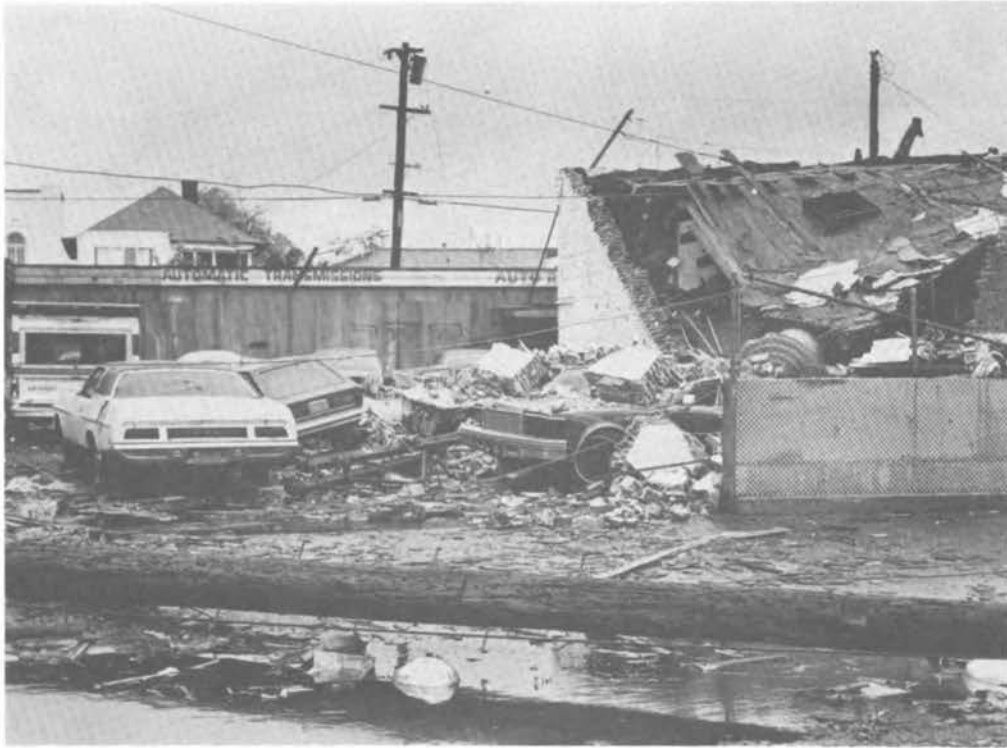
Unreinforced masonry buildings built before 1934 suffered more damage than did the newer reinforced masonry buildings that were designed to resist earthquake forces. In addition to having reinforced walls, the newer buildings were better tied together and their roofs were securely anchored to the exterior walls. Roof and glass damage, however, was still evident in these newer buildings.

FIGURE 19 Failed masonry bearing wall.

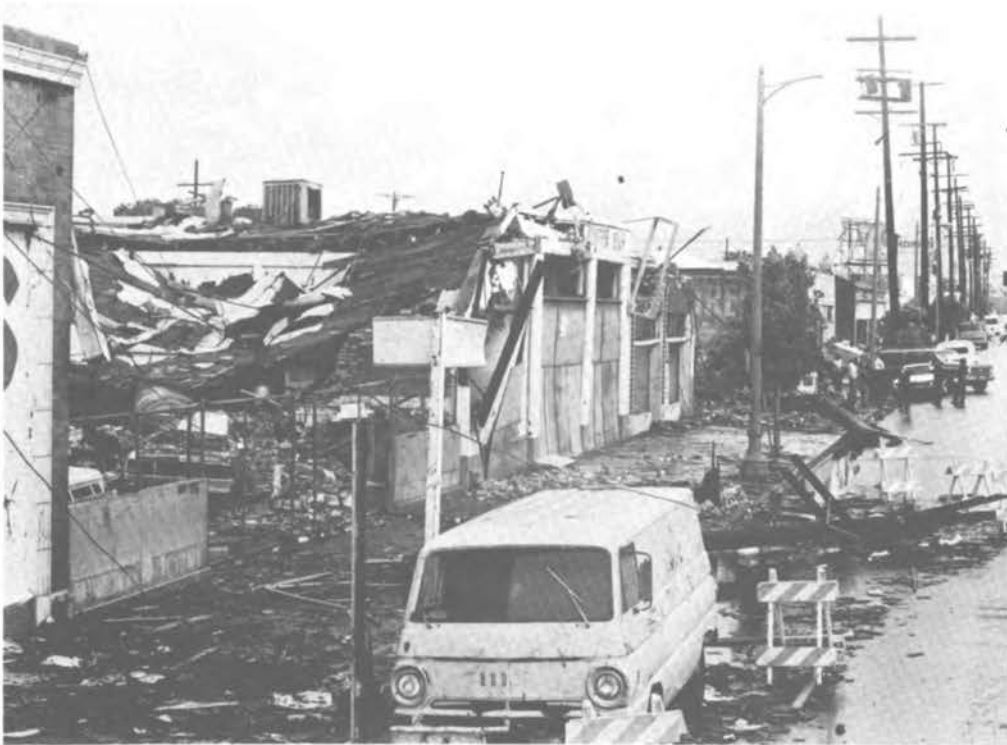
FIGURE 20 Failed masonry bearing wall.

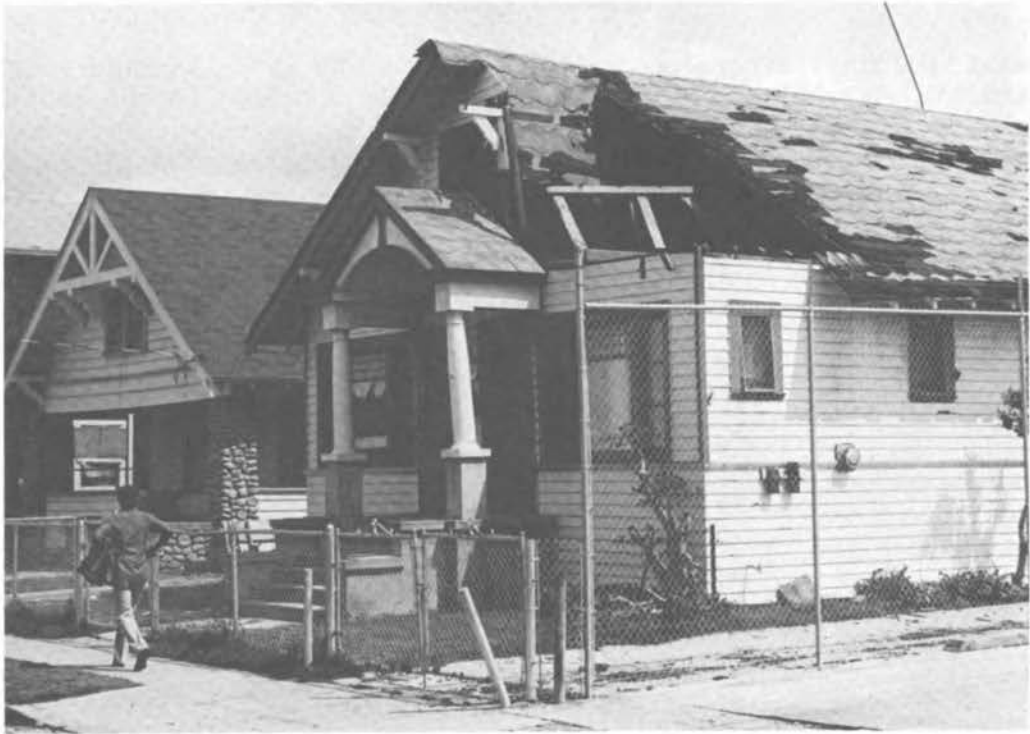
Old wood buildings experienced the type of damage shown in Figures 21, 22, and 23. This type of damage was primarily confined to the roof and upper part of the structure and in many cases was quite severe. The damage to such wood frame buildings was more extensive than the damage observed to the concrete and masonry buildings in the immediate vicinity. Figure 24 is an aerial view that graphically depicts the severity of damage received by the various types of buildings.

FIGURE 21 Damaged roof system at 268-70 West Forty-first Street.

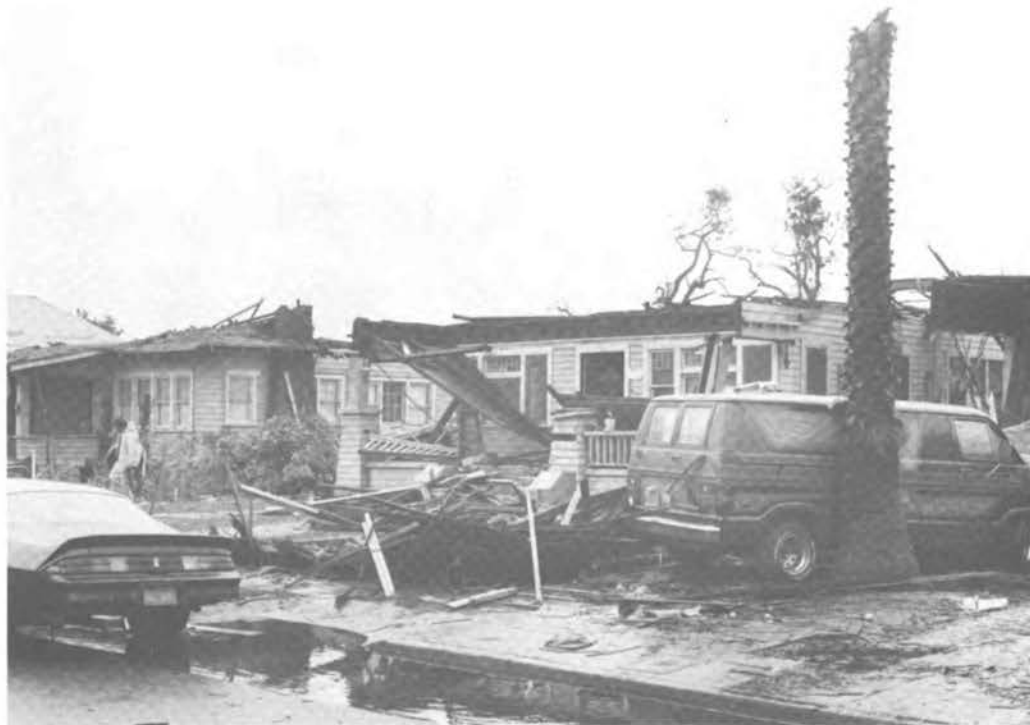
FIGURE 22 Damaged wood building in the 200 block of West Fortieth Place.

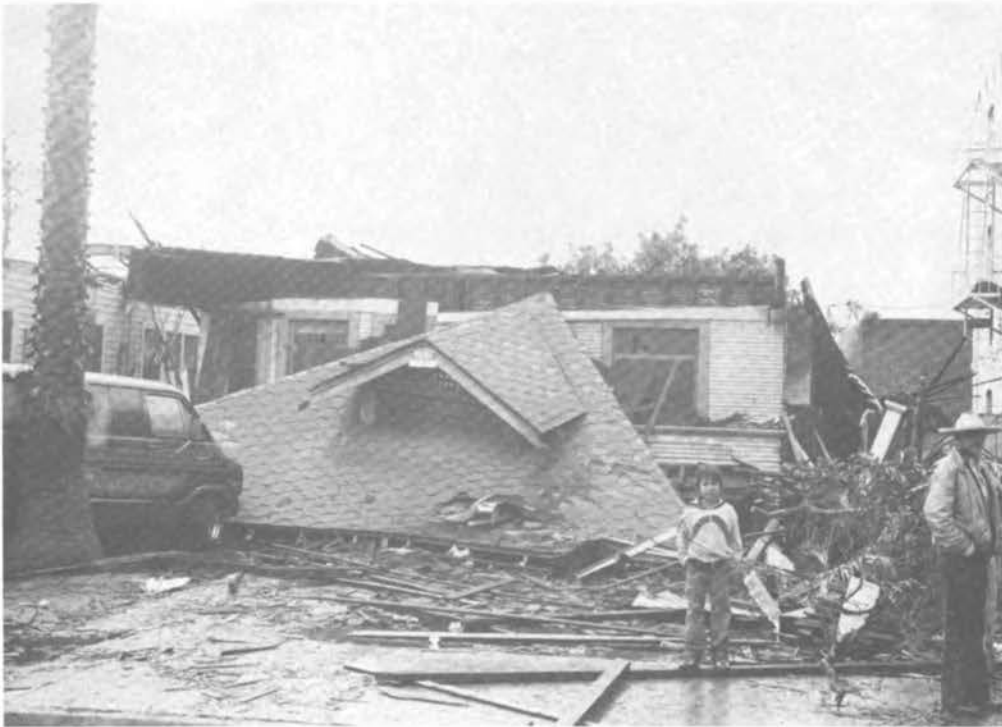
FIGURE 23 Collapsed roof at 260 West Fortieth Place.

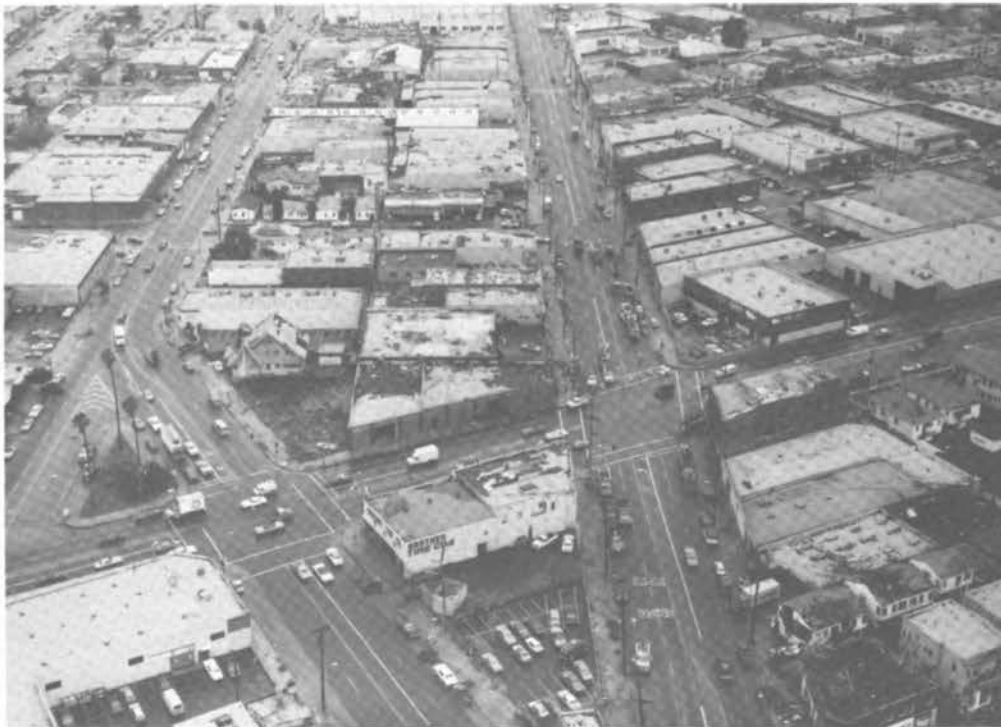
FIGURE 24 Aerial view of damaged area.

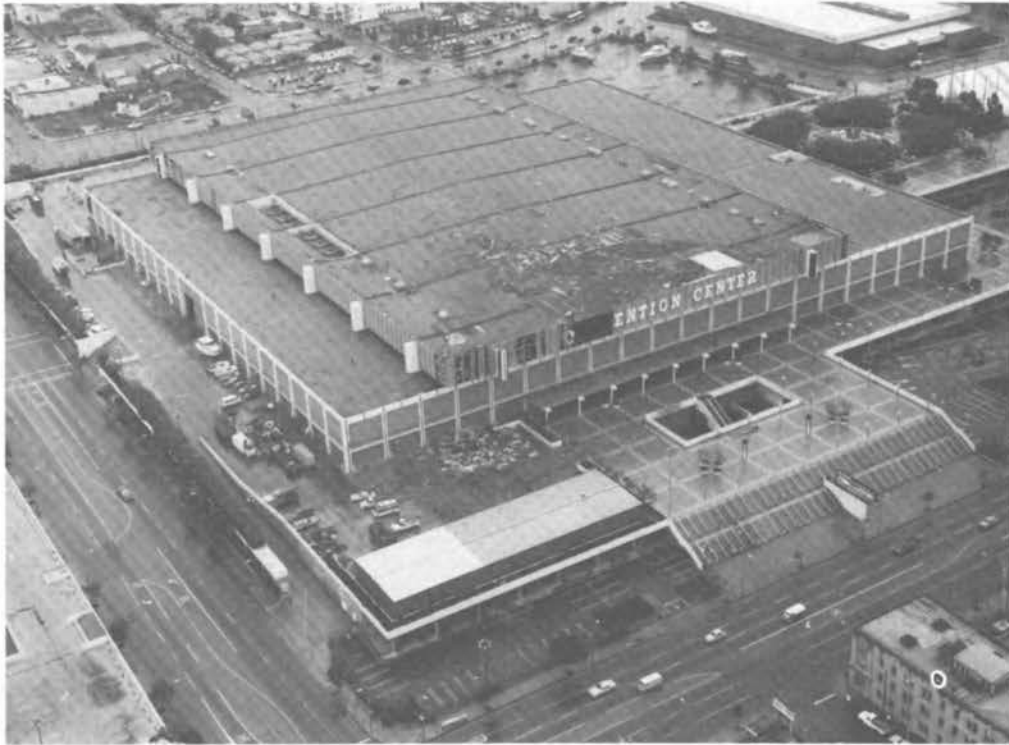
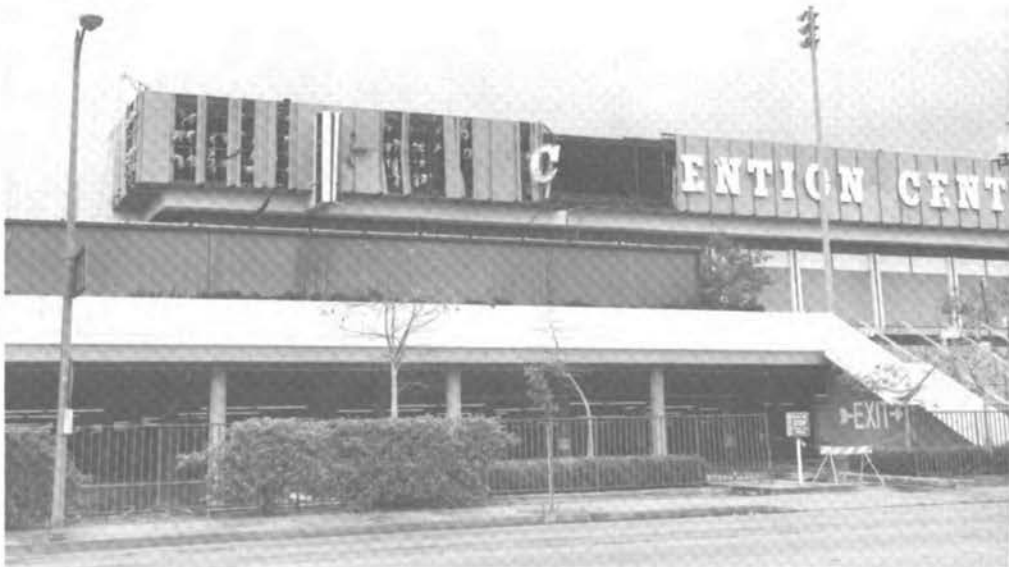
FIGURE 25 The Los Angeles Convention Center.

The Los Angeles Convention Center experienced significant structural damage to the roof and upper-level panels during the tornado, as shown in Figures 25 and 26. As indicated by these figures, the path of the tornado from south to north produced wind force pressures sufficiently strong to tear the roof and cause members to fail, particularly in the southeast corner of the building. The City of Los Angeles has subsequently repaired the damage at a total cost of \$3 million.

The Los Angeles Convention Center, constructed in 1971, represents state-of-the-art design for such buildings. No special wind study was performed on this building, and no special design considerations other than the wind pressures of the Uniform Building Code were used. In general, the structure behaved quite well from the perspective of its structural strength capacity. There was no evidence of any imminent collapse of primary structural systems that might have threatened human safety.
