The October 1985 Landslide at Barrio Mameyes, Ponce, Puerto Rico

Francisco Silva-Tulla, Consulting Engineer, Geotechnics
12 Baskin Road, Lexington, Massachusetts

Committee on Natural Disasters
Commission on Engineering and Technical Systems
National Research Council

NATIONAL ACADEMY PRESS
Washington, D.C. 1986

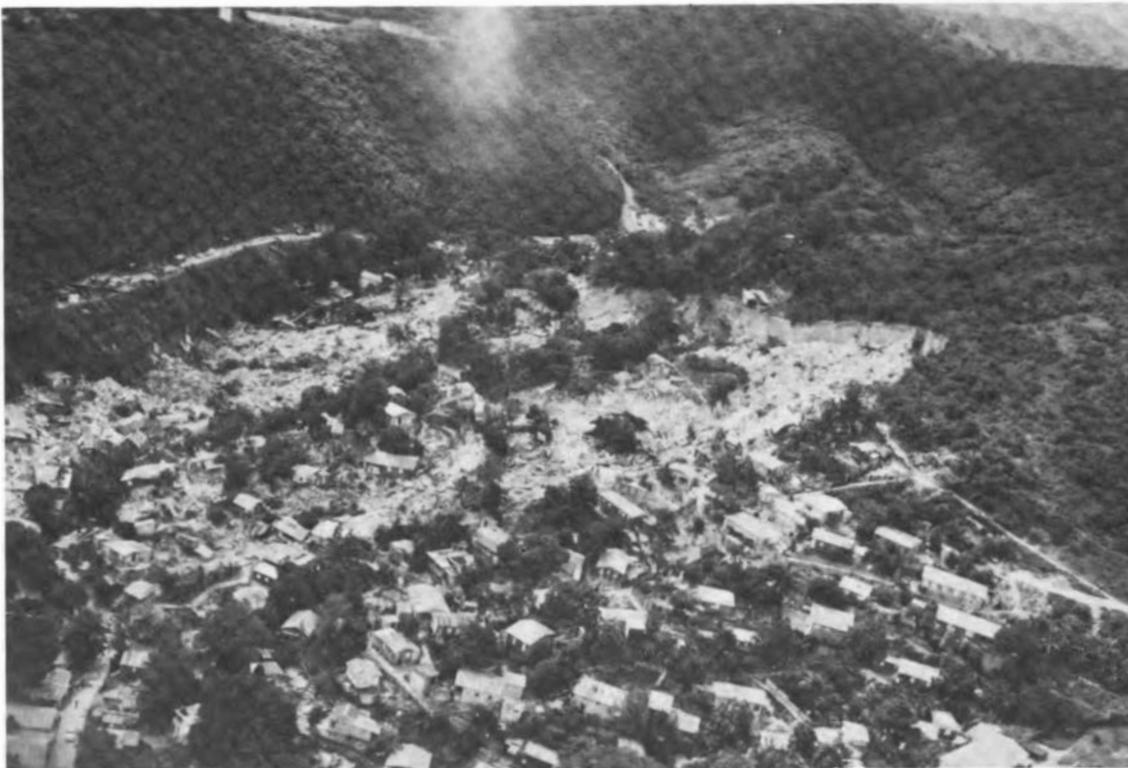
Figures 1 through 3 show aerial views of the Mameyes landslide. The roughly triangular slide covers an area of about 25,000 m² (the base of the triangle equals approximately 190 m and the height of the triangle equals approximately 230 m, measured from a 1:1,000 aerial photograph displayed at the disaster operations center). The subsoil consists of weathered Juana Diaz formation, a calcareous sandstone overlain by chalky limestone, with bedding planes striking N 87 W and dipping 20 SW. Before the slide, the ground surface sloped 20 to 25 degrees in the general direction of the bedding planes' dip. Two intersecting joint sets with a nearly vertical dip and strikes of N 63 E and N 60 W define the head of the slide (the apex of the triangle). The scarp at the head of the slide varies in height from 5 to 10 m. A relatively intact soil block dominates the center of the slide area. Slide debris surrounds this soil block, which moved downslope about 30 m. Near the toe of the landslide, debris 10 to 12 m deep accumulated over a reinforced concrete box culvert through which La Colectora Creek flows. The culvert apparently remained functional after the landslide.

FIGURE 1 Aerial view of Mameyes landslide.

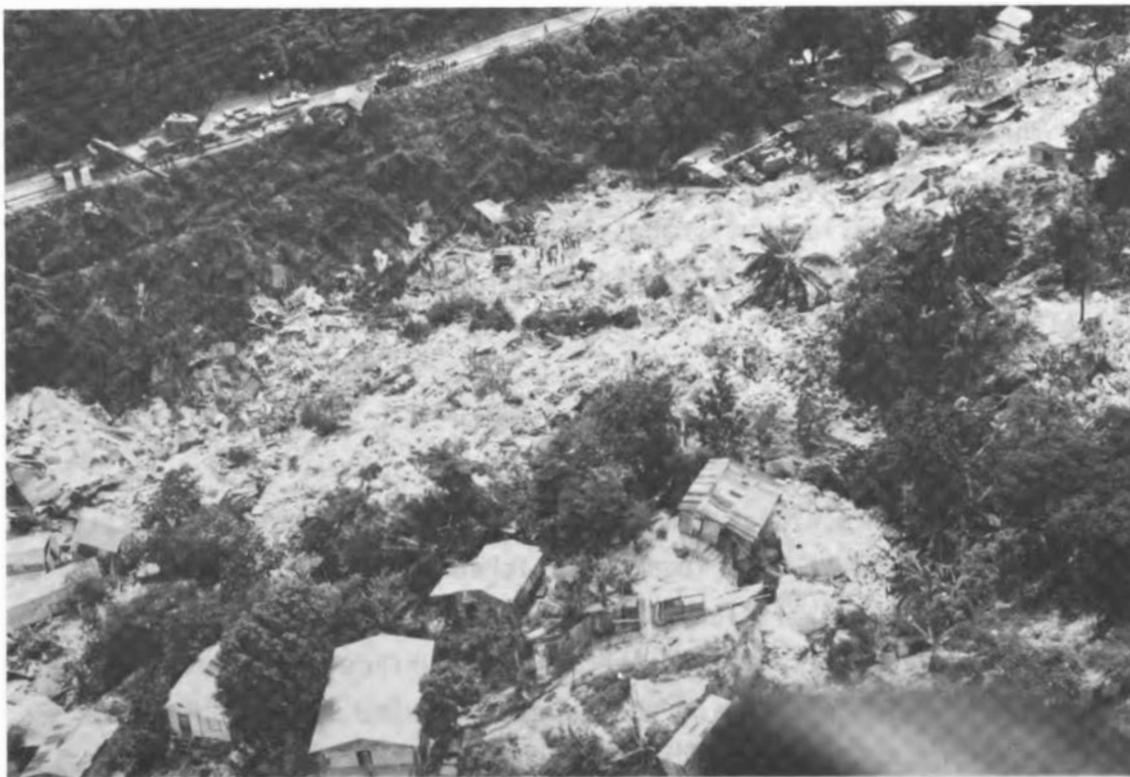
FIGURE 2 Toe of landslide.

The numerous discontinuities in the weathered rock mass provided the water easy access to the failure plane. One week after the landslide, water continued to seep out near the toe of the slide.

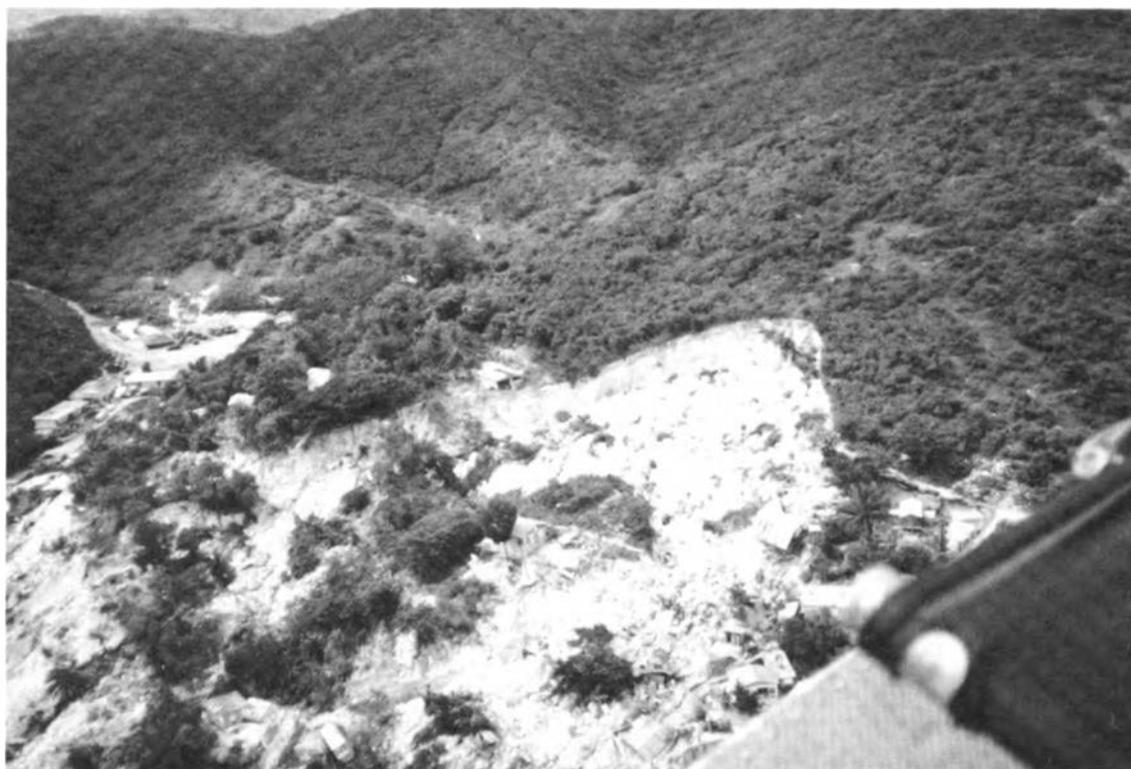
FIGURE 3 Head of Landslide.

The high vertical scarp at the head of the Mameyes slide suggests that the weathered rock at this location cracked along joint planes and probably contributed little resistance to the sliding mass. The shear strength of the material along the sliding surface undoubtedly played an important role in controlling the landslide. The slide could have occurred along a "clean" bedding plane or, more probably, along a clay

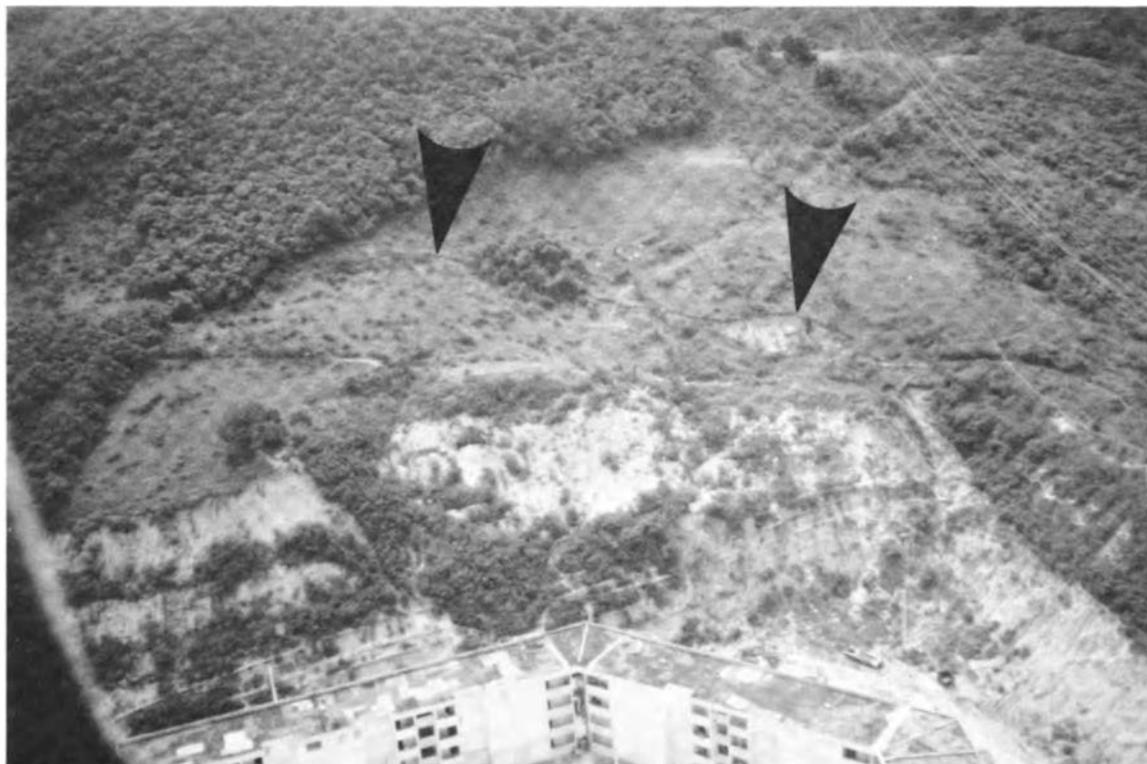
An inspection of the area from a helicopter revealed other slopes that are densely built with houses and appear similar to the slope on which the Mameyes landslide occurred. Figure 4 shows a 140-m-wide active landslide detected behind the Las Terrazas public housing development. The landslide exits the slope 15 m above the ground floor elevation of a four-story building located less than 12 m from the toe of the slope.

FIGURE 4 Active landslide above Las Terrazas housing development.

The geotechnical safety program should seek to predict and prevent similar landslides. The program should include establishment of performance criteria, a safety assessment of potentially unstable slopes, field instrumentation and field surveillance, periodic performance evaluations, design and construction of remedial measures (if needed), and development of contingency plans. The program should also seek to provide the Commonwealth of Puerto Rico with a sound technical basis to regulate development on potentially unstable slopes.

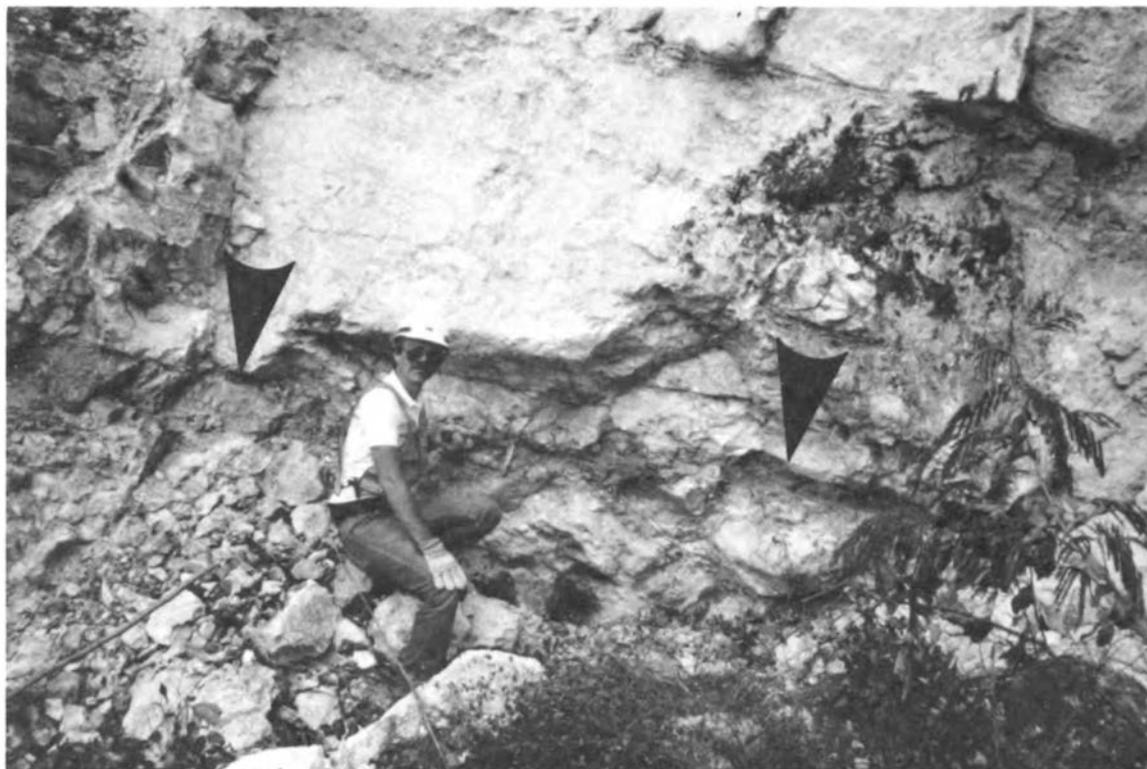
layer like the one shown in Figure 5. This 8-cm-thick layer contained a stiff, fissured, plastic clay. Similar clays frequently sustain large changes in effective stress upon wetting (pore pressures change from highly negative to zero or positive) and experience strain softening. At other locations in the landslide area, boulder-size clay pockets existed and joints and bedding planes contained thin clay deposits.

FIGURE 5 Stiff, fissured, plastic clay layer (8 cm thick).
