Heat-Straightening Repair of Damaged Steel Bridge Girders: Fatigue and Fracture Performance

NCHRP REPORT 604

**Heat-Straightening Repair of
Damaged Steel Bridge Girders:
Fatigue and Fracture Performance**

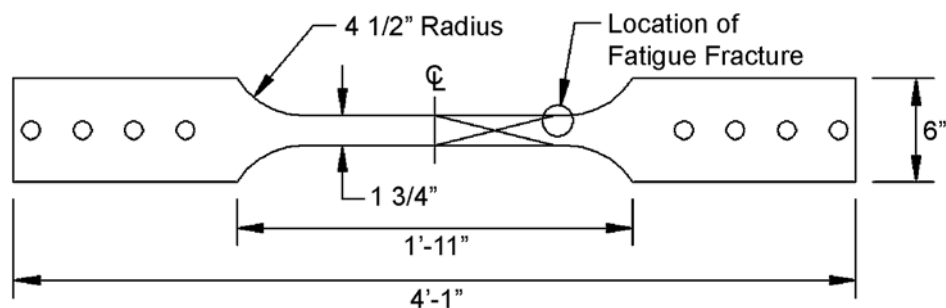
Figure 2.1. Location of fatigue fracture of heat-shortened eyebar.

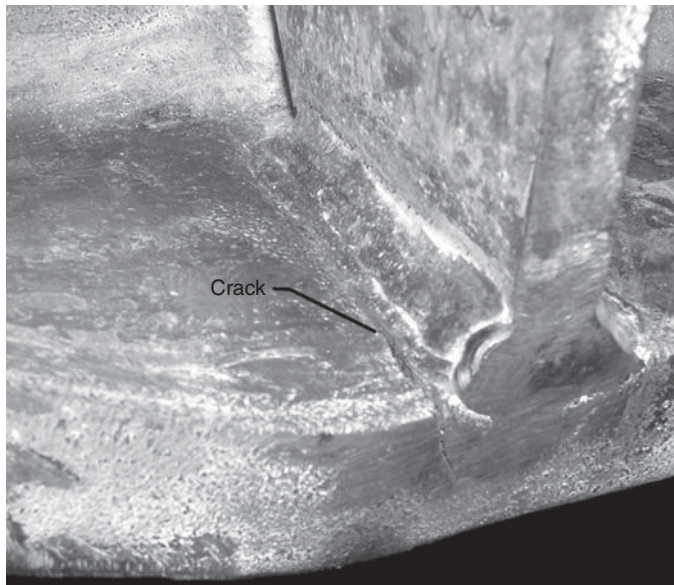
Figure 2.2. Crack at Stiffener 2 on Specimen 1D/R-1.

The heat-straightening was halted and the crack was completely ground out to prevent further propagation. Because of the reduced thickness of the flange, a repair weld (see Figure 2.3) was made prior to finishing the heat-straightening repair to ensure that further damage would not result. After completion of the repair weld, the area was UT inspected by a certified outside contractor and was accepted in accordance to AWS D1.5-2002. This type of cracking, although very minor, also occurred at Stiffener 1, where the localized damage was not as severe.

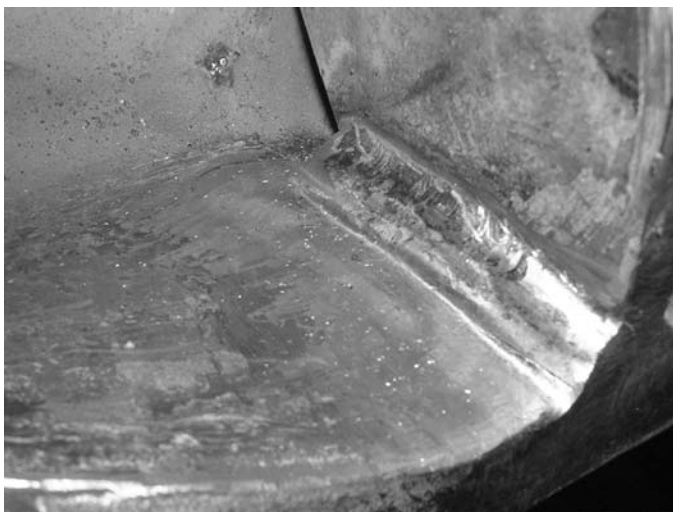
Figure 2.3. Repair weld at Stiffener 2 on Specimen 1D/R-1.

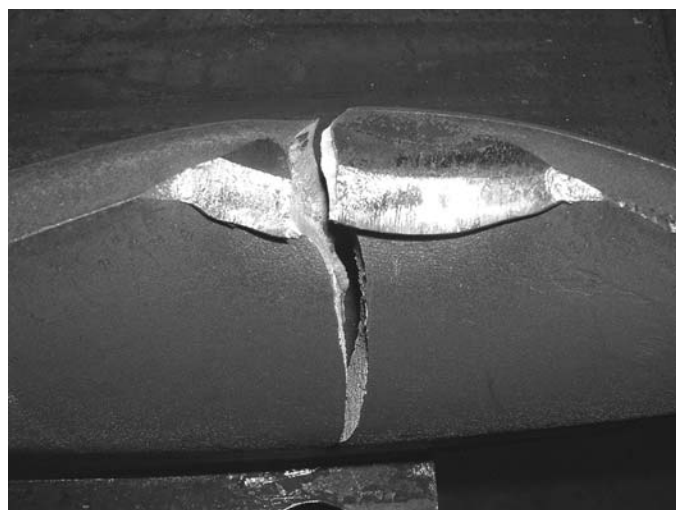
Examination of this region demonstrated that there is a relatively thin layer of cold-worked material that has very low fracture toughness. In addition, there are multiple small cracks in this low-toughness material due to the extreme strains and rolling of the material at the exact point of the impact. The brittle fractures observed in the lab initiated at one of these dis-

Figure 2.10. Crack at Stiffener 1 due to subsequent impact at Cover Plate 1, Specimen 2D/R-1.

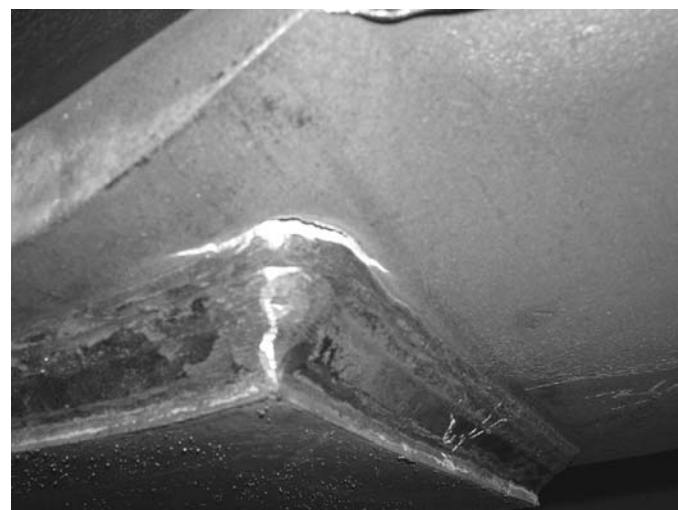
Figure 2.11. Tear at Cover Plate 1, Specimen 2D/R-1.

In order to prevent cracking that formed at flange-stiffener welds during the heat-straightening repair of Specimens 1D/R-1 and 1D/R-2, the weld toe was treated by using a 0.25 in. (6 mm) tree-radius end rotary file. This was performed after the impact and prior to beginning the heat-straightening repair. For the first D/R cycle, this prevented any cracking or tearing at this weld toe. However during the second repair cycle, minor cracking still formed at these treated areas. Upon discovery, these cracks were ground out and inspected using both PT and MT methods. Minor hairline fractures also formed on the underside of the flange in the localized damage region and were subsequently ground out and inspected.

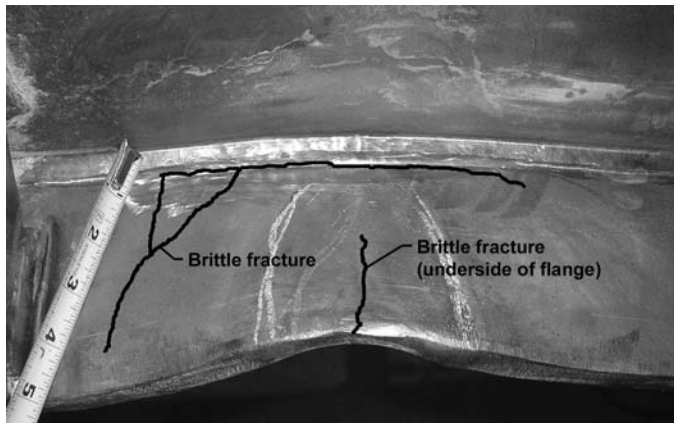
Figure 2.14. Brittle fracture near Stiffener 1, Specimen 2D/R-2.

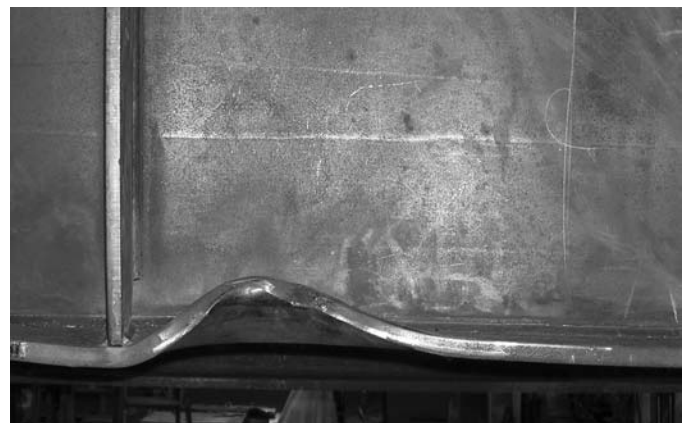
Figure 2.27. Localized damage at a transverse stiffener detail.

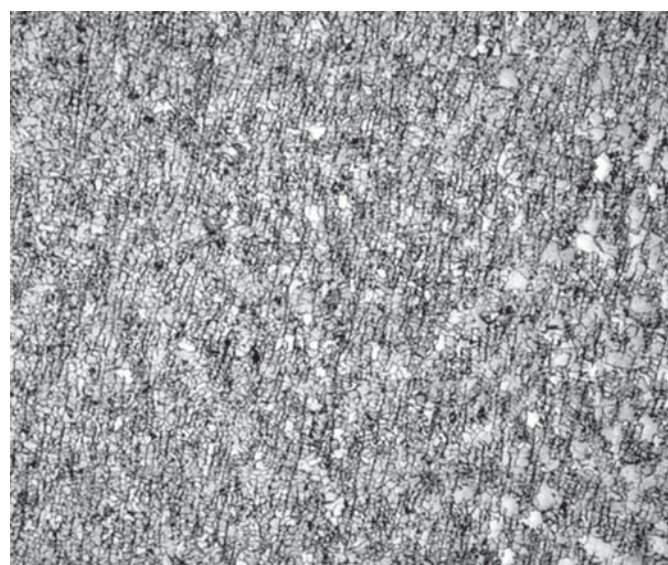
Figure C-3. Overheated specimen after one D/R cycle (1000X), 1D/R-2.
