NCHRP REPORT 656

**Criteria for Restoration
of Longitudinal Barriers**

**Hampton C. Gabler
Douglas J. Gabauer
Carolyn E. Hampton**

VIRGINIA POLYTECHNIC INSTITUTE AND STATE UNIVERSITY
Blacksburg, VA

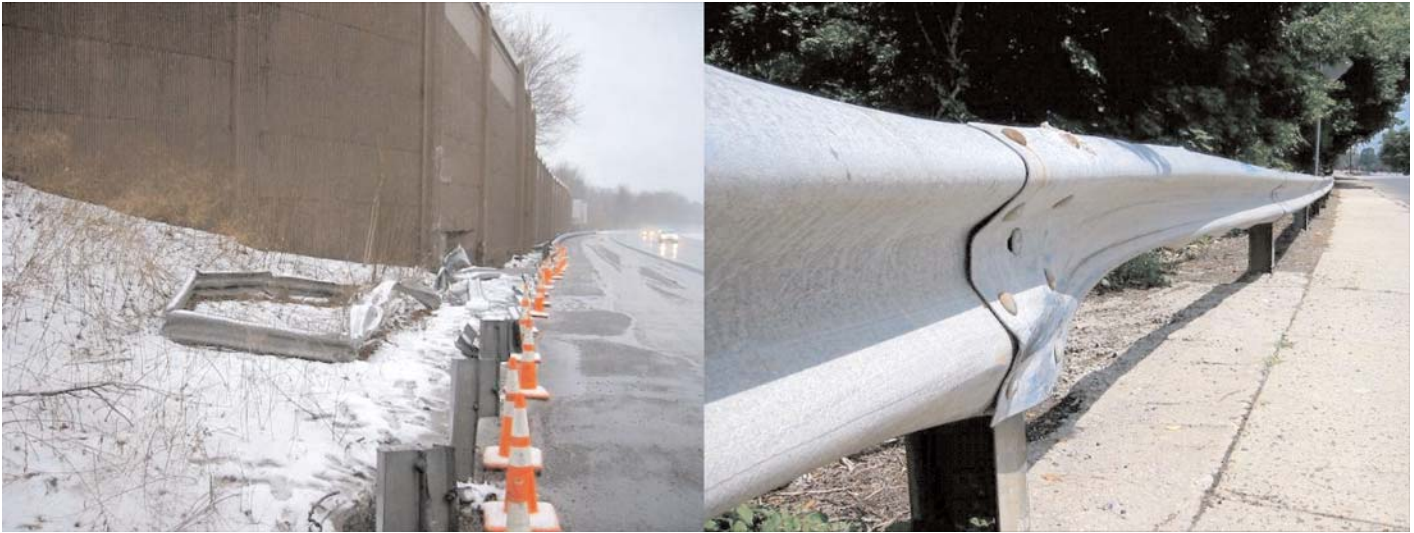
Figure 1. Catastrophic vs. minor guardrail damage.

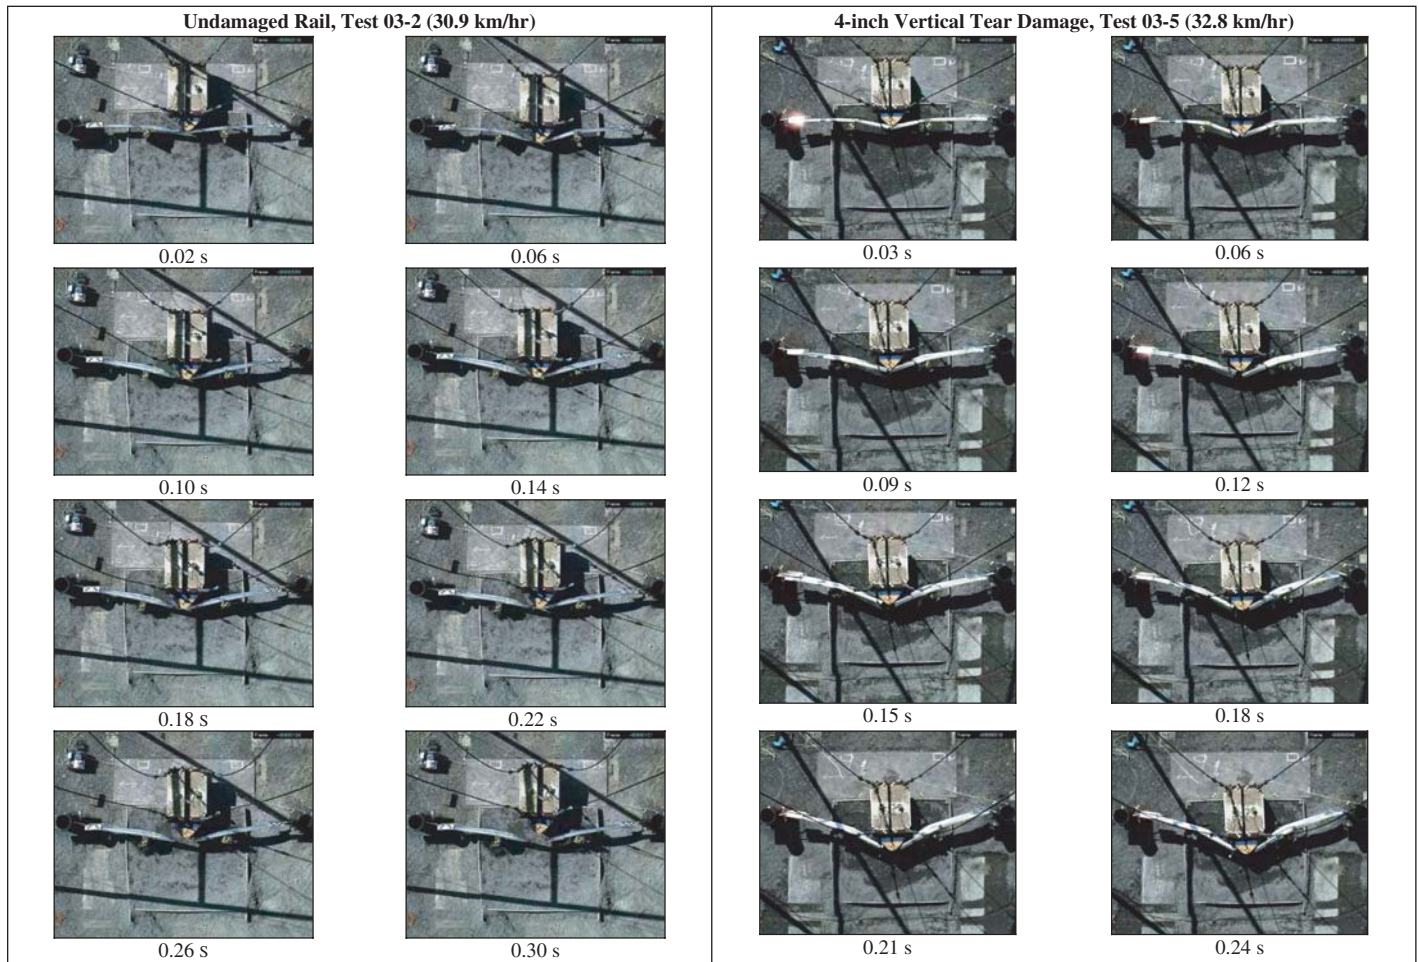
Pendulum testing of a strong-post w-beam barrier with a vertical (transverse) tear resulted in complete rail rupture. This was due both to the loss in an available cross section to carry the tensile load as well as the introduction of a stress concentrator. Although the vertical tear in the pendulum test was relatively severe (roughly one-fourth of the w-beam cross section), the research team believes that any vertical tear represents a stress concentrator sufficient to cause further tearing should the barrier be subjected to a secondary impact. A second pendulum test was conducted for a small vertical tear of 13 mm (0.5 inches) in length. A pendulum impact at 20 mph caused this small tear to grow ominously to a length of 4 inches. The research team concluded that no vertical tear is safe. To be cautious, the research team has classified vertical rail tears of any length as a damage mode that should be repaired with high priority (Exhibit 1.0).

Figure 17. Sequential overhead photographs for undamaged section (left) and 4-inch vertical tear damage (right).

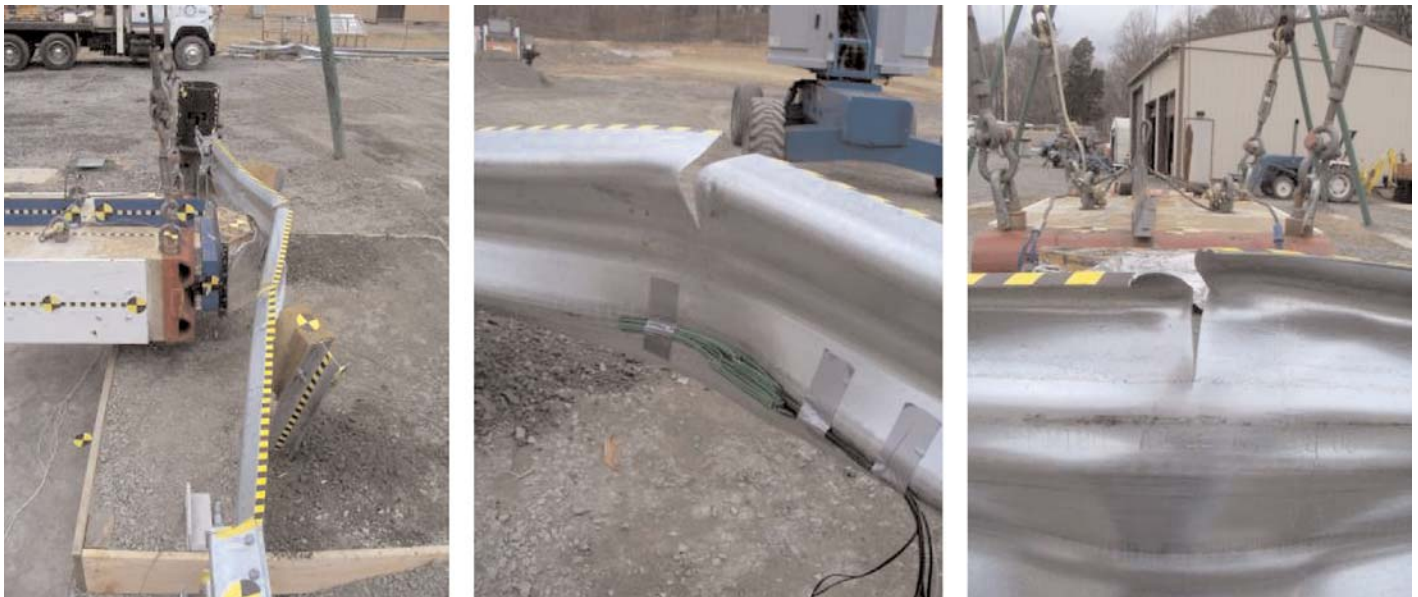
Figure 18. Test 08-2: overall damage (left) and detail views of the additional tearing caused by the pendulum impact (center), and post damage at splice location (right).

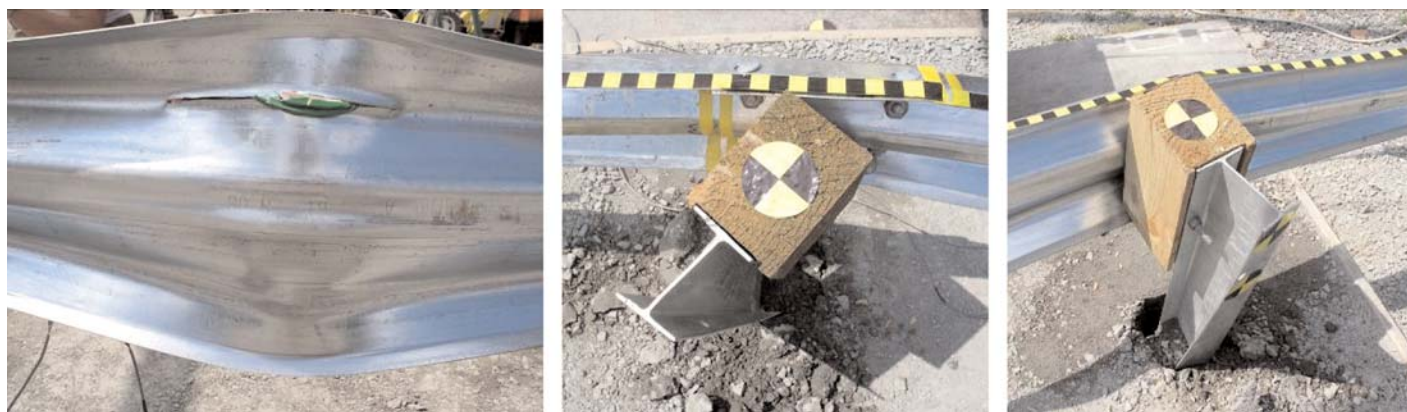
Figure 20. Test 07-3: detailed view of impact location (left), post damage at splice (center), and non-splice location (right).

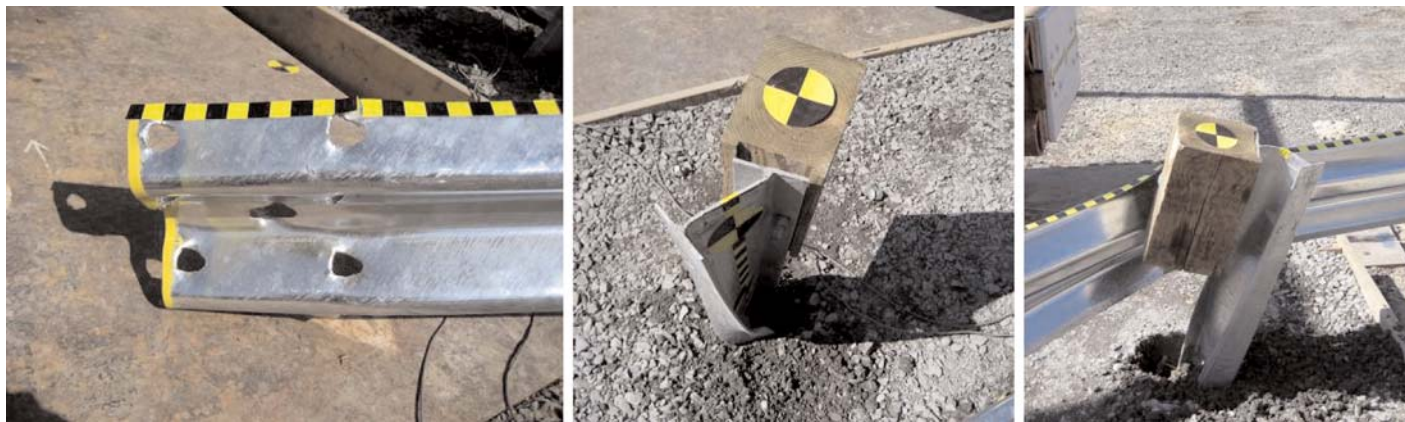
the splice bolts pulling through holes in the rail with none of the individual splice bolts fracturing. At both the splice and non-splice location, the post bolt pulled through the rail element. The splice failure and post damage is shown in Figure 22.

Figure 22. Test 02-1: detailed view of splice failure (left), post damage at splice (center), and non-splice location (right).

As a result, the research team has recommended that the repair threshold for horizontal tears be those exceeding a length of 12 inches and a width of 0.5 inches. The rationale for the width specification is that horizontal tears with sufficient width reduce the tensile capacity of the rail through a reduction in available cross-section area in the area of the tear. The research team's recommendation is that larger horizontal tears should be repaired with a medium priority (Exhibit 2.0).

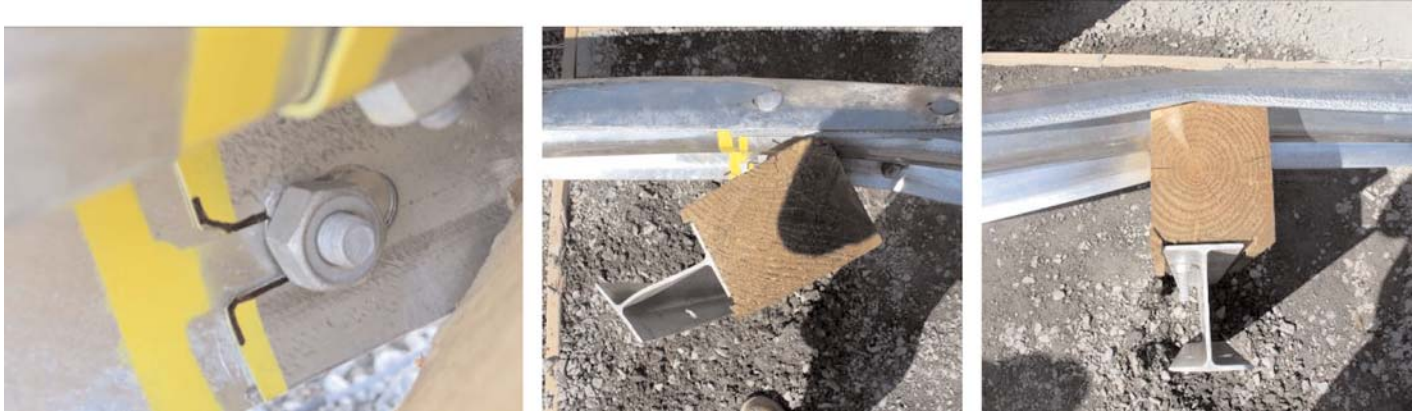
A pendulum test of a strong-post w-beam barrier with splice damage resulted in successful containment of the pendulum mass. The splice damage consisted of extending the hole for a single splice bolt to the end of the rail (e.g., no bearing capacity for that particular bolt). Under a pendulum impact at 29.3 km/hr (18.2 mph), this barrier was able to contain the impacting pendulum mass with performance indistinguishable from the undamaged barrier section. It is known however from full-scale crash testing as well as the splice failures observed in the pendulum tests that the splice is a weak point in the guardrail system. Balancing these two observations, the research team recommends a repair threshold of 2 or more splice bolts with any guardrail material missing around the bolts with high priority. In the case of damage to a single splice bolt, the research team assigned the repair a medium priority (rather than a low priority) based on the fact that the splice is the weak point in the rail element (Exhibit 3.0).

Figure 24. Test 07-4: Detail view of splice bolt damage after test (left) and post damage at splice (center) and non-splice location (right).

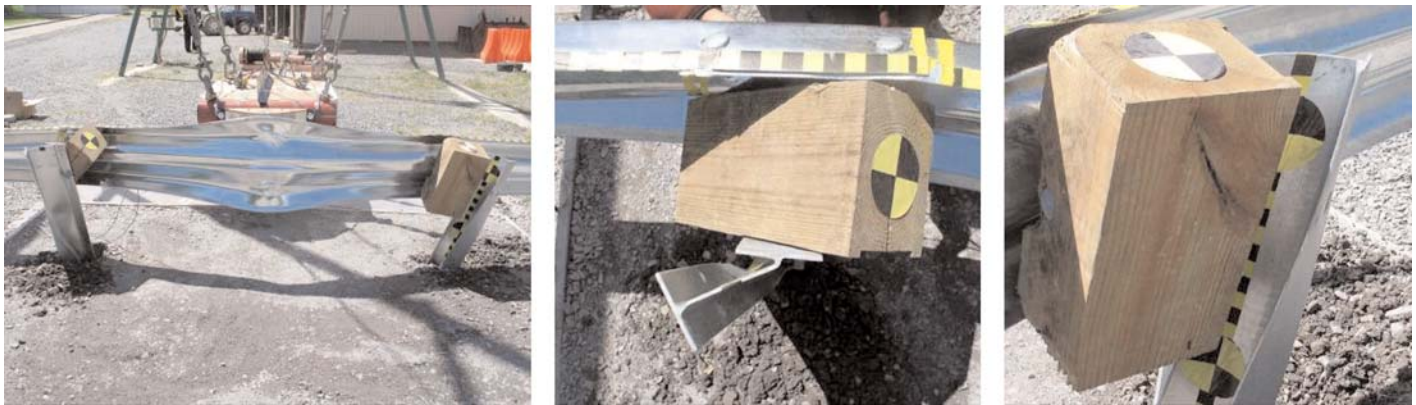
Figure 27. Test 03-8: Overall damage (left) and post damage at splice (center) and non-splice location (right).

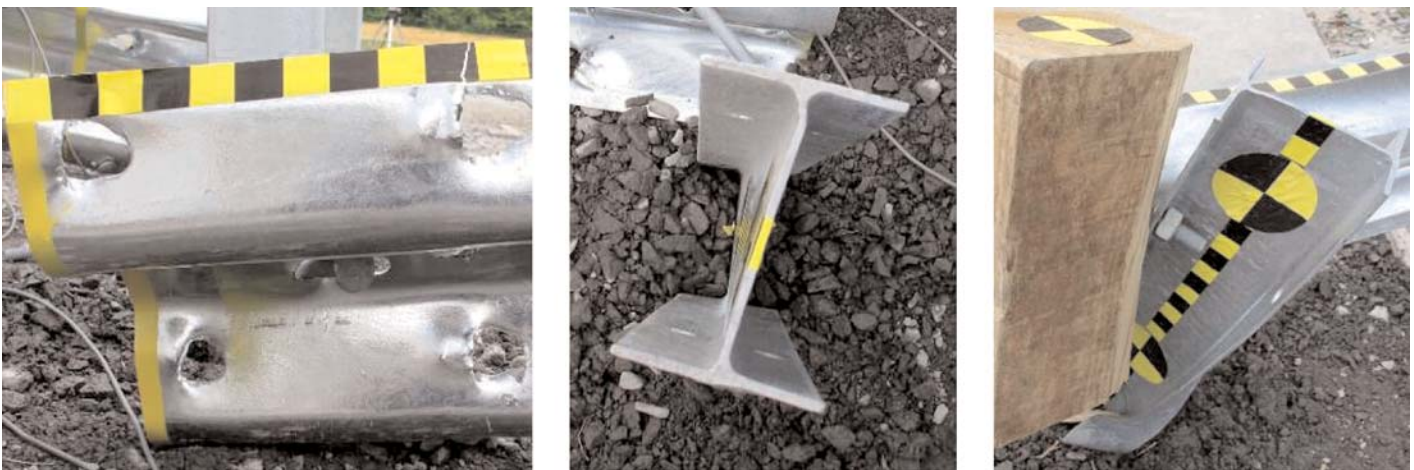
Figure 30. Test 03-7: splice failure (left) and post damage at splice (center) and non-splice location (right).

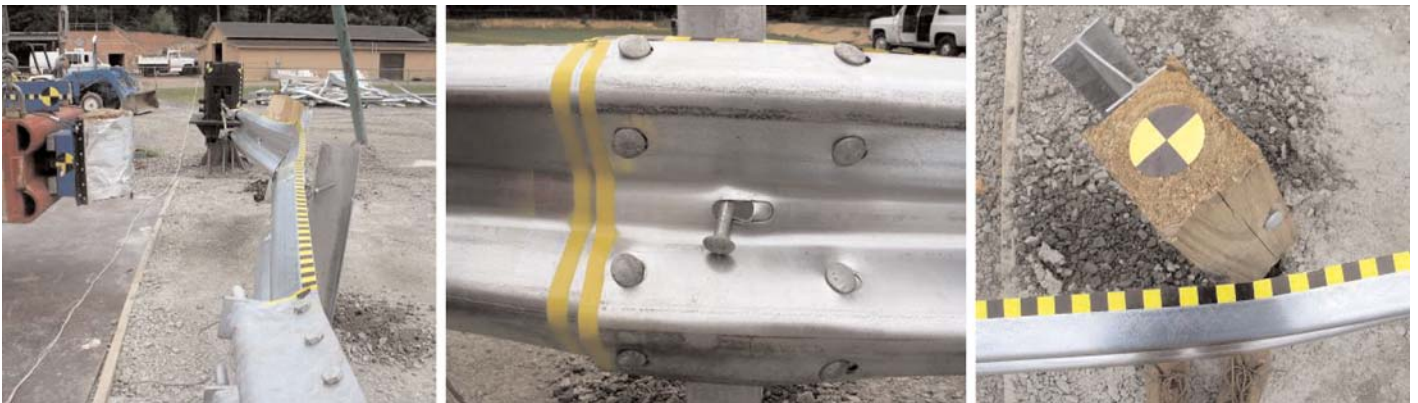
Figure 32. Test 07-5: overall damage (left), detail view of damage at splice (center), and post damage at non-splice location (right).

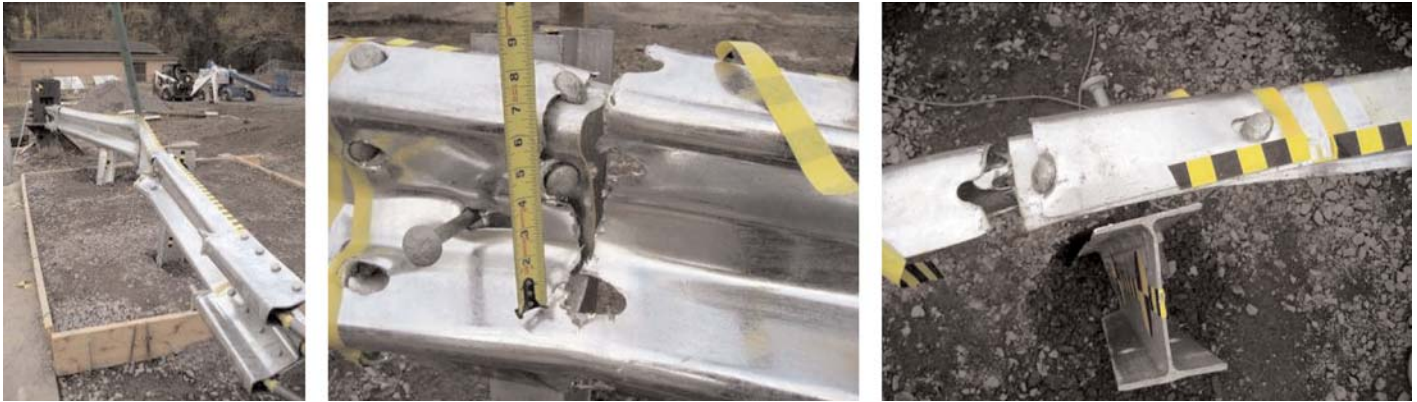
Figure 33. Test 01-4: overall damage (left), rail tear at splice (center), and post damage at splice location (right).

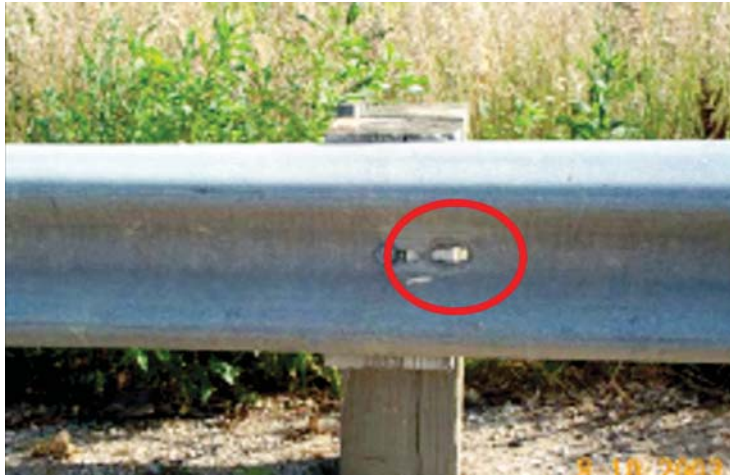
Field Example

Multiple holes in a rail section or holes with a diameter exceeding a height of 1 inch could lead to rail tearing as seen in the vertical tear pendulum tests. To avoid the possibility of catastrophic rail failure, these modes were assigned a high priority for repair. A special case was a hole of any size which intersects either the top or bottom edge of the rail. Because a hole which disrupts either the upper or lower surface of a rail has the characteristics of a vertical tear, this damage mode has the potential for the same catastrophic failure of the rail that was observed in the pendulum tests of vertical tears. This damage mode was given a high priority for repair (Exhibit 6.0).

Figure 34. Hole damage evaluated in pendulum tests.

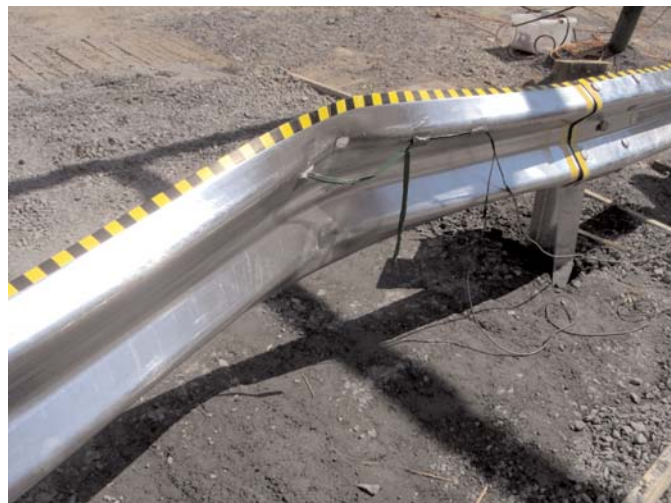
Figure 35. Damage near a hole in Test 07-2.

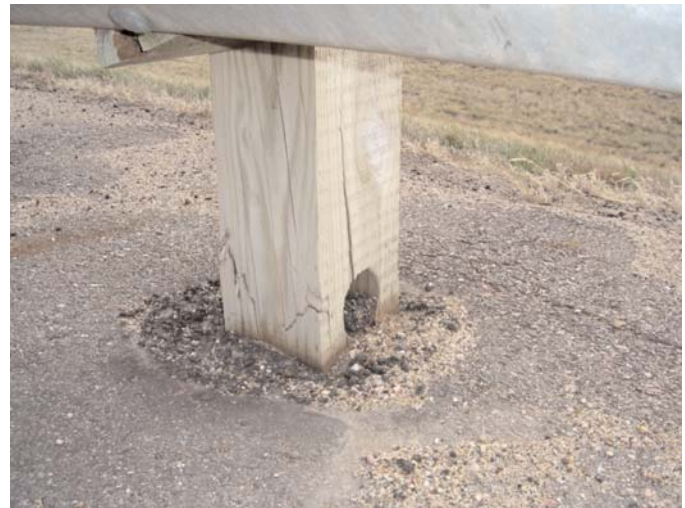
Figure 64. Wood post with cross-grain cracking (photo: courtesy of South Dakota DOT).

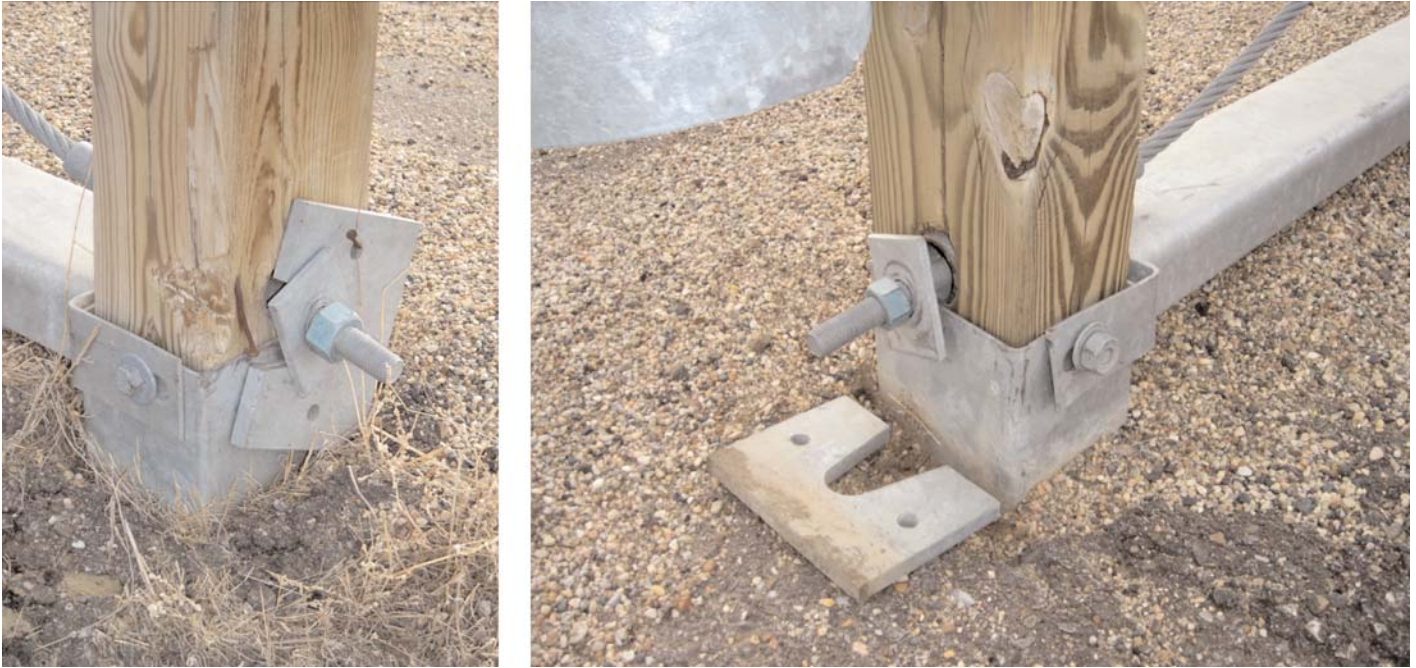
Figure 65. Misaligned or missing bearing plates (photo: courtesy of South Dakota DOT).

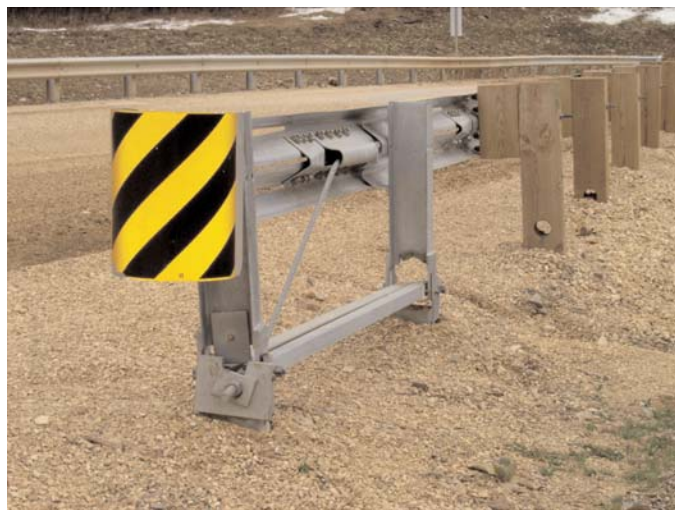
Figure 66. Incorrect stub height (photo: courtesy of South Dakota DOT).

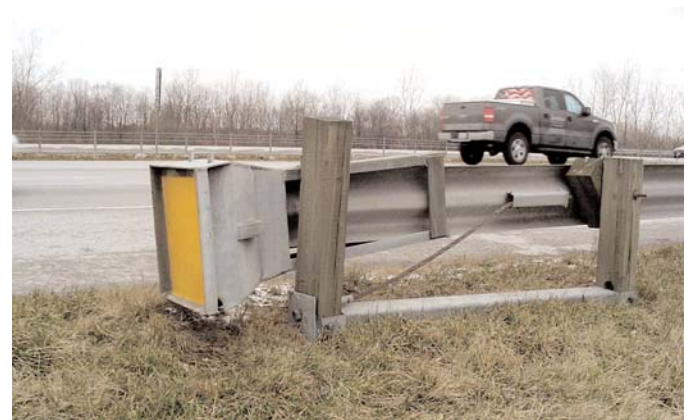
Figure 67. Misaligned impact head because of missing lag bolts (photo: courtesy of Ohio DOT).

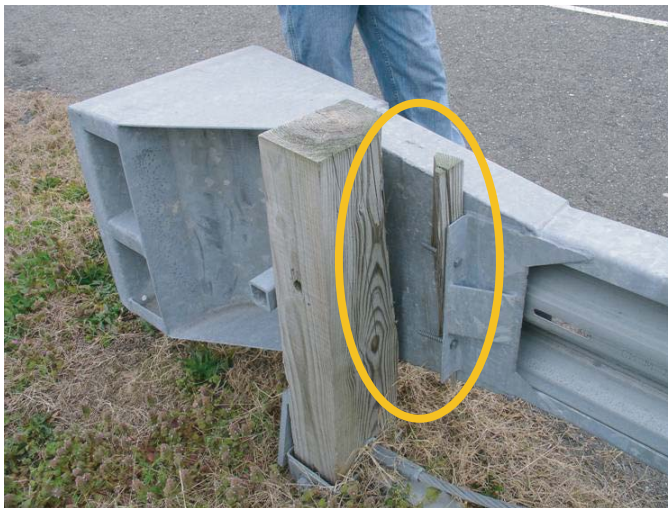
Figure 68. Failed attachment of lag bolts to end post.
