Assessment of Remaining Fatigue Performance of High Mast Illumination Poles

Thesis

The University of Texas at Austin
May 2014

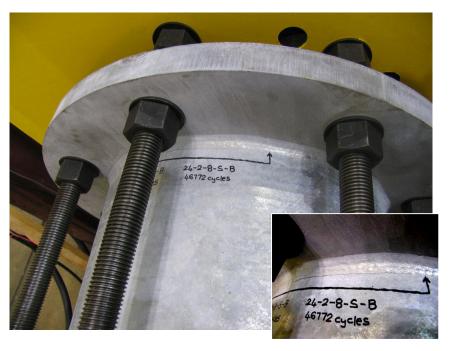
The locations of the cracks are shown in Figure 2.13 and Figure 2.14Figure 2.13: Typical failure of fillet welded socket connection (Rios, 2007). The cracks initiated at the toe of the weld of the extreme tension fiber and propagated through the wall thickness and the connection cross-section.

Figure 2.13: Typical failure of fillet welded socket connection (Rios, 2007)

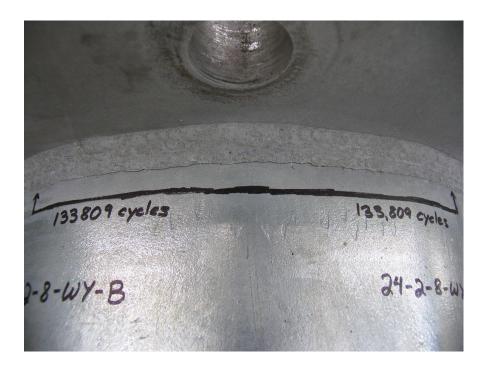
The location of the cracks is shown in Figure 2.16, Figure 2.17 and Figure 2.18. The cracks initiated at the toe of the weld of the extreme tension fiber and propagated through the wall thickness and the connection cross-section.

Figure 2.16: Typical failure of Wyoming full penetration weld connection (Rios, 2007)

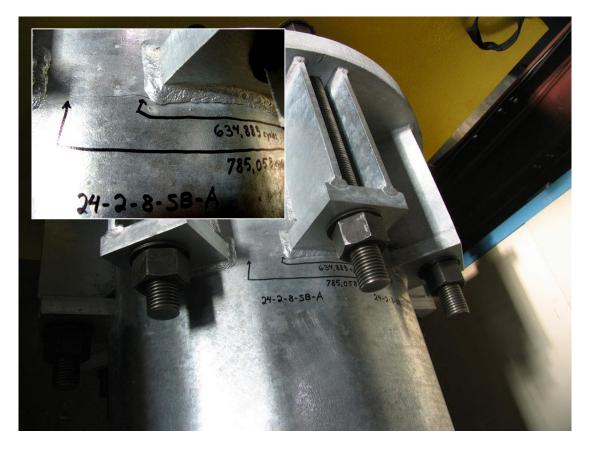
The location of the cracks can be shown in Figure 2.20. As opposed to the other crack locations, cracks in the stool base detail initiated at the toe of the cap plate weld and the propagated following the weld toe before continuing into the pole wall. This was a result of transferring the maximum stresses further away from the base plate.

Figure 2.20: Typical failure of stool base detail connection (Rios, 2007)

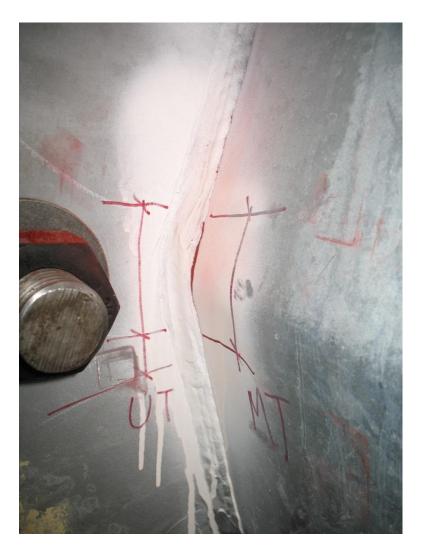
Figure 4.18: Crack location and width using MT and UT

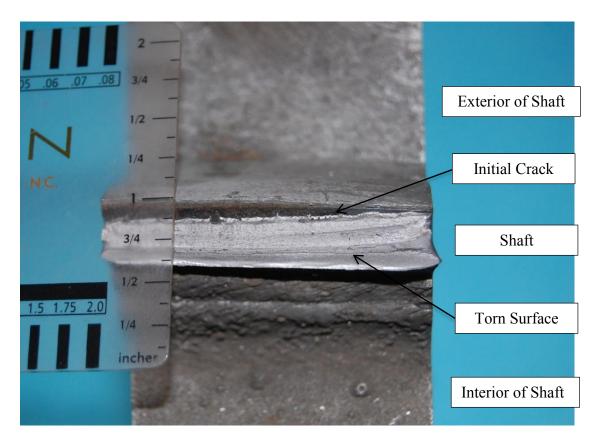
Figure 4.23: Close up of crack at Bend 4

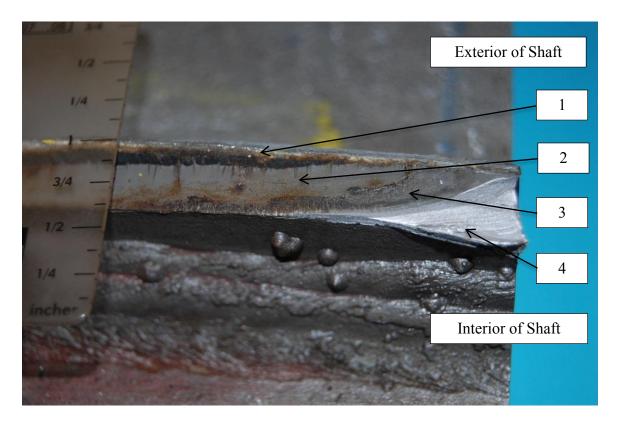
Figure 4.24: Close up of crack at Bend 12

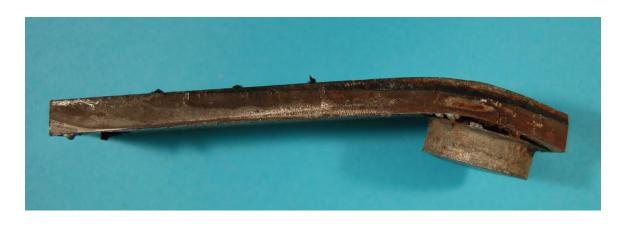
Figure 4.25: Close up of crack at Bend 8

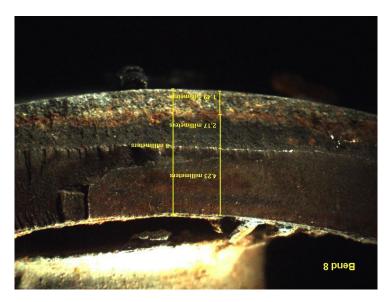
Figure 4.26: Stereoscope image of crack at Bend 8

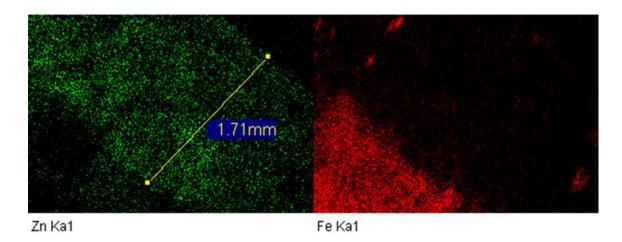
Figure 4.27: Scanning Electron Microscope (SEM) image of outer edge of crack at Bend 8

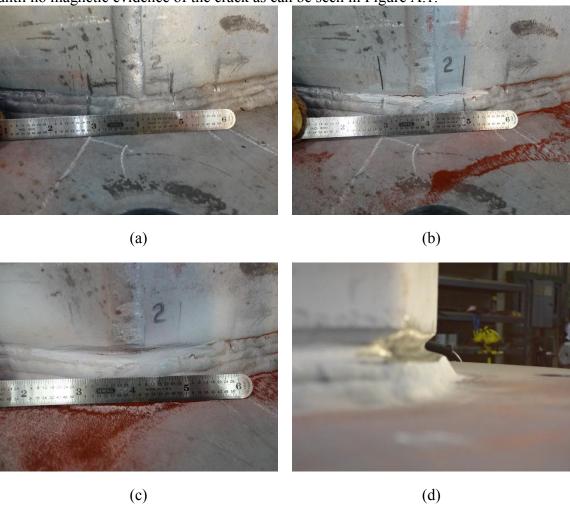
Figure A.1: Crack identification and elimination. Identifying the crack (a), grinding the cross-section to expose the crack (b), no magnetic evidence of the crack (c), remaining cross-section (d)
