FLOOD OF 31 JULY 1976
IN
BIG THOMPSON CANYON, COLORADO

D. B. Simons, J. D. Nelson, E. R. Reiter, and R. L. Barkau

Colorado State University
Fort Collins, Colorado

Committee on Natural Disasters
Commission on Sociotechnical Systems
NATIONAL RESEARCH COUNCIL

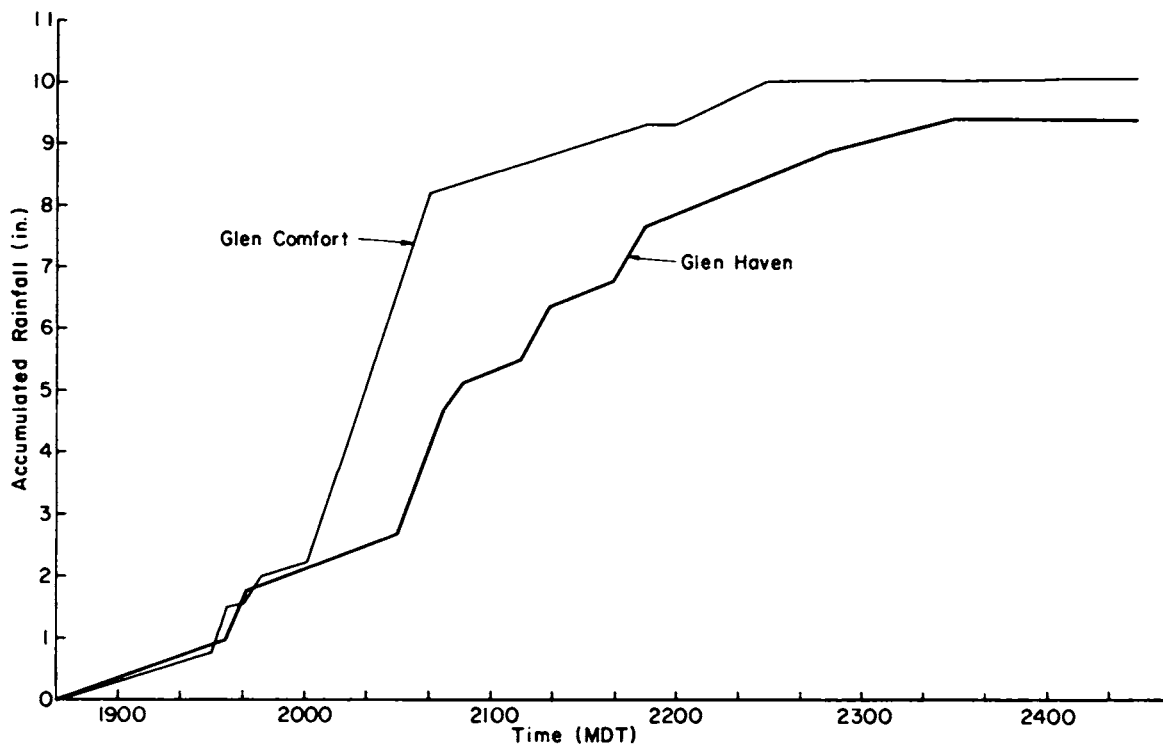
FIGURE 4 Accumulated Rainfall vs. Time for Glen Comfort and Glen Haven, 31 July 1976 (Maddox 1977)

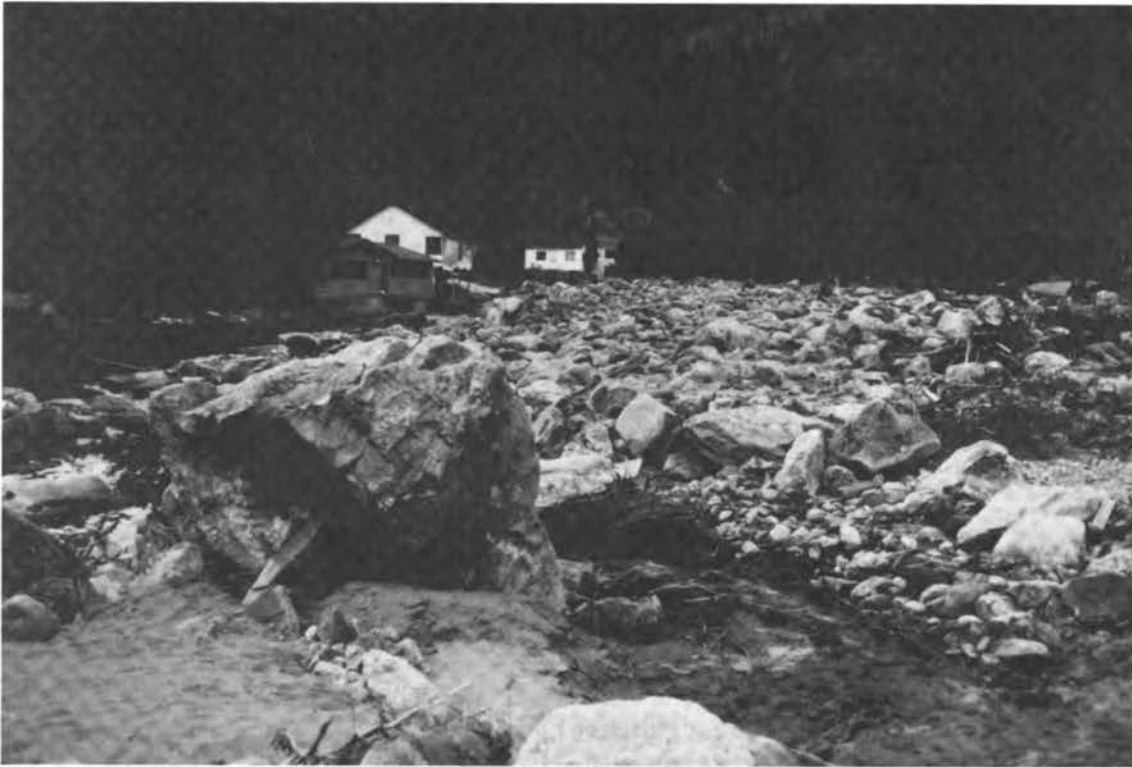
FIGURE 14 Boulder Deposit Upstream of Drake

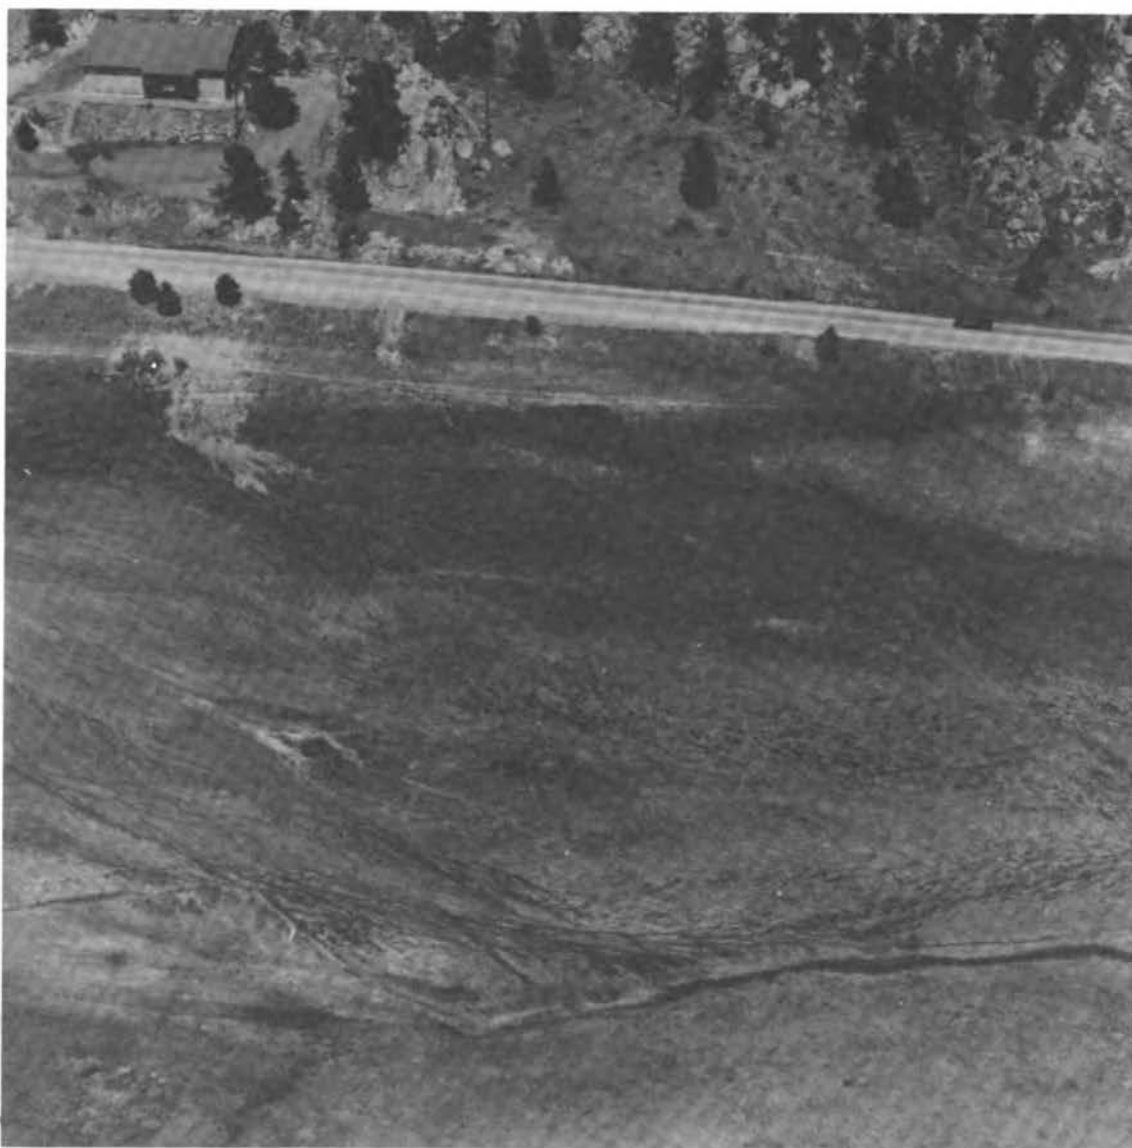
FIGURE 15 Sheet Erosion along Dry Gulch near Estes Park

Sheet erosion results from the suspension of fine surface materials by overland flow. Sheet erosion most commonly occurs on the gentle to moderate (5 to 15%) slopes where rainfall is so intense that the infiltration capability of the soil is exceeded. Poorly developed soils of granitic origin (gruss) with little vegetative cover are subject to severe erosion. During the 1976 flood, sheet erosion removed almost 6 inches of gruss from intense rainfall areas (Doehring 1976). Soils that had developed from the weathering of metamorphic rocks were less susceptible to severe erosion. On steeper slopes sheet erosion was replaced by rill wash and Gullying. Figure 15 shows an area of sheet erosion along Dry Gulch near Estes Park.

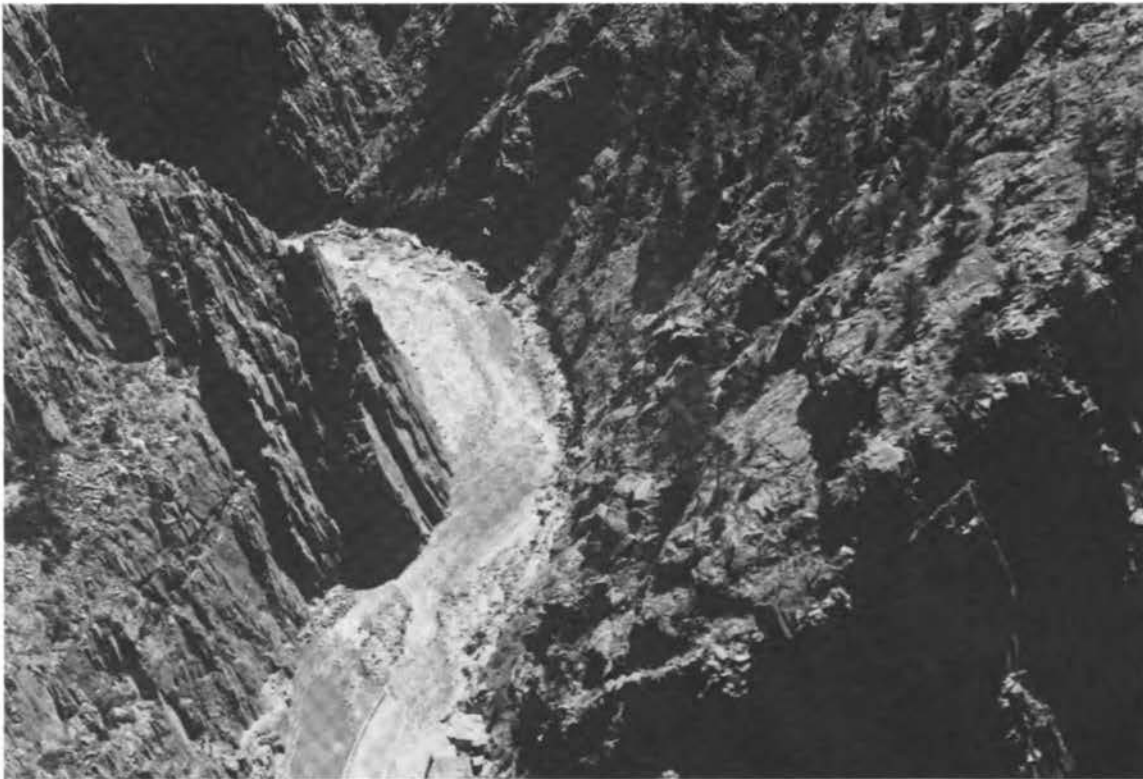
FIGURE 16 Erosion along Outside and Deposition
along Inside of Stream Bed

stream's competence (maximum particle size moved by the stream) and its ability to erode and carry sediment. Velocity is related principally to the following factors: cross-sectional area, channel geometry, and stream gradient (slope). Decreasing the cross-sectional area and increasing the stream gradient both increase the velocity. Changes in channel geometry which reduce wetted perimeter also increase velocity. Local changes in velocity can also be significant when flow is concentrated on the outside of bends. In this case, the velocity along the inside is reduced causing deposition to occur, while the velocity on the outside is increased, causing scour (Figure 16).

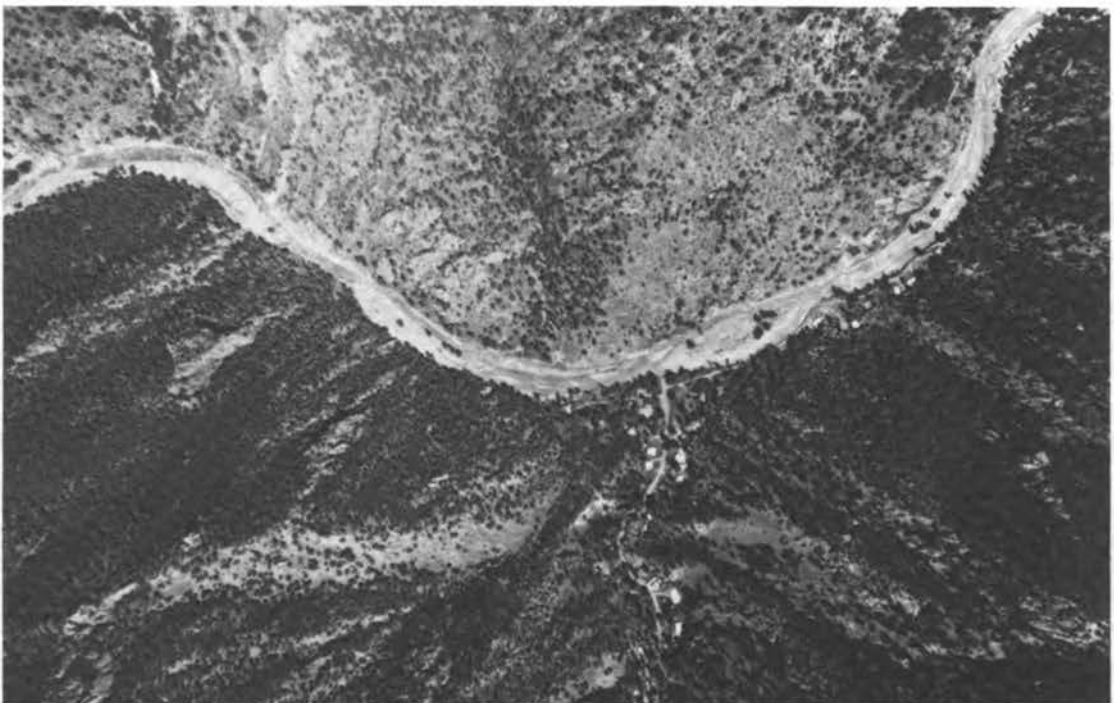
FIGURE 24 Waltonia Area

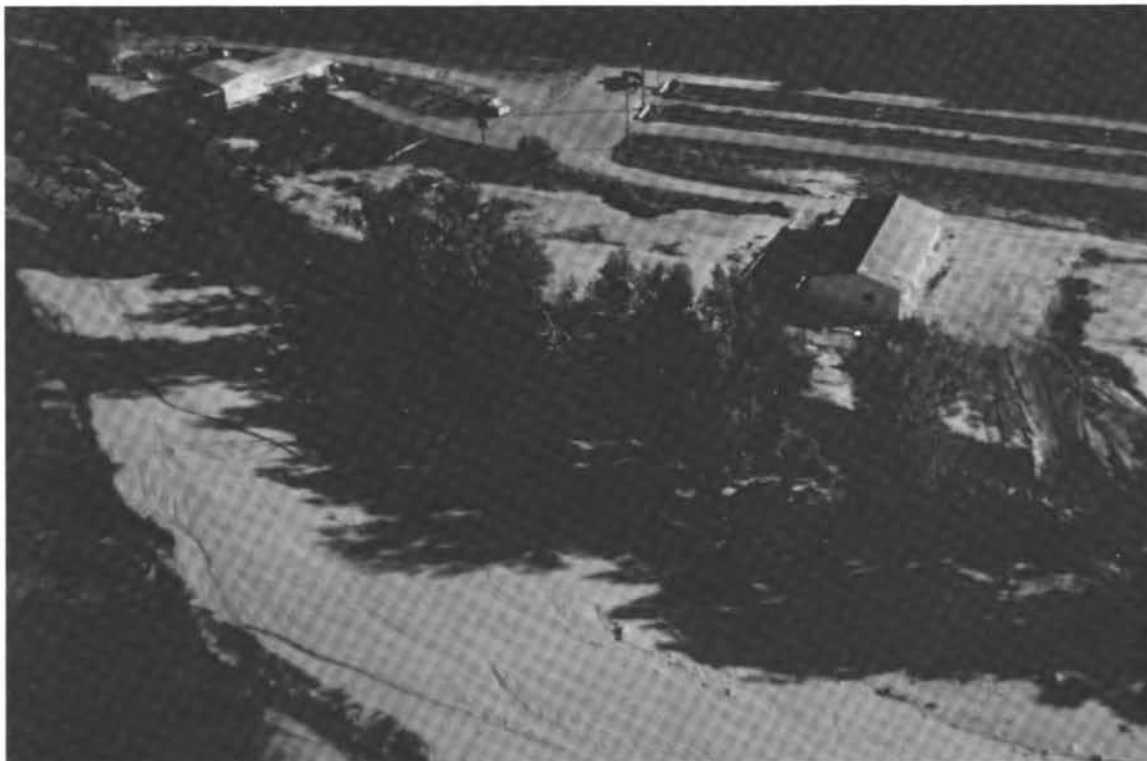
FIGURE 28 Deposits along the North Fork near the Fish Hatchery just Upstream from Drake

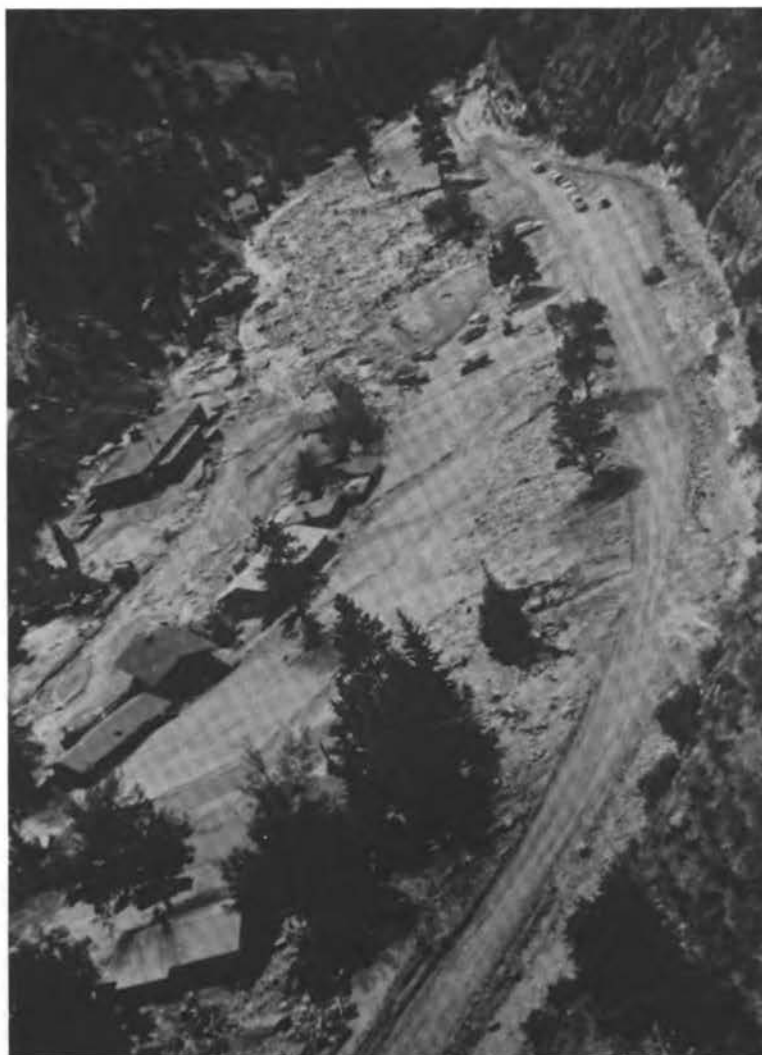
FIGURE 29 Grading of Materials Deposited by the Big Thompson River at Drake

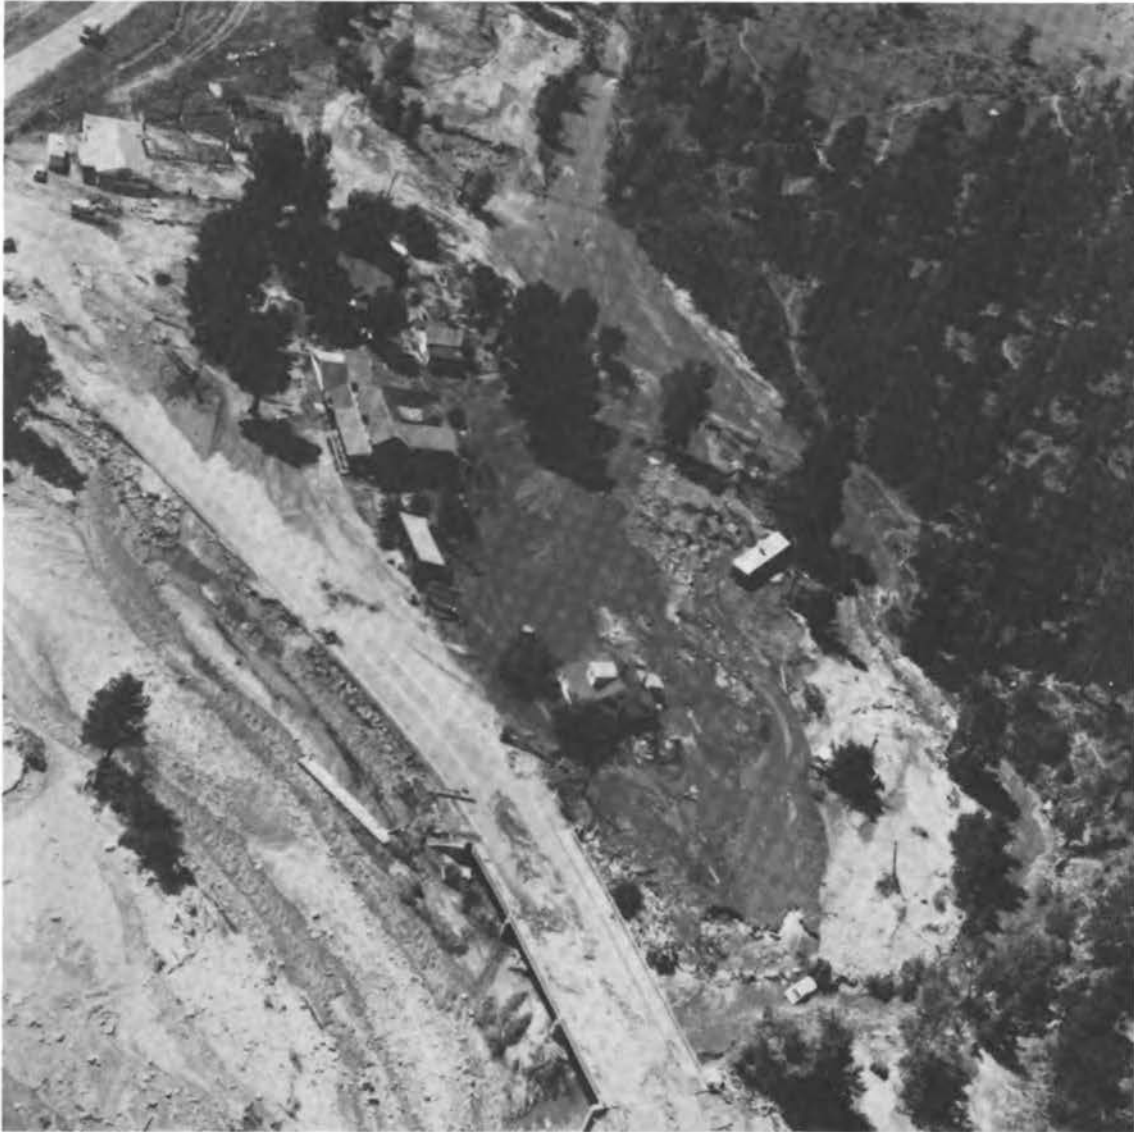
FIGURE 31 Deposits from the North Fork at Drake

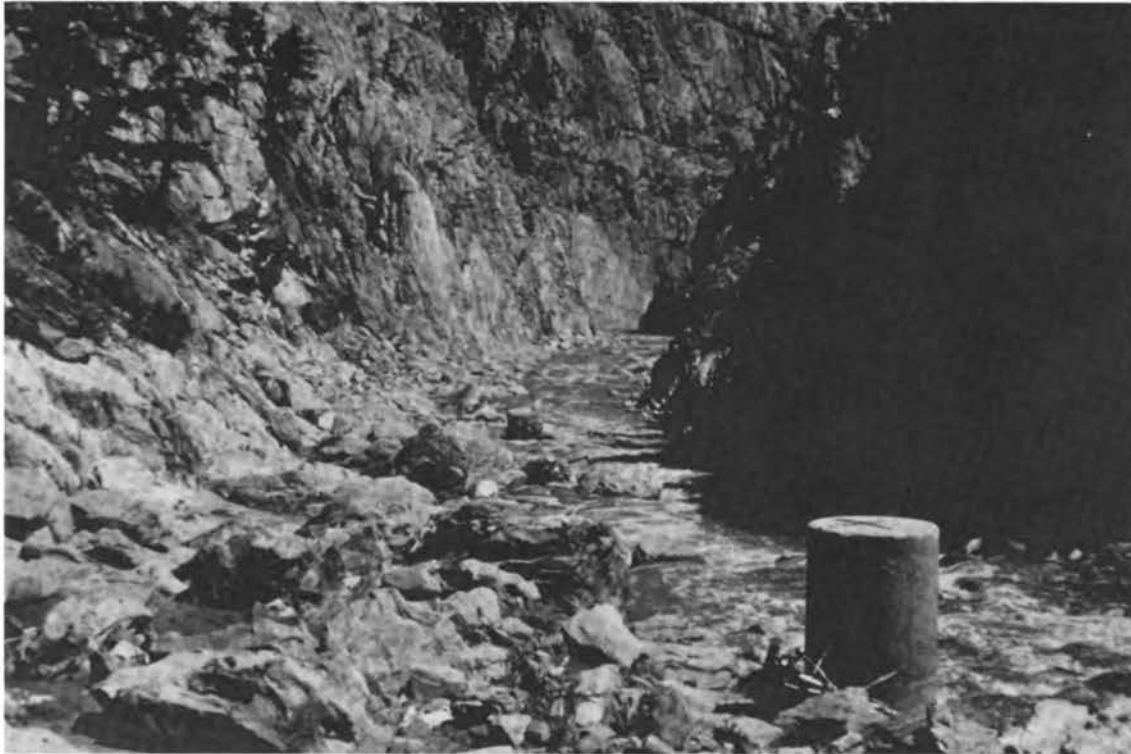
FIGURE 33 Scour in the Narrows Area near the Bureau of Reclamation Diversion Structure

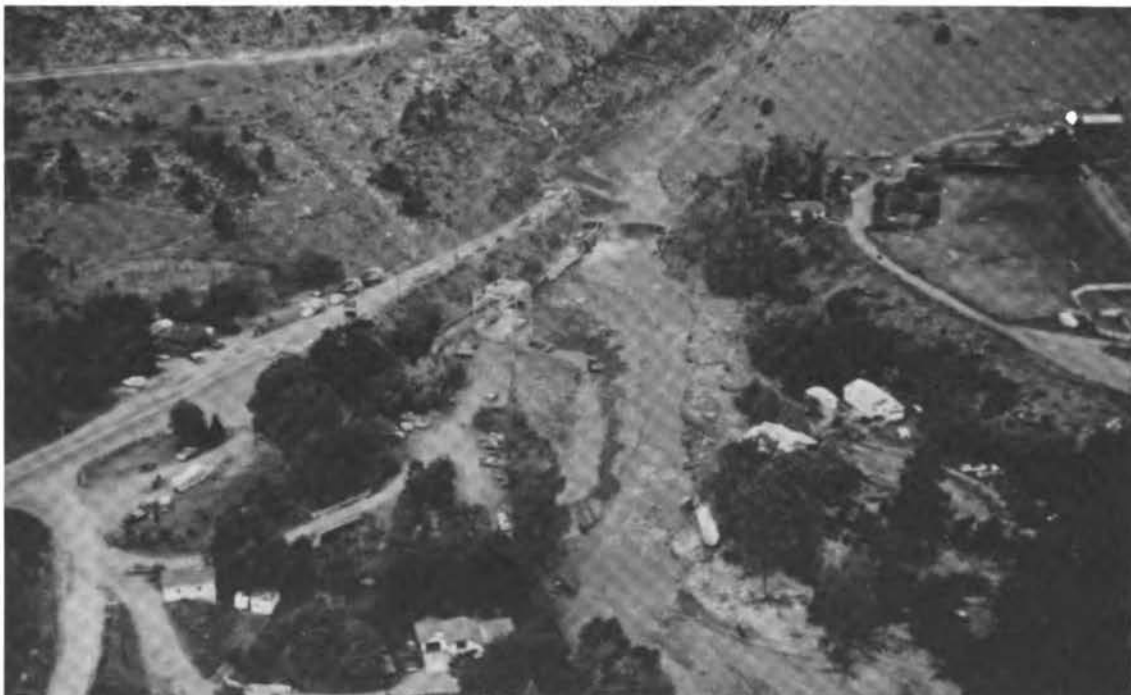
FIGURE 34 Deposits below the Mouth of the Canyon

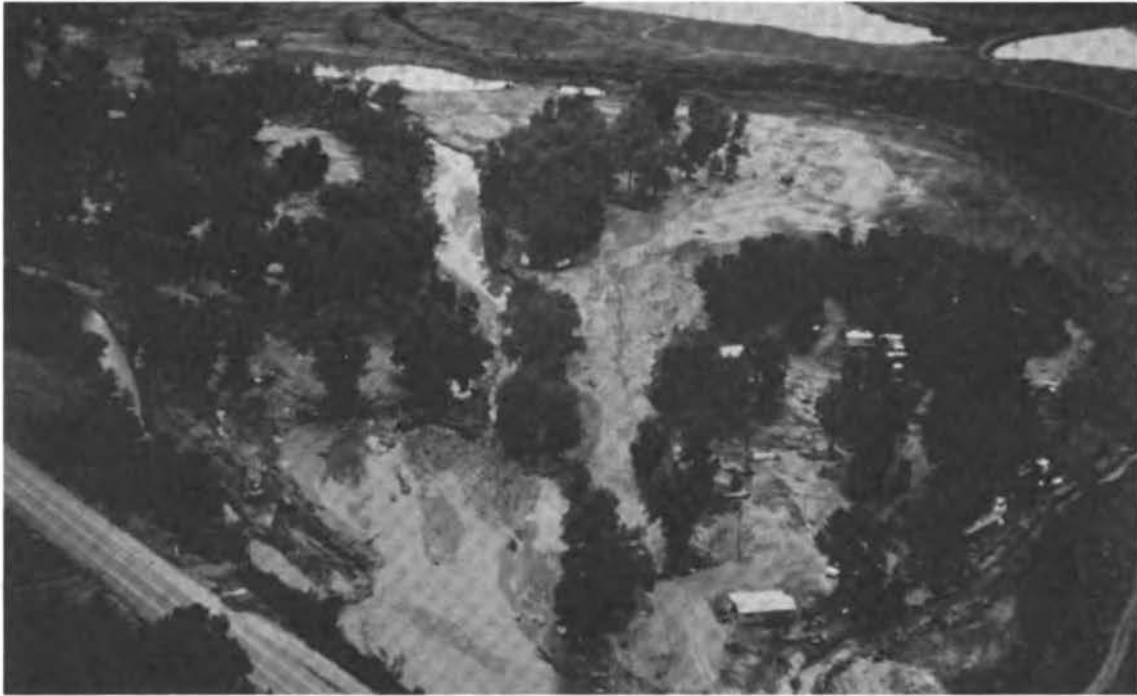
FIGURE 35 Overbank Deposits in the Plains Area

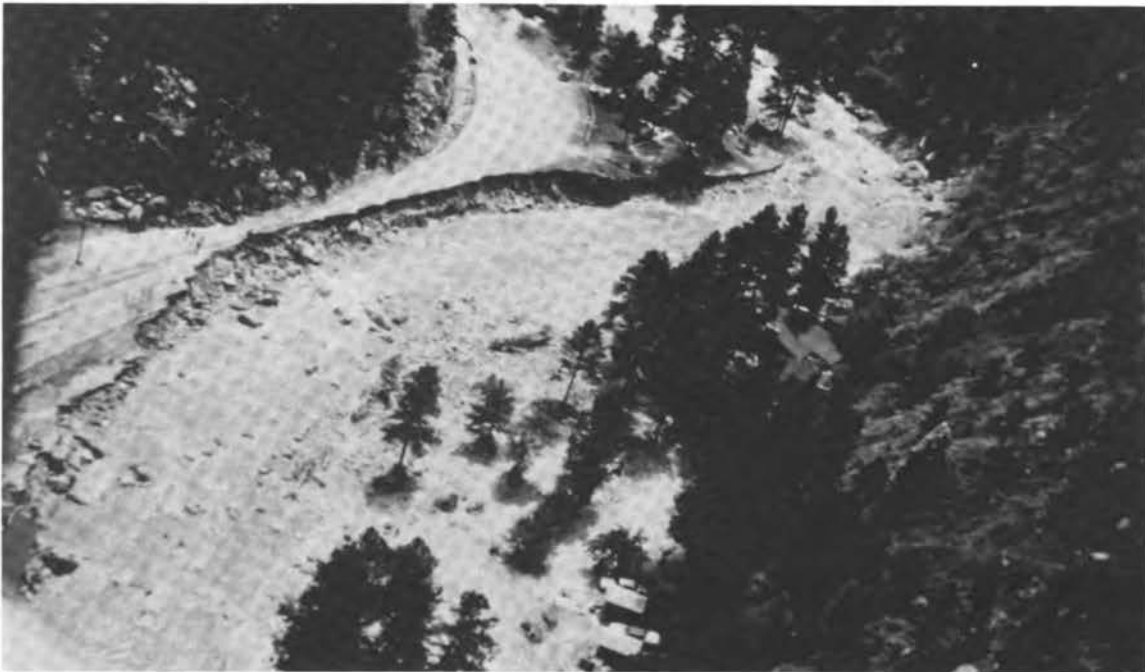
FIGURE 36 Erosion of Outside Bend on U.S. Highway 34

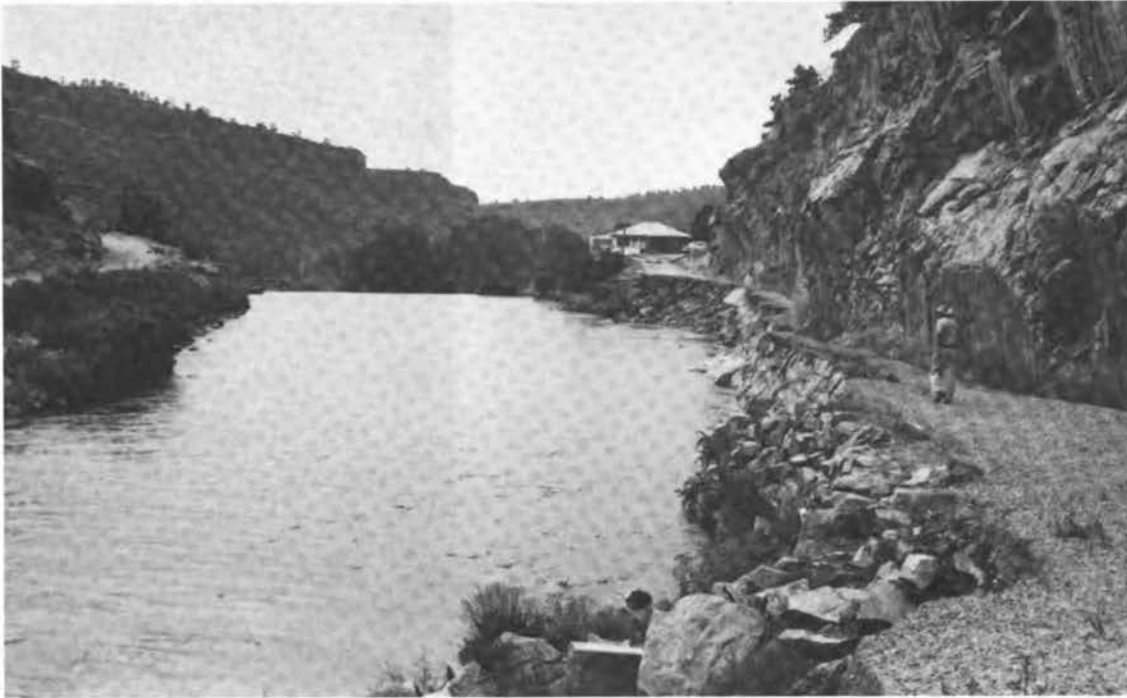
FIGURE 37 Erosion of Road between Bridge and Dam at Loveland Filtration Plant

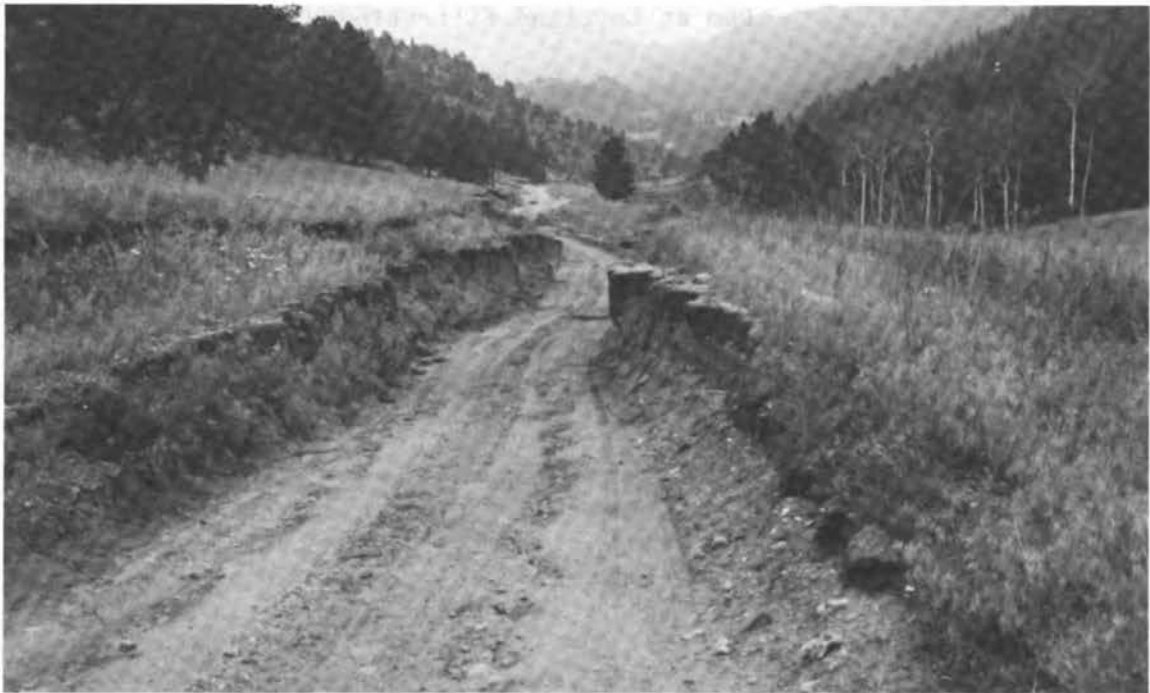
FIGURE 39 Extensive Gullying in Dunraven Glade Area

Extensive gulying along roadways was also evidenced in the Dunraven Glade area north of the North Fork. Such gulying can be seen in Figure 39. Extensive erosion was fairly common along roadways or around man-made structures.

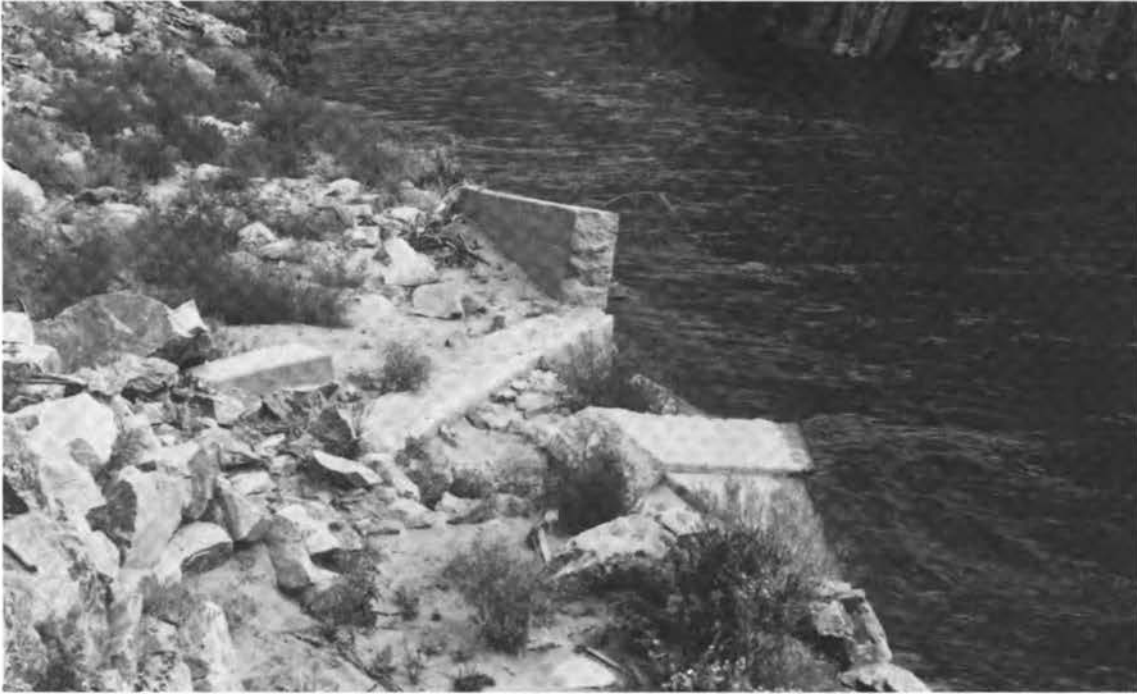
FIGURE 42 Close-up View of Right Abutment Shown in FIGURE 41

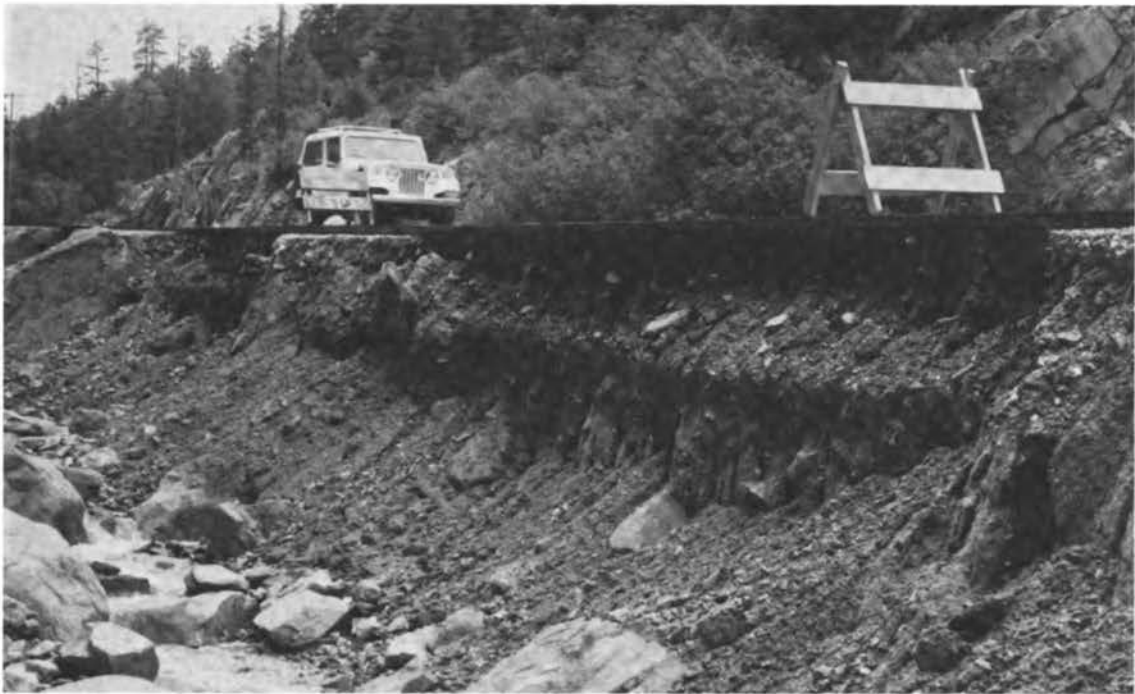
FIGURE 43 Repaired Highway Embankment Washed out by Subsequent Storm

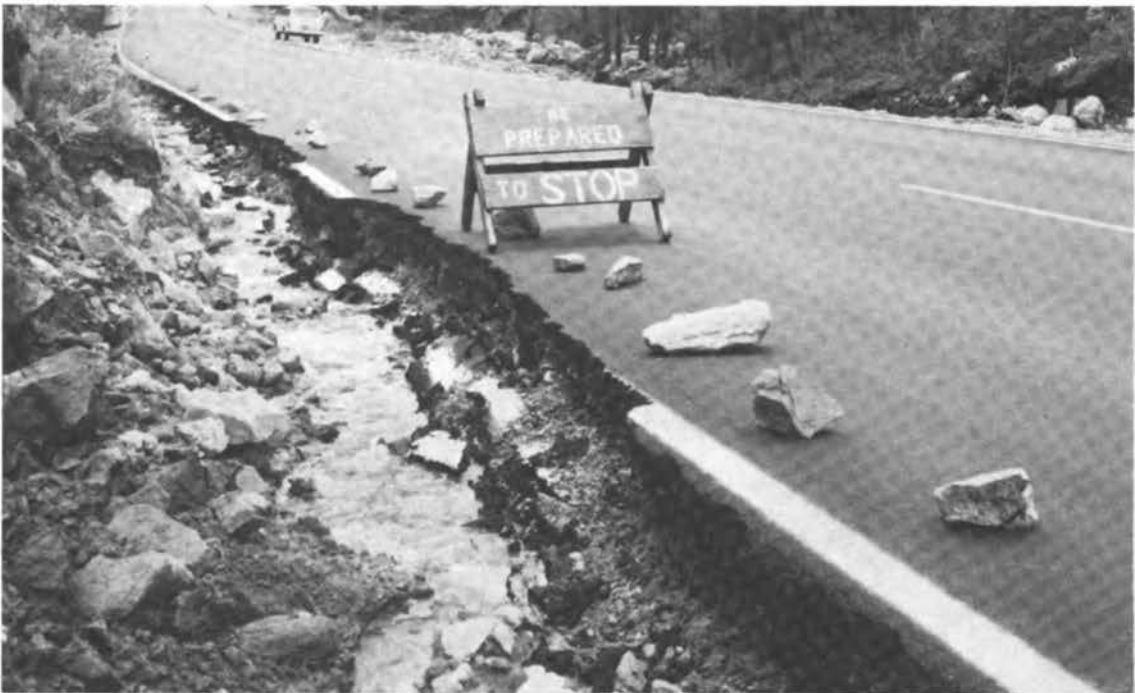
FIGURE 44 Repaired Pavement Eroded by Scour in Drainage Ditch

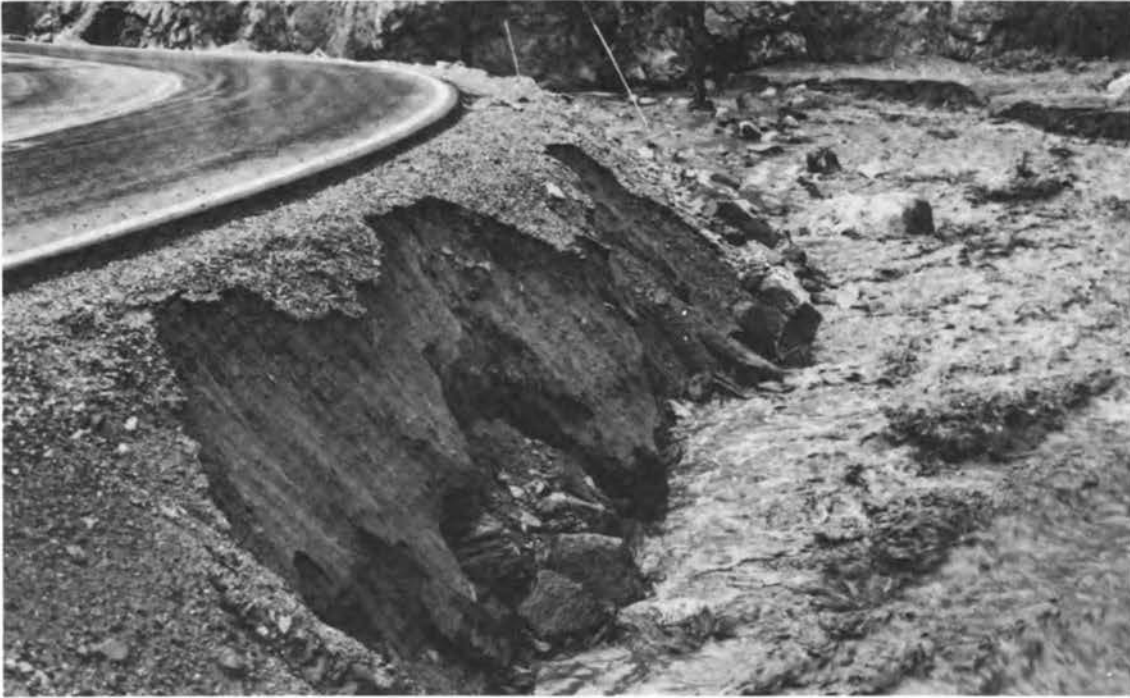
FIGURE 45 Repaired Highway Embankment Eroded by Water from Tributary

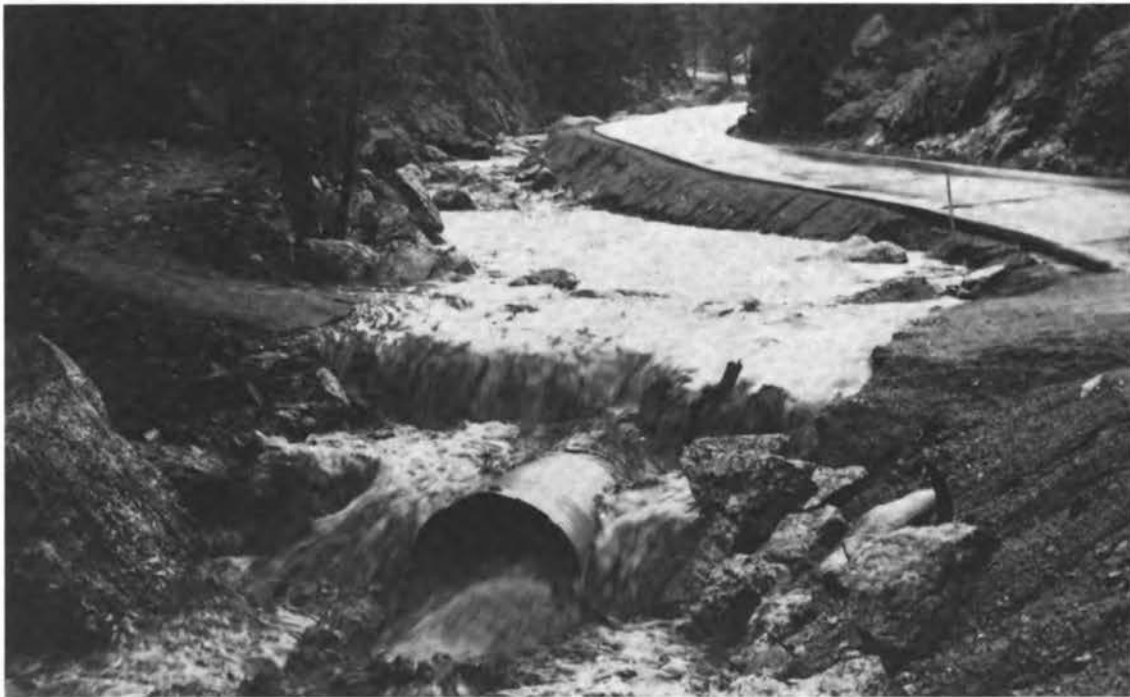
FIGURE 46 Storm Waters Washing over Culvert

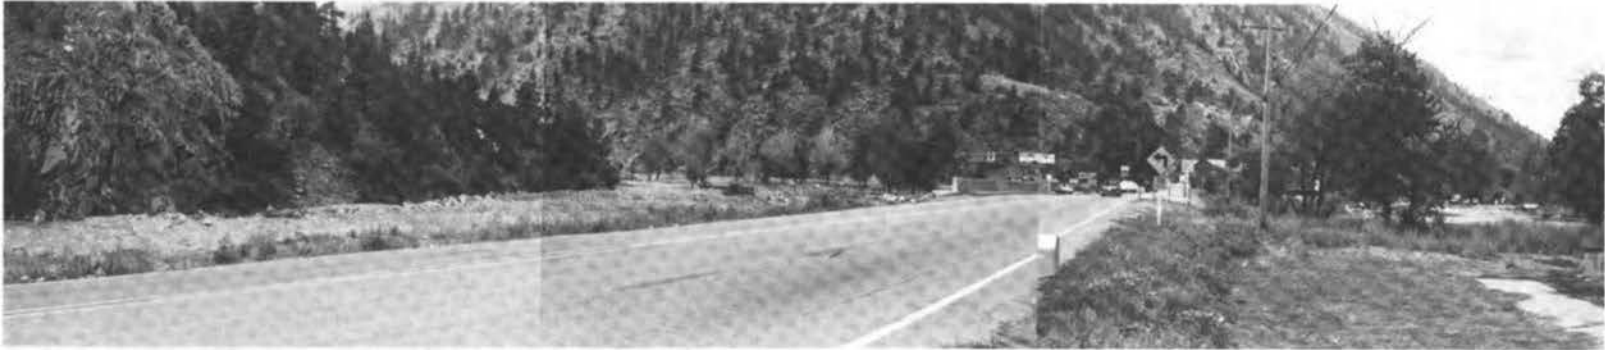
FIGURE 47 Town of Drake after the Flood

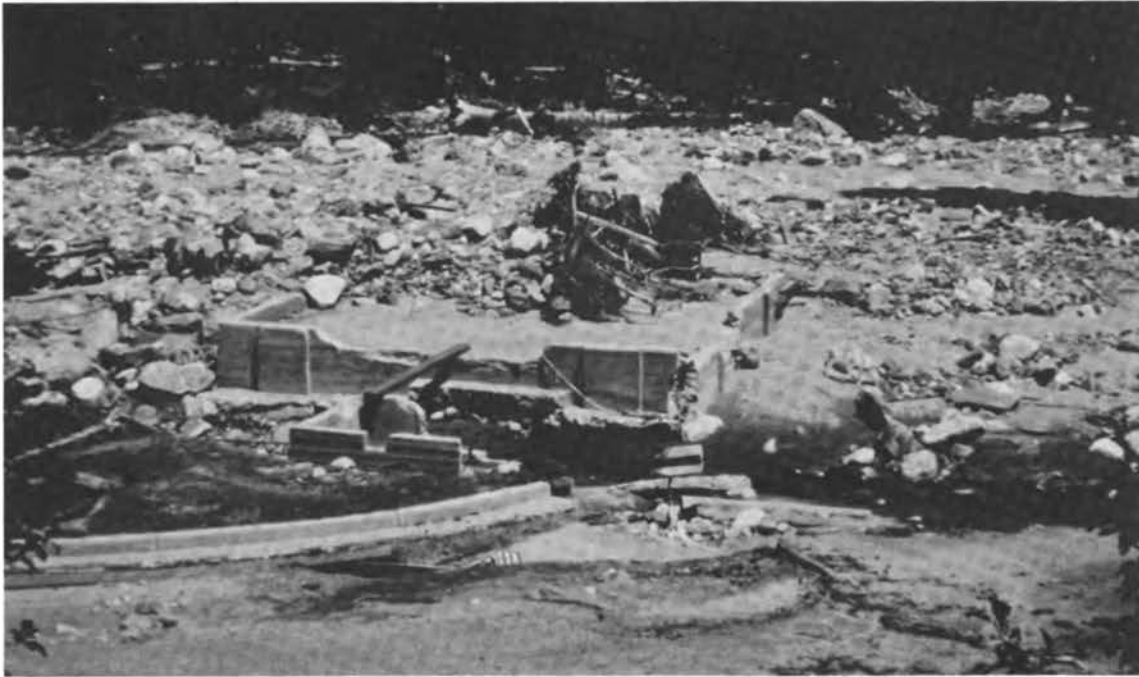
FIGURE 48 Loveland Power Plant

Figure 48 shows the remains of the Loveland City Power Plant. The foundation structure survived well but the entire masonry superstructure and large generators were washed away. Wooden structures were often floated off the foundations and deposited at a different point.

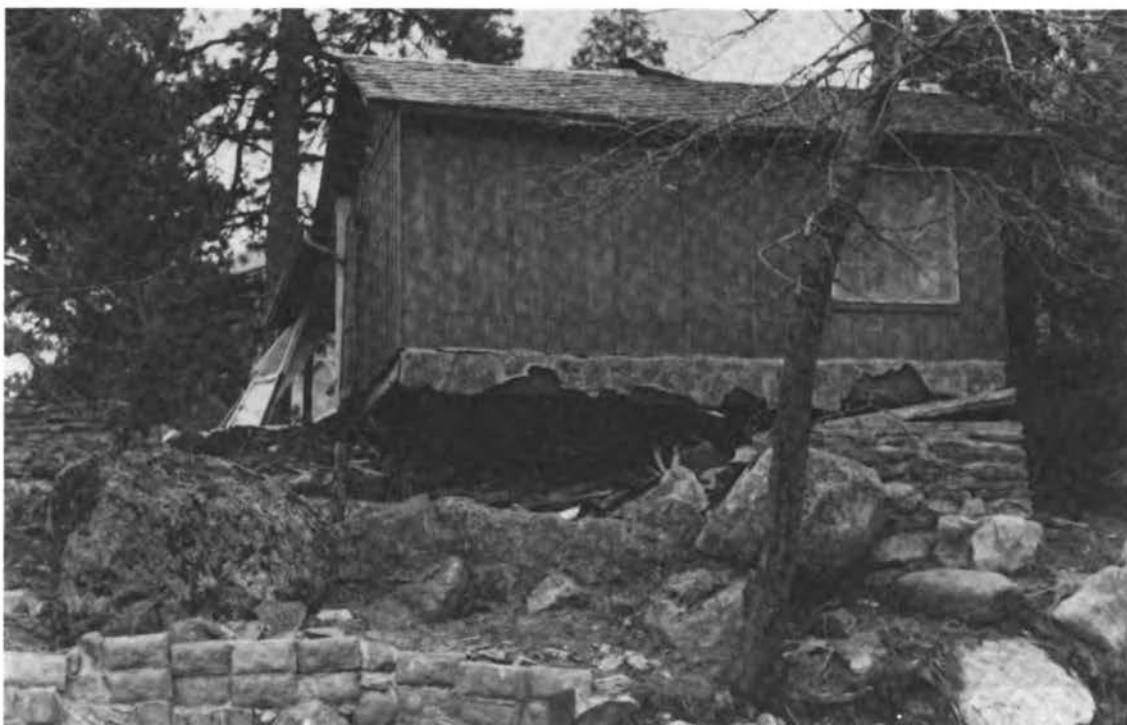
FIGURE 49 Failure of Timber Foundation with Stone Masonry Facing

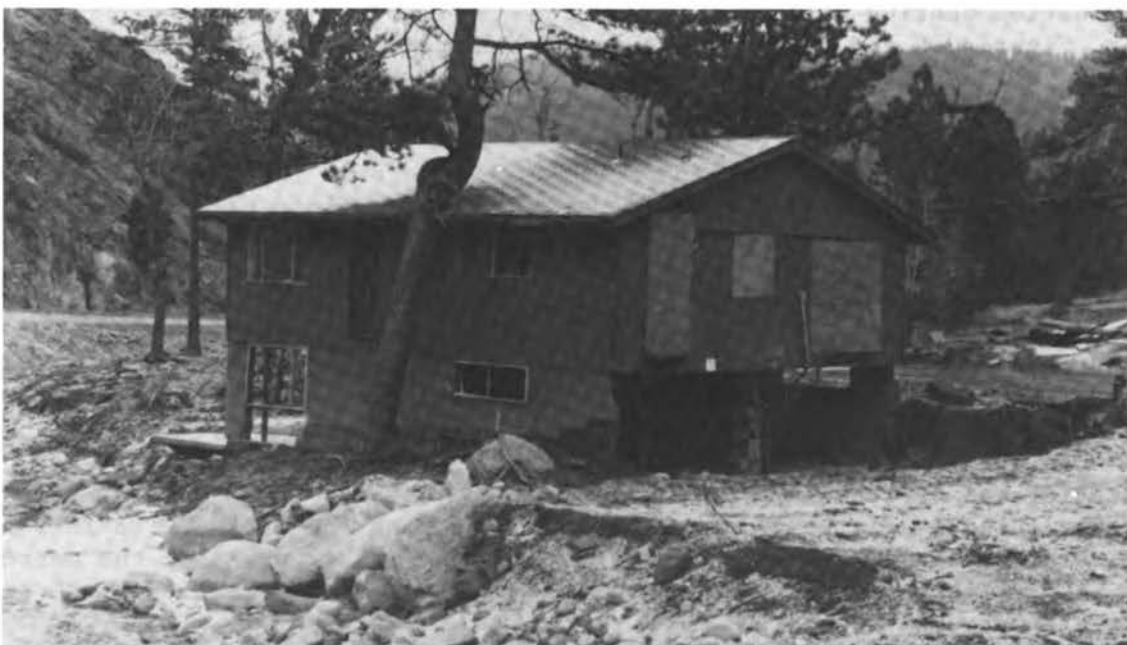
FIGURE 50 Failure of Concrete Block Foundation

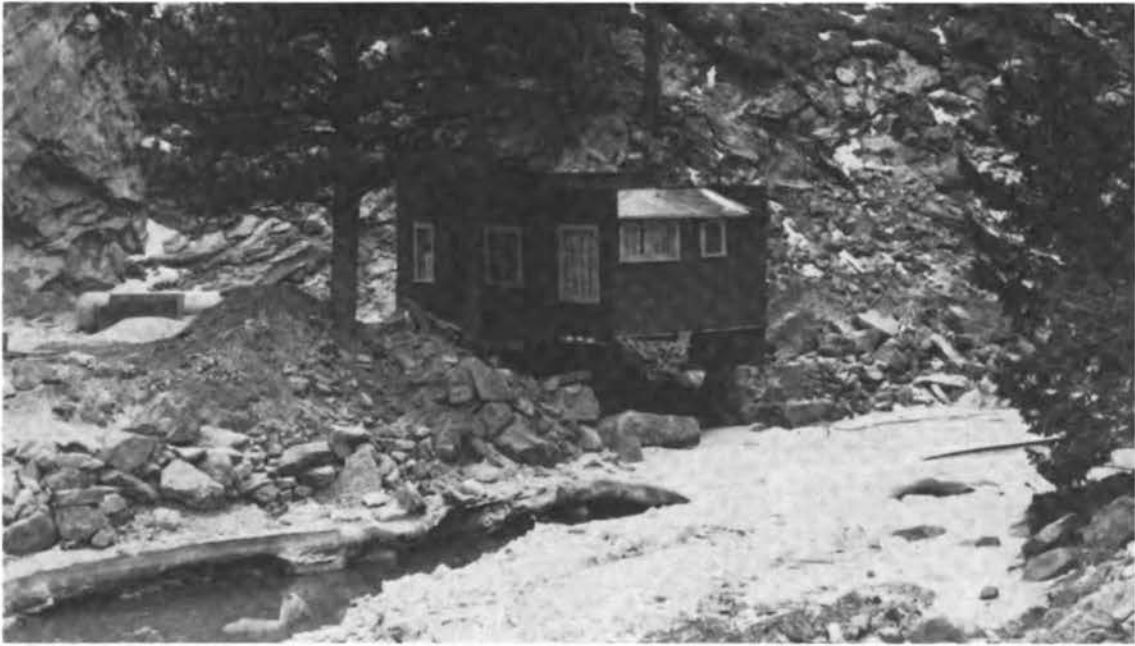
FIGURE 51 Erosion of Foundation Bearing Material

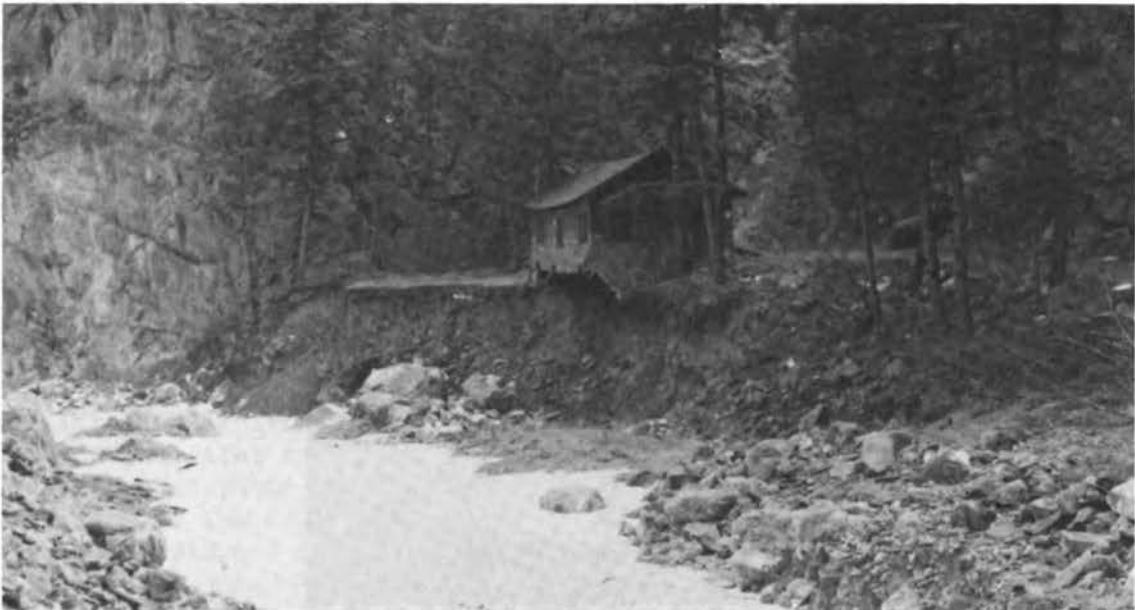
The structure in Figure 52 was constructed on a debris fan formed below a gulch that is normally dry. In the following section this type of failure will be discussed in more detail with regard to slope stability. The point to be made, however, is that, although the floodwaters

FIGURE 52 Erosion of Debris Fan below Foundation

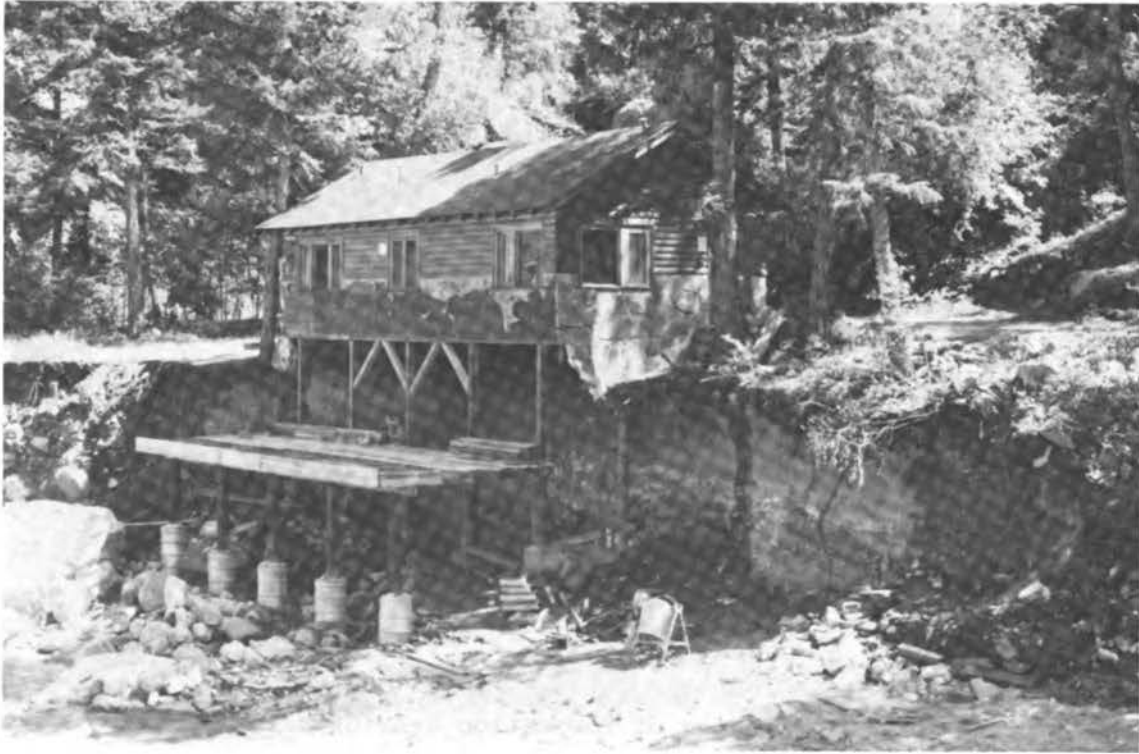
FIGURE 53 Remedial Measures Being Taken for Foundation Repair

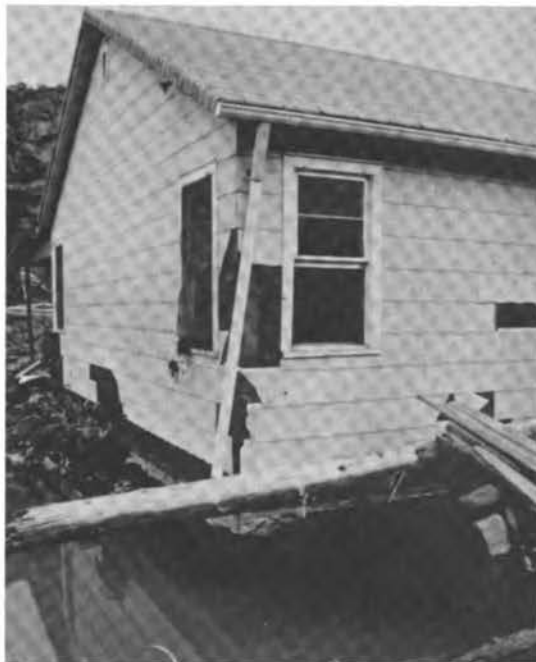
FIGURE 54 Erosion below Slab on Grade Foundation
