FLOOD OF 31 JULY 1976
IN
BIG THOMPSON CANYON, COLORADO

D. B. Simons, J. D. Nelson, E. R. Reiter, and R. L. Barkau

Colorado State University
Fort Collins, Colorado

Committee on Natural Disasters
Commission on Sociotechnical Systems
NATIONAL RESEARCH COUNCIL

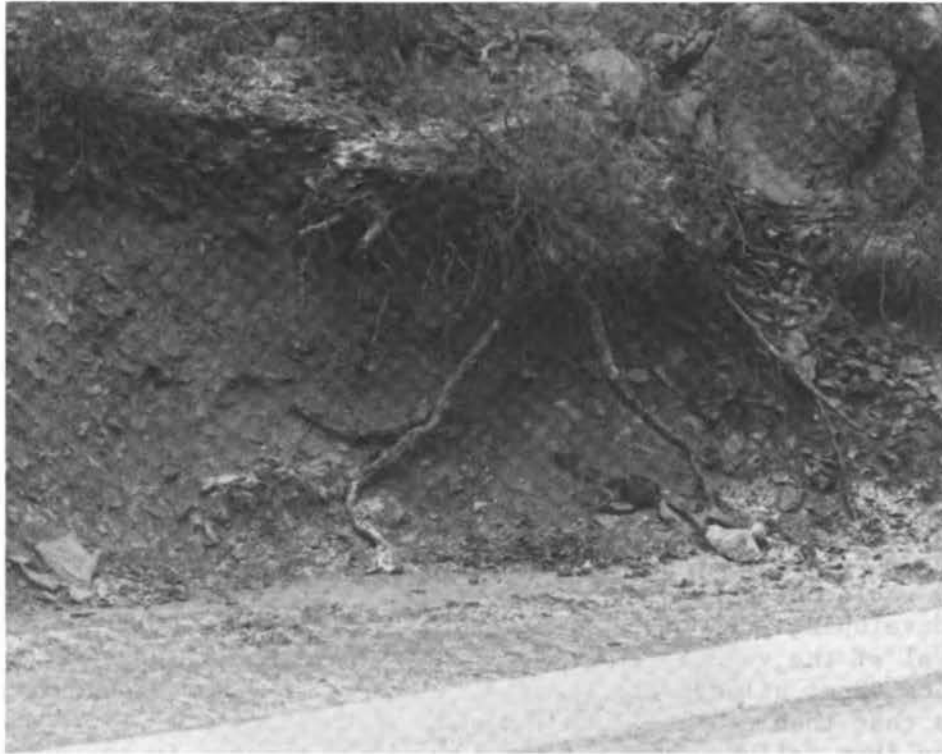
FIGURE 55 Root Zone of Soil Cover

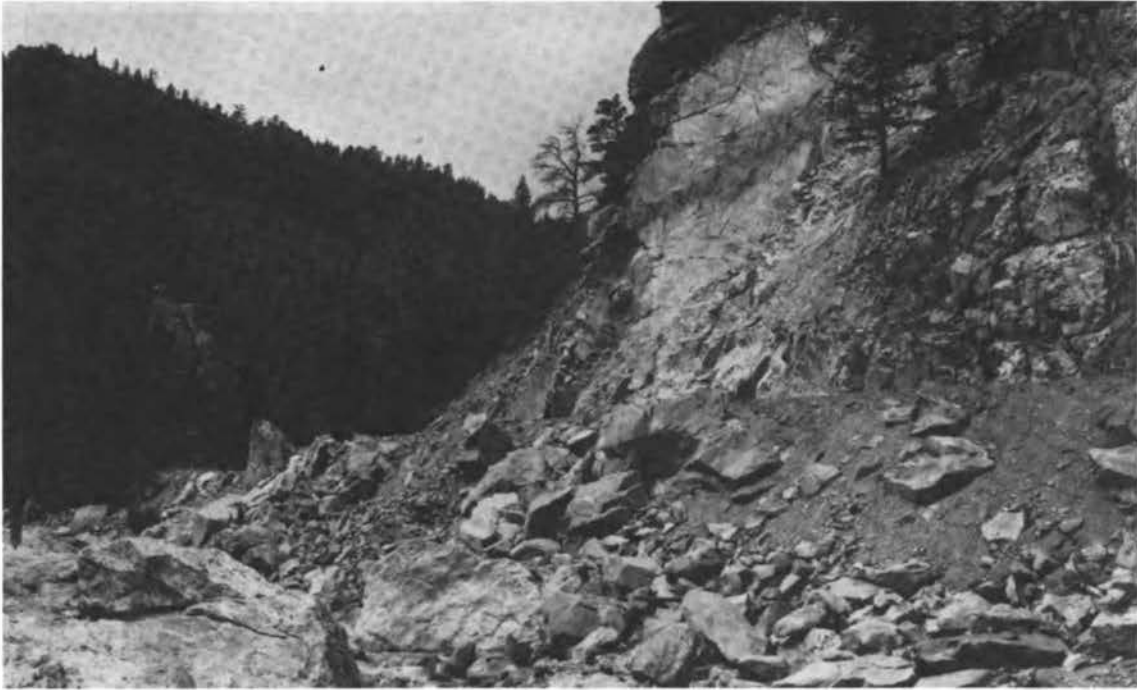
FIGURE 56 Rock Fall along Highway

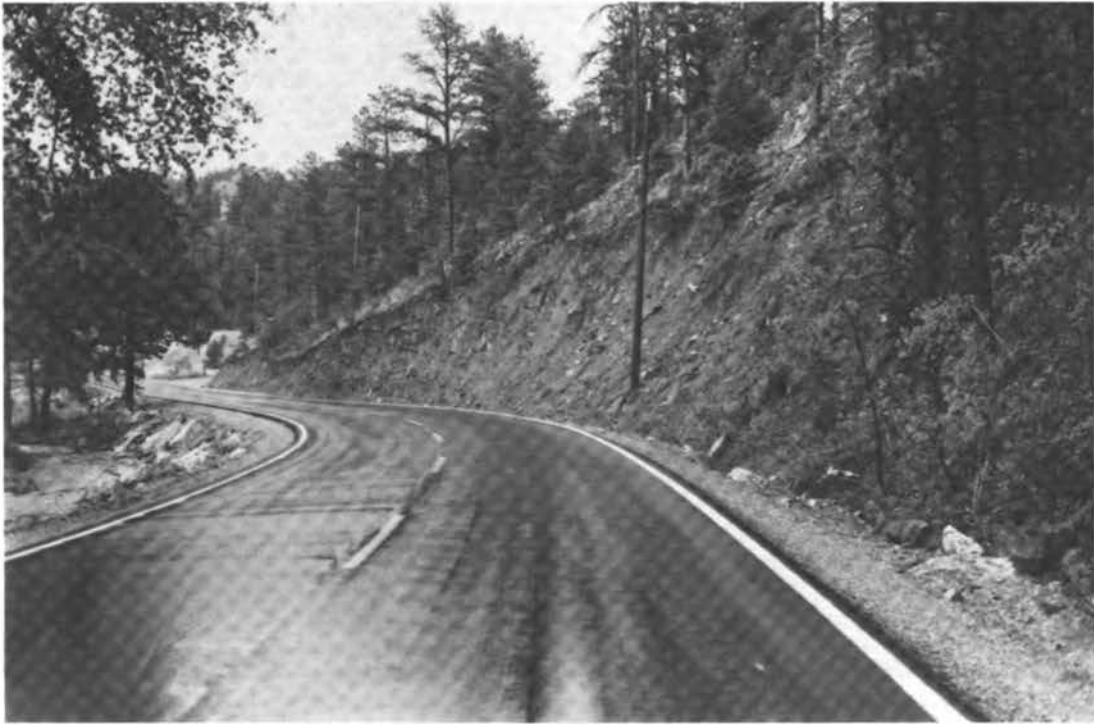
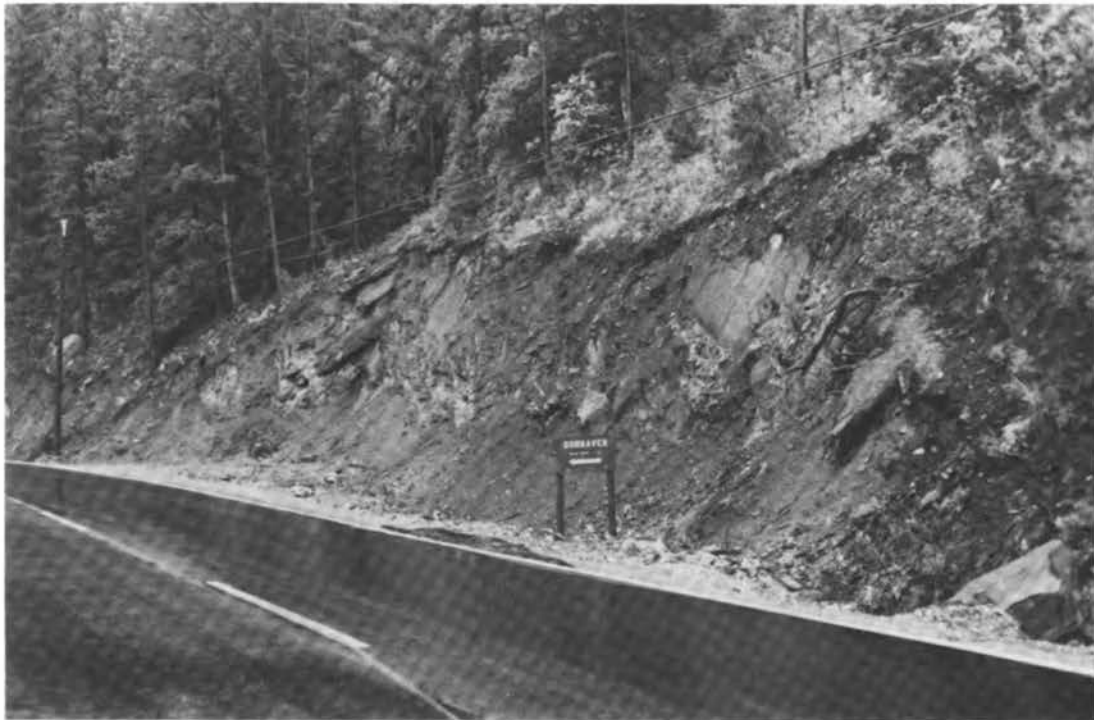
Figure 58, taken about one year after the flood, shows two slopes along the road approximately 6 miles upstream from Drake along the North

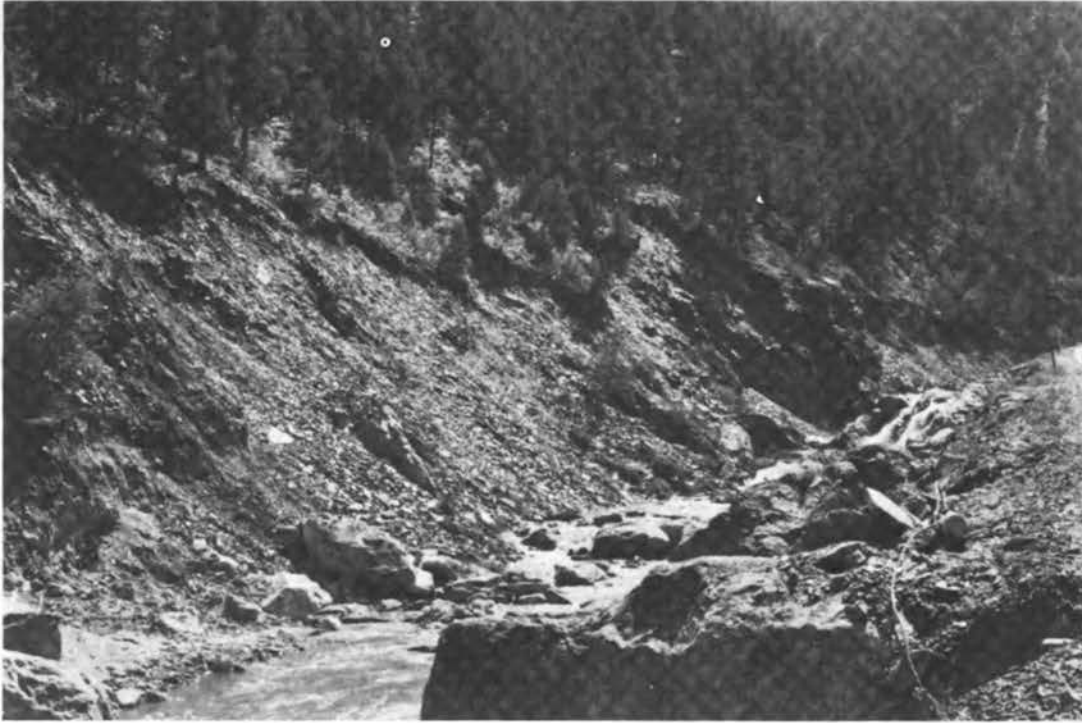
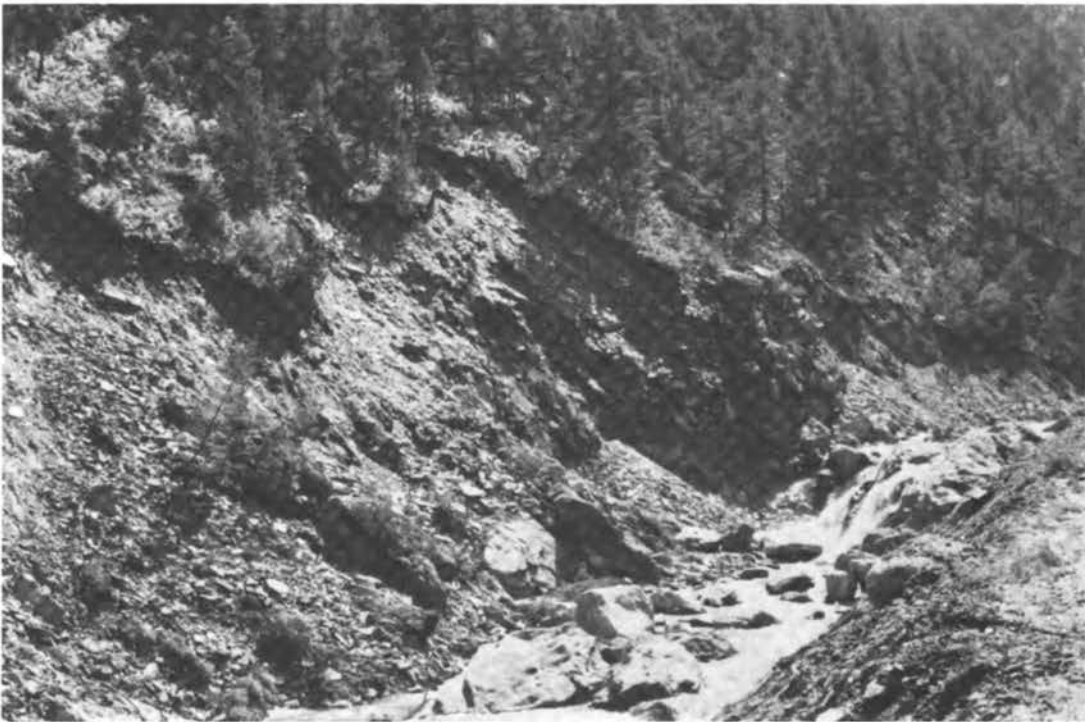
FIGURE 59a

FIGURE 59 Slope Failure in Colluvium along Big Thompson River
Approximately 3 to 4 Miles west of Drake

The soil and rock debris at the bottom of the slides was deposited sometime after the flood. River flows in the year after the flood have been abnormally low and the material at the toes of the slopes continues to accumulate. In subsequent periods of high flow this material may be

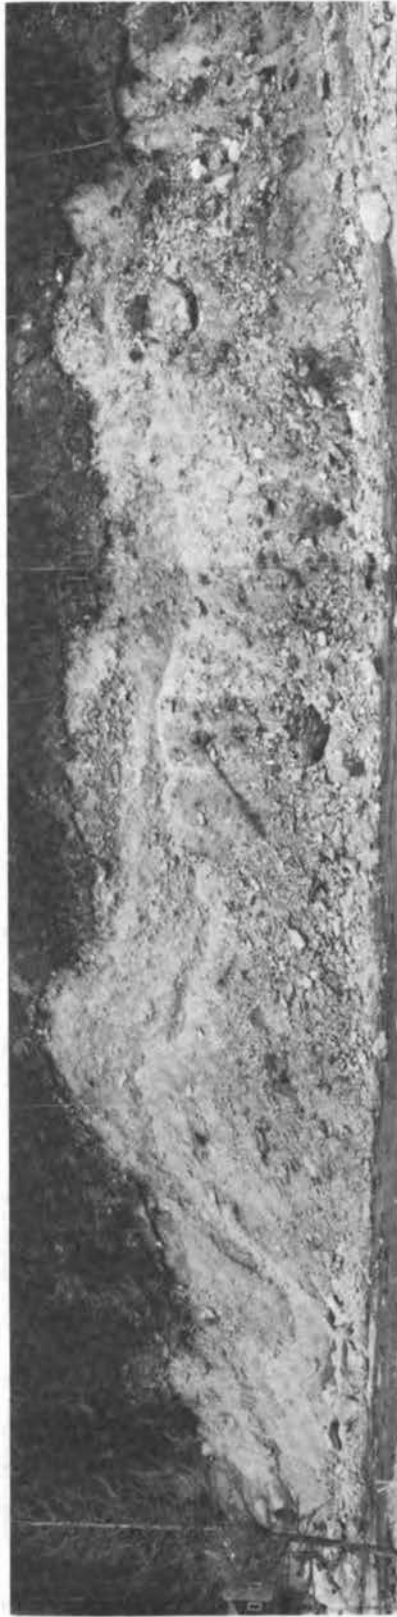
FIGURE 60 Slope Failure at Drake

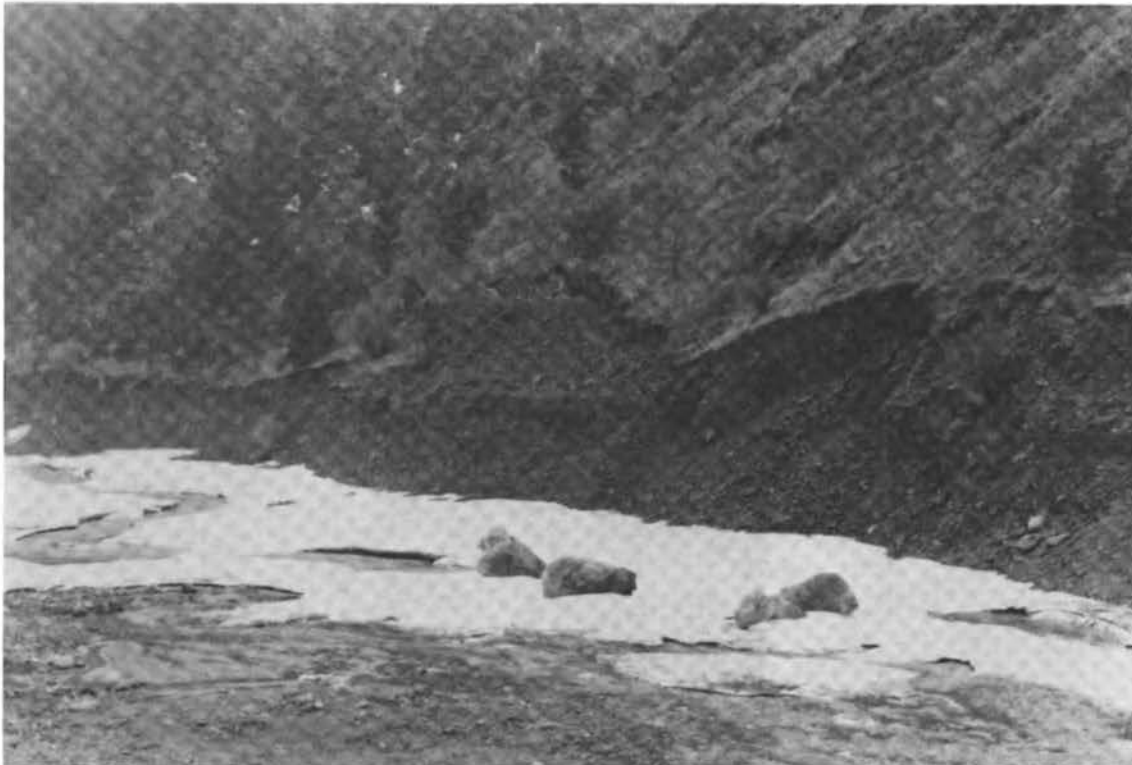
FIGURE 61 Slope Failure Formed about One Week after the Flood

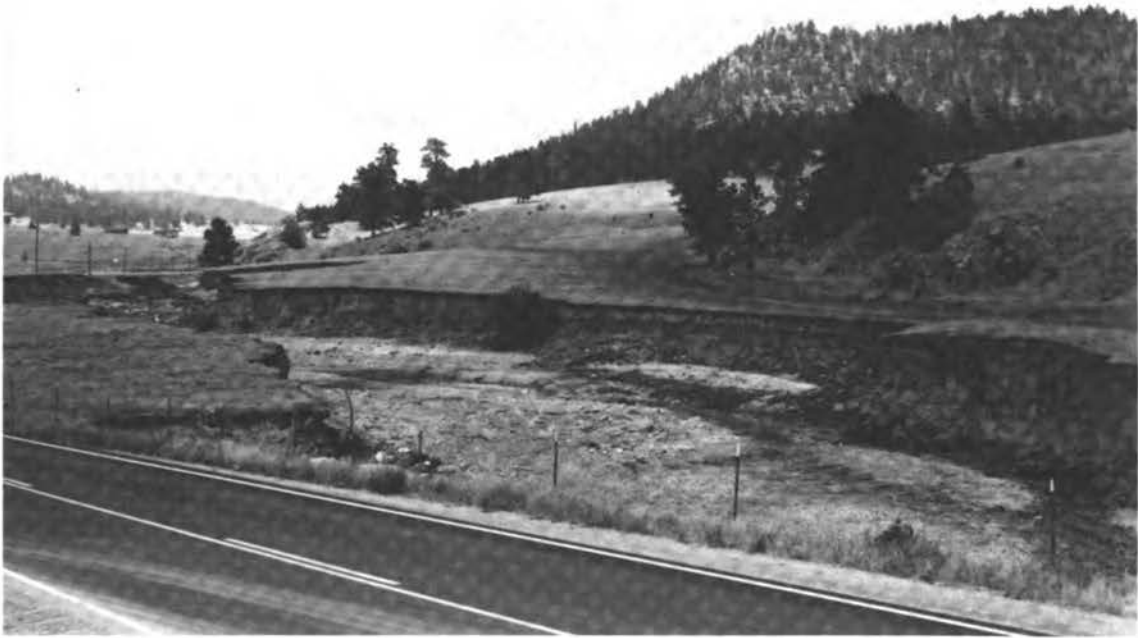
Another class of slope failure includes the erosion of debris fans where they existed in the floodplain. Figure 62 shows an area in Olympus Heights near Estes Park along Dry Gulch; the large amount of

FIGURE 62 Erosion along Dry Gulch

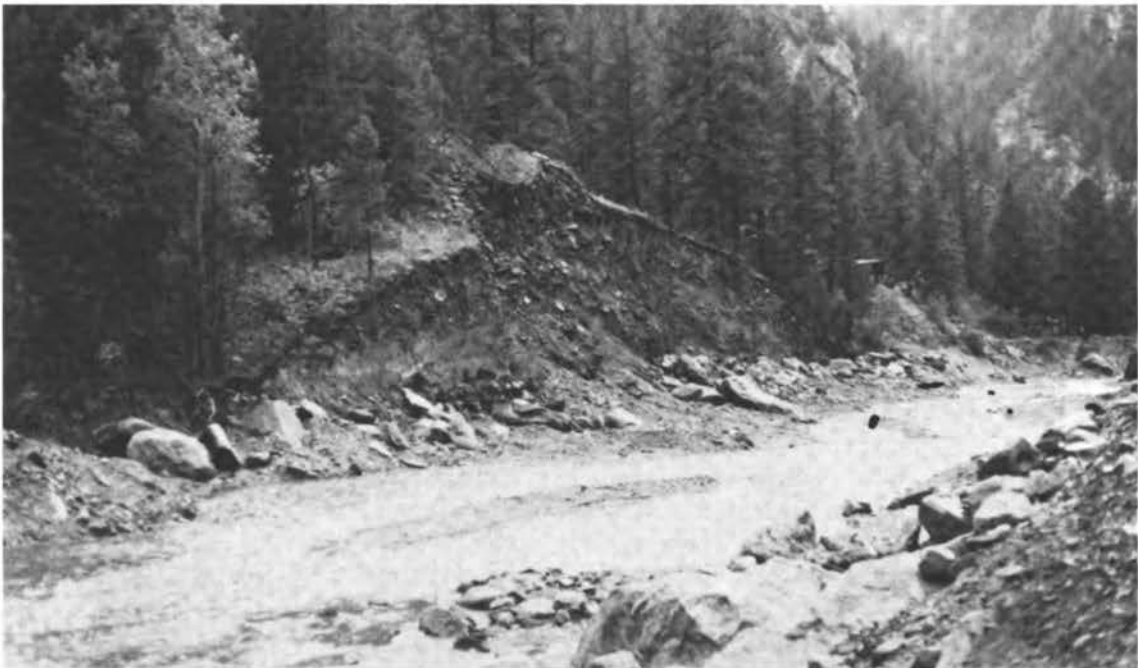
FIGURE 63 Erosion of Debris Fan

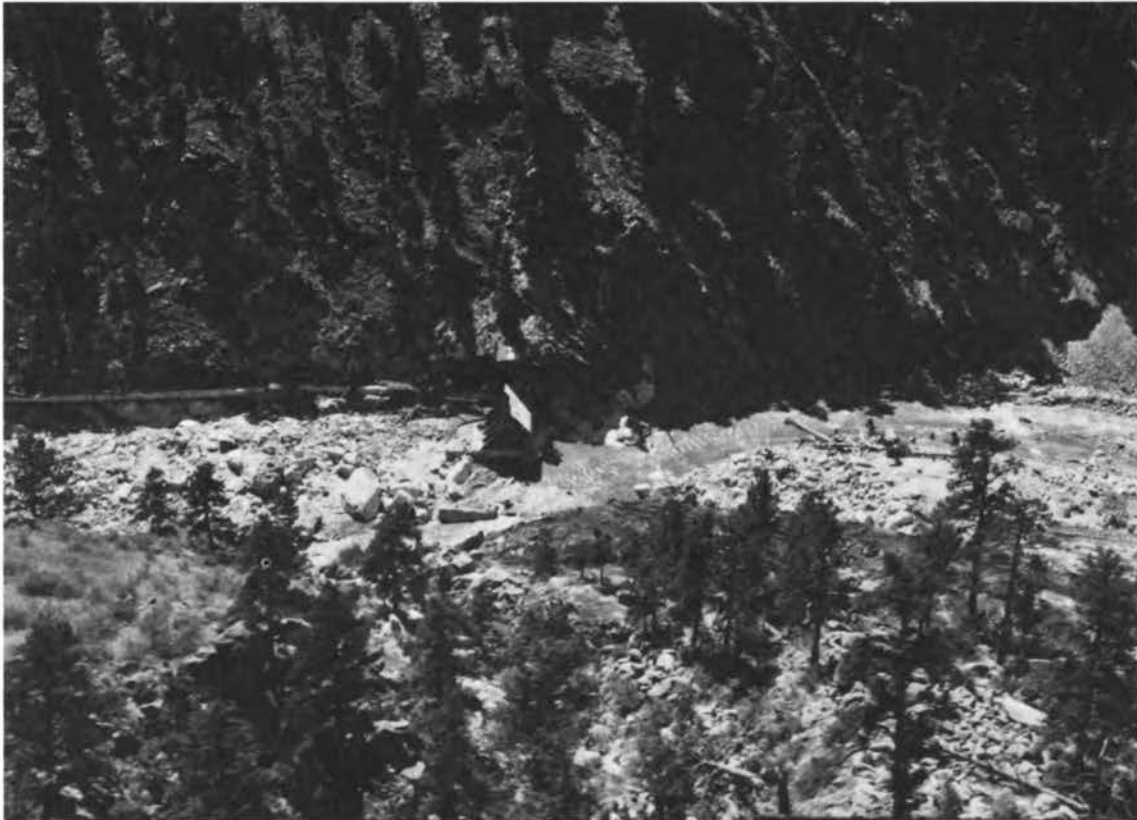
FIGURE 64 Remains of Loveland Hydroelectric Dam

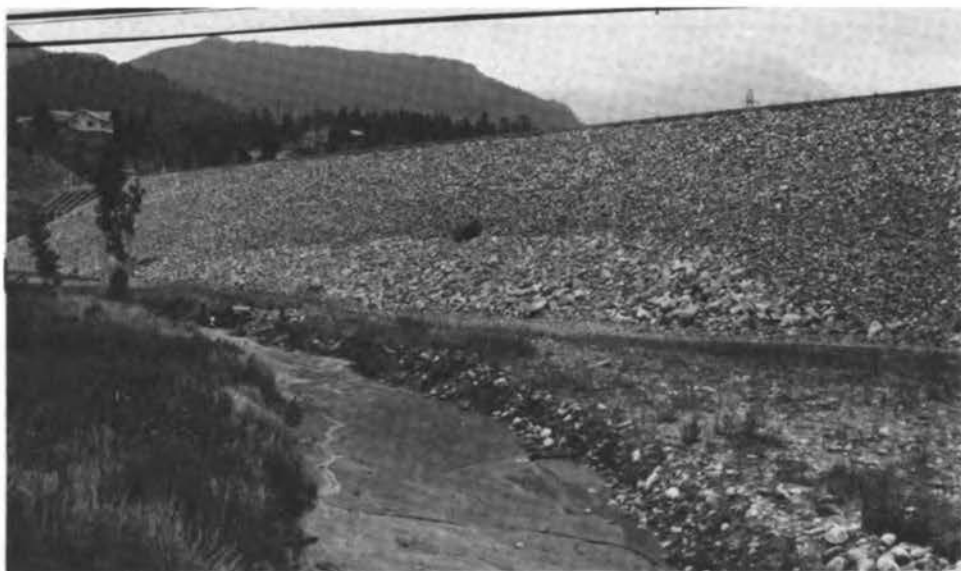
FIGURE 65 Olympus Dam

The area above Olympus dam contributed little to the flooding downstream. Light rainfall raised water levels on the streams above Lake Estes but caused only minor flooding. At 2055 MDT, the gates of Olympus dam were closed, cutting off flow from upstream. The 108 cfs which was being released prior to closure was very small compared to the flood discharge downstream. Consequently, the area above Olympus dam can be considered non-contributing.

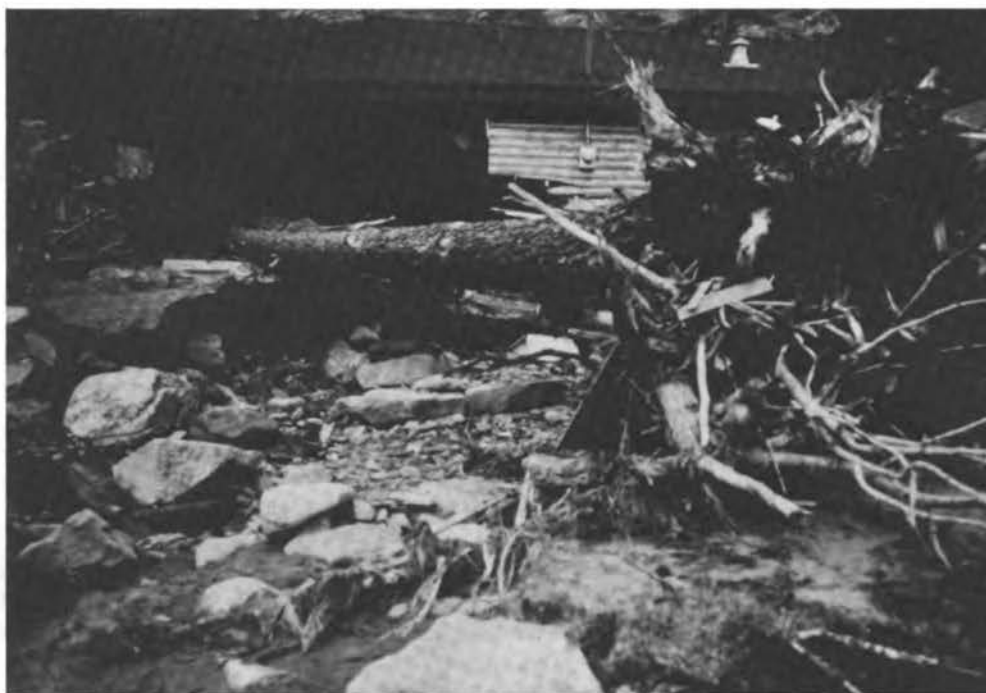
FIGURE 66 House Damaged by Tree Hurlled through Upstream Wall

During the night of the Big Thompson flood almost 500 structures were damaged to some extent: 242 structures were damaged less than 50%, and 252 were damaged more than 50% (U.S. Corps of Engineers, 1976). Damage was mainly concentrated along the valley floor, although some damage to structures along higher ground were reported due to landslides, rock-falls, and other mass wasting processes. Destruction came mostly from battering by debris and materials moved by the stream. Figure 66 shows a house where the stream hurled a tree through the upstream wall.

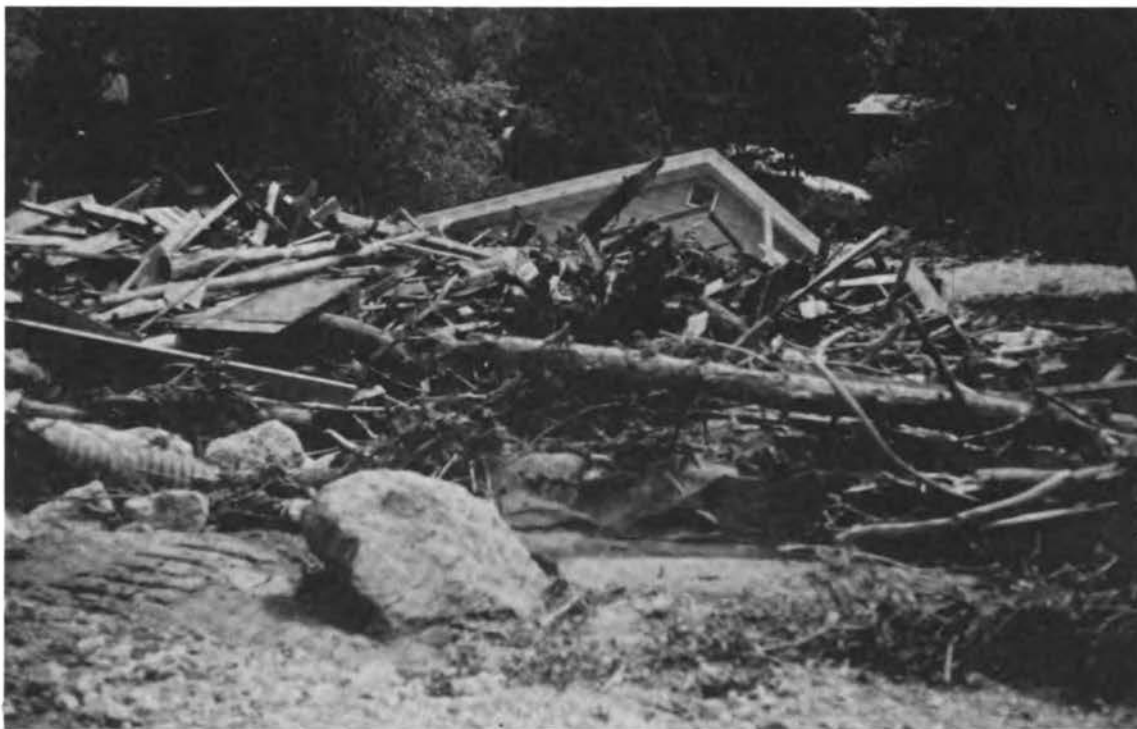
FIGURE 67 House near Drake Flattened by Boulders and Debris

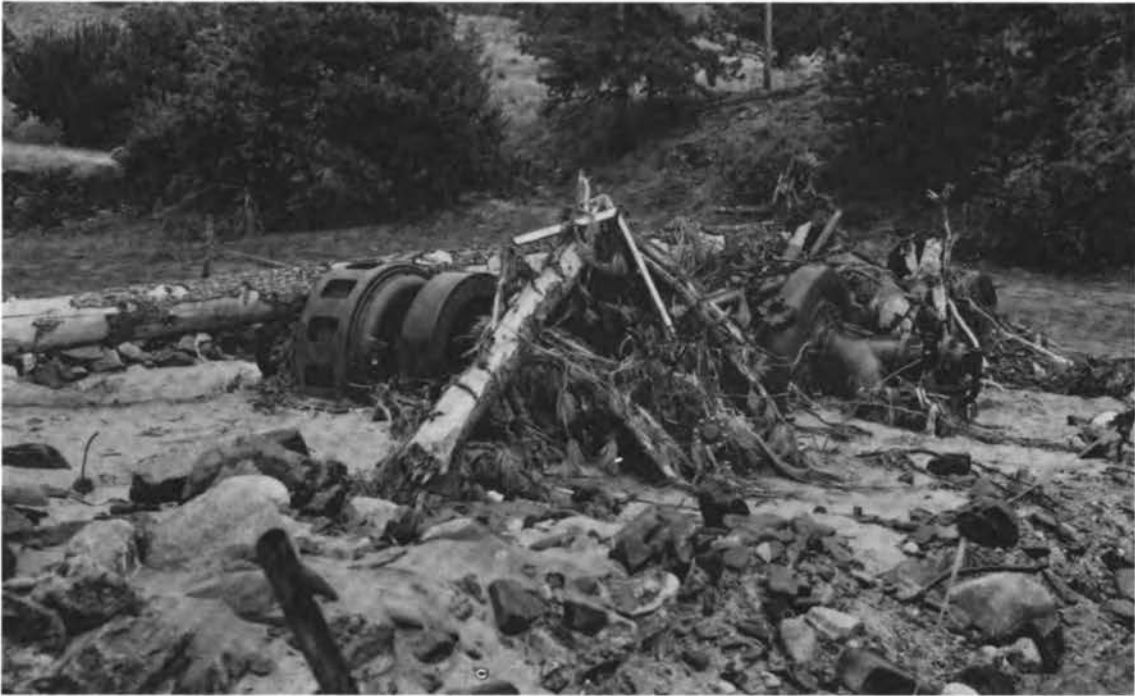
FIGURE 69 Remains of Loveland Power Plant at Loveland Mountain Park

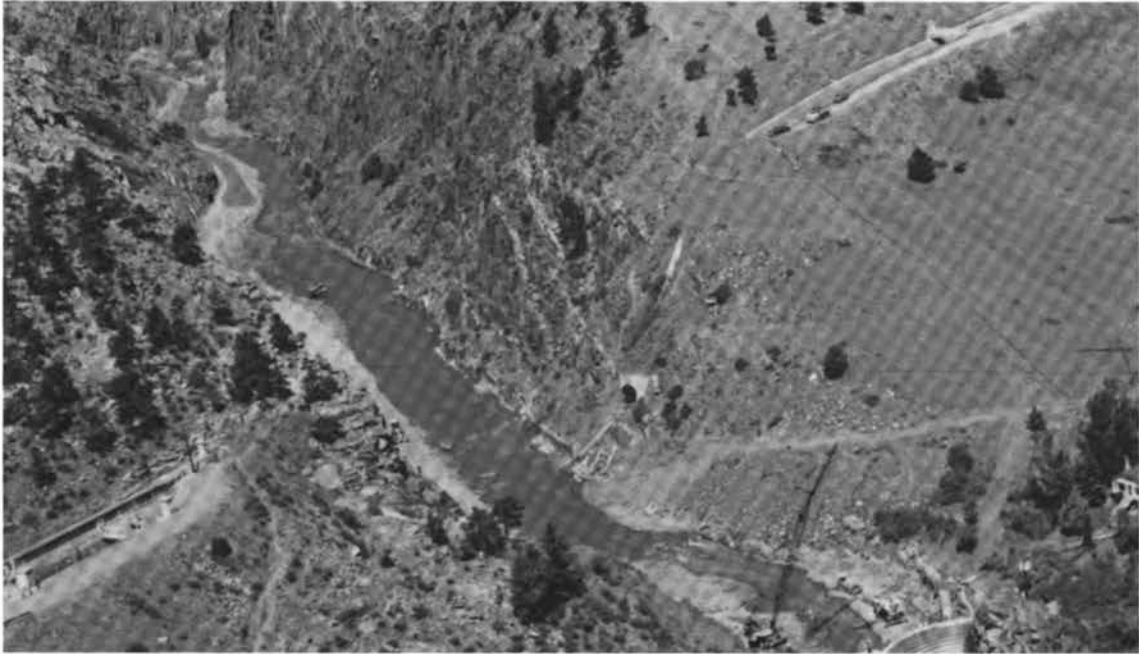
**FIGURE 70 Siphon Support Structure and Feeder Canal
Located at the Mouth of the Canyon**
