Hurricane Diana, North Carolina, September 10-14, 1984 (1986)

Hurricane Diana North Carolina September 10-14, 1984

Committee on Natural Disasters
Commission on Engineering and Technical Systems
National Research Council

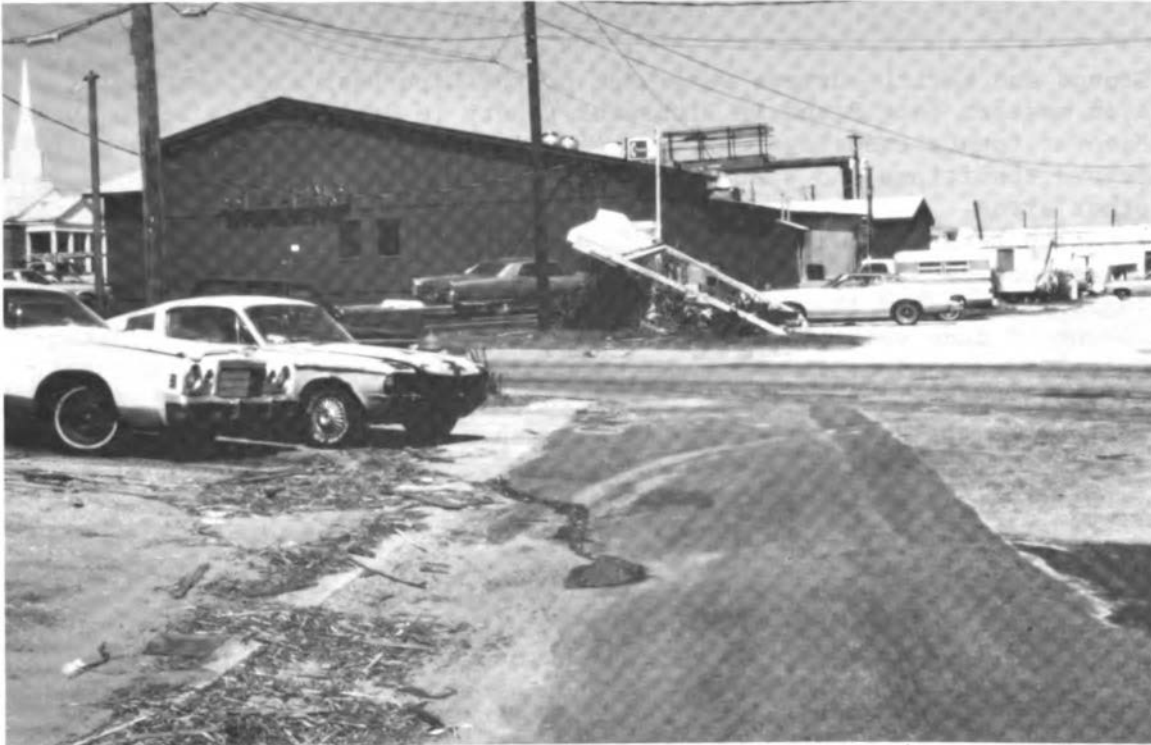
FIGURE 2.9 Storm surge drift line in Carolina Beach.

The maximum height and landward penetration of the surge waters were marked by drift line deposits. A drift line composed of eelgrass and other debris was found around the City Hall in Carolina Beach after floodwaters overtopped a municipal dock. This building housed the police department and served as a Red Cross relief center. Dauphine and Canal streets were flooded by several feet of water during the peak surge, and drift material was found along the entrance to a Hardee's

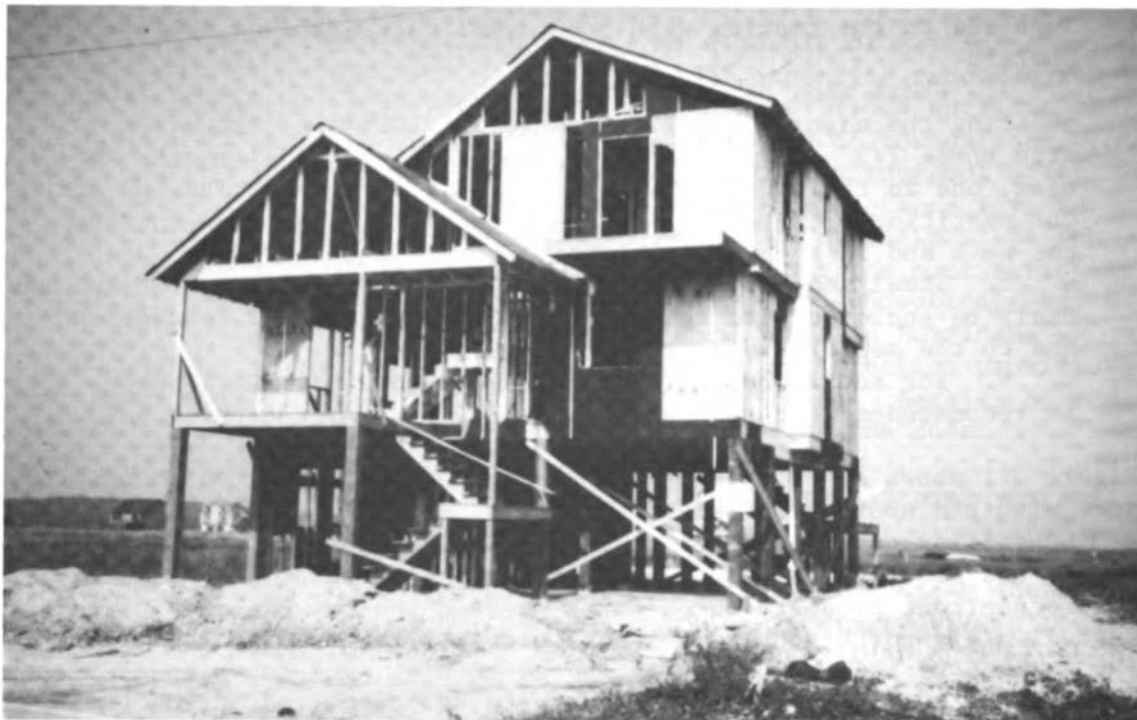
FIGURE 3.1 Typical coastal construction, North Carolina.

Figure 3.1 shows an example of a building being constructed in accordance with the above requirements.

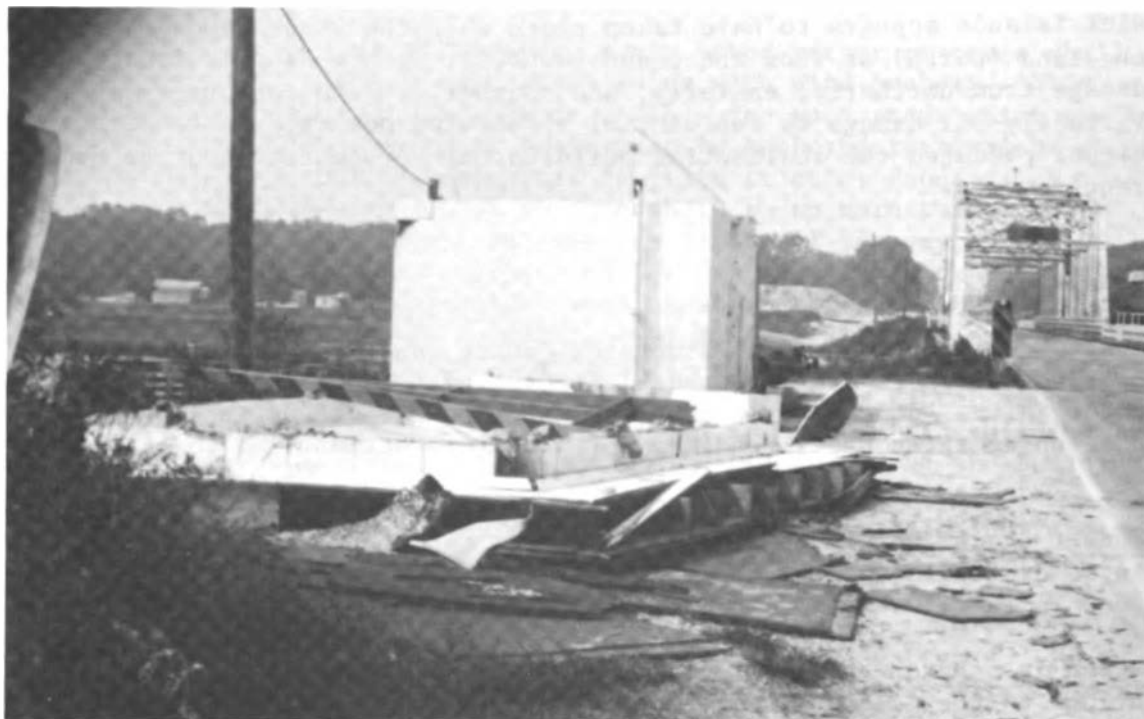
FIGURE 3.2 Roof failure of masonry building, Ocean Isle Beach.

Ocean Isle Beach A flat-roofed masonry building associated with the bridge to the island lost its complete roof and the top layer of masonry blocks. The walls were unreinforced, and the roof was connected in the usual way with grouted anchors (Figure 3.2). Several inadequately tied porches had been removed, sometimes with parts of adjacent roofs.

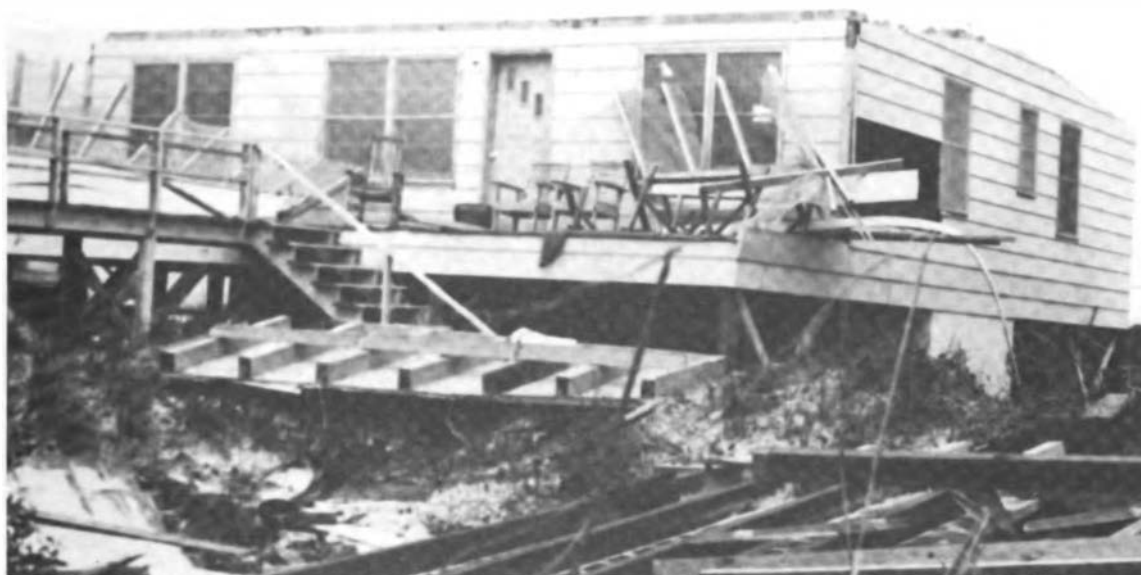
FIGURE 3.10 The "Blue Haven," Long Beach.

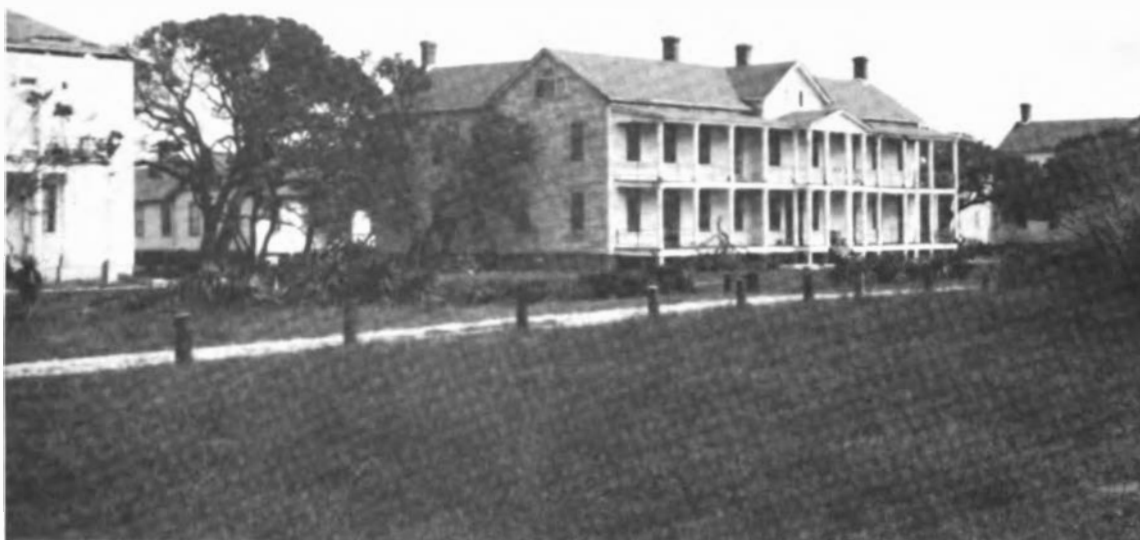
FIGURE 3.16 Undamaged military building, Fort Caswell.

At the extreme eastern end of Oak Island is Fort Caswell, now used as a Baptist assembly ground. Many of the buildings were clearly old. One unused building suffered porch and roof damage (Figure 3.15), but a similar adjacent building remained virtually untouched (Figure 3.16). One masonry wall had collapsed from a northerly wind, but an overflight of the area indicated virtually no damage to the rest of the buildings, including tall brick chimneys. This suggests that the military required an extremely high standard of construction when the fort was constructed.

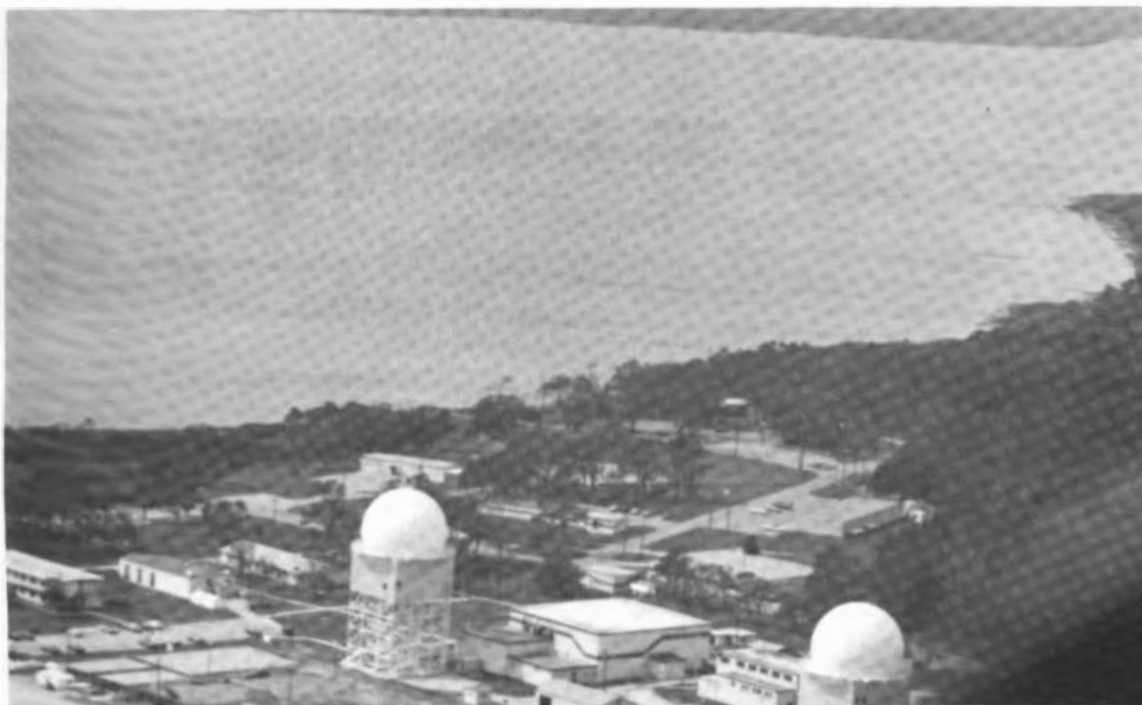
FIGURE 3.21 Undamaged radomes, Fort Fisher.

Fort Fisher The North Carolina Marine Resources Center, an engineered reinforced concrete building, suffered only minor flashing damage on the roof. An anemometer on the roof recorded a peak wind speed of 92 mph. A military base at Fort Fisher contains two large radomes (Figure 3.21). These and most of the base appeared to have been undamaged. Recent wood-framed condominium developments in the area were also undamaged.

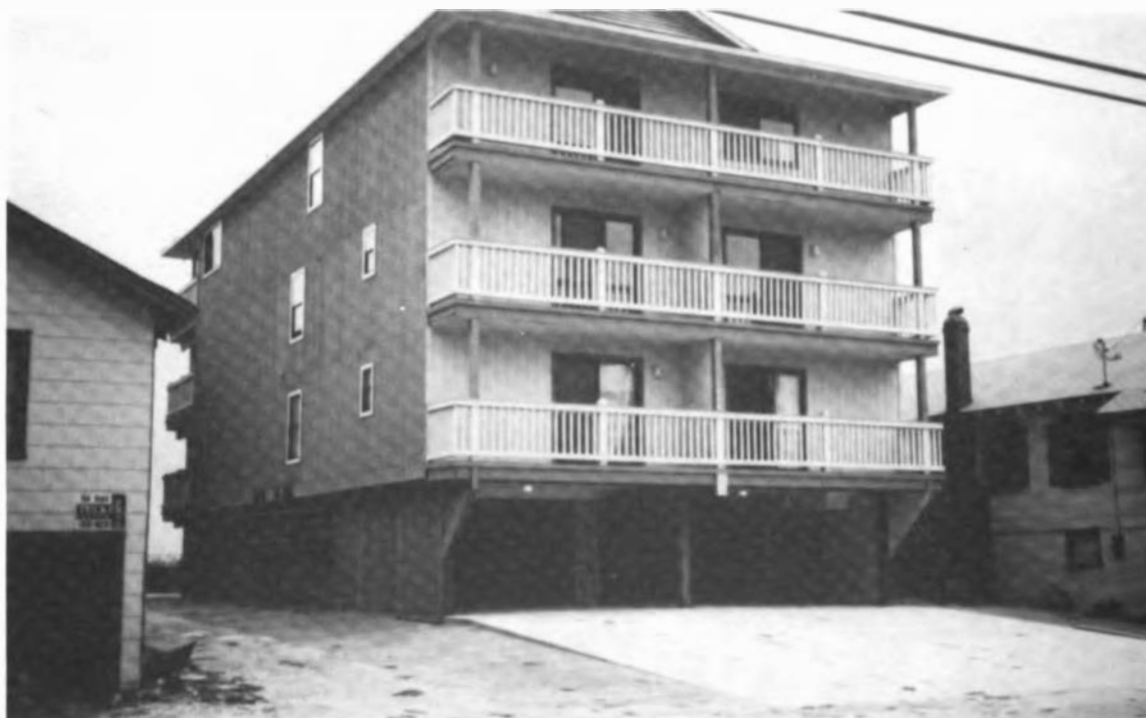
FIGURE 3.29 Undamaged condominium, Carolina Beach.

A subsequent structural analysis and wind tunnel test (Readling, 1986) showed that even without tie-down rods the roof of the structure was unlikely to have failed at wind speeds experienced in Diana. However, even if the internal walls had gypsum wallboard, shear failure of the type observed could have occurred. The survival of similar completed structures nearby (Figure 3.29) was probably the result of adequate shelter rather than an adequate structural system.

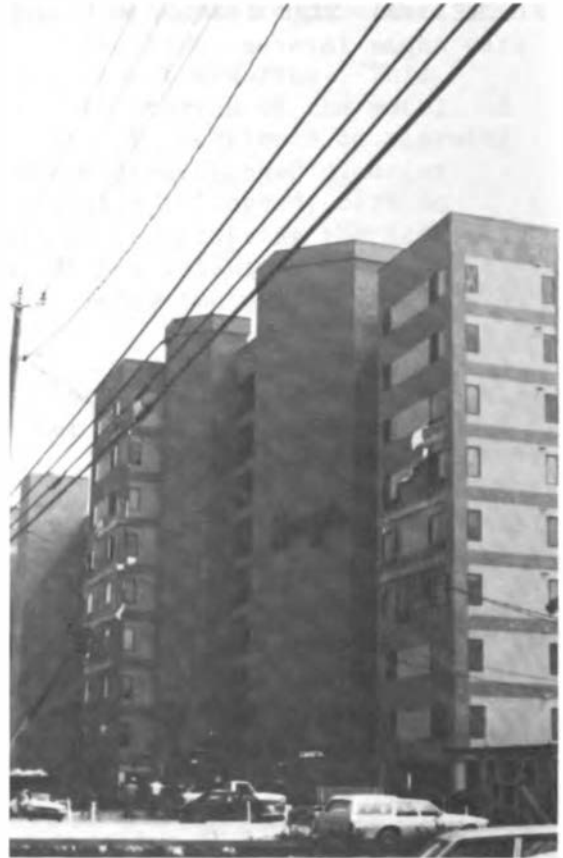
FIGURE 3.35 Cladding failure, North Myrtle Beach.

One major building in South Carolina was damaged by winds of about 50 to 60 mph. This eight-story building in North Myrtle Beach lost much of its exterior cladding. Close inspection of the cladding system showed that it was unsuitable for hurricane-prone locations.

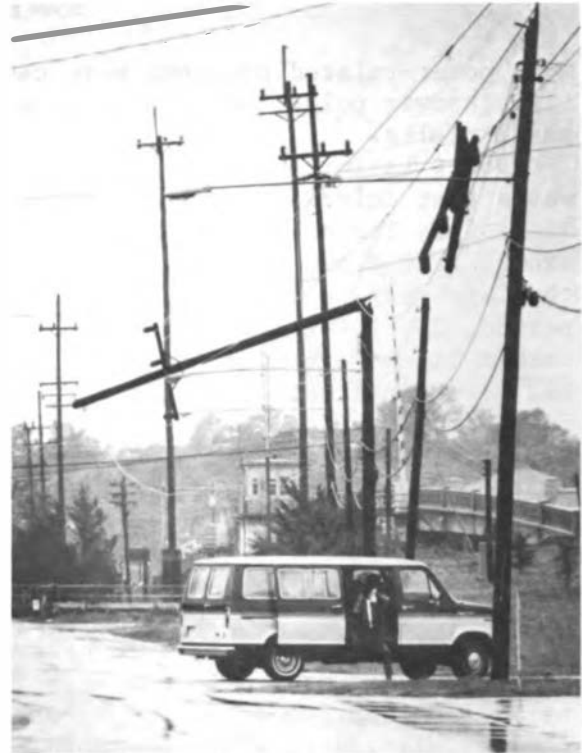
FIGURE 3.36 Downed telephone poles in Wrightsville Beach. The top of another pole hangs by a strand on the right. Photograph courtesy of Wilmington Morning Star, September 13, 1984; staff photograph by Gray Honeycutt.

Most problems with telephone service were caused by high wind, fallen trees, and downed poles and wires leading to houses (Figure 3.36). Total loss of service was confined to small areas in New Hanover and Brunswick counties. The fact that many Southern Bell lines were laid underground reduced the scale of damage. The most frequently cited problems were sluggish and sporadic service because of overloaded exchanges and circuits. No major problems were reported in Columbus and Bladen counties.

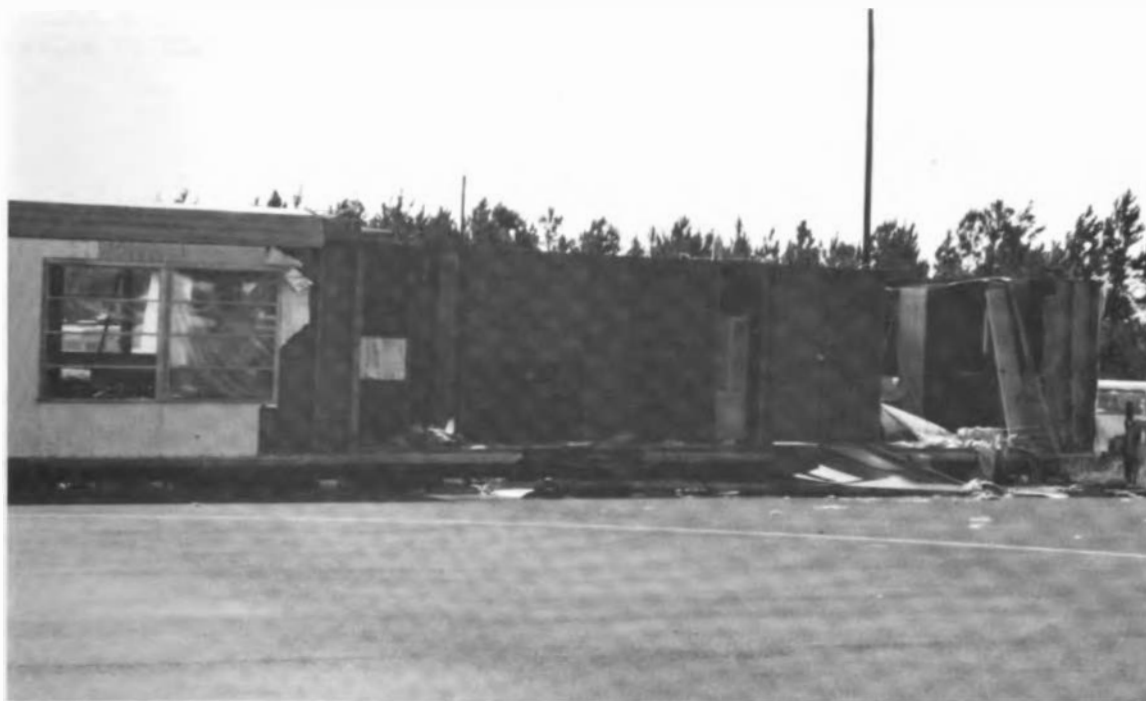
FIGURE 3.37 Brunswick County Airport Office.

No damage was reported at the New Hanover County (Wilmington) Airport, the region's major civil aviation facility. Brunswick County Airport, on the mainland near Yaupon Beach, suffered major damage. The airport office, housed in a mobile home that had been securely tied down, did not overturn but received serious wall and roof damage (Figures 3.37 and 3.38). The new terminal building remained on cinder blocks but lost one end to wind damage. A total of four small planes were damaged by wind and by the collapse of a hangar (Figure 3.39).

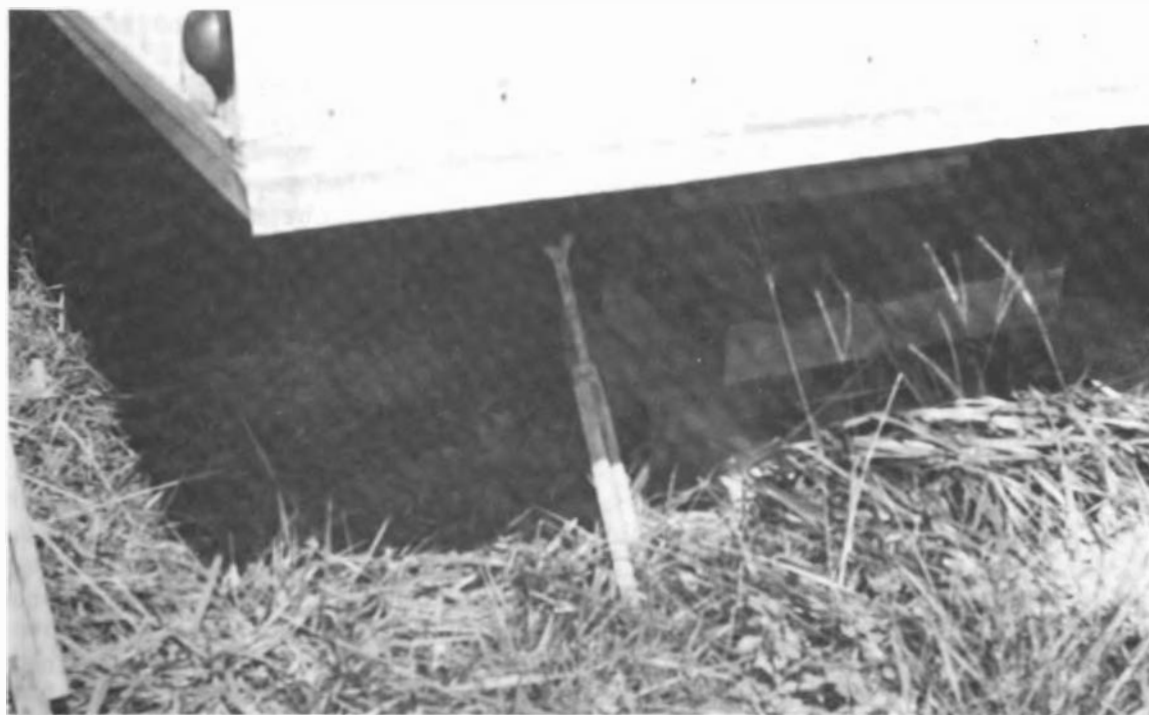
FIGURE 3.38 Typical tie-down at the Brunswick County Airport Office.

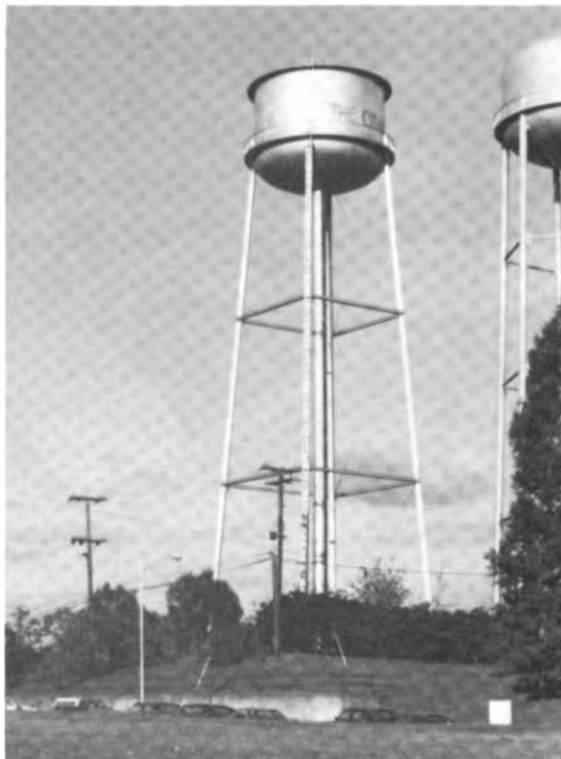
FIGURE 3.40 Water tower of similar design to the one that collapsed.

The most spectacular failure of an engineered lifeline structure was the collapse of a 120-ft-high water tower containing 100,000 gallons of water. This tower had been built in Carolina Beach during 1934 by the Chicago Bridge and Iron Company and had survived several hurricanes. Figure 3.40 shows a tower of similar design located in South Carolina. An eyewitness reported that the failure occurred at approximately

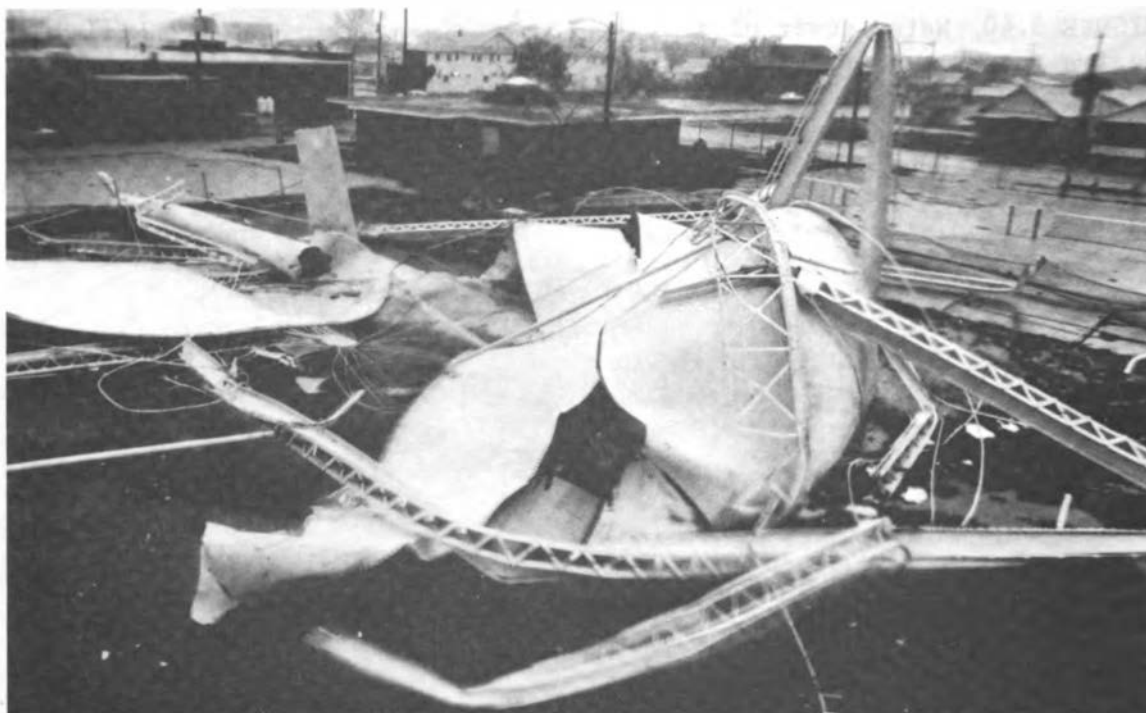
The collapse of an old elevated water tank constituted the most spectacular failure of an engineered structure. The failure was probably induced by vibrations and excessive cyclic stresses, possibly caused by a tornado or wind-induced vortices.

12:30-1:00 a.m. on Thursday, September 13, when the wind was from the north. The witness said that the tank appeared to rise slightly and then the tower collapsed more or less in place (Figure 3.41). As the tank hit the ground, it burst. The ensuing flood struck and burst open the back door of an adjacent library, demolished a pump house, and knocked a large hole in the wall of a control building.

Such a collapse would require the failure in tension of the holding bolt of a windward leg and the subsequent overloading and buckling of the remaining legs. Site investigation of the collapsed tower indicated that it may have been subjected to wind-induced vortices and vibration and that the anchor bolts appear to have failed in tension. Calculations based on the original drawings of the tower indicated that, if the tank was full, it would require a wind speed--at the level of the tank--of between 150 mph and 180 mph to initiate this type of failure. These speeds are inconsistent with the minor damage observed in adjacent structures. There are, therefore, three possible explanations for the failure. First, the tank may not have been full even though officials believed it to be so. However, it must have contained a considerable weight of water to cause the observed water damage in the vicinity. A second possibility is that the upper levels of the tower were in fact subjected to very high wind speeds, perhaps caused by a tornado that did not touch the ground. Third, the tower may have experienced some form of resonant response to the wind, amplifying the effect of wind forces and introducing the possibility of fatigue failure of the structural components.

FIGURE 3.41 The tangled remains of Carolina Beach's 50 year-old 100,000-gallon water tower, which fell Wednesday, September 12, 1984. Photograph courtesy of Wilmington Morning Star, Friday, September 14, 1984; staff photograph by Jack Upton.

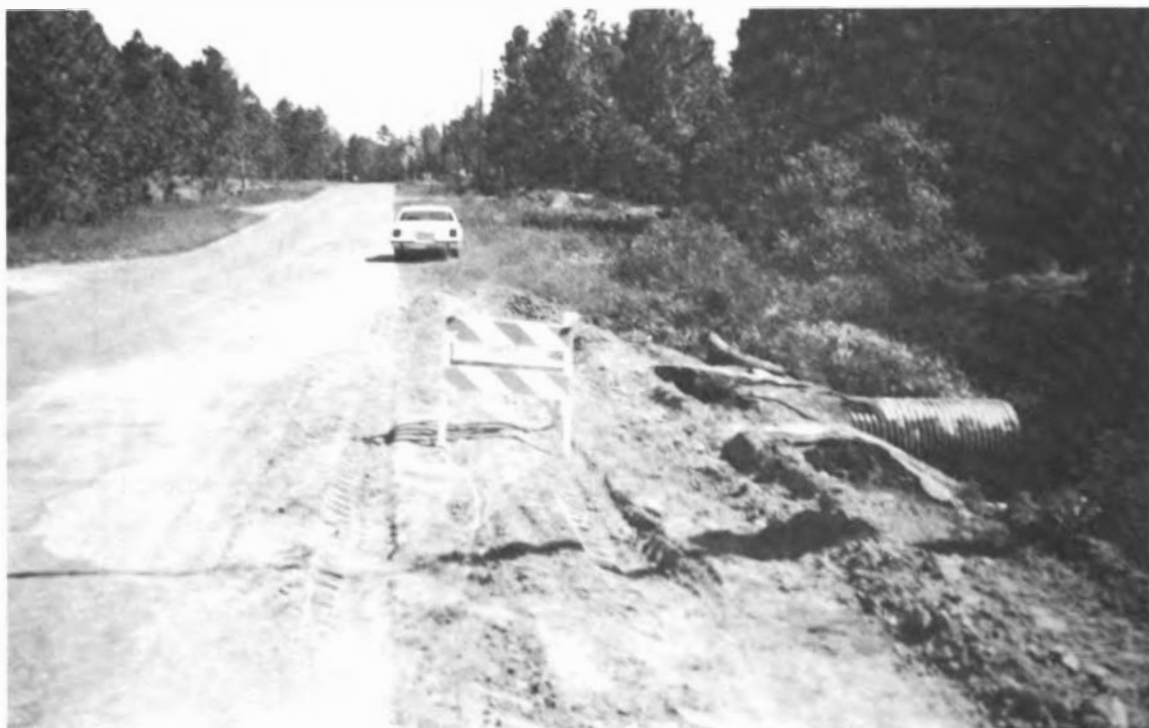
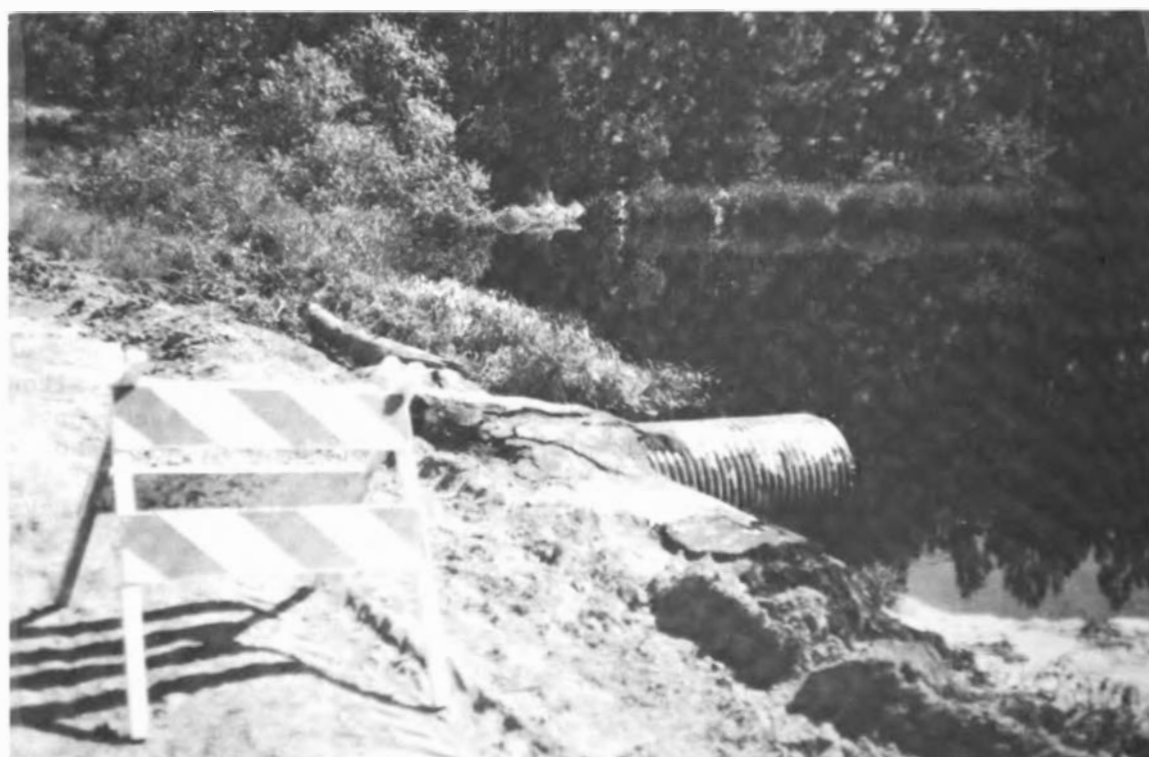
FIGURE 3.43 Drainage pipe of dam 3 on Boiling Spring Lakes clogged by fallen branches and debris.

The North Carolina Highway Patrol directed traffic through 3 ft of water on the adjacent two-lane road (N.C. 87). If the water had continued to rise in Big Lake, trouble would have developed at dam 5 (Alton Lennon Road), near the federal government's railroad line to the Sunny Point Army Terminal. North Lake, which flows into Big Lake, was also overflowing on Boiling Spring Road (3 in Figure 3.42). The Corps of Engineers sandbagged North Lake, slowing the flow of water into Big Lake and relieving pressure on the dam.

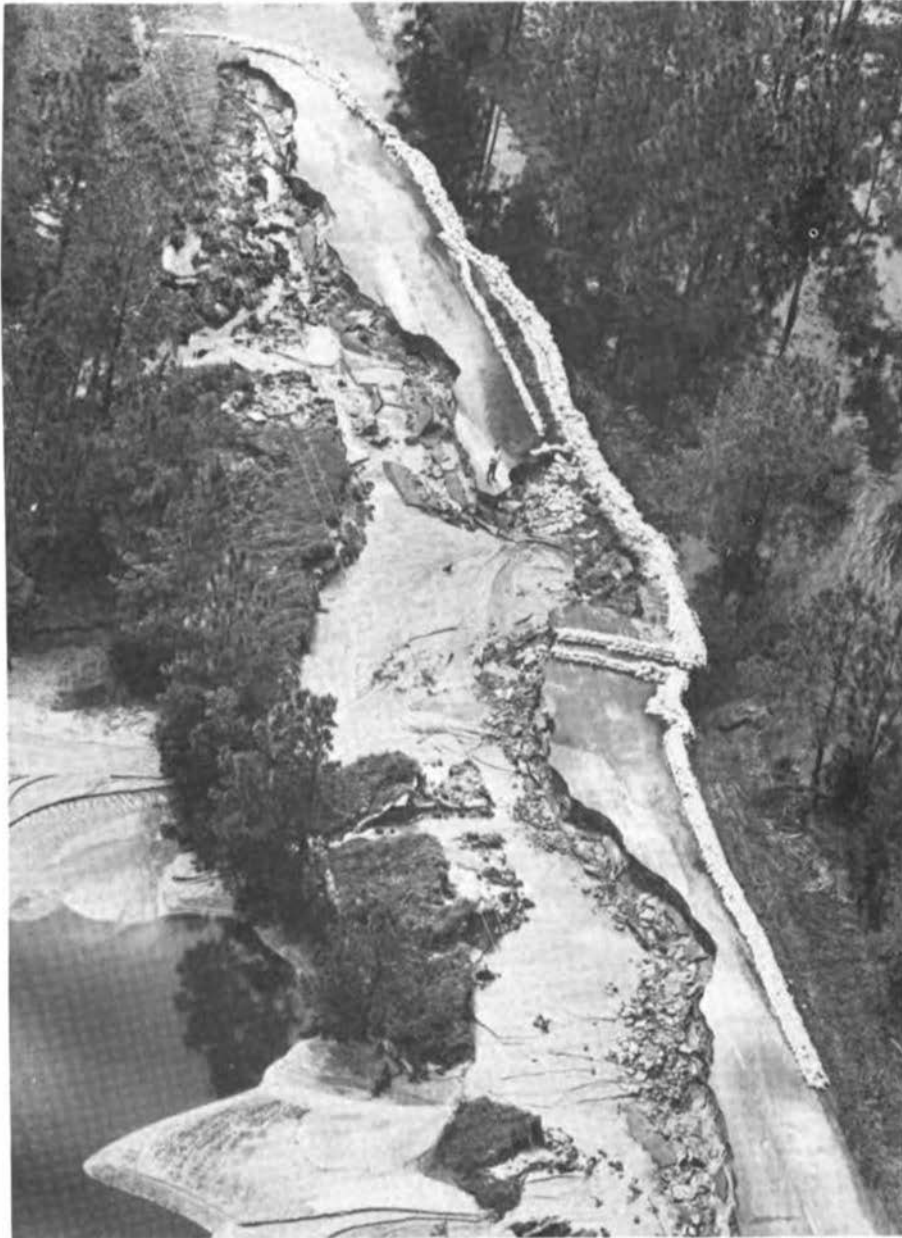
Five earth dams and road embankments are located on the Boiling Spring Lakes in Brunswick County (Figure 3.42). High water deposited by Hurricane Diana caused Big Lake to overflow onto N.C. 87, and the drainage pipes at three of the five dams (1, 2, and 3 in Figure 3.42) were clogged by fallen branches, leaves, and debris so that the embankments were subjected to critical flow conditions and overtopping (Figure 3.43). Figure 3.44 shows a typical failure induced by the overtopping, in which a section of road atop dam 1 was washed out due to the loss of shear strength from seepage into the dam materials. Figure 3.45 shows a schematic illustration of the failure. Sandbags placed by the U. S. Army Corps of Engineers on September 13 and 14 kept the dams from totally collapsing (Figure 3.46).

FIGURE 3.46 Washed-out section of road atop a dam in Boiling Springs Lakes. Sandbags placed by the U.S. Army Corps of Engineers kept the dam and other dams from collapsing. Photograph courtesy of Wilmington Morning Star, Saturday, September 15, 1984; staff photograph by Dan Sears.
