The March 5, 1987, Ecuador Earthquakes: Mass Wasting and Socioeconomic Effects

Committee on Natural Disasters, National Research Council

The March 5, 1987, Ecuador Earthquakes Mass Wasting and Socioeconomic Effects

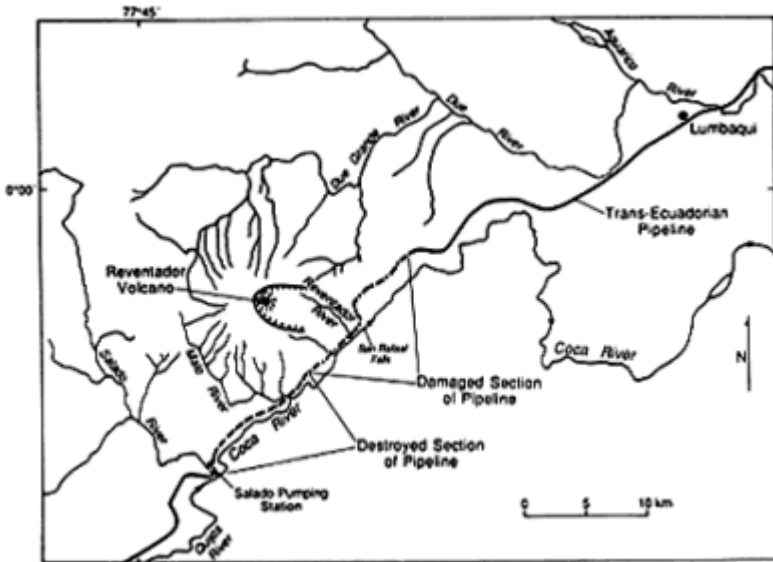
FIGURE 1.2
Area of study of mass wasting and flooding caused by the 1987 earthquakes, showing sections of damage to the Trans-Ecuadorian pipeline.

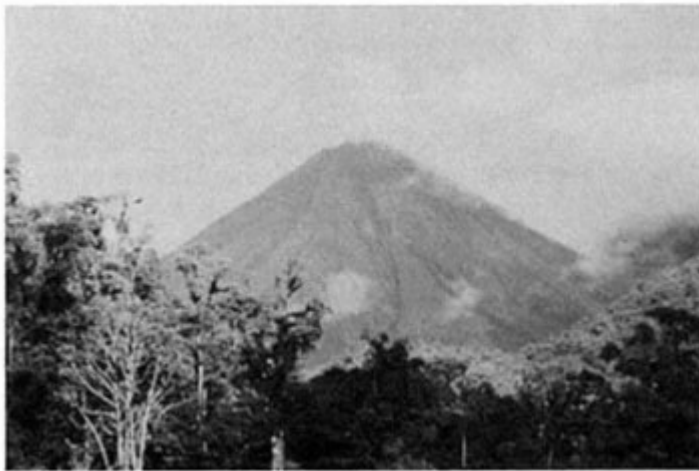
FIGURE 1.3
Reventador Volcano (elevation 3,562 m). (1978 photograph by S.D. Schwarz.)

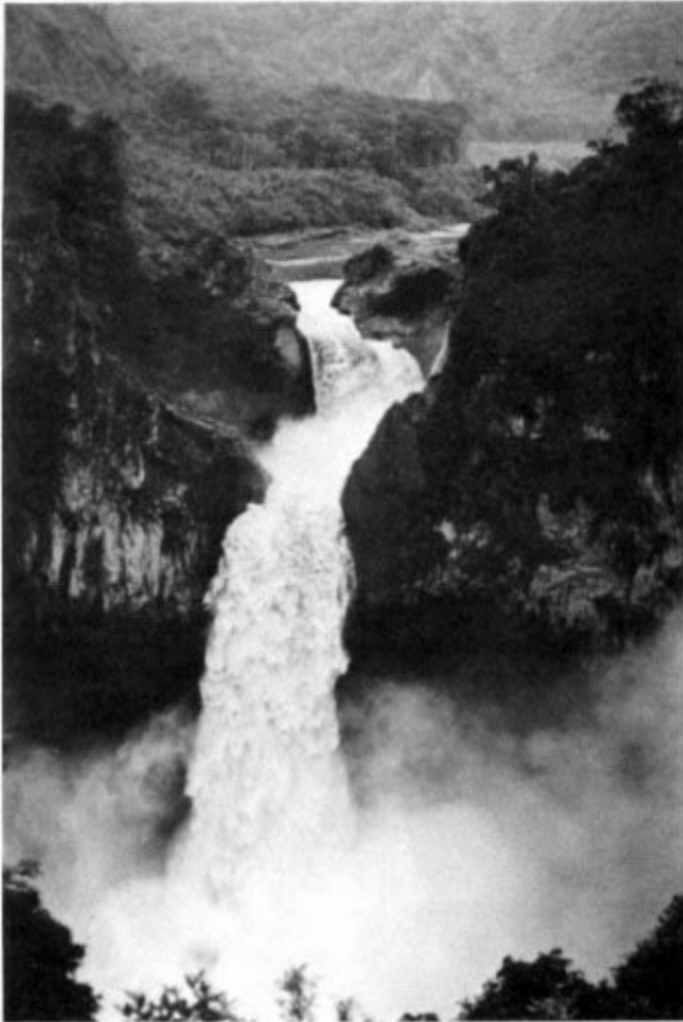
FIGURE 1.5
San Rafael Falls (height approximately 120 m) on the Coca River downstream from Reventador Volcano. The lip of the falls is formed by erosion-resistant lava flows. This falls is the approximate downstream limit of serious landslide/flood damage along the Coca River.

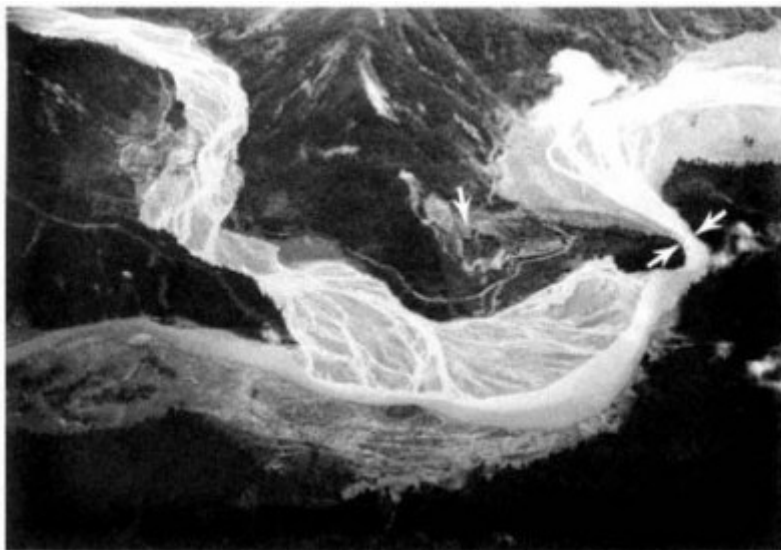
FIGURE 1.6

Aerial view of the confluence of the Quijos River (lower left) and the Salado River (upper left) to form the Coca River (flowing to the right). Postearthquake braided debris-flow and flood deposits are as much as 15 m thick in the valley bottoms. Bedrock constriction of the Coca River (indicated by two arrows near right edge of photo) probably caused short-lived damming of the river, which contributed to upstream flooding and rapid sedimentation. Note landslide (single arrow near center of photo) that badly damaged the Salado pumping station on the Trans-Ecuadorian oil pipeline.

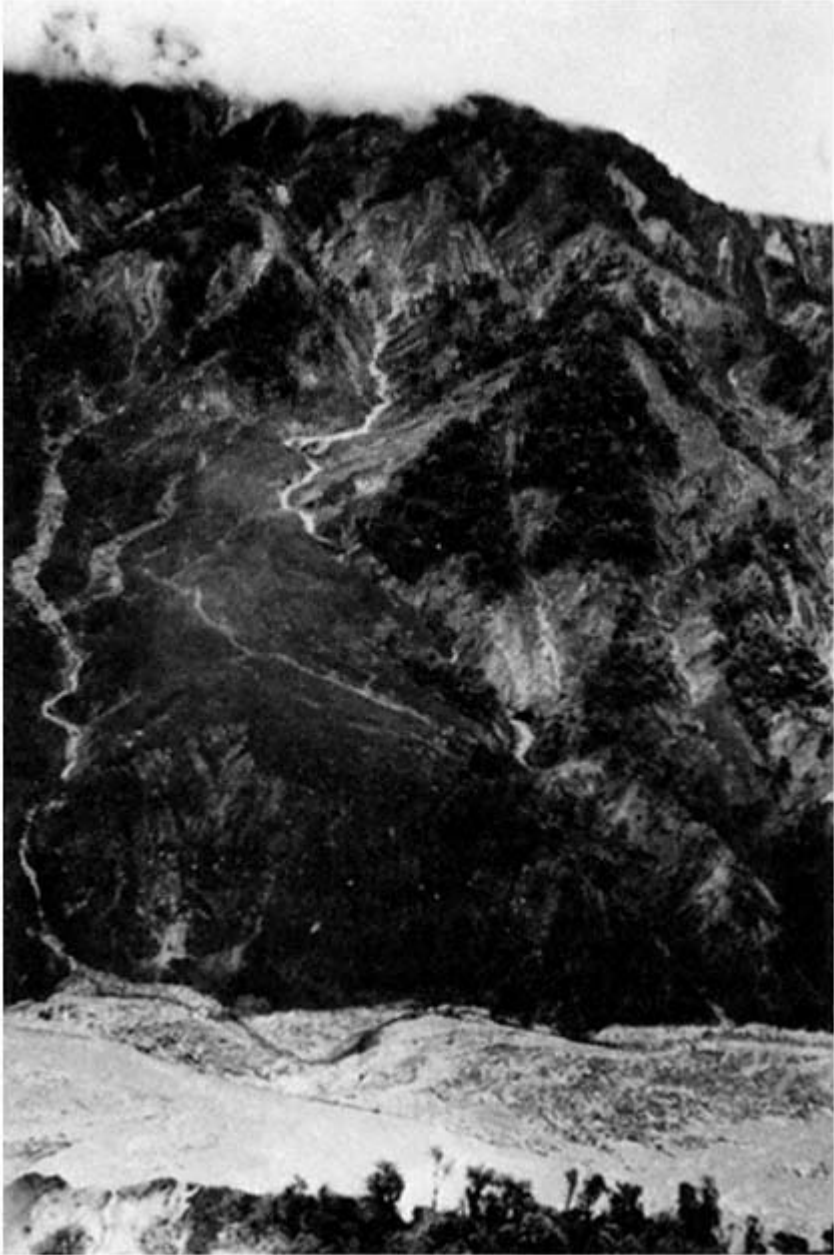
FIGURE 1.7
NE (left) valley wall of the Malo River, showing extreme denudation of slopes due to slips/avalanches /flows caused by the March 5, 1987, earthquakes.

The earthquake-induced slope failures were very fluid. About 600 mm of rain fell in the region in the month preceding the earthquakes; thus, the surface soils had a high moisture content. The slope failures commonly started as thin slips, which rapidly turned into very fluid debris avalanches and debris flows. The surficial materials and the thick jungle vegetation covering them flowed down the slopes into minor tributaries and then were carried into the major rivers (Salado, Quijos, Malo, Coca, Dué, Dué Grande, and Aguarico: Figure 1.2). Millions of tons of silty, gravelly sand, as well as tree remains and other organic matter, were deposited in the rivers (Figure 1.6). Many of the slopes were almost entirely denuded of their soil and jungle covers (Figure 1.7).

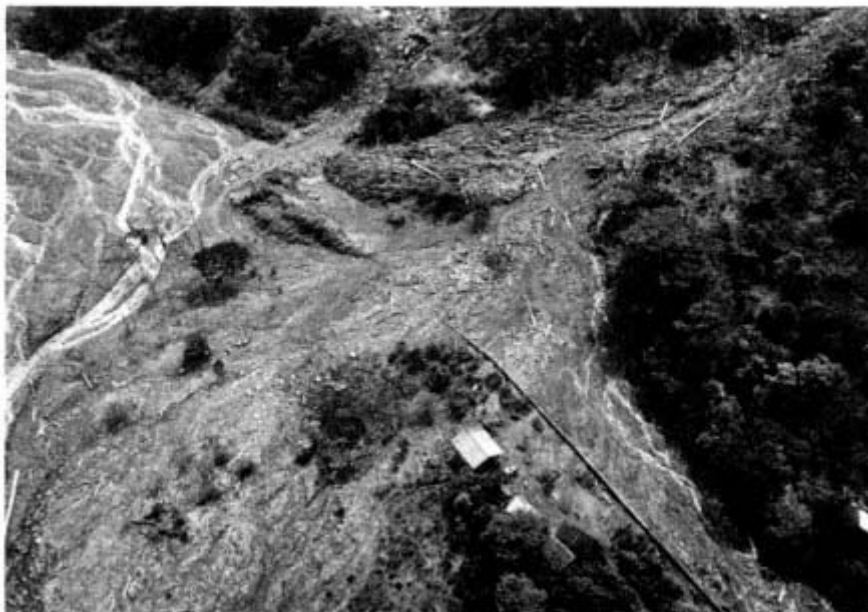
FIGURE 1.8

Aerial view of destruction of the Trans-Ecuadorian oil pipeline and adjacent highway by a debris flow issuing from a minor tributary of the Coca River. Location is near mouth of the Reventador River.

Given the size of the mass-wasting catastrophe in the Reventador area, damage caused by direct impact of deep-seated slides or slumps was secondary to that caused by thin slips, avalanches, flows, and floods. Although individual slides did some damage to the Trans-Ecuadorian pipeline (Figure 1.8), roads, and structures, the greatest destruction of property was caused by flood surges in the main rivers (Figure 1.9). Because of antecedent precipitation, the rivers were near flood stage before the earthquakes occurred, so that the large volumes of landslide debris that flowed into the

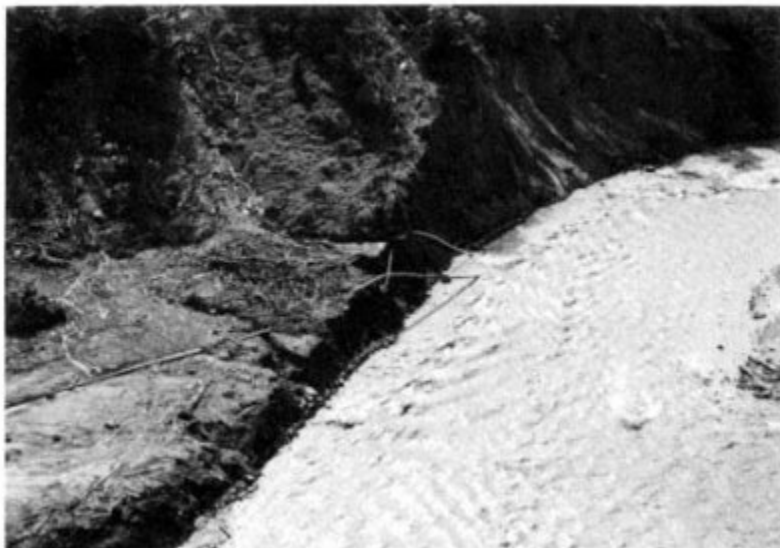
FIGURE 1.9

Destruction of Trans-Ecuadorian oil pipeline and highway by flood erosion on the left bank of the Coca River as a result of the March 5, 1987, earthquakes.

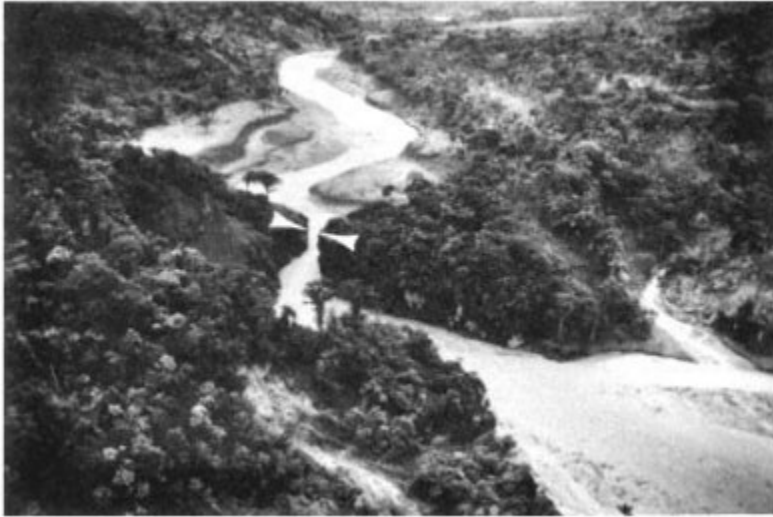
FIGURE 1.10

Upstream view of Salado River, showing location of bedrock constriction (white arrows) that caused short-lived damming of the river. Note trimline in jungle cover along lower valley wall upstream of the river constriction. This trimline indicates position of the shoreline that was formed by damming of the river to a level 10–15 m above current river level.

valleys further raised the river stages (Nieto and Schuster, 1988). It is likely that the highest flood surges were caused by breaching of short-lived dams on tributaries carrying large sediment loads, by large debris flows moving directly off valley walls, or by debris blockages at narrow constrictions of the river channels (Figure 1.10).

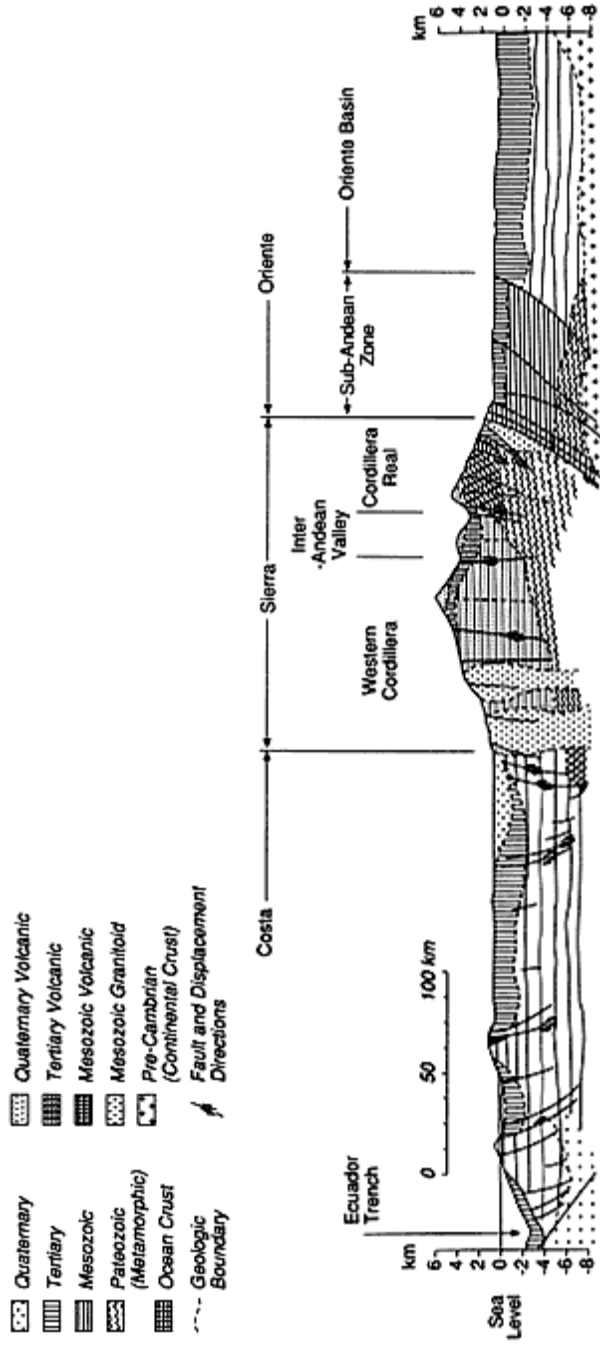
FIGURE 2.2
 E-W geologic cross section through Ecuador at approximately 1° 30' S latitude (after Baldock, 1982b; simplified by Hakuno et al., 1988).

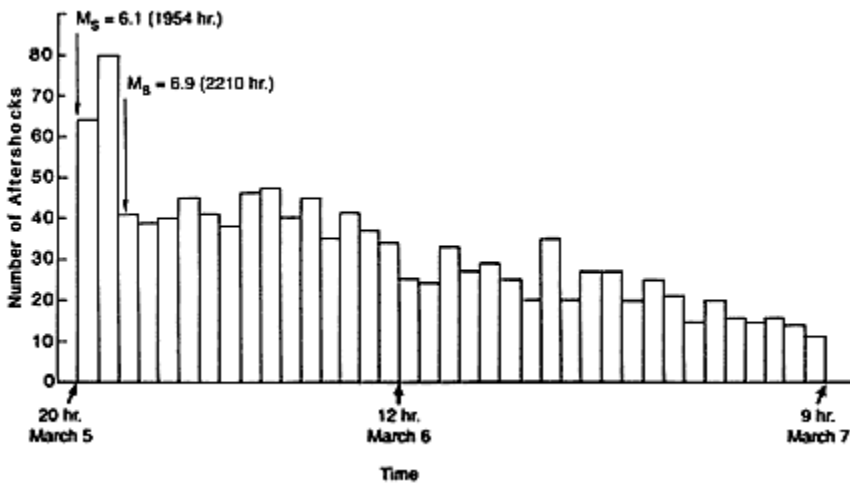
FIGURE 3.4

In Figure 3.4 are shown the number of aftershocks as a function of time following the 19:54 foreshock of the March 5 earthquake. As can be seen, the seismic activity decreased rapidly during the first 38 hr. The number of

aftershocks per hr, immediately after the foreshock, was about 64 events, which increased to nearly 80 events before the main earthquake, and then decreased to an average of 40 events per hr during the next 14 hr. The number of events diminished to an average of 30 per hr during the subsequent 13 hr, and further decreased to an average of 15 events per hr during the next 18 hr. The total number of aftershocks in this 38-hr time lapse was 1,240. Relocations were done for 36 aftershocks that occurred between 19:54 and 22:10 on March 5 and for which the *S*-arrival times could be clearly read. The first group of 19 aftershocks, which occurred between 20:11 and 20:56, fall very tightly on a line with a NW direction, N 49°W. This trend is parallel to the lineament of the Salado River, shown in Figure 3.1. These aftershocks occurred in the region that sustained the highest degree of damage to the environment and to man-made structures. However, the second group of 17 aftershocks, which occurred between 20:57 and 22:03, do not correlate with any of the known faults in the region; however, their epicentral locations are dispersed throughout the meizoseismal area and do not

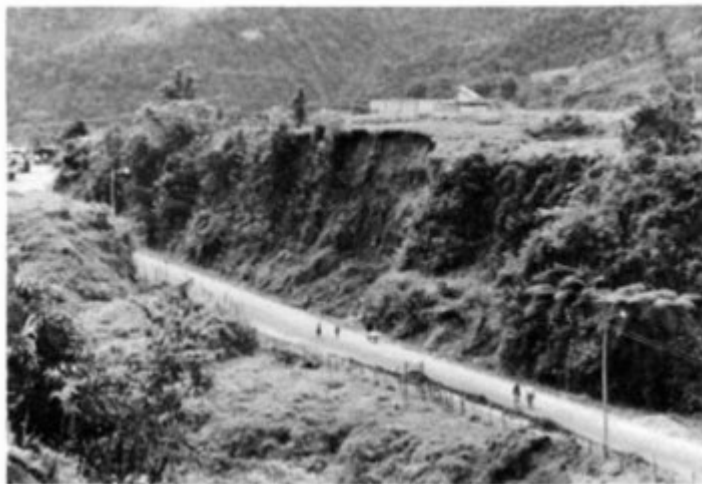
FIGURE 5.2

Thin earth slide (center of photo) on steep face of alluvial terrace on western edge of the town of Baeza.

This traverse extends from the town of Baeza down the Quijos River, where it joins the Salado River to form the Coca River (Figure 5.1). In general, the denudation around Baeza was only moderate. Some shallow debris flows in residual soils could be seen on the crests of slopes around the town. In addition, a small number of rock slides and rock glides, as well as a few slips and slumps in old and recent alluvial terraces (Figure 5.2), were observed. Landslide intensity increased progressively from El

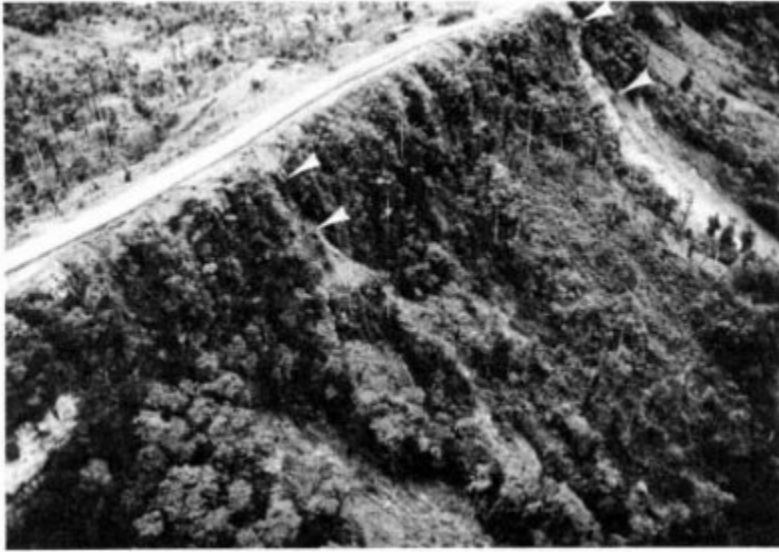
FIGURE 5.3

Landslides (largest examples are indicated by arrows) in residual soils at the top of the N valley wall of the Quijos River between El Chaco and the confluence of the Quijos and Salado Rivers. Because slide-resistant sedimentary bedrock (light-colored outcrop at the lower left) is close to the surface, these slides/avalanches are shallow and generally limited to existing gullies. Although the slides endangered the Trans-Ecuadorian pipeline and highway (angling across top of photo above the landslides), they caused little actual damage because they were so shallow.

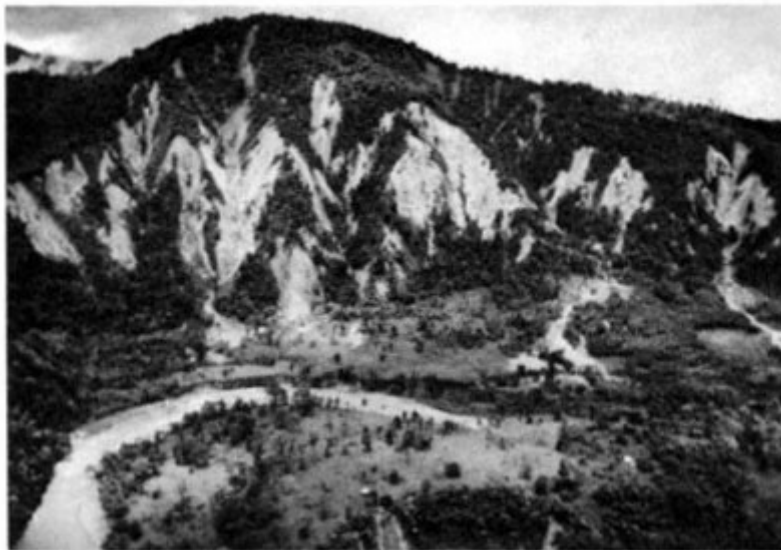
FIGURE 5.4

Landslide activity on the NW (left) valley wall of the Quijos River just upstream (SW) from its confluence with the Salado River. The earthquake-triggered slope failures began as thin slips on the steep (45 to 50°) headwalls of the slopes, and were transformed into debris avalanches and debris flows that cascaded down the gullies onto the low terrace that forms the left bank of the river.

From Baeza to about 20 km to the NE, the Quijos River follows the contact between Paleozoic and Mesozoic rocks (Baldock, 1982), probably coincident with a major thrust; the Trans-Ecuadorian highway and pipeline lie on the W (left) side of the Quijos valley (Figure 5.1). For the next 20 km to the confluence of the Quijos and Salado rivers, the highway and pipeline begin to climb over Cretaceous sedimentary and metasedimentary rocks. These lifelines follow high elevations and drainage divides, which, in turn, coincide with hogbacks formed by generally massive quartzose sandstones that occur within the Mesozoic sequence. Note that the residual soil veneer on the steep slope of the hogback is very thin or nonexistent, as is generally the case in this area. Consequently, the earthquake-induced landsliding was also very shallow. Slope failure began as slips at the highest points of the steep slopes; the slip surfaces coincide with the top of weathered rock and the slips moved rapidly downslope, becoming debris flows (Figure 5.3). This type of landsliding endangered the highway and pipeline, but the slips were generally very thin (less than 1 m) and seldom reached the channel of the Quijos (Figure 5.4).

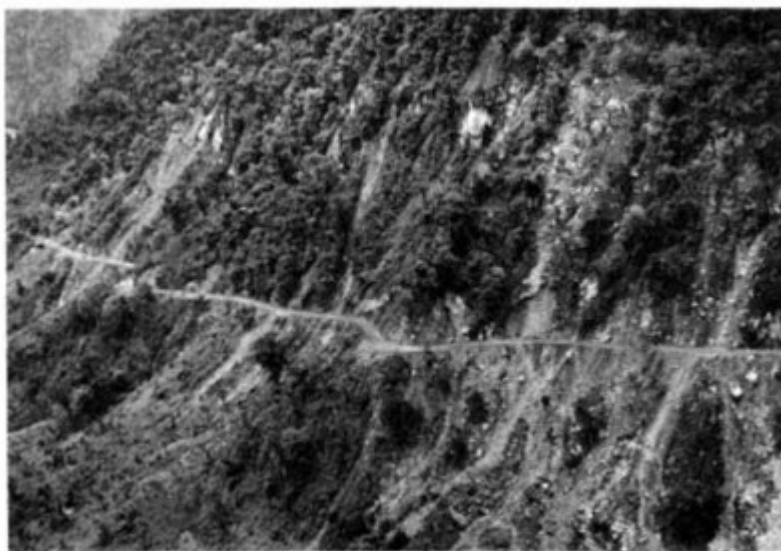
FIGURE 5.5

Landslides along the Trans-Ecuadorian highway 3 km W of its crossing of the Salado River. These rock falls, slides, and avalanches, which were triggered by the March 5, 1987, earthquakes, had blocked the highway almost continuously in the stretch shown in this photograph. The highway was passable at the time of this April 25, 1987, photograph because of the efforts of Corps of Engineers (Ecuadorian Army) highway maintenance crews.

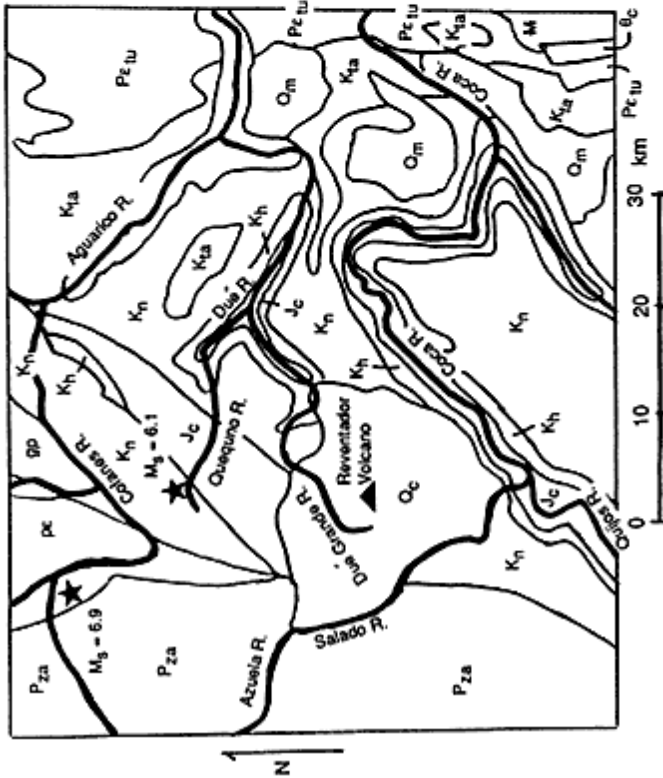
FIGURE 5.6
 Geologic map of the Reventador Volcano area (modified from Baldoock, 1982).

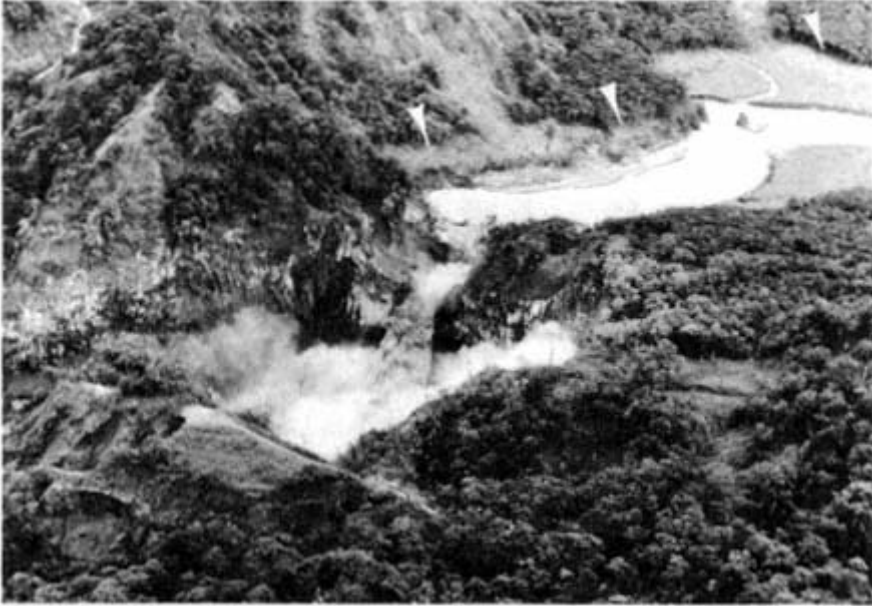
FIGURE 5.7

April 1987 aerial view of San Rafael Falls on the Coca River downstream from Reventador Volcano. Note the vegetation trim line (arrows), which indicates the maximum height of the debris flow/flood, about 20 m above the current level of the Coca River. There is a strong probability that constriction of the river at the falls caused short-lived "hydraulic" damming of the river.

INECEL gaging station just upstream from San Rafael Falls (Figures 5.1 and 5.7) on the Coca River registered flow rates of 2,600 and 3,400 m³/sec, respectively. These discharges have estimated return periods of 5 and 20 years, respectively. A few days before the earthquake, the flow rates diminished. Thus, the gaging station measured 450 m³/sec at 1700 on March 5; the estimated discharge at 2300 was 600 m³/sec. These values, however, are more than twice the average flow of the Coca River.

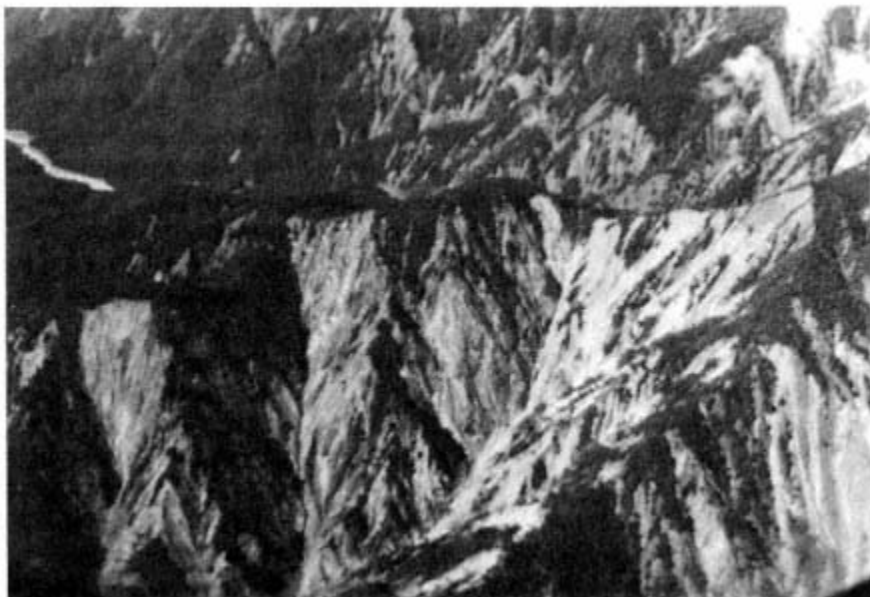
FIGURE 5.8

Ridge NW of Reventador Volcano from which jungle vegetation has been stripped by landslides triggered by the earthquakes. The slope failures started as thin slips on the steep (about 50°) upper slopes. As they moved downward, the saturated, vegetation-charged masses were transformed into debris avalanches and then to debris flows (that discharged into the Dué Grande River (out of the photo at the bottom). (Photograph by Ken Nyman, Cornell University).

More than 90 percent of the observed landslides began as shallow slips or slides of residual soils and highly weathered rock on the uppermost parts of the slopes of the main valleys or on the slopes of the lower-order tributaries (Figure 5.8). Average thicknesses of these slips were from 1.5 to 2.0 m, with a thickness range of a few decimeters to 5 m. The failing masses

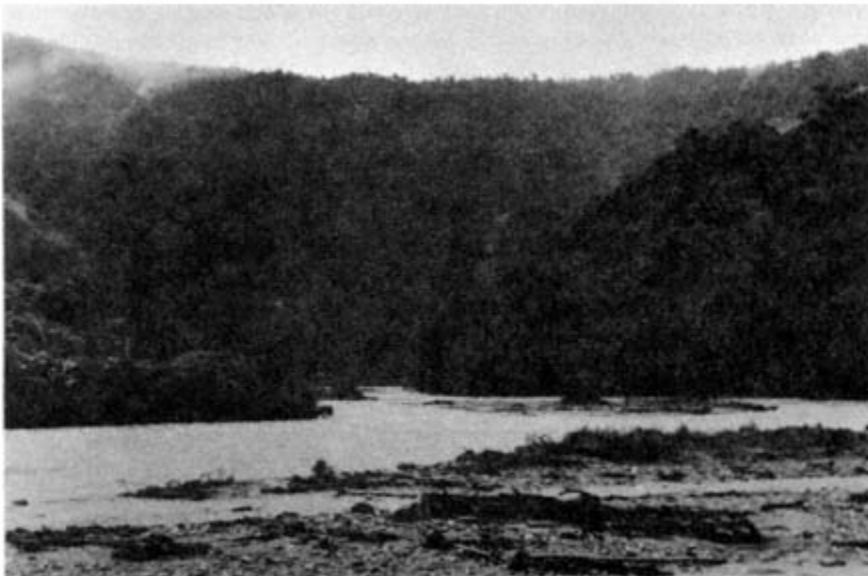
FIGURE 5.9A

1978 view showing the jungle-covered right (SE) valley wall of the Coca River at the confluence (photograph by S. D. Schwarz).

FIGURES 5.9A, B, C Views down the Salado River to the confluence of the Salado and Quijos Rivers to form the Coca River.

Coca River, between the Salado pumping station and the Malo River, failures occurred mainly on slopes steeper than 35 to 40°. The same threshold values were obtained for the valley walls of the Salado River and of the Coca River at the confluence of the Salado and Quijos rivers (Figures 5.9 A,B,C). However, on the upper slopes of the ancient cone of Reventador Volcano at elevations above 3,500 m, we observed failure on slopes between 30 and 35°, involving what appear to be very recent ashes. Other types of landslides (rock avalanches, rock slides along high road cuts, slumps and slides along alluvial terraces, and topples of stress-relief slabs) occurred throughout the entire area, but only sporadically.

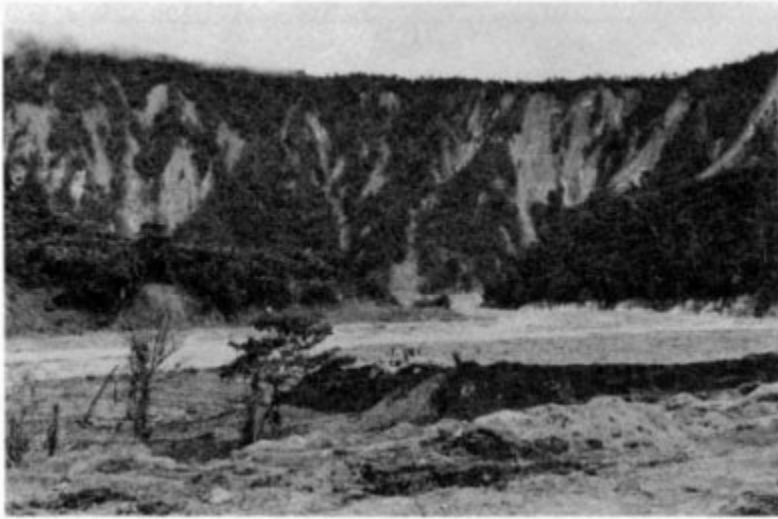
FIGURE 5.9B
April 1987 view of the same valley wall showing widespread denudation due to March 5 landsliding.

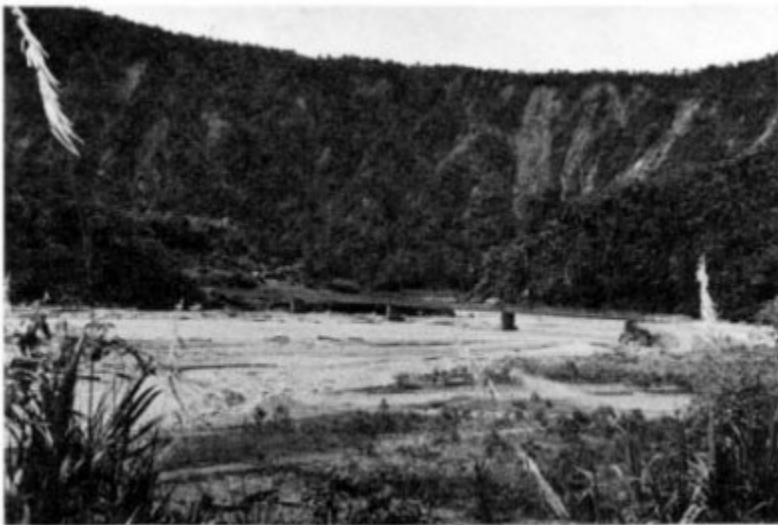
FIGURE 5.9C
June 1990 view of the same valley wall showing partial recovery of vegetation on 1987 landslide scars. Note reconstructed Trans-Ecuadorian highway bridge across the Salado River.

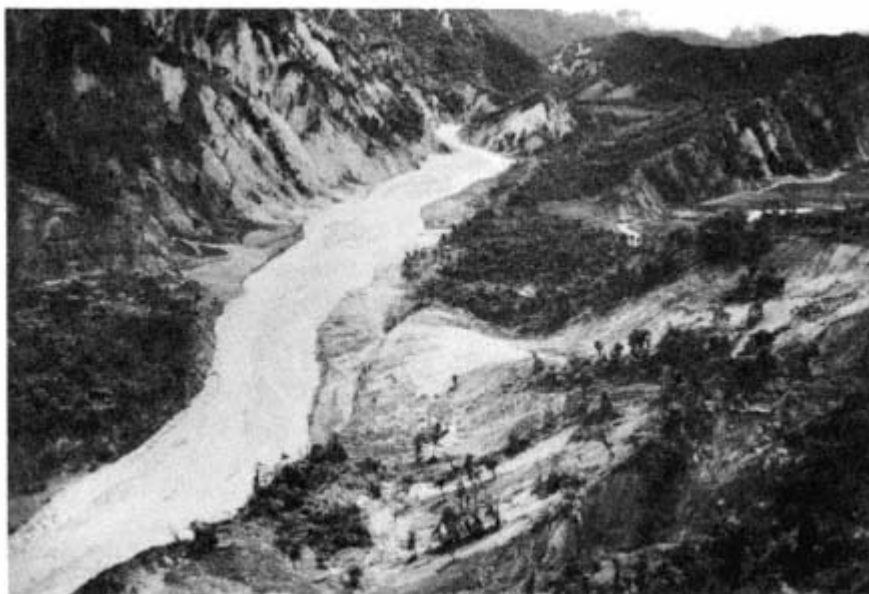
FIGURE 5.11

Upstream view of the Salado River showing remains (center foreground) of a debris flow that entered the river from the right (NE) valley wall. It is probable that this debris flow briefly dammed the river at this point.

Salado River—variable denudation intensity; range: less than 25 percent to 50 percent; most intense denudation appears to be in first- and second-order gullies of upper reaches of the Salado River, and in third-, fourth-, and lower-order tributaries of lower portions of the Salado River (Figure 5.11).

from Crystal Creek (Webb et al., 1988). In the Reventador area, the only case of such debris-flow damming that we identified was caused by a flow that issued from the Malo River into the Coca River during the night of March 5–6. Apparently, this debris-flow blockage was no more than a few meters high, and it probably was overtopped and breached within an hour or two after forming. However, this low, short-lived dam must have been the main cause of the large amounts of sediment (estimated thickness: 20 m) that were deposited in the channel of the Coca River immediately upstream from the mouth of the Malo River (Figure 5.21). Possibly, another such debris-flow blockage occurred where the Salado River enters the Quijos-Coca River, because a large amount of sediment was deposited at this point (Figures 5.16 and 5.17). The same process probably occurred on a smaller scale at other locations where steep gullies flow into the Salado (Figure 5.11), Malo, and Dué Grande rivers.

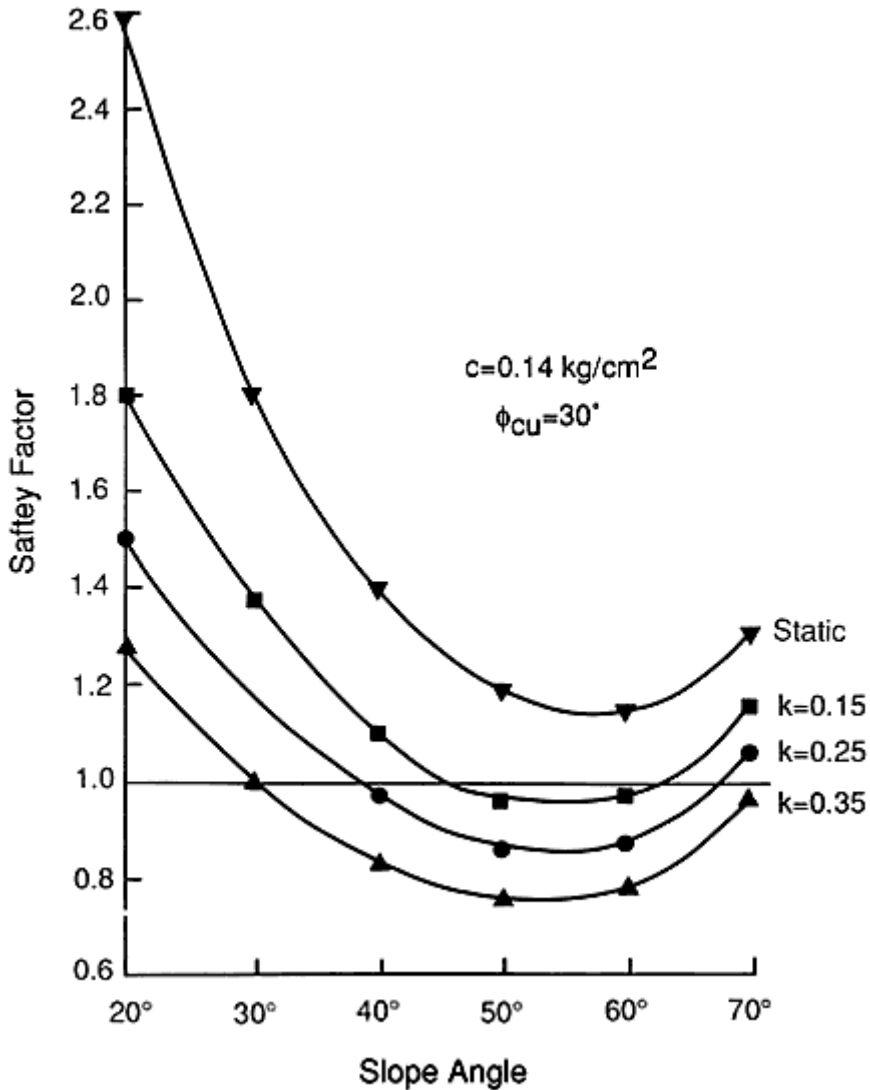
FIGURE 5.12
Pseudostatic and static safety factors vs. slope angle for $\phi_{cu} = 30^\circ$ and $c = 0.14$ kg/cm^2 .

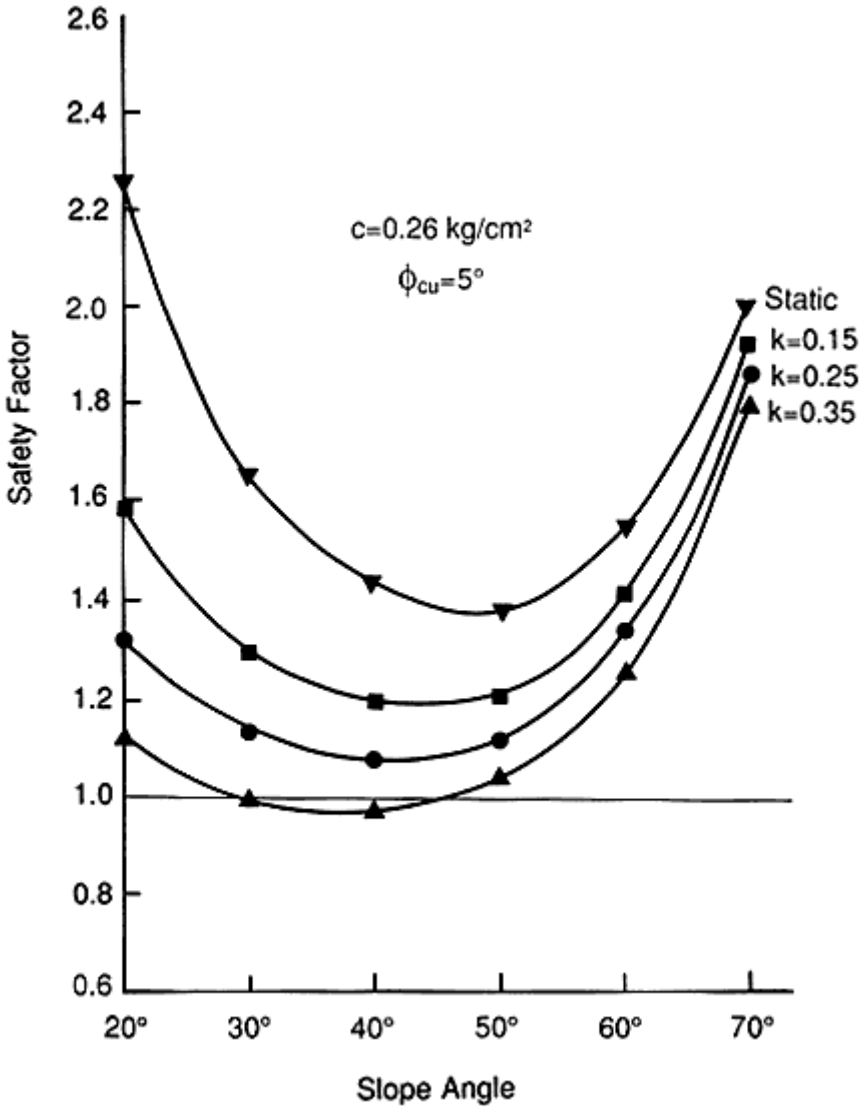
FIGURE 5.13
Pseudostatic and static safety factors vs. slope angle for $\Phi_{cu} = 5^\circ$ and $c = 0.26 \text{ kg/cm}^2$.

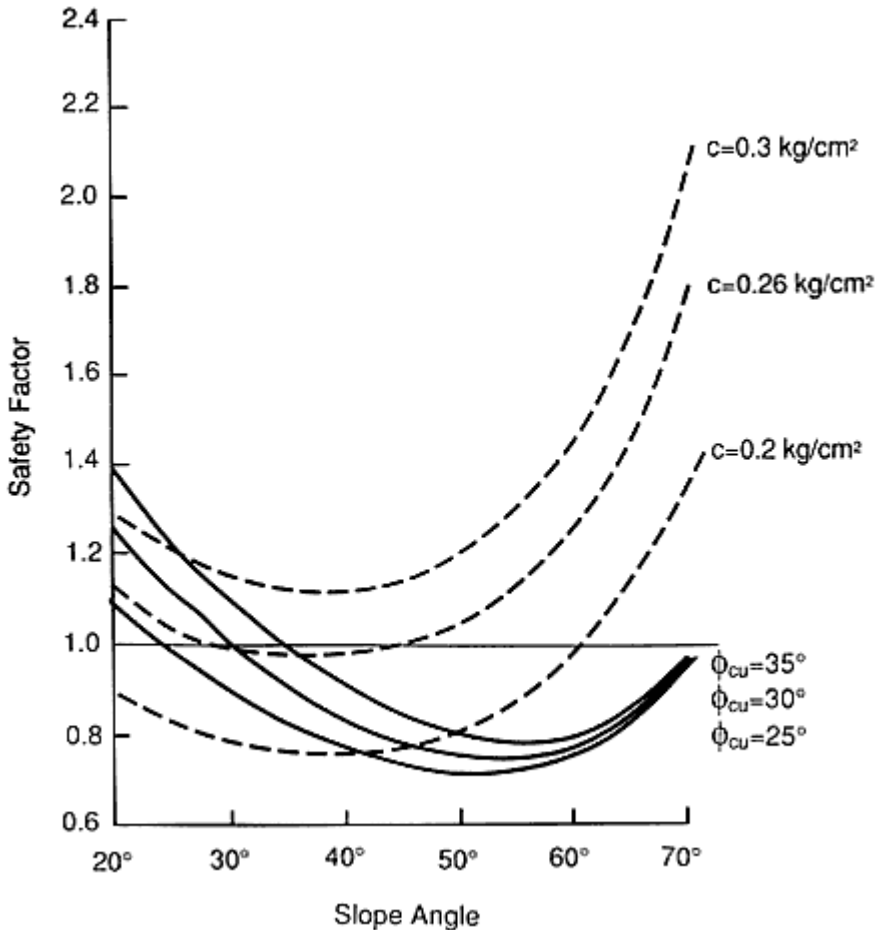
FIGURE 5.14
Comparative plot showing influence of variation in Φ_{cu} and c on the factor of safety for $k = 0.35$.

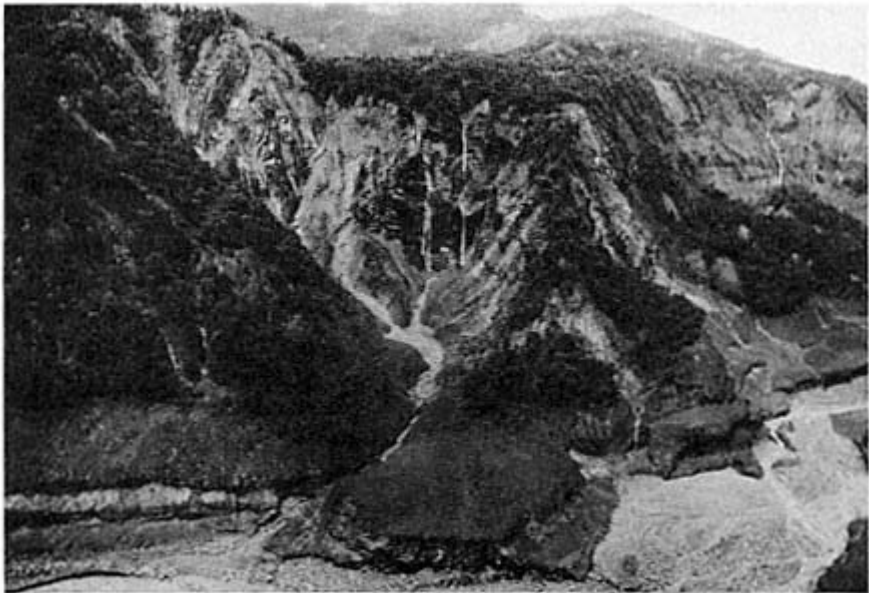
FIGURE 5.15

Aerial view of the NE valley wall of the Malo River showing extreme denudation of slopes due to slips/avalanches/flows and of the valley bottom due to debris flows and flooding. Note the vegetation trimline that indicates the maximum height of the debris flow/flood, about 25 m above the current river level.

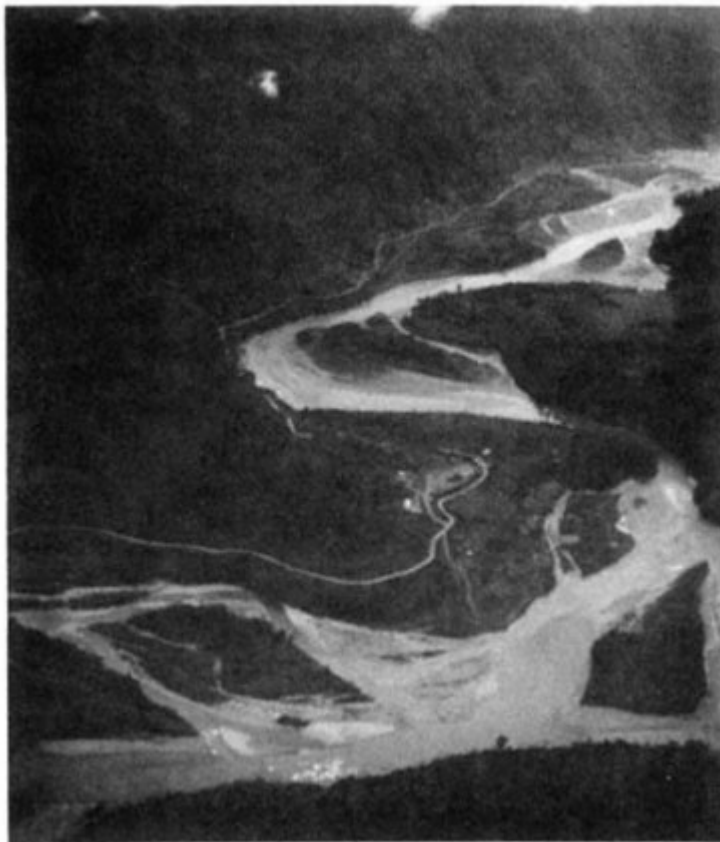
FIGURES 5.16A

Aerial oblique views looking downstream at the confluence of the Salado and Quijos rivers to form the Coca River. (A) 1978 view (photograph by William Savage, Pacific Gas and Electric). (B) April 1987 view illustrating that braided debris-flow and flood deposits (as much as 20 m thick) have covered much of the

FIGURE 5.16B
floodplain. Bedrock constriction of the Coca River (indicated by two arrows at the right) probably caused short-lived "hydraulic" damming of the river that contributed to upstream flooding and sedimentation. Note landslide (single arrow near center of photo) that badly damaged the Salado pumping plant of the Trans-Ecuadorian oil pipeline.

"hyperconcentrated flows" or "mud floods." However, based on (1) depths of sediment deposited in the rivers, (2) "trimlines" on the lower valley walls, which indicated the heights to which the rivers rose when charged with the debris flows, and (3) damage to the Trans-Ecuadorian pipeline and highway due to deposition and erosion, we know that considerable flooding occurred (Figures 5.16A,B, 5.17A,B, and 5.18). Figure 5.19 indicates

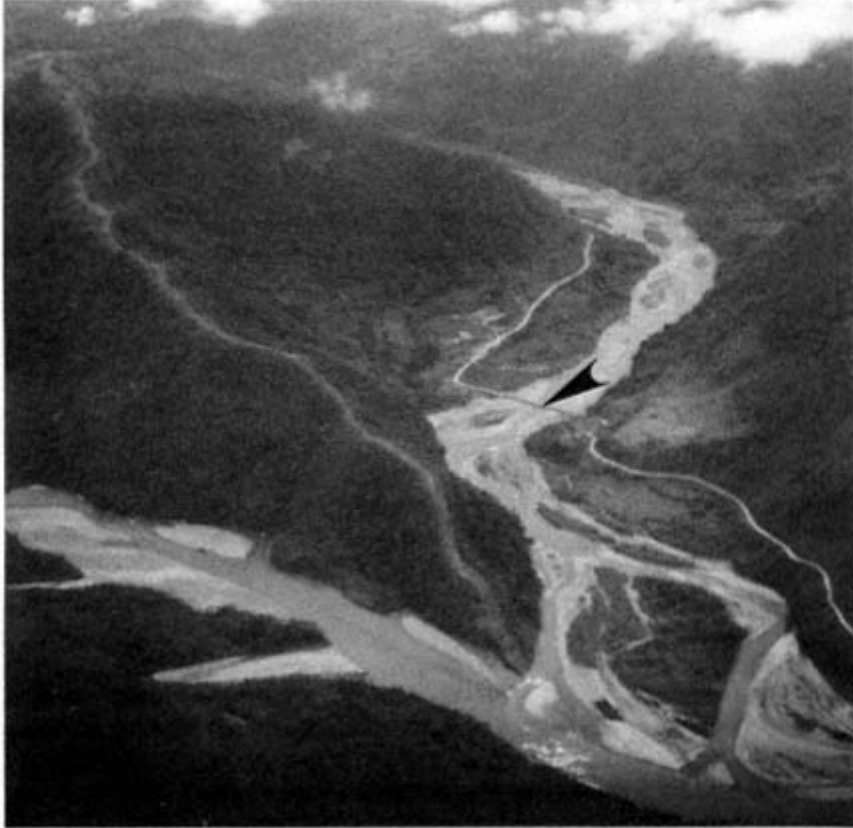
FIGURE 5.17A

Looking up the Salado River from the confluence of the Salado and Quijos rivers. (A) 1978 photo showing the Trans-Ecuadorian highway bridge (arrow) across the Salado River. Note the Trans-Ecuadorian pipeline where it snakes down the ridge at the left to its crossing at the mouth of the Salado River.

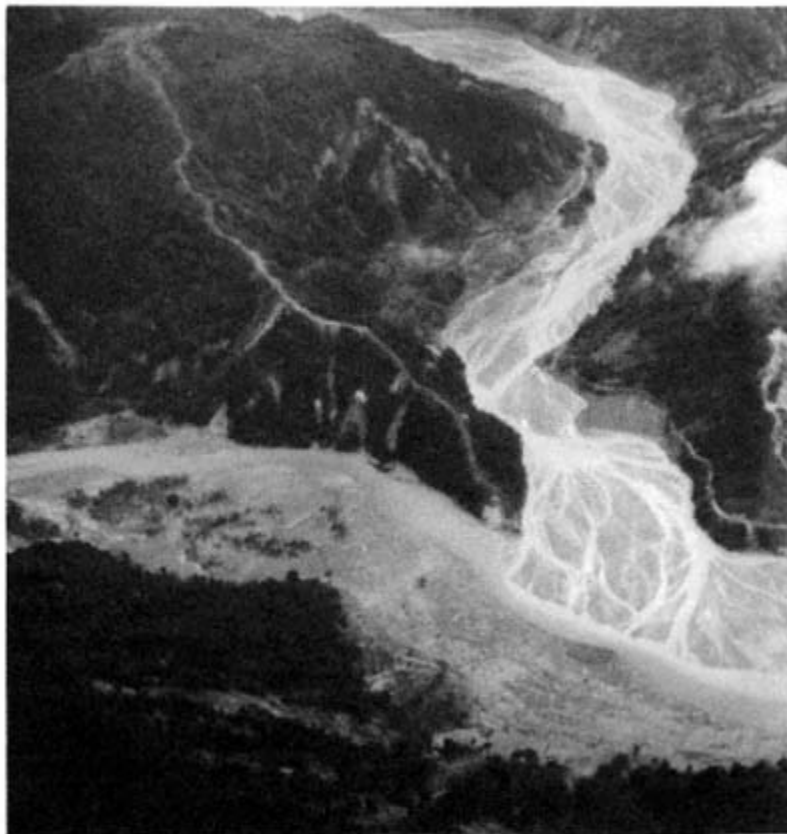
FIGURE 5.17B

(Photograph by William Savage, Pacific Gas and Electric.) (B) April 1987 photograph showing extreme sedimentation in the Quijos, Salado, and Coca river channels due to the March 5, 1987, debris flows and flooding. Note absence of the Salado River highway bridge, which had been washed out.

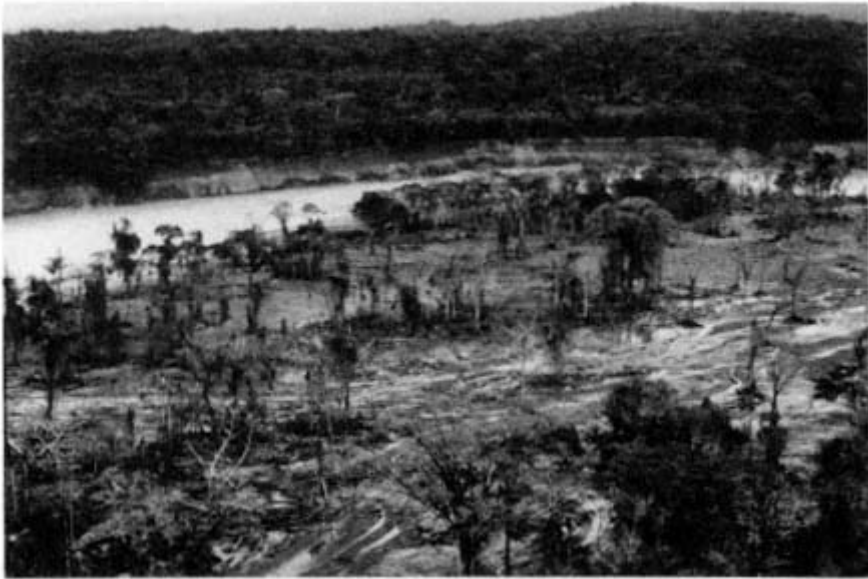
FIGURE 5.18

Evidence of March 5, 1987, flooding on the left (N) bank of the Aguarico River near the town of Lumbaqui. The flood has removed much of the vegetative cover from the low terrace in the foreground.

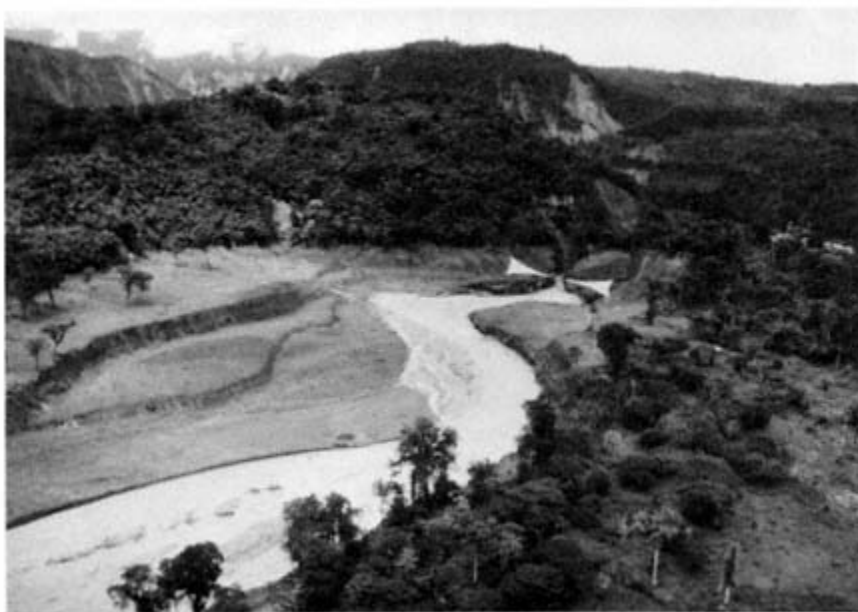
FIGURE 5.20

Downstream view of the Salado River showing location of bedrock constriction (arrows) that caused short-lived damming of the river. Note trimline in jungle cover along lower left valley wall upstream of the river constriction. This trimline indicates the maximum height (about 10 m above current river level) to which the debris flood rose.

We have noted evidence of "hydraulic" damming at four locations in the Coca River drainage (Figure 5.19): (1) of the Salado River 7 km upstream from its confluence with the Quijos/Coca River (Figure 5.20), (2) of the

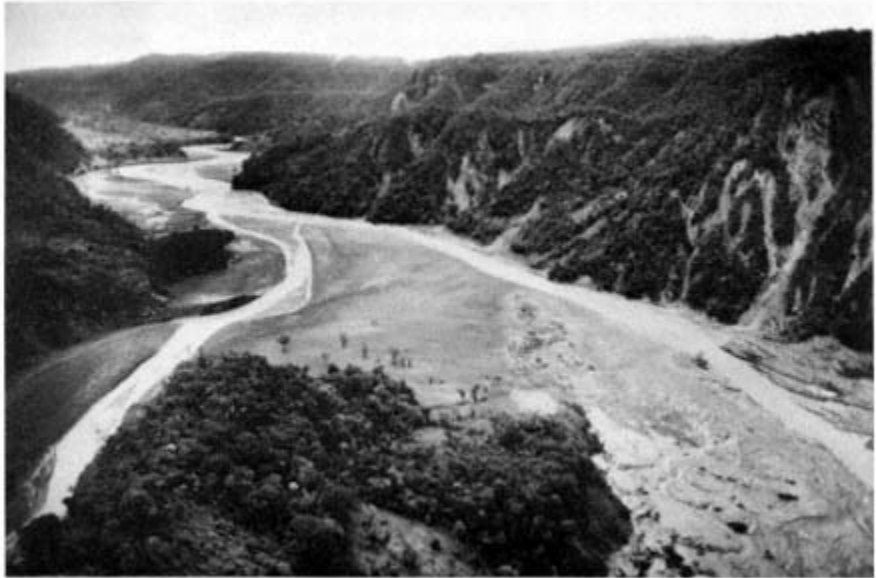
FIGURE 5.21

Looking downstream at the confluence of the Malo River (flowing from the lower left) with the Coca River. A debris flow issuing from the Malo River during the night of March 5, 1987, formed a short-lived dam of the Coca River, resulting in deposition of a large amount of sediment in the Coca channel in the right foreground.

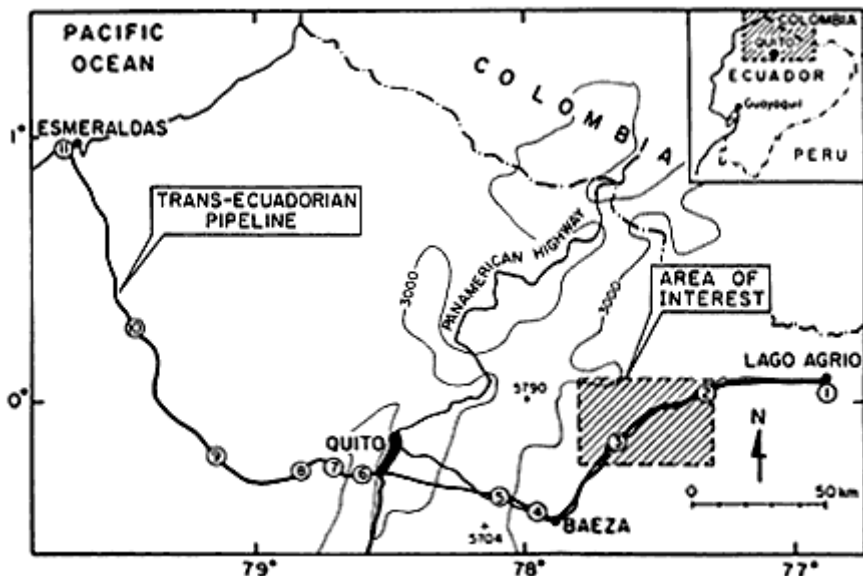
FIGURE 6.1
Route and station locations of the Trans-Ecuadorian pipeline.
