The March 5, 1987, Ecuador Earthquakes: Mass Wasting and Socioeconomic Effects

Committee on Natural Disasters, National Research Council

The March 5, 1987, Ecuador Earthquakes Mass Wasting and Socioeconomic Effects

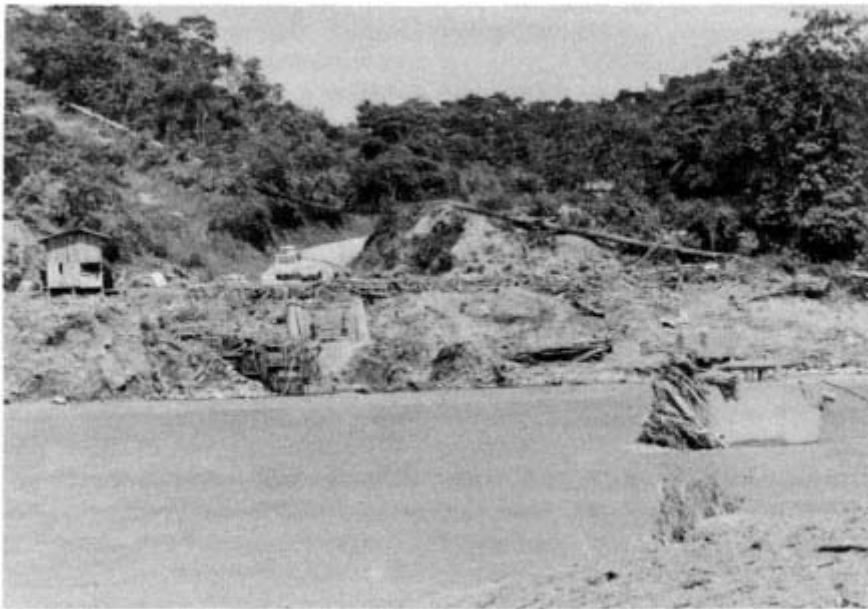
FIGURE 6.4

Trans-Ecuadorian pipeline on the W bank of the Aguarico River pulled southward by flood waters. Note the remnant pier and abutment of the bridge.

which was severed on the W side of the river at its junction between the bridge and concrete abutment. Figure 6.4 provides a view of the E side of the river where the pipeline had entered the bridge abutment as an aboveground structure. W of this location, the pipeline was pulled longitudinally and displaced off its supports for a distance of 4 km.

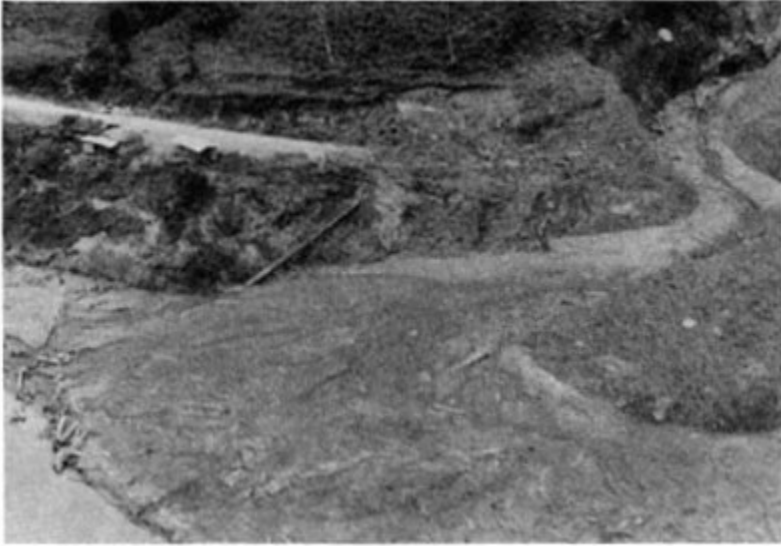
FIGURE 6.6

Pipeline broken by a debris flow that has eroded 6 m below the pipeline right of way.

Figures 6.6 through 6.9 show photographs taken during helicopter reconnaissance approximately 3 weeks after the earthquakes. The locations of the photographs are identified as 6 through 9 in Figure 6.5, each corresponding to its respective figure number.

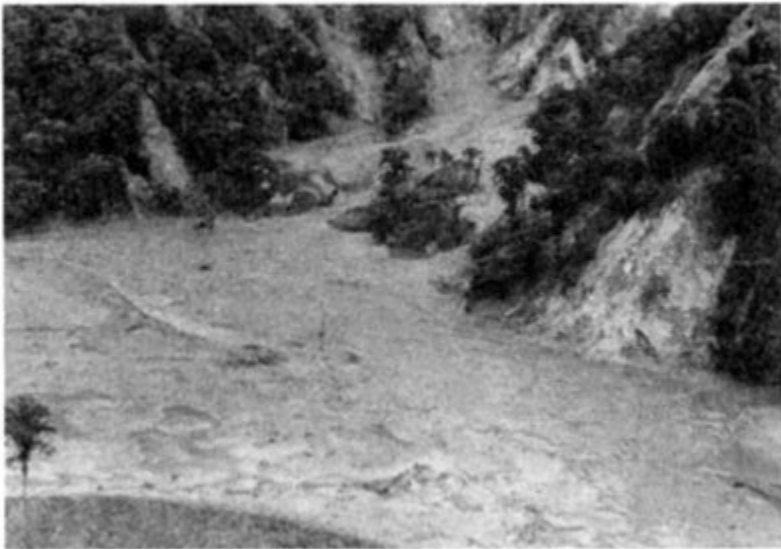
FIGURE 6.7

Flooding along the Coca River. Note the broken and deformed pipeline at the left side of the photograph.

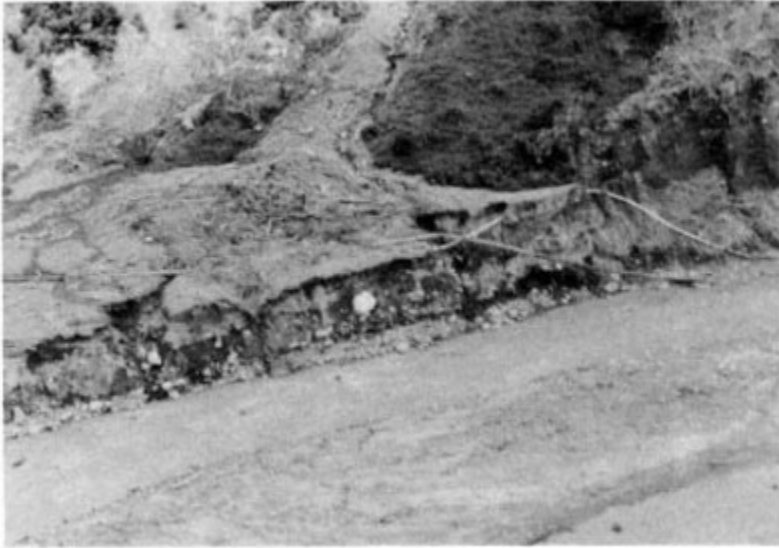
FIGURE 6.8
Trans-Ecuadorian and Poliducto (white) pipelines ruptured by debris flow and deep erosion along the Coca River.

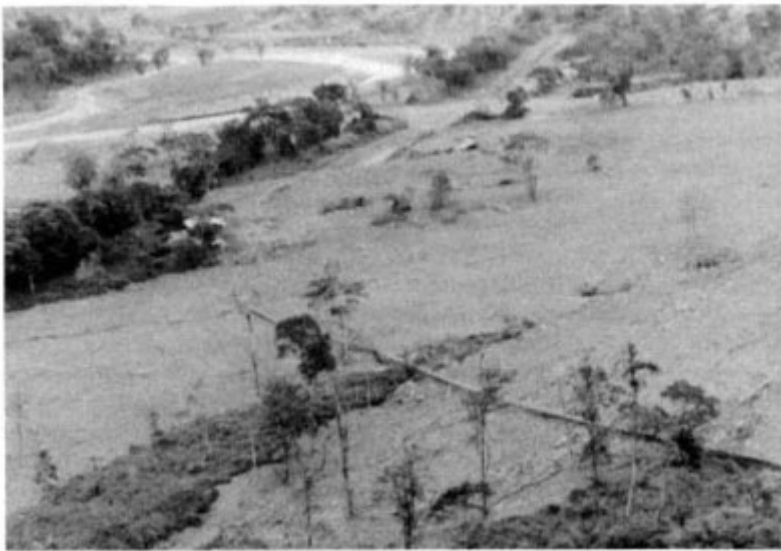
FIGURE 6.9
Broad fan of a very large debris flow with the Trans-Ecuadorian pipeline deformed in the direction of debris movement.

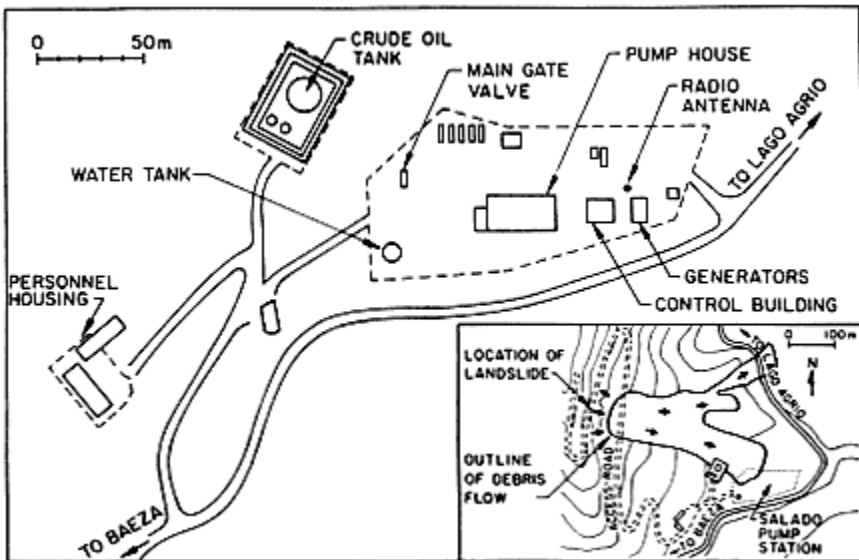
FIGURE 6.10
Plan view of the Salado pump station.

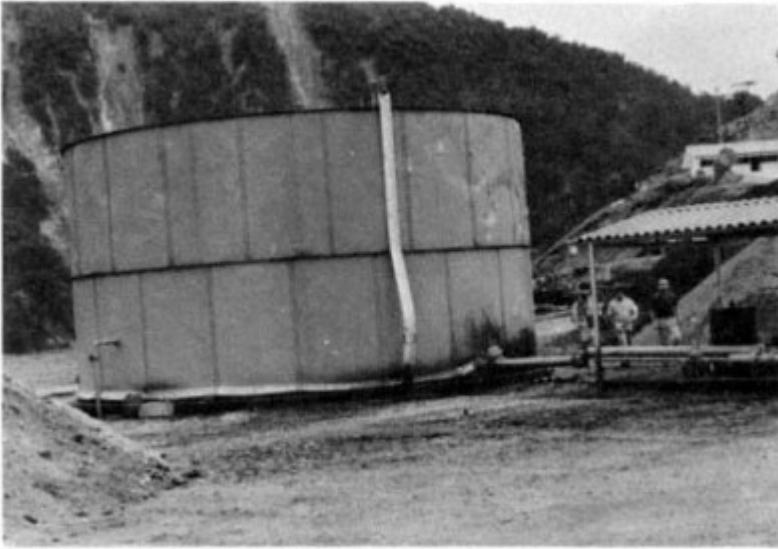
FIGURE 6.12
Damaged water-storage tank at the Salado pump station.

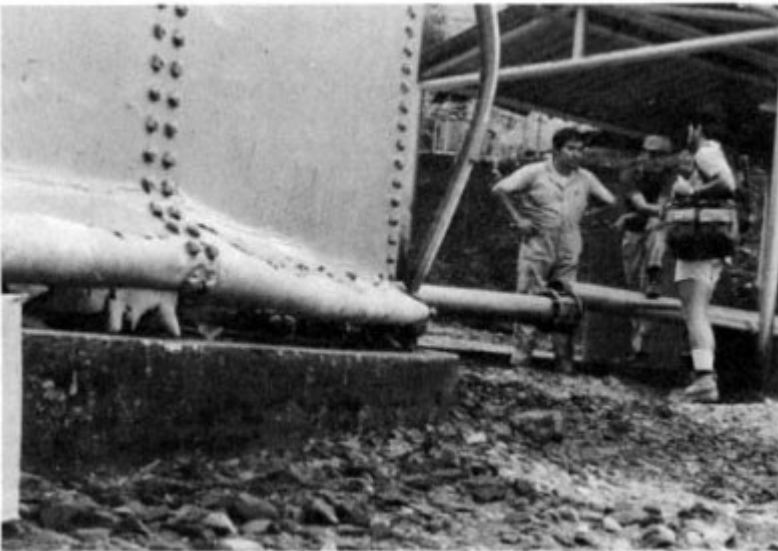
FIGURE 6.13
Circumferential buckling and pipe pullout of the water tank at the Salado pump station.

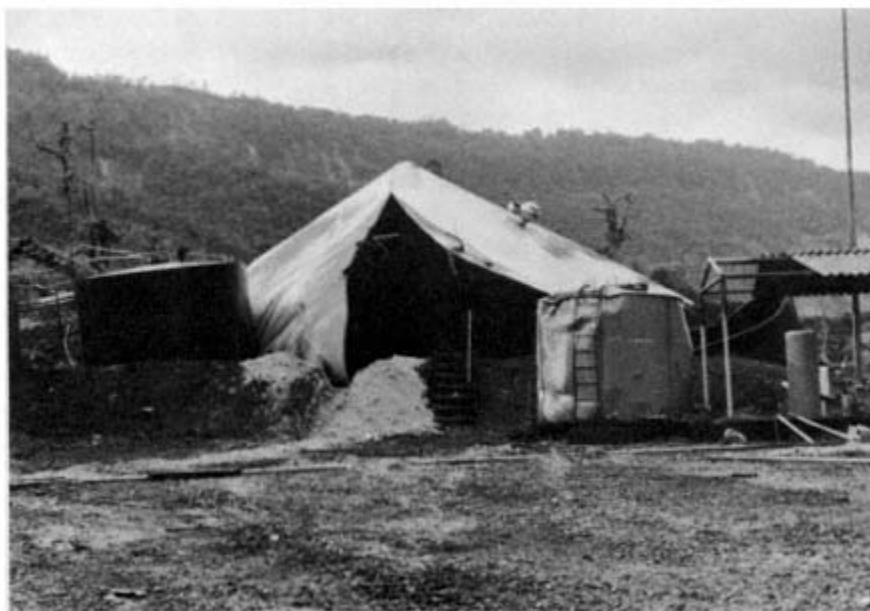
FIGURE 6.14
Oil tank destroyed by landslide debris at the Salado pump station.

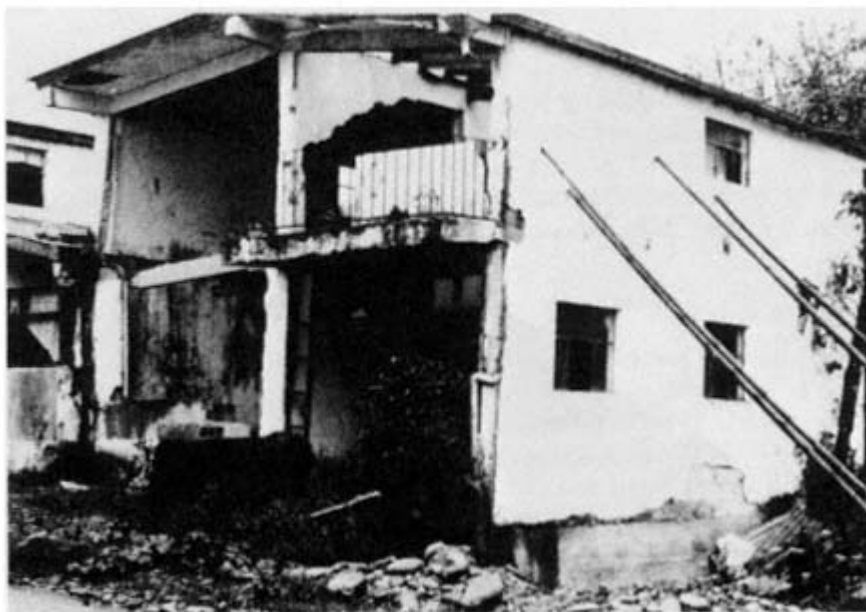
FIGURE 7.2
Damaged concrete-block dwelling in Baeza, Napo Province.

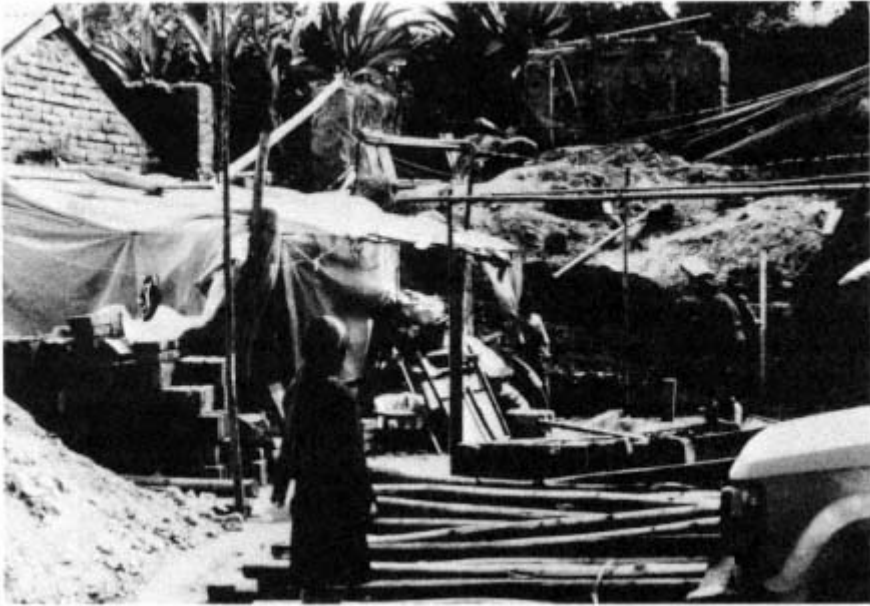
FIGURE 7.4

Temporary dwelling of plastic sheeting used as a residence while family builds a new home using a metal frame, Tabacundo, Pichincha Province.

The town of Tabacundo (Figure 4.3) provided one example of a community in which many stages of housing reconstruction could be seen at one time. The temporary housing being used ranged from crude, makeshift shacks, to tents from foreign donors, to small houses of wood slabs. Many lots had been completely cleared of the damaged structures, and construction was beginning (Figure 7.4). Some residents were rebuilding with their own resources, while about 120 households had received metal frames, donated by a German organization, to provide support for walls made of brick infill. Other people were building more traditional adobe buildings. The community was given a machine for compacting the adobe bricks to make them more seismic-resistant, and we were told that technical assistance was available in the community from Ecuadorian agencies. The people could request certain building materials from Civil Defense; these materials were delivered by trucks provided by the municipal government.

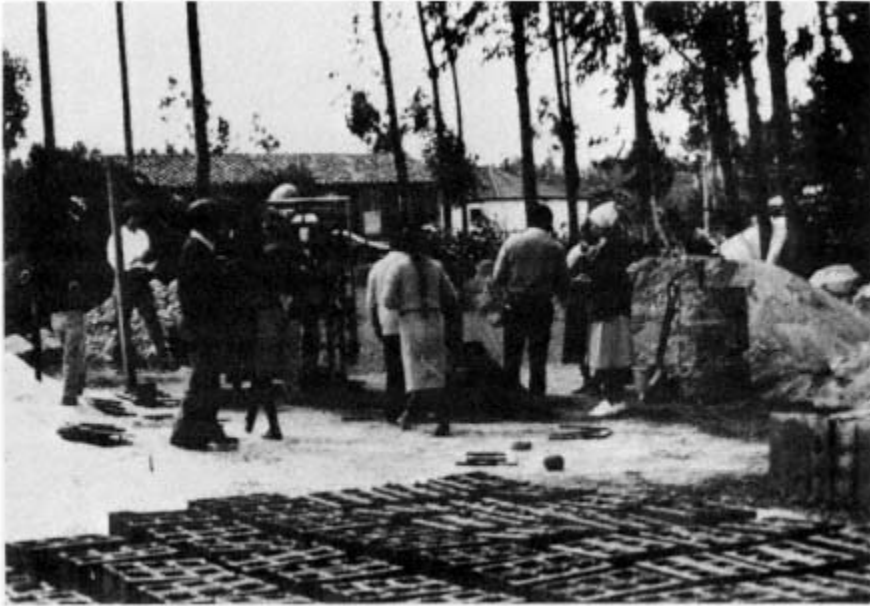
FIGURE 7.5

Minga (traditional community work group) making mud bricks using a brick-compacting machine that had been donated to the community, Tabacundo, Pichincha Province.

In most small Andean communities, the population of Indian descent typically uses the traditional social practice of the *minga*, or ad hoc work group, to complete community projects. A specific project is selected and a work group, sometimes involving most of the people in the village, is formed to complete it. In Tabacundo, the *minga* tradition was being used in the reconstruction of housing. For example, a *minga* work group was observed making adobe bricks using a new compacting device (Figure 7.5).
