Improving the Compatibility of Vehicles and Roadside Safety Hardware

Prepared for:
National Cooperative Highway Research Program

Submitted by:
A. Eskandarian
G. Bahouth
K. Digges
D. Godrick
M. Bronstad
The George Washington University
Washington, D.C.

February 2004

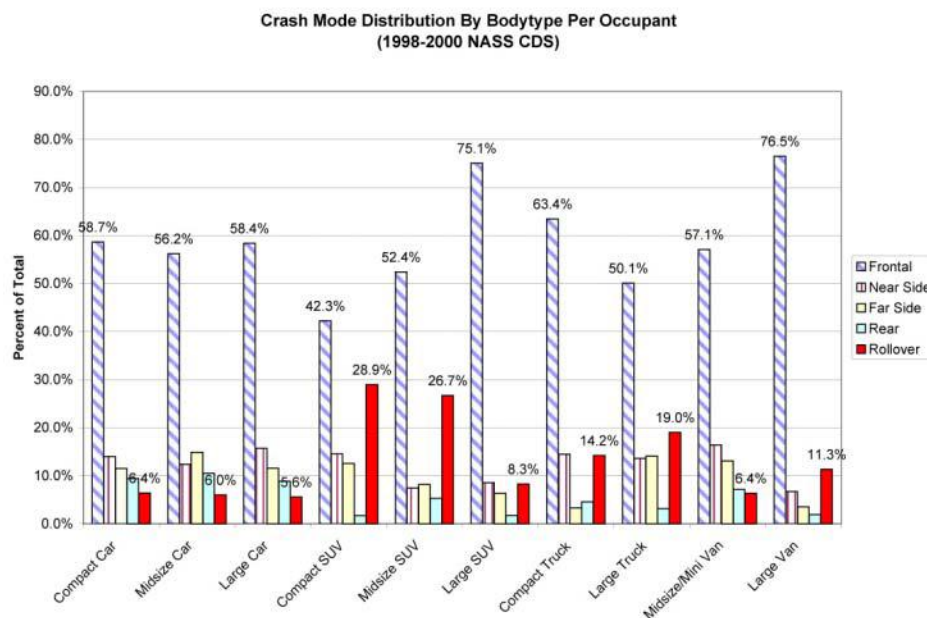
Figure 2.01 Crash involvement of passenger vehicles by impact mode (1998-2000 NASS/CDS)

Figure 2.1 shows crash mode distribution by body type for these vehicle classes listed above. The figure includes frontal, near side, far side, rear and rollover crashes. Frontal crashes are defined as impacts where the Principal Direction of Force (PDOF) is 10 o'clock through 2 o'clock and the General Area of Damage (GAD) is "front." Nearside crashes occur when the GAD is side and the occupant in question is seated on this side of the vehicle. Far side crashes are side impacts where the occupant is seated on the non-struck side of the vehicle. Rear crashes involve a PDOF of 5 through 7 o'clock and a "rear" GAD. A crash is classified as a rollover if a vehicle undergoes at least one quarter-turn. In addition to the percent of total, included in the figure is the percent involvement of frontal and rollover crashes for each class. It can be observed from the figure that compact and midsize SUV's are nearly six times more likely to be involved in rollover events than midsize cars.

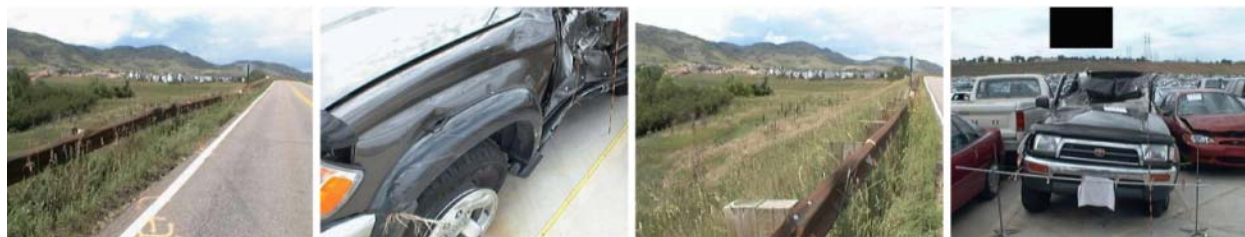
Figure 2.03: Case 1: Summary

Rollover Classification

Number of Harmful Events 3
 Rollover Initiation Type CLIMB-OVER
 Location of Rollover Initiation ROADSIDE/MEDIAN
 Rollover Initiation Object OTHER BARRIER
 Contacted
 Location on Vehicle where Principal
 Tripping Force was Applied UNDERCARRIAGE
 Direction of Initial Roll ROLL LEFT

Nr. Quarter Turns 5 QUARTER TURNS
 Impact Speed < 0.5 KMPH
 Total, Longitudal, and Lateral delta-V < 0.5 KMPH < 0.5 KMPH < 0.5 KMPH
 Estimated delta-V with SEVERE 3
 Sequence number
 CDC 0 T Z D O 6
 Run off Road
 Damage (C1-C6) 0 0 0 0 0 0
 Crush (L and D) 0 0

Traffic Flow NOT DIVIDED
 Number of Travel Lanes TWO
 Roadway Alignment CURVE RIGHT
 Roadway Profile UPHILL GRADE
 Roadway Surface Type ASPHALT
 Roadway Surface Condition DRY
 Light Conditions DARK/LIGHTED
 Atmospheric Conditions NO ADVERSE COND
 Relation to Intersection NONINTER/NONJUNC
 Traffic Control Device
 Police Reported Alcohol ALCOHOL PRESENT
 Presence

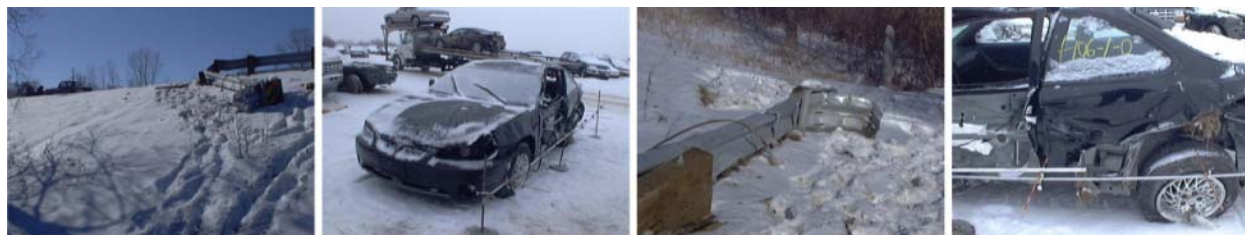
Figure 2.05: Case 2: Summary

Rollover Classification

Number of Harmful Events 2
 Rollover Initiation Type TRIP-OVER
 Location of Rollover Initiation ROADSIDE/MEDIAN
 Rollover Initiation Object OTHER FIXED OBJECT
 Contacted
 Location on Vehicle where Principal
 Tripping Force was Applied WHEELS/TIRES
 Direction of Initial Roll ROLL LEFT

Nr. Quarter Turns 5 QUARTER TURNS
 Impact Speed < 0.5 KMPH
 Total, Longitudal, and Lateral delta-V < 0.5 KMPH < 0.5 KMPH < 0.5 KMPH
 Estimated delta-V with DELTA V CODED 1
 Sequence Number
 CDC 11 L D E W 3
 Run off Road
 Damage (C1-C6) 29 15 13 23 7 4
 Crush (L and D) 443 0

Traffic Flow ONE WAY
 Number of Travel Lanes THREE
 Roadway Alignment CURVE RIGHT
 Roadway Profile LEVEL
 Roadway Surface Type ASPHALT
 Roadway Surface Condition SNOW OR SLUSH
 Light Conditions DARK
 Atmospheric Conditions SNOW
 Relation to Intersection NONINTER/NONJUNC
 Traffic Control Device
 Police Reported Alcohol ALCOHOL PRESENT
 Presence
 Alcohol Test (< 95 indicates BAC 0.xx) 16

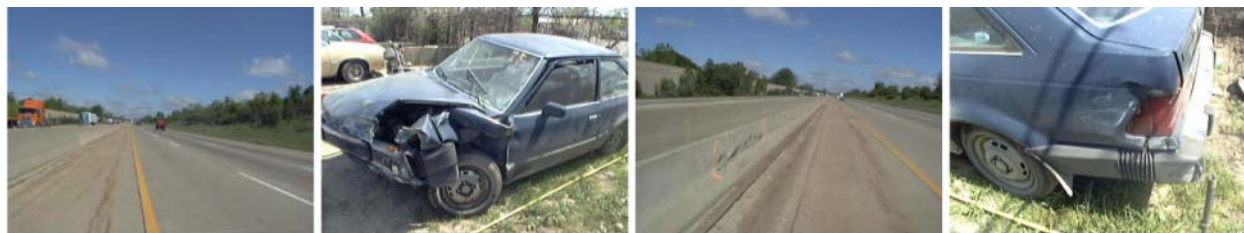
Figure 2.07: Case 3: Summary

Rollover Classification

Number of Harmful Events 1
 Rollover Initiation Type NO ROLLOVER
 Location of Rollover Initiation NO ROLLOVER
 Rollover Initiation Object NO ROLLOVER
 Contacted
 Location on Vehicle where Principal
 Tripping Force was Applied NO ROLLOVER
 Direction of Initial Roll NO ROLLOVER

Nr. Quarter Turns NO ROLLOVER
 Impact Speed 998
 Total, Longitudal, and Lateral delta-V 30 28 10
 Estimated delta-V with Sequence Number DELTA V CODED 1
 CDC 11 F D E W 2
 Run off Road
 Damage (C1-C6) 45 38 26 16 4 0
 Crush (L and D) 140-16

Traffic Flow DIVIDED WITH BARRIER
 Number of Travel Lanes THREE
 Roadway Alignment STRAIGHT
 Roadway Profile LEVEL
 Roadway Surface Type ASPHALT
 Roadway Surface Condition DRY
 Light Conditions DAY LIGHT
 Atmospheric Conditions NO ADVERSE COND
 Relation to Intersection NONINTER/NONJUNC
 Traffic Control Device
 Police Reported Alcohol Presence NO ALCOHOL

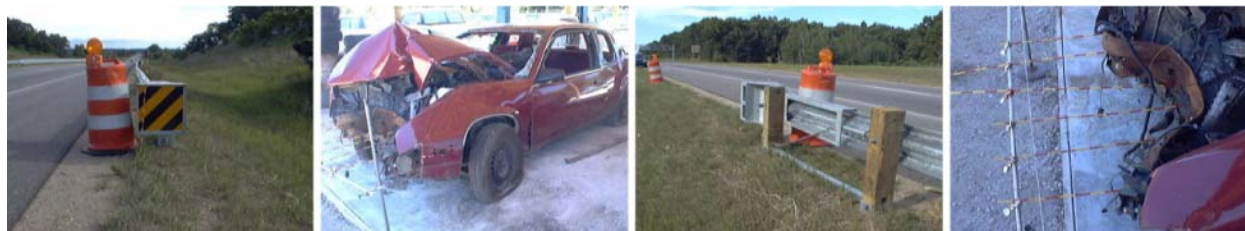
Figure 2.09: Case 4: Summary

Rollover Classification

Number of Harmful Events 1
 Rollover Initiation Type NO ROLLOVER
 Location of Rollover Initiation NO ROLLOVER
 Rollover Initiation Object NO ROLLOVER
 Contacted
 Location on Vehicle where Principal
 Tripping Force was Applied NO ROLLOVER
 Direction of Initial Roll NO ROLLOVER

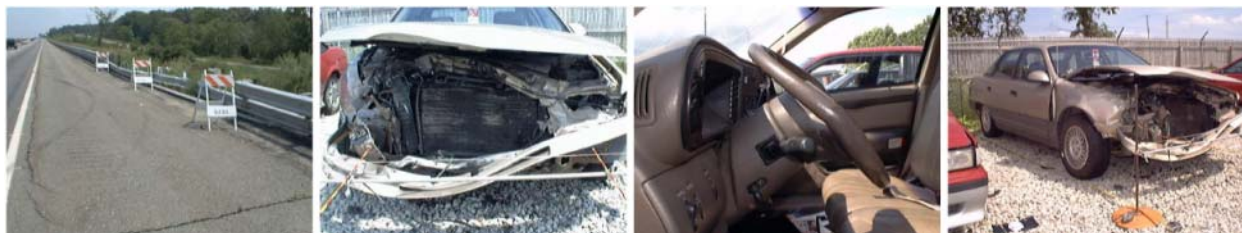
Figure 2.11: Case 5: Summary

Rollover Classification

Number of Harmful Events 3
 Rollover Initiation Type NO ROLLOVER
 Location of Rollover Initiation NO ROLLOVER
 Rollover Initiation Object NO ROLLOVER
 Contacted
 Location on Vehicle where Principal
 Tripping Force was Applied NO ROLLOVER
 Direction of Initial Roll NO ROLLOVER

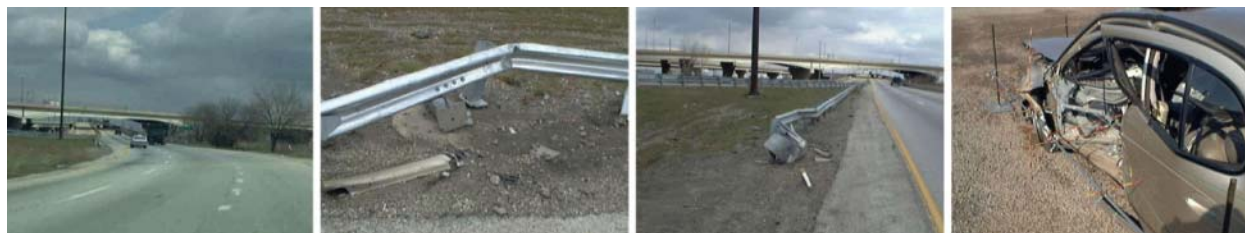
Figure 2.13: Case 6: Summary

Rollover Classification

Number of Harmful Events 2
 Rollover Initiation Type NO ROLLOVER
 Location of Rollover Initiation NO ROLLOVER
 Rollover Initiation Object NO ROLLOVER
 Contacted
 Location on Vehicle where
 Principal
 Tripping Force was Applied NO ROLLOVER
 Direction of Initial Roll NO ROLLOVER

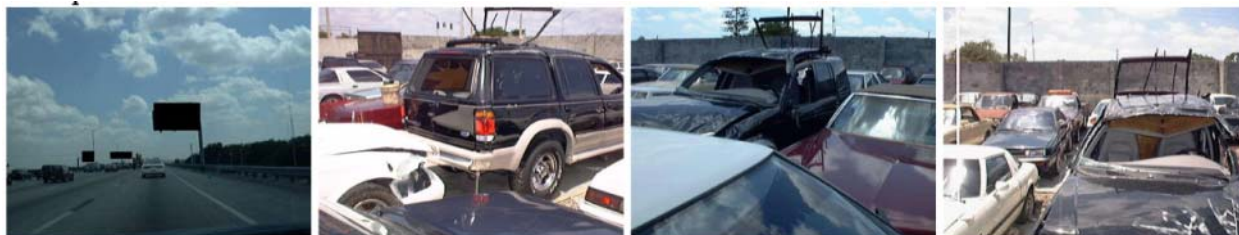
Figure 2.15: Case 7: Summary

Rollover Classification

Number of Harmful Events 4
 Rollover Initiation Type BOUNCE-OVER
 Location of Rollover Initiation ROADSIDE/MEDIAN
 Rollover Initiation Object CONCRETE BARRIER
 Contacted
 Location on Vehicle where Principal
 Tripping Force was Applied END PLANE
 Direction of Initial Roll ROLL RIGHT

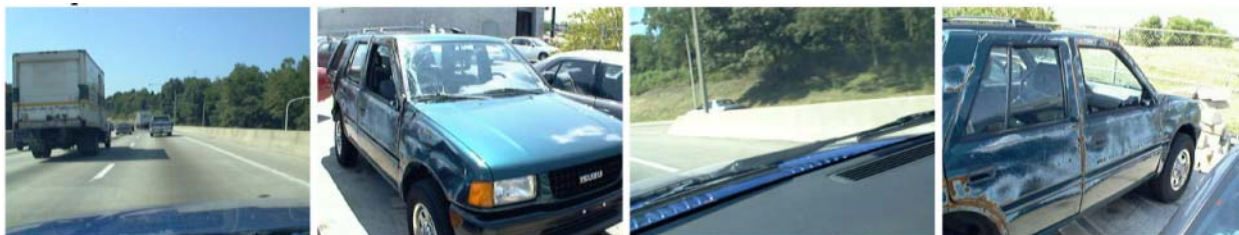
Figure 2.17: Case 8: Summary

Rollover Classification

Number of Harmful Events 2
 Rollover Initiation Type BOUNCE-OVER
 Location of Rollover Initiation ROADSIDE/MEDIAN
 Rollover Initiation Object CONCRETE BARRIER
 Contacted
 Location on Vehicle where Principal
 Tripping Force was Applied SIDE PLANE
 Direction of Initial Roll ROLL RIGHT
 Age 2 Height 61 Weight 23

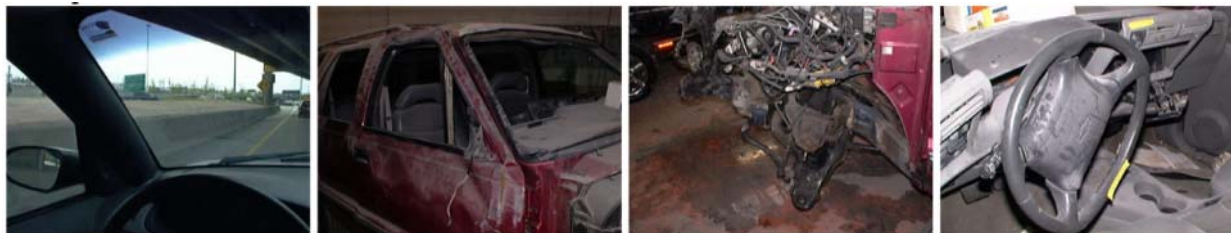
Figure 2.19: Case 9: Summary

Rollover Classification

Number of Harmful Events 2
 Rollover Initiation Type BOUNCE-OVER
 Location of Rollover Initiation ROADSIDE/MEDIAN
 Rollover Initiation Object CONCRETE BARRIER
 Contacted
 Location on Vehicle where Principal
 Tripping Force was Applied END PLANE
 Direction of Initial Roll ROLL RIGHT

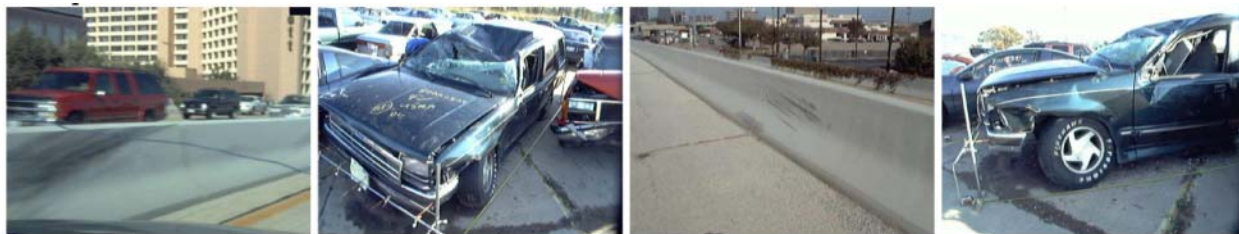
Figure 2.21: Case 10: Summary

Rollover Classification

Number of Harmful Events 4
 Rollover Initiation Type TRIP-OVER
 Location of Rollover Initiation ROADSIDE/MEDIAN
 Rollover Initiation Object GROUND
 Contacted
 Location on Vehicle where Principal
 Tripping Force was Applied WHEELS/TIRES
 Direction of Initial Roll ROLL LEFT

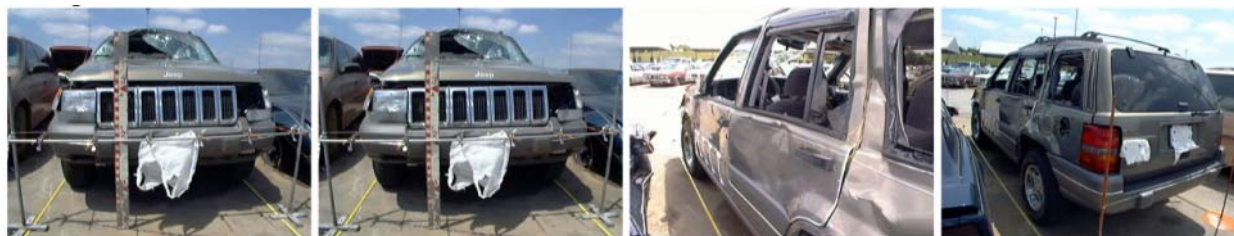
Figure 2.23: Case 11: Summary

Rollover Classification

Number of Harmful Events 2
 Rollover Initiation Type CLIMB-OVER
 Location of Rollover Initiation ROADSIDE/MEDIAN
 Rollover Initiation Object OTHER BARRIER
 Contacted
 Location on Vehicle where Principal
 Tripping Force was Applied UNDERCARRIAGE
 Direction of Initial Roll ROLL LEFT

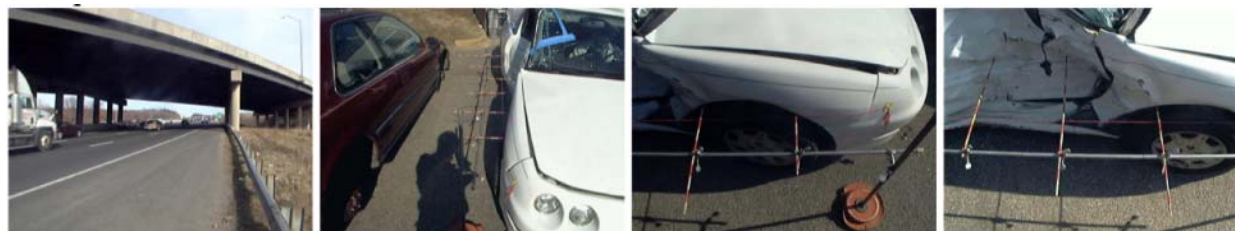
Figure 2.25: Case 12: Summary

Rollover Classification

Number of Harmful Events 5
 Rollover Initiation Type NO ROLLOVER
 Location of Rollover Initiation NO ROLLOVER
 Rollover Initiation Object NO ROLLOVER
 Contacted
 Location on Vehicle where
 Principal
 Tripping Force was Applied NO ROLLOVER
 Direction of Initial Roll NO ROLLOVER

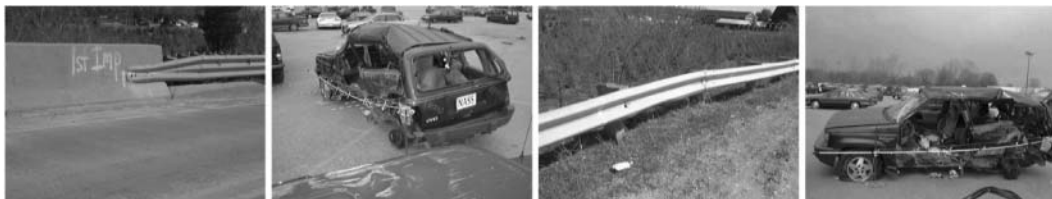
Figure 2.27: Case 13: Summary

Rollover Classification

Number of Harmful Events 3
 Rollover Initiation Type NO ROLLOVER
 Location of Rollover Initiation NO ROLLOVER
 Rollover Initiation Object NO ROLLOVER
 Contacted
 Location on Vehicle where
 Principal
 Tripping Force was Applied NO ROLLOVER
 Direction of Initial Roll NO ROLLOVER

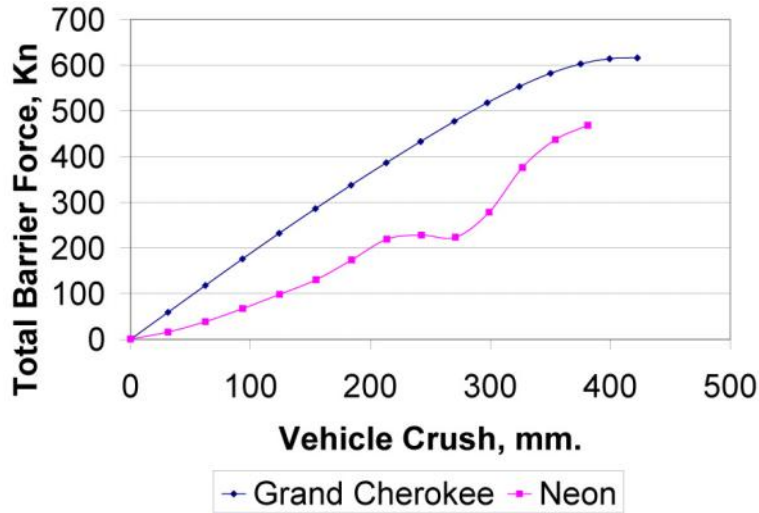
Figure 3.4: Total Barrier Force vs. Vehicle Crush

The linear stiffness is sensitive to the accuracy of the zero time step selected for the barrier force data. The force level is less sensitive than the stiffness to the zero time step selection. Consequently, force rather than stiffness is a preferred metric at the selected crush values.

At a crush of 200 mm, the Jeep Grand Cherokee exerts almost twice as much force as the Dodge Neon. This difference in stiffness will result in a higher extent of crush for the Dodge Neon in a frontal crash involving the two vehicles. This difference illustrates the stiffness differences between the two vehicles. These differences are shown in Figure 3.4 above.
