NCHRP REPORT 490

**In-Service Performance of
Traffic Barriers**

M. H. RAY, J. WEIR, AND J. HOPP
Worcester Polytechnic Institute
Worcester, MA

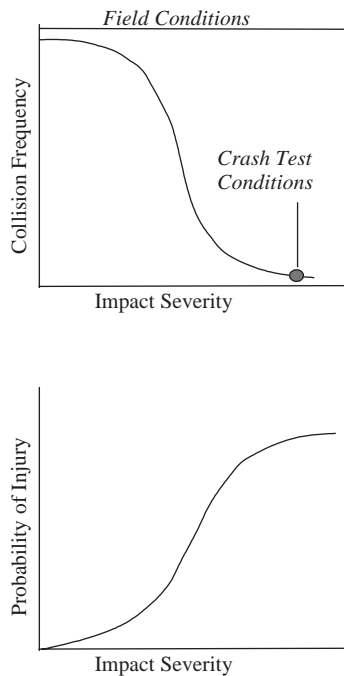
Figure 2. Relationship among collision frequency, impact severity, and occupant injury.

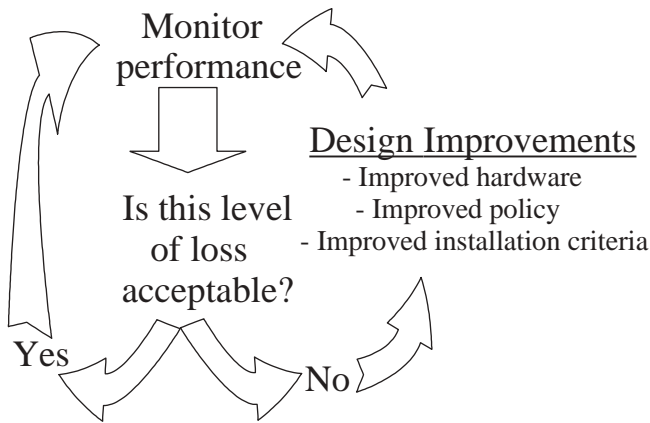
Figure 3. The in-service performance evaluation process.

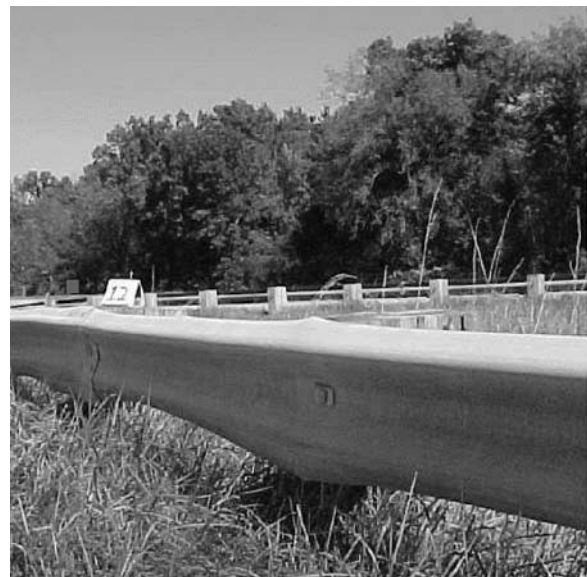
Figure 7. An example of minor guardrail damage.
