**TCRP REPORT 71**

**Track-Related Research**

***Friction Control Methods  
Used by the Transit  
Industry***

Transportation Technology Center, Inc. (TTCI)  
Pueblo, CO

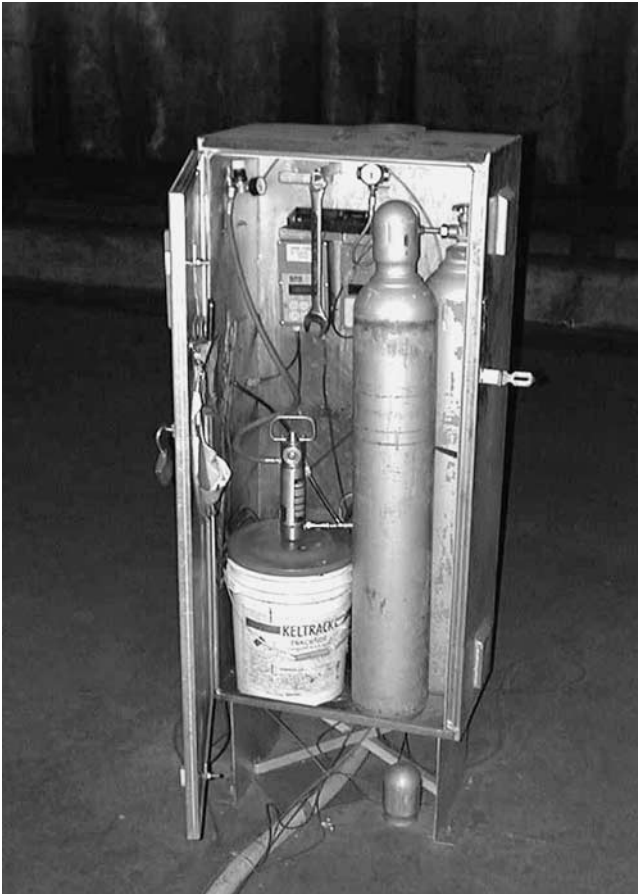
Figure 1. Nitrogen gas-charged lubricant/friction modifier cabinet.

One manufacturer uses a charged container of compressed nitrogen gas to deliver friction control materials. The lubricant/friction modifier reservoirs and gas bottle are housed in a steel cabinet mounted alongside the track. A vibration sensor, magnetic valve, and nozzle housing are mounted on the railroad tie, as shown in Figure 1. A 9-volt battery and nitrogen gas power the system, allowing it to be installed at sites regardless of electric power availability. There is no direct mechanical contact between the system and the rail or wheels, thereby reducing the wear on system components. Maintenance and service consist of lubricant/friction modifier refills and nitrogen gas bottle replacements. Service intervals depend on traffic density and may range from 2 to 12 months. In addition, the manufacturer recommends replacing the battery annually.

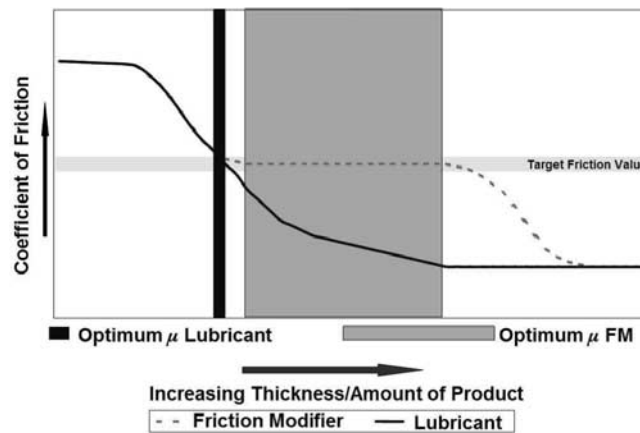
Figure 4. Friction modifier (FM) and lubricant performance.

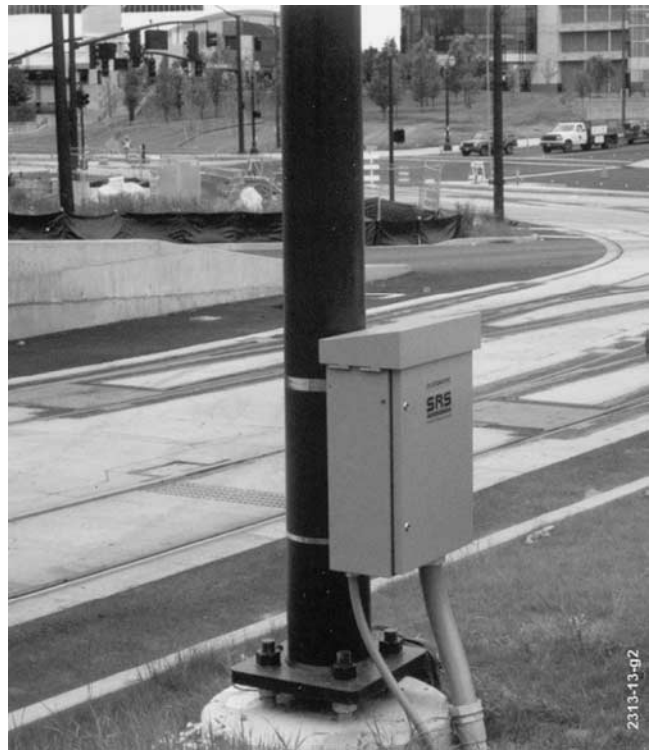
Figure 9. Applicator system enclosure.

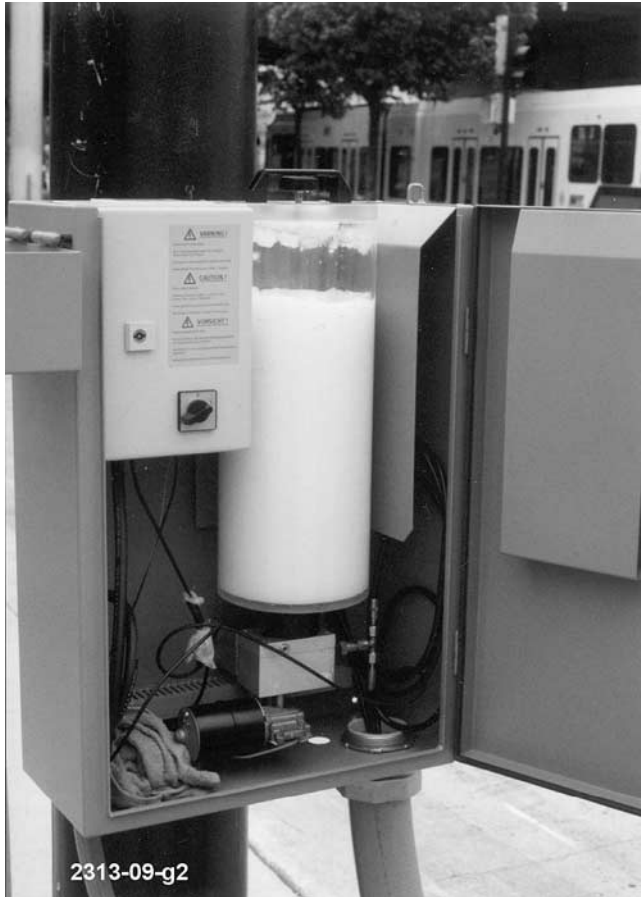
Figure 10. Interior view of the applicator system, showing grease reservoir.

The grease reservoir is a clear plastic container allowing easy inspection of lubricant level (see Figure 10). Although refilling can be accomplished in the field, the preferred method

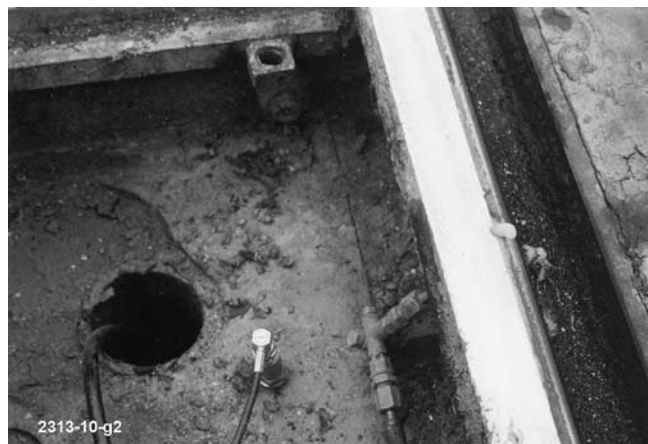
Figure 12. Grease flow after manual operation of the application system.

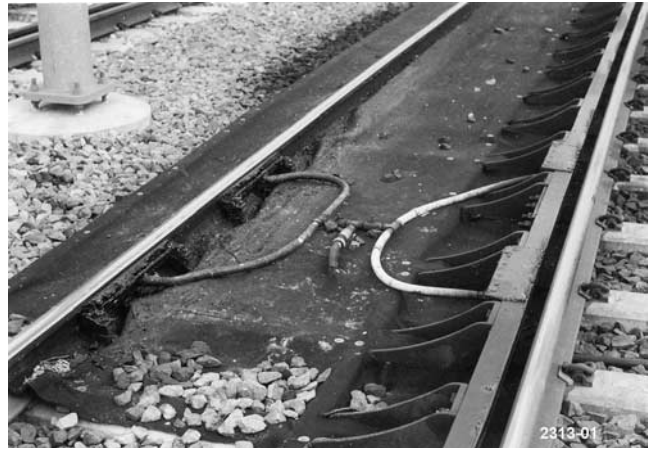
Figure 13. Location receiving both gage face and restraining rail lubrication.

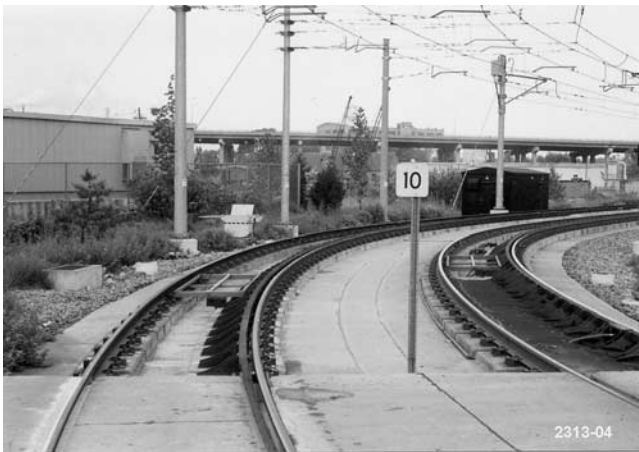
Figure 16. Two mainline curve lubricator applicators supplied from one centrally located reservoir and pump system.

The HB approach places one lubricator pump mechanism (tank/reservoir and pump) midway between both ends of a curve and feeds the applicator bars by long hoses (up to 100 feet long) in each direction. The system is activated by one sensor that is installed on only one of the two tracks. For example, a sensor installed on the northbound track will activate the system for a prescribed interval only after every northbound train. Southbound trains will not activate the sys-

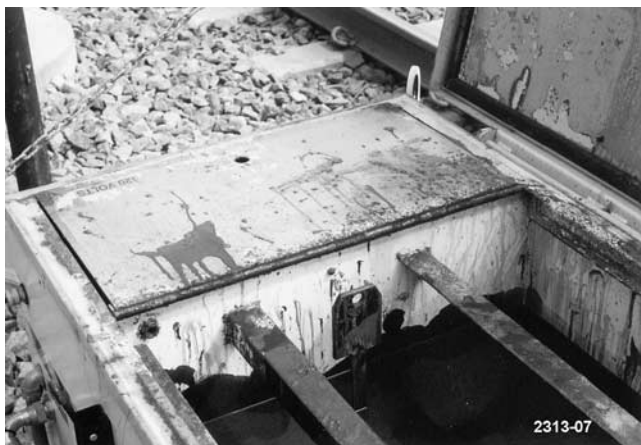
Figure 18. Corrosion of tank components caused by friction control material carrier.

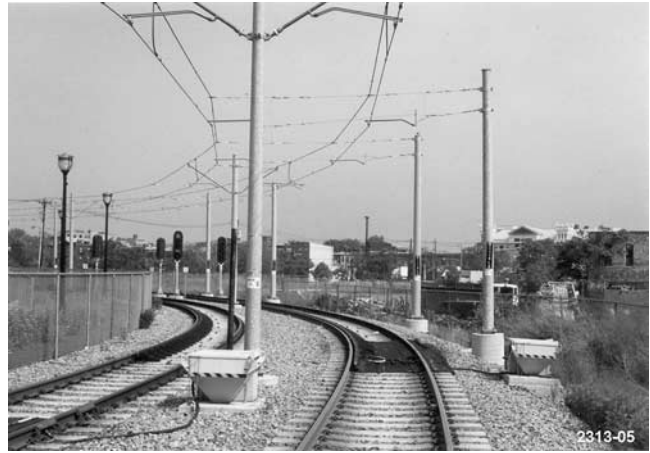
Figure 19. Site with soybean-based lubrication applied for gage face and restraining rail wear protection (right track) and friction control material applied to the top of the running rail (left track).

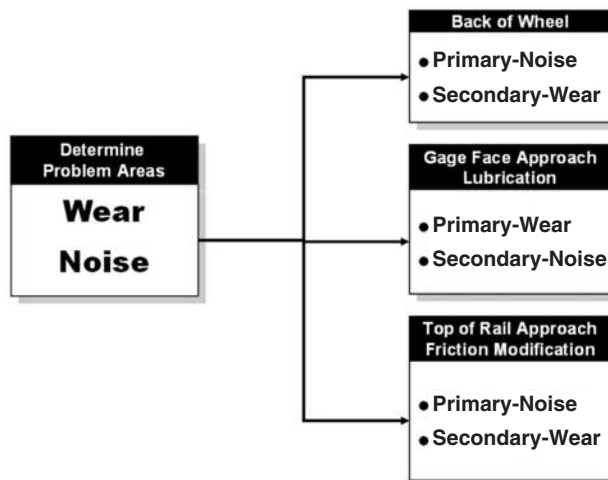
Figure 20. Problem area identification.

1. Determine the concept (Figure 20):
  - TOR (use of friction modifiers),
  - Gage face (use of lubricants), or
  - Combination (including back of wheel issues).
2. Determine the application platform (Figure 21):
  - Onboard or
  - Wayside.
3. If the wayside platform is used, determine the application transfer mode (Figure 23):

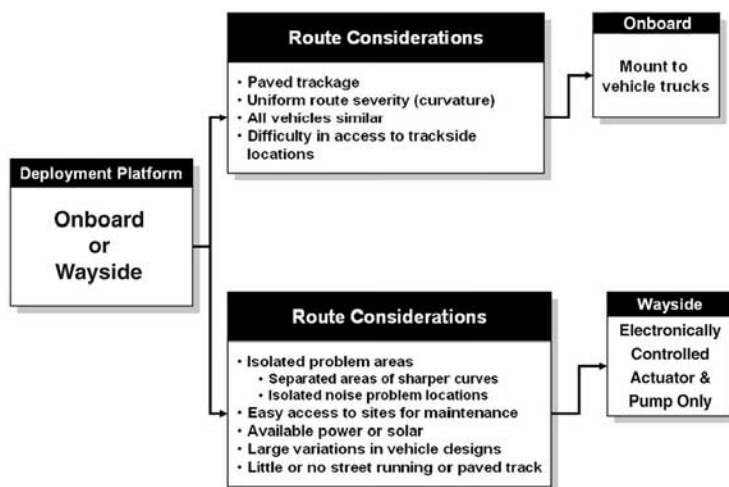
Figure 21. Onboard versus wayside applicators: route issues.

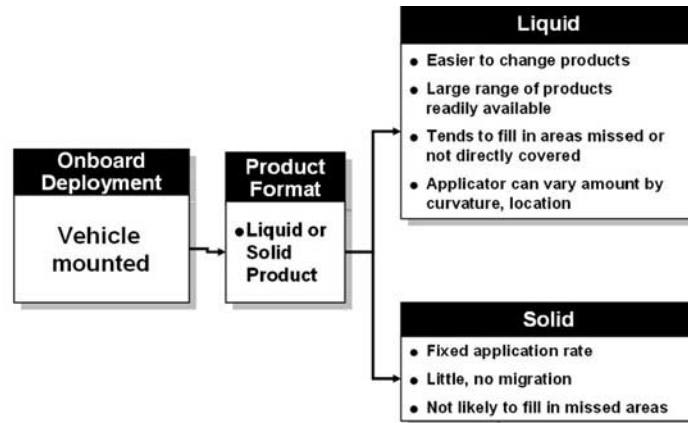
Figure 22. Onboard deployment: product format options.

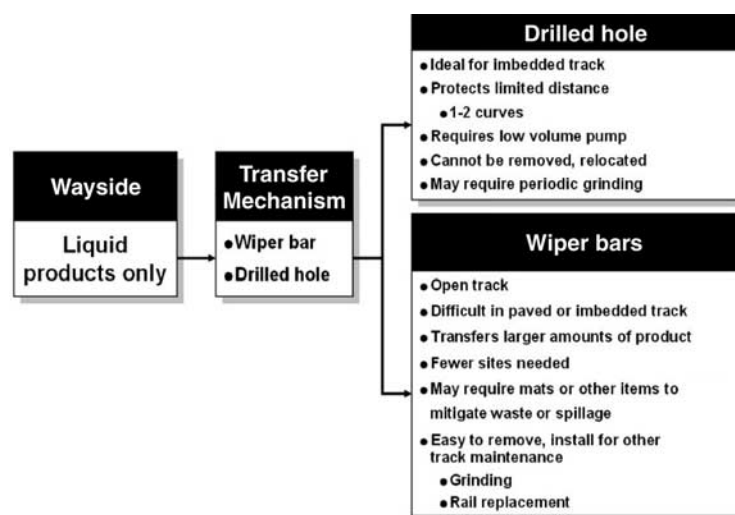
Figure 23. Wayside applicator issues.

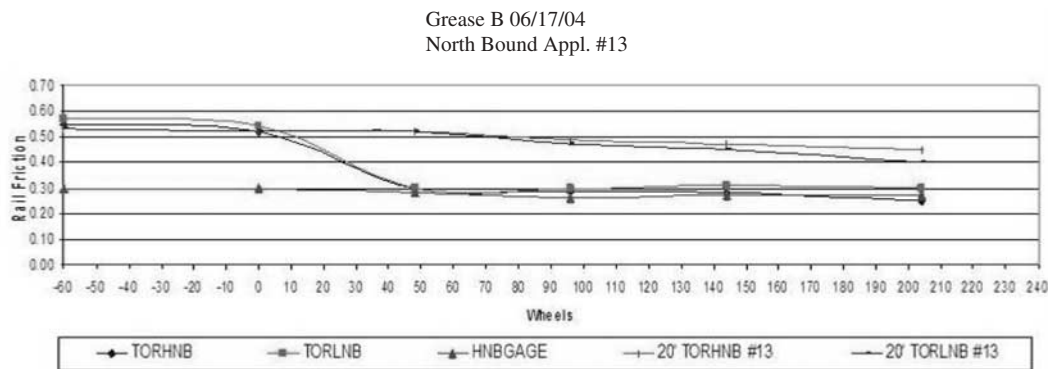
Figure 10. Time (axle) history of friction, lubricant B, northbound trains.

A typical time history plot based on axle counts is shown in Figures 10 and 11. For the examples shown here (from Appendix B), performance is for Product B. Figure 10 shows friction as measured on northbound trains where the lubricant applicator was approximately 200 feet from the measured site. For southbound trains, friction was measured about 1,200 feet from the applicator and is shown in Figure 11. In addition,

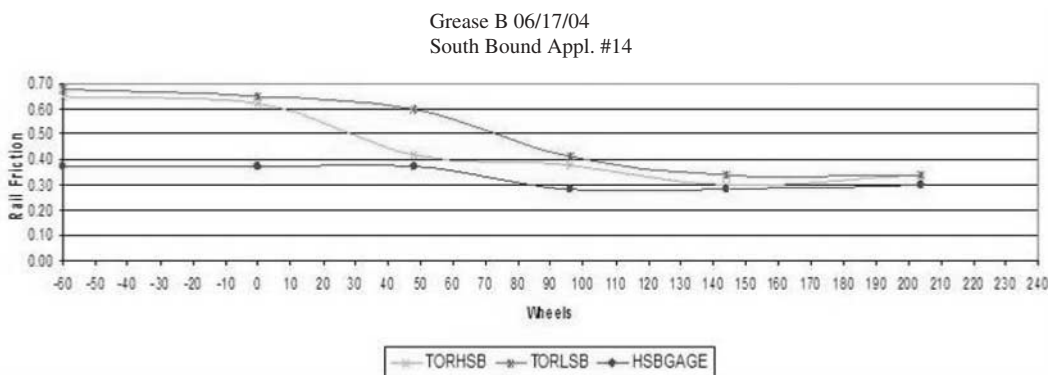
Figure 11. Time (axle) history of friction, lubricant B, southbound trains.

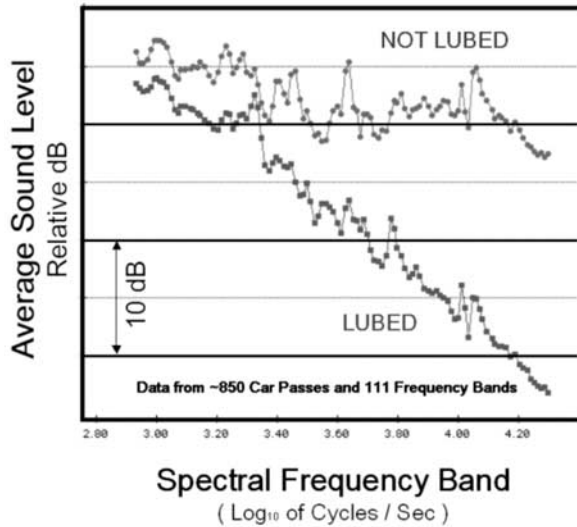
Figure 13. Average spectral sound level for conditions of dry and lubricated rail.

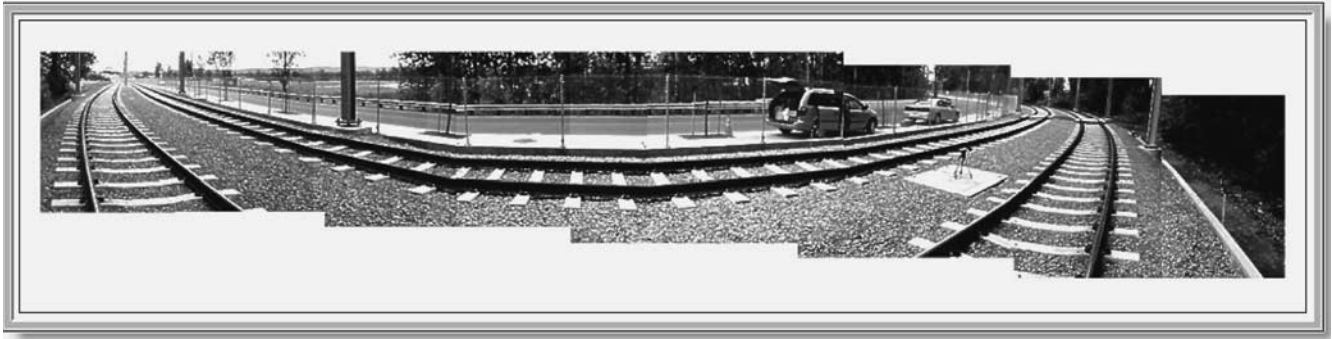
**Figure 2—Photo of test site near north end of transit line close to the Portland Expo Center. Note: Northbound rail is near photographer. Southbound rail is nearest autos in the photo.**

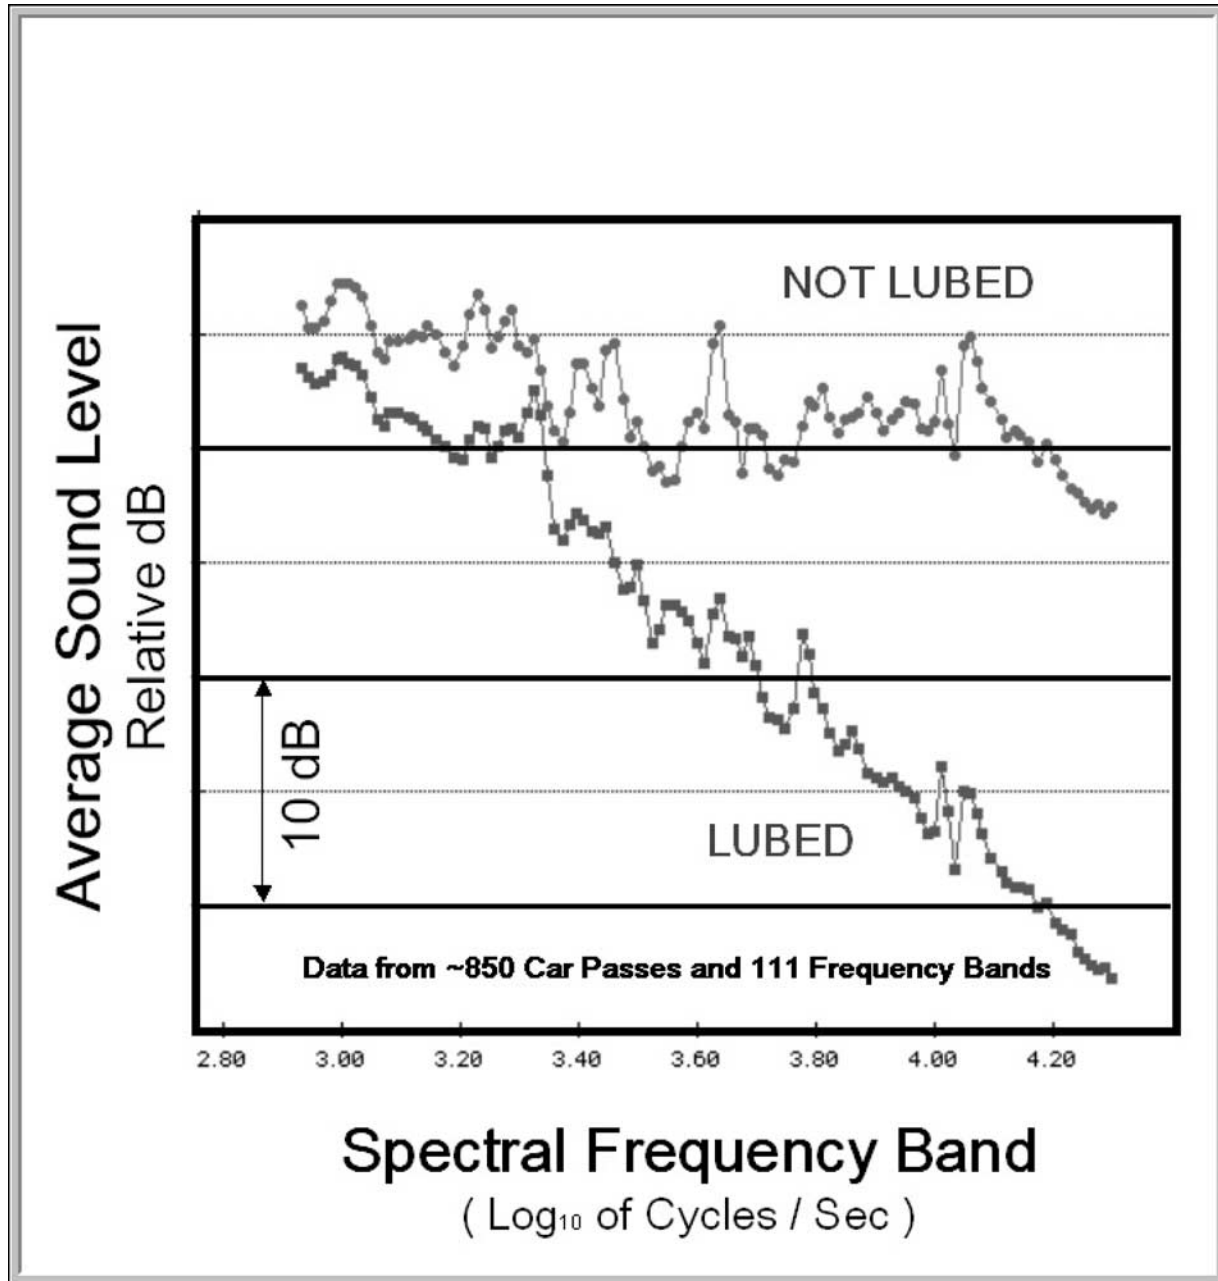
**Figure 3—Image depicting average spectral sound levels for dry and lubricated rail.**

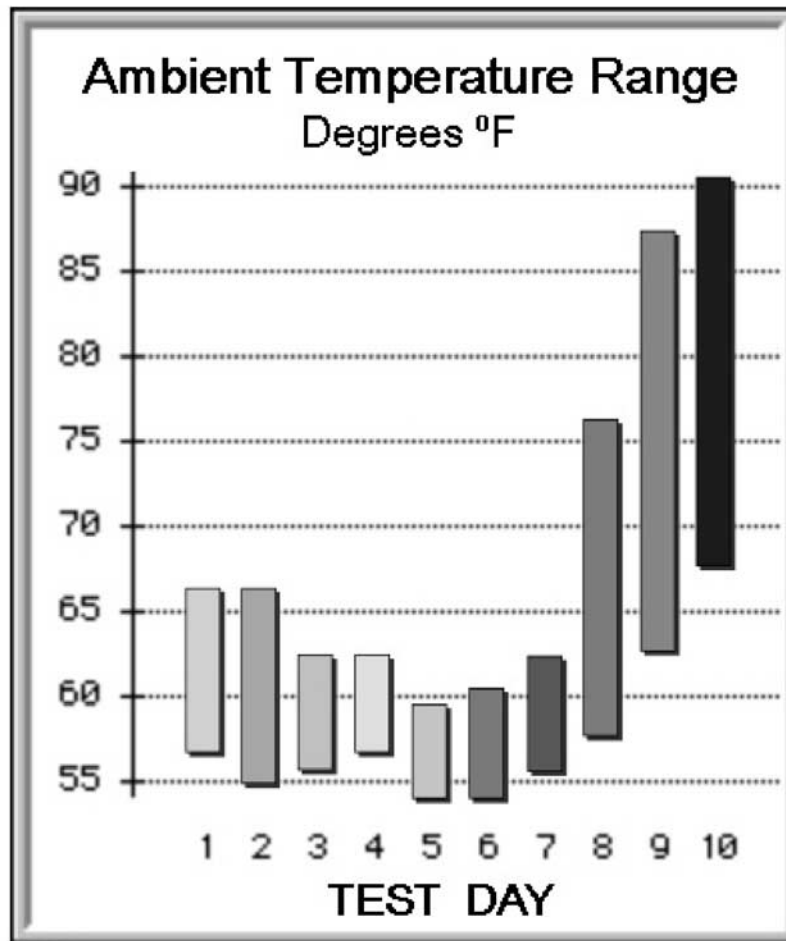
Figure 6—Displays of temperature ranges observed during study.

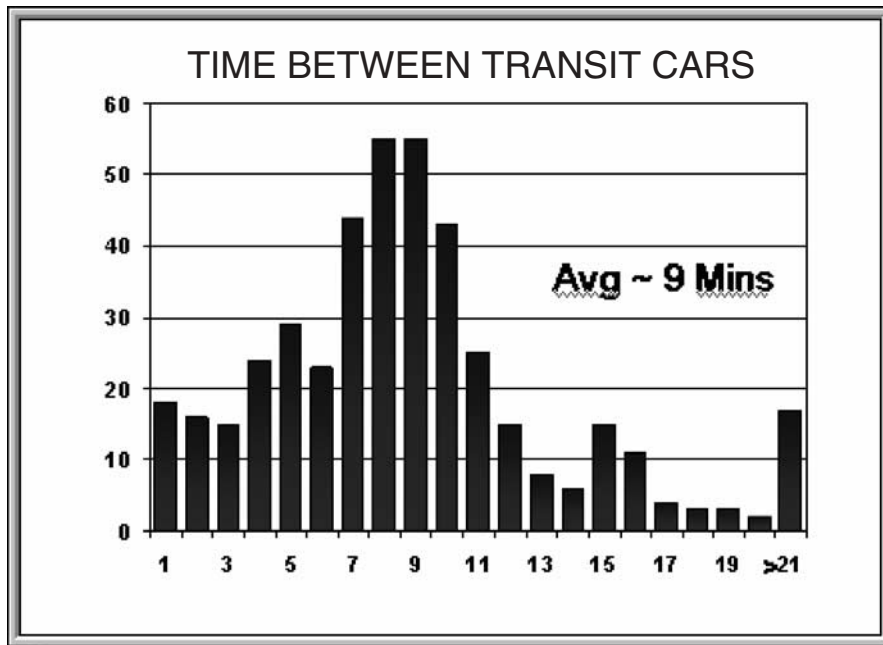
**Figure 7—Histogram of time between transit cars observed during study.**

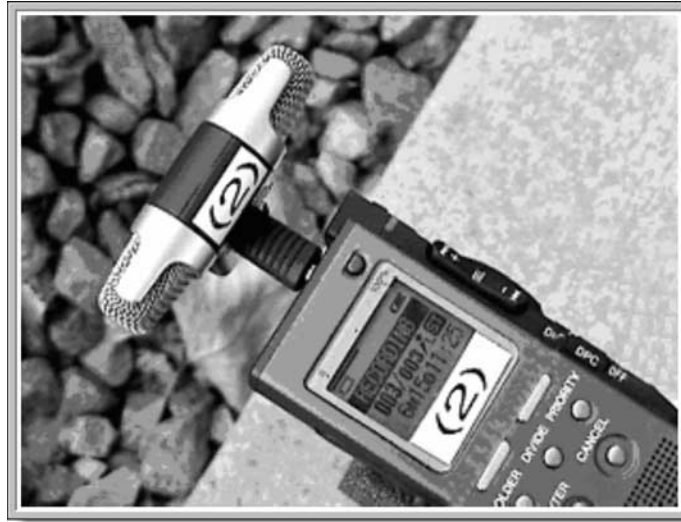
**Figure 10—Image of stereo microphone recorder deployed outside of both tracks during study.**

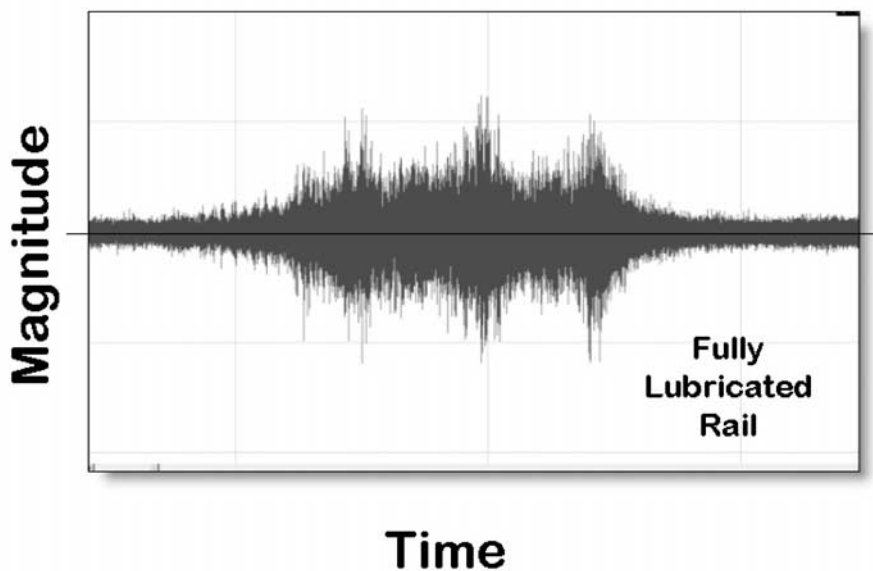
**Figure 12—Typical time-based noise recordings taken on dry and lubricated rail.**

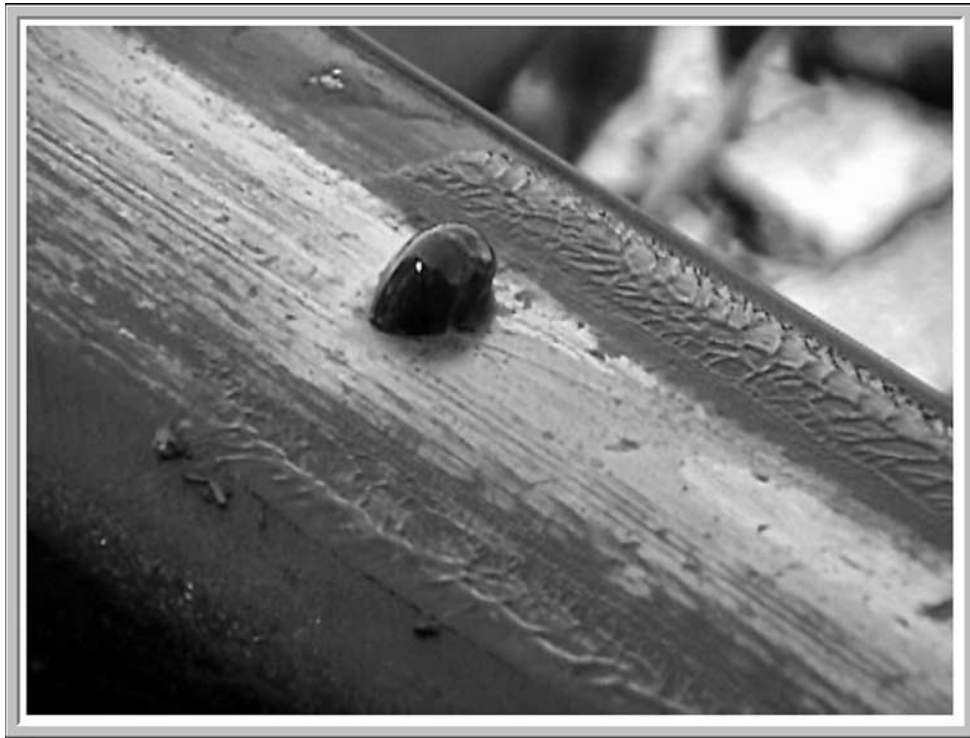
**Figure 17—TOR at point of lubrication showing extruded bead of grease.**

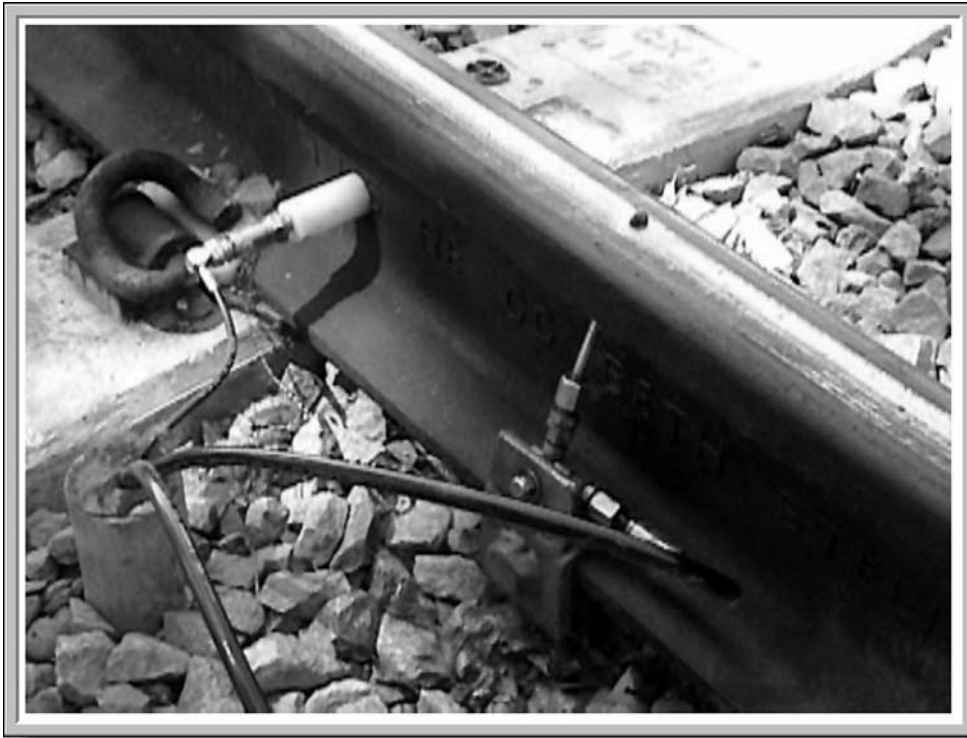
**Figure 18—TOR at point of lubrication showing pressure feed tubes leading to rail.**

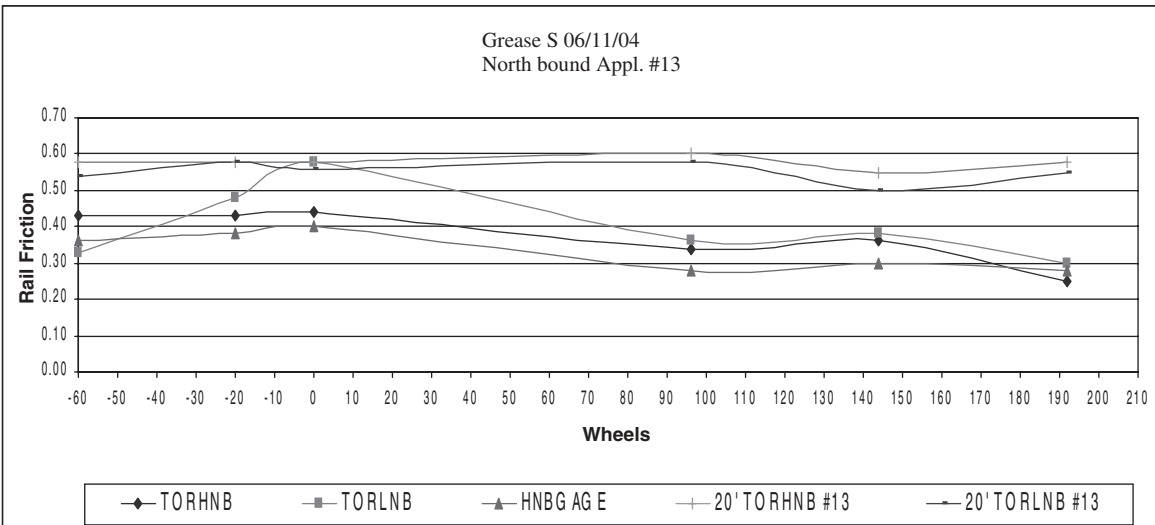
The following two plots for Grease S are based on raw data; however, rain interfered during some of the application period.
