Rubblization of Portland Cement Concrete Pavements

TRANSPORTATION RESEARCH
CIRCULAR

Number E-C087

**Rubblization of
Portland Cement
Concrete Pavements**

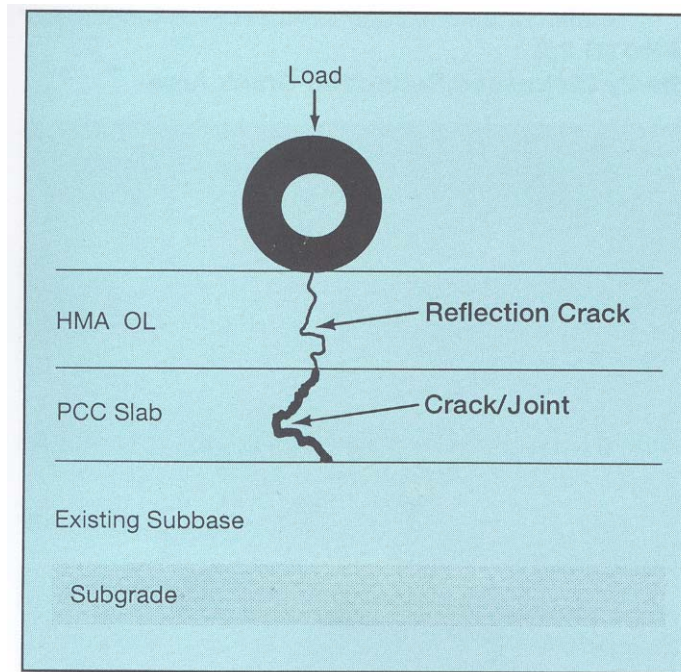
FIGURE 1 Schematic of reflection cracking (I).

Reflection cracking can occur in an HMA overlay over any joint or crack in the PCC pavement. The current state-of-the-technology does not provide accurate methods to predict the occurrence and growth of the reflection crack. **Figure 1** schematically illustrates reflection crack distress in an HMA overlay placed over a joint or crack of an existing PCC slab. **Figure 2** illustrates the mechanism through which the crack develops and propagates in the HMA layer.

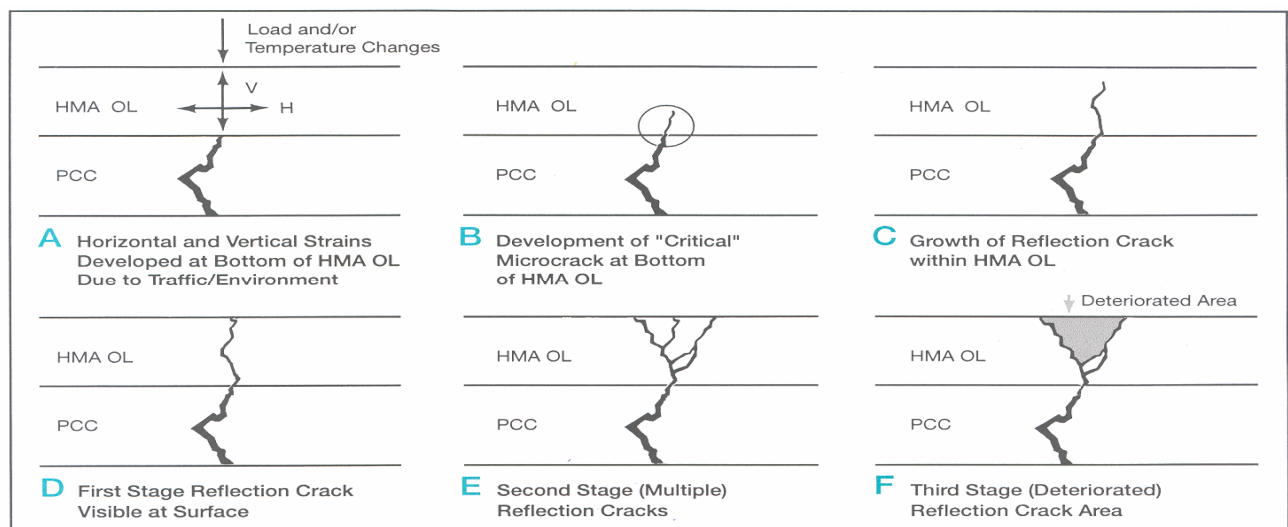
FIGURE 2 Growth of reflection cracks (I).

PCC slabs expand and contract with seasonal changes in temperature. This movement causes the development of forces at the bottom of the HMA layer as shown in **Figure 2a**. The combination of forces at the bottom of the HMA overlay will eventually cause the development of a microcrack at the bottom of the HMA overlay as shown in **Figure 2b**. With time, this microcrack will grow and eventually reflect upwards to the surface of the HMA overlay as shown in **Figures 2c** and **2d**. As temperature and loading cycles continue, multiple cracks will form and eventually result in significant deterioration of the HMA surface as shown in **Figures 2e** and **2f**. **Figure 3** illustrates a distressed reflection crack area in an HMA overlay over an existing PCC pavement.

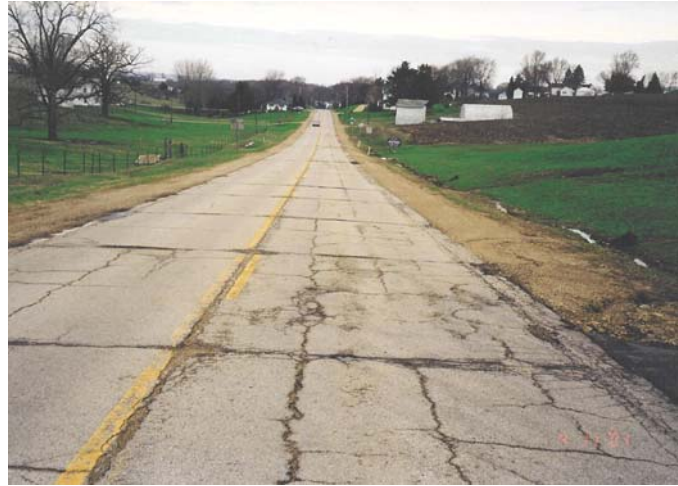
**FIGURE 3 Reflection cracking in HMA overlay over PCC pavement.
(Photo courtesy of Antigo Construction.)**

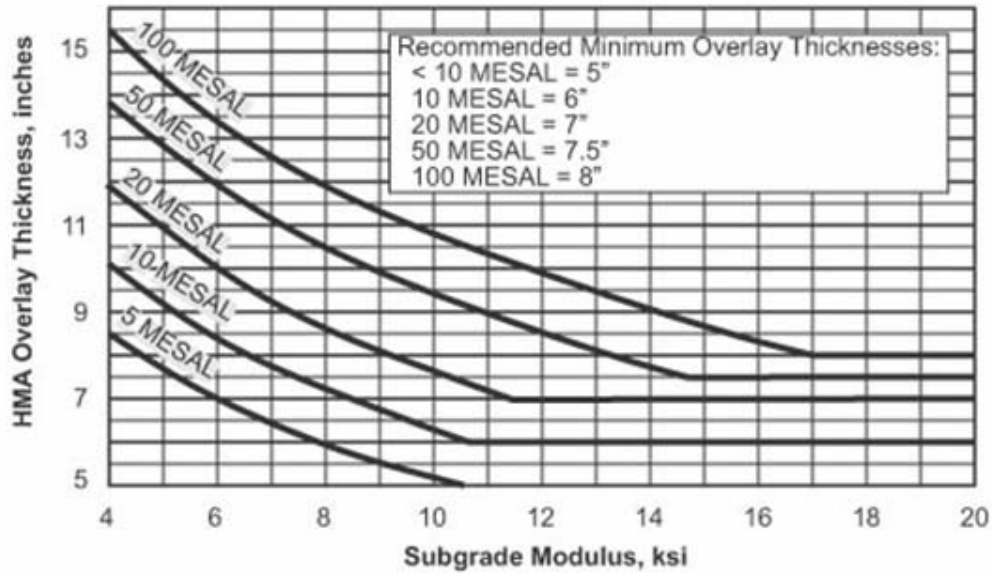
FIGURE 4 HMA overlay thickness versus subgrade modulus (7-in. rubblized PCC, $SN_{sb} = 0.4$). (27)

PerRoad allows the rubblization designer to evaluate existing conditions and to develop an appropriate overlay thickness. The PerRoad Software has been used by NAPA to develop design charts which are presented in Information Series 132 (27). The NAPA publication provides the rubblization designer with the tools necessary to determine the overlay thickness required. Figures 4 and 5 illustrate the graphic design charts that were developed with PerRoad.

Figure 4 shows the overlay thickness versus subgrade modulus for a 7-in. rubblized PCC pavement with a subbase structural number of 0.4. For example, consider a subgrade modulus of 8 ksi. It can be observed that the overlay thickness varies from 6 to 12 in. for traffic counts from 5 to 100 MESAL. The figure also indicates minimum overlay thicknesses. These values were established to ensure adequate prevention of reflection cracking for a specific structural requirement. Figure 5 illustrates the same ideas but with a subbase structural number of 1.6. It is noted that with the better subbase material, the required overlay thickness is reduced. Note again the 8 ksi subgrade modulus. Until you reach approximately the 50 MESAL traffic level, the minimum overlay requirements are in effect. But at even the highest traffic level of 100 MESAL, the overlay thickness is only 9 in.

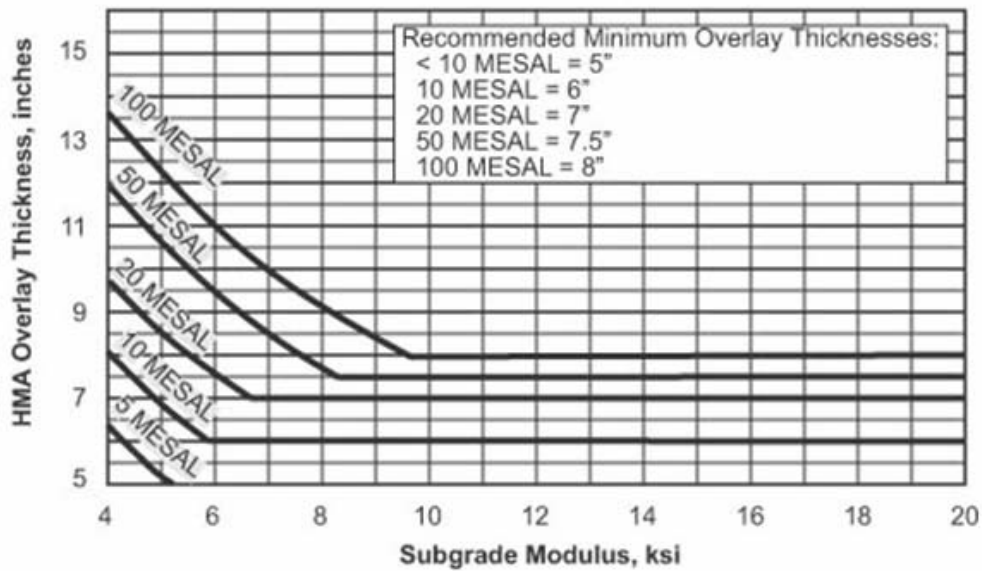
FIGURE 5 HMA overlay thickness versus subgrade modulus (7-in. rubblized PCC, $SN_{sb} = 1.6$). (27)

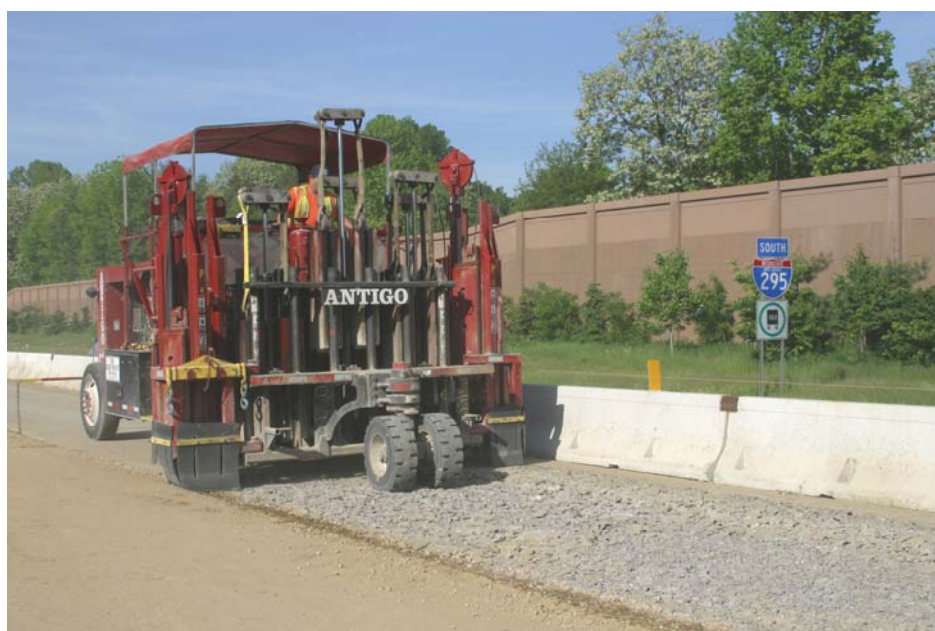
FIGURE 6 MHB for PCC rubblization. (Photo courtesy of Antigo Construction.)

The Multi-Head Breaker (MHB) has sixteen 1,200- to 1,500-lb drop hammers mounted laterally in pairs with half the hammers in a forward row and the remainder diagonally offset in a rear

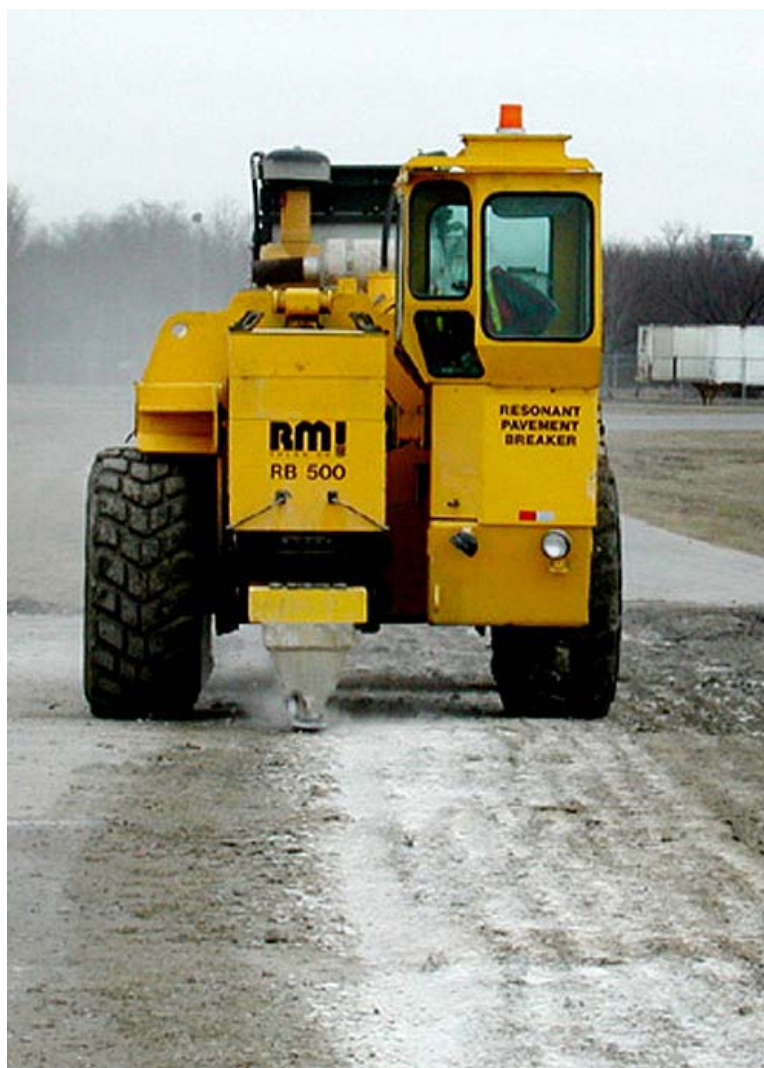
FIGURE 7 RFB for PCC Rubblization. (Photo courtesy of RMI.)

Using the RFB, the breaking begins at the centerline and proceeds to the outside edge of the pavement. The breaking pattern is approximately 8 in. wide, thereby requiring approximately 18 to 20 passes to break a 12 ft wide lane. The RFB is generally required to operate at a maximum amplitude of one inch to avoid disruption of base and prevent damage to underground structures. The RFB encroaches about 3 to 5 ft onto the adjacent lane to rubblize near the centerline of the pavement. Since the RFB has wheel loads of 20,000 lbs and a total weight of 60,000 to 70,000 lbs, the fractured pavement, shoulder and subgrade must be adequate to support multiple passes of the equipment (6).

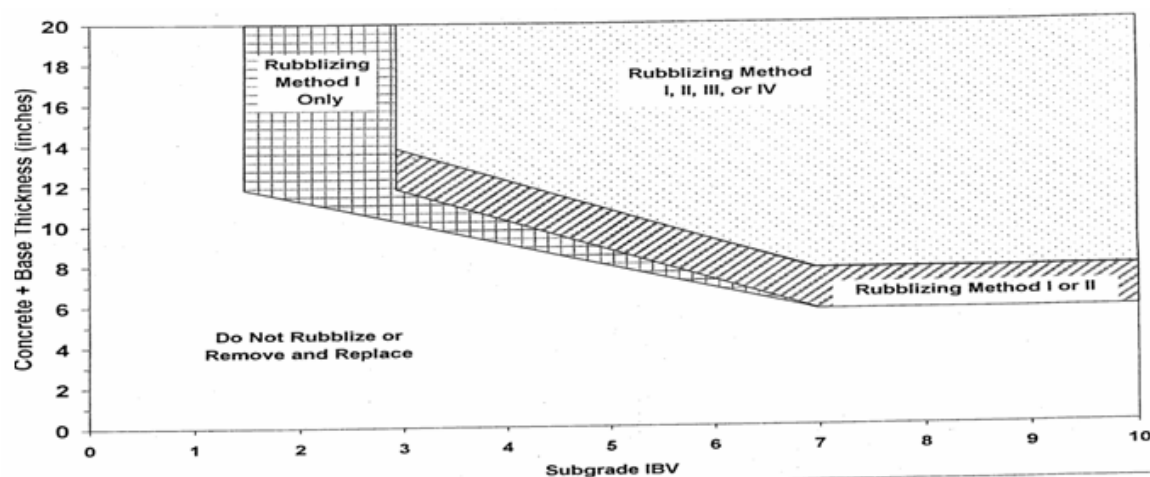
FIGURE 8 Illinois DOT rubblization type selection guide (3–5).

The Illinois Department of Transportation (IDOT) recommends splitting the top twelve inches of the subgrade into two equal layers, determining the DCP for each layer, and using the average of the two values to determine the type of rubblization method to be used (3,4,5). The selection of rubblization method will be discussed later in this paper.

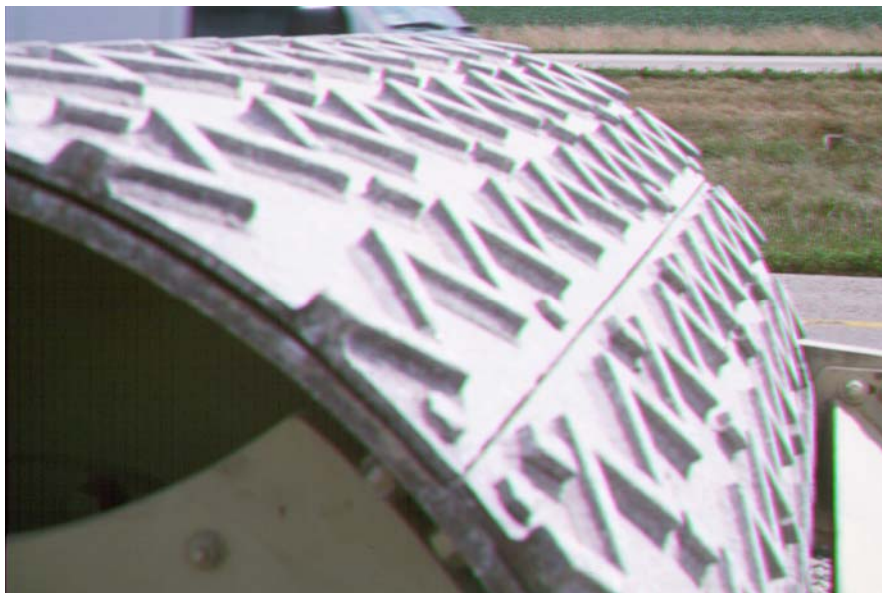
FIGURE 9 Roller with Elliott Grid. (Photo courtesy of Antigo Construction.)

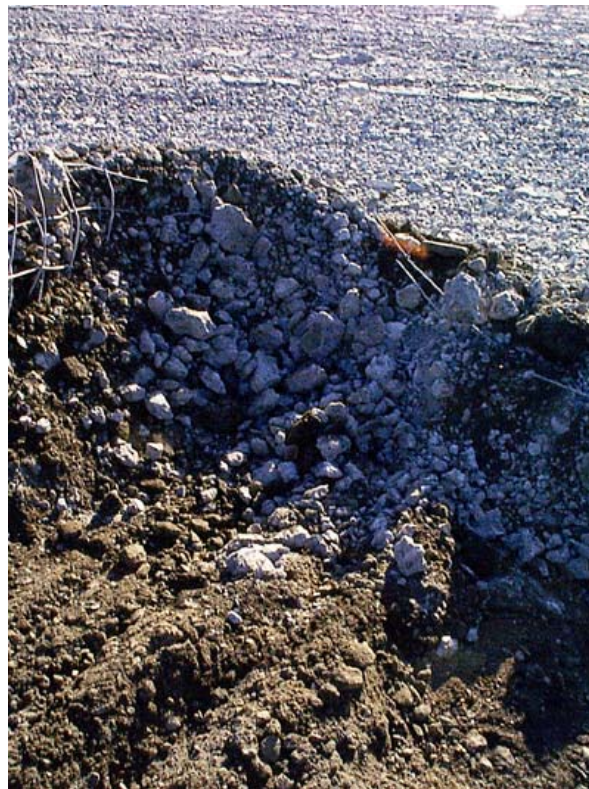
FIGURE 10 Rubblization test hole. (Photo Courtesy of RMI.)

A typical specification requires less than 9- to 10-in. size particles on the surface and a maximum of 12-in. particle size in the lower half of the broken pavement. However, Arkansas DOT requires that the maximum particle size be 8 in. with the majority of particles being in the 1-to 3-in. range (ADOT specifies the RFB only). If the rubblization process does not achieve these maximum particle size requirements, the contractor must repeat the process, use other equipment to achieve the requirements or remove and replace the materials (13). Experience has shown that segments of 12 to 18 in. in the lower half of the slab do not adversely impact the effectiveness in reducing reflection cracking.

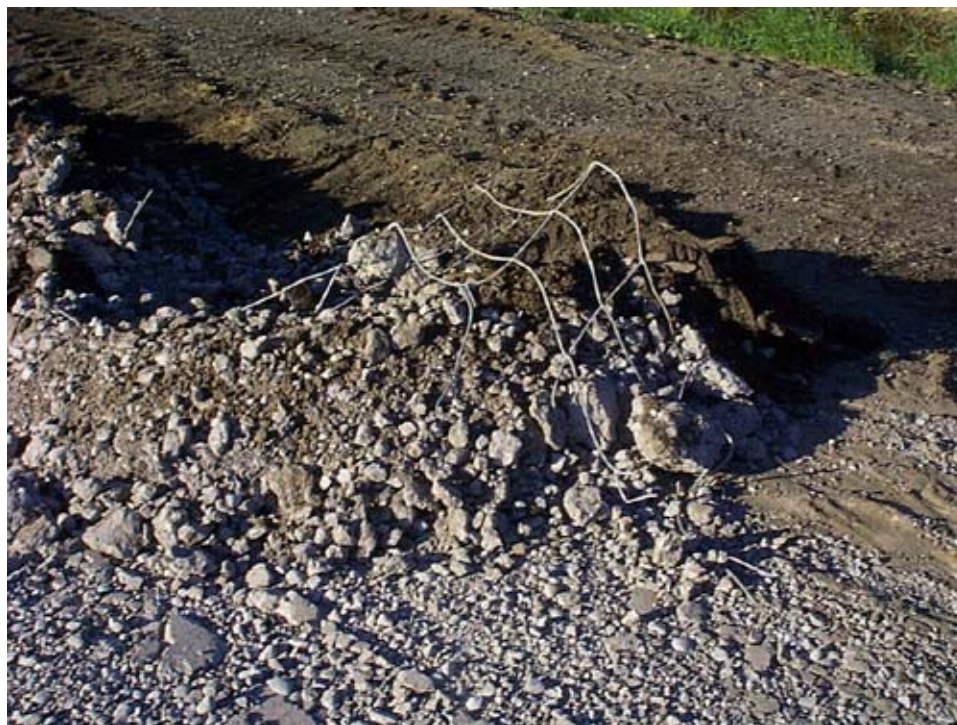
FIGURE 11 Exposed reinforcing steel after rubblization. (Photo Courtesy RMI.)

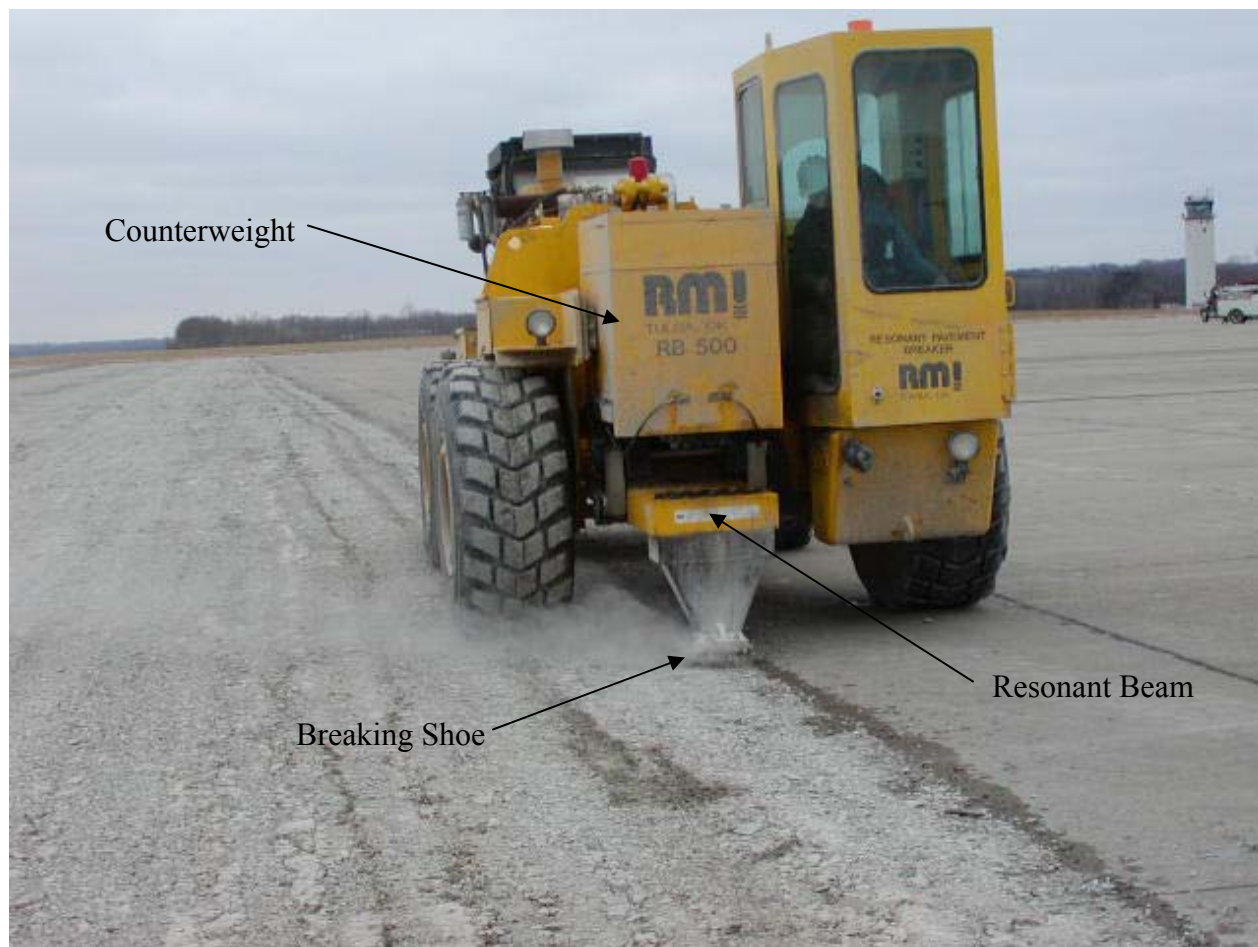
FIGURE 1 Resonant pavement breaker (courtesy RMI, Inc.)

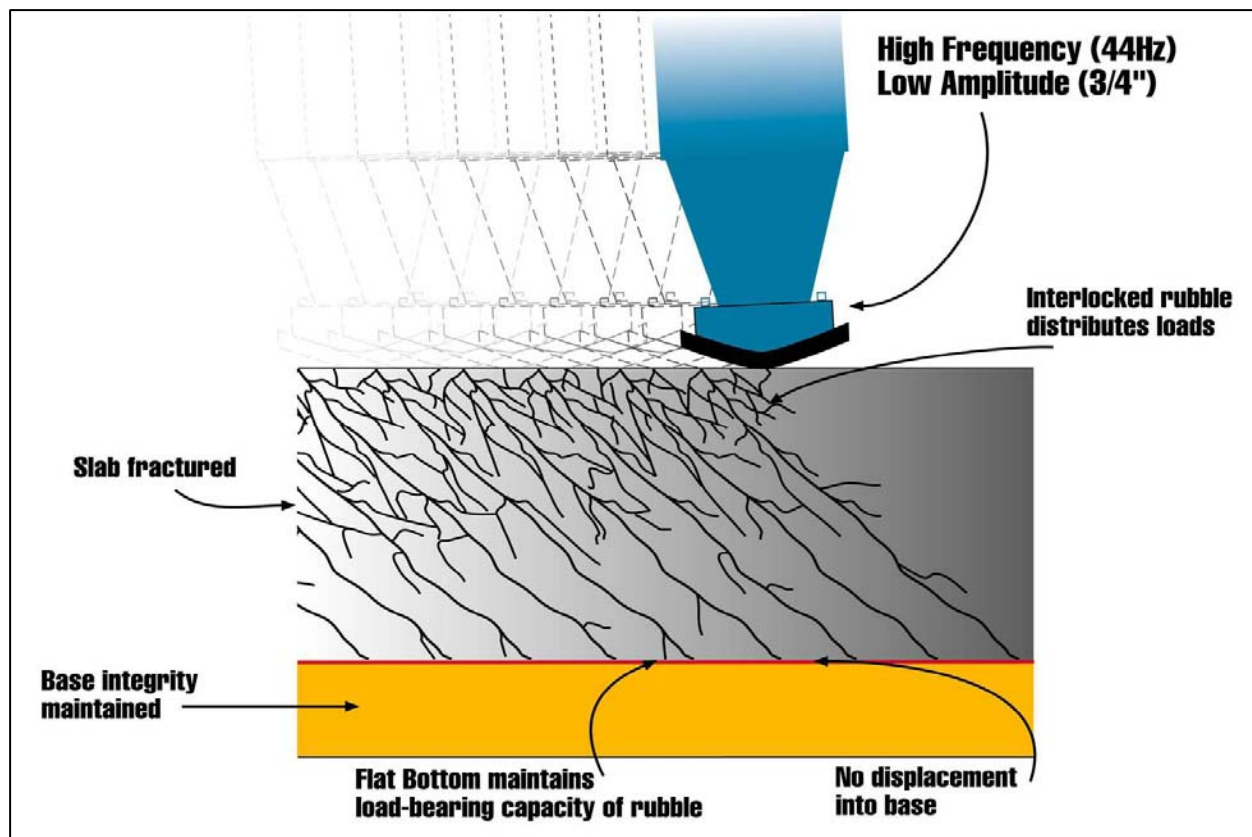
FIGURE 2 Illustration of PCC fracturing resulting from Resonant Rubblization (1).

The mechanics of how the concrete fractures have not been reported in detail, but the cracking resembles “shear-compression” failure described by Ferguson (2) for reinforced concrete beams. In this mode of failure, diagonal cracks may “initiate approximately a 45-degree crack,” followed by crushing on the surface as the crack propagates up through the concrete.

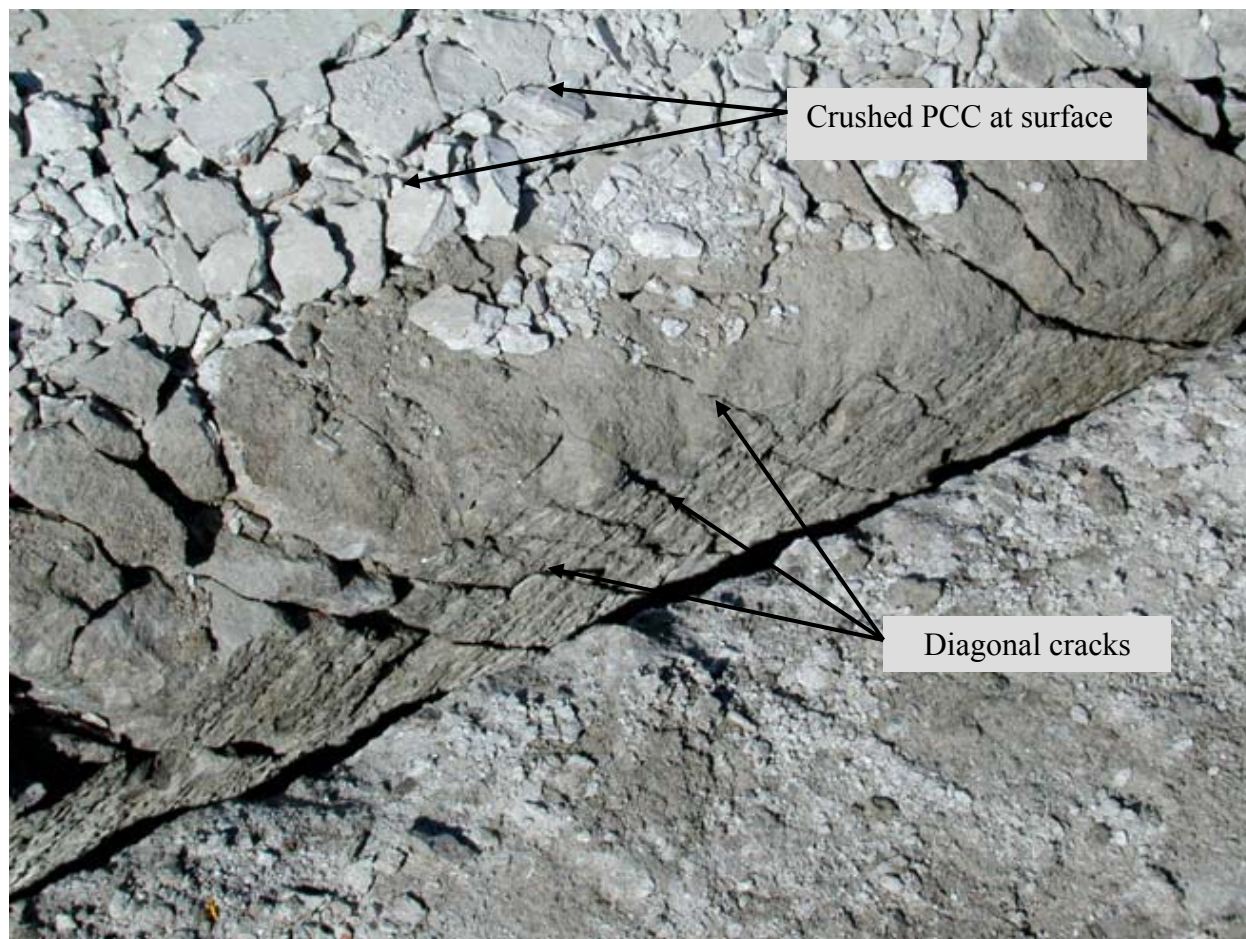
FIGURE 3 Resonant broken PCC pavement.

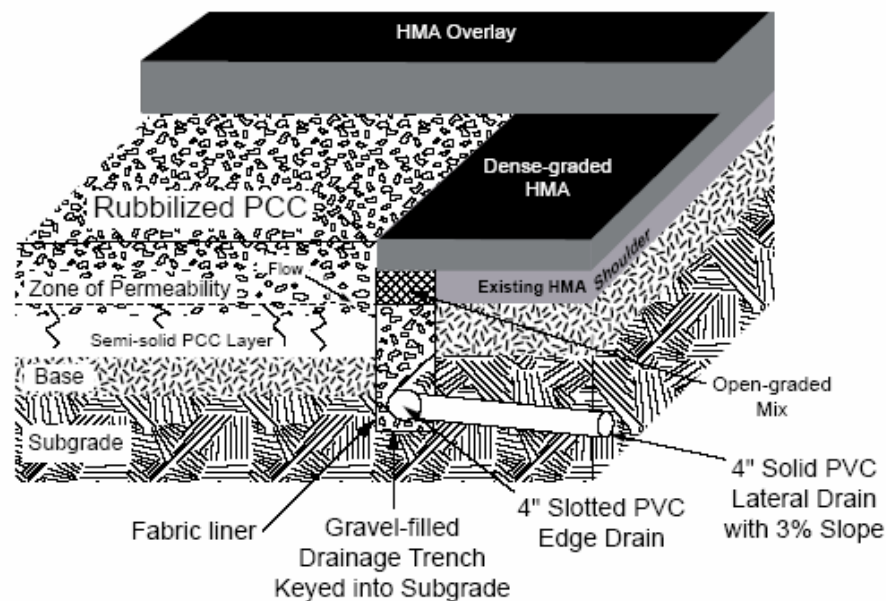
FIGURE 4 Longitudinal edge drain system for rubblized PCC pavement (3, Figure 15–2).

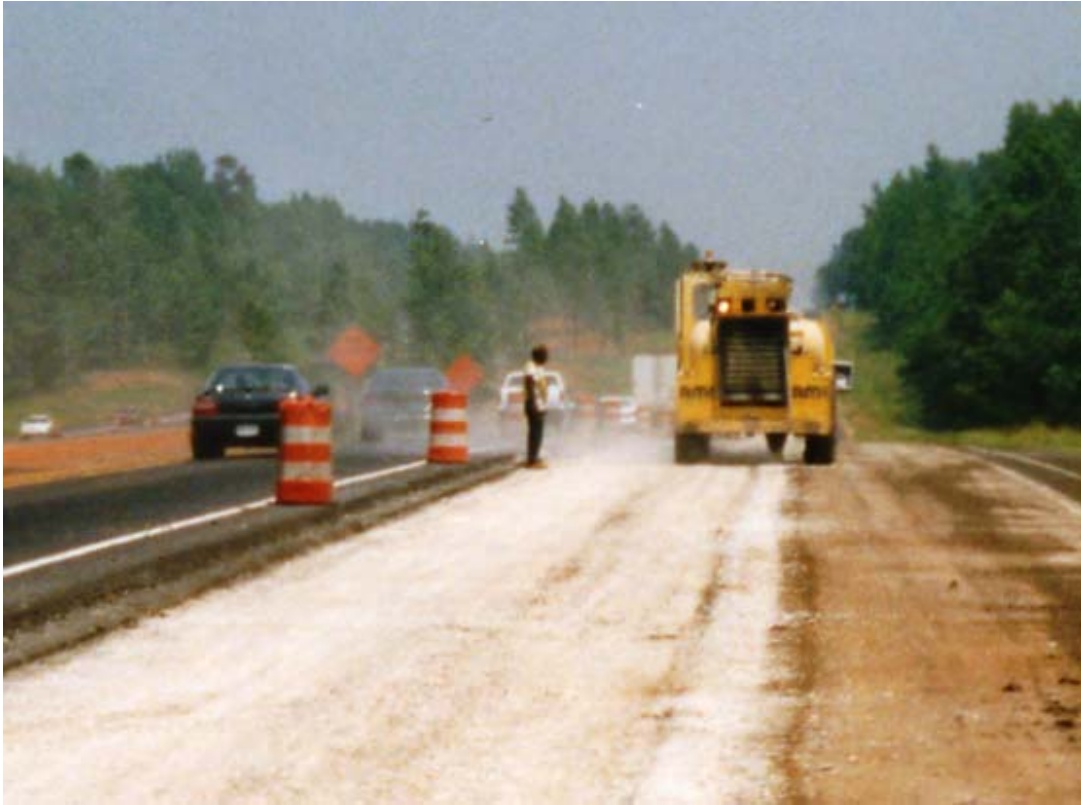
FIGURE 5 Resonant rubblizing starting from pavement edge.

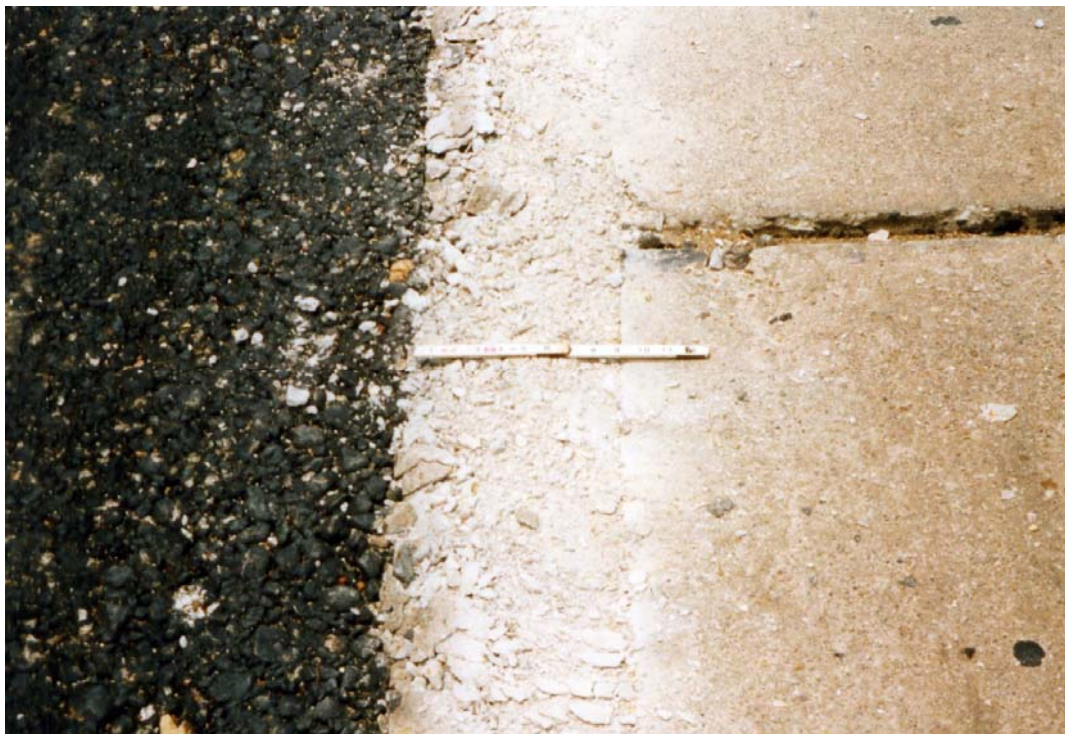
FIGURE 6 Rubblized surface adjacent to shoulder.

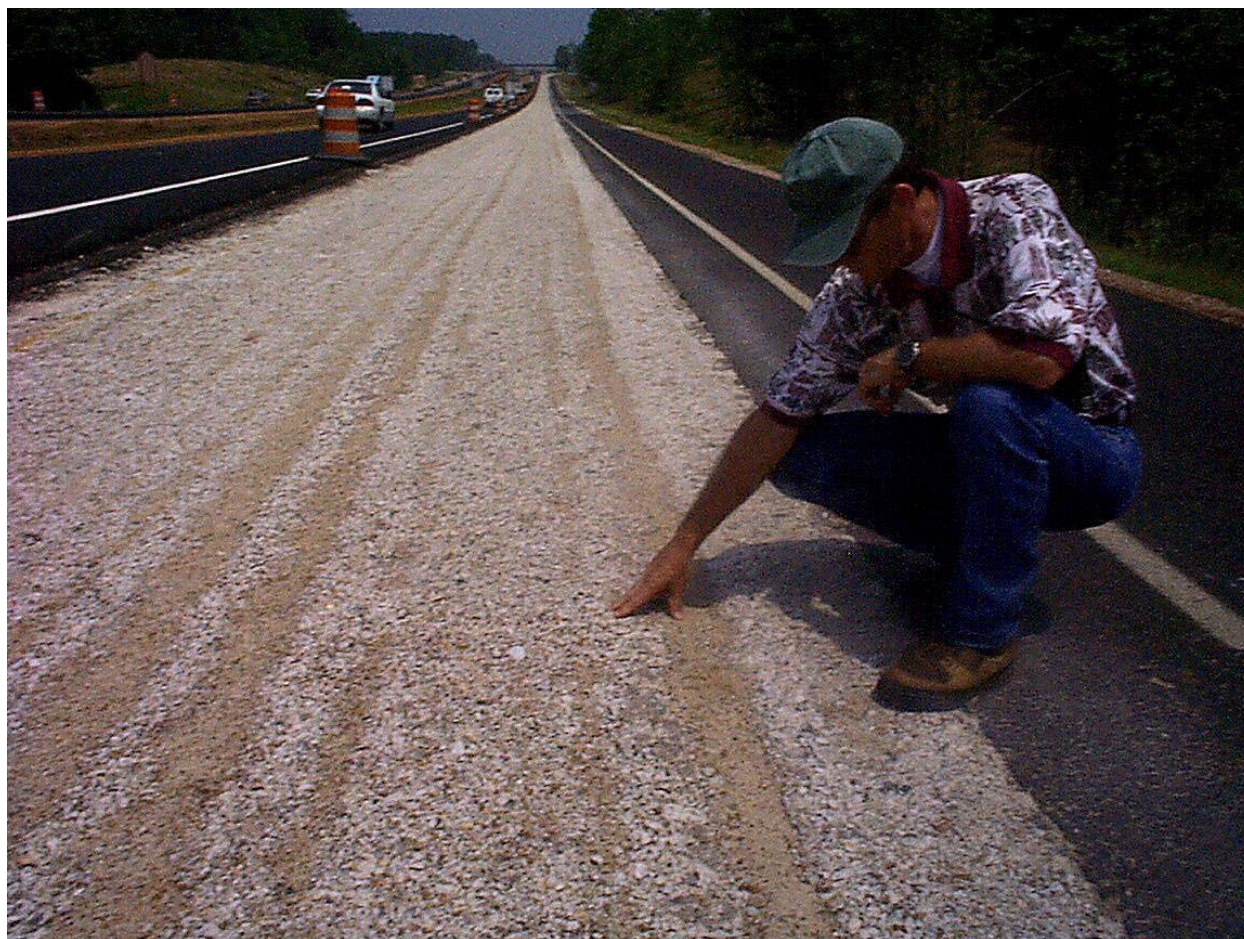
FIGURE 7 Resonant rubblized PCC, before rolling.

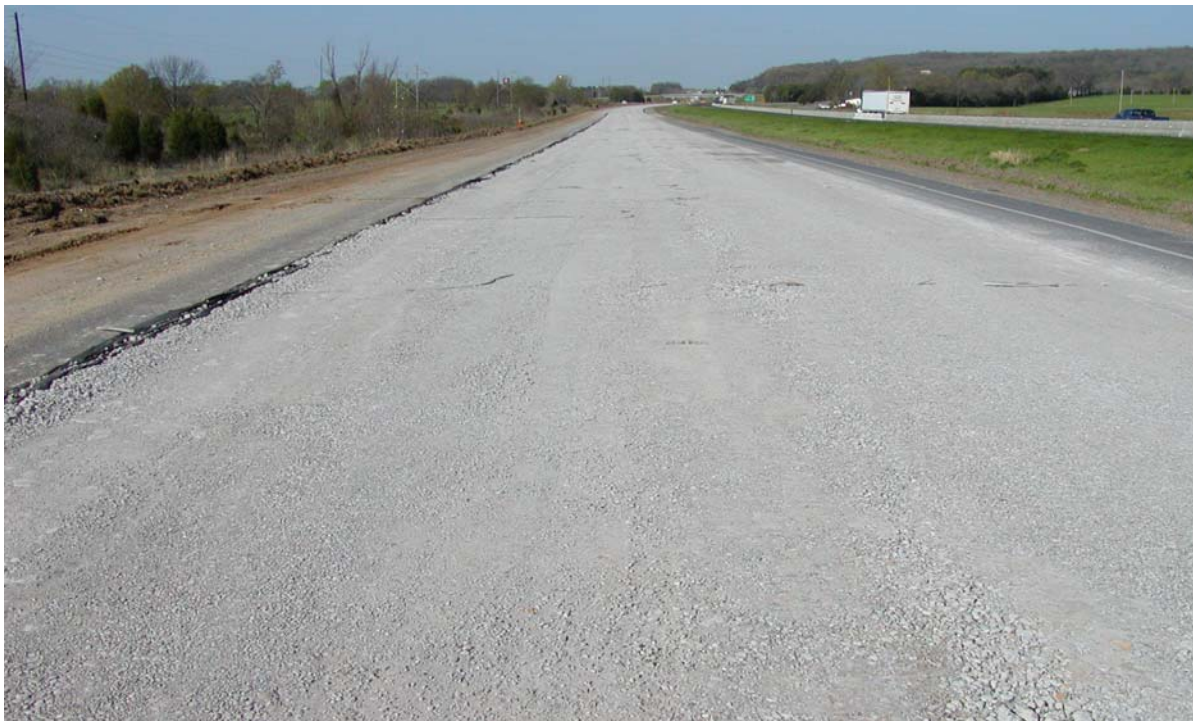
FIGURE 8 Resonant rubblized PCC, after rolling. (Photo courtesy of RMI, Inc.)

Rolling the surface is performed to prepare the surface for placing the overlay. The operational characteristics and mass of the RPB, moving up and back over the pavement surface provide any proof rolling or seating of material at areas where voids developed under the slab such as at faulted transverse joints or punchouts. As mentioned before, the rubblized PCC is loosened superficially by the resonant breaker, with the remainder of the material intact except for fissures that extend through the concrete. Tandem vibratory rollers (min. 9000 kg, 10 tons) operating at the highest frequency setting available are required by specification, as are pneumatic-tired rollers in some states. Two to four passes of the tandem vibratory roller, depending on how the material responds to rolling, are normally applied, with the roller operating at a forward speed that results in at least 33 impacts/meter (10 impacts/ft). It was originally thought that the rolling should occur while the material was in a dry state—this has changed over time with experience. As with rolling any unbound material, moisture lubricates particle surfaces and facilitates particle reorientation. **Figure 8** shows a rubblized and rolled surface ready to be paved.

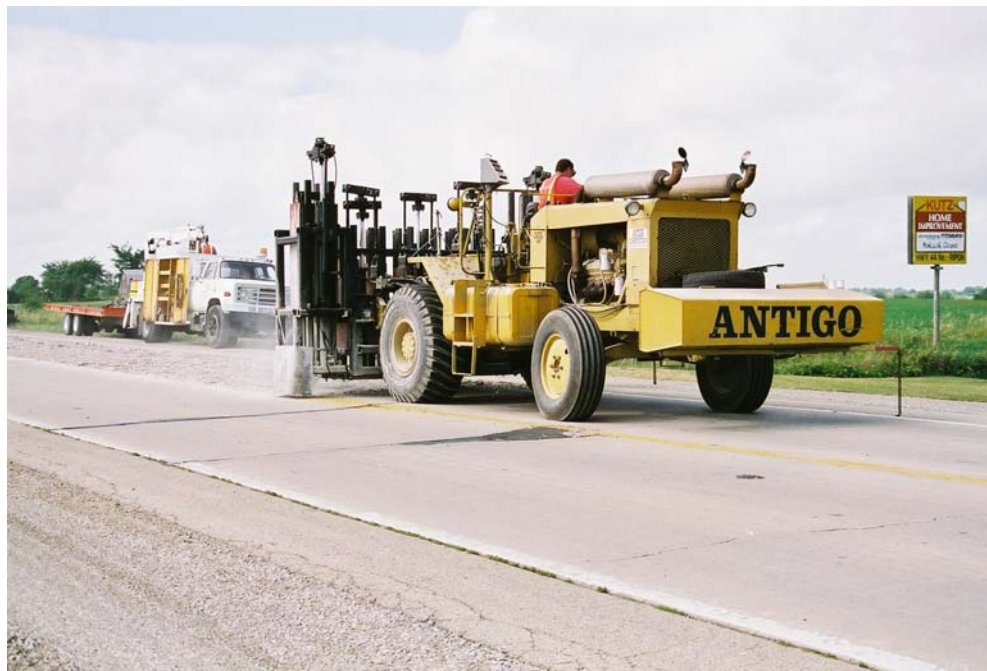
FIGURE 1 The “prototype” MHB (1995).

The prototype MHB (Figure 1) was built on an existing Bomag MPH100 chassis and first used in 1995. It was outfitted with 1,000-lb (4.4-kN) interior hammers and 1,500-lb (6.6-kN) wing hammers. The maximum hammer drop height was 48 in. (1.2 m). A second MHB prototype was built in 1996 on an existing Wirtgen concrete breaker chassis with the same hammer specifications as the first MHB. After operating these two MHBs for 2 years, a standard design was developed and the third and fourth MHBs were manufactured from the ground up and went to work in 1997 with the same hammer specifications as the prototypes. Figure 2 shows a current MHB model.

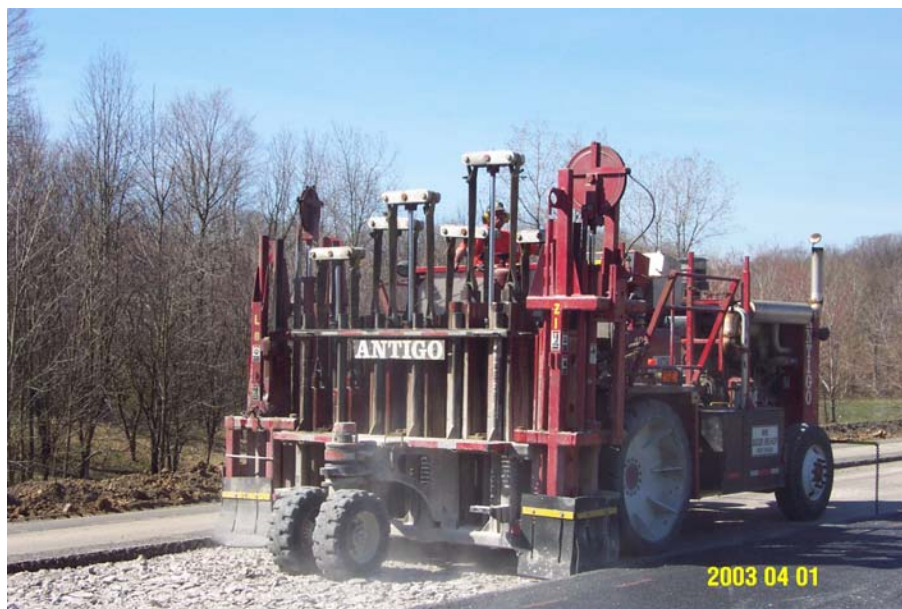
FIGURE 2 A recent model MHB.

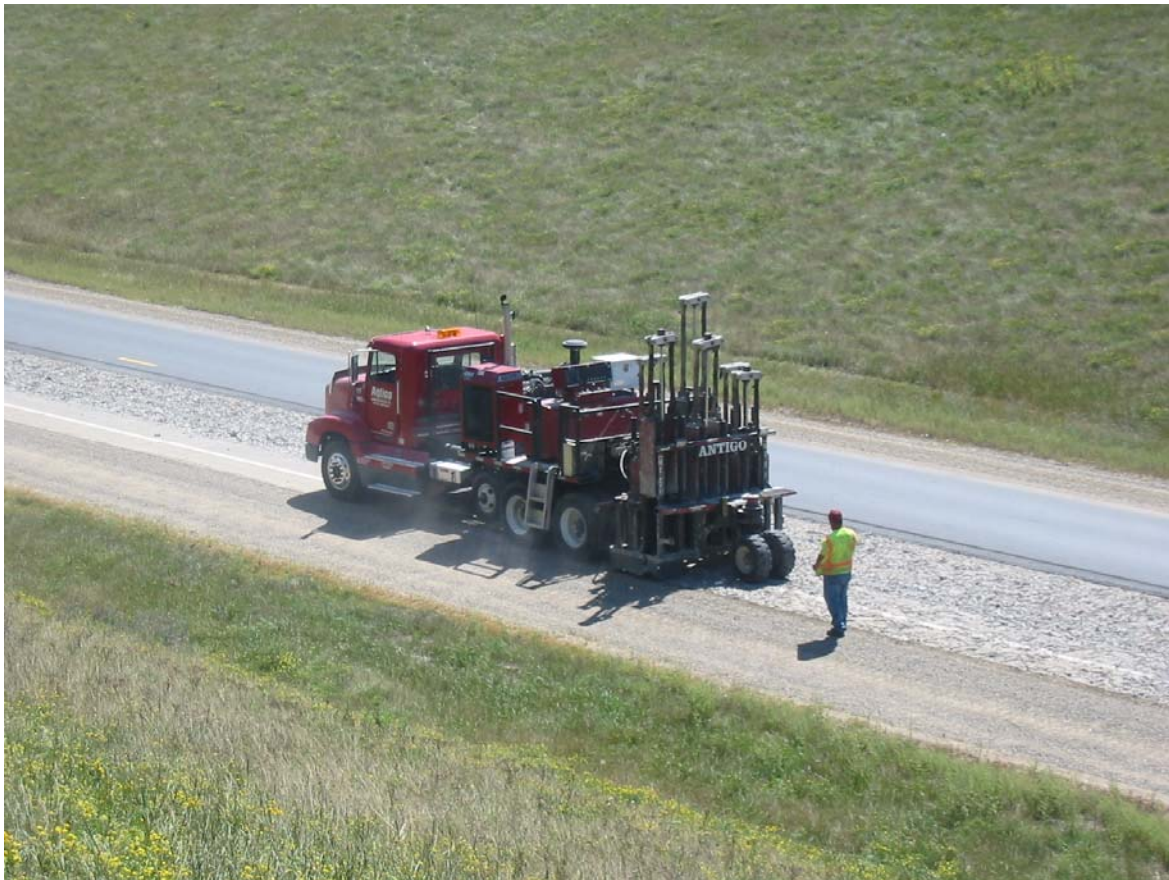
FIGURE 3 The MHBT.

The most recent MHB development was the introduction in 2003 of a truck-mounted MHB (MHBT) shown in [Figure 3](#). This is an 8-ft (2.44-m) wide MHB mounted on a truck. The operator can drive the truck from project to project and operate it in the same manner as the conventional chassis MHB. In order to meet maximum axle weight rules, the MHBT carries 1,200 pound (5.3 kN) hammers but the front row hammers have a maximum drop height of 72 in. (1.83 m). The higher drop height compensates for the lesser weight hammers when compared to the current standard 1,500-lb (6.6-kN) hammers on the chassis MHBs. The MHBT utilizes a wireless remote control that allows the operator to control it from the best vantage point.

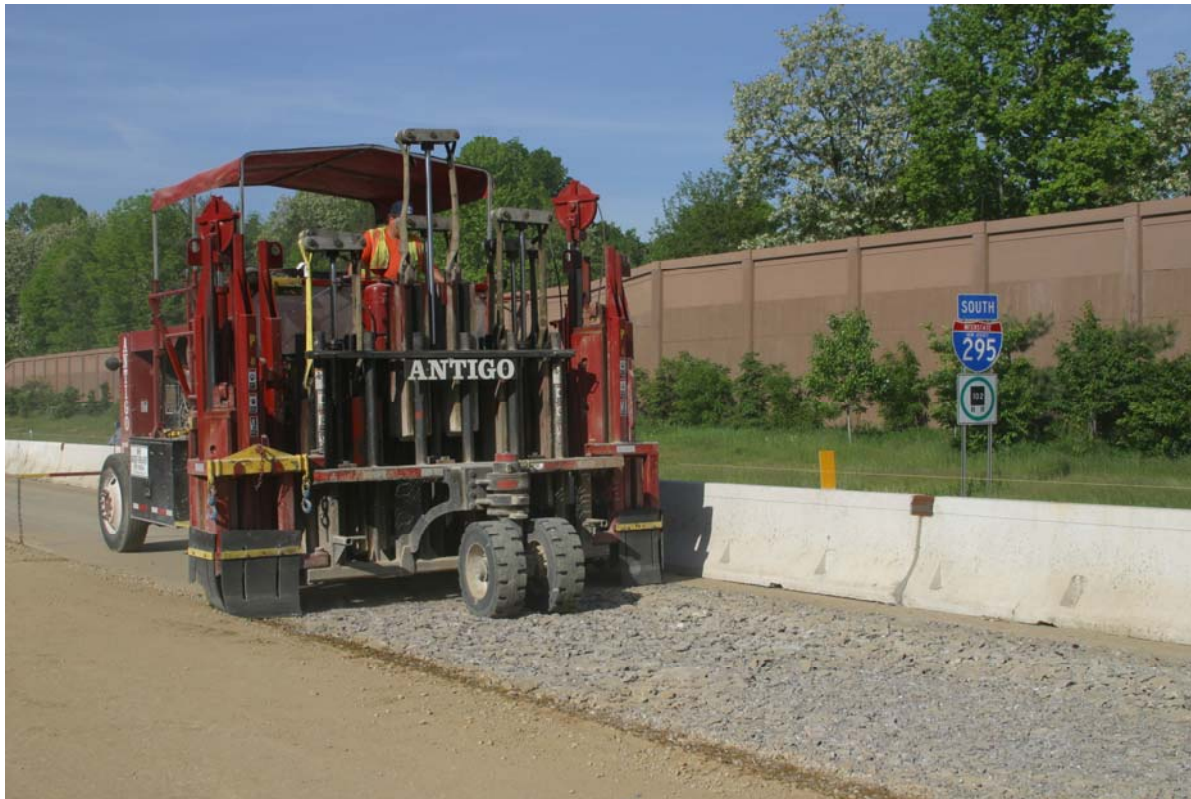
FIGURE 4 The MHB operating working close to a barrier.

- The MHB is a lane-width/one-pass machine.
- The MHB can operate close to the pavement centerline/edge (traffic is frequently diverted to the adjoining shoulder lane/shoulder during construction) and traffic barriers without unduly interfering with traffic (Figure 4).
- By varying MHB operating characteristics (hammer weights, number of hammers, hammer drop heights, and travel speed) the MHB can produce a wide range of fracture patterns to accommodate individual project conditions such as
 - Differing specifications (rubblization to B/C/S),
 - Variable support (PCC thickness/concrete quality, base/subbase) conditions, and
 - Subgrade strength/modulus.
- Drop height and travel speed can be adjusted by the MHB operator “on the fly.”

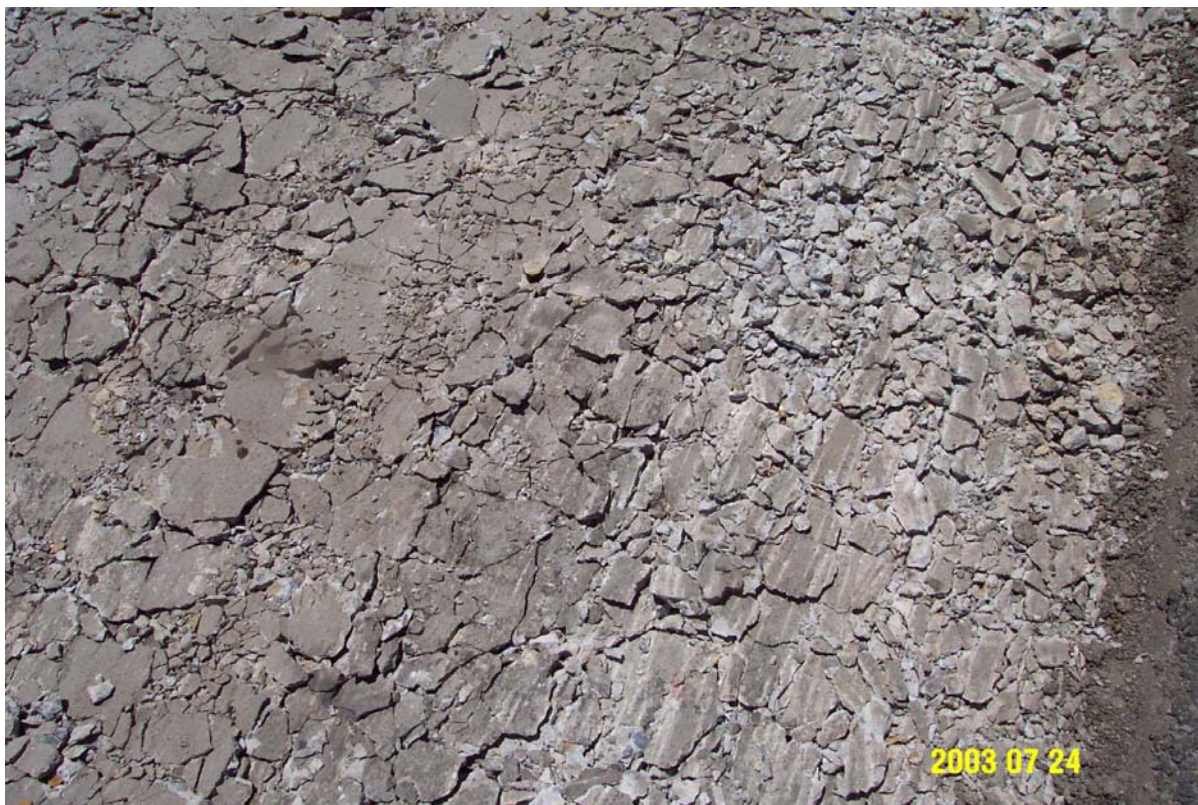
FIGURE 5 Note the “flaky” rubblized PCC surface.

- Install (if specified) the underdrain system.
- Remove any existing HMA overlay(s).
- Repair/replace any “unsound” PCC patches (either concrete or HMA).
- Rubblize the PCC to meet specification. (The surface of the MHB rubblized PCC is typically “flaky” in nature—see [Figure 5](#)).

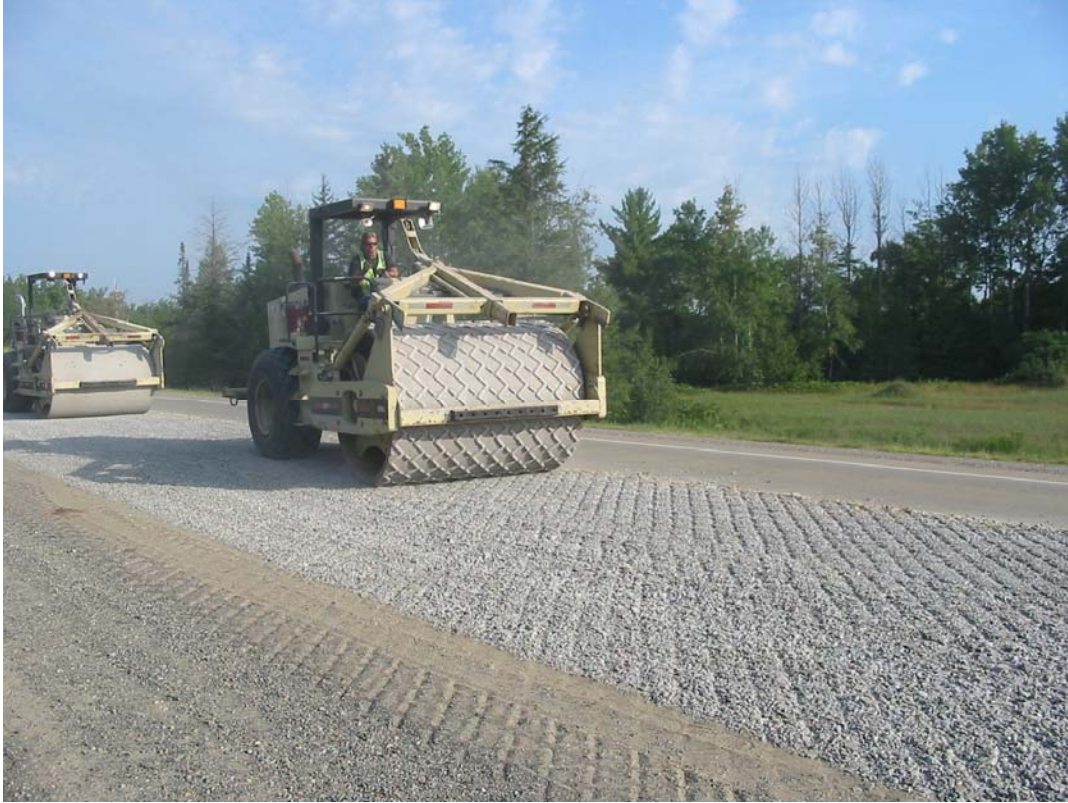
FIGURE 6 A vibratory Z-grid roller followed by a vibratory steel-wheeled roller.

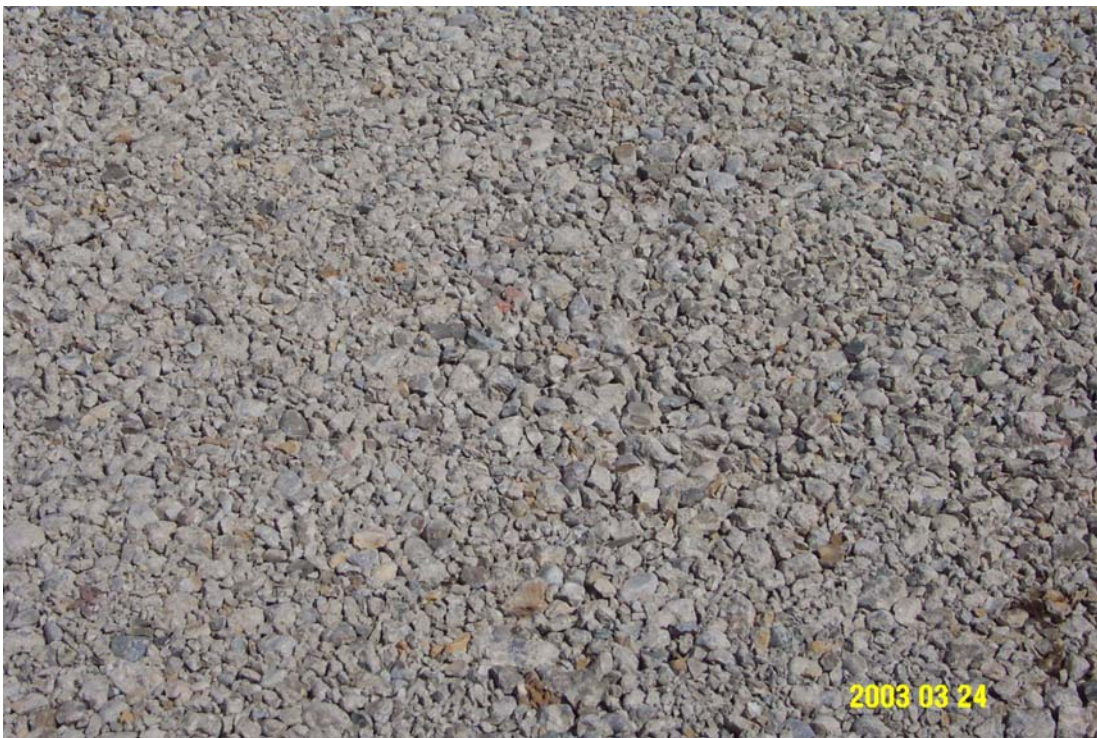
FIGURE 7 The final rubblized and compacted PCC surface.
