Rubblization of Portland Cement Concrete Pavements

TRANSPORTATION RESEARCH
CIRCULAR

Number E-C087

**Rubblization of
Portland Cement
Concrete Pavements**

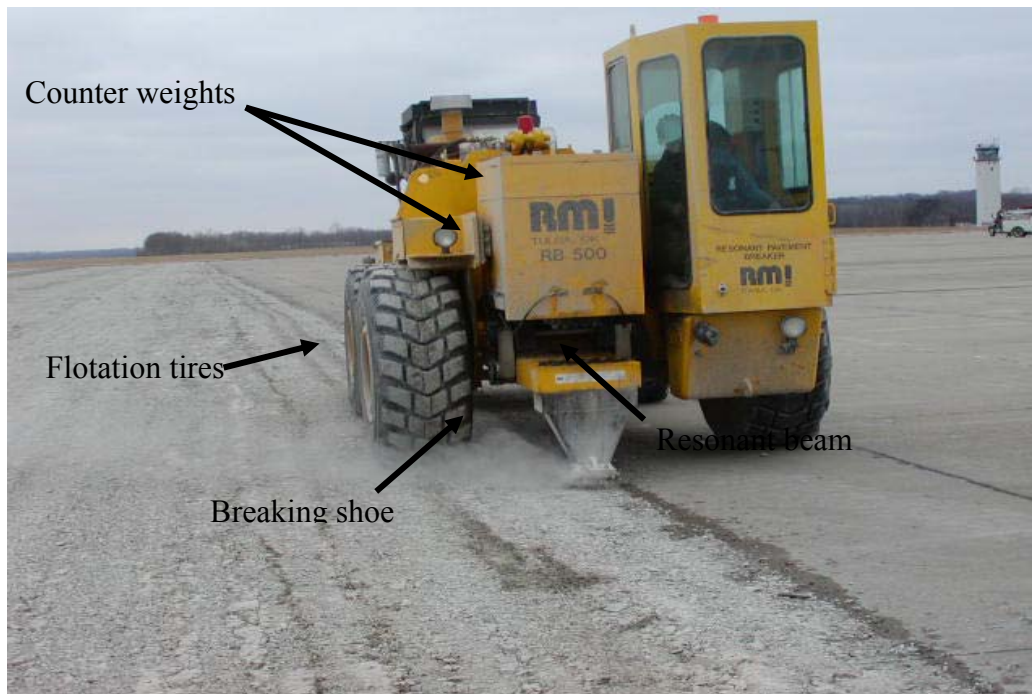
FIGURE 1 Resonant concrete pavement breaker.

The vibrating foot rubblizes the concrete pavement in narrow strips as the machine moves forward along the free edge or unfractured edge of the existing pavement. The forward speed of the machine depends on the size of the machine, slab thickness, the stiffness of the PCC, and the support provided by the subgrade. Generally, one machine can be expected to rubblize from 5000 to 7000 m² (6,000 to 8,000 yd²) per workday shift, with thick airfield pavement work being on the low end of this range. For critical projects, multiple machines can be employed to expedite the process.

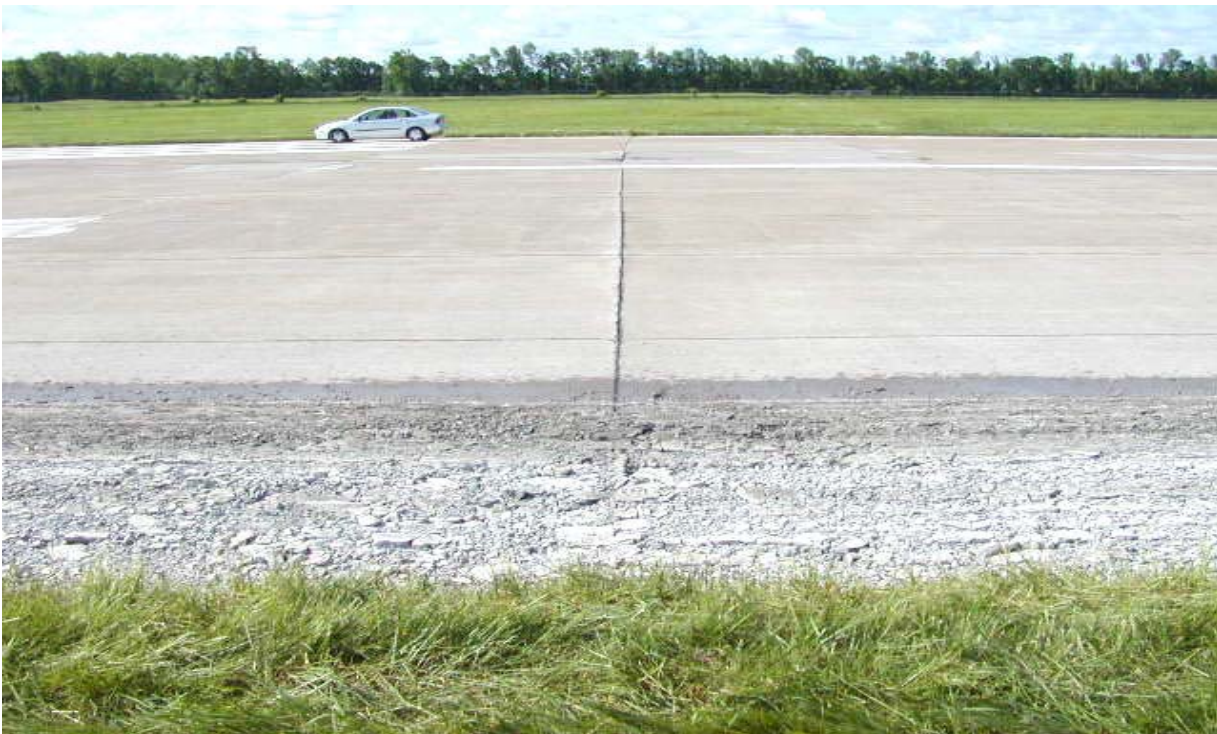
FIGURE 2 Starting from free edge.

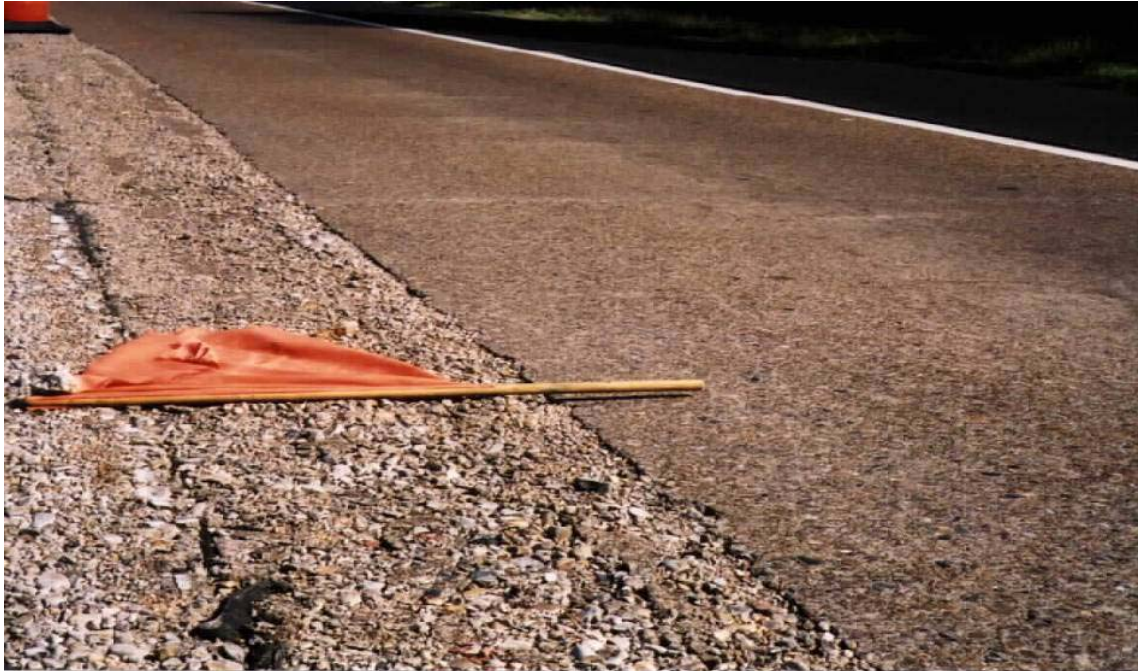
FIGURE 3 Vertical displacement prior to rolling.

As RPBs work along the unfractured edge of an existing PCC pavement, a small amount of horizontal and vertical expansion takes place (**Figure 3**). Early airfield rubblization projects required relief joints (**Figure 4**) to be cut full-depth through the pavement at fix intervals to take up the horizon expansion that accumulates as large areas are rubblized. Recent advancements in RPB design and technology, including significant horsepower increases, have all but eliminated the need for cutting relief trenches in the pavement prior to rubblization. However, certain combinations of older and smaller breakers and thicker pavement sections can result in situations where relief trenches are still necessary. The need for relief trenches will show up in the form of the “hammer and anvil” effect as described above and reduced breaking effectiveness.

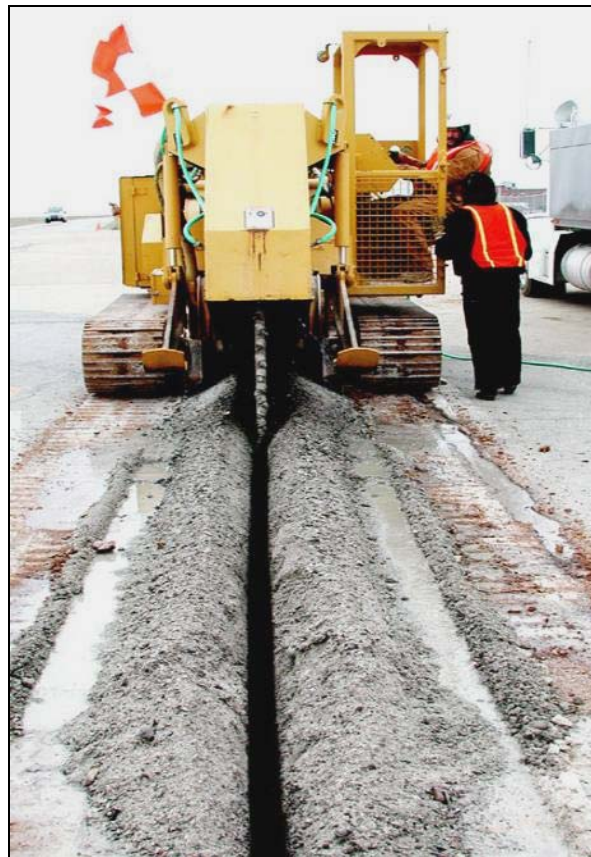
FIGURE 4 Relief trench cut with a wheel saw.

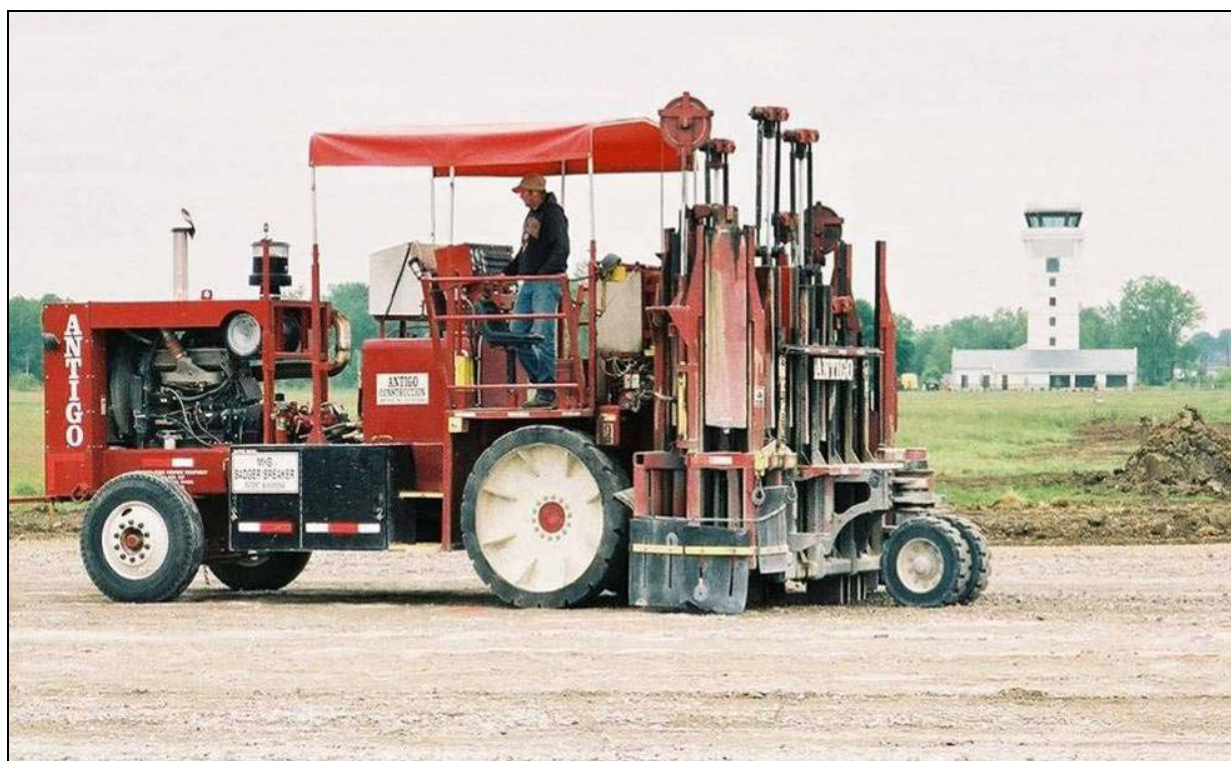
FIGURE 5 MHB.

Rubblization using a MHB requires a single pass over an area to be rubblized. The tractor or power unit travels on the unbroken slab as it moves forward and tows the breaking unit behind. Because it is a single pass technique, there is no need for the MHB to travel on the rubblized surface. Fracturing of the slab is controlled by a set combination of drop height, frequency of the impacts and the forward speed of the machine as determined by a test strip/pit.

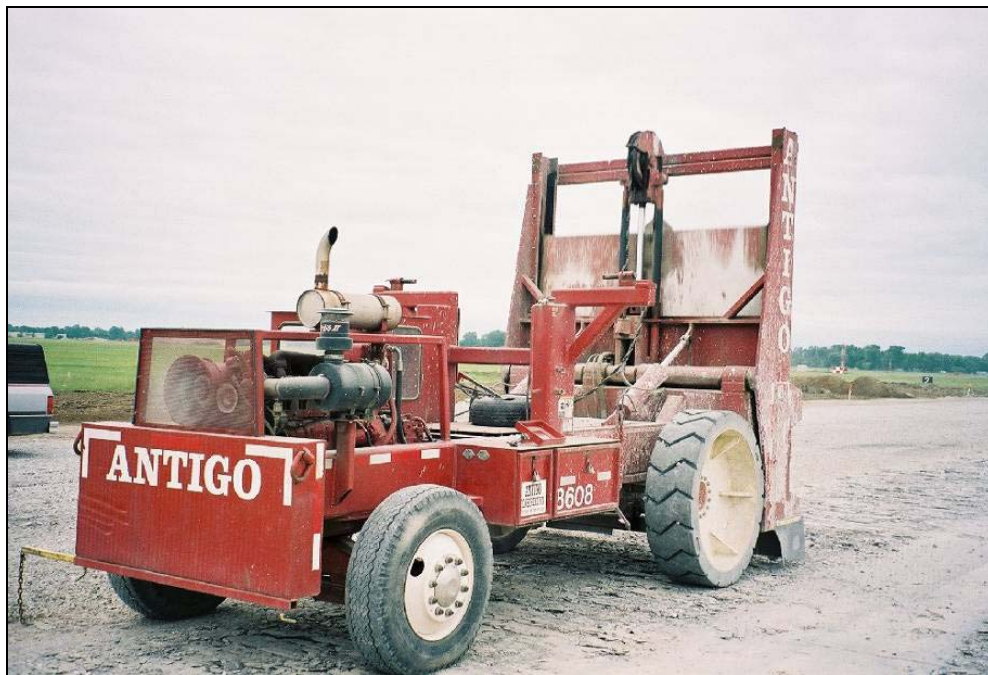
FIGURE 6 Guillotine style breaker.

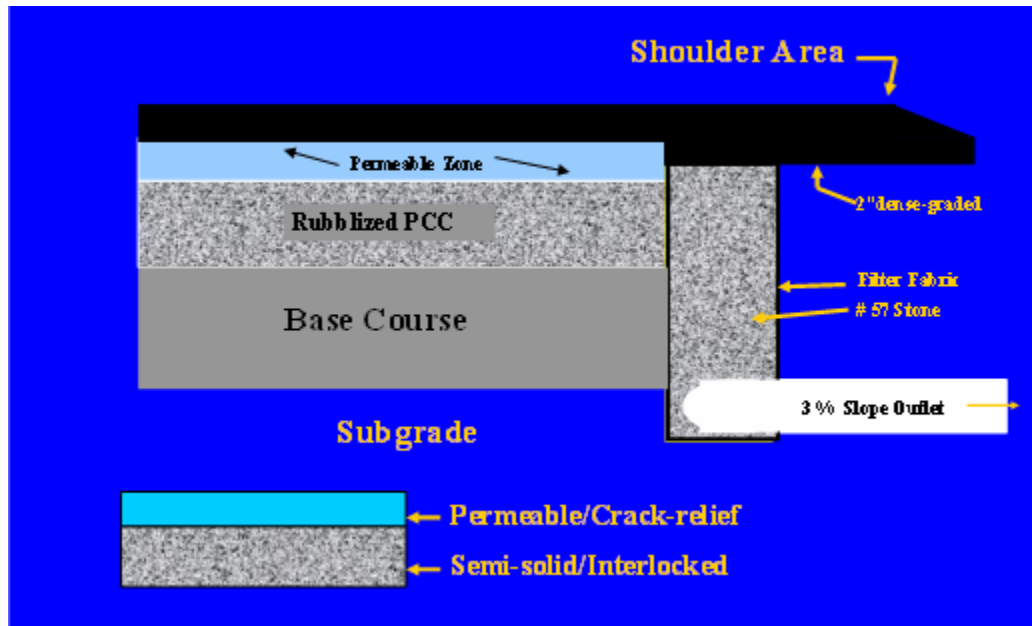
FIGURE 7 Typical side drainage system.

During the service life of the pavement, the underdrain system must have sufficient capacity and depth to collect and carry the water being discharged from the subgrade, the old permeable base, and the top or “permeable zone” of the rubblized layer (Figure 7). The trench depth must be deep enough to accomplish the intended drainage function. It is recommended that the trench depth be deep enough to allow the top of the pipe to be located a minimum of 5-cm (2 in.) below the bottom of the permeable base material. The filter fabric and trench backfill

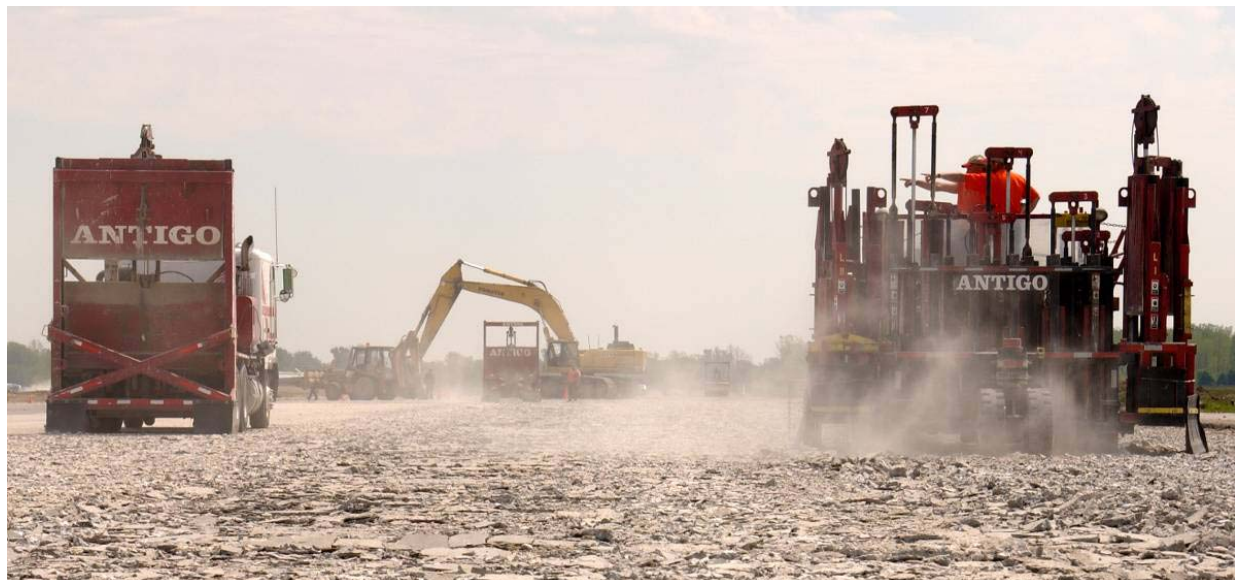
FIGURE 8 Dust generated during rubbleization.

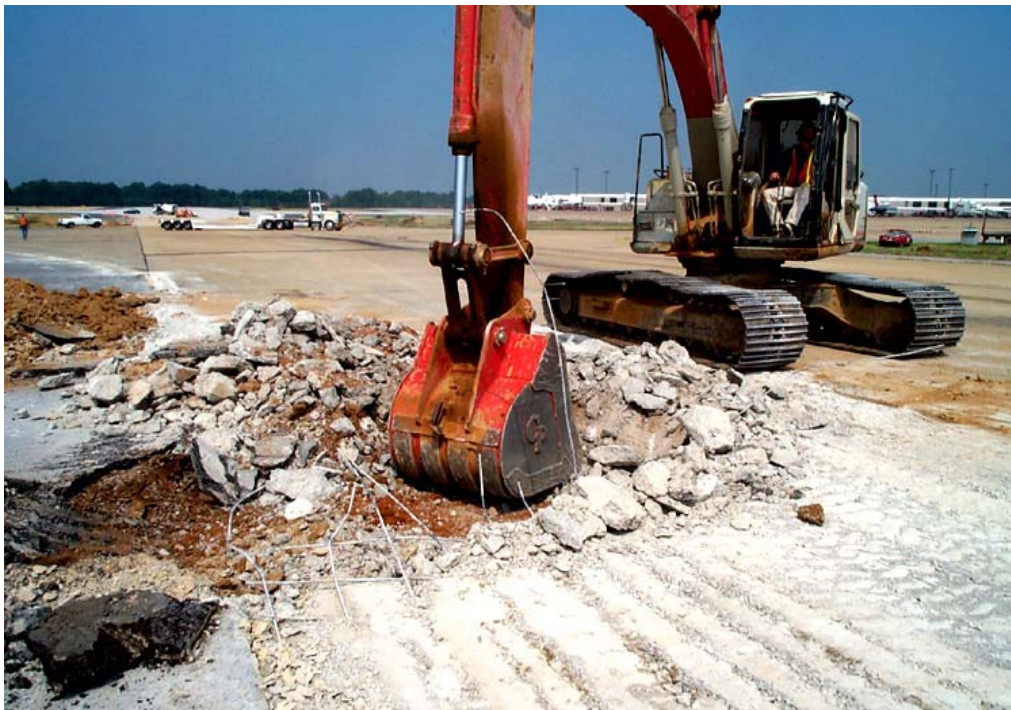
FIGURE 10 Test pit showing complete debonding of steel.

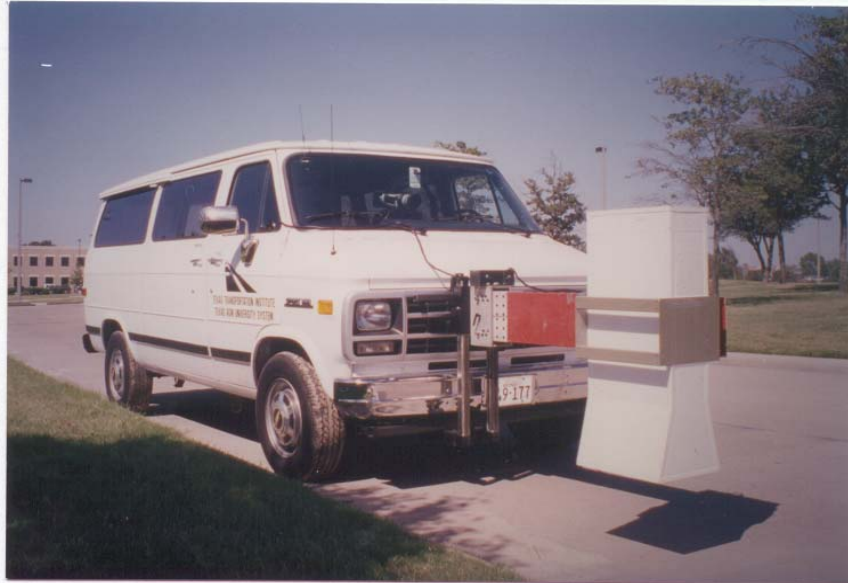
(a) TTI GPR Equipment

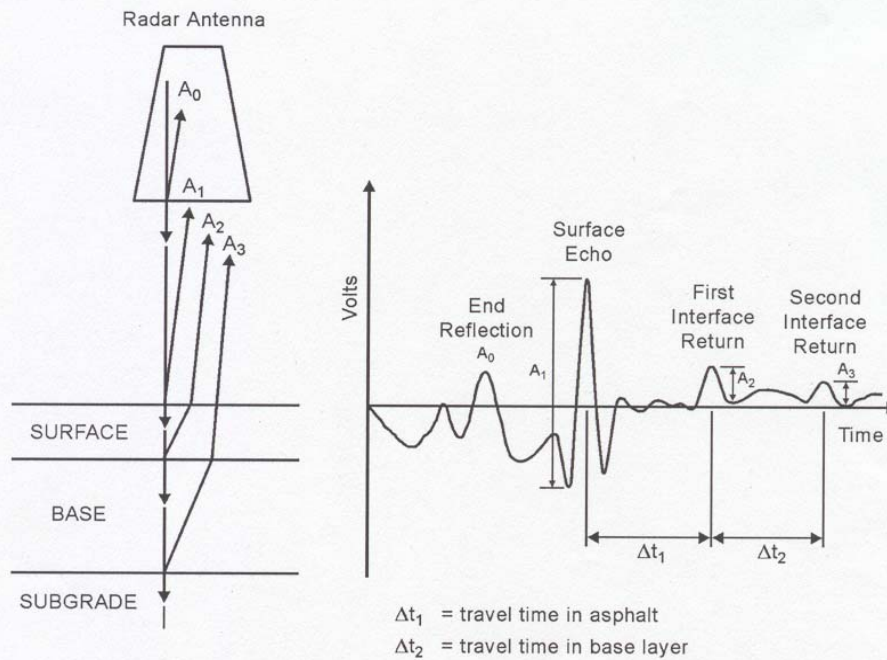
(b) Principles of GPR. The incident wave is reflected at each layer interface and plotted as return voltage against time of arrival in nanoseconds.

The examples below illustrate how changes in the engineering properties of the pavement structure would influence the typical GPR trace shown in [Figure 1b](#).

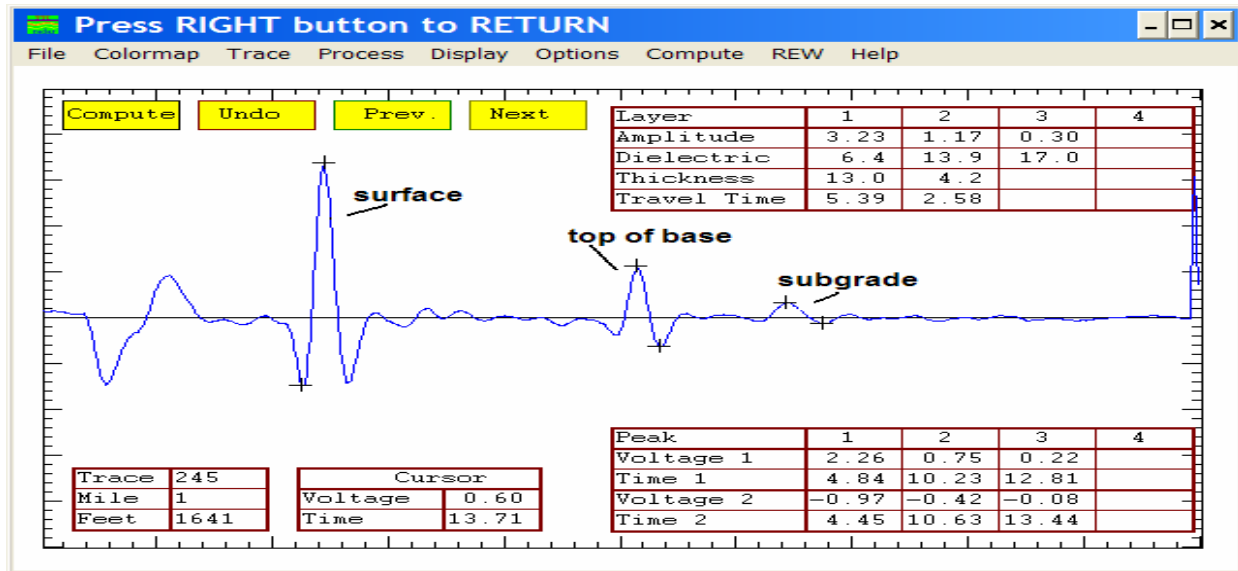
FIGURE 2 One individual GPR trace from a thick HMA pavement.

It is noted that the zero on the depth scale is the reflection from the surface of the pavement. The important feature of this figure are the lines marked H, I, and J. These are the reflection from the surface, top and bottom of base respectively. The pavement is homogeneous and the layer interfaces are easy to detect. The variation in surface dielectric is shown at the bottom of the figure. For good quality uniform density HMA this would be almost a horizontal line. Significant areas of high dielectrics would indicate wet areas on the surface. Significant dips in surface dielectric are associated with areas of low density areas in the mat, typically “truck-end” segregation.

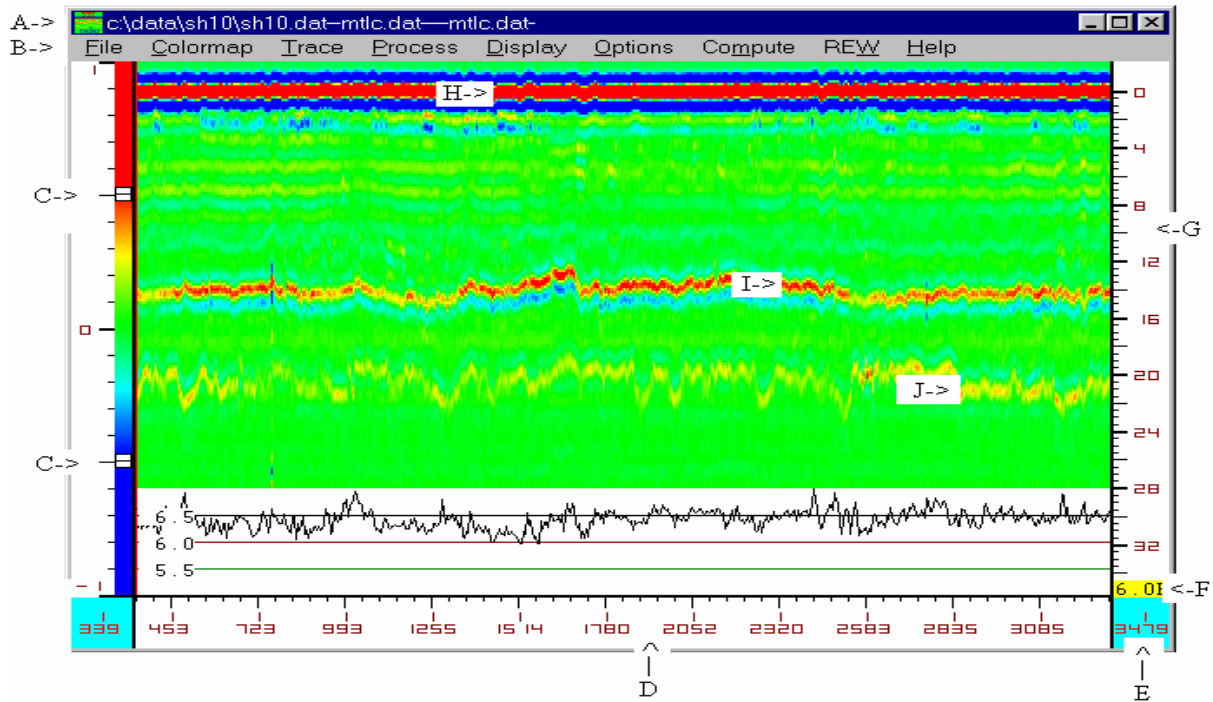
FIGURE 3 Color-coded GPR traces for a 2500-ft section.

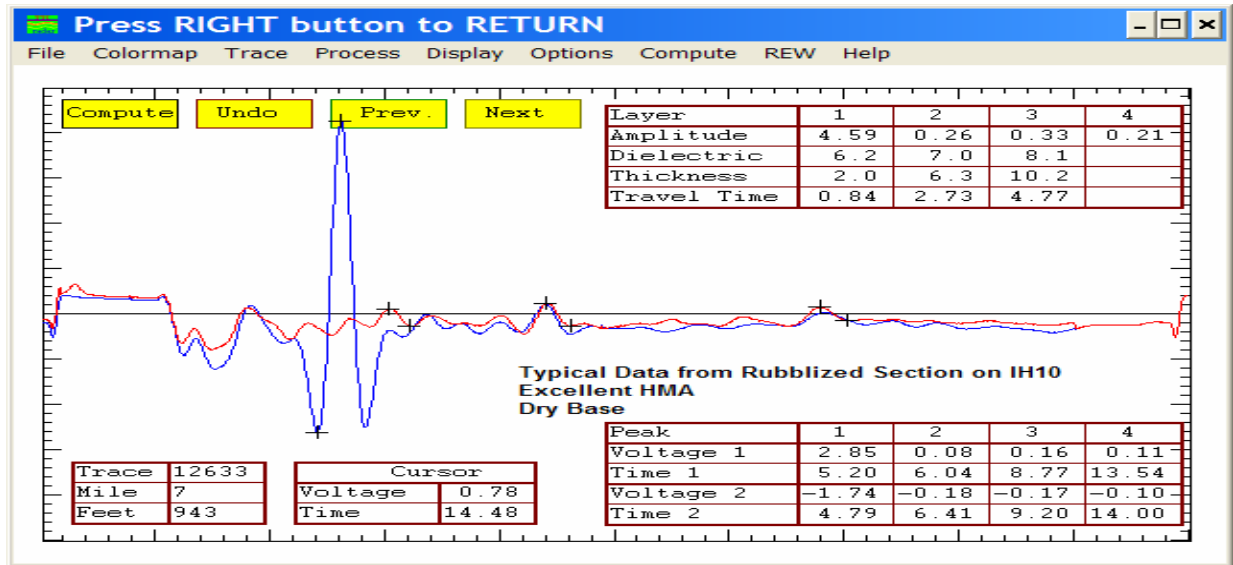
FIGURE 4 Typical trace obtained on Job 2 (ideal case: no defects).

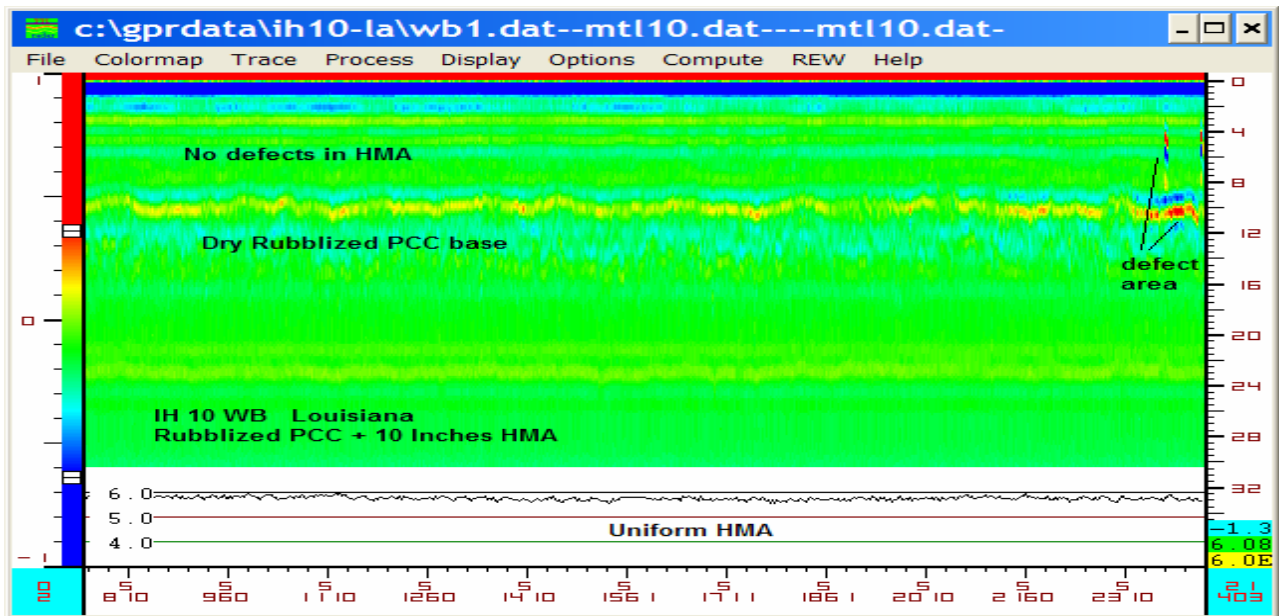
FIGURE 5 Typical Colormap display for Job 2 (ideal case), small defect area at right of display.

There is one small defect areas to the far right of [Figure 5](#). There is a localized strong red/blue reflection at approximately mid depth in the HMA layer. The location and significance of this defect will be discussed later in this paper.

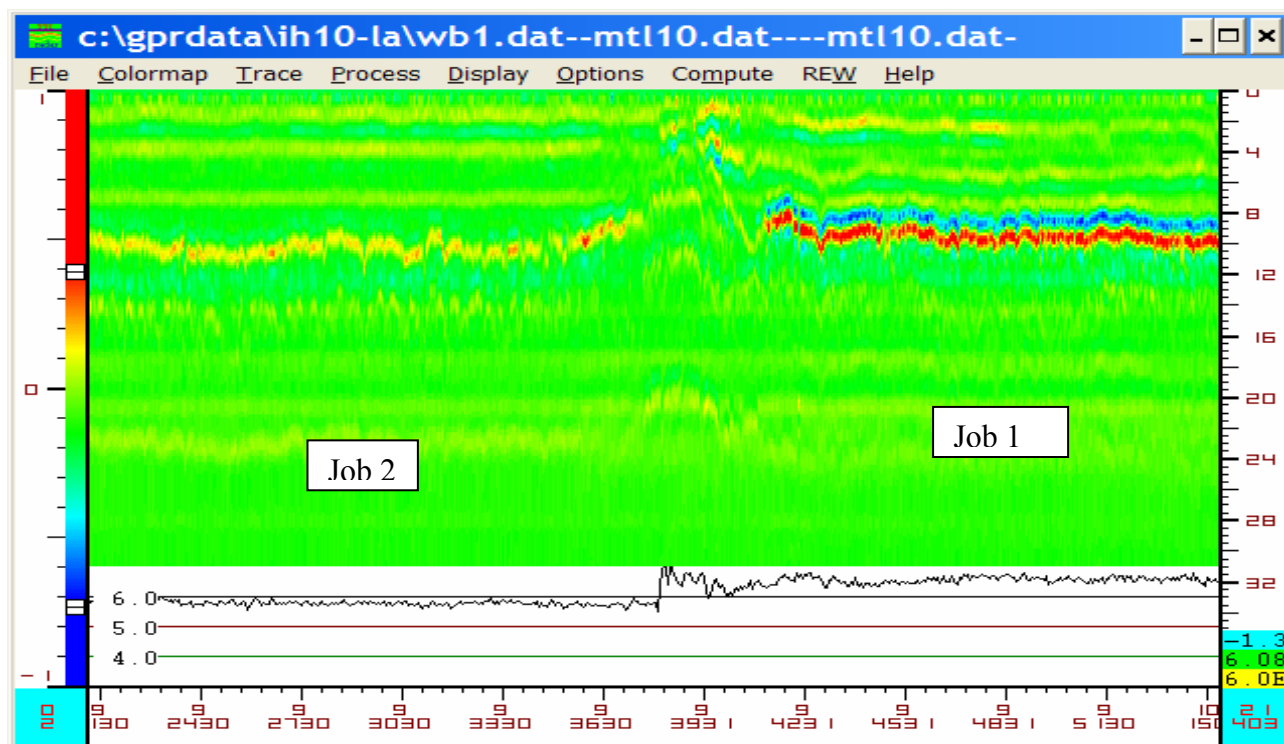
FIGURE 6 Transition from Job 2 to Job 1 WB I-10.

There are several clear differences between Jobs 1 and 2. Job 2 is judged as ideal data. The transition from Job 2 to Job 1 is shown below in Figure 6. One big difference between the jobs is the interface at the top of the rubblized concrete. As shown below the pattern changes from a faint yellow line to a stronger blue/red line. Two factors could be causing this stronger reflection. The first and most probable are density problems at the bottom of the lower Superpave binder

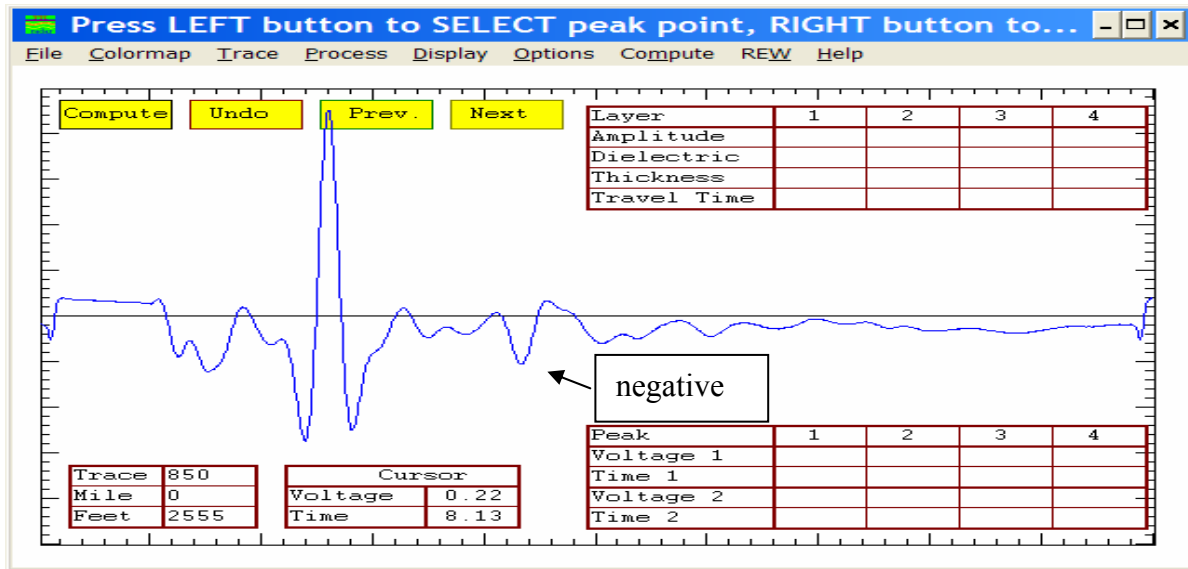
FIGURE 7 Potential defect area in Job 1. Negative or inverted reflection at bottom of HMA indicates potentially poor compaction at the bottom of the binder course.

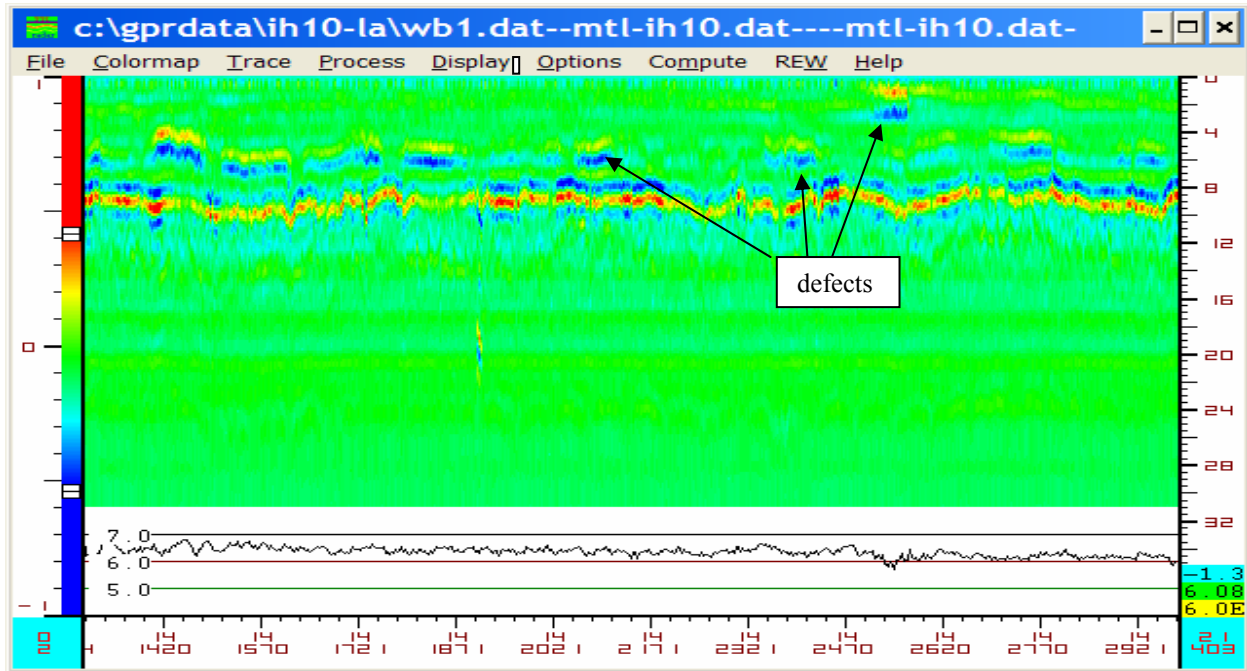
FIGURE 8 WB I-10 Job 1, blue areas in HMA indicate possible localized compaction problems or segregation.

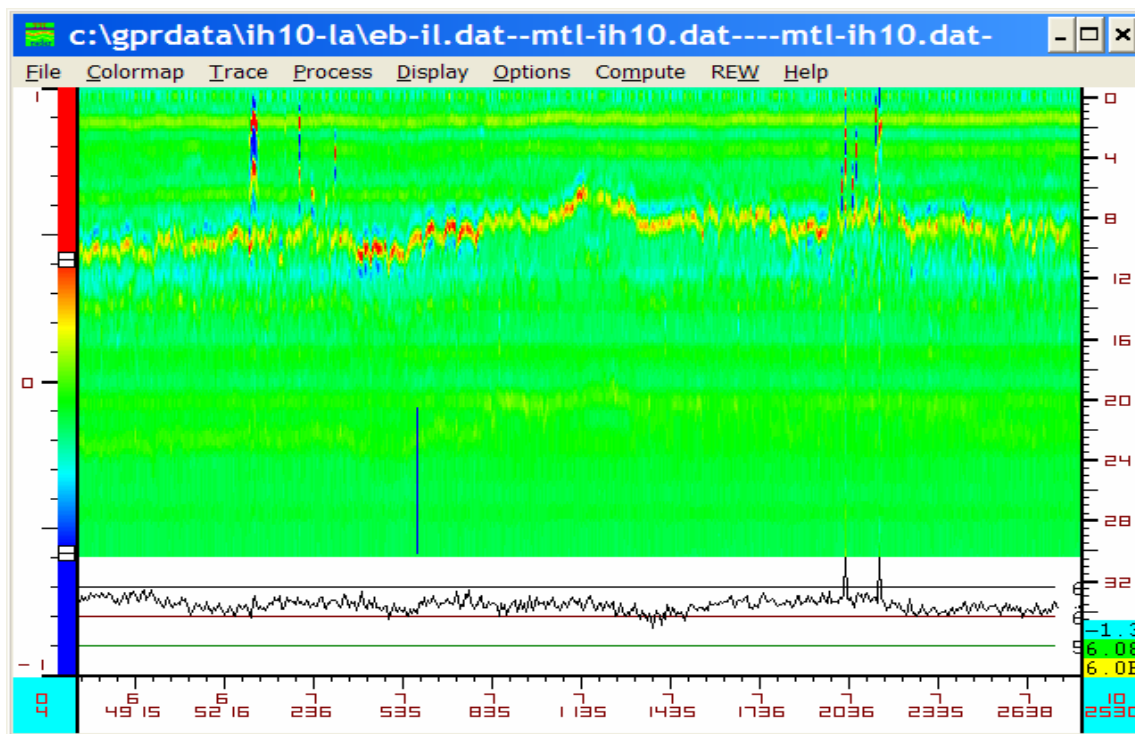
FIGURE 9 Localized potential problems areas in HMA at on/off ramps.

It appears that the drainage systems may not be functioning where the concrete ramps meets the main lanes. The on and off ramps were not rubblized. The potential problem areas are localized to a few GPR traces. However the reflections in these areas are very high. It was

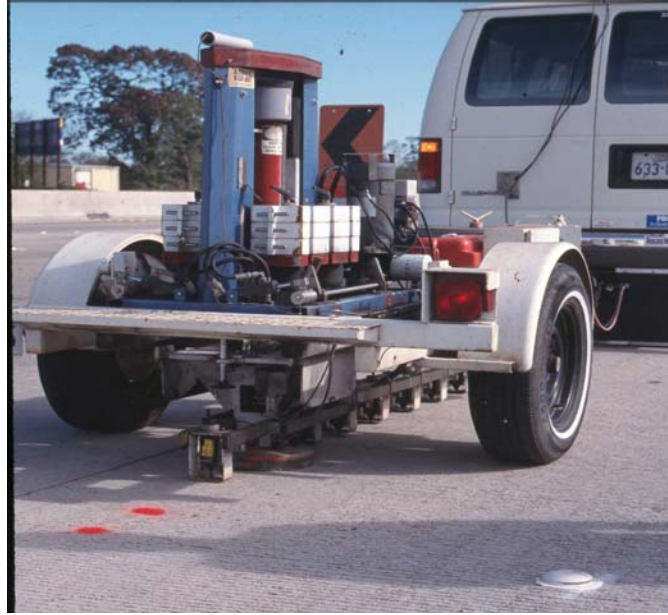
FIGURE 11 TxDOT’s FWD.

On I-10 the FWD data was collected in the outside lane EB direction starting at MP 94, with data collected at 0.2-mi intervals for approximately 6 mi. The temperature of the HMA layer at the time of testing was measured by drilling a hole to a depth of 2 in. The temperature

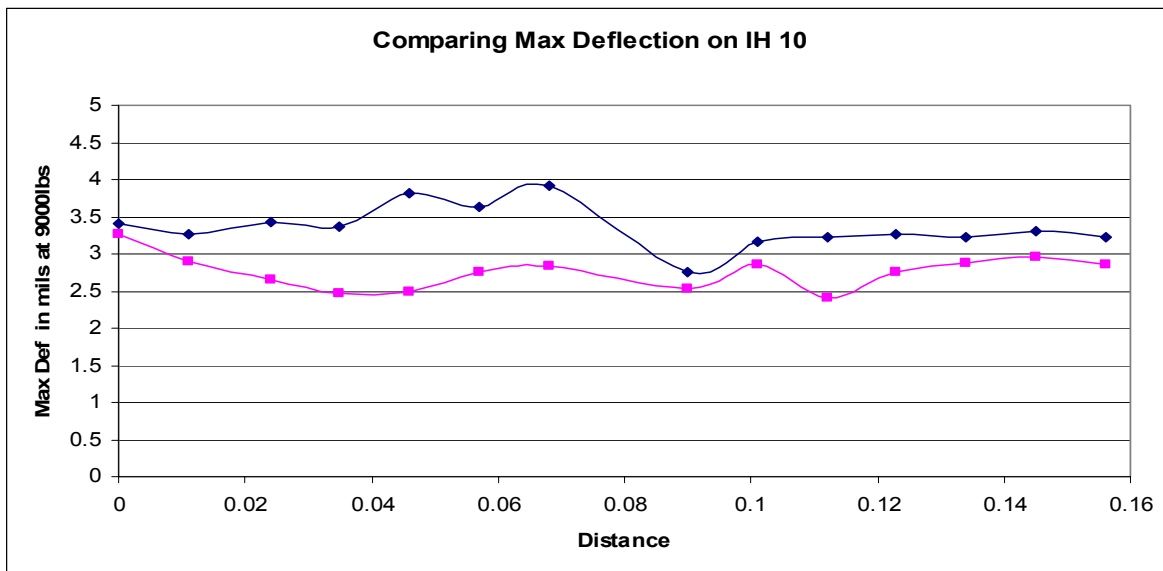
FIGURE 12 Comparing deflection from the rubblized section (Job 2) with an uncracked concrete slab.

A second set of deflection data was also collected mid-slab on different section of jointed concrete on I-10 which was about to be rubblized. This was an intact 10-in. thick portland cement concrete (PCC) slab made with gravel aggregates. [Figure 12](#) compares the normalized

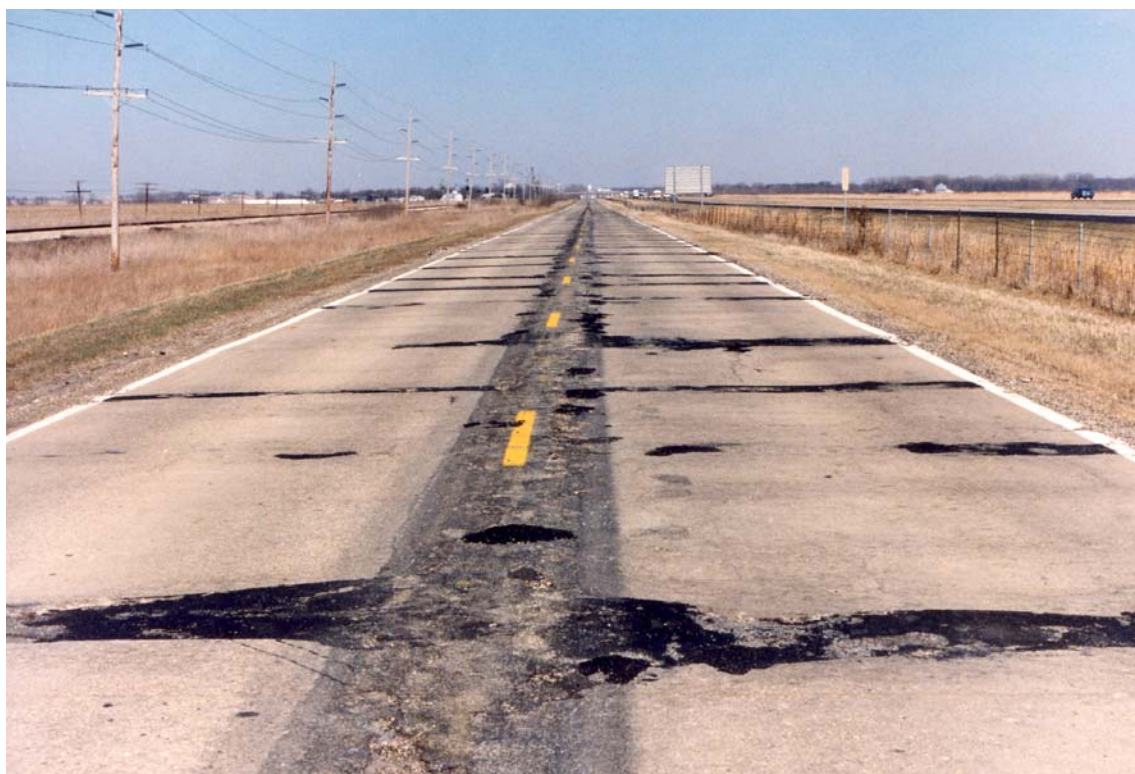
FIGURE 1 Prime candidate project for rubblization.

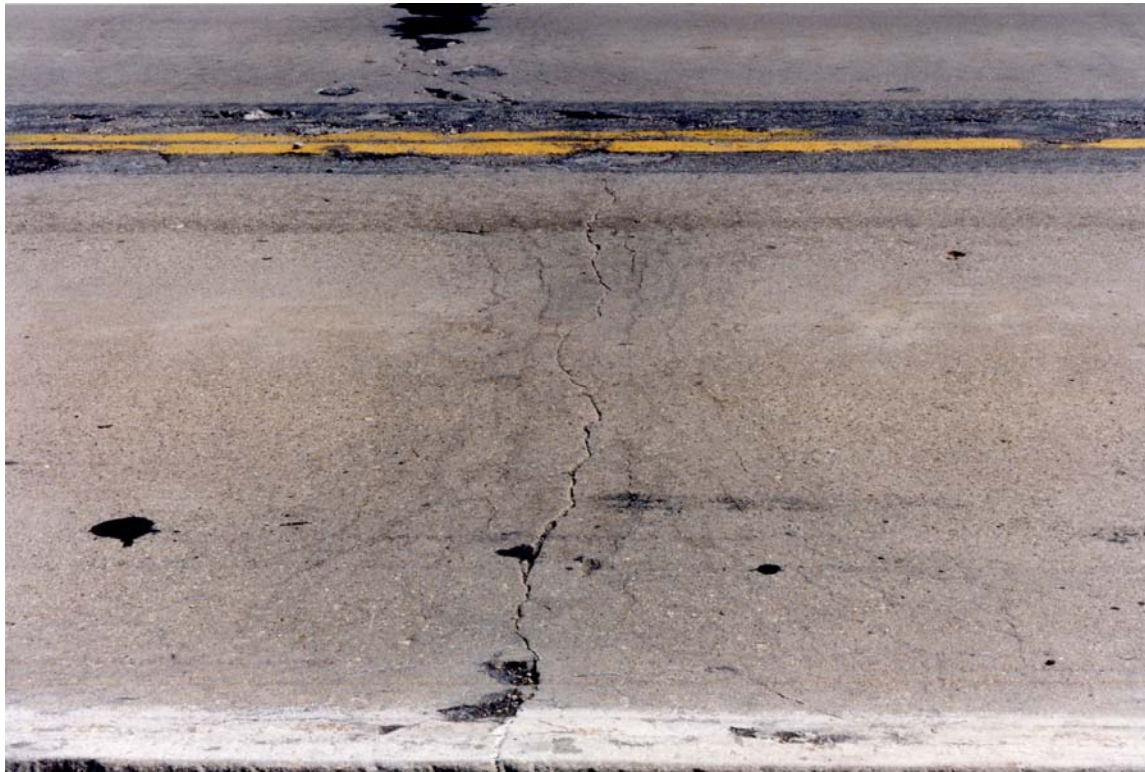
FIGURE 2 D cracking distress at transverse crack.

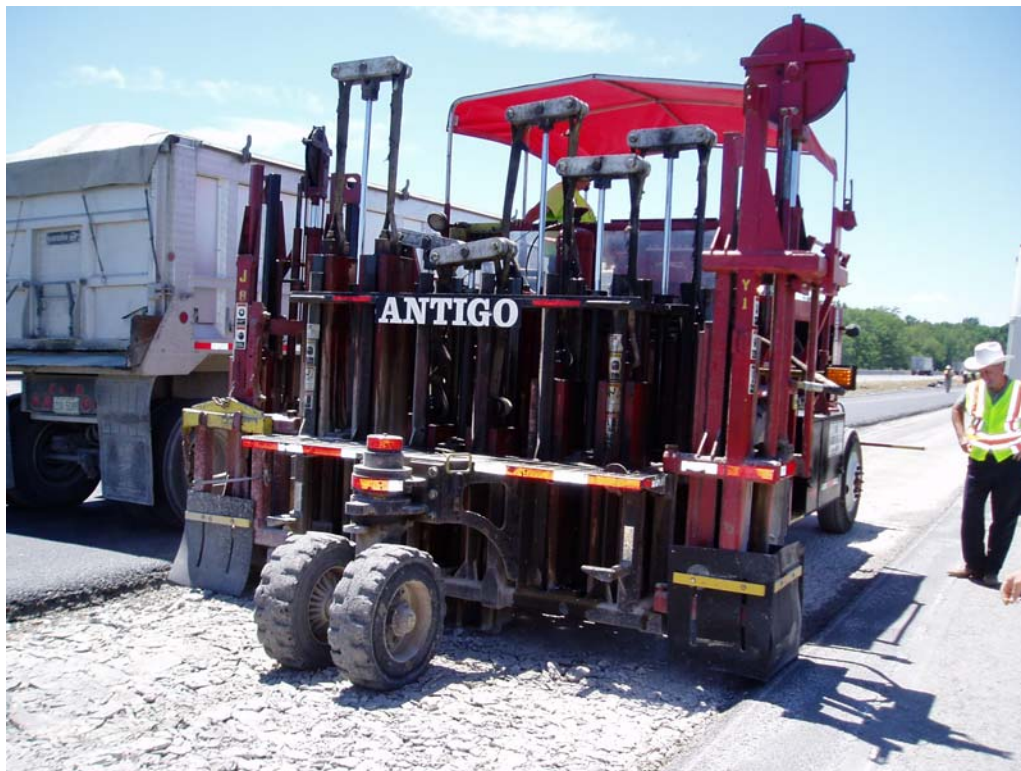
FIGURE 3 Multi-head breaker.

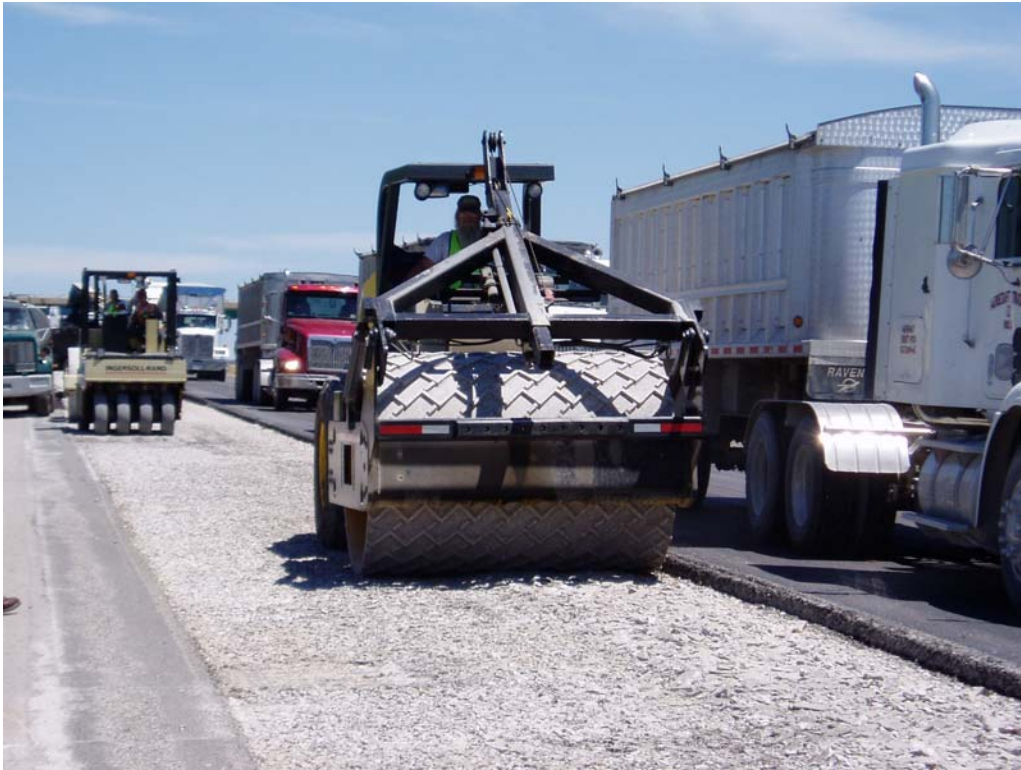
FIGURE 4 Z-pattern steel grid roller.

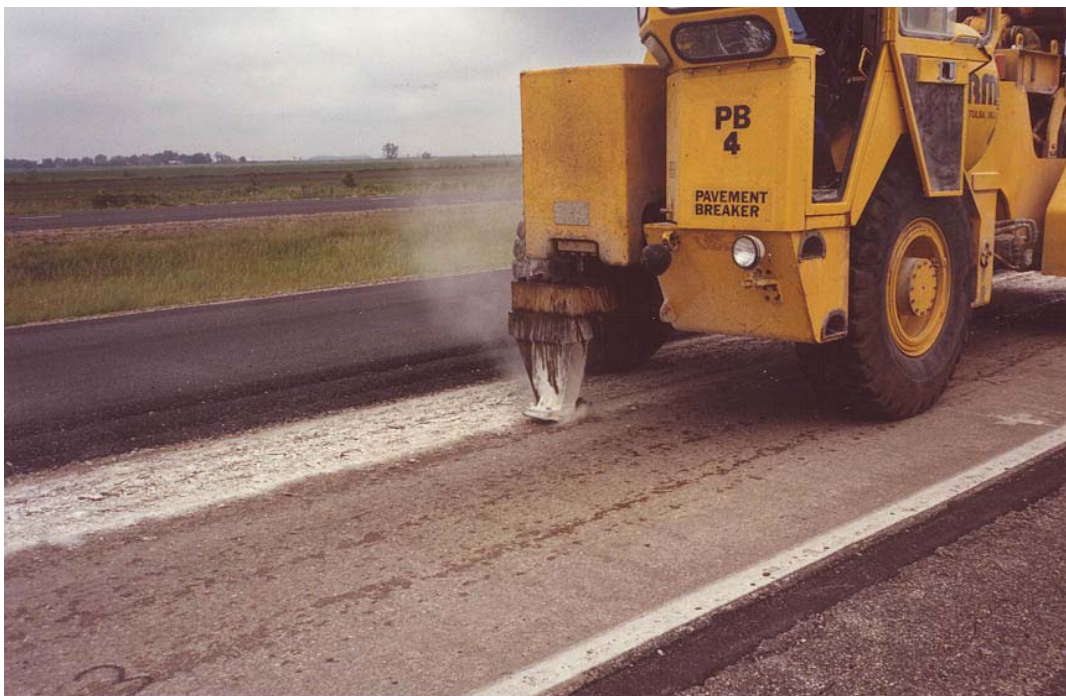
FIGURE 5 Resonant frequency breaker.
