## Acoustic Rail-Break Detection Demonstration at MTA New York City Transit

# Research Results Digest 76

## ACOUSTIC RAIL-BREAK DETECTION DEMONSTRATION AT MTA NEW YORK CITY TRANSIT

This digest summarizes the results of TCRP Project D-7/Task 10, "Acoustic Rail-Break Detection Demonstration at MTA New York City Transit." The digest was prepared by the Transportation Technology Center, Inc. (TTCI) of Pueblo, Colorado. Richard P. Reiff served as principal author.

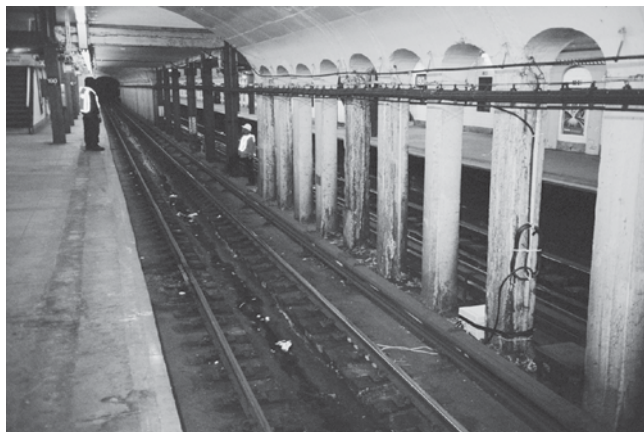
**Figure 3** View looking northward of transmitter location midway along 190th Street station. Cables can be seen between the case and rail. The transmitter case is located between pillars, center between tracks.

Transmitter location—190th Street station (Figures 3 and 4)

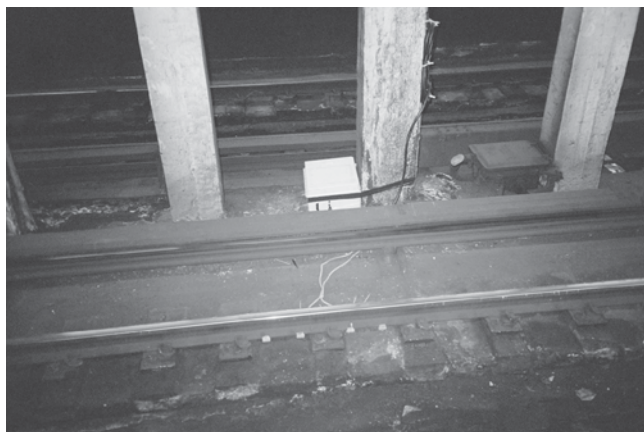
**Figure 4** View of the transmitter case, which was subsequently mounted to one of the center pillars.

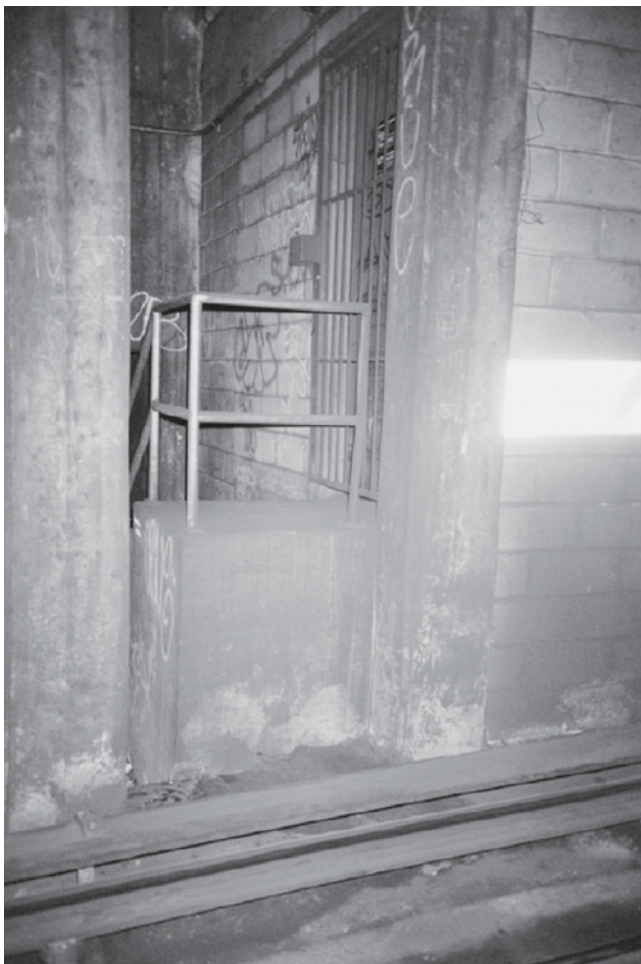
**Figure 8** View of receiver location. Access to relay Room is through fenced doorway.

Exterior and interior of site (Figures 8 and 9)

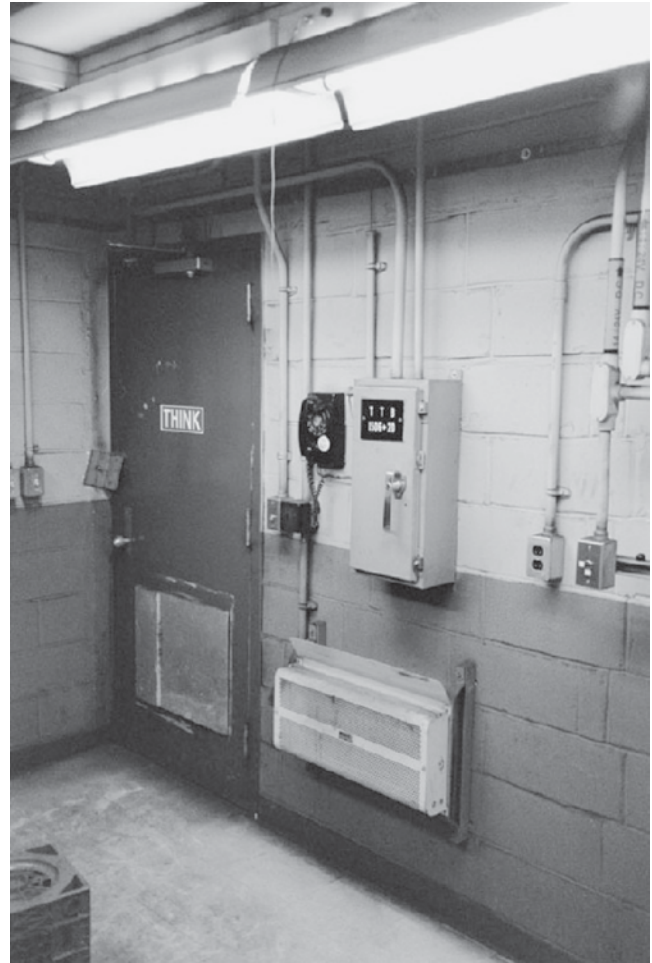
**Figure 9** View of interior of relay room for receiver station and data transmission line.
