Rail Base Corrosion Detection and Prevention

Rail Base Corrosion Study

Under Transit Cooperative Research Program (TCRP) Project D-7, the Transportation Technology Center, Inc., (TTCI) studied the effects and prevention of rail base corrosion.

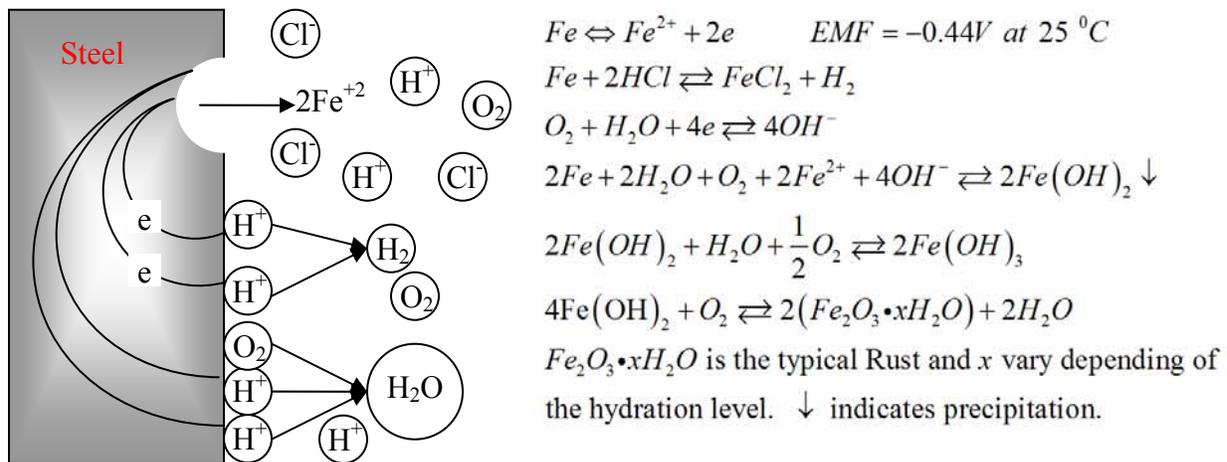
Figure 1. Electrochemical effects and reactions occurring during corrosion of Fe present in steel in aerated systems containing water (H₂O) and chlorine ions. HCl is a byproduct of dissolved chlorines + DC.

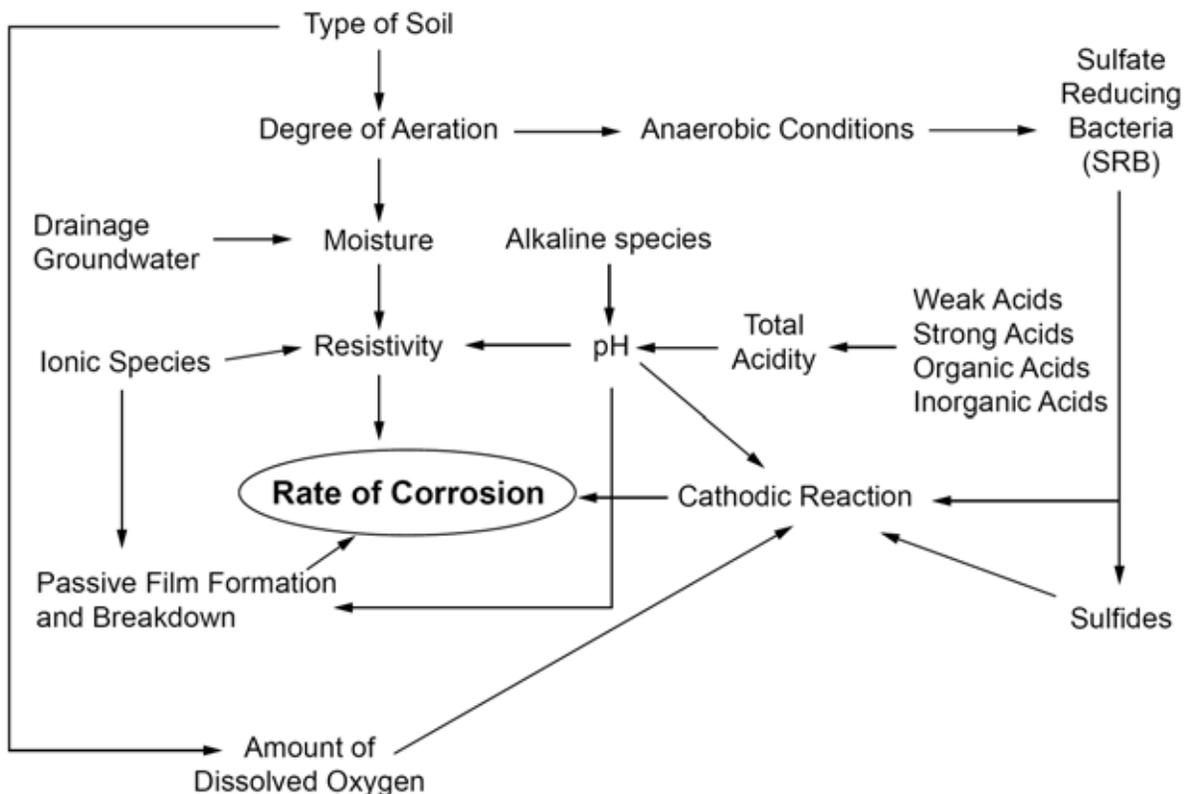
Figure 2. Relationship of variables affecting the rate of corrosion in soil (2).

Polluted water in liquid form represents the essential electrolyte required for electrochemical corrosion reactions. A distinction is made between saturated and unsaturated water flow in soils. The latter represents movement of water from wet areas to dry soil areas. Water is usually directed against gravity, and its flow is dependent on pore size and distribution, texture, structure, and organic matter. Figure 2 shows a detailed diagram with the parameters affecting the corrosion rate (2).

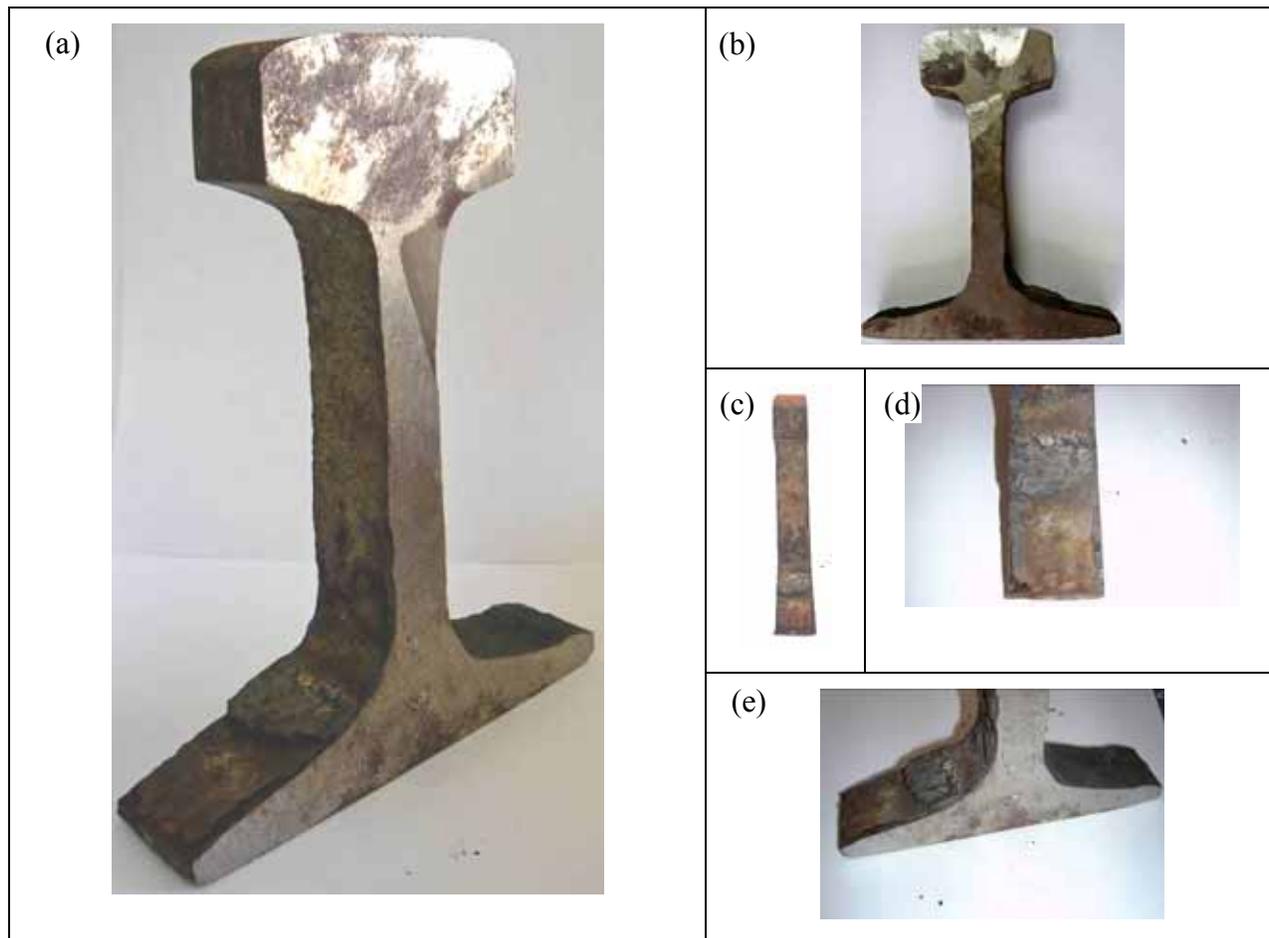
Figure 3. Macro pictures of a 115-lb rail showing corrosion at the base of the rail. Different views of a section of rail donated by the St. Louis, Missouri, Metro System: (a) 3-D image, (b) front (c) side views, (d) and (e) corroded section of the rail.

The metallographic samples were prepared using standard grinding and polishing procedures. The phases present in the microstructure were revealed using 2% Mital as the etching agent. The surfaces of the NDE samples were mechanically ground. Figure 3 shows a series of macro-images of a sample containing corrosion at the base of the rail.

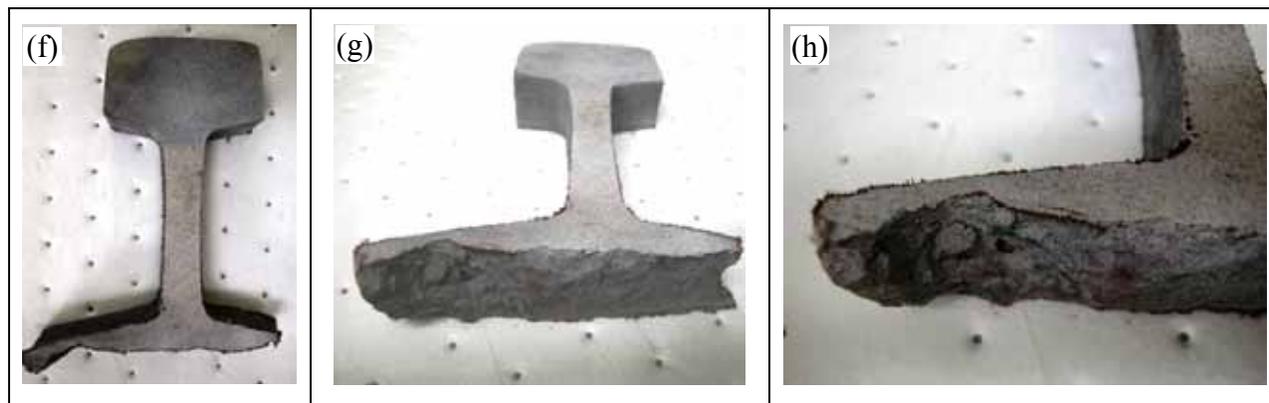
Figure 3 (continued). Different views of a section of 100-lb rail showing severe corrosion at the base of the rail. The rail was donated by Port Authority Trans-Hudson, New Jersey. This rail was used for the magnetic particle evaluation.

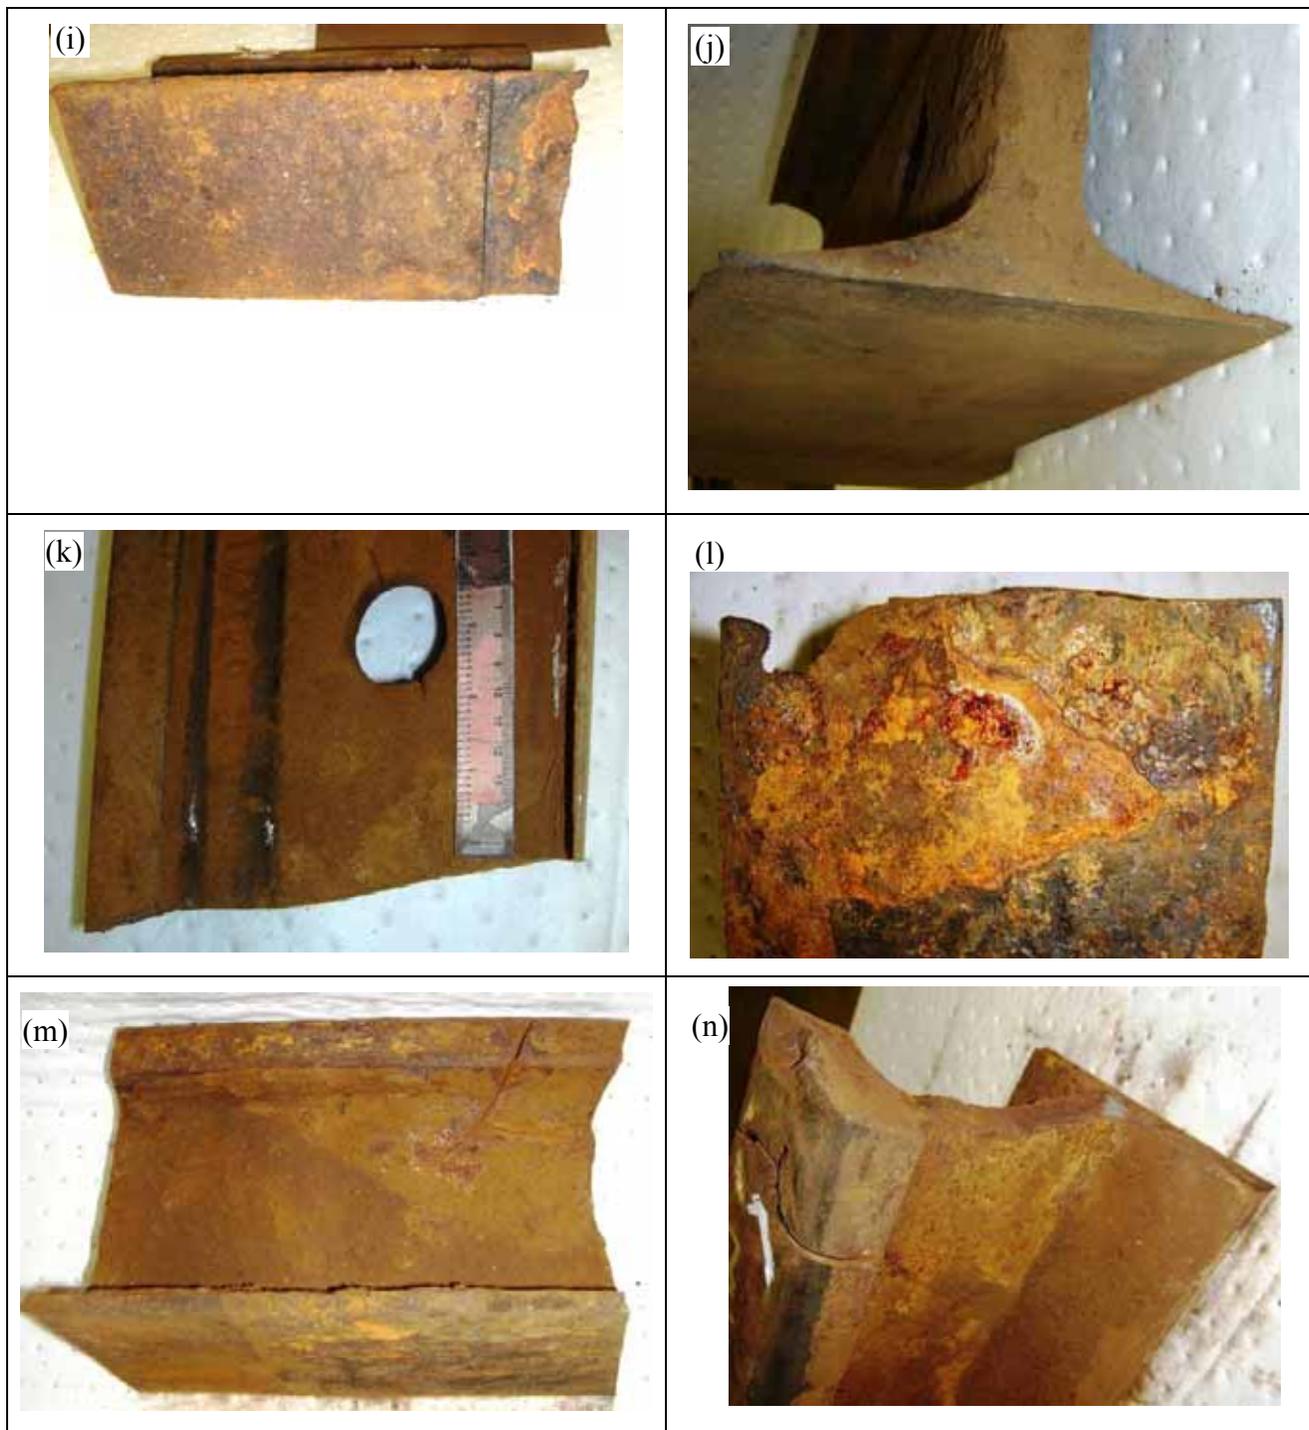
Figure 3 (continued). Sections of 136-lb rail showing different types of corrosion at the base of the rail. The presented macro-images of the rails show the rail donated by Amtrak. All of these rails failed due to corrosion in various locations along the east coast. The samples were used in the following way: (i) metallographic analysis, (j,k) numerical FEA simulations, (l,m,n) other examples. Note, view (i) shows one of the most severe corrosion conditions.

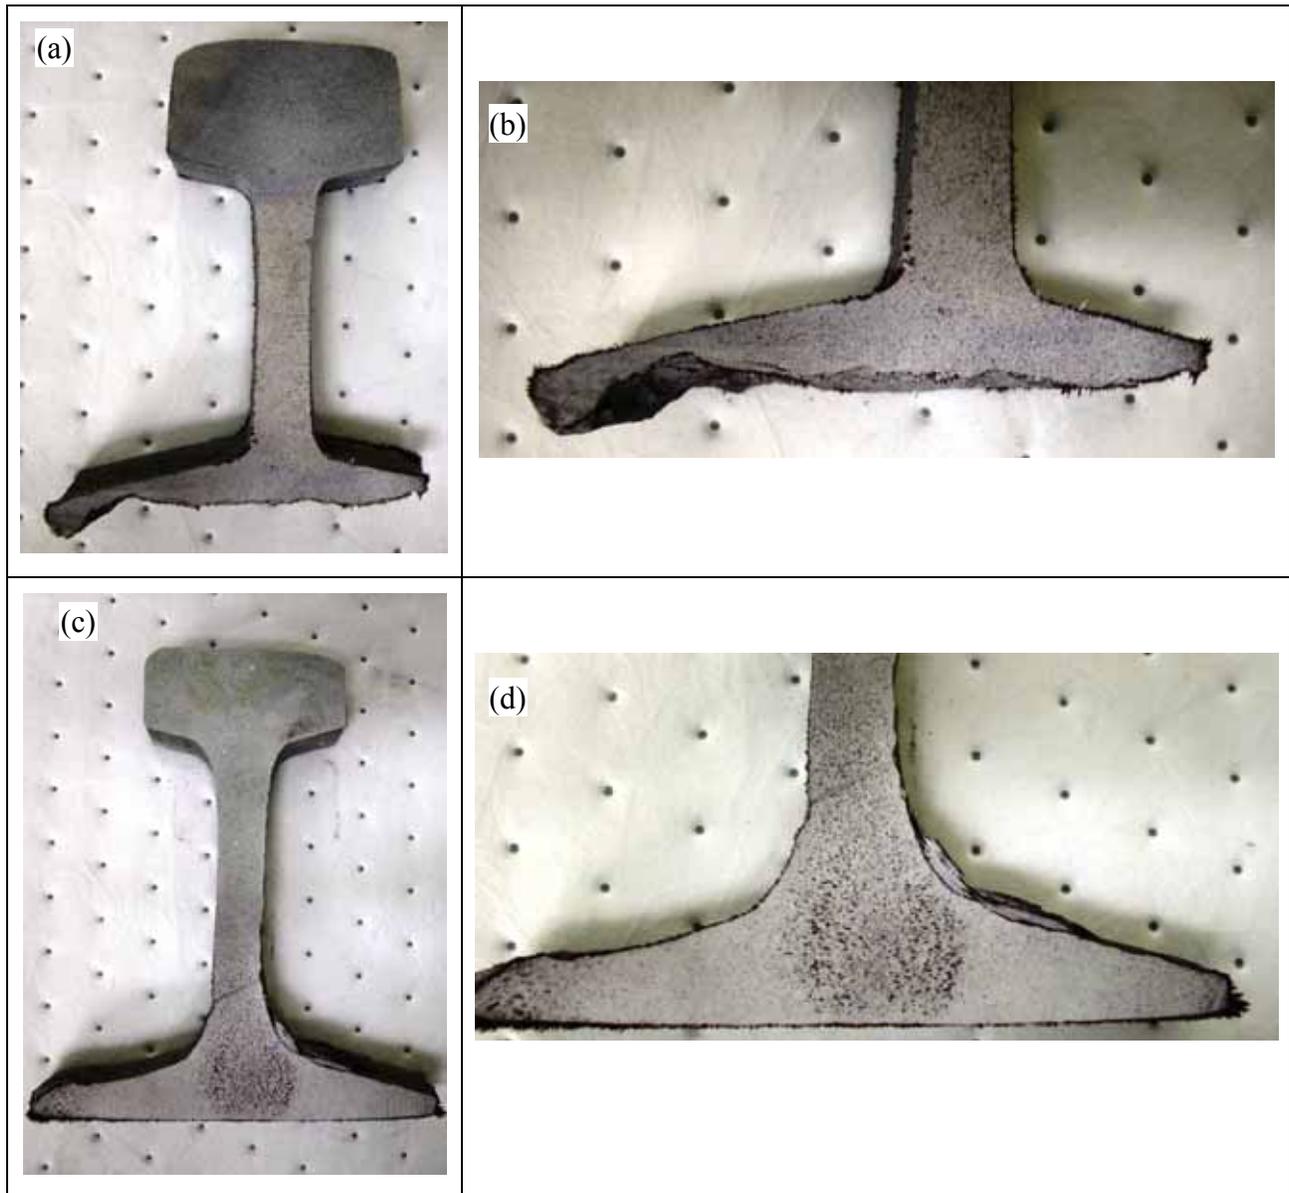
Figure 4. Pictures of the magnetic particles evaluation of the rail base for the Port Authority Trans-Hudson (a,b) and St. Louis, Missouri, Metro System (c,d). Note that there is no apparent evidence of cracks growing from the base of the rail to the parent material.

After applying the particles and magnetic field to the samples, there was no evidence of cracks growing into the parent material from the rail base. Under these circumstances, micro-cracking cannot be detected using magnetic particle inspection. Therefore, a more sensitive analysis, using an optical microscope, was performed to inspect for micro-cracking from the rail base into the parent material. It was found that rail base corrosion does not accelerate the crack formation or propagation to the parent rail. Therefore, it is concluded that there is no compromise of the rail's integrity due to the presence of micro-cracks; nonetheless, corrosion, in particular, pitting is usually an accelerator of fatigue-corrosion conditions. The details of this analysis are discussed in more detail in the following section including Figures 5-8.

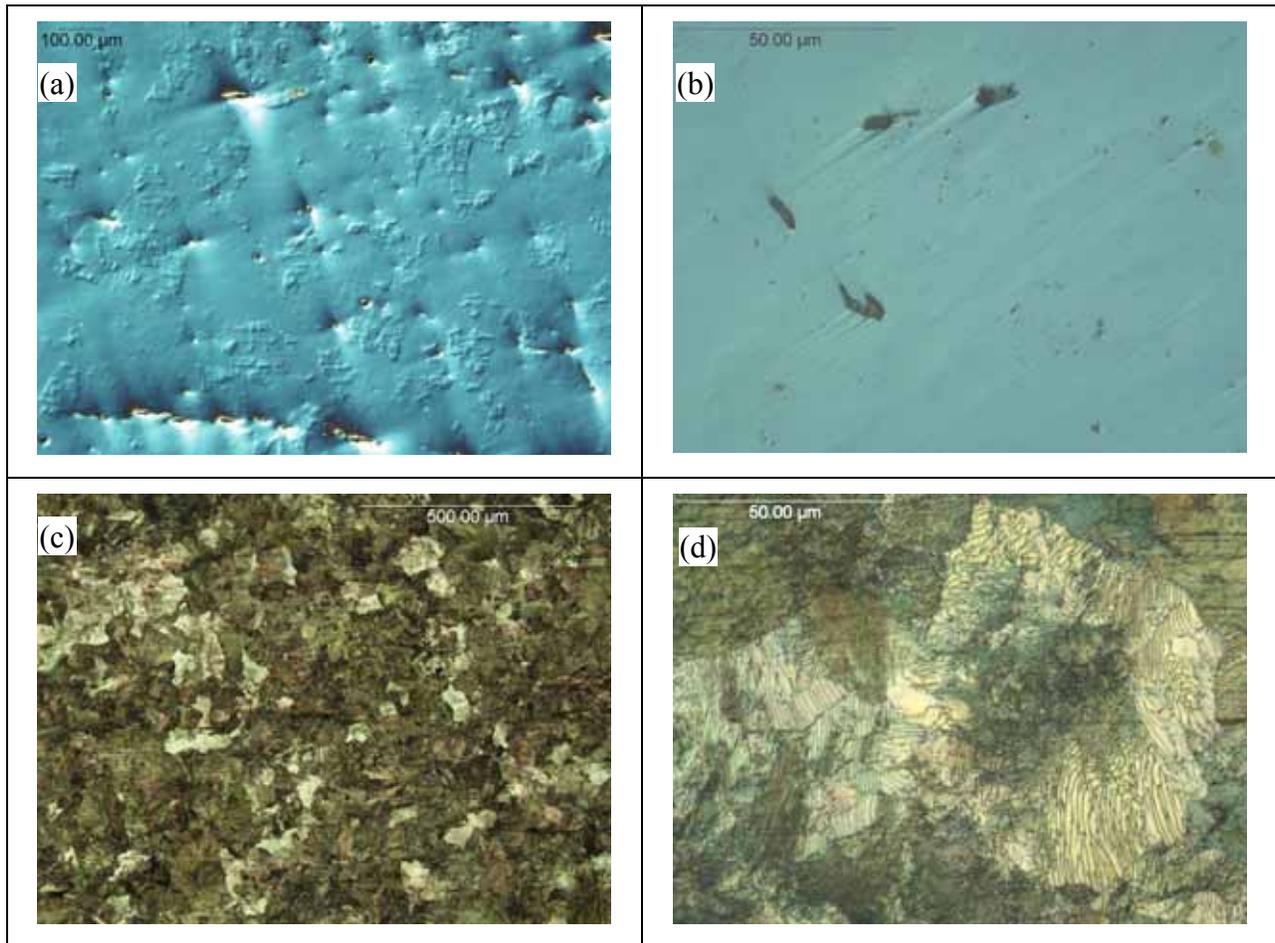
Figure 5. Microstructure of the 115-lb rail donated by the St. Louis, Missouri, Metro System. The sample in as-polished conditions at various magnifications (a) 100 X, (b) 1000 X and the sample in as-etched conditions (c) 100 X and (d) 1000 X. Note the large amount of inclusions on the as-polished (a, b) samples and the pearlitic microstructure (c, d). This sample was extracted in close vicinity of the corroded area.

The St. Louis, Missouri, Metro System donated the rail for this analysis. Figure 5 shows the microstructure of both the as-polished and as-etched conditions at different magnifications for a section of the corroded 115-lb rail. It is clear that the microstructure of both samples corresponds to the typical fully pearlitic microstructure of the standard or high strength rails. Note the amount of inclusions, coarse pearlite, interlamellar structure (typical of pearlite), and grains observed on the rail.

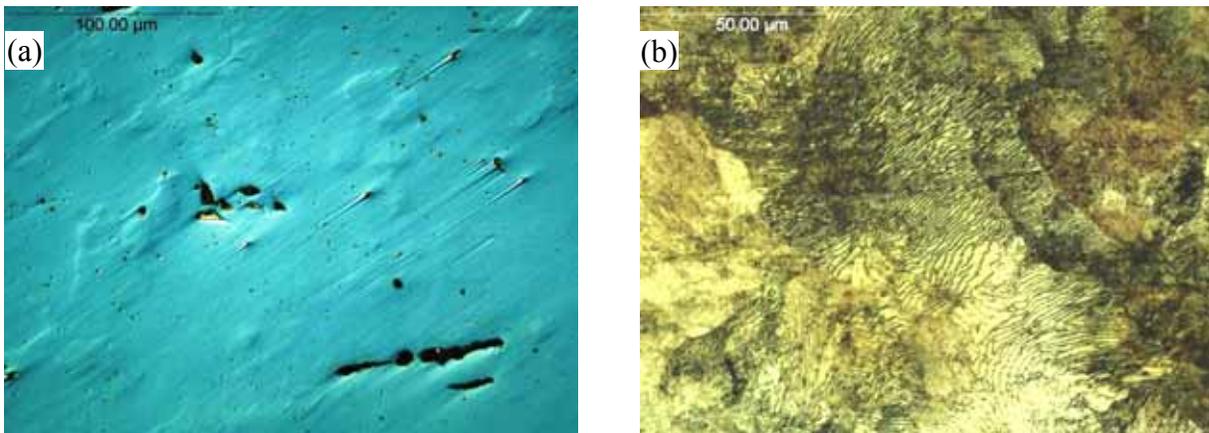
Figure 6. Microstructure of the 115-lb rail donated by the St. Louis, Missouri, Metro System. The sample in (a) as-polished, 500X and (b) as-etched conditions 1000 X, respectively.

Figure 6 shows the microstructure of both the as-polished and as-etched conditions at different magnifications for a noncorroded railhead section from the 115-lb rail. Comparing the microstructure of the rail in close vicinity to the corroded area (Figure 5) with the microstructure of a location free of corrosion (Figure 6), no significant change in the microstructure of the material is shown. This means that corrosion has no effect on the microstructure, except for the section that reacts with oxygen and water or other elements or compounds forming other phases.

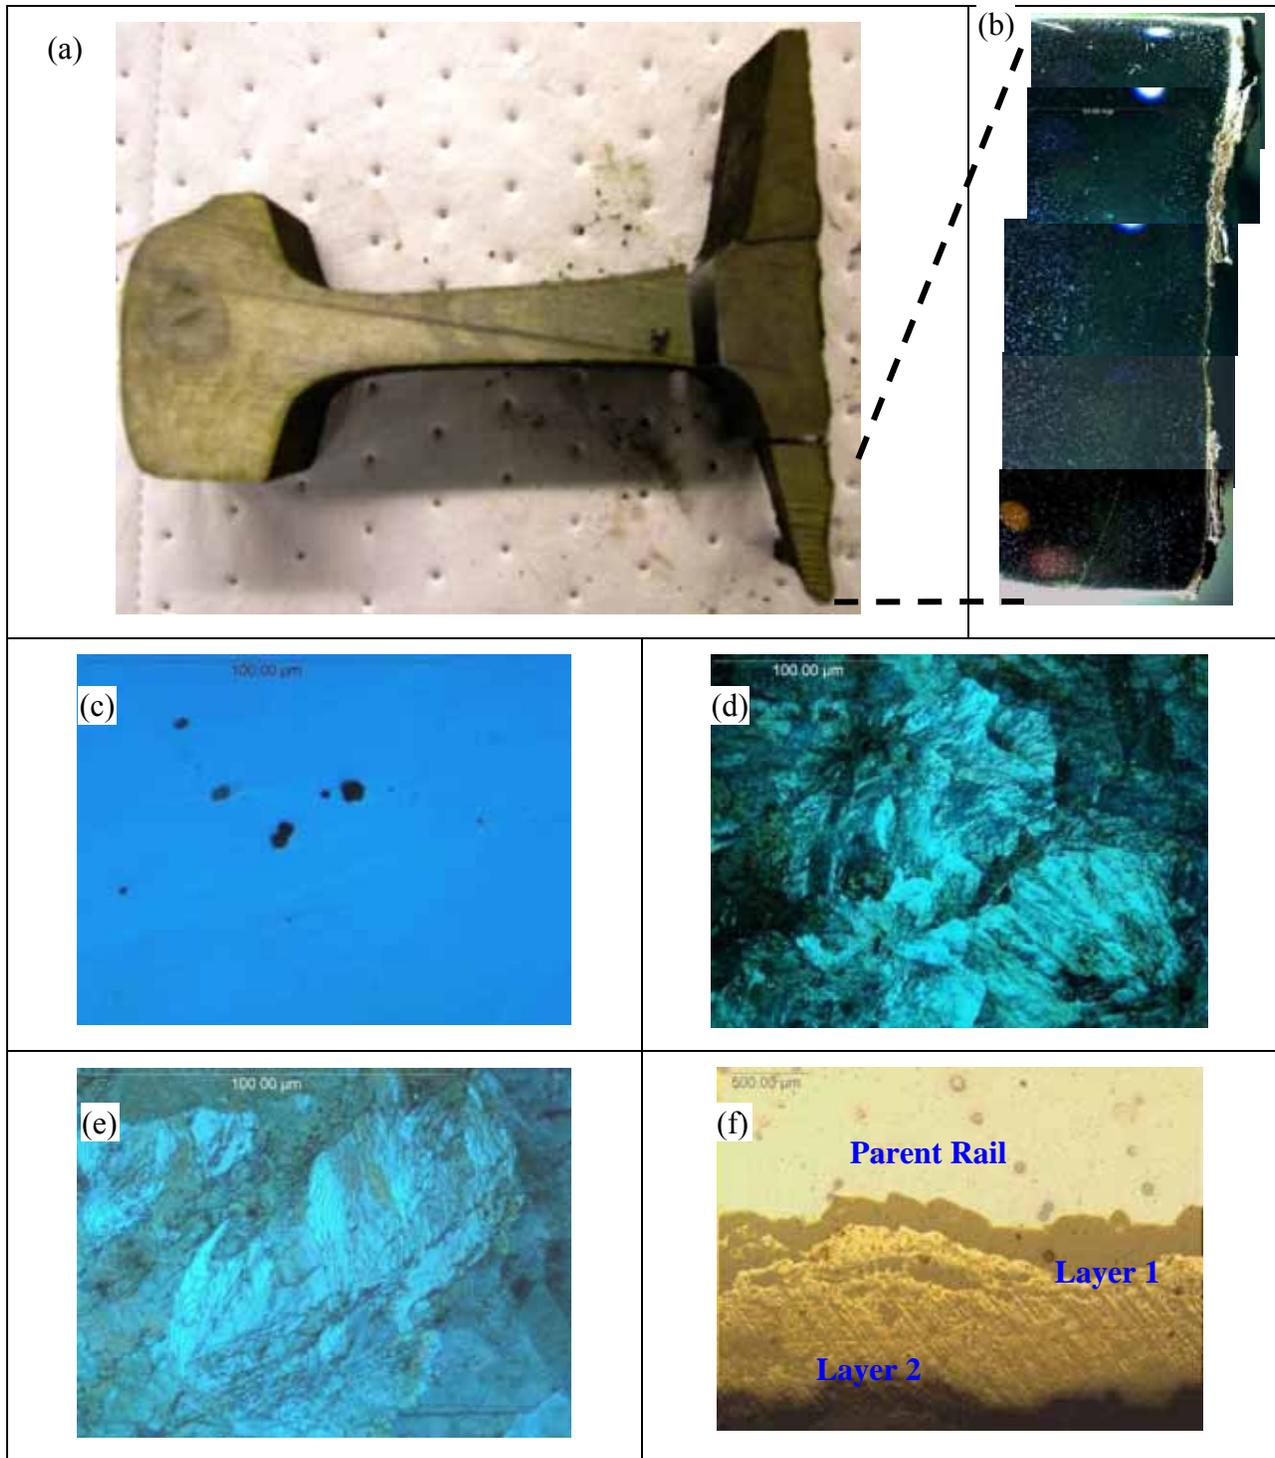
Figure 7. Macro- (a,b) and micro- (c-f) pictures of the 136-lb rail donated by Amtrak. (a) Cross section of the rail showing how the samples were extracted for analysis, (b) magnified section of the base of the rail showing no micro-cracks, microstructure (a) as-polished (1000 X) and as-etched (d) 500 X, (e) 1000 X and (f) difference between parent rail and corroded sections typical of rust.

The separate sections of the rail were polished and analyzed using the stereoscope and optical microscope under polished and etched conditions. The rail section shown in Figure 7a was used to identify the effect of corrosion (i.e., micro-cracks) on the parent rail. As discussed earlier, micro-cracking can cause catastrophic failures, so a more in-depth study was completed during the metallographic analysis. Figure 7b confirms the magnetic particle inspection results, which determined that there is no evidence of micro-cracking in the sample. Figure 7c-e displays the microstructure of the 136-lb rail. These images do not show significant differences in microstructure when compared with the images of the 115-lb rail in Figures 6 and 7.

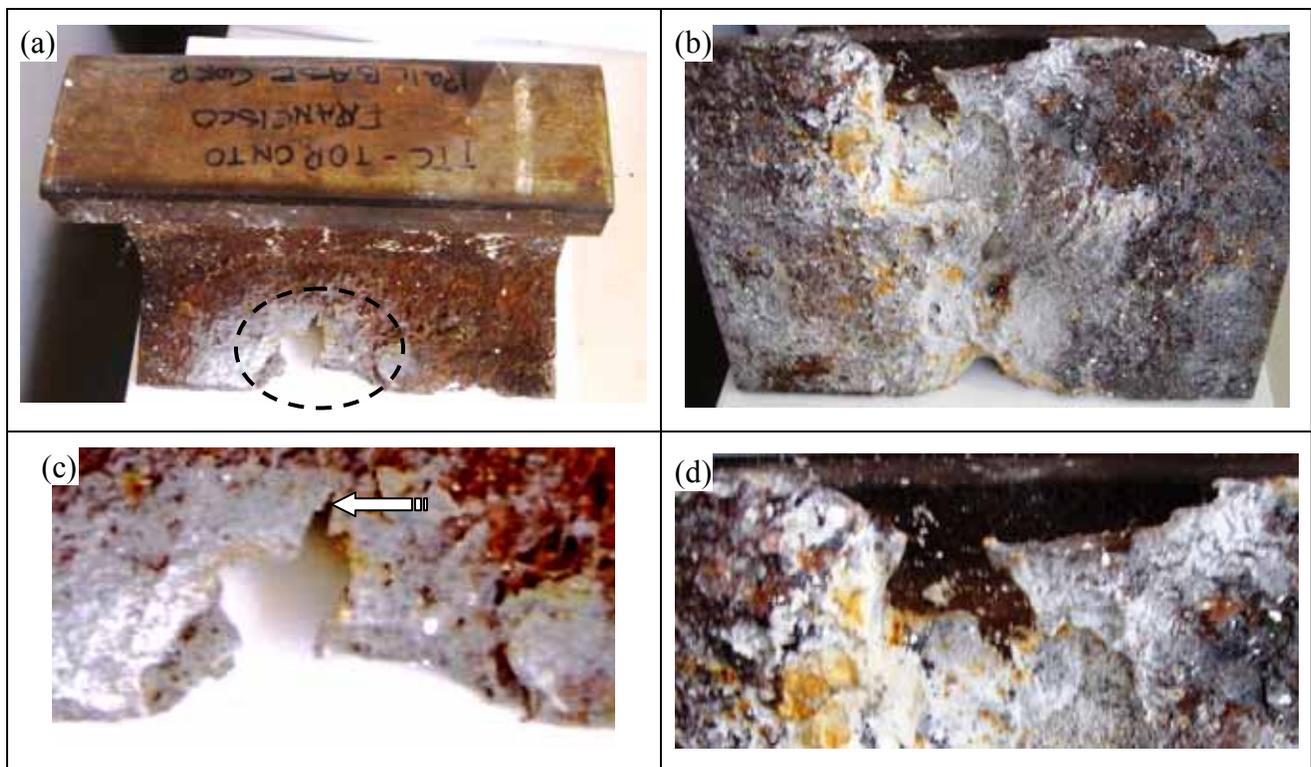
Figure 8. Pictures of the 115-lb rail used for the simulation. Pictures a-d show different angles and details of the effects of corrosion on the base of the rail. This rail was provided by TTC-Toronto, Canada. The arrow shows the location with the sharpest edge (stress concentrator).

Based on the survey results, 100- and 115-lb rails are the most common rails used in transit systems. The first numerical simulation was conducted using a 115-lb rail provided by the Toronto Transit Commission (TTC). Figure 8 shows a section of the rail sample with severe corrosion. These images make it obvious that the structural integrity of the corroded rail is drastically compromised. The images also help to define the challenges associated with the detection of the corrosion because it occurs at the base, most likely over the tie, hiding the corrosion from visual detection. Several of the transit authorities reported that rail corrosion was not detected sometimes until the rail was removed from the tracks because the corrosion was hidden at the base of the rail (7,9).

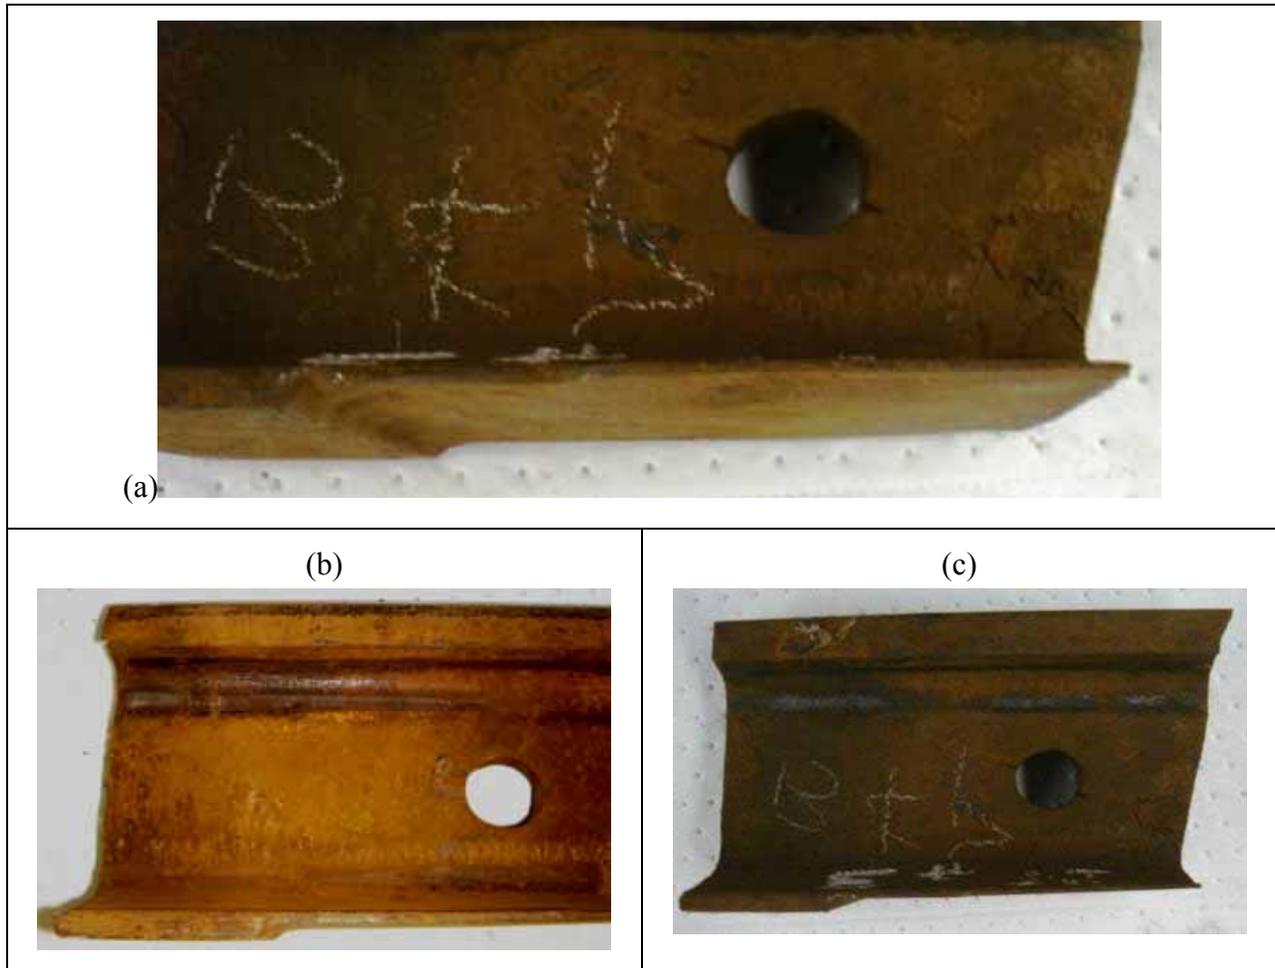
Figure 9. Pictures of the 136-lb rail donated from Amtrak for the rail base corrosion project showing a clear reduction from the base of the rail. Note: each transit authority has its own safety standard. However, most of them agree that a reduction in rail base between 1/8" to 1/4" is the maximum permissible allowance for immediate replacement of the rail.

detailed images of the thin section. Contrary to the previously mentioned corrosion, this type of corrosion is easily detected by visual inspection. Each transit system has specific safety standards to prevent break failure for this corrosion condition, but most of them agree that the rail needs immediate replacement when 1/8 in. to 1/4 in. of the base has been removed (8-10).

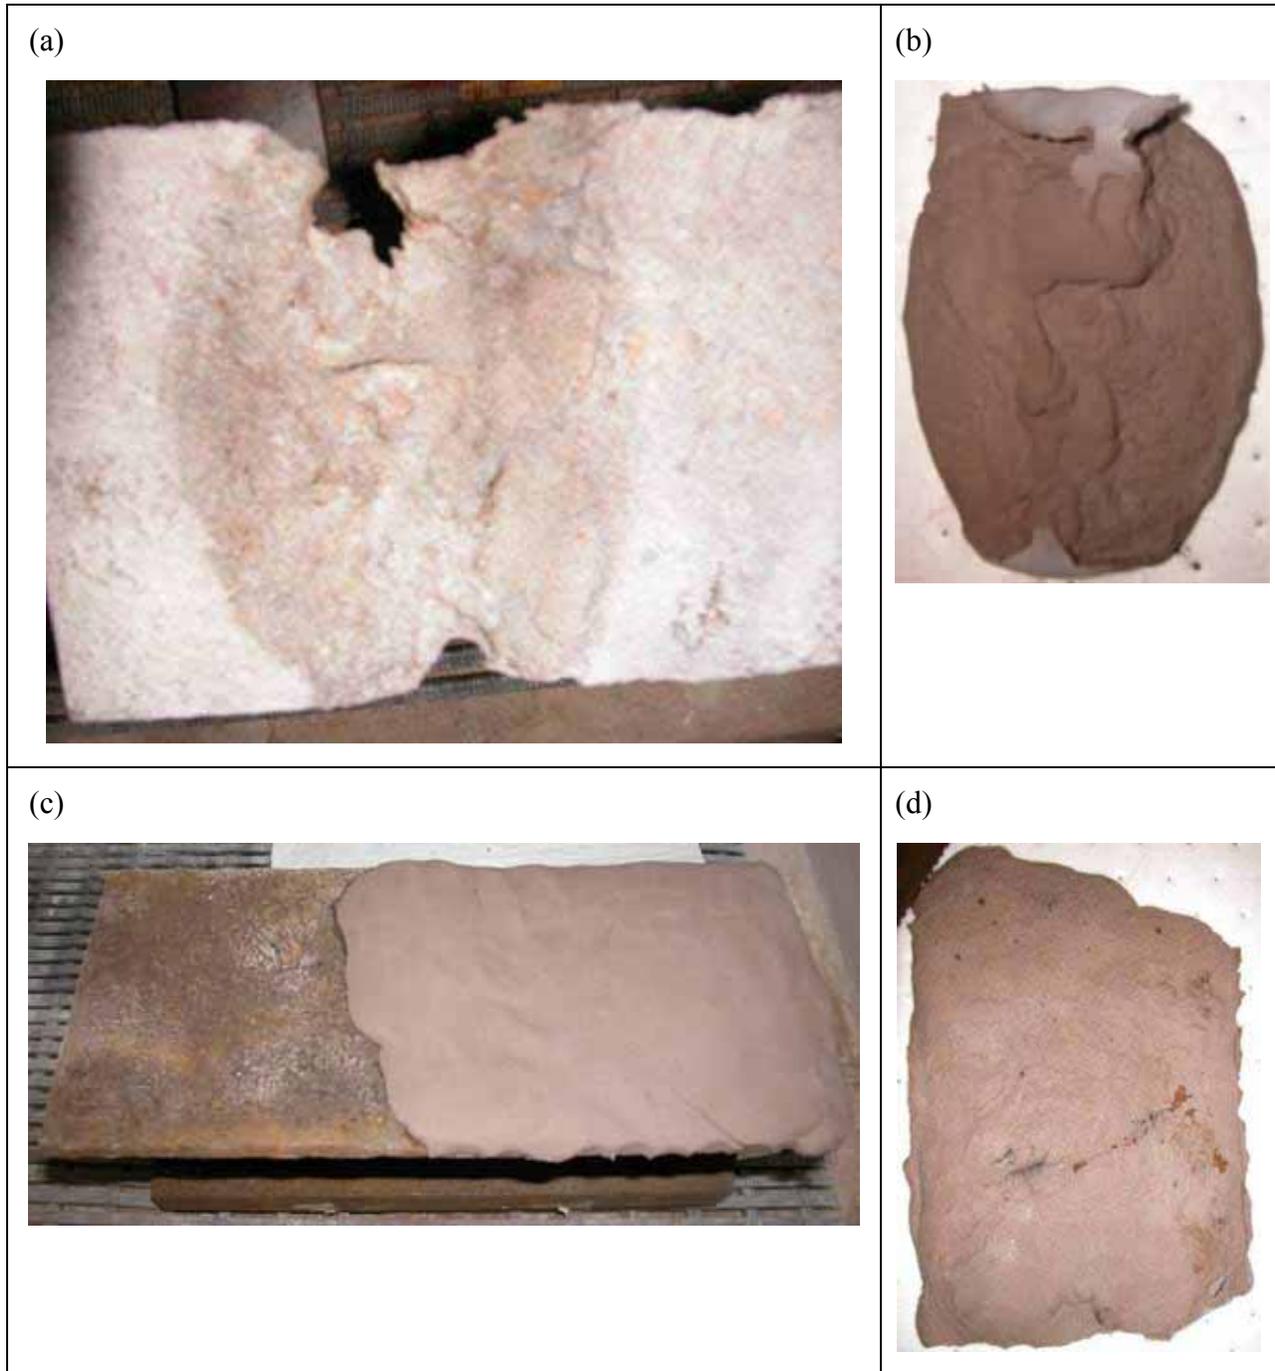
Figure 10. Pictures of the clay molds used to copy the detail and main features of the base of the rails for the numerical simulations. (a,b) 115-lb rail and (c,d) 136-lb rail.

Two procedures were used to closely approximate the effects of corrosion from the base of the 115- and 136-lb rails. The first procedure used a mold of the rail base to copy the detail and determine the rough dimensions of the corrosion effects. Figure 10 shows the mold created during the first procedure.

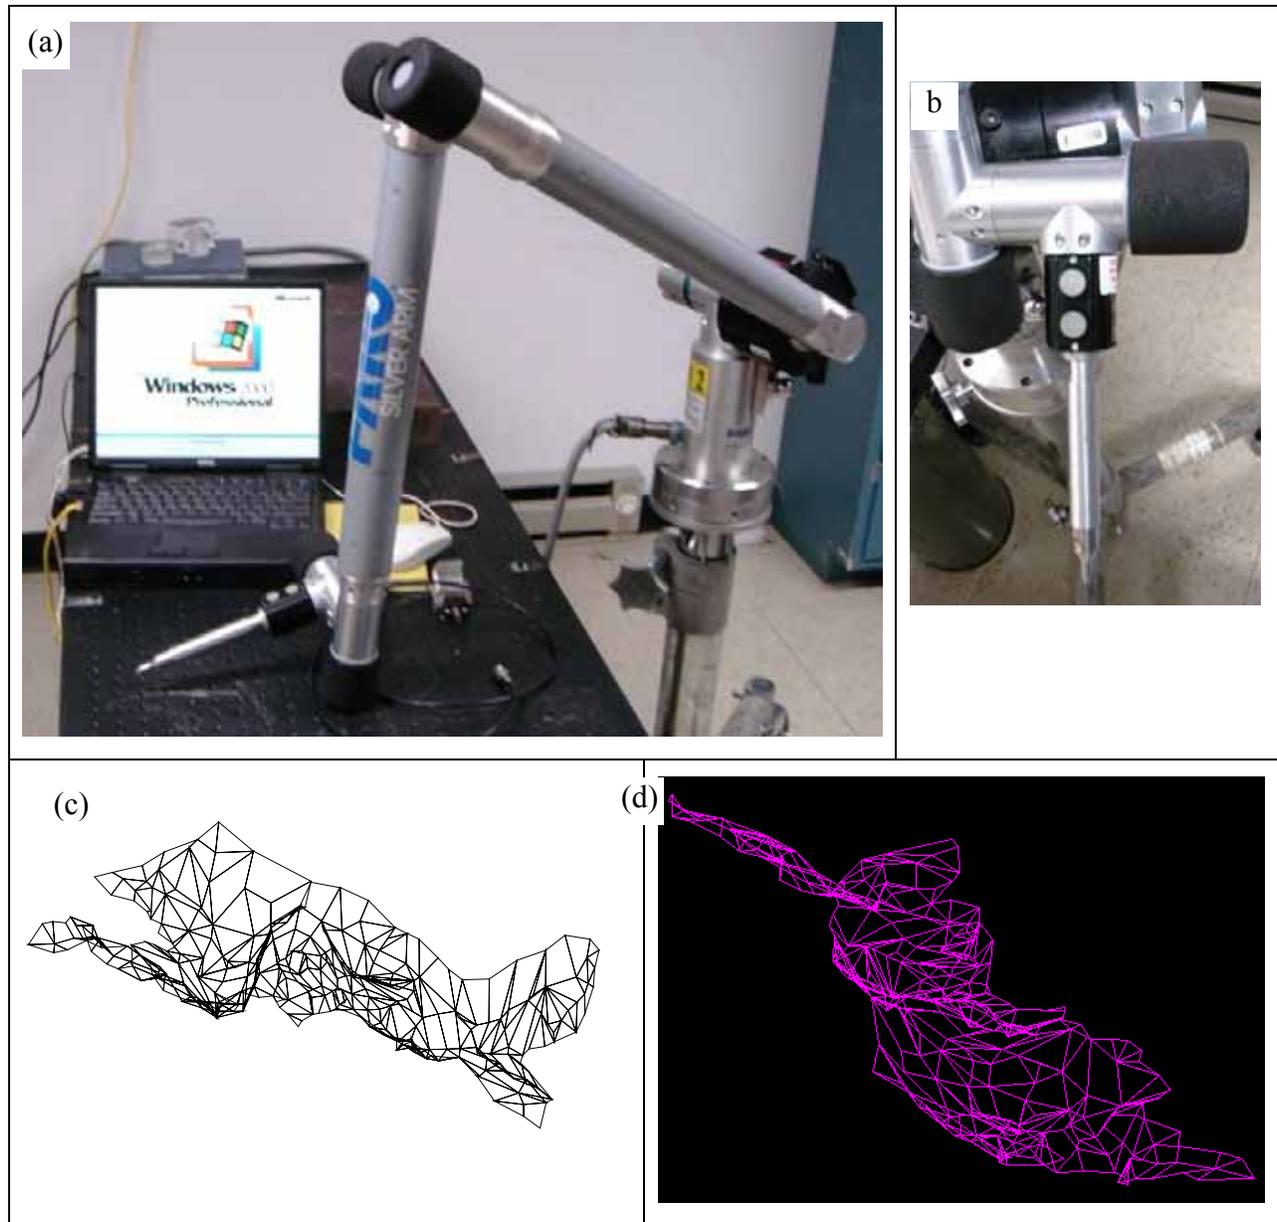
Figure 11. (a,b) Pictures of the FERRO-Silver ARM surface digitizer and (c,d) 3-D images of the corrosion effects at the base of the rail.

The second approach used the FARRO-Silver ARM digitizer to make an electronic digitalization of the rail. The FARRO-Silver ARM and electronic image are shown in Figure 11. The FARRO-Silver ARM produces a precise three-dimensional digitalization of the exposed surfaces. The digital data were directly used in ANSYS® to build a highly reliable model that represents the characteristics of the corroded rail.

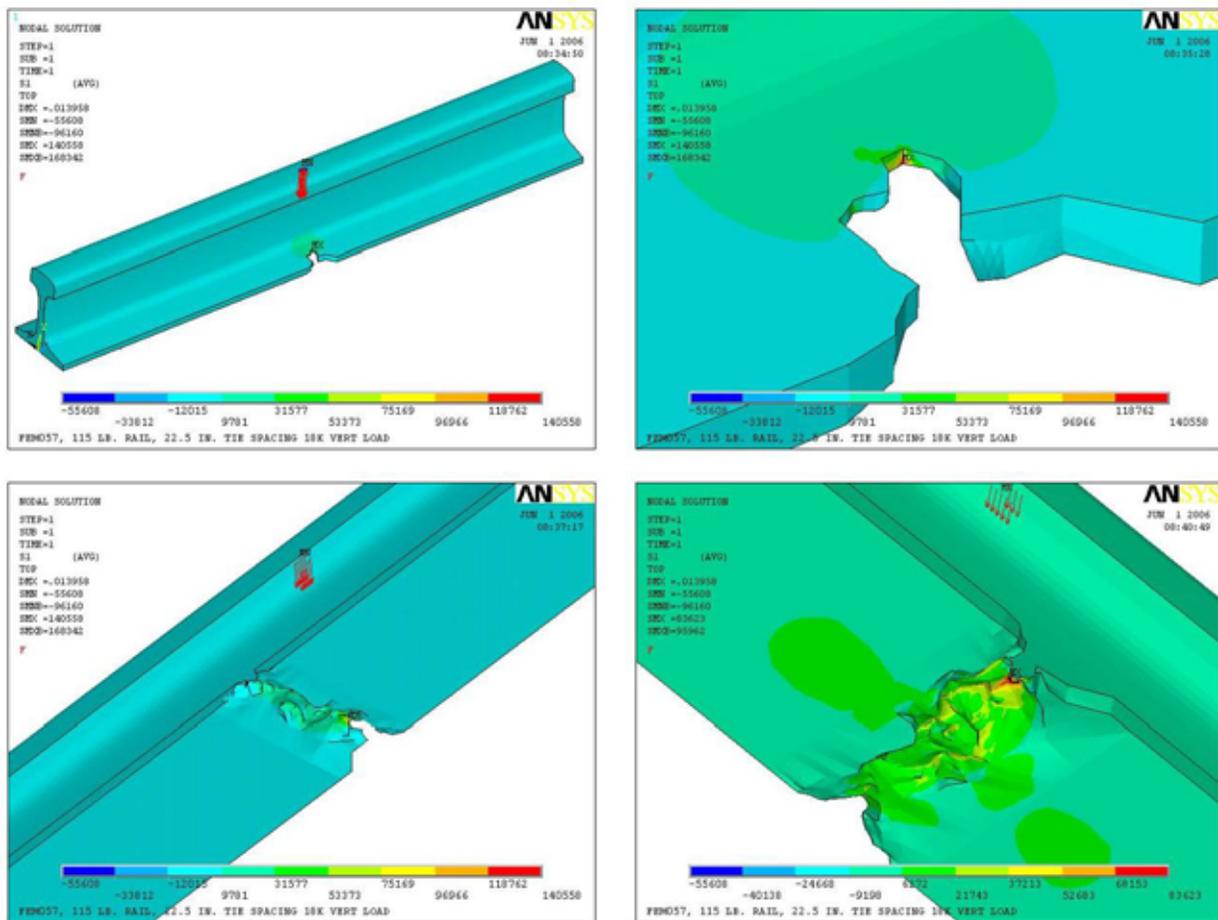
Figure 12. Results of the FEA analysis for the 115-lb rail. Notice the very high level of stresses reaching values as high as the yield strength (120 ksi) of rail steel.

Figure 12 shows the results of the FEA simulations. The maximum stress due to the stress concentration effects of corrosion was approximately 120 ksi, which is close to the yield strength of the steel used for this rail type. These data indicate that for this rail type, under these corrosion conditions, catastrophic failure can occur at any time. Figure 12 also shows that areas of high stress concentration occur more often near the sharp edges than the areas where extensive corrosion has occurred, which directly correlates to the stress concentration theory (12).

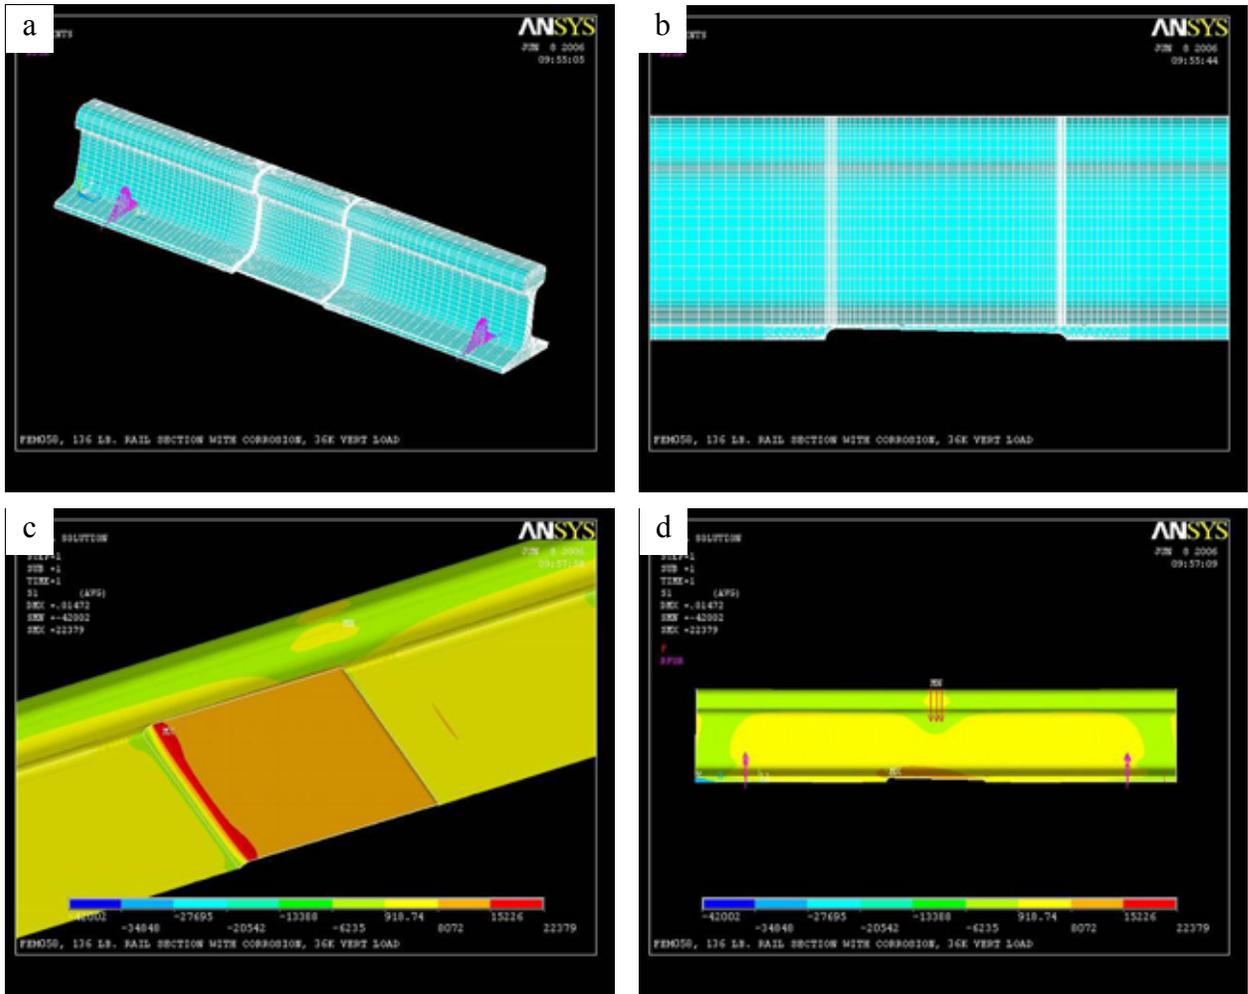
Figure 13. Results of the FEA analysis for the 136-lb rail. Notice that the highest stress is approximately 22.3 ksi and is found distributed along the sharp edge formed by the tie plate.

Figure 13 shows the results of the FEA simulations for a 136-lb rail with base reduction of 1.5 mm. This simulation used a thickness value of 1.5 mm because it was the thinnest rail base found among the donated rails. The maximum stress of 22 ksi was located along the radius formed by the tie plate and perpendicular to the sharp edge and extended along the width of the rail. Comparing these results with the results of the 115-lb rail concludes that this type of corrosion provides less stress concentration than the sharp angles produced in the previous case.

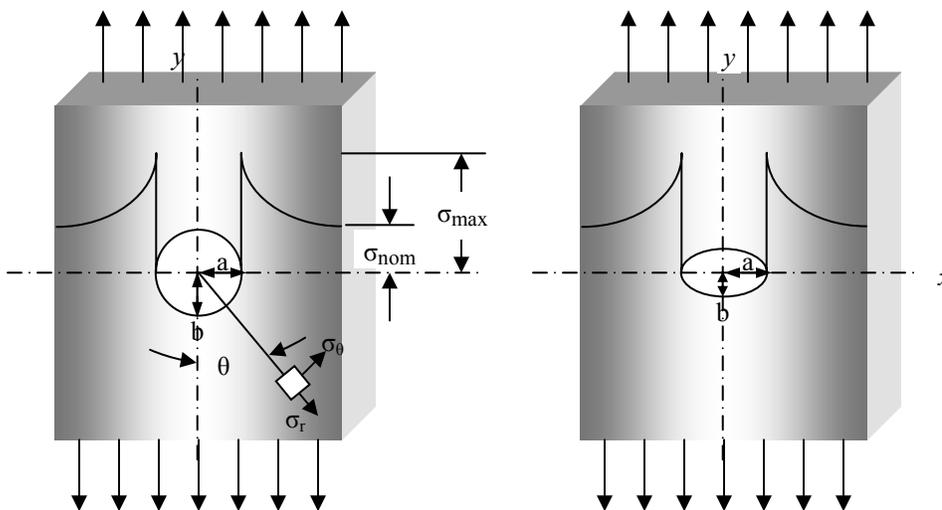
Figure 14. Stress distribution due to (a) spherical and (b) elliptical holes, respectively, along a component(12).

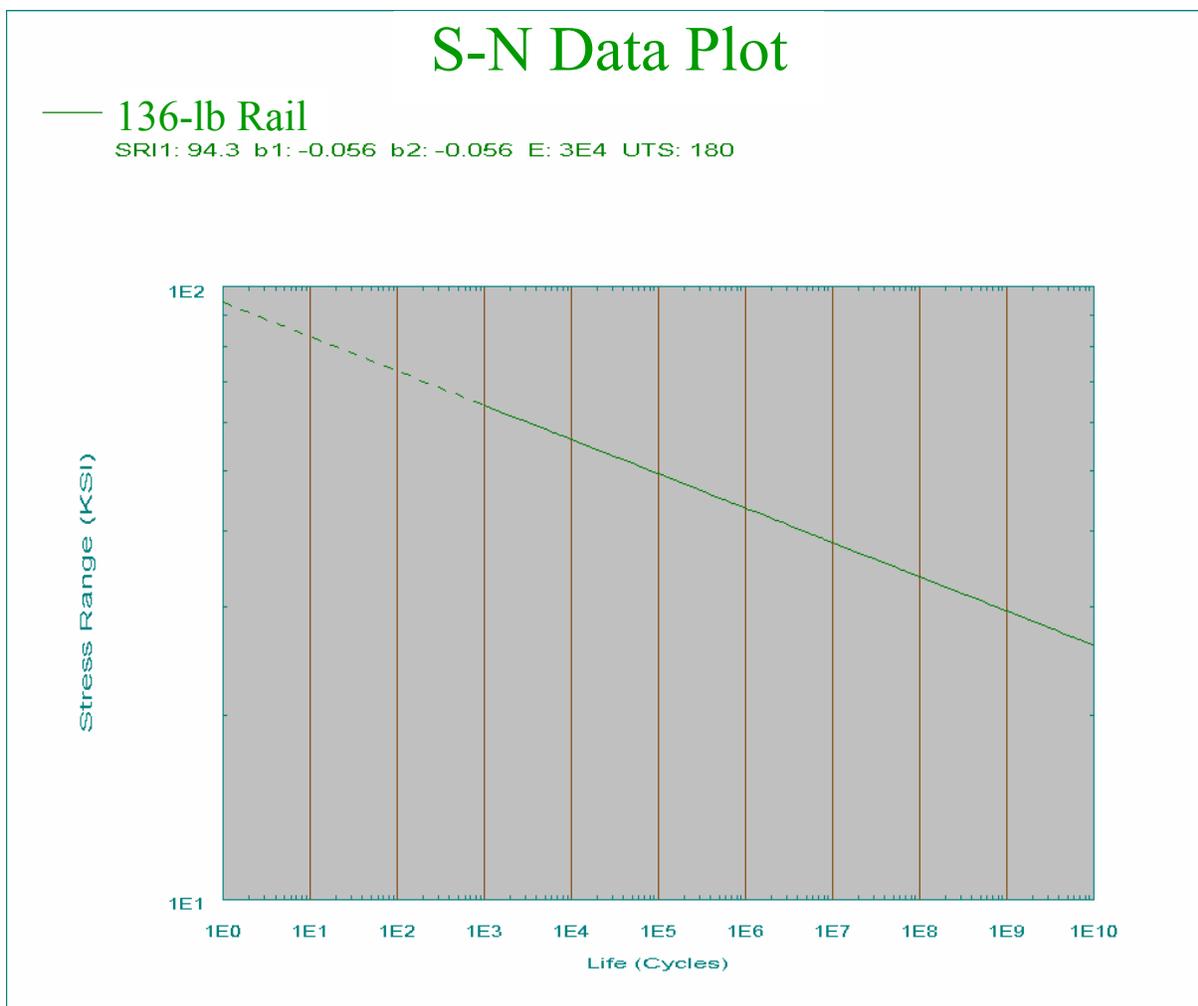
Figure 15. S-N curve for 136-lb rail steel.

Estimated life (for 50% of the locations) until crack initiation with this type of base corrosion is approximately $1.39E7$ to $1.87E7$ “load blocks” or “trains.” This is equivalent to 176 to 237 years, if there are 216 trains passing through the location each day. This implies that this type of situation is not as dangerous for rail's integrity as the presence of sharp edges. However, it is very important to notice that the “razor sharp” effect (9) was not found in any of the rails provided for the current research. Therefore, by introducing this effect on the numerical simulation, the rail's life can be reduced considerably.
