Rail Base Corrosion Detection and Prevention

Rail Base Corrosion Study

Under Transit Cooperative Research Program (TCRP) Project D-7, the Transportation Technology Center, Inc., (TTCI) studied the effects and prevention of rail base corrosion.

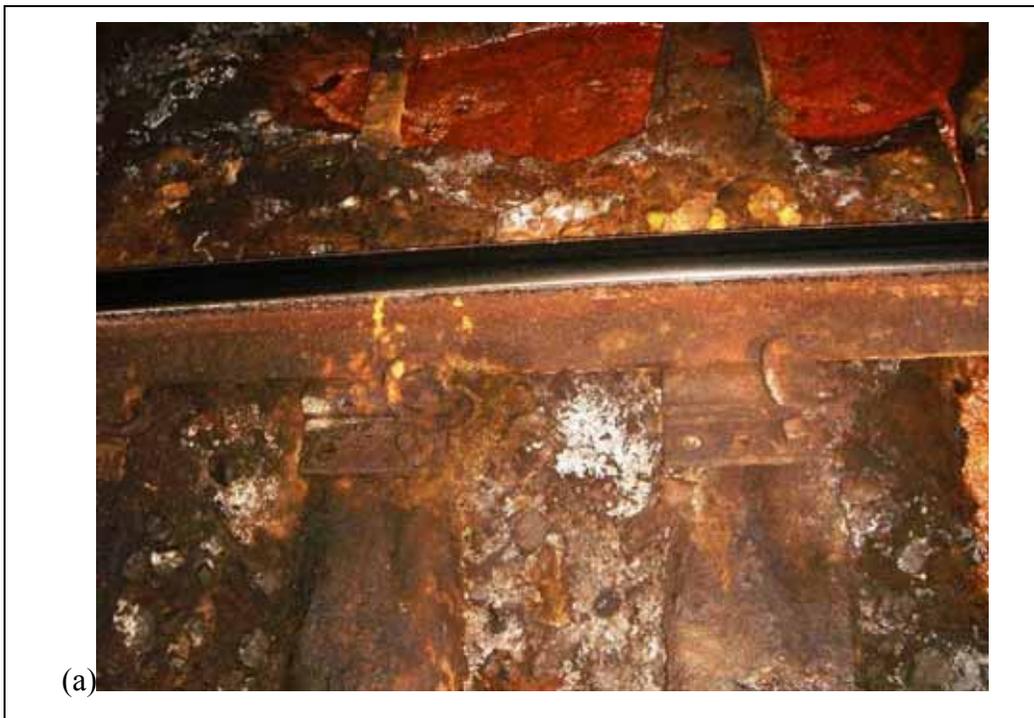
Figure 16. (a) Salts deposited along the tracks at Port Authority Trans-Hudson.

The chemical analysis as reported by the Edmonton Transit System includes mainly alkaline salts, chlorides, and sulfates (7). This was further confirmed by other transit authorities (13-15). Appendix E shows the chemical analysis conducted by the Edmonton Transit System.

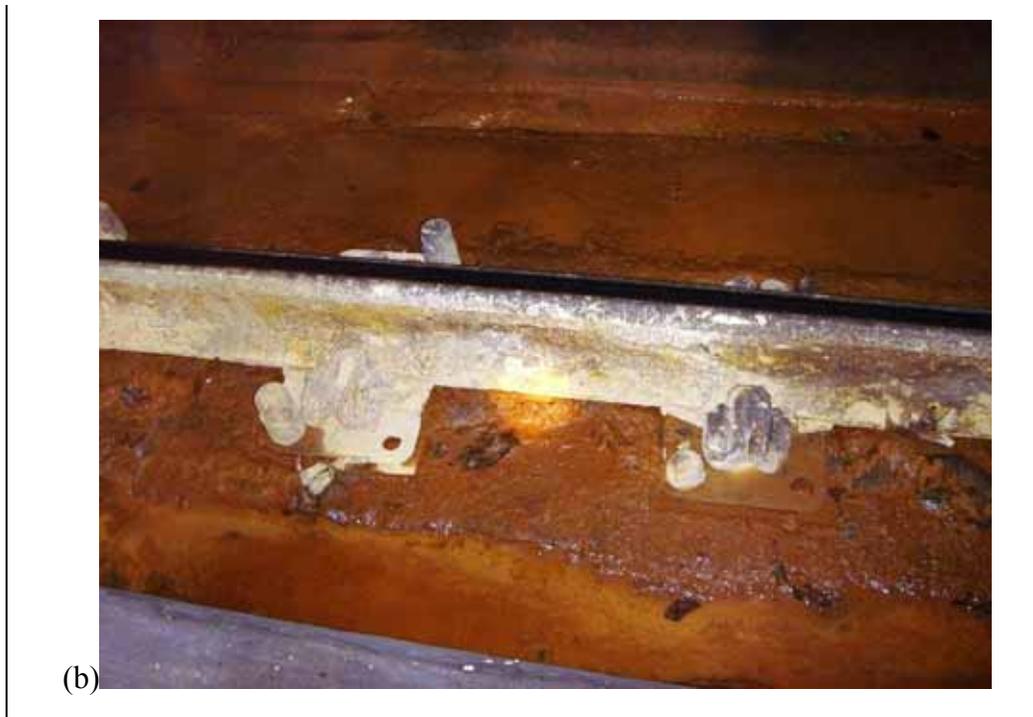
Figure 16. (b) Salts deposited along the tracks at Southeastern Pennsylvania Transportation Authority.

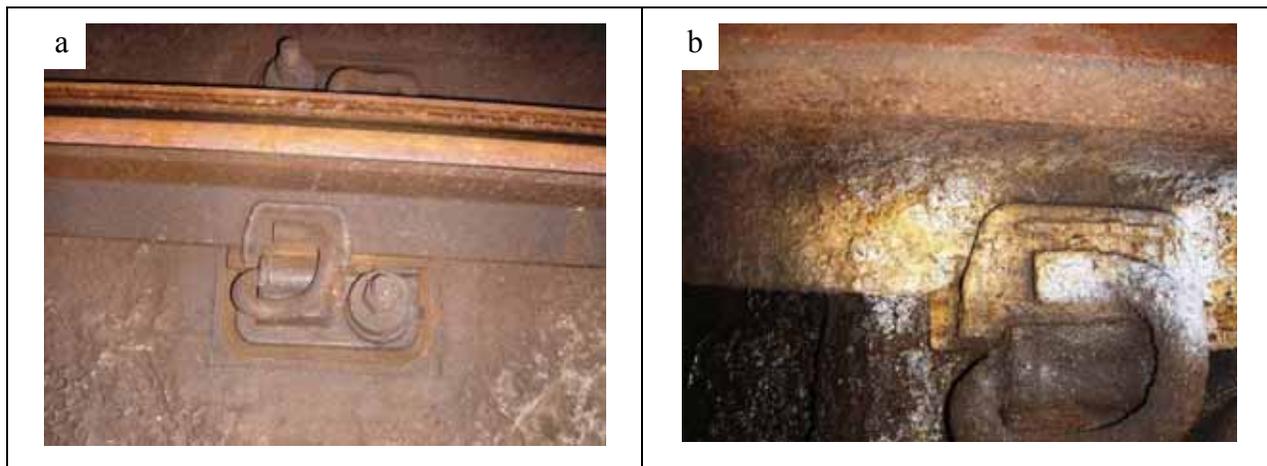
Figure 17. Examples of Pandrol clips showing (a) good condition and (b) salts deposited around the Pandrol clip. Both pictures were taken at the Toronto Transit Commission subway during the site visit.

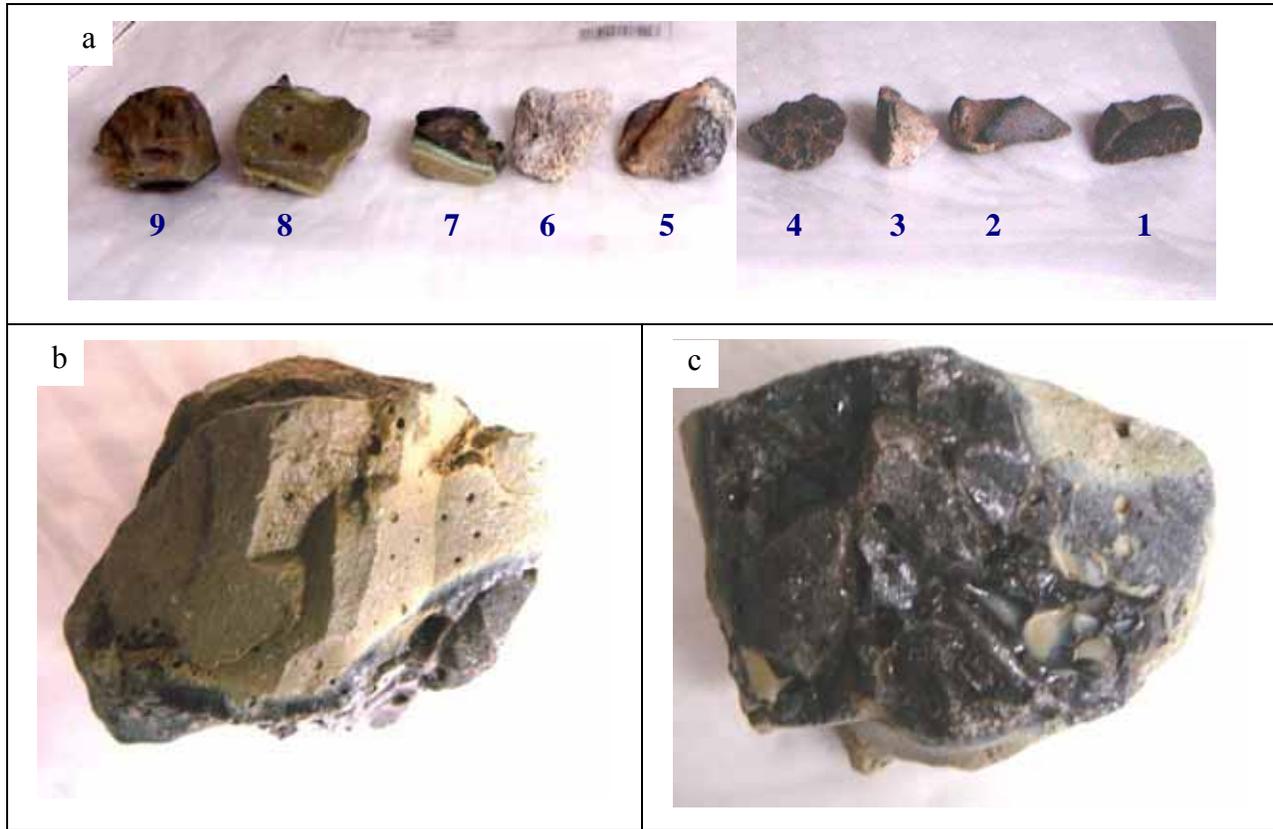
Figure 18. Ballast specimens used for the resistivity test: (a) all tested ballast and slag based ballast (b) green section, and (c) black/glassy section.

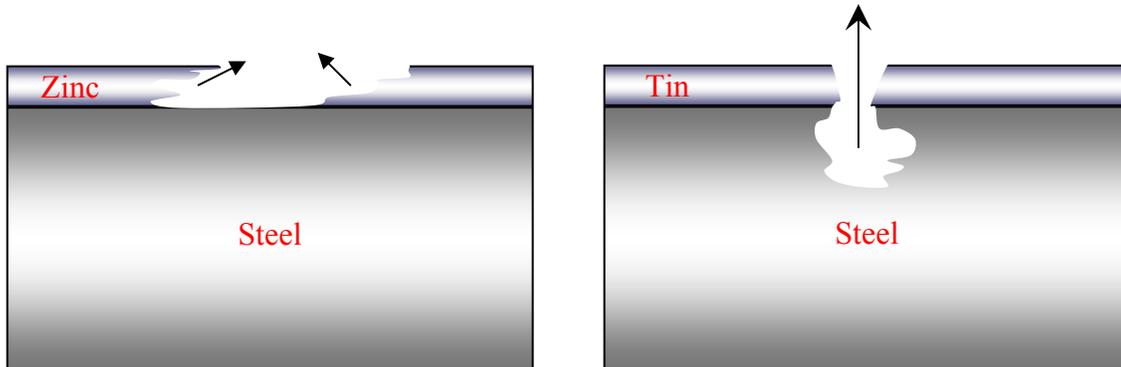
Figure 19. Examples of galvanic corrosion using zinc and tin on steels. Note that while zinc makes a protective layer preventing the corrosion of steel, tin is protected by the corrosion of steel.

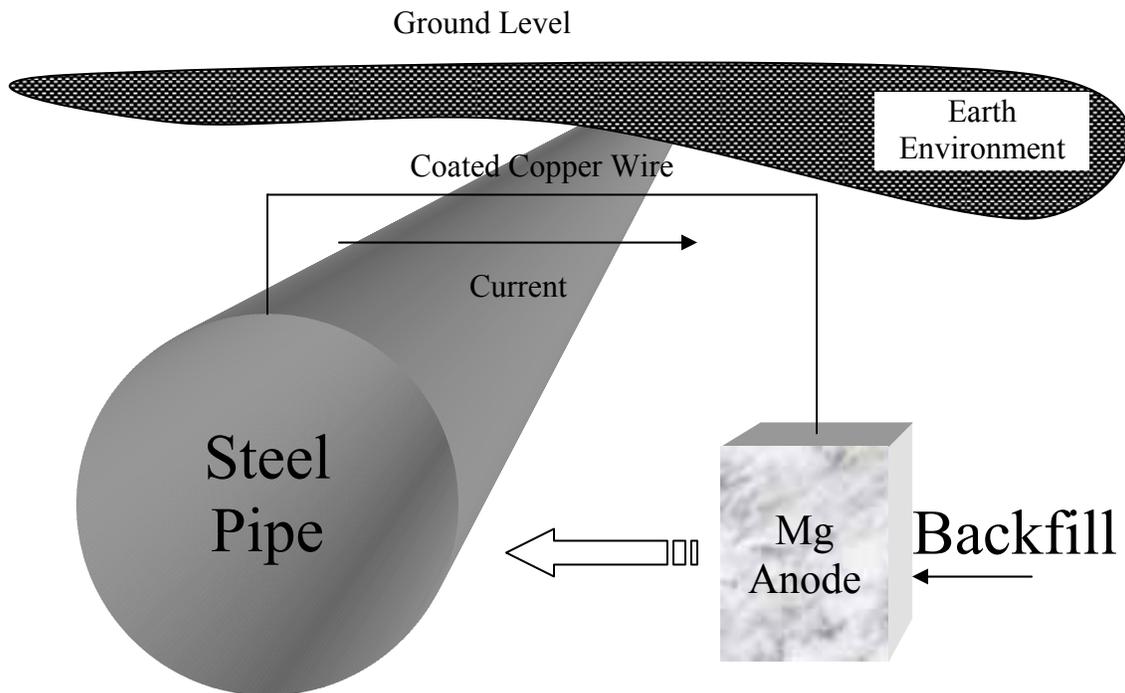
Figure 20. Protection of an underground pipeline with a magnesium anode (1).

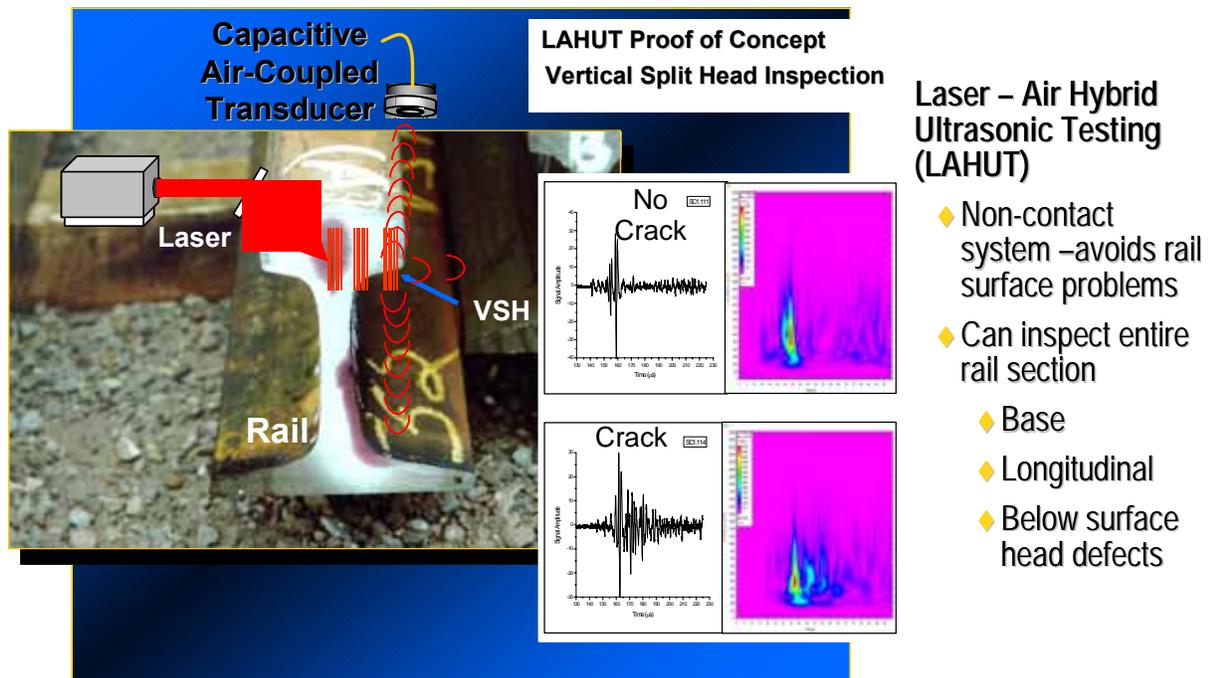
Figure 21. Principles of emerging technologies for rail flaw detection (37).

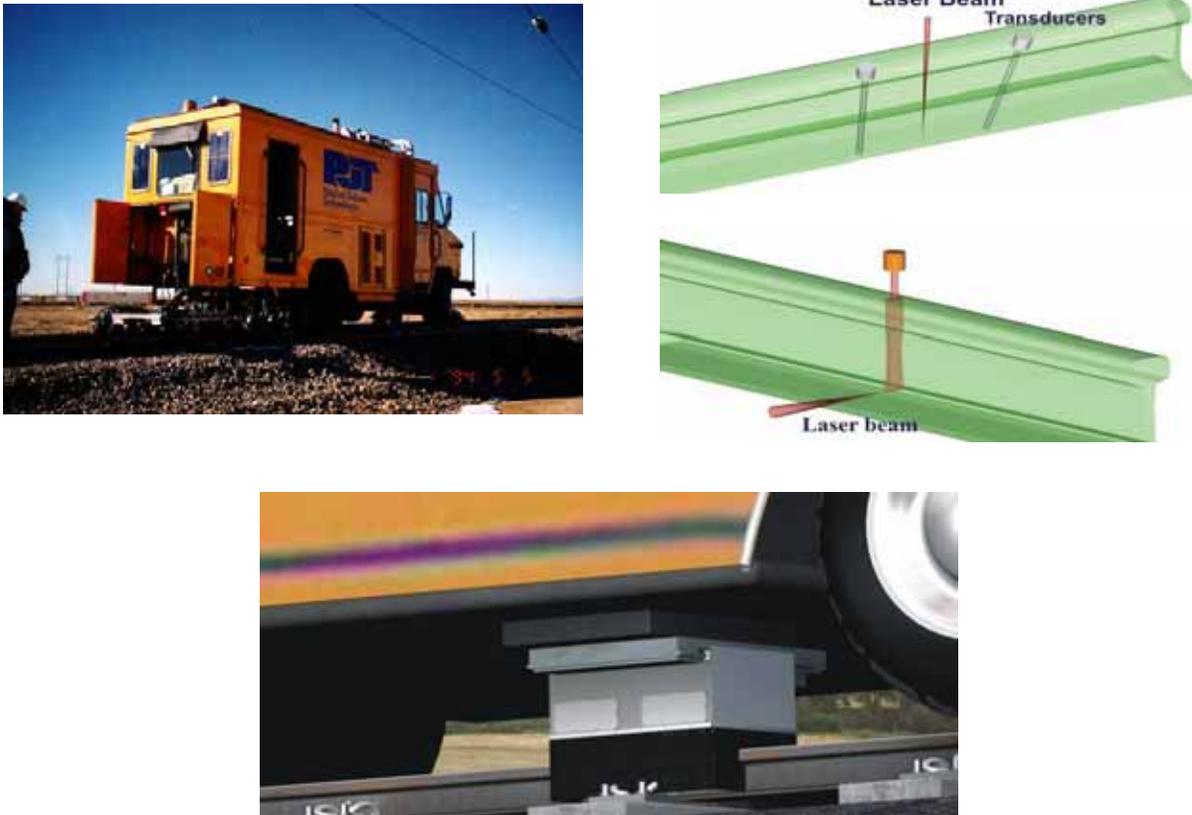
Figure 22. (a) Rail flaw detection vehicle showing (b) location of the lasers and transducer and (c) ultrasonic device monitoring a rail in service (37).

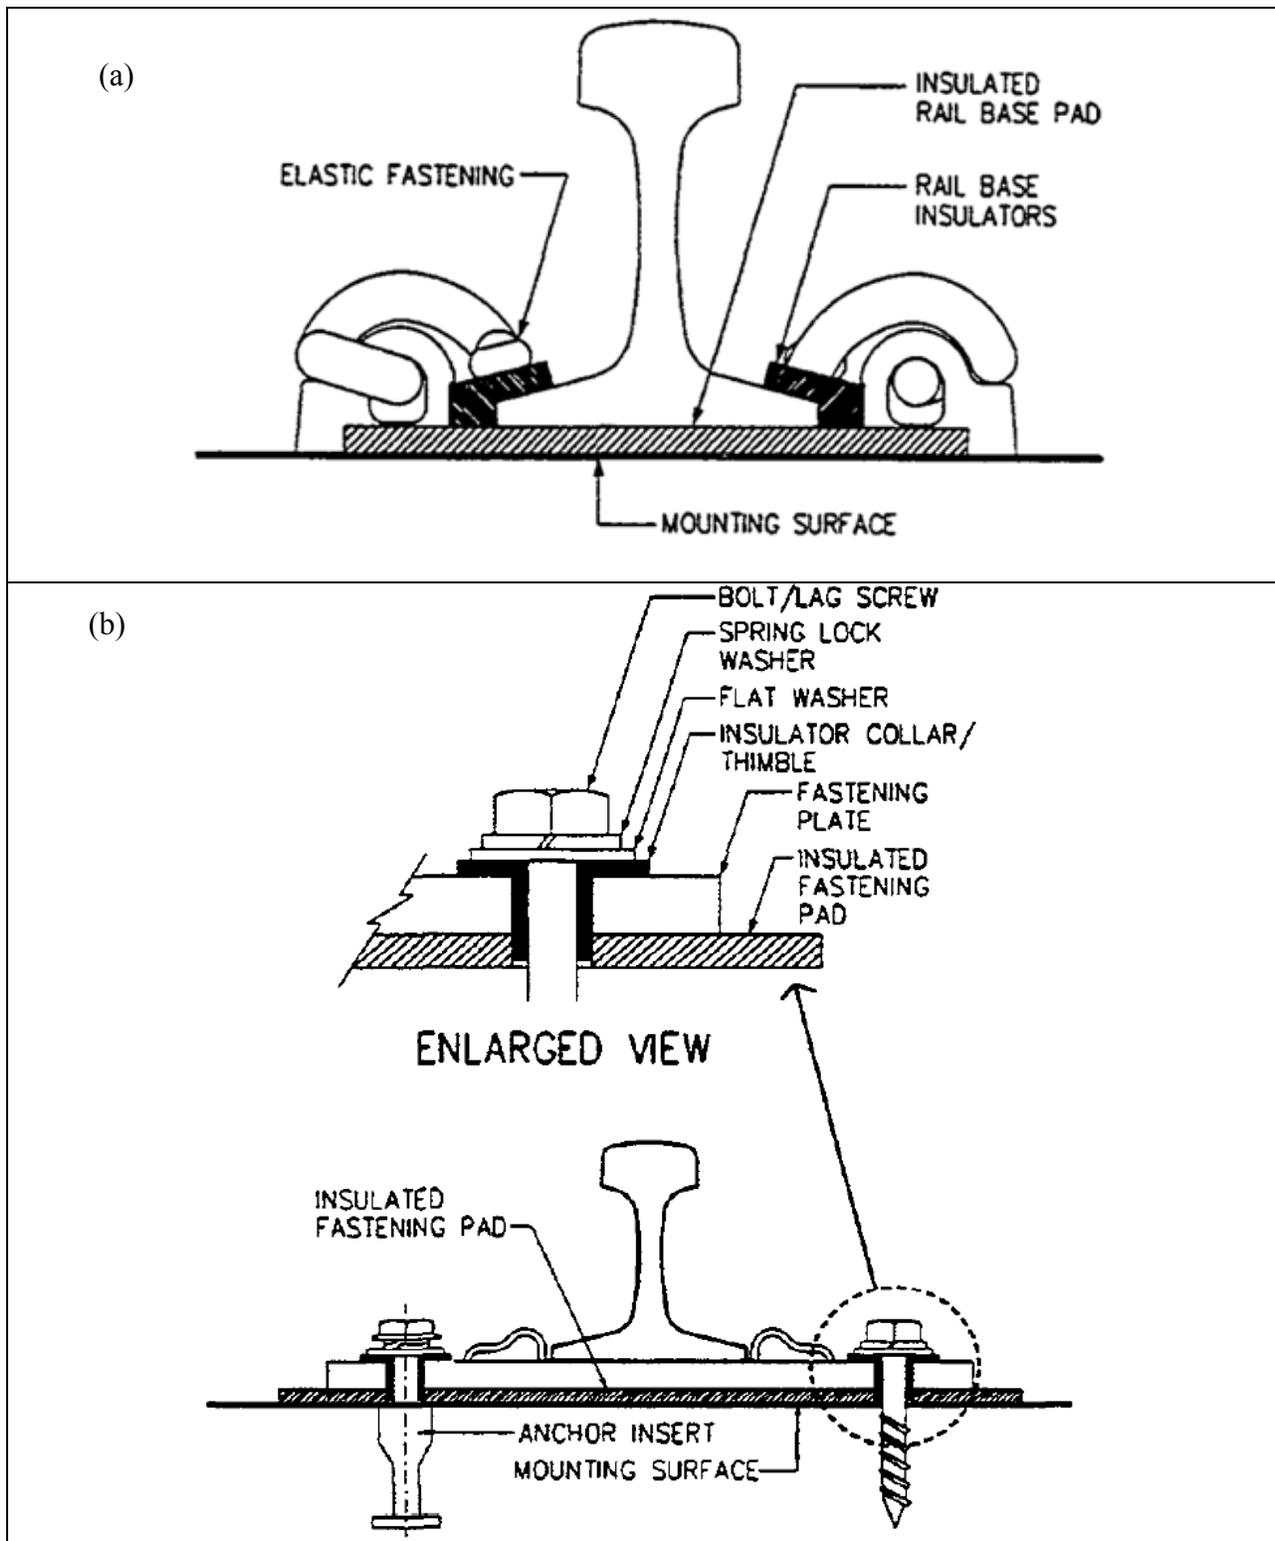
Figure 23. Examples of tracks insulating (a) insulation at the rail base and (b) isolation of the fastening or fastener base. For more information consult reference 16, Chapter 5.

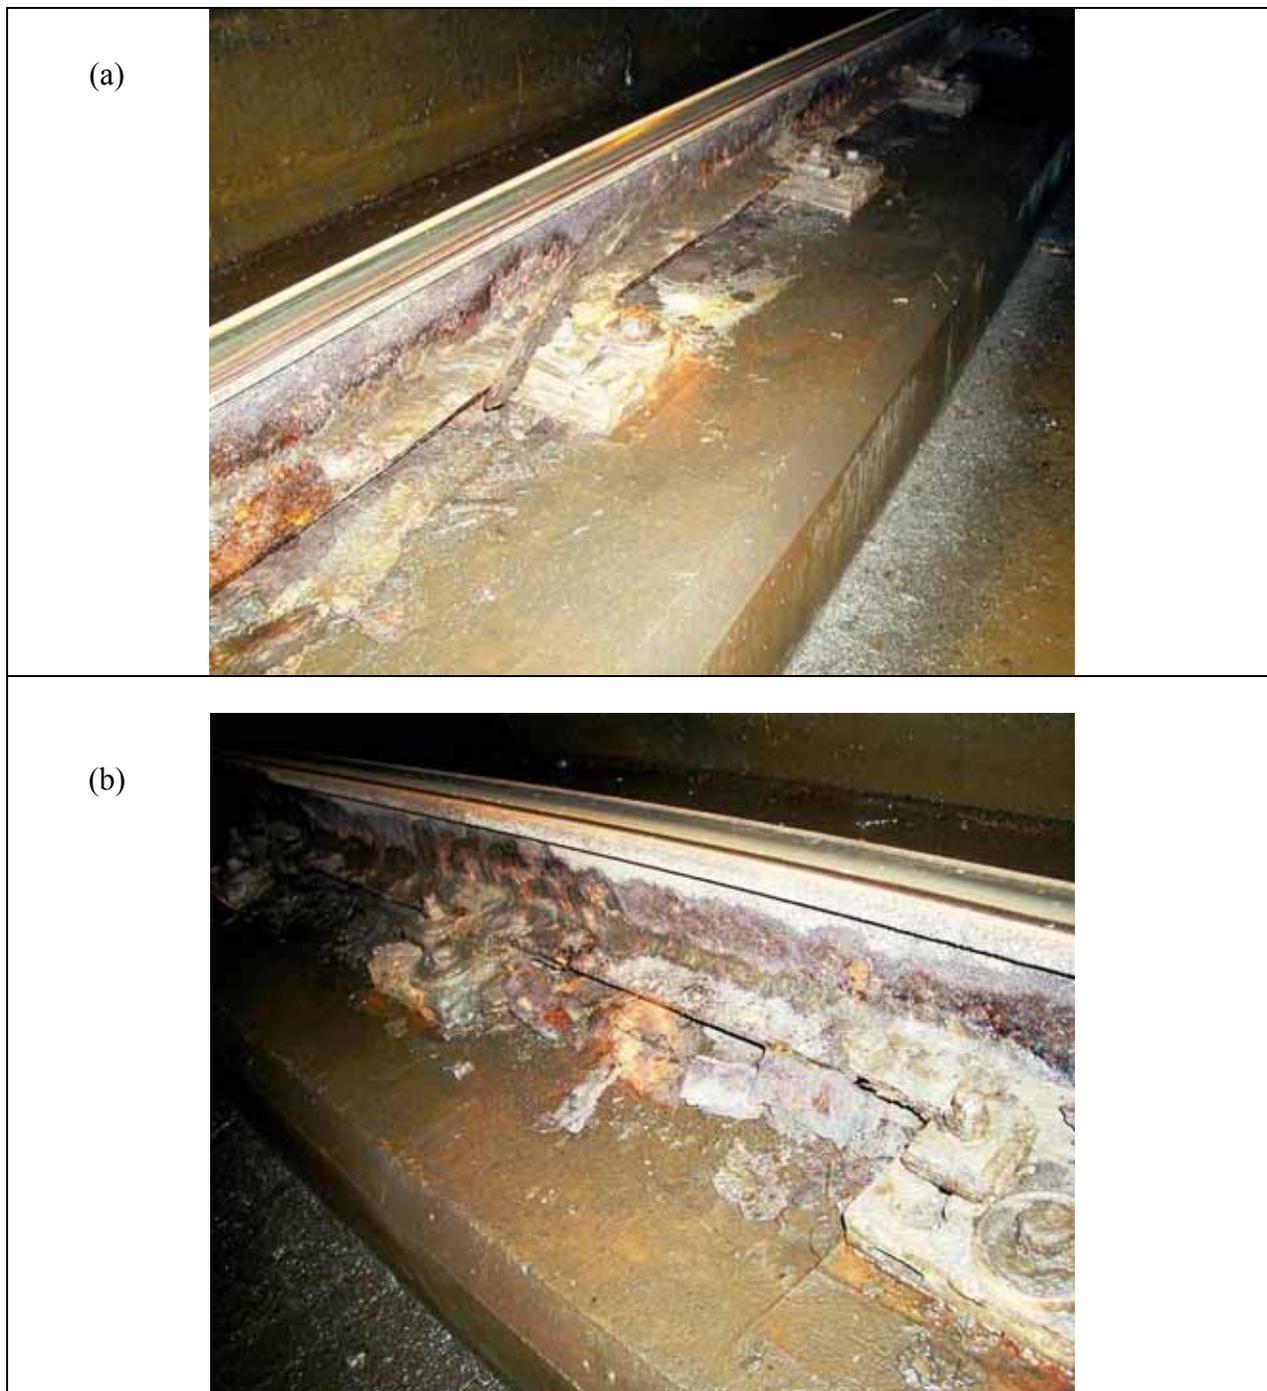
Figure 24. Wet tracks and detrimental corrosion effects on rails, fastening system, and tie plates. Notice the rust shells peeling out of the rail tracks.

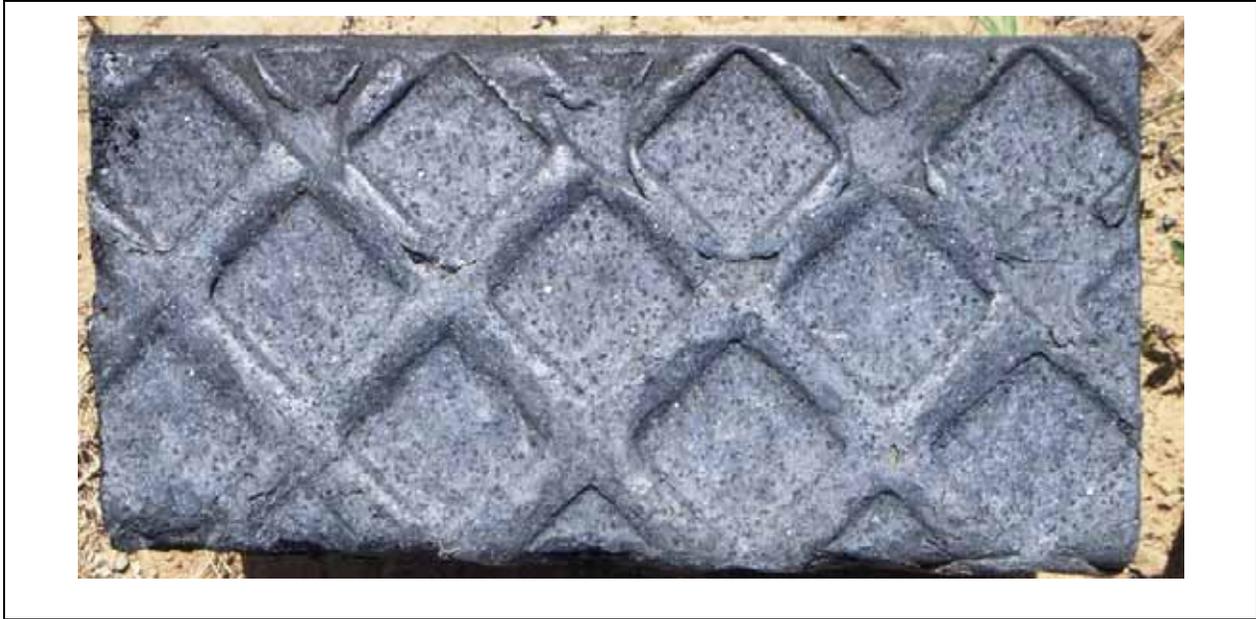
Figure 25. One of the plastic composite ties used for the electrical resistance laboratory test at TTCI.

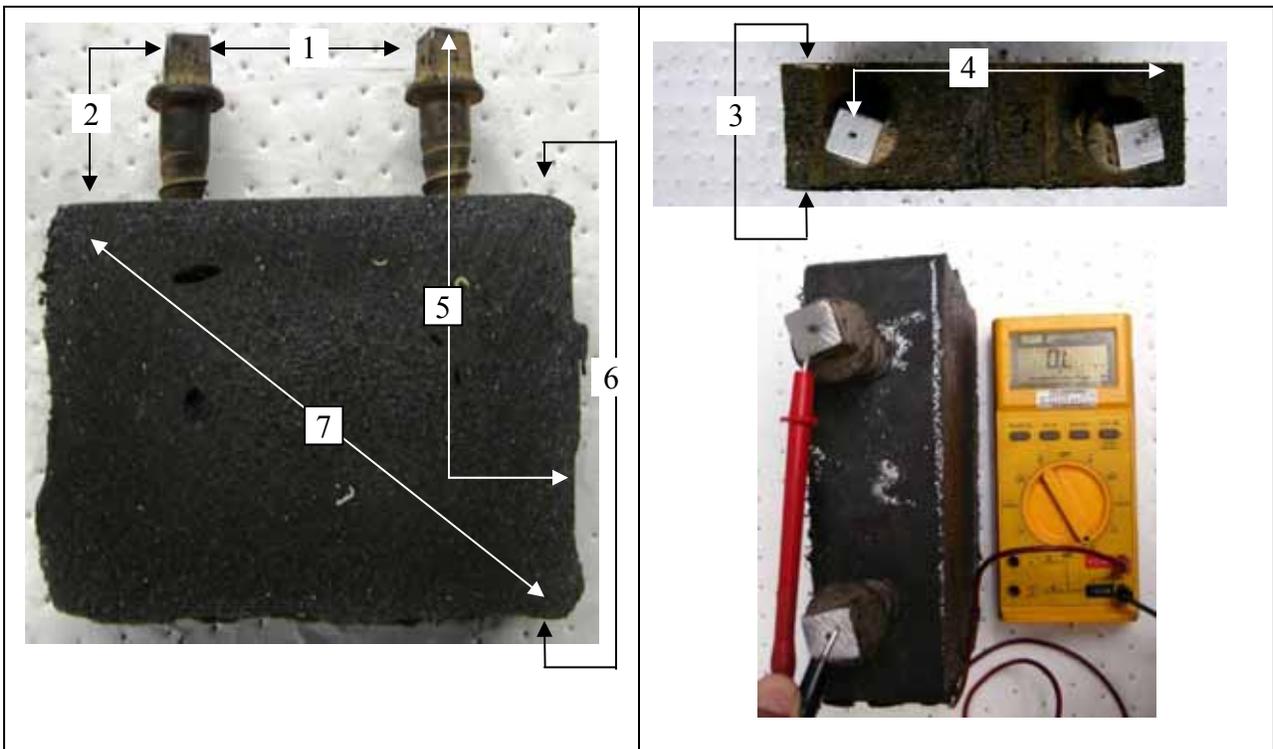
Figure 26. The electrical resistance measurements were taken at seven locations under dry and water-soaked conditions using a typical ohmmeter.

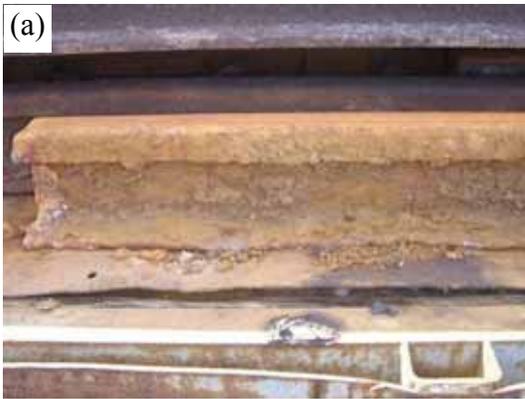
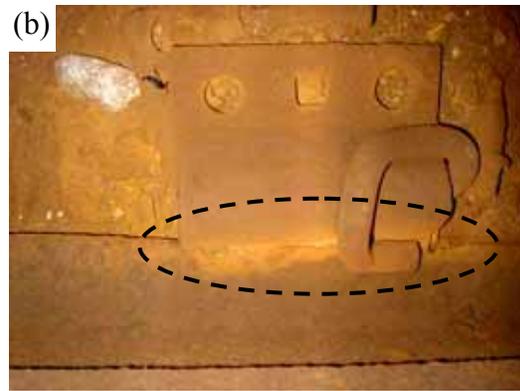
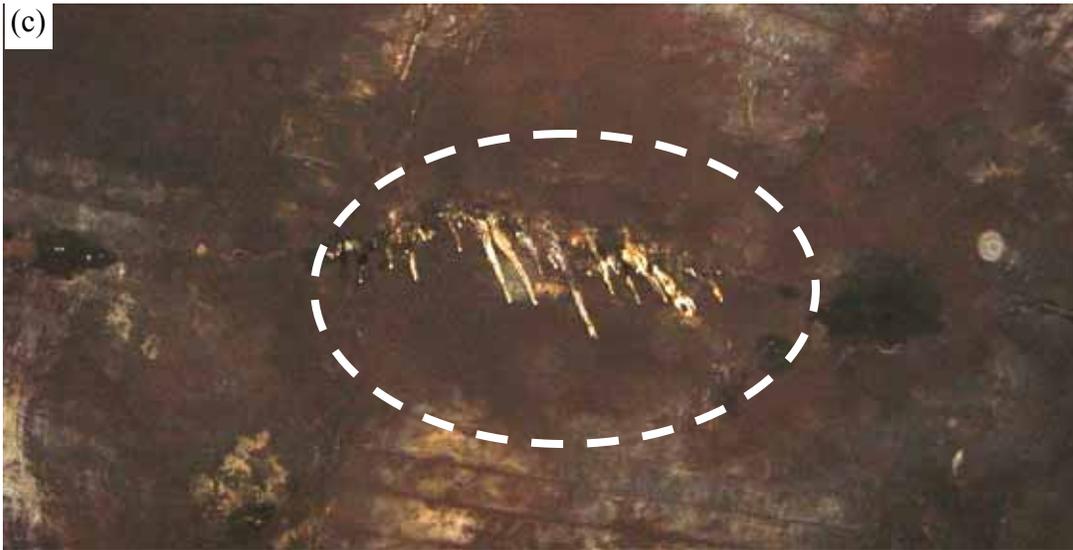
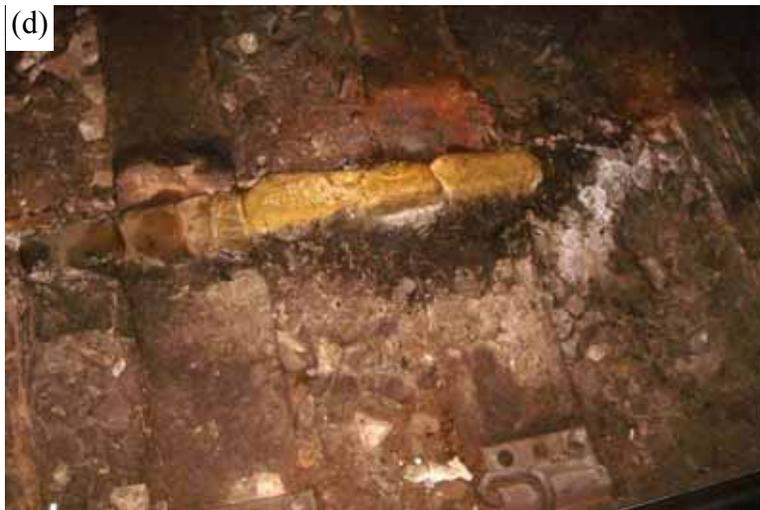
PATH Transit System showing (a, b) rail corrosion, (c) ice spikes from sealant used to prevent water leaks in the tunnel, and (d) salts deposited along the tracks. Note: The site visit was conducted during January 2006 and due to the weather conditions in New York and New Jersey, the water leaks froze forming the ice spikes shown in photo (c).

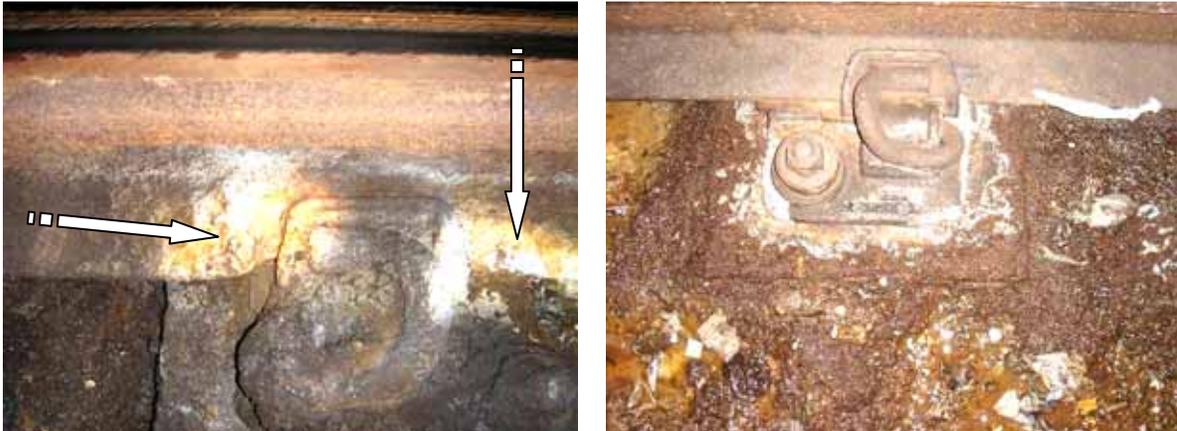
TTC-Toronto tracks showing deposited salts and resulting corrosion.

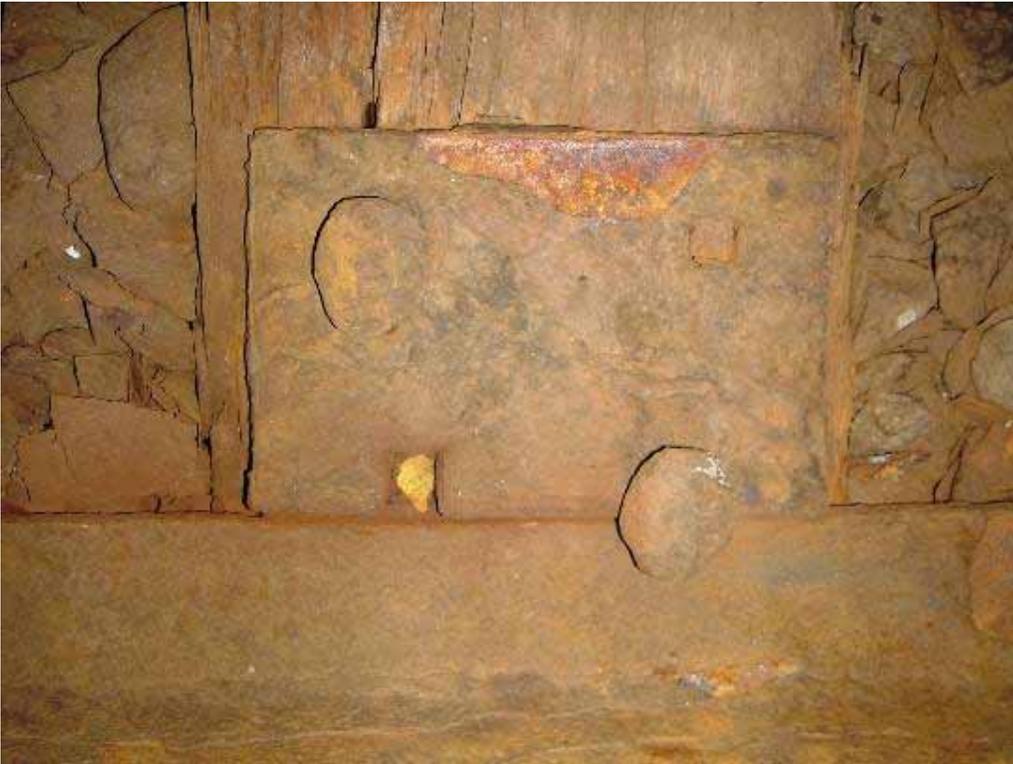
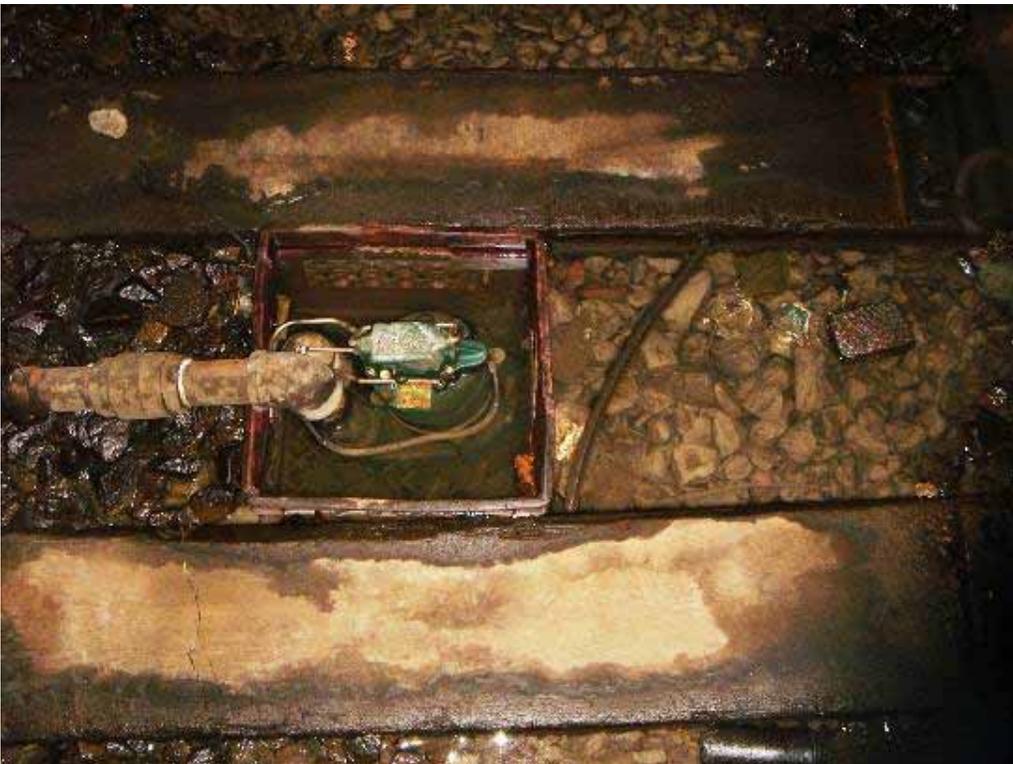
Amtrak tracks showing flooded tracks and pumping system used to remove water from the track.

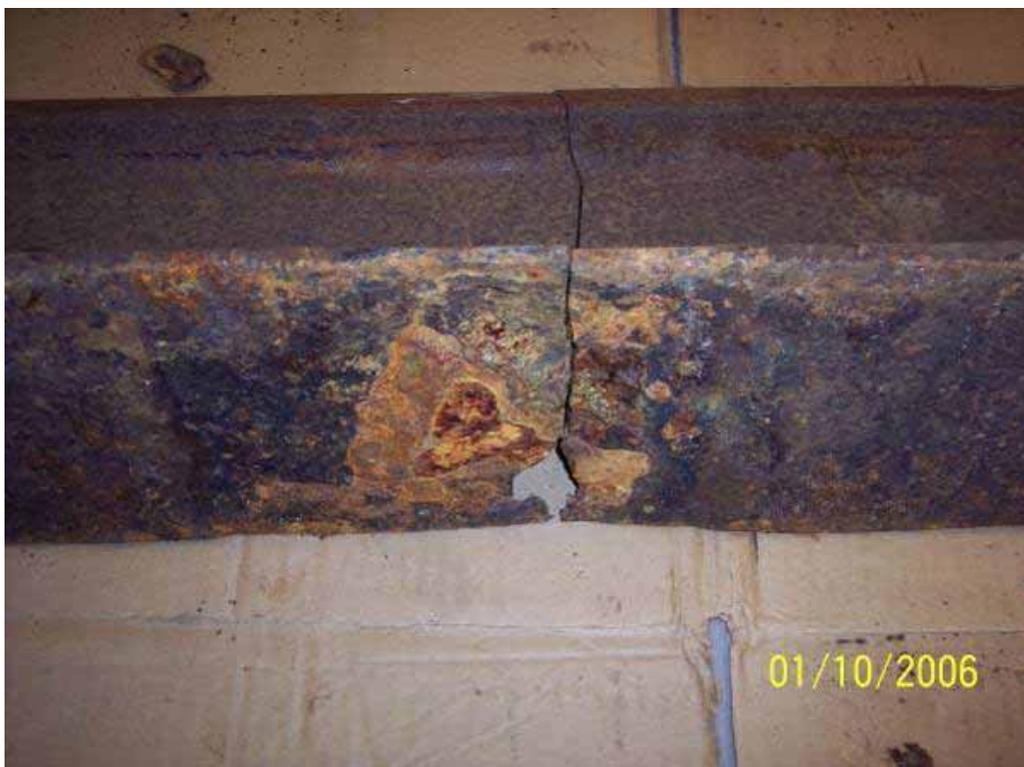
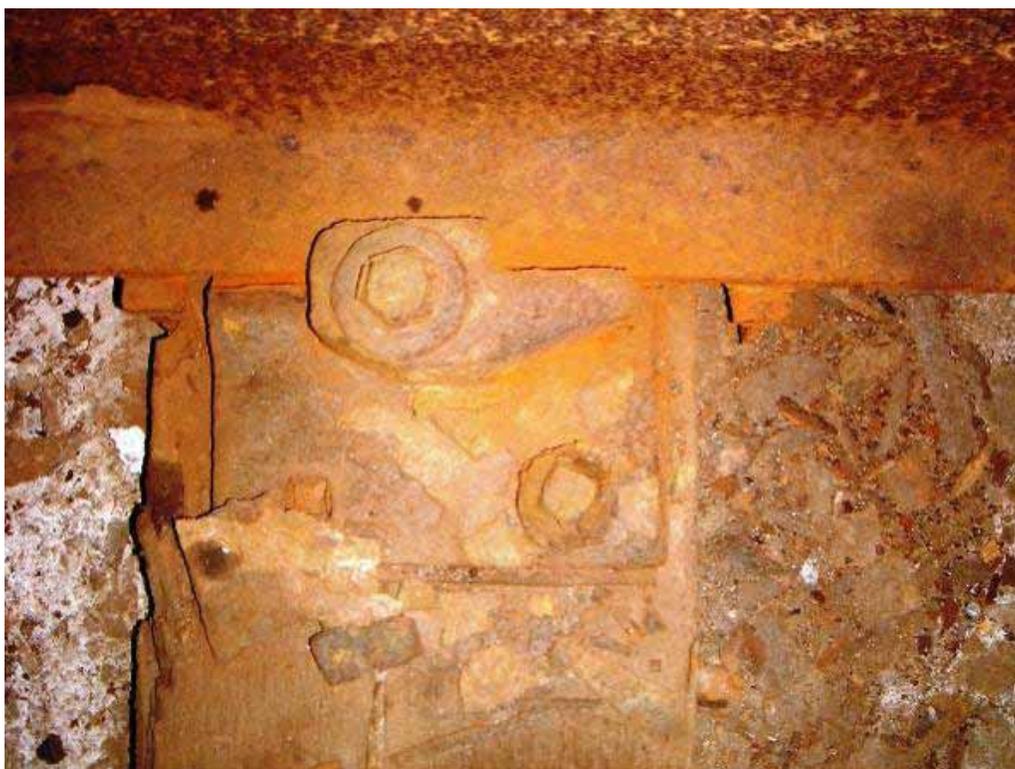
Rail donated by Amtrak (Baltimore) and a location on the tracks showing severe corrosion.

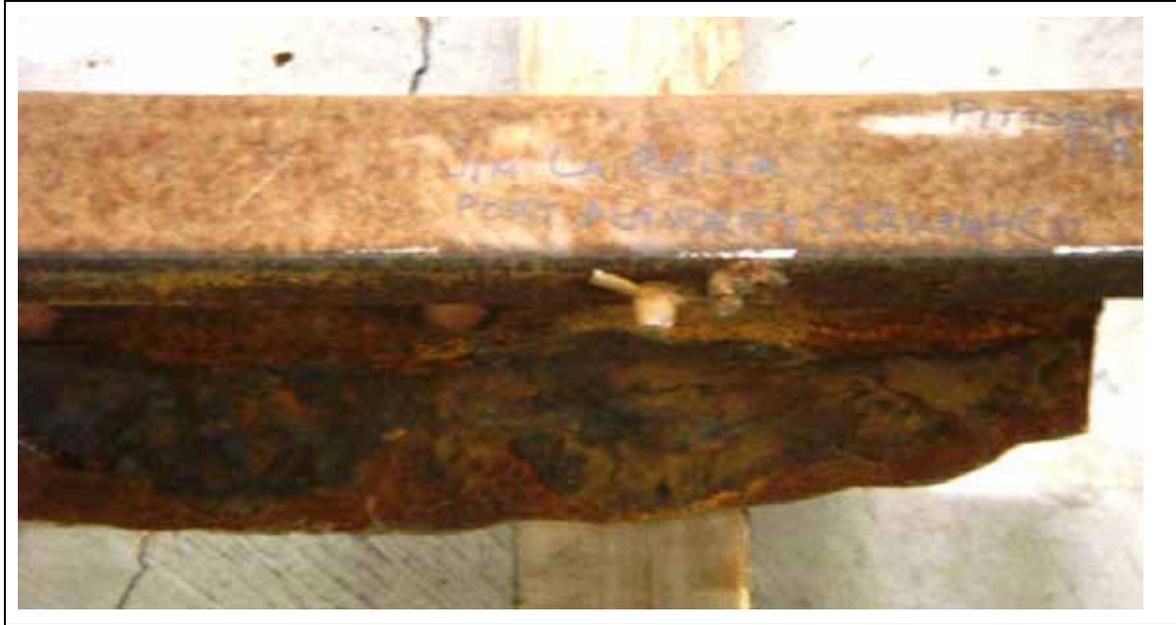
Rail donated by PAAC showing severe corrosion at the base.

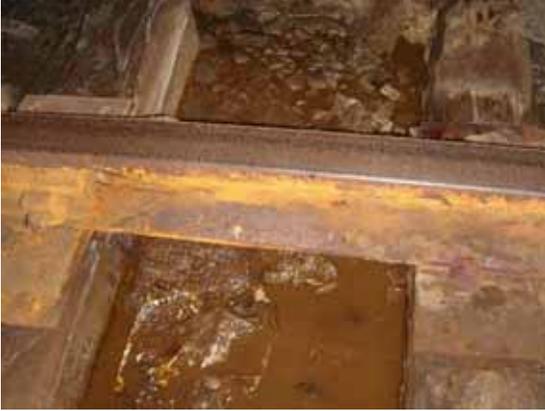
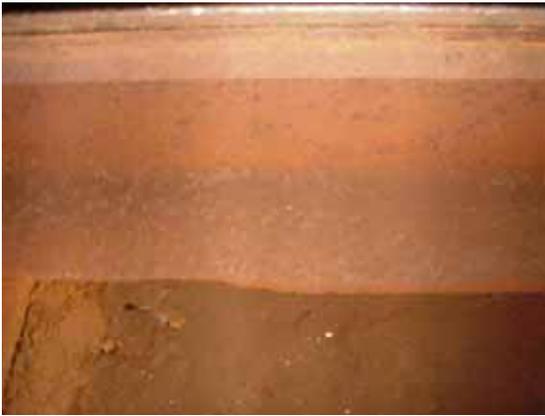
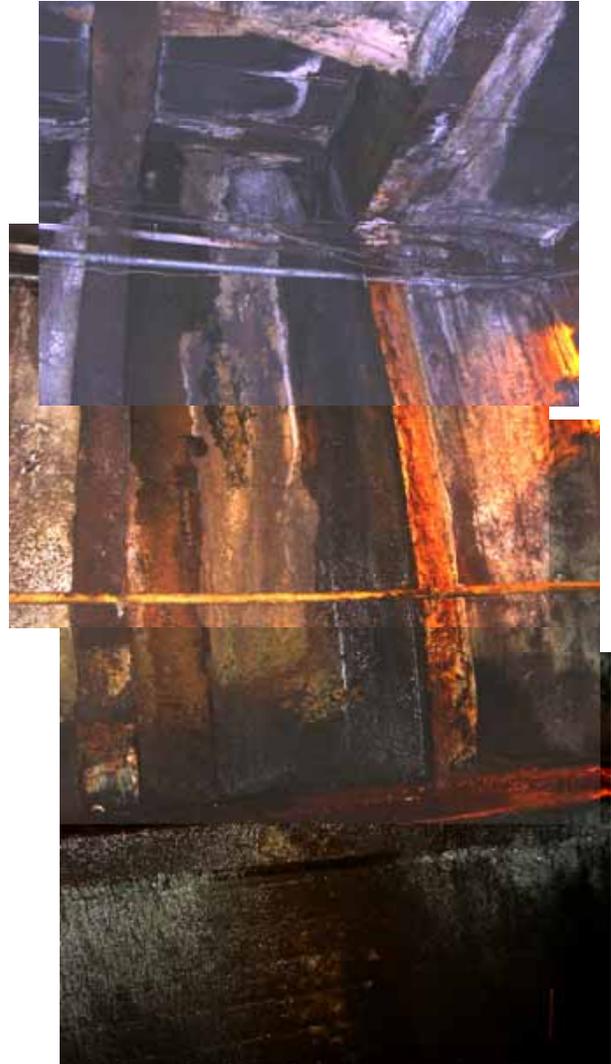
MTA-NYCT tunnels showing severe water leakage from the walls, severe humidity under the tracks, and erosion of the rail base.

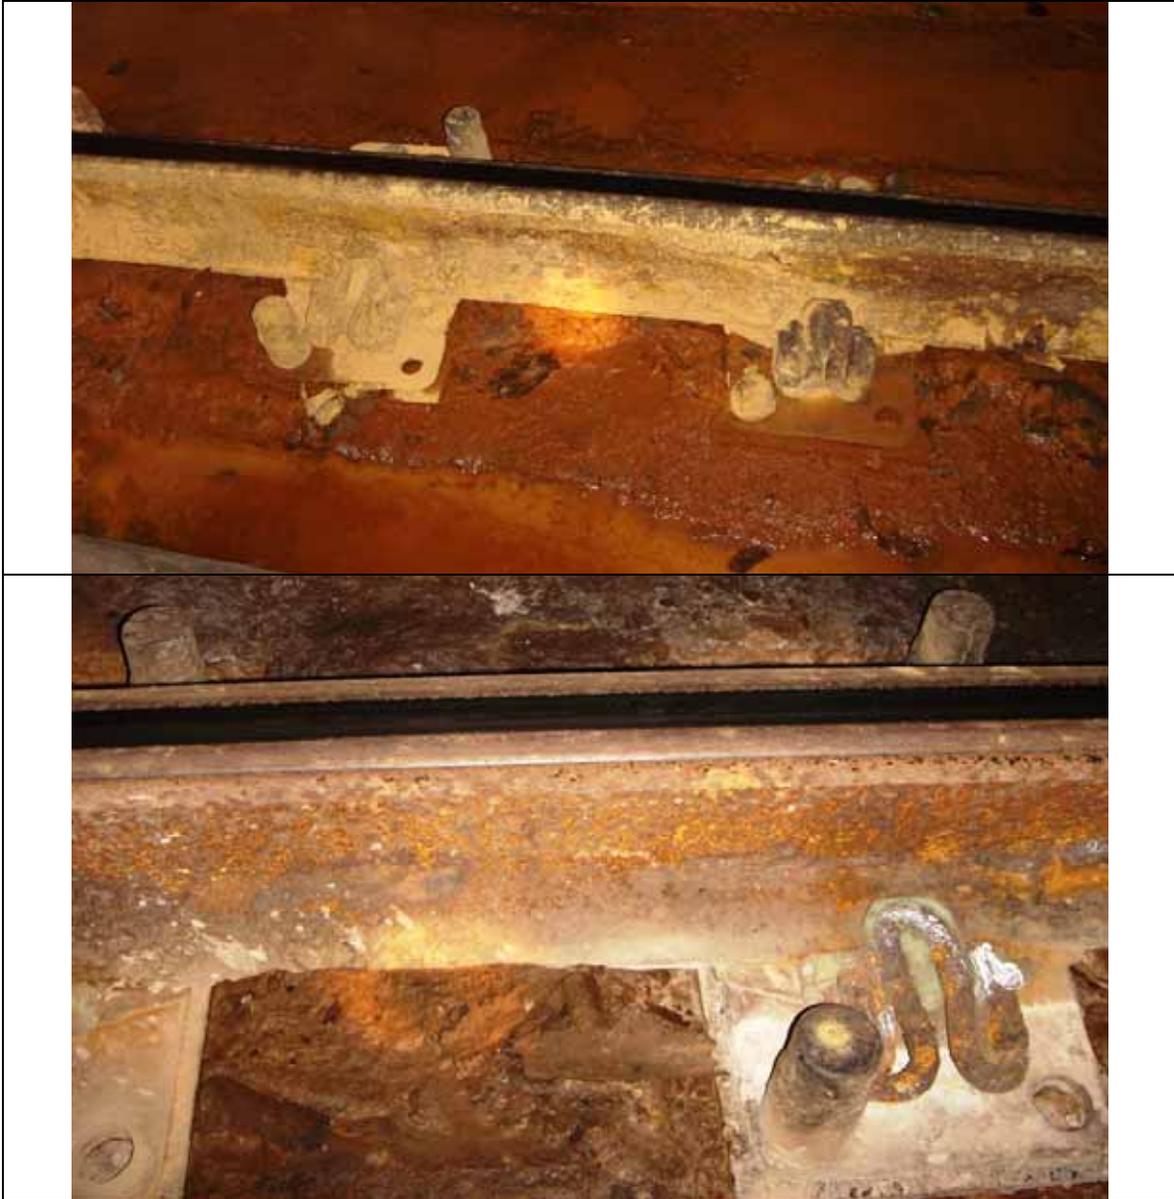
Light rail SEPTA tunnels showing severe corrosion.

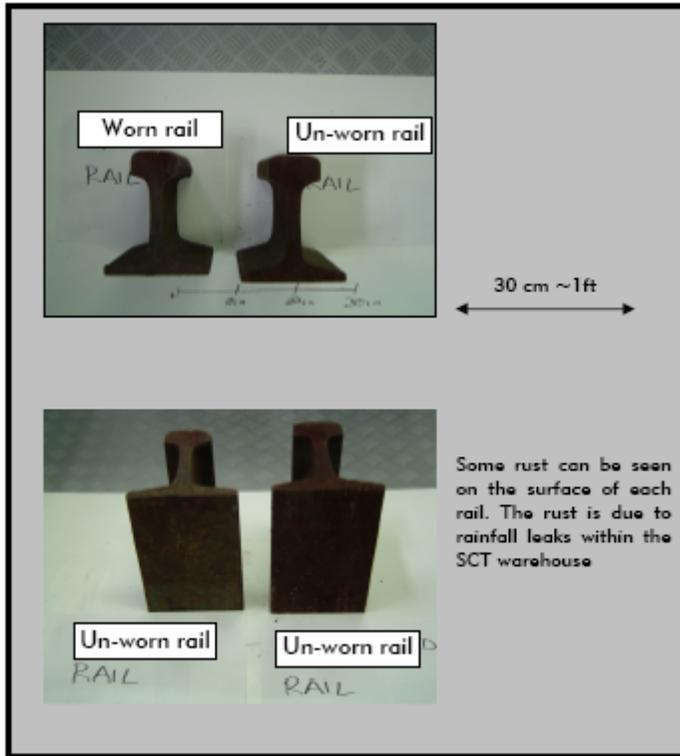
Figure D2. Rails from STC in the as received condition.

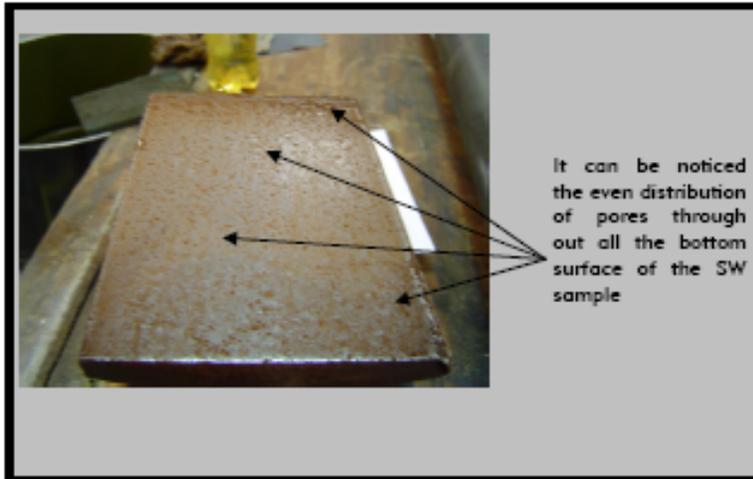
Figure D3. Bottom end of the SW sample, showing some porosity.

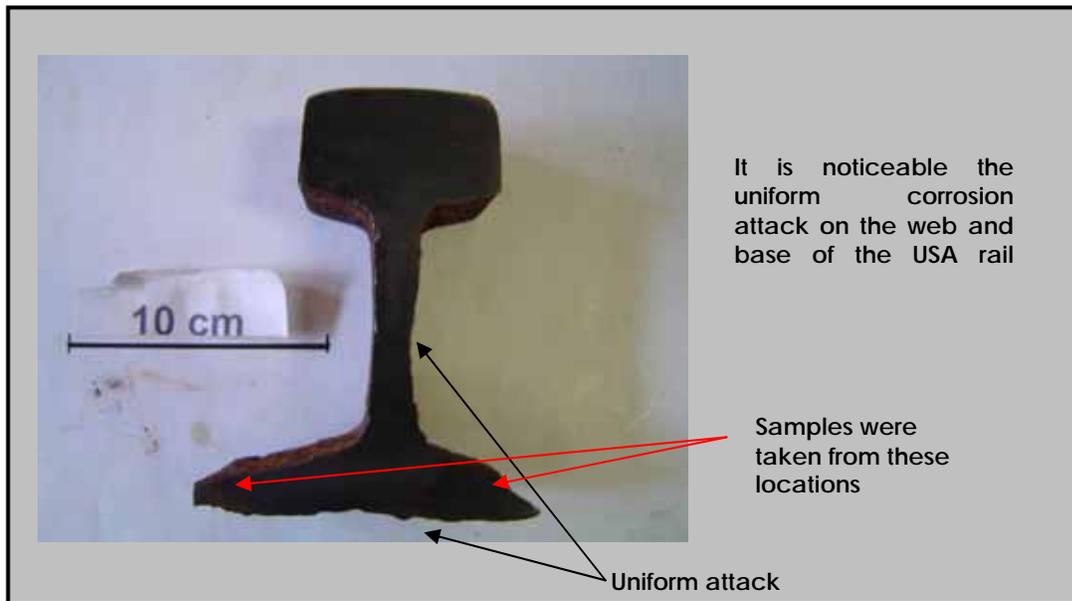
Figure D4. USA rail sample in the as received condition.

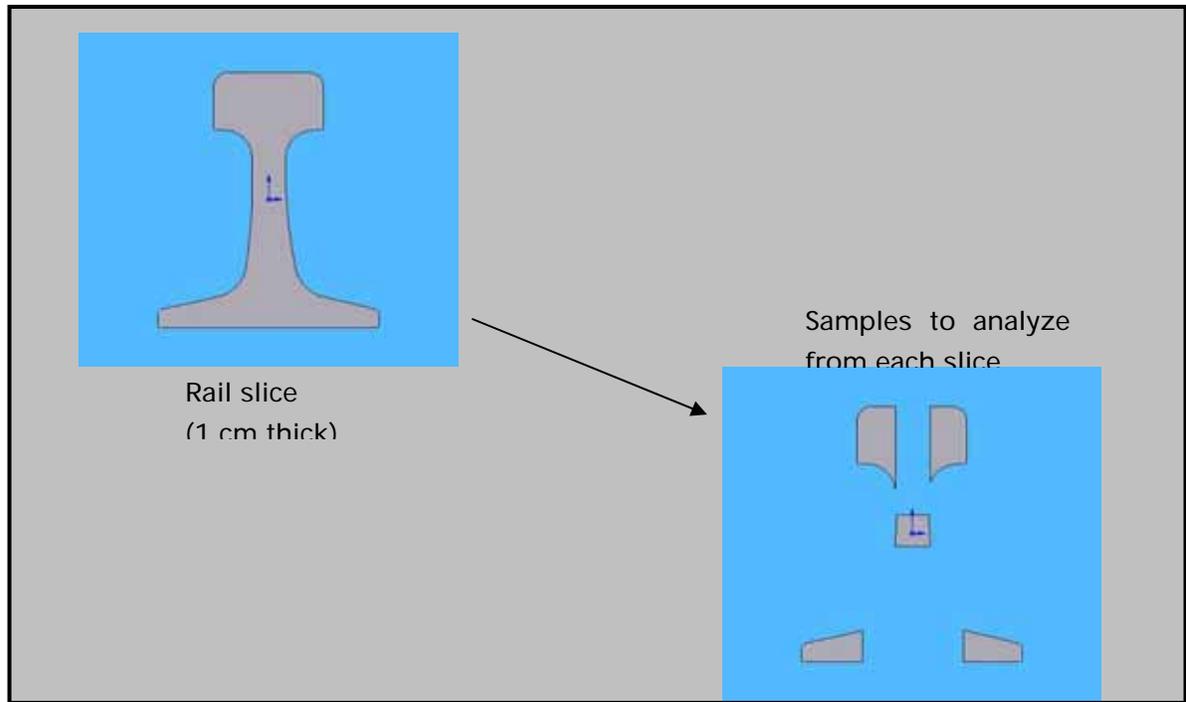
Figure D5. Actual samples from each rail to analyze.
