Rail Base Corrosion Detection and Prevention

Rail Base Corrosion Study

Under Transit Cooperative Research Program (TCRP) Project D-7, the Transportation Technology Center, Inc., (TTCI) studied the effects and prevention of rail base corrosion.

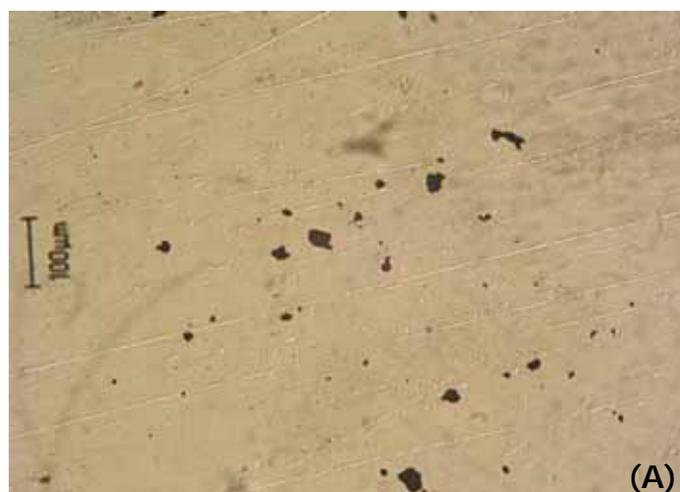
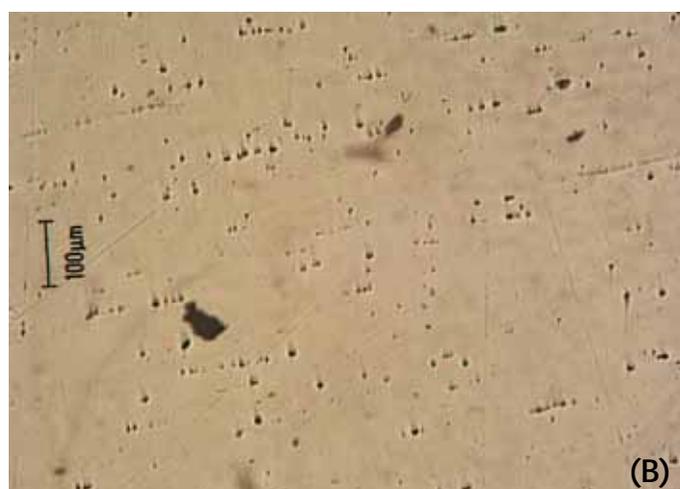
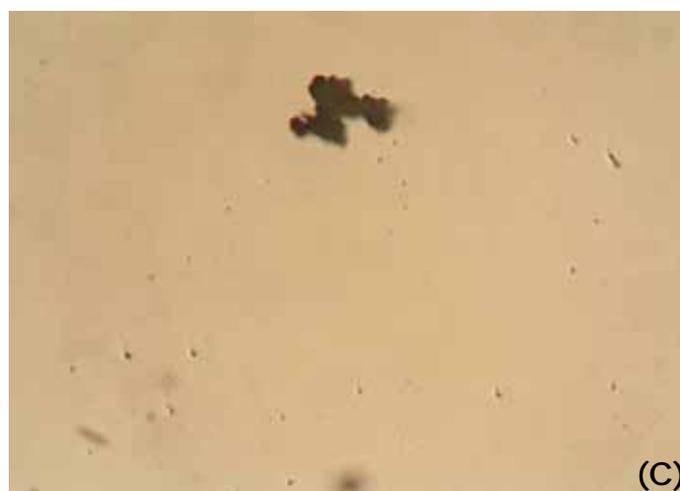
Figure D6. Non-metallic inclusions in the different rail samples: (a) SW, (b) SU and (c) USA

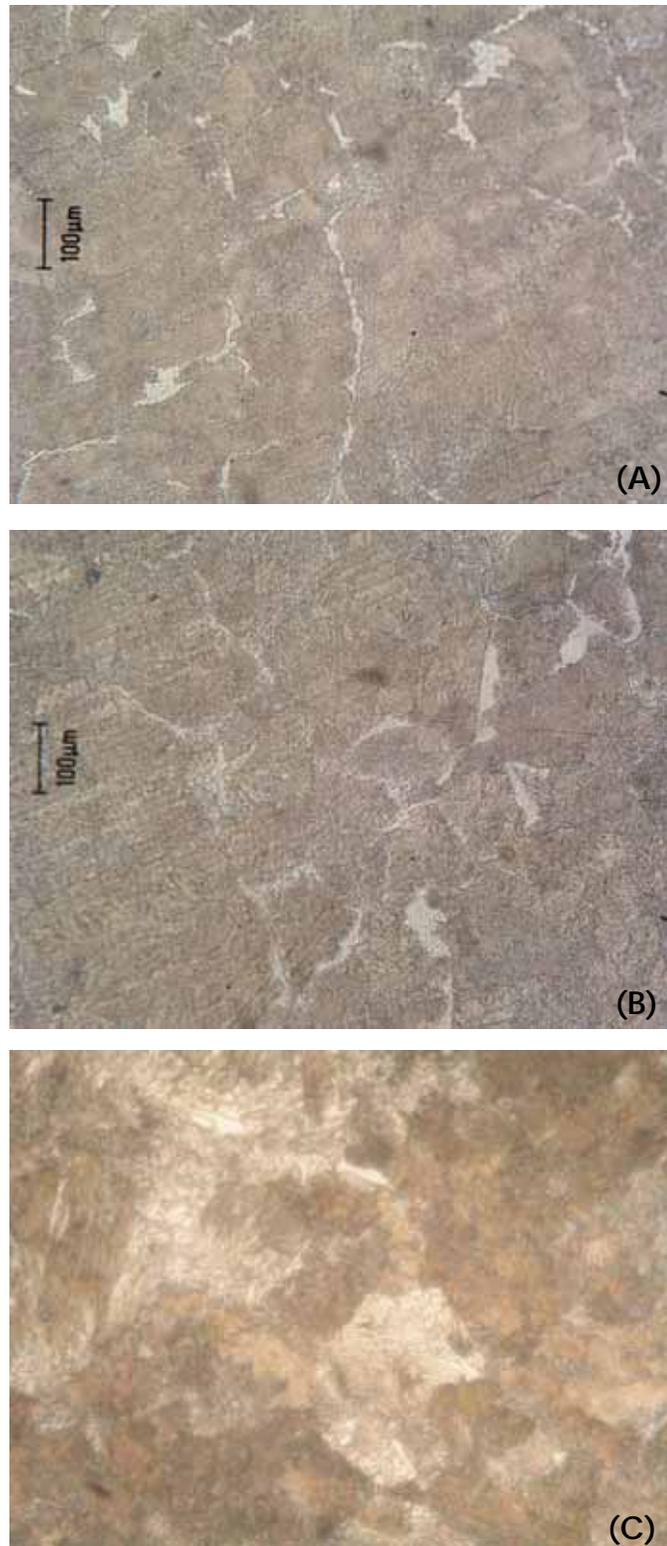
Figure D7. Metallographic examination of the different rails samples: (A) SW, (B) SU, (C) USA.

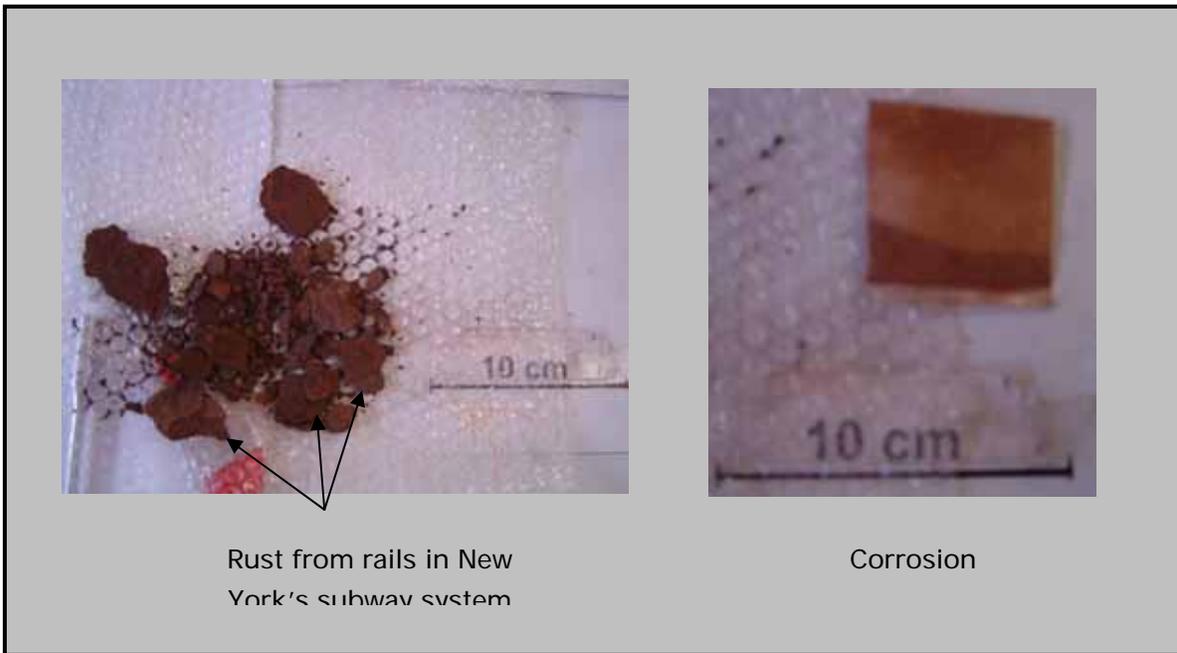
Figure D8. Corrosion products found in New York's subway system.

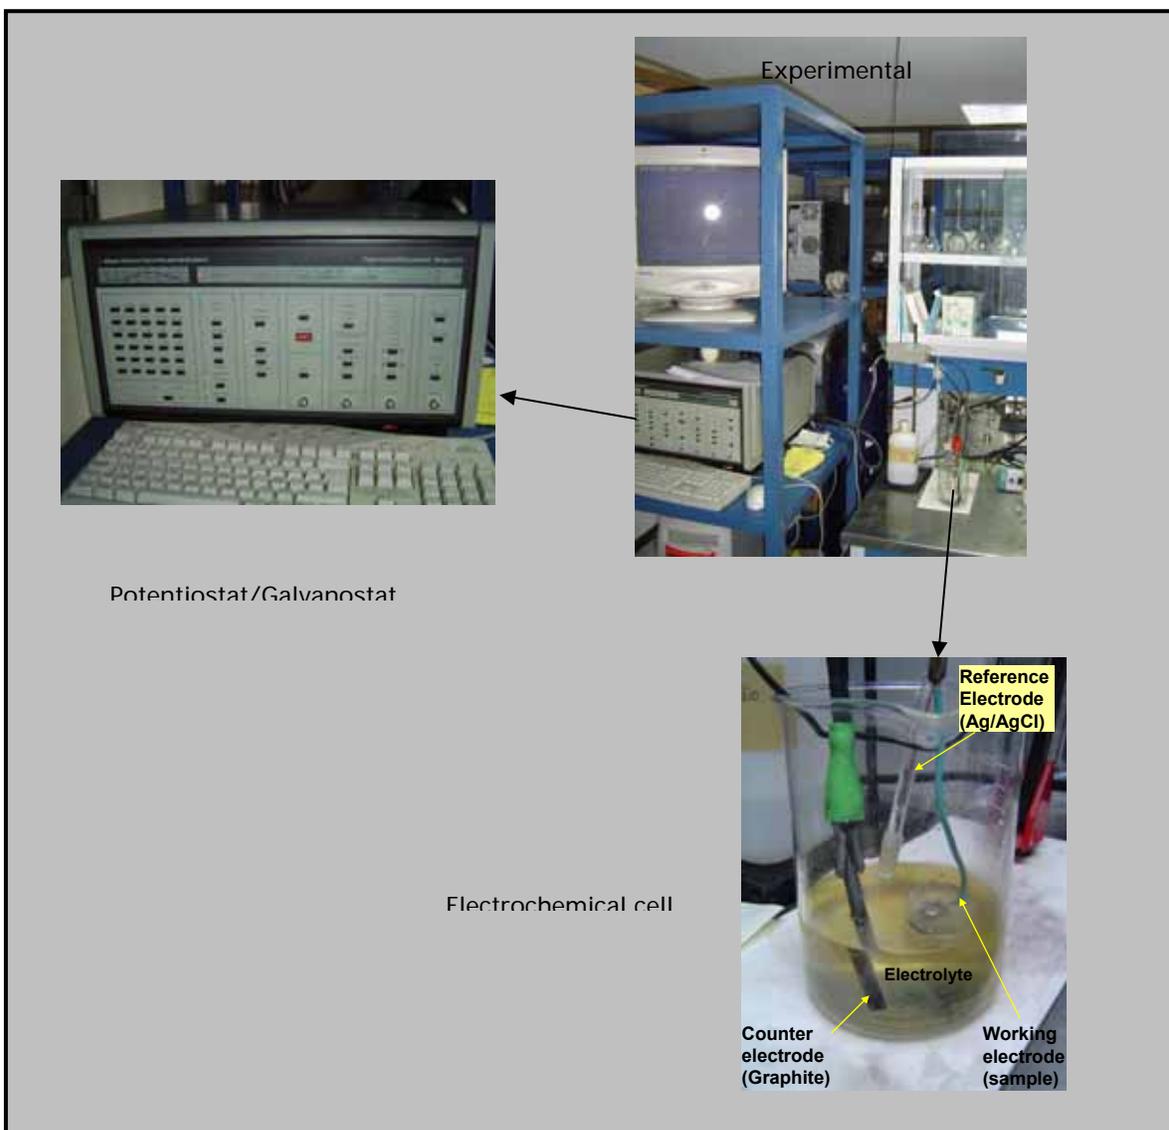
Figure D9. Experimental set up for corrosion tests.

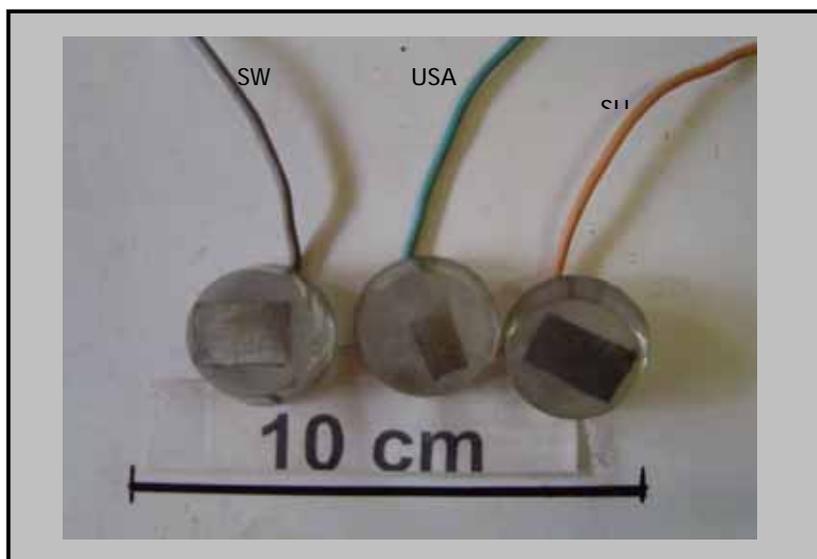
Figure D10. Probes used for corrosion testing. The picture shows the probes after being corroded in 0.1 M KCl electrolyte.

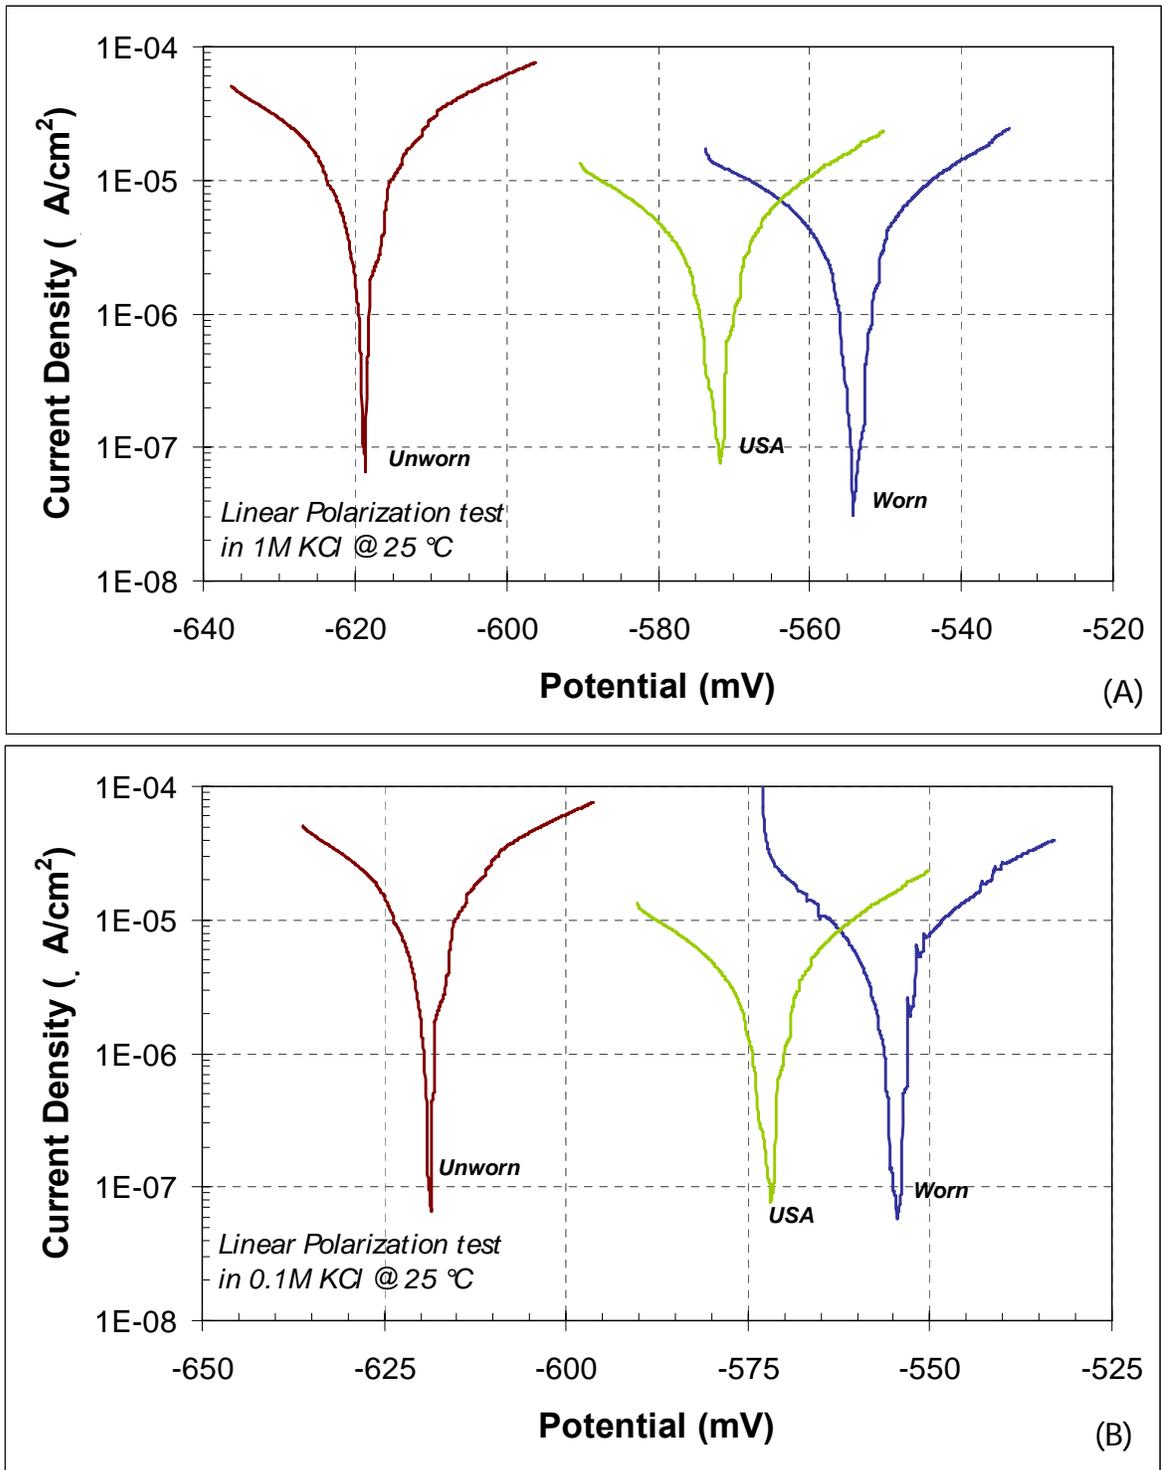
Figure D11. Corrosion resistance of the different rails in KCl. (A) 1M KCl electrolyte, (B) 0.1 M KCl electrolyte.

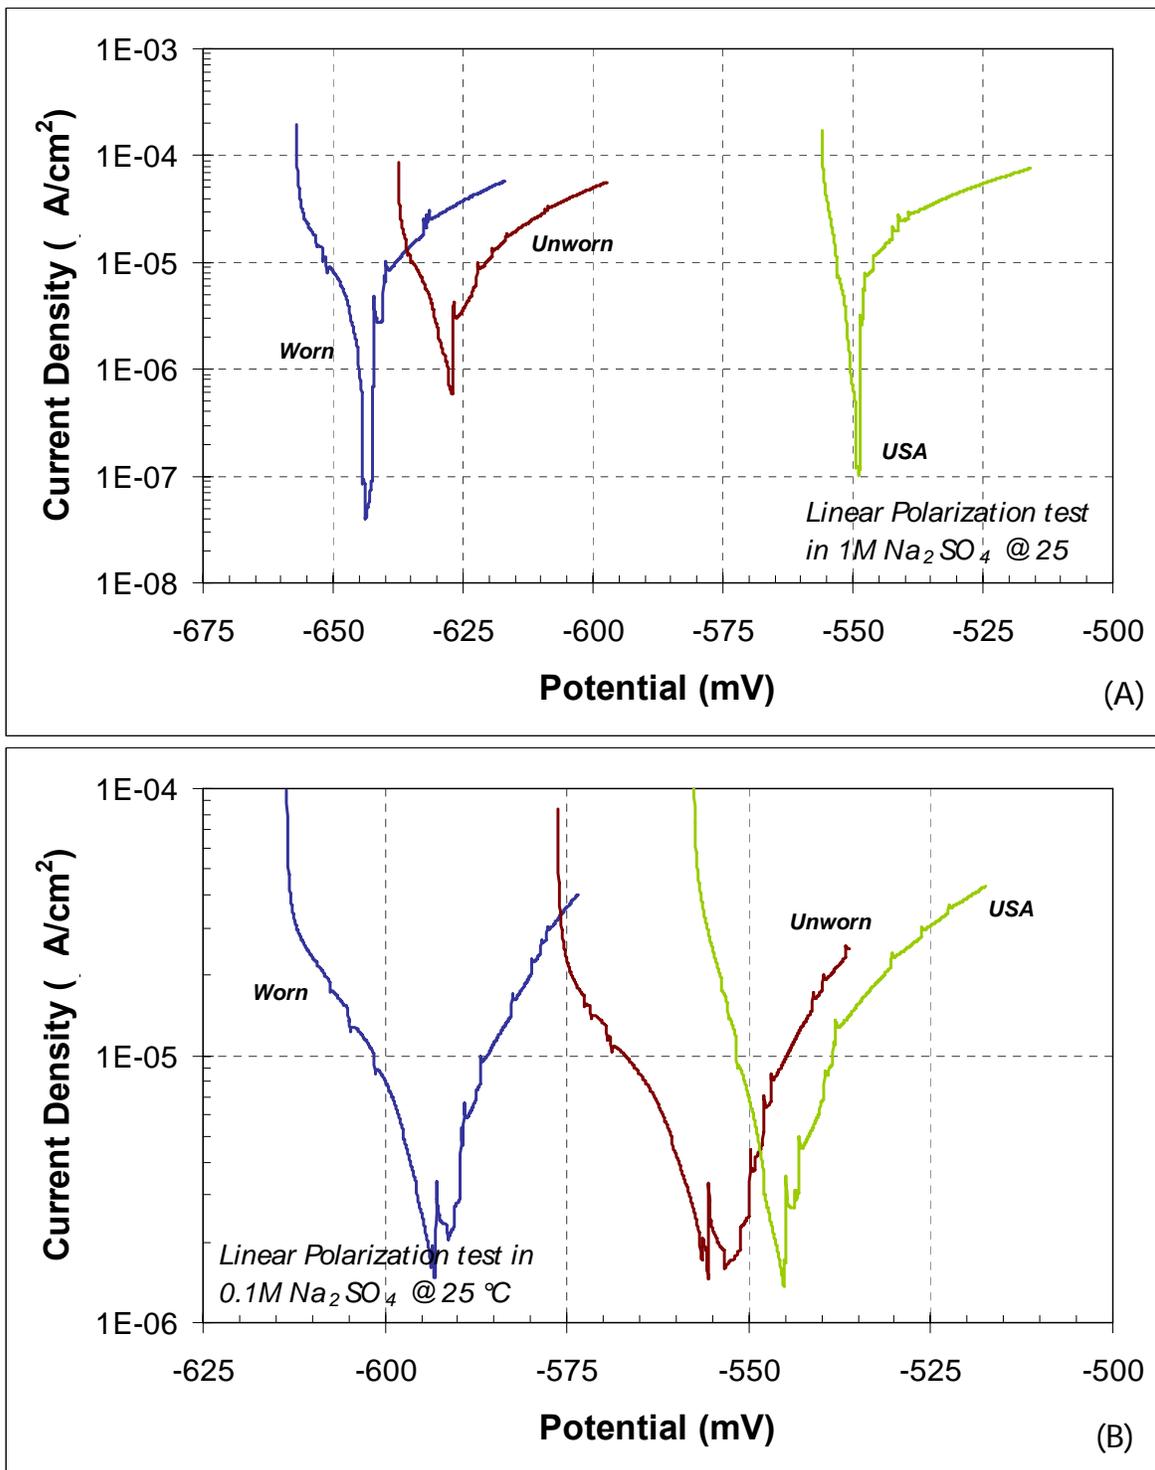
Figure D12. Corrosion resistance of the different rails in Na₂SO₄. (A) 1M Na₂SO₄ electrolyte, (B) 0.1 M Na₂SO₄ electrolyte.

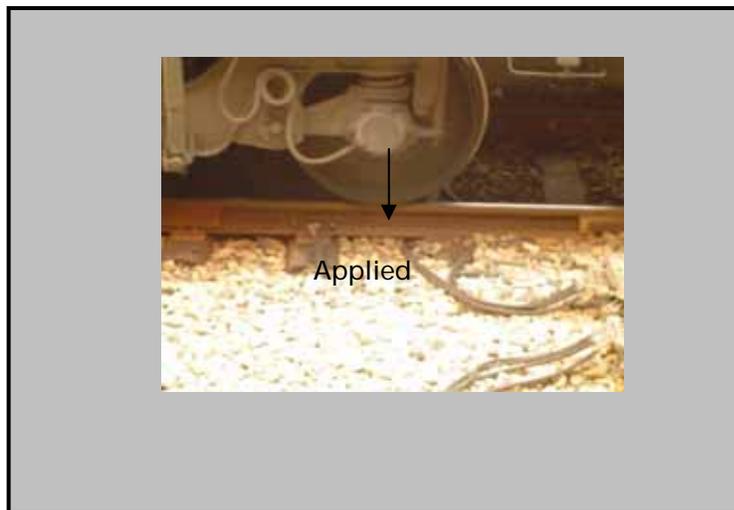
Figure D15. Actual situation to model.

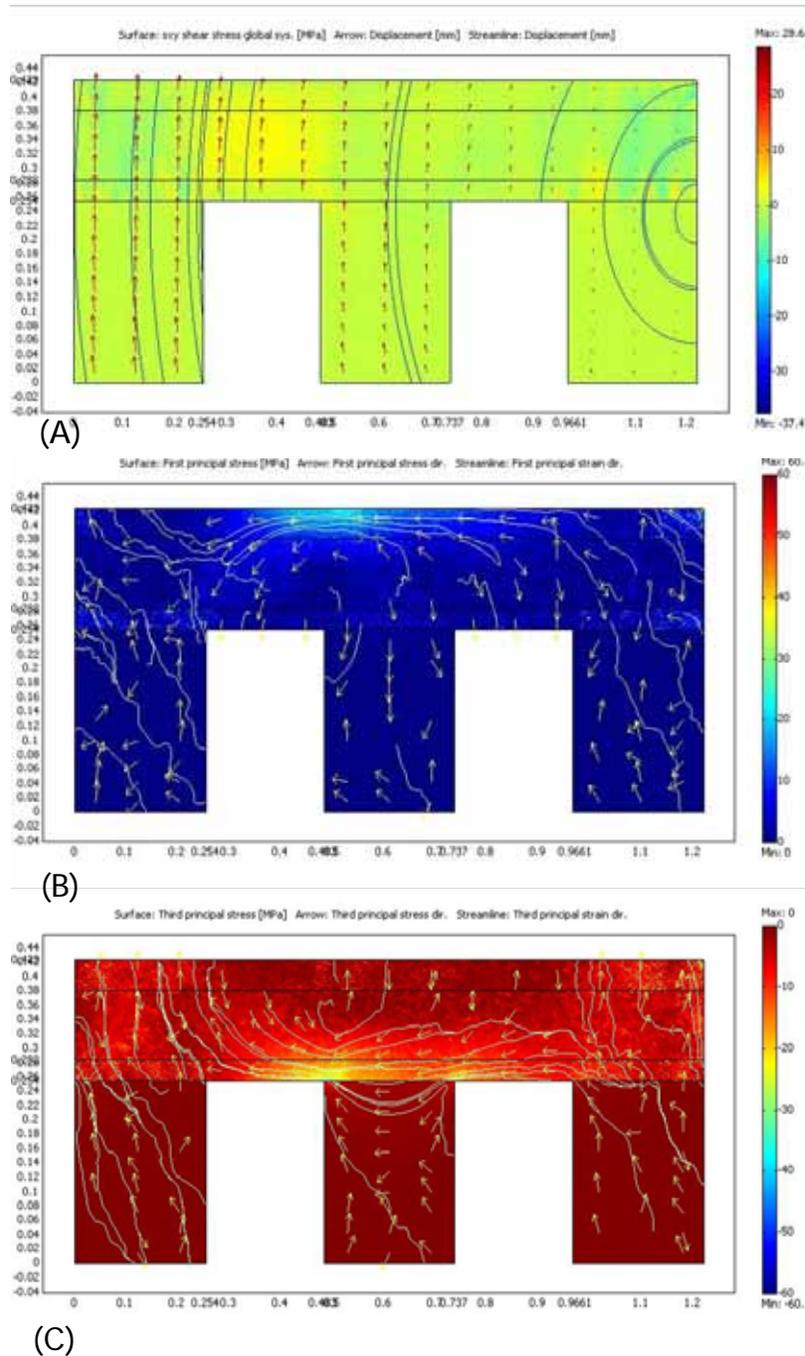
Figure D17. Numerical results for a load applied to an un-attached rail, the loads are applied on top of every beam except from that in the middle. (A) Shear stresses developed along with the deformation of the rail, (B) Tensile stresses developed along with the tensile strain. (C) Compression stresses developed along with the path of strain.

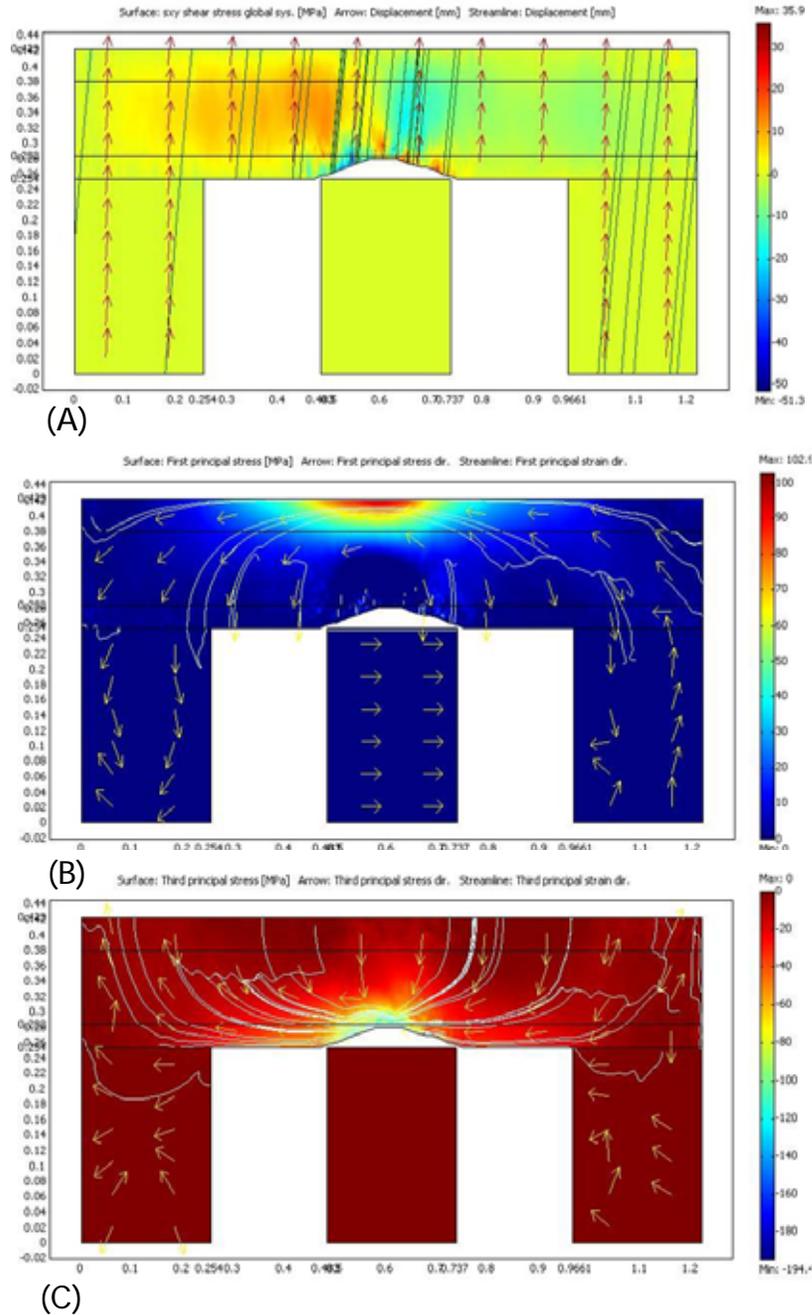
Figure D18. Numerical results for a load applied to a rail with uniform attack, the loads are applied on top of every beam. (A) Shear stresses developed along with the deformation of the rail, (B) Tensile stresses developed along with the tensile strain. (C) Compression stresses developed along with the path of strain. As seen in this figure high compressive stresses develops along the crack formed, however these stresses do not affect drastically the mechanical behavior of the rails.

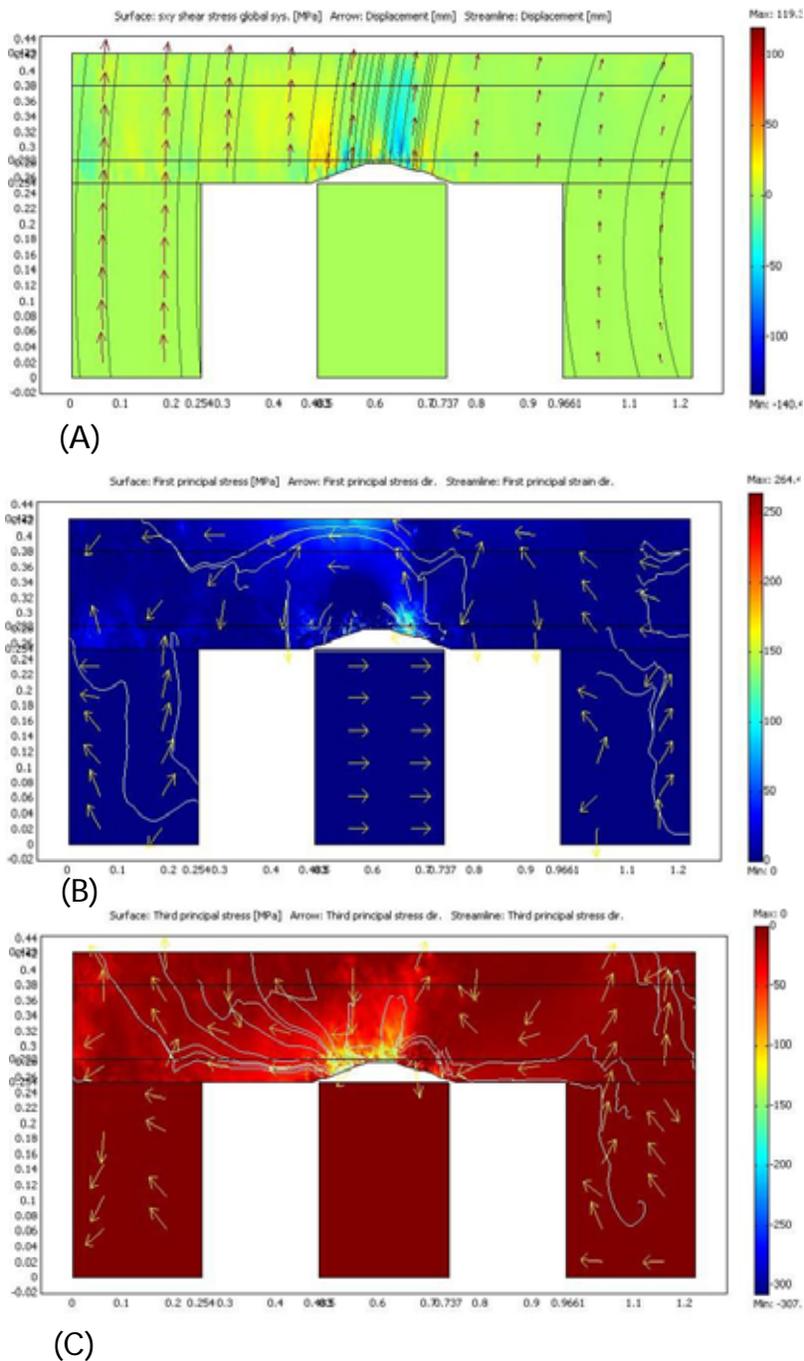
Figure D19. Numerical results for a load applied to a rail with uniform attack, the loads are applied on top of every beam except from that in the middle. (A) Shear stresses developed along with the deformation of the rail, (B) Tensile stresses developed along with the tensile strain. (C) Compression stresses developed along with the path of strain.

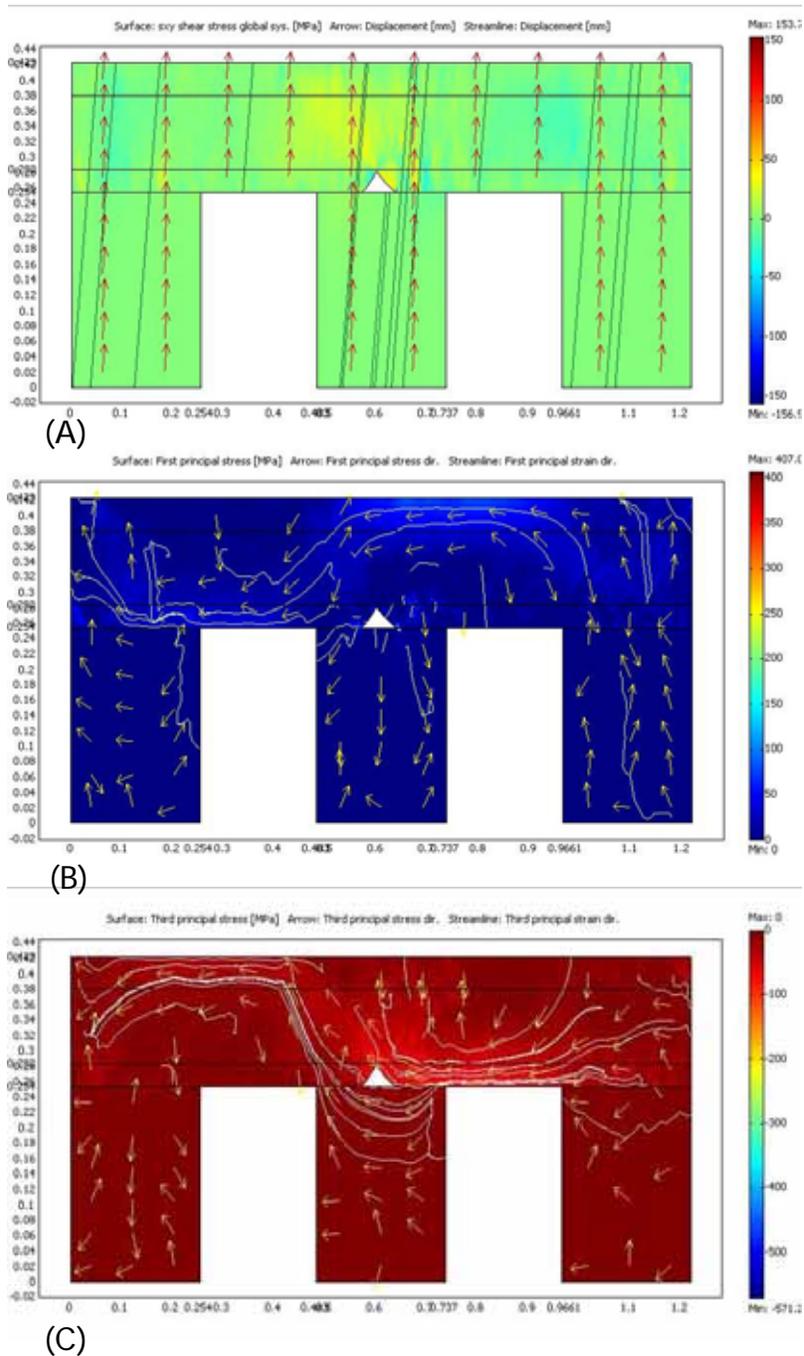
Figure D20. Numerical results for a load applied to a rail with a sharp crack, the loads are applied on top of every beam. (A) Shear stresses developed along with the deformation of the rail, (B) Tensile stresses developed along with the tensile strain. (C) Compression stresses developed along with the path of strain.
