Appendixes to TCRP RRD 84: Audible Signals for Pedestrian Safety in LRT Environments

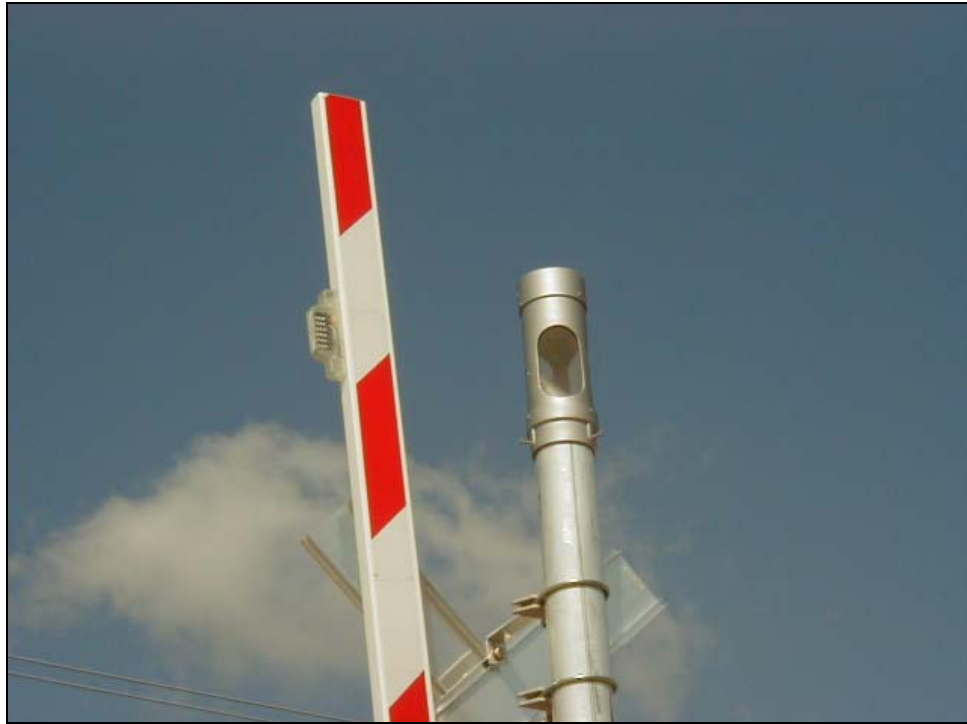
Figure 1. Example of a Typical Electronic Crossing Bell (Calgary)

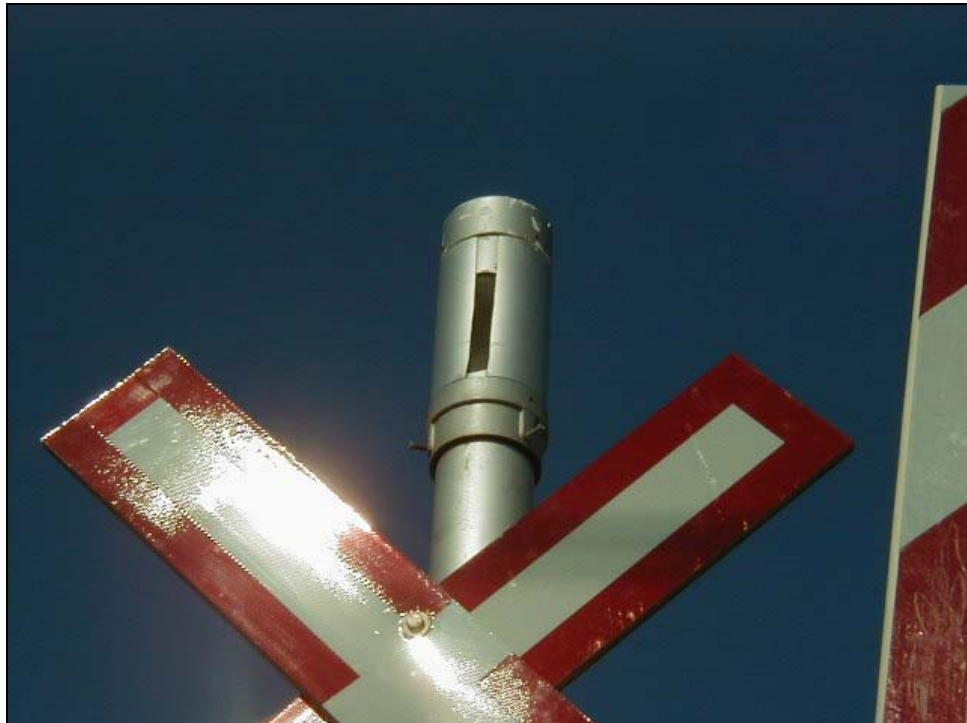
Figure 2. Example of an Electronic Crossing Bell with a Shield (Calgary)

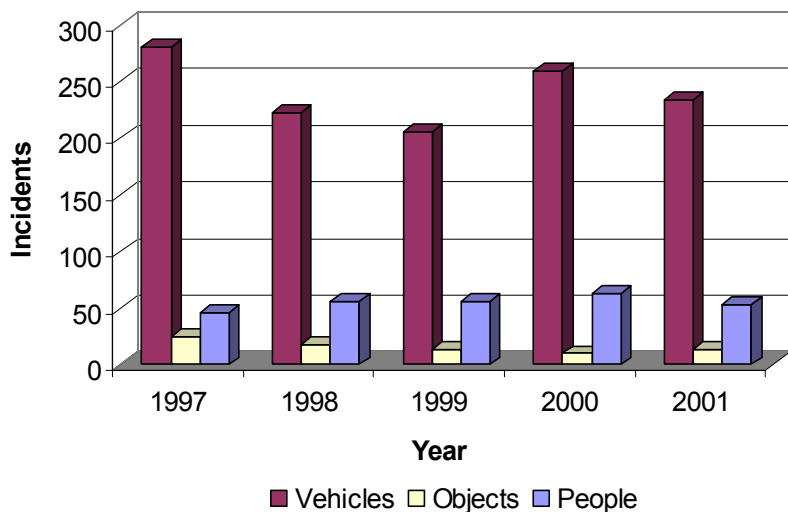
Figure 2. LRT Incidents Involving Vehicles, Objects, and People (1997 to 2001)

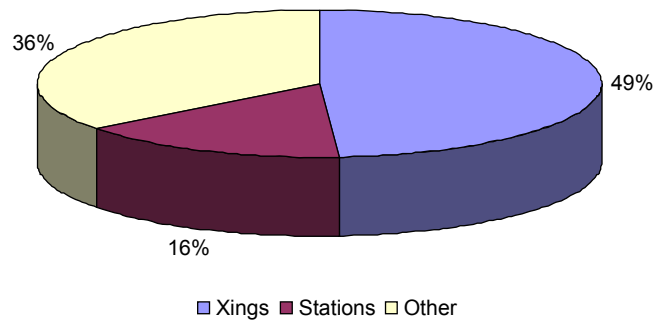
Figure 4 and Figure 5 provide a percentage breakdown of the fatal and non-fatal pedestrian/LRT injuries by crossing, station, and other locations. As shown by the graphs, fatal injuries are most likely (54%) to occur at other locations whereas non-fatal injuries occur more commonly at crossings (49%) than at stations or other locations.

Figure 5. Percent of Non-Fatal Pedestrian/LRT Injuries by Location

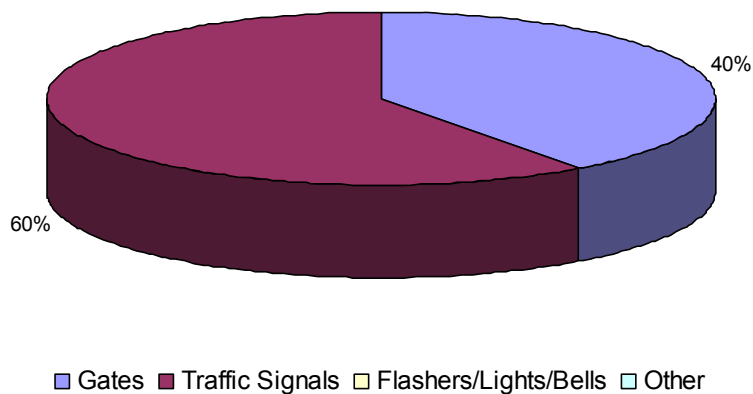
As can be seen in Figure 6 and Figure 7, there is a substantially larger percentage of fatal accidents (60%) occurring at traffic signal controlled crossings compared to non-fatal accidents (42%).

Figure 6. Percent Fatal Pedestrian/LRT Injuries by Active Device

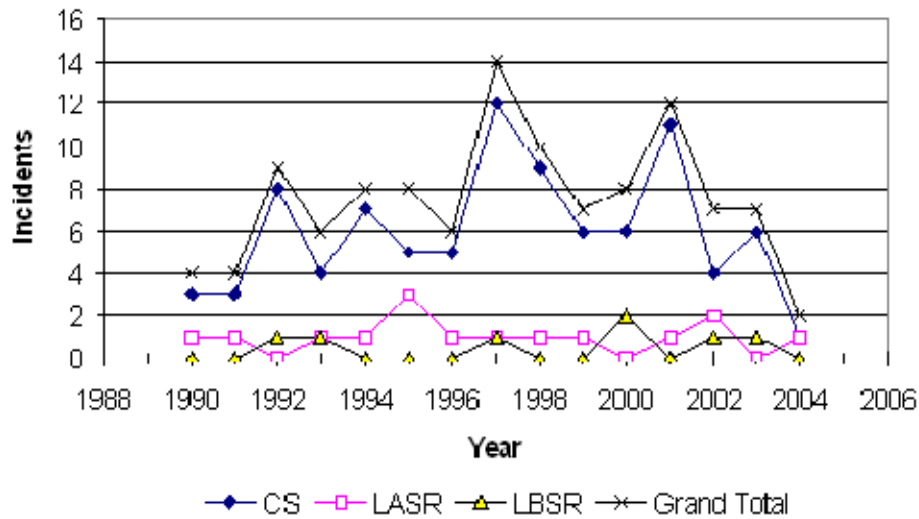
Figure 12 shows the accident rate by segment and in total on the Blue Line since just after it opened in July 1990. Although there is a spike in the Cab Signal segment and total accidents in 1998 and a dip in 1996, pedestrian/LRT accidents rates have been fairly steady over the past 13 years, averaging slightly over 7 per year on the Cab Signal segment. Although there may have been minor increases in total annual revenue service miles over the years (i.e. change from 1 to 2 and 2 to 3 car trains), the general operation of the Blue Line has remained consistent. To our knowledge LA Metro has not installed any innovative audible devices or wayside horns.

Figure 12. Pedestrian/LRT Accidents over Time

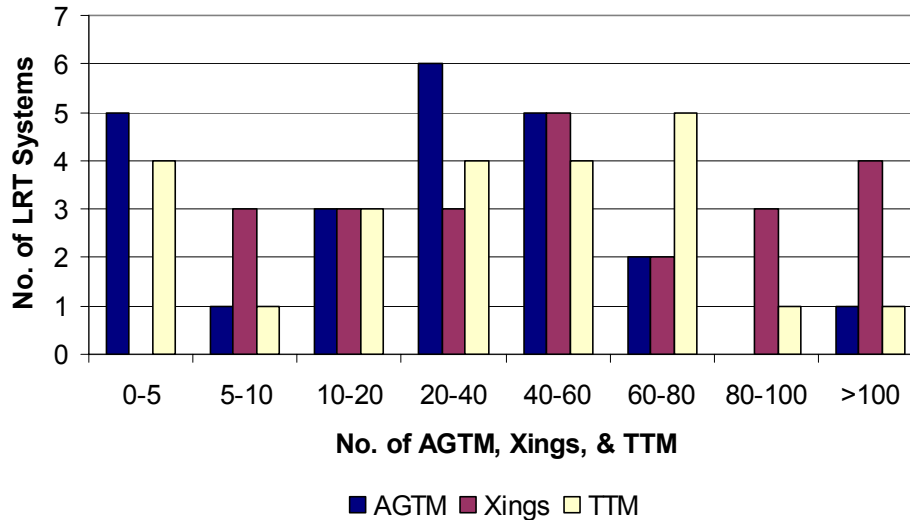
Figure 16 shows the distribution of the operational parameters listed above. These are average values for the period of time each agency reported to the NTD between 1997 and 2003. As can be seen, there is a wide variation in the number of at-grade track miles (AGTM), grade crossings (Xings), and of total track miles (TTM).

Figure 16. Histogram Showing the Breakdown of Operational Parameters

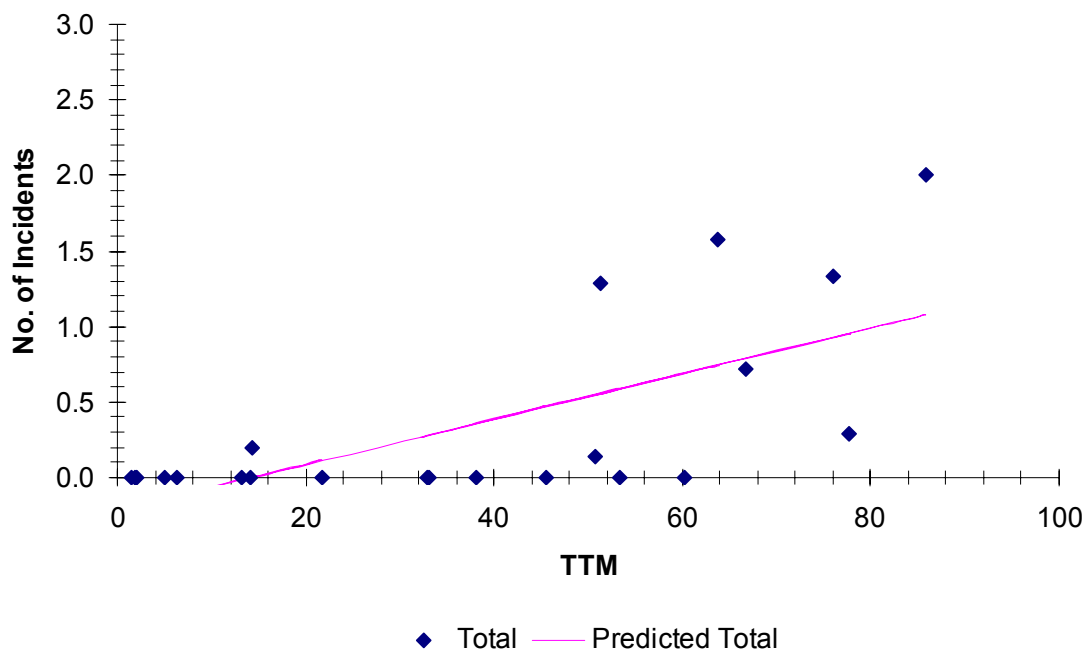
Figure 19. Best Fit Line for Average Annual Pedestrian/LRT Incidents at Grade Crossings and the Number of Total Track Miles

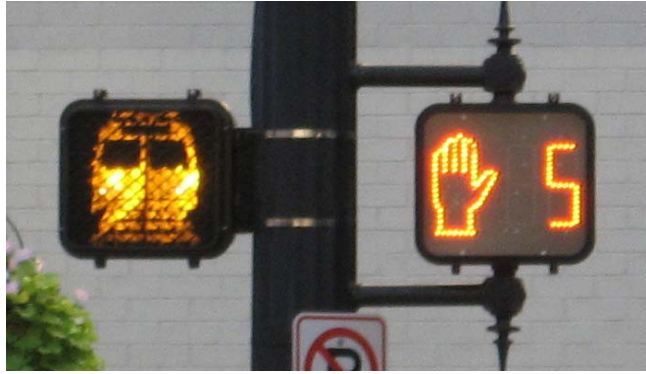
Figure 2 Visual train warning sign

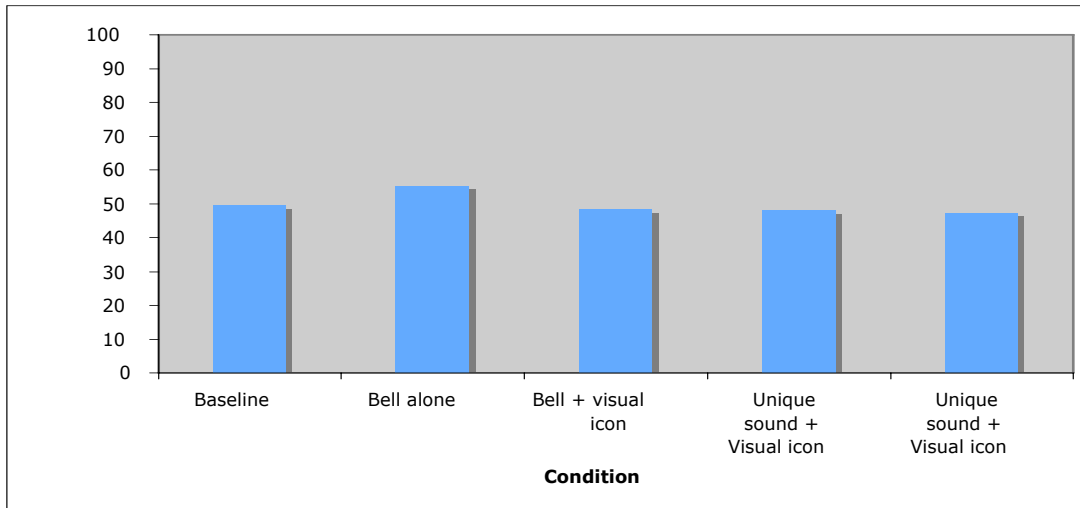
Figure 3 The percent of violators during each treatment condition

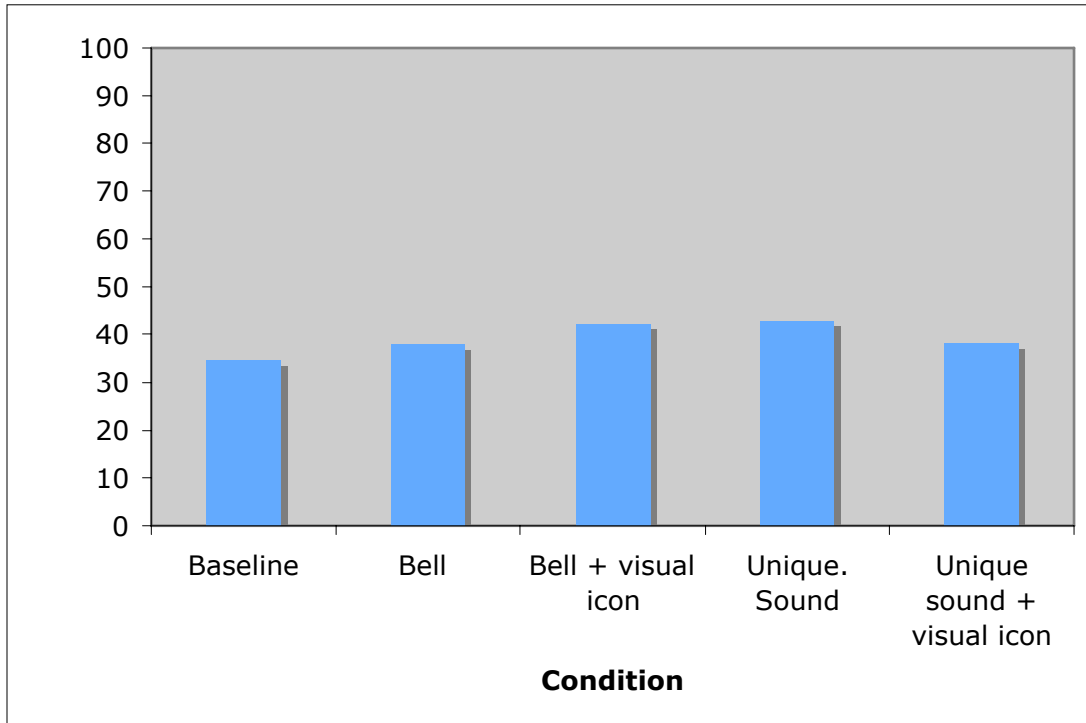
Figure 4 Percentage of violators looking for the train before crossing the track

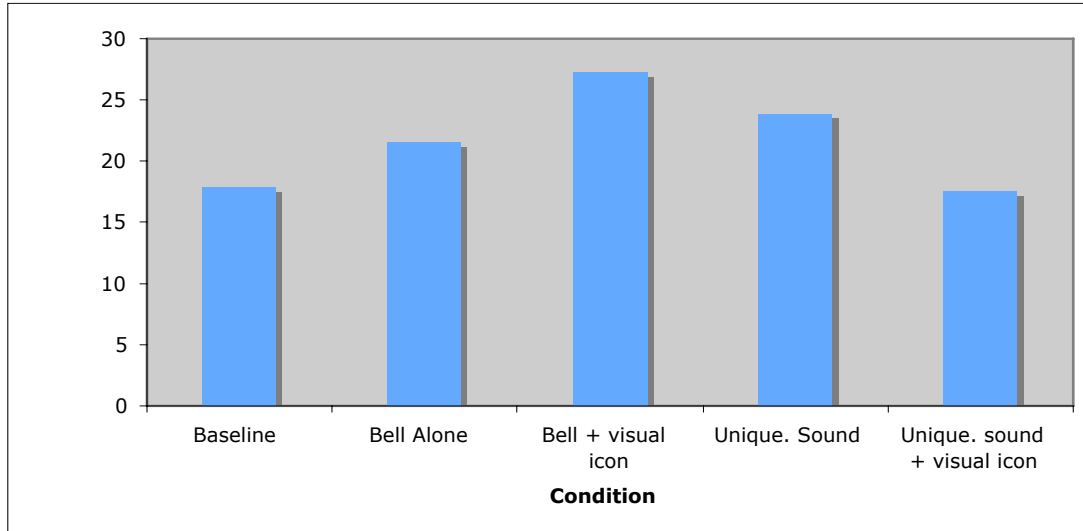
Figure 5 Percent violators dashing across rails during each condition

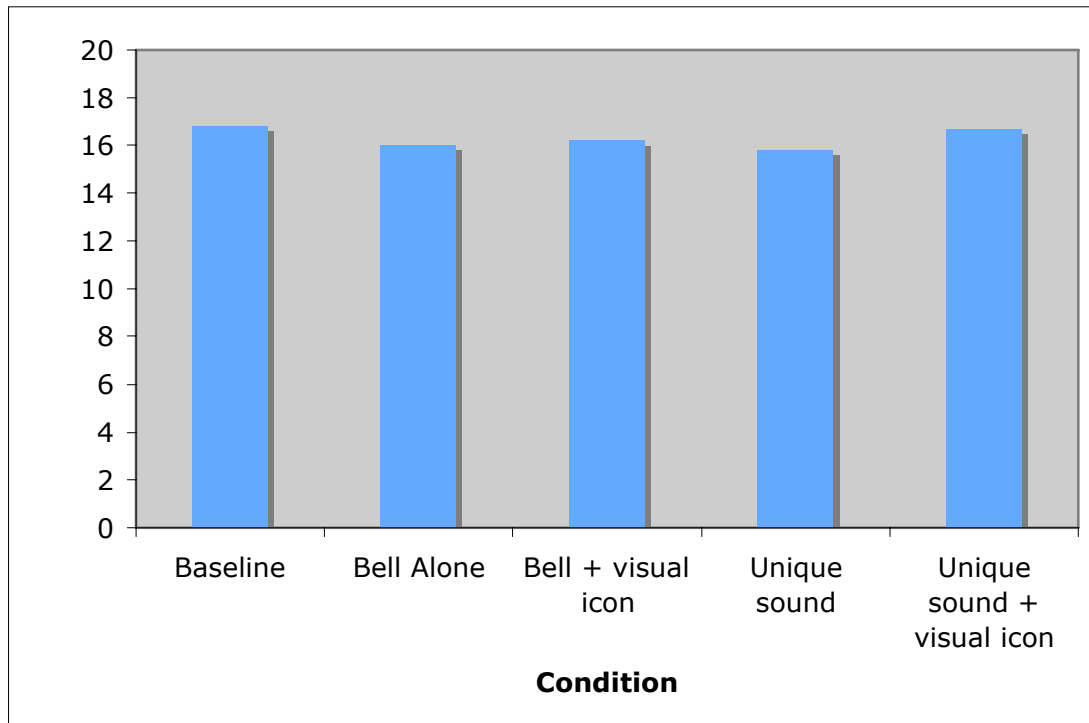
The mean violation interval in seconds is presented in Figure 6. These data varied between a low of 15.8 seconds in the unique sound alone condition and a high of 16.8 seconds in the baseline condition. These data were analyzed using an ANOVA and no difference was found between the mean intervals for each condition.

Figure 6 The mean interval between violations and train arrival

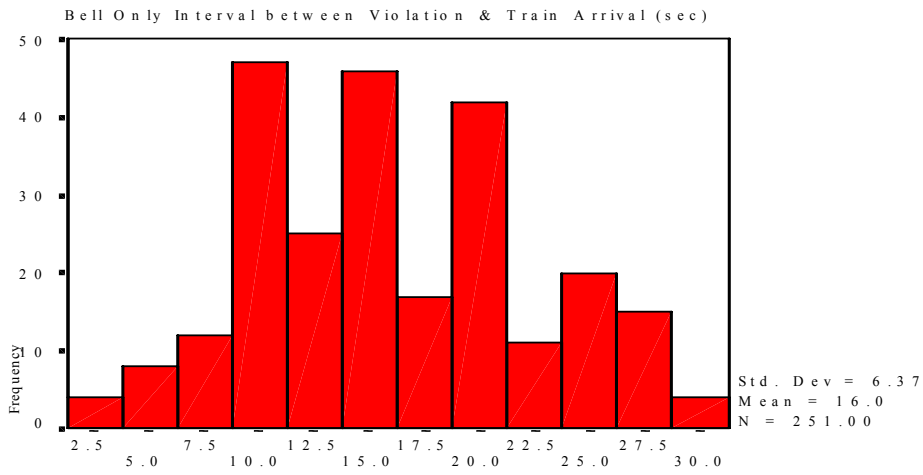
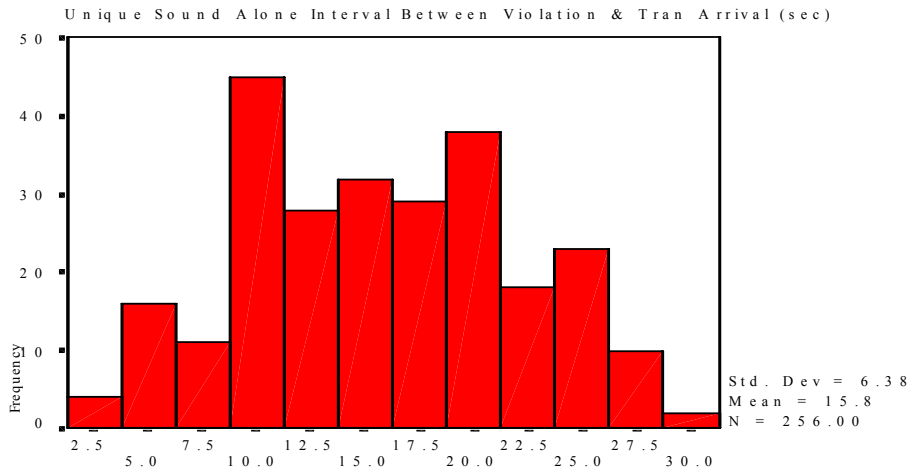
Baseline Interval Between Pedestrian Violation & Train Arrival (sec)

Bell Only Interval between Violation & Train Arrival (sec)

Unique Sound Alone Interval Between Violation & Train Arrival (sec)

Figure 7 Histograms showing the frequency of violations for each time period
