Audible Signals for Pedestrian Safety in LRT Environments

Research Results Digest 84

AUDIBLE SIGNALS FOR PEDESTRIAN SAFETY IN LRT ENVIRONMENTS

This digest summarizes the results of TCRP Project D-10. The digest was prepared by Korve Engineering, A Division of DMJM Harris, in conjunction with ATS Consulting, LLC; Fidell Associates; Center for Education and Research in Safety; and Bear Consulting.

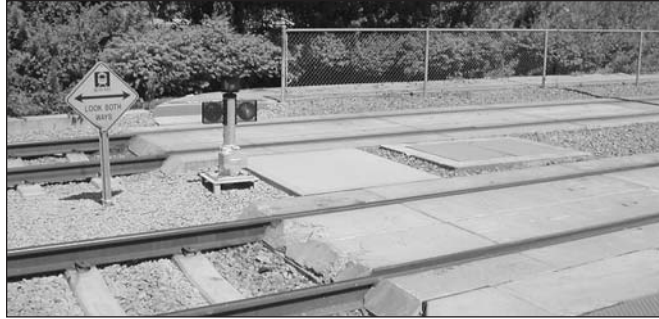
Figure 5 Portland Tri-Met “Mini” Pedestrian Crossing Device.

4.4.1.2 Mini Devices. Three transit agencies use a Mini (low-rise) pedestrian device at some pedestrian-only crossings. Figure 5 shows a Mini device installed on the Westside Line on Portland's Tri-Met system. Tri-Met has this device installed at 28th Street and at S.W. Baseline Road. Devices similar to the Tri-Met device have been installed between tracks at crossings along the triple-track section of the BNSF main line in Chicago, Illinois, where Metra commuter rail service operates.

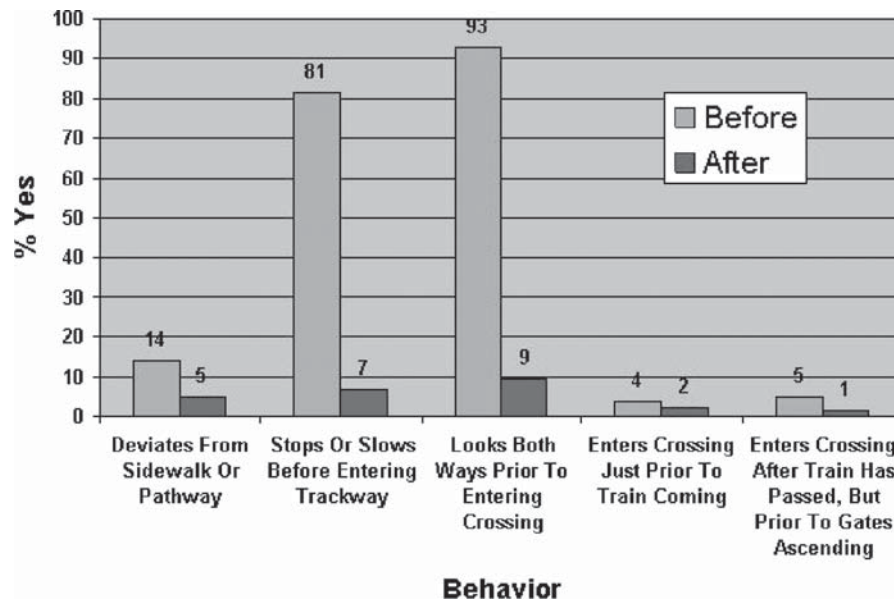
Figure 7 “Mini” Device Pedestrian Behavior Study Results.

significant level, as shown by the first, fourth, and fifth bars in the figure. The second and third bars measure behaviors that indicate pedestrian caution when approaching the crossing. The study results indicate that cautious behavior was very prevalent in the before condition and dropped dramatically in the after condition. The before condition was a passive crossing that was so confusing that pedestrians had to slow down and look both ways before venturing further. The after condition, with its active device, relieved the pedestrians of the need to slow down and look both ways. Instead, they relied on the highly noticeable device to tell them when a train was coming.

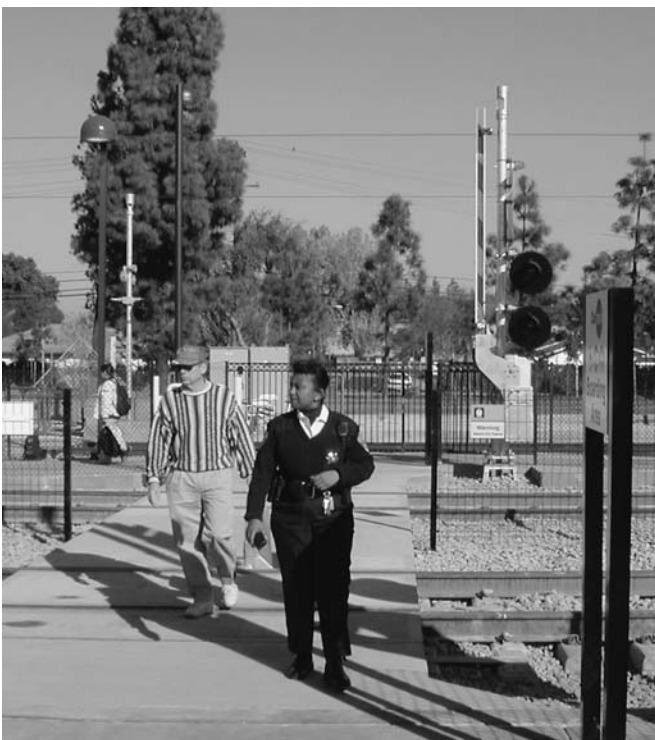
Figure 8 Vertical Mounted Flashing Light Device with Audible.

The Peninsula Corridor Joint Power Board (Caltrain) has installed a flashing light device with pedestrian crossing gates on the Tasman West light rail line at the Downtown Mountain View transit center (see Figure 8). This device is intended to control foot traffic between the bus transit center and the LRT platform across the Caltrain commuter rail tracks. The Mountain View device has the flashing light assembly mounted vertically instead of horizontally. (The MUTCD railroad committee has proposed language in process to allow mounting the flashing light assembly in this configuration.)
