Appendixes to TCRP Report 117: Design, Operation, and Safety of At-Grade Crossings of Exclusive Busways

TCRP Web-Only Document 36: Appendixes to TCRP Report 117

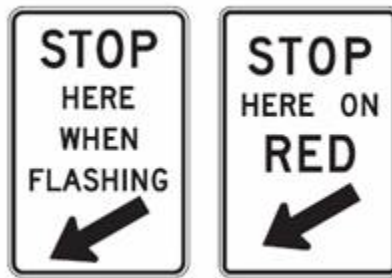
STOP HERE WHEN FLASHING is used to inform drivers of the point which they are to stop when flashing lights have been activated. STOP HERE ON RED draws attention to the stop required on at the intersection. It may be used where stop violations occur frequently. These signs are illustrated in Figure A-3.

Figure A-3: MUTCD Signs R8-10 and R10-6 (Source: MUTCD 2003)

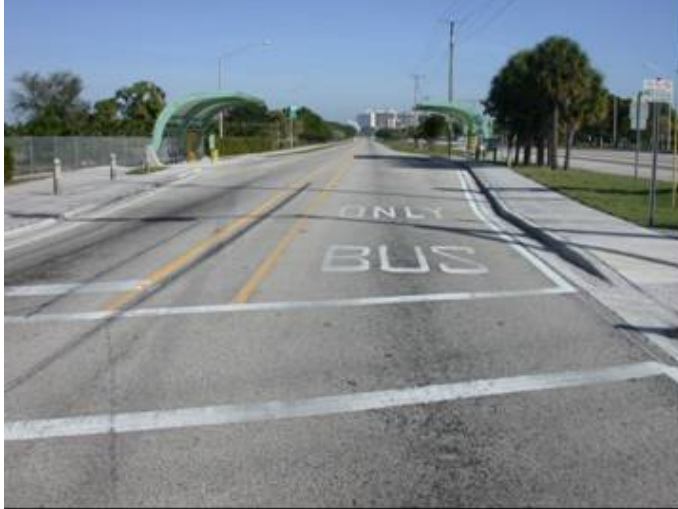
Pavement markings are also suggested for light rail crossings under the guidelines of the MUTCD. Identical markings should be placed in each approach lane. The markings should be retroreflectorized white. Pavement markings are not required if the traveling speed of the light rail vehicles is less than 40 mph (60 km/h). In Miami-Dade, pavement markings are used at the approach of intersections on the busway to show the busway is a “BUS ONLY” facility (Figure A-6) for drivers of automobiles that may consider making a turn onto the busway.

Figure A-6: Miami-Dade Busway Pavement Markings

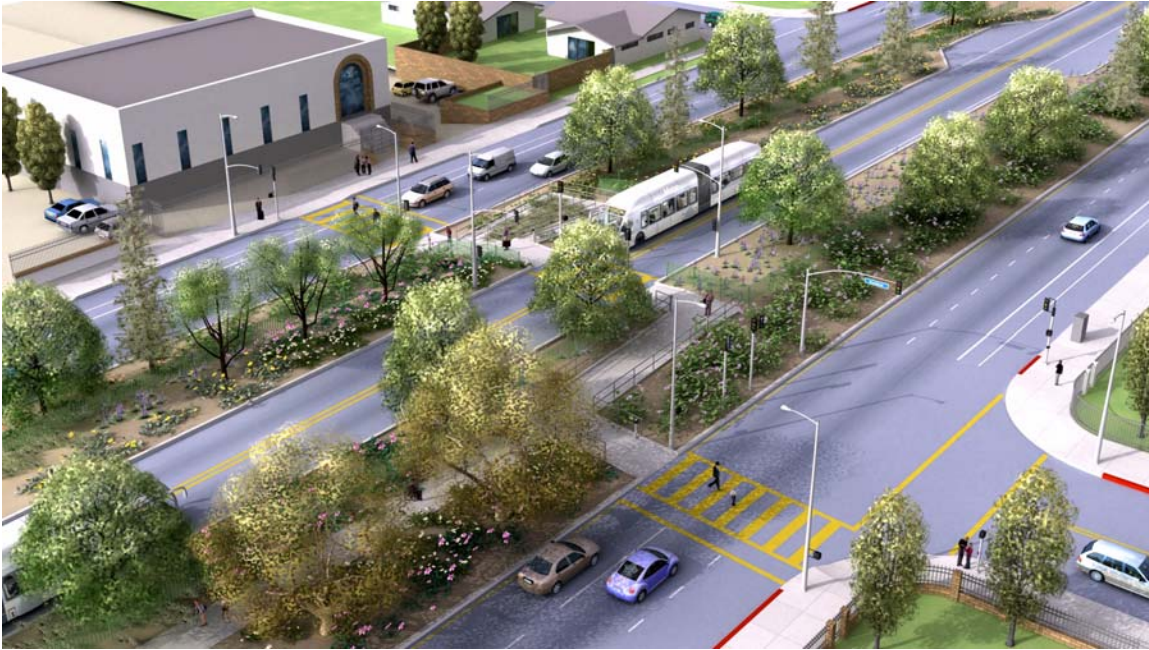
busway and the parallel street in one movement. There is ample room for pedestrians to store in the median, between the parallel street and the busway.

Figure D-1: Graphic Illustrating Zigzag Design at Pedestrian Crossings

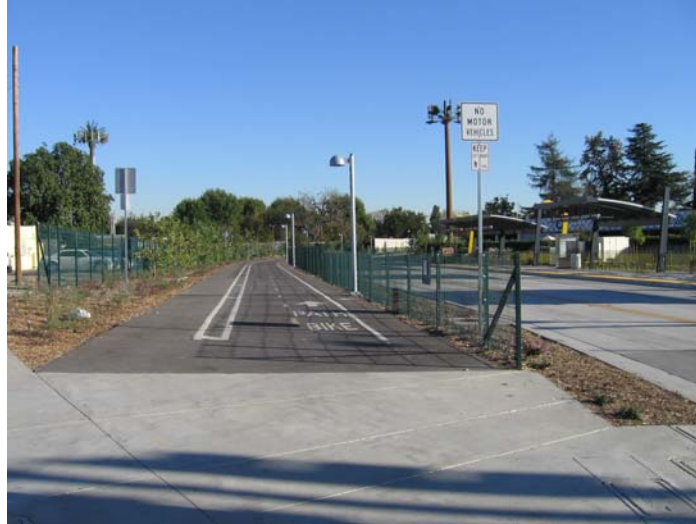
The MOL includes a 14-mile bikeway, 8 miles of which is concurrent with a pedestrian path. The bicycle/pedestrian path is 17' wide except in a few sections where the available right-of-way is constrained. The bicycle path allows for two directions of travel separated by a dashed yellow line. The pedestrian walking area is separated from the bicycle area by a double white line with a diagonal hatch pattern. The path is separated from the bus travel lanes by a fence. The bicycle/pedestrian path is pictured in Figure D-3. All stations are equipped with bicycle lockers and racks. Bicycles are also allowed on the buses.

Figure D-3: Bicycle/Pedestrian Path along the Metro Orange Line

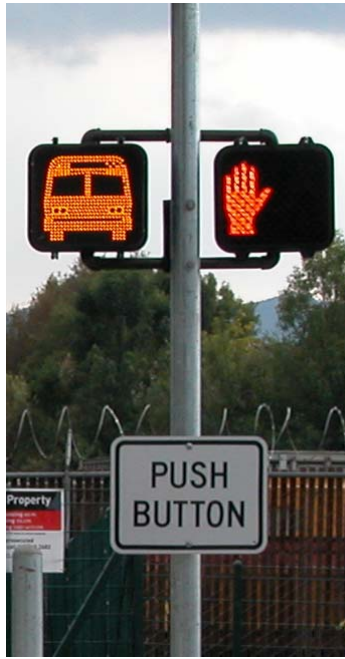
Pedestrian crossings are equipped with traditional pedestrian signals at most intersections and pedestrian countdown signals at high volume crossings. As previously noted, there are four midblock pedestrian crossings. These pedestrian crossings are also equipped with a special busway approaching LED signal. This is illustrated in Figure D-4. The LED indication of the bus flashes when a bus is approaching.

Figure D-4: Pedestrian Signal Bus LED Indication

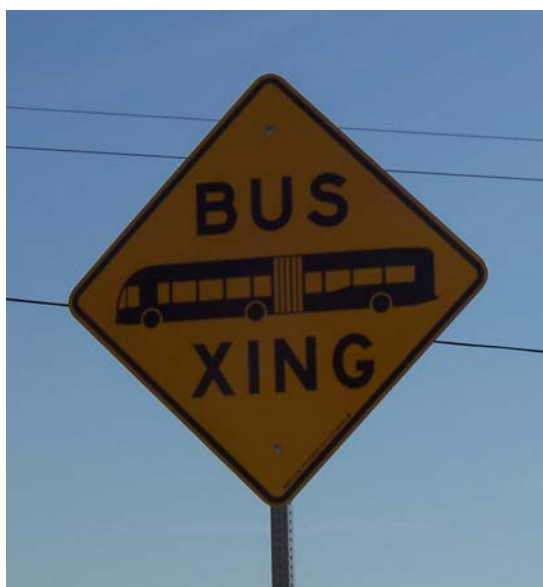
the intersection approaches. This sign is displayed in Figure D-5. This sign was developed by LADOT staff. The bus graphic on the sign is based on the outline of the Orange Line buses.

Figure D-5: Busway Crossing Warning Sign

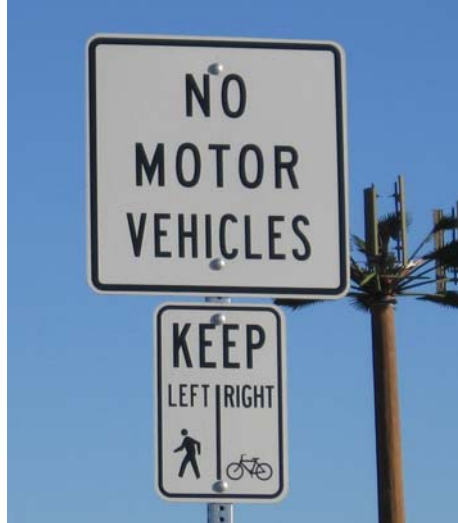
The bicycle/pedestrian paths are signed to deter motor vehicles from entering the path and to instruct pedestrians and bicycles of the appropriate placement in the path. This is displayed in Figure D-6. There are two lanes, one in each direction, for bicycle traffic.

Figure D-6: Signs at the entrance to Pedestrian/Bicycle Path

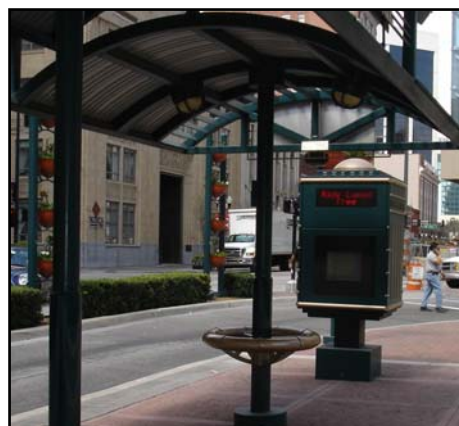
Station platforms are level with the sidewalk and are provided, and they are non-skid and weather resistant for added safety. Station lengths are approximately 50 feet with varying width depending on the station location. Each station is equipped with a covered waiting area to protect from the sun and rain and a kiosk that provides information on the next LYMMO bus arrival. Each station is equipped with a sign indicating the station location such as “Church & Orange.”

Figure E-2: A LYMMO Station

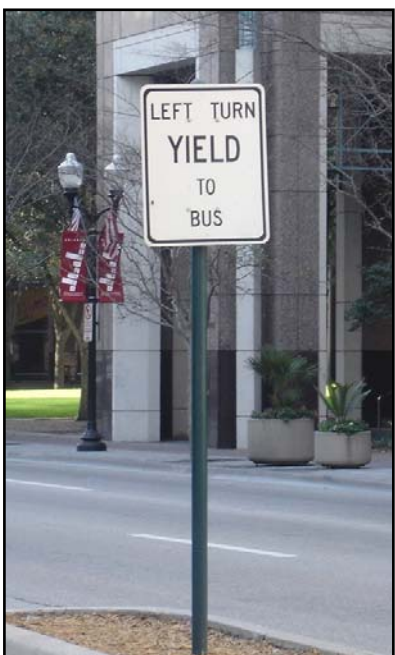
Figure E-3: Left Turn Yield Sign

A few segments of the busway run contraflow. Orange Avenue is a one-way southbound road used by general purpose traffic. The busway runs northbound contraflow on this roadway. Orange Avenue is intersected by a bank driveway just south of the stop at Church Street. Drivers entering the bank were not expecting northbound vehicles to their left which created a safety problem. Signs were installed to tell drivers to look left and yield to buses as shown in Figure E-3.

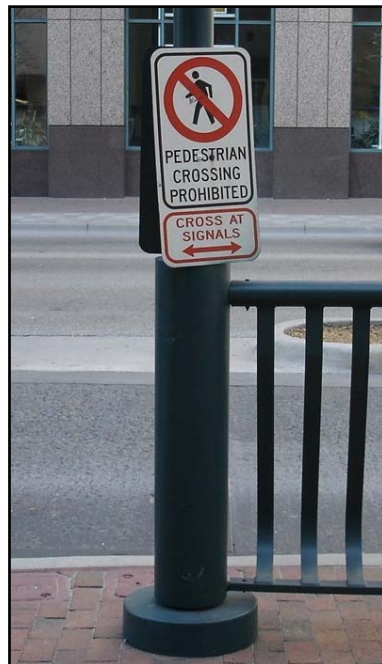
An example of the signs used to prohibit pedestrians from crossing and encourage them to cross at the traffic signals is pictured in Figure E-4.

Figure E-4: Signs Prohibiting Pedestrians from Crossing

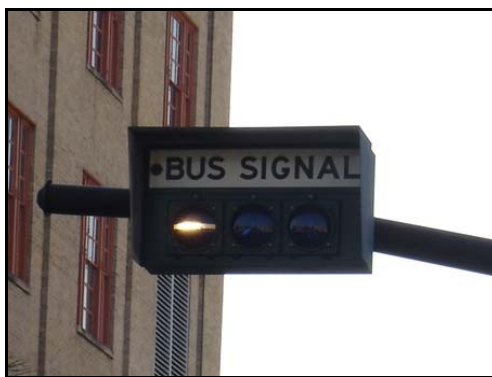
The LYMMO system employs transit signals for the busway. The transit signals are illuminated white bars on a three-aspect display unit signifying Stop, Caution/Prepare and Go. An example is provided in Figure E-5. All of the downtown signals are equipped with programmable heads. Louvers are not an option due to the proximity of intersections in the downtown environment.

Figure E-5: LYMMO Bus Signal

The bus signals have a five to seven second green (vertical line), followed by a three section change period. Intersections do not have an all red phase. This timing allows two buses to progress through the intersection.

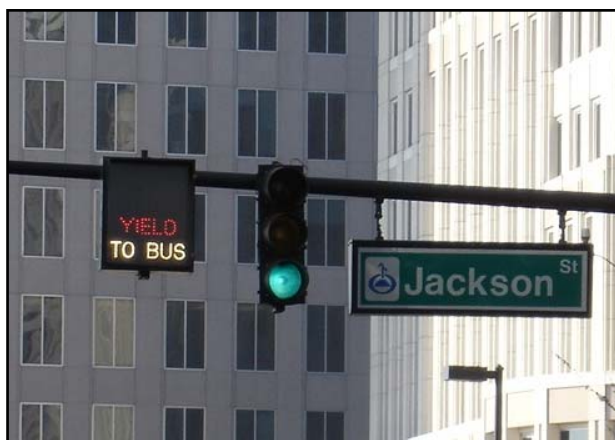
At one intersection, Orange Avenue and Jackson, left-turning vehicles must yield to northbound buses. Orange Avenue is one-way southbound at this intersection; the busway is one-way northbound. A dynamic sign is used at the intersection to instruct left-turning vehicles to yield when buses are approaching. This sign is pictured in Figure E-6.

Figure E-6: Dynamic Sign at Jackson Street and Orange Avenue

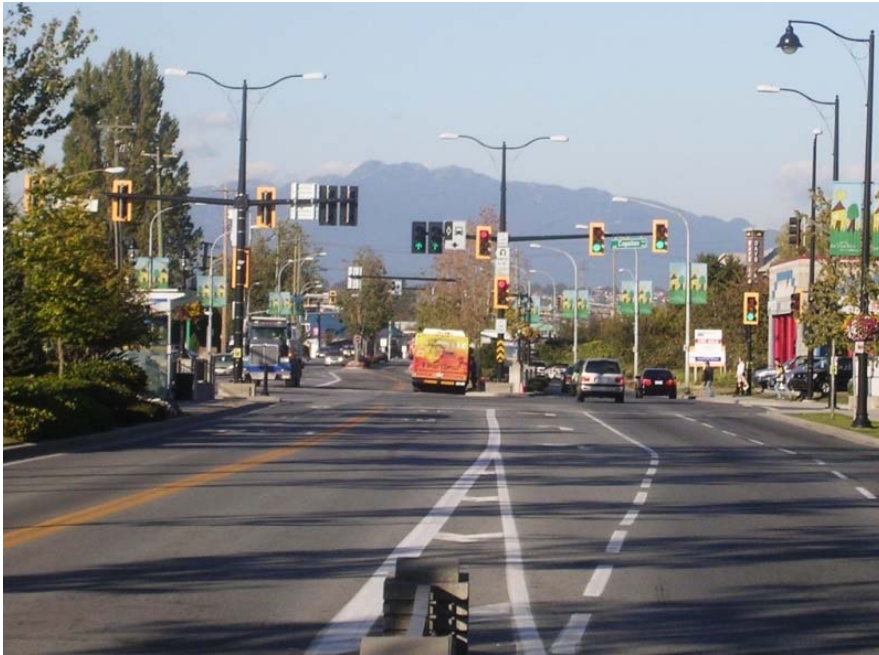
The busway is separated from general traffic by raised medians in most sections of the busway. However, at many intersection approaches, the busway separation from the general purpose traffic is only denoted by pavement markings. This occurs on the approaches to intersections where there is not sufficient right of way to provide both a left turn lane and a raised median of sufficient width to physically separate the busway. The interviewed staff noted that they would strongly prefer physical separation along the entire length of the busway, but this was not possible at most intersections. An example of a section separated by pavement markings on the approach is presented in Figure G-3.

Figure G-3: Example of Painted Separation between Busway and General Purpose Traffic on Capstan Way Intersection Approach

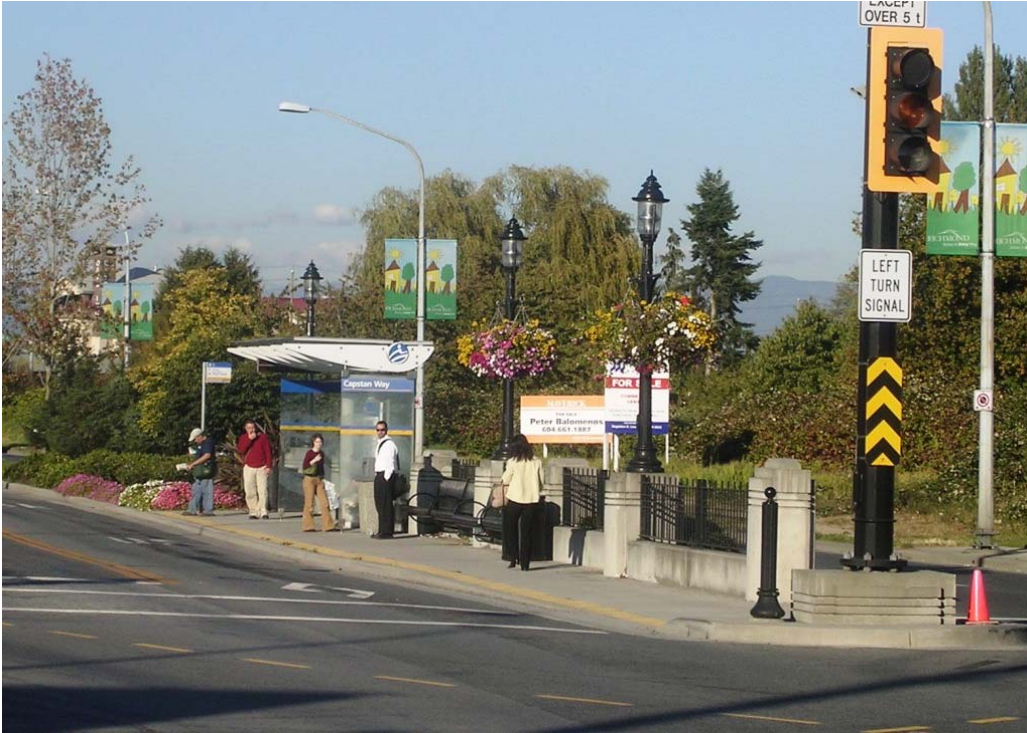
Figure G-4: Decorative Fencing and Landscaping at a Station Stop

Passengers load and unload at bus stops along the right side of the median busway. As a result, the intersections at which bus stops are located have high pedestrian volumes. Pedestrians are channelized to cross at the traffic signals through the use of decorative fencing and landscaping. Figure G-4 provides an example of this at the Capstan Way northbound stop. The area leading to the station is channelized with decorative fencing. The pedestrians are deterred from exiting the station away from the intersection through the use of landscaping. In practice, however, some pedestrians enter or leave the platform by walking around the end of the bus shelter and through the plantings.

The City of Richmond decided to use this type of decorative fencing and dense landscaping because it was more aesthetically pleasing than continuous rail. Originally, the landscaping included some concrete bands to separate the planting beds. These bands were used by pedestrians as mini-walkways for midblock crossings. The majority of these bands have been removed to deter midblock crossings.

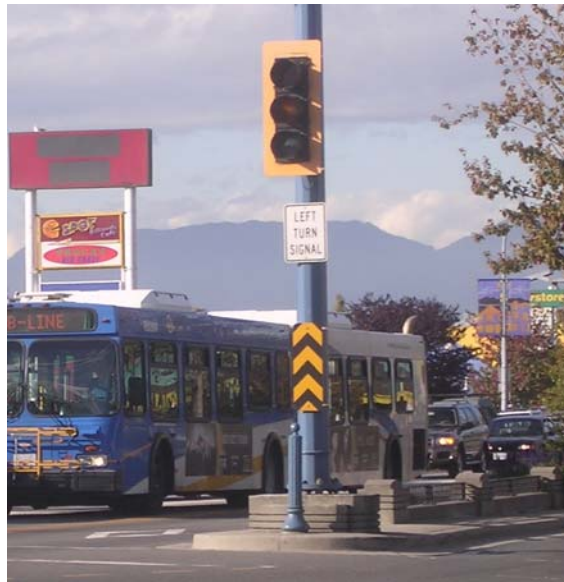
At each busway intersection, a roadside delineator sign is used to delineate the busway island. This sign and placement is depicted in Figure G-6. This sign could potentially help deter unauthorized entry, however its primary purpose is to keep vehicles from hitting the median or the post.

Figure G-6: Example of Roadside Delineator Sign on Busway Island

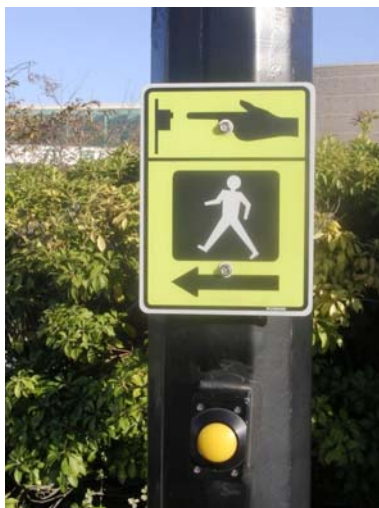
Each intersection is assisted with a pedestrian push button to activate the pedestrian interval. A graphic sign is displayed above the push button to communicate to the pedestrians to push the buttons. An example of a pedestrian push button and the accompanying sign is presented in Figure G-7.

Figure G-7: Pedestrian Push Button and Sign

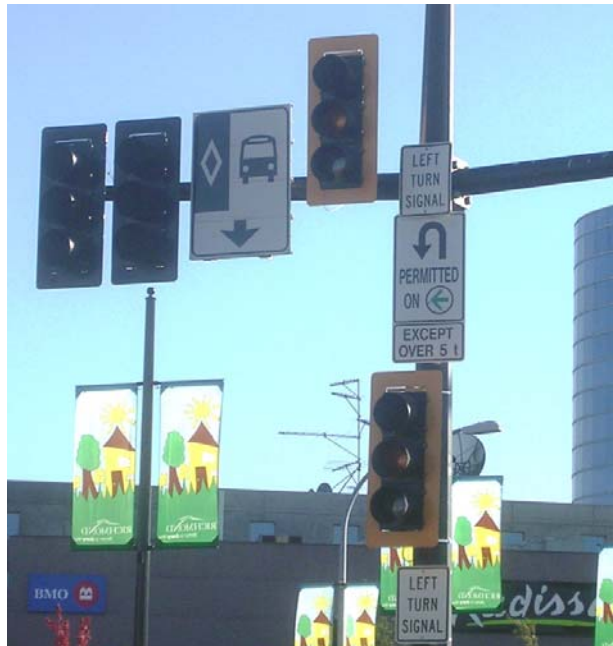
At some busway intersection locations, vehicles are legally allowed to make a U-turn from on the mainline from the left turn lane. This concession was necessary to alleviate concerns expressed by the local businesses that the busway would limit access along No. 3 Road. A sign located near the left turn signal indicates that the U-turn is permitted on the green left turn arrow indication. Figure G-8 illustrates this sign and its placement on the traffic signal pole between left turn signals. As noted in a supplementary plaque accompanying the sign, U-turns are not permitted for vehicles over five tons. In Canada, U-turns are not allowed unless posted.

Figure G-8: Placement of Sign Permitting U-Turn
