Light Rail Vehicle Collisions with Vehicles at Signalized Intersections

TCRP SYNTHESIS 79

**Light Rail Vehicle Collisions with
Vehicles at Signalized Intersections**

A Synthesis of Transit Practice

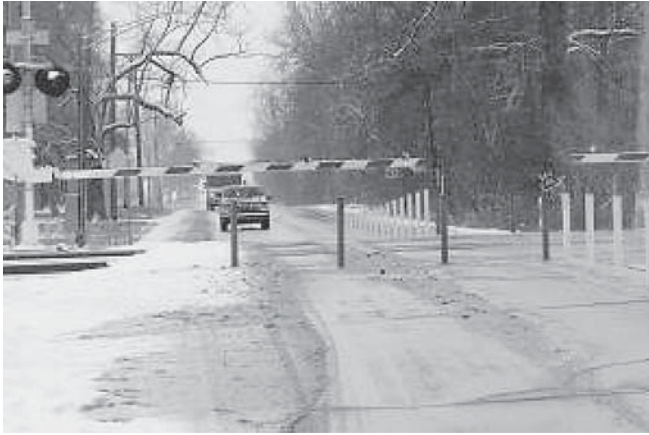
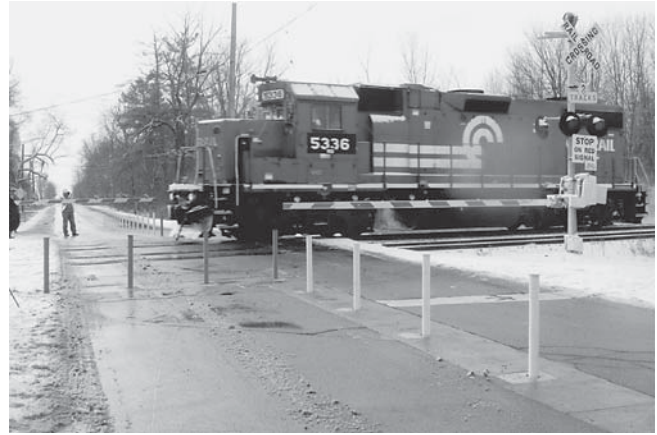
FIGURE 2 Retractable barriers under test in Wayne County, Michigan (Courtesy: Michigan Department of Transportation).

the FHWA, are currently testing a type of retractable barrier to discourage drivers from driving around the crossing gates at a crossing in Wayne County (9). The delineators are activated by a signal from the crossing gate system and reach their full deployment in about 6 s (Figure 2). Metro in Los Angeles is interested in the possible trial application of these same retractable barriers across the far side of the marked crosswalk to block the left-turn pocket lane. Los Angeles noted a number of potential issues with this application, including interaction of the delineators with pedestrians in the crosswalk, vehicles encroaching into the crosswalk, life expectancy of the delineators with the number of up-and-down cycles required for light rail operations, and failure of the delineators.

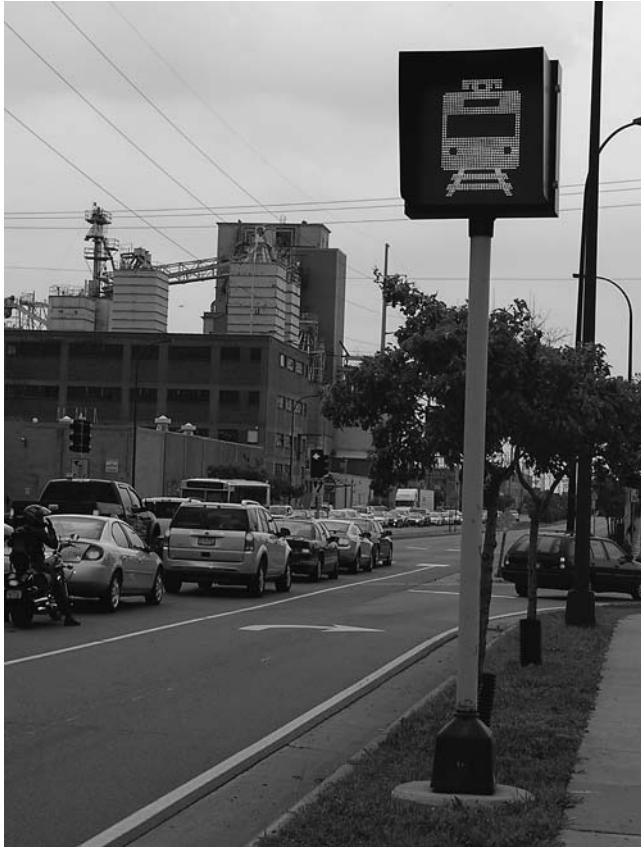
FIGURE 4 Train-activated warning sign—Hiawatha Line, Minneapolis (Courtesy: Calvin Henry-Cotnam).

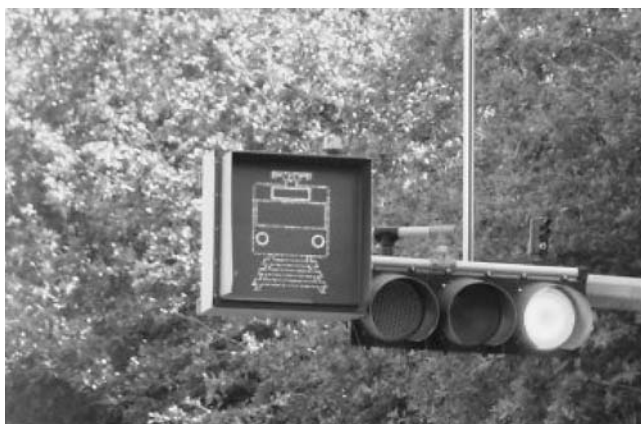
FIGURE 5 Train-activated warning sign in Houston.

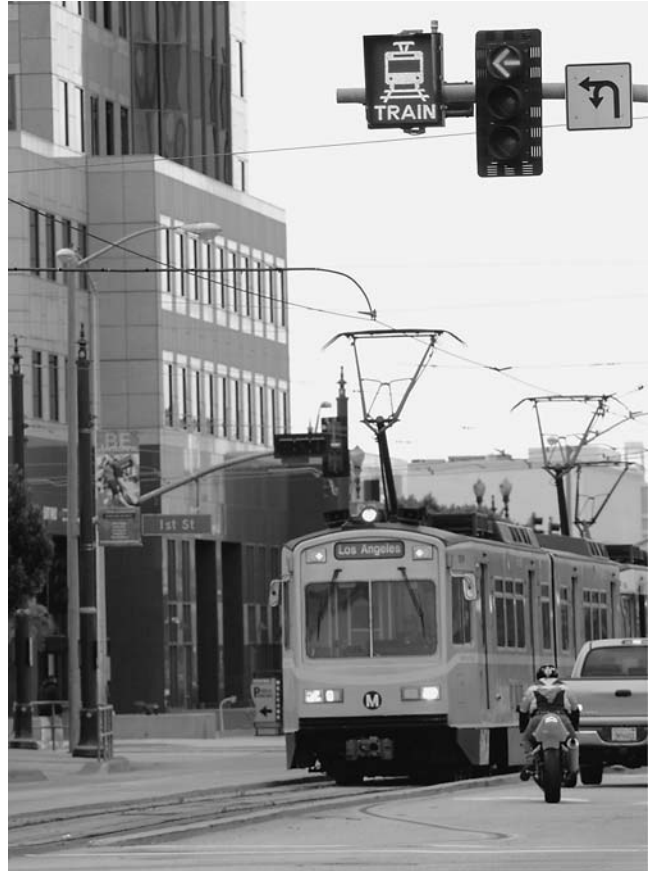
FIGURE 6 Train-activated warning sign in Los Angeles.

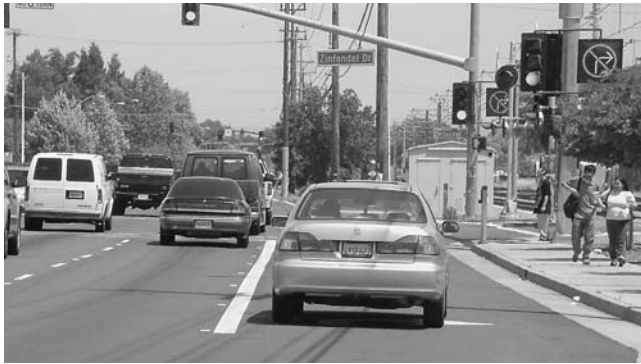
FIGURE 9 No right-turn activated blank-out sign in Sacramento (Courtesy: Sacramento Regional Transit District).

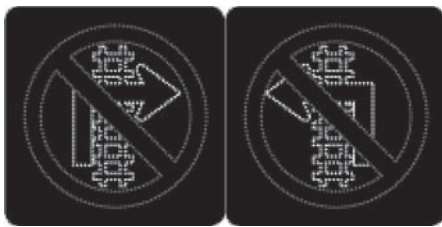
FIGURE 10 No left-/right-turn-activated blank-out signs with tracks symbol (Courtesy: Metropolitan Transit Authority of Harris County, Texas).

pedestrian heads to display the words, “No Left Turn,” to the use of the “No Right/Left Turn Across Tracks” activated blank-out signs suggested in the *MUTCD* (R3-1a, R3-2a signs shown in Figure 7) (10). To restrict turns when an LRV is approaching, some agencies use the activated blank-out versions of the *MUTCD* no right- or left-turn symbol sign (R3-1/R3-2) shown in Figure 8, as was recommended in *TCRP Report 17* (1). Sacramento RT formerly used activated blank-out signs with the words, “No Left/Right Turn.” Currently they use the activated blank-out versions of the R3-1 and R3-2 symbol signs, as shown in Figure 9, which they believe work better than the text versions of the signs. METRO in Houston uses no right- or left-turn activated blank-out symbol signs that incorporate the tracks symbol, as illustrated in Figures 10 and 11.

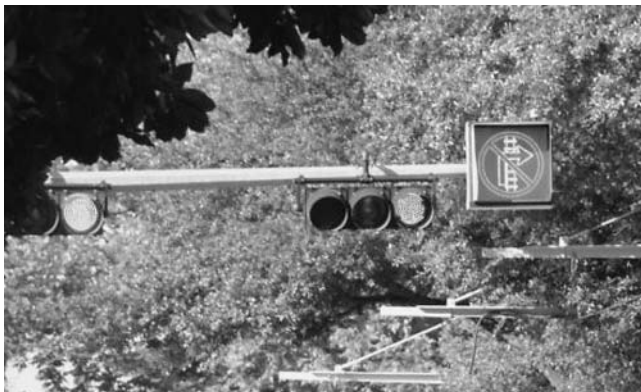
FIGURE 11 No right-turn-activated blank-out sign with tracks symbol in Houston.

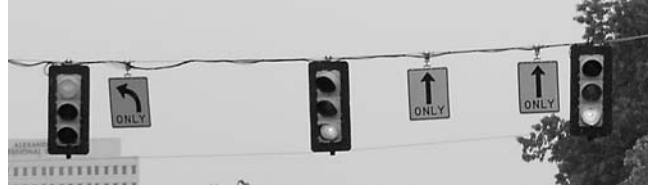
FIGURE 12 MUTCD overhead lane-use control signs.

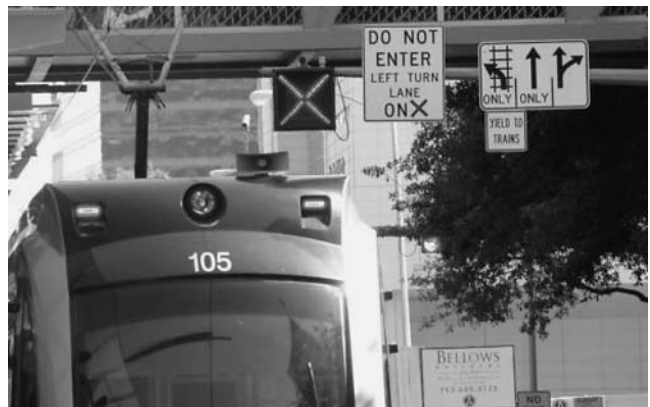
FIGURE 13 Overhead lane-use control signs in Houston (Courtesy: Houston METRO).

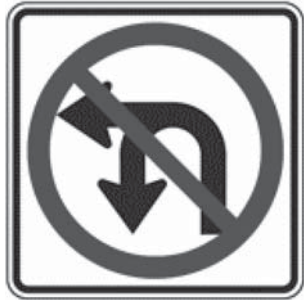
FIGURE 14 Combination no left-turn and no U-turn sign (MUTCD R3-18 sign).

Signalized intersections that incorporate LRT by design are complex intersections. When a multitude of signs are present at these intersections it can cause visual clutter, increase driver information processing time, and increase the potential for missing important information regarding permitted or prohibited movements and LRT presence. Consolidating traffic sign messages where possible and eliminating unnecessary redundancies can reduce the visual clutter as well as the chance of driver error (4). One way to reduce the number of signs placed at the intersection is to use the MUTCD combination “No left-turn/No U-turn” symbol sign (R3-18) instead of two separate signs (Figure 14).

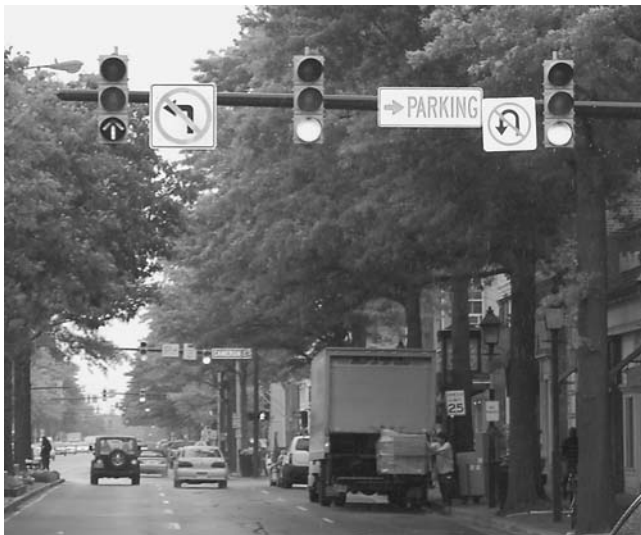
FIGURE 15 Example of sign clutter and misplacement.

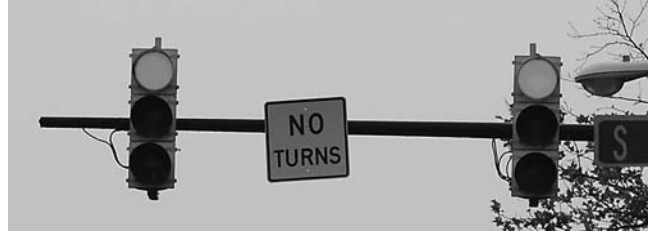
FIGURE 16 Use of the MUTCD No Turns sign.

Sign placement can also help motorists focus on the information that is intended for them. For example, left- and U-turn-prohibition signs should be placed in the median, on the far-left side, or on the left side of the signal mast arm (not on the right side of the intersection). Figure 15 shows an example of the No U-turn sign placed over the far-right lane of traffic and where the combination No left-turn/No U-turn sign would be appropriate to reduce sign clutter. Likewise, right-turn-prohibition signs should only be placed on the right side of the intersection. When both right and left turns are prohibited at an intersection, the MUTCD No Turns sign (R3-3) can be placed on the signal mast arm (4) (Figure 16).

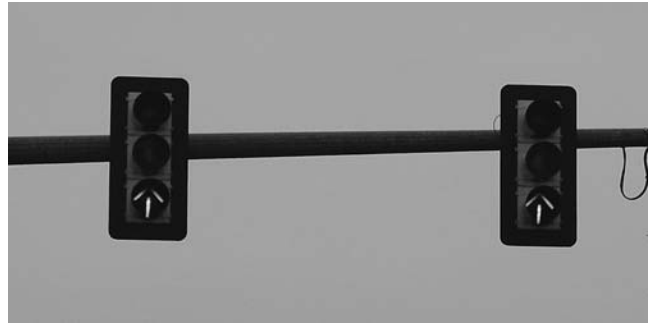
FIGURE 19 Use of green arrow aspects for through traffic.

In an effort to provide positive guidance, the *METRORail Traffic Safety Assessment* report recommended the use of green arrow aspects on traffic signal heads instead of green balls and redundant turn-prohibition signs (4) (Figures 19 and 20). Coifman and Bertini also recommend the use of green arrow aspects for through traffic to reduce the chance that a driver turning left will mistake the through traffic signals for the turning movement, which can happen for a number of reasons. First, there are generally more through signals than turn arrows. Second, the surface area of the green ball is greater than the surface area of an arrow, making it more prominent. Third, the transmittance of a green filter is greater than that of a red filter. For these reasons, the through traffic signal balls have a greater probability of being perceived by a driver than do the left-turn arrow signals (3). If green arrow aspects are used for through movements, a green ball should still be used in the right lane where right turns are permitted across the parallel crosswalk pedestrian movement.

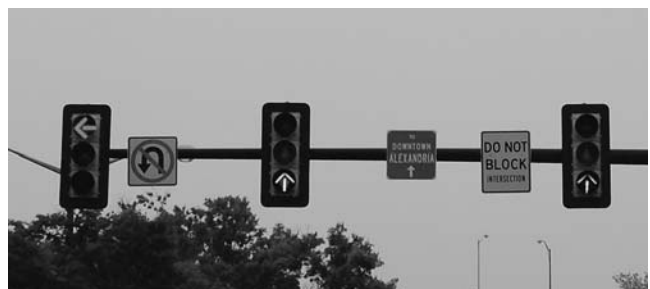
FIGURE 20 Use of arrows to control traffic movements.

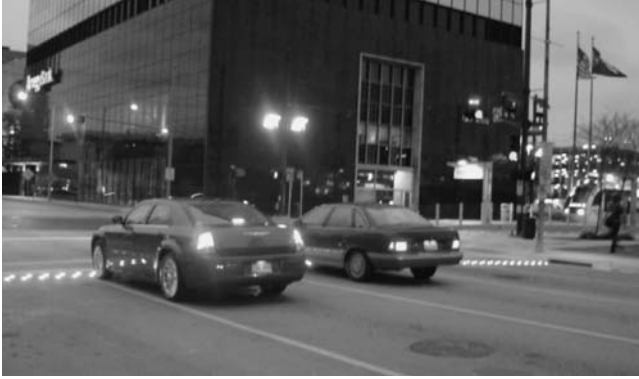
FIGURE 21 In-roadway lights in Houston (Courtesy: METRO).

In-roadway lights are defined in the *MUTCD (10)* as “special types of highway traffic signals installed in the roadway surface to warn road users that they are approaching a condition on or adjacent to the roadway that might not be readily apparent and might require the road users to slow down and/or come to a stop” (10). In 2006, Houston METRO began testing an application of in-roadway lights to get motorists’ attention to stop at the red lights on the cross-street approaches to signalized intersections with LRT and to reduce encroachment into the intersection. The lights being tested by METRO are red, installed along the stop bar, and flicker at a fast rate. An application of the in-roadway lights at one intersection in Houston is illustrated in Figure 21, as an LRV approaches from the right.

Over the past year, METRO has installed in-roadway lights at 11 intersections and experienced only two red-light running accidents at the 11 intersections since installation (the lights have been installed at the intersections on average for about 11 months). This compares with about eight red-light running accidents per year on average at these same intersections for the previous 3-year period, a reduction METRO views as significant.

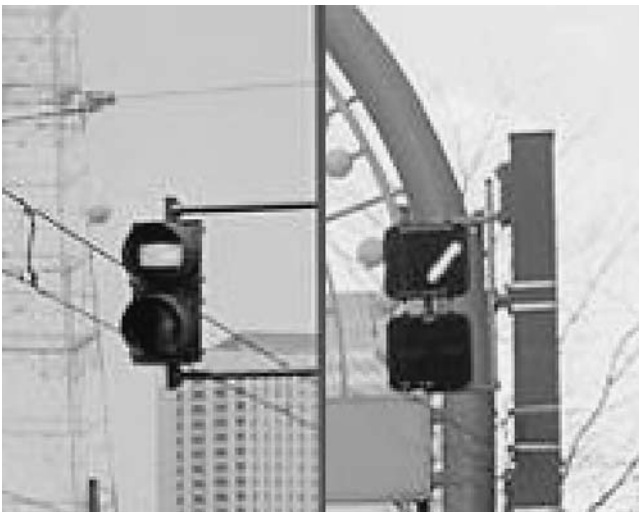
FIGURE 22 LRT signals (Courtesy: Jon Bell).

The use of LRT signals that look similar to traffic signals (e.g., colored ball, “T,” or “X” signals) tend to confuse motorists (e.g., motorists may interpret a green “T” signal that is visible from a left-turn pocket as a left-turn arrow). Therefore, LRT signals should be clearly distinguishable from conventional traffic signal displays in terms of format and color and their indications should be meaningless to motorists without the provision of supplemental signs. LRT bar signals are white, monochrome bar signals that are separated in space from motor vehicle signals (1) (Figure 22).

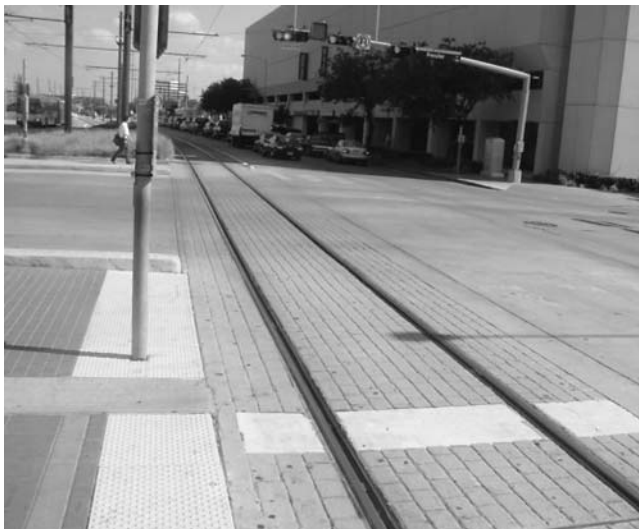
FIGURE 23 Contrasting pavement treatment in Houston (Courtesy: Houston METRO).

Contrasting pavement treatments include colored concrete, brick, etc. (Figure 23). They are used to improve the conspicuity of the tracks and to delineate the dynamic envelope of the train. Along the Metro Blue Line in Los Angeles, at locations with side-running operation, drivers on the cross-street approach to the intersection encroach into the dynamic envelope of the train. To keep drivers back, LACMTA enhanced the crosswalk before the tracks to make it more noticeable by using a colored concrete pattern. Contrasting pavements on the

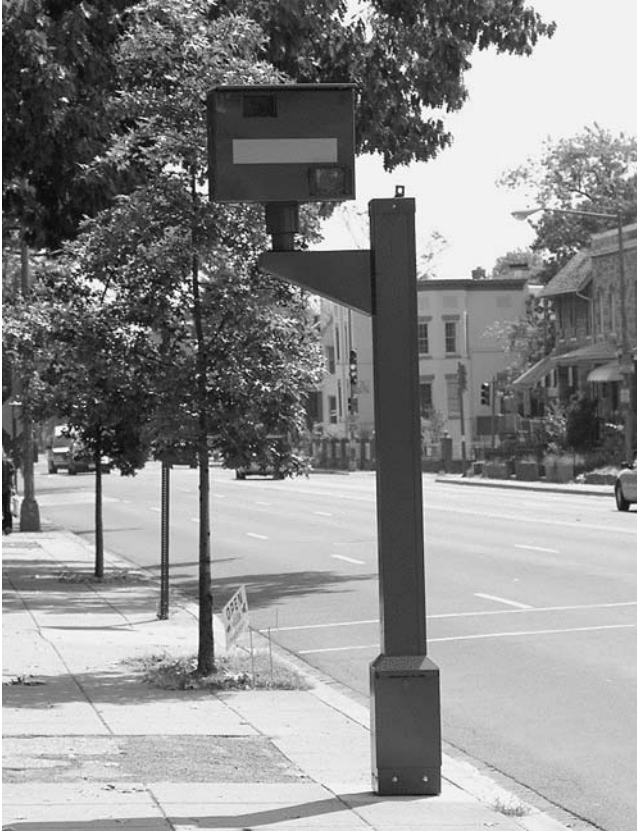
FIGURE 25 Photo enforcement camera (Courtesy: Los Angeles County MTA).

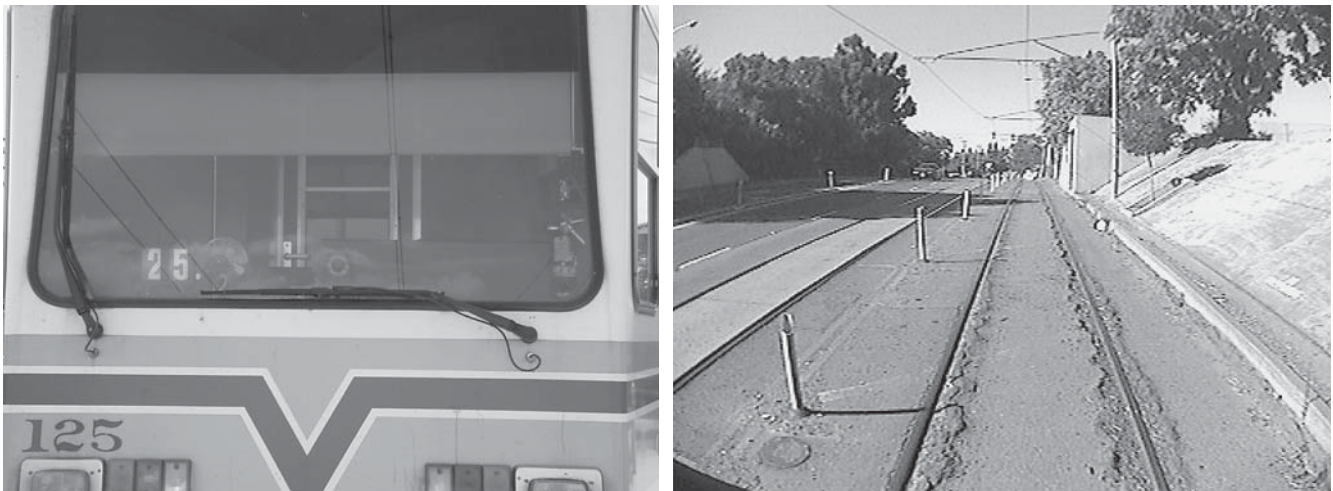
FIGURE 26 Sacramento RT's train-mounted camera (left) and view from camera (right) (Courtesy: Sacramento Regional Transit District).

Several agencies, including Houston METRO, Sacramento RT, and LACMTA have train-mounted cameras that are positioned outward. Figure 26 shows Sacramento RT's train-mounted

camera. In the photograph on the left, the camera is positioned in the center of the front windshield of the train just above the windshield wiper. The photograph on the right shows the view captured by the camera from the train. Figure 27 shows Houston METRO's train-mounted camera. In the photograph on the left, the camera is positioned on the exterior front-right of the train. The photograph on the right shows the view captured by the camera from the train. These cameras have been helpful in reviewing collisions to determine causes, which can in turn help agencies identify appropriate mitigation strategies to reduce collisions.

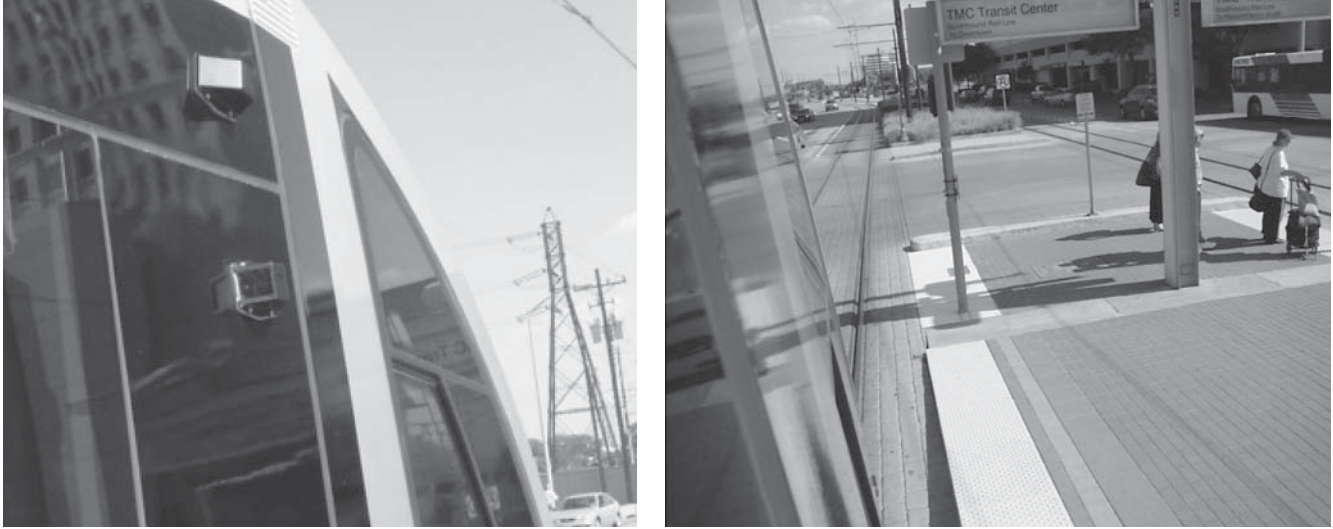
FIGURE 27 Houston METRO's train-mounted camera (*left*) and view from camera (*right*) (*Courtesy: Houston METRO*).

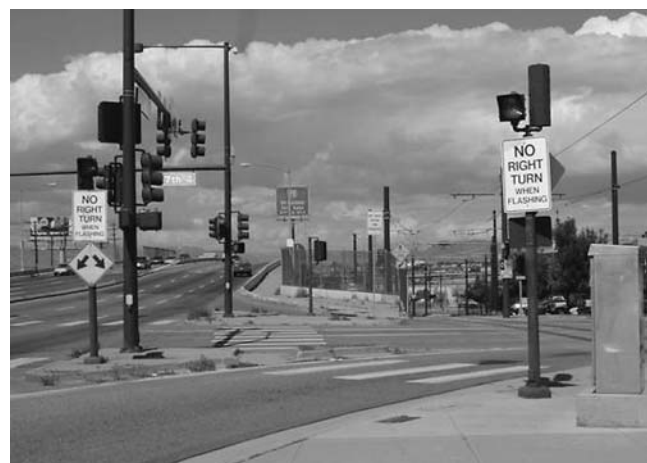
FIGURE 28 No Right Turn When Flashing sign from Colfax Avenue to 7th Street in Denver.

To control permissive right turns at this location, RTD used static “No Right Turn When Flashing” signs associated with a flashing yellow light (Figure 28); however, this did not work well. Drivers did not know why they were not allowed to turn

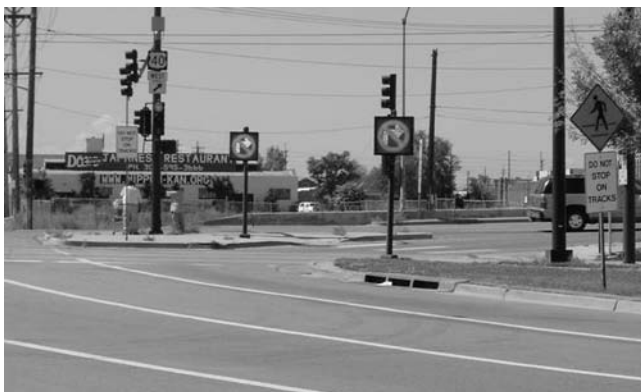
FIGURE 29 LRV-activated turn prohibition signs—7th Street to Colfax Avenue in Denver.

when the globe was flashing, so they turned anyway and some were struck by LRVs. RTD has replaced these signs with LRV-activated turn-prohibition signs (Figure 29), which activate when turns are prohibited, and these signs work better at controlling right turns than the flashing yellow. However, there are still drivers who violate the signs. RTD plans to add the LRV-activated train-approaching warning signs to provide additional information to drivers about why they are not allowed to turn.

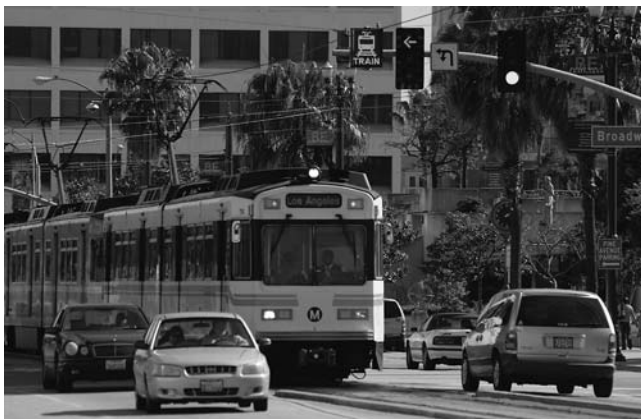
FIGURE 30 Los Angeles Metro Blue Line (Courtesy: Los Angeles County MTA).

The LACMTA Metro Blue Line opened in 1990, extending 22 miles from downtown Los Angeles to downtown Long Beach. About 6.48 miles of the Metro Blue Line is street-running, the majority of which is median-running (Figure 30), with less than 1 mile of side-running operations. There are approximately 28 crossings with gates and 62 without gates, all of which are actively controlled. The trains operate at 35 mph in the street-running sections of the alignment.

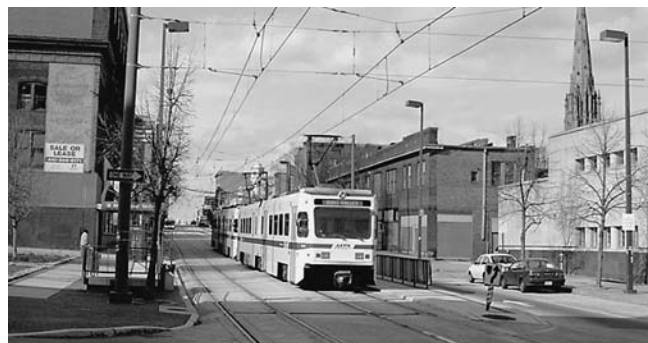
FIGURE 31 Baltimore's light rail (Courtesy: Jon Bell).

The 1.9-mile section of the Central Light Rail Line along the Howard Street corridor was constructed within the existing right-of-way on Howard Street, with two parallel tracks that run along the west side of the street for the majority of its length (Figure 31). The segment includes 17 non-gated signalized intersections. The LRT alignment includes semi-exclusive type b.3 (protected by 6-in. high curbs between crossings) and type b.4 (separated by mountable curbs, striping, and/or lane designation). Originally, there was no vehicle traffic allowed along Howard Street; however, in 1997, northbound one-way vehicular traffic was added, resulting in a rise in the rate and number of reported accidents involving LRVs, motor vehicles, and pedestrians.

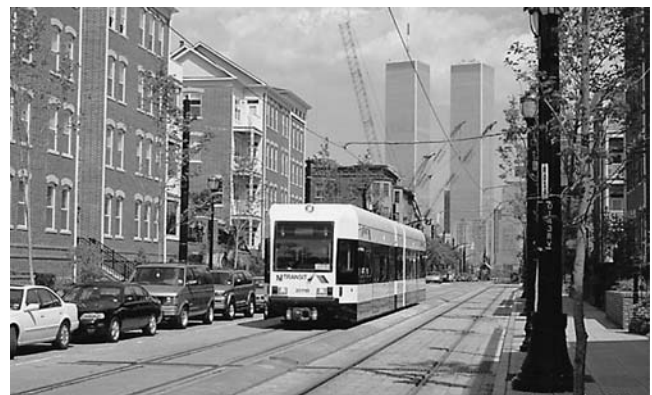
FIGURE 32 Hudson–Bergen alignment (Courtesy: Jon Bell).

The New Jersey Transit’s Hudson–Bergen Line opened in April 2000 with approximately 6 miles of track. New Jersey Transit has added track in increments since the April 2000 opening. As of February 2006, the line has a total of 20 miles of track. Eight of the 20 miles operate in an exclusive right-of-way, and 12 miles operate in a non-exclusive right-of-way (Figure 32).

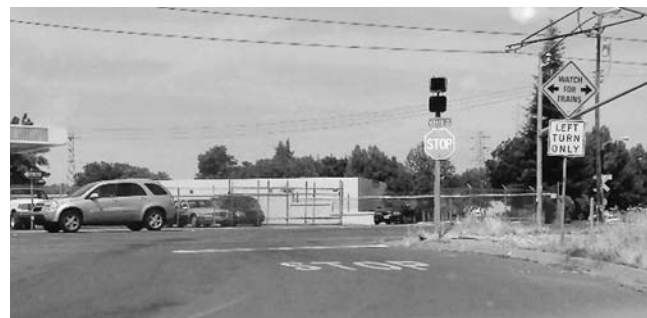
FIGURE 33 Ahern Street approach to 12th Street with pedestrian head train approaching warning sign (Courtesy: Sacramento Regional Transit District).

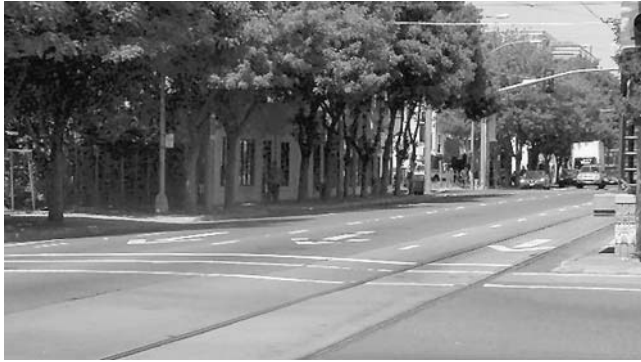
FIGURE 34 12th Street mixed-use right-of-way in Sacramento (Courtesy: Sacramento Regional Transit District).

Sacramento RT has mixed-use operations along parts of 12th Street, which is a one-way street running into downtown Sacramento. It carries four lanes of automobile traffic, dropping lanes one-by-one into downtown, where there are two lanes. The southbound tracks share the eastern-most lane with automobile traffic, whereas the northbound train operates in its own right-of-way (Figure 34). Therefore, drivers make left turns in a shared lane with the train and turn across the tracks carrying trains in the opposing directions (Figure 35). The problem that Sacramento RT is currently experiencing is that

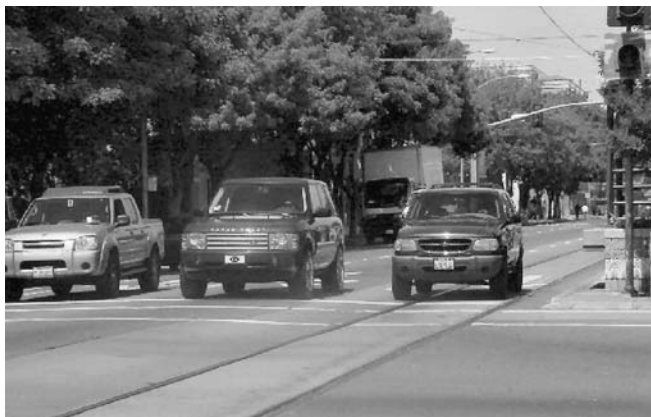
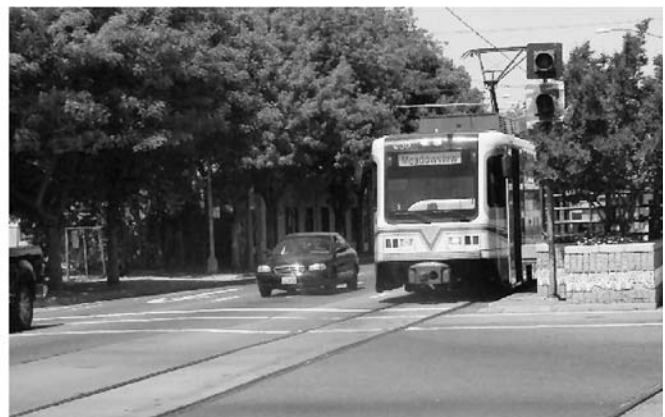
FIGURE 35 12th Street and E Street: Vehicle occupying shared lane (left) and LRV occupying shared lane (right) (Courtesy: Sacramento Regional Transit District).
