Selected Appendices for TCRP Report 137: Improving Pedestrian and Motorist Safety Along Light Rail Alignments

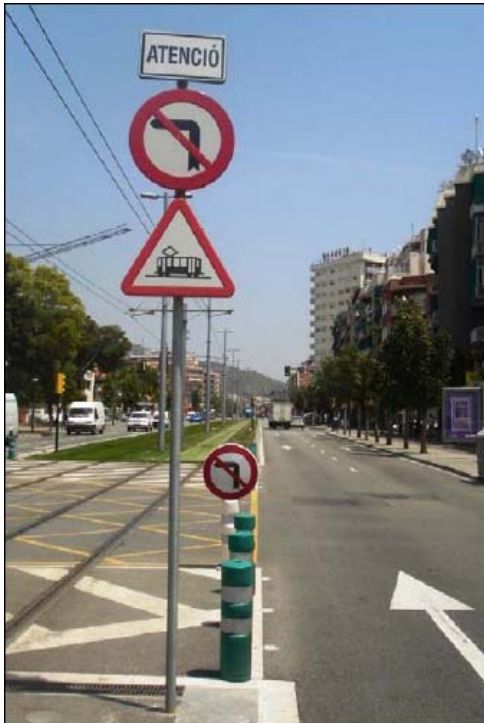
Figure 1: Left-turn prohibition signs in Barcelona

A study by Farran examined the impact of innovative pedestrian and motor vehicle traffic control designs and practices applied on the LRT Line recently (April 2004) opened in Barcelona, Spain (7). The study examined a combination of treatments used to prevent left turns. The treatments comprised two consecutive “No Left turn” signs placed on the left hand side of the road, a LRV symbol warning sign, and a supplementary plaque. The “No Left turn” sign located furthest from the crossing is mounted at the top of a white bollard at a height of approximately three feet, well within the motor vehicle driver’s cone of vision. Both the sign and the bollard are made of flexible plastic material glued to the pavement. In addition, the left-turn prohibition becomes more evident to the driver and the width of the intersection is narrowed by installing green flexible retroreflective plastic bollards that are glued to the pavement. Finally, a straight arrow pavement marking is located on the travel lane to further emphasize the turn prohibition. Typical examples are shown in **Figure 1** and **Figure 2**.

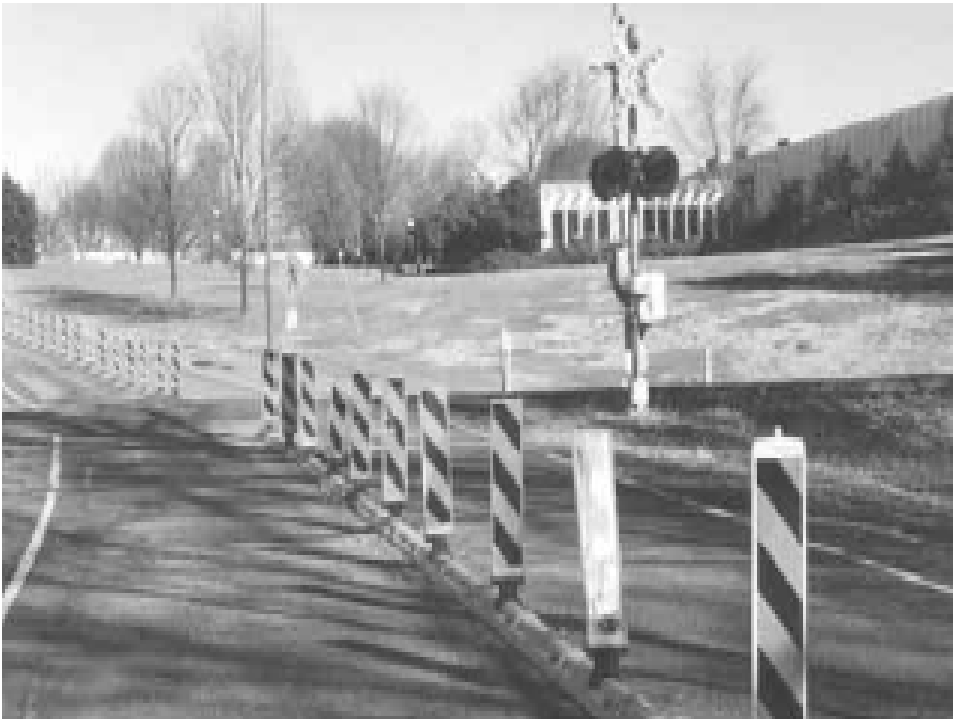
Figure 4: Flexible posts in Harrisburg, North Carolina

Korve et al. recommend that raised medians with barrier (non-mountable) curbs be used on roadway approaches to LRT crossings where roadway geometry and widths allow (2). For LRT crossing locations where the roadway is not physically wide enough to construct a raised median with barrier curbs, other traffic channelization devices such as bollards, traffic dots (see **Figure 3**) and flexible posts (see **Figure 4**) should be considered.

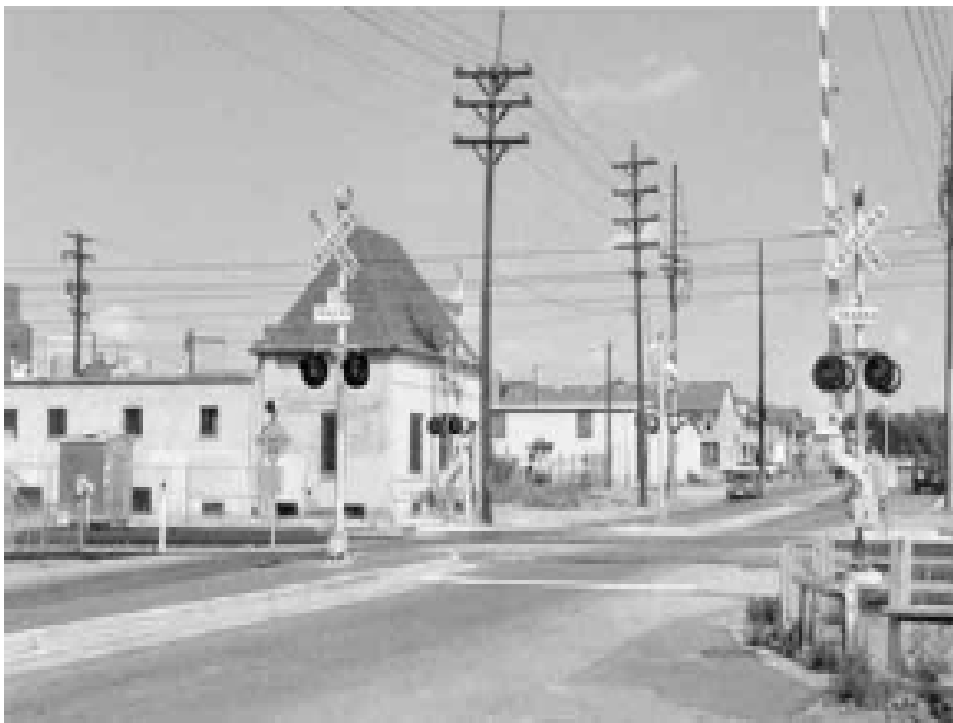
Figure 5: Raised medians with barrier curbs in Denver, Colorado

Due to the presence of slower freight trains operating on adjacent tracks, motorists at the two Denver crossings had come to expect long delays between the start of the flashing light signals and the arrival of a freight train. As a result, a significant number of motorists were accustomed to driving around the lowered automatic gate arms. “High-Speed Train Approaching” warning signs with an LRV-activated flashing yellow beacon had little success in decreasing the rate of automatic gate violations. RTD then installed the raised medians with barrier curbs to deter motorists from driving around the automatic gates. According to RTD representatives, this has “reduced the rate of violations to almost zero” (2).

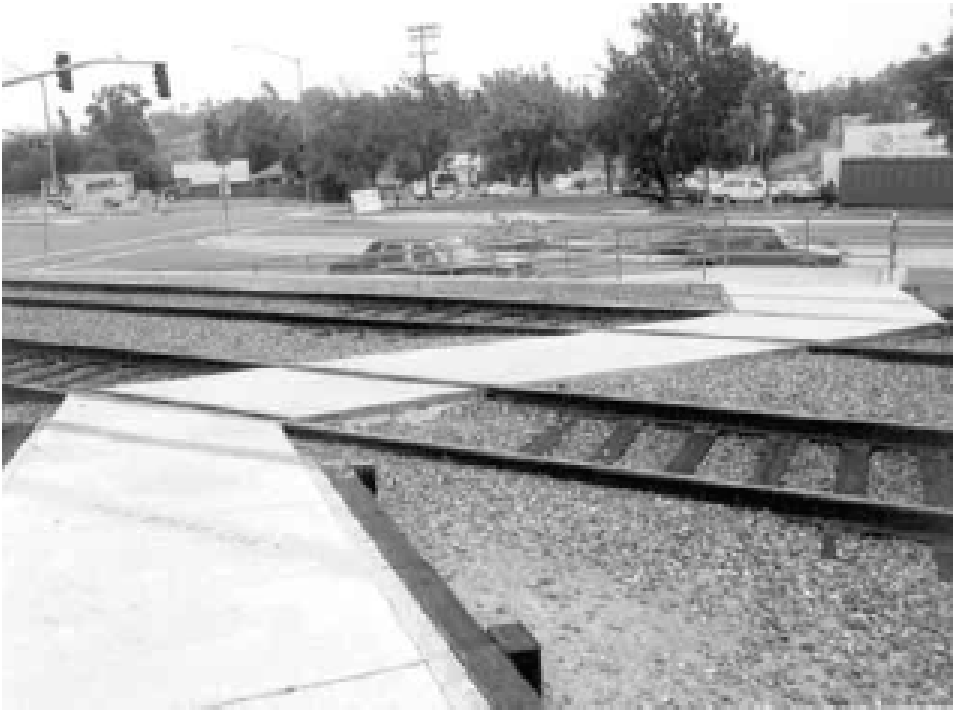
Figure 9: Example of Z-crossing (City of Lemon Grove, California)

Calgary Transit has used both Z-crossings and bedstead barrier crossings. As shown in **Figure 9** and **Figure 10**, these pedestrian barriers are installed in a zigzag style pattern on sidewalks and at LRT stations. The configuration of the paths forces pedestrians to face the direction of a potentially approaching LRV. Z-crossings should be used only at pedestrian crossings with adequate sight distance (if pedestrians are turned to face approaching LRVs but cannot see them because of obstructions, the Z-crossing is useless). Z-crossings and bedstead crossings should not be used where LRVs operate in both directions on a single track, because pedestrians may be looking the wrong way in some instances. Although pedestrians may also look in the wrong direction during LRV reverse-running situations, reverse running should not negate the value of Z-crossings and bedstead barrier crossings as this type of operation is performed at lower speeds and is typically used only during maintenance or emergencies (2,14).

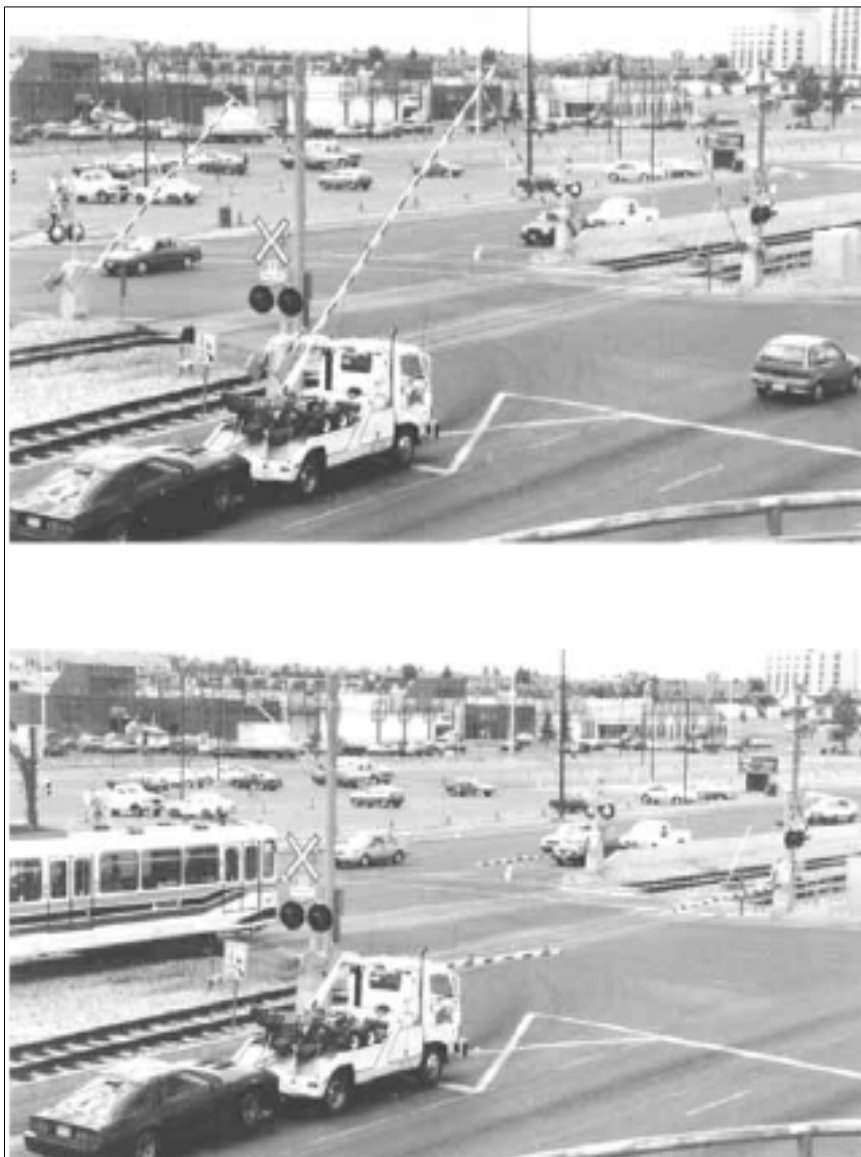
Figure 13: Quasi four-quadrant gate system in Calgary, Alberta

This way of orienting automatic gates has been used by several transit agencies, including Tri-Met in Portland and Calgary Transit in Alberta (**Figure 13**). No quantified evidence related to the safety impacts of realigning automatic gates has been found (2). As an alternative to installing left-turn gates parallel to the LRT alignment, left turns could be prohibited at all times by using No Left-turn signs and appropriate motor vehicle channelization (**Figure 12**).

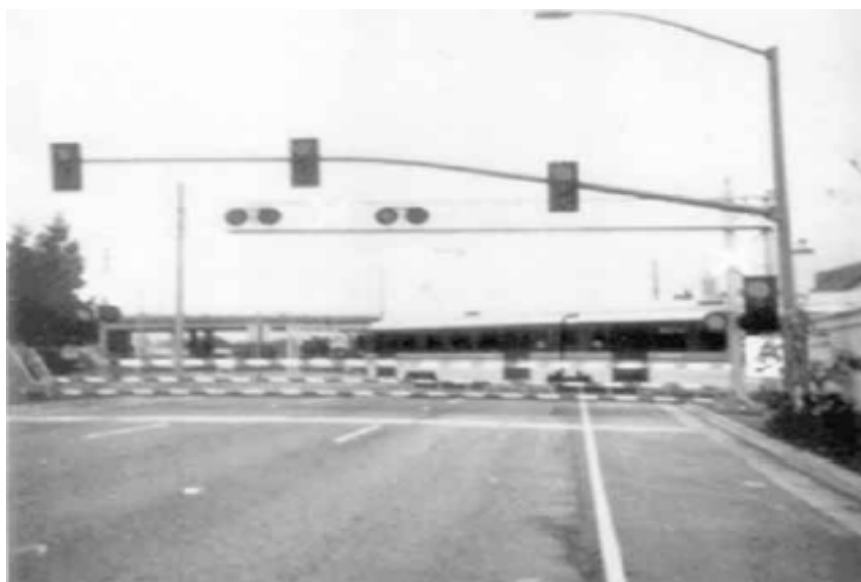
Figure 14: Safety barrier gate in San Jose, California

The safety barrier gate is a movable gate designed to close a roadway temporarily at a highway-rail crossing. A housing mechanism contains electro-mechanical components that lower and raise the gate arm. The gate arm itself consists of three steel cables, the top and bottom of which are enclosed aluminum tubes (**Figure 14**). When the gate is in the down position, the end of the gate fits into a locking assembly that is bolted to a concrete foundation. Safety barrier gate testing has demonstrated that the gate can safely stop a pickup truck traveling at 72 km/h (45 mph). Gates have been installed in Madison, Wisconsin (highway-rail grade crossing) and Santa Clara County, California (highway-light rail transit grade crossing) (16). No additional information of the effectiveness of these devices has been found, though the Santa Clara example was out of operation for several years and eventually dismantled in early 2008 due to maintenance problems as the gate was designed for building security and not frequent operation as required for the LRT. Santa Clara LRVs are now required to stop before crossing the roadway (based on communications with José Farrán, April 2008).

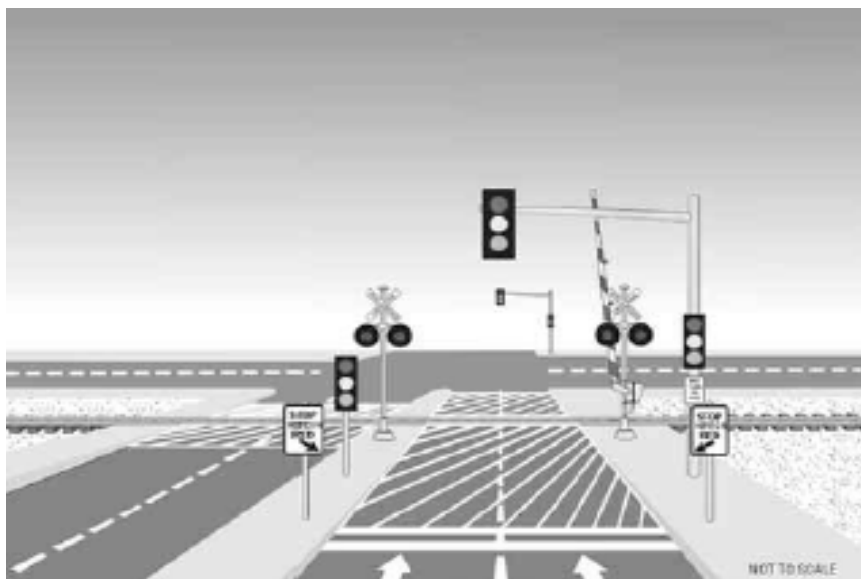
Figure 15: Pre-signal locations at gated crossings

As shown in **Figure 15**, pre-signals can be installed on the near side of the LRT crossing, upstream of the traffic signals that control the public street intersection. When an LRV approaches the crossing, the pre-signals turn red to stop motor vehicles on the near side of the LRT crossing. The pre-signals turn red before the traffic signals at the intersection (i.e., the downstream traffic signals), thereby clearing motor vehicles off the tracks and, at the same time, not allowing any more motor vehicles to move onto the tracks. The traffic signals located downstream at the intersection should use programmable visibility (commonly referred to as PV) traffic signal heads to minimize any possibility of confusion with the pre-signals. An added benefit of pre-signals is that they can be operated in conjunction with the intersection signals so that, on every signal cycle at the intersection, the pre-signals prevent queues from forming between the intersection stop bar and the LRT tracks, whether or not an LRV is approaching the crossing (2).

Using pre-signals can be an effective solution to improving safety at LRT crossings for motorists. Research suggests that motorists using crossings located in an area characterized by signalized intersections respond well to traffic signals. As most LRT systems are constructed in urban areas, traffic signals are familiar and generally more credible than flashing light signals (2).

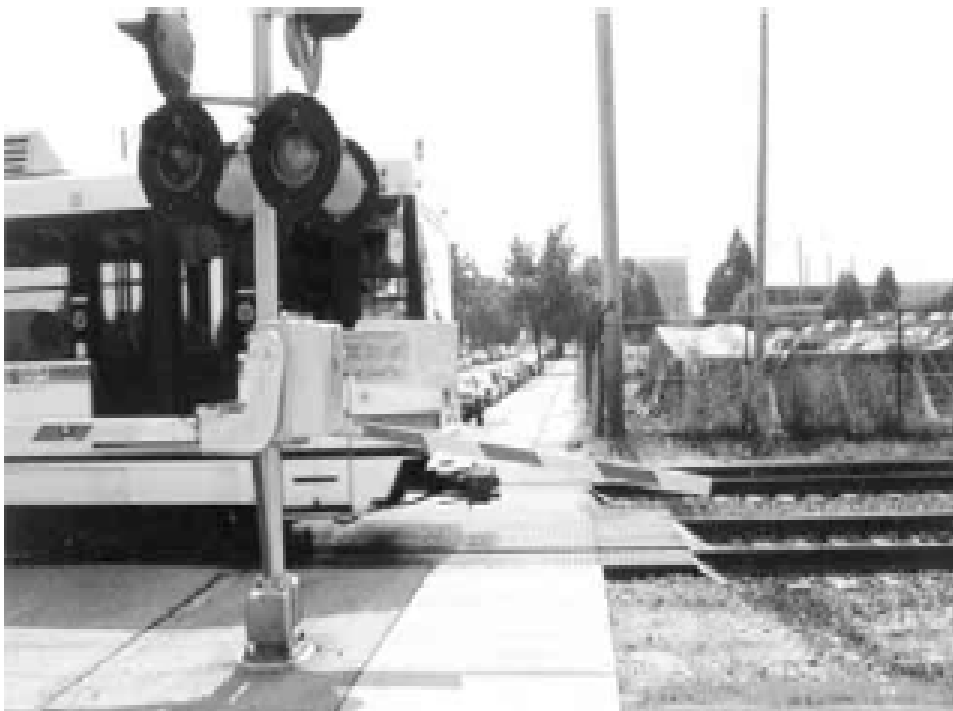
Figure 16: Pedestrian automatic gate

Korve et al. recommend that pedestrian automatic gates (**Figure 16**) be installed at all pedestrian crossings (sidewalks or other designated pathways) where sight distance is limited

To avoid compromising the safety of a pedestrian trapped between the tracks and the automatic gate as it lowers, some transit agencies (such as the LACMTA in Los Angeles) have installed pedestrian automatic gates set back from the track so that pedestrians have a refuge area between the track and gate where they can wait safely. The setback distance is wide enough to accommodate a wheelchair. An alternative solution, used by CalTrain, a commuter railroad in northern California, is a swing gate installed next to the pedestrian automatic gate. **Figure 17** shows a swing gate at a pedestrian only crossing at a station platform.

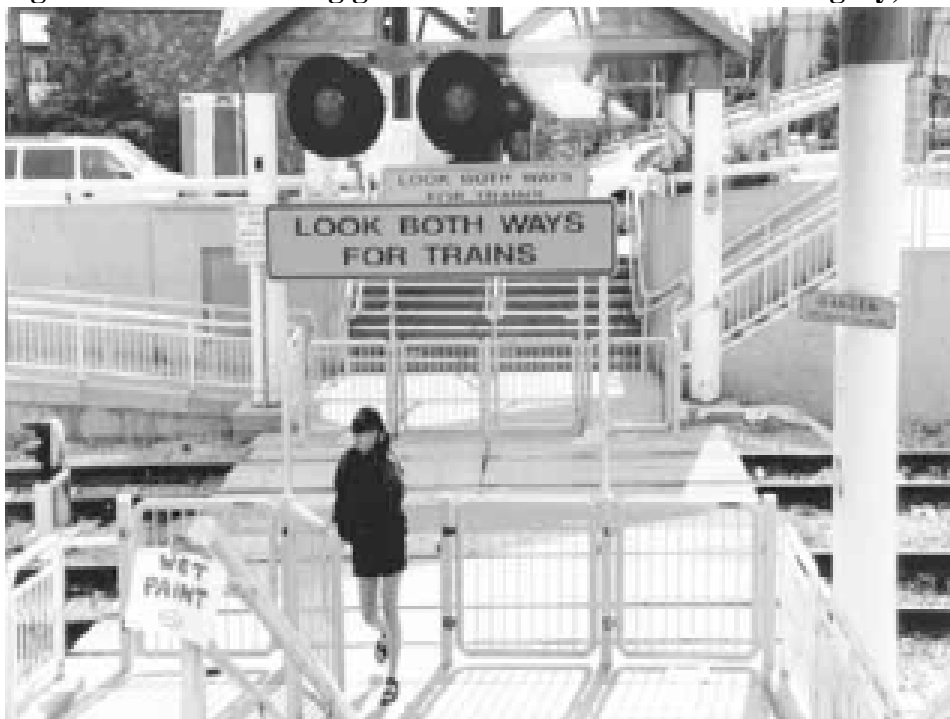
Figure 18: Manual swing gates with overhead flashers in Calgary, Alberta

Figure 18). The swing gates are similar to those installed by the LACMTA, by San Diego Trolley Inc., and by Metrolink in St. Louis, Missouri. The gates are intended to prevent pedestrians from crossing into the track area without pausing and checking. As pedestrians are required to actively open the gates, they are forced to be more alert to the risks associated with crossing the LRT tracks. The gates also provide a positive barrier between where it is safe and where it is dangerous to stand when an LRV is approaching (2). Transit officials in Calgary have, however, reported that pedestrian violations of the swing gates (opening the gates while the warning devices are flashing) have increased following the initial reductions in risky behavior that occurred immediately after the gates were installed (2).

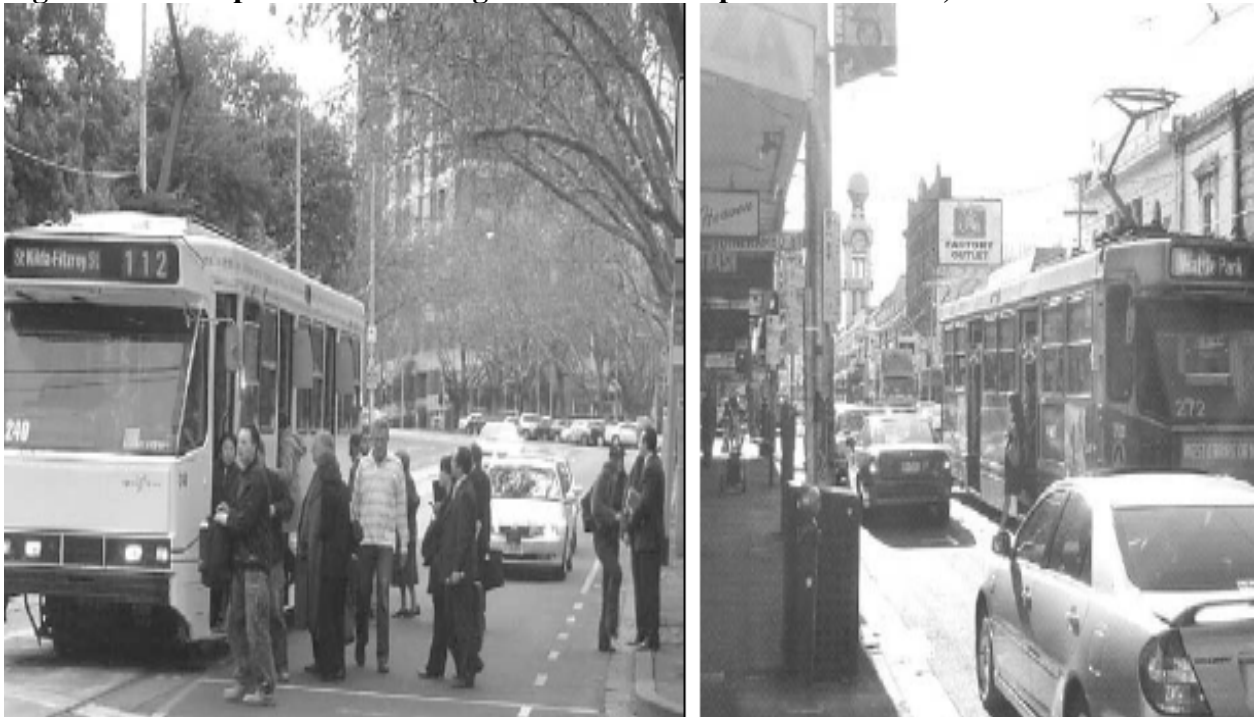
Figure 22: Examples of curbside light rail transit stops in Melbourne, Australia.

Curbside stops have been identified as a major passenger safety concern (26). They are thought to lead to 25 pedestrian road traffic accidents and a far higher number of near misses each year in Melbourne, Australia (26). A number of alternative designs have been adopted to replace curbside stops in Melbourne (**Figure 23**).

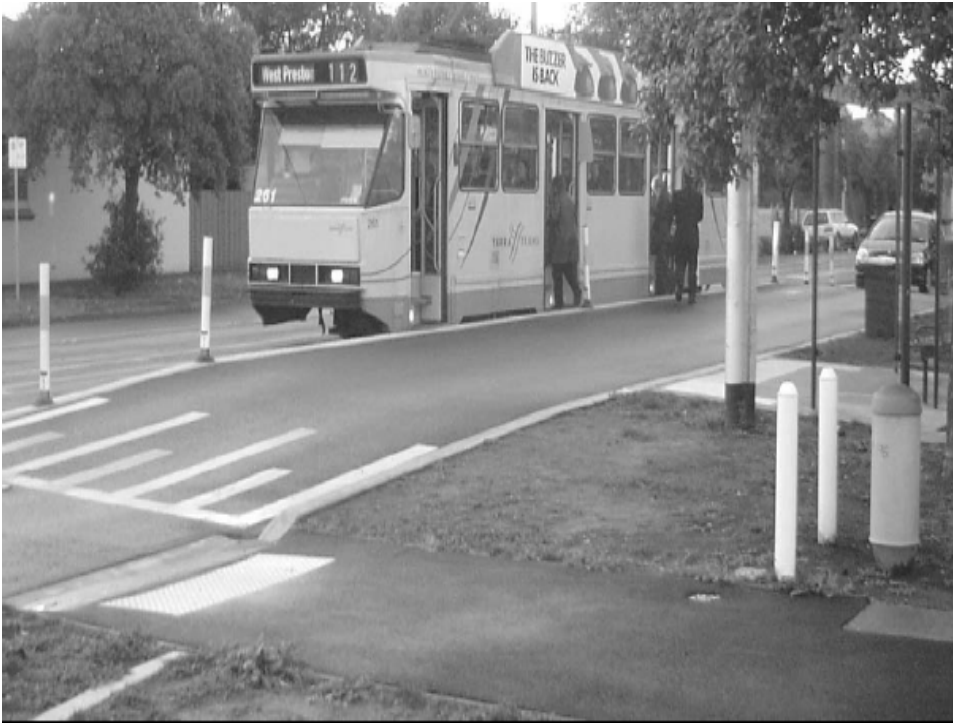
Figure 24: Easy access stop in Melbourne, Australia

A new design called the “Easy Access Stop” was developed by the City of Port Phillip in association with VicRoads (Melbourne’s Road Management Authority) and Yarra Trams (the operator of Melbourne’s tram system) (**Figure 24** and **Figure 25**). The easy access stop was originally designed to improve passenger access to LRVs, to reduce vehicle speeds on the approach to and through the stop, and to improve patron safety while boarding and alighting a tram. No casualty or property damage accidents have been reported at or near the easy access stop since implementation. Concerns regarding the possibility of vehicles falling off the platform on to the tram tracks, or straddling the platform/tram track area have so far proved unfounded (26).

No quantified information on the safety impacts on these alternative designs was found. These alternative designs have not been evaluated in North America and may need to be studied to meet ADA requirements.

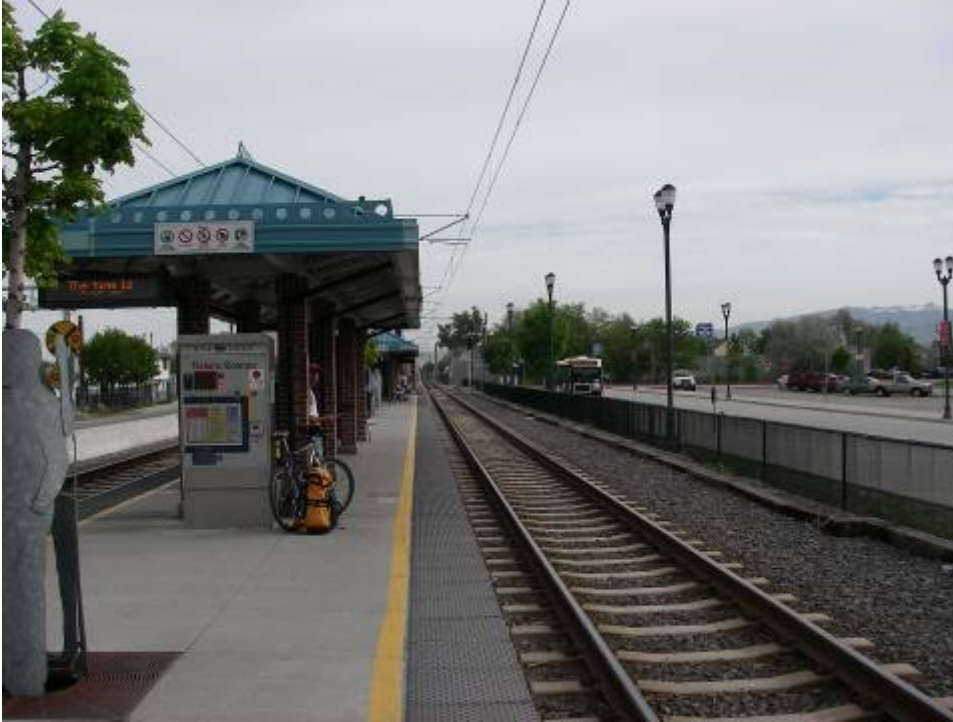
Exhibit 2: Example of Exclusive Alignment

The southern portion of the Salt Lake / Sandy line is Automatic Block Signal (ABS) controlled, and shared with Union Pacific. The line is an exclusive ROW with at-grade crossings. Ron pointed out that the alignment has potential pedestrian crossing concerns, but there have been very few incidents. Trains approach the stations at 35 mph and accelerate quickly when leaving the stations. **Exhibit 2** shows a typical station on the southern portion of the line.

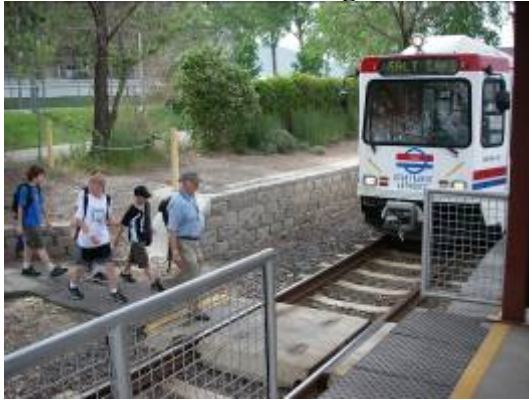
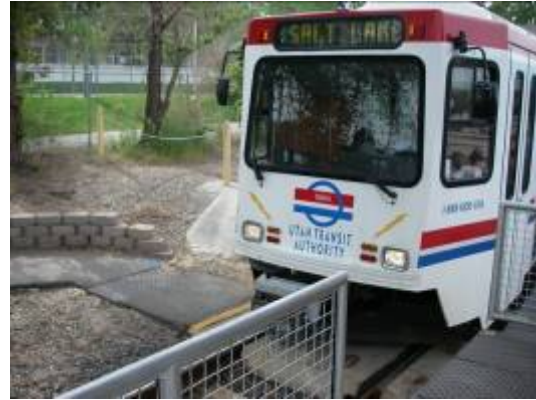
Exhibit 3: Station Crossing

Exhibit 3 is an example of an interesting, although originally unintentional, pedestrian safety measure at the final station on the Salt Lake / Sandy line. The train stops and waits while customers board. Then, the train pulls forward to the raised accessible platform. When the train is in its forward position, it acts as a pedestrian gate.

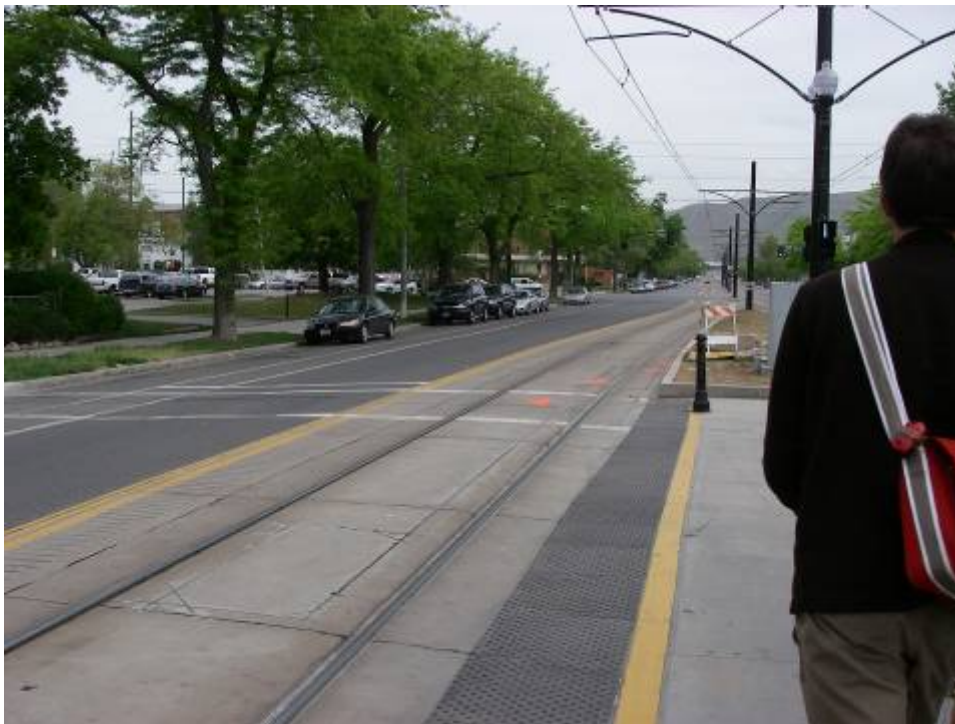
Exhibit 4: Semi-exclusive Alignment - Rumble Strip and Pavement Markings

The downtown area is a mostly semi-exclusive ROW. The LRT has a shared ROW separated by rumble strips or barrier curbs. Rumble strips are shown in **Exhibit 4**, and barrier curbs are shown in **Exhibit 5**. A short portion of the downtown line is mixed traffic operations. Trains operate at 25 mph. The downtown area also includes unsignalized midblock crossings.

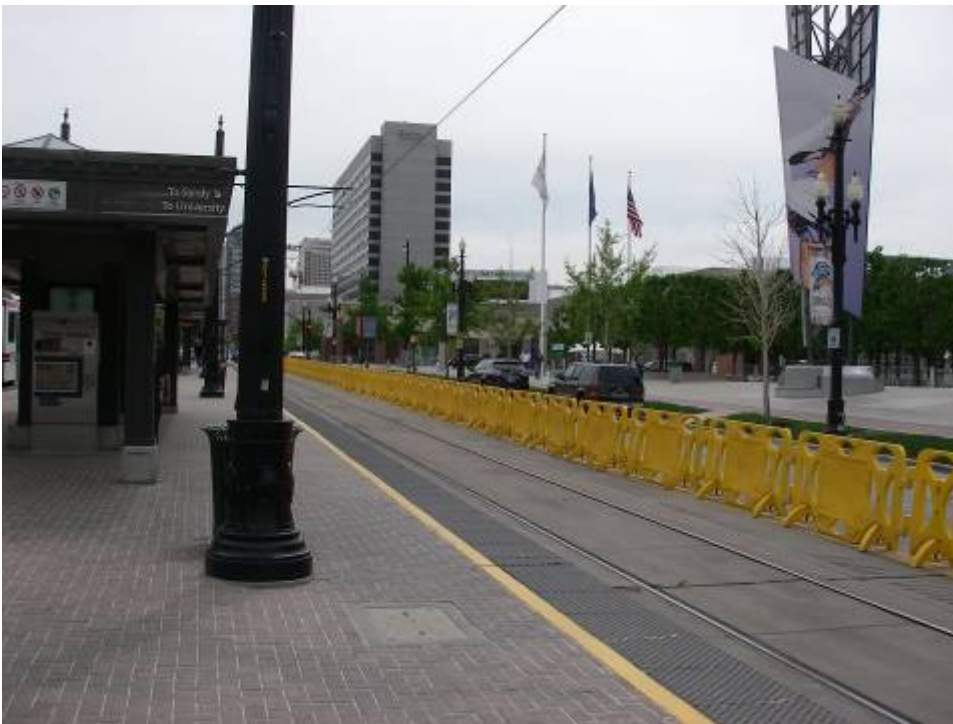
Exhibit 6: Temporary Barrier at Stadium

A portion of the downtown alignment runs in front of a stadium where there are significant concerns with crowd control after games. UTA has addressed this concern by installing temporary barriers for special events. This arrangement is shown in **Exhibit 6**.

- Temporary barriers for crowd control – these work well, but are not a long term solution. UTA is interested in what other agencies do for high pedestrian volume locations.

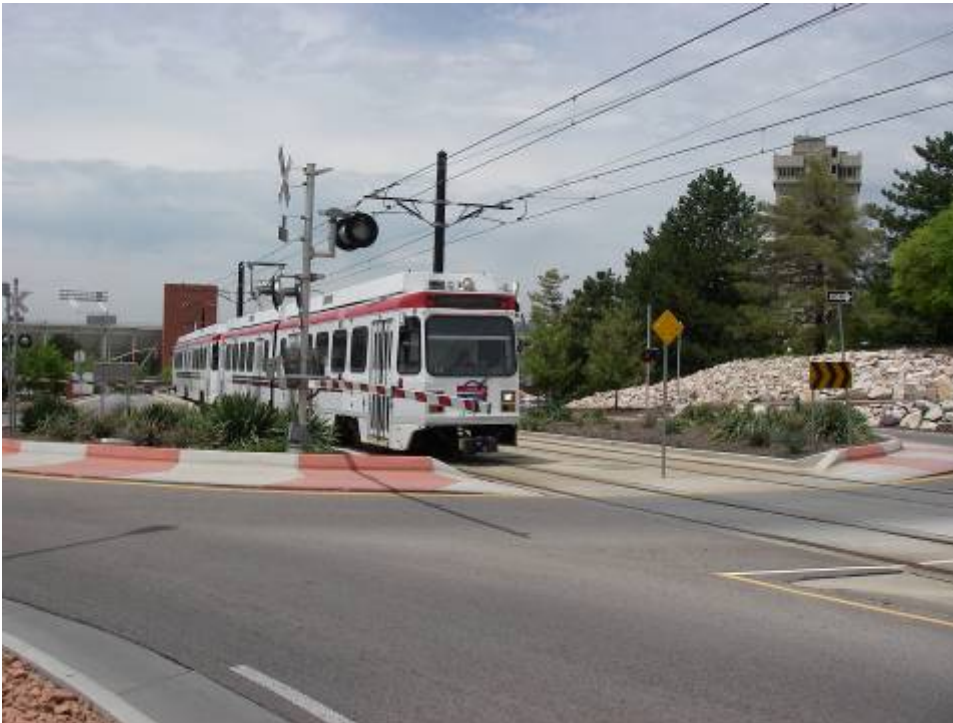
Exhibit 7: University Line Intersection Treatment at Roundabout

The University Line runs in a semi-exclusive median alignment with curbs separating the tracks from vehicles. Portions of this line reach speeds up to 40 mph. A few locations on the University Line have caused concern. Near the intersection of Wasatch and Medical, an intersection has experienced some collisions between the train and right turning vehicles. Throughout the University, jaywalking is a problem. The University Stadium is another location for concern, but there have been only a few incidents here. Like the downtown stadium location, the University Stadium station experiences a high volume of pedestrians after special events. UTA has staff on site after special events to direct the crowds. The University Line also includes a roundabout with four rail crossing gates. The roundabout crossing has experienced few problems. It is shown in **Exhibit 7**.
Exhibit 7

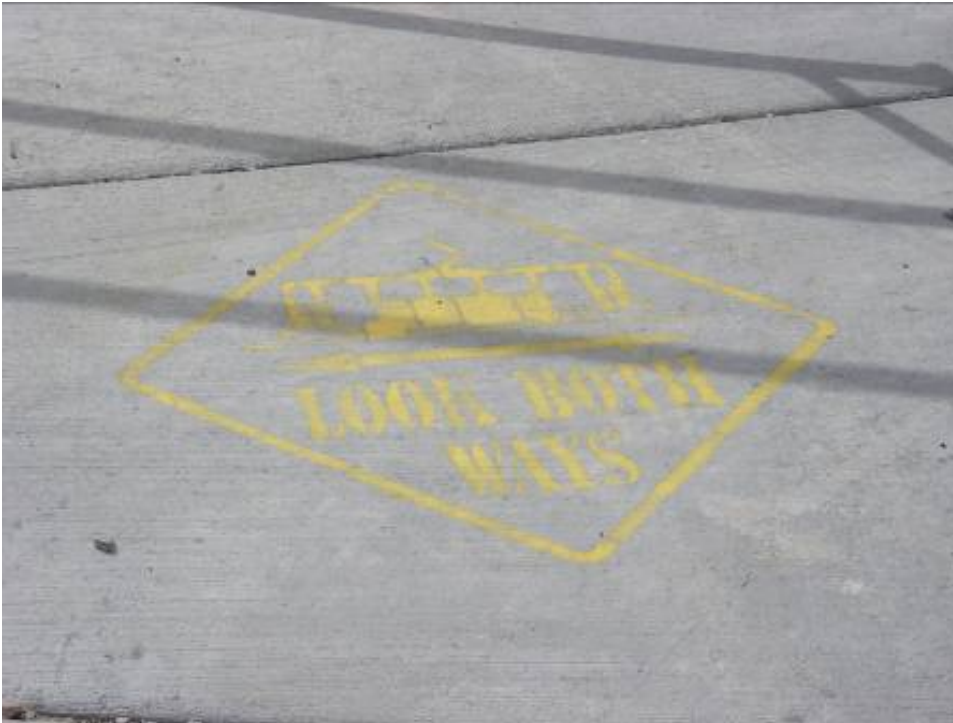
Exhibit 8: Look Both Ways Painted Sign

The painted signs shown in **Exhibit 8** are not standard MUTCD.

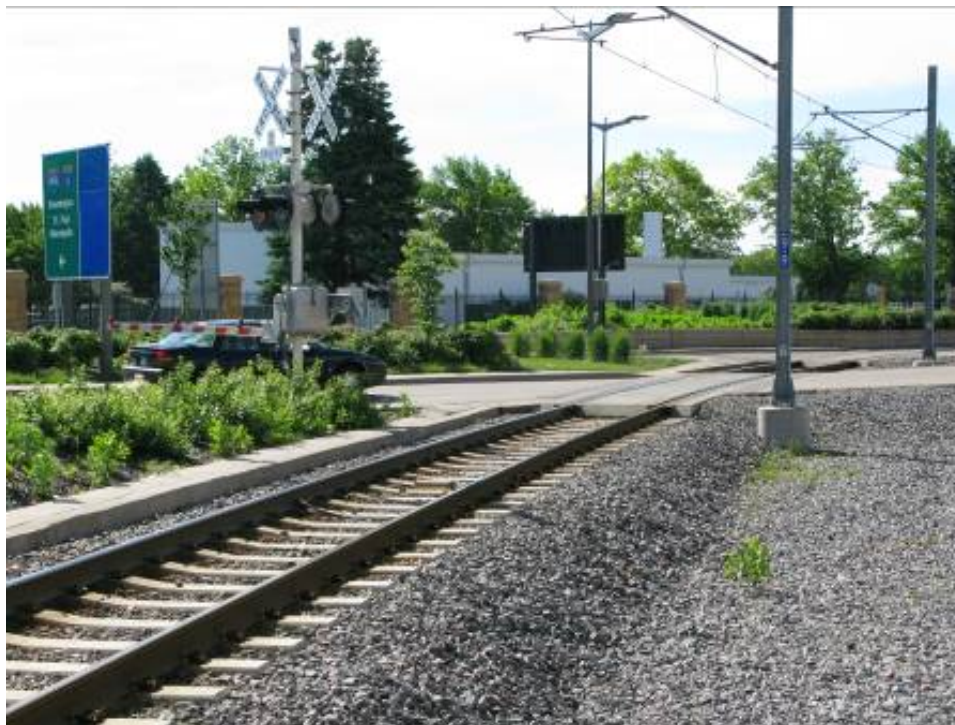
Exhibit 2: Vehicle Violating Gates

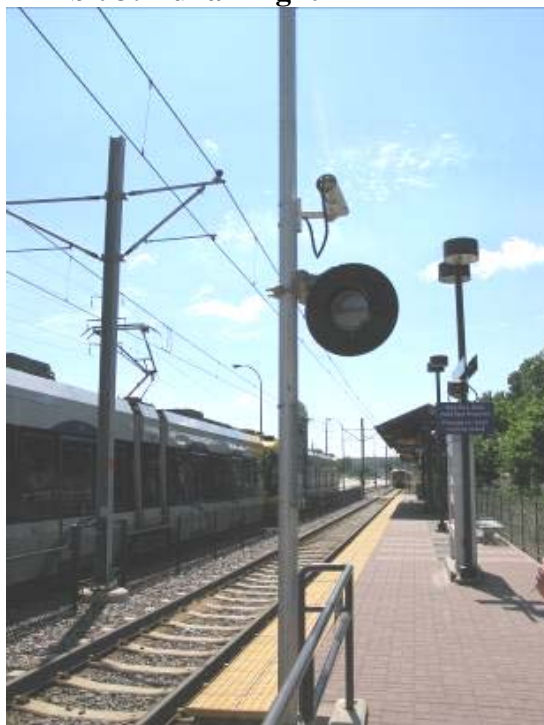
Exhibit 3: Lunar Light

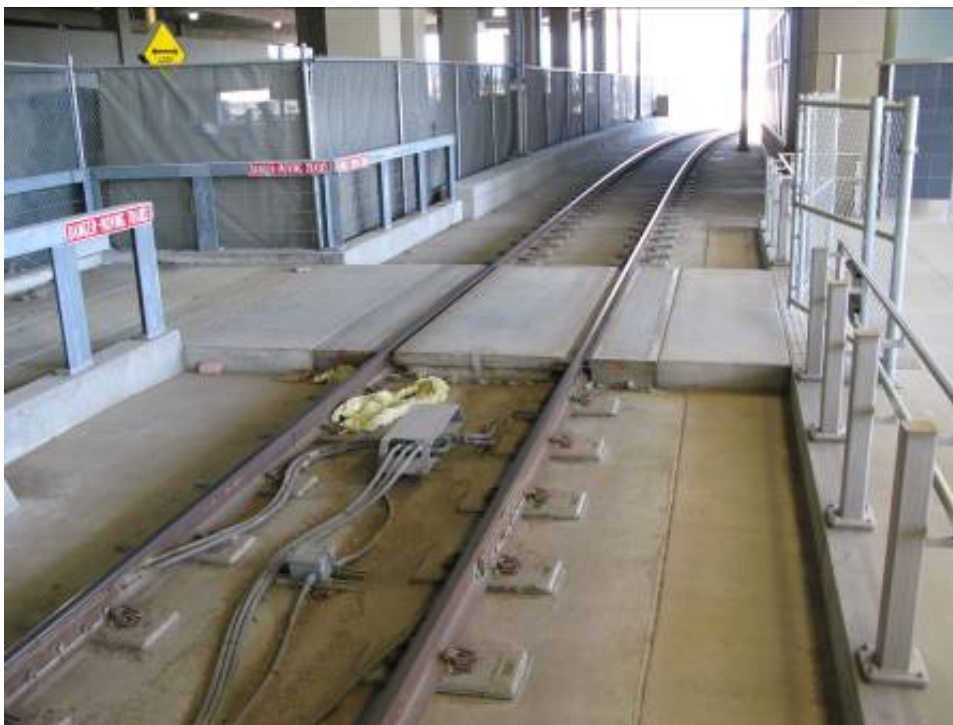
Exhibit 4: Closed Crossing at Airport – LRVs arriving on the curve from the top of the photo could not easily see pedestrians in this crossing.

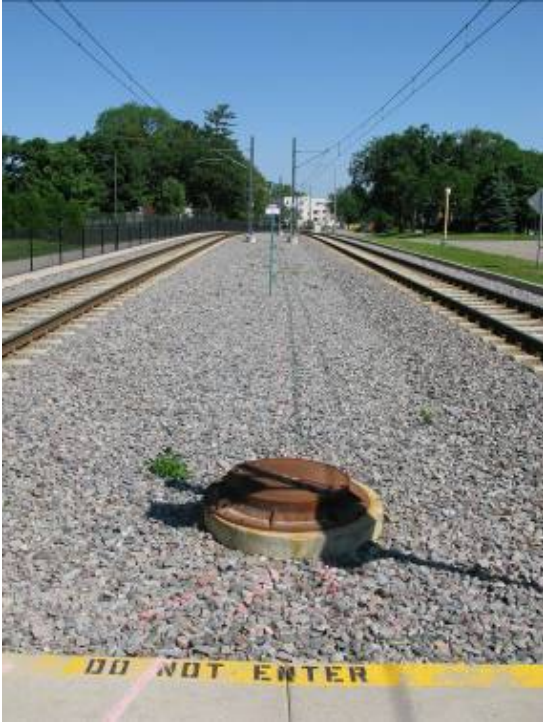
Exhibit 5: Typical Type b.2 Semi-exclusive Alignment

After Fort Snelling Station, the line changes to Type b.2 semi-exclusive side running with wide medians and curbs that separate the LRT from the roadway. At stations, the LRT area is fenced, restricting pedestrian movement. The most significant problems in these locations are vehicle / bicycle gate violations and pedestrians crossing against the signals. **Exhibit 5** and **Exhibit 6** show examples of the typical alignment in these areas.

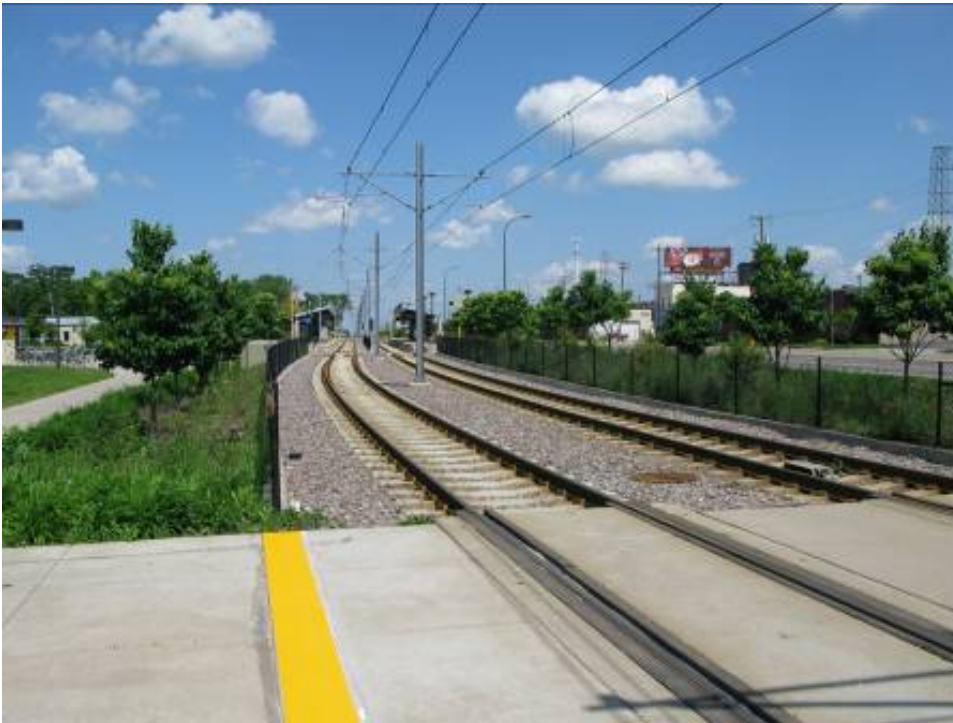
Exhibit 6: Typical Type b.2 Station

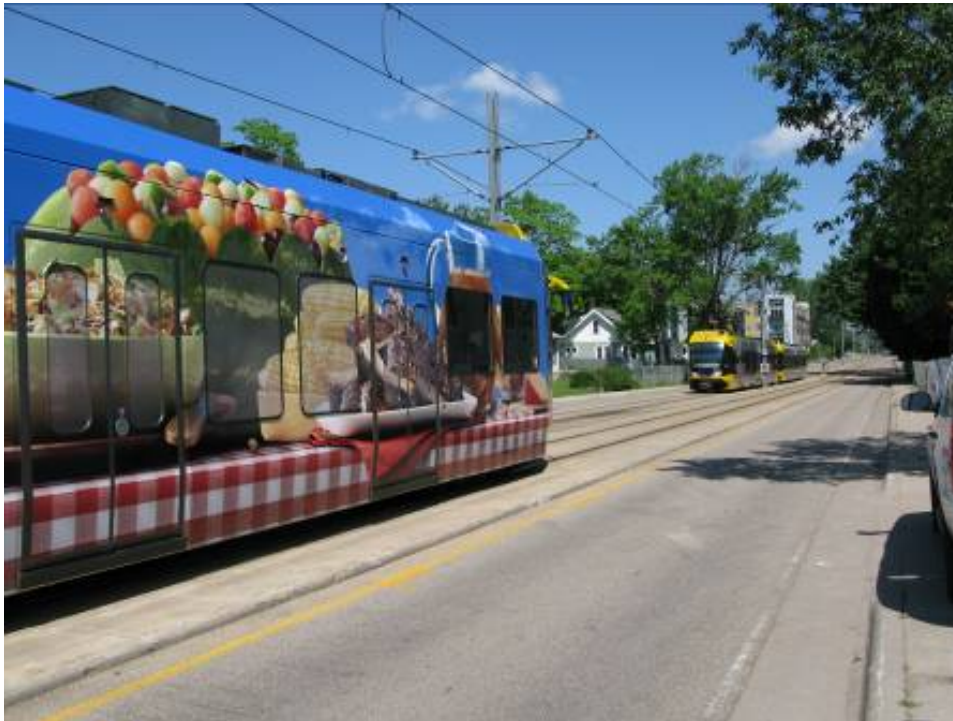
Exhibit 7: Trains Passing on Type b.4 Alignment

One portion of the southern part of the line is Type b.4 semi-exclusive center running with mountable curbs and a single lane of road traffic on each side. U-turns are restricted in this area, but left turns are permitted. Operators proceed with caution through this area due to the frequent mid-block left turns by vehicles. The signs prohibiting U-turns were added on every catenary pole after opening. **Exhibit 7** shows trains passing on this portion of the alignment.

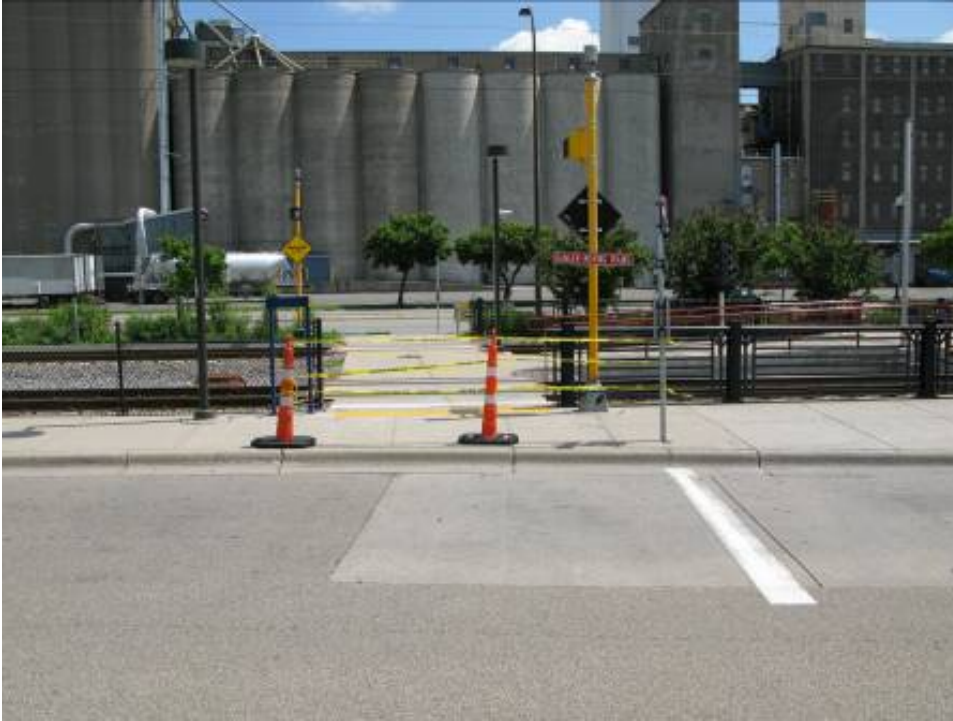
Exhibit 8: Pedestrian Crossing (before) - Temporary Pedestrian Guidance

At the 38th Street Station, Metro Transit had experienced problems with the pedestrian access to the station. Pedestrians were exiting a bus at the bus stop and running to get the train on the platform. These pedestrians were in danger of being struck by a train on the other track. Metro Transit installed temporary barriers to force pedestrians to walk around to the platform access. These barriers were present at the time of the site visit and formed a partial Z-crossing, as shown in **Exhibit 8**. As operator feedback on the temporary barrier was positive, a permanent barrier was later installed. The permanent barrier is shown in **Exhibit 9**. The effectiveness of the barrier has not been determined.

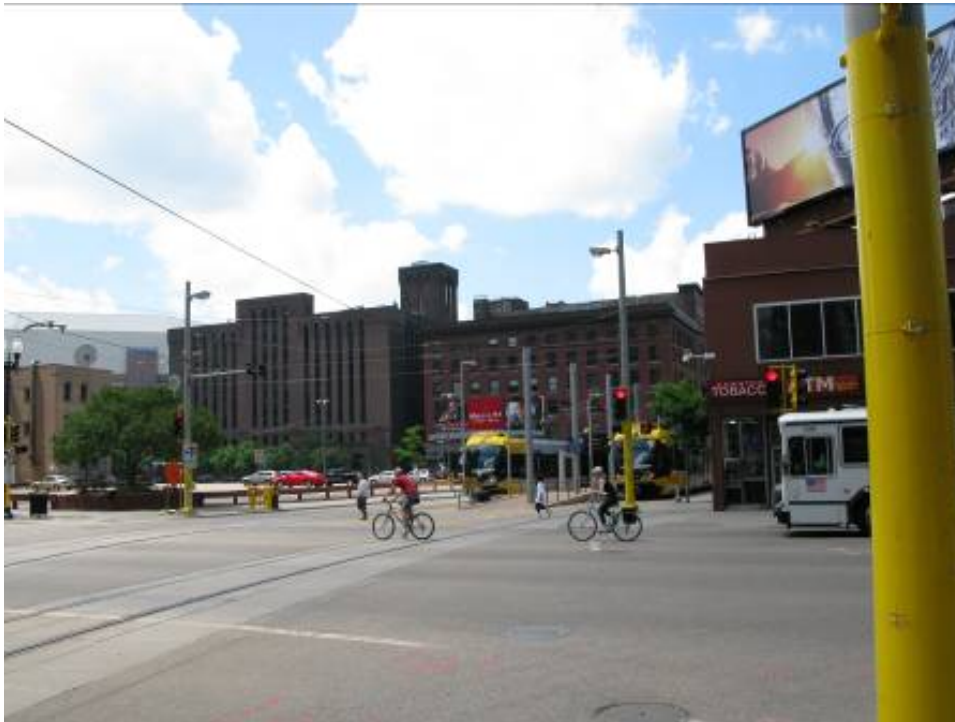
Exhibit 10: Downtown Alignment

Exhibit 10 shows the terminal stop of the downtown alignment.

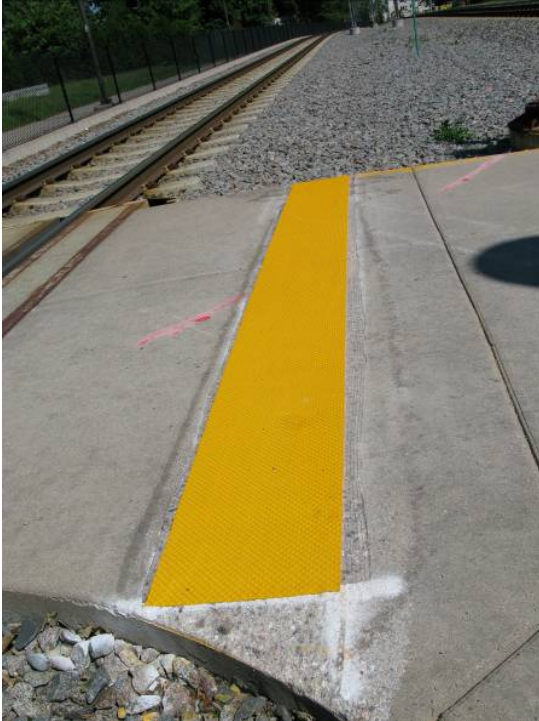
Exhibit 11: New Reflective, Tactile Strips

Metro Transit has recently begun upgrading tactile strips on the pedestrian pathway to warn pedestrians that they are entering an LRT area. An example of a strip is shown in **Exhibit 11**. **Exhibit 12** shows two additional types of pedestrian signage used by Metro Transit. The “Danger Moving Trains” sign is installed at pedestrian crossing locations. The small stop signs are a recent addition to encourage pedestrians and bicyclists to stop and look for an oncoming train. The effectiveness of the signs is not known.

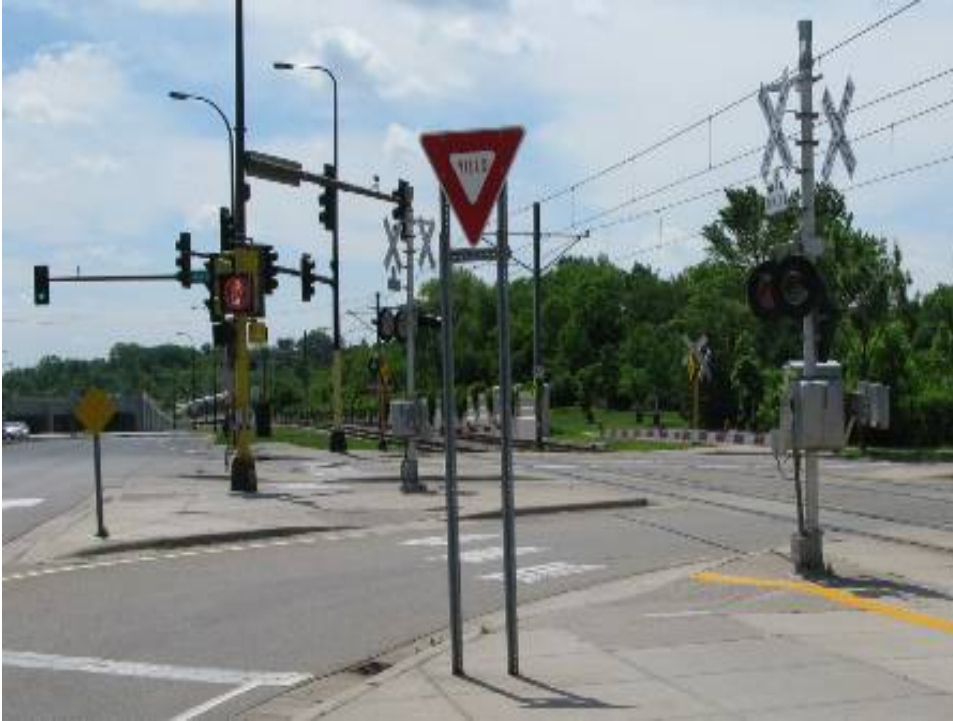
Exhibit 13: Intersection with Blank Out No Right Turn Sign

Metro Transit uses vehicle gates at most crossing locations. Blank out no left / right turn signs are installed at some problem intersections. Some of these signs were not standard MUTCD, as shown in **Exhibit 13**

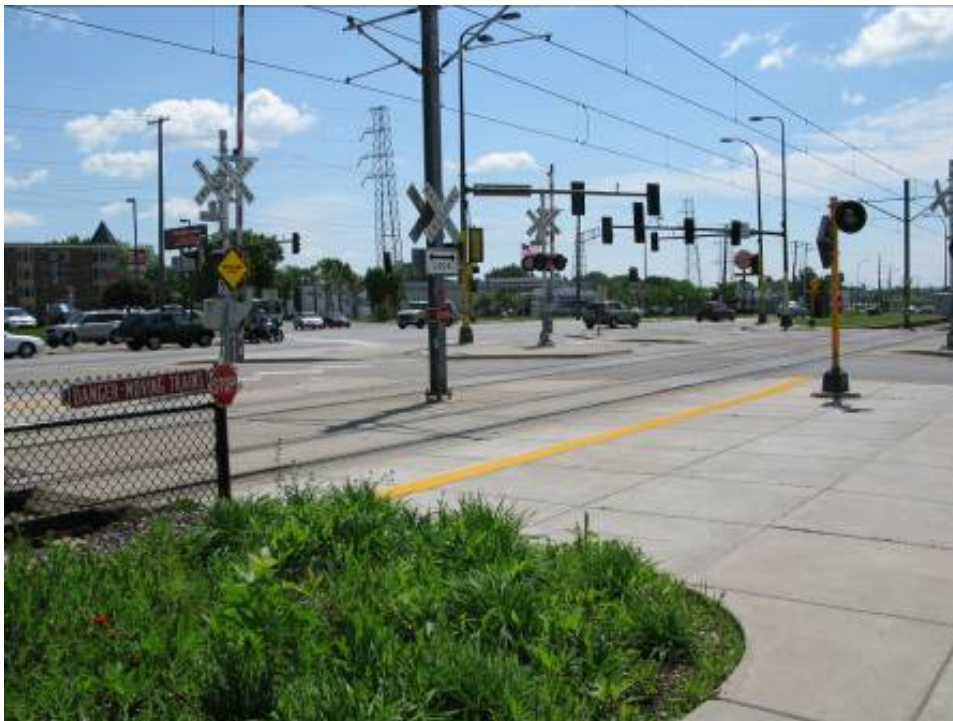
Exhibit 14: Pedestrian / Bicycle Problem Intersection – the Wide Area between the End of the Fence and the Road provides Little Control of Movements across the Tracks.
