Selected Appendices for TCRP Report 137: Improving Pedestrian and Motorist Safety Along Light Rail Alignments

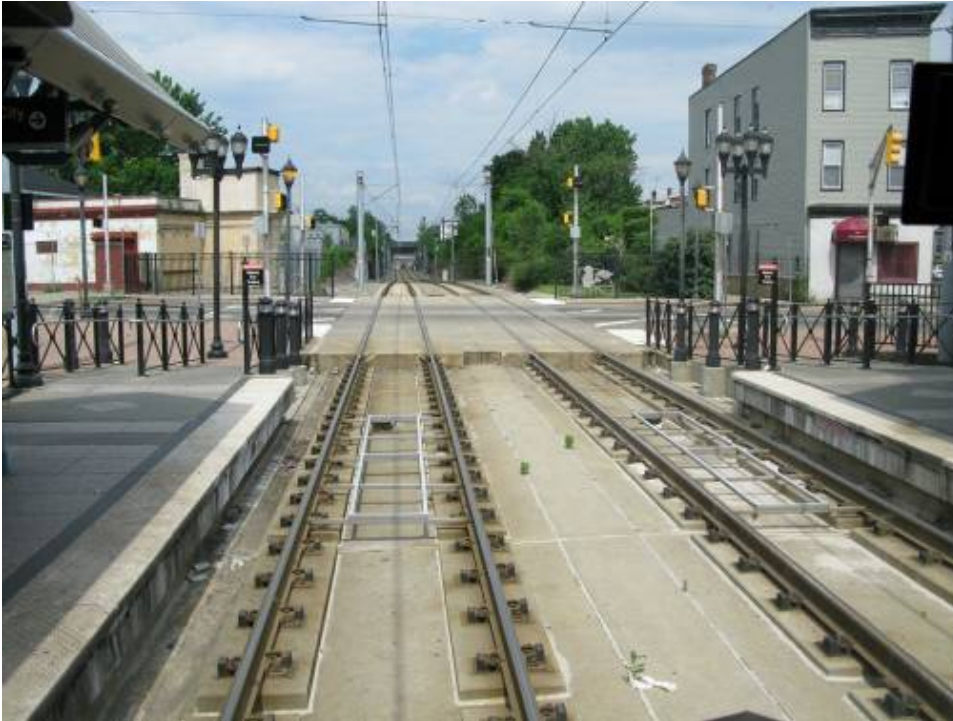
Exhibit 2: Typical Type b.1 Alignment

The northern portion of the alignment, from Tonnelle Avenue Station to the 2nd Street Station in Hoboken, is largely Type b.1 alignment with at grade crossings. **Exhibit 2** shows a typical cross section from this alignment type. Crossings are normally signal controlled with a limited number of gated crossings. In areas where there is significant pedestrian activity, the alignment is fenced or otherwise protected to control pedestrians.

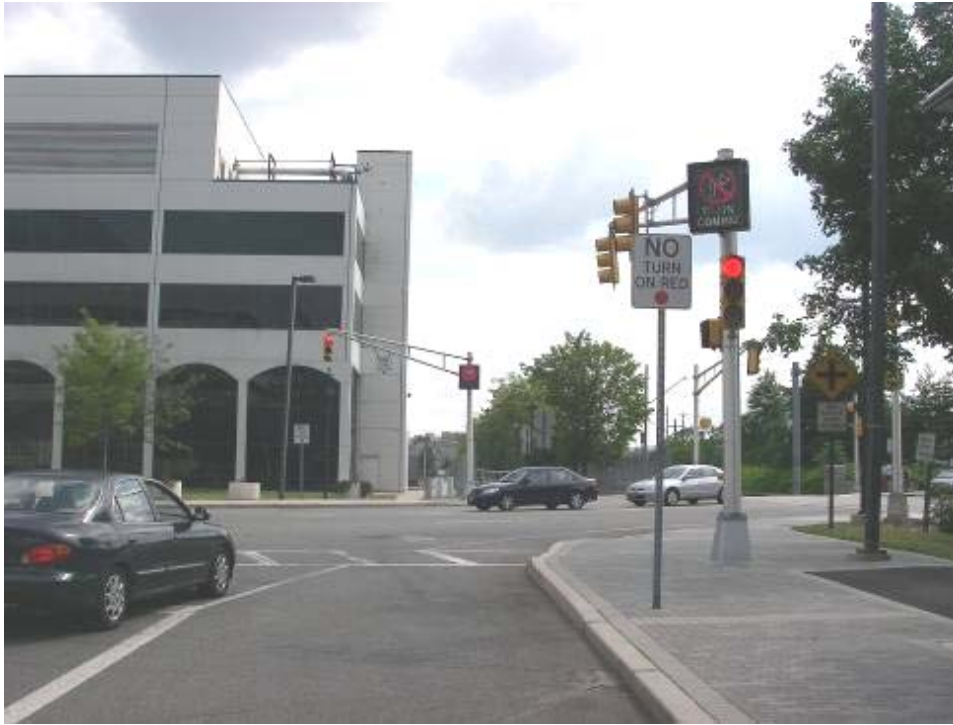
Exhibit 3: Blank-out no right turn sign

NJT has installed blank out signs at a number of locations in response to LRT-vehicle collisions and close calls. **Exhibit 3** shows blank out no right turn signs operating at an at-grade crossing near Lincoln Harbour Station. The sign was installed to increase awareness of the presence of an LRV after an LRV and NJT bus collided at this location. There had also been a number of close calls.

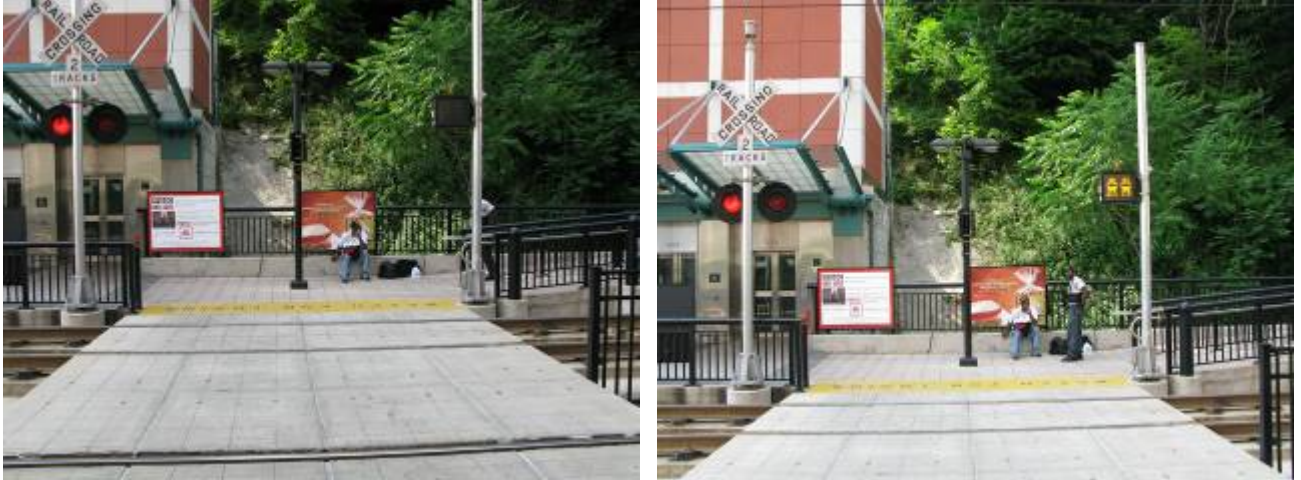
Exhibit 4: Second Train Coming Blank Out Sign at Pedestrian Crossing (Left: Before First Train, Right: Between First and Second Trains)

Exhibit 4 shows the second train coming operations. The picture on the left shows the cross buck lights flashing indicating the first train is approaching. The picture on the right shows the second train sign and cross buck lights, indicating that a second train is approaching.

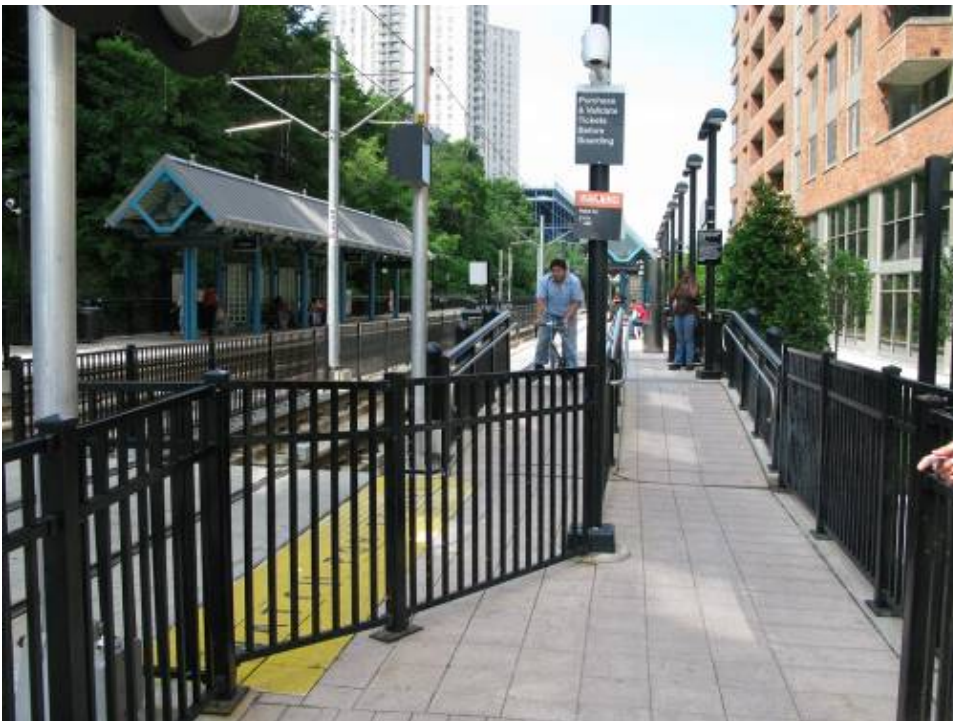
Exhibit 5: Z-crossing

Exhibit 4 and **Exhibit 5** show a tactile pavement marking that NJT is installing at all stations on the HBLR line. The yellow tactile stripe, which reads, “WATCH FOR TRAINS,” is being installed at all locations where pedestrians are near the dynamic envelope of the train.

- Z-crossings force pedestrians to look at the train. This only works under normal LRT operating conditions (not reverse running).
- National consistency is important so that drivers and pedestrians have the same expectations no matter where they are in the country.

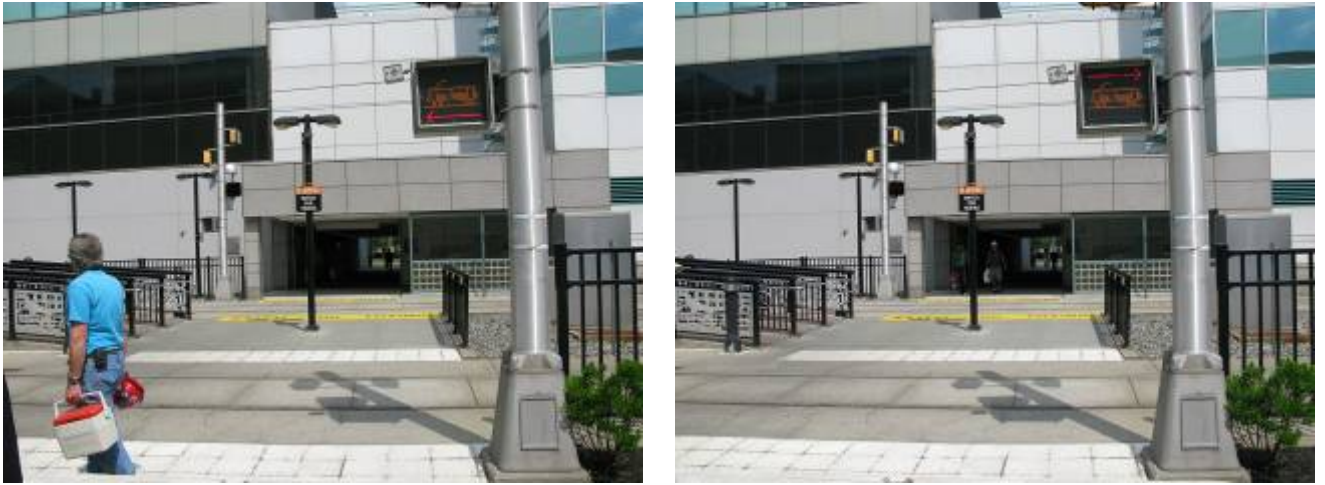
Exhibit 6: Second Train Warning Blank Out Sign

The Pavonia-Newport Station serves Harbor Center mall and is another location with high pedestrian volumes. This location also has a blank out second train coming sign. The sign has arrows that alternate when the train is approaching. The arrows do not indicate the direction from which the train is approaching. **Exhibit 6** shows the operation of the second train coming sign at this location.

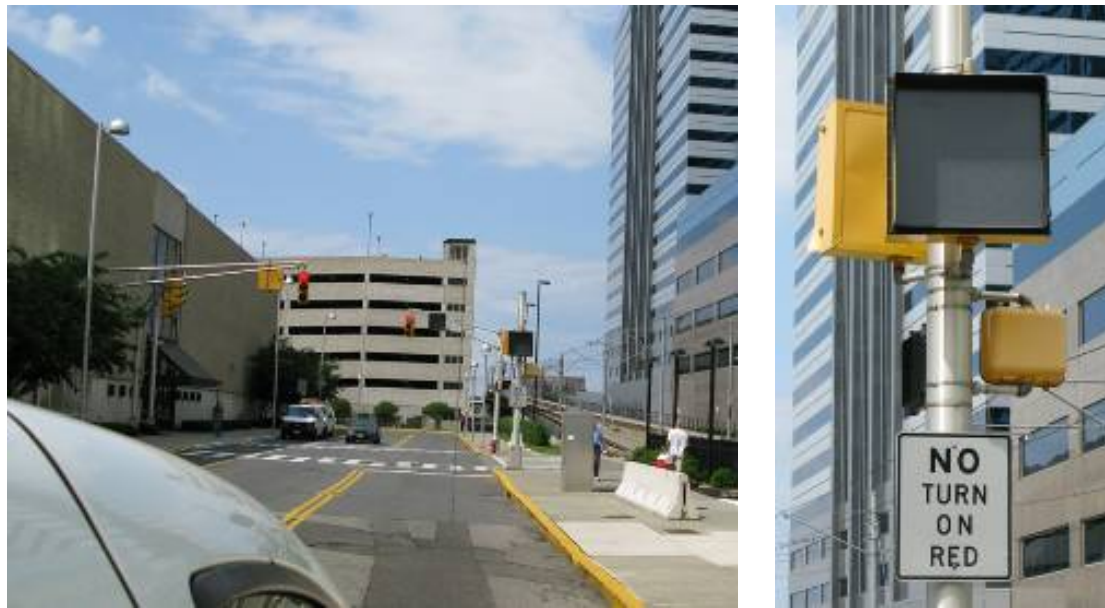
Exhibit 7: Blank Out No Right Turn Sign (Left: Intersection, Right: Detail)

The Pavonia-Newport station also has a blank out no right turn sign to prevent vehicles from turning right across the tracks when a train is approaching. This sign is shown in **Exhibit 7**.

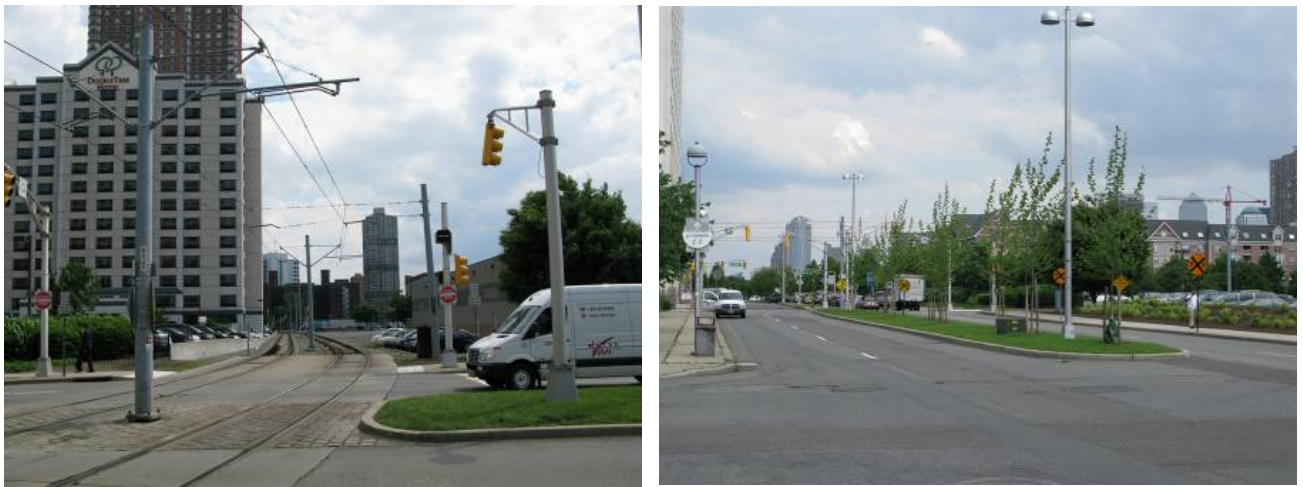
Exhibit 8: Problem Crossing (Left: Vehicle over Stop Bar, Right: Signage approaching Intersection)

Between Pavonia-Newport Station and Harsimus Cove Station, there is an at-grade crossing that has experienced some problems. The crossing is controlled by traffic signals, but motorists often fail to stop behind the stop bar when the light is red. This puts them in danger of being within the dynamic envelope of the train. NJT has installed a number of warning signs. Train operators move through this area with the brake already engaged in case a vehicle is on the tracks.

Exhibit 8 shows the intersection. The top photo shows a vehicle over the stop bar and in the crossing, but a safe distance from the train. The photo on the bottom shows the signage leading up to the crossing. The crossing is at the signals at the end of the median.

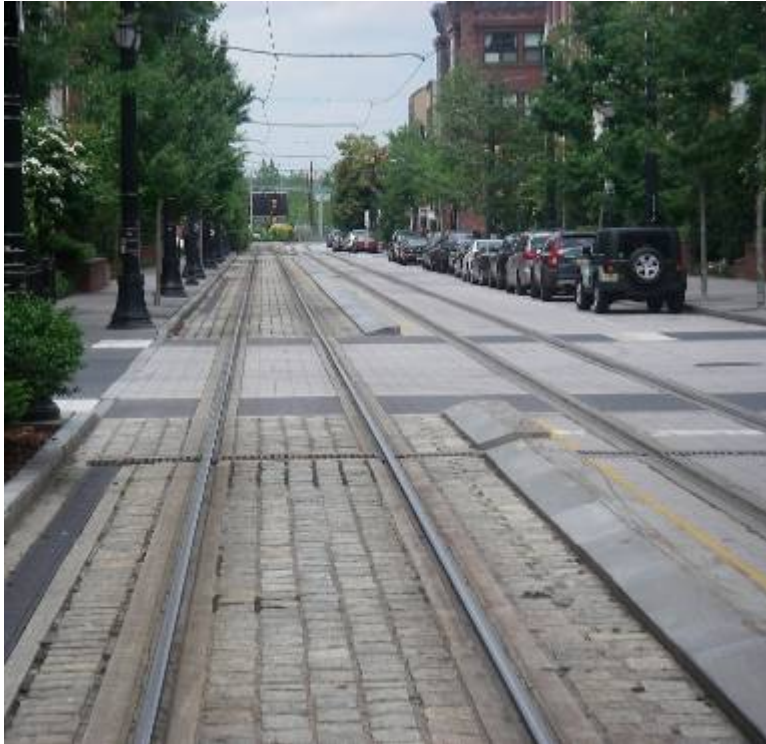
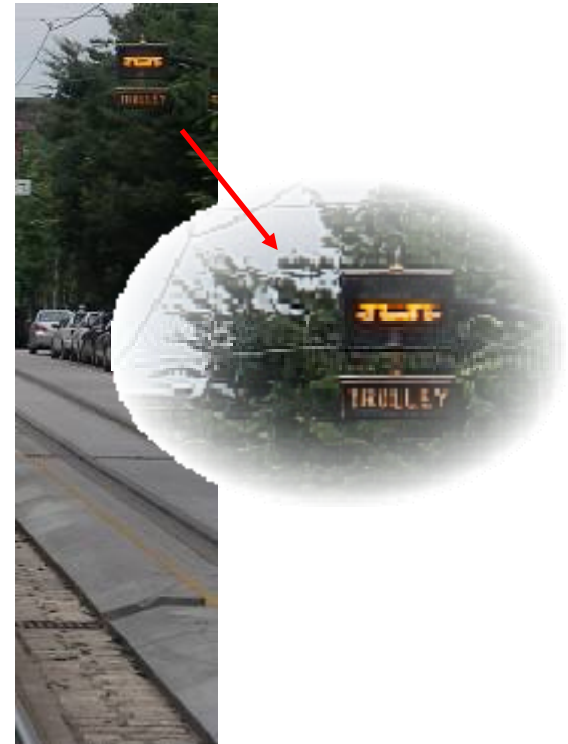
Exhibit 9: Type c.1/b.3 Alignment (Right: Trolley Warning Blank Out Sign on Shared Type c.1 Lane)

Approaching the financial district from the north, the alignment enters the street. Most of the alignment at this point is Type b.3, median running with curbs and textured concrete to differentiate the LRT space from the vehicle and pedestrian space. One small section has one LRT track as Type b.3 and a second track as Type c.1. The Type c.1 track is shared by vehicles and the LRT. A blank out sign warns vehicles when an LRV approaching from behind on the track (“trolley” is displayed on the sign). **Exhibit 9** shows this unusual alignment type where the LRT operates two-way and street traffic operates one-way.

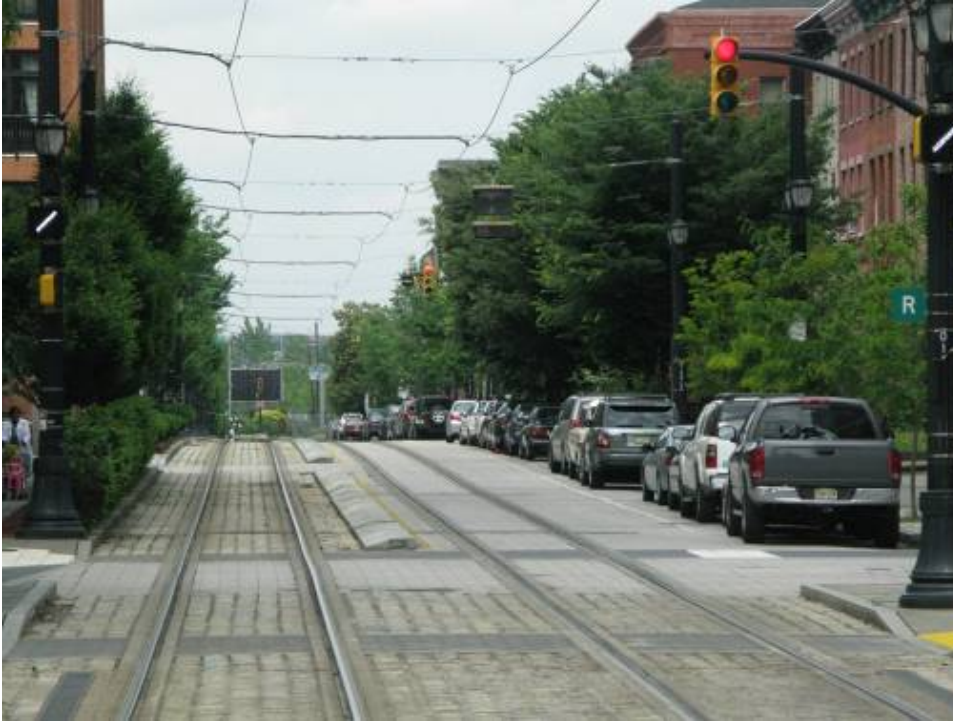
Exhibit 10: Type c.1/b.3 to Type c.3 Transition

Exhibit 10 shows the transition from this short stretch of shared alignment to an unusual alignment which is possibly Type c.3, but which is not so much a pedestrian mall as a segregated LRT running down the center of the alignment with sidewalks on each side. No vehicles are permitted in this section. The LRT-only lanes are clearly designated by the pavement type. The paving stone type treatment has the added bonus of being tactile so drivers and pedestrians feel the difference in the pavement if they stray onto the LRT-only alignment.

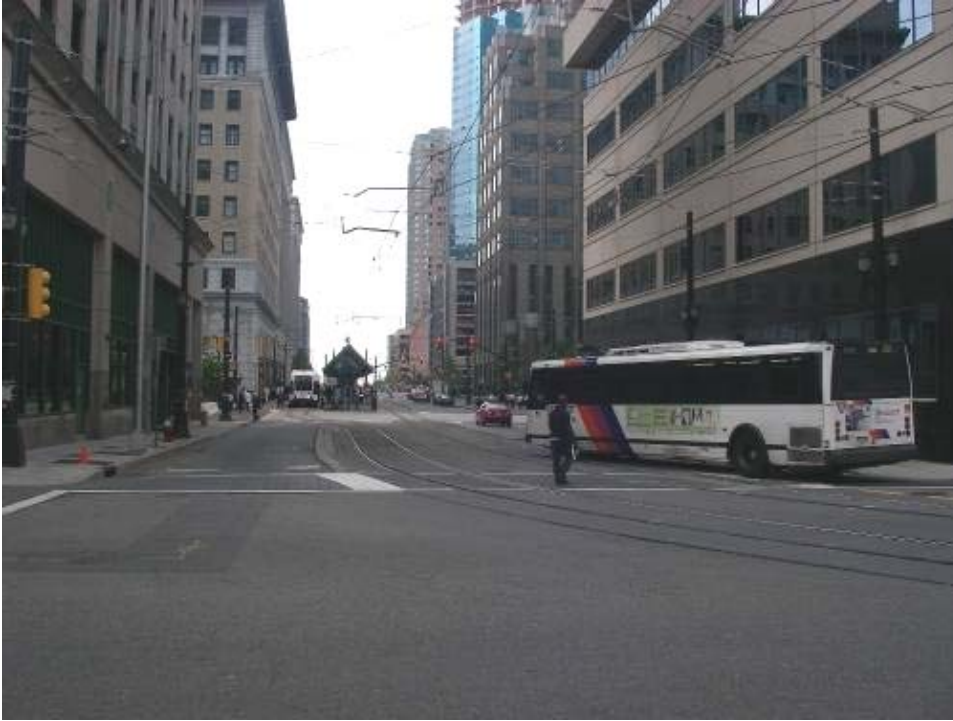
Exhibit 11: Transition alignment

In the financial district, the alignment varies considerably as the tracks shift alignment within the street. LRT lanes are designated by textured concrete throughout the financial district. Most of the LRT alignment is protected by small curbs, but there are sections with no curbs. **Exhibit 11** shows a section of the track where the alignment crosses lanes. The section is near the financial district.

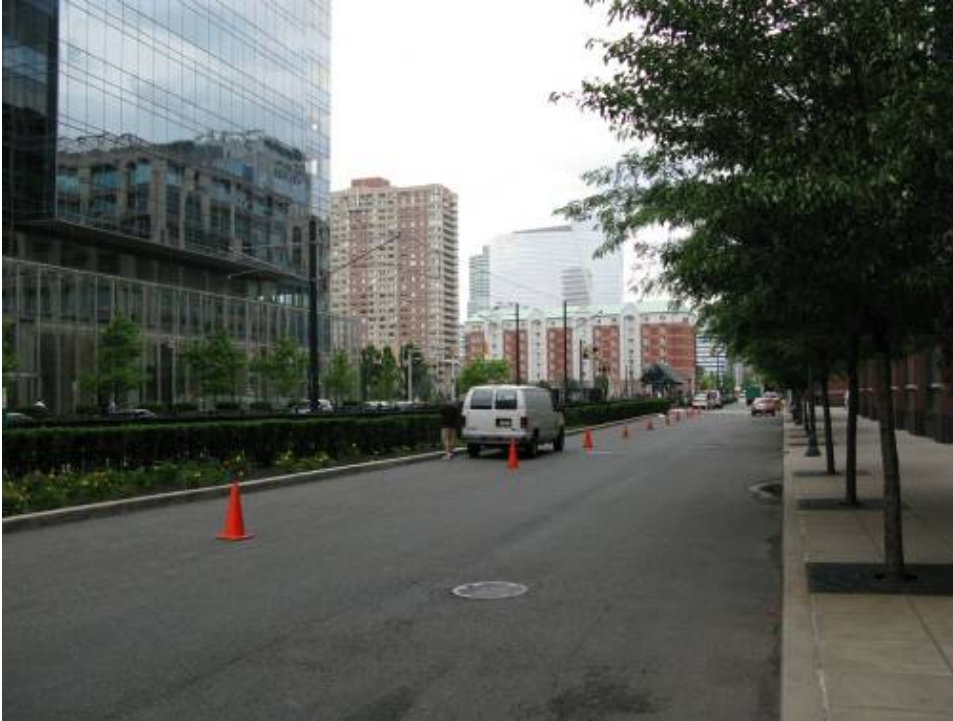
Exhibit 12: Pedestrian Fencing and Landscaping

The Harborside Financial Center Station is extremely busy. Pedestrians cross the tracks to access the station, and also to cross the street. The LRT alignment is protected with significant landscaping and fencing to deter pedestrians from making illegal crossings. Midblock crossings are permitted at one central location. This location is at one side of the station and is consistent with pedestrian desire lines between the buildings, reducing the temptation to cross the LRT track at another location. The station also has pedestrian signal heads, but very few pedestrians were obeying the signals during the site visit. The station platform is very wide and provides refuge for pedestrians between the two tracks.

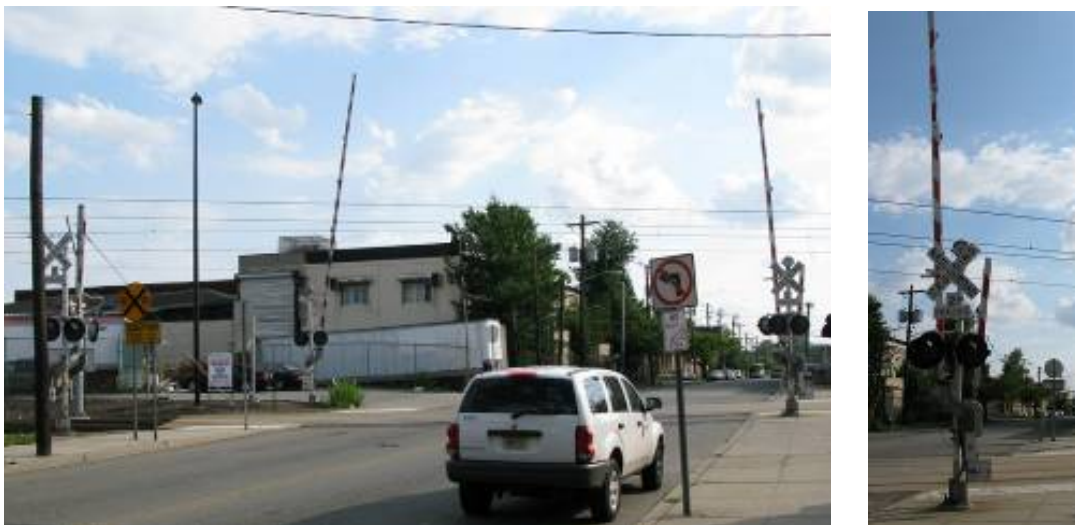
Exhibit 15: Pedestrian and Vehicle Gates (Left: Gates Up, Right: Pedestrian Gate Detail)

NJT was also able to provide an example of vehicle and pedestrian gates in operation together. Dave Morgan commented that adding pedestrian gates to the installation of vehicle gates is only nominally more expensive than vehicle gates alone. **Exhibit 15** and **Exhibit 16** show the vehicle and pedestrian gates in various stages of operation.

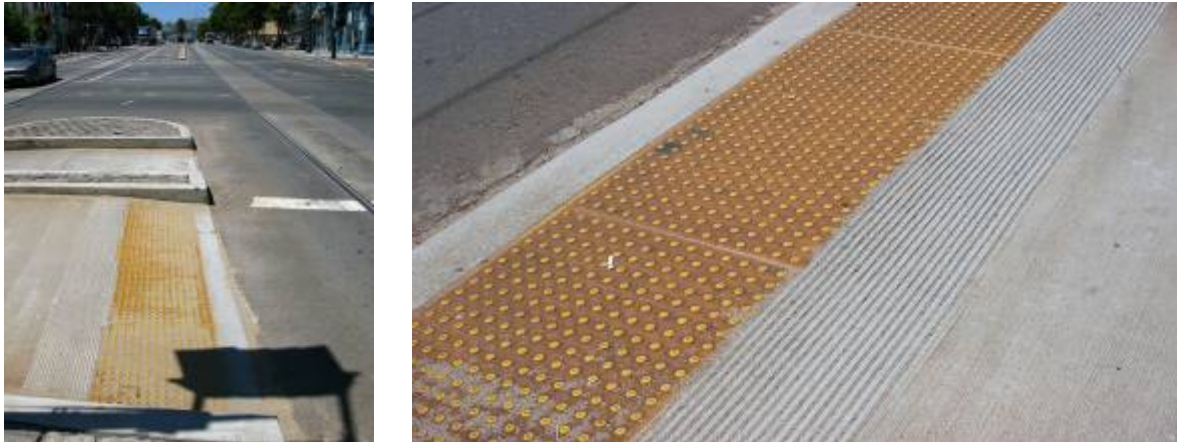
Exhibit 2: Median on Streetcar Alignment

The streetcar portion of the alignment (the J line) has some interesting pavement markings that were not seen in any other city on the site visits. As streetcars are normally treated like buses, and have slower speeds and more frequent stops than typical LRT operations, the LRT applicability of treatments used for streetcar alignments is limited, but some specific markings and tactile treatments are worth noting. **Exhibit 2** shows the median treatment on a portion of the streetcar alignment. This treatment was also seen at pedestrian crossings on the LRT lines, on station platforms, and at crosswalks at a number of locations throughout San Francisco. The yellow tactile strip is not exclusive to the LRT/streetcar dynamic envelope; it seems to be used as a warning for all types of crossings and danger zones.

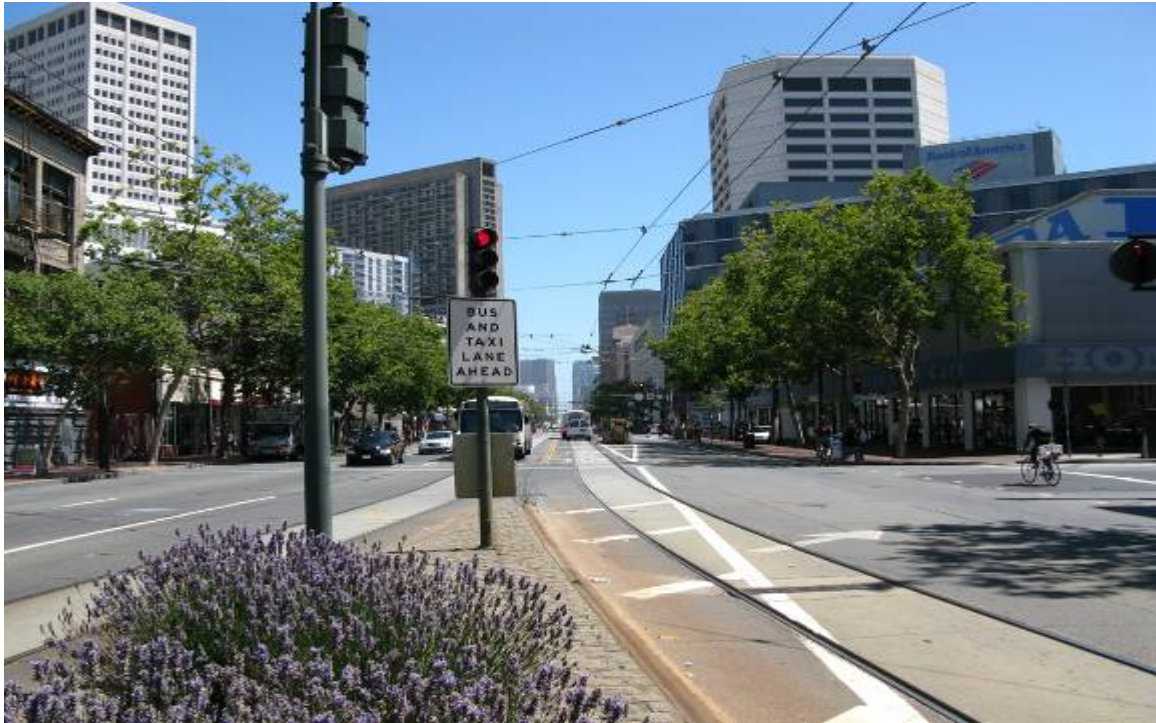
Exhibit 4: Pavement Markings on Streetcar Alignment

In many locations along the streetcar line, passenger vehicles cross over the streetcar alignment. In some cases, the cross-over lanes are limited to buses and taxis, but in other locations they are general purpose lanes. Painted arrows, lane markings, and text indicate the land that vehicles should use. **Exhibit 4** shows a location where the streetcar track transitions from general purpose to streetcar, bus, and taxi only. At some locations along the streetcar alignment, pole mounted delineators are also used to separate traffic lanes from shared streetcar/traffic or streetcar/bus/taxi lanes. These types of delineators are shown in **Exhibit 5**. **Exhibit 5** also shows possible maintenance issues with pole mounted delineators as drivers clearly do not always stay within their lane.

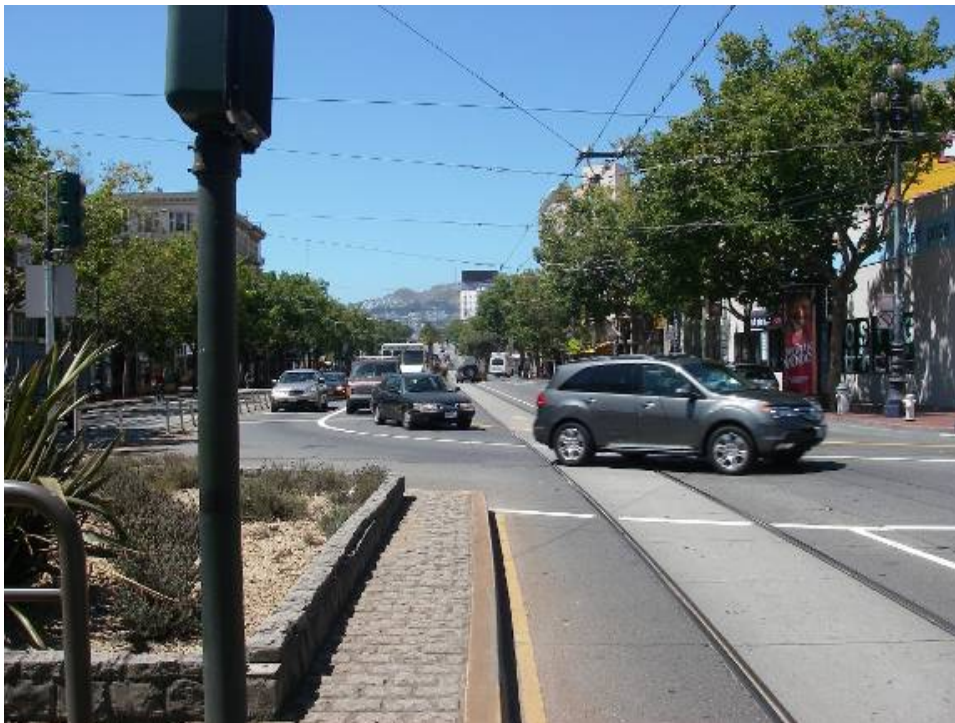
Exhibit 6: Left Turn over Tracks, from between Streetcar Tracks

Exhibit 6 shows an intersection alignment that is used in several places throughout the streetcar system. The streetcar is running in a Type c.1 alignment with shared lanes. Tracks are separated by a wide median with a pedestrian refuge. Vehicles may be operating in the same lane as the streetcar tracks, or to the right of this lane. To turn left, drivers must make a normal lane change, crossing over and to the left of one set of tracks. This is the same maneuver that is made on a roadway without a streetcar, and drivers should be accustomed to shoulder checking left in order to enter the left lane. After crossing into the turn lane, the drivers are out of the streetcar lane. Drivers then make a normal turning maneuver over the opposing tracks and lanes. This separates the two track crossings and simplifies the maneuver, making it very similar to an ordinary left turn that is not over streetcar tracks.

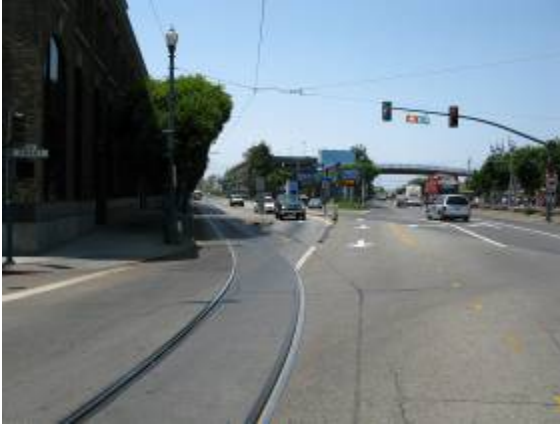
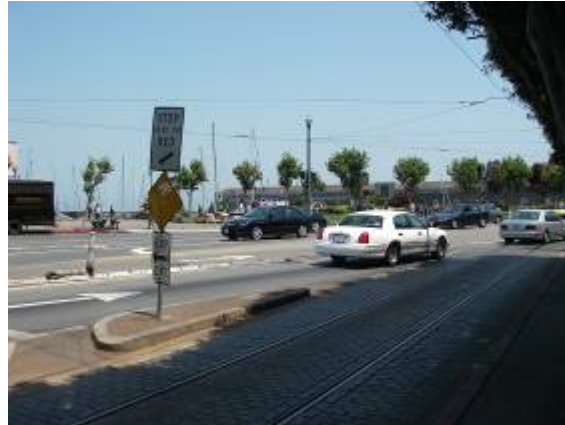
Exhibit 7: Vehicle Lane Crossing Streetcar Alignment

On the streetcar alignment, the effectiveness of most of the safety treatments depends on LRT and vehicle operator training, and responsiveness to pavement markings and road signs. There is often nothing separating the streetcars from normal traffic operations. **Exhibit 7** is an example of a location where right turning vehicles must cross the streetcar alignment. Drivers must stay out of the tracks as the train approaches. The traffic signals are pre-timed with a separate phase for the streetcar.

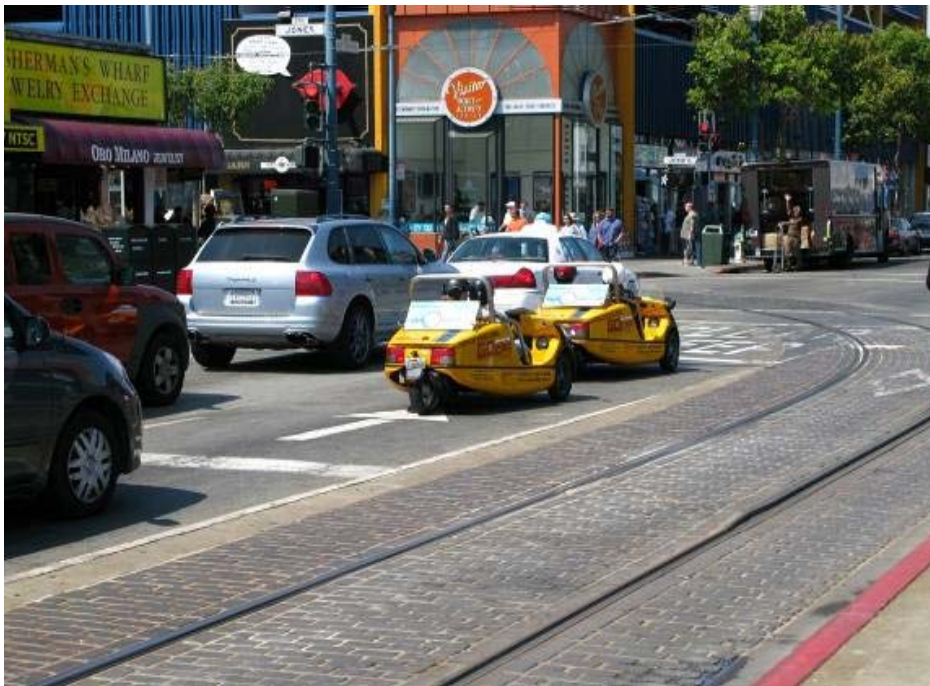
Exhibit 8: Streetcar Alignment turning across Vehicle Lanes, showing Textured Pavement following the Track to Delineate the Dynamic Envelope, and KEEP CLEAR Painted on the Lane

Exhibit 8 shows the streetcar turning across the vehicle lanes. This intersection is also controlled by pre-timed signals, with the streetcar having its own phase.

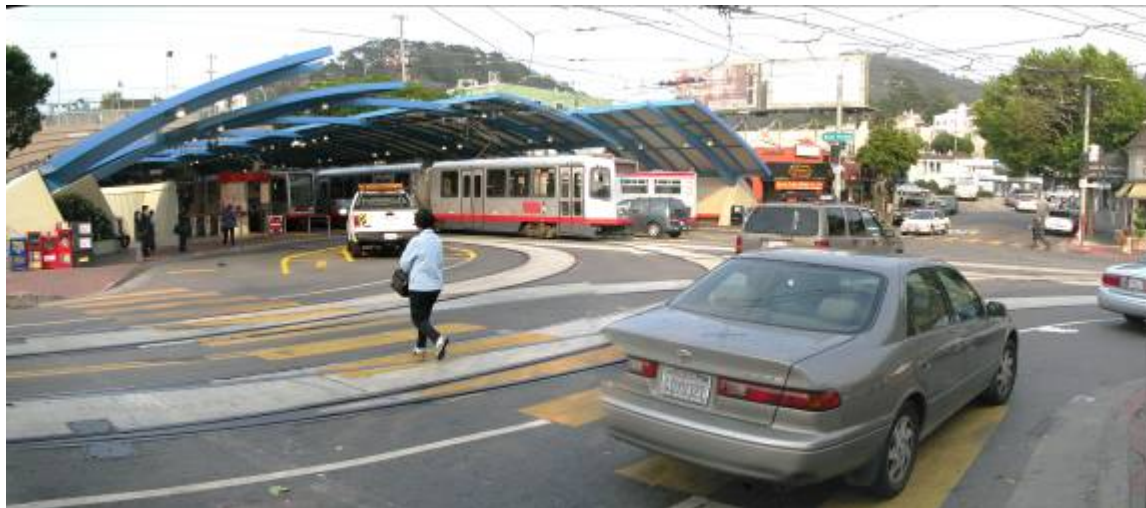
Exhibit 9: West Portal

Three of the LRT lines leave the exclusive tunnel alignment at West Portal. The semi-exclusive and non-exclusive portions of these alignments begin their southern alignments at this point. At West Portal, pedestrians, vehicles, and LRT all interface at the opening of a tunnel, with the tunnel forming a fourth leg to the T-intersection of three streets. The street traffic is controlled only by stop signs, but activity seems to be fairly slow and careful, and does not appear as chaotic as might be imagined.

There have been some instances where drivers have entered the tunnel, occasionally traveling a significant distance underground. Leaving the tunnel, the LRT trains operate like streetcars in a Type c.1 alignment. The intersection provides transit signals to coordinate LRV movements for the three directions (tunnel and two of the street legs), and Muni staff are usually present to direct traffic when necessary in peak periods. (Dedicated parking for Muni vehicles is marked to the right at the tunnel entrance.) **Exhibit 9** and **Exhibit 10** show the configuration of the West Portal entrance.

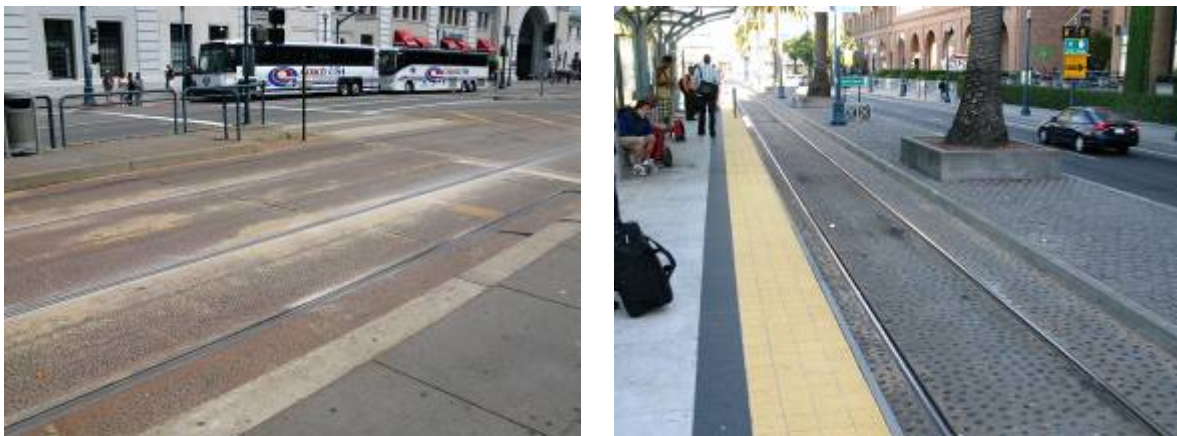
Exhibit 11: Pavement Texturing Between Tracks

On some sections of the LRT alignment, San Francisco has used special texturized pavement to indicate lanes that are reserved for LRT. Two examples of this pavement are shown in **Exhibit 11**. Both alignment sections are Type b.2 with wide medians and curbs separating the LRT tracks from other vehicle lanes.

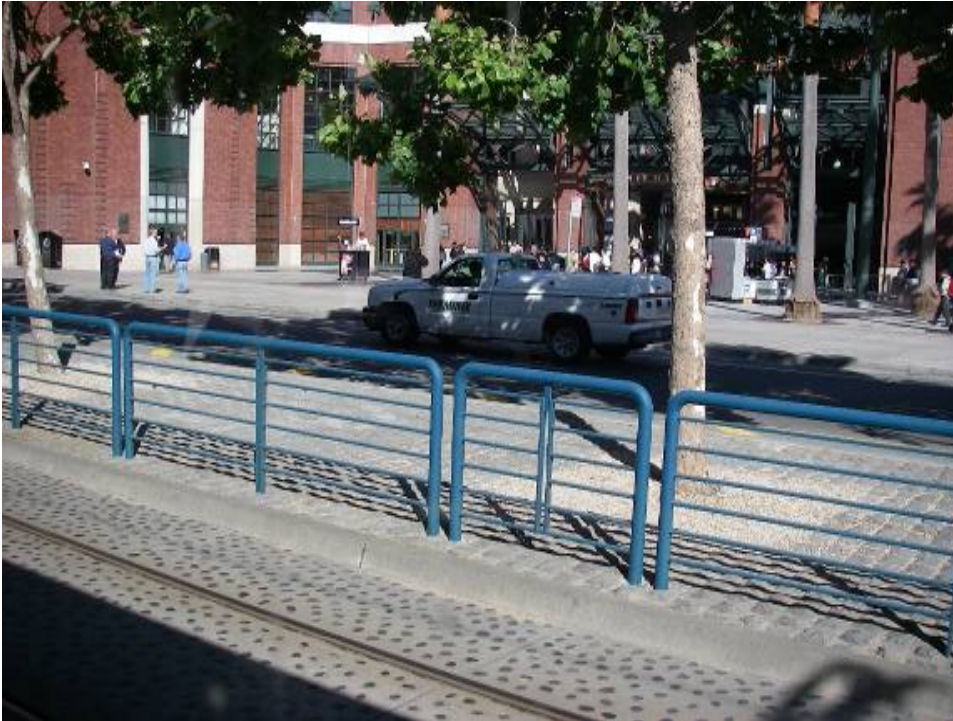
Exhibit 12: Fencing at Stadium

San Francisco, like the other sites visited, experiences some problems with crowds around the stadium stops before and after games. The tracks around the stadium are largely Type b.2 semi-exclusive with either permanent or temporary fencing. **Exhibit 12** shows the type of permanent fencing that separates pedestrians and vehicles from the tracks around the stadium.

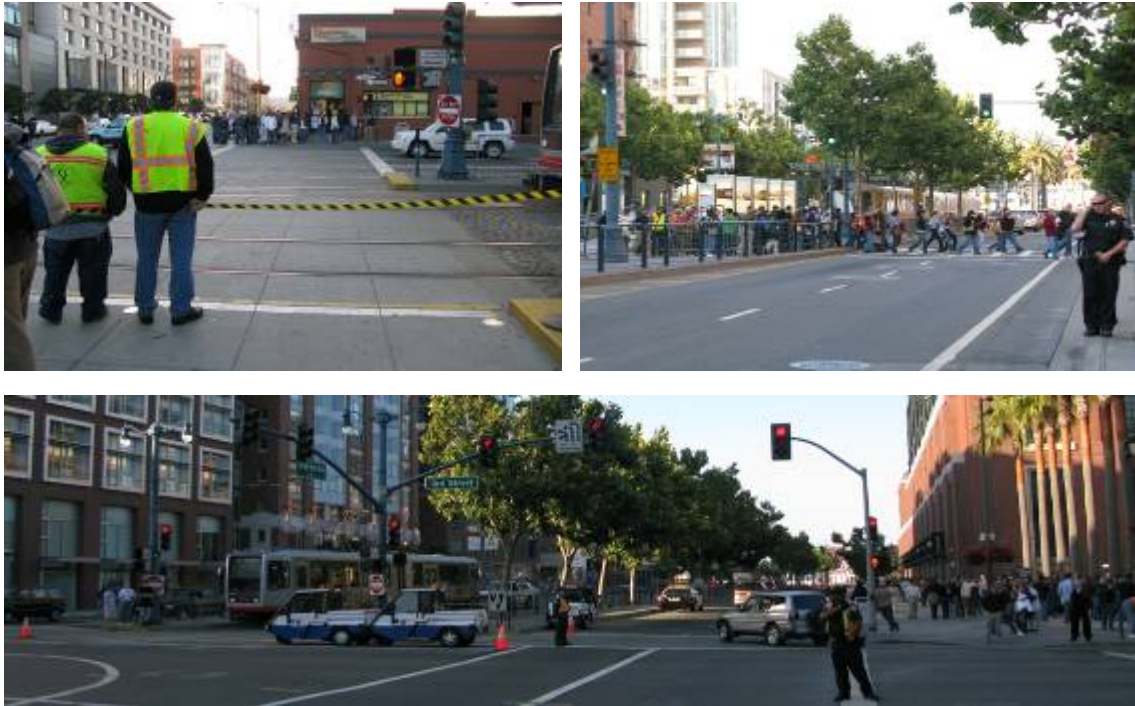
Exhibit 13: Crowd control around Stadium

The project team had the chance to see the crowd control measures implemented by SF Muni before a game. These measures are shown in **Exhibit 13**. SF Muni staff block the tracks as the train passes. Staff allow the crowds to cross when it is safe, with the use of fabric caution tape devices of the type often seen in bank queues. SF Muni staff also installed additional temporary steel barriers in locations where the permanent barriers did not provide adequate coverage.

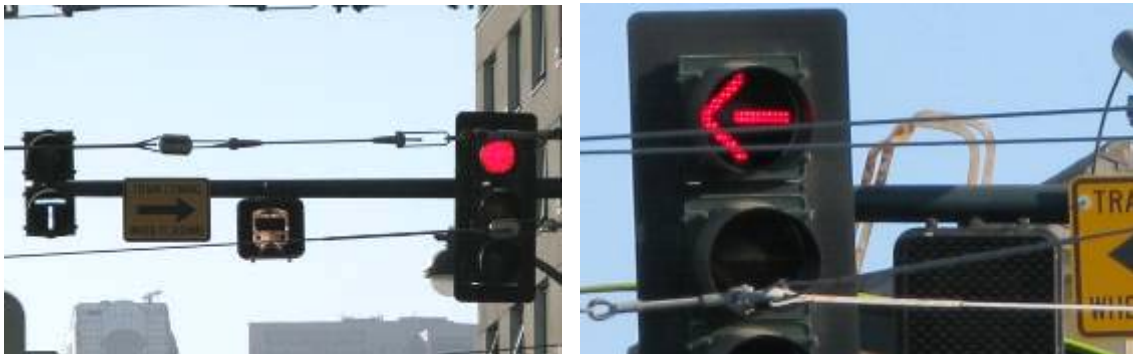
Exhibit 15: Train Coming Sign

SF Muni uses blank-out train signs along the alignment, both for pedestrians and for vehicles. For vehicles, the signs reinforce the stop lights or red arrows. SF Muni staff informed the study team that the signs for pedestrians are intended to act as second train coming signs, but said that the signs' operation was inconsistent and unpredictable.

Exhibit 15 shows two vehicle-oriented train coming signs, installed on mast arms next to standard vehicle signals. **Exhibit 16** shows pedestrian Train Coming signs. All but one of the pedestrian blank-out Second Train Coming signs observed were white. The exception was white on a red background (partially failed) as shown. The signs were lit in conjunction with the "Do not cross" pedestrian signal on some, but not all, signal cycles.

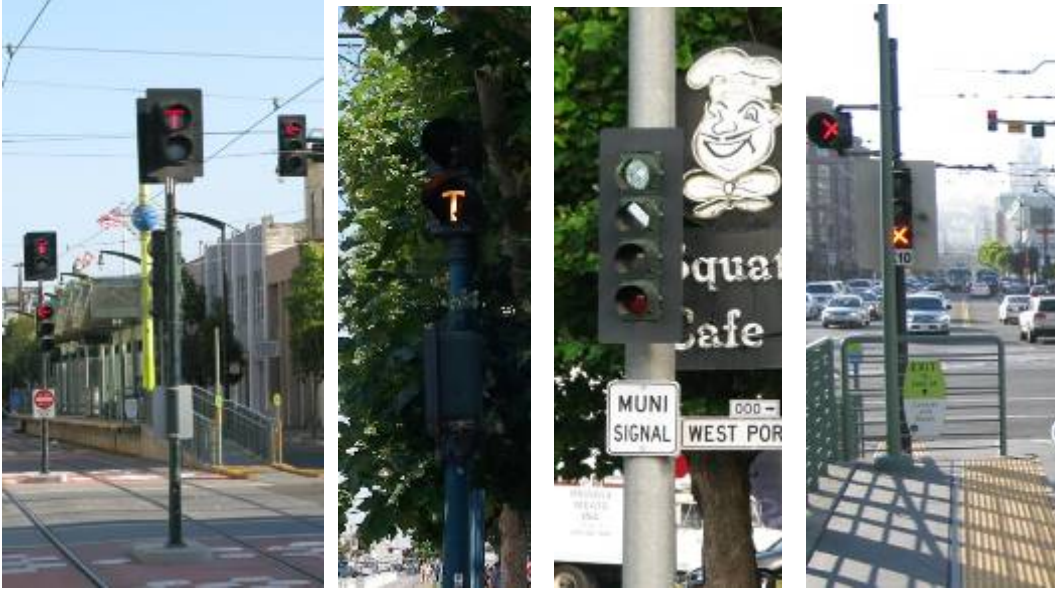
Exhibit 17: LRT Signal types

Because the Muni system has been built over a number of years, it includes a number of different signal types, placements and signing strategies. Red and white transit signals, shown as "T"s, are used at many locations through San Francisco. The red signals inform operators that it is not safe to proceed, while the white signals inform operators that it is safe to proceed. Crosses ("X") were also observed in some locations, and white bars were observed in others. **Exhibit 17** shows the range of signal types observed in San Francisco.

A Muni staff member noted that SF Muni has been installing train signals for over 60 years, and many of the signals have not been upgraded. The California MUTCD indicates that white bar signals, without triangles, should be used for LRT signals.

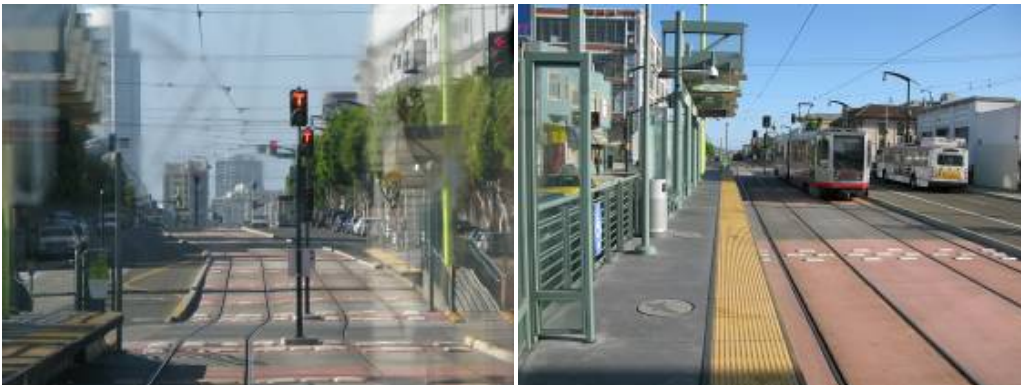
Exhibit 18: T-Signals on Type b.2 Semi-Exclusive Alignment

The T line is largely Type b.2 semi-exclusive with some portions of Type c.2 shared alignments. Throughout the T line, small white bumpers have been installed as a tactile warning to drivers that they are driving on the LRT tracks. These bumpers, the “T” signals, and the curb separation from vehicle lanes are shown in the two photos in **Exhibit 18**. Muni staff reported that the bumpers seem to be effective. The bumpers give a clear visual and tactile warning, but there are some maintenance concerns because they are easily destroyed.

These bumps, shown in **Exhibit 19**, are yellow, and they are smaller and rounder than the white bumpers shown in **Exhibit 18**. The yellow bumpers seemed to be restricted to the pavement directly beside station access points.

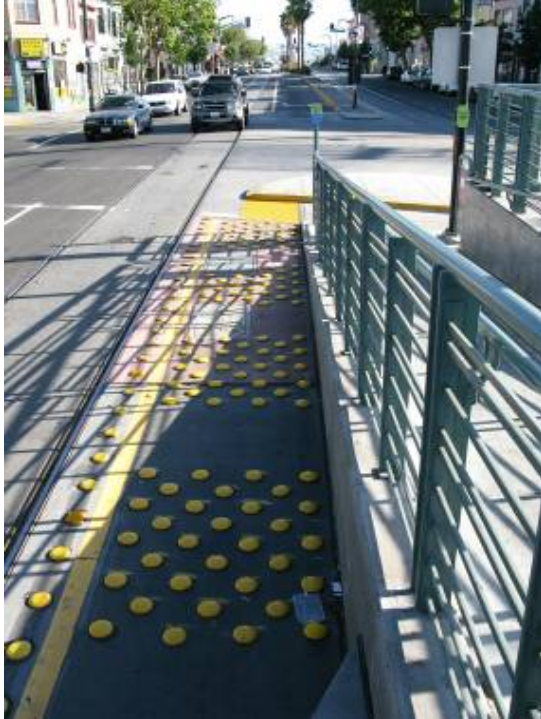
Exhibit 19: Yellow Warning "Bumps"

SF Muni uses a second type of bumpers beside stations on Type c.1 portions of the alignment.

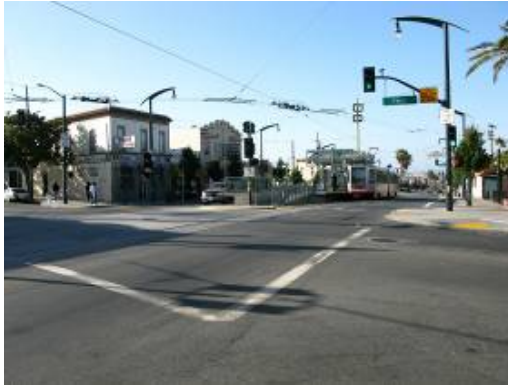
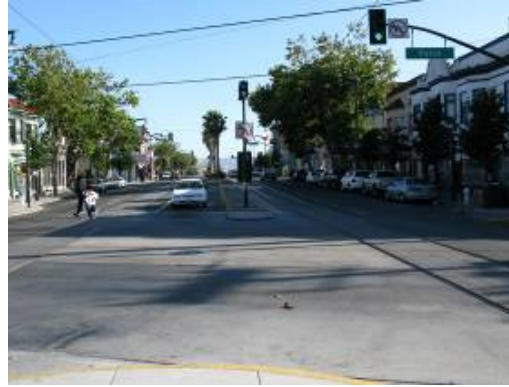
Exhibit 20: Type c.1 Alignment on T line

At some points along the T line, the alignment transitions to type c.1, and the LRT operates in shared lanes. **Exhibit 20** shows this type of alignment, and shows that the intersection's alignment and signage are very similar to those of a typical intersection. In the picture on the left, turns are restricted for vehicles approaching the camera. The photo on the right shows the turn restriction signage. Vehicles approaching the camera in the picture on the right have a left turn arrangement that is similar to that of portions of the streetcar line described earlier. The series of photos in **Exhibit 21** shows the signage and process for these left turns over the track.

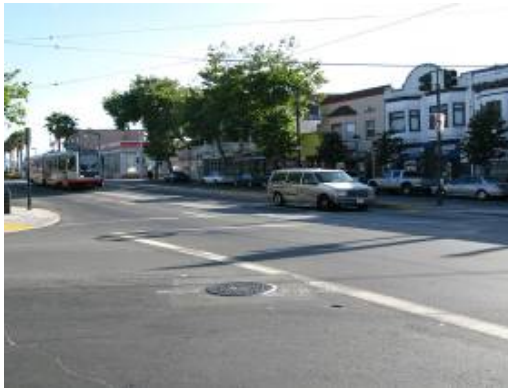
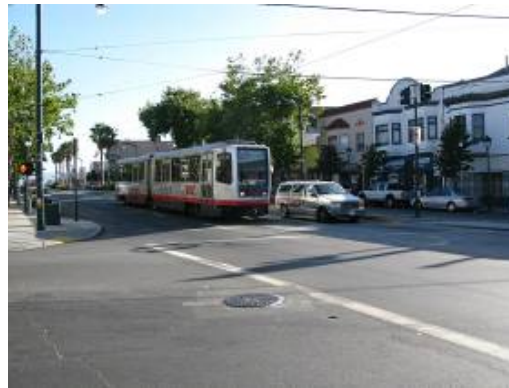
Exhibit 21: Left Turns on Type c.1 Alignment

In the first photo of **Exhibit 21**, a vehicle is in the left turn lane, waiting to turn left. This vehicle has already lane changed off of the tracks and is shown left of the LRT tracks. To make a left turn, only the opposing train and vehicles are conflicting. The second photo shows an LRV about to proceed through the intersection in the lane to the right of the turning car.

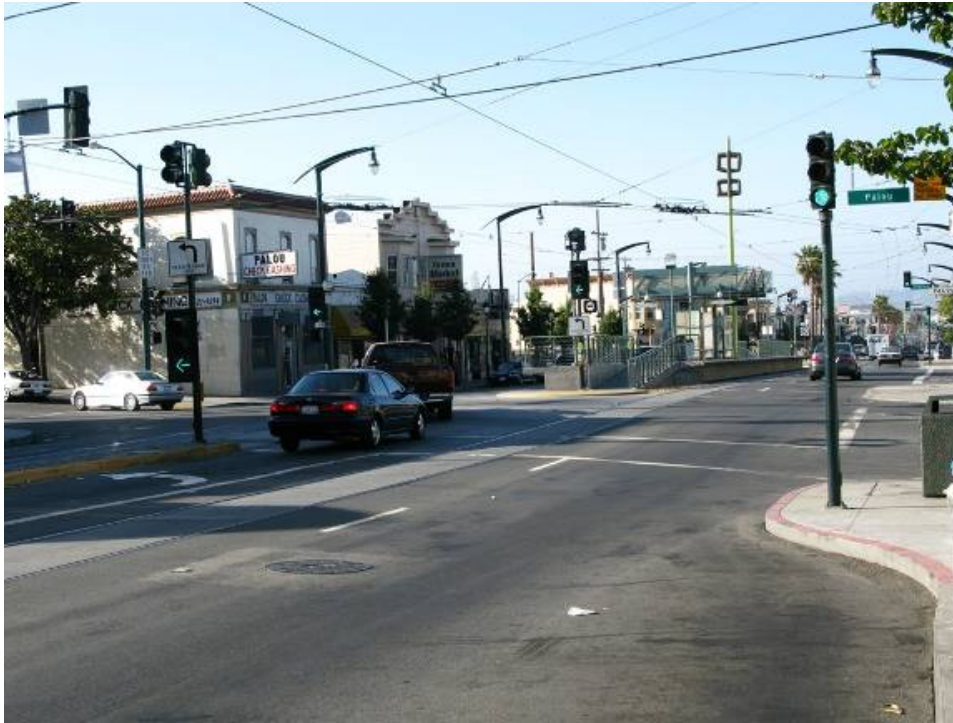
Exhibit 22: Left Turn with Blank-out Sign

As shown in **Exhibit 22**, the intersection is also equipped with a blank-out train sign. The sign shown is lit, but no train can be seen, and left turns are permitted. The sign may indicate that a train is approaching from behind. For this type of alignment, it may be more beneficial to use the blank-out sign to indicate when a train is approaching in the opposing traffic lanes, and when left turns are prohibited.

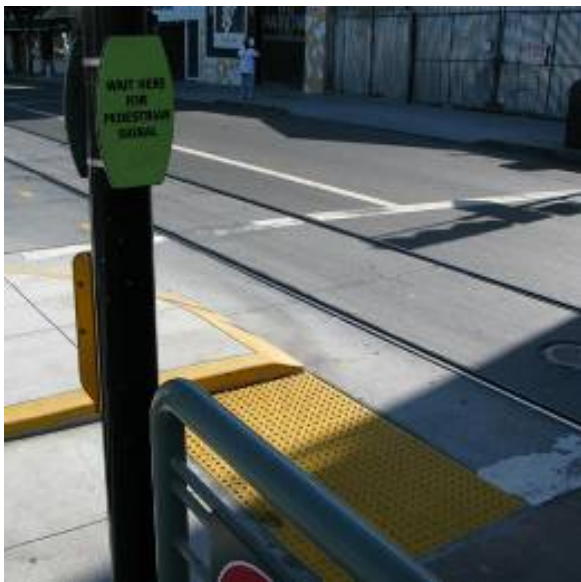
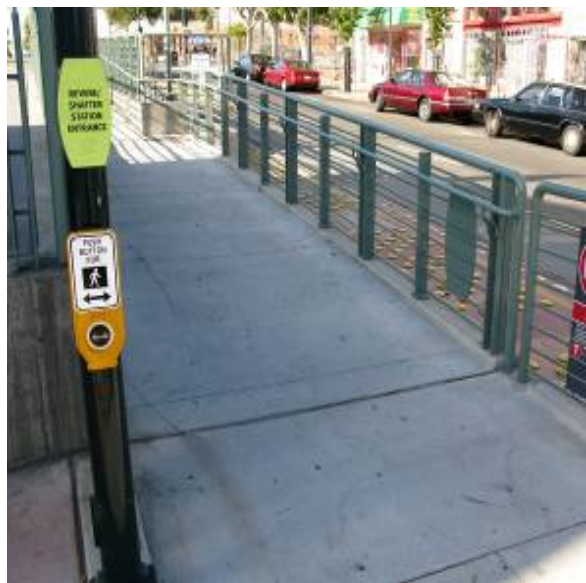
Exhibit 23: Pedestrian Crossing Treatment

Like the streetcar alignment, the T-line has tactile yellow striping between pedestrian refuge areas and the tracks. This is shown in **Exhibit 23**. **Exhibit 23** also shows a “Wait here for Pedestrian Signal” sign that is used throughout the T-line. These waiting areas also feature pedestrian push buttons.
