Selected Appendices for TCRP Report 137: Improving Pedestrian and Motorist Safety Along Light Rail Alignments

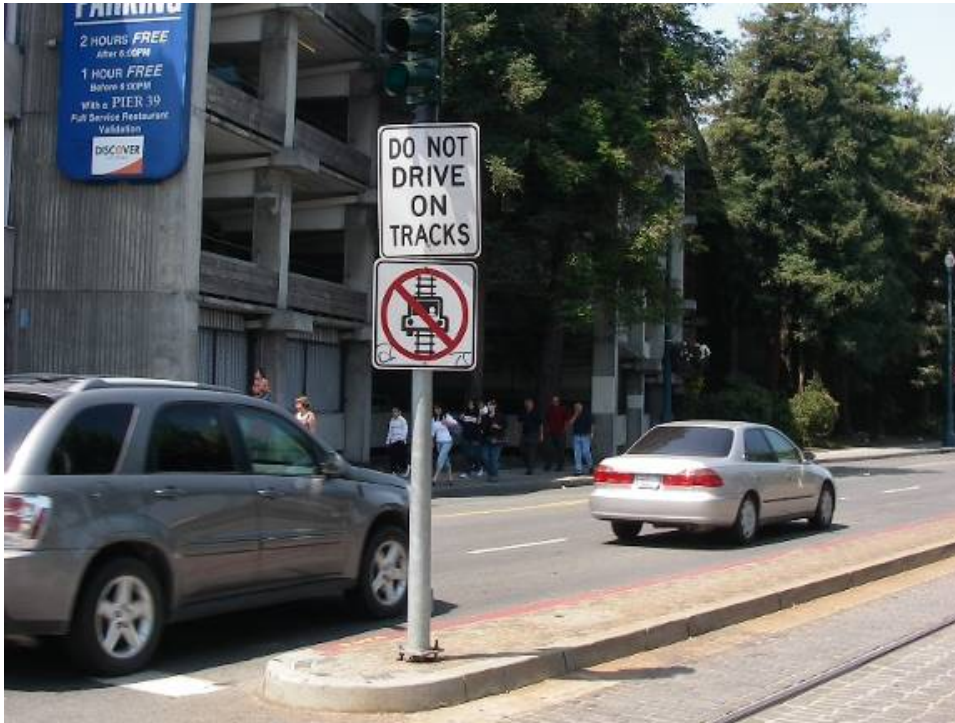
Exhibit 24: Do Not Drive on Tracks with Non-standard Lower Sign

As discussed, San Francisco has a mix of signal types. The city also has a mix of signage. Some of the signage is standard to the California version of the MUTCD, and some signage is non-standard. **Exhibit 24** shows a standard “Do Not Drive on Tracks” sign combined with a non-standard variation of the Do Not Drive on Tracks sign. **Exhibit 24** also shows an installation of brick paving in the LRT/streetcar only lane.

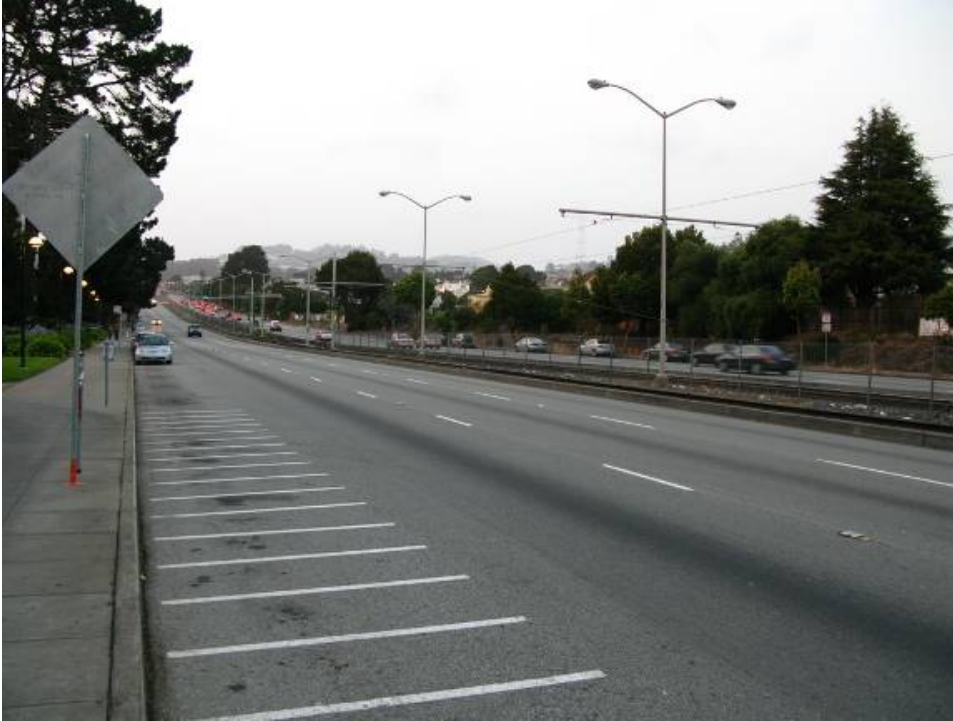
Exhibit 25: M line - Median Running Type b.2 Semi-exclusive

The M line, which runs south to SF State, is median running Type b.2 semi exclusive. A sample of the alignment is shown in **Exhibit 25**. The line runs down the median of a busy arterial roadway and is separated from the vehicle lanes by curbs. Some of the alignment also has intertrack fencing. In this area, the roadway and LRT line divide the University campus from a residential area, and there may be students who attempt to cross the tracks. The study team noted that in one location, the intertrack fencing was discontinuous to allow for the tracks to cross (in order to allow reverse running). This location, shown in **Exhibit 26**, is unfortunately also aligned with a stairway accessing the residential community on the other side of the roadway. The study team speculated that there may be more pedestrian crossings in this location because of the alignment of the stairway and the break in the fencing.

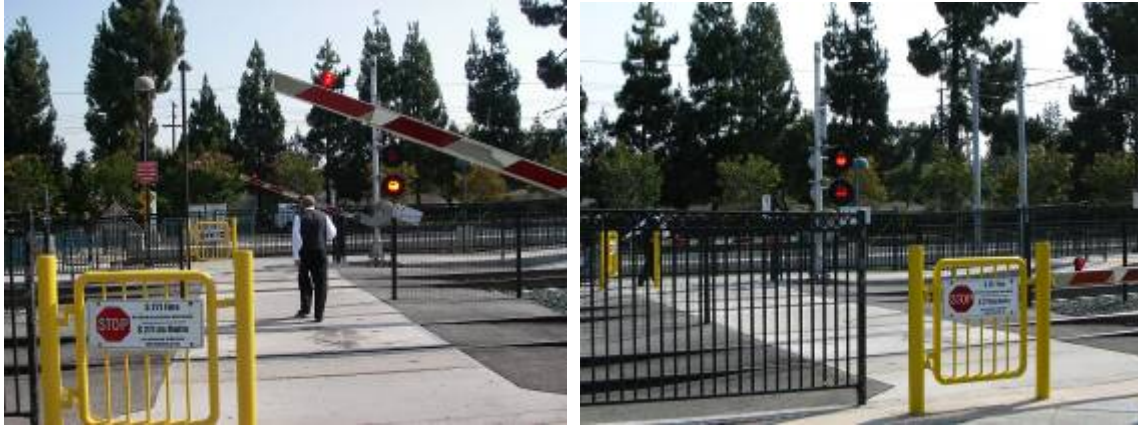
Exhibit 28: Combination Pedestrian Gates and Swing Gates

One of SCVTA's most complex pedestrian crossing environments is at the Downtown Mountain View terminus station where SCVTA's Mountain View-Winchester, CalTrain, and a number of bus routes operate. Riders accessing the LRT line must first cross the commuter rail tracks. The commuter rail track crossing is controlled by a pedestrian gate/swing gate combination, as shown in **Exhibit 28**.

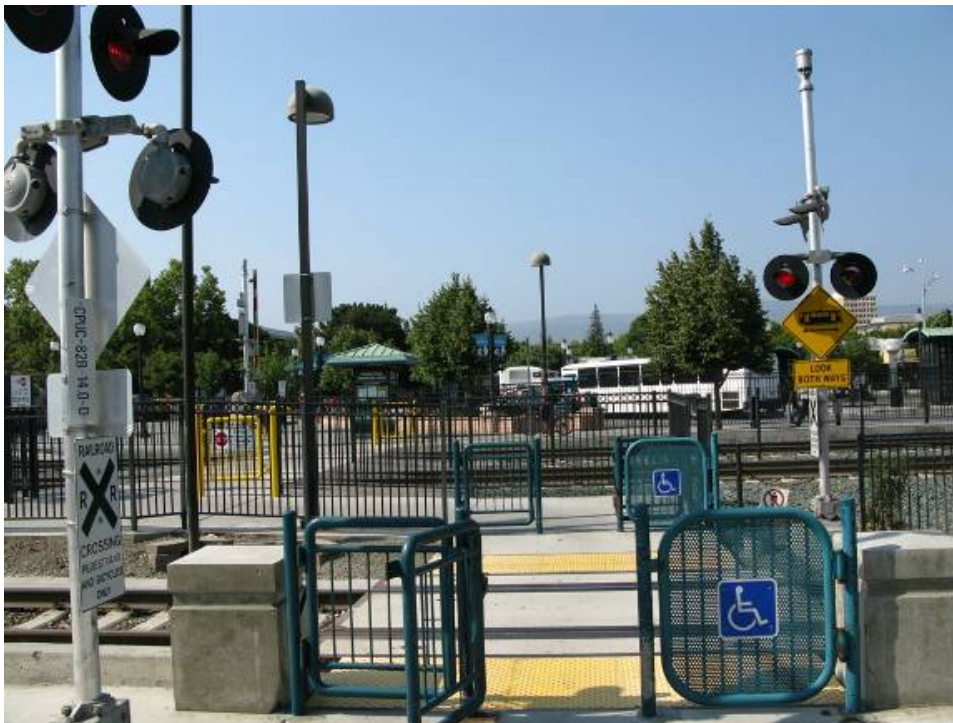
Exhibit 29: Pedestrian Swing Gates

Access across the LRT tracks is controlled by swing gates which are designed to make pedestrians pause and open the gates before walking across the tracks. The gates are intended to increase the level of pedestrian attention. The gates at the Mountain View station, shown in **Exhibit 29**, were no longer operating as originally intended. The springs have aged, and the gates do not automatically close. Other safety treatments at the Mountain View crossing include a “Look Both Ways” sign with static second train symbol, and standard flashing light signals on both sides of the tracks. There is also a non-standard “Railroad Crossing” warning sign mounted to the flashing light pole.

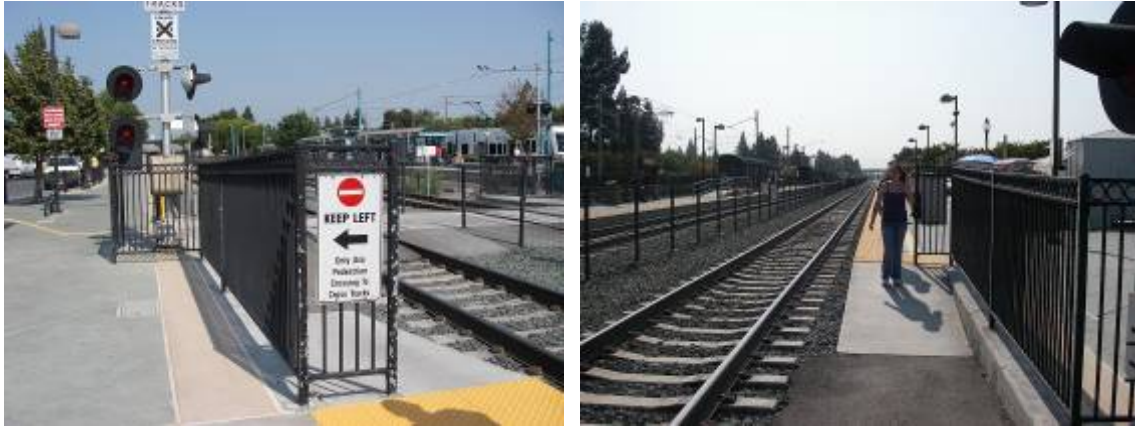
Exhibit 30: Contradictory Messages for Pedestrians – A Ramp is Provided for the Route that People Should Not Use

At the station, the study team noticed that pedestrians transferring from CalTrain to the LRT were moving directly from the commuter rail platform to the crossing without passing the gate. This is shown in **Exhibit 30**. This pedestrian behavior is an example of pedestrians taking the easiest path, despite warnings or increased risk.

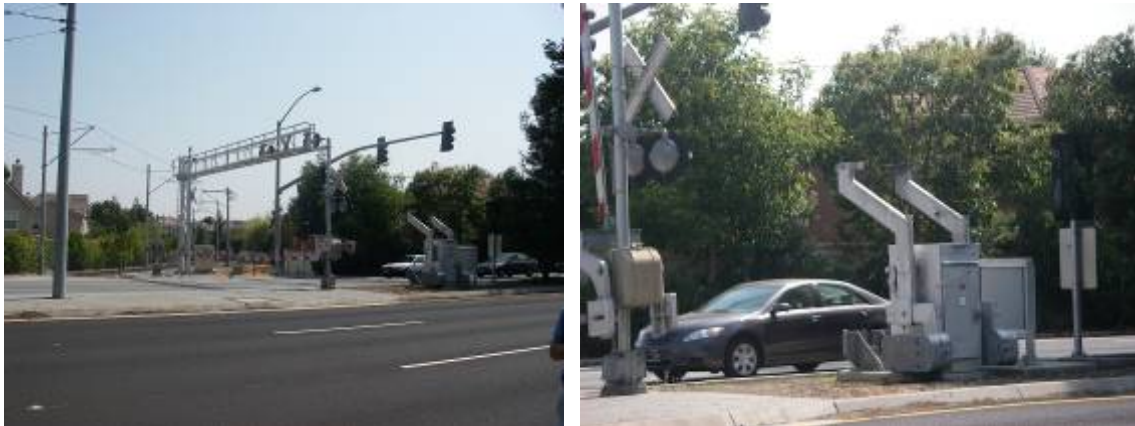
Exhibit 31: Replacement Gate at High Speed Crossing

SCVTA had a test site for the installation of a high speed vehicle gate designed to stop vehicles moving at high speeds. The gate installation site is shown in **Exhibit 31**. The gate arms have been removed, and a new, traditional two quadrant gate has been installed. The gate arms were removed because they were difficult to maintain as they were not designed to be raised and lowered as frequently as necessary for LRT operations.

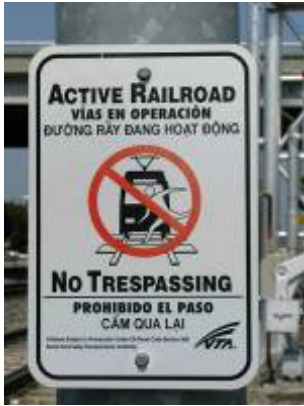
Exhibit 32: No Trespassing Sign

Because of the geometry of this location, it would be very easy for pedestrians to enter the LRT alignment. The alignment is marked with non-standard warning signs for pedestrians. The signs are printed in three languages. An example is shown in **Exhibit 32**.

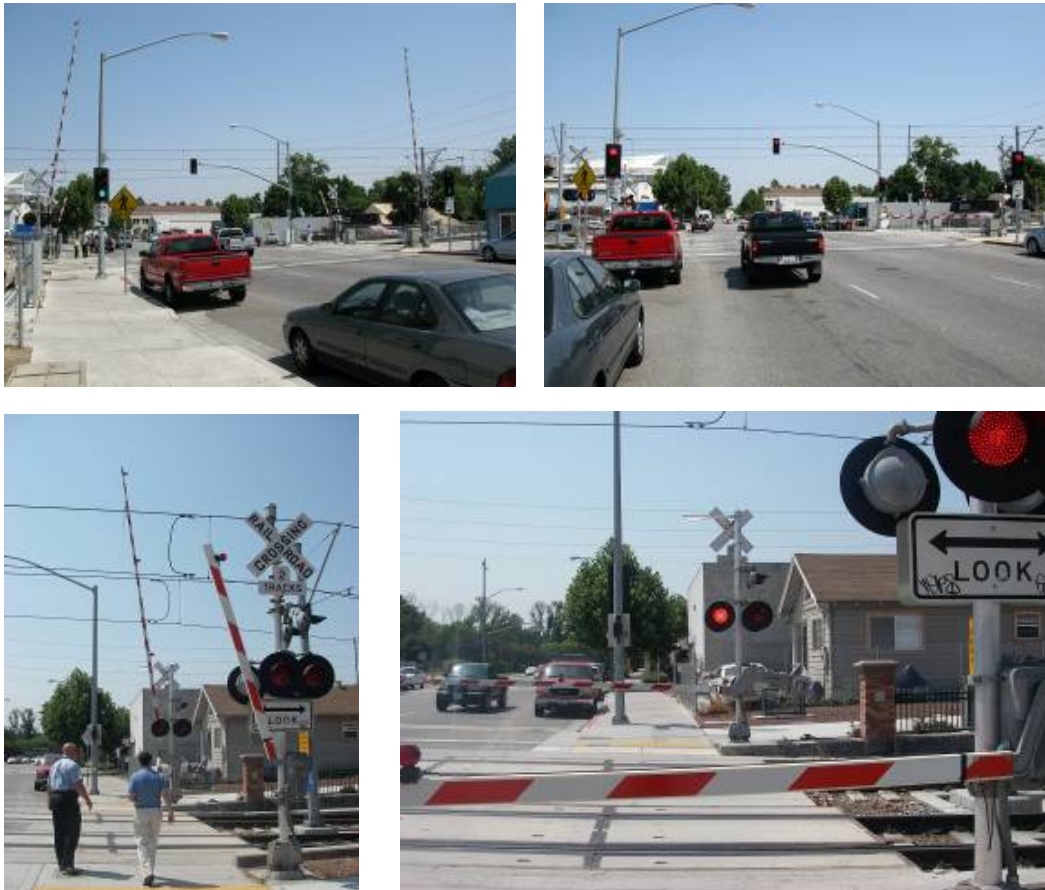
Exhibit 33: Two Quadrant Vehicle Gate with Pedestrian Gates

SCVTA also has an at-grade crossing with two quadrant vehicle gates and pedestrian gates. The crossing is near the San Jose Diridon Station in downtown San Jose. As the crossing is close to HP Pavilion, a local stadium, it is subject to crowds of pedestrians after games. The arrangement of the gates is shown in the series of photos in **Exhibit 33**.

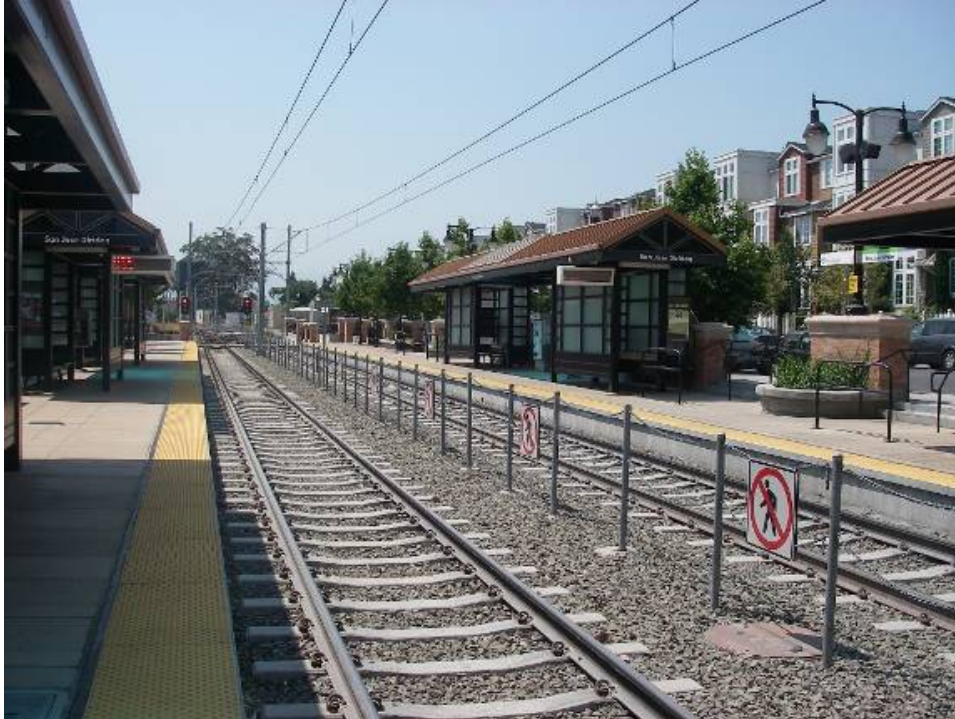
Exhibit 34: Didiron Station with Pedestrian Fencing, Landscaping, and Intertrack Fencing

The San Jose Diridon Station includes a busy pedestrian crossing. The station has a medium density residential development directly adjacent to the station with pedestrian crossings to access the LRT platform, the CalTrain station, and SCVTA buses. The crossings are carefully channelized with pedestrian fencing, landscaping, and intertrack fencing guiding pedestrians. The crossings also include pedestrian swing gates. The station is shown in **Exhibit 34** and **Exhibit 35**.

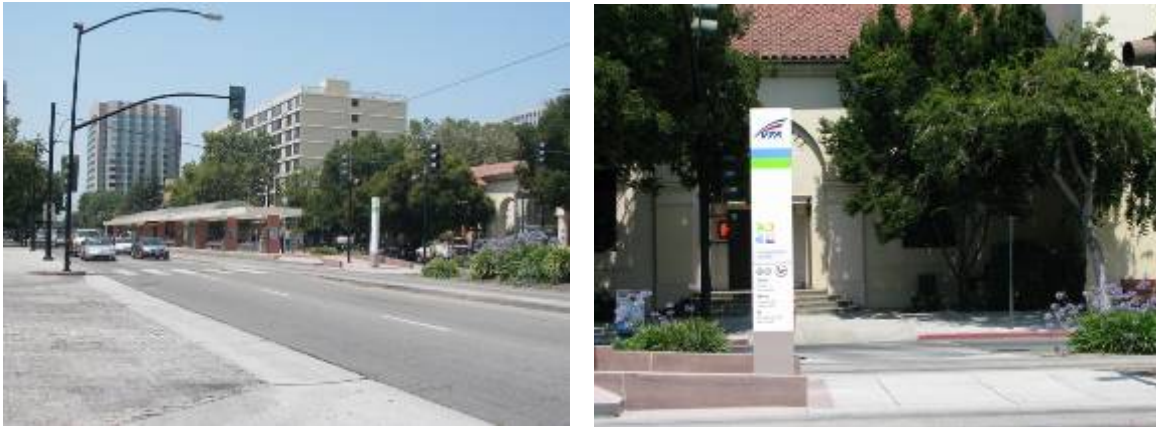
Exhibit 36: Pedestrian Half Signal at Conference Center Station

The Convention Center Station in Downtown San Jose also has an interesting pedestrian environment. The station is located mid-block between several important cultural venues. Pedestrian half signals stop traffic to allow pedestrians to cross to the station and to walk between venues, as shown in **Exhibit 36**. These signals are not always used. **Exhibit 37** shows a worn path through the landscaping in another location. The tracks are enclosed in level concrete, making the tracks on each side of the landscaping appear like a sidewalk rather than an LRT alignment from the viewpoint of pedestrians on the other side of the street. This may encourage pedestrians to walk along the tracks.

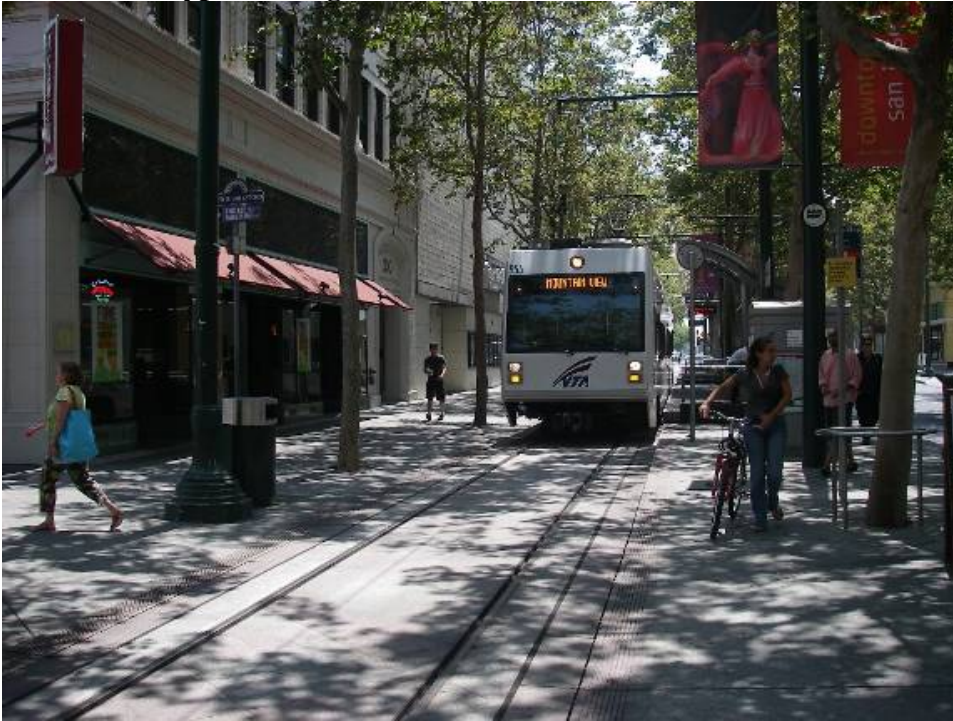
Exhibit 38: Type c.3 Alignment with Pedestrian Mall

Through a portion of downtown San Jose, the two tracks of the LRT line run on opposite sides of a block as a Type c.3 alignment in a pedestrian mall. Operators run at low speeds through this area and use their horns and bells to warn pedestrians to clear the track. **Exhibit 38** shows the LRT operating in this alignment type. This area is particularly difficult because of large pedestrian volumes generated by the nearby university campus and local entertainment establishments.

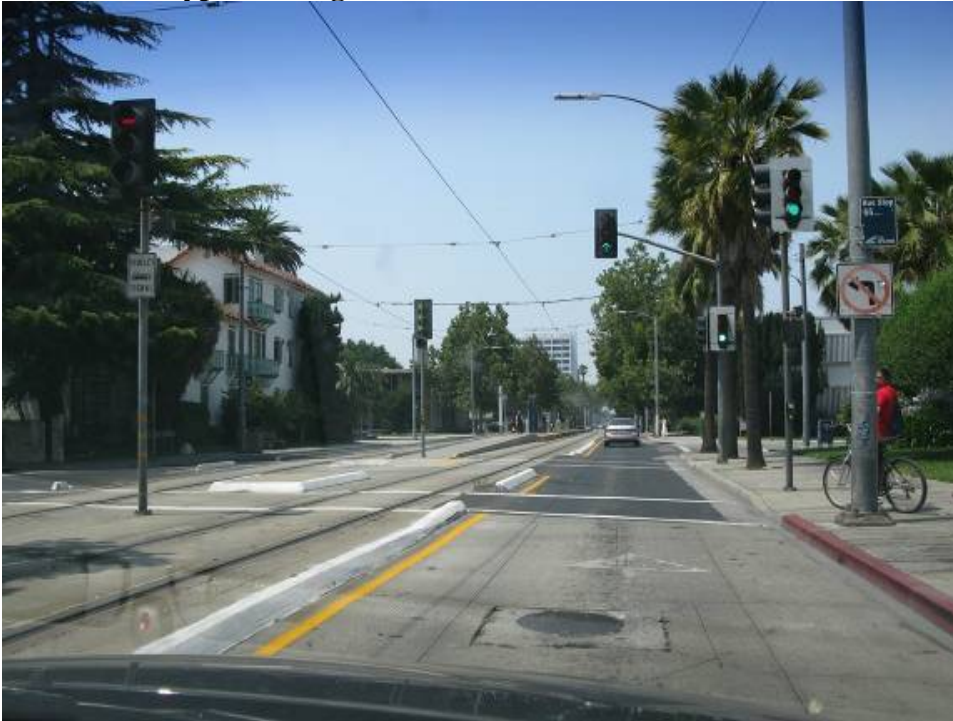
Exhibit 39: Type b.3 Alignment with Barrier Curbs

Most of the remainder of the SCVTA LRT is median running Type b.3 semi-exclusive with barrier curbs. A sample of this alignment type is shown in **Exhibit 39**. At grade intersections throughout this part of the system are signal controlled with priority for LRT in some locations. Many intersections have blank-out train signs as shown in **Exhibit 40**. The team also noted the presence of the “Trolley” symbol sign. This sign is not in the MUTCD, but was also noted on other site visits. This sign is shown in **Exhibit 41**. **Exhibit 42** shows an unusual non-MUTCD sign at an intersection along the SCVTA alignment.

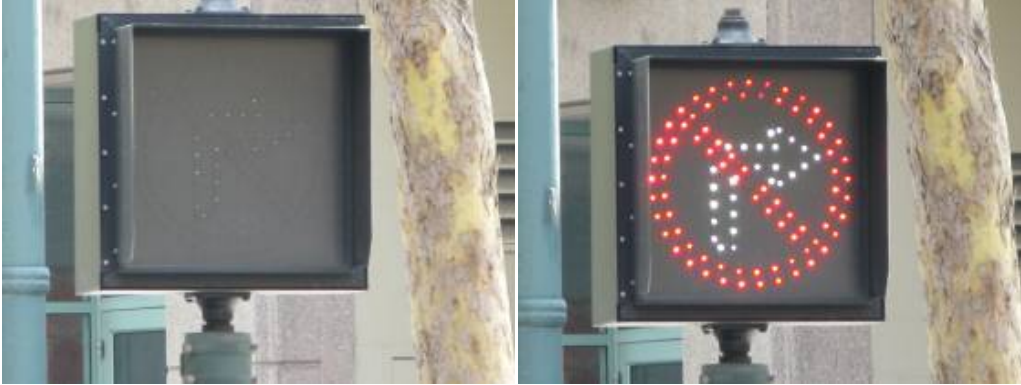
Exhibit 43: No Right Turn Blank-out Sign

SCVTA uses Train Coming and turn prohibition blank-out signs at various locations throughout the system. These signs are posted to increase driver and pedestrian awareness of risk, and to warn against making an illegal movement in the presence of a train. **Exhibit 43** shows a no right turn blank-out sign, and **Exhibit 44** shows a train blank-out sign.

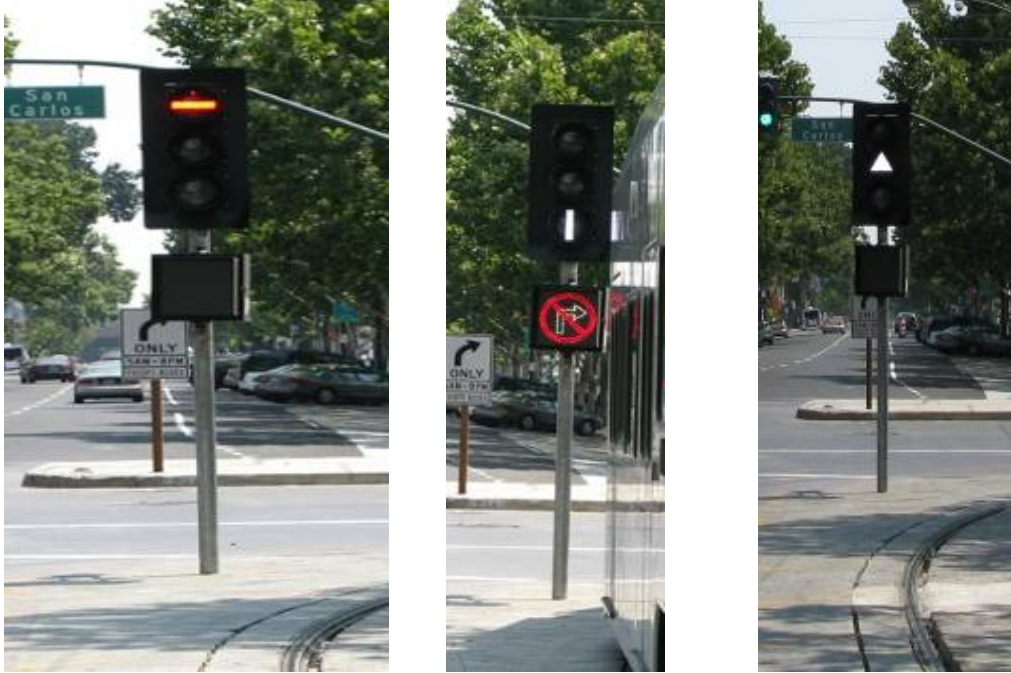
Exhibit 45: SCVTA LRT Signals

Exhibit 45 shows SCVTA's variation of the standard MUTCD three-lens LRT signal with flashing triangle. The top "STOP" bar is red instead of the standard white. The other signals in **Exhibit 45** are a flashing white triangle to indicate "PREPARE TO STOP" and vertical or 45 degree bar to indicate "GO".

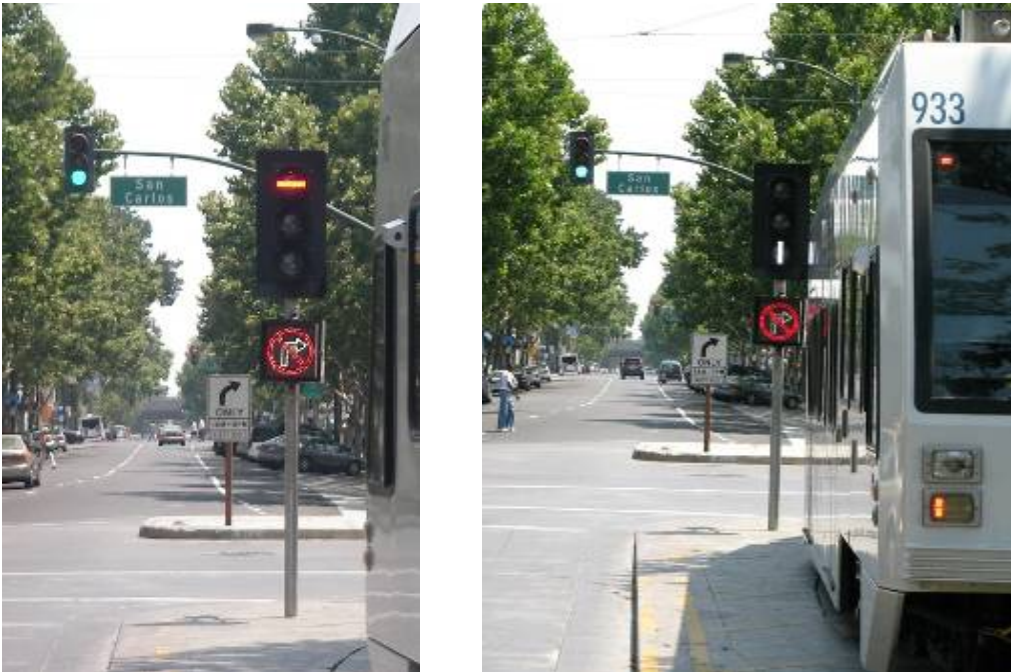
Exhibit 46: Vehicle and LRT signals – Train at Crossing

Exhibit 46 and **Exhibit 47** provide an example of how the LRT signals, blank-out sign, and vehicle signals operate in conjunction. The photos were taken at the intersection of San Carlos and 2nd Street at the exit from the divided portion of the alignment. The train is turning right into the median of San Carlos from its side running alignment on 2nd Street.
