Colorado's Full-Scale Field Testing of Rockfall Attenuator Systems

TRANSPORTATION RESEARCH
CIRCULAR

Number E-C141

**Colorado's Full-Scale
Field Testing of Rockfall
Attenuator Systems**

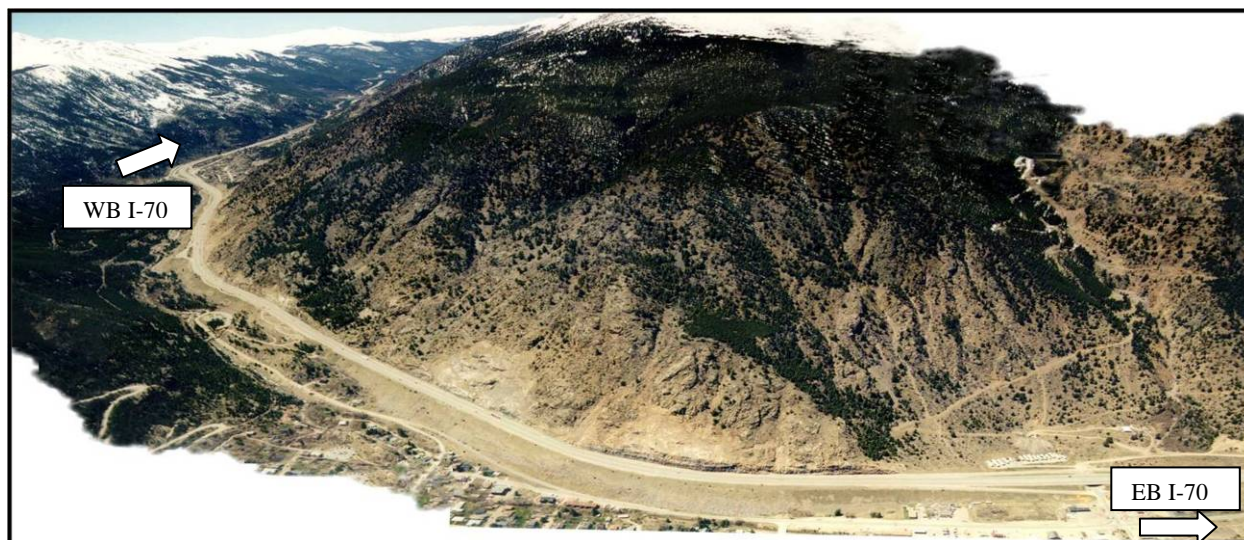
FIGURE 2 Composite photograph of Georgetown Incline.

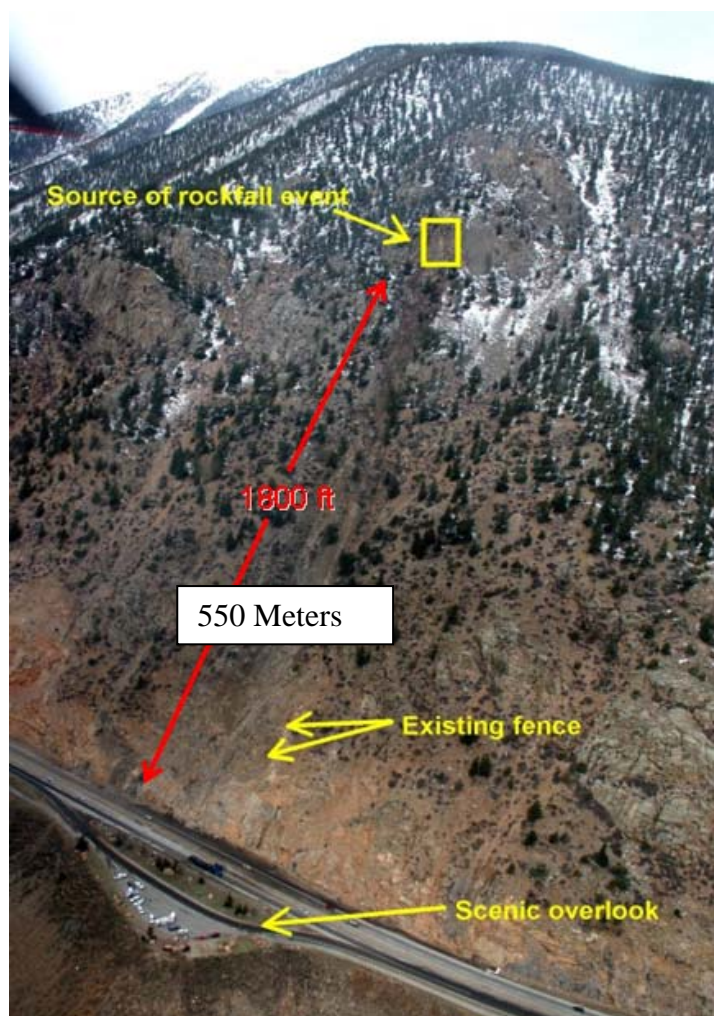
FIGURE 3 Aerial view of Georgetown Incline section of Interstate 70 showing extensive slope distance between source area and roadway for rockfall event of April 2004.

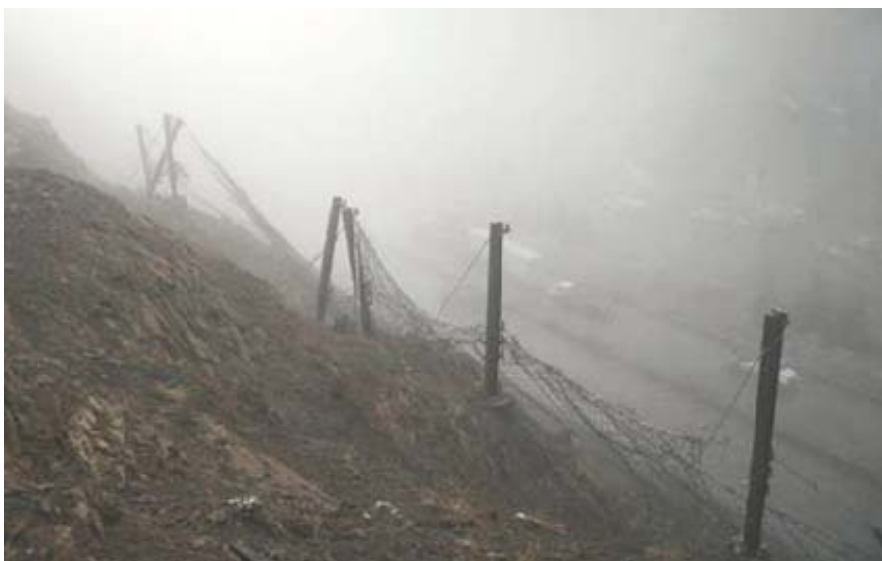
FIGURE 4 Damaged fence following April 2004 rockfall event.

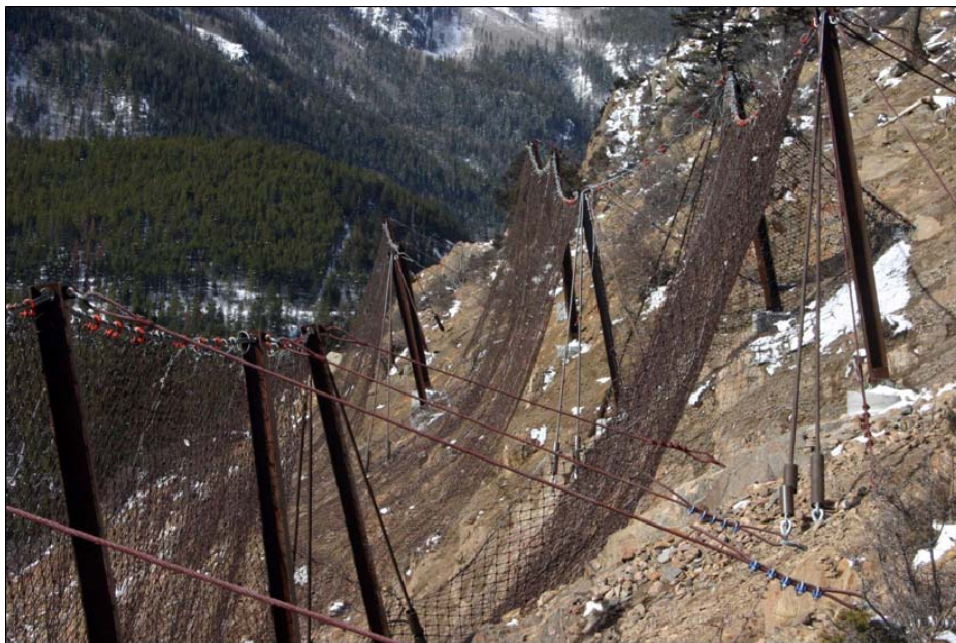
FIGURE 6 View of prototype attenuator system installed above Georgetown Incline.

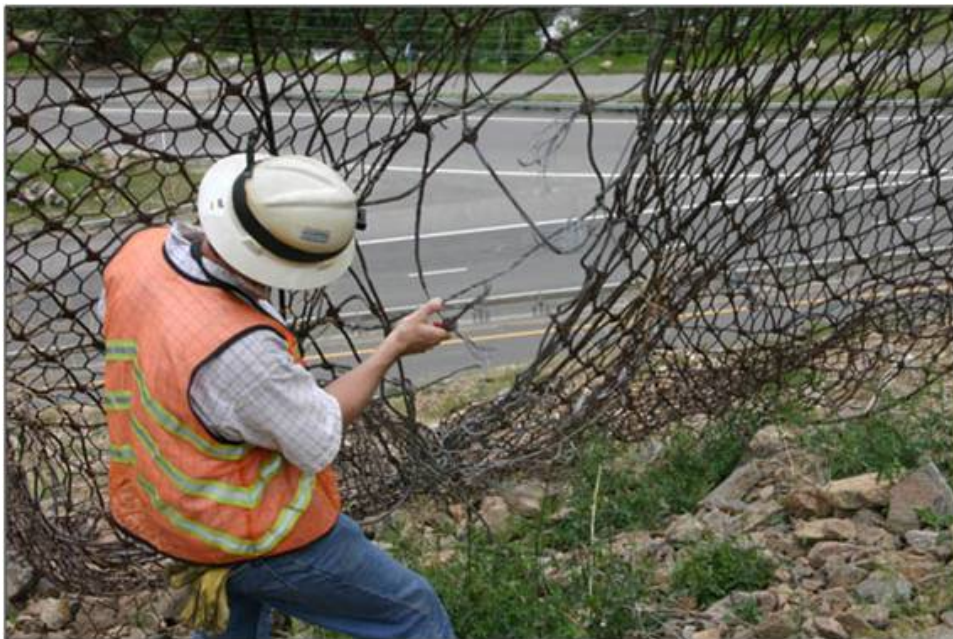
FIGURE 8 Damage to prototype attenuator at Georgetown (damage caused by either stretching or cutting of 8-mm wire rope cable net).

However, after a period of use, periodic inspections of this prototype attenuator system revealed that the system had experienced multiple rockfall impacts. Damage consisted of ripped netting, post damage, and general stretching and/or ripping of the panels (Figure 8). The prototype attenuator appeared to function as intended, but the lack of guidelines to design this type of attenuator system hindered the more widespread adoption of attenuators. Based on the performance and testing of the prototype barrier and the large observed bounce heights, a more rigorous testing program was required, and this program is the subject of this Circular.

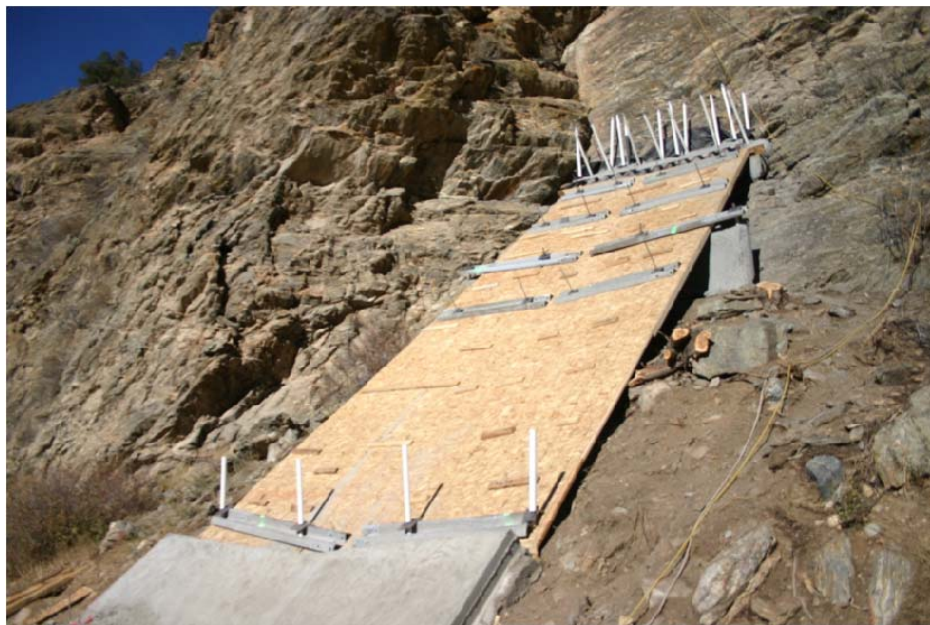
FIGURE 11 Construction of concrete ramp.

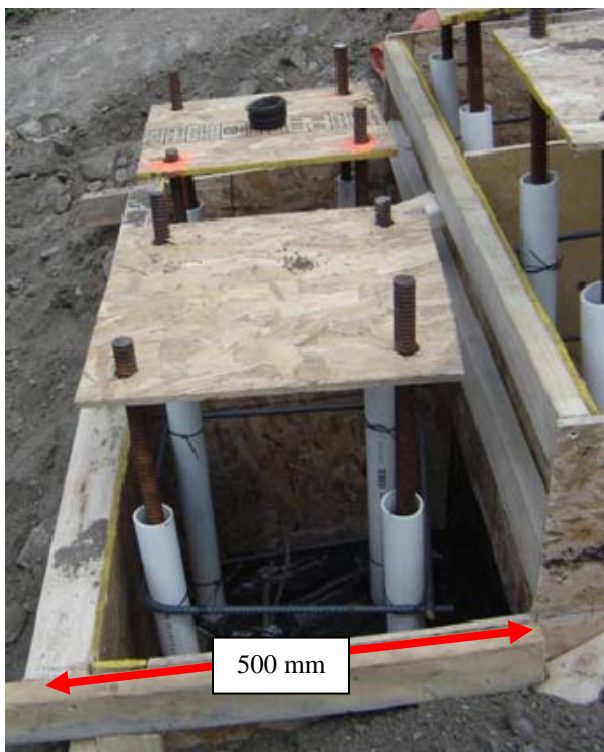
FIGURE 12 Post foundation with concrete forms prior to concrete placement.

Foundations for the attenuator posts were located at the base of the concrete ramp (Figures 12 and 13). The post foundations were constructed by drilling four No. 8 threaded bars approximately 1.2 m (4 ft) into silty-sandy, cohesionless overburden to match the spacing of the base plate of the attenuator post. The base plate was 500 mm by 500 mm (20 in. by 20 in.). The bars were grouted into the ground and No. 4 bar stirrups were placed around the No. 8 bars on 150 mm (6 in.) vertical spacing. The No. 8 bars were sleeved so the foundations could be removed for general panel testing and replaced when the posts were tested. The rough dimensions of the individual bases for the posts were 500 mm by 500 mm by 500 mm (20 in. by 20 in.). Figure 10 depicts a scaled drawing of the foundation bases.

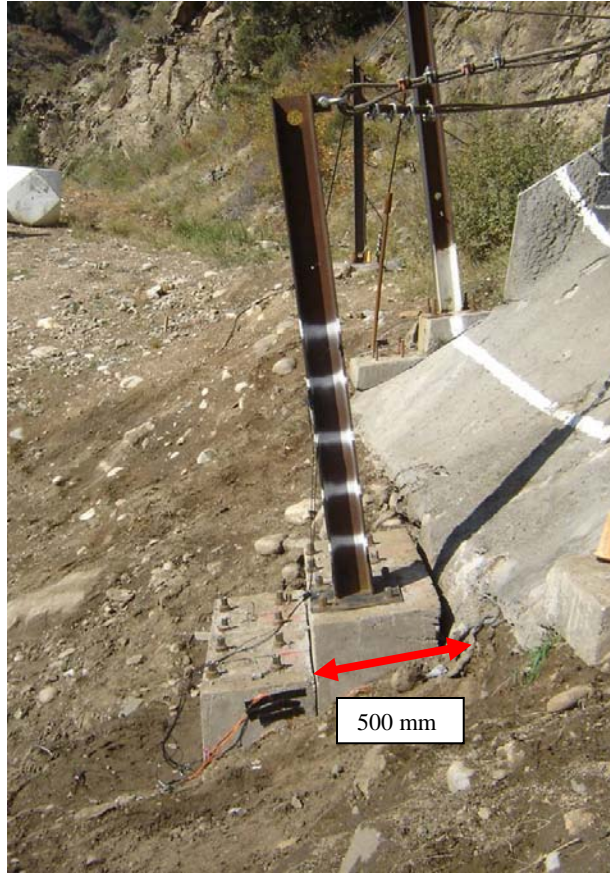
FIGURE 13 Attenuator post attached to foundation prior to testing.

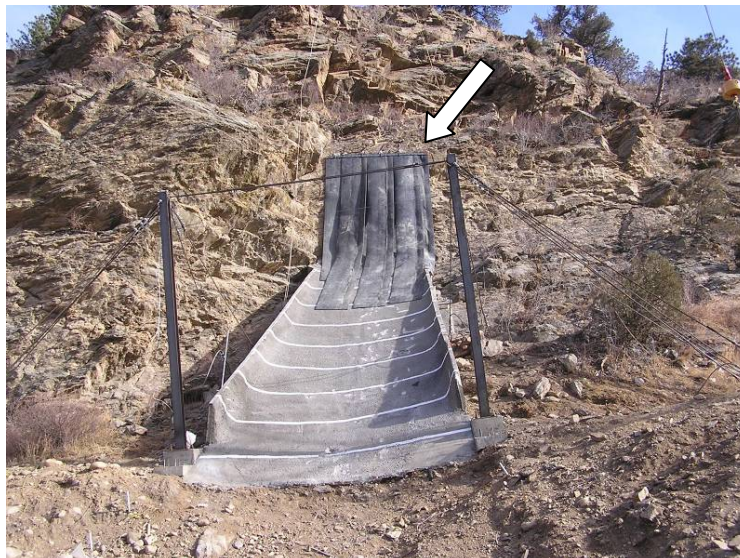
FIGURE 14 Rubber conveyor belts (trimmed to top of concrete ramp prior to testing) were used to protect rock face from impact damage (arrow depicts top of conveyor).

Because the site for the test facility was privately owned, it was deemed necessary to protect the rock face from potential damage from rock impacts. Rubber conveyor belts were draped over the rock face and onto the uppermost section of the concrete ramp; they smoothed the transition between the near-vertical rock face and the inclined concrete ramp and provided a damping effect that directed the concrete rocks into the attenuator (Figure 14). Tests without the conveyor belt resulted in greater variability in the bounce heights and trajectory paths of the boulders.

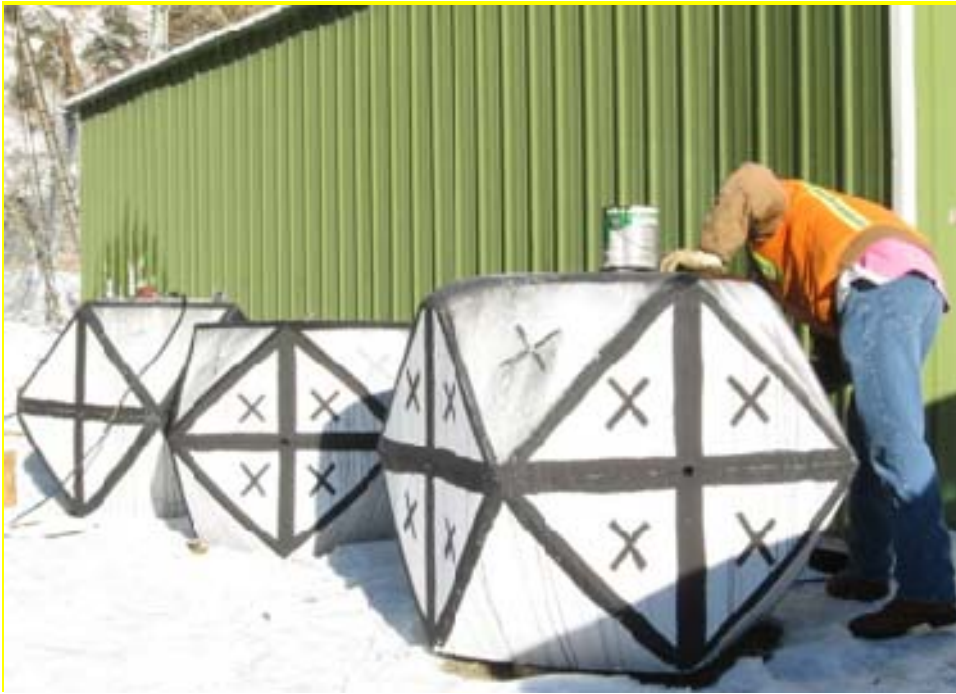
FIGURE 17 Finished cuboctahedrons.

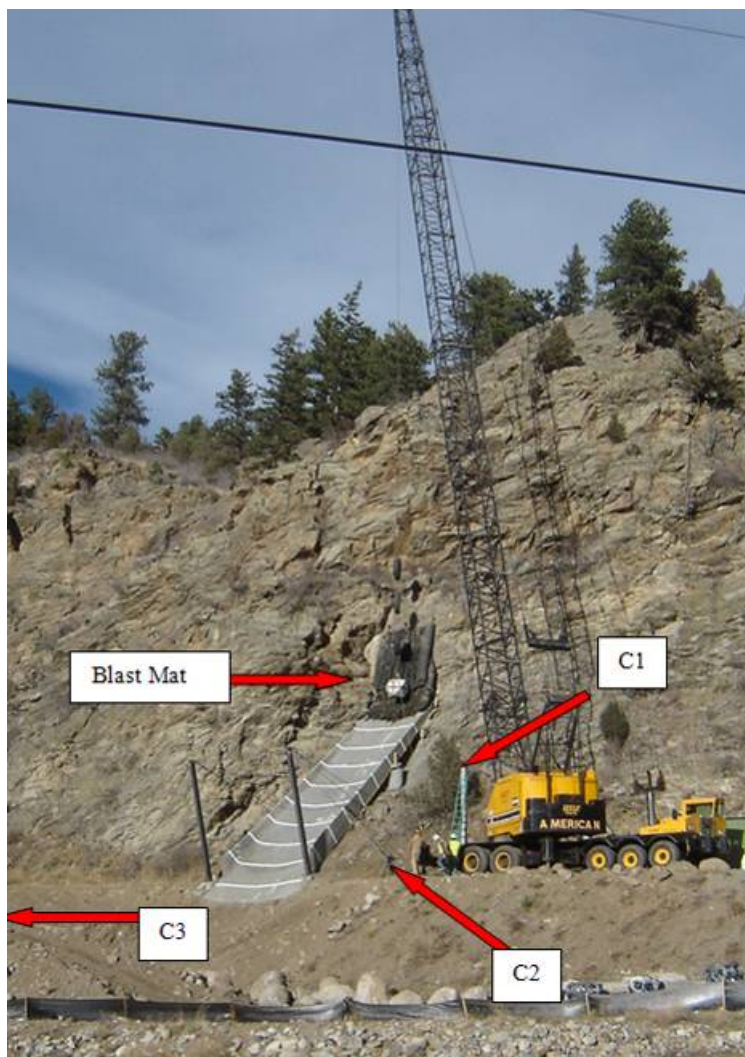
FIGURE 18 Completed Hidden Valley test facility (red arrows depict high-speed camera locations C1, C2, and C3).

Three high-speed cameras were used for documenting the testing. The cameras consisted of AOS Technologies X-3 high-speed cameras (Figure 18). Cameras were set at 250 frames per second.

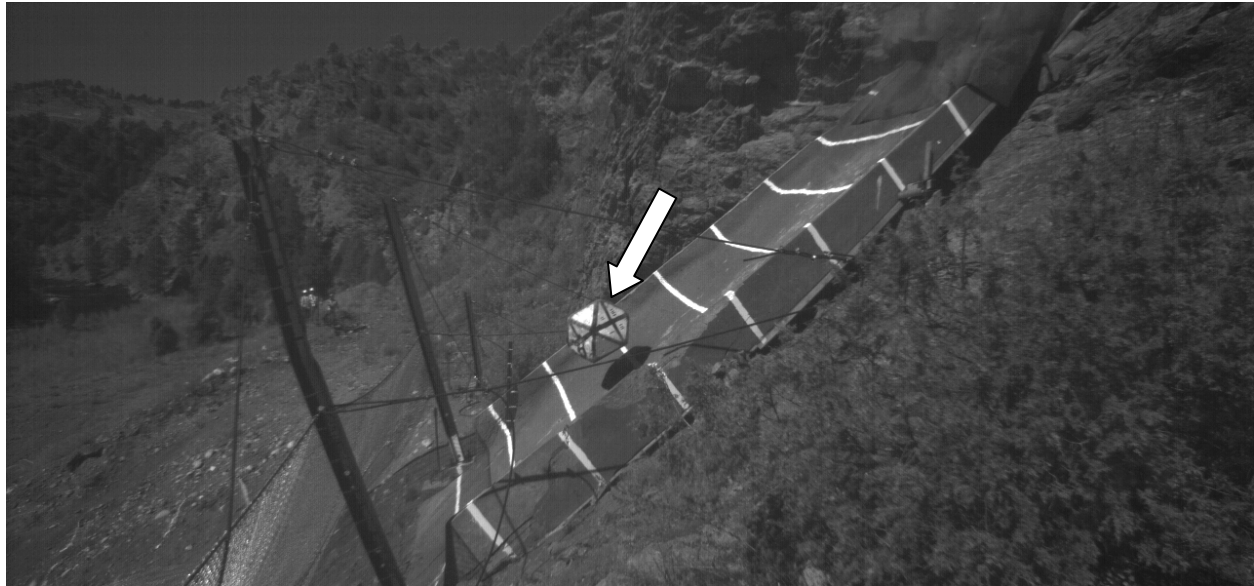
FIGURE 19 Example of photograph taken with Camera 1 prior to impact with net, above post support (white strips are marked on 1.5 m [5 ft] centers; white arrow depicts location of rolling boulder).

- Camera 1 was used to determine velocity and subsequent energy as the boulder was moving down the concrete ramp into the attenuator panel. From this vantage point, it was possible to visually compute the translational and rotational energy of the rock prior to impact with the panel using distance traveled over time.
- Camera 2 was used to evaluate the interaction of the rock with the attenuator panel as the rock traveled under the panel and exited or was entrapped by the system. Unfortunately dust and debris often obscured the photographic image, making exit velocity calculations difficult.
- Camera 3 was used to see the rock in elevation view as it traveled underneath the attenuator panel.

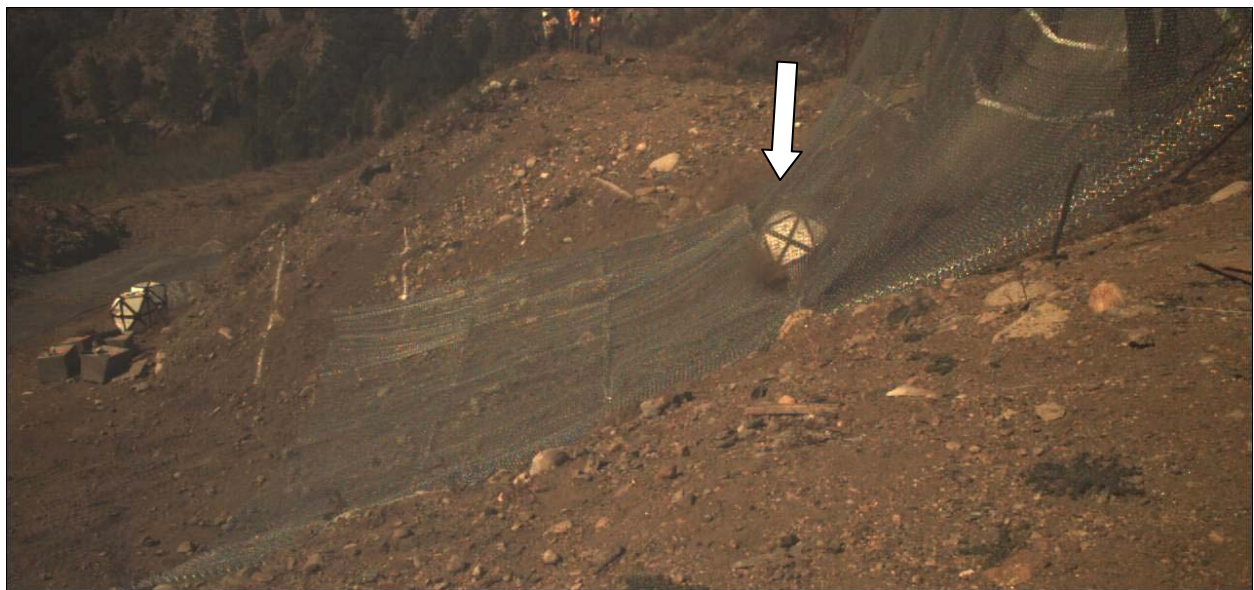
FIGURE 20 Example of photograph taken with Camera 2 during impact with net, below post support (white arrow depicts location of rolling boulder).

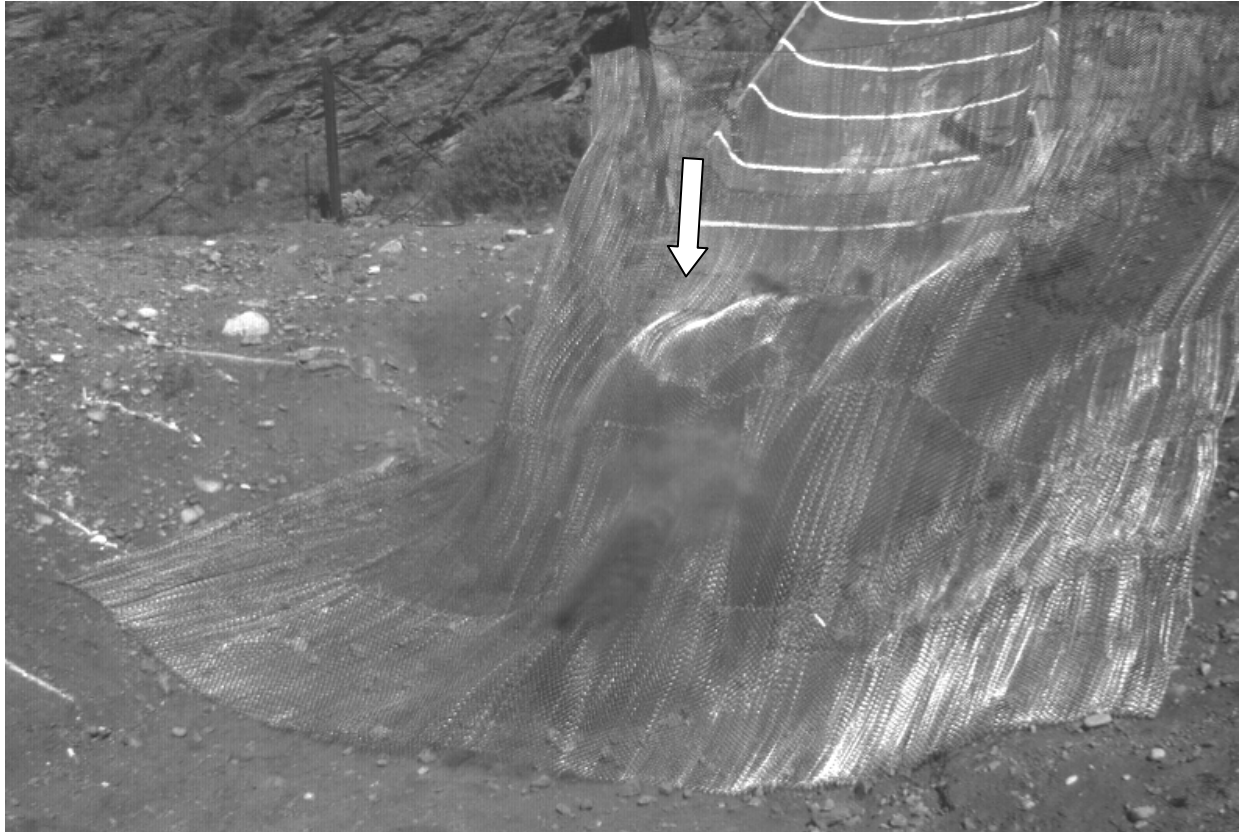
FIGURE 21 Example of photograph taken with Camera 3 during impact with net, below post support (white arrow depicts location of rolling boulder).

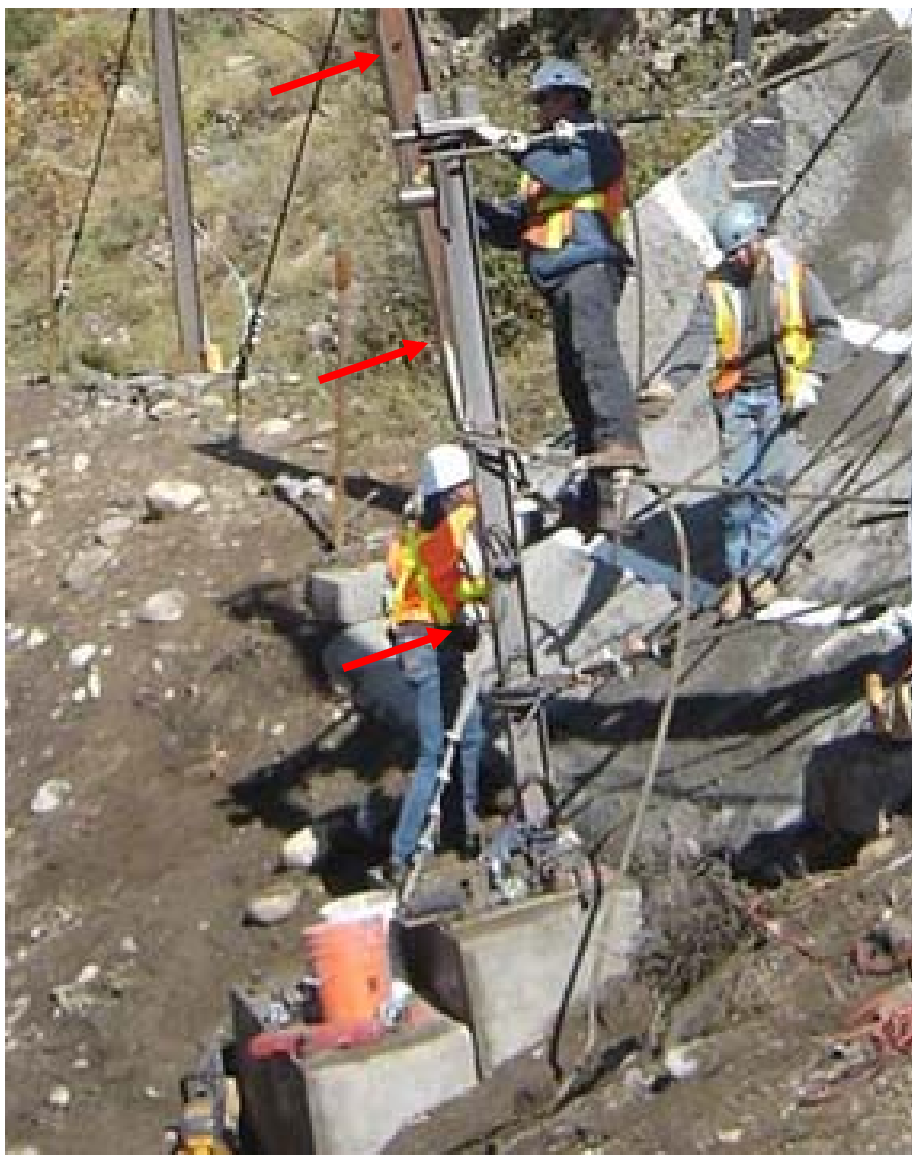
FIGURE 37 Pinned post attached to post foundation (arrows point to uphill anchor locations).

The posts were approximately 2.8 meter (9.2 ft) high and were secured with uphill anchors attached at the top, mid-span, and close to the bottom (Figure 37). Field measurement of the post indicated it would compare in the US System to a W 5 x 16, with a section modulus of approximately $4.6 \text{ cm}^3/\text{cm}$ ($8.5 \text{ in}^3/\text{ft}$). The base plate dimensions were 500 mm by 500 mm (20 in by 20 in). Strain gauges were also attached near the bottom and mid-span of the post (Figure 38).

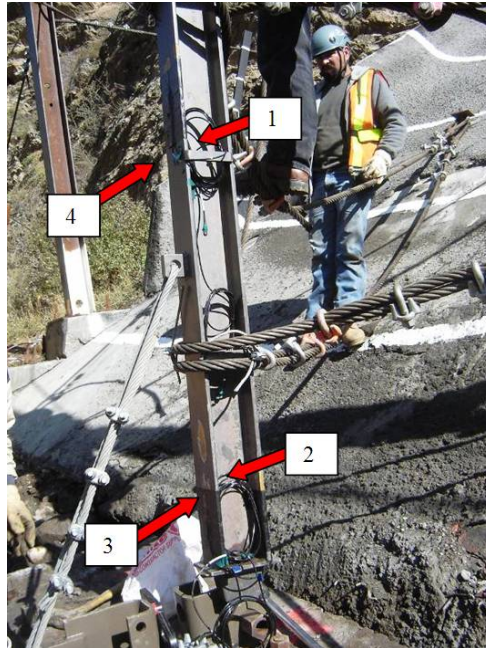
FIGURE 38 Pinned-post base attached to post foundation with strain gauges (numbers correspond to strain gauge designation and attachment location on post).

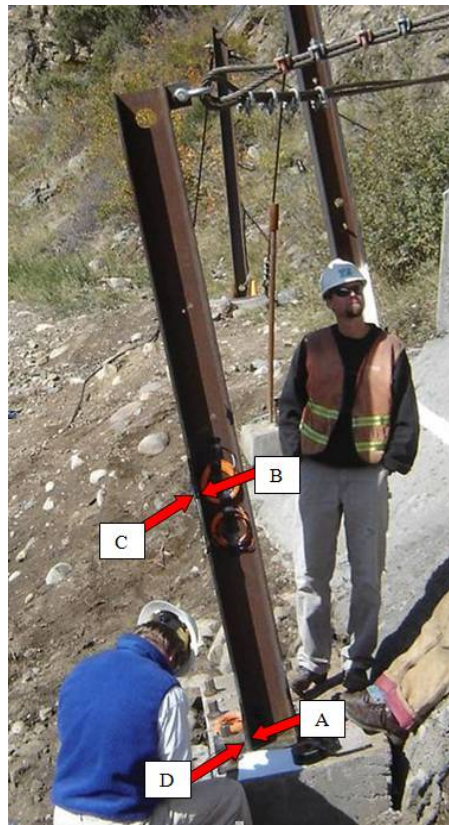
FIGURE 39 Fixed-base post attached to post foundation with strain gauges (letters correspond to strain gauge designation and attachment location on post).

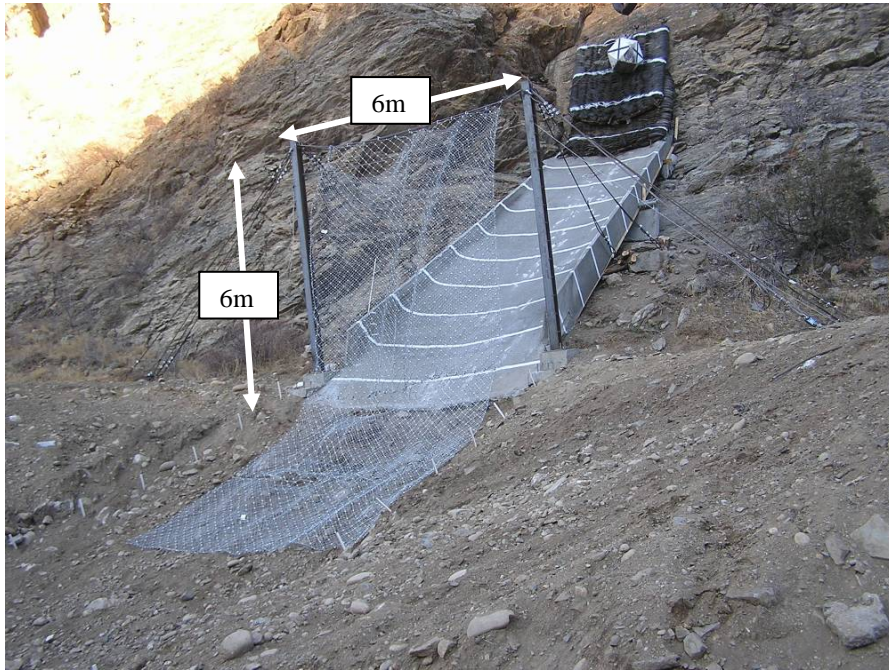
FIGURE 41 Initial two-post system depicting two vertical posts 6 m high and 6 m apart.

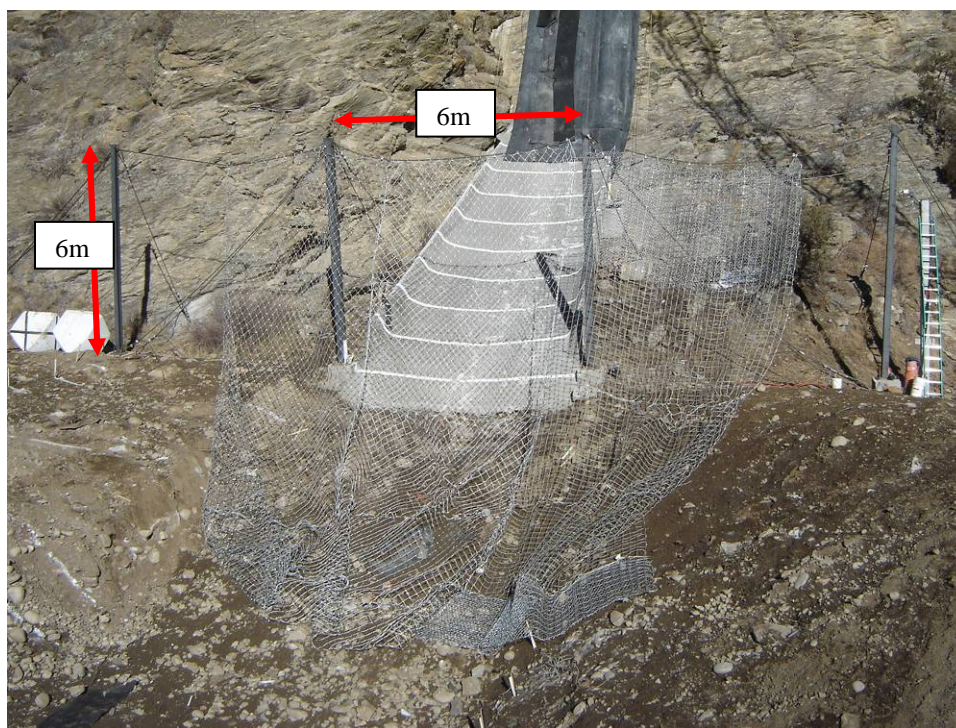
FIGURE 43 Four-post system depicting four vertical posts 6 m high and 6 m apart.

Faced with this response of the single-panel test attenuator, a second attenuator design was constructed using four posts to support multiple net panels. This design utilized four 6-m (20-ft) posts spaced 6 m (20 ft) apart (Figure 43). This configuration reduced the enveloping effect of the attenuator on the impacting test rocks.

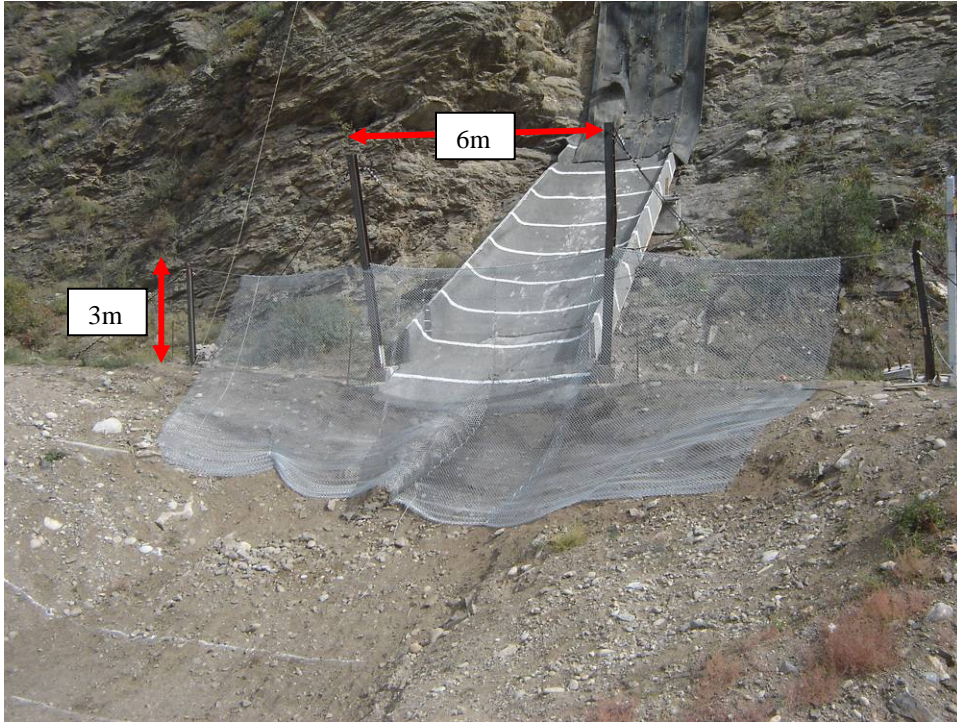
FIGURE 44 Four-post system depicting four vertical posts with support wire rope 3 m high and post spacing at 6 m.

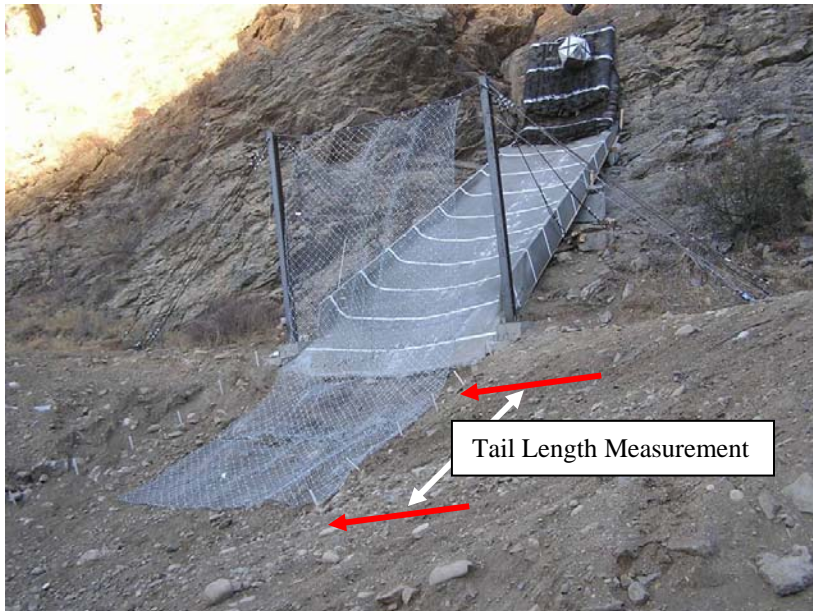
FIGURE 45 Measurement of tail length for net panel in contact with ground.

The tail lengths were varied from 5 to 30 feet. For most fabrics, a short tail was first placed on the ground and a preliminary test was conducted. More tail was added if it appeared the rock rolled too freely through the net panels and little reduction in velocity was observed. The tail length was measured where the panel was in contact with the ground (Figure 45).

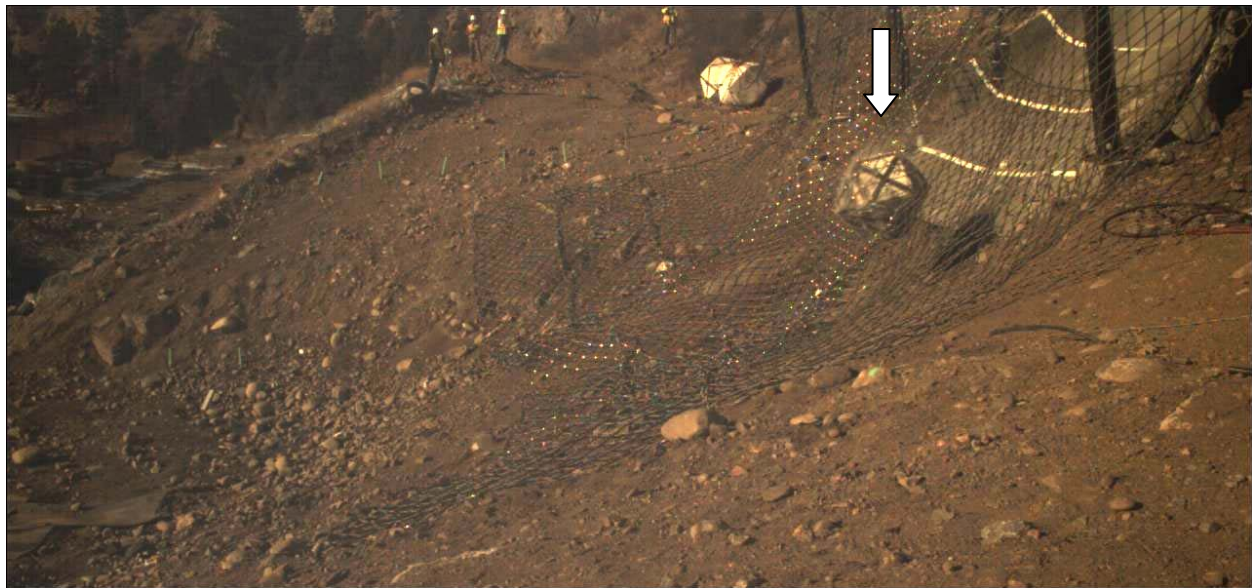
FIGURE 46 Cuboctahedron rock (in upper right corner) prior to impacting panel depicted by white arrow.

High-speed video recordings of each test were collected by three cameras placed so as to obtain distinct views of the rock trajectory before, during and after its impact with the attenuator, and the reactions of the attenuator system to the impact (section 3.1 and Figures 19, 20, and 21). Figures 46 to 52 provide seven sequential images, representing selected frames from one high-speed camera recording, of a typical test, in this case a 12 mm cable net system being impacted by an approximately 1,700 kg (3,700 lb) test rock (Type B in Table 2).

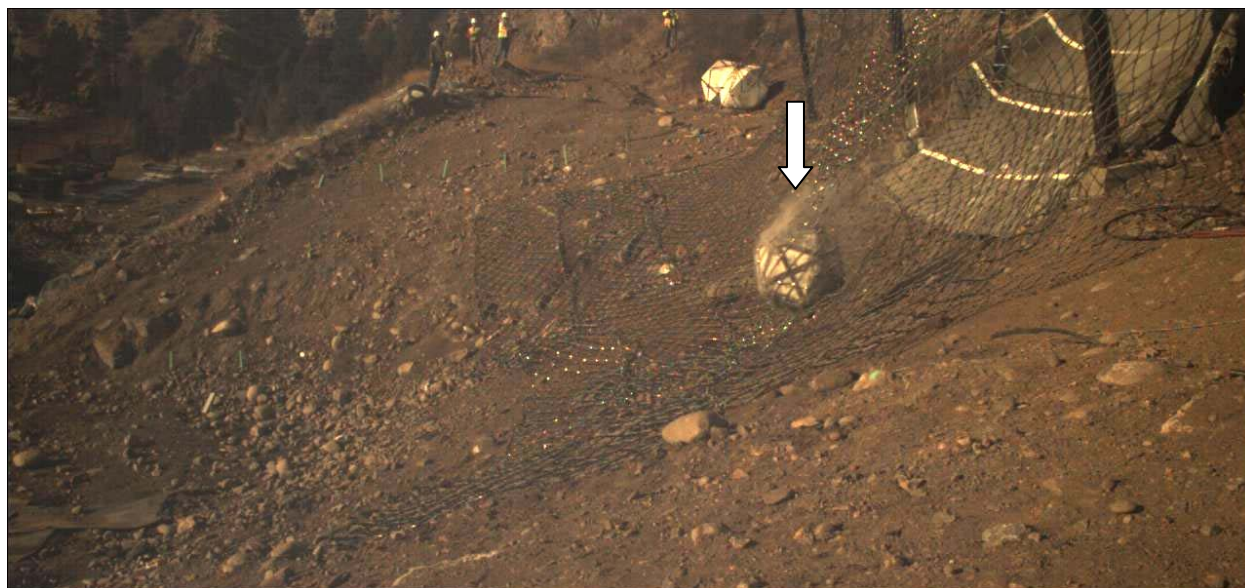
FIGURE 47 Rock traveling into panel.

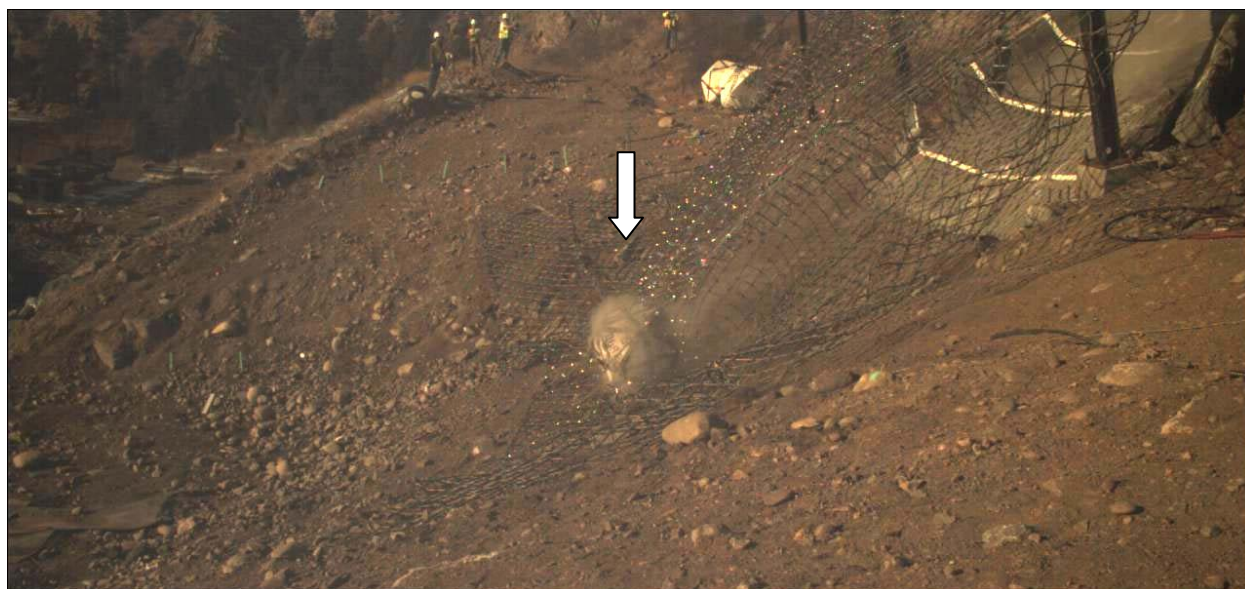
FIGURE 48 Rock engaging panel and beginning to lift tail portion.

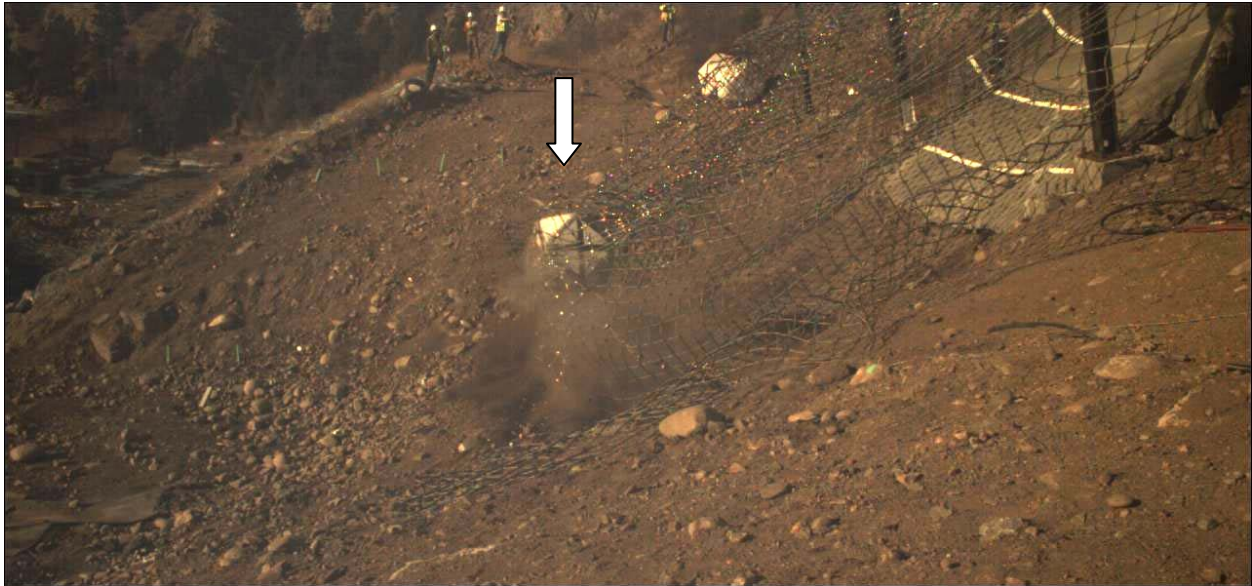
FIGURE 49 Translational velocity slowing, panel lifting vertically attenuating energy.

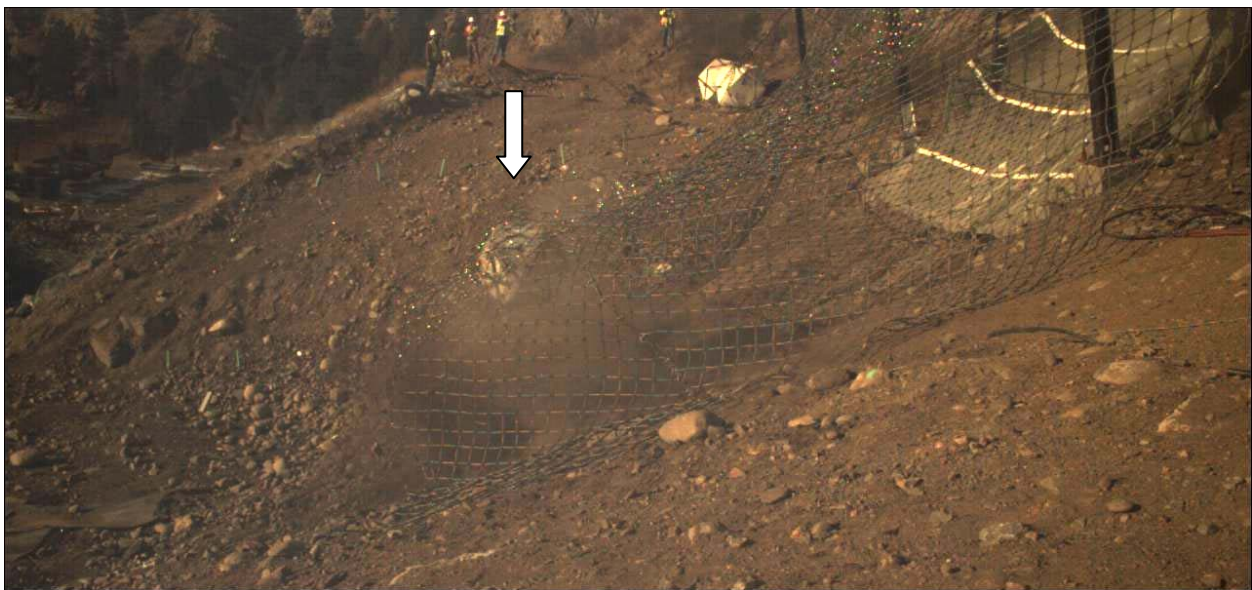
FIGURE 50 Rock momentum greatly reduced as panel and rock vertically rise.

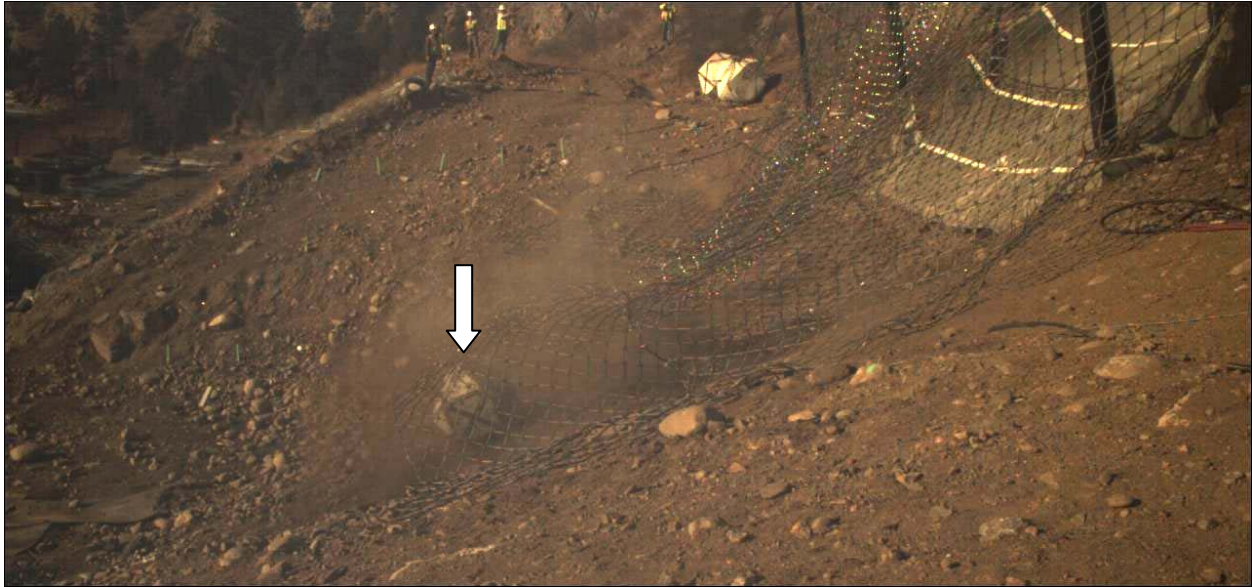
FIGURE 51 Rock released from attenuator with reduced energy.

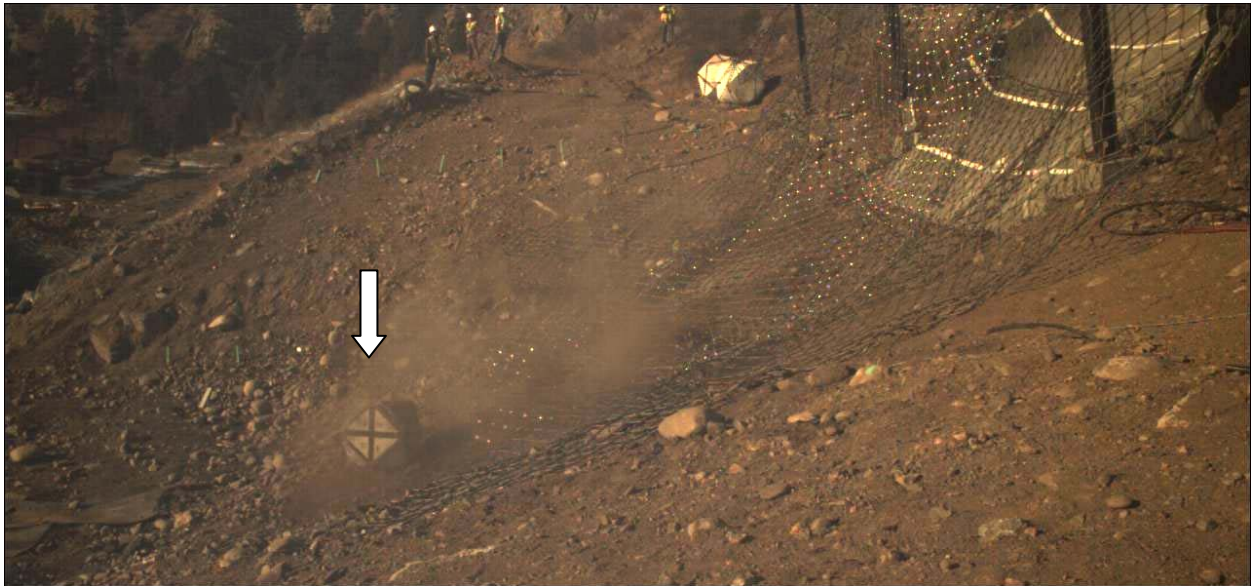
FIGURE 52 Rock fully released at much reduced velocity (at this point, would begin to reaccelerate until it impacts another attenuator or final catchment or barrier).

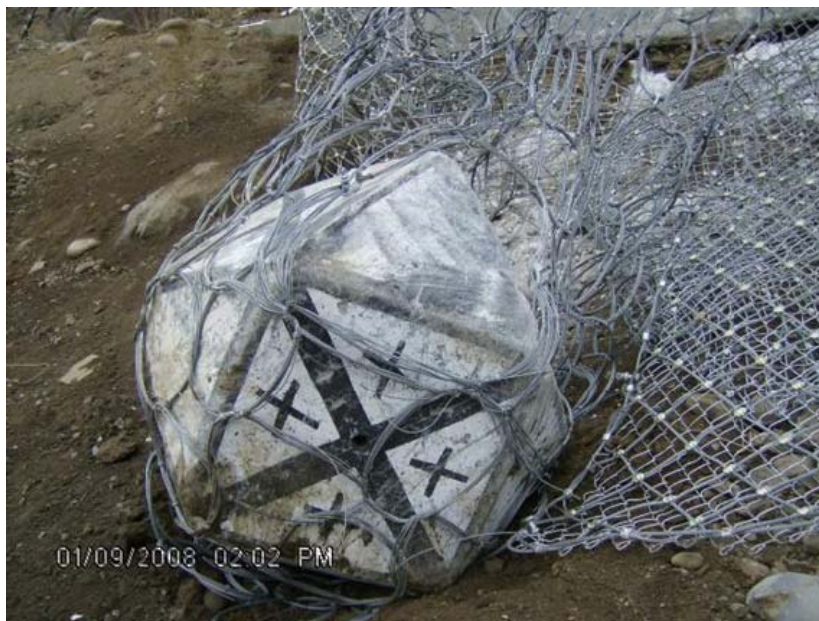
FIGURE 53 Deformation of large-aperture ring net.

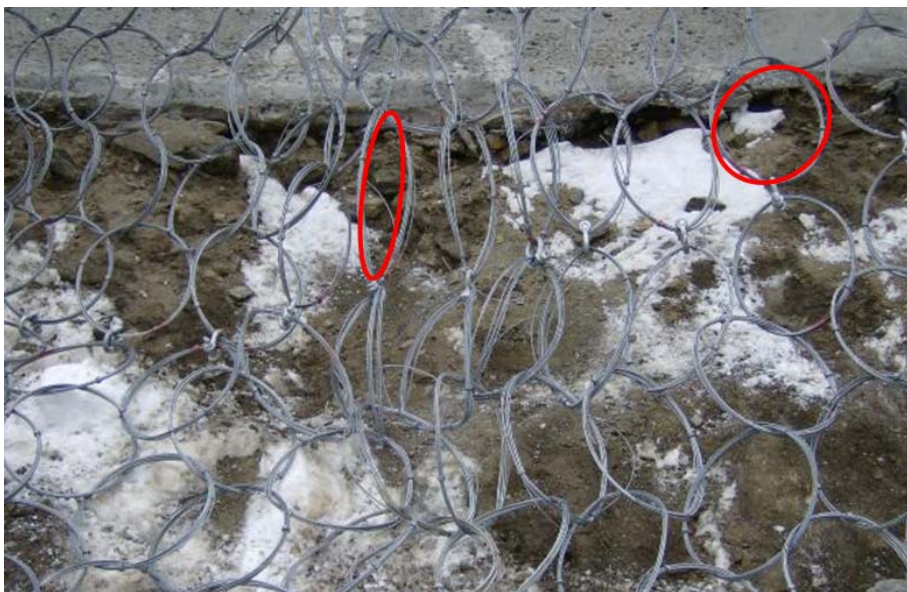
FIGURE 54 Typical deformation of ring-net panel (red outlines compare deformed and unaffected apertures).

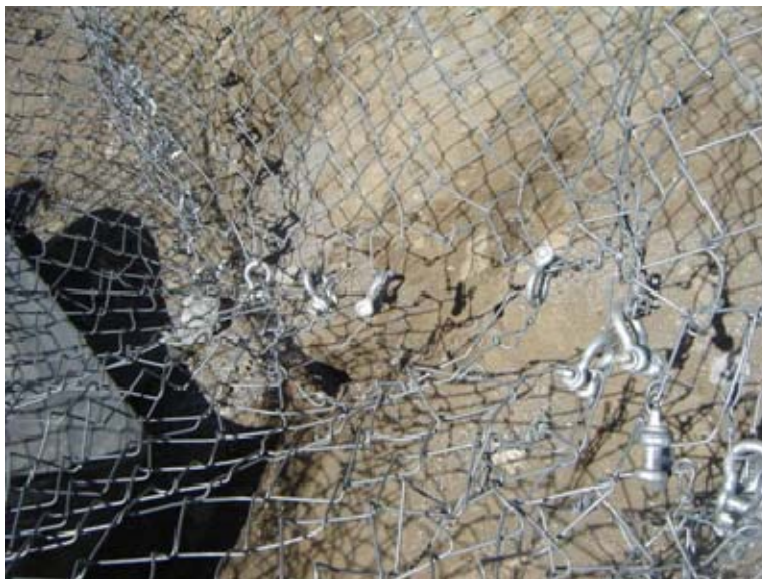
FIGURE 55 Stretching and damage along seam of 4-mm high-tensile-strength wire net.

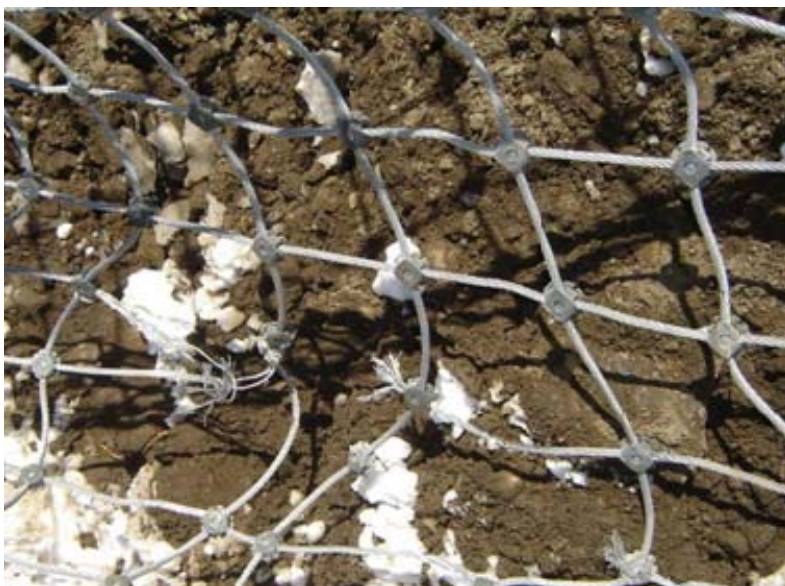
FIGURE 56 Significant damage to 8-mm cable net constructed with interlocking clips.

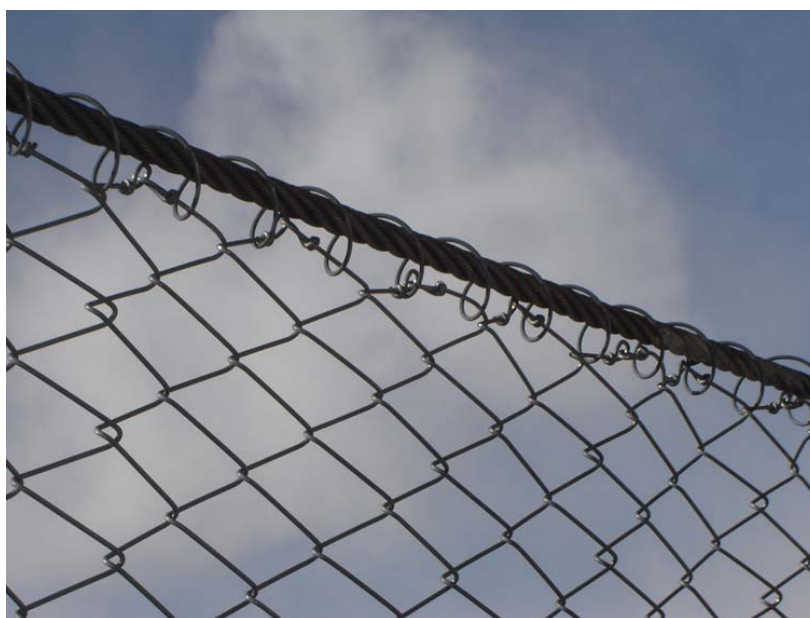
FIGURE 57 Attaching chain-link panel to support cable.
