Colorado's Full-Scale Field Testing of Rockfall Attenuator Systems

TRANSPORTATION RESEARCH
CIRCULAR

Number E-C141

**Colorado's Full-Scale
Field Testing of Rockfall
Attenuator Systems**

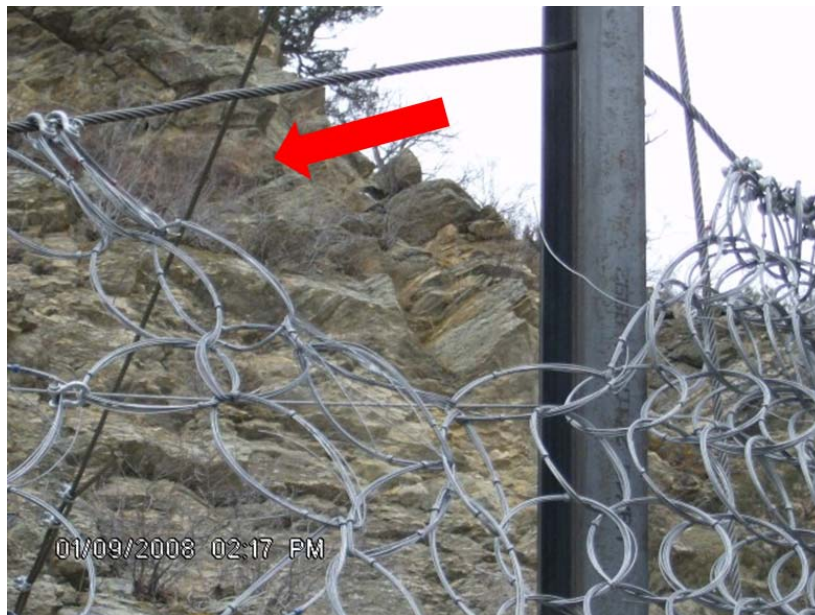
FIGURE 58 Bunching of ring net attached with shackles to support cable.

In some tests, additional “bunching” of parts of the net panel, usually at the point of primary impact, resulted when sections of the mesh panels slid together. This was most commonly observed on some of the cable nets, when the clips slid along the wires (Figure 59).

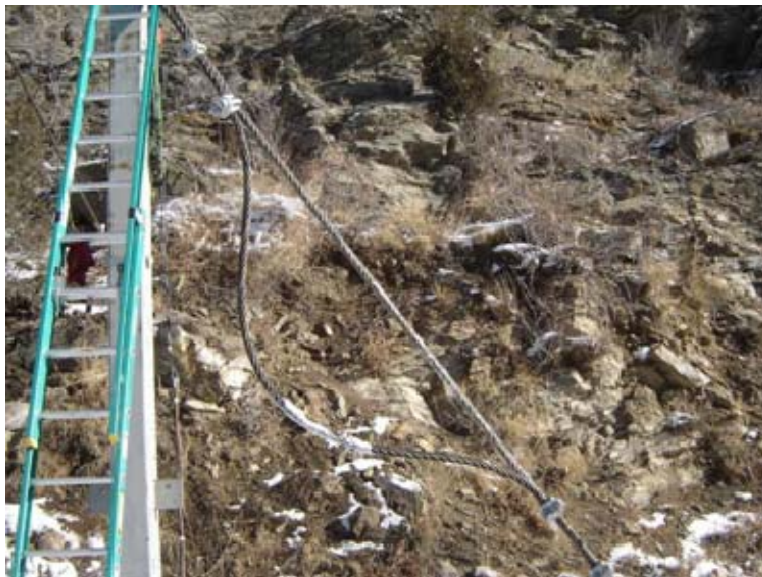
FIGURE 60 Field-designed friction-brake assembly installed on main support cable.

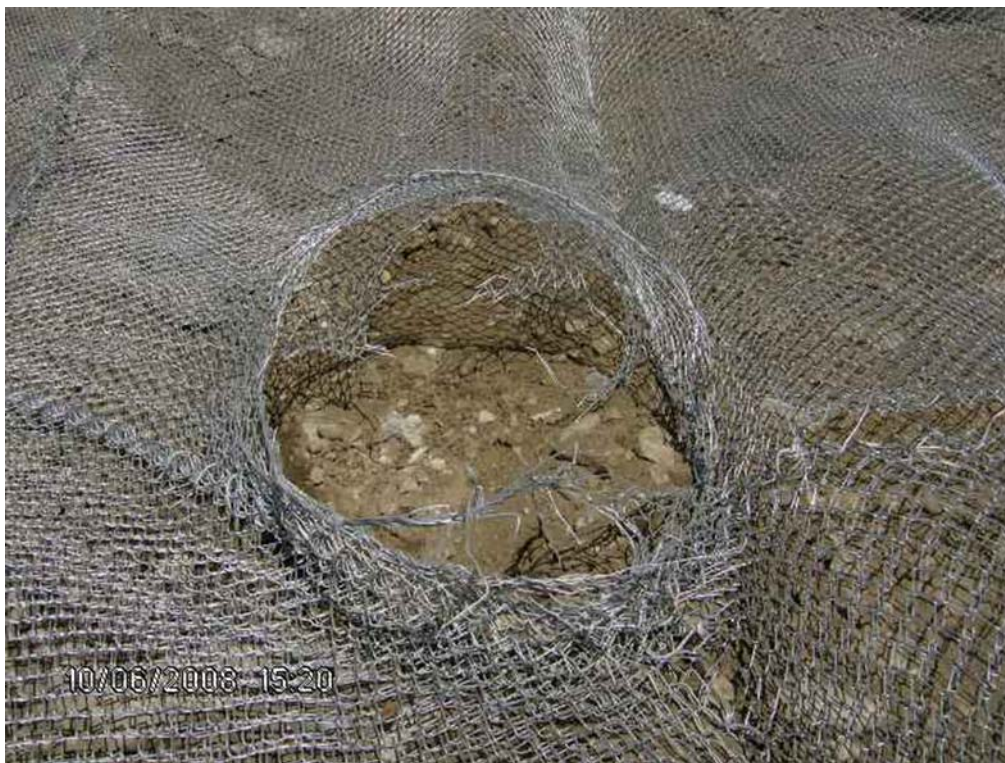
FIGURE 61 Severe damage to attenuator tail constructed with relatively light-weight, double-layer chain link mesh.

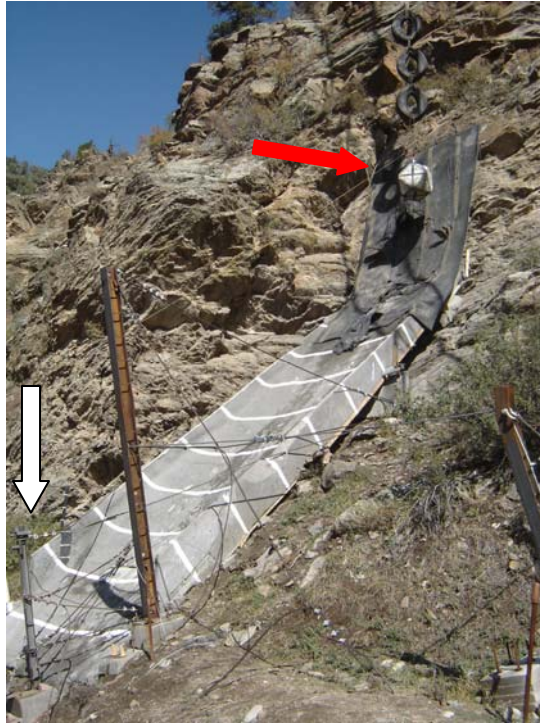
FIGURE 62 Test 120 prior to release of rock at mid-height on ramp (red arrow indicates location of rock prior to drop; white arrow indicates pin-connection post at bottom of ramp).

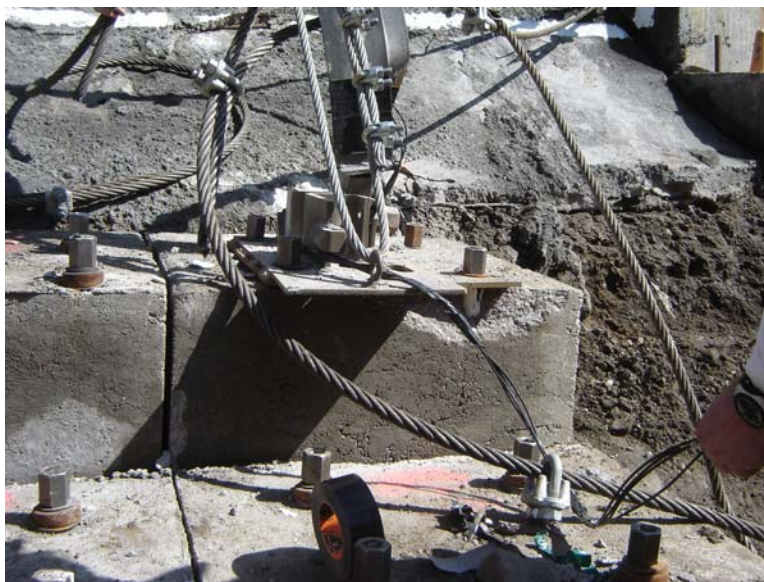
FIGURE 65 Minor concrete spalling as result of Test No. 120 (looking up ramp).

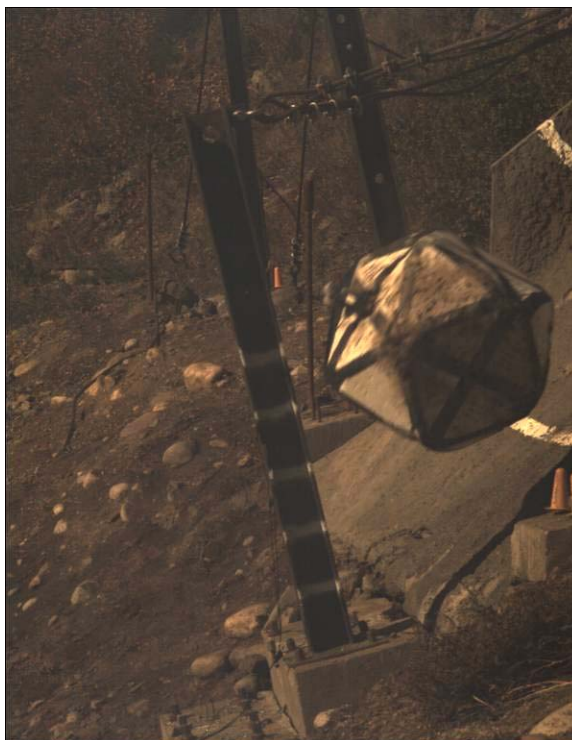
FIGURE 66 Fixed-connection post just prior to impact (Test No. 122).

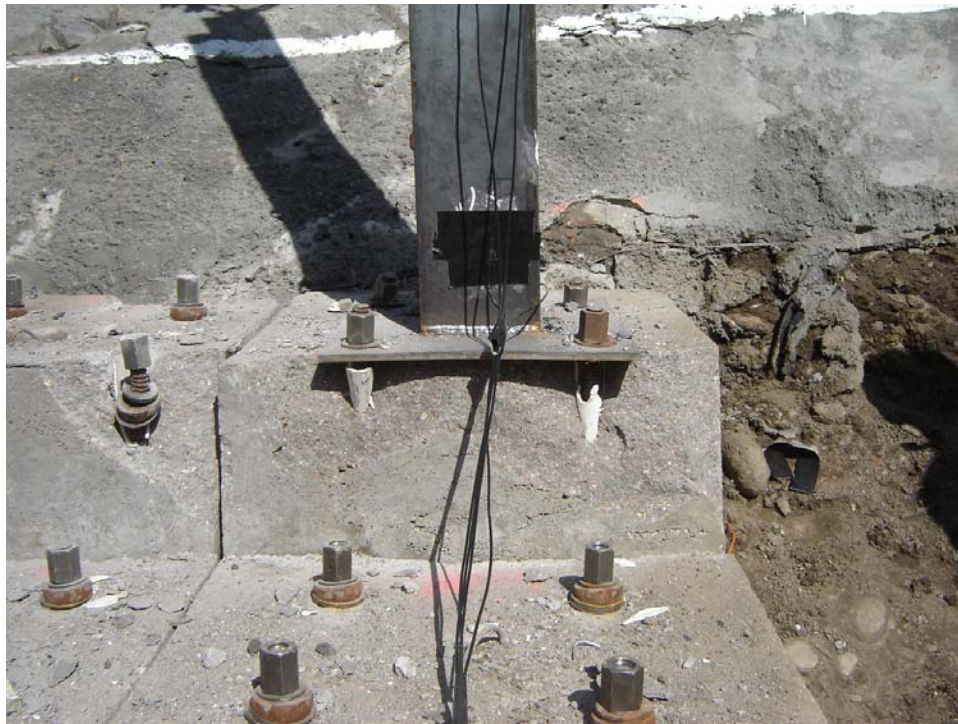
FIGURE 69 Fixed connection post base placed on same base for Test No. 120 (concrete spalling after Test No. 122 looking up ramp).

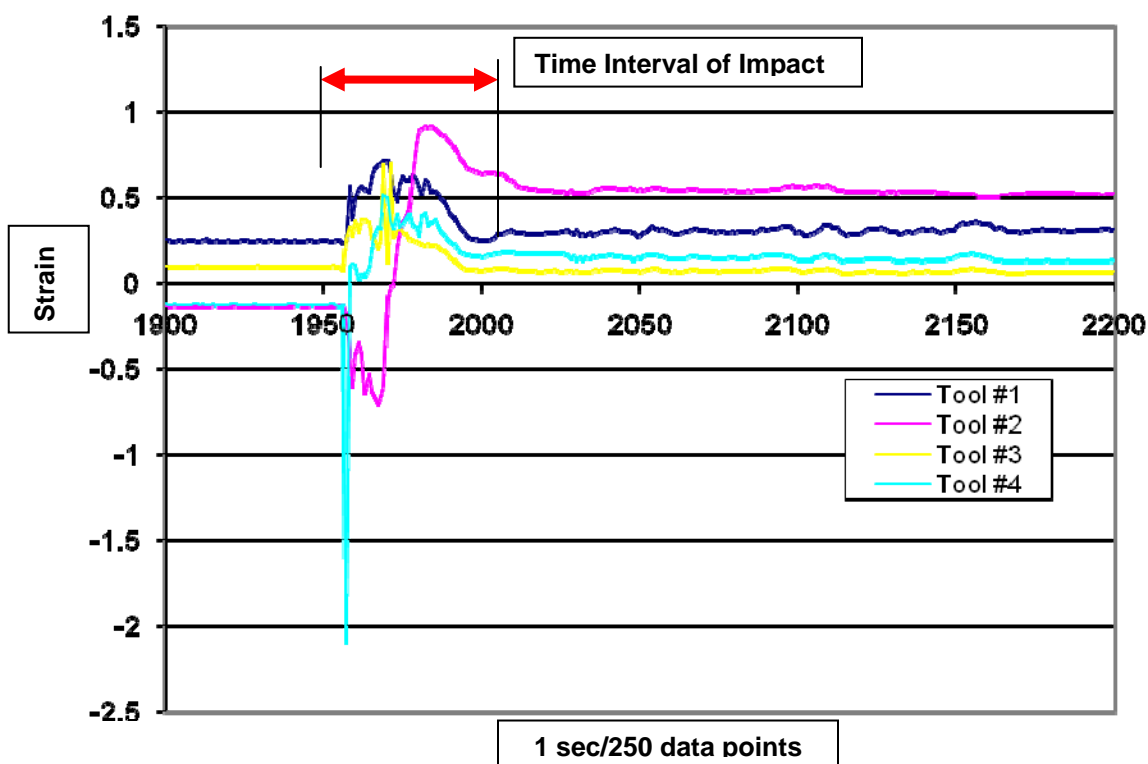
FIGURE 70 Strain gauge data collected during Test 120 for pin-connection post (time interval of impact denoted by red arrow).

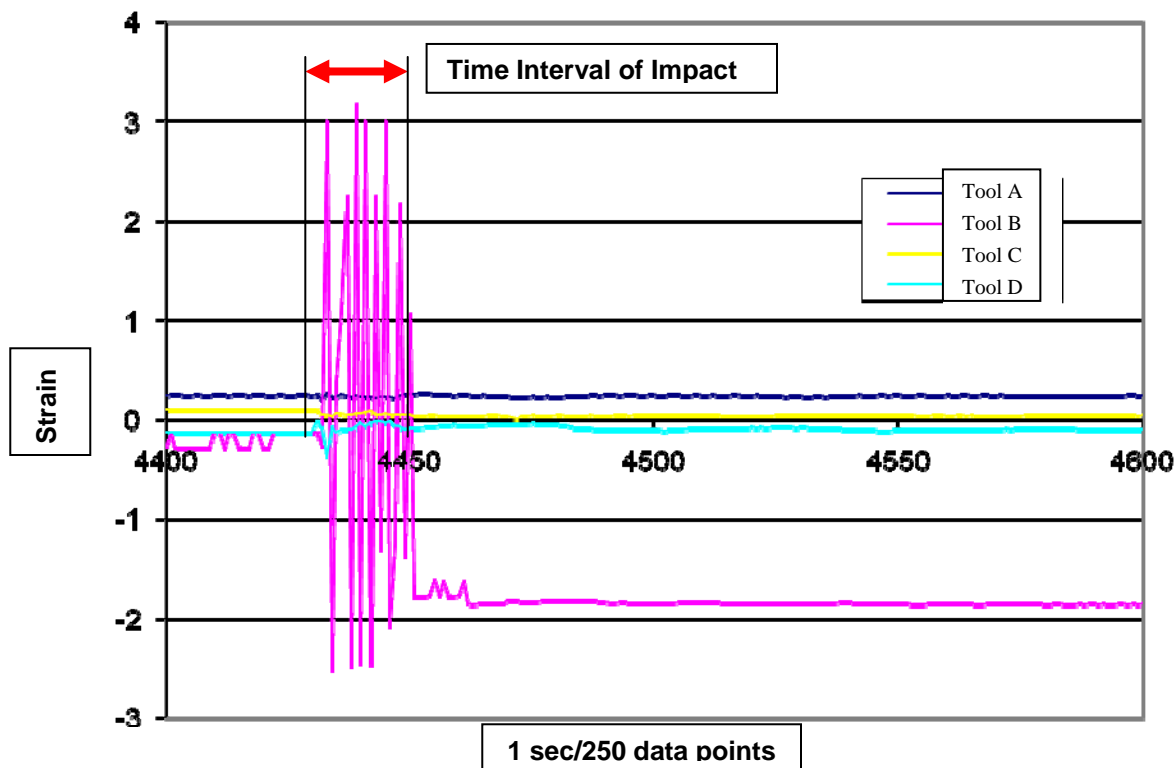
FIGURE 71 Strain gauge data collected during Test 122 for fixed-connection post (time interval of impact denoted by red arrow).

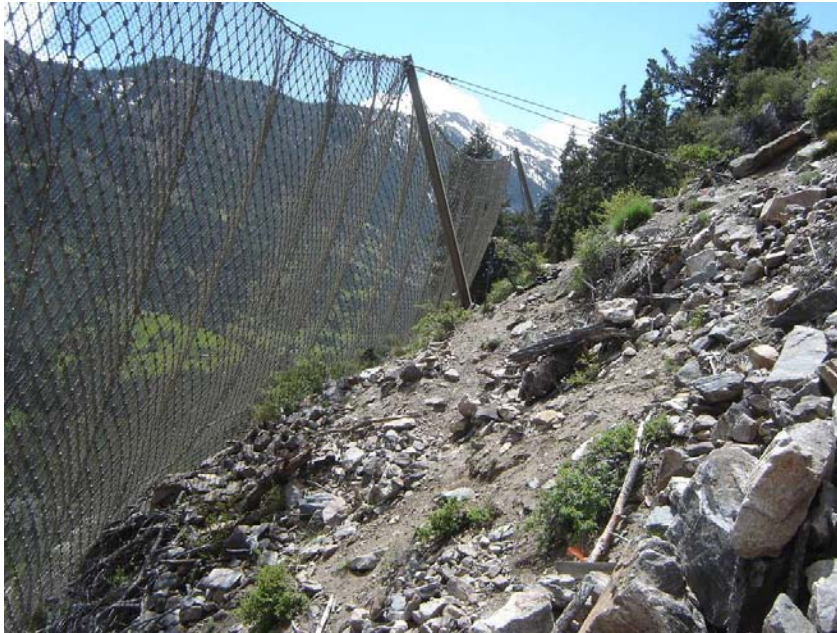
FIGURE 72 View of Attenuator A (looking southwest).

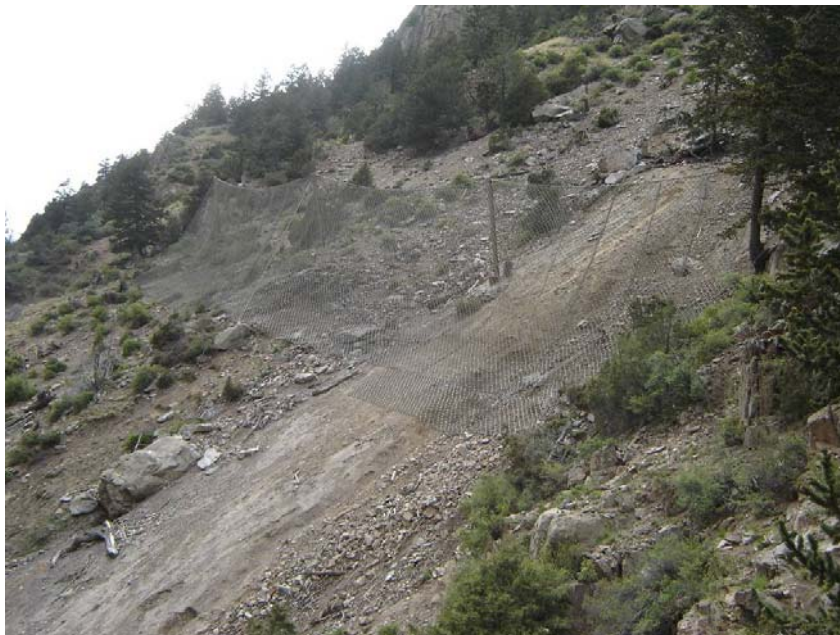
FIGURE 73 View of Attenuator A (looking west).

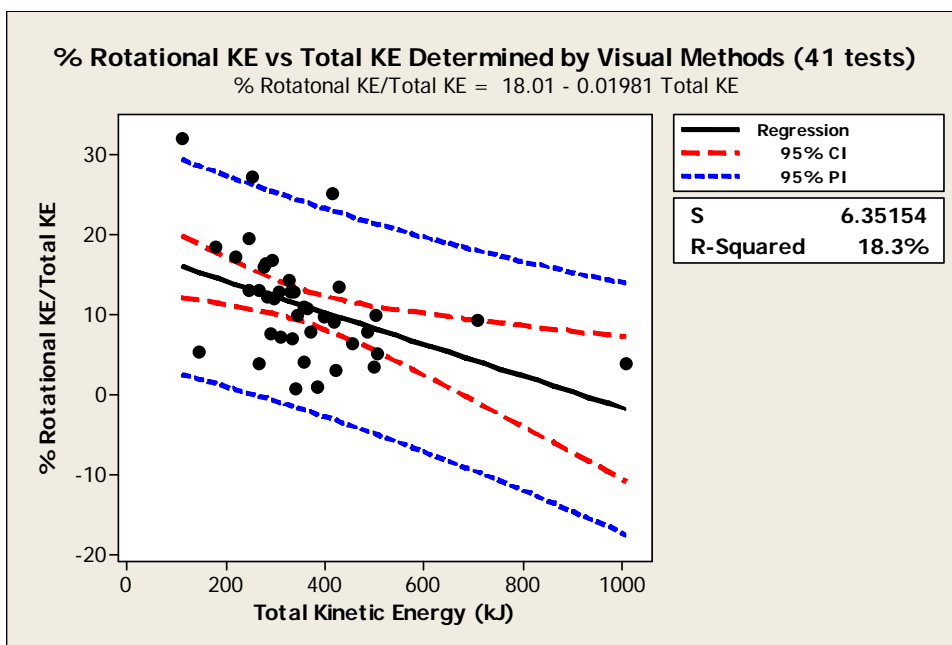
FIGURE B-4 Linear regression of percentage of rotational kinetic energy to total kinetic energy determined for 41 tests by visual analysis of the video records.

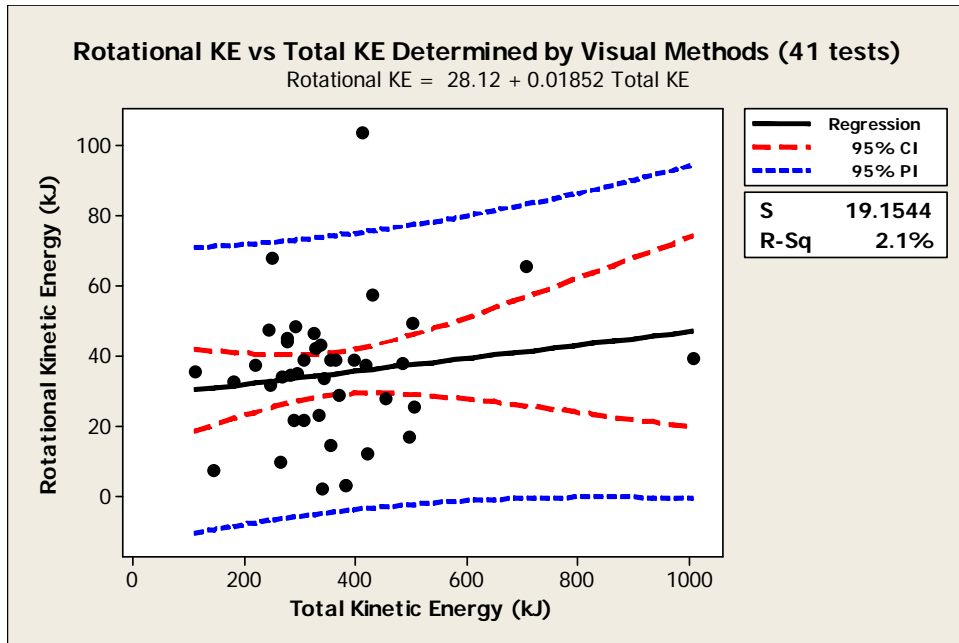
FIGURE B-5 Linear regression of rotational kinetic energy to total kinetic energy determined for 41 tests by visual analysis of the video records.

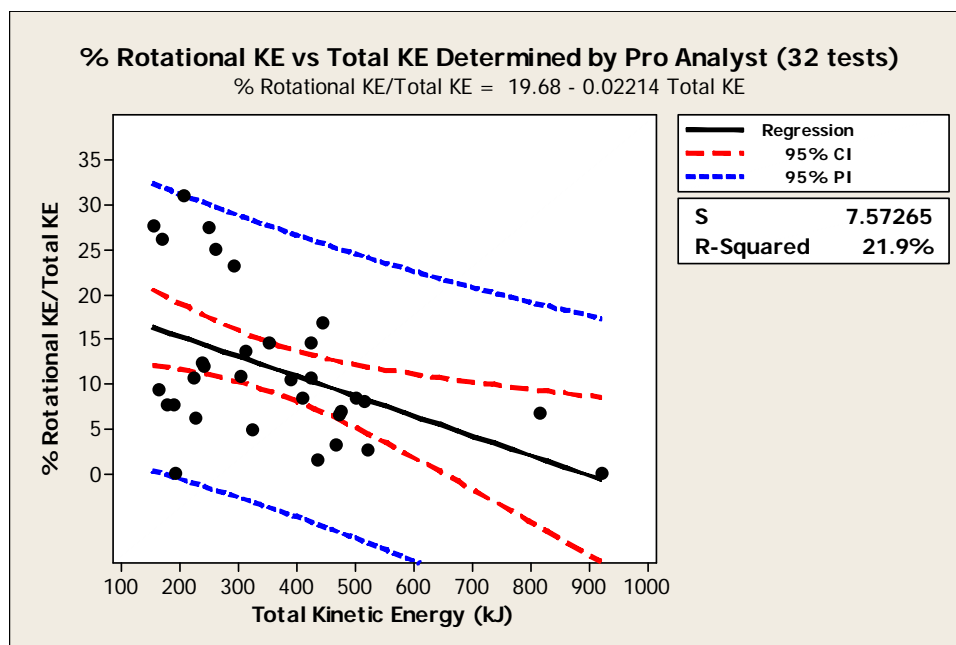
FIGURE C-4 Linear regression of percentage of rotational kinetic energy to total kinetic energy determined for 32 tests by applying ProAnalyst motion-analysis software to video records.

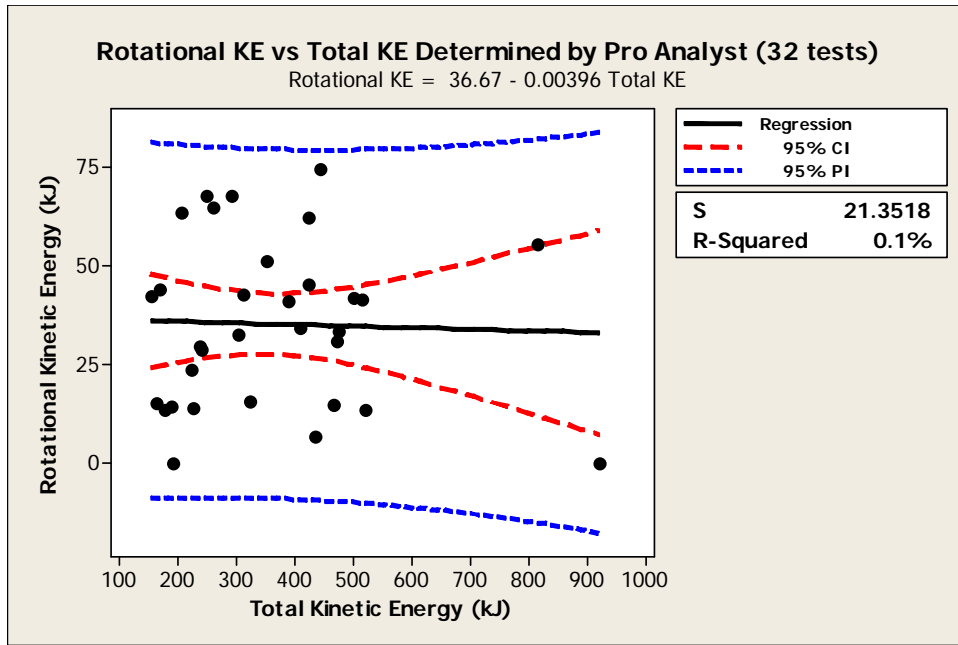
FIGURE C-5 Linear regression of rotational kinetic energy to total kinetic energy determined for 32 tests by applying ProAnalyst motion-analysis software to the video records.

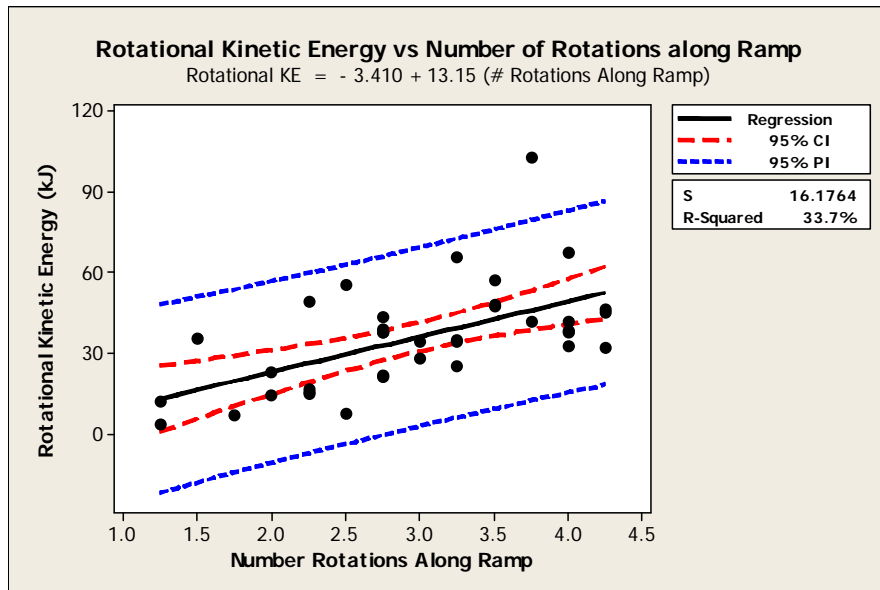
FIGURE E-1 Rotational kinetic energy estimated by visual methods versus observed number of rotations along the ramp.

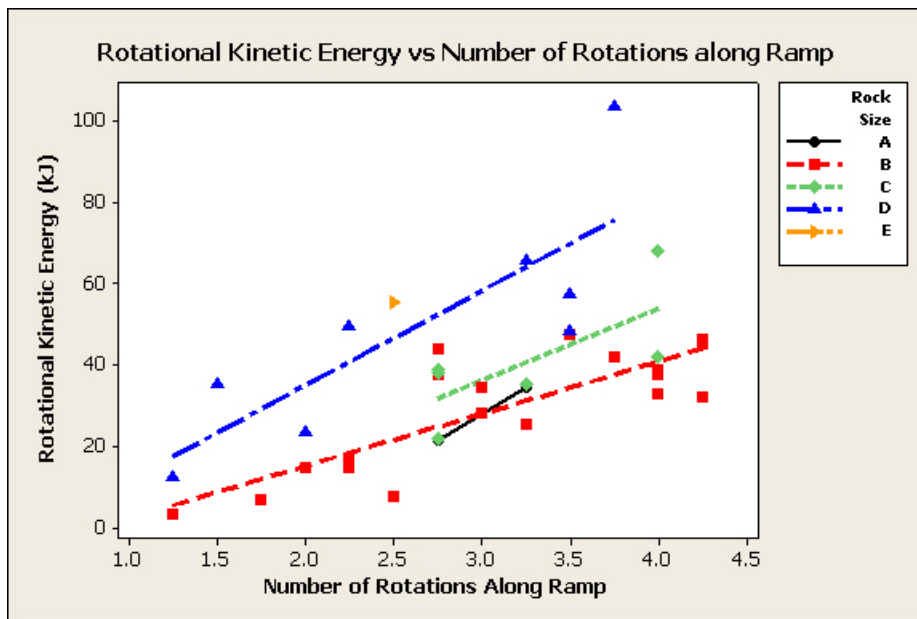
FIGURE E-2 Rotational kinetic energy estimated by visual methods versus observed number of rotations along the ramp, with subsets showing size of rock in test.

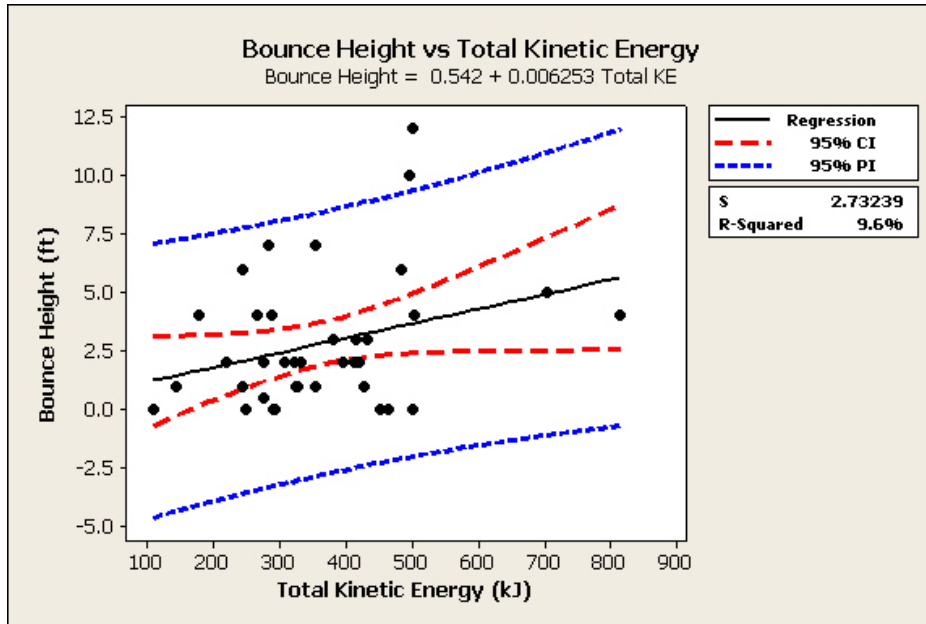
FIGURE E-3 Bounce height versus total kinetic energy estimated by visual methods.

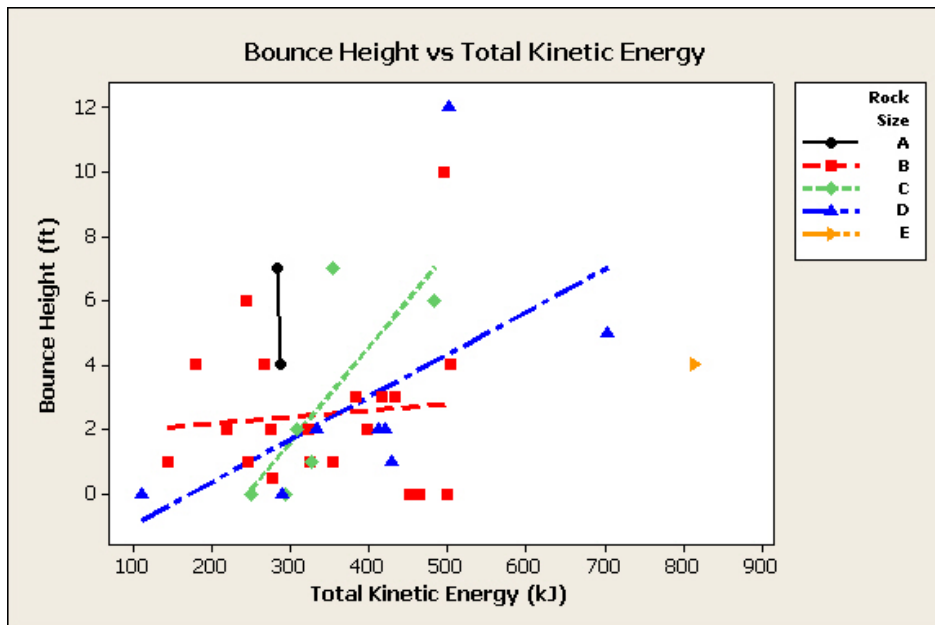
FIGURE E-4 Bounce height versus total kinetic energy estimated by visual methods, with subsets showing size of rock in test.

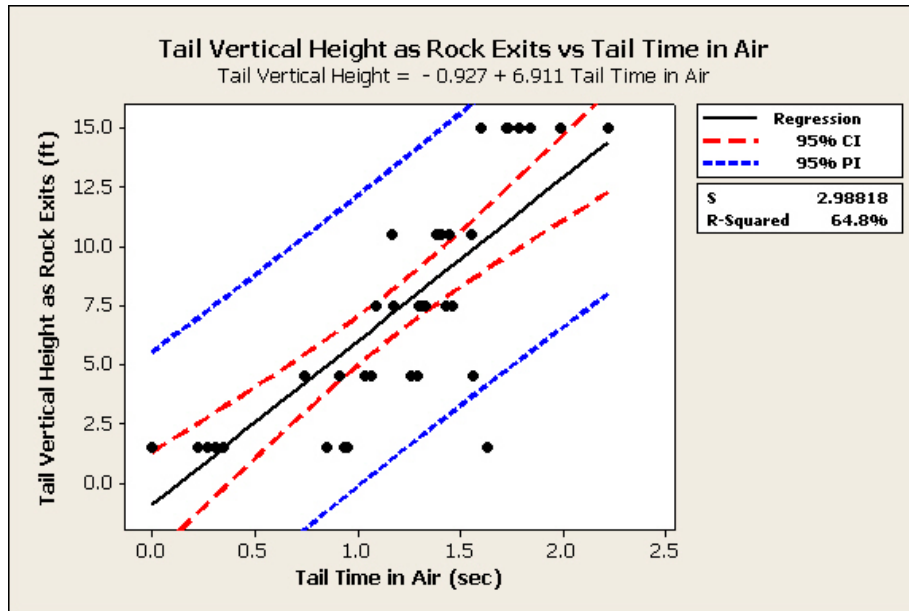
FIGURE F-1 Linear regression of panel tail vertical height as rock exits versus time in the air.

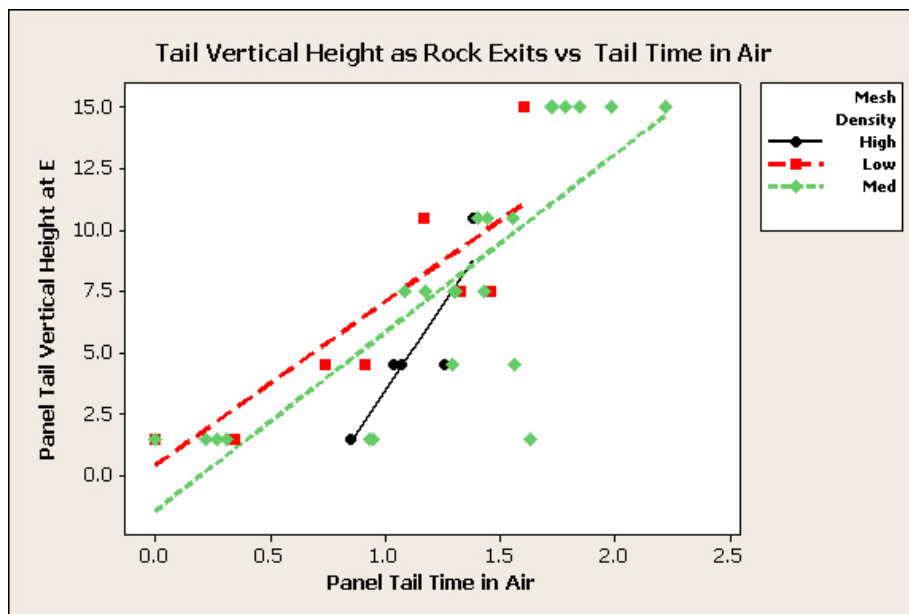
FIGURE F-2 Panel tail vertical height as rock exits versus time in the air, with subsets showing mesh densities (Low ≤ 4 kg/m²; Medium = 4-7 kg/m²; High ≥ 7 kg/m²).

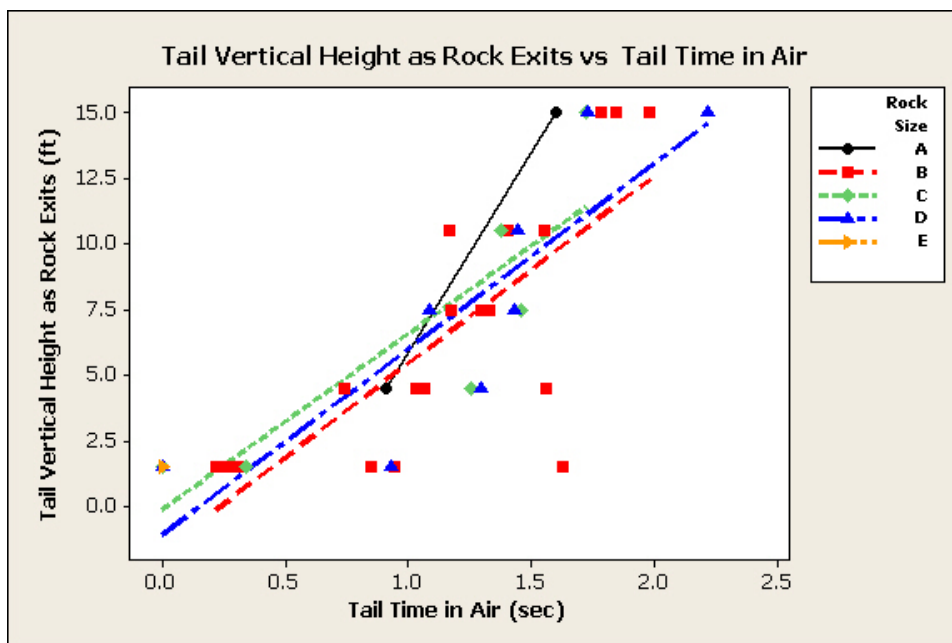
FIGURE F-3 Panel tail vertical height as rock exits versus time in the air, with subsets showing size of rock in test.

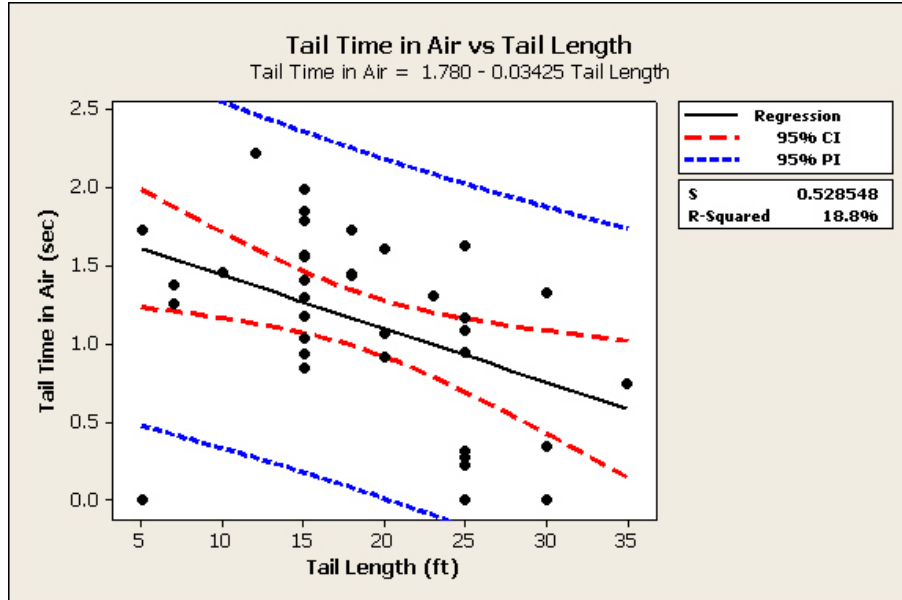
FIGURE F-4 Tail time in the air versus tail length, with subsets showing size of rock in test.

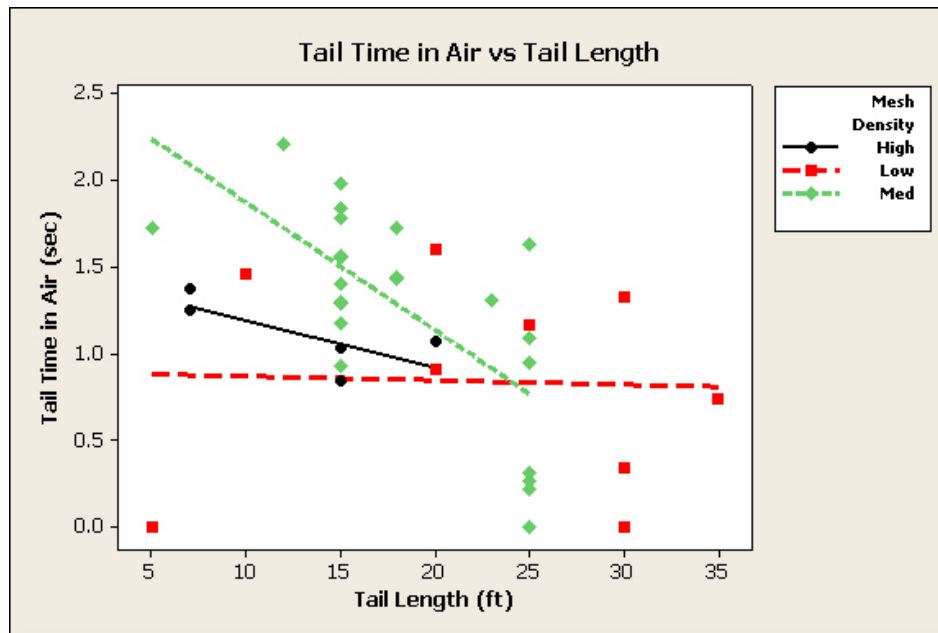
FIGURE F-5 Tail time in the air versus tail length, with subsets showing mesh densities (Low $\leq 4 \text{ kg/m}^2$; Medium = 4-7 kg/m^2 ; High $\geq 7 \text{ kg/m}^2$).

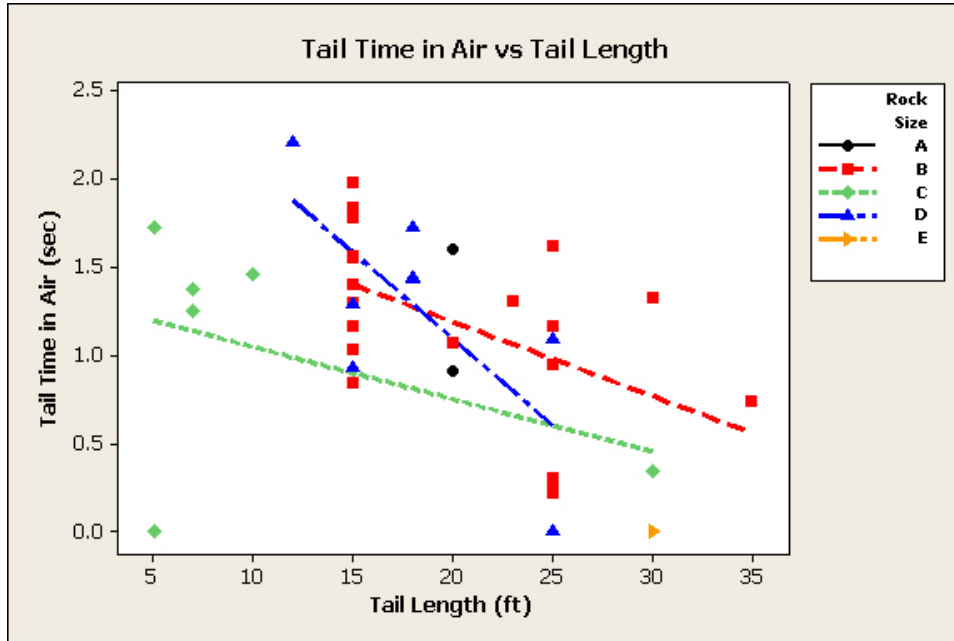
FIGURE F-6 Tail time in the air versus tail length, with subsets showing size of rock in test.

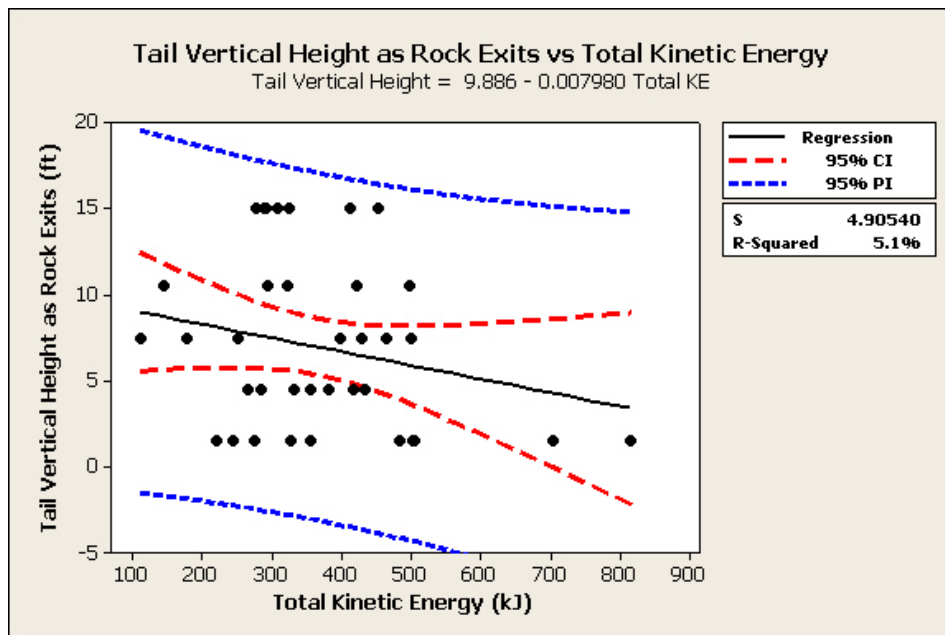
FIGURE F-7 Tail vertical height as rock exits versus total kinetic energy(est. by visual methods).

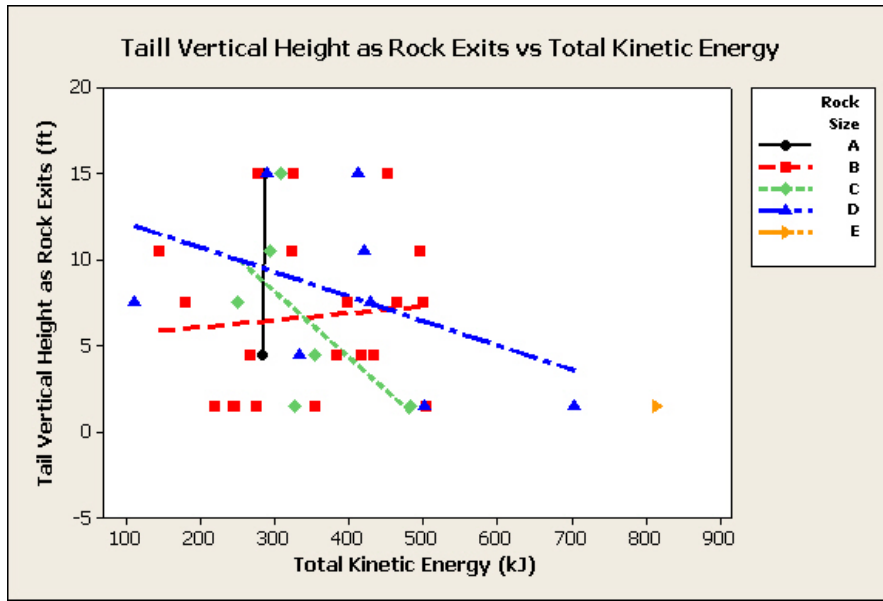
FIGURE F-8 Tail vertical height as rock exits versus total kinetic energy (est. by visual methods), with subsets showing size of rock in test.

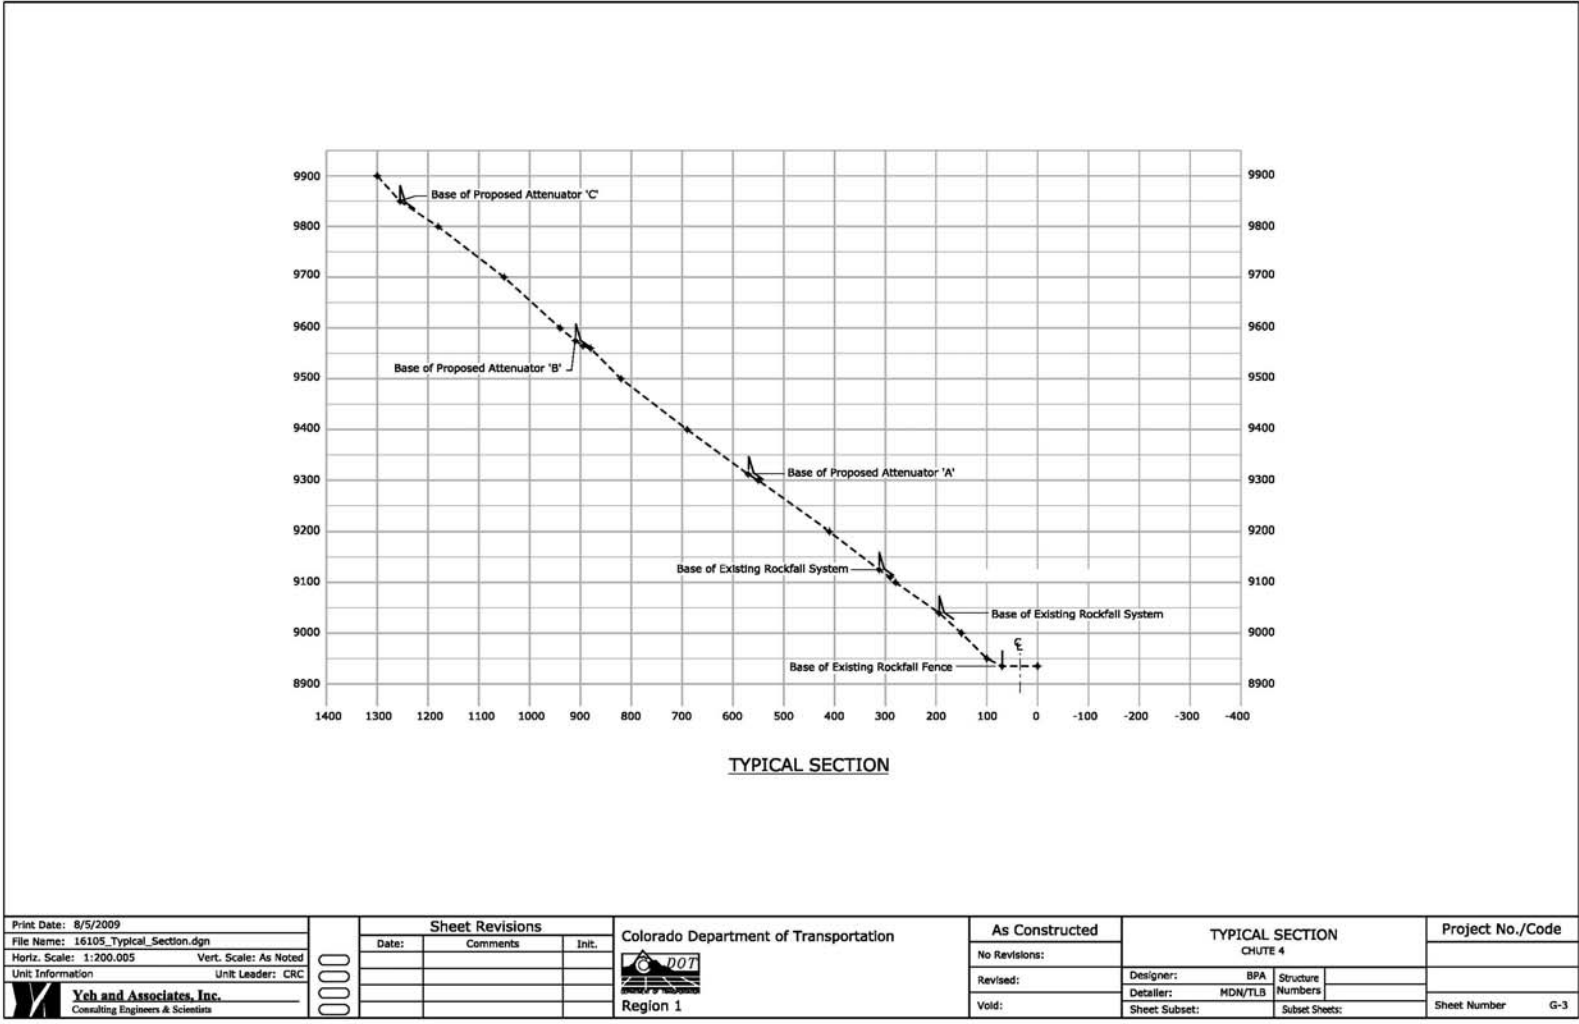
FIGURE G-3 Typical section through Chute 4 (principal rockfall location being mitigated).

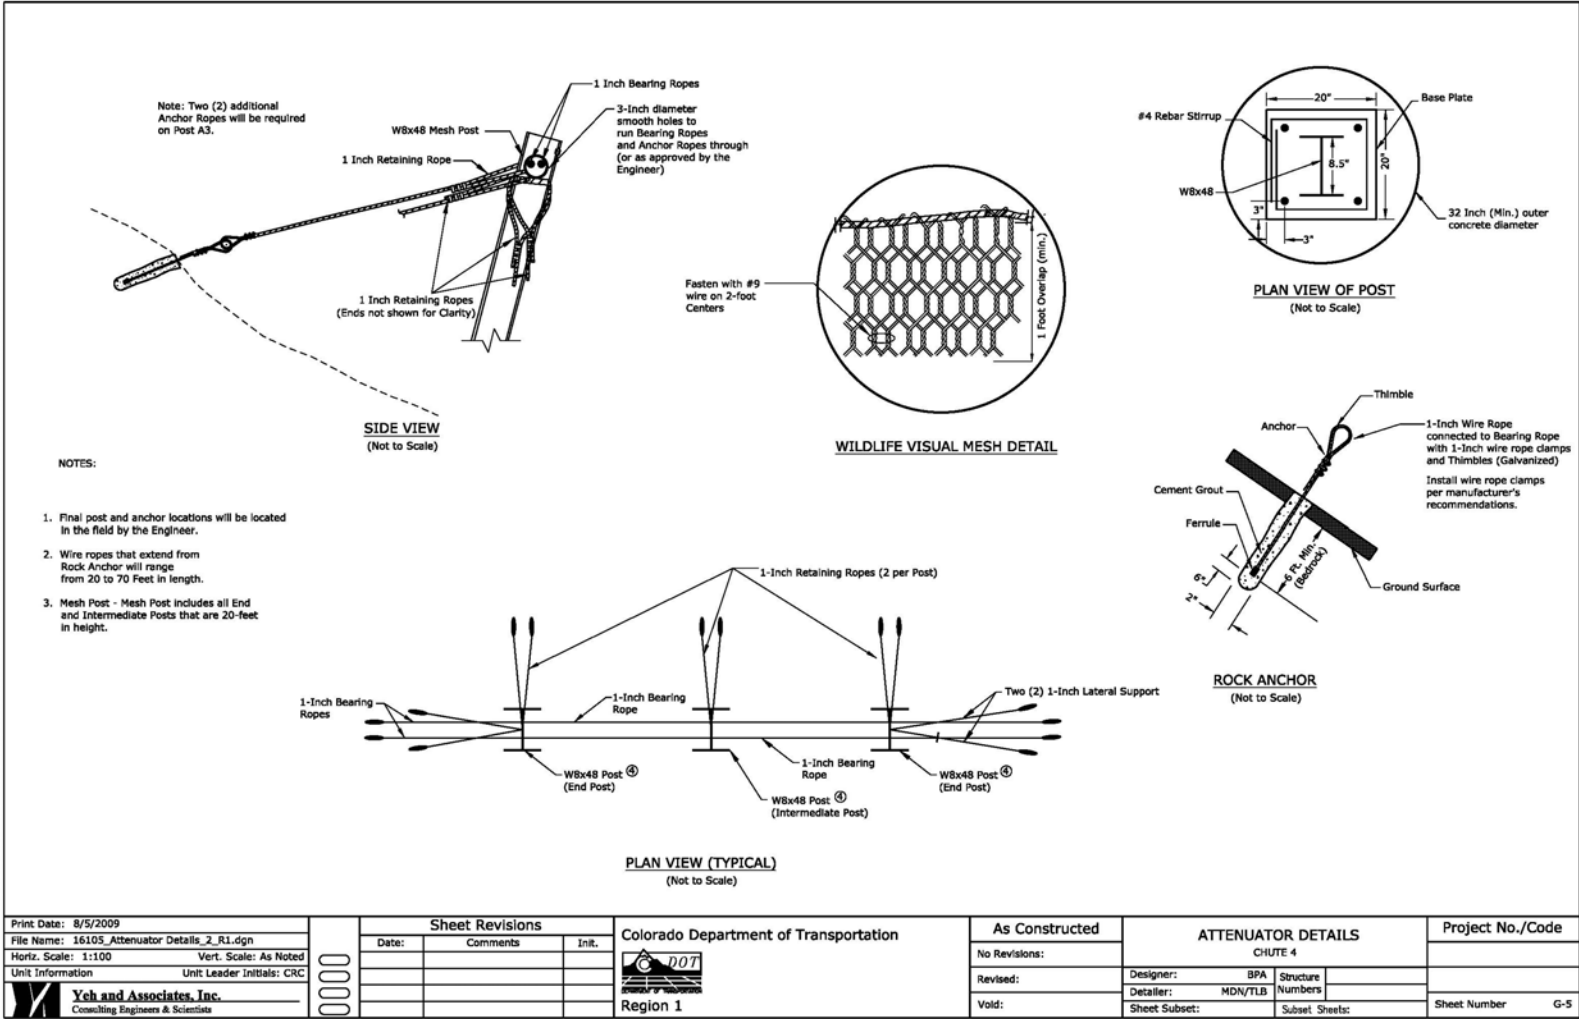
FIGURE G-5 Components used in attenuator installation.
