NCHRP SYNTHESIS 393

**Adjacent Precast Concrete Box Beam Bridges:
Connection Details**

A Synthesis of Highway Practice

CONSULTANT
HENRY G. RUSSELL
Henry G. Russell, Inc.
Glenview, Illinois

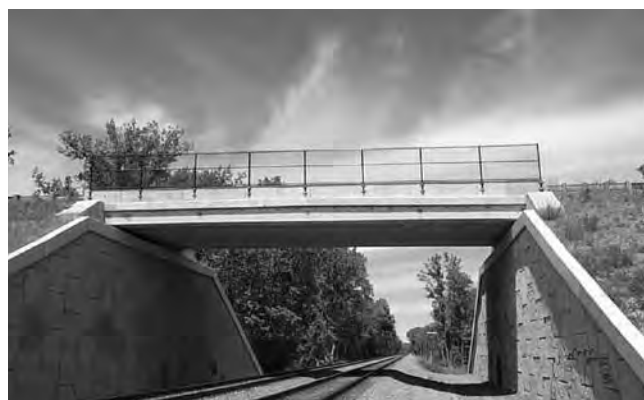
FIGURE 1 Single-span box beam bridge over railroad (Source: New York State DOT).

Bridges built with adjacent precast, prestressed concrete box beams are a common and economical solution in many states, because they can be constructed rapidly and deck forming is eliminated. The bridges may be single span as shown in Figure 1 or multiple spans as shown in Figure 2. They have proved to be economical for major river crossings, such as shown in Figure 3. Although this bridge resembles an arch, the superstructure consists of adjacent precast, prestressed concrete box beams.

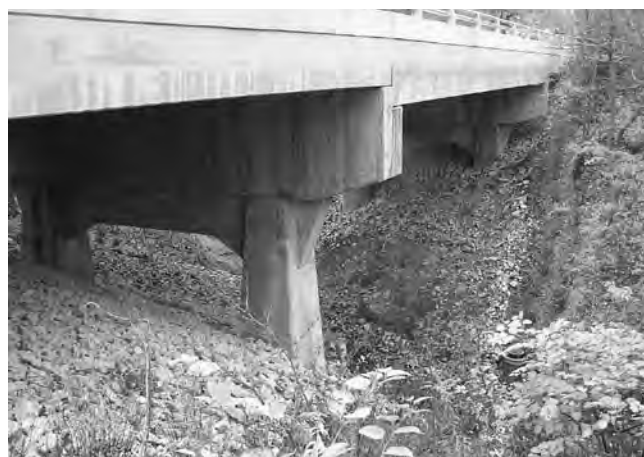
FIGURE 2 Three span box beam bridge over a ravine (Source: Illinois DOT).

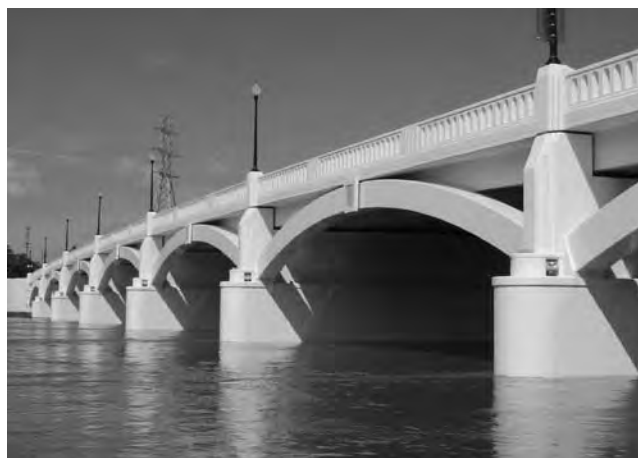
FIGURE 3 Adjacent box beam bridge to replicate an arch bridge (Source: Henry G. Russell).

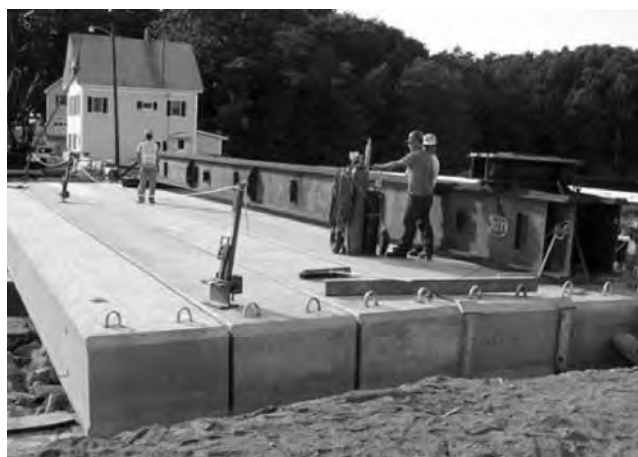
FIGURE 4 Adjacent box beams used for the superstructure of the Davis Narrows Bridge, Maine (Source: Maine DOT).

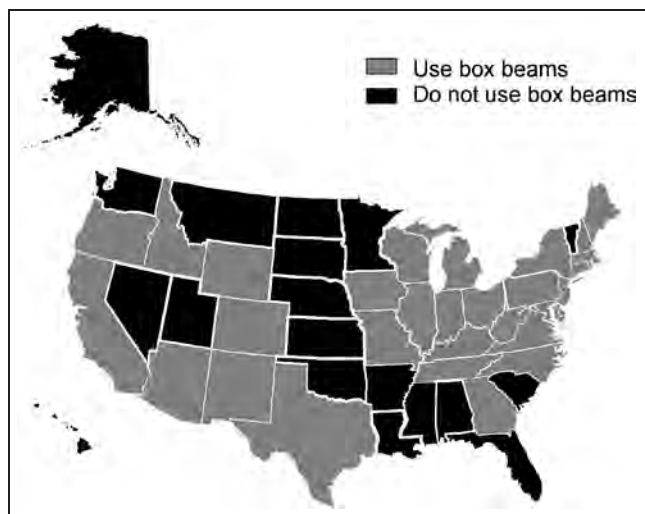
FIGURE 5 Usage of box beam bridges by state.

Fifty-eight complete responses were received, including 21 from owners who do not use adjacent box beam bridges. A follow-up was made with those states that did not respond to determine whether they used box beams. The usage by state highway agencies is illustrated in Figure 5. In subsequent chapters, the information from the survey is summarized as state responses and total survey responses. In some cases, the percentages total more than 100 because more than one answer was possible, and some states reported the use of multiple practices.

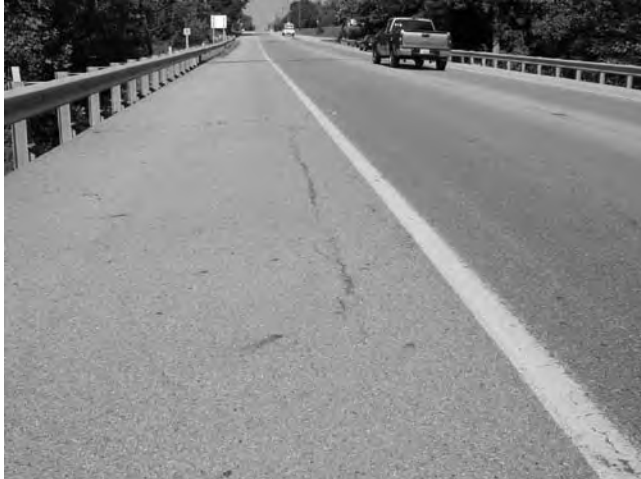
FIGURE 18 Longitudinal cracking in asphalt riding surface (Source: Henry G. Russell).

The most common types of observed distress are longitudinal cracking along the grout-to-box beam interface and water and salt leakage through the joint. Reflective cracks are often visible in the riding surface, as shown in Figures 18 and 19.

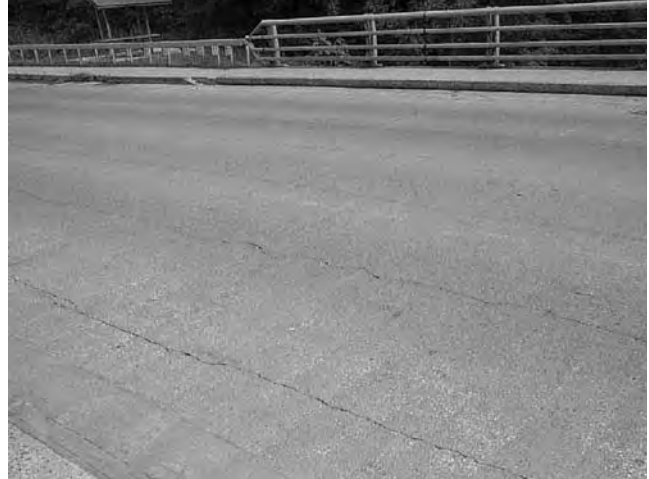
FIGURE 19 Longitudinal cracking in composite concrete deck (Source: New York State DOT).

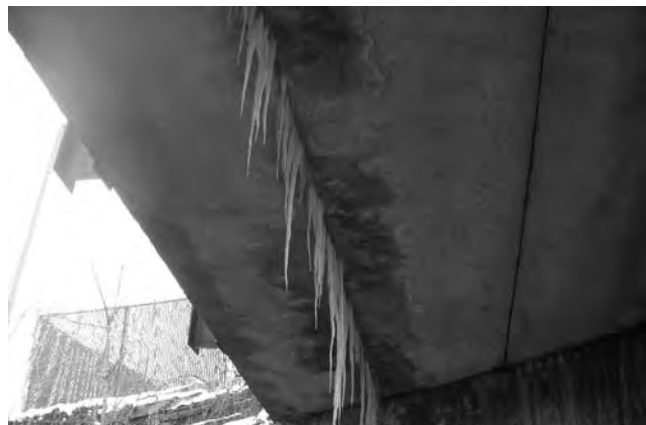
FIGURE 20 Leakage through longitudinal joints (Source: Pennsylvania DOT).

Harries (2006) reported that there does not appear to be a practical manner to assess the condition of the shear keys between adjacent beams. However, water dripping from the joints between beams during a period of rain (or icicles as shown in Figure 20) or longitudinal staining caused by water “wicking” along the beam soffit (see Figure 21) represents observable evidence that the shear key is degraded.

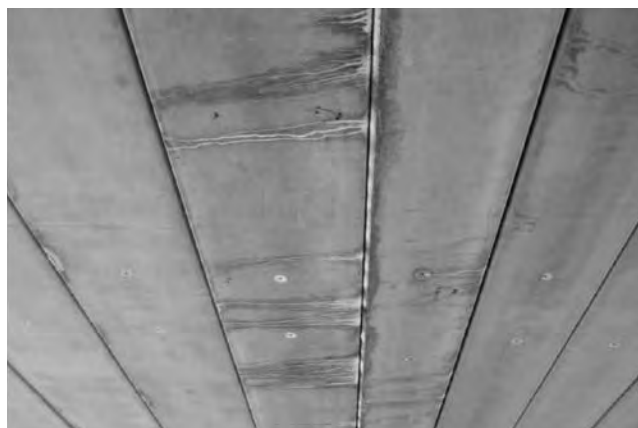
FIGURE 21 Efflorescence on the underside, indicating leakage through the joints (Source: New York State DOT).

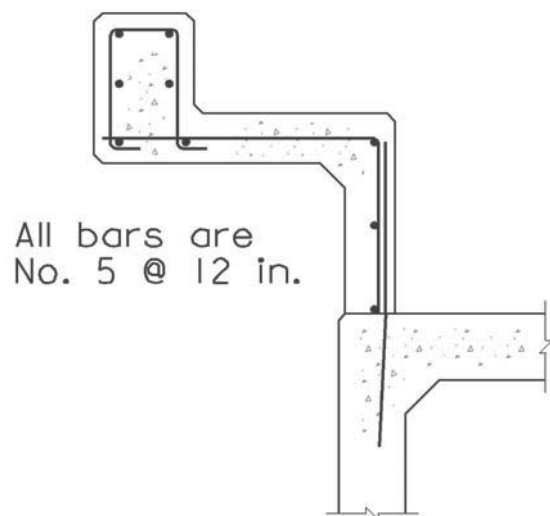
a. Concrete barrier

FIGURE C2 Selected details for barrier connections.

The following drawings were selected from the survey response to illustrate the range of connection details that are utilized. For illustration purposes, the drawings have been simplified.
