Operation of Light Rail Transit through Ungated Crossings at Speeds over 35 MPH

CHAPTER 4: MODELING/SIMULATION OF LIGHT RAIL OPERATING CONDITIONS: NORTH FIRST STREET FROM EAST BROKAW ROAD TO TRIMBLE ROAD

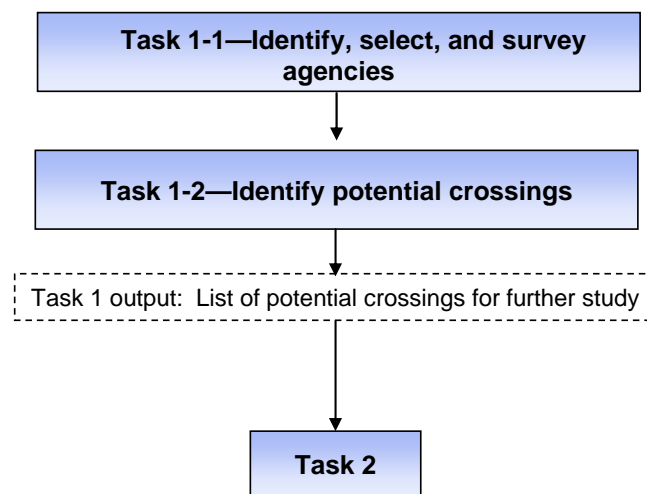
Figure 1. Subtask Flow Diagram for Task 1

Figure 1 illustrates the flow of the Task 1 subtasks, as well as the Task 1 output that will feed into Task 2. The findings from both of the Task 1 subtasks are discussed in more detail below.

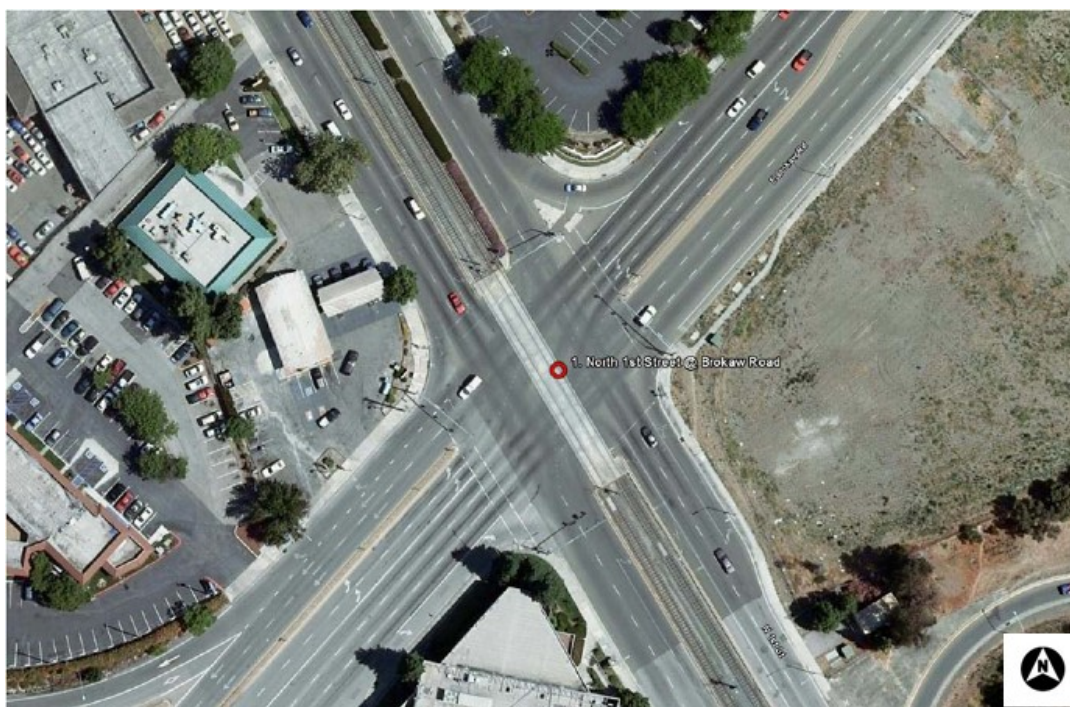
Figure 4. Aerial View of North First Street and Brokaw Rd.

Figure 4, Figure 5, and Figure 6 show the geometry of the three study sites using aerial imagery.

Table 5 summarizes the general geometric characteristics of the three study intersections. The designs of the study intersections, in general, provide separate lanes for the different movements (left-turn, through, right-turn). Two of the intersections are at right angles, with the intersection at Brokaw Rd. being at a slight skew (approximately 75 degrees). The intersection designs provide sufficient sight distance for all four approaches to each of the three intersections.

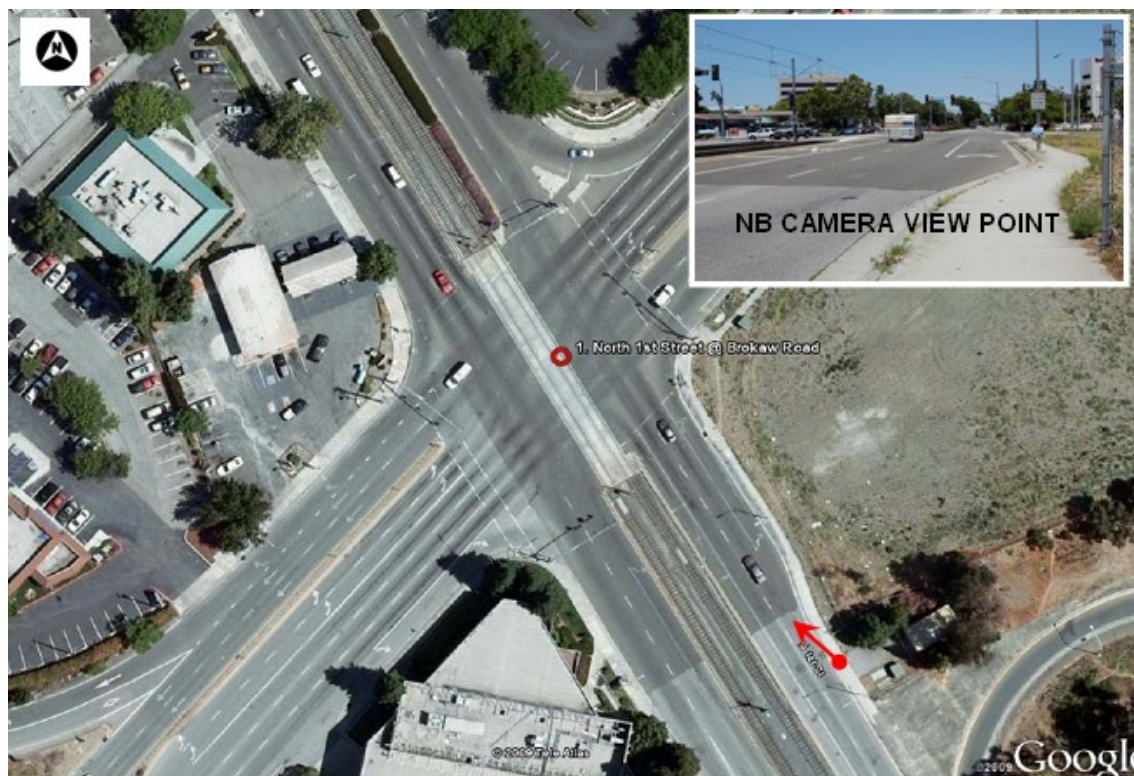
Figure 7. North First Street at Brokaw Road

Cameras were set up at approximately 200-250 feet in advance of the curb line of the intersection. This allowed the camera to capture all vehicular, pedestrian and light rail movements on the North First St. approaches, as well as observing the cross-street movements. At Brokaw Rd. and Trimble Rd., cameras were set up to on the northbound approaches to the intersections. At Charcot Ave., cameras were set up on both the northbound and southbound approaches to the intersection. Cameras were also positioned to capture the through and left-turn signal indications. Figures 7 through 9 show the placement, orientation, and capture area of the cameras at Brokaw Rd., Charcot Ave., and Trimble Rd., respectively.

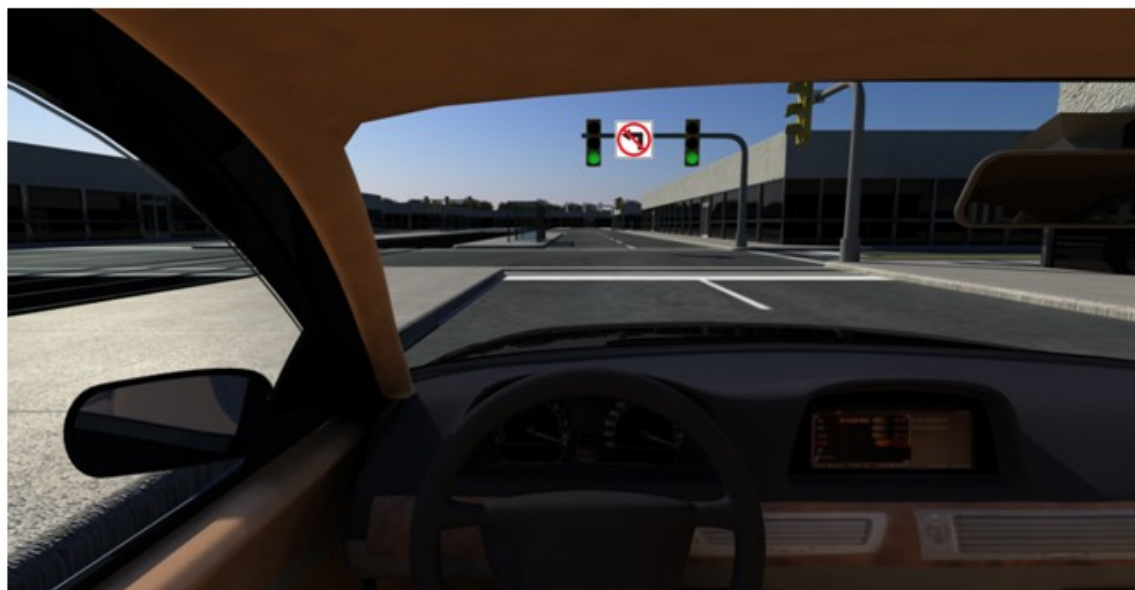
10a. (R3-2)

Participants were shown 27 different simulated scenes from the driver’s perspective in an automobile. The No Left Turn Allowed Scenario is illustrated in Figure 10. In this scenario, participants were told that the driver was traveling parallel to a light rail line and needed to turn left at the first intersection where a left turn was allowed. Under this scenario, participants were shown eight different scenes. In each scene, the left-turn movement was restricted at the intersection, and a passive sign was provided to indicate this restriction to drivers. However, the scenes varied in terms of whether the through movement had circular green or green arrow displays and the type of sign present (three different signs were used, as shown in Figure 10).

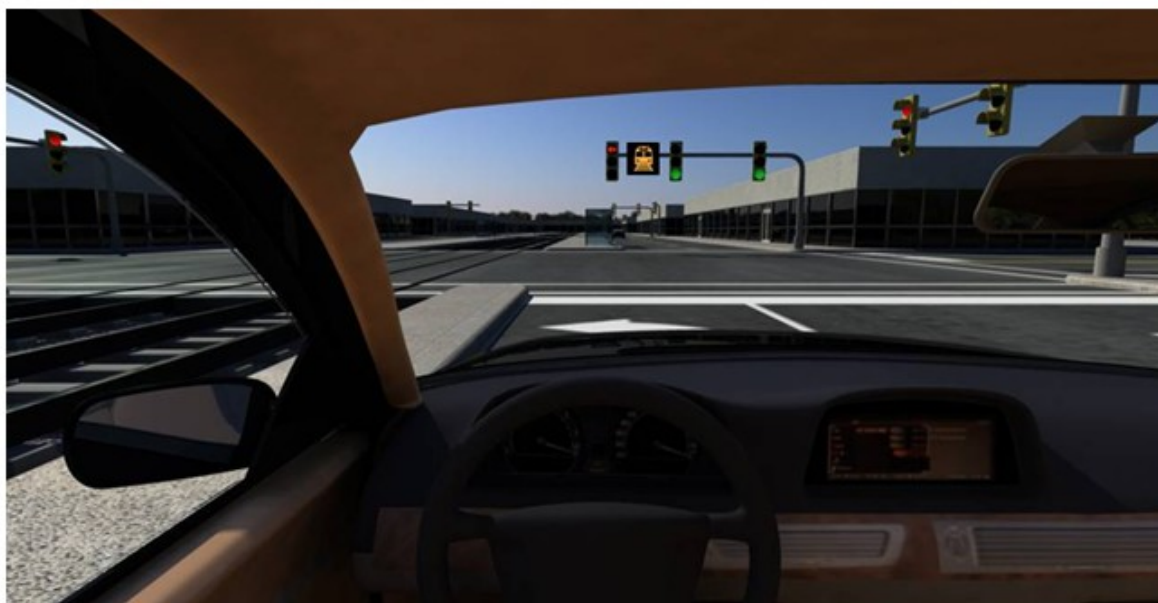
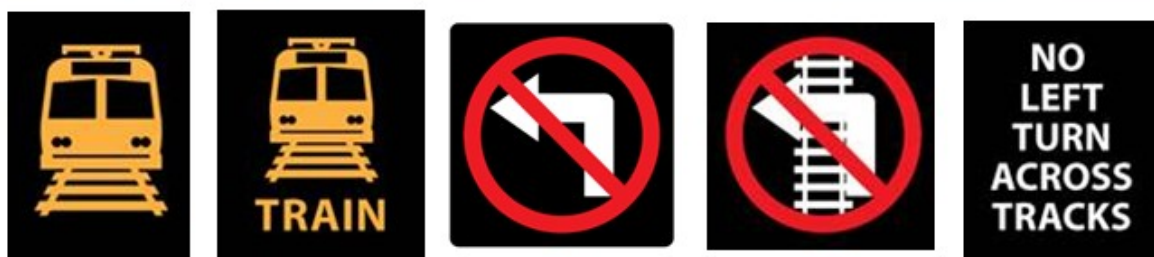
11a. (W10-7)

The Left Turn Allowed Scenario is illustrated in Figure 11. In this scenario, participants were also told that the driver was traveling parallel to a light rail line and needed to turn left at the first intersection where a left turn was allowed. Under this scenario, participants were shown ten

different scenes. In each scene, a left turn was allowed at the intersection, and an active blank-out warning sign was provided to indicate to the driver if a train was approaching. However, the scenes varied in terms of whether the left-turn movement had the green or red arrow signal display, whether the through movement had circular green displays or green arrow displays, whether a train was approaching, and the type of active blank-out sign present (five different activated blank-out signs were used, as shown in Figure 11).

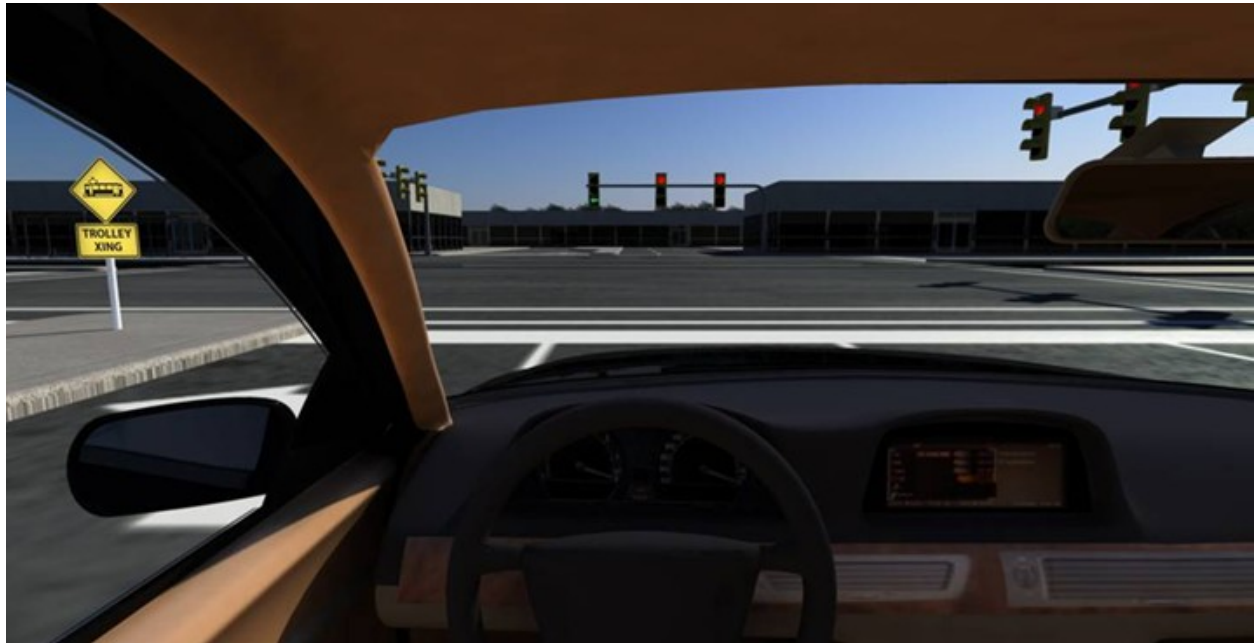
The Cross-Street Scenario is illustrated in Figure 12 and Figure 13. In this scenario, participants were told that the driver was traveling on a street running parallel to a light rail line and needed to go through the intersection, crossing over the tracks. Both through movements and left-turn movements were allowed at the intersection shown in this scenario; however, the car was positioned in a through lane. Under this scenario, participants were shown nine different scenes. In each scene, some form of warning sign was present, whether it be passive, active, or both. The scenes varied in terms of whether the left-turn movement had a green or red arrow signal display, whether the through movement had green or red signal displays, whether a train was approaching, and the type of passive and active traffic control devices that were present (two different passive signs were used—a trolley crossing warning sign and the R15-7 regulatory sign,

Figure 12. Cross-Street Scenarios with Various Combinations of Traffic Signal Displays and Two Different Passive Signs (Trolley Crossing Warning and R15-7)

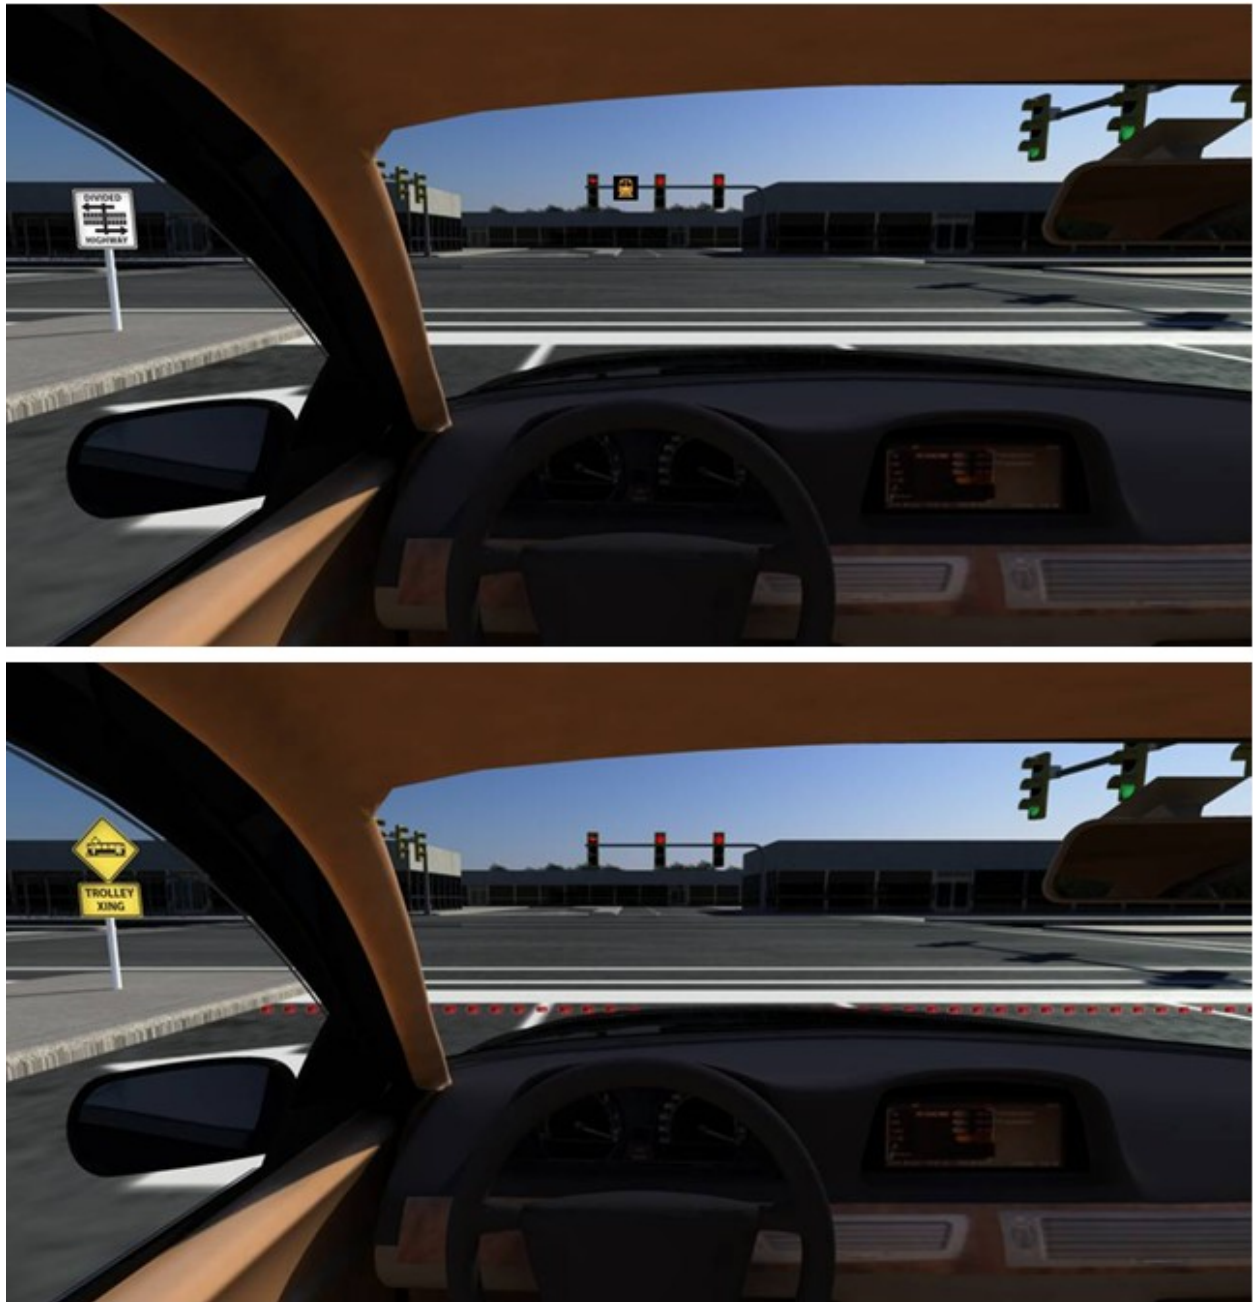
as shown in Figure 12—and two different active devices were used—the W10-7 sign (shown in the top picture of Figure 13) and in-pavement lights (shown in the bottom picture of Figure 13).

Figure 13. Cross-Street Scenarios with Various Traffic Signal Displays and Two Different Types of Active Traffic Control Devices (W10-7 Sign and In-pavement Lights)

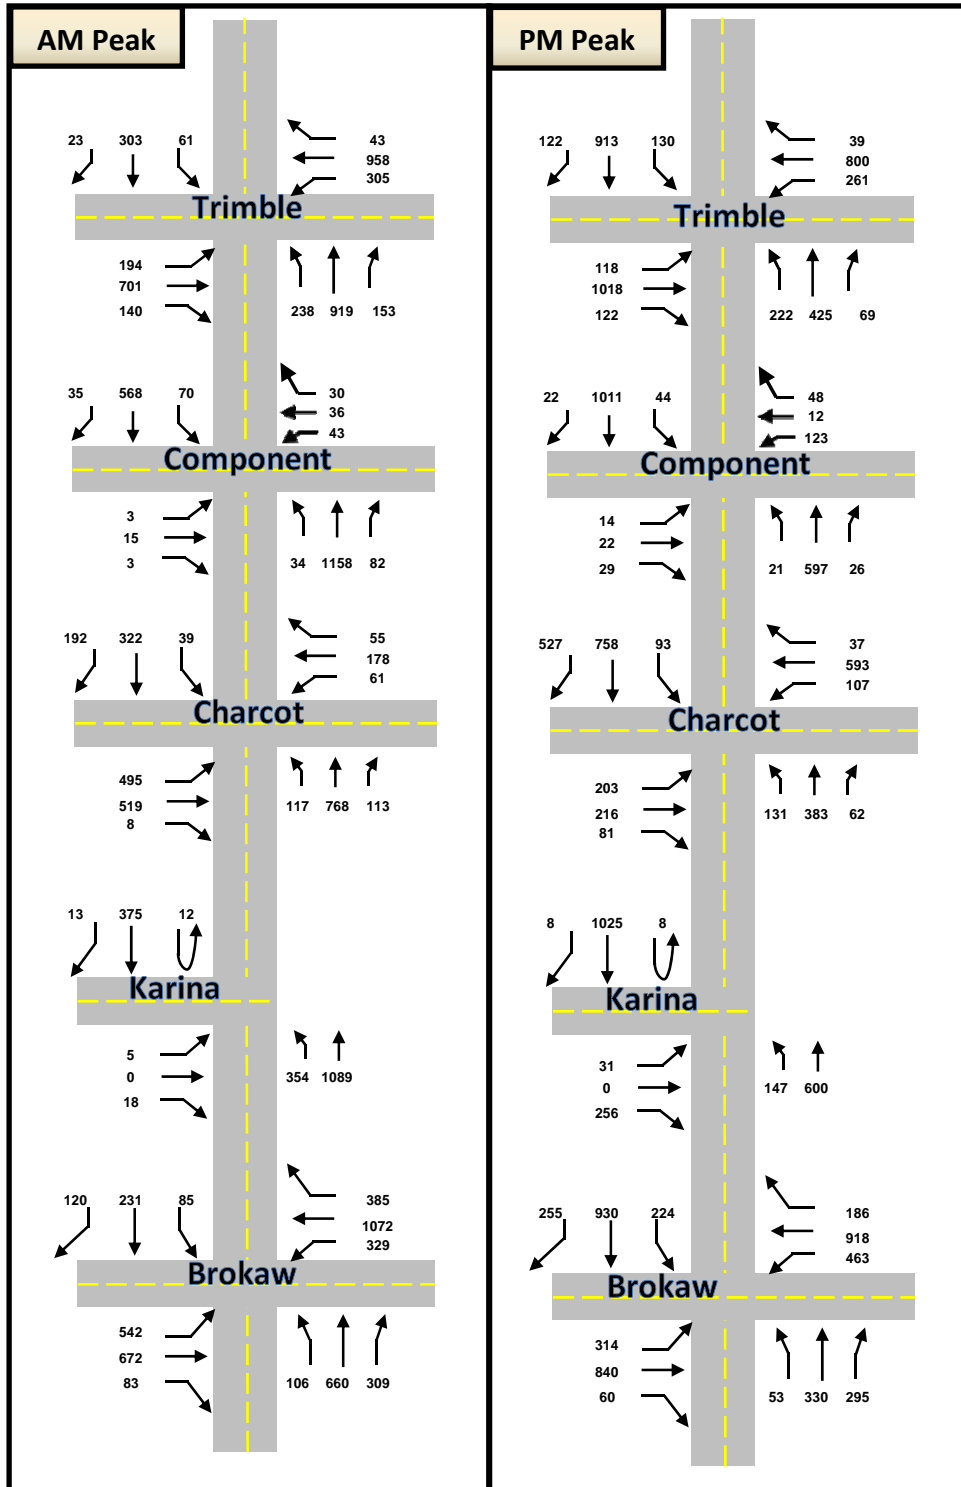
Figure 15. Volume Balanced Networks

Routing decision points were placed at the origin links and destination links to define the vehicle routing. These routes are static in this model, meaning vehicles are routed from a starting point to a defined destination point using a static percentage for each destination. In order to allow for

adequate lane changing distance, the routing decisions were placed according to the observed driver behavior in the model, and adjusted so that vehicles had adequate time to make the decision to change lanes to reach their desired destination. Because origin-destination data was not obtained, as it is not crucial to the purpose of this study, routing decisions were placed following each intersection, so that all of the source links feed the destination links proportionately.

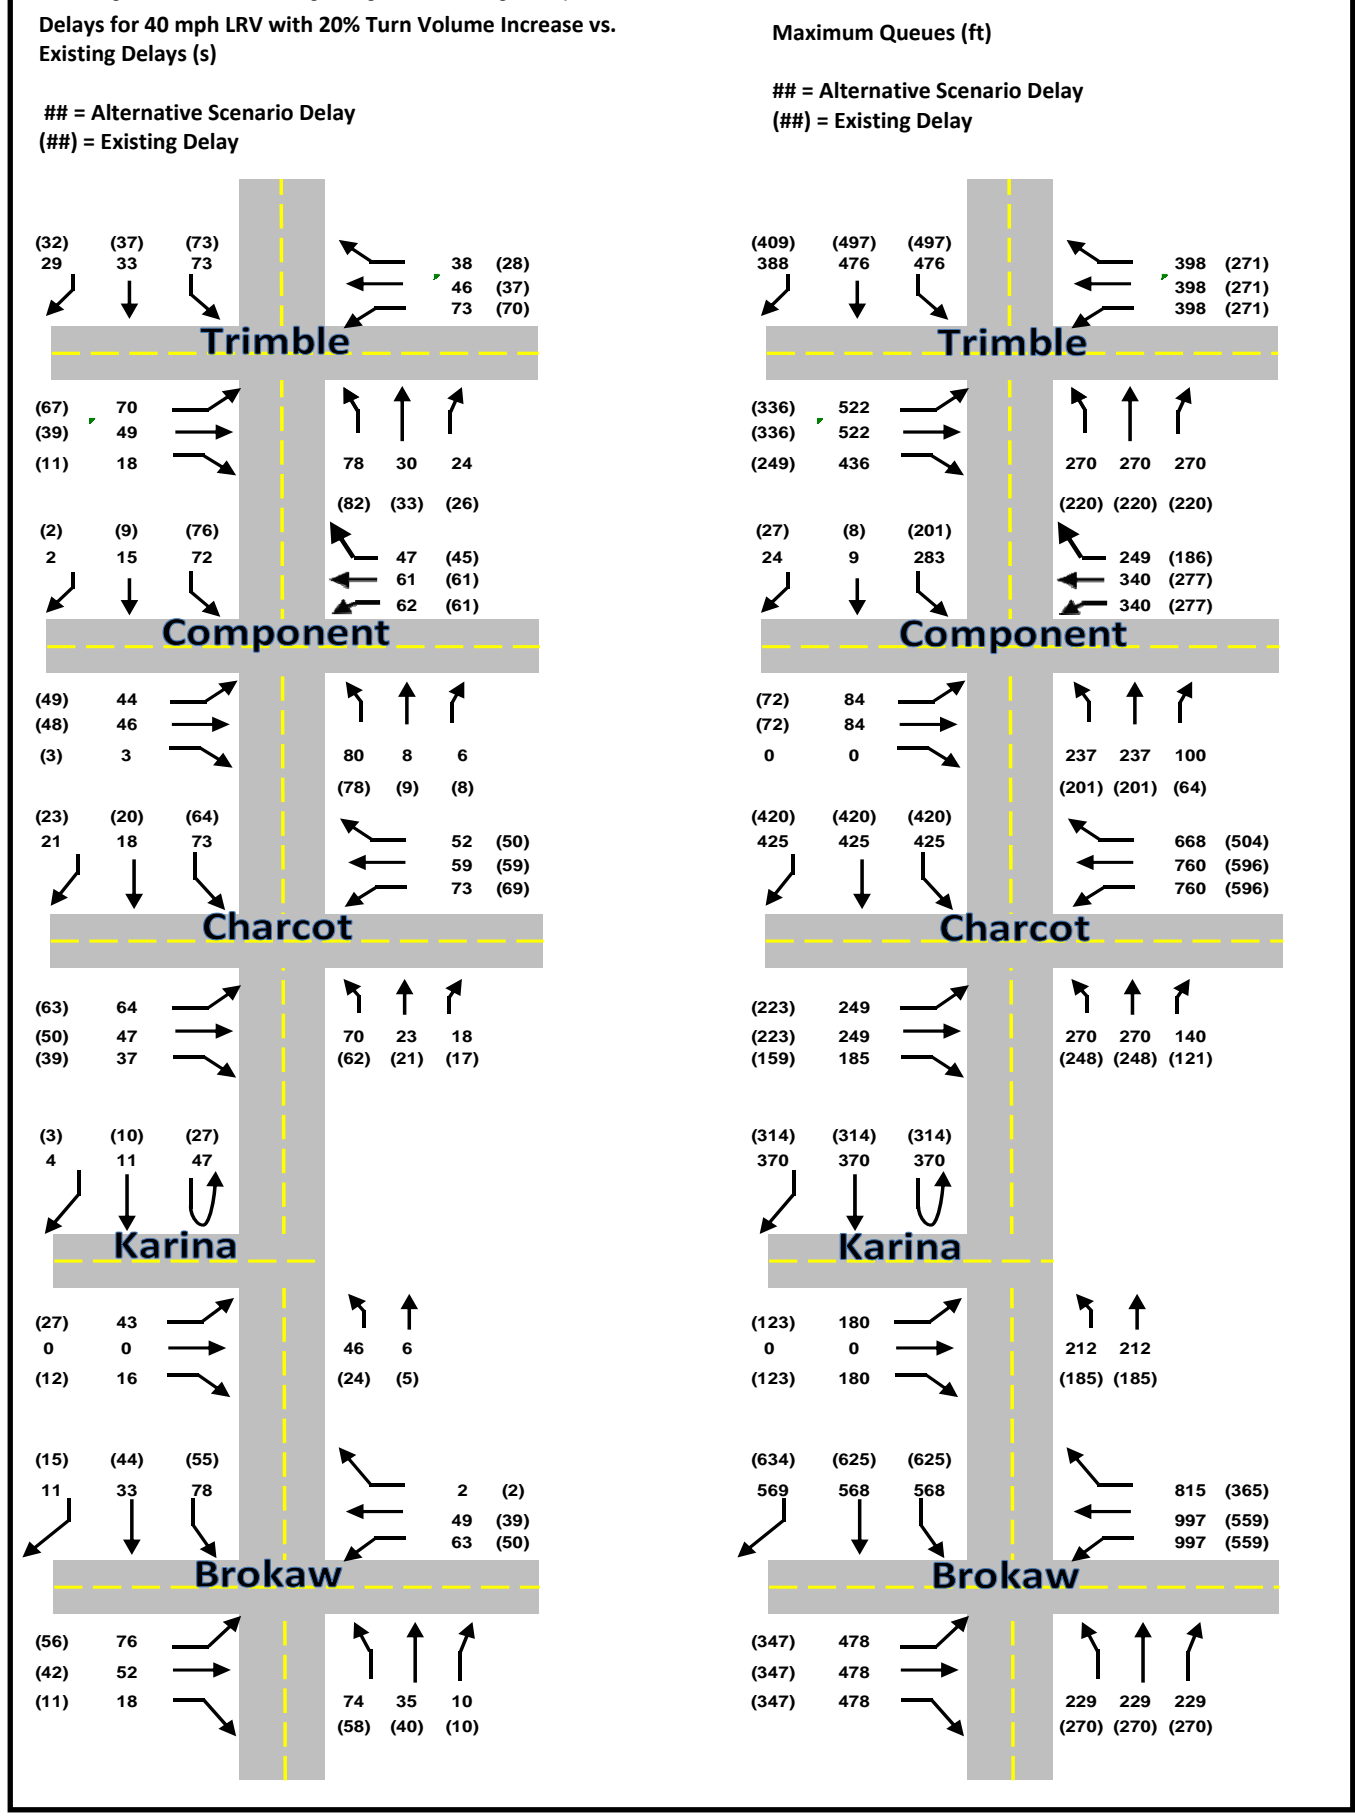
Figure 30. PM Peak Delays and Queues for Scenario with 45 mph LRV and 20% Turning Volume Increase vs. Existing Conditions
