SHRP 2 REPORT S2-R06D-RW-4

Nondestructive Testing to Identify Delaminations Between HMA Layers

Volume 4

Phase 2 of the SHRP 2 R06D research project for stress wave detection of delaminated (debonded) asphalt pavement layers focused on the use of spectral analysis of surface waves and impact echo (SASW and IE) tests to determine the condition of asphalt pavements. Olson Engineering has added four transducer wheels to the Bridge Deck Scanner (BDS) to accelerate the testing. The new system with six transducer wheels was used again on the NCAT Pavement Test Track site to verify the accuracy of the test results from the new system. Then the BDS with six transducer wheels was used to determine the conditions of asphalt pavements in Florida and Kansas.

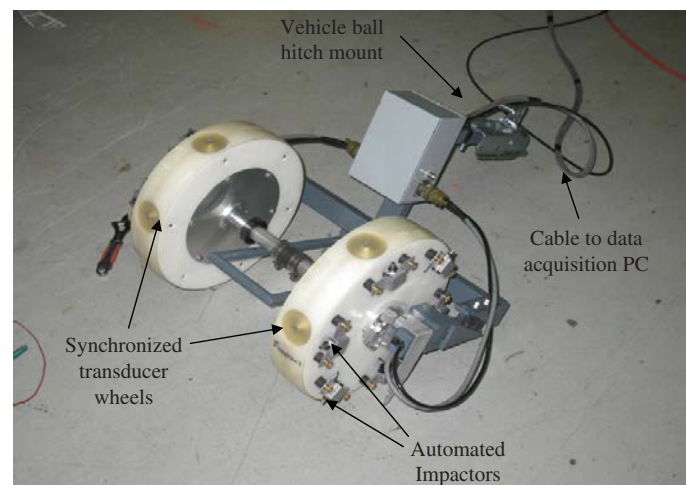
Figure 2.1. Photograph of the IE/SASW system used during Phase 1 testing.

The basic BDS two-wheel system essentially consists of two transducer wheels made of high-density polyethylene (HDP) with six embedded Olson Instruments IE sensor heads around the circumference of the wheel at 6-in. intervals to allow for tests every 6 in. The sensor heads were paired with a small steel solenoid impactor. The wheels were coupled together with a rubber isolated axle that provided alignment of both displacement transducers for SASW testing or misalignment (offset 30°) of the two wheels in the case of IE testing to make impact at both wheels for IE tests only. The system had onboard signal conditioning and was controlled by an Olson Instruments Freedom Data PC. The Freedom Data PC performed all trigger and timing functions as well as the data acquisition and the data analysis and presentation. Figures 2.1 and 2.2 show photographs of the two-wheel pair IE/SASW scanner in use during Phase 1 testing at the test track.

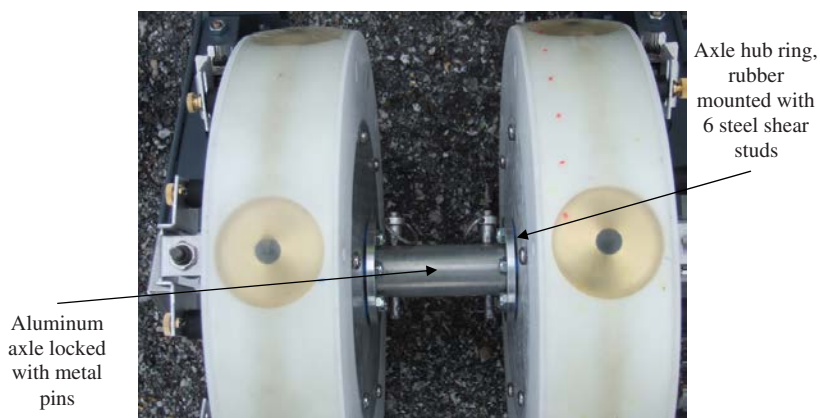
Figure 2.3. Current IE/SASW scanning system, showing new axle configuration and 6-in. transducer spacing shown inline for SASW testing (offset for alternating IE testing).

The major upgrade implemented to the IE/SASW scanning system was the expansion from a single pair of two wheels to three separate wheel pairs for a total of six wheels. The decision to expand to six measurement wheels was made when the testing plan was to perform IE testing on 2-ft spacings to cover a full 12-ft lane width in a single pass, leaving 1 ft of space on either side. However, as described above, through additional analysis, recommendations by the research team, and additional laboratory testing, the optimal test configuration for asphalt pavement delamination detection was determined to be IE/SASW with a 6-in. displacement transducer spacing, as shown in Figure 2.4. With a spacing of 2 ft between each pair of wheels, it would require five or six pairs of wheels to provide full coverage of a single 12-ft lane. Therefore, when testing was conducted at the Florida and Kansas test sites, two passes were performed to cover the full lane width. Additional expansion of the system could be completed in the future to eliminate the need for two passes.

The additional four measurement wheels (two pairs) were constructed to be nearly identical to the original pair of transducer wheels. This construction included six IE/SASW transducers per wheel evenly spaced around the circumference at 6-in. intervals, six impactor solenoids, and electronic circuitry for signal conditioning, solenoid firing, and data acquisition triggering. As the four new wheels were built, a few slight modifications were made to improve the design: a lip of the HDP wheel was added to secure the urethane tire (which previously had slowly rolled off the transducer wheel on long scans) and a variable attenuator circuit was added to the signal conditioning to allow the signal to be reduced in voltage amplitude to avoid

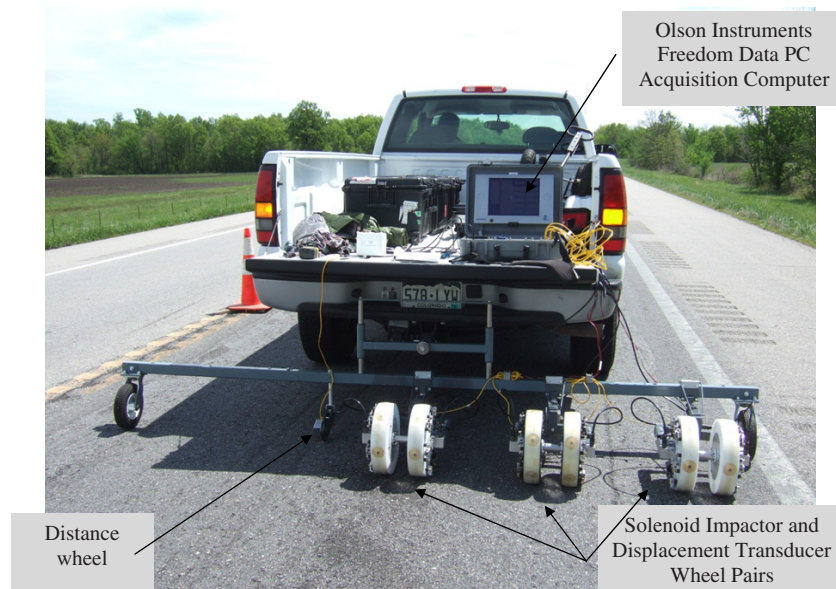
Figure 2.4. Current IE/SASW scanning system, showing the SASW test setup of 6-in. transducer spacings with distance of 2 ft between pairs.

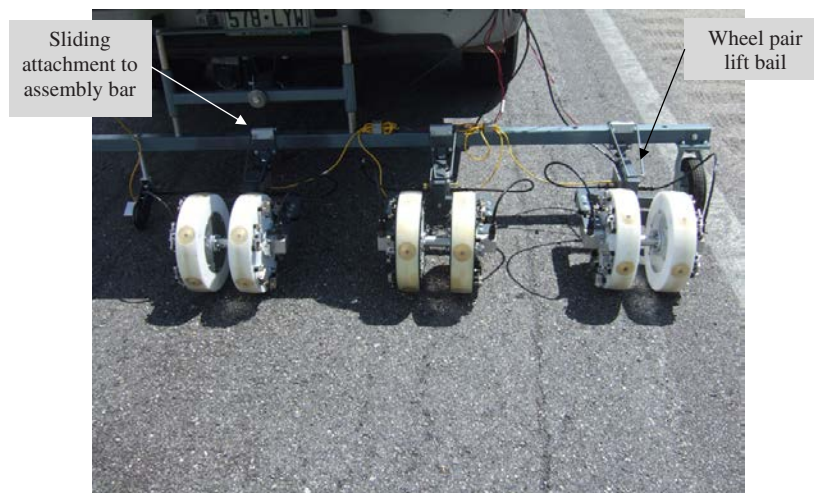
Figure 2.6. Current IE/SASW scanning system, showing the sliding connection system and lift bails.

Several other miscellaneous upgrades were also completed to improve the ease of use, ease of setup, and simplicity. For instance, the assembly of the wheel-pair carriage was simplified and redesigned to make it easier and quicker to assemble. The towing assembly mounted to the truck was also slightly altered, adding more pin (rather than bolted) connections to ease field assembly (see Figure 2.5). The attachment of the wheel pairs to the towing assembly was changed to a clamping attachment that could slide on the towing assembly bar, creating endless configuration possibilities. Lift bails were added to the towing assembly to allow the transducer wheels to be picked off the asphalt surface to back the system up or reposition the truck with greater ease (see Figure 2.6). The

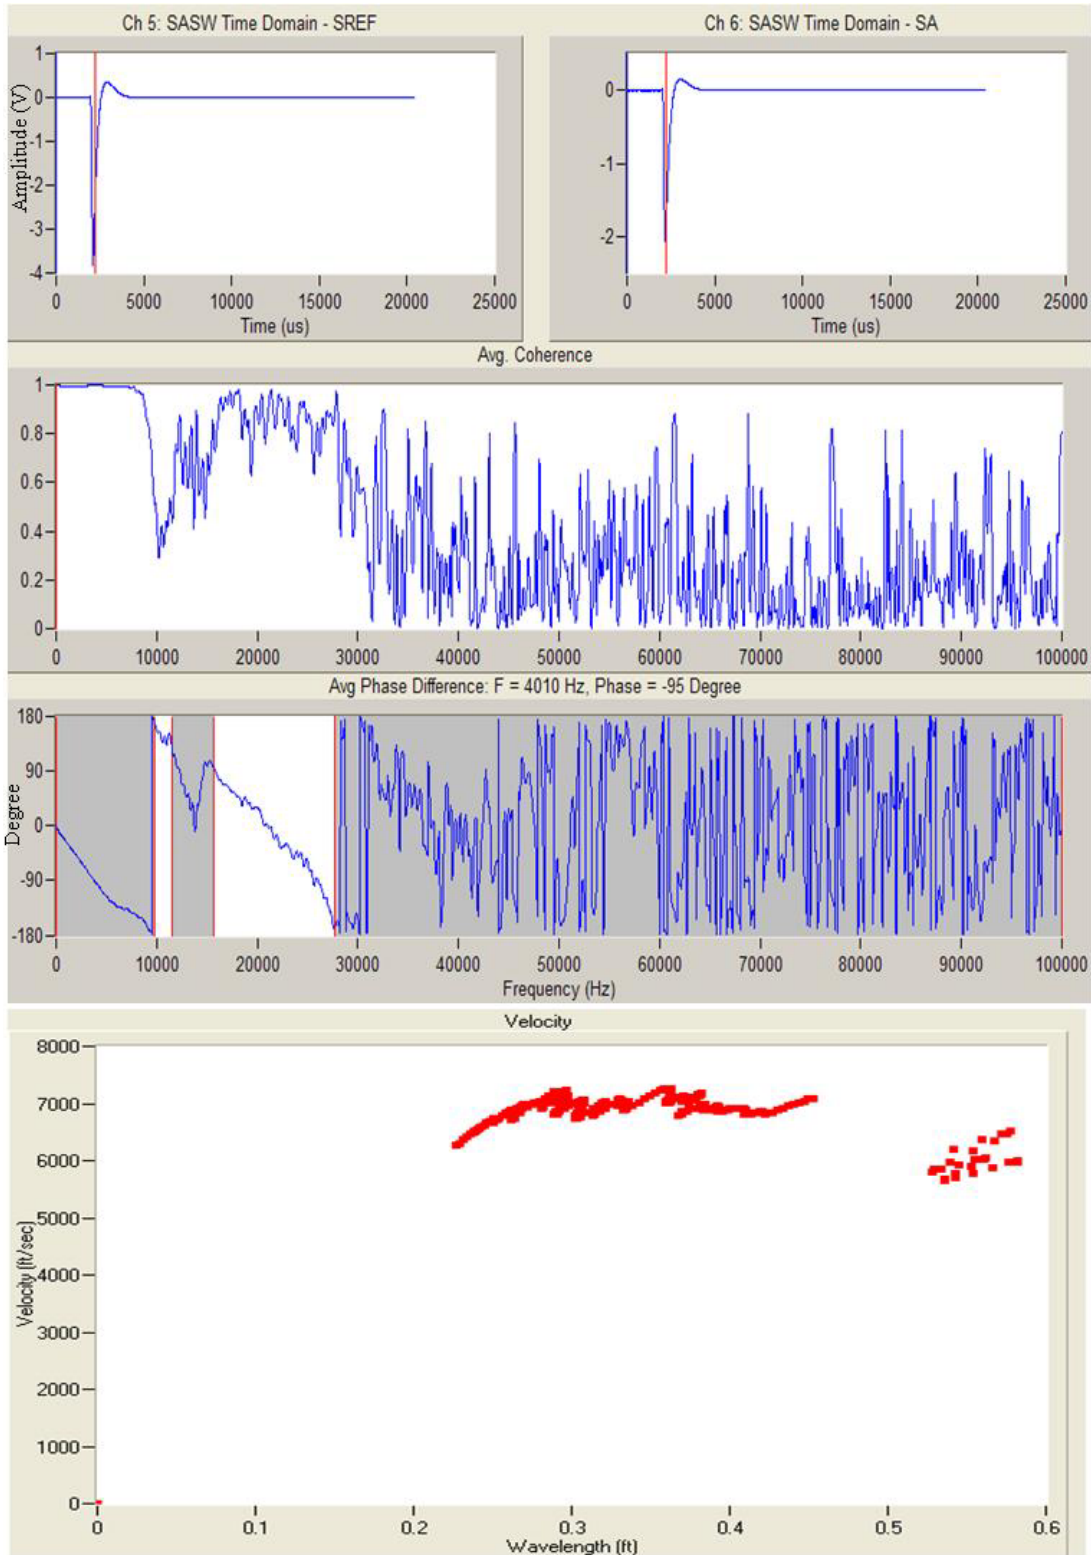
Figure 2.9. Example SASW data processing from noncontact microphones from NCHRP IDEAS BDS research.

In the NCHRP IDEAS BDS research, SASW tests were conducted with two of the same microphones that were used as noncontacting transducers. The distance between the two microphones was 4 in. (10.1 cm), and a solenoid impactor was used as an impact source. The microphones were mounted 3 in. (7.6 cm) above the concrete slab, and the source was located between 8 and 18 in. (20.3 and 45.7 cm) away from the closest microphone. Good-quality SASW data (top trace in Figure 2.9) with a good coherence up to 10,000 Hz (second trace from top in Figure 2.9) was captured by both microphones. The SASW data shown in Figure 2.9 were exponentially windowed after the large amplitude surface wave pulse traveled by the data to eliminate other wave vibration modes. The surface wave velocity can be calculated from the phase plot (third trace from top in Figure 2.9) as a function of wavelength (velocity = frequency × wavelength). The surface wave velocity is calculated to be approximately

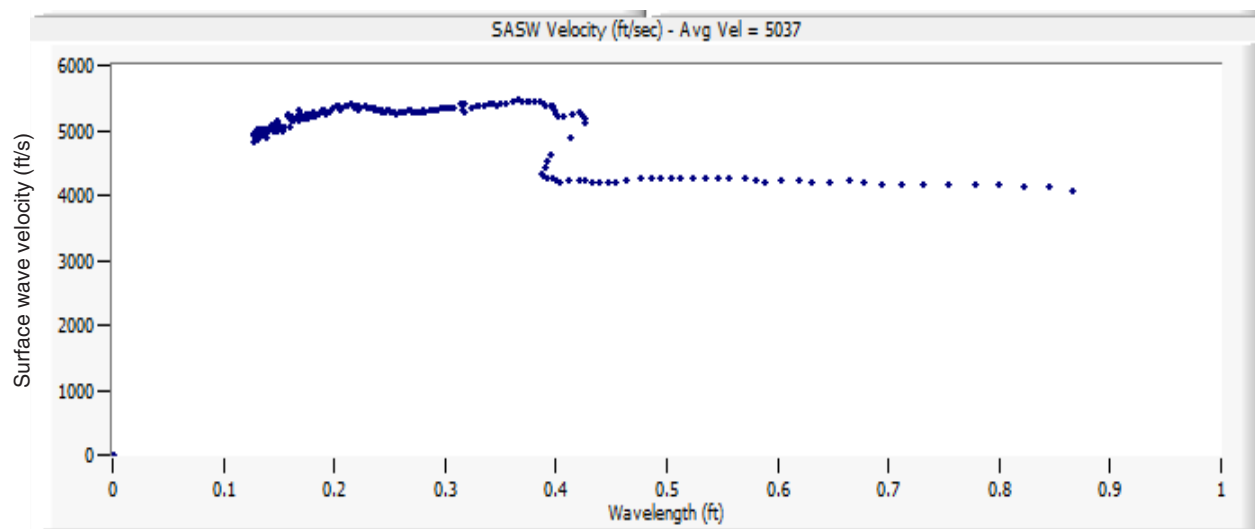
Figure 2.11. A dispersion curve from a location with debonding at a depth of 5 in.

Sound pavement yields a high and constant surface wave velocity shown as a flat and horizontal line in a dispersion curve throughout the depth of the pavement. A typical example is shown in Figure 2.10. It was found that the presence of a sharp drop in the surface wave velocity within the dispersion curve acted as a reliable indication of potential debonding within asphalt pavements. The location (wavelength) of the velocity drop related closely to the depth of the debonding. Figure 2.11 presents a dispersion curve (surface wave velocity versus wavelength) from a location from Section 1 from the NCAT site.

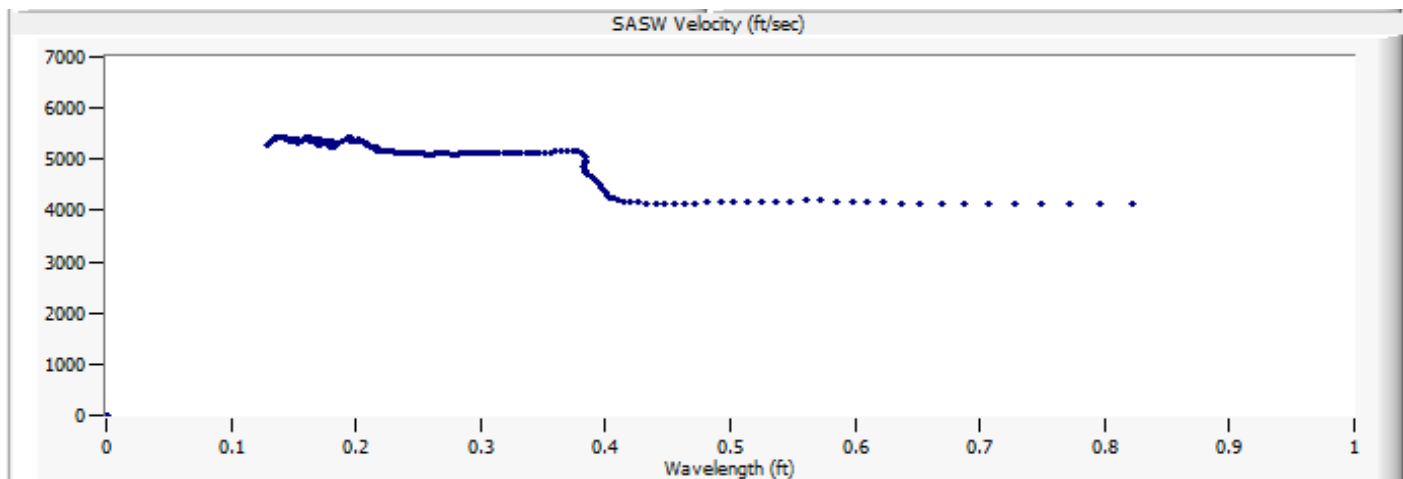
Note: Surface wave velocity decreases from ~5,200 ft/s (vertical scale) to ~4,300 ft/s at a wavelength of 0.4 ft (~5 in.) and indicates the presence of the delamination.

Figure 2.13. SASW dispersion curve example of baghouse dust delamination built at a depth of 5 in.

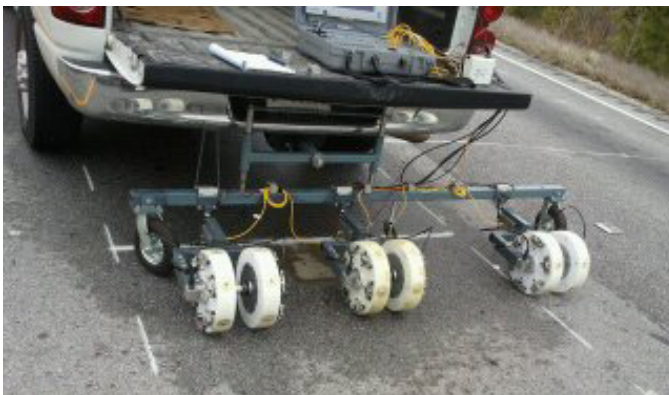
Figure 2.15. Test setup for IE and SASW at NCAT test track.

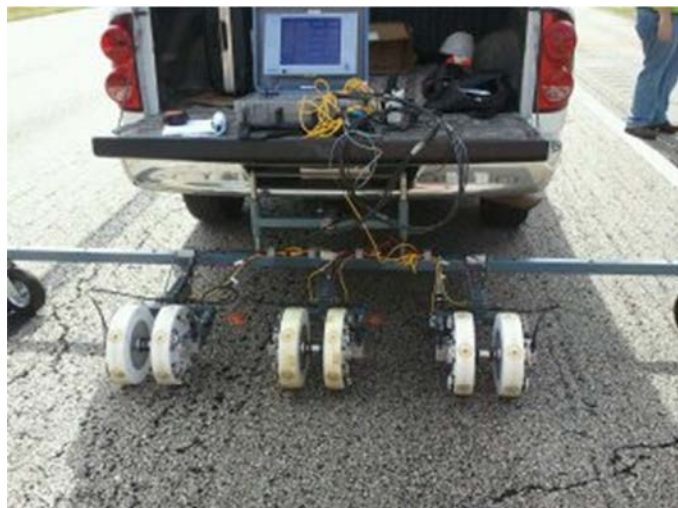
Figure 2.28. Test setup for Florida test site with six transducer wheels.

Note: The wheel pairs were spaced at 6 in.; separate wheel pairs were spaced at 2 ft on-center and two separate runs were performed to cover entire lane width.

The Florida test site was on I-75 near Gainesville, Florida. The BDS system was connected to the hitch of a towing vehicle, as shown in Figure 2.28. The six transducer wheels were coupled

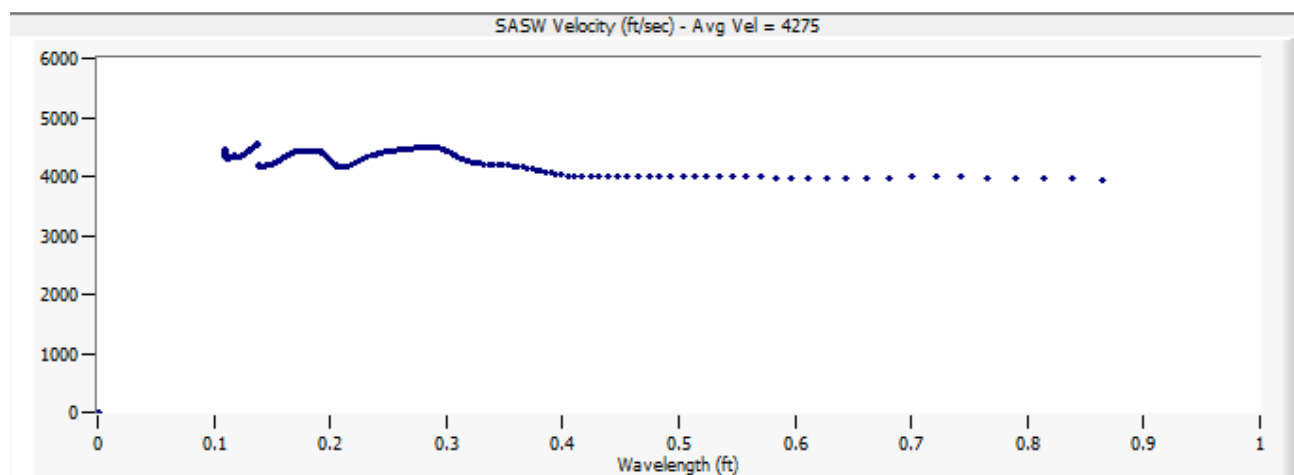
Figure 2.29. Example of dispersion curve indicative of sound pavement.

1. A relatively constant and high value ($\geq 3,500$ ft/s) of surface wave velocity from depths of 0.1 to 0.7 ft, as shown in Figure 2.29. This condition indicates sound pavement. Note that fewer than 2% of the tested locations were assessed with this condition.

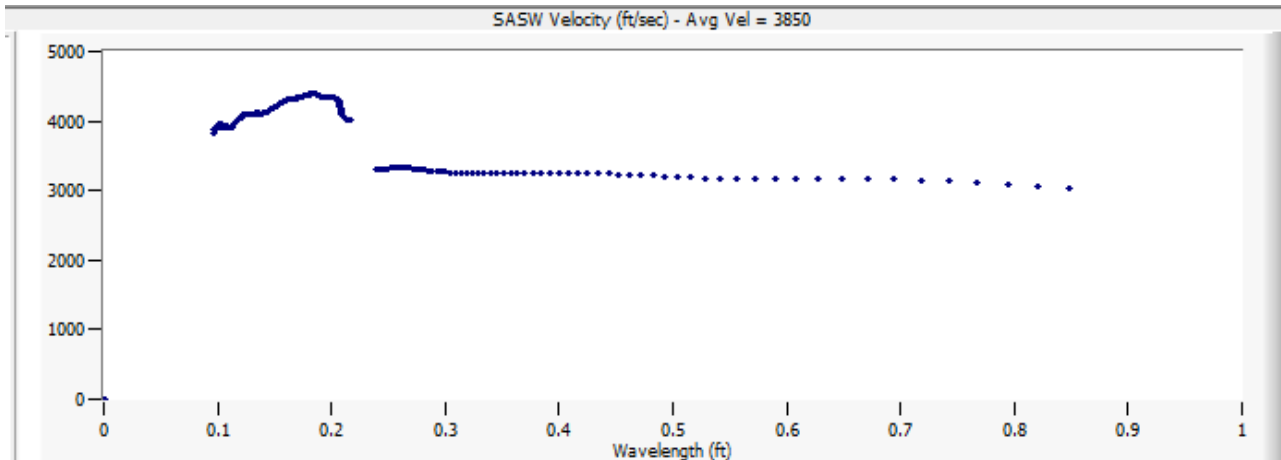
Figure 2.30. Example of dispersion curve indicative of debonding condition.

2. A sharp drop (≥ 500 ft/s drop) of surface wave velocity between 0.2 and 0.4 ft. The location of the drop was most likely the depth of debonding or a thin layer of low velocity (low strength) material. Figure 2.30 presents a dispersion curve from a location where debonding (or a layer of low-strength material) was most likely present at around 0.24 ft. Note that the majority of test results presented this type of condition.

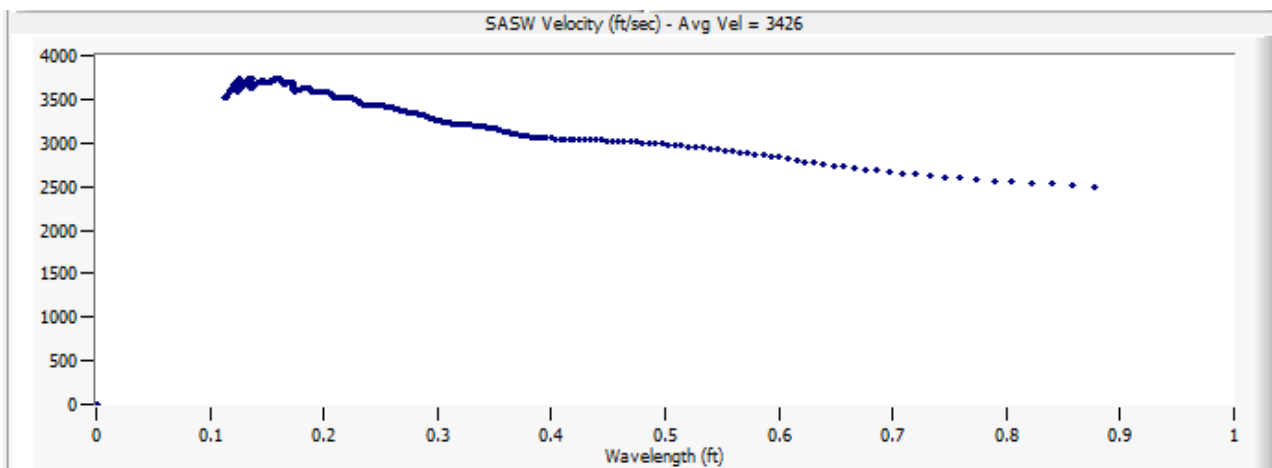
Figure 2.31. Example of dispersion curve indicative of degradation of pavement at greater depths.

3. A slow drop of surface wave velocity in the dispersion curve, as shown in Figure 2.31. This category indicates the condition of degradation of pavement at greater depths. Note that approximately 5% of the tested locations were identified with this type of condition.

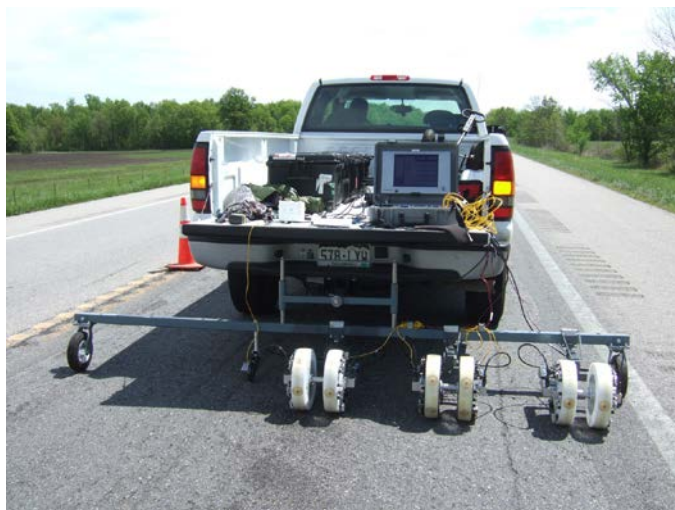
Note: The wheel pairs were spaced at 6 in.; separate wheel pairs were spaced at 2 feet on-center, and two separate runs were performed to cover the entire lane width.

Figure 2.32. Test setup for Kansas test site with six transducer wheels.
