**SHRP 2 REPORT S2-R06G-RR-1**

Mapping Voids, Debonding, Delaminations, Moisture, and Other Defects Behind or Within Tunnel Linings

ANDREW WIMSATT, JOSHUA WHITE, CHIN LEUNG, AND TOM SCULLION
Texas A&M Transportation Institute

This report presents the findings of SHRP 2 Renewal Project R06G—High-Speed Non-destructive Testing Methods for Mapping Voids, Debonding, Delaminations, Moisture, and Other Defects Behind or Within Tunnel Linings. The study was divided into two phases to (1) establish testing criteria and prioritize the techniques to be developed and evaluated under the project on the basis of tunnel operators' requirements and (2) conduct the necessary technology development for those techniques recommended.

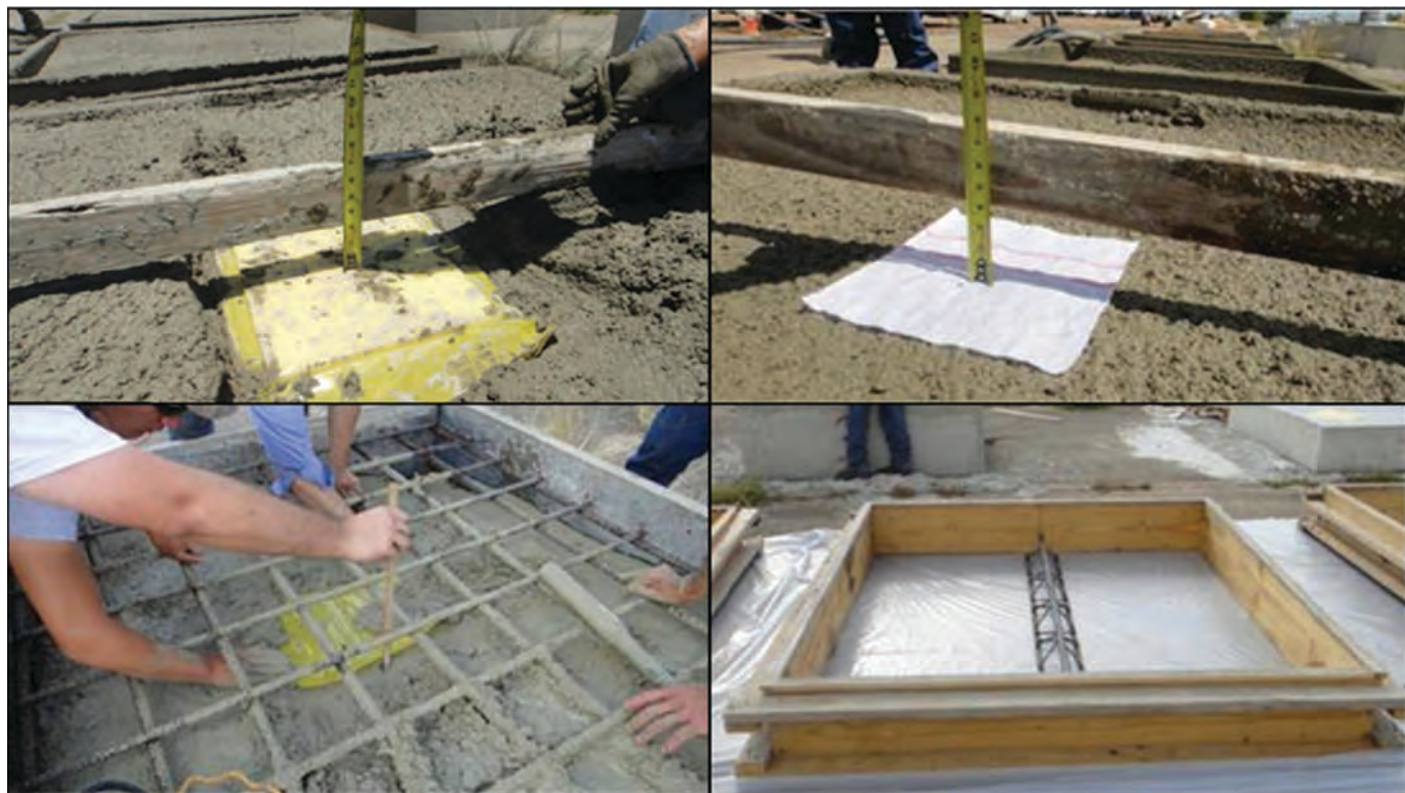
Figure 2.1. Construction of slabs with simulated defects.

Eleven normal-weight concrete slabs and 13 shotcrete slabs were constructed to simulate various defects. The concrete slabs were used to mimic typical concrete tunnel linings with and without reinforcing steel. The shotcrete slabs were constructed to mimic applications in which shotcrete is sprayed on as a finished layer, as typically found in tunnel linings. A specially designed lattice girder, also typical in tunnel wall construction, was used as reinforcement in the shotcrete slabs (Figure 2.1, bottom right).

The simulated delaminations in the slabs were constructed from three types of material. Delaminations were imitated by using 0.05-mm (0.002-in.) plastic square sheets and 0.25-mm (0.01-in.) cloth squares (Figure 2.1, top right). Air-filled voids (Figure 2.1, top left) were constructed by inserting foam squares 13 mm (0.5 in.) thick in vacuum-sealed plastic bags. Water-filled voids (Figure 2.1, bottom left) were constructed in a similar manner by placing water-filled Ziploc bags within vacuum-sealed plastic bags and carefully padding the defect

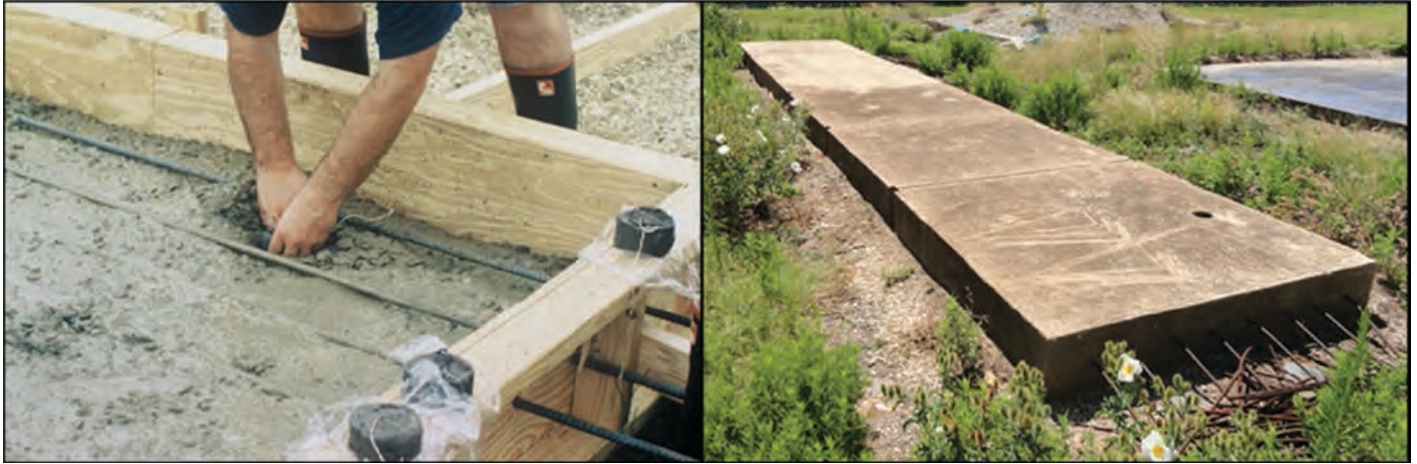
previous research project. These slabs contain manufactured clay lumps of different diameters. The clay lumps are a high-plasticity clay, classified as Bureson Clay CH (AASHTO A-7-6) with a plasticity index (PI) range of 35 to 45. The slabs and lumps are shown in Figure 2.2 and are summarized in Table 2.2 (Specimens A2 through F2). These six specimens consist of two sets of three slabs: one set with steel reinforcement and one set without. In each set, one slab was designated as the control with no clay lump contaminations. The remaining two had various

Figure 2.2. Clay lump slab construction.

levels of lumps of documented sizes corresponding to three regions of interest: (1) lumps below the reinforcement that represent typical lumps dense enough not to be quickly displaced toward the surface via vibration, (2) lumps that are caught in the reinforcing steel layer on their path toward the surface, and (3) lumps that are dispersed between the reinforcement and the top surface. The depth of the slabs is nominally 305 mm (12 in.), but all measurements are taken as approximate since neither ground truth data were retrieved nor any accurate pictures were taken to confidently support documented placement.

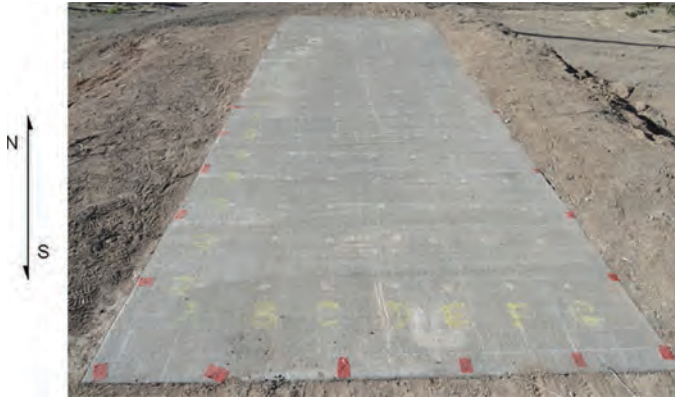
(0.08 in.); sizes ranging from 305 mm by 305 mm to 610 mm by 1220 mm (12 in. by 12 in. to 24 in. by 48 in.); and depths above reinforcing steel at 64 mm (2.5 in.) below the surface and below two layers of reinforcing steel at 152 mm (6 in.), with some located above prestressed girders supporting the slab. The deck, as shown in Figures 2.3 and 2.4, measures 2.4 m by 6.1 m by 0.2 m (8 ft by 20 ft by 8.75 in.) and rests on three prestressed concrete girders. Simulated defects constructed in the deck consist of nine artificial delaminations, five cracks, and two corroded reinforcement mats, all of which are summarized in Table 2.3.

Figure 2.3. Simulated bridge deck at UTEP in El Paso, Texas.

sheets. The No. 5 corroded steel mats were electrically merged and attached to the normal reinforcement. The corrosion depth was measured to be 1–2 mm (0.04–0.08 in.) before pouring the concrete.

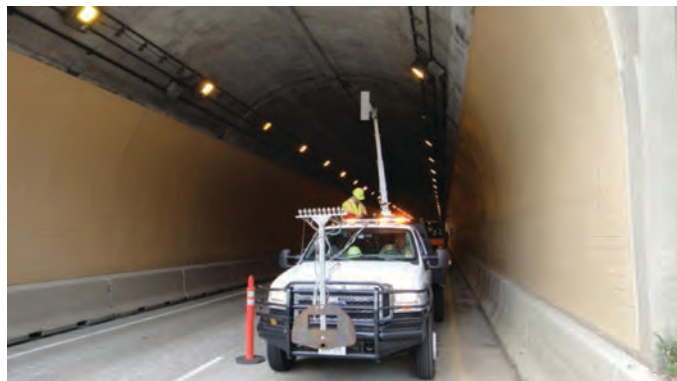
Figure 2.9. TTI air-coupled GPR system collecting data in No Name Tunnel.

The No Name Tunnel was constructed in 1965 and is located approximately 7.5 miles west of the Hanging Lake Tunnel. The team collected air-coupled GPR data and infrared images only in the westbound bore, which is approximately 1,000 ft long. The upper portion of the tunnel has a concrete surface; the sides are tiled. Figure 2.9 shows the TTI

air-coupled GPR system collecting data in the tunnel. Plan sets were not available.

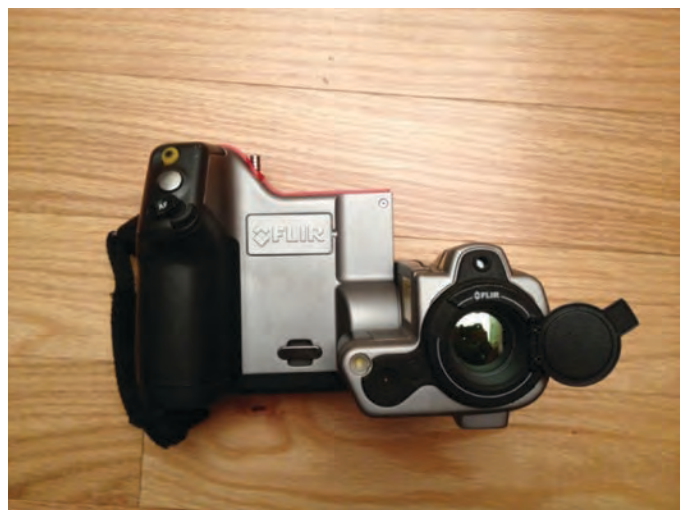
Handheld thermal cameras (Figure 2.13) have improved significantly over the past decade, with consistently higher image resolutions and improved temperature accuracy occurring over time. The research team used the FLIR T300 thermal camera. The researchers analyzed the images for changes in tunnel lining temperature, which could indicate possible defects within or behind the lining. The team believes that the images from such cameras can be used to determine where to conduct testing with in-depth NDT devices and techniques.

Figure 2.13. FLIR T300 thermal camera used in the study.

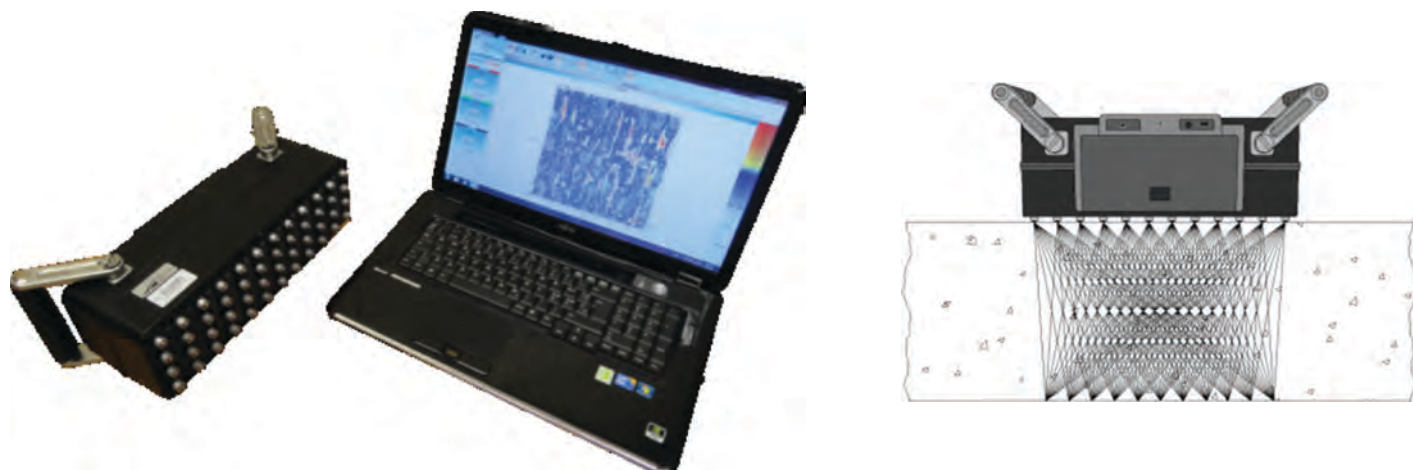
The ultrasonic tomography (UST) system used in this study is a device with an array of ultrasonic transducers that transmit and receive acoustic stress waves for the inspection of concrete structures. The system used here, the A1040 MIRA, is produced by Acoustic Control Systems (Figure 2.14).

Figure 2.14. A1040 MIRA system (left) and transmission/reception of acoustic waves and corresponding echo intensity (right).

The tomograph, shown in Figure 2.14 (left), uses a 4-by-12 grid of mechanically isolated and dampened transducers that can fit the profile of a rough concrete testing surface with a variance of approximately 10 mm (0.4 in.). Each row of four transducers transmits stress waves sequentially while the remaining rows act as receivers. In this manner, there is a wide coverage of shear wave pulses that reflect at internal interfaces where the material impedance changes.

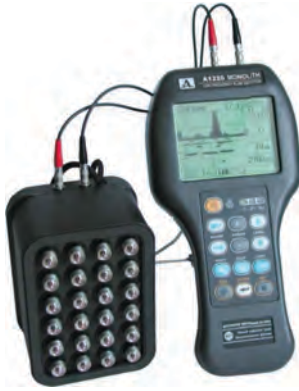
An ultrasonic transducer is used to generate and/or receive ultrasonic waves in/from a test medium. Ultrasonic echo technique involves sending and receiving ultrasonic pulses from the same side of the test object, by the same or two separate transducers. The ultrasonic pulse velocity is correlated to material strength or quality. The measurement of propagation time is used to localize cracks, voids, and delamination and/or to estimate the thickness of a structure. Structural boundaries and defects that are large enough (with respect to the ultrasonic wavelength) induce a high contrast in acoustic impedance and result in the reflection of ultrasonic waves. The reflected waves are detected in ultrasonic scans, and the two-way travel time is used to estimate the reflector location

Figure 2.16. Ultrasonic echo equipment A1220 Monolith by ACSYS.

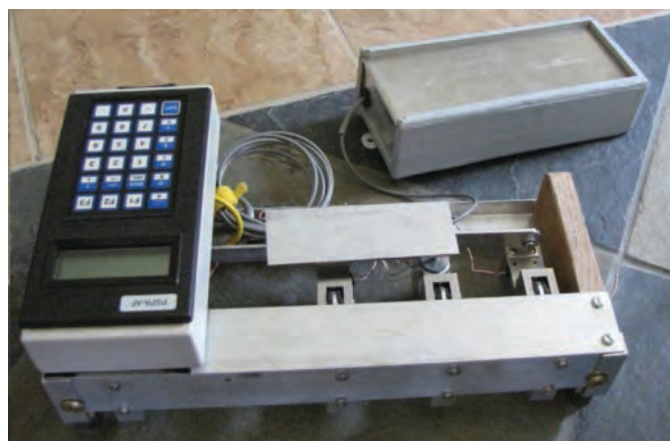
(b) New version

Figure 2.18. Portable seismic property analyzer (PSPA).

As shown in Figure 2.18b, the PSPA has been redesigned to make it more user friendly and compact for tunnel work. The new PSPA is self-contained and eliminates the need for an external computer to collect data. The waveforms collected in the field are stored in a removable flash memory. The new PSPA is also lighter compared with the traditional PSPA (8 lb versus 16 lb). Data collection with the new PSPA is a two-hand operation, which can accommodate the curvature within the tunnel more easily. Data acquisition with the new PSPA is on average two to three times faster than with the traditional one. The new PSPA is also equipped with three receivers to better optimize the data collection for the combined IE-USW methods. The power source for the device is six AAA batteries placed in a container that operators can carry on their belts. Typical signals collected with the PSPA are shown in Figure 2.19. These signals are used to develop USW dispersion curves and the IE amplitude spectra. The advantage of combining USW and IE methods in a single device is that once the test is performed, the variations in the modulus (an indication of the quality of concrete) and return resonance frequency (an indication of the full thickness or depth of delamination) of a slab can be assessed concurrently.

USW and IE measurements can be performed with these two methods simultaneously with the PSPA shown in Figure 2.18. The traditional PSPA is a box containing a solenoid-type impact hammer and two high-frequency accelerometers (Figure 2.18a). All controls and data acquisition are in a computer connected to the box. The two receivers allow the calculation V_p using the USW method. The test at a single point is simple

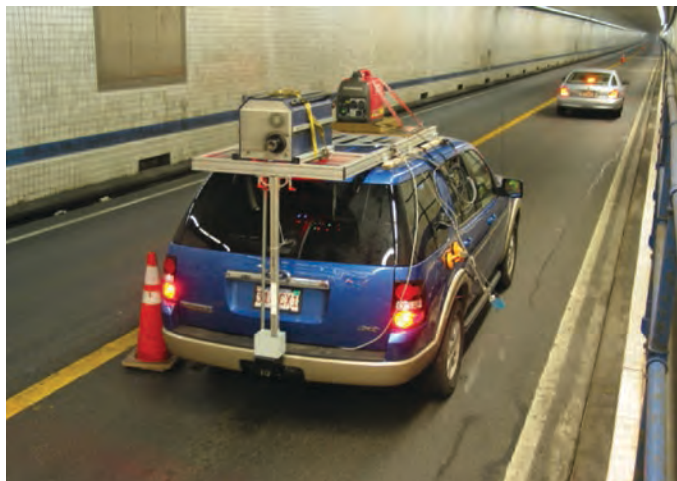
The SPACETEC scanner (Figure 2.22) is a mature system developed specifically for the inspection of railway and roadway tunnels. Therefore, employing this technology for this project required no additional hardware and software development. The scanner system has been used to survey many miles

Figure 2.22. SPACETEC scanner in the Chesapeake Channel Tunnel.

of railway and roadway tunnels (mostly railway) in various countries but was never used in the United States before this project.

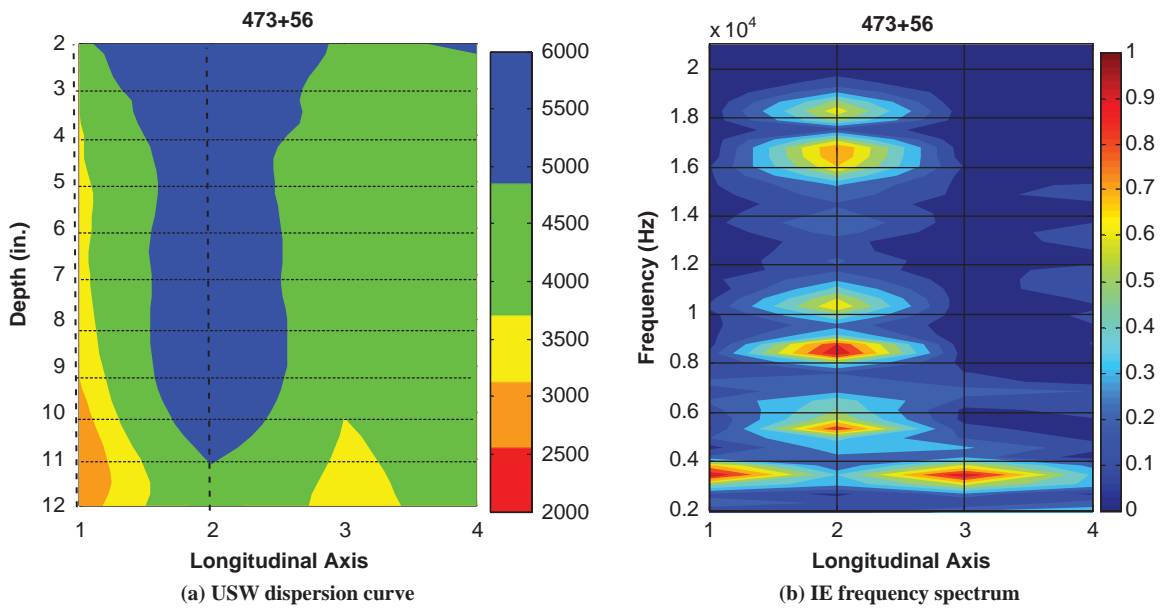
Figure 3.10. PSPA results on a cracked area in the Chesapeake Channel Tunnel.

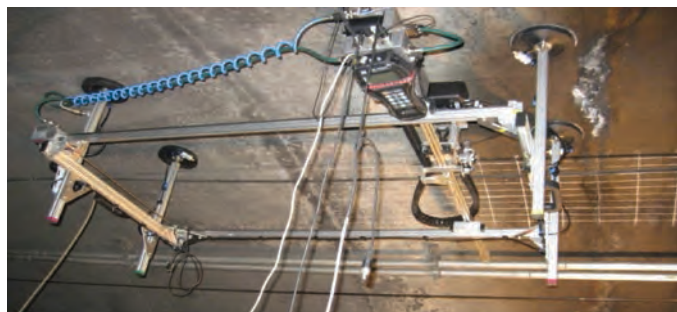
Figure 3.11. BAM scanner with ultrasonic echo device.

project were mounted on an automated scanning device that BAM developed. Figure 3.11 shows the BAM scanner with the ultrasonic echo device. It can be carried in a relatively small, lightweight package. Its size allows the scanner to be transported in cars and carried through small openings to reach difficult-to-access areas such as the vents above tunnels. The equipment commonly used for NDT of structures—including GPR, ultrasonic echo, and IE devices—can be easily attached to the scanner for testing and detached after completing the measurements. The scanning and NDT data acquisition are controlled by a single notebook. This simplifies the control and reduces the amount of equipment and weight of the measurement system. Appendix W summarized the findings and applications of the Federal Institute for Materials Research and Testing (BAM).

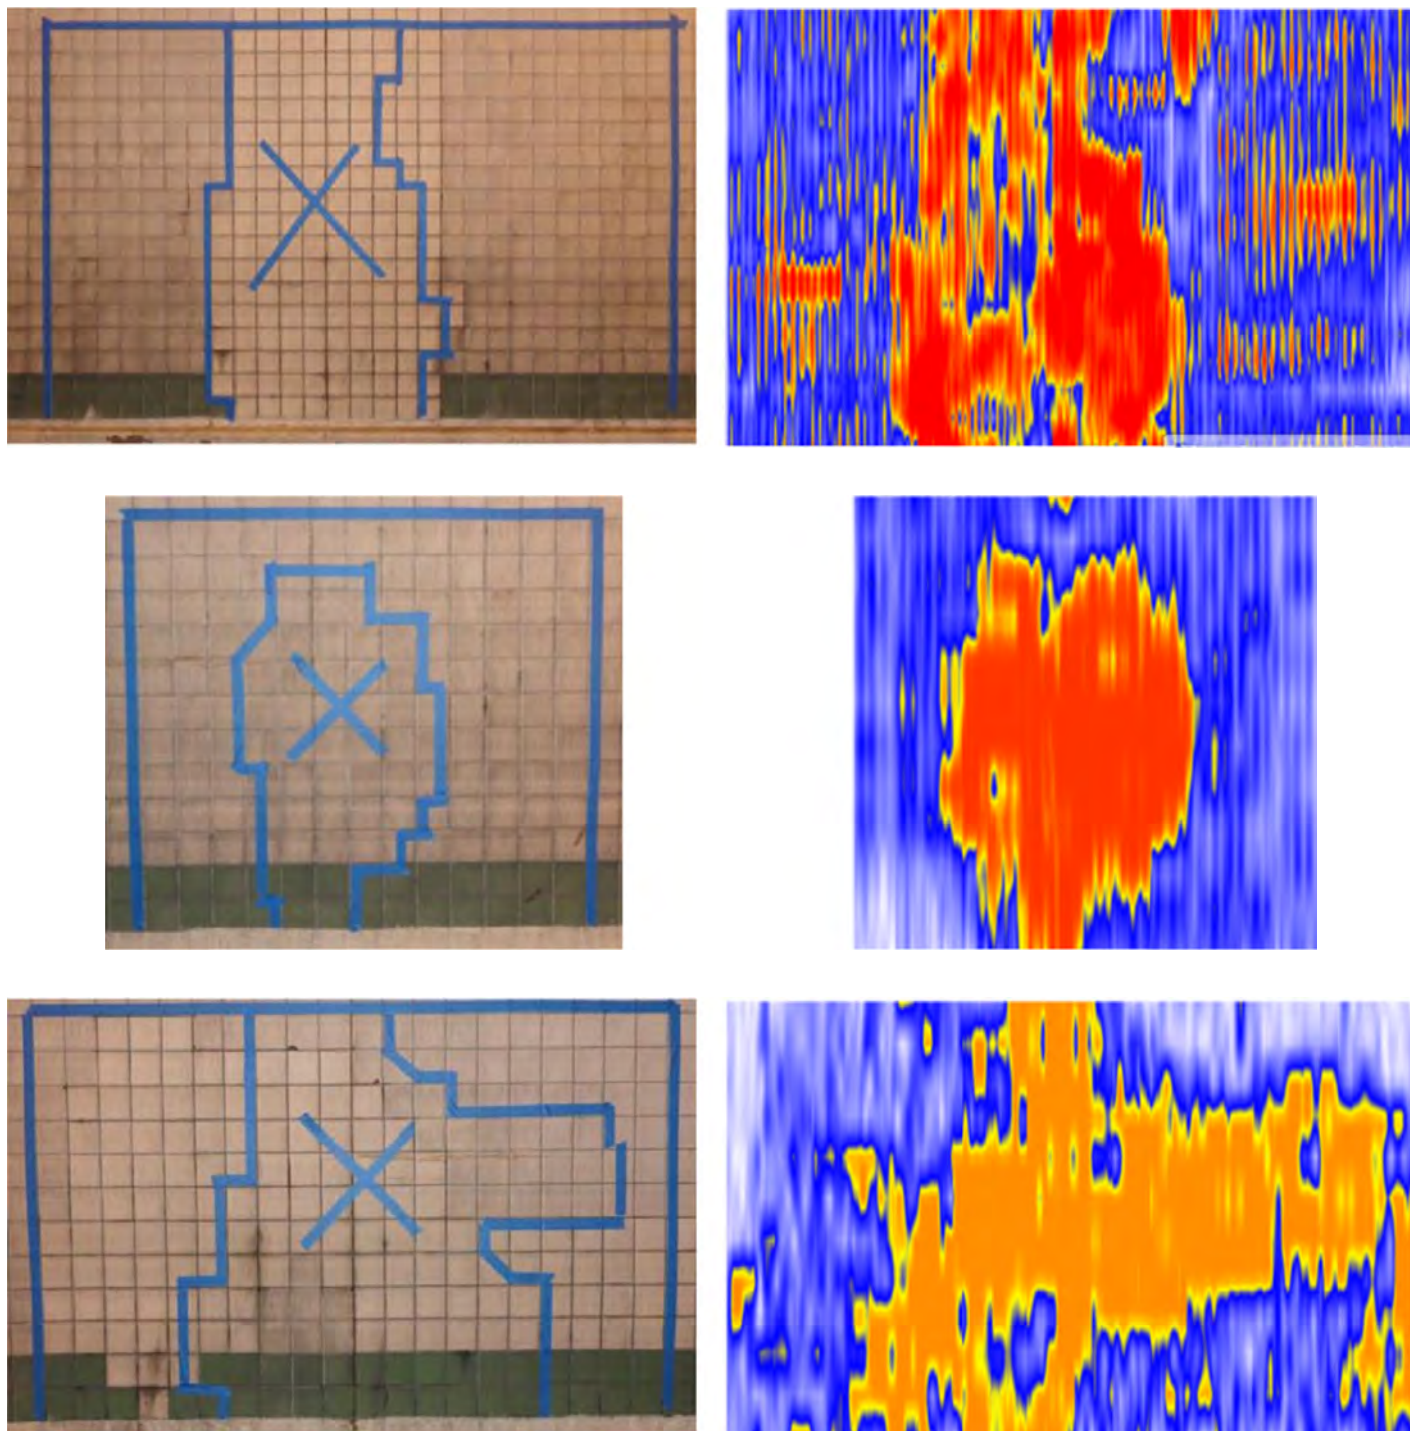
Figure G.1. Debonded regions of tile (left) paired with the associated UST C-scans (right).

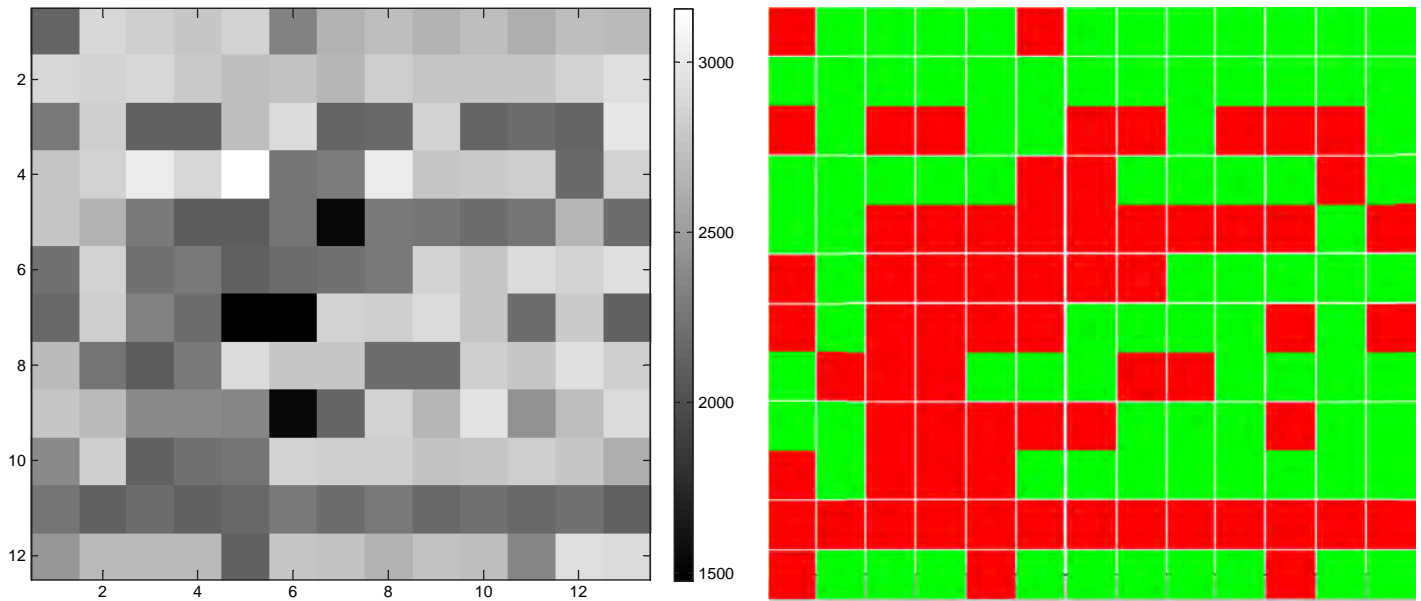
Figure G.2. Debonded regions of tile (top) paired with the acoustic sounding results (bottom).

bond. This pass-fail decision will be based on how close the fundamental frequency of the tile is to the threshold value. As in the first mode of operation, the operator will select a section of tile representing a fully bonded state for the program to determine the fundamental frequencies associated with bonded sections. The user will then tap each tile in a predetermined order.

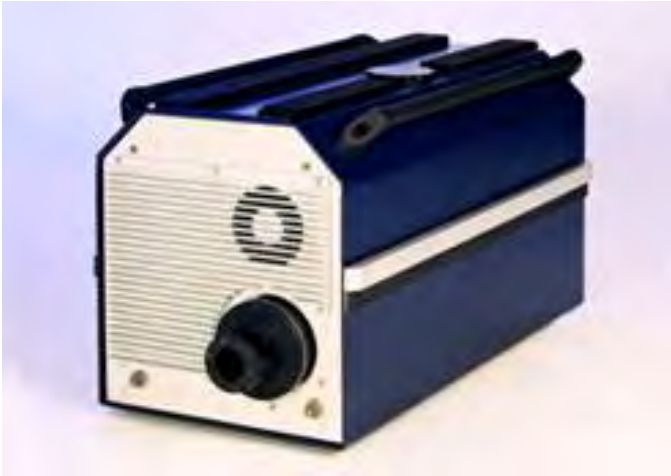
Figure I.1. SPACETEC TS3 scanner.

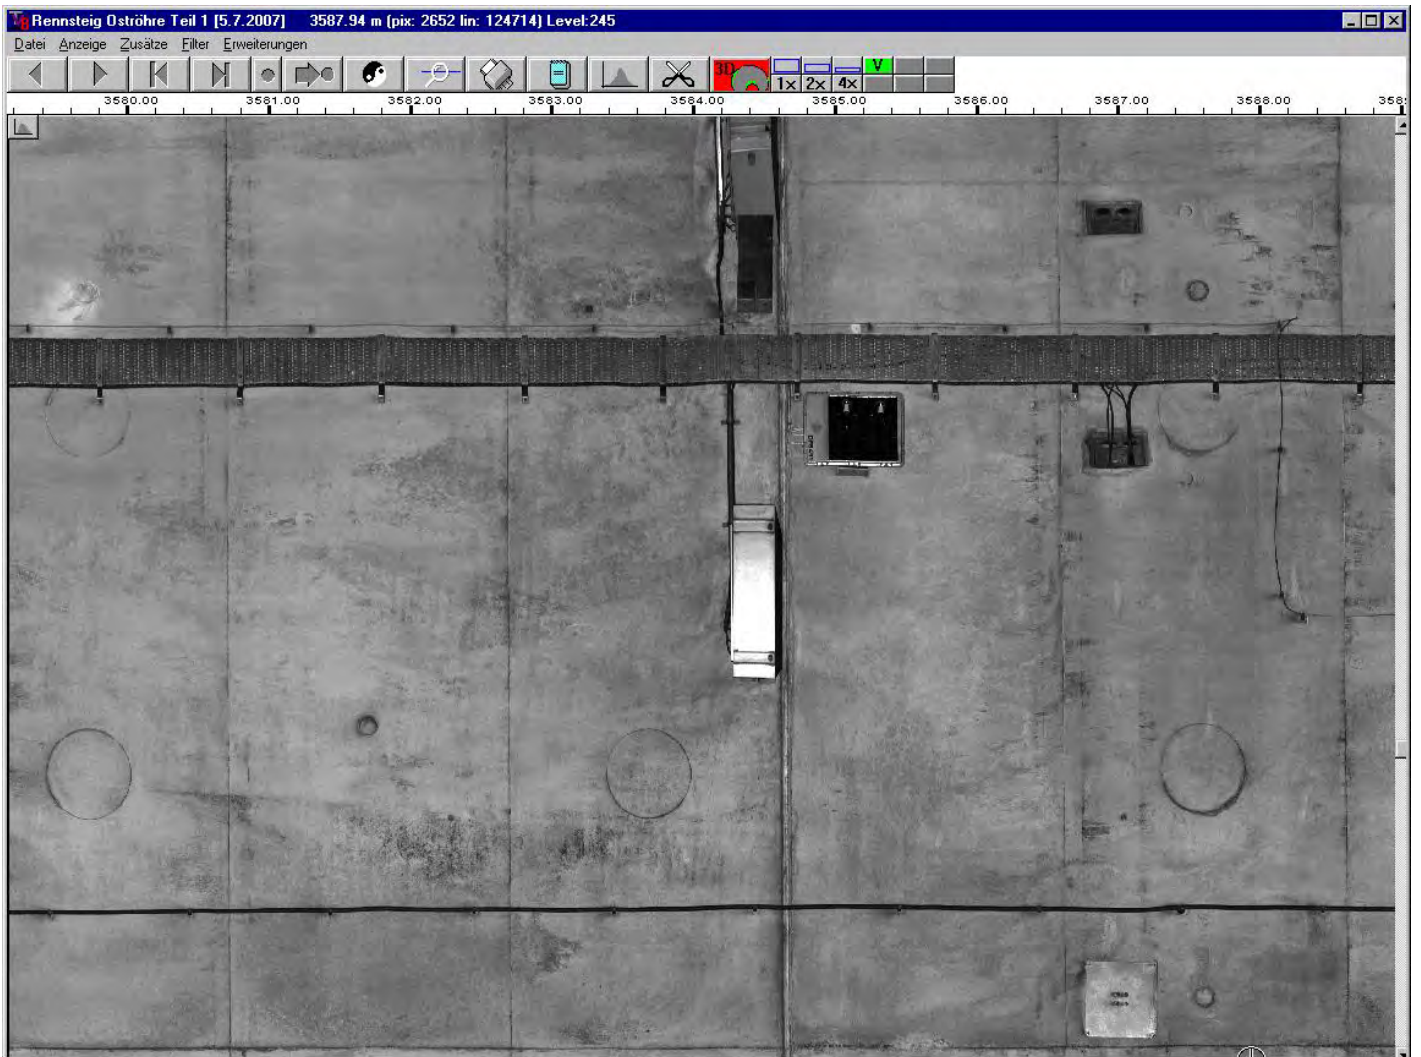
Figure I.3. Visual image of conditions of a shotcrete lining in a motorway tunnel.

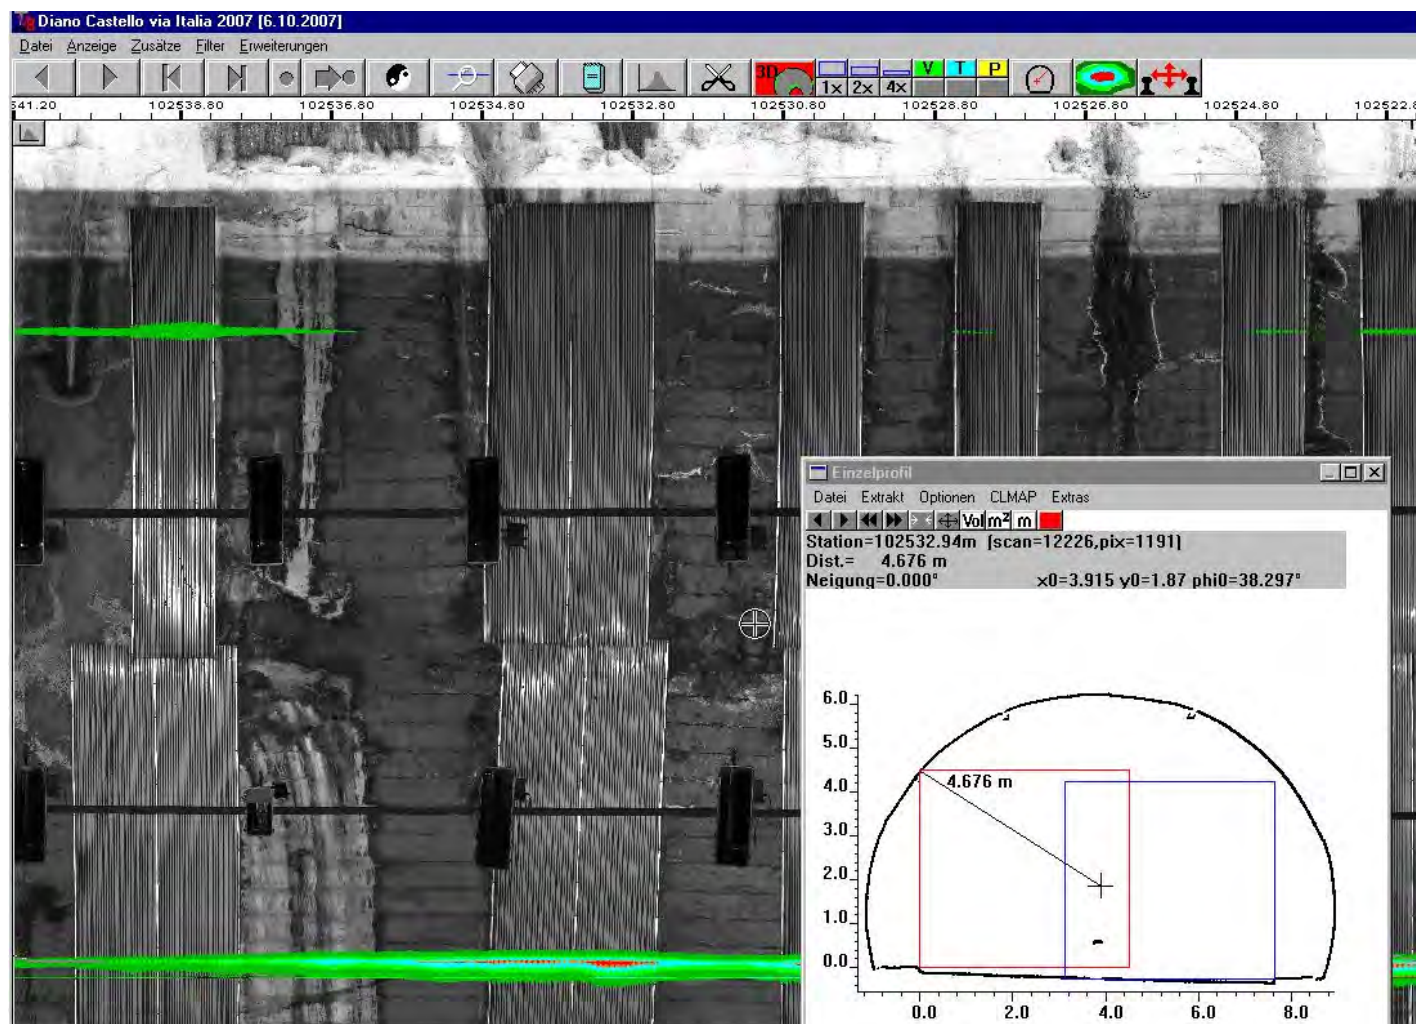
Figure I.4. Structural gauge investigation in motorway tunnel. Red spots indicate obstructions to given clearance profile. Users can determine cut volume and affected area on screen.

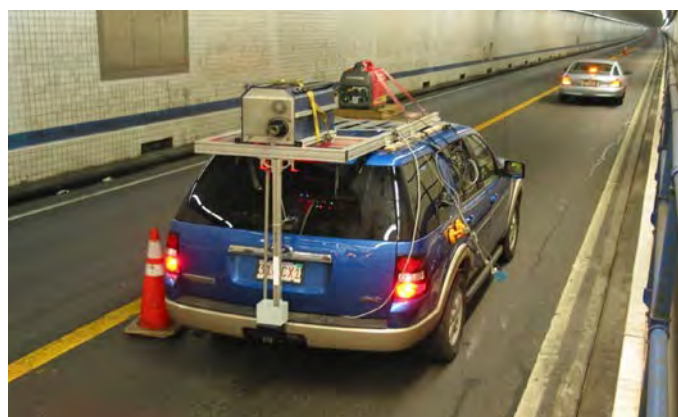
Figure I.7. Inspection vehicle in Chesapeake Tunnel.

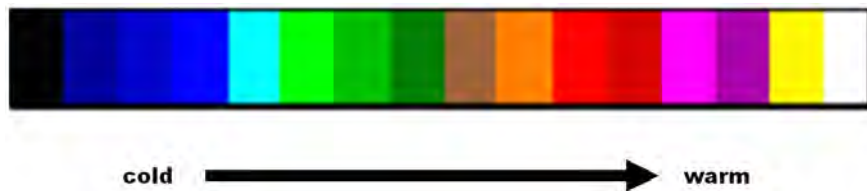
Figure I.9. Color scale for thermographic images.

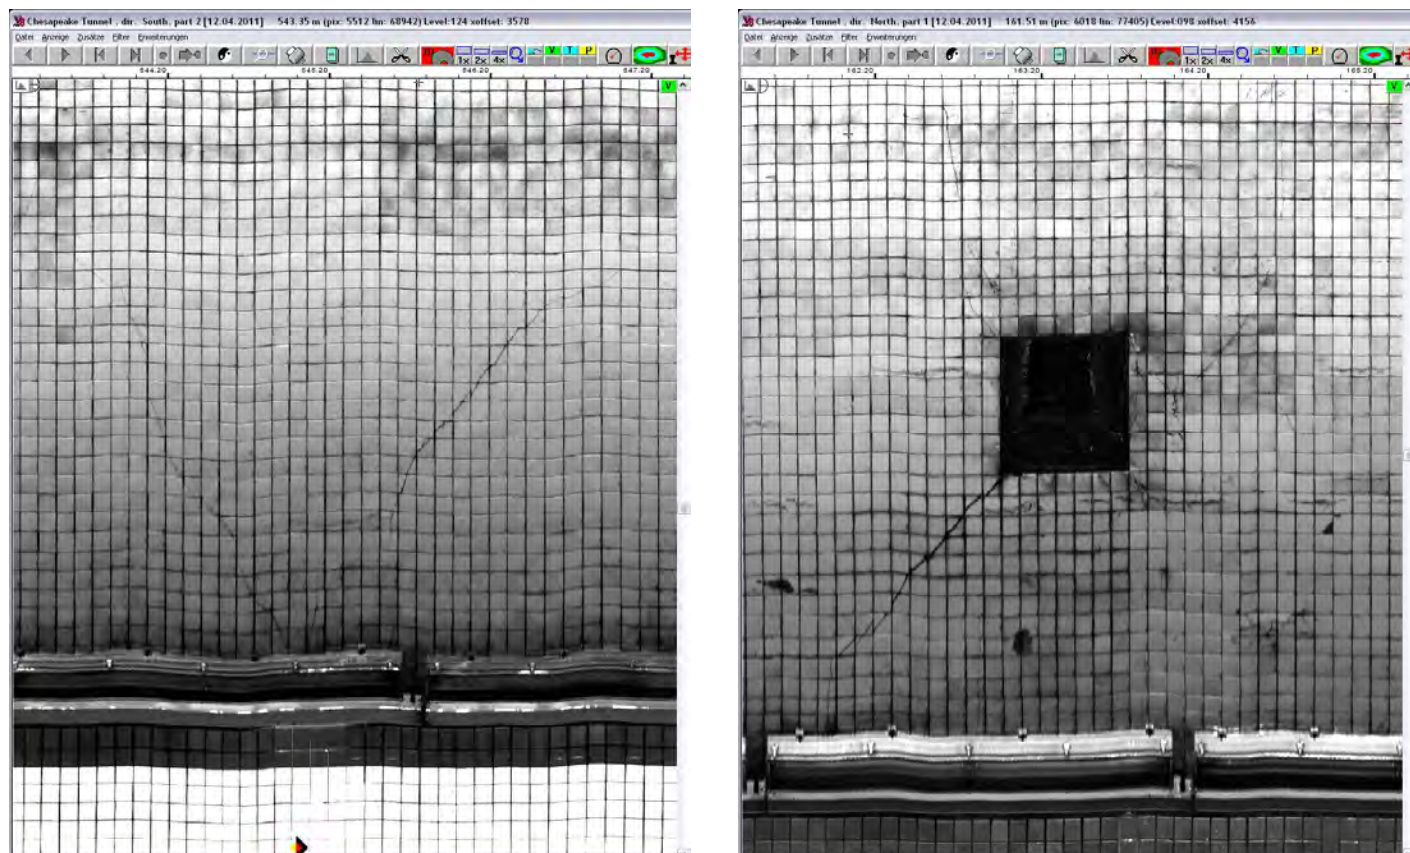
Figure I.10. Development of split ceramic tiles: south, 544 m (left); north, 163 m (right).

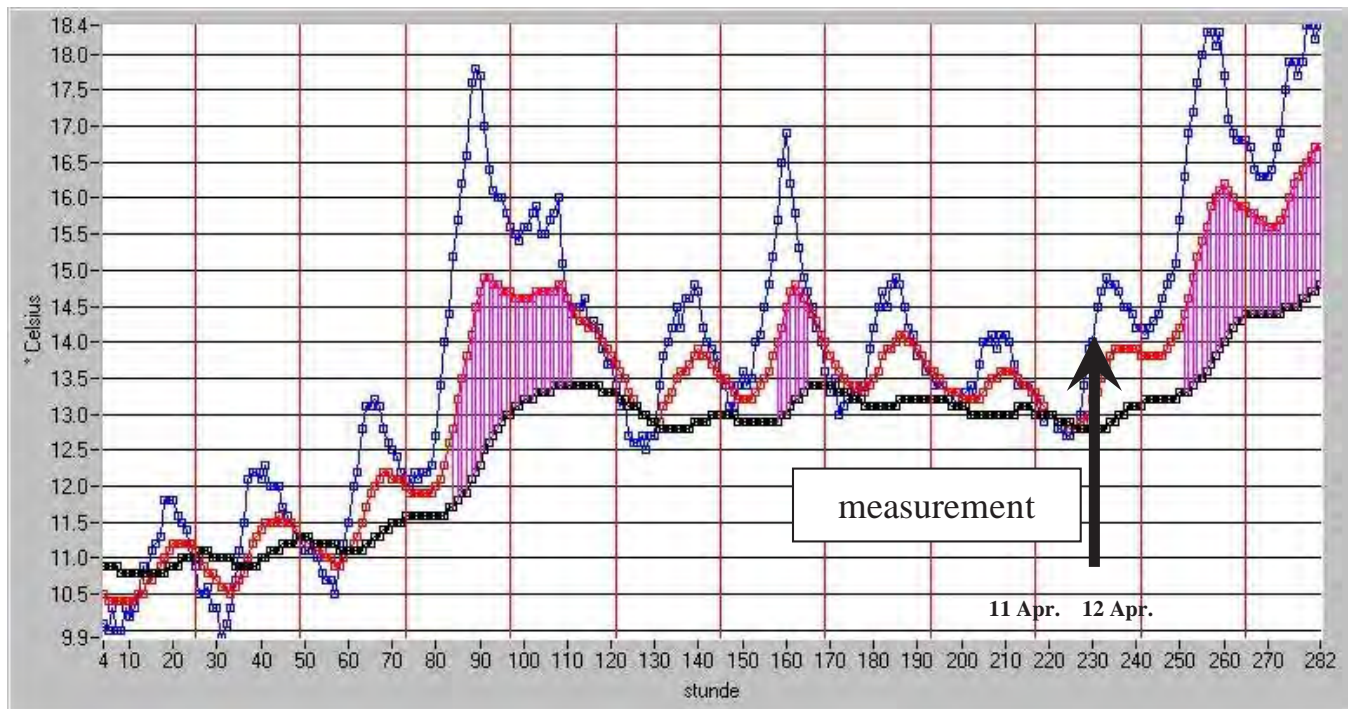
**Figure I.12. Temperature alignment before thermographic survey. (Note: stunde = hour.)**

The quasistationary measuring conditions were adjusted naturally with the corresponding weather conditions and air

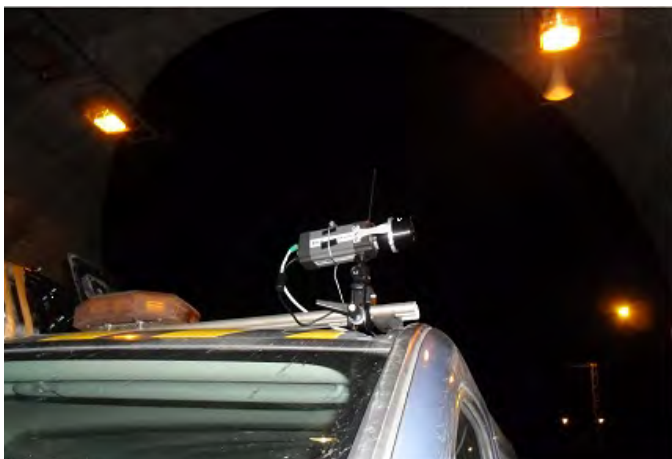
Figure J.4. Thermal camera installed on van roof in first measurement.

present examples of FLIR thermal camera mounting systems used on the survey van. The mounting system presented in Figure J.5 was judged to be better because an analysis of the data indicated that it reduced the thermal reflection of the van, which was causing noise in the data.

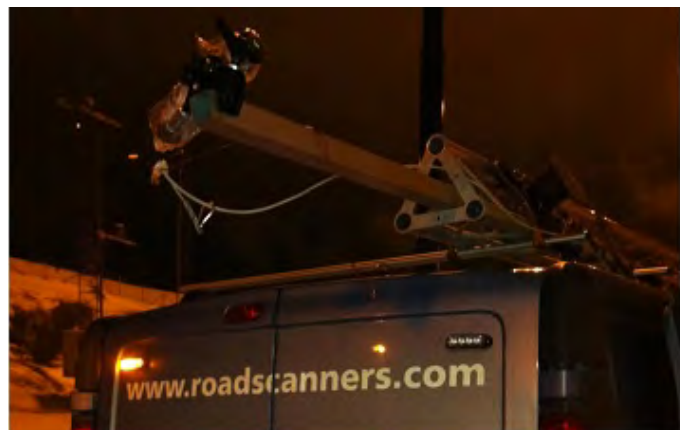
Figure J.5. Thermal camera installed on end of beam behind van.

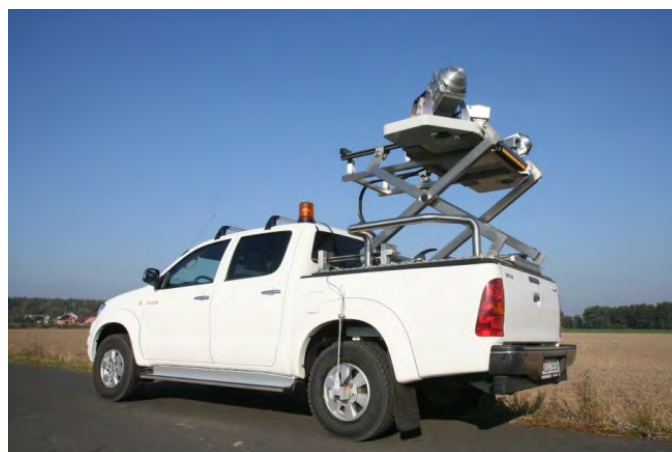
The goal in the laser scanner tunnel tests was to test whether the method could provide valuable information concerning the tunnel lining condition and shape. The Category A laser scanner data were collected by GEOVAP Ltd., from the Czech Republic, using the company's quantum three-dimensional (3-D) technique based on Lynx laser scanner hardware. The GEOVAP survey vehicle and equipment are shown in Figure J.6. Data analysis and all presentations done by GEOVAP used the

Figure J.6. Category A laser scanner survey system used in this research.

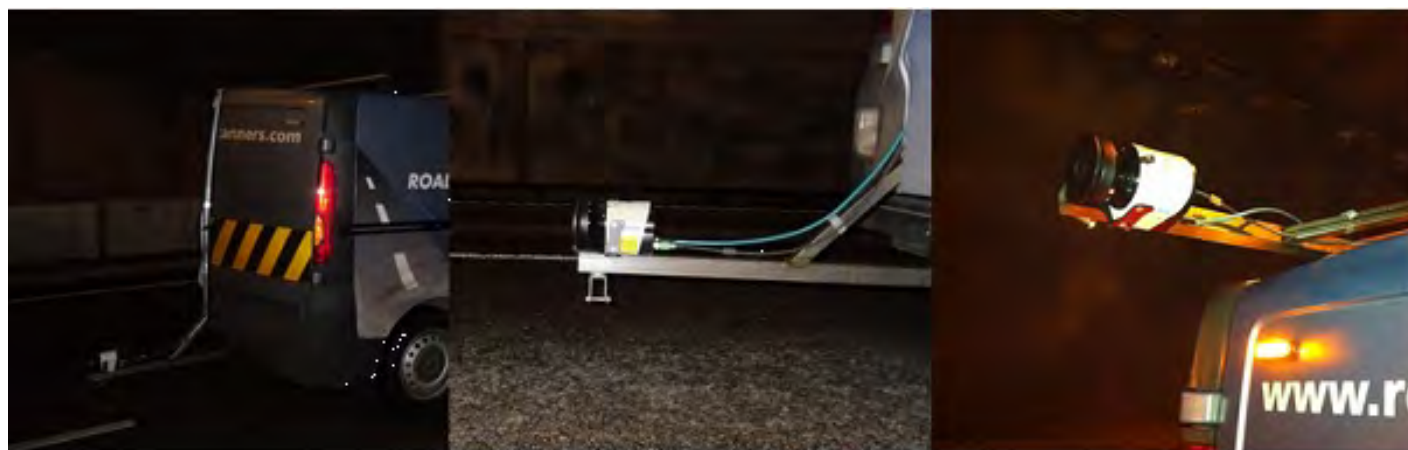
company's own software. The Category B laser scanner data were collected by Roadscanners Oy using a model SICK LMS151 laser scanner. The survey van equipment is presented in Figure J.7. The data analysis was done with a new Road Doctor laser scanner module, which is an additional module for the Road Doctor Pro software. The module facilitates integrated analysis of the laser scanner data and other survey data in Road Doctor Pro software.

Figure J.7. Category B laser scanner mounting systems used in this research.

When the laser beam angle is known, as in the setups described above, and beams are sent in different directions from a moving vehicle with a known position, it is possible to make a 3-D surface image—a point cloud—of the road and its surroundings. A point cloud can have billions of points with accurate x, y, z coordinates and reflection or remission characteristics. Since all points have coordinates, it is possible to measure distances between points and changes between those distances. This gives extra value to tunnel management tasks, for instance,

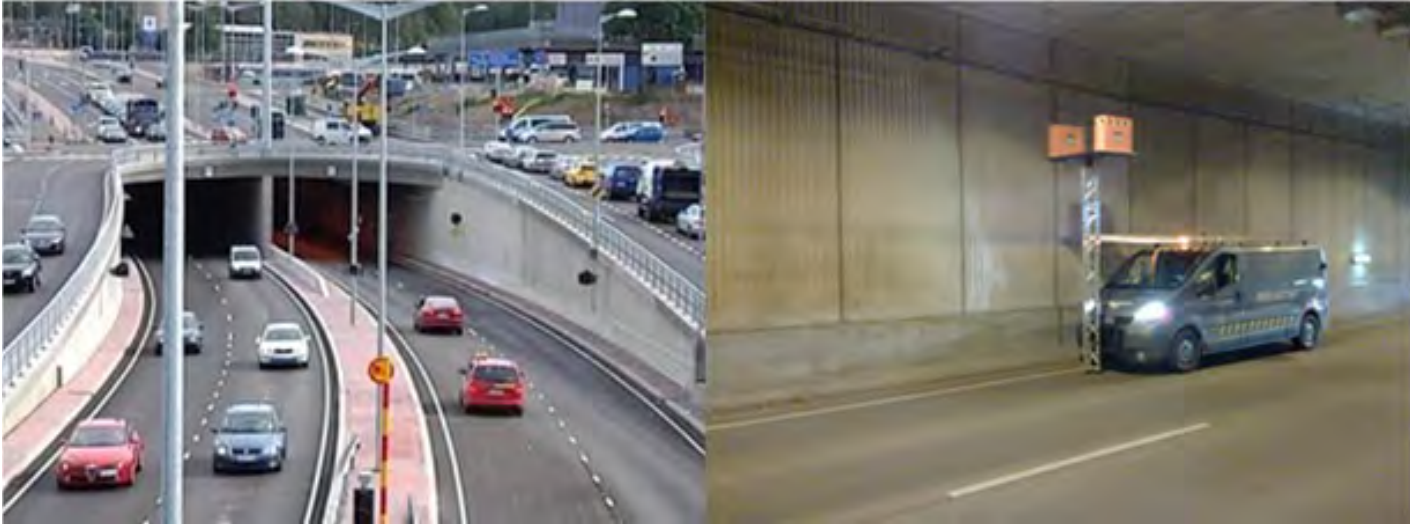
Figure J.10. Hakamäentie Tunnel opening (left) and GPR measurement van in the tunnel (right).

The GPR measurements in the Vuosaari Tunnel consisted of four parallel lines on the right-side wall in the southbound tunnel. Measurement lines were at heights of 1.6 m, 2.1 m, 2.4 m, and 3.1 m. The GPR measurements in the Hakamäentie Tunnel consisted of basic measurement lines at heights of 1.5 m, 2.0 m, 2.5 m, and 3.0 m. Additionally, GPR measurement repeatability, measurement speed, and GPR antenna distance from the wall were tested on the tunnel wall at a height of 2 m. Data collection speed tests were conducted using the following speeds: 6 km/h, 20 km/h, and 30 km/h. Antenna distance to the tunnel wall in the speed tests was approximately 80 cm. The effect of GPR antenna distance to the tunnel wall was tested at distances around 0.5 m, 1.0 m, and 1.5 m.

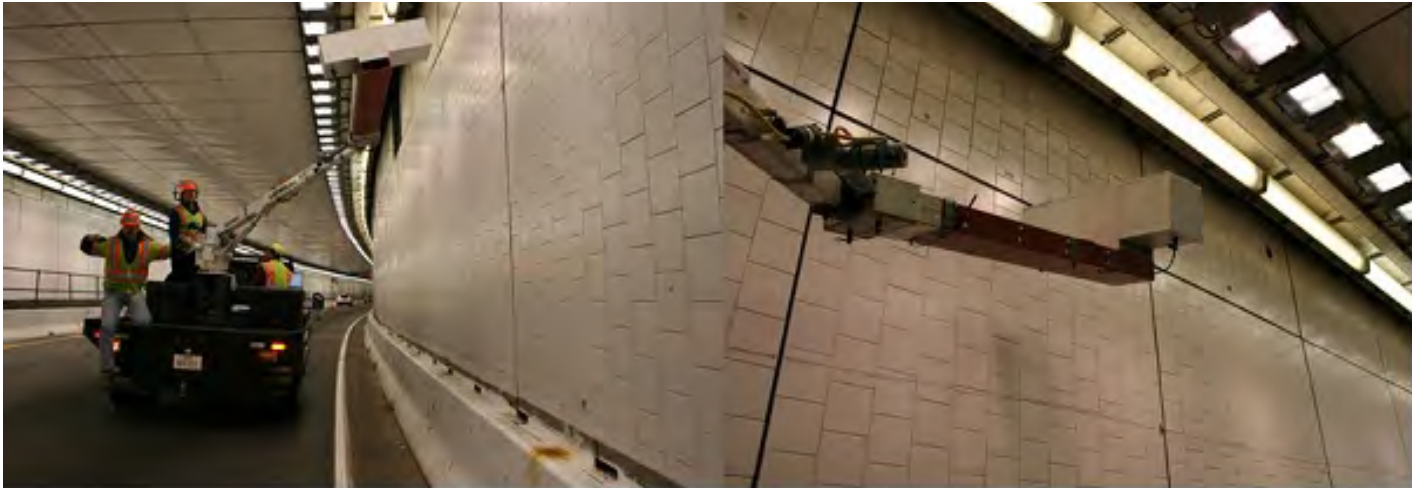
Figure J.14. GPR antenna mounted on a crane. This system, developed and used by Texas A&M Transportation Institute, was used in SHRP 2 U.S. tunnel tests.

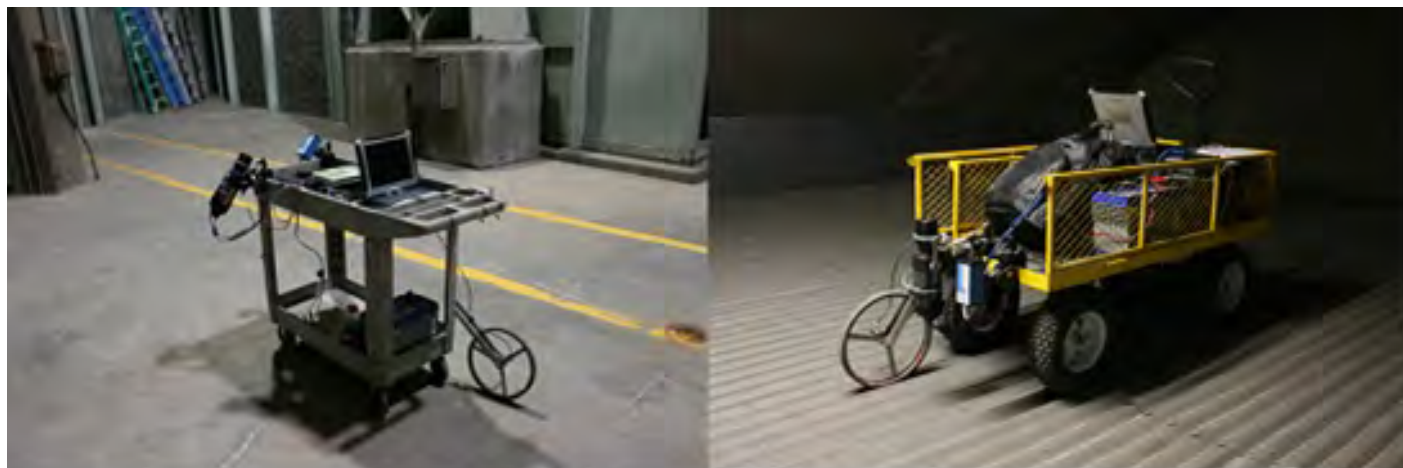
Figure J.16. Thermal video collection carts used in tunnel air duct measurements in the United States.

Thermal video collection can also be done without a vehicle; all the required devices can be installed on a cart. Part of the thermal video collection in the United States was done in tunnel air ducts, which were not accessible by vehicle. A thermal video-logging cart consisted of a thermal video camera, normal video camera, DMI kit, control laptop, and battery. This system can also be used when measuring road tunnels and difficult-to-reach locations. Two different carts used in air duct measurements are shown in Figure J.16.

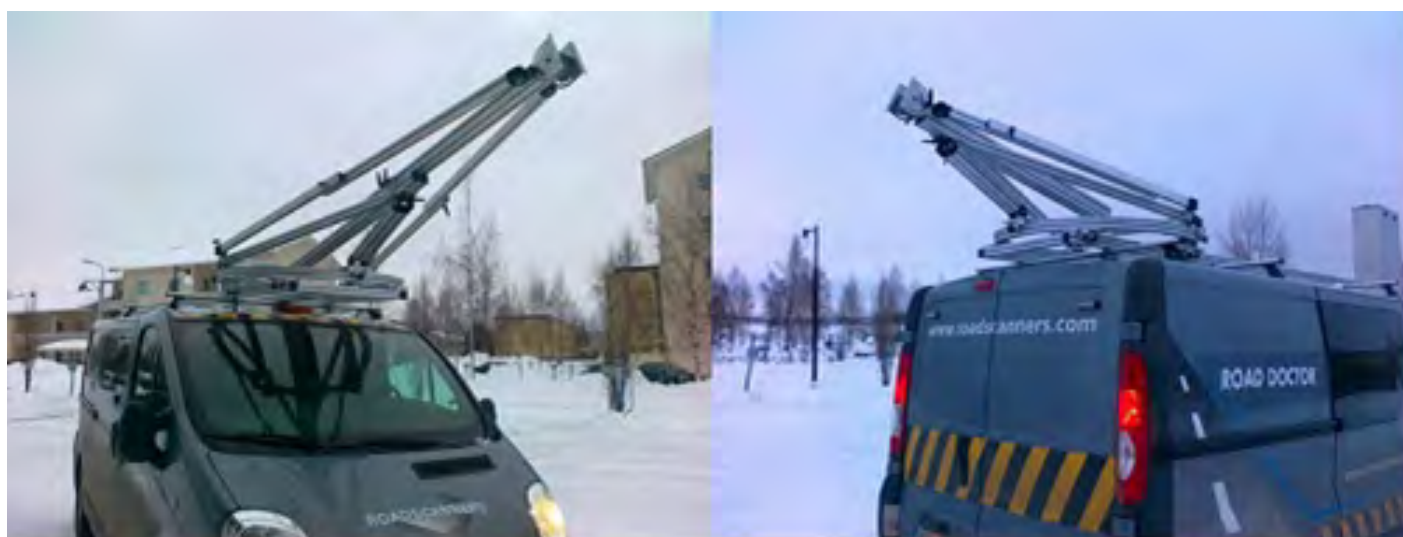
Figure J.17. New Roadscanners van roof-mounted rack system for laser scanner and thermal camera data collection.
