**SHRP 2 REPORT S2-R06G-RR-1**

Mapping Voids, Debonding, Delaminations, Moisture, and Other Defects Behind or Within Tunnel Linings

ANDREW WIMSATT, JOSHUA WHITE, CHIN LEUNG, AND TOM SCULLION
Texas A&M Transportation Institute

This report presents the findings of SHRP 2 Renewal Project R06G—High-Speed Non-destructive Testing Methods for Mapping Voids, Debonding, Delaminations, Moisture, and Other Defects Behind or Within Tunnel Linings. The study was divided into two phases to (1) establish testing criteria and prioritize the techniques to be developed and evaluated under the project on the basis of tunnel operators' requirements and (2) conduct the necessary technology development for those techniques recommended.

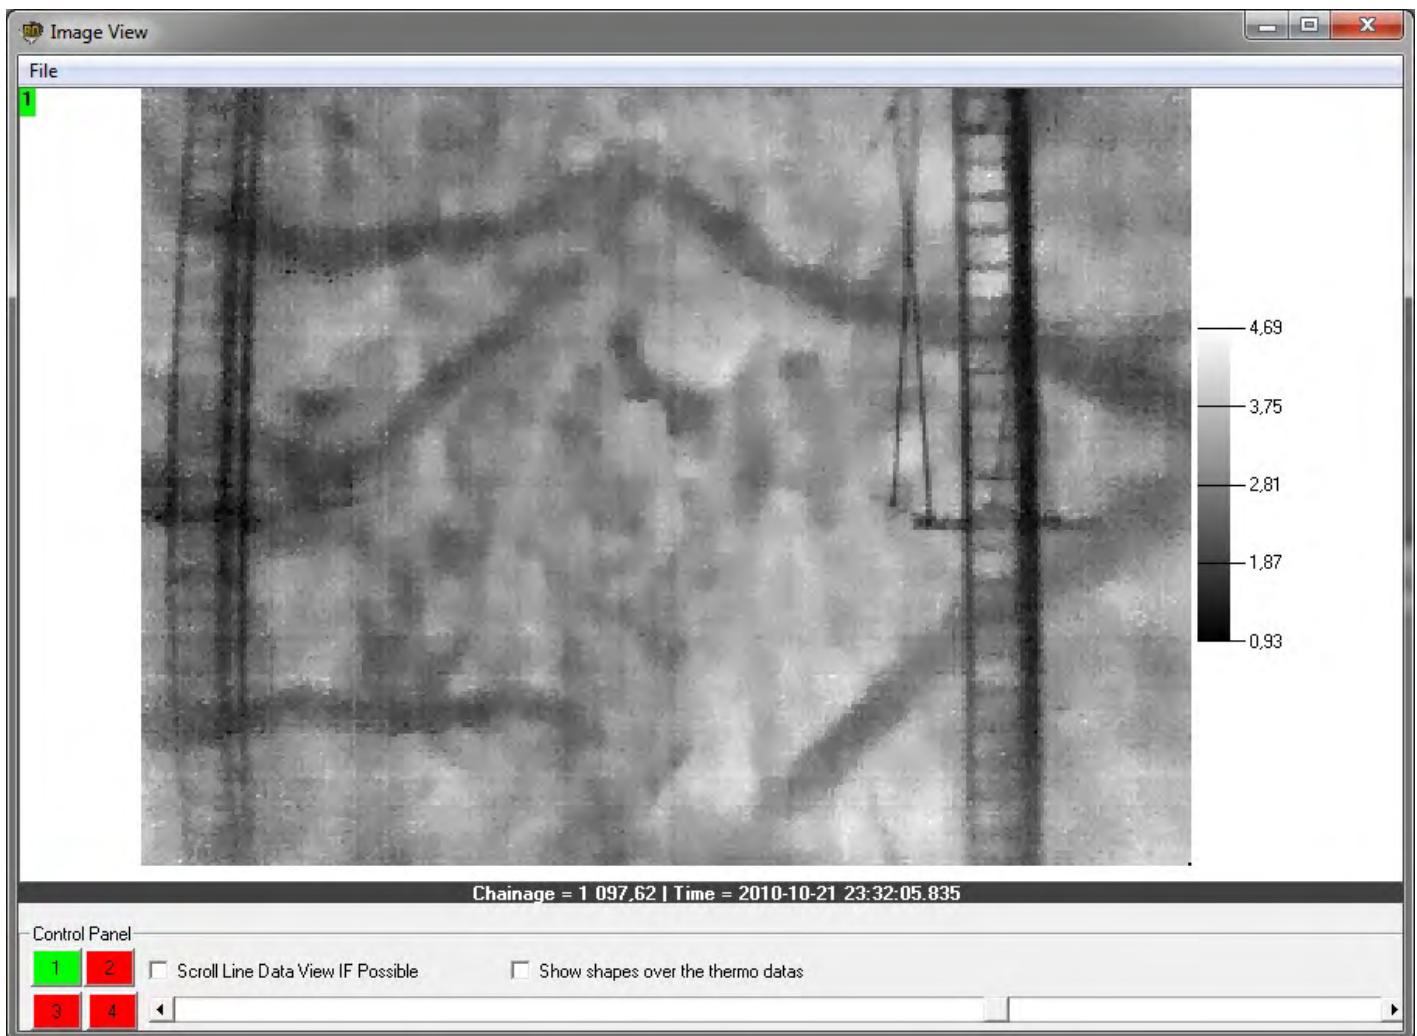
Figure J.22. Thermal video view in Road Doctor software display using example from Vuosaari Tunnel roof.

The RDTD module allows analysis of the thermal data directly from the thermal video. For that, the supported data type is converted into *.RDTD format. Compared with thermal maps, thermal video analysis is recommended because thermal video analysis gives more detailed information concerning thermal anomalies (Figures J.21 and J.22). A maximum of four thermal videos can be analyzed in the same view at once.

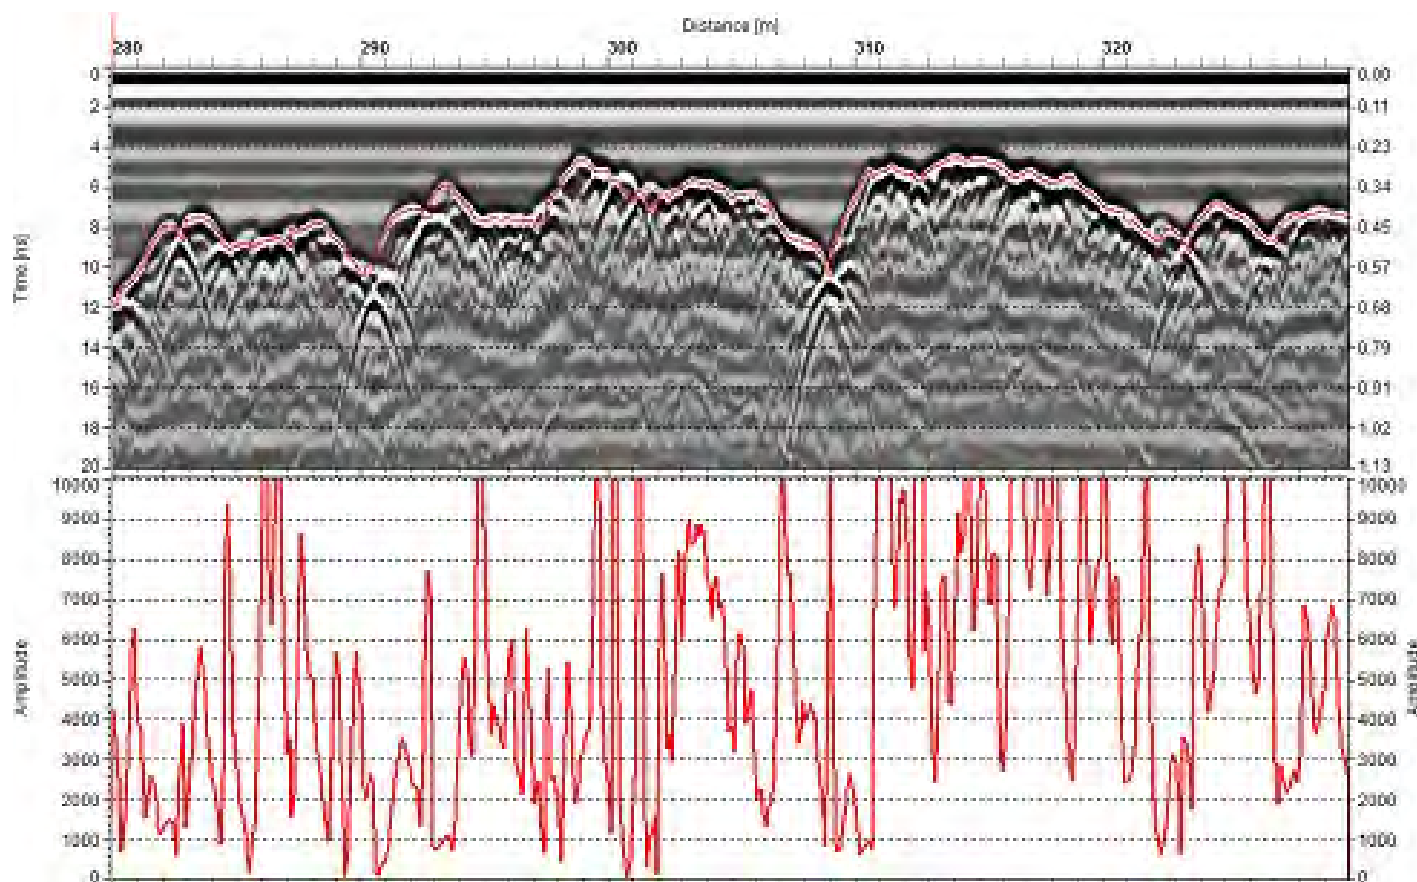
Figure J.27. Interpreted surface reflection of air-coupled 1-GHz horn data (top) and amplitude of interpreted surface reflection (bottom) in Vuosaari Tunnel. Y-axis in GPR data (right) represents distance to wall (calculated with Er:1).

To collect information concerning the effect of seasonal changes on the GPR data results, GPR data were collected in summer, winter, and autumn. Then the surface dielectric values were compared with one another. The comparison data are presented in Figure J.28. The dielectric maps were similar in each season, but the most detailed information was collected in early summer.

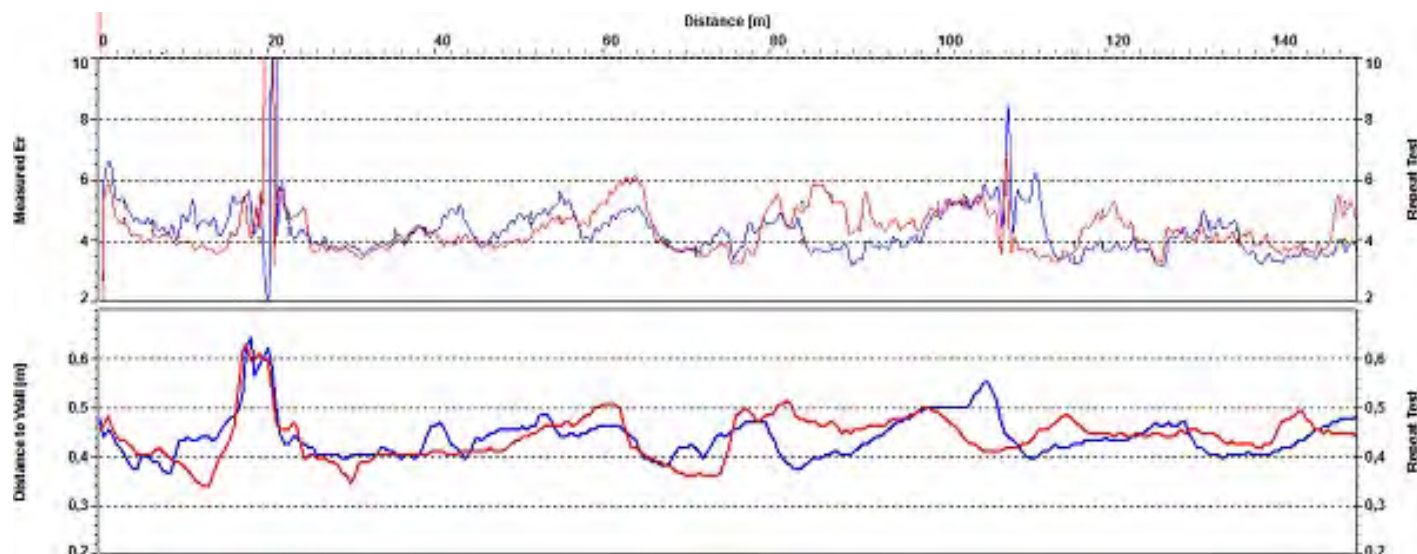
Figure J.29. Results of surface dielectric values repeatability tests (top) and antenna-to-wall distance (bottom). Red, run 1; blue, run 2.

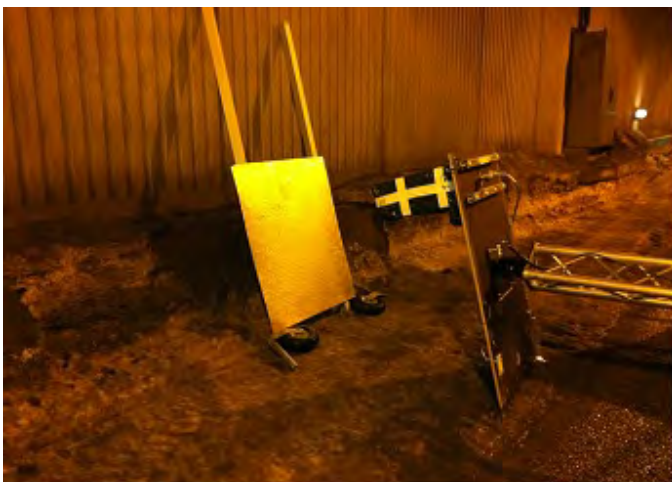
Figure J.32. GPR metal reflection data collection during winter tests in 2011.

by 1 m—was found to be too small at distances of 1.0 m and 1.5 m (Figure J.32). The GPR signal did not reflect from the metal as expected, and signal loss was too high. From a distance of 1.0 m, the signal was 20% weaker, and from a distance of 1.5 m, it was 50% weaker compared with the signal received from the 0.5-m distance.

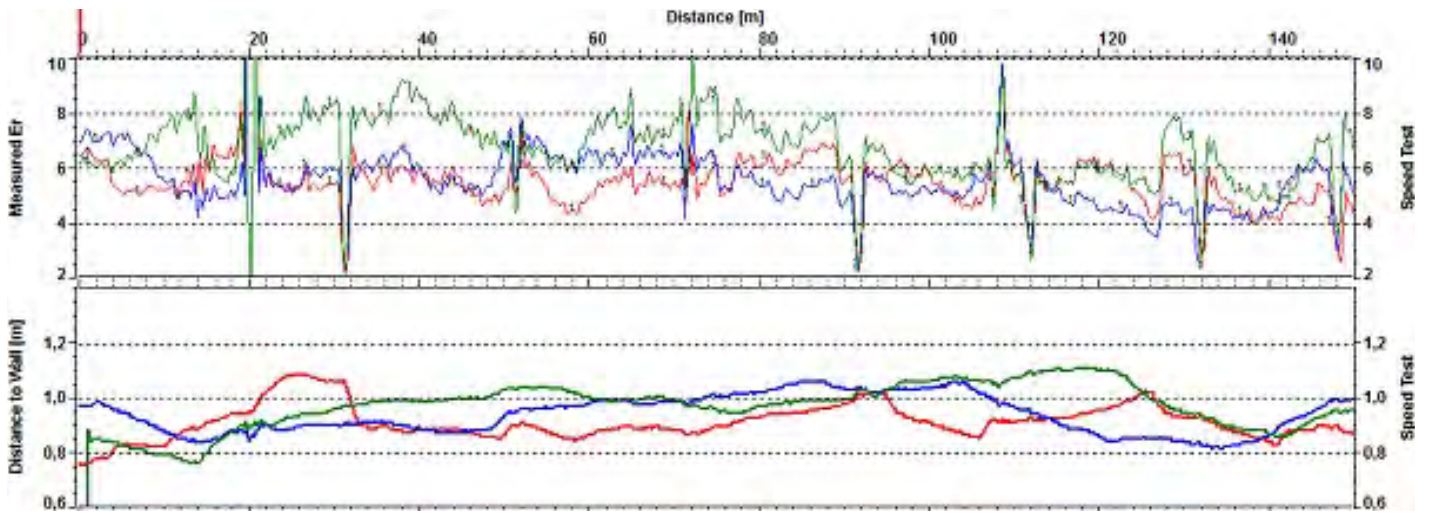
Figure J.33. Surface dielectric values in speed tests (top) and antenna-to-wall distance (bottom). Red, 6 km/h; blue, 20 km/h; and green, 30 km/h.

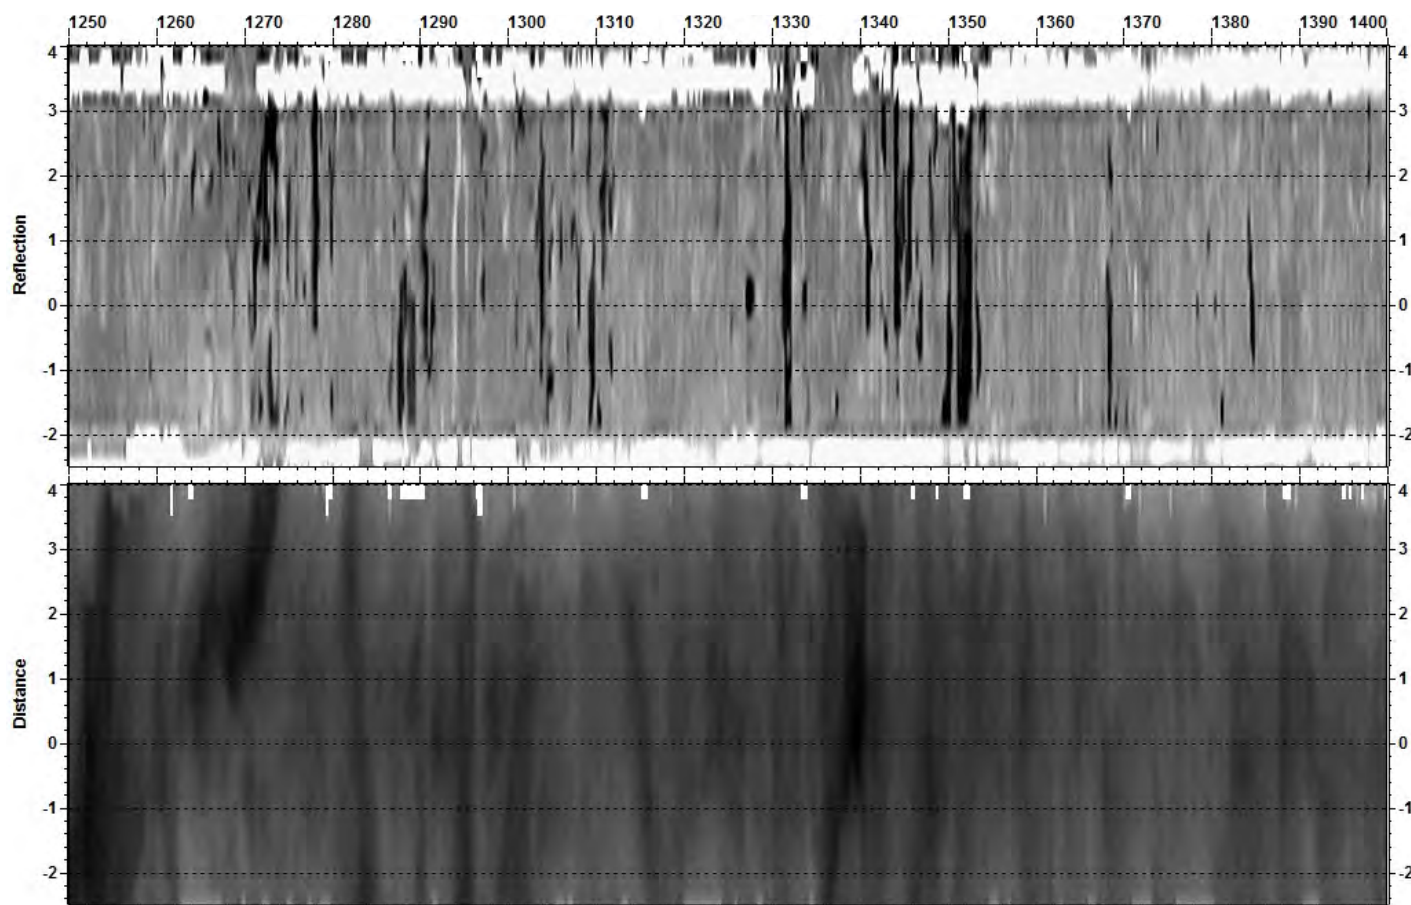
Figure J.38. Category B laser scanner data from Vuosaari Tunnel (right-side wall at 1250–1300 m). In remission data (top data field), darker areas represent potential moisture anomalies; in wall shape information (bottom data field), darker areas are farther from road.

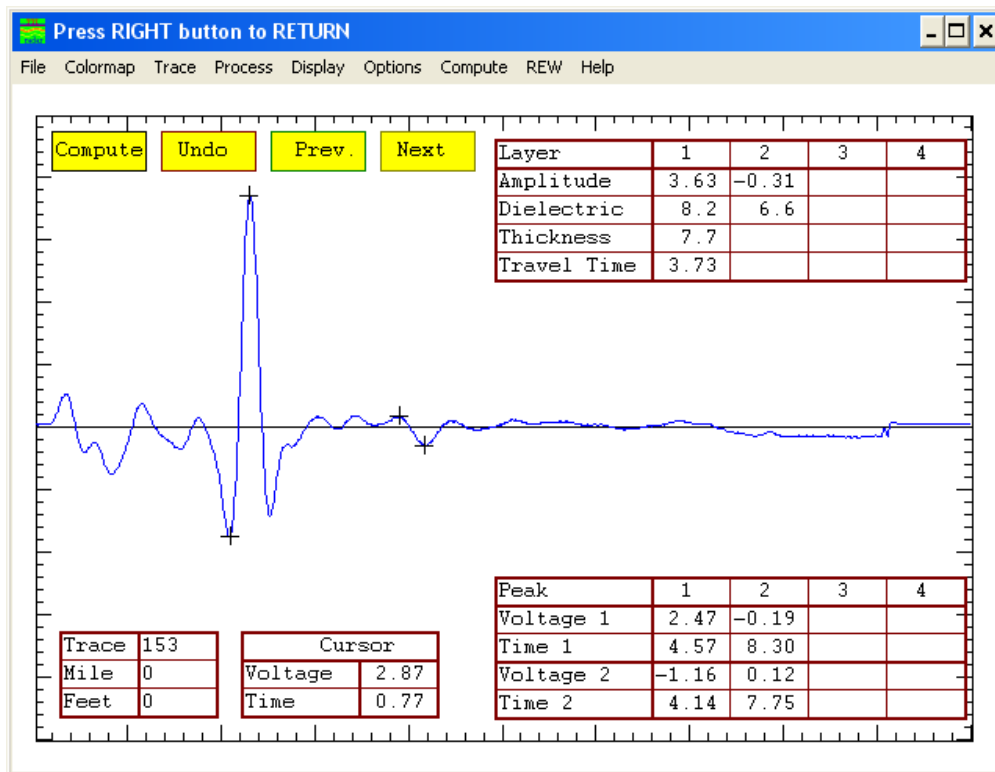
Figure K.2. Analysis of air-coupled GPR data on Specimen D.

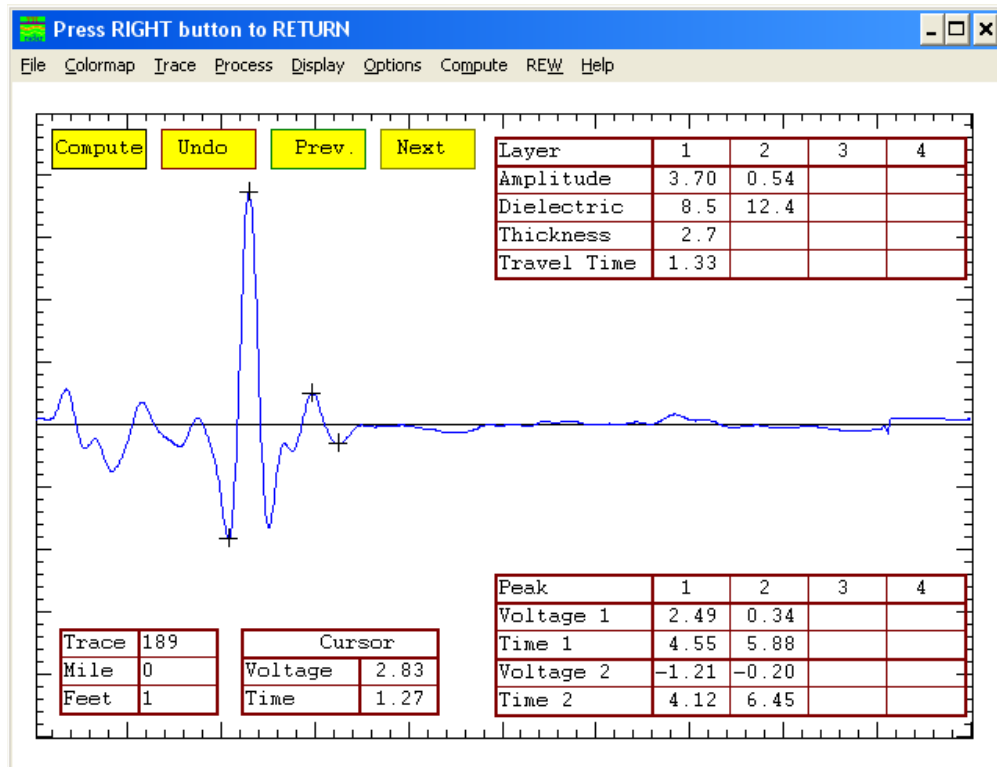
Figure K.4. Analysis of air-coupled GPR data on Specimen G.

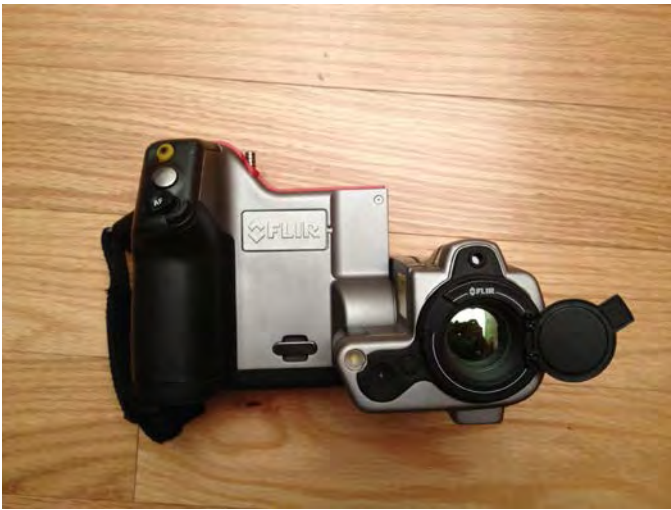
Figure L.1. FLIR T300 infrared camera.

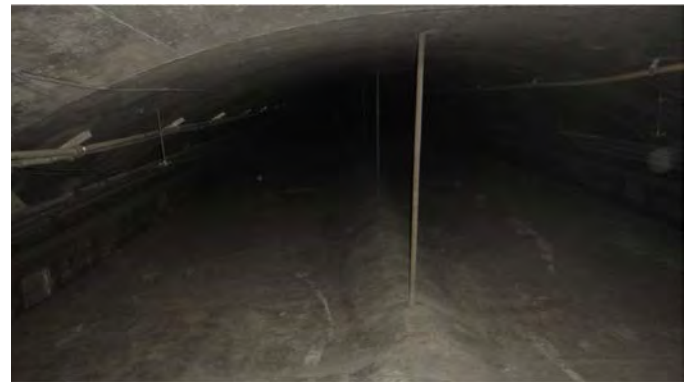
Figure L.6. Visual image of the top of the Chesapeake Channel Tunnel.

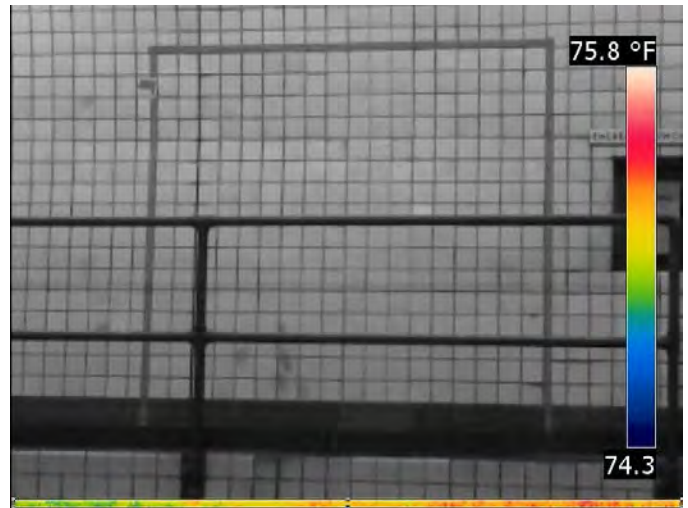
Figure L.9. FLIR T300 visual image of Figure L.8.

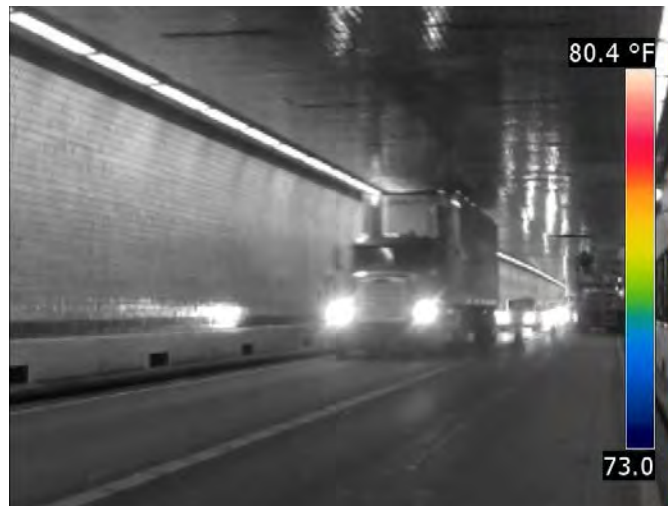
Figure L.11. FLIR T300 visual image of Figure L.10.

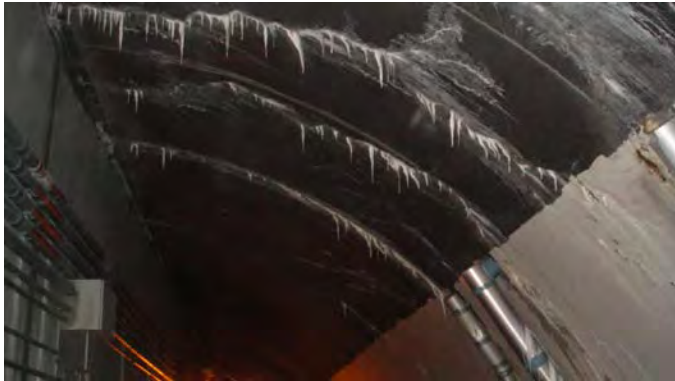
Figure L.17. Visual image of the top of the Eisenhower Memorial Tunnel.

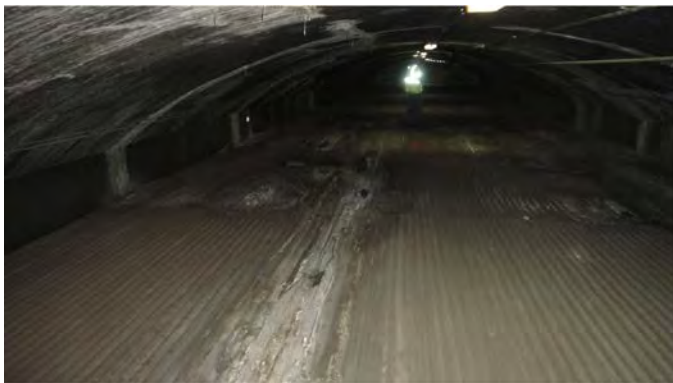
Figure L.25. Visual image of the top of the Hanging Lake Tunnel. Note staining around cracks.

Figure L.24 through Figure L.35 show the images taken in the Hanging Lake Tunnel.

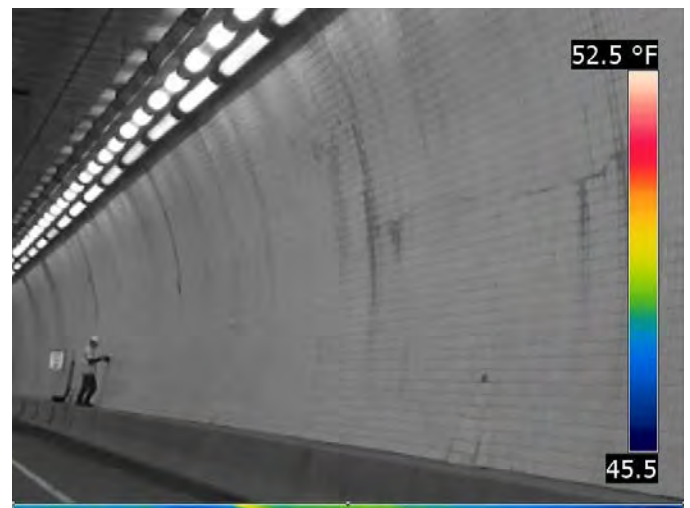
Figure L.28. FLIR T300 visual image of Figure L.27.

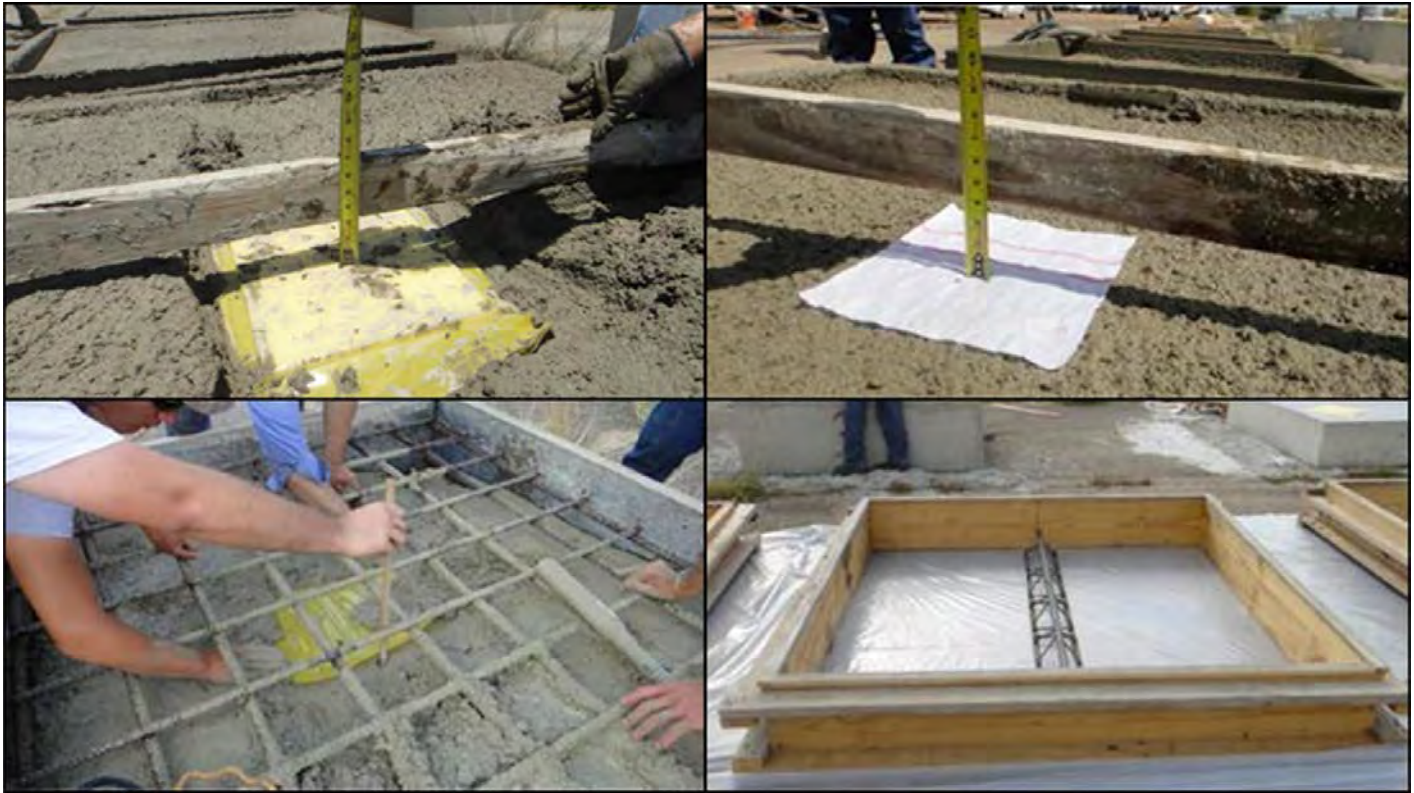
Figure M.3. Construction of slabs with simulated defects.

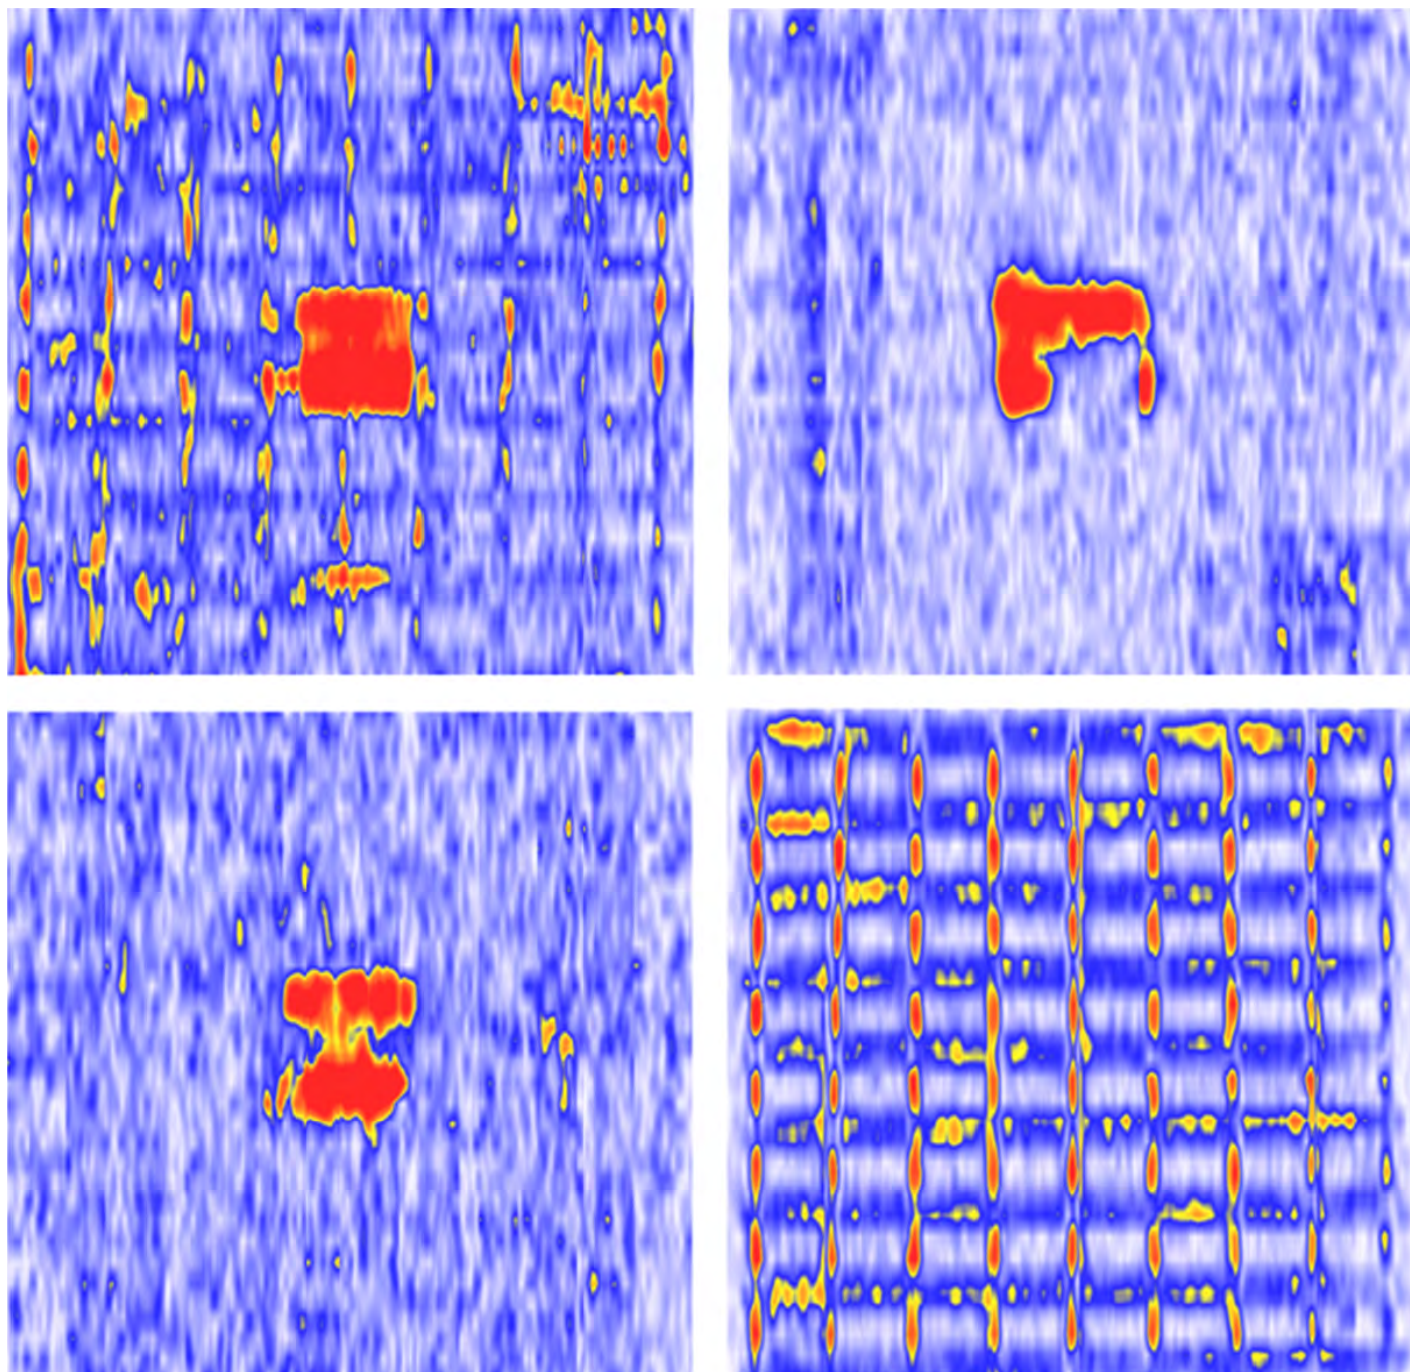
Figure M.5. Typical C-scans of simulated defects in concrete slabs: Specimens Theta (top left), Lambda (top right), Kappa (bottom left), and Gamma (bottom right).

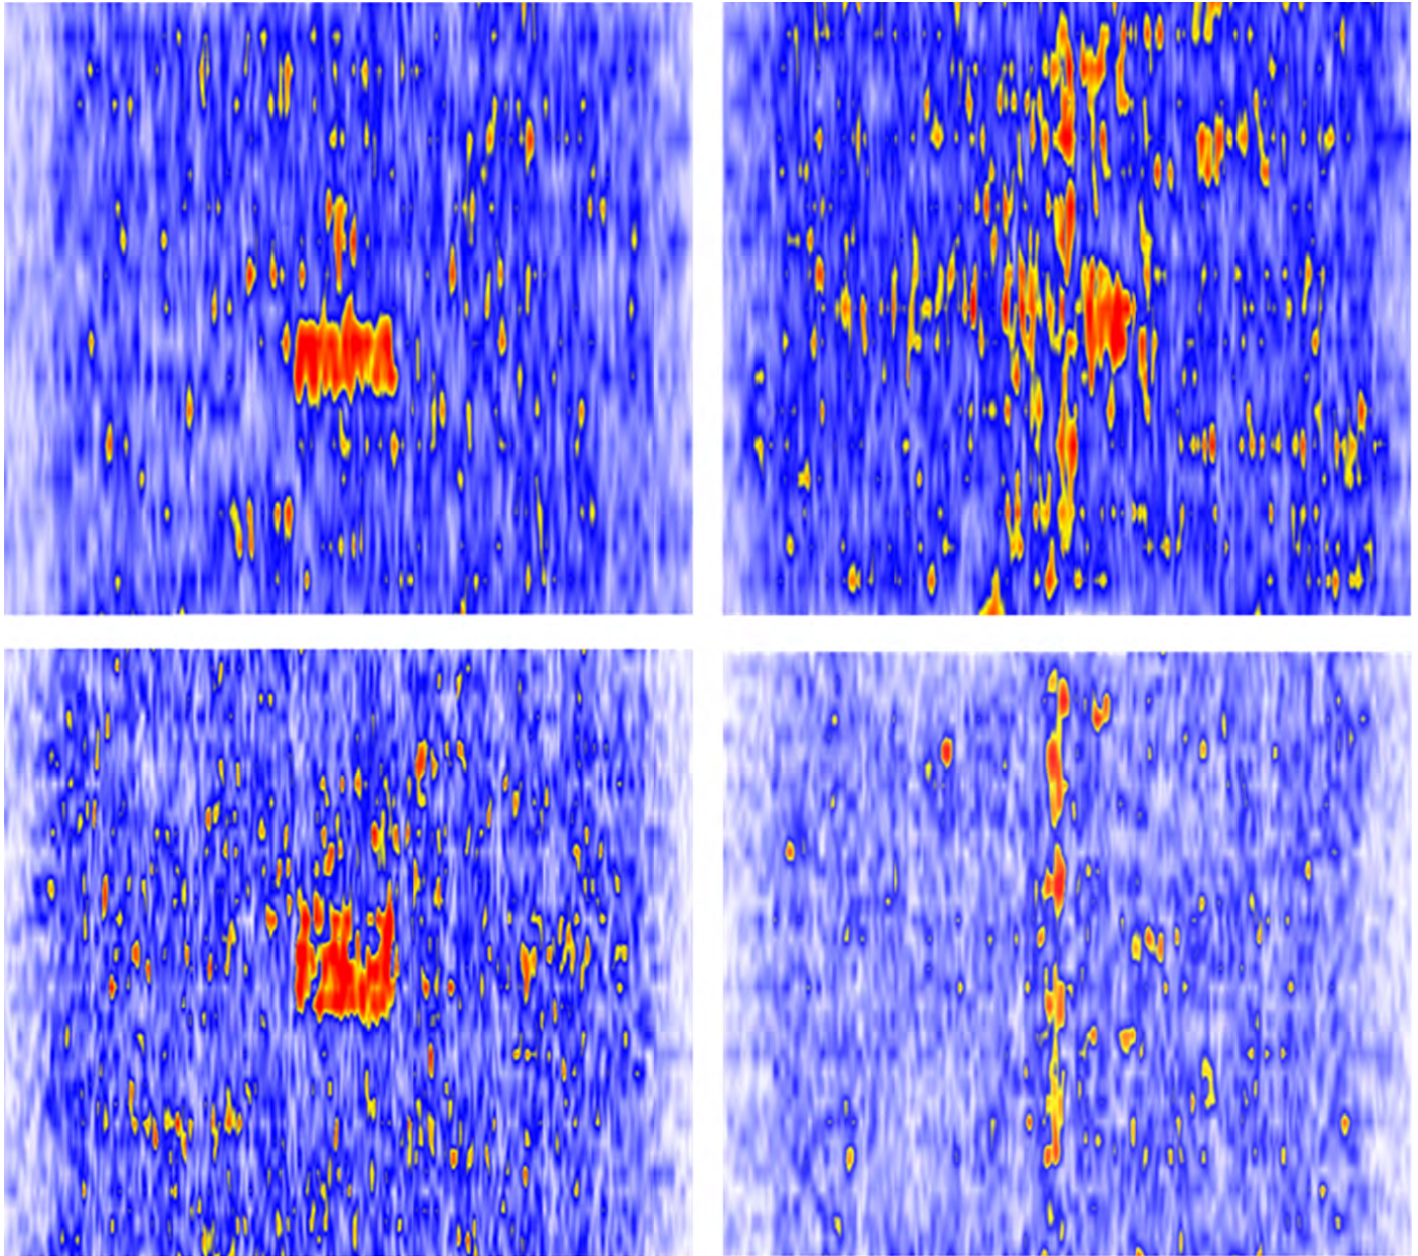
Figure M.6. Typical C-scans for simulated defects in shotcrete slabs: Specimens D (top left), E (top right), I (bottom left), and M (bottom right).

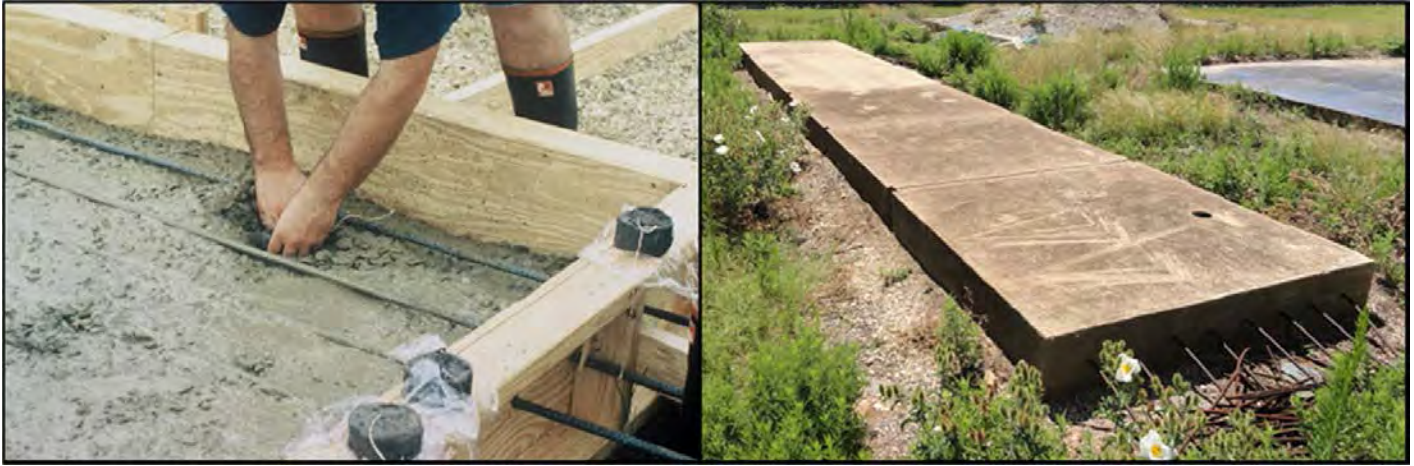
Figure M.7. Clay lump slab construction.

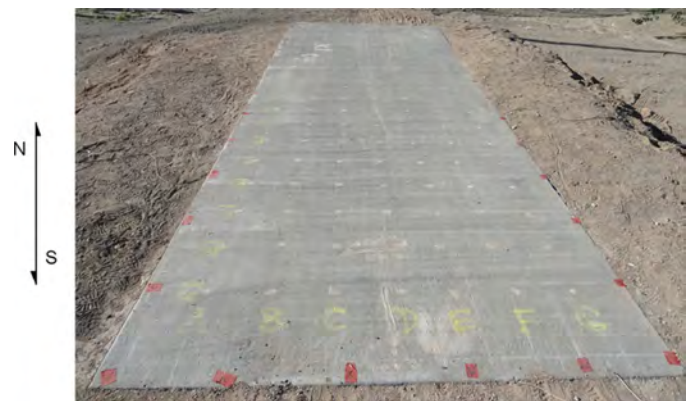
Figure M.10. Simulated bridge deck at University of Texas at El Paso.

(2.5 in.) below the surface, and below two layers of reinforcing steel at 152 mm (6 in.), with some located above prestressed girders supporting the slab. The deck, pictured in Figures M.10 and M.11, measures 2.4 m by 6.1 m by 0.2 m (8 ft by 20 ft by 8¾ in.) and rests on three prestressed concrete girders. Simulated defects constructed in the deck consist of nine artificial delaminations, five cracks, and two corroded reinforcement mats, all of which are summarized in Table M.2.

In constructing the deck, 27.6 MPa (4,000 psi) concrete was used, and two layers of No. 5 longitudinal and transverse steel were placed at 254 mm and 203 mm (10 in. and 8 in.) on center, respectively, at centroid depths of 83 mm and 184 mm (3.25 in. and 7.25 in.) from the surface. The 28-day strength and modulus exceeded 34.5 MPa (5,000 psi) and 27.6 MPa (4,000 psi),

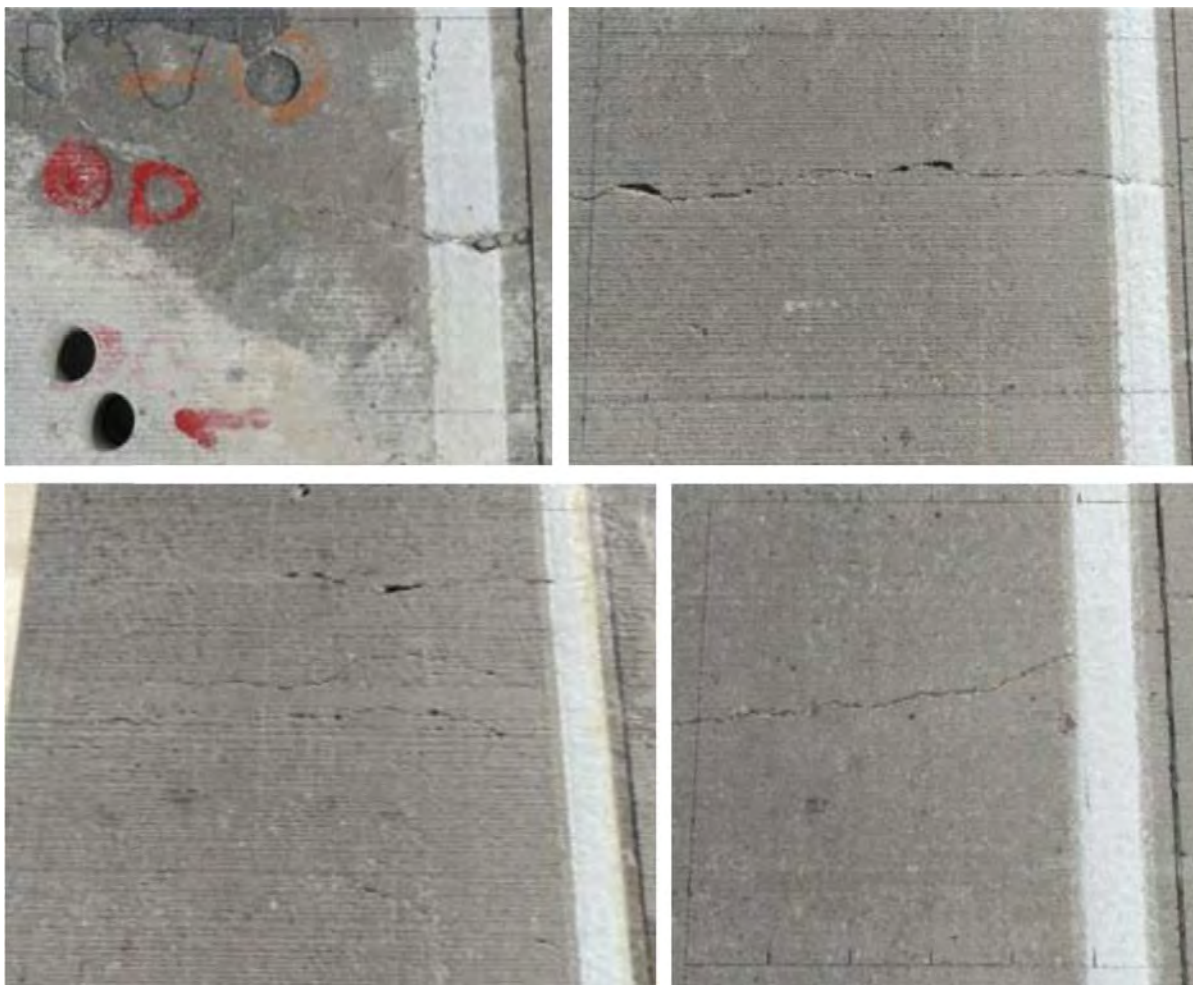
Figure M.22. Four areas tested on I-20 in Fort Worth, Texas.

The UST results of the first area tested (Figure M.22, top left) are shown in Figure M.23. These are typical B-, C-, and volume-scans that are seen in the other scanned areas. The two B-scans in Figure M.23 (left) show an area with delamination at the level of longitudinal reinforcement (top B-scan) and an area with no delamination, but a backwall reflection at the top layer interface (bottom B-scan). The C-scan (Figure M.23, center) shows the width of the delamination at the level of reinforcement. Figure M.24 shows all four areas scanned with their appropriate C-scans overlaid on the image. All delaminations in these figures are at the level of reinforcement (see Tables M.3 through M.6 for details).

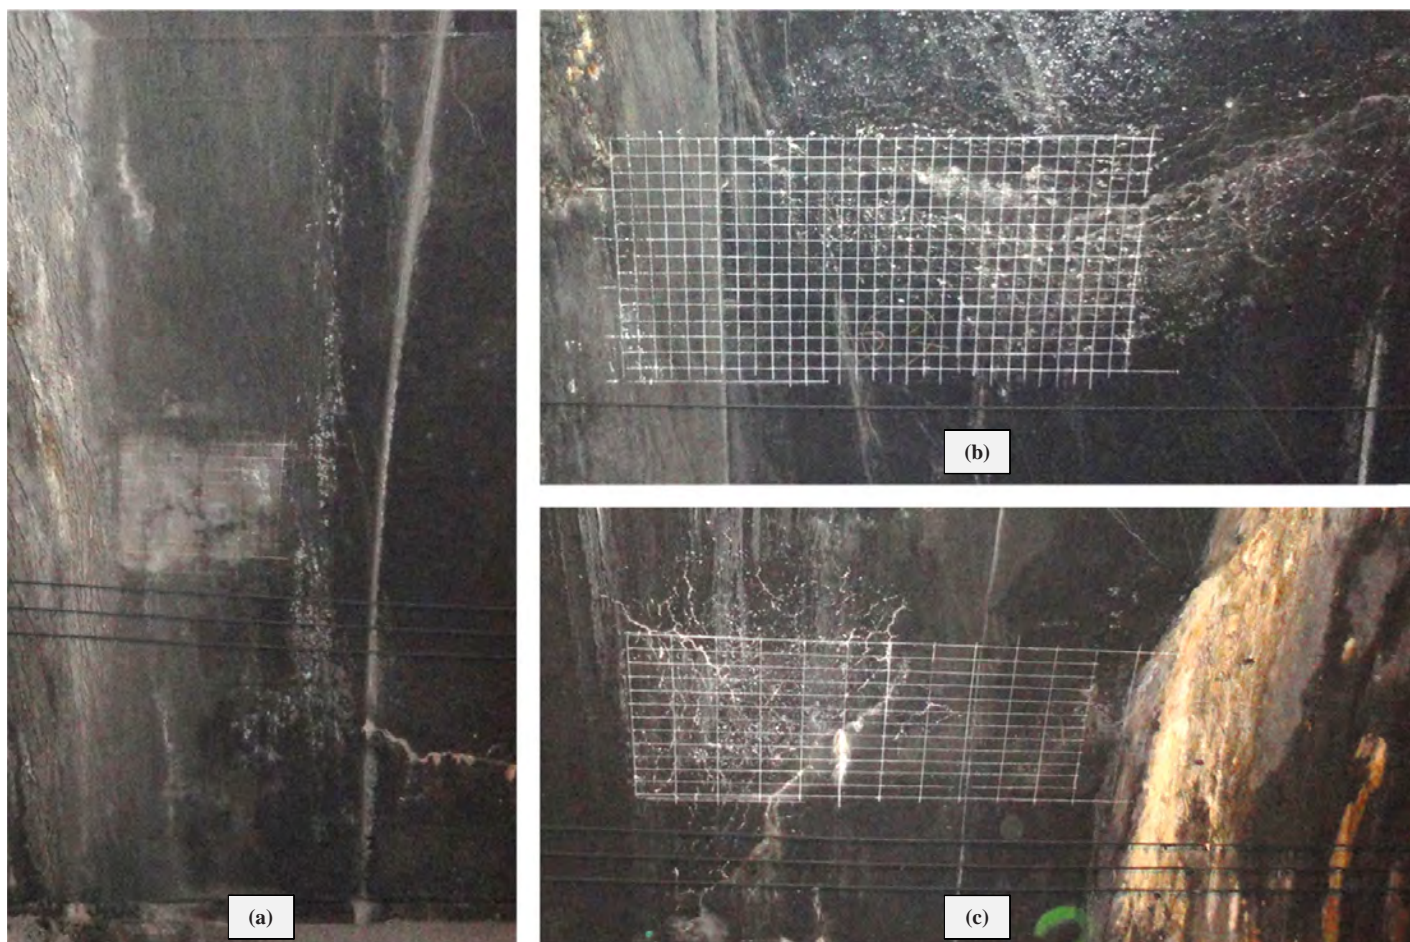
Figure M.31. Scanned areas within Eisenhower Memorial Tunnel: (a) sound concrete, (b) surface cracking and crazing near joint, and (c) surface cracking and crazing near joint and crack with stalactite formation.

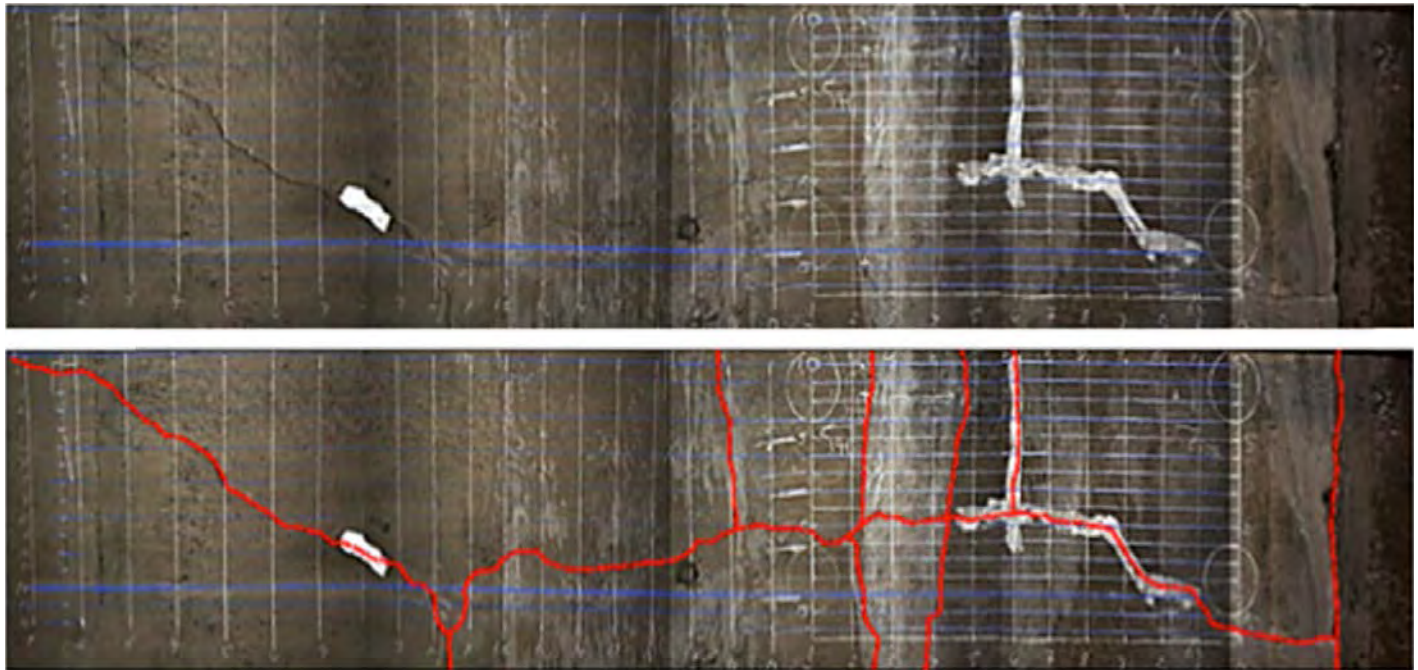
Figure M.37. Image collage of extensive map with cracks (shown in red).

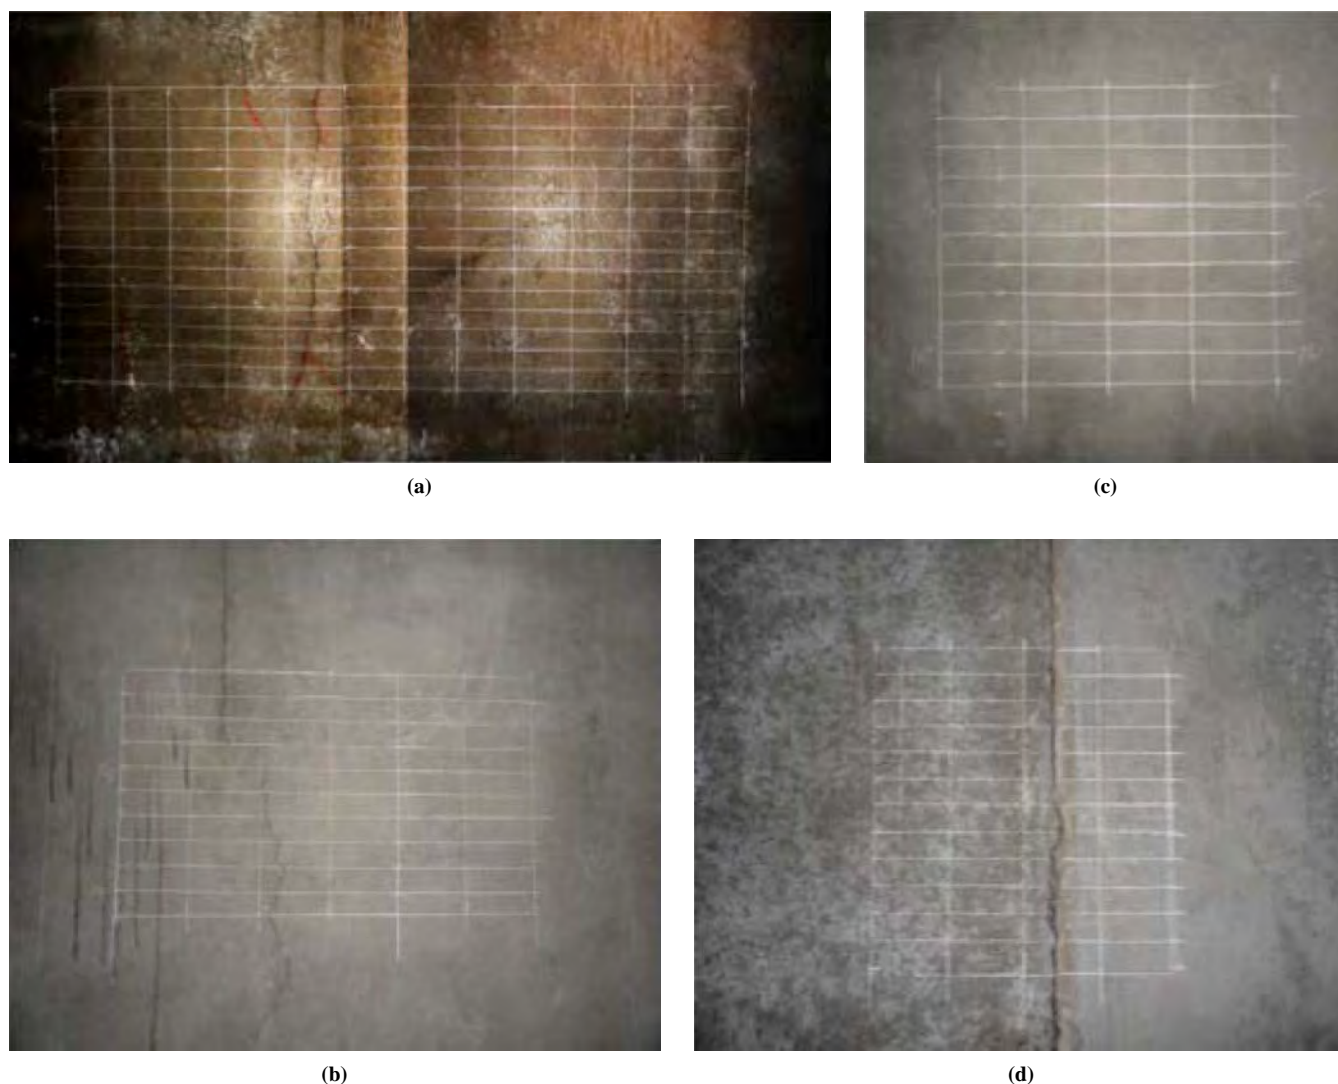
Figure M.38. Images of areas tested at Hanging Lake Tunnel: (a, b) severe vertical cracks, (c) sound concrete, and (d) lining joint.

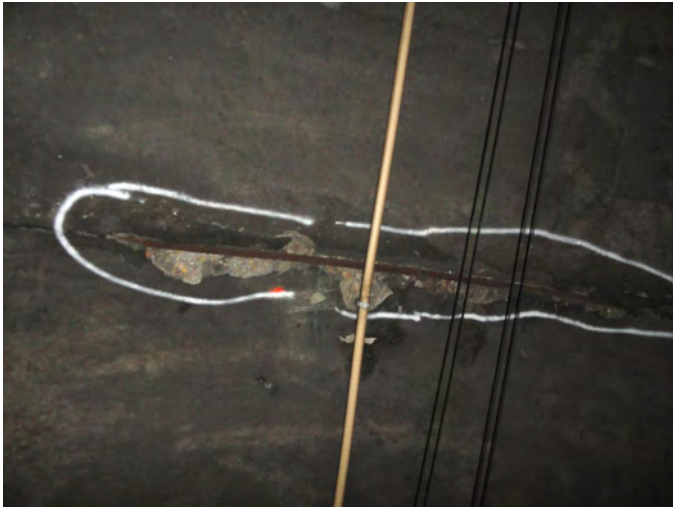
Figure M.47. Typical spalling and corrosion.
