**SHRP 2 REPORT S2-R06G-RR-1**

Mapping Voids, Debonding, Delaminations, Moisture, and Other Defects Behind or Within Tunnel Linings

ANDREW WIMSATT, JOSHUA WHITE, CHIN LEUNG, AND TOM SCULLION
Texas A&M Transportation Institute

This report presents the findings of SHRP 2 Renewal Project R06G—High-Speed Non-destructive Testing Methods for Mapping Voids, Debonding, Delaminations, Moisture, and Other Defects Behind or Within Tunnel Linings. The study was divided into two phases to (1) establish testing criteria and prioritize the techniques to be developed and evaluated under the project on the basis of tunnel operators' requirements and (2) conduct the necessary technology development for those techniques recommended.

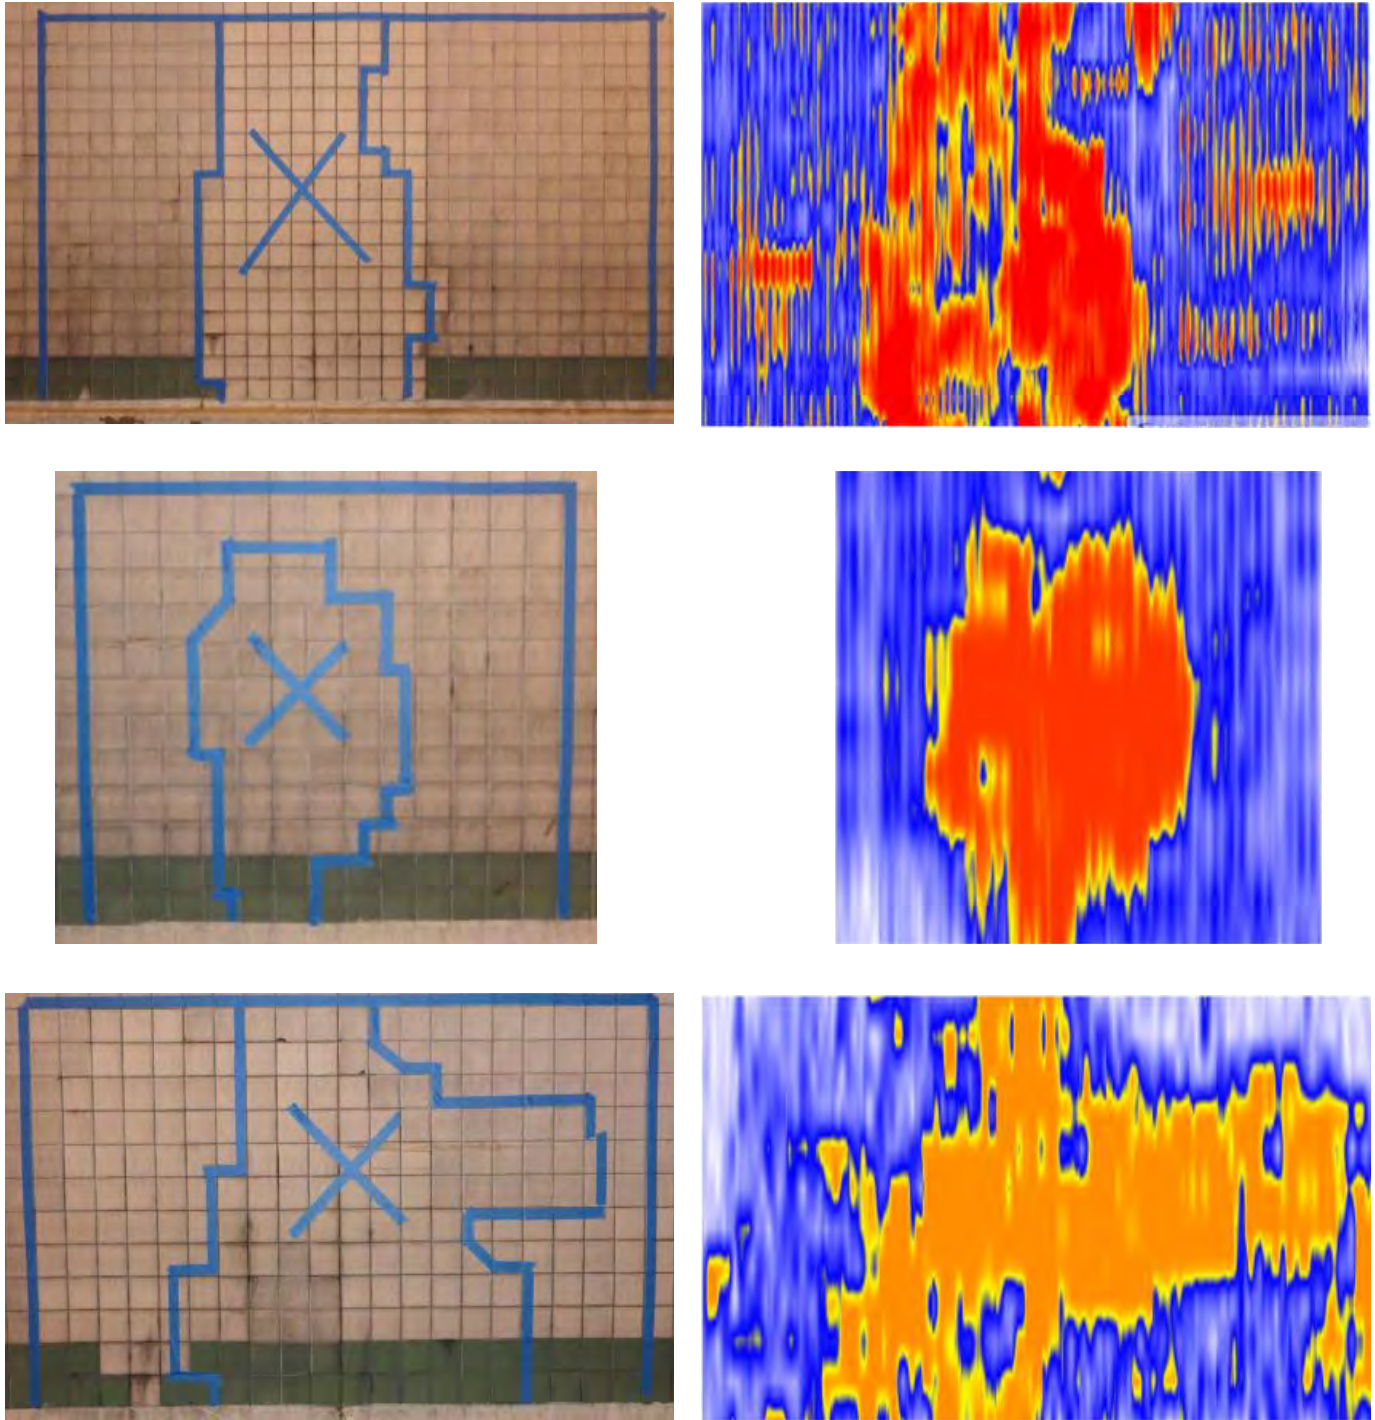
Figure M.58. *Tile linings via UST (left) paired with the associated C-scans (right).*

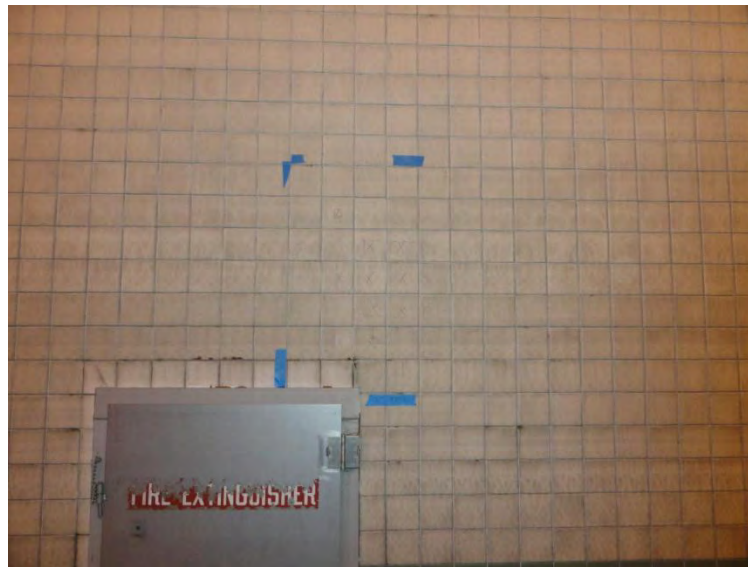
Figure M.60. Tile lining tested at Washburn Tunnel.

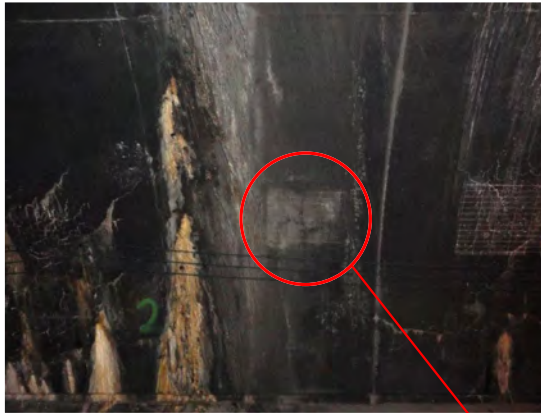
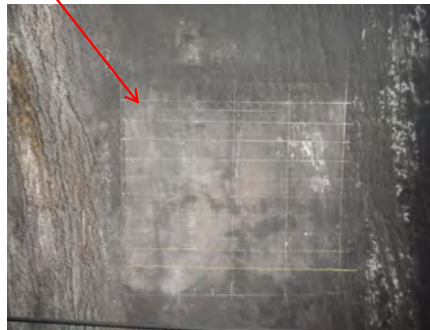
Figure N.1. Images of test site ET 10.4-1, 2.

Defects	Notes	Reinf. Detail	
No significant defect noticed, except for strip of area (~9.4" wide, 16.2" deep) consistently found in other maps. Possibly structural steel reinforcement.	Backsurface not discernible. Area tested as representative of sound concrete.	Hoop reinf: ~4.2" deep @ ~9.9" on center. Longitudinal reinf: below hoop reinforcement.	$V_{\text{shear}} = 2751 \text{ m/s}$ X-step: 150 mm Y-step: 50 mm Max Depth: 1000 mm Frequency: 50 kHz Dillon, CO Eisenhower Tunnel ET 10.4-1, 2 Segment 8 TAMU/TII 10/2011

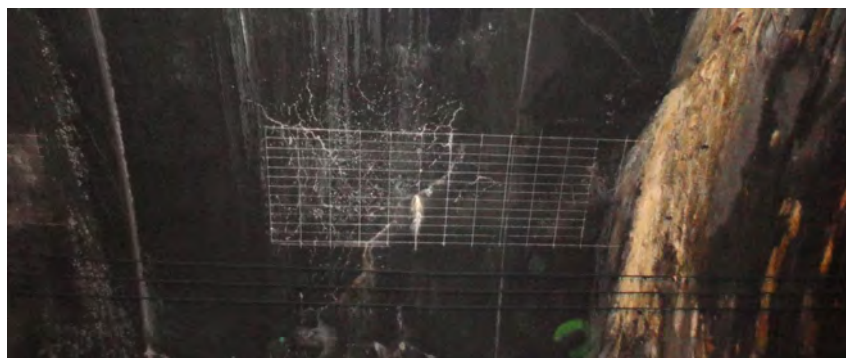
Figure N.3. Image of test site 10.4-3.

Defects	Notes	Reinf. Detail	
No significant defect noticed, except for strip of area (~12.2" wide, 17.2" deep) consistently found in other maps. Possibly steel structural reinforcement.	Backsurface not discernible. Area tested because of surface cracking and crazing, nearby stalactite formation. Could not test over stalactite crack due to obtrusions.	Hoop reinf: ~3.7"-5.1" deep @ ~10.1" on center. Longitudinal reinf: below hoop reinforcement.	$V_{\text{shear}} = 2751 \text{ m/s}$ X-step: 150 mm Y-step: 50 mm Max Depth: 750 mm Frequency: 50 kHz Dillon, CO Eisenhower Tunnel ET 10.4-3 Segment 8 TAMU/TTI 10/2011

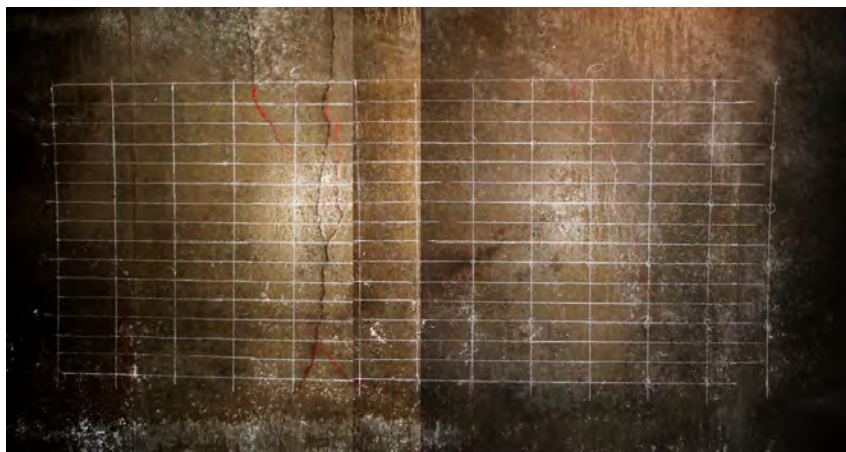
Figure N.7. Image of test site HLT 10.5-1, 2, 3.

Defects	Notes	Reinf. Detail	
Apparent delamination extending 12.3" deep, originating from surface crack; possibly connecting to another crack located approximately 35" to the right of surface crack	Backsurface possibly seen at 27.6" in depth. Severe cracking. Area also tested by BAM.	Hoop reinf: 4.6"- 6.2" deep @ 15.7" on center. Longitudinal reinf: above and possibly below hoop reinforcement @ 14.1" on center.	V _{shear} = 2159 m/s X-step: 150 mm Y-step: 50 mm Max Depth: 2500 mm Frequency: 50 kHz Glenwood Springs, CO Hanging Lake Tunnel HLT 10.5-1, 2, 3 Segment 57 + 3.4 TAMU/TTI 10/2011

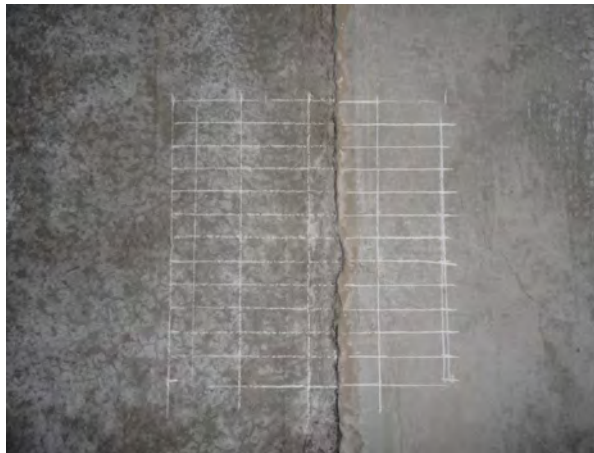
Figure N.9. Images of test site HLT 10.5-4.

Defects	Notes	Reinf. Detail	
Suspected debonding around east (right) side of joint. Surface crack around area might support this. Suspected debonding extends a maximum of 9" deep.	Backsurface not detected. Area tested because of natural joint. This map should be extended east to detail more of possible debonding.	Hoop reinf: ~3.6" deep on center.	V _{shear} = 2159 m/s X-step: 150 mm Y-step: 50 mm Max Depth: 1000 mm Frequency: 50 kHz
			Glenwood Springs, CO Hanging Lake Tunnel HLT 10.5-4 Segments 54/55 Joint TAMU/TTI 10/2011

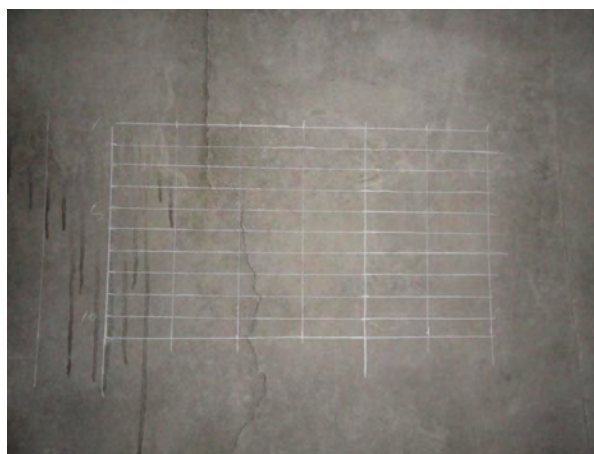
Figure N.13. Image of test site HLT 10.5-8, 9.

Defects	Notes	Reinf. Detail	
No significant defect noticeable. Backwall reflection varies 2-3" in depth. This may be lower reinforcement reflection or backwall delamination (see HLT 10.5-8,9).	Backsurface possibly 24.5" - 29.6" deep. Area tested because of single surface crack. Note strong echoes emanating from region of reinforcement. This is possible sign of debonding.	Hoop reinf: ~3.7" deep @ 15.9" on center. Longitudinal reinf: below hoop reinforcement. .	Vshear = 2159 m/s X-step: 150 mm Y-step: 50 mm Max Depth: 2500 mm Frequency: 50 kHz
			Glenwood Springs, CO Hanging Lake Tunnel HLT 10.5-8, 9 Segments 49 TAMU/TTI 10/2011

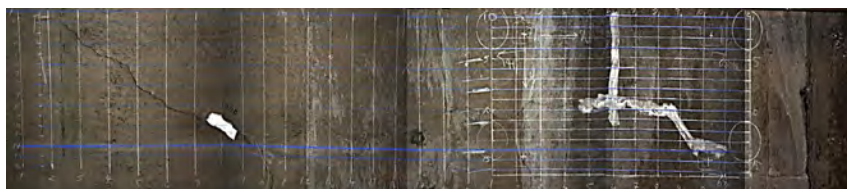
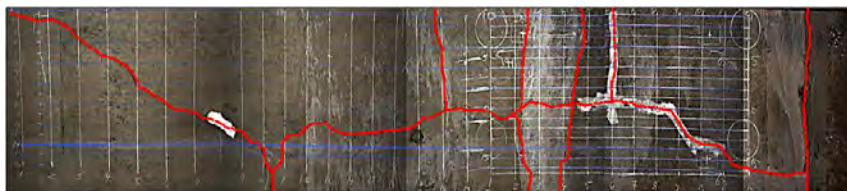
Figure N.15. Images of test site HLT 10.5-10, 11, 12.

Defects	Notes	Reinf. Detail	
Significant delamination/debonding discovered which stretched over 11', ranging from 8"-20" below the surface.	Backsurface not discernible due to high presence of delamination/debonding. Area tested because of severe surface cracking.	Hoop reinf: ~2.9"-5.1" deep @ ~16.4" on center. Longitudinal reinf: above hoop reinforcement.	V _{shear} = 2159 m/s X-step: 150 mm Y-step: 50 mm Max Depth: 1000 mm Frequency: 50 kHz
			Glenwood Springs, CO Hanging Lake Tunnel HLT 10.5-10, 11, 12 Segment 55 TAMU/TTI 10/2011

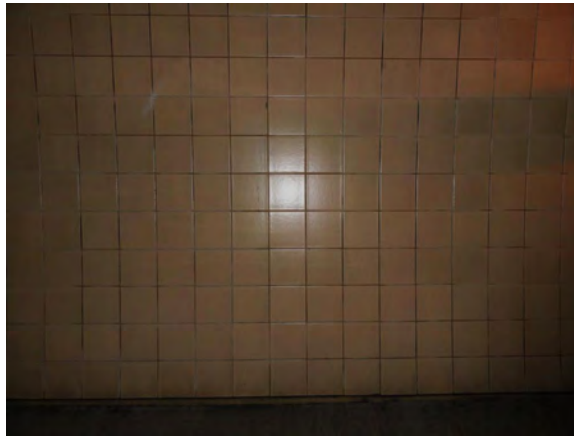
Figure N.17. Image of test site HLT 10.5-13.

Defects	Notes	Reinf. Detail	
No significant defect noticed.	Backsurface not discernible. Area tested on surface of tile. Hair-line crack present.	Hoop reinf: ~5.1" deep @ ~16.3" on center. Longitudinal reinf: below and possible above hoop reinforcement @ ~14.0" on center.	Vshear = 2159 m/s X-step: 150 mm Y-step: 50 mm Max Depth: 1000 mm Frequency: 50 kHz
			Glenwood Springs, CO Hanging Lake Tunnel HLT 10.5-13 Interior Tile Lining TAMU/TII 10/2011

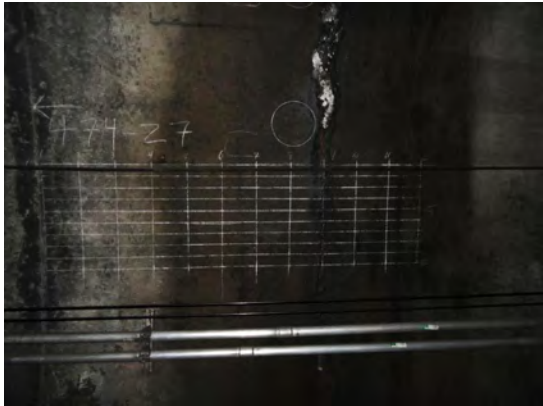
Figure N.23. Images of test site CBBT 10.11-5.

Defects	Notes	Reinf. Detail	
Significant shallow defects, such as shallow cracks (~9" deep) and possibly shallow delaminations (~2" deep), which seem to produce the ringing.	Backsurface at ~24.1" deep. Area tested because of live crack. Significant ringing may suggest debonding of longitudinal reinforcement.	Hoop reinf: ~2.0"-2.6" deep @ ~12.0" on center. Longitudinal reinf: below hoop reinforcement.	Vshear = 2710 m/s X-step: 150 mm Y-step: 50 mm Max Depth: 1000 mm Frequency: 50 kHz Norfolk, VA Chesapeake Tunnel CBBT 10.11-5 Sta. 474+27 TAMU/TTI 10/2011

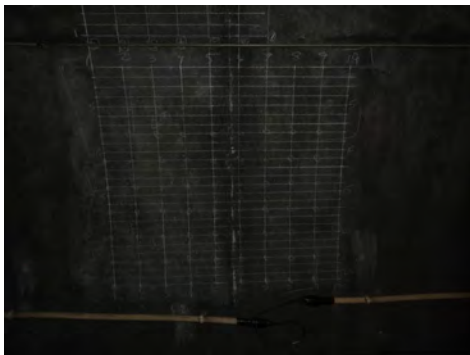
Figure N.25. Images of test site CBBT 10.11-7, 8.

Defects	Notes	Reinf. Detail	
Hammer tapping revealed hollow region as shown by shallow reflective region in the C- and B-scans. Significant cupped-shaped delaminations as deep as 19.2"	Backsurface at 24.1"-26.0" deep. Area tested because of high dielectric reading from GPR scan. No significant visual distress noticeable, but hammer sounding revealed shallow delamination in Region II.	Hoop reinf: ~2.2" deep @ ~12.1" on center. Longitudinal reinf: below hoop reinforcement @ 16.2" on center.	V _{shear} = 2710 m/s X-step: 150 mm Y-step: 50 mm Max Depth: 1000 mm Frequency: 50 kHz Norfolk, VA Chesapeake Tunnel CBBT 10.11-7, 8 (Region II) Sta. 486+67 TAMU/TTI 10/2011

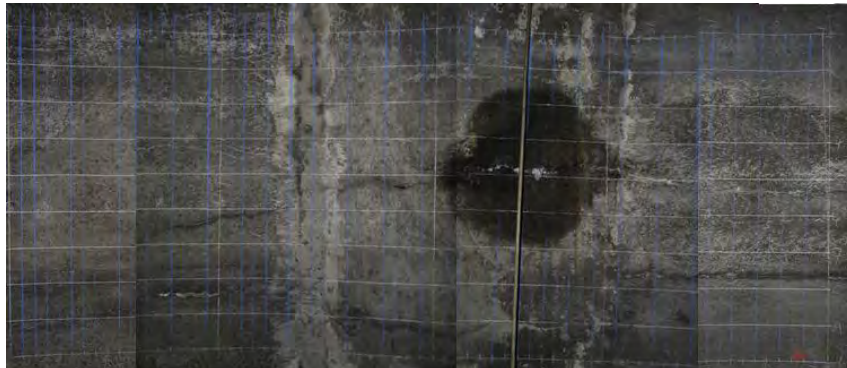
Figure N.29. Images of test site CBBT 10.11-10.

Defects	Notes	Reinf. Detail	
Heavy ringing made internal inspection difficult. Possible deep delamination (~17.7" deep and possibly 19" wide) and evidence of surface crack extending ~9.8" deep.	Backsurface at 22.7"-25.9" deep. Area tested because of large surface crack and small area of water intrusion.	Hoop reinf: ~2.7"-3.2" deep @ ~11.7"-12.4" on center. Second layer of hoop reinf. directly beneath top layer. Longitudinal reinf: below first layer of hoop reinforcement @ ~17.1" on center.	Vshear = 2710 m/s X-step: 150 mm Y-step: 50 mm Max Depth: 1000 mm Frequency: 50 kHz
			Norfolk, VA Chesapeake Tunnel CBBT 10.11-10 Sta. 491+25 TAMU/TTI 10/2011

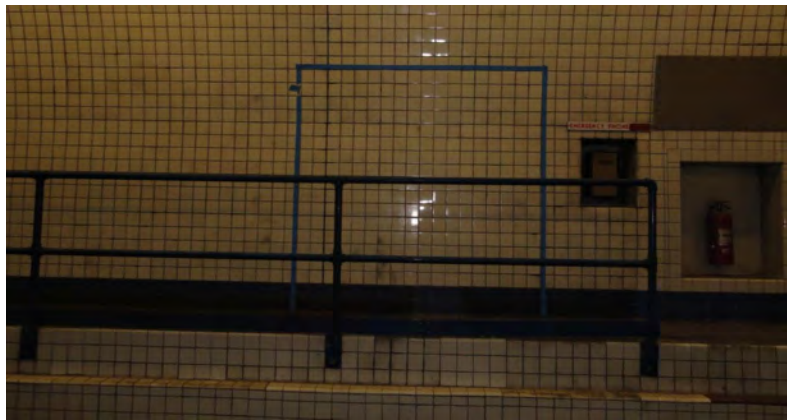
Figure N.31. Image of test site CBBT TILE 10.11-11.

Defects	Notes	Reinf. Detail	
Heavy ringing made internal inspection difficult. Possible deep delamination (~15.7" deep and 20.3" wide).	Backsurface at 25.0"-30.0" deep. Area tested was tiled lining over a joint where tile has debonded. Determined area via hammer sounding.	Hoop reinf: ~4.3"-7.7" deep @ ~12.1" on center. Second layer of hoop reinf. seen beneath top layer in one location-possibly splice area. Longitudinal reinf: below hoop reinforcement @ ~13.0" on center.	Vshear = 2710 m/s X-step: 110 mm Y-step: 110 mm Max Depth: 750 mm Frequency: 50 kHz Norfolk, VA Chesapeake Tunnel CBBT TILE 10.11-11 Approx. Sta. 488 TAMU/TTI 10/2011

Defects	Notes	Reinf. Detail	Vshear = 2710 m/s X-step: 110 mm Y-step: 110 mm Max Depth: 750 mm Frequency: 50 kHz Norfolk, VA Chesapeake Tunnel CBBT TILE 10.11-11 Approx. Sta. 488 TAMU/TTI 10/2011
Heavy ringing made internal inspection difficult. Possible deep delamination (~15.7" deep and 20.3" wide).	Backsurface at 25.0"-30.0" deep. Area tested was tiled lining over a joint where tile has debonded. Determined area via hammer sounding.	Hoop reinf: ~4.3"-7.7" deep @ ~12.1" on center. Second layer of hoop reinf. seen beneath top layer in one location-possibly splice area. Longitudinal reinf. below hoop reinforcement @ ~13.0" on center.

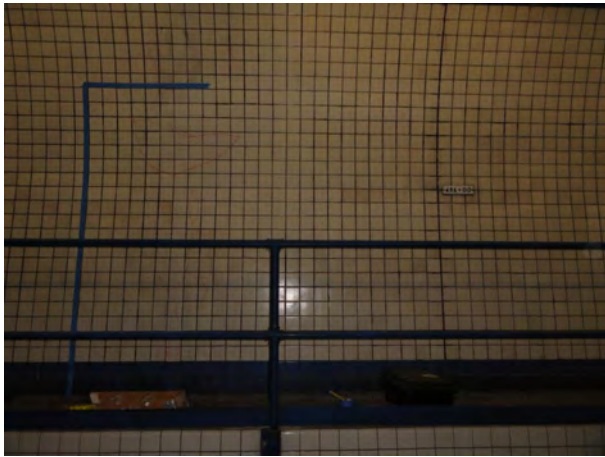
Figure N.33. Image of test site CBBT TILE 10.11-12.

Defects	Notes	Reinf. Detail	
Heavy ringing made internal inspection difficult. Possibly multiple cracks as deep as 8.6".	Backsurface at 28.1"-31.0" deep. Area tested was tiled lining. Hammer sounding did not indicate debonding, but SPACETEC infrared scans showed area of question..	Hoop reinf: ~4.8"-9.4" deep @ ~11.7" on center. Longitudinal reinf: below and possibly above hoop reinforcement.	Vshear = 2710 m/s X-step: 110 mm Y-step: 110 mm Max Depth: 1000 mm Frequency: 50 kHz Norfolk, VA Chesapeake Tunnel CBBT TILE 10.11-12 Sta. 486-09 TAMU/TTI 10/2011

Defects	Notes	Reinf. Detail	
Heavy ringing made internal inspection difficult. Possibly multiple cracks as deep as 8.6".	Backsurface at 28.1"-31.0" deep. Area tested was tiled lining. Hammer sounding did not indicate debonding, but SPACETEC infrared scans showed area of question..	Hoop reinf: ~4.8"-9.4" deep @ ~11.7" on center. Longitudinal reinf: below and possibly above hoop reinforcement.	Vshear = 2710 m/s X-step: 110 mm Y-step: 110 mm Max Depth: 1000 mm Frequency: 50 kHz Norfolk, VA Chesapeake Tunnel CBBT TILE 10.11-12 Sta. 486-09 TAMU/TTI 10/2011

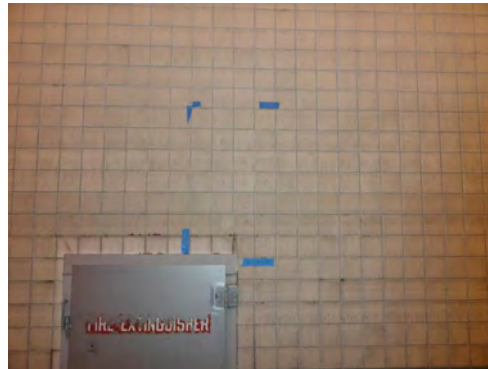
Figure N.37. Images of test site WT 9.16-1.

Defects	Notes	Reinf. Detail	
Significant shallow debonding/delamination. Deep delamination approximately 13" deep (B-scan image).	Backsurface not discernible. Area tested because of debonding located via hammer sounding.	Hoop reinf: ~6.8" deep.	V _{shear} = 2710 m/s X-step: 110 mm Y-step: 110 mm Max Depth: 500 mm Frequency: 50 kHz Houston, TX Washburn Tunnel WT 9.16-1 West Side TAMU/TI 9/2011

Defects	Notes	Reinf. Detail	
Significant shallow debonding/delamination. Deep delamination approximately 13" deep (B-scan image).	Backsurface not discernible. Area tested because of debonding located via hammer sounding.	Hoop reinf: ~6.8" deep.	Vshear = 2710 m/s X-step: 110 mm Y-step: 110 mm Max Depth: 500 mm Frequency: 50 kHz
			Houston, TX Washburn Tunnel WT 9.16-1 West Side TAMU/TTI 9/2011

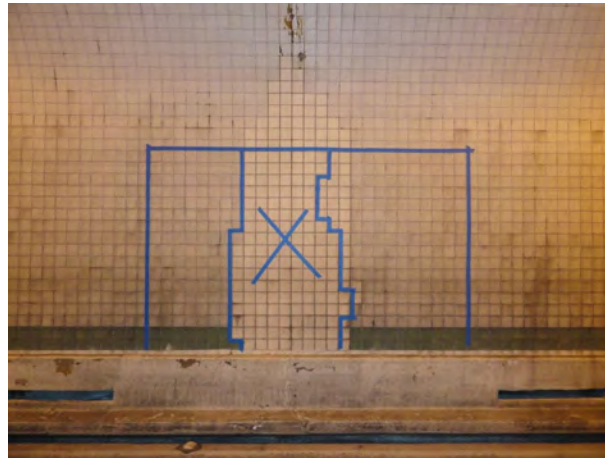
Figure N.39. Image of test site WT 9.16-2.

Defects	Notes	Reinf. Detail	
Significant shallow and deep debonding/delamination. Delamination as deep as approximately 18" deep (B-scan image).	Backsurface not discernible. Area tested because of debonding located via hammer sounding.	Hoop reinf: ~4.8"-5.2" deep @ 12.2 on center. Longitudinal reinf: below hoop reinforcement.	Vshear = 2710 m/s X-step: 110 mm Y-step: 110 mm Max Depth: 500 mm Frequency: 50 kHz
			Houston, TX Washburn Tunnel WT 9.16-2 West Side TAMU/TTI 9/2011

Defects	Notes	Reinf. Detail	
Significant shallow and deep debonding/delamination. Delamination as deep as approximately 18" deep (B-scan image).	Backsurface not discernible. Area tested because of debonding located via hammer sounding.	Hoop reinf: ~4.8"-5.2" deep @ 12.2 on center. Longitudinal reinf: below hoop reinforcement.	V _{shear} = 2710 m/s X-step: 110 mm Y-step: 110 mm Max Depth: 500 mm Frequency: 50 kHz
			Houston, TX Washburn Tunnel WT 9.16-2 West Side TAMU/TTI 9/2011

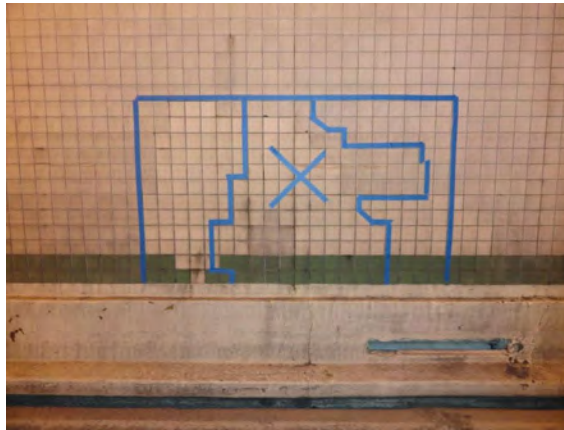
Figure N.41. Image of test site WT 9.16-3.

Defects	Notes	Reinf. Detail	
Significant delaminations/debonding throughout. Delaminations as deep as 10.7" below surface.	Backsurface not discernible. Area tested because of debonding located via hammer sounding.	Hoop reinf: ~4.9" deep @ 13.4" on center. Longitudinal reinf: below hoop reinforcement.	V _{shear} = 2710 m/s X-step: 110 mm Y-step: 110 mm Max Depth: 500 mm Frequency: 50 kHz
			Houston, TX Washburn Tunnel WT 9.16-3 West Side TAMU/TI 9/2011

Defects	Notes	Reinf. Detail	
Significant delaminations/debonding throughout. Delaminations as deep as 10.7" below surface.	Backsurface not discernible. Area tested because of debonding located via hammer sounding.	Hoop reinf: ~4.9" deep @ 13.4" on center. Longitudinal reinf: below hoop reinforcement.	Vshear = 2710 m/s X-step: 110 mm Y-step: 110 mm Max Depth: 500 mm Frequency: 50 kHz Houston, TX Washburn Tunnel WT 9.16-3 West Side TAMU/TTI 9/2011

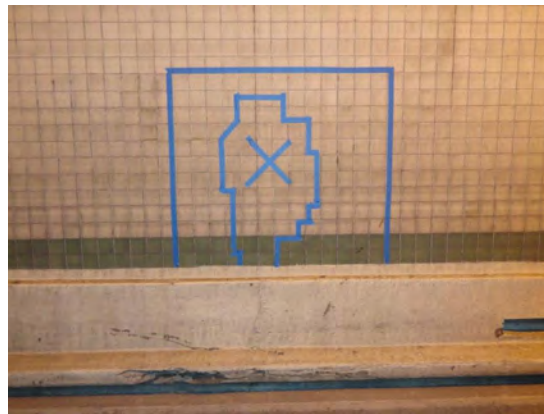
Figure N.43. Image of test site WT 9.16-4.

Defects	Notes	Reinf. Detail	
Significant delaminations/debonding throughout. Possible delaminations 11.7" deep.	Backsurface not discernible. Area tested because of debonding located via hammer sounding.	Hoop reinf: ~4.7" deep @ 11.7" on center. Longitudinal reinf: below hoop reinforcement.	Vshear = 2710 m/s X-step: 110 mm Y-step: 110 mm Max Depth: 500 mm Frequency: 50 kHz
			Houston, TX Washburn Tunnel WT 9.16-4 West Side TAMU/TTI 9/2011

Defects	Notes	Reinf. Detail	Vshear = 2710 m/s
Significant delaminations/debonding throughout. Possible delaminations 11.7" deep.	Backsurface not discernible. Area tested because of debonding located via hammer sounding.	Hoop reinf: ~4.7" deep @ 11.7" on center. Longitudinal reinf: below hoop reinforcement.	X-step: 110 mm Y-step: 110 mm Max Depth: 500 mm Frequency: 50 kHz
			Houston, TX Washburn Tunnel WT 9.16-4 West Side TAMU/TTI 9/2011

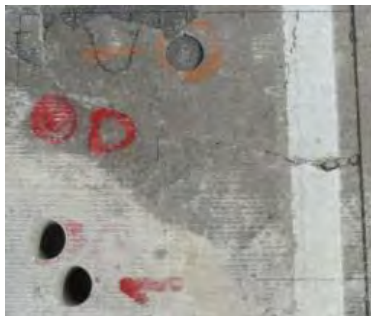
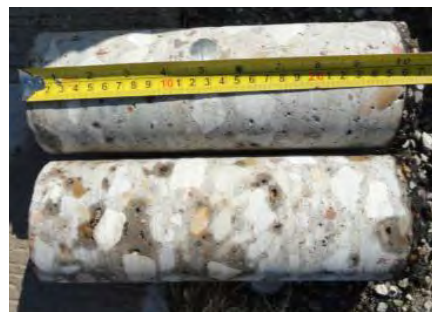
Figure N.45. Images of test site WT 9.27-1.

Defects	Notes	Reinf. Detail	
Significant delamination on both sides of surface crack, ranging from 4.2"-5.0" from top surface.	Top layer of pavement 10.2" below surface. Area tested because of transverse surface cracking. Pavement depth confirmed by 2 cores, both indicating 10.2" thickness and one indicating 5.0" reinf.	Longitudinal reinf.: ~4.6"- 5.0" deep @ 5.6" on center. No transverse reinforcement located in this area.	V _{shear} = 2770 m/s X-step: 150 mm Y-step: 50 mm Max Depth: 500 mm Frequency: 50 kHz Ft. Worth, TX I-20 IH20 9.27-1 MP 426 + 0.5, RM 2871 TAMU/TTI 9/2011

Defects	Notes	Reinf. Detail	
Significant delamination on both sides of surface crack, ranging from 4.2"-5.0" from top surface.	Top layer of pavement 10.2" below surface. Area tested because of transverse surface cracking. Pavement depth confirmed by 2 cores, both indicating 10.2" thickness and one indicating 5.0" reinf.	Longitudinal reinf.: ~4.6"- 5.0" deep @ 5.6" on center. No transverse reinforcement located in this area.	V _{shear} = 2770 m/s X-step: 150 mm Y-step: 50 mm Max Depth: 500 mm Frequency: 50 kHz Ft. Worth, TX I-20 IH20 9.27-1 MP 426 + 0.5, RM 2871 TAMU/TTI 9/2011

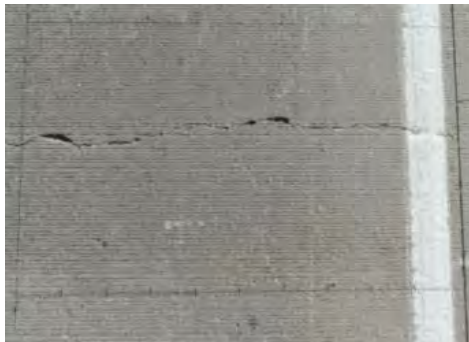
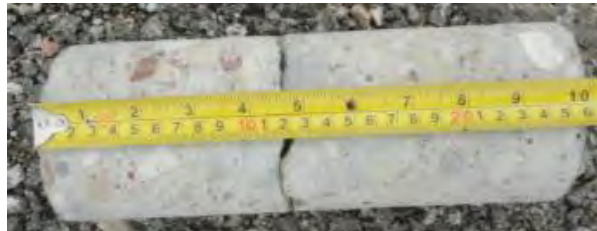
Figure N.47. Images of test site IH20 9.27-2.

Defects	Notes	Reinf. Detail	
Significant delamination on both sides of surface crack, ranging from 4.5"-5.3" from top surface.	Top layer of pavement 10.4" below surface. Area tested because of transverse surface cracking. Pavement depth confirmed by 2 cores, indicating 9.4"-10.4" thickness.	Longitudinal reinf.: ~4.5"- 5.2" deep @ 7.1" on center. No transverse reinforcement located in this area.	Vshear = 2770 m/s X-step: 150 mm Y-step: 50 mm Max Depth: 500 mm Frequency: 50 kHz Ft. Worth, TX I-20 IH20 9.27-2 MP 426 + 0.5, RM 2871 TAMU/TTI 9/2011

Defects	Notes	Reinf. Detail	
Significant delamination on both sides of surface crack, ranging from 4.5"-5.3" from top surface.	Top layer of pavement 10.4" below surface. Area tested because of transverse surface cracking. Pavement depth confirmed by 2 cores, indicating 9.4"-10.4" thickness.	Longitudinal reinf.: ~4.5"- 5.2" deep @ 7.1" on center. No transverse reinforcement located in this area.	V _{shear} = 2770 m/s X-step: 150 mm Y-step: 50 mm Max Depth: 500 mm Frequency: 50 kHz Ft. Worth, TX I-20 IH20 9.27-2 MP 426 + 0.5, RM 2871 TAMU/TTI 9/2011

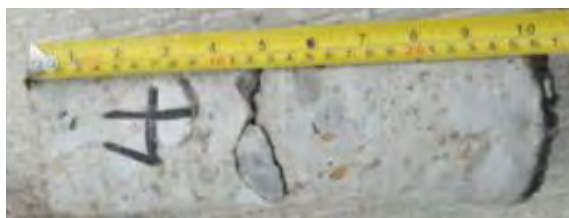
Figure N.49. Images of test site IH20 9.27-3.

Defects	Notes	Reinf. Detail	
Significant delamination on both sides of surface crack, ranging from 4.6"-5.1" from top surface.	Top layer of pavement approximately 10.2" below surface. Area tested because of transverse surface cracking. Pavement depth confirmed by 2 cores, indicating 10.2" thickness.	Longitudinal reinf.: ~4.8"- 5.0" deep @ 7.2" on center. No transverse reinforcement located in this area.	V _{shear} = 2770 m/s X-step: 150 mm Y-step: 50 mm Max Depth: 500 mm Frequency: 50 kHz Ft. Worth, TX I-20 IH20 9.27-3 MP 426 + 0.5, RM 2871 TAMU/TTI 9/2011

Defects	Notes	Reinf. Detail	
Significant delamination on both sides of surface crack, ranging from 4.6"-5.1" from top surface.	Top layer of pavement approximately 10.2" below surface. Area tested because of transverse surface cracking. Pavement depth confirmed by 2 cores, indicating 10.2" thickness.	Longitudinal reinf.: ~4.8"- 5.0" deep @ 7.2" on center. No transverse reinforcement located in this area.	V _{shear} = 2770 m/s X-step: 150 mm Y-step: 50 mm Max Depth: 500 mm Frequency: 50 kHz Ft. Worth, TX I-20 IH20 9.27-3 MP 426 + 0.5, RM 2871 TAMU/TTI 9/2011

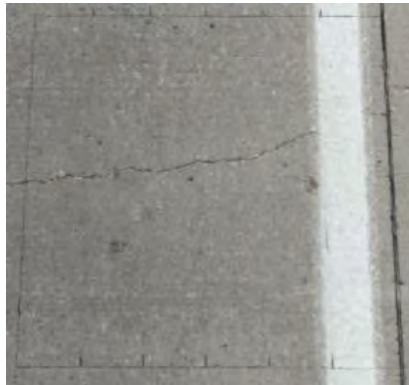
Figure N.51. Image of test site IH20 9.27-5.

Defects	Notes	Reinf. Detail	
Significant delamination on both sides of surface crack, approximately 5.0" from top surface.	Top layer of pavement approximately 10.1" below surface. Area tested because of transverse surface cracking. No cores taken in this location.	Longitudinal reinf.: ~4.6"- 5.2" deep @ 7.0" on center. No transverse reinforcement located in this area.	Vshear = 2770 m/s X-step: 150 mm Y-step: 50 mm Max Depth: 500 mm Frequency: 50 kHz Ft. Worth, TX I-20 IH20 9.27-5 MP 426 + 0.5, RM 2871 TAMU/TTI 9/2011

Defects	Notes	Reinf. Detail	V _{shear} = 2770 m/s
Significant delamination on both sides of surface crack, approximately 5.0" from top surface.	Top layer of pavement approximately 10.1" below surface. Area tested because of transverse surface cracking. No cores taken in this location.	Longitudinal reinf.: ~4.6"- 5.2" deep @ 7.0" on center. No transverse reinforcement located in this area.	X-step: 150 mm Y-step: 50 mm Max Depth: 500 mm Frequency: 50 kHz
			Ft. Worth, TX I-20 IH20 9.27-5 MP 426 + 0.5, RM 2871 TAMU/TTI 9/2011

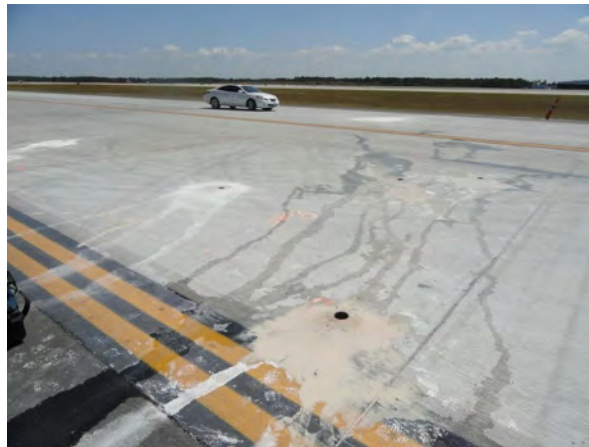
Figure N.53. Image of test site IAH 6.9-1.

Defects	Notes	Reinf. Detail	
Significant debonding at at runway/subbase (7.6"-8.1" deep) and verified by coring. Possible further debonding in deeper layers (26.9" and 37.7" deep).	Top layer of pavement approximately 7.6"-8.1" below surface; second layer 26.9" below surface; third layer 37.7" below surface. Area tested because of surface cracking and hammer sounding revealing possible debonding. Image is of typical runway segment.	None.	Vshear = 2885 m/s X-step: 200 mm Y-step: 100 mm Max Depth: 1000 mm Frequency: 50 kHz Houston, TX IAH IAH 6.9-1 Sta 83+00 T/W WA E TAMU/TI 6/2011

Defects	Notes	Reinf. Detail	
Significant debonding at at runway/subbase (7.6"-8.1" deep) and verified by coring. Possible further debonding in deeper layers (26.9" and 37.7" deep).	Top layer of pavement approximately 7.6"-8.1" below surface; second layer 26.9" below surface; third layer 37.7" below surface. Area tested because of surface cracking and hammer sounding revealing possible debonding. Image is of typical runway segment.	None.	Vshear = 2885 m/s X-step: 200 mm Y-step: 100 mm Max Depth: 1000 mm Frequency: 50 kHz
			Houston, TX IAH IAH 6.9-1 Sta 83+00 T/W WA E TAMU/TTI 6/2011

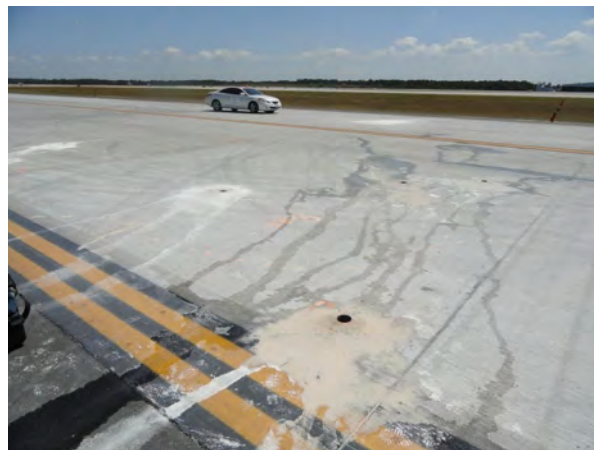
Figure N.55. Image of test site IAH 6.9-2.

Defects	Notes	Reinf. Detail	
Significant debonding at at runway/subbase (7.1" deep) and verified by coring. Possible further debonding in deeper layers (25.6" and 37.5" deep).	Top layer of pavement approximately 7.1" below surface; second layer 25.6" below surface; third layer 37.5" below surface. Area tested because of surface cracking and hammer sounding revealing possible delaminations. Image is of typical runway segment.	None.	Vshear = 2885 m/s X-step: 200 mm Y-step: 100 mm Max Depth: 1000 mm Frequency: 50 kHz Houston, TX IAH IAH 6.9-2 Sta 82+75 T/W WA E TAMU/TTI 6/2011

Defects	Notes	Reinf. Detail	Vshear = 2885 m/s
Significant debonding at at runway/subbase (7.1" deep) and verified by coring. Possible further debonding in deeper layers (25.6" and 37.5" deep).	Top layer of pavement approximately 7.1" below surface; second layer 25.6" below surface; third layer 37.5" below surface. Area tested because of surface cracking and hammer sounding revealing possible delaminations. Image is of typical runway segment.	None.	X-step: 200 mm Y-step: 100 mm Max Depth: 1000 mm Frequency: 50 kHz
			Houston, TX IAH IAH 6.9-2 Sta 82+75 T/W WA E TAMU/TTI 6/2011

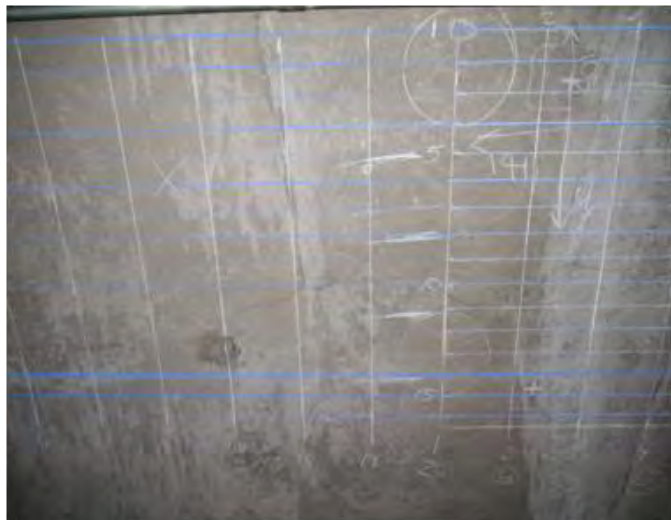
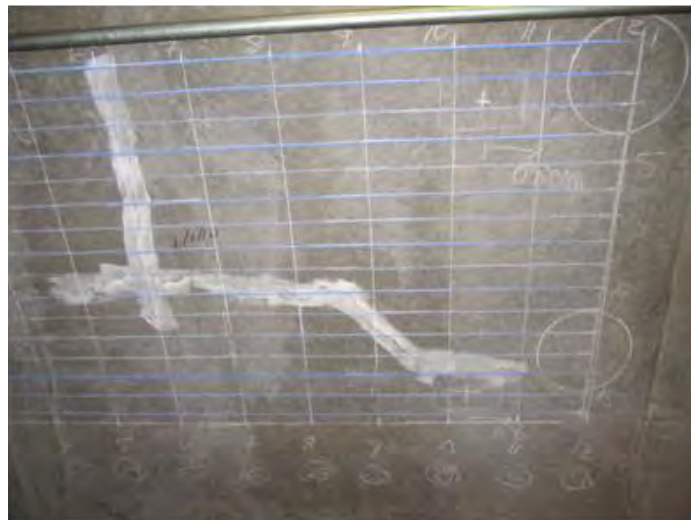
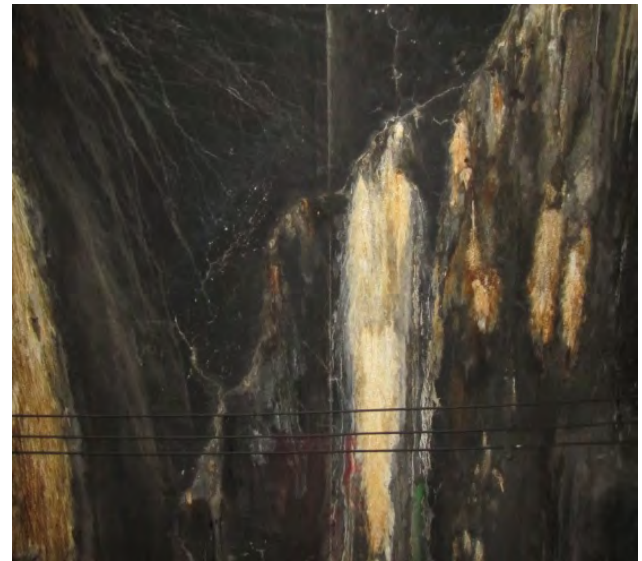
Figure P.6. Amplitude spectra along with actual photographs for intact and defective points in Eisenhower Tunnel showing good, poor, and severe conditions, and representative amplitude spectrum for intact and defective points.

The amplitude spectra for an intact point and two defective points along with the photograph taken through visual inspection are shown in Figure P.6. Compared with the intact point, either lower or higher peak frequencies control the response at defective points, as discussed above. Based on an average compression wave velocity of 13,800 ft/s measured for the concrete and Equation P.1, a nominal

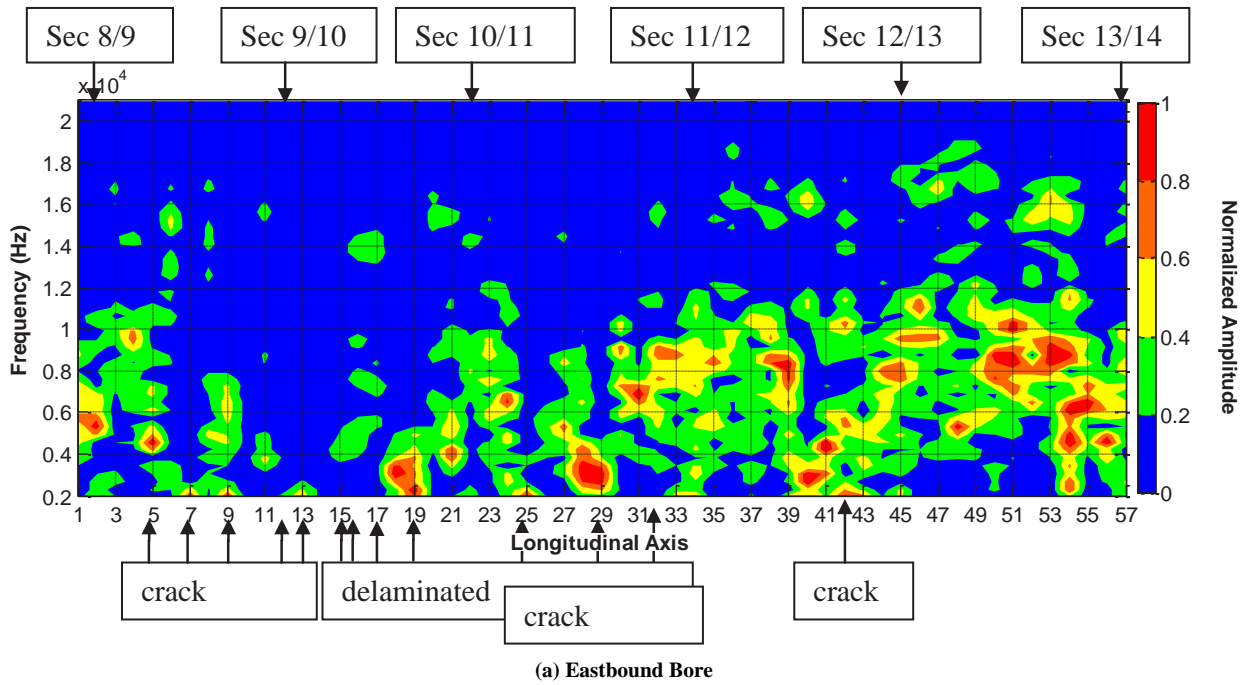
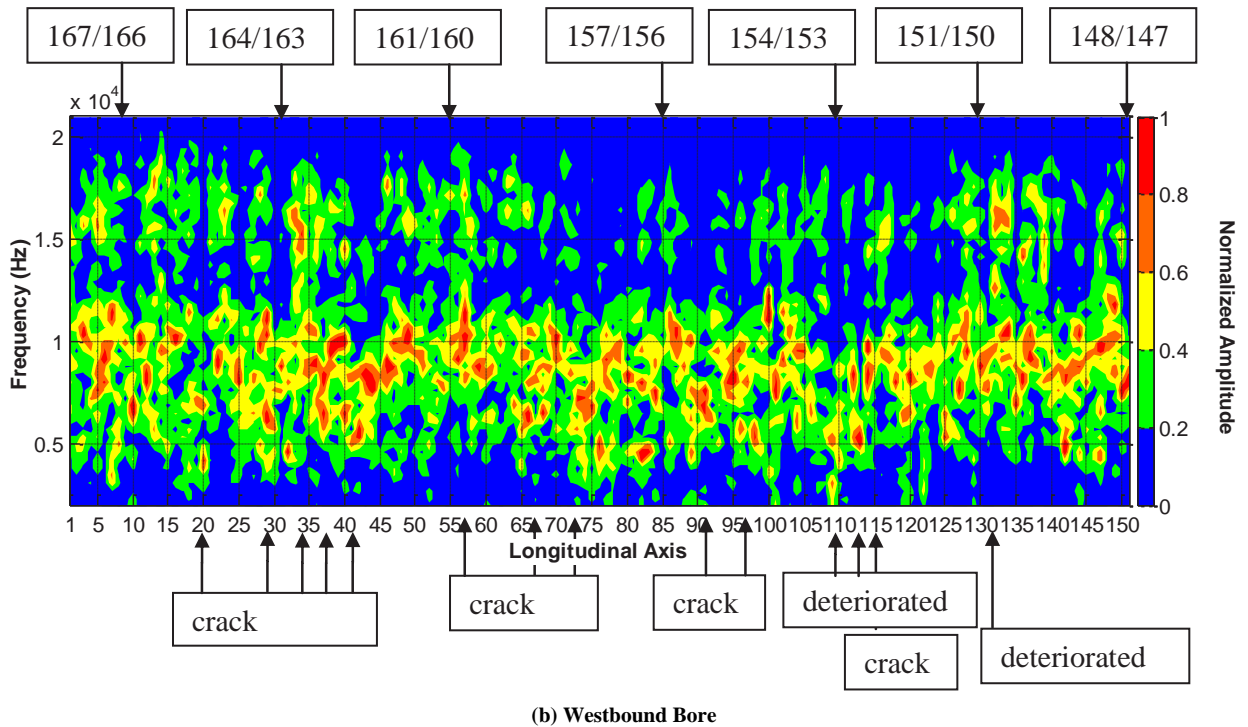
Figure P.7. IE spectral B-scans along Eisenhower Memorial Tunnel.

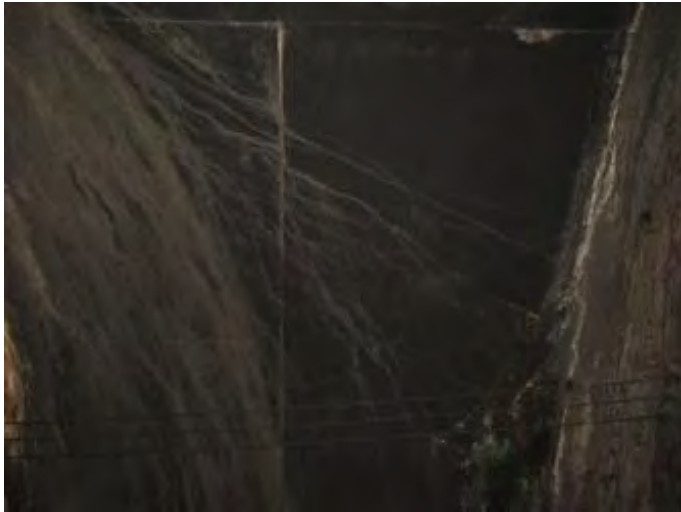
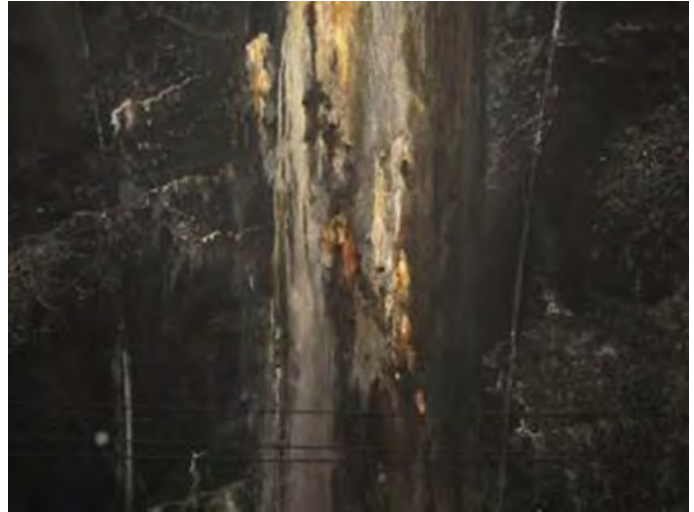
Figure P.8. Photographs of intact and defective points along with representative dispersion curve for both points, in Eisenhower Memorial Tunnel.

Figure P.8 shows a typical USW dispersion curve for an intact area and a defective point along with actual photographs. The dispersion curve shifts to lower moduli where severe flaws are present.

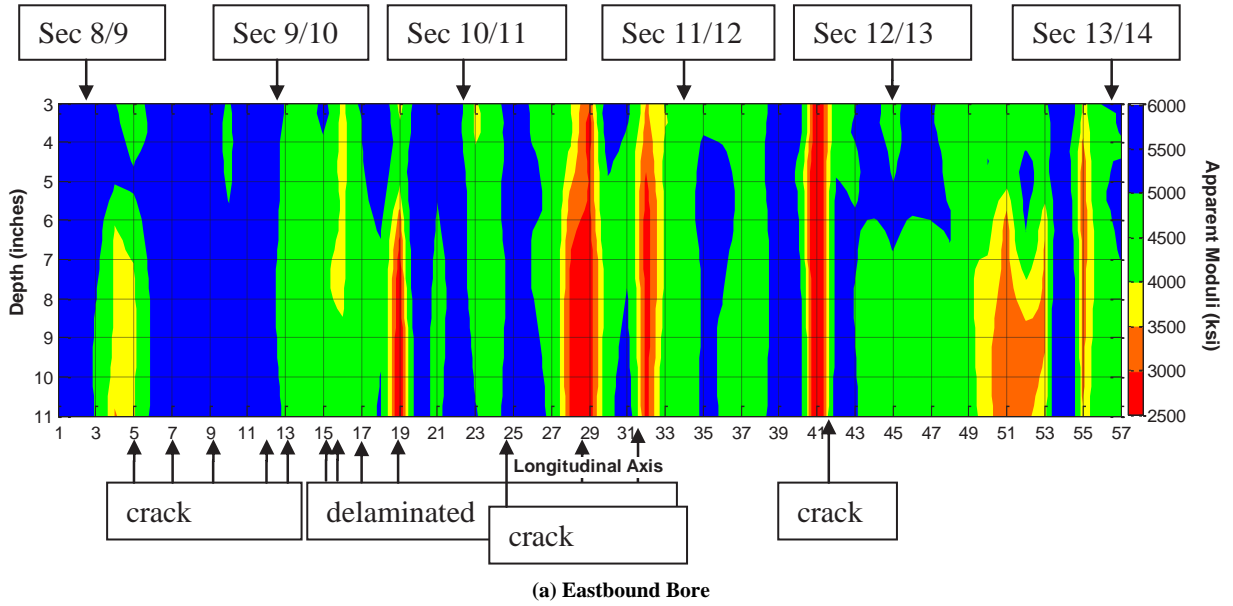
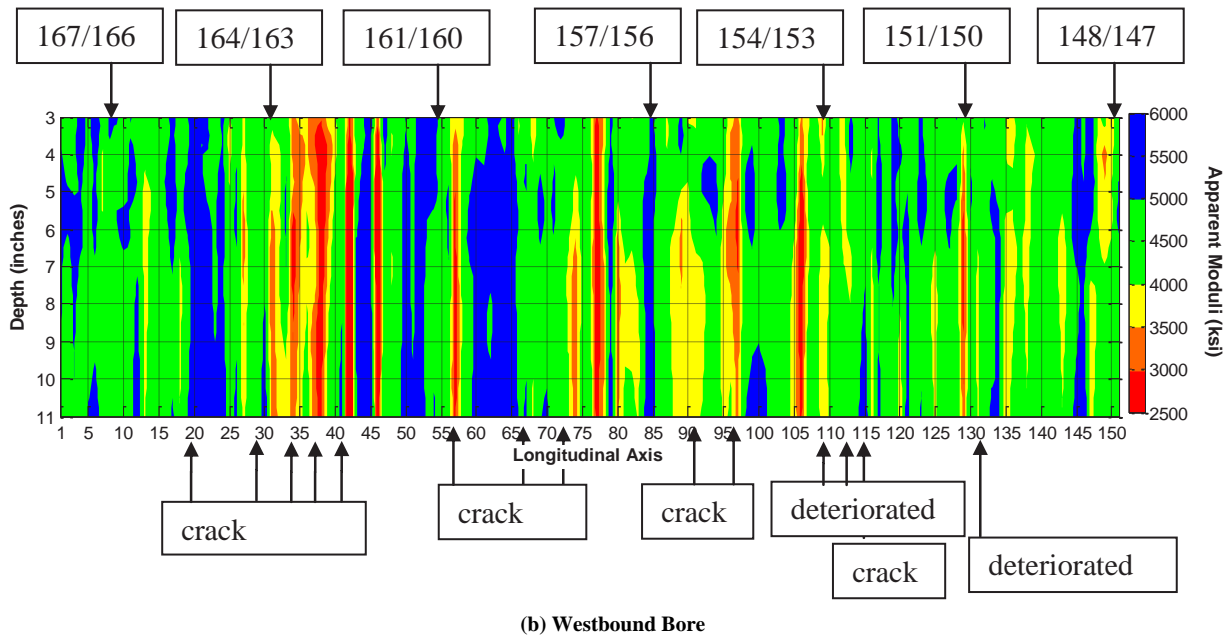
Figure P.9. Variation of modulus with depth, in Eisenhower Memorial Tunnel.

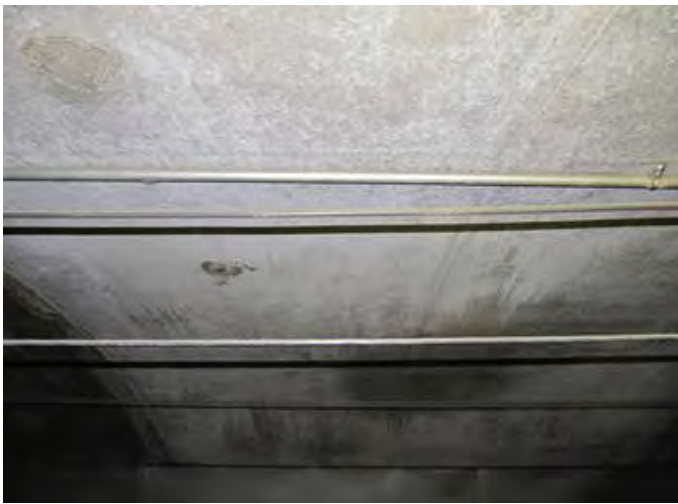
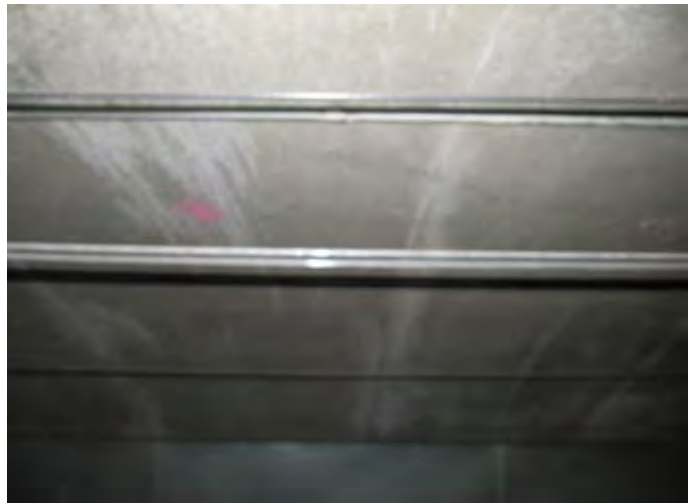
The actual condition of liners at the time of testing is shown in Figures P.10a and P.10b. The amplitude spectra for selected intact and defective points are shown in Figure P.10c. Based on an average compression wave velocity of about 14,000 ft/s measured for the concrete, the dominant frequency corresponding to the tunnel thickness (15 in.) is around 5.4 kHz. Compared with the intact point, higher peak frequencies mostly control the response at the defective points.

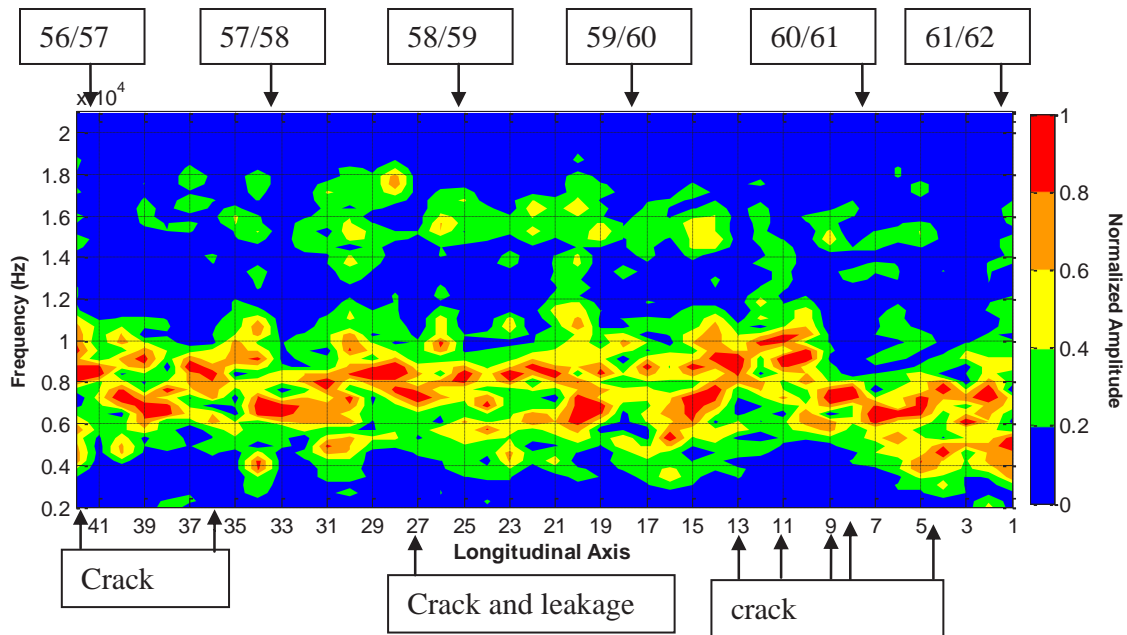
Figure P.11. IE spectral B-scan along Hanging Lake Tunnel.

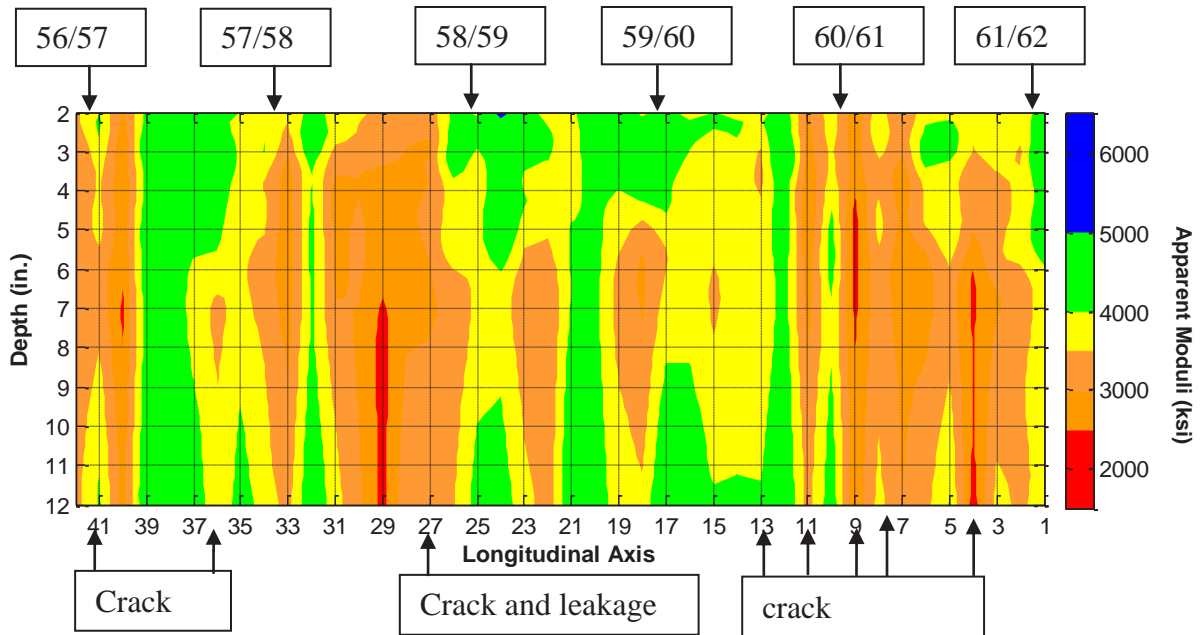
Figure P.15. Variation of apparent modulus with depth along Hanging Lake Tunnel.

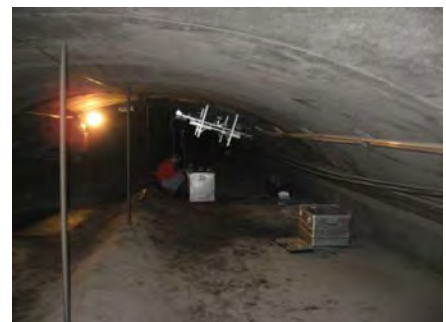
(b)

Figure Q.4. Construction information for the Chesapeake Bay Bridge-Tunnel (a) and supply air duct where most measurements took place (b).

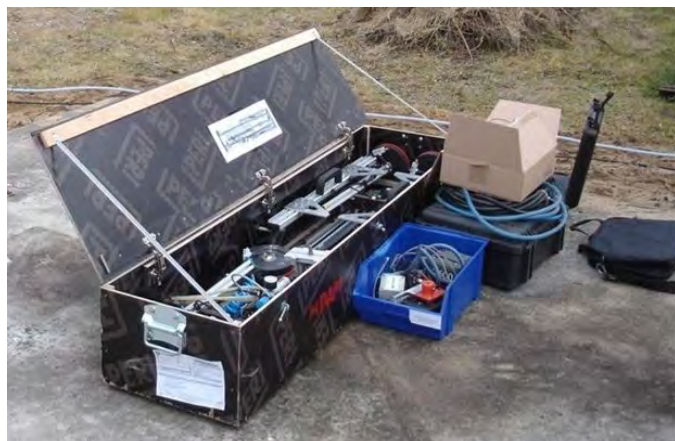
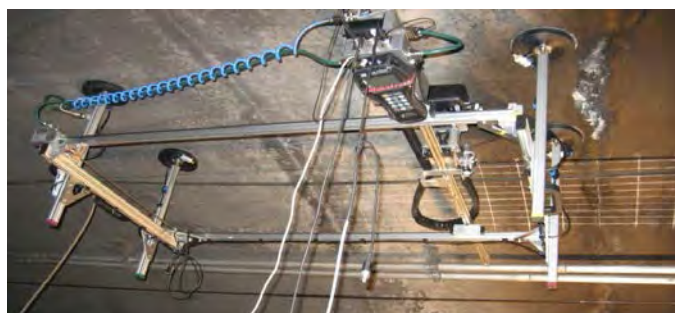
Figure Q.5. ZFP scanner packed in its custom-made box (a) and on site in Chesapeake Bay Bridge-Tunnel with ultrasonic echo transducer mounted on it (b).
