**SHRP 2 REPORT S2-R06G-RR-1**

Mapping Voids, Debonding, Delaminations, Moisture, and Other Defects Behind or Within Tunnel Linings

ANDREW WIMSATT, JOSHUA WHITE, CHIN LEUNG, AND TOM SCULLION
Texas A&M Transportation Institute

This report presents the findings of SHRP 2 Renewal Project R06G—High-Speed Non-destructive Testing Methods for Mapping Voids, Debonding, Delaminations, Moisture, and Other Defects Behind or Within Tunnel Linings. The study was divided into two phases to (1) establish testing criteria and prioritize the techniques to be developed and evaluated under the project on the basis of tunnel operators' requirements and (2) conduct the necessary technology development for those techniques recommended.

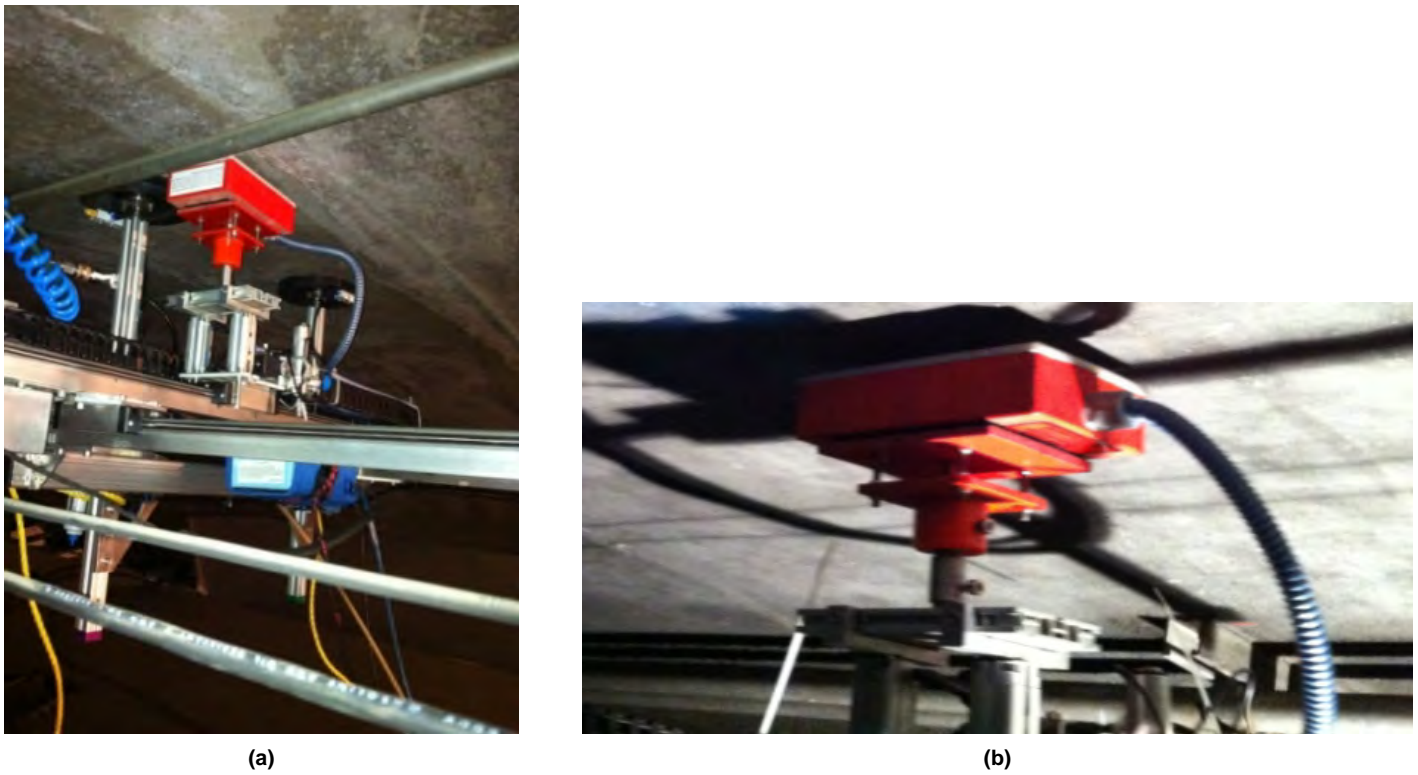
Figure Q.6. 1.5-GHz ground-coupled GPR antenna mounted on the scanning system (a) and close-up view (b).

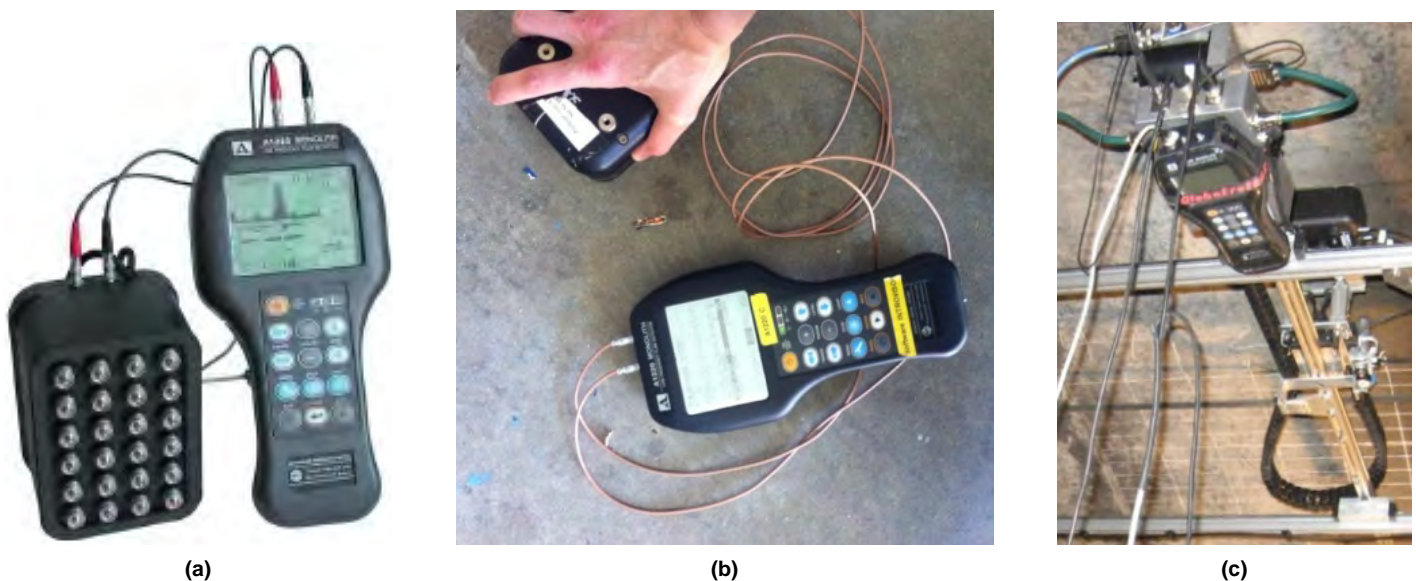
Figure Q.10. Ultrasonic A1220 from Acoustic Control Systems (a) used for point measurements by hand (b) and used for profile measurements by automated scanning device (c).

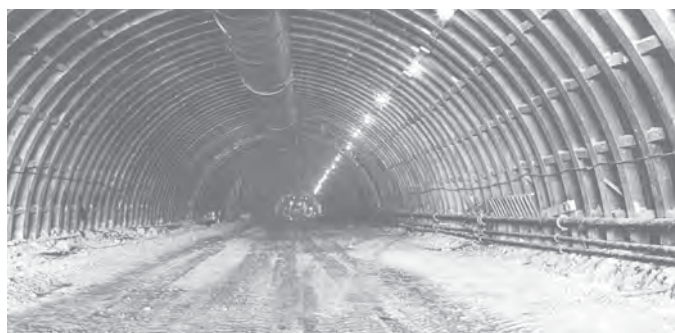
Figure Q.22. Photograph of construction of Eisenhower Memorial Tunnel sometime between 1968 and 1973 (Colorado DOT 2011). Steel beams could be anomaly seen in GPR and ultrasonic echo data.

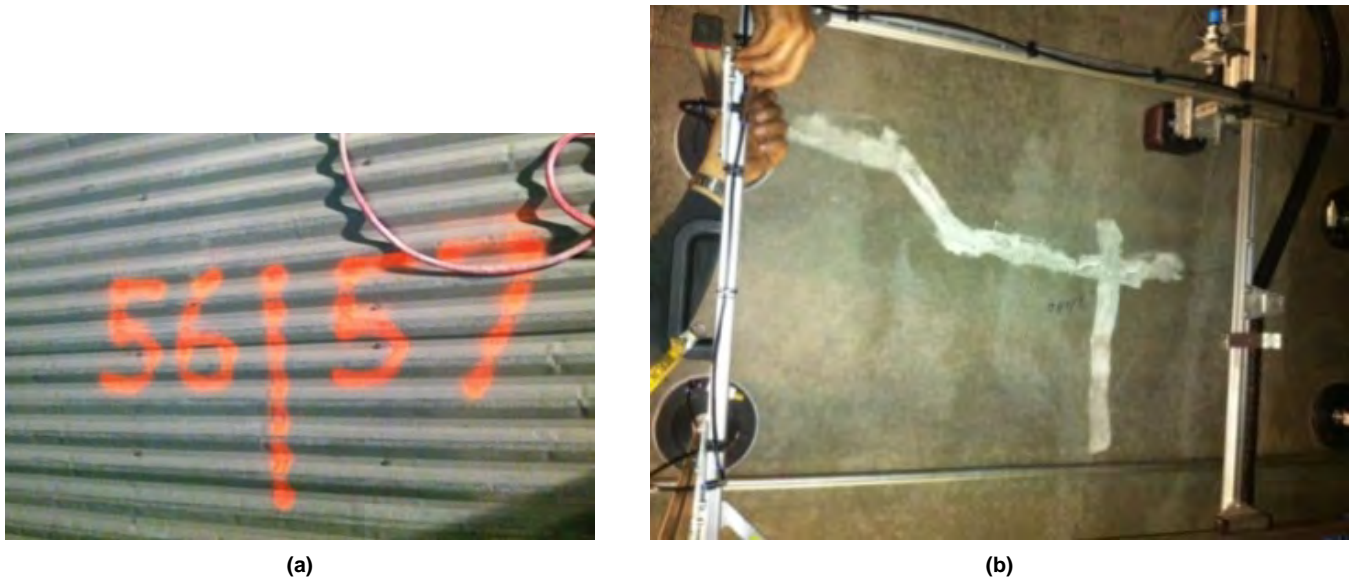
Figure Q.23. Mark on tunnel vent floor of HL1 used as reference to identify sections (a) and location of repaired crack across test field in relation to scanner aperture (b).

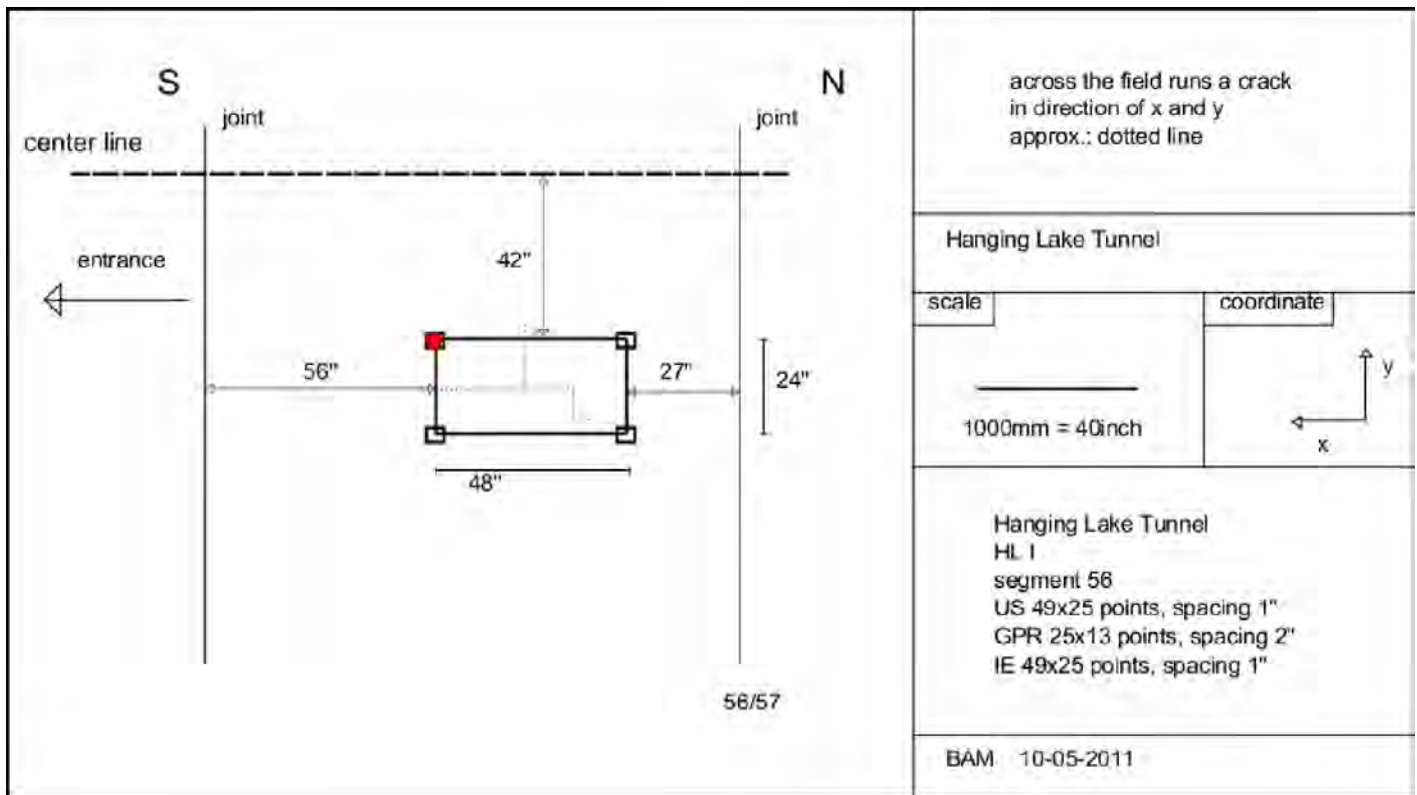
Figure Q.24. Sketch of test area, HL1, Segment 56.

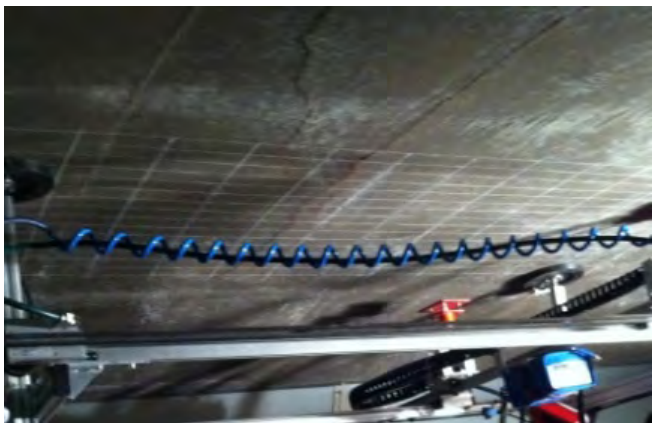
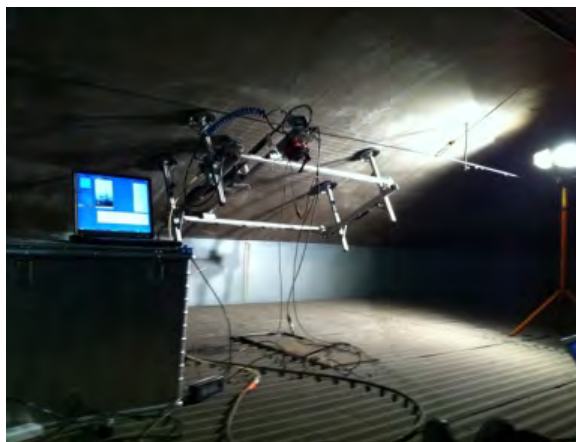
Figure Q.34. HL2: (a) crack running across test area, (b) NDT scanner mounted on tunnel ceiling, and (c) scanning of test area.

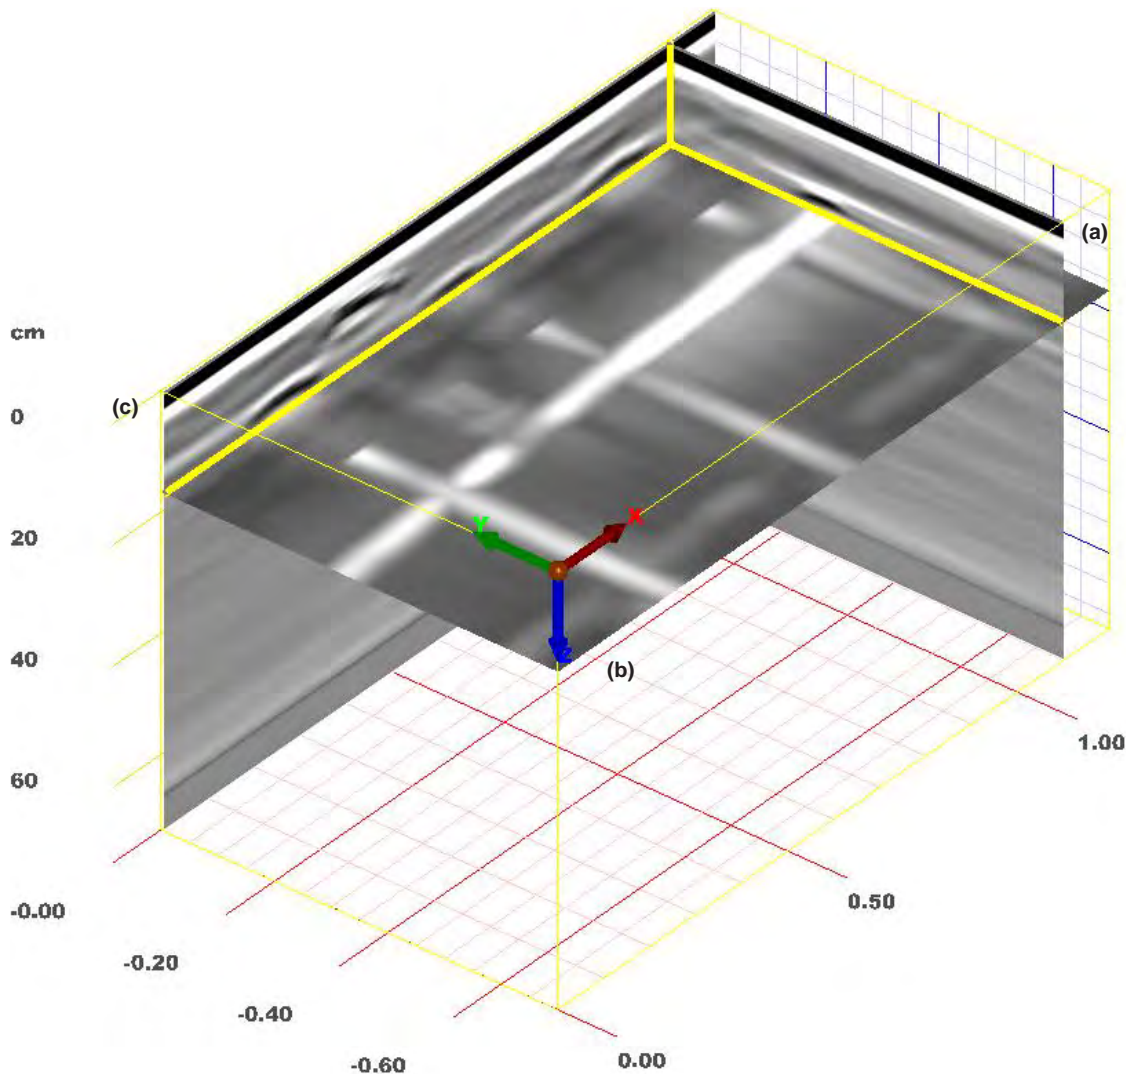
Figure Q.35. HL2, GPR: 3-D image of volume positioned to reveal reinforcing elements, with B-scan (a) positioned at $x = 44$ in.; C-scan (b) at $z = 6.5$ in., 3-in. width; and D-scan (c) at $y = 0$ in.

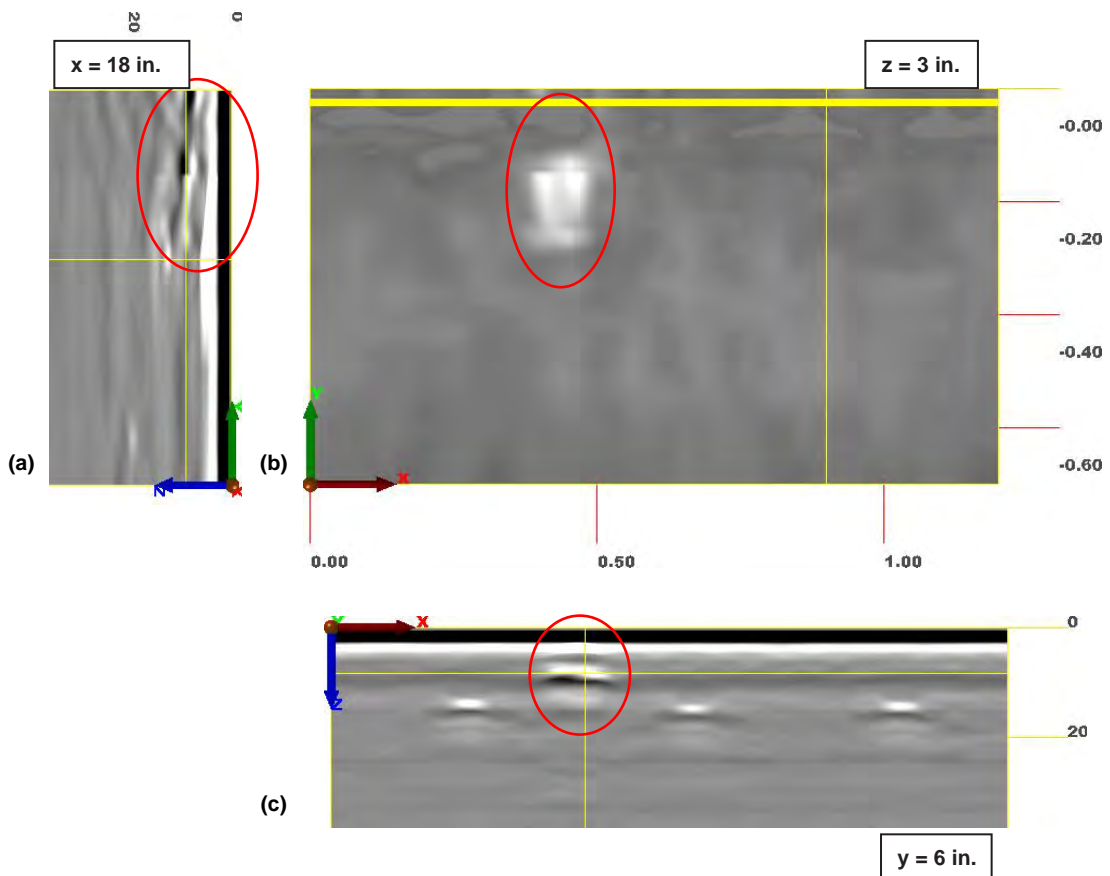
Figure Q.39. HL2, GPR: B-, C-, D-scans showing reflections caused by presence of a surface crack.

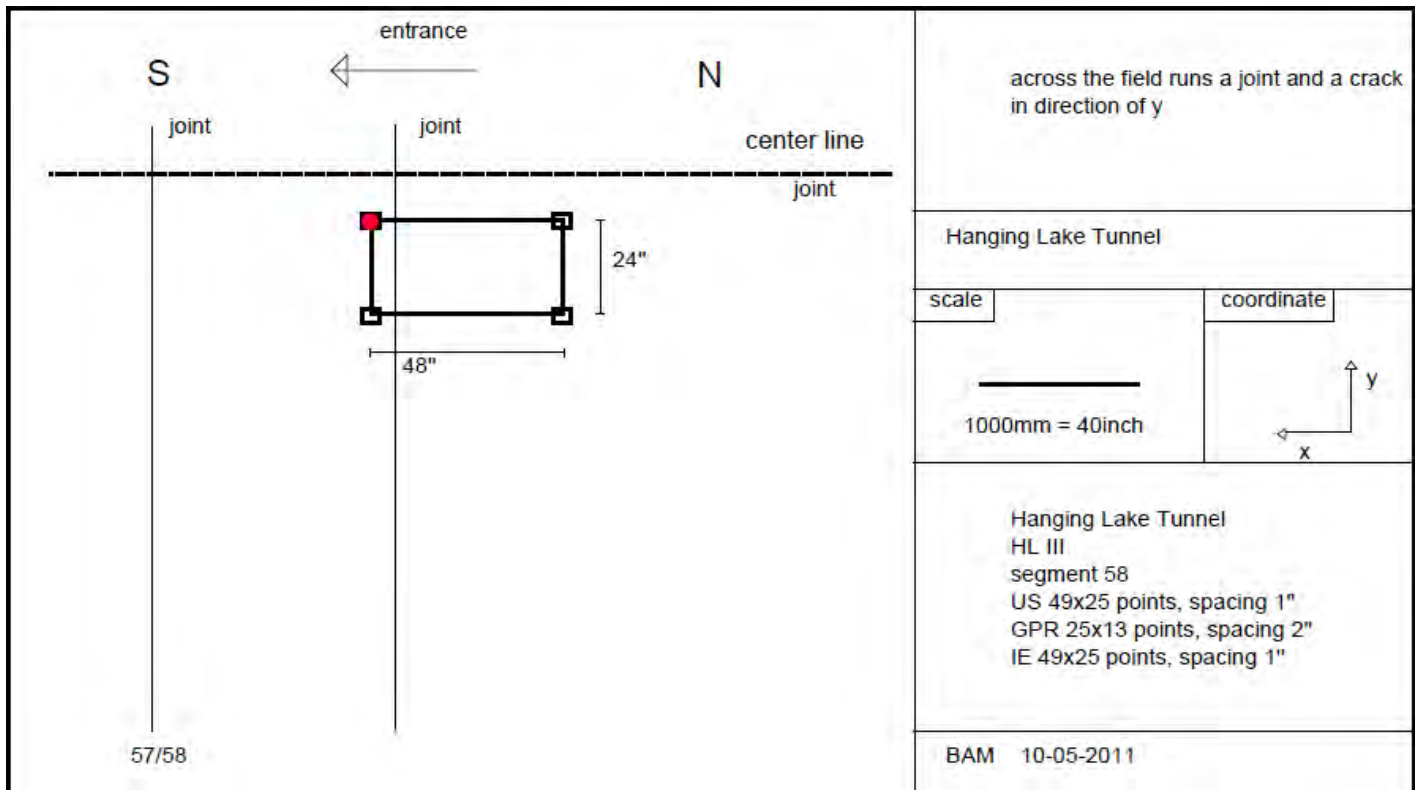
Figure Q.45. Sketch of test area HL3, segment 58, Hanging Lake Tunnel.

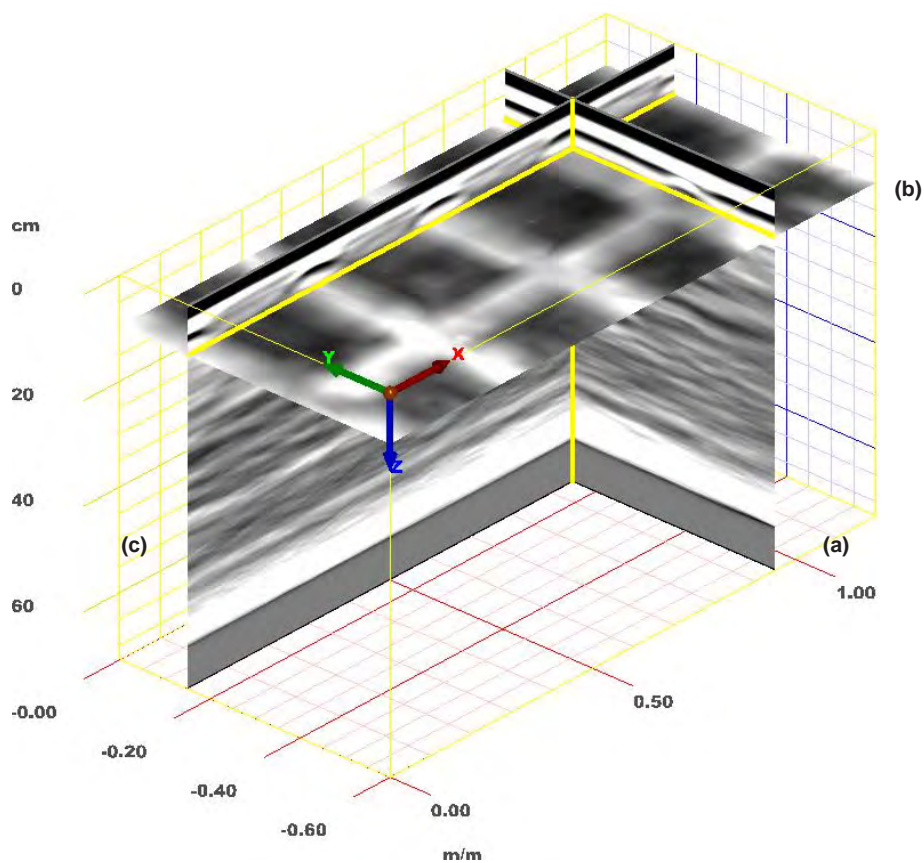
Figure Q.54. CPB1, GPR: 3-D image of volume positioned to reveal reinforcing elements, with B-scan (a) positioned at $x = 38$ in.; C-scan (b) at $z = 4$ in., 1 in. wide; and D-scan (c) at $y = 6$ in.

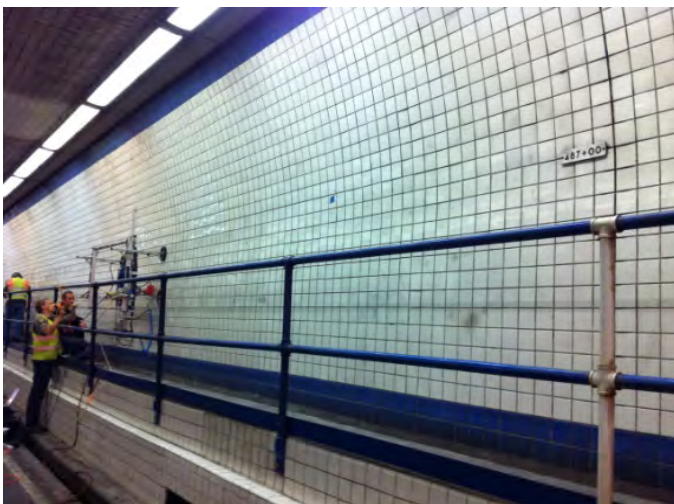
Figure Q.88. Test area CPB4 near Station 486+28.

Steel bars were found in both the x - and y -directions in GPR C-scans. The bars in the y -direction appeared to be spaced 12 in. apart, at $x = 0$ in., $x = 12$ in., $x = 24$ in., $x = 36$ in., and $x = 48$ in., running from 7-in. to 8-in. deep. The bars in the x -direction were at $y = 4$ in., $y = 12$ in., and $y = 30$ in., at $z = 6$ in., $z = 10$ in., and $z = 8$ in., respectively. Figure Q.90 includes several C-scans at various depths.

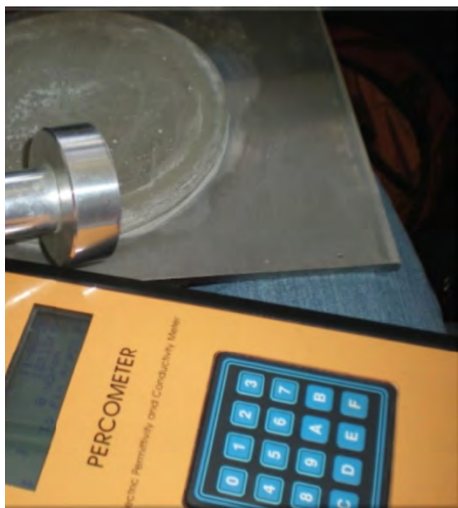
Figure S.4. Determination of percometer penetration depth with cement paste cast on stainless steel at different thicknesses. Probe of percometer uses a frequency of 40 MHz to 50 MHz.

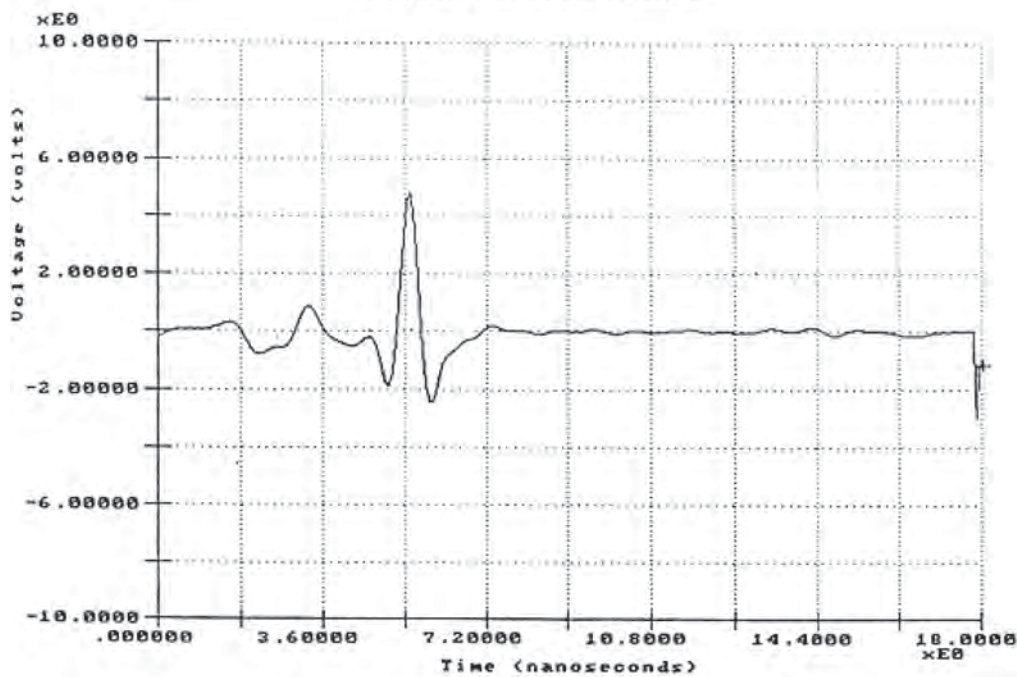
Unacceptable Metal Plate Reflection Fails Specification Tests 5 and 6.1

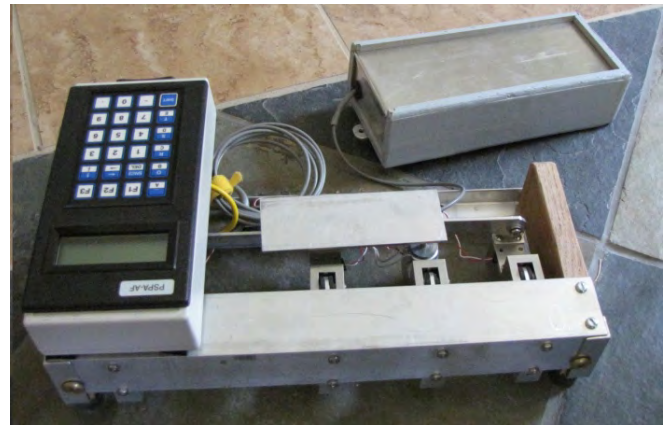
(b)

Figure U.1. Portable seismic property analyzer.

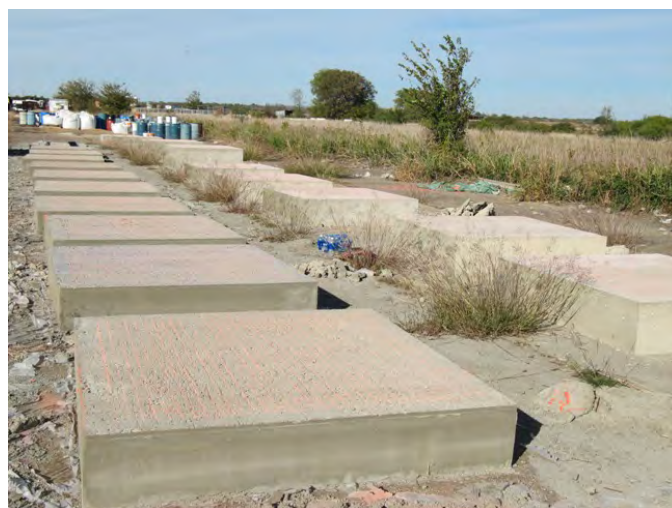
Figure U.3. Overall view of TTI slabs.

An overall view of the test slabs is shown in Figure U.3, and their characteristics are summarized in Table U.1. Two sets of slabs were tested in this study. Each slab was 6 ft by 6 ft. The first set of specimens included six intact concrete slabs with thicknesses of 12 in., 15 in., 18 in., and 24 in., and three defective 15-in.-thick slabs with embedded 1-ft by 1-ft delaminated zones in the center of the slabs. The last three slabs contained defects at depths of 1 in., 2 in., and 3 in. from the top surface. Two other concrete

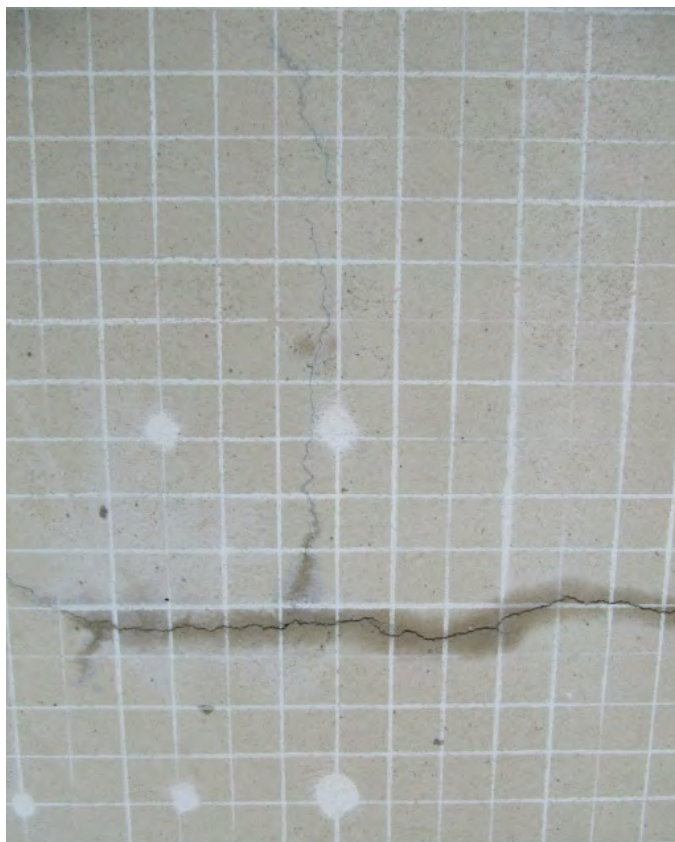
(b) Slab view in 2013

Figure U.7. Crack progression on Slab 2 in a two-year period: (a) in 2011 and (b) in 2013.

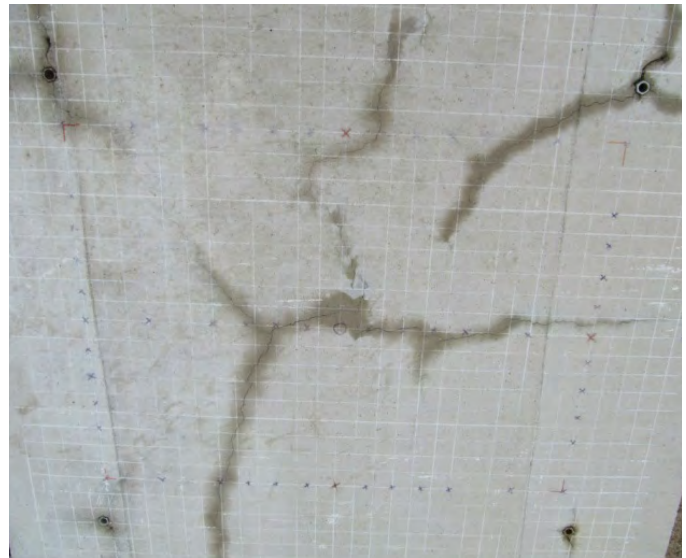
(b) Slab view in 2013

Figure U.22. Crack progression on Slab 10 in a 2-year period of testing.

Slabs 10 and 11 (Figures U.22 through U.26) contained voids at a depth of 8 in. from the surface of the specimens. As reflected in Figure U.22, slab 10 contained several surficial cracks. Comparing Figures U.22a and U.22b, these cracks progressed between 2011 and 2013. The cracks are reflected in the USW results from the traditional and new PSPAs (Figures U.23c and U.24a). The progression of the vertical crack during the 2-year period can be observed in the USW map in

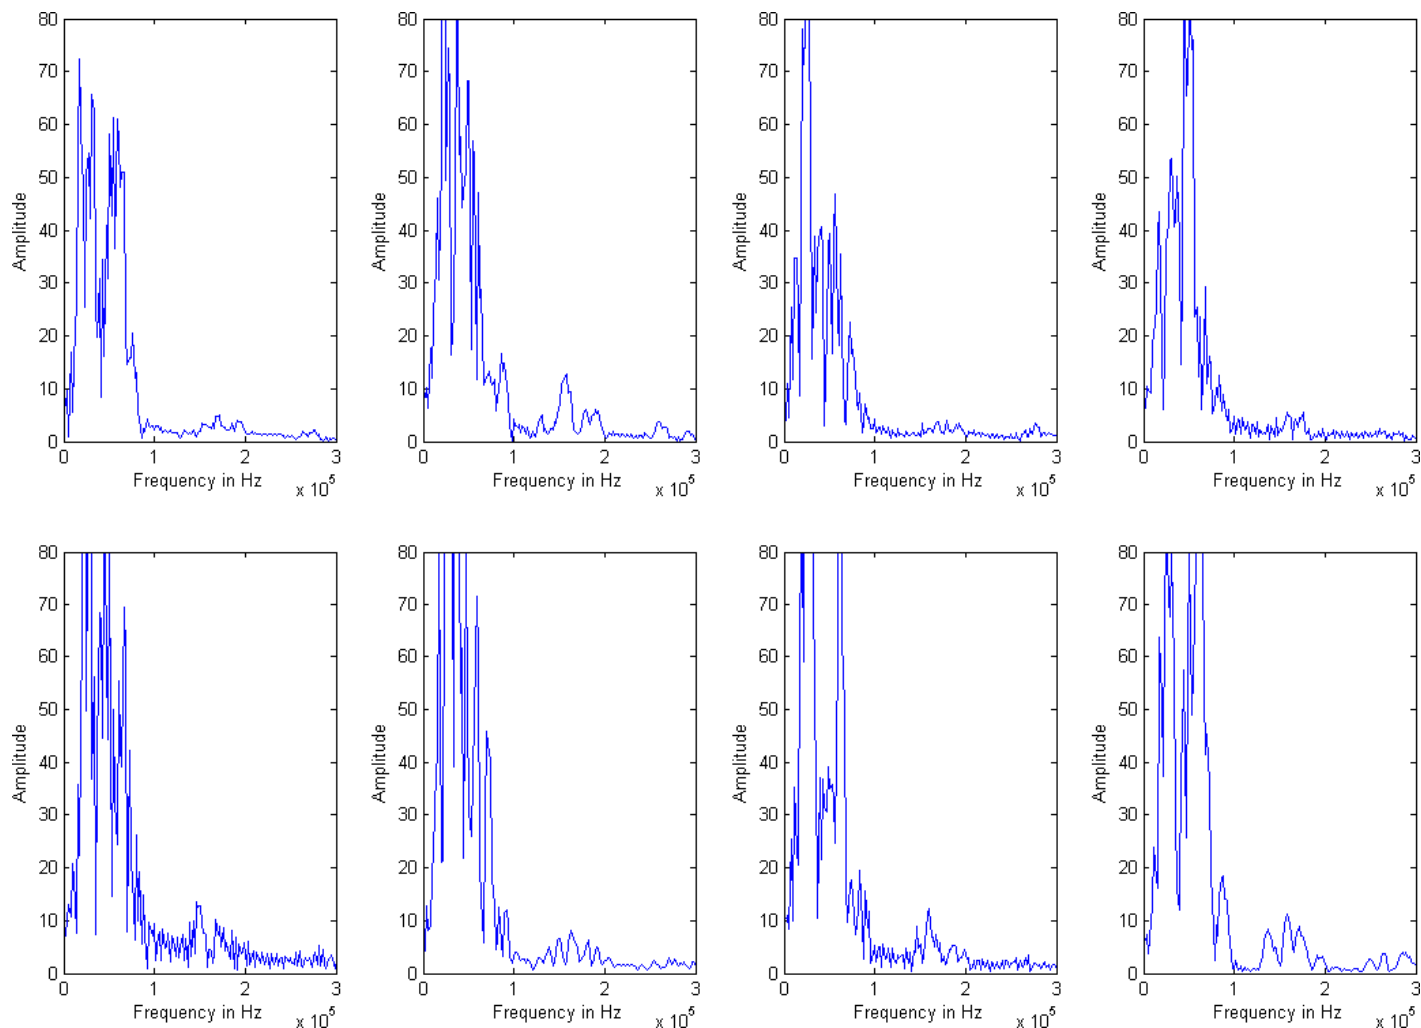
Figure V.11. Frequency spectra of ultrasonic echo signals along the third row of the eight-tile by eight-tile grid at about Station 483 of the Chesapeake Channel Tunnel, where the thermal anomaly in SPACETEC data was detected.

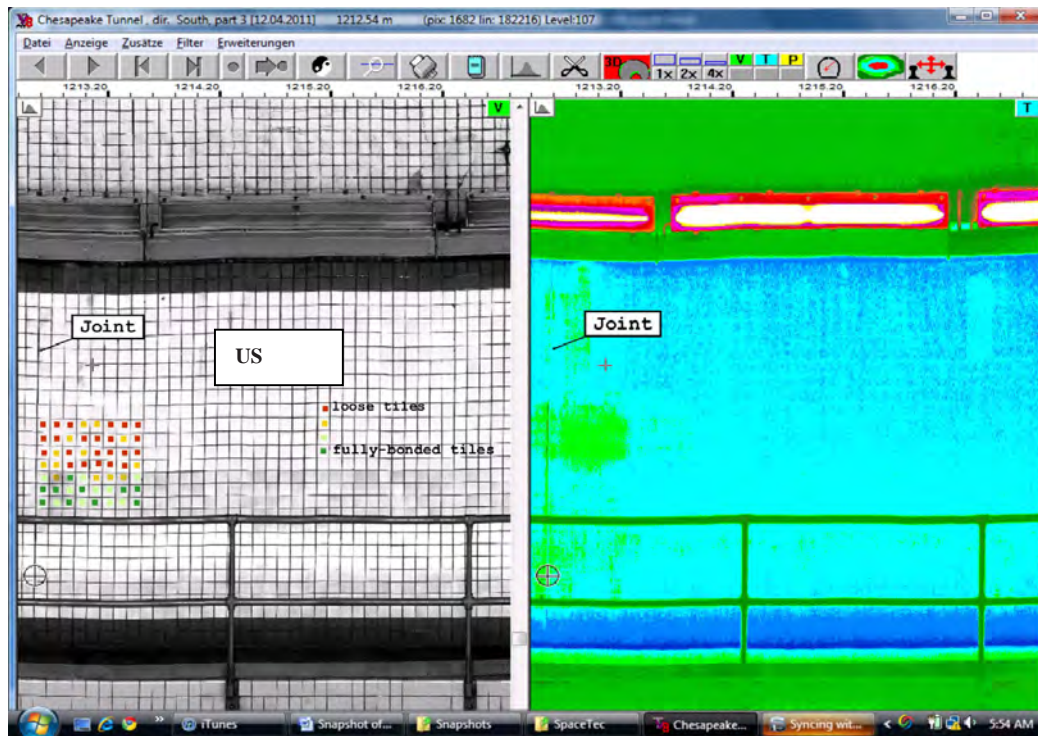
Figure V.12. Visual image (left) and thermal image (right) at about Station 483 of the Chesapeake Channel Tunnel. Bonding conditions of tiles around the location of the thermal anomaly (warm spot) evaluated based on ultrasonic echo (US) measurements are color coded and superimposed on the thermal image.

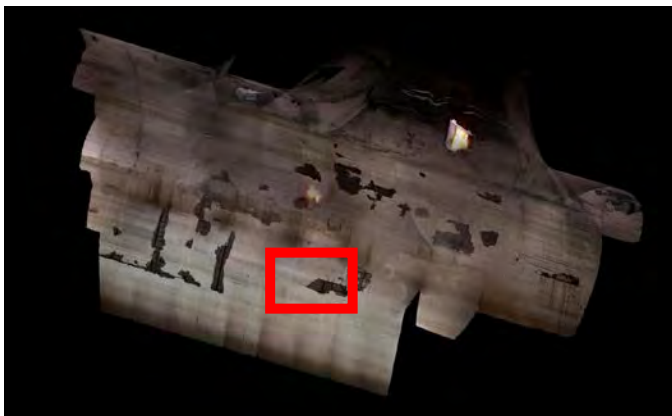
Figure X.2. Three-dimensional model of Liberty Tunnel inbound tube by the ventilation shaft.

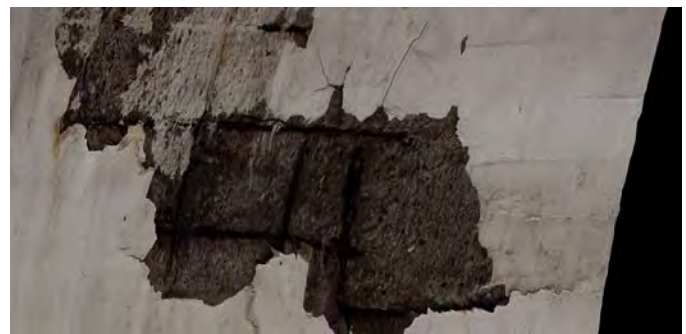
Figure X.4. Foreshortened view of spalling by ventilation shaft.

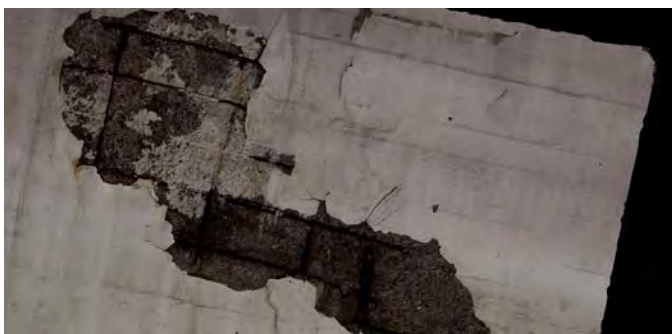
Figure X.3. Liberty Tunnel: Detail of spalling by ventilation shaft.

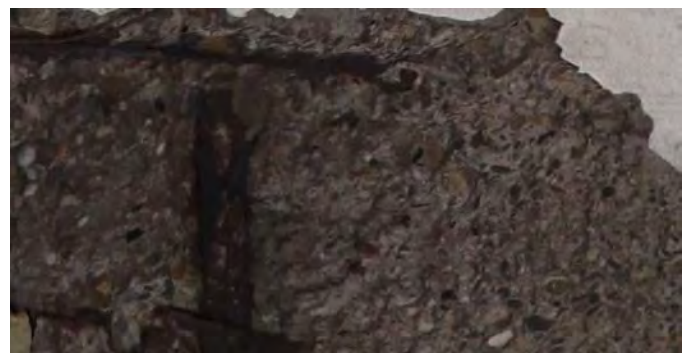
Figure X.5. Detail of exposed aggregate and rebar by ventilation shaft.

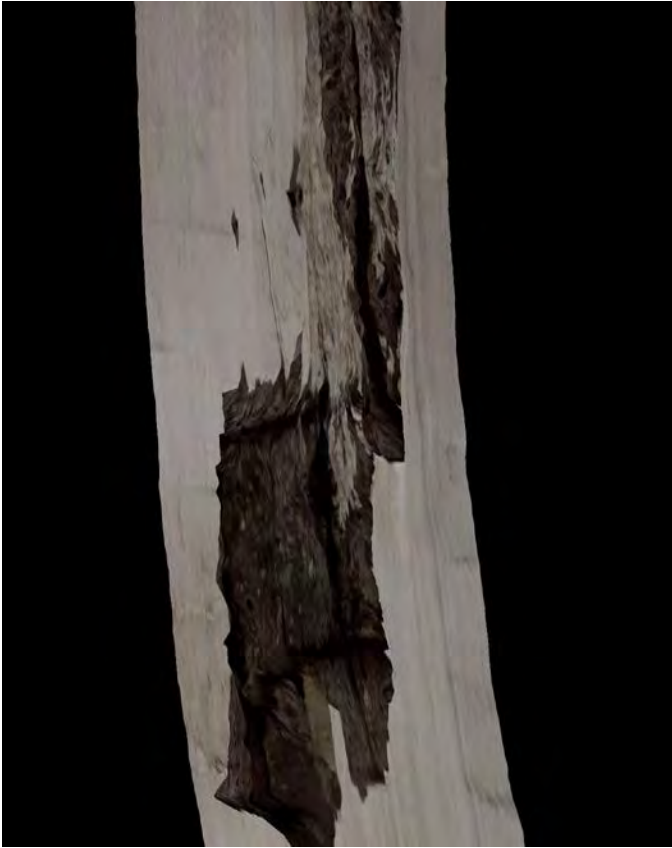
Figure X.6. Backside view of spalling by ventilation shaft to better appreciate depth and extent of spalling.

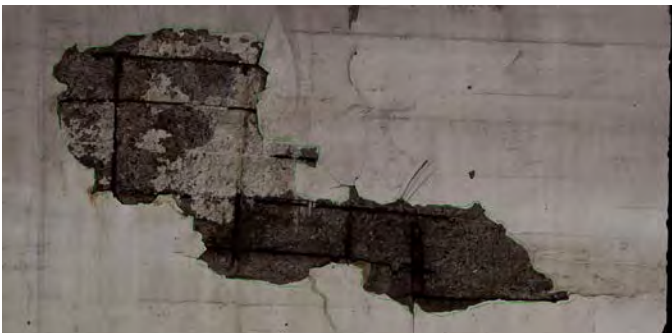
Figure X.7. Closed polyline to determine area of spalling by ventilation shaft.

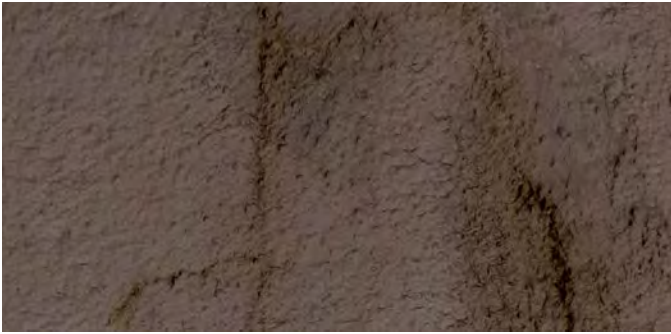
Figure X.12. Detail of shotcrete cracks on left wall by southern portal with digitized cracks toggled off.

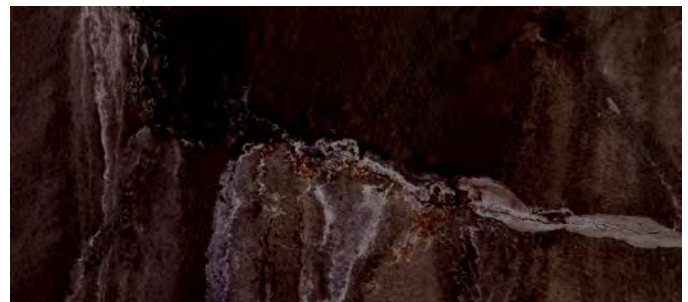
Figure X.21. Clean air supply duct, south-west ventilation building, detail of south lining wall from within duct.
