Bridges for Service Life Beyond 100 Years: Innovative Systems, Subsystems, and Components

**SHRP 2 REPORT S2-R19A-RW-1**

Bridges for Service Life Beyond 100 Years:
Innovative Systems, Subsystems, and Components

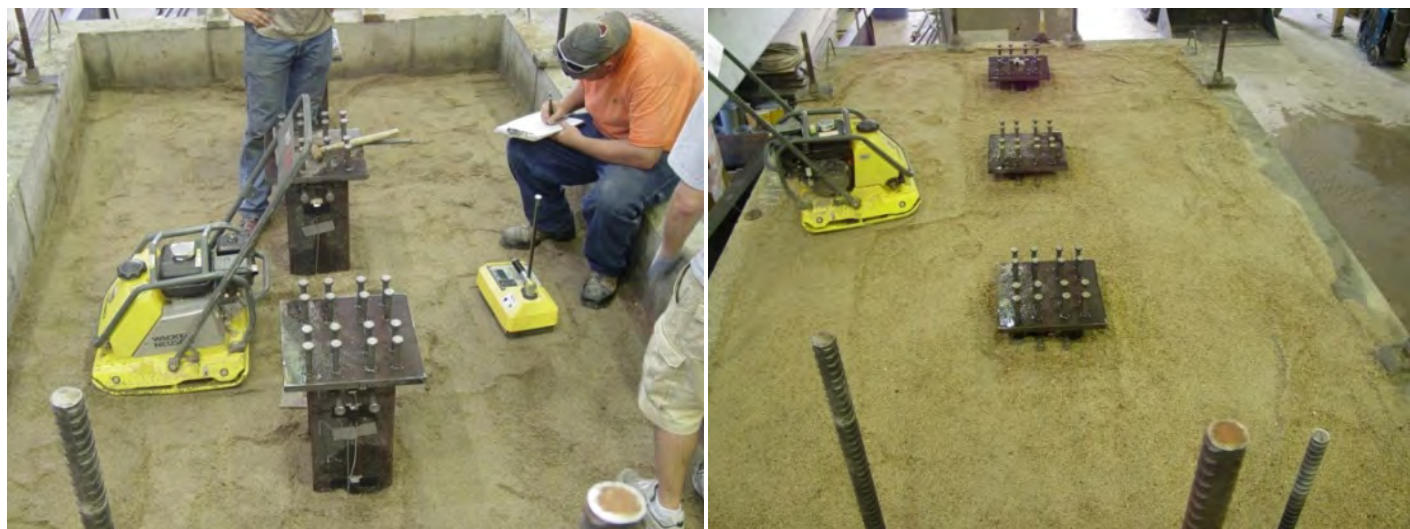
Figure 3.56. The relative density of the compacted soil is measured using a nuclear density device.

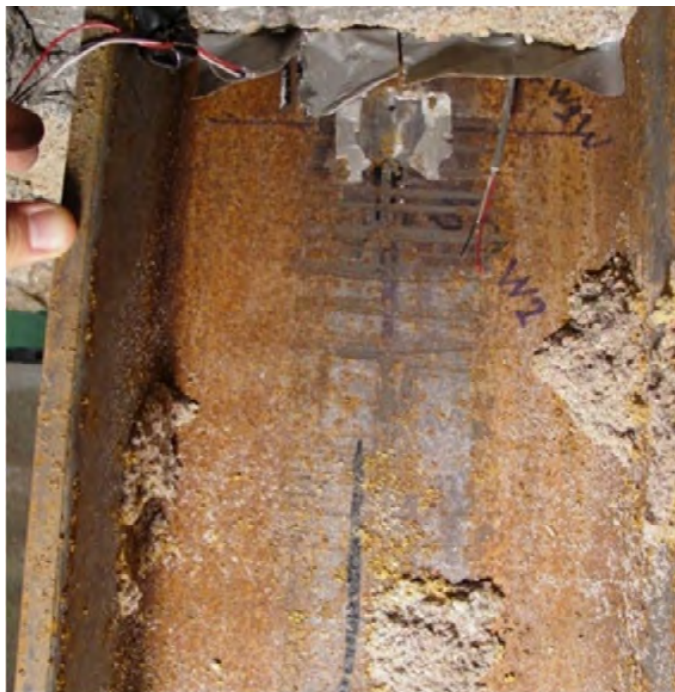
Figure 3.61. Yield lines of the web on a small pile.

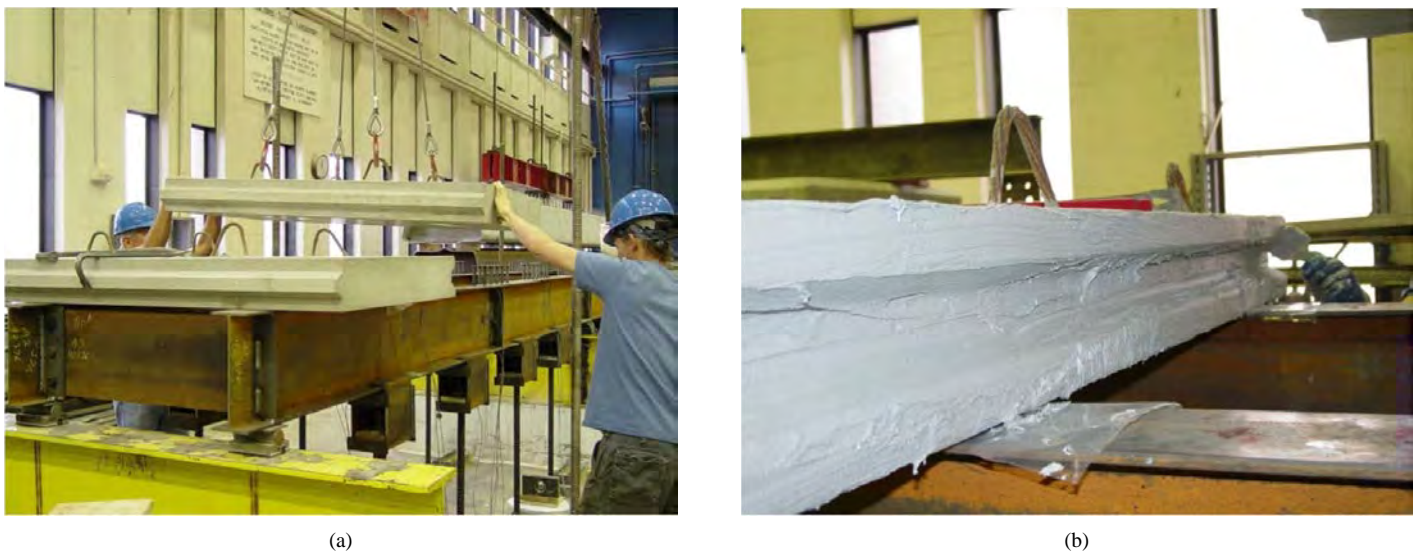
Figure 3.86. (a) Placing precast concrete panels and (b) high-strength epoxy spread over the match-cast shear key.

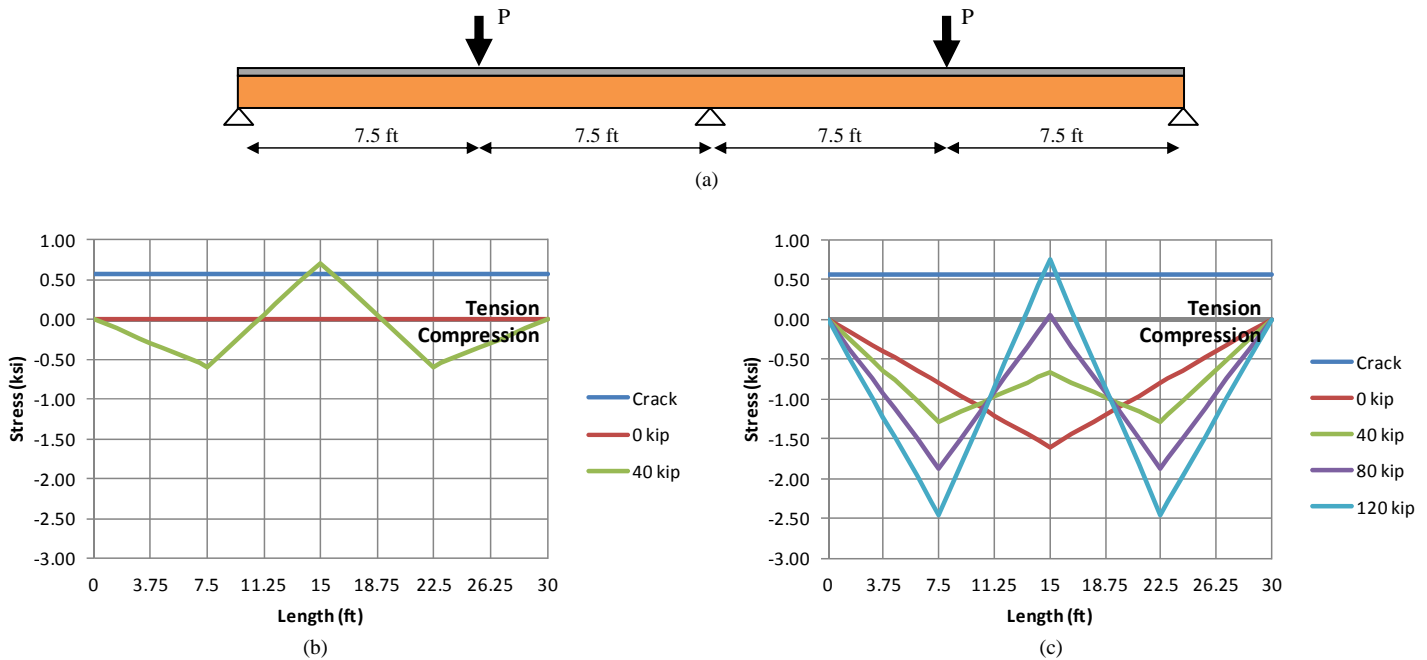
Figure 3.90. (a) Schematic of required moment (force P) to crack the deck and stress analysis between (b) conventional construction and (c) self-stressing construction.

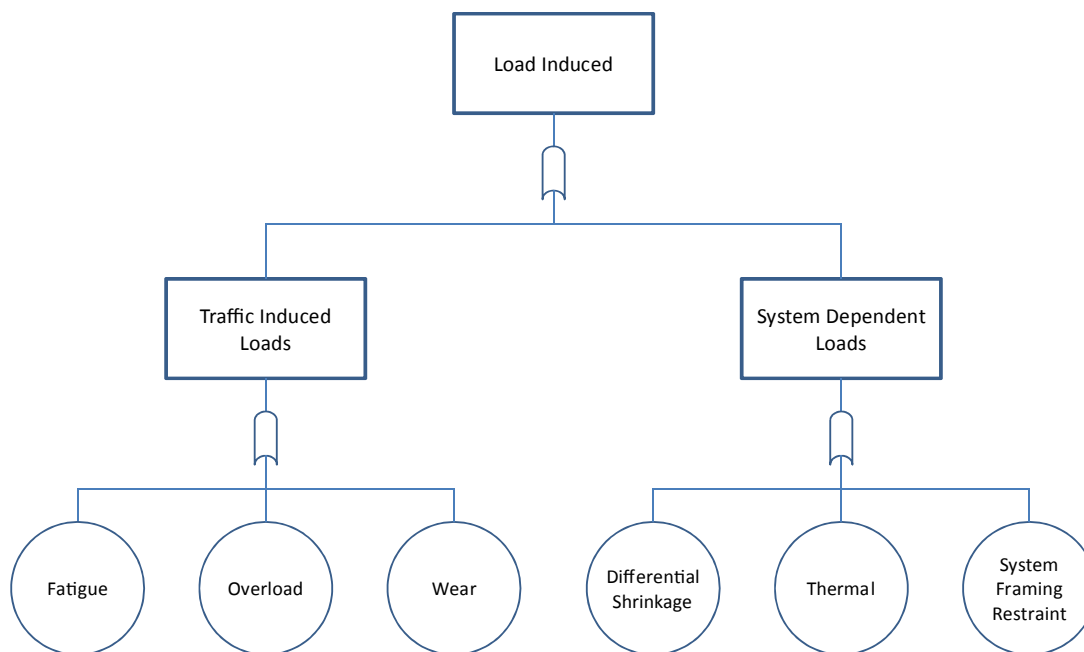
Figure 3.99. Continuation of fault tree for load-induced factor shown in Figure 3.98.

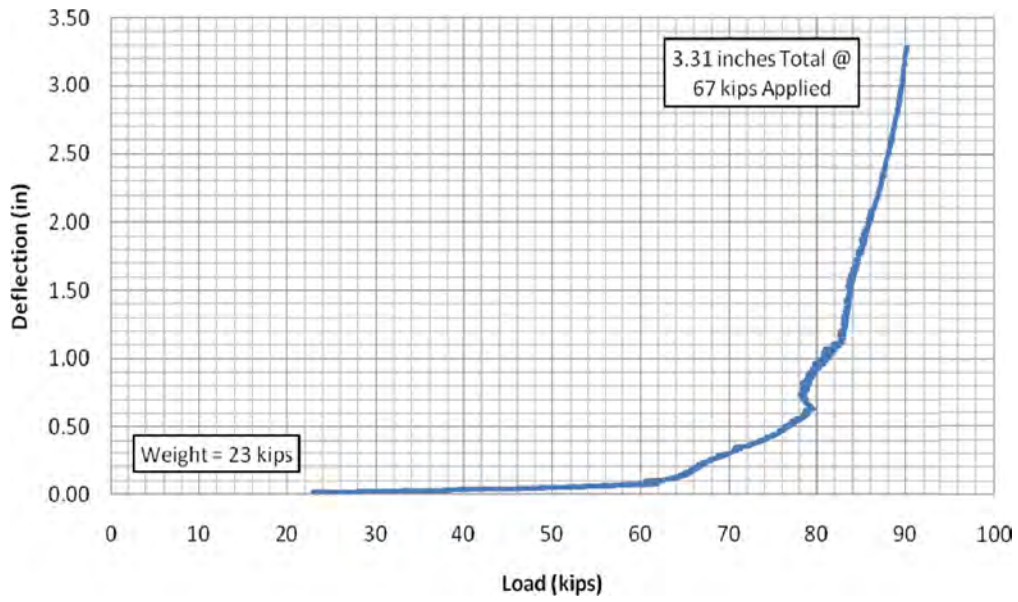
Figure C.27. Total load versus deflection of specimen.

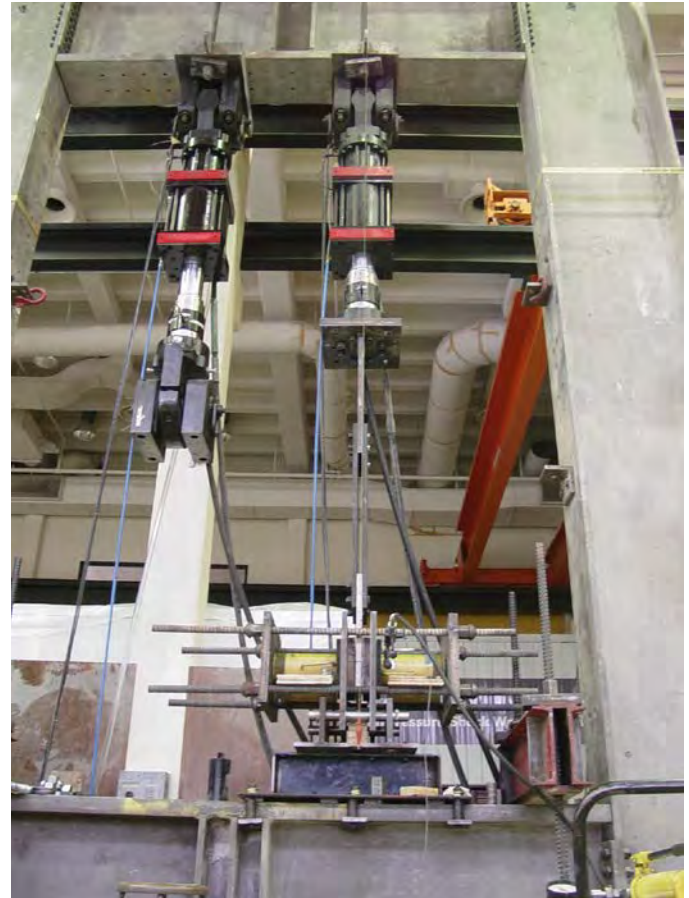
Figure D.22. Completed test fixture in test frame.

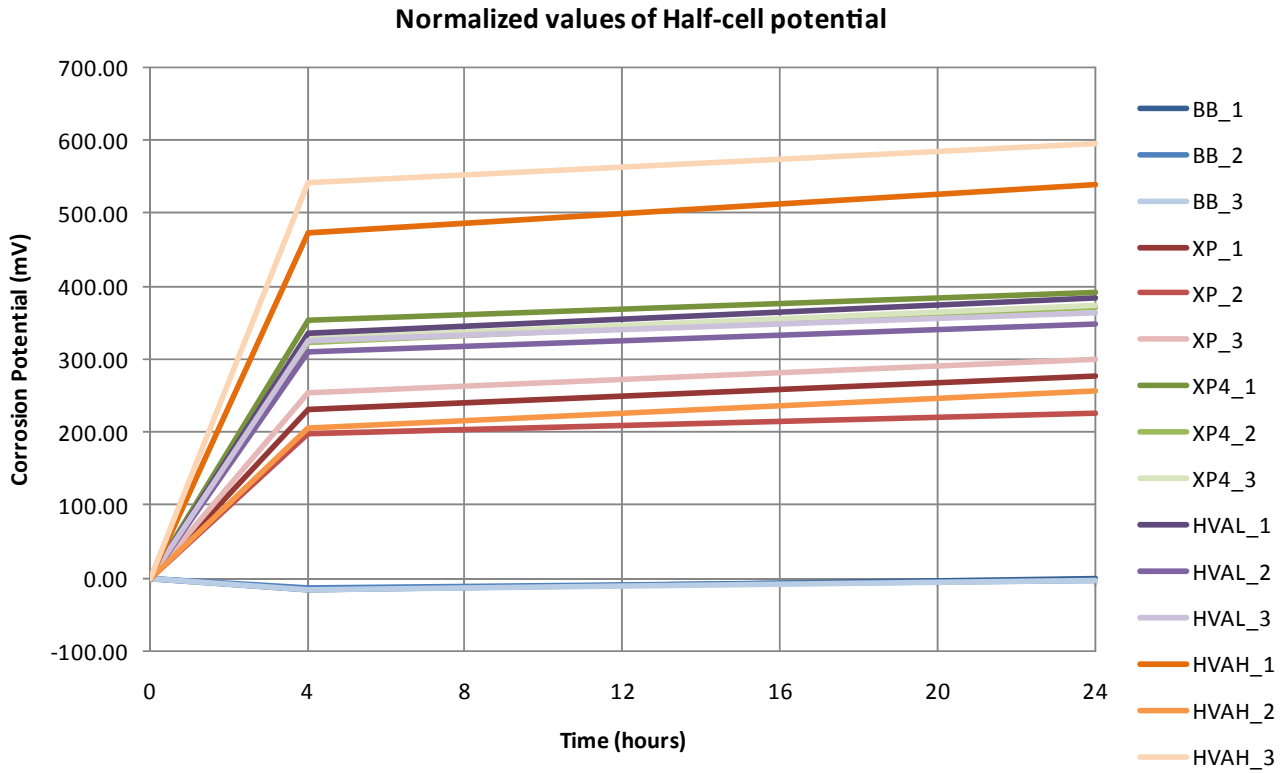
Figure F.36. Normalized values of half-cell potential during fourth depolarization.
