Thermal barrier coatings for diesel engine exhaust application

Degree project for master of science in engineering, mechanical engineering

Date: Spring semester 2014, 2014-06-09

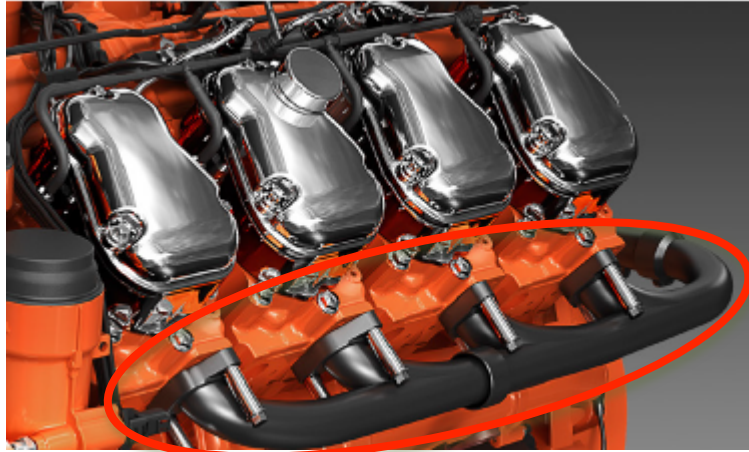
Figure 1 View of exhaust manifold mounted onto Scania engine DC 16. Source: http://scania.com/_system/img/doc/engines/i/DC1686A_566kW.pdf

The exhaust manifold primary function is to collect the exhaust from the individual cylinder heads and consolidate the exhausts through the turbo charger. This component, due to its position and function exhibits different operating condition based on both time and position. As can be seen in Fig.1, the manifold stretches from left to right and the flow rate and temperature increases with the numbers of cylinders being connected. Generating the highest temperature and flow rate after all four cylinder heads.

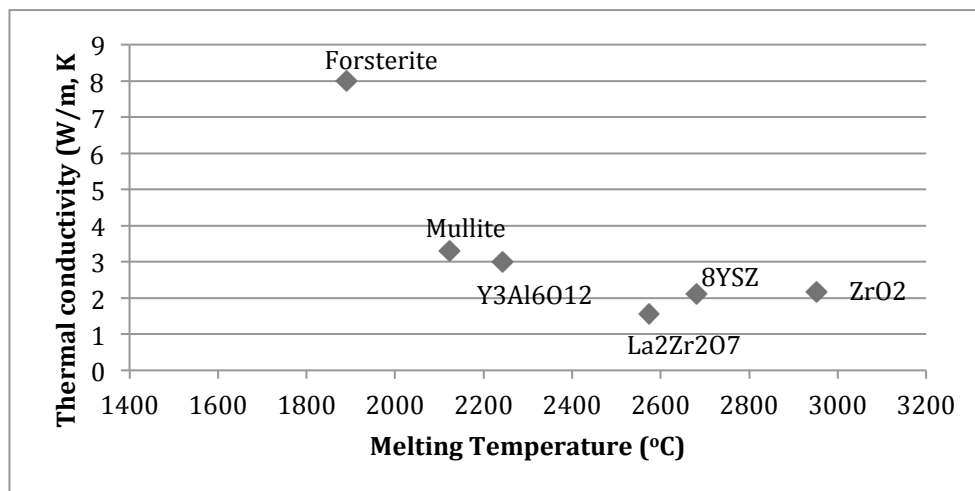
The radiation component that is generated due to photons is a large contributing factor in the thermal conductivity at high temperatures. Literature has shown that dense materials act as black bodies, absorbing much of the radiated heat. If the amount of defects in the material is increased, the radiation component decreases due to reflection of the photons [28]. In Fig. 11, the coefficient of thermal conductivity at room temperature for some common TBCs is presented. [6].

Figure 11 Thermal conductivity at room temperature of selected TBC material [6].

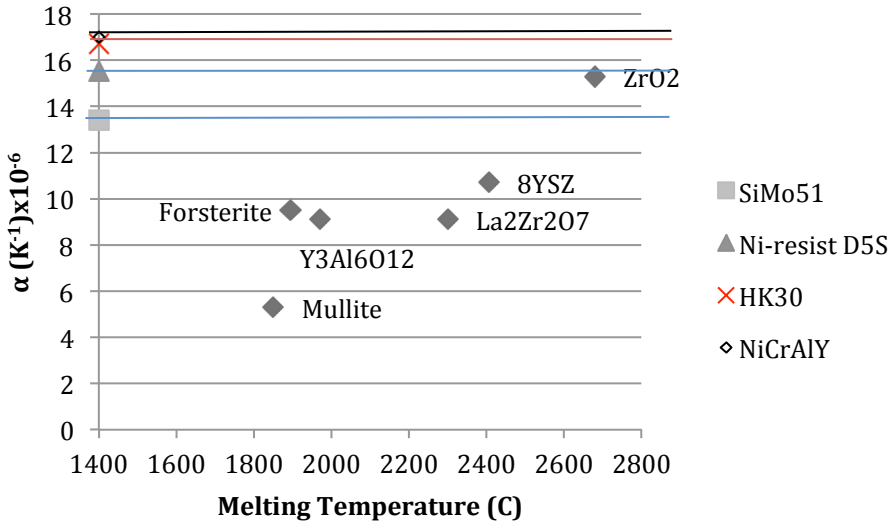
One of the key aspects when designing and choosing a TBC system, in terms of topcoat and bondcoat is the thermal expansion of the individual components [6]. To generate a durable and effective TBC, the thermal expansions of the components should match each other, reducing the thermal stresses induced during the cycling [6]. If the difference in thermal expansion between the topcoat and the underlying material is large enough the generated mismatch stresses will results in failure of the TBC system [8]. The thermal expansion/contraction depends on the coefficient of thermal expansion and the difference in temperature affecting the different layers in the system [6] Fig.12. Shows the linear CTE of some common topcoat materials together with the common substrates for exhaust components and the NiCrAlY bondcoat [6].

Figure 12 Linear CTE of selected TBC materials [6]

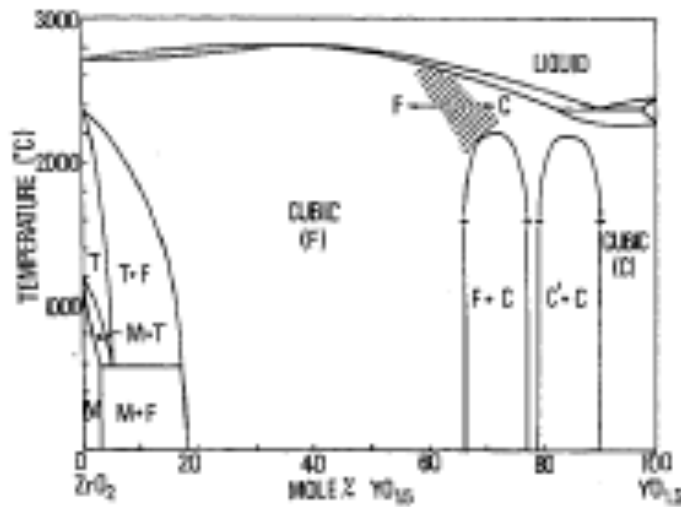
Figure 14 Phase evolution in Yttria- Zirconia system [39]

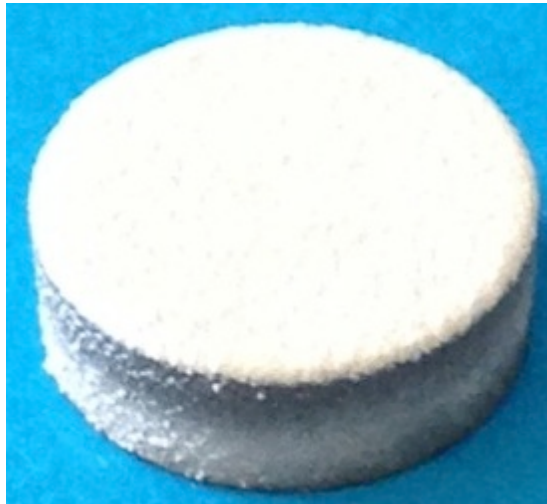
The samples used for this evaluation can be seen in figure 17. The coins were constructed with a radius of 6mm and a thickness of the substrate of 4mm.

Figure 17 Air Plasma sprayed prepared sample

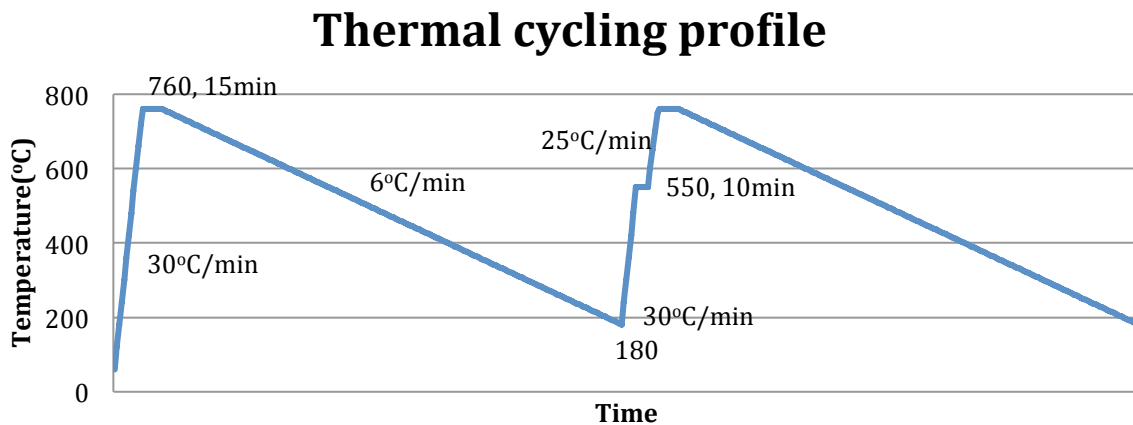
Four test specimens of each TBC systems were placed into the furnace and the cycle shown in Fig. 19 was repeated over a time period of 1000h, generating a total of 170 cycles. Every 15 cycle, the furnace was stopped to be able to analyse the surfaces of the test specimens. After half the time, 500 h, one specimen of each TBC system was removed from the furnace and a cross section analysis was performed together with surface analysis. The remaining samples were then analysed every 15 cycle and held in the furnace until the complete cycle time had ended. These samples were then analysed using the same procedure as for 500h.

Figure 19 Thermal cycling profile and programmed values

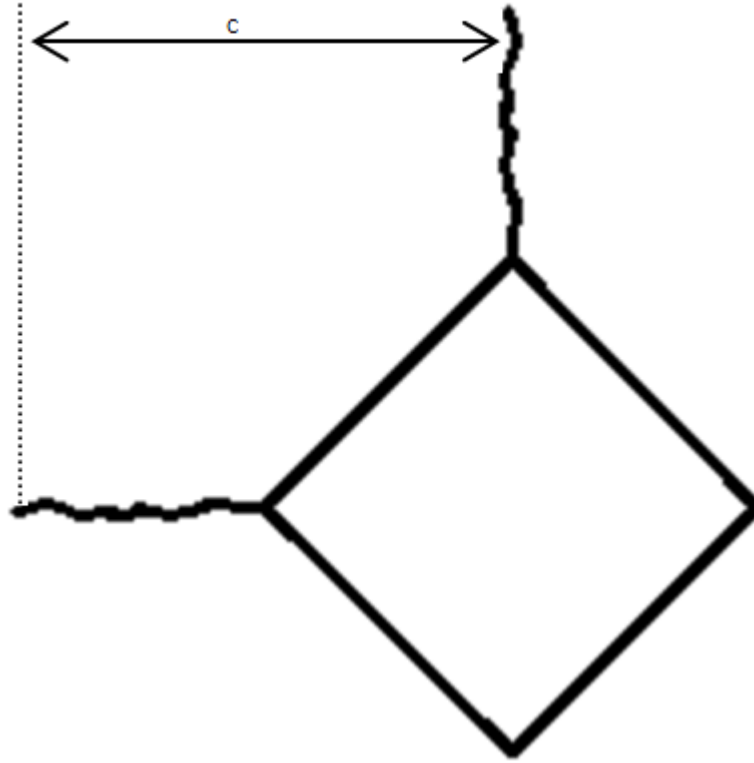
Using the cracks initiated by the indentation during Vickers hardness test, the fracture toughness can be determined for brittle ceramic materials [86]. The method applies to use micro Vickers indentation with a load of 300g and measure the length of the initiated crack. A schematic view of the indentation can be seen in figure 22.

Figure 22 Schematic view of measurement of indentation generated cracks.

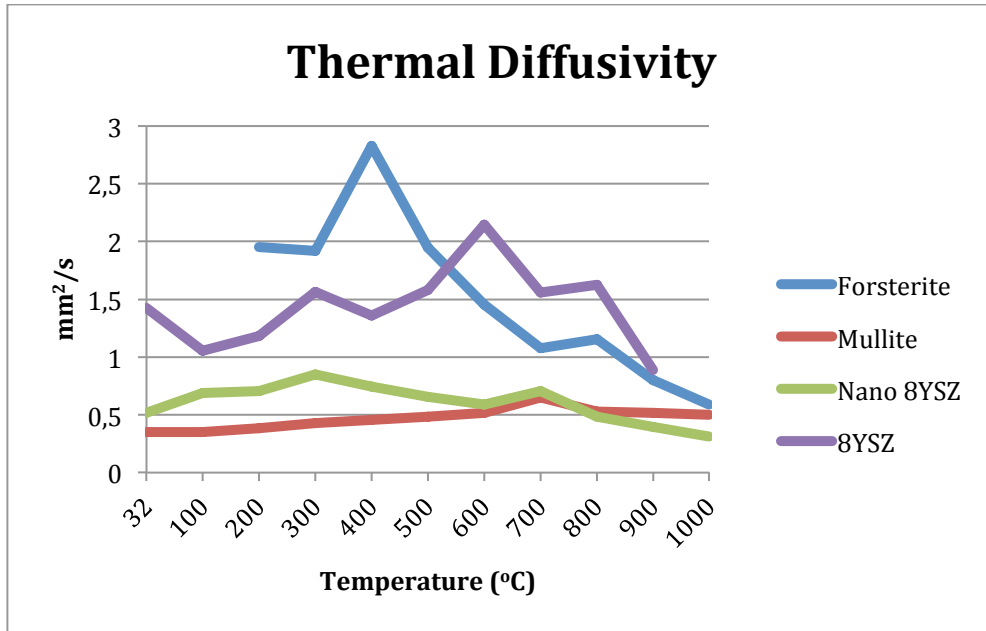
Fig. 23 below shows the thermal diffusivity of the different coating materials, with the exception of $\text{La}_2\text{Zr}_2\text{O}_7$ measured using laser flash. $\text{La}_2\text{Zr}_2\text{O}_7$ are not shown due to malfunction of the analysis software during these measurements.

Figure 23 Thermal diffusivity of the coated systems

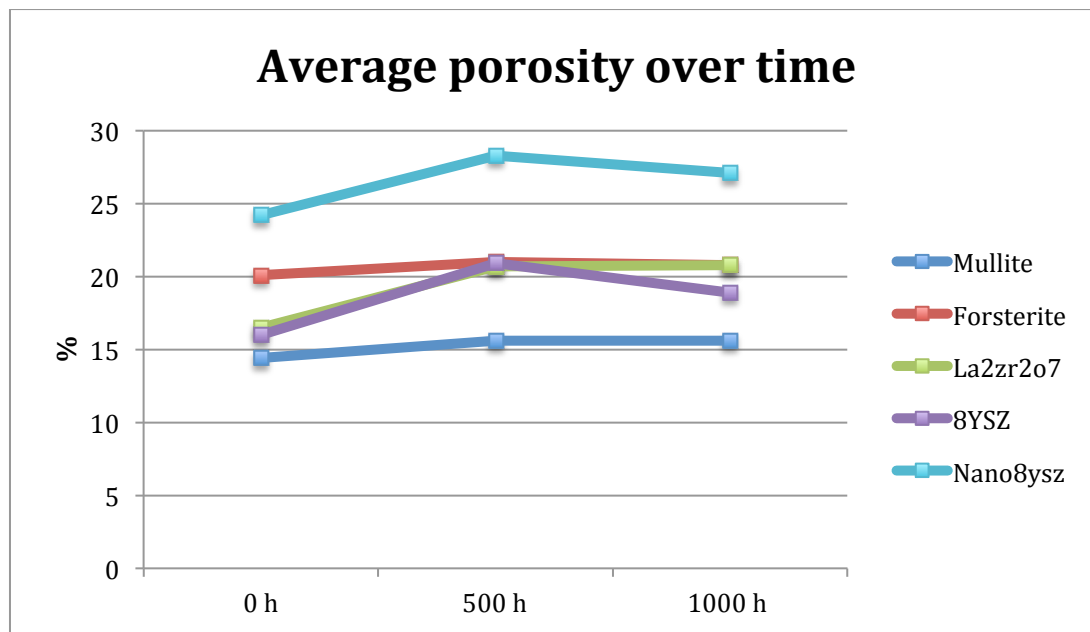
The porosity measured using image analysis are shown in Fig. 25. As can be seen in the figure, the zirconia-based coatings exhibit the same type of behaviour. The three coatings shows an increase in porosity over the first 500h, with initial slopes of 0,82, 0,98 and 0,84 %/100h corresponding to 8YSZ, Nano 8YSZ and La2Zr2O7. The increase is followed by a stabilisation of the porosity for La2Zr2o7 and a small increase can be seen for both of the 8YSZ coating. The Mullite and Forsterite coating does not show the same large increase during the first 500h, they instead act stable over the timespan.

Figure 25 The measured average porosity measured at 0, 500 and 1000h.

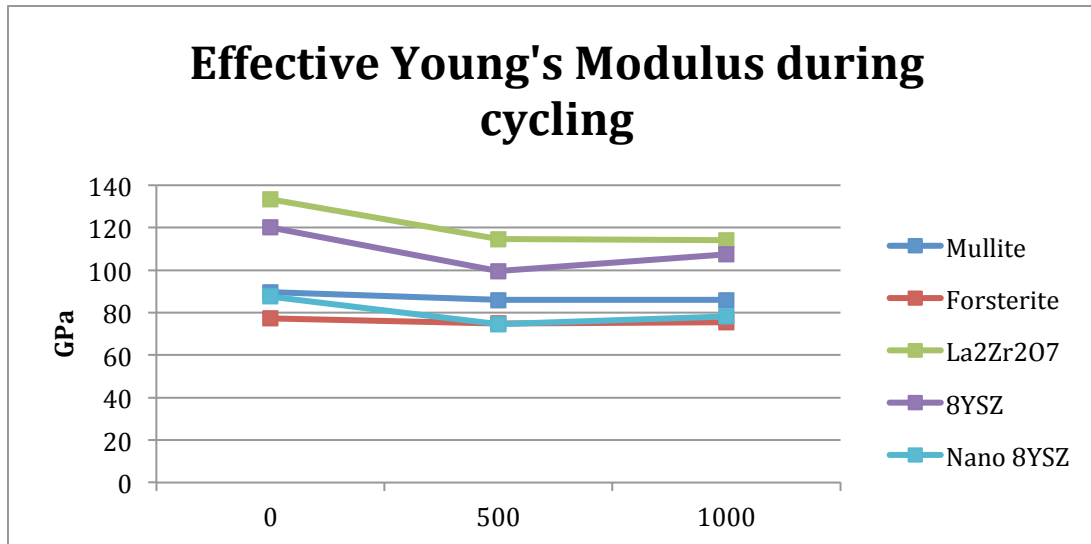
Figure 26 effective Young's modulus as a function of porosity measured over time

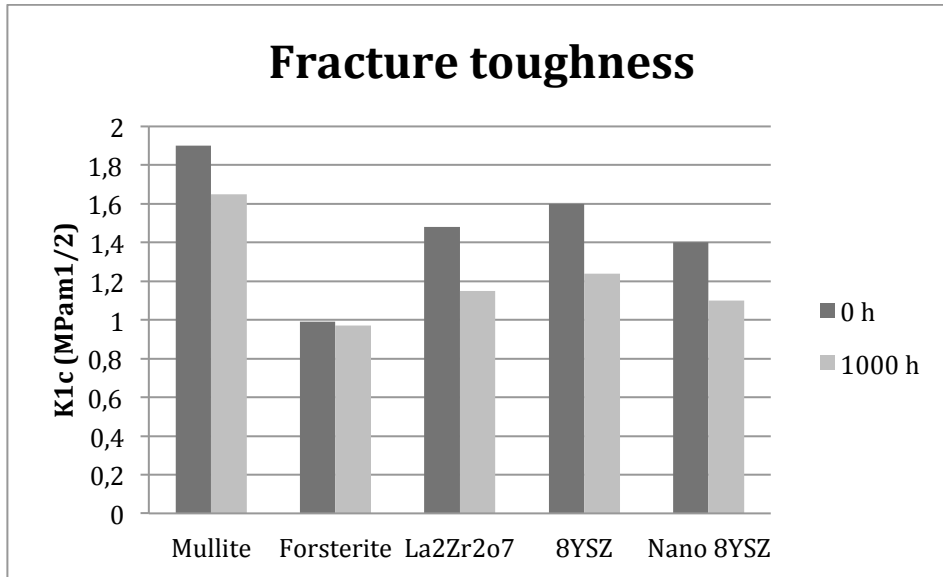
The fracture toughness of the ceramic materials can be seen in Fig 28. As the figure shows, there is a decrease in K_{Ic} after 1000 h, for all of the analysed materials. The fracture toughness varies between 1,9 and 1,65 for the strongest, Mullite, and between 0,99 and 0,97 for the weakest, Forsterite. As can be seen from the figure, the zirconia-based coatings shows almost similar decrease. The decrease for the Zirconia-based coatings vary between, 22% for $La_2Zr_2O_7$, 22,5% for 8YSZ and 21,5% for Nano 8YSZ.

Figure 28 Fracture toughness of the different coatings between 0 h and 1000 h.

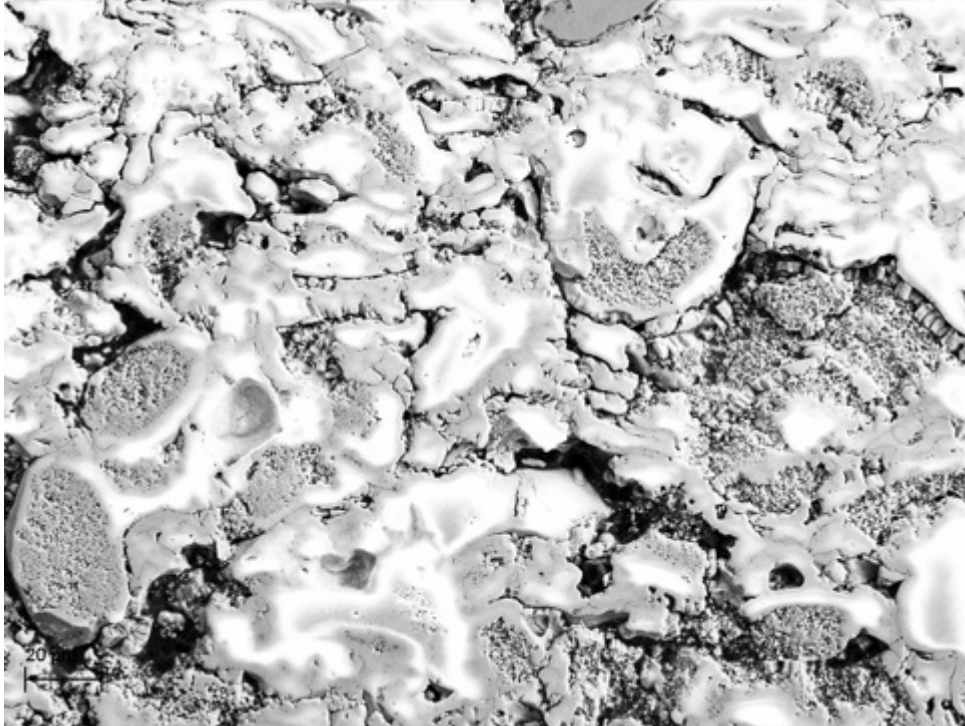
Figure 46 nano 8YSZ coated onto d5s showing the coatings nanozones and micro cracked matrix.
