Fate of the Houston Skyline: **Strategies adopted for Rehabilitating Mid- Century Modern High-Rises**

Urmila Srinivasan
M.Arch II, Preservation
May 2014

Graduate Program in Historic Preservation
School of Architecture
University of Texas at Austin

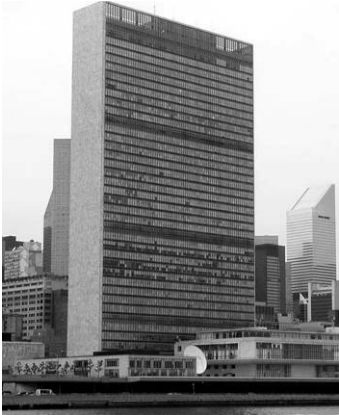
Fig 1.1. The United Nations Secretariat Building by Harrison and Abramovitz (New York, 1950) was based on Le Corbusier's (or Niemayer's) scheme for the same project.

Description of Form: Two Large expanses of gridded curtain walls were held between two blank walls. The horizontal slab was mostly expressed, which reflected the lines of movement. Mostly offices were organized along lines of corridors which ran parallel to these large curtain walls. The blank walls at the ends terminated these corridors giving the building its expressive quality. The structural system is only secondary.

These characteristics were first realized in Mies van der Rohe’s 860 Lake Shore Drive (Chicago, 1951) which was designed as residential apartments. Three buildings, which followed this, were the ones that actually served as a model for all future designers of high-rises. (See Fig 1.1,1.2,1.3 for description of their form). Raised on columns these buildings look as if they could be picked and planted anywhere in the world.⁹ Each of these buildings have a distinct form that reflected the designers’ rationale. Of these buildings Mies’ Seagram building was the one that was duplicated and imitated by both designers and developers in every American downtown. His design gave the imagery required for corporate America. Efficiency, cleanliness, organization and standardization, was a perfect fit for big business in this country.¹⁰

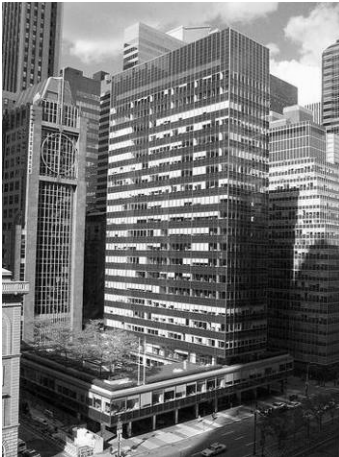
Fig.1.2. Lever House designed by Gordon Bunshaft of Skidmore, Owings and Merrill (New York, 1952).

Description of Form: A slab raised on columns with a rectangular tower rising from it. The horizontal slab was again expressed, but there were glass curtain walls on all four sides showing that space was undifferentiated and flexible.

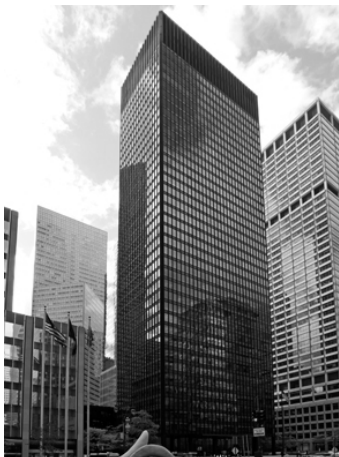
Fig.1.3. The Seagram Building designed by Mies van der Rohe (New York, 1958, with Philip Johnson).

Description of Form: A tower raised on columns in a plaza. The main concern was the expression of a spatial grid, and not the skeleton. The spatial grid was expressed in steel, a symbol of the technology of that time. The plan is a wide rectangle with a central service core. All four sides are similar which again showed that the space inside was undifferentiated and flexible.

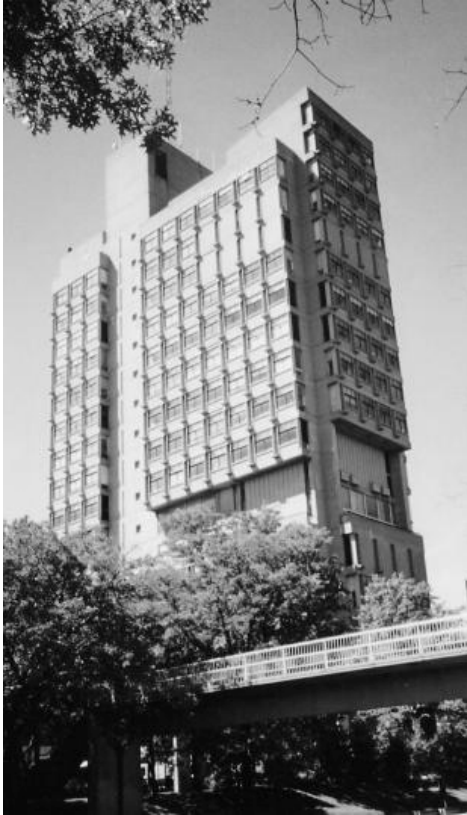
Fig.1.5. The exposed concrete façade of Boston University Law Tower was designed by Josep Lluís Sert between 1960 and 1965. Initially there were talks of demolishing this building, but it was eventually rehabilitated.

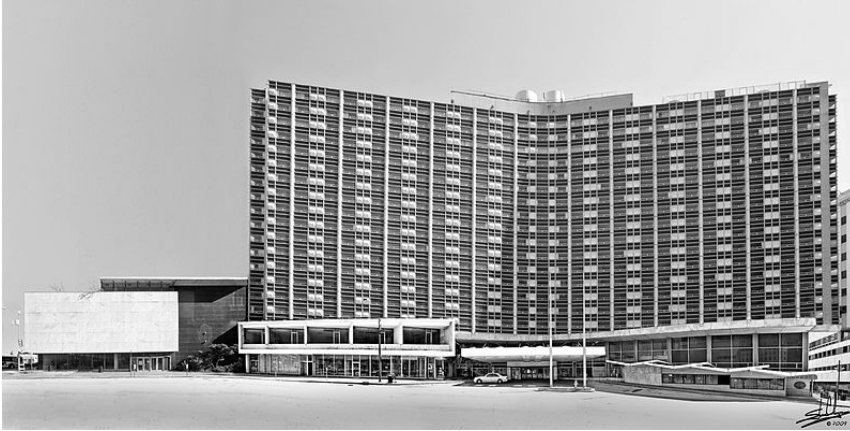
Fig.1.6. Staler Hilton in Dallas has been an endangered modern building for several years. The curtain wall has porcelain enamel panels.

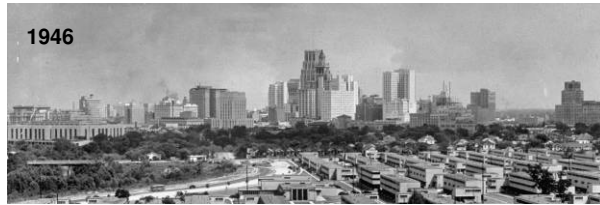
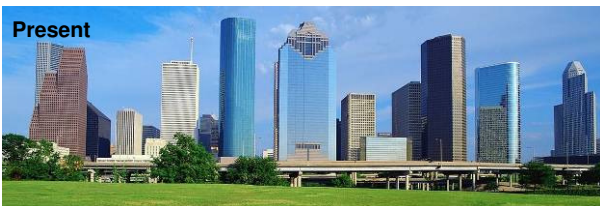
Fig.2.1. The images show the development of the Houston Skyline. The MCMH are not very tall and buildings from the 1920s dominate the skyline even in the late 1960s. Currently they are completely dominated by the building from the 1970s and 1980s.

building continue to dominate the skyline of Houston today. (See Fig.2.1. for development of Houston's Skyline, and Fig.2.2 for number of high-rises constructed in each decade).

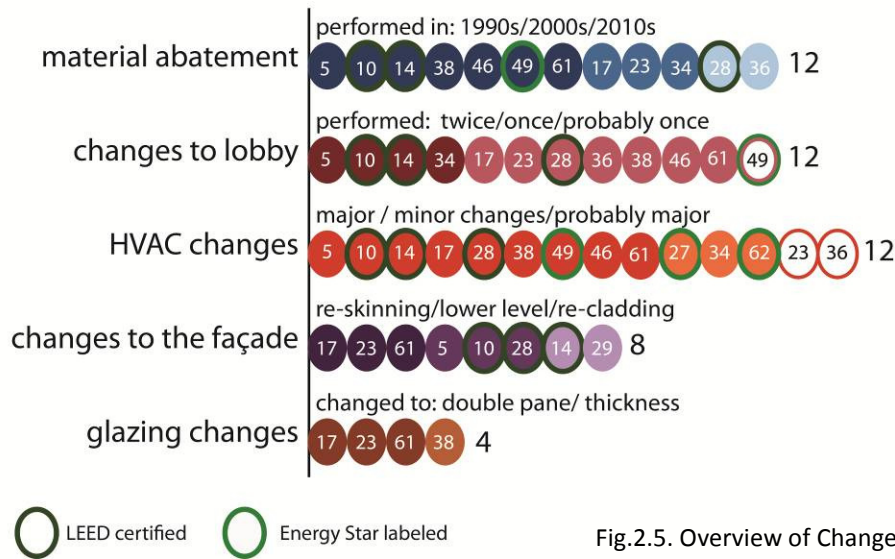
Fig.2.5. Overview of Changes

Of the 63 MCMH in Houston only three buildings have undergone a complete re-skinning. (Fig.2.5) All three of them were vacant for several years, and have undergone complete character change. The re-skinning was undertaken both due to material deterioration of the façade and to eliminate negative perception of the building and bring it to a Class A status office building. Of these only one building had a glass curtain wall. There are also cases where there has been failure of thin stone veneer. Two buildings which had marble cladding on their expressed concrete frames were re-clad due to deterioration of the marble, which was also posing to be a threat for pedestrians. One building was re-clad with granite and the other was re-clad with metal panels. Three other buildings have undergone minor façade changes at

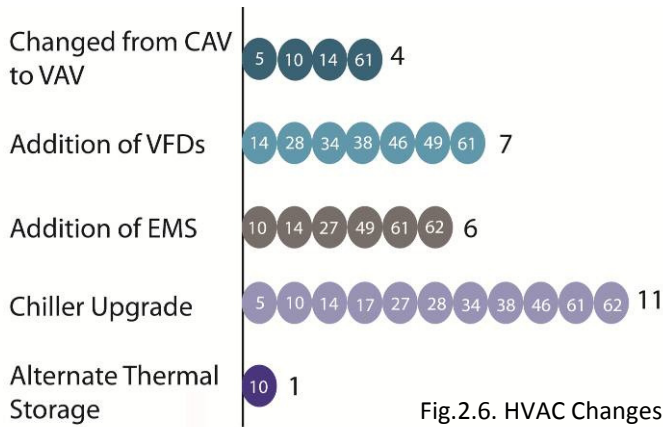
Fig.2.6. HVAC Changes

has replaced CAVs. Along with CAV systems Variable Frequency Drives (VFDS)⁸ and electronically controlled Energy Management Systems (EMS) take into consideration the constantly changing occupancy levels in a building. It is expensive to change from a CAV to a VAV system and many buildings from the 1950s and the 1960s have CAV systems. The installation of a variable frequency drive (VFD) on both supply and return air fans in CAV systems can reduce airflow at night and on weekends.

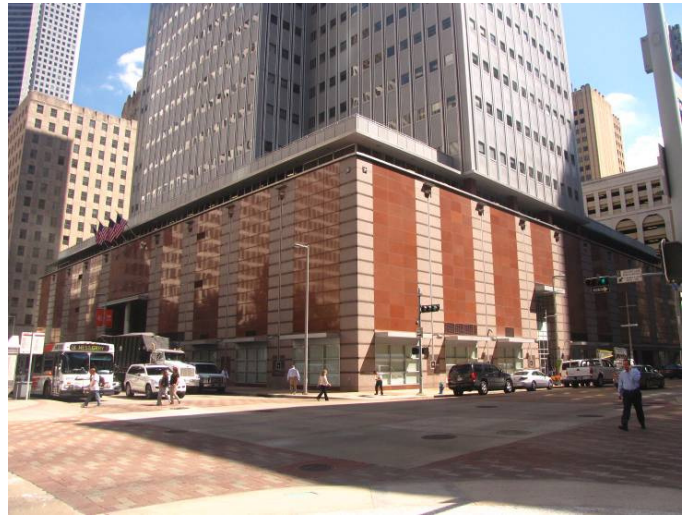
Fig.2.7. 919 Milam was initially owned by Bank One. Image on the left shows an early rendering of the building. Image on the right shows changes made to the podium. The completely red granite clad podium of 919 Milam was broken with vertical strips of grey granite that expressed the inner columns of the building. Here the red granite was removed and reused in place. The more post-modern modification of the faced is not considered authentic to the starker original modern façade.

the ground level as a way of improving their status in the market. The easiest way to give a face-lift to a high-rise is to make changes to the lobby façade. All these three buildings had changed ownership or had low occupancy levels, and the owner felt there was a need to upgrade the status of the building. (See Fig. 2.7 – 2.14 for details of individual examples).

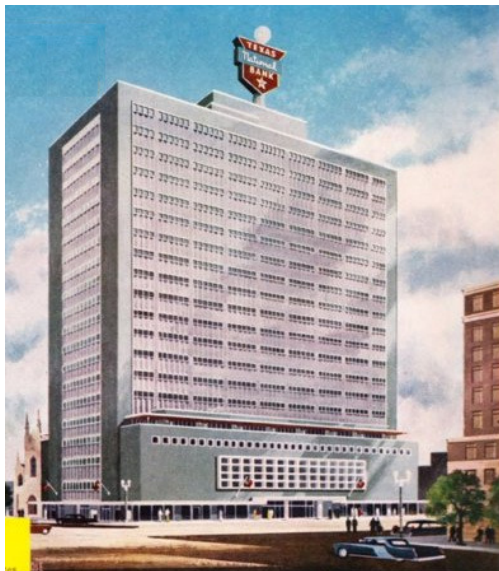
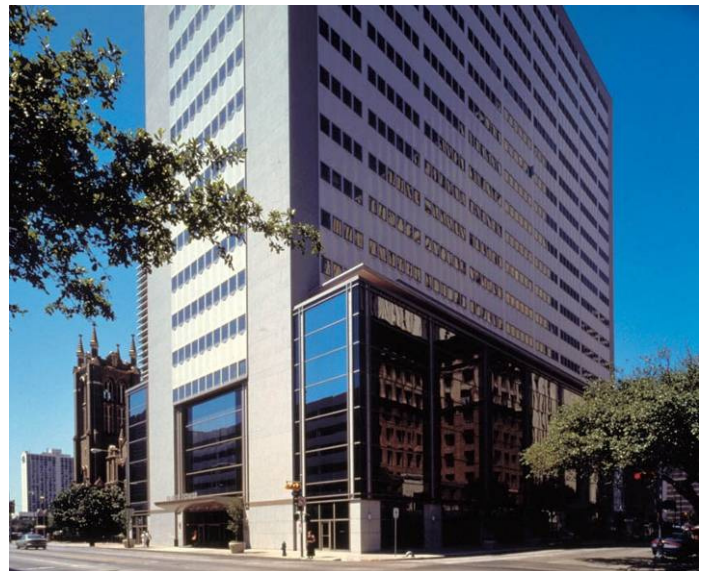
Fig.2.8. The first five floors of the Travis Tower were re-skinned. The challenge here was to conduct the façade change while the tenant still occupied the spaces.

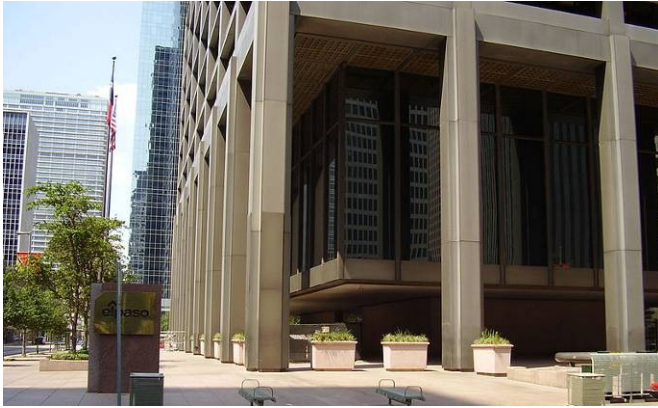
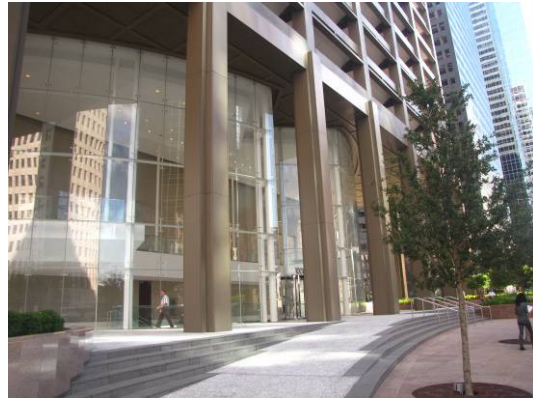
Fig.2.9. The Tenneco Building now the KinderMorgan Building underwent its first major renovation after 40 years. The Image on the left is before the renovation and the image on the left is after. The elevated lobby did not have a sufficient ground presence, and it was wrapped with a curved glass curtain wall.

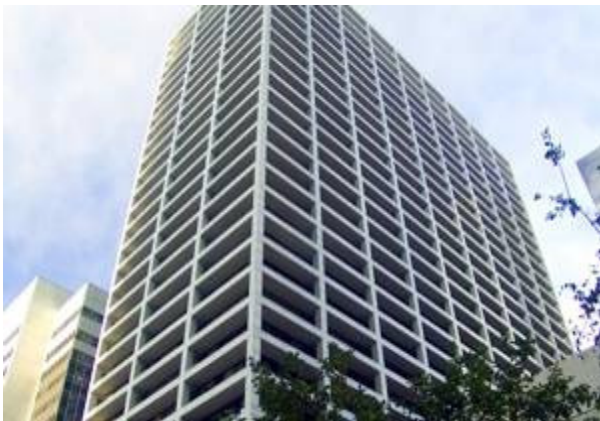
Fig.2.10. One City Centre which was originally First City Bank, had marble cladding on the external skeleton, which had deteriorated and was falling. It was re-clad with granite which is less porous therefore more durable.

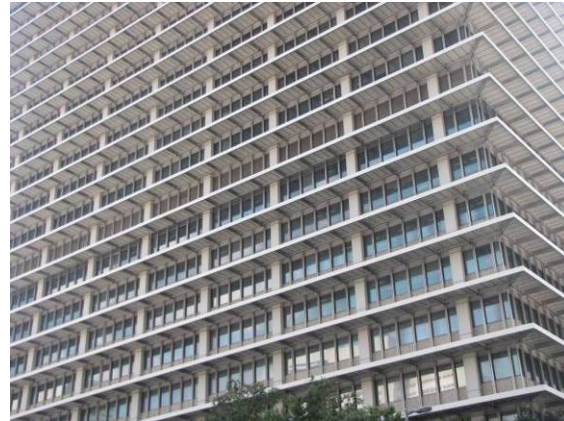
Fig.2.11. The ExxonMobil Building had marble cladding on the columns, which had deteriorated. The marble was replaced with Aluminum panels as that was easier to finish than stone.

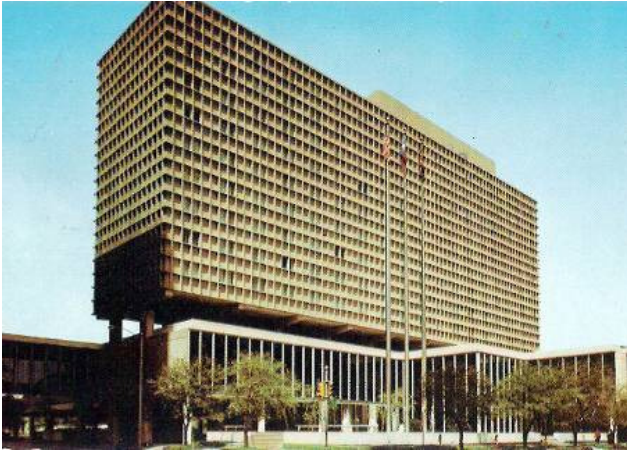
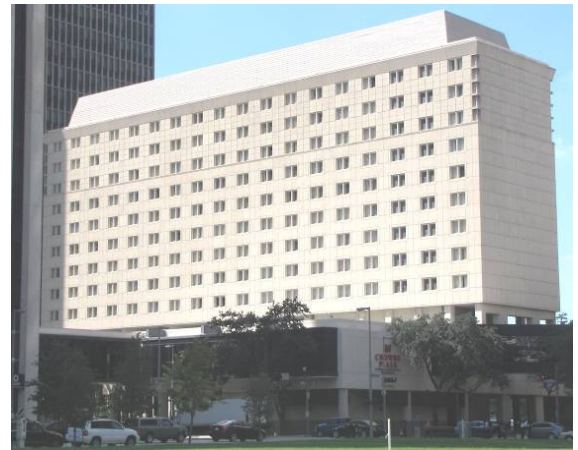
Fig.2.12. Hotel Sonesta (image above) was vacant for 10 years before it was renovated and re-opened in 2001. There was a new faced added to this building that completely changed the character.

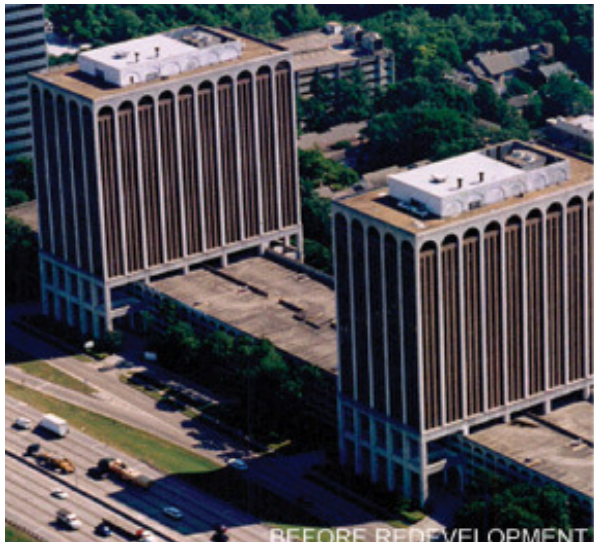
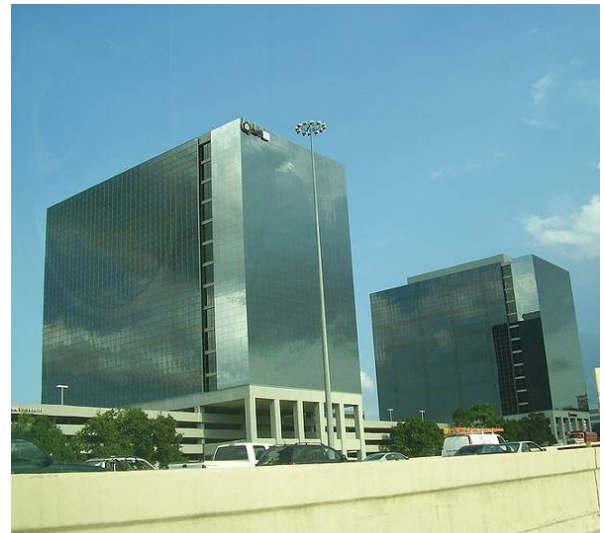
Fig.2.13. Park Towers was re-skinned after being vacant for ten years. It took on a new façade with a double glazed blue curtain wall. This was a real estate decision, as the new façade increase the floor area of the building and gave it a new appearance.

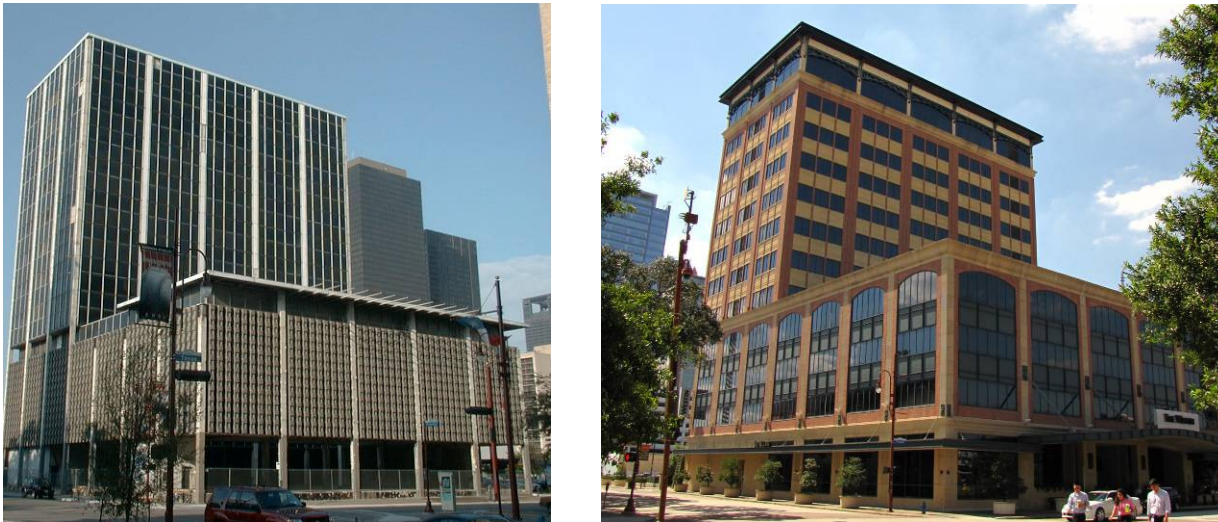
Fig.2.14. The World Trade Center (above) was vacant for several years and the curtain wall was in a bad state. Water had infiltrated and had caused severe damage. The tiles on the podium had also deteriorated and the building was completely re-skinned. It was rehabilitated to a hotel and has recently been bought by Westin.

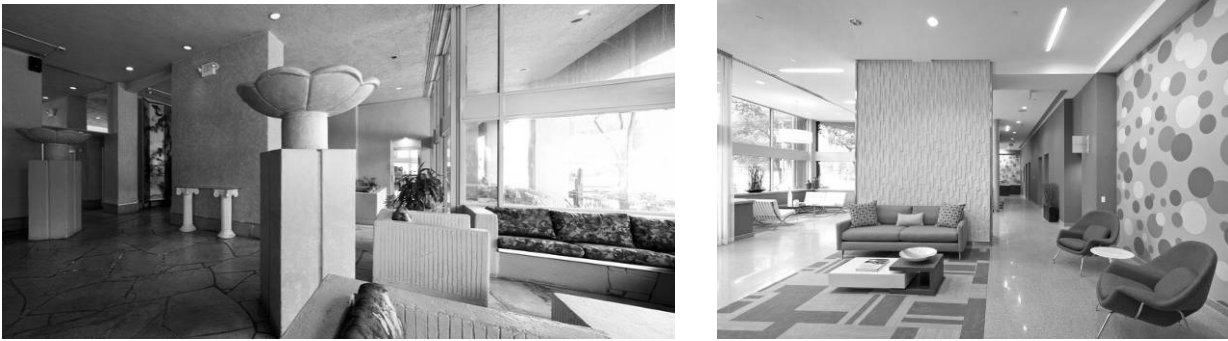
Fig.2.16. The original Houston House interiors (above) had a very dated and heavy appearance and was changed to a more something more open and contemporary (below), but still keeping some of the modern aesthetic. Some call it the “Modern Revival” style.

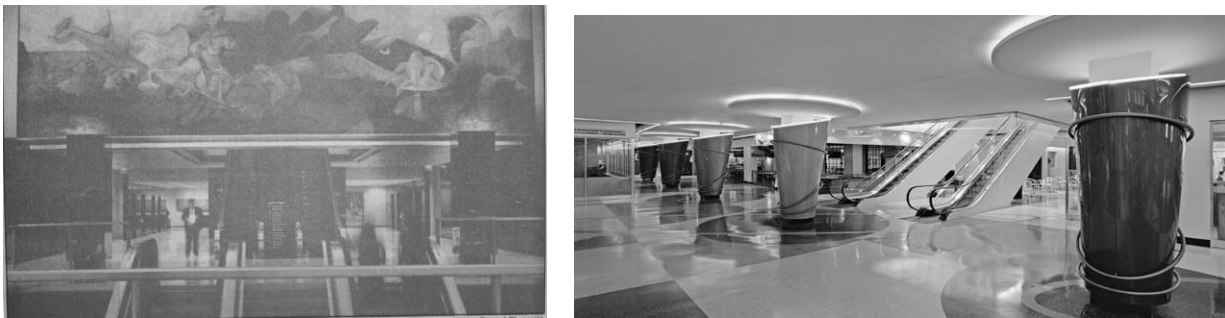
Fig.2.17. Bank One (above two) was a fine example of large banking halls in Houston designed by Knoll and Joseph Whited. It was renovated in the 1990s with colored aluminum cladding on columns and floor patterns that alluded to symbols from the 1950s. The lobby was huge and part of it was converted to parking. As in many renovations the painting Americas by Rufino Tamayo was moved from this building.

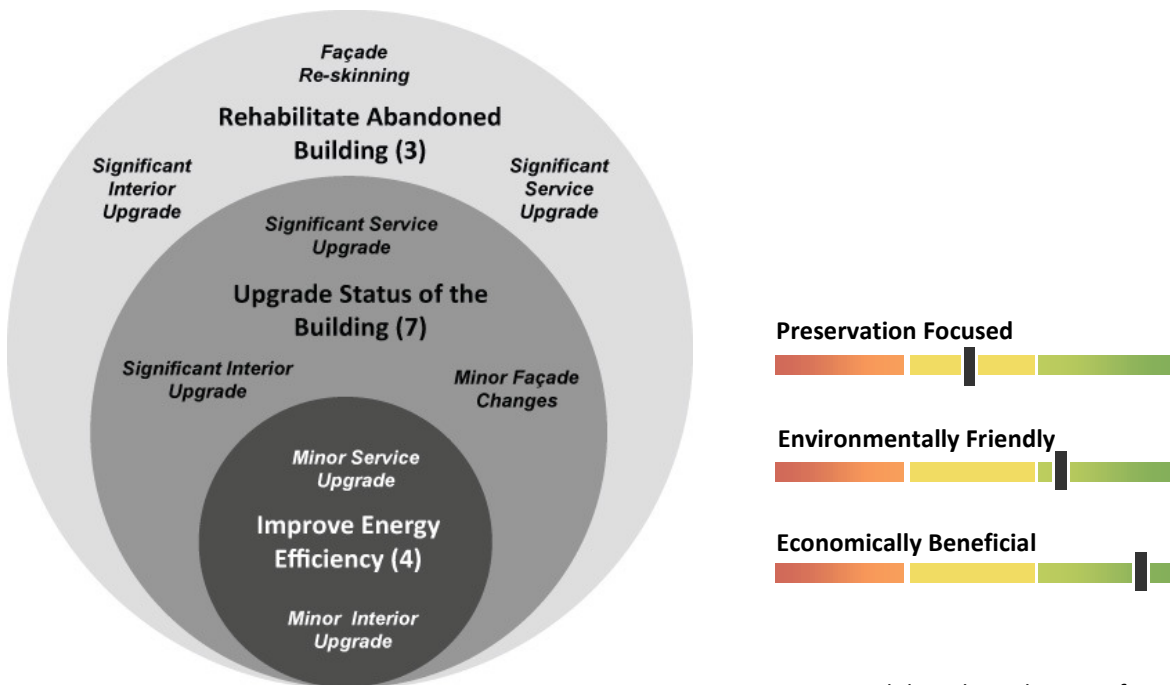
Fig.2.18. Summary of Strategies adopted for Renovation.

The second one which is the most common was to increase the value and status of the building. This would involve a significant change in HVAC and other services that would improve the energy efficiency of the building, and result in cost savings. Interiors are changed considerably to give the building a new look, and in some cases some cosmetic changes are made to the lower level of the buildings.

The third category is to rehabilitate a vacant building. This involved strategies adopted for improving energy efficiency and real estate status of the building, and additionally it also involved re-skinning. Rehabilitating vacant building does not necessarily require a complete façade change, but in this case the buildings were vacant for almost a decade and their facades had deteriorated considerably due to deferred maintenance. The owner also perceived a need to change the appearance and have a new character, which would increase the real estate value and perception of the building.

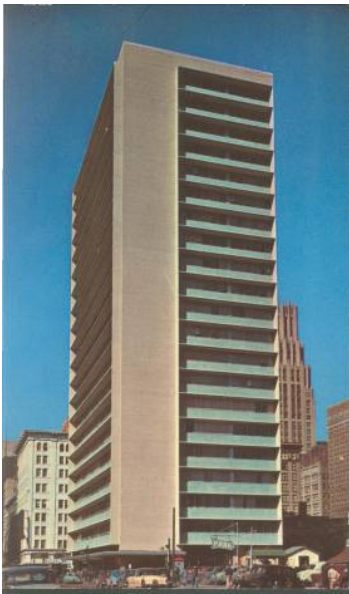
Fig. 2.20. Melrose Building, the first modern high-rise in Houston, built in 1952 by Lloyd Morgan and Jones.

them were rarely the tallest buildings when they were constructed, these buildings ushered in the modern era in Houston high-rise construction. The new style suited the entrepreneurial spirit of Houston in the 1950s, and simultaneously pointed to a future in space technology that the city was looking forward to in the 1960s.¹⁴ As already stated these buildings are not iconic and did not set any particular trend in high-rise design, though some of them have been published in national journals and have won awards at the both local and national levels. They are often cited for their deep set windows, horizontal shading elements and brise-soleils which seem environmentally responsive.¹⁵ (Fig. 2.20, 2.21 & 2.22).

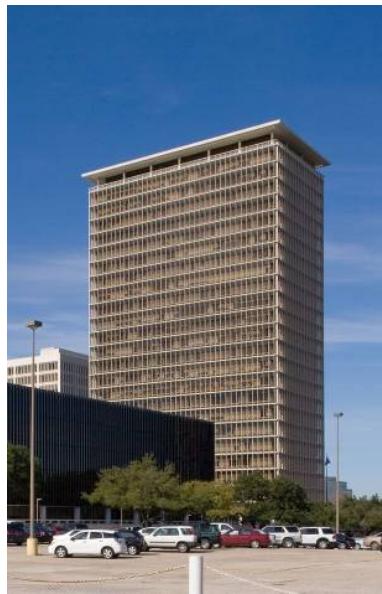
Fig.2.21. The Wortham Tower known for its deep set windows and brise-soleil. Built in 1965 by Lloyd Morgan and Jones.

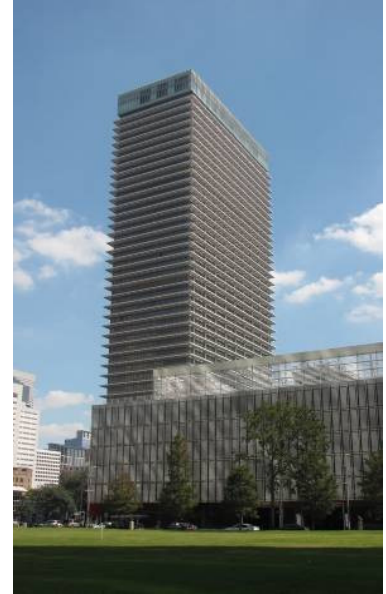
Fig.2.22. The ExxonMobil Building by Welton Becket and Associates, built in 1963. Has been sold and is going to be re-skinned.

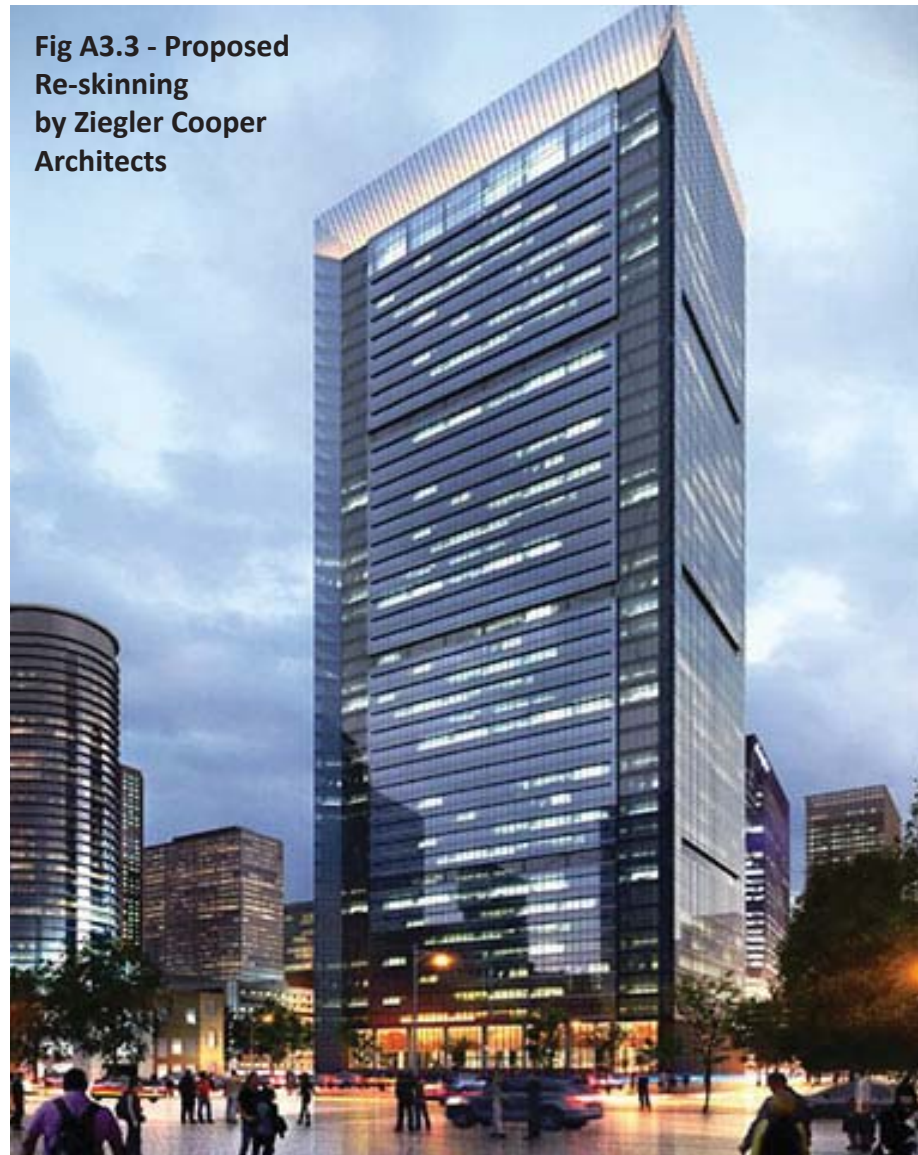
Fig A3.3 - Proposed
 Re-skinning
 by Ziegler Cooper
 Architects

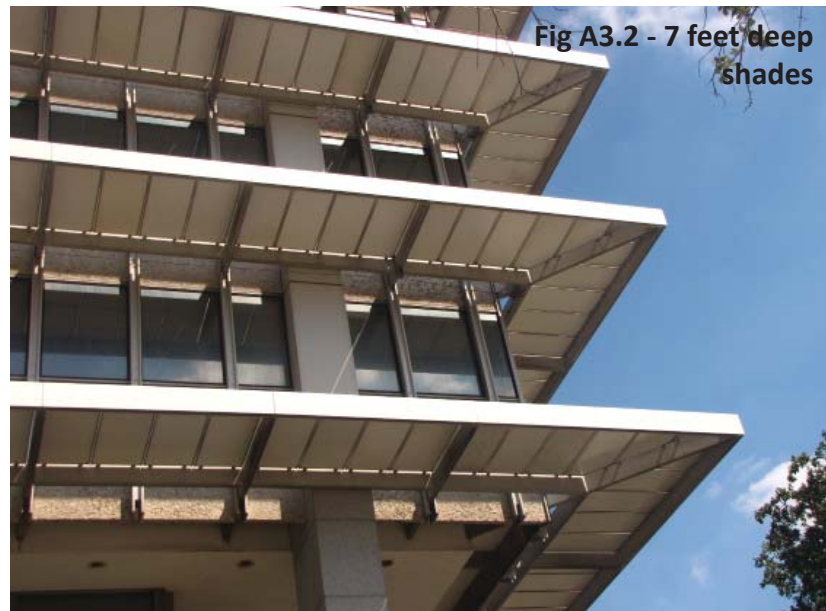
Fig A3.2 - 7 feet deep
 shades

The Exxon Mobil Building on 800 Bell Street in Houston Downtown was constructed by Welton and Becket Associates in 1963. Initially built as the Humble Oil building, it was the tallest building west of the Mississippi. The most character defining feature of this building was the 7 feet sun shade which protected the building from the hot summer sun in Texas. Supported on Aluminum out-riggers the shades are made of porcelain enamel aluminum panels. The exposed columns are clad with marble, which was replaced in the 1990s with aluminum panels. An Architectural Record article from October 1963 discusses the manner in which these shades make the building energy efficient. The shades are held off of the column, which allows airflow, and prevents any hot spots. The building has been recently bought over and there is a re-skinning proposed by Ziegler Cooper Architects. The details of the proposal are not available, but the 7 feet shades are going to be made into occupied office space. Of all the mid-century modern high-rises this is the most significant building (See Appendix 2), and it is 50 years old. This faces a fate similar to other mid-century modern high-rises that are not iconic. Often developers believe that re-skinning is necessary to improve the status of the building. I have performed some qualitative facade studies to evaluate different options for this building.

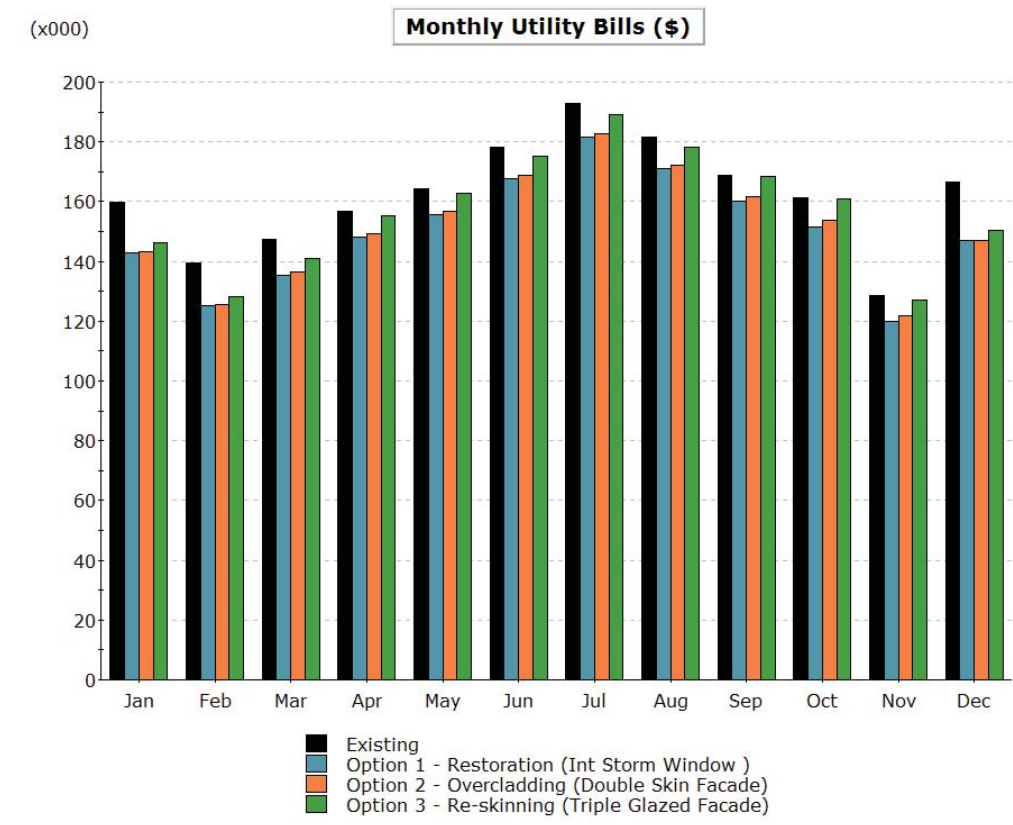
Existing (annual bill: \$ 2,080,449)
 Option 1 (annual bill: \$ 1,880,614)
 Option 2 (annual bill: \$ 1,853,191)
 Option 3 (annual bill: \$ 1,916,648)
